## HOPE CEMETERY COMMISSION MEETING

Monday May 8, 2023 – 4:00 P.M.  
Parks, Recreation & Cemetery Administrative Office  
Meeting Room A  
50 Officer Manny Familia Way Worcester, MA 01605

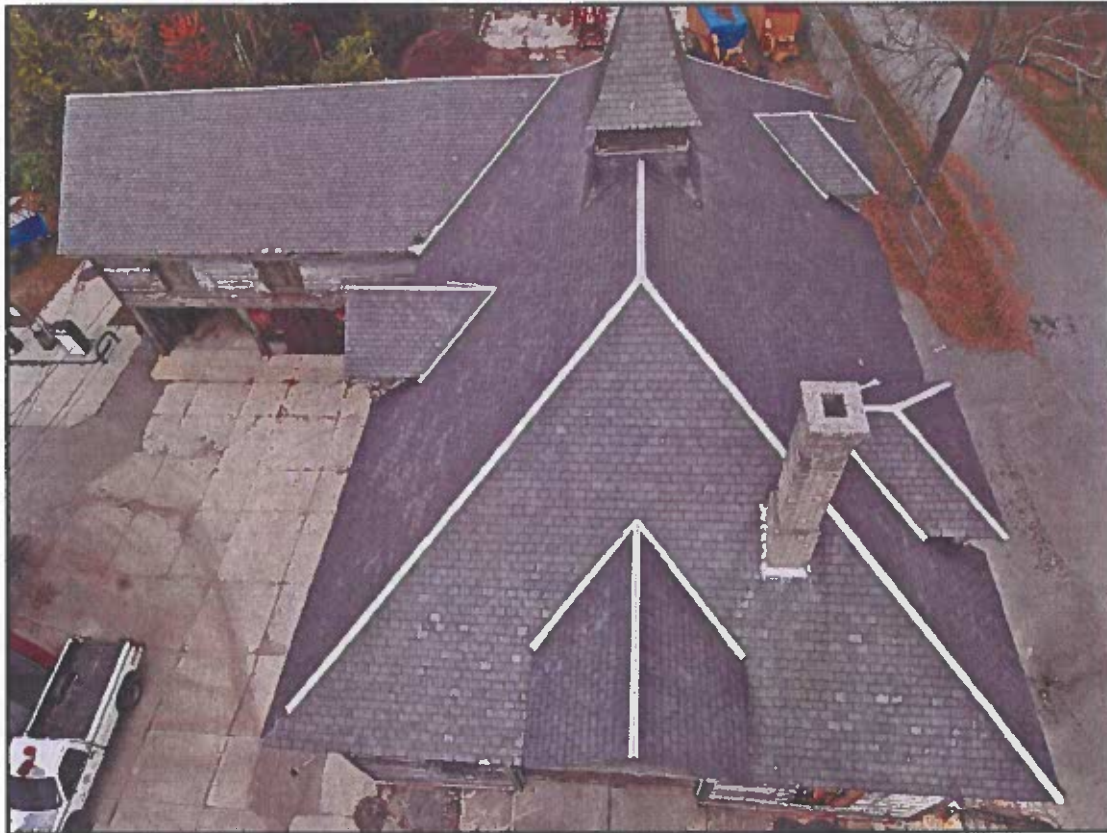
**Photo 1:** Overview of roof from south end.

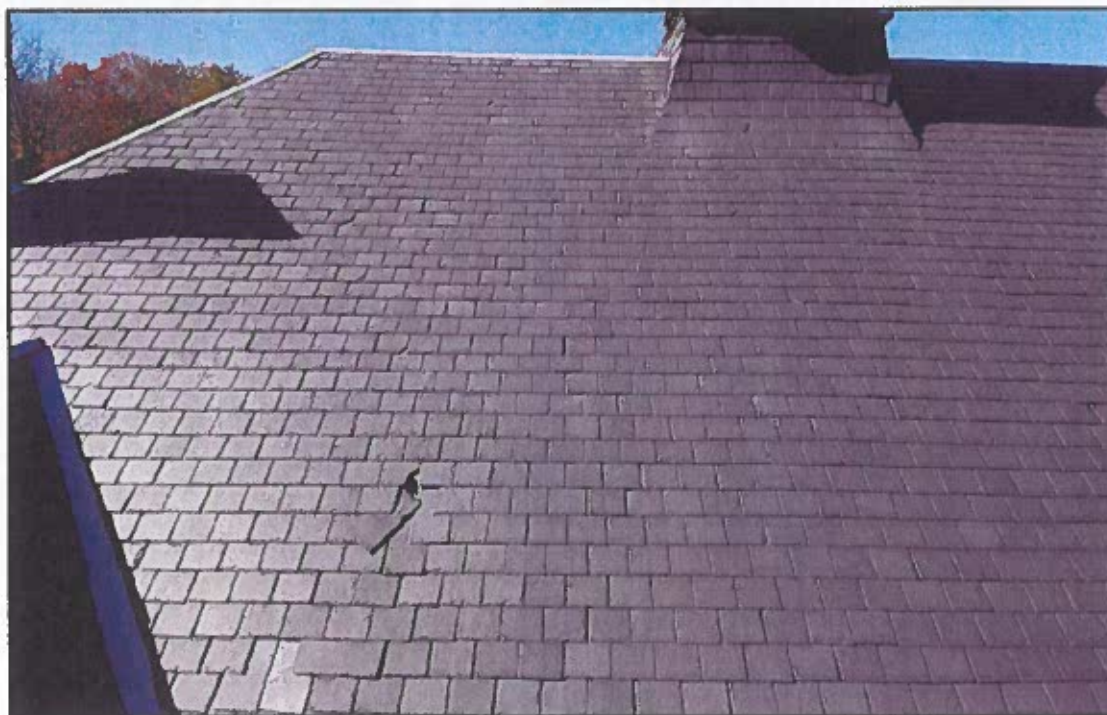
**Photo 2:** Southern end of east roof pitch.. Only a few slates show defects.

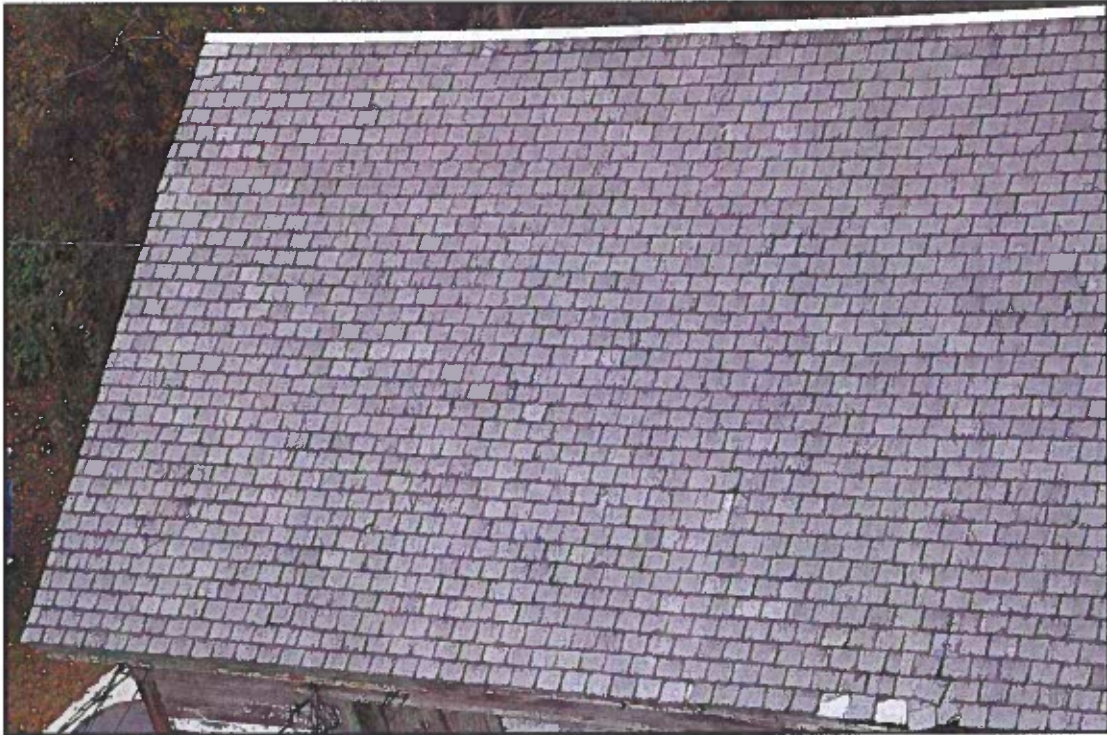
**Photo 3:** South pitch of ell barn roof. Note missing slates at lower right have caused considerable rot in the cornice directly below.

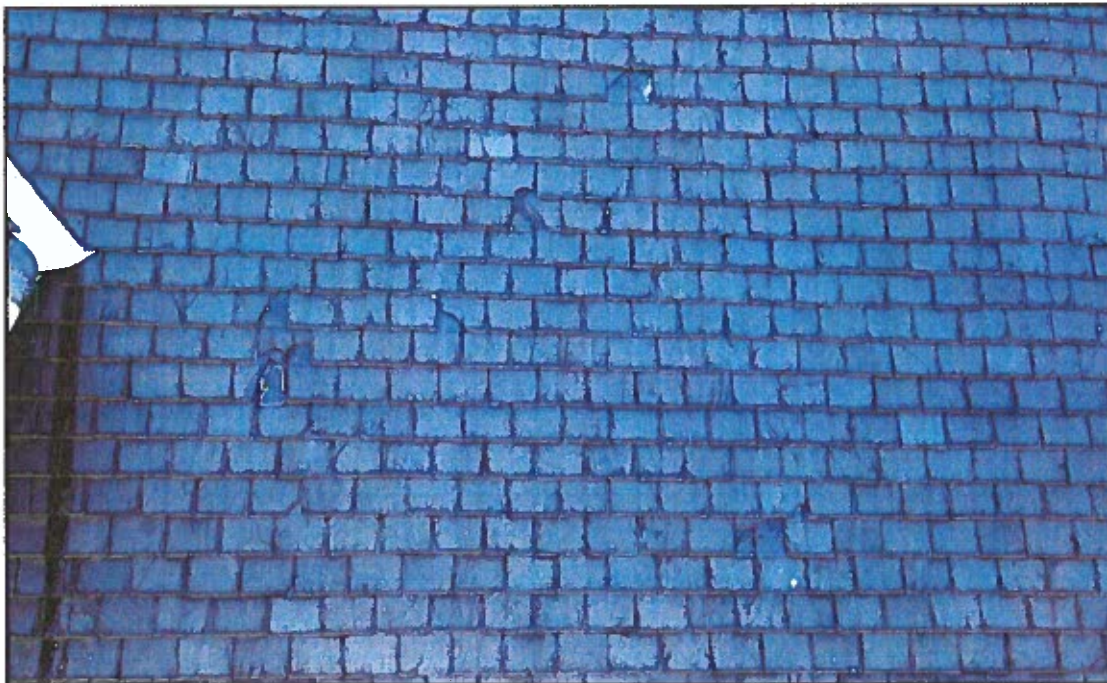
**Photo 4:** North pitch of main barn roof next to dormer.. This section has substantially more broken and cracked slate than other portions of the roof.

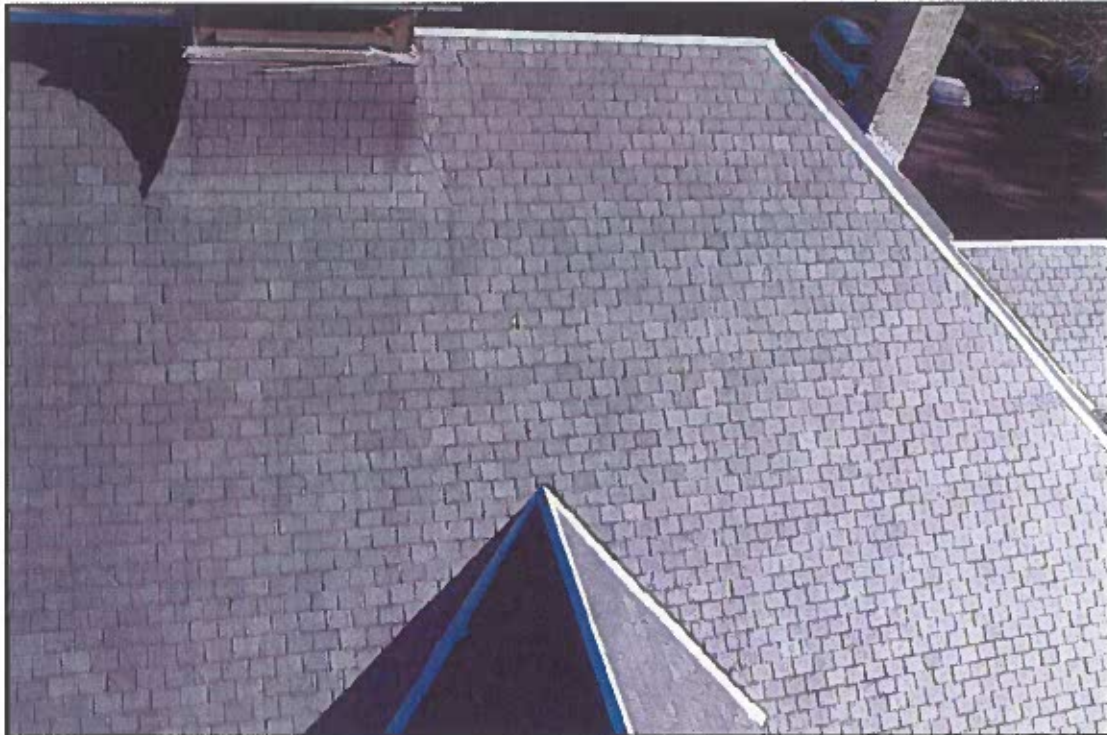
**Photo 5:** Southern end of west roof pitch on main barn. Only a few slates show defects.

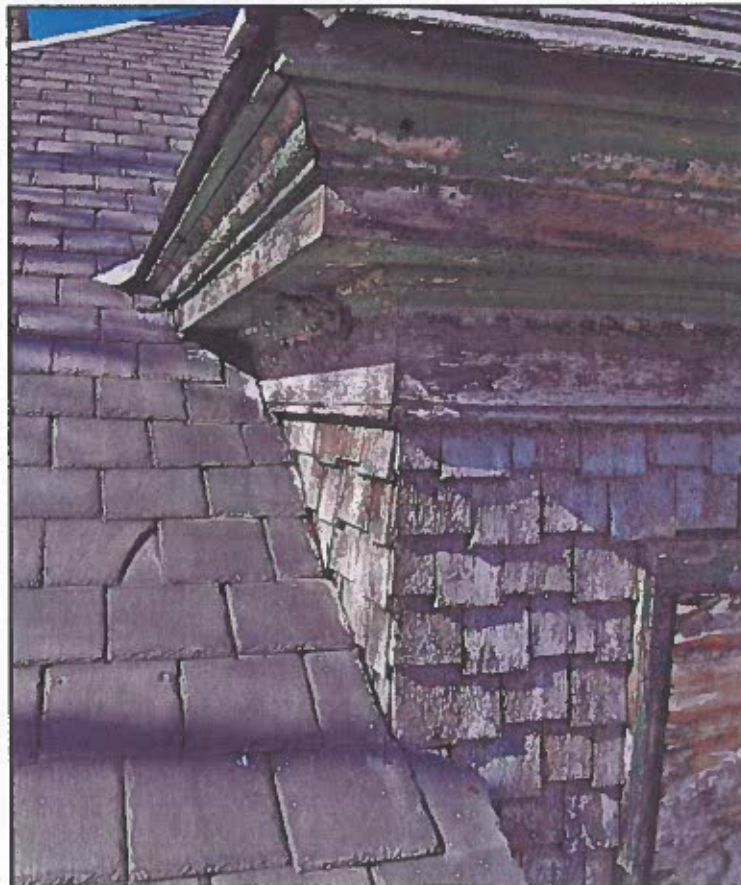
**Photo 6:** Detail of east pitch of main barn roof at southern dormer showing that wood shingles on dormer cheek wall extend below slate, and that the only flashings appear to be the original ones for the wood shingles under the slate.

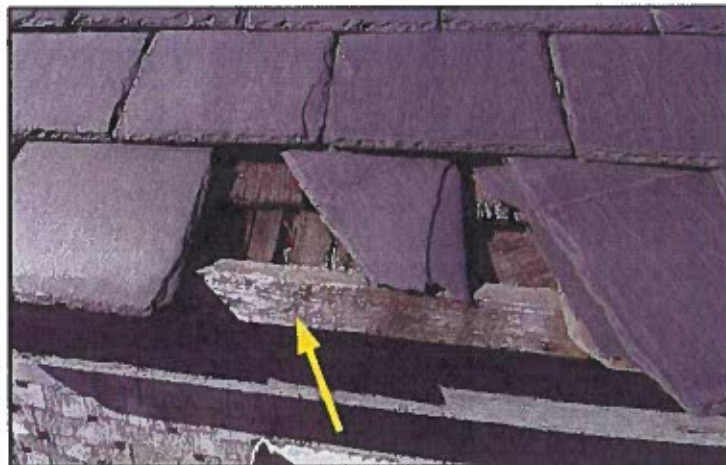
**Photo 9:** Roof edge at east pitch showing original wood shingles still in place under slates, and 2" high wood fillet (arrow) that was added to the crown molding when the slates were installed.

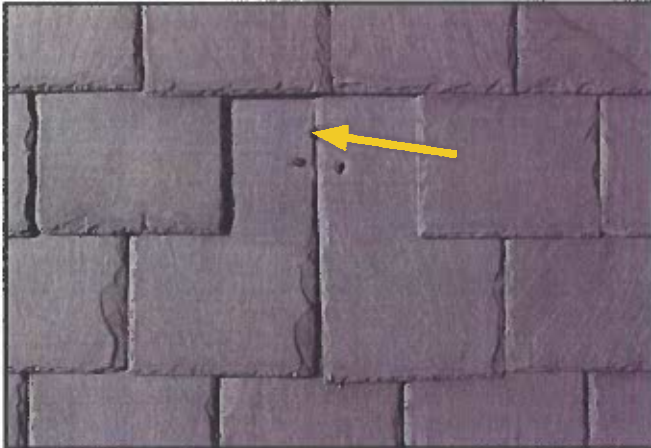
**Photo 10:** Slate defects - missing slate leaves joint between slates of the lower course exposed to the weather (Arrow) and potential leak. Replace missing slate.

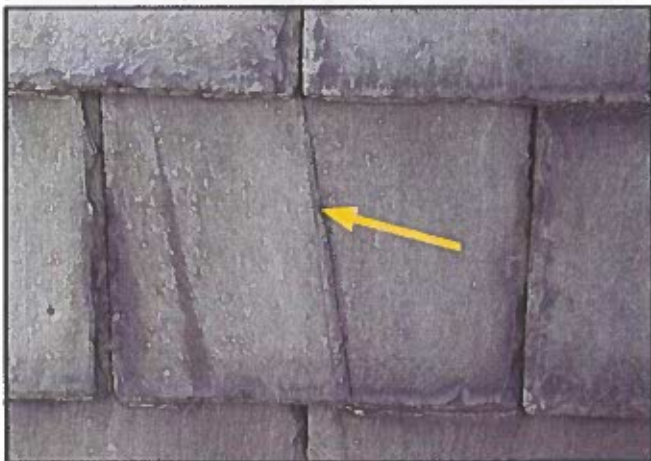
**Photo 11:** Slate defects - Cracked slate where crack is over or near joint of slates in the next course down is potential leak, Replace cracked slate or slip copper sheet under crack.

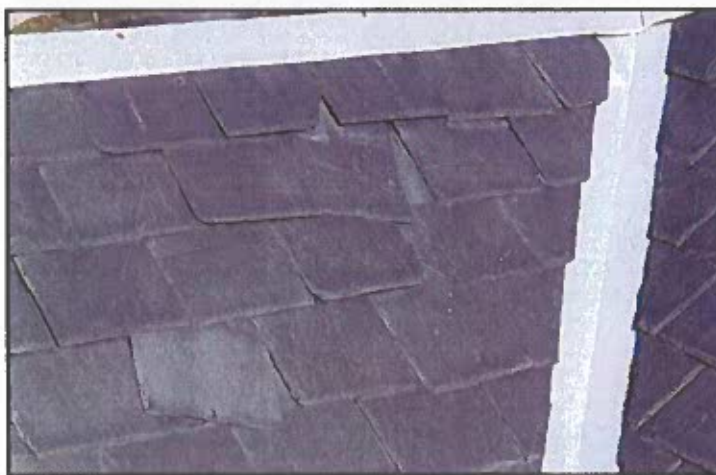
**Photo 13:** Slate defects - Slipped slates at top of valley shown in Photo 12 need to be refastened. This may be due to a failure of the nails to hold in the wood shingles below.

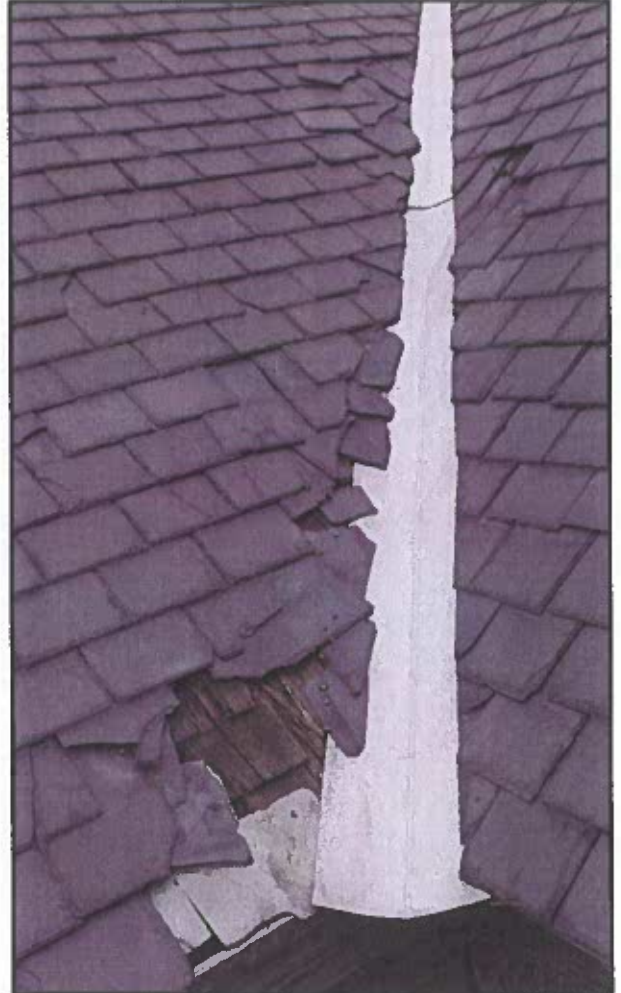
**Photo 12:** Slate defects - Substantial number of broken slate at south valley between ell barn and main barn roofs risks major water damage to framing below roof and should be repaired as soon as possible. Aluminum valley remains intact. Note wood shingles under missing slates.

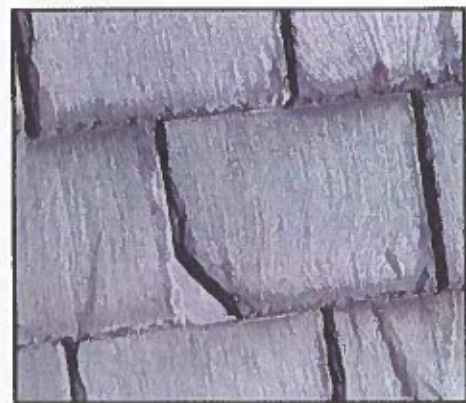
**Photo 14:** Slate defects - Broken corner. As break is not within 2" of joint between slates in course below, it can be left as is.

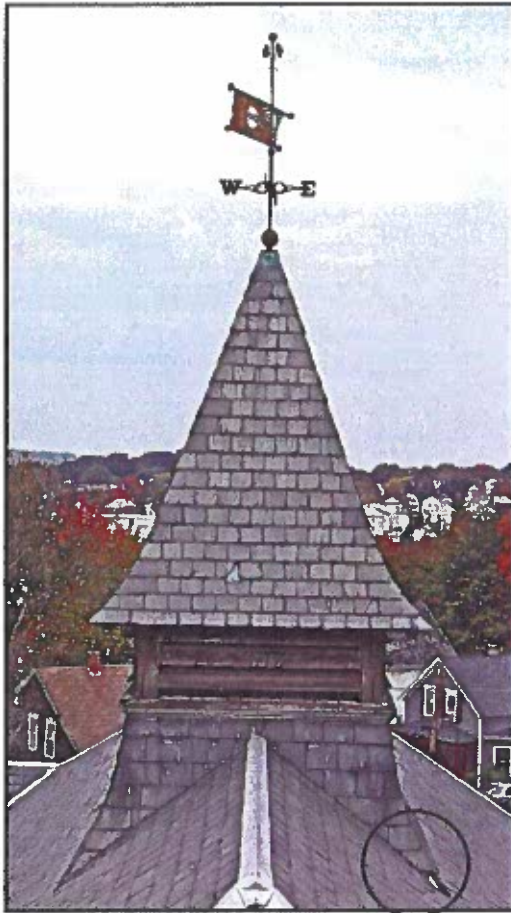
**Photo 15:** Overview of south side of cupola and weathervane.

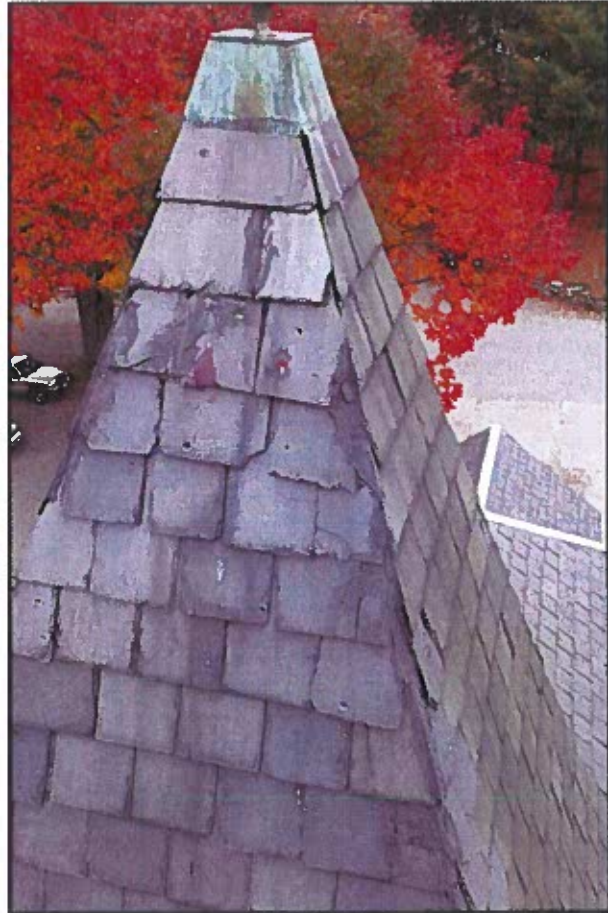
**Photo 16:** North side of cupola showing numerous loose or ragged slate with a number of roofing cement patches. Slates do not match the other sides. The slate on this face should be rehung, preferably with slate that is a better match to the original slate.

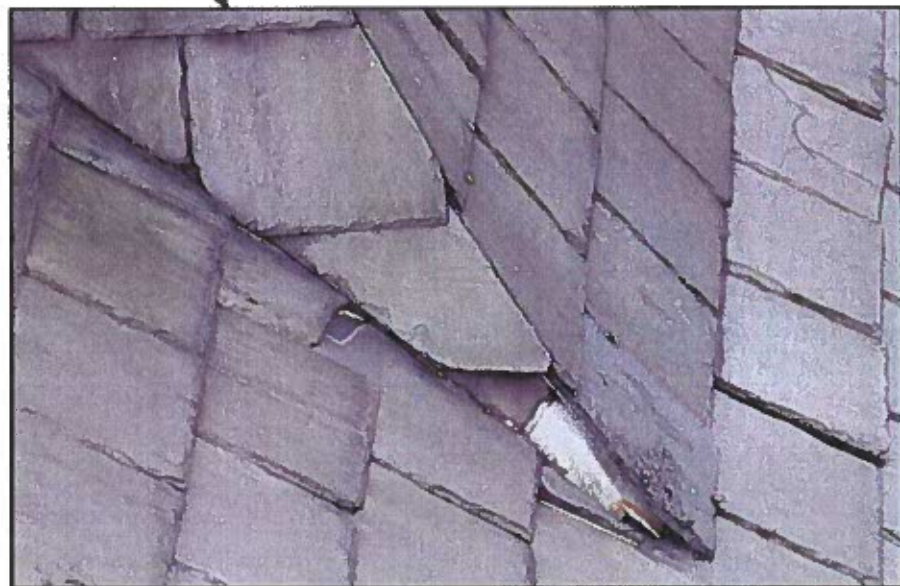
**Photo 17:** Flashing between cupola cheek wall and main roof is very worn where it is visible at the cupola base (arrow) and should be replaced with new copper flashings.

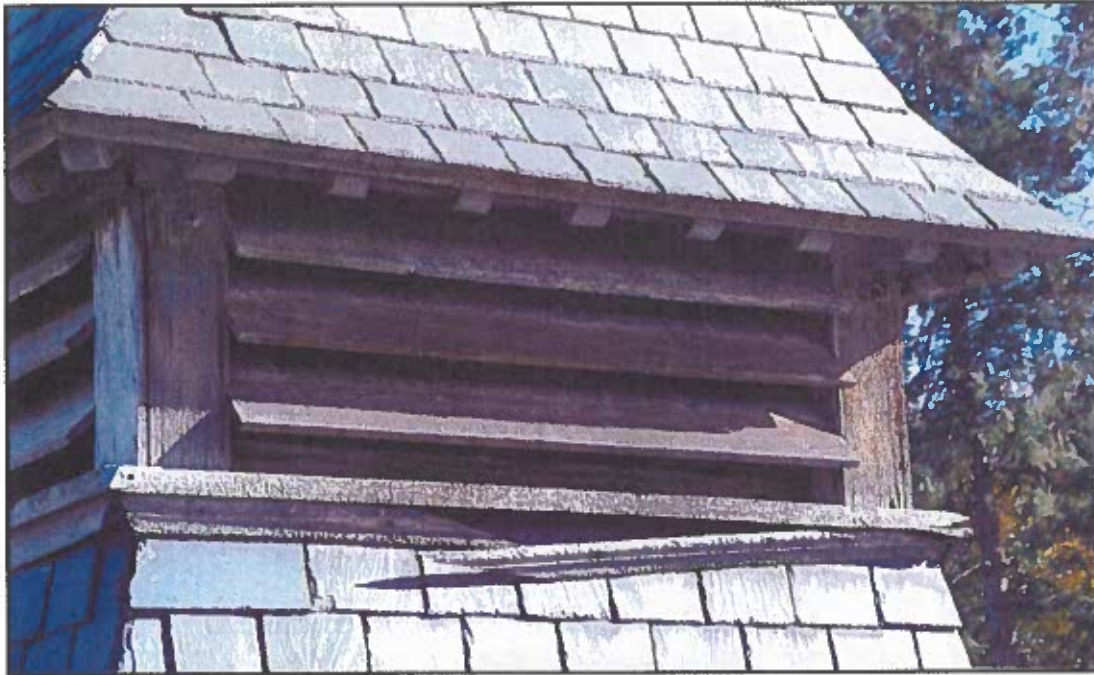
**Photo 18:** West face of cupola showing broken bed mold under sill. Bed mold on north face (left) is a mismatched replacement. Corner boards are weathered with small splits. Rounded modillion blocks under eaves appear to remain sound. Replace bedmolds and split cornerboards.

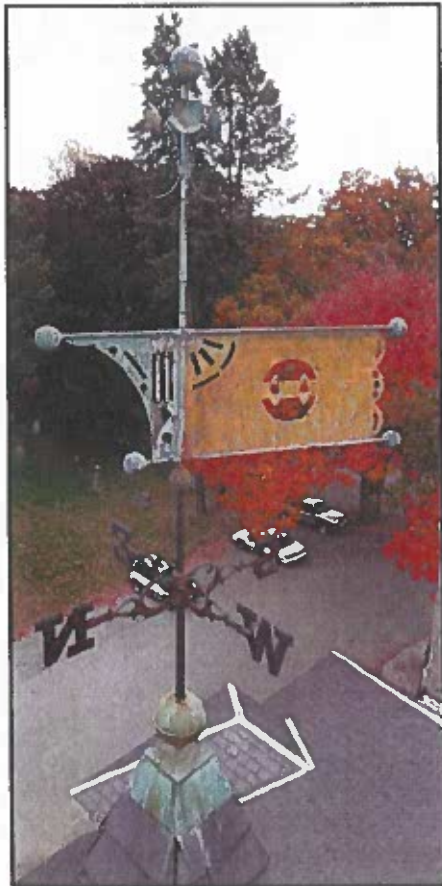
**Photo 20:** Overview of weathervane. Remaining gold color is probably the yellow ground for the gilding, which has worn off.

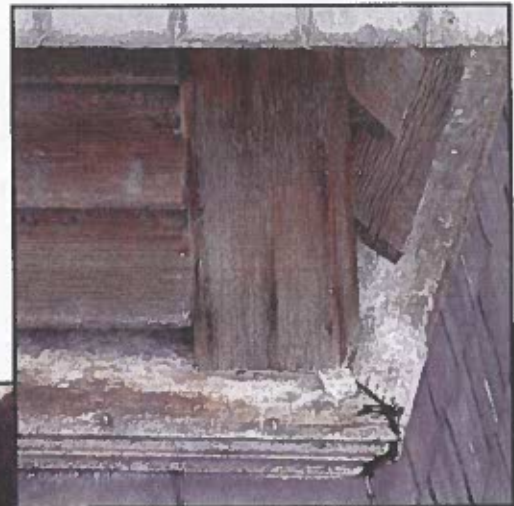
**Photo 19:** Detail of cupola showing gap at sill corner that was original covered with flashing, and moderate weather checking in louvers. Reflash sill corner joints. Replacement of louvers is an option, but not critical as they seem to be solid despite the weathering.

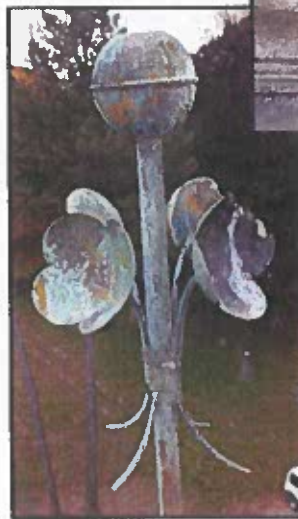
**Photo 21:** Detail ornament at top of vane showing traces of yellow ground indicating they were originally gilded.

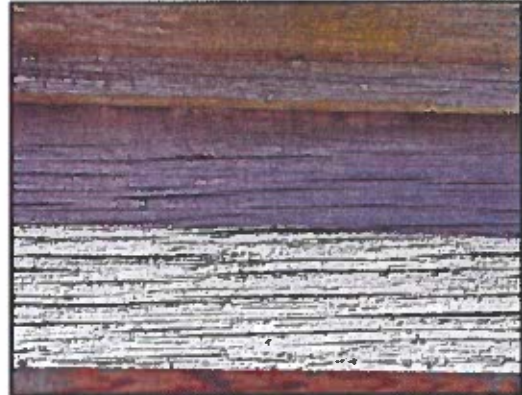
**Photo 22:** Detail of cornice fascia showing typical minor weather checking of otherwise sound wood. That the wood has lasted this long without rotting despite the absence of paint suggests it is more rot resistant than much modern replacement wood, and warrants retention if no other defects are present.

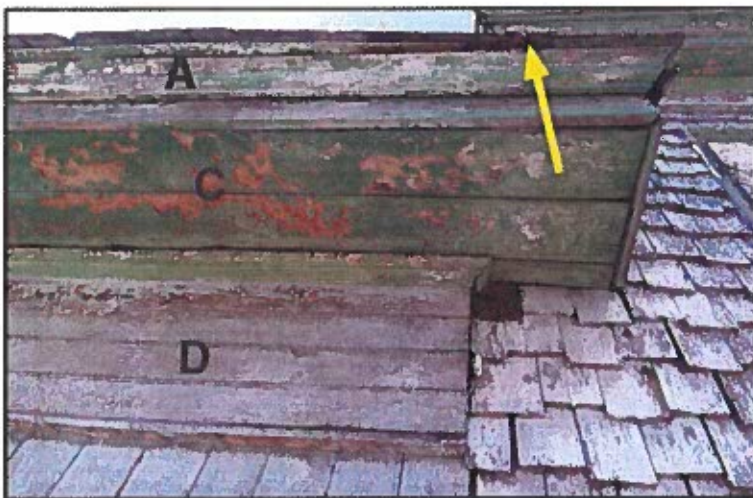
**Photo 23:** "C" marks soffit on underside of cornice. "D" marks entablature, and "A" marks cornice crown molding. Area shown is where former leak at dormer #4 has caused soffit boards to spread apart and edge of slate to dip due to loss of portion of support fillet (arrow). Soffit boards may need to be reset or replaced to close gaps.

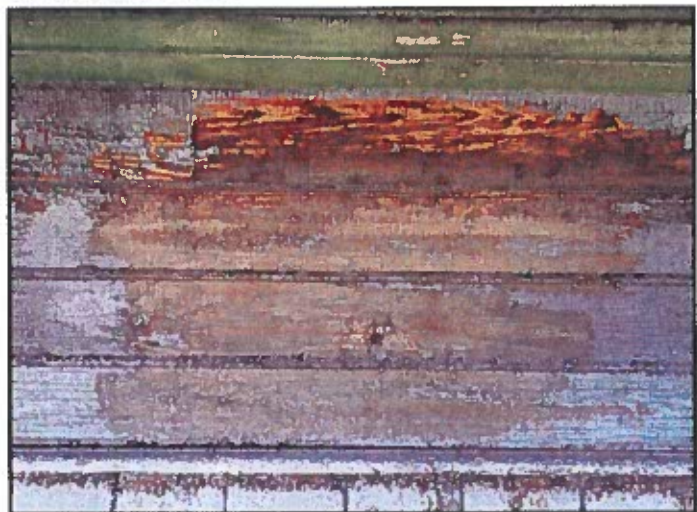
**Photo 24:** Entablature on east facade showing area where existing paint was easily scraped back to bare wood with a hand scraper. This indicates that paint to bare wood removal should be routine. The wood surface should be lightly sanded after scraping to remove surface weathering.

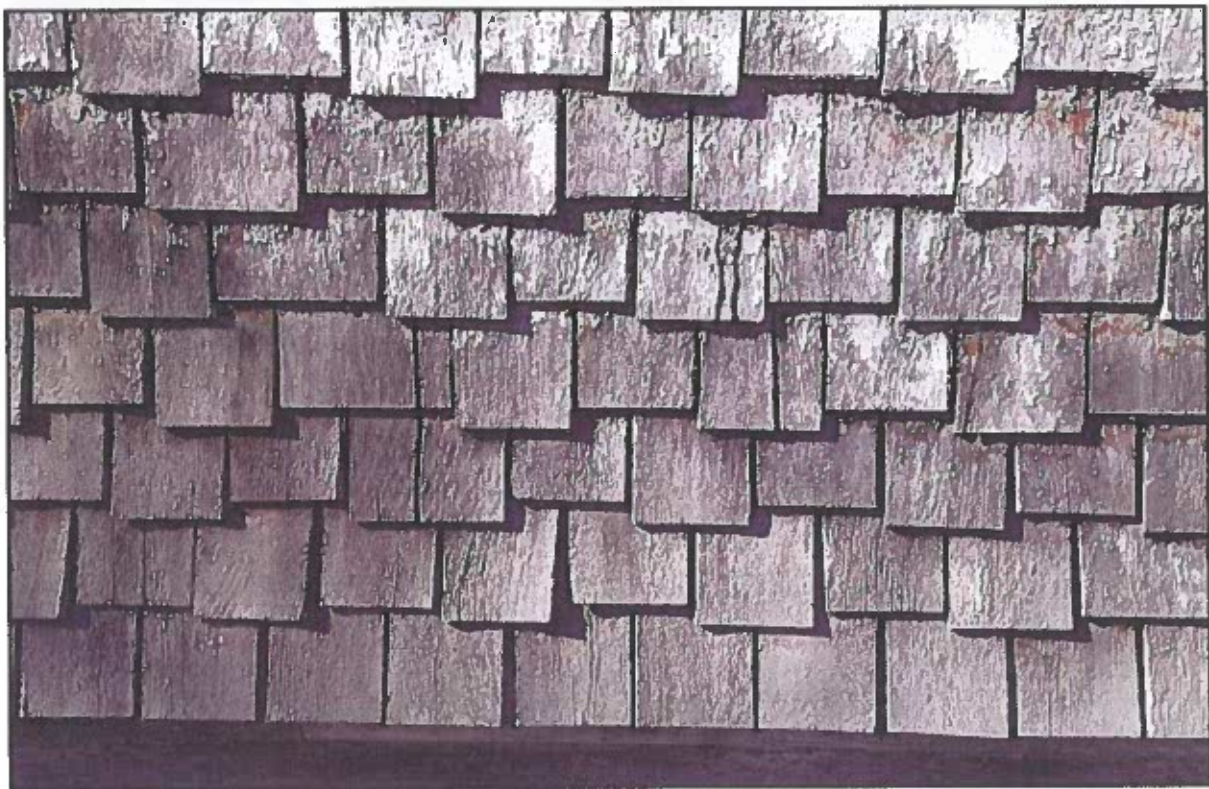
**Photo 27:** Section showing a few split or warped shingles. This illustrates the worst conditions observed on the east facade, and is still considered acceptable to leave as is with scraping to remove paint and repainting.

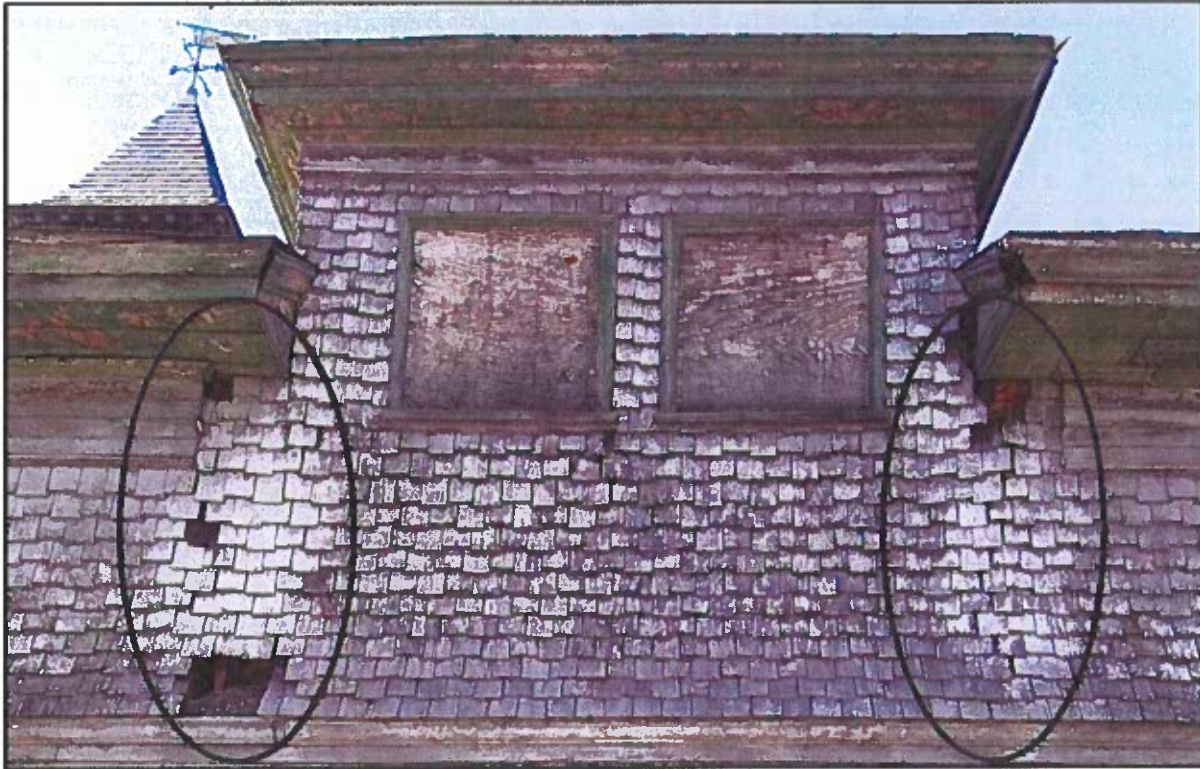
**Photo 28:** Shingle band below Dormer #4 on east facade showing damage to shingles from form former roof leak. Shingles in the indicated areas will require complete replacement to correct the damage and make the wall water-tight.

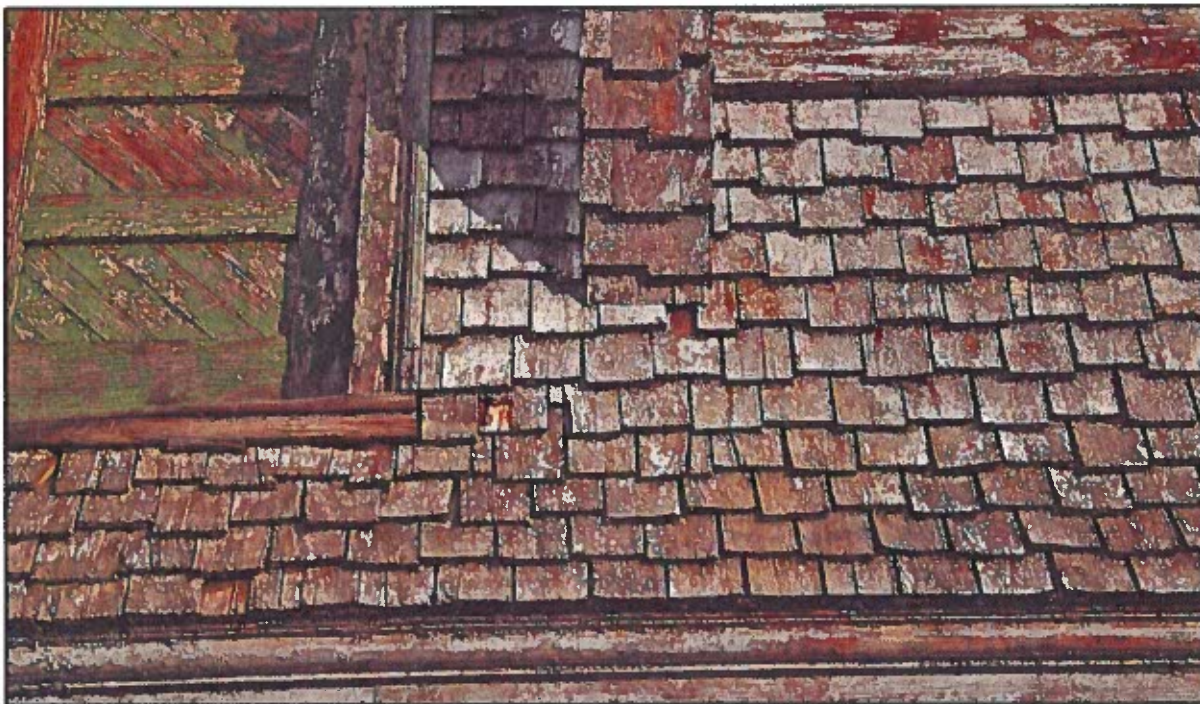
**Photo 29:** Shingle band adjacent to Dormer #1 on west facade showing many warped, split and missing shingles in lower portions. The extent of damaged shingles warrants complete replacement of shingles in this area, and possibly across the entire west facade.

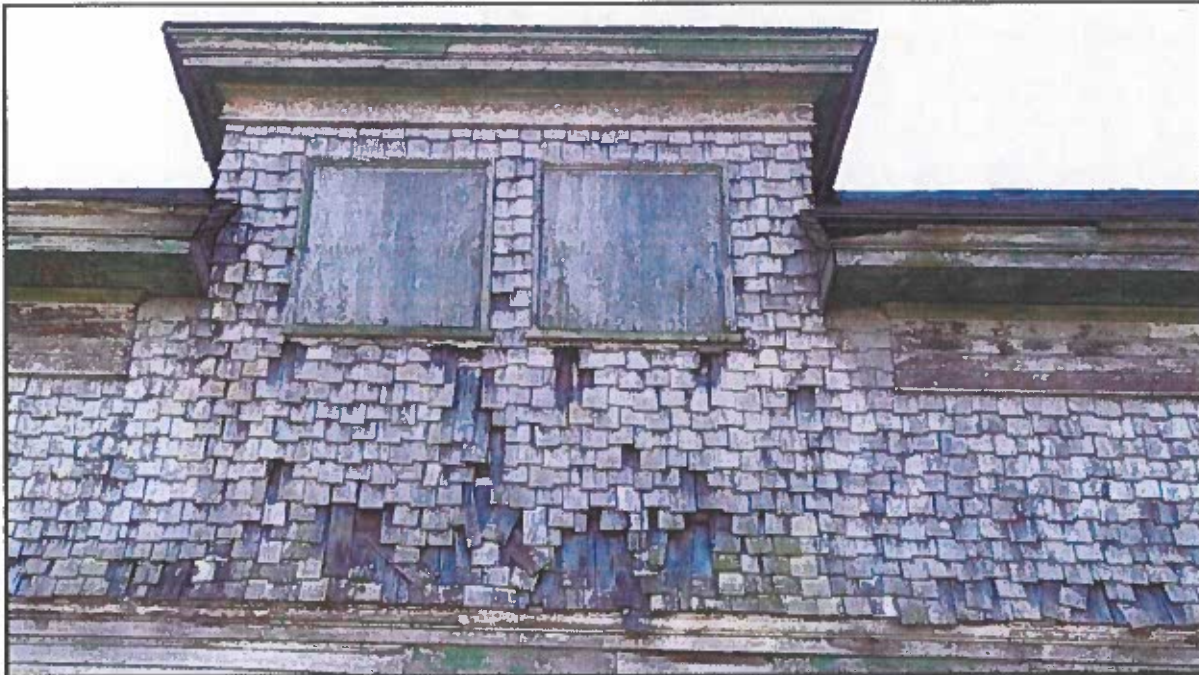
**Photo 30:** Shingle band adjacent to Dormer #5 on north facade showing many loose and missing shingles in lower portions. The extent of damaged shingles warrants complete replacement of shingles on this facade. Replacing only the damaged courses is not recommended as the top course of replacement shingles will not have proper cover over their nailing.

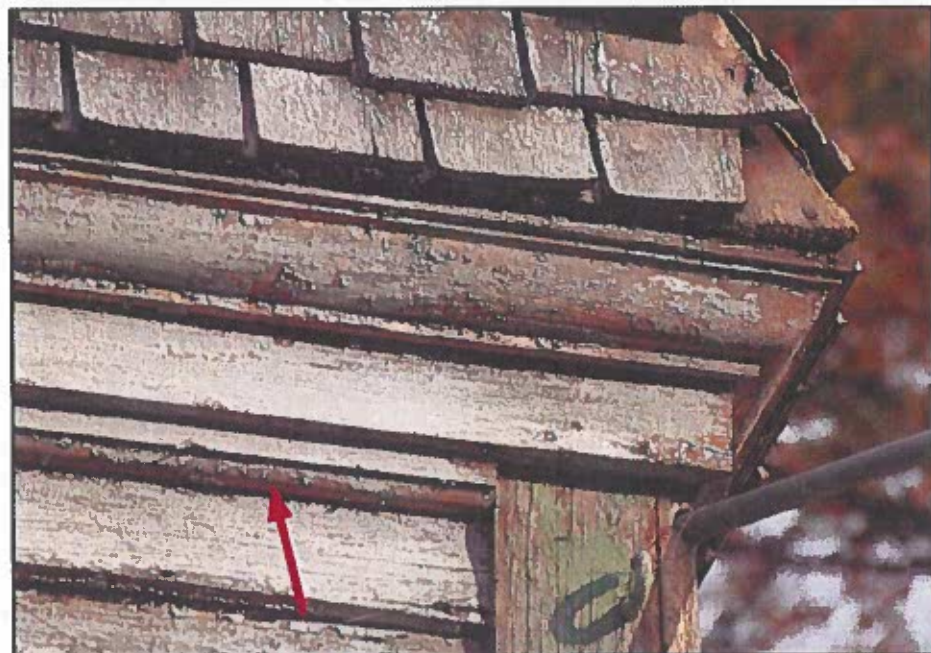
**Photo 31:** Detail of belt course below shingle band showing typical condition with only minor weathering. The belt course can be retained around the entire main barn (it is not present on the ell barn). However, the lowest member (arrow) and possibly other elements above it, may have to be taken off and reinstalled for proper installation of new clapboards.

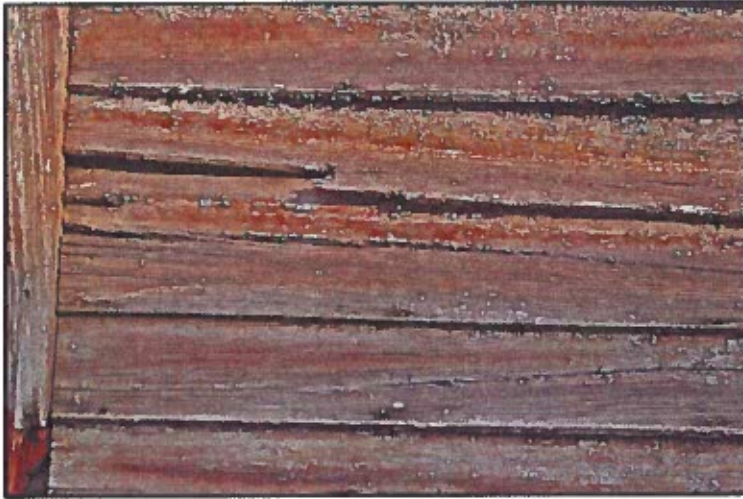
**Photo 32:** Typical clapboard conditions at west facade of main barn; severely weathered with extensive warping and splitting. All clapboards on the west facade should be replaced. The west facade of the ell barn and the south facade of the main barn are in similar poor condition.

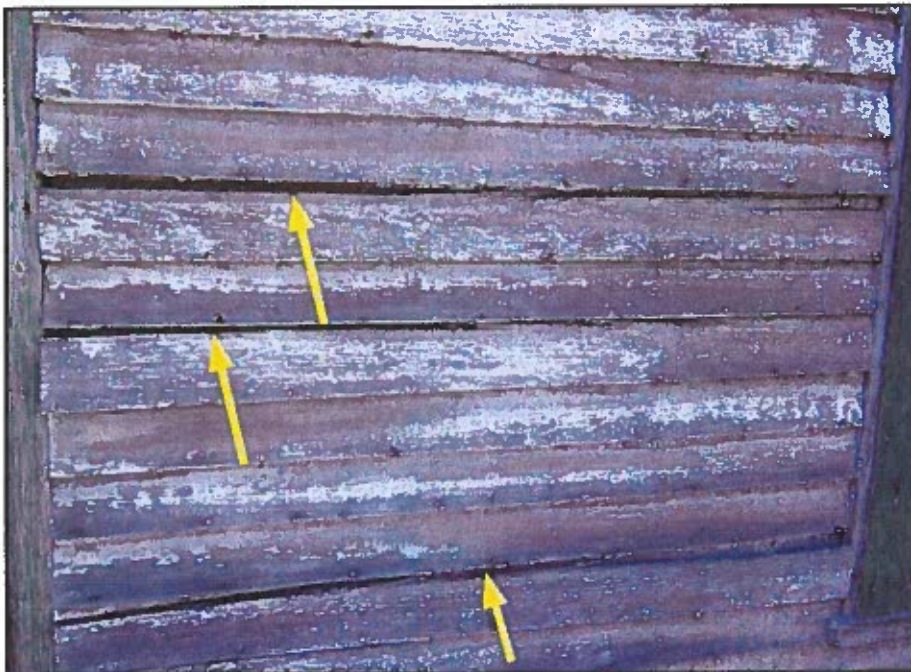
**Photo 33:** Typical clapboard conditions at east facade of main barn; At first glance they look better than the west facade, but a significant number have splits just under the laps (arrows) or are moderately warped. All clapboards on this facade should be replaced.

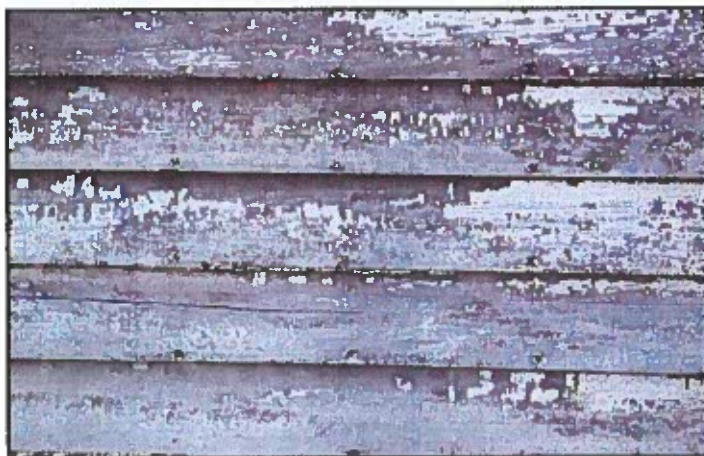
**Photo 34:** Typical clapboard conditions at north facade of main barn; weathering is moderate and splits are less severe and less frequent. Retaining the existing clapboards in place is feasible with replacement limited to badly split ones and the areas of missing clapboards around the windows.

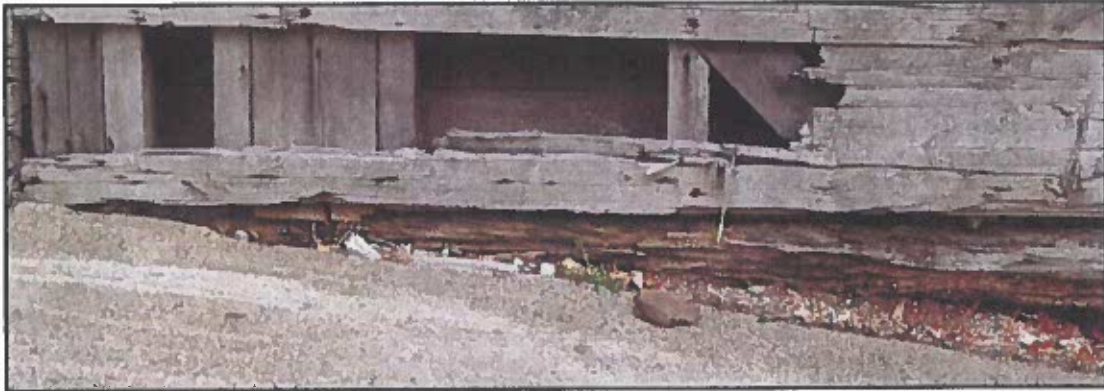
**Photo 35:** Sill at west facade of main barn to right of former door. The face of the sill has rotted, although the core may still be sound based on limited probing. The concrete apron aggravates the situation. At minimum repair involves splicing in new wood to replace the rot, and providing flashing for water protection. Further investigation is needed to determine the extent of rot, including the area under the door threshold.

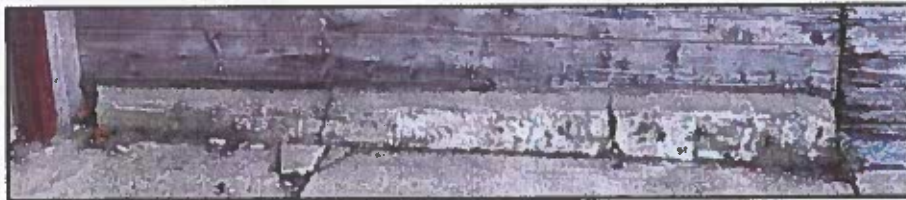
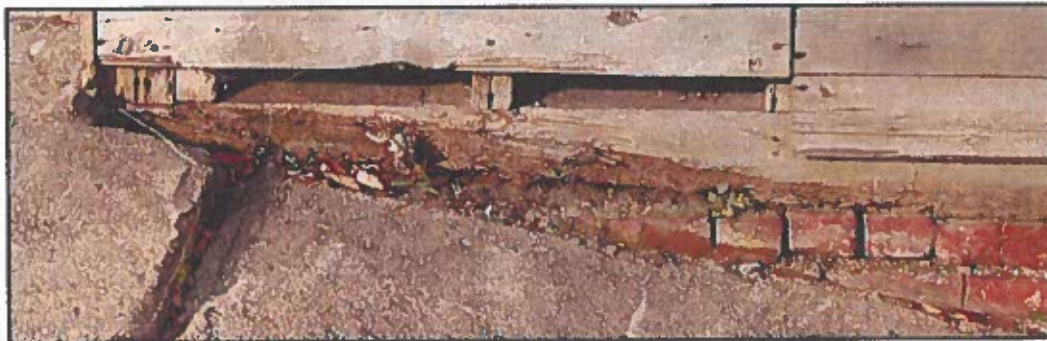
**Photo 37:** Sill at south facade of main barn to right of door. The face of the sill has rotted. Its condition and treatment need further investigation, similar to the sill in photo 35.

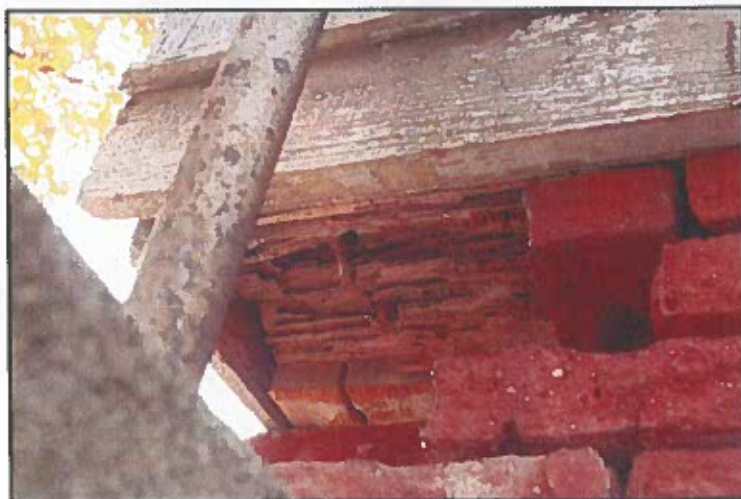
**Photo 38:** Sill at southeast corner of main barn. The underside of the east sill has lost several inches from insect damage and rot, while the south sill remains sound. The core of the east sill above the damage seems to be sound, and the visible damage only extends a couple of feet to the right. However, further probing should be done to verify the extent of damage. The sill needs to be repaired by piecing in sound wood to replace the deteriorated material, and the brick foundation rebuilt down to sound brick and mortar. In this case the full 12" depth of the wall need rebuilding at the top.

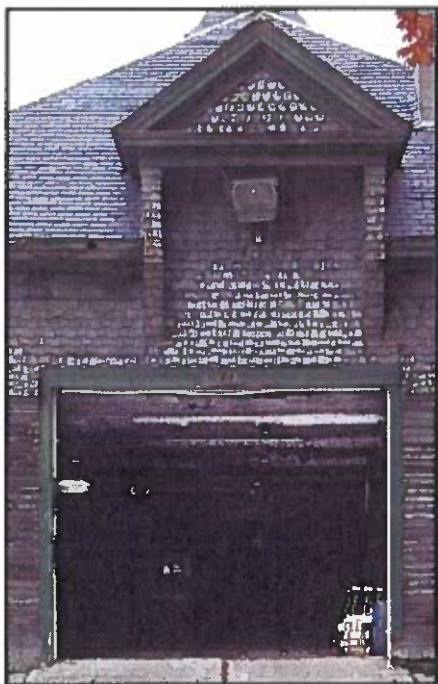
**Photo 39:** South facade main door. The opening has been widened to the left and increased in height to accommodate an overhead door and large vehicles. The top of the original door would likely have been below the belt course.

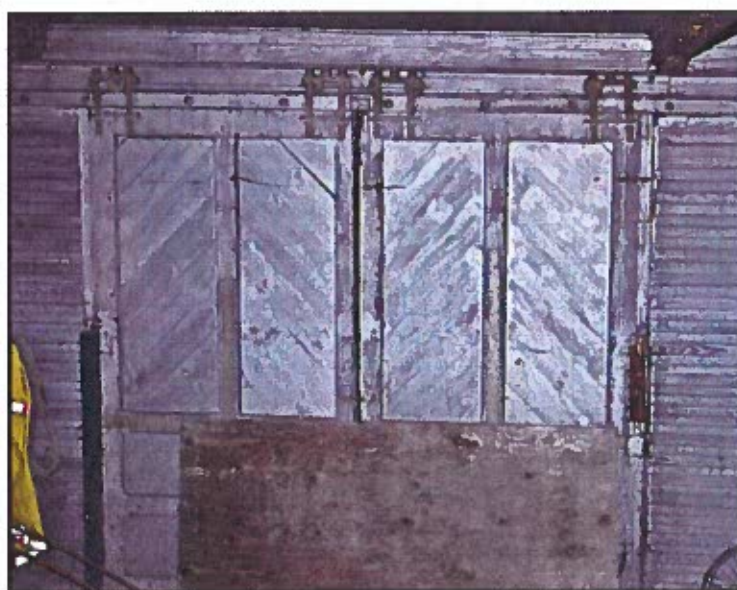
**Photo 42:** Original west facade main barn door with its original track and hardware remains in place behind the closed in opening. The original matched boarding that made up the panels may have been replaced with new boarding.

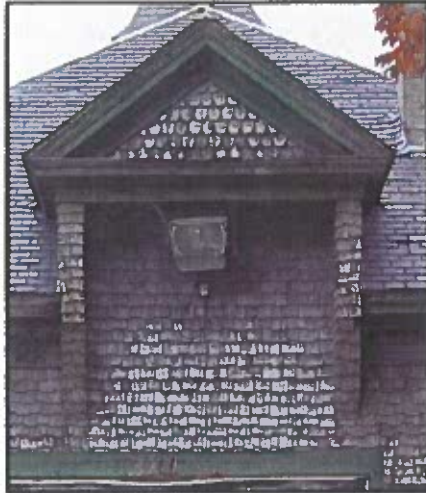
**Photo 43:** South facade dormer with shingled wall covering the original loft doors shown in photo 44 at right. Its original appearance matched the west facade dormer in photo 45 below.

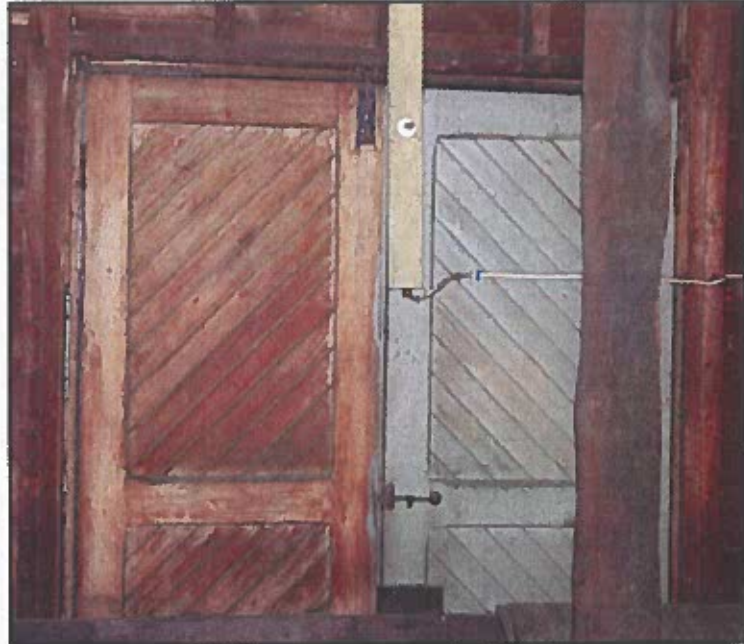
**Photo 44:** Original loft doors at the south facade of the main door remain intact behind the exterior shingled wall of the south dormer (see photo 39 at left). The doors should be repaired as needed and restored as a visible exterior feature of the dormer.

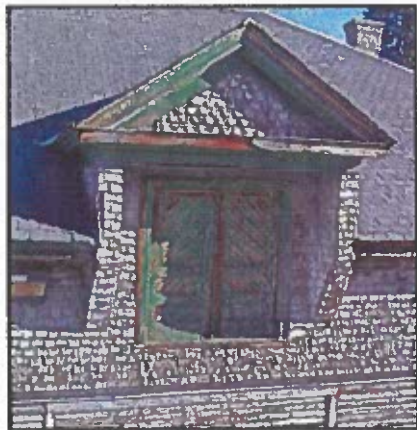
**Photo 45:** West facade dormer with original loft doors still in place. The doors should be retained and preserved as a significant historic feature. The trim on the dormer is extensively weathered needs to be replaced.

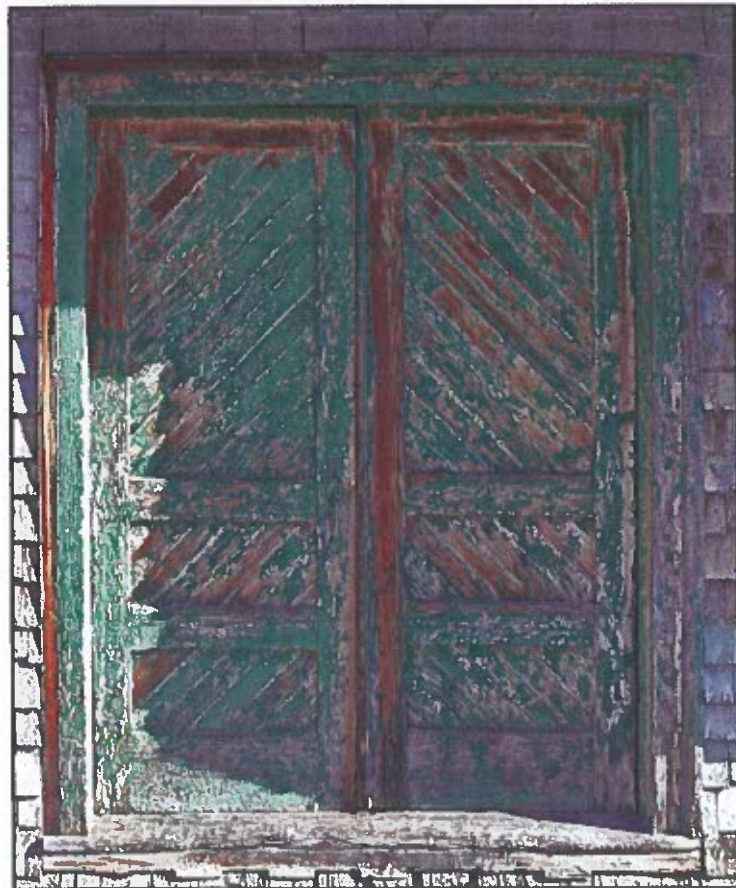
**Photo 46:** Original loft doors of west facade dormer. The original door and door jamb is intact. Missing moldings need to be replaced on the door frame, and some wood repairs need to be done to the rails and stiles of the doors, and the sill of the door frame may need replacement due to weathering.

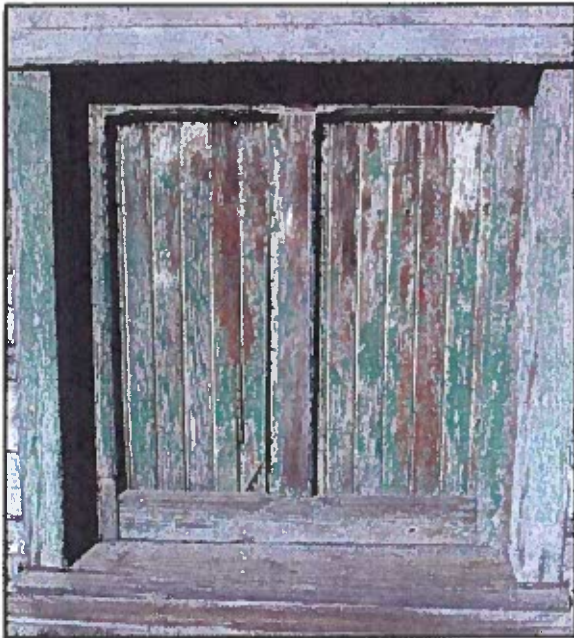
**Photo 47:** Original loft door of ell barn south facade. There are two original doors which should be retained and preserved. They are functional but have weathered surfaces and will need some carpentry repairs.

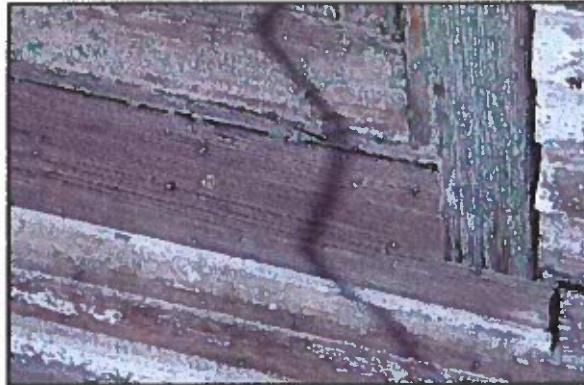
**Photo 48:** Deeply weathered surface of ell loft door sills will require extensive epoxy consolidation or replacement.
