## HOPE CEMETERY COMMISSION MEETING

Monday May 8, 2023 – 4:00 P.M.  
Parks, Recreation & Cemetery Administrative Office  
Meeting Room A  
50 Officer Manny Familia Way Worcester, MA 01605

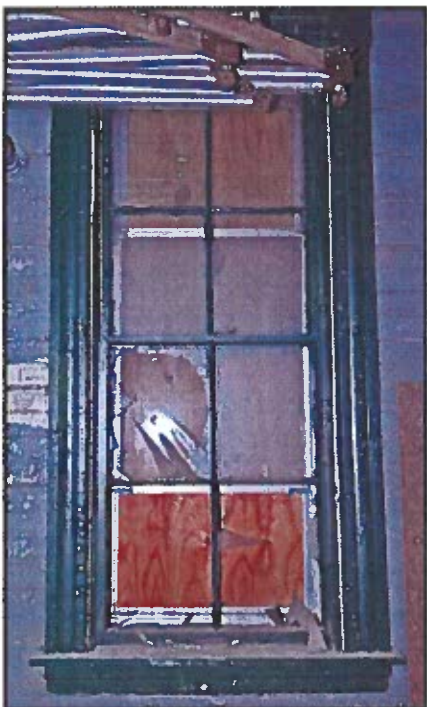
**Photo 49:** Interior side of first floor main barn window showing molded casings that should be retained and preserved. Sash are intact and can probably be retained with new glass and glazing.

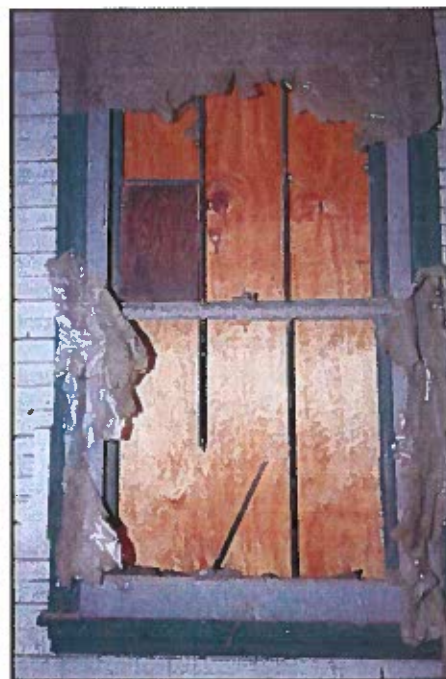
**Photo 50:** Interior side of first floor main barn window showing molded casings that should be retained and preserved. Sash are missing muntins (i.e., glazing bars), and should be replaced with matching new wood sash set in the existing original frame.

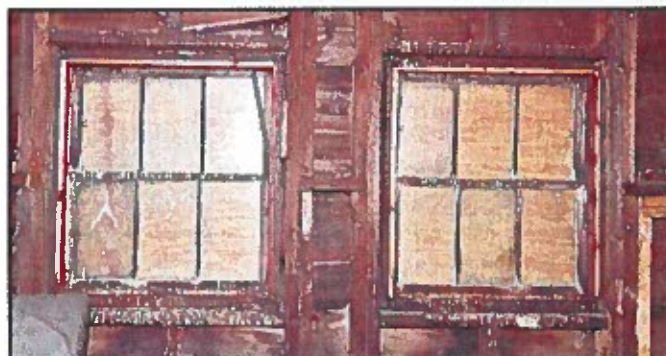
**Photo 50:** Interior side of loft floor main barn dormer windows showing intact sash in frames without casings. The sash and frames should be retained and preserved with reglazing unless the exterior side shows severe damage.

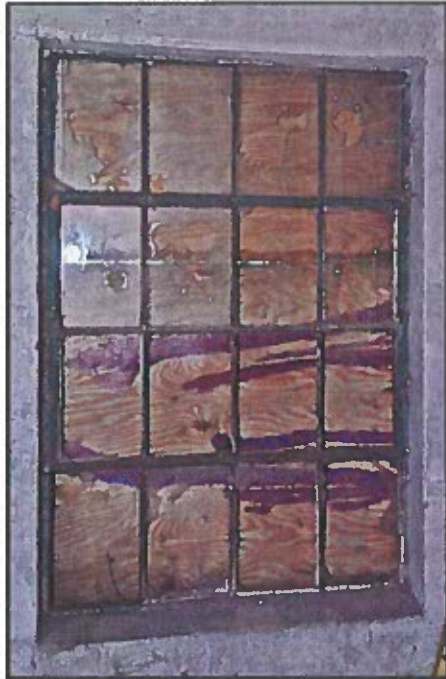
**Photo 51:** Interior side of ell basement steel window with substantial rust. Replacement with new wood or metal window matching the size and pane configuration would be acceptable.

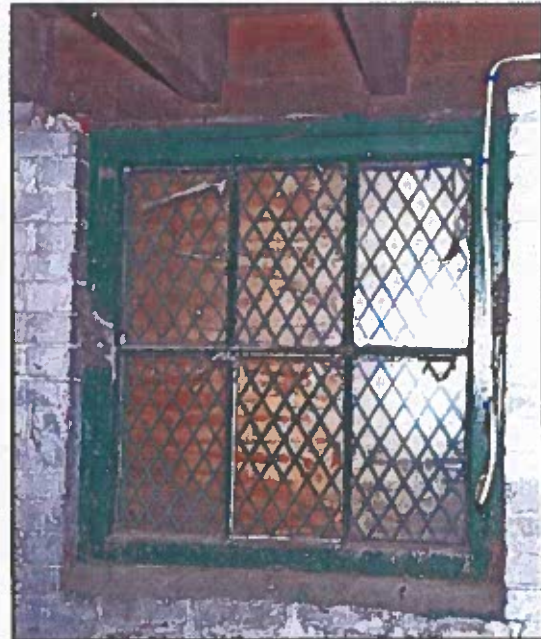
**Photo 52:** Interior side of main barn basement window with intact sash and old protective grill on the exterior. Both the sash and the grills should be retained when the sash is intact.

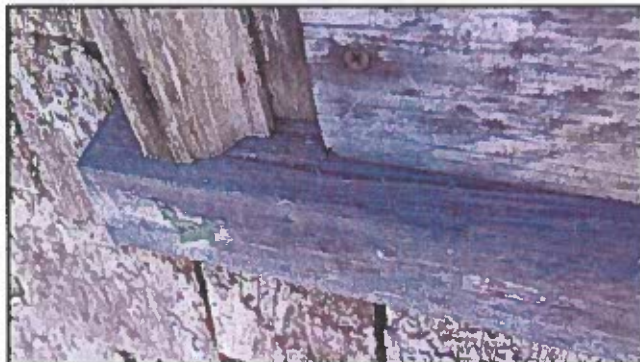
**Photo 53:** Exterior of main barn dormer window with moldings on the side casing. Sill has a deep crack, but can probably be saved by using epoxy consolidation and filling materials.

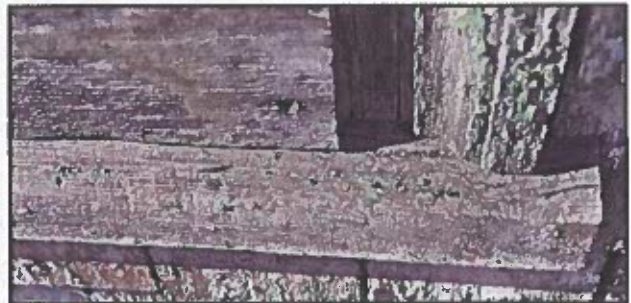
**Photo 54:** Another dormer sill. This one has only minor weathering and should be retained sanding and painting.

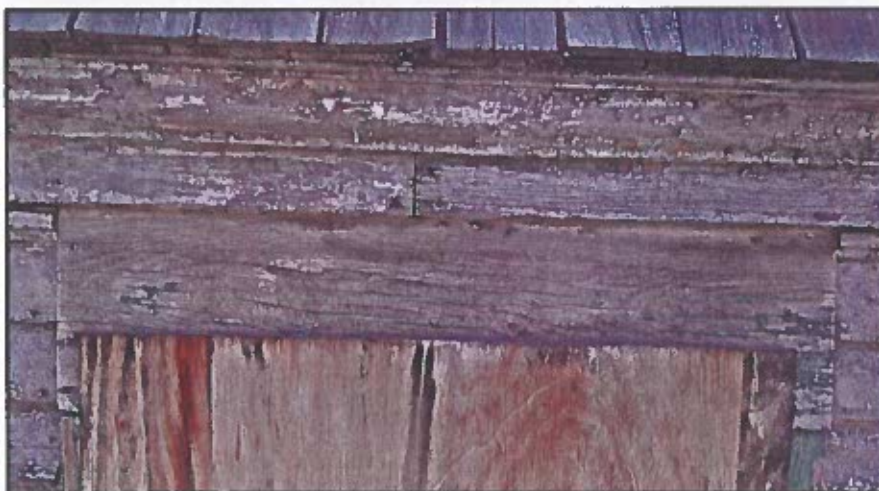
**Photo 55:** Typical first floor exterior window frame on main barn having moderate weather cracking on the flat surface casings. Casings in this condition can be retained, perhaps filling the cracks with epoxy fillers prior to repainting. Alternatively, they can be replaced with matching new wood, but the new wood may be less rot resistant than the existing weathered wood.

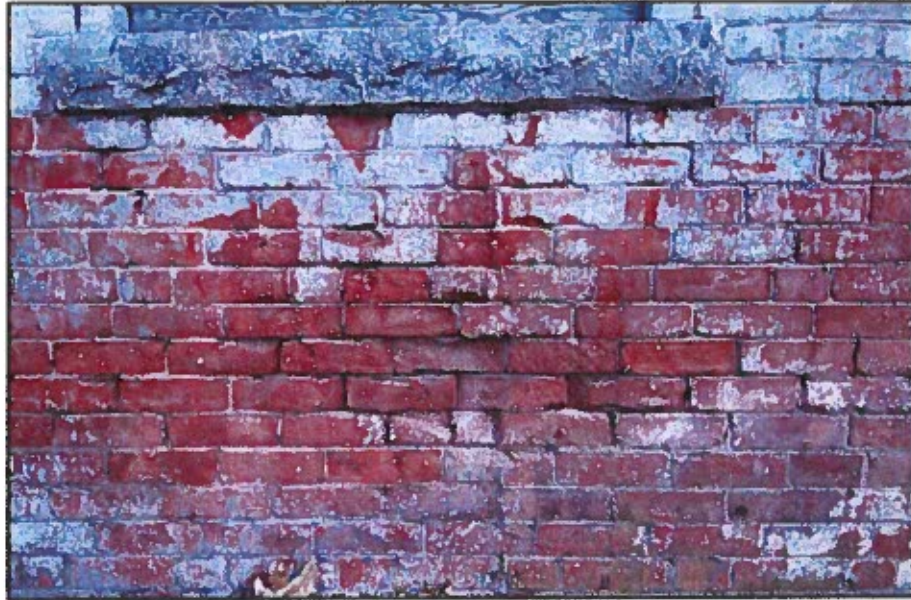
**Photo 57:** Brick below basement window sill of main barn east facade with open mortar joints and a number of bricks that are loose and bulging out from the wall. All the loose bricks should be taken out and reset in new mortar, and all joints in the area 100% cut and repointed using a mortar matching the relatively low strength of the existing original mortar.

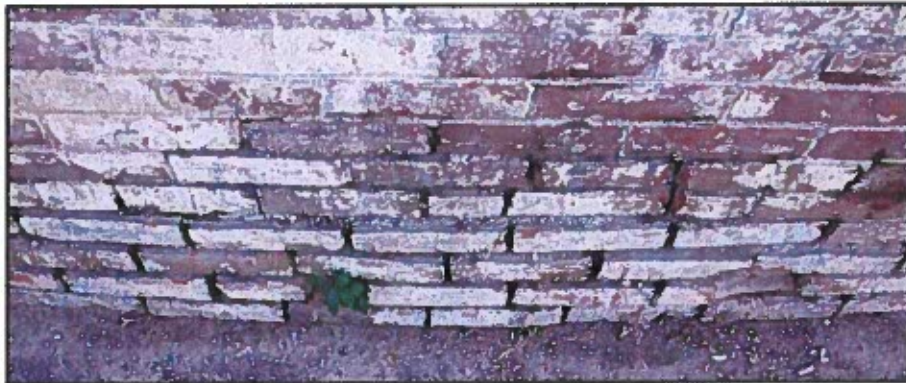
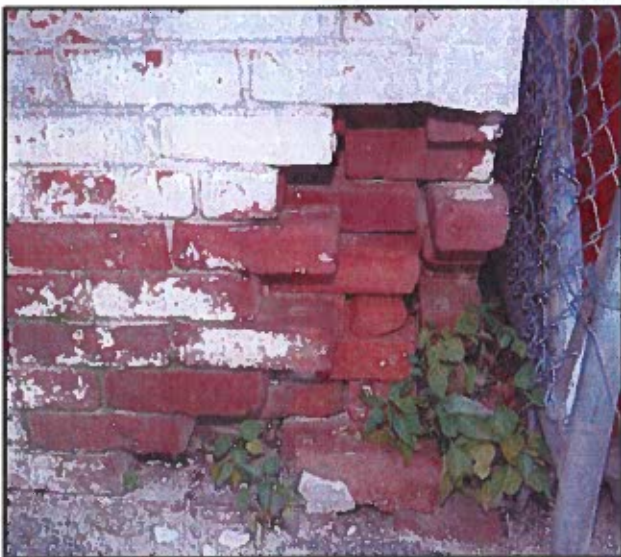
**Photo 58:** Foundation at northeast corner of main barn with loose and missing brick. This section should be rebuilt with matching brick.

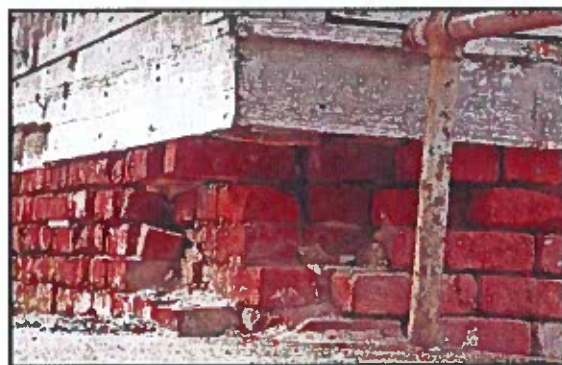
**Photo 59:** Foundation at southeast corner of main barn with loose and missing brick extending through the full depth of the 12" thick wall. This section should be rebuilt for the full depth of the wall with matching brick after the sill above it has been repaired.

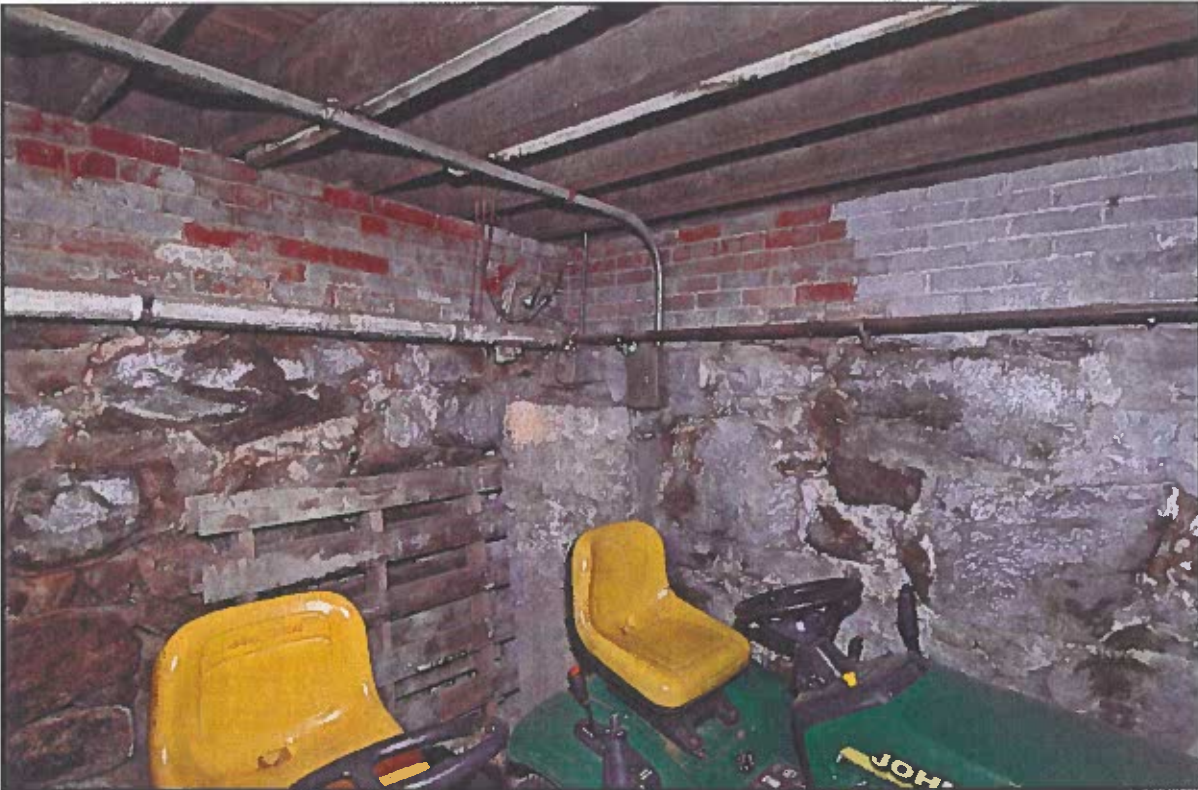
**Photo 60:** Interior of basement at southwest corner showing fieldstone laid in mortar below grade with brick from about 6" below grade up to the underside of the wood sills. As viewed from this side the sills generally appeared intact without visible damage.

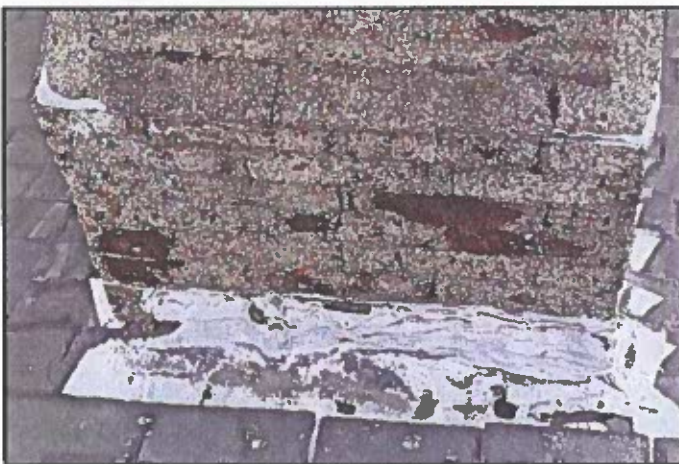
**Photo 61:** Chimney flashing at roof has numerous large holes that are causing leaks in the roof below.

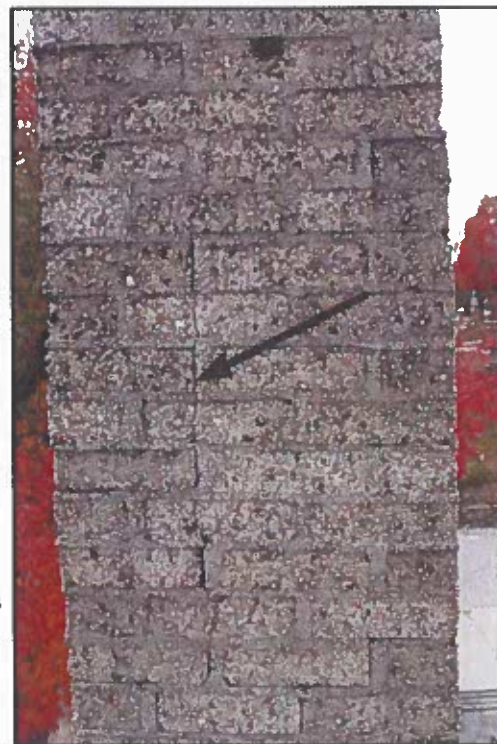
**Photo 62:** Chimney has numerous long cracks through both bricks and mortar joints, and is built with poor quality cement bricks that have eroded surfaces. As it is not visually important to the roof and has only minor historical value, it can be removed. If it is to be retained, it should be completely rebuilt with new brick of similar color.

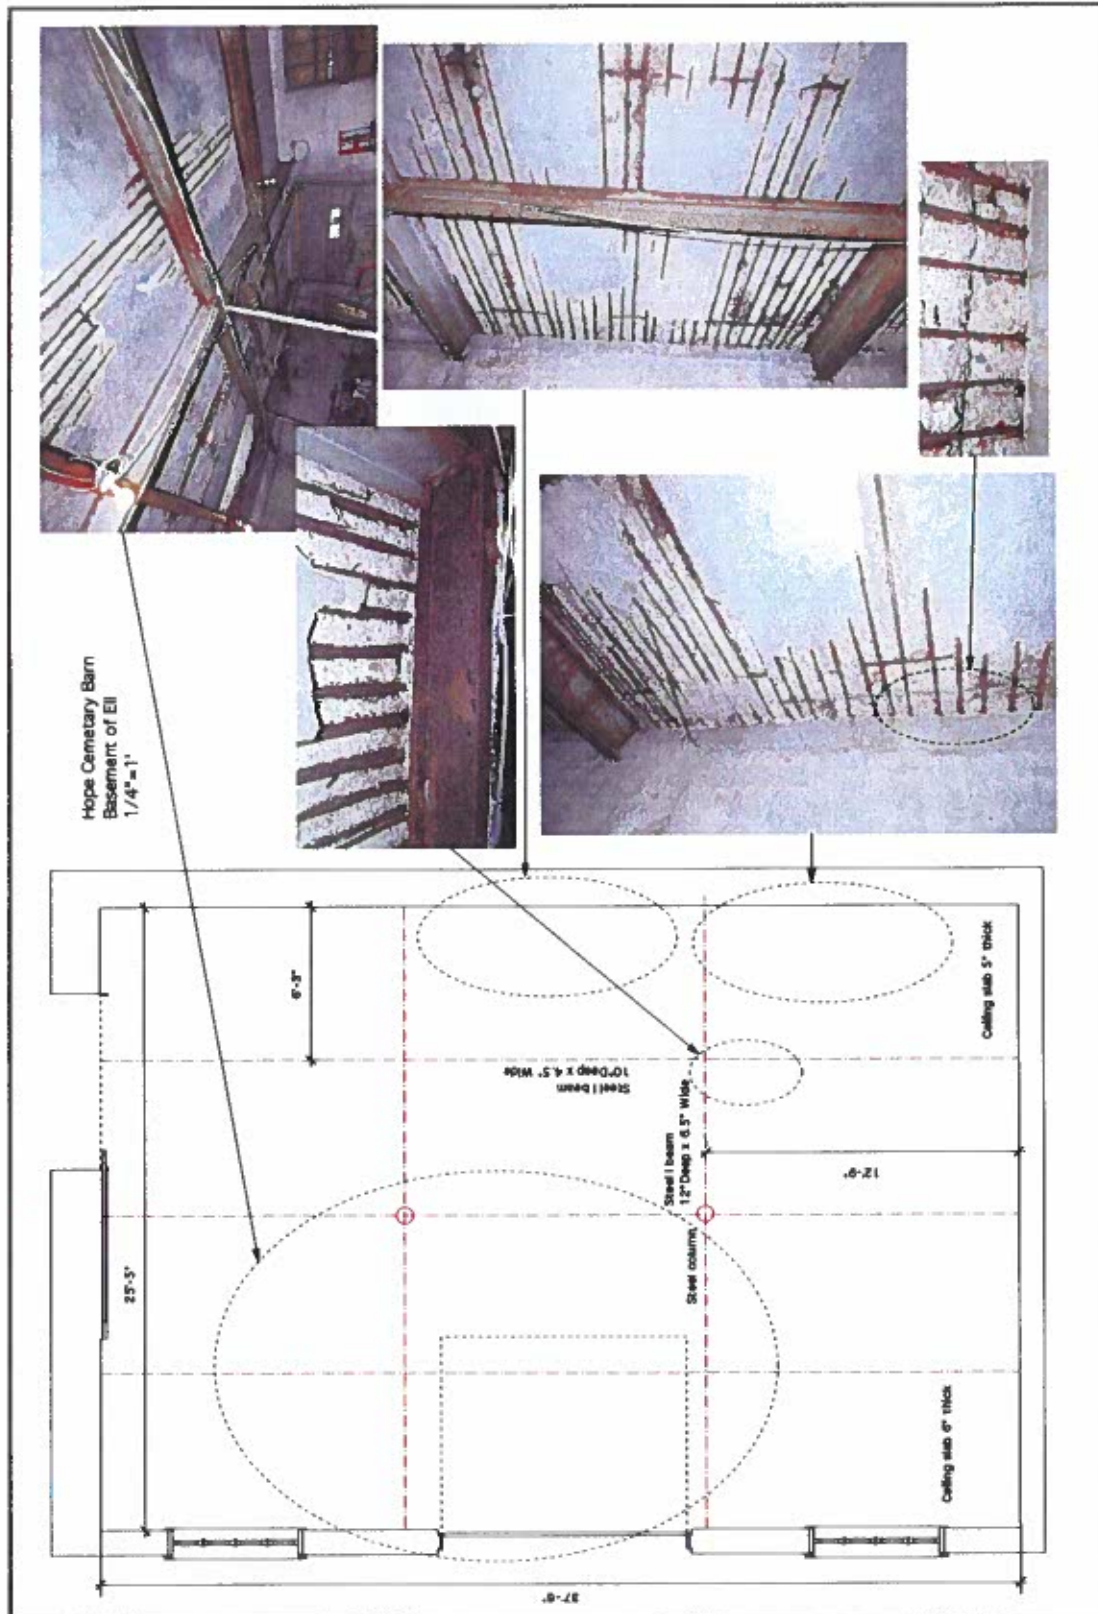
Hope Cemetery Barn  
Basement of Ell  
1/4" = 1'

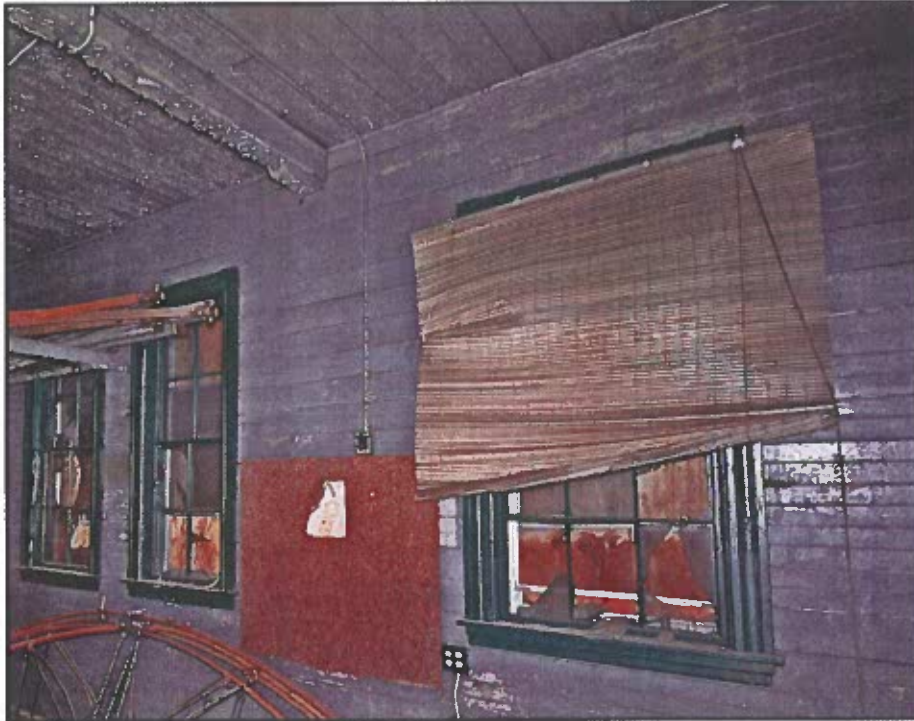
**Photo 64:** Interior of main barn first floor showing matched boarding on walls and ceiling that is the original interior finish and should be retained and preserved. Beam in ceiling is the bottom chord of a loft level roof truss

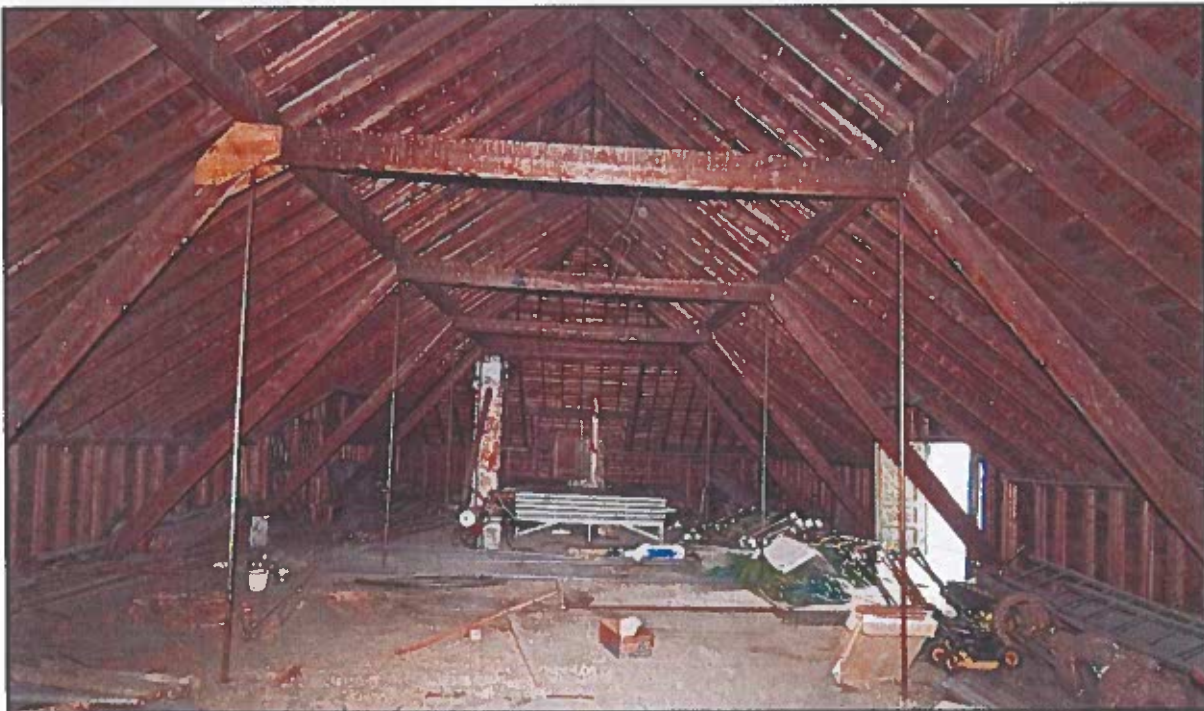
**Photo 65:** Interior of main barn loft floor showing queen rod roof trusses and exposed framing and sheathing. Stored items should be sorted items that are obsolete and of no historic value to the cemetery removed. There is considerable dust and fiber debris on the floor (especially at the side walls) that is a potential fire hazard and should be vacuumed out.

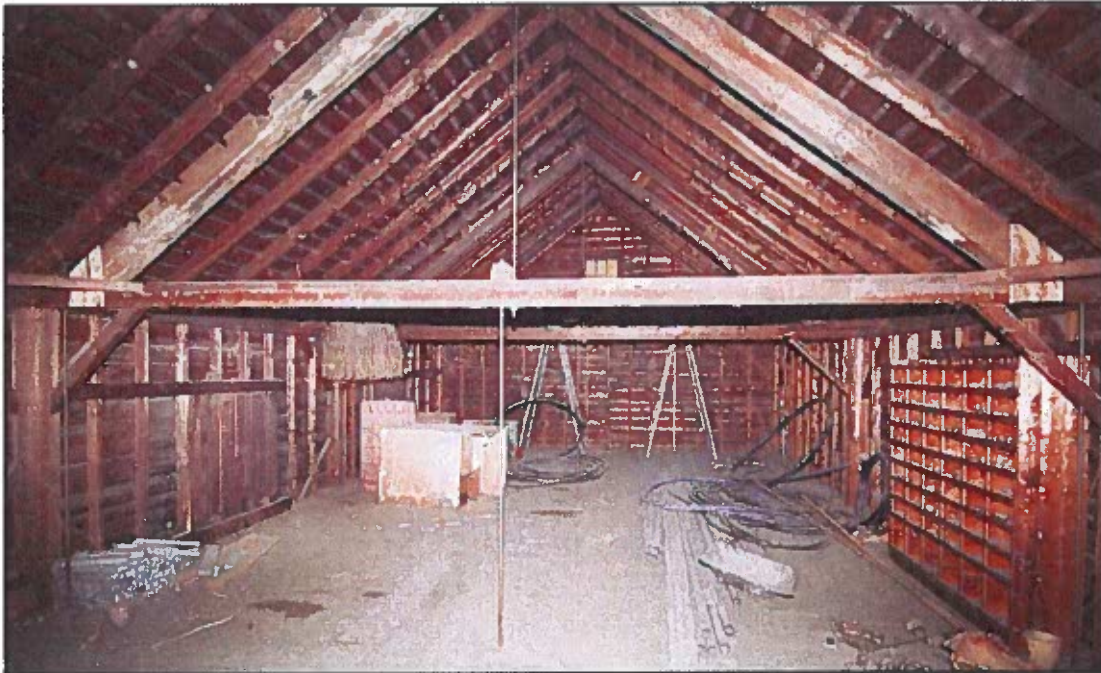
**Photo 66:** Interior of ell barn loft floor showing roof trusses and exposed framing. There is considerable dust and fiber debris on the floor (especially at the side walls) that is a potential fire hazard and should be vacuumed out.

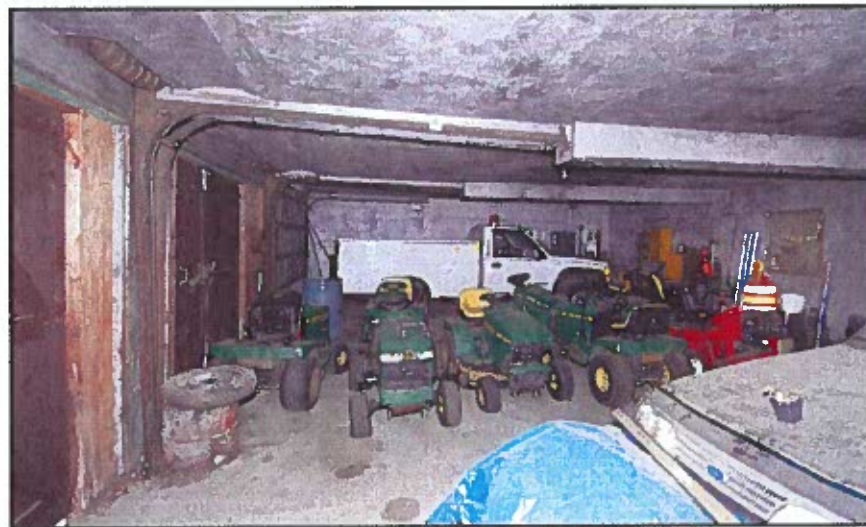
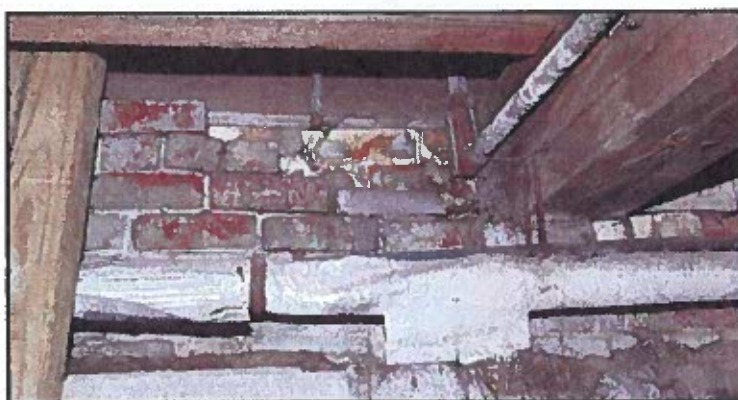
**Photo 68:** Basement of main barn showing obsolete steam pipe with deteriorating insulation that may contain hazardous materials. The insulation should be evaluated by a professional hazardous materials consultant and remediated as directed by the consultant.

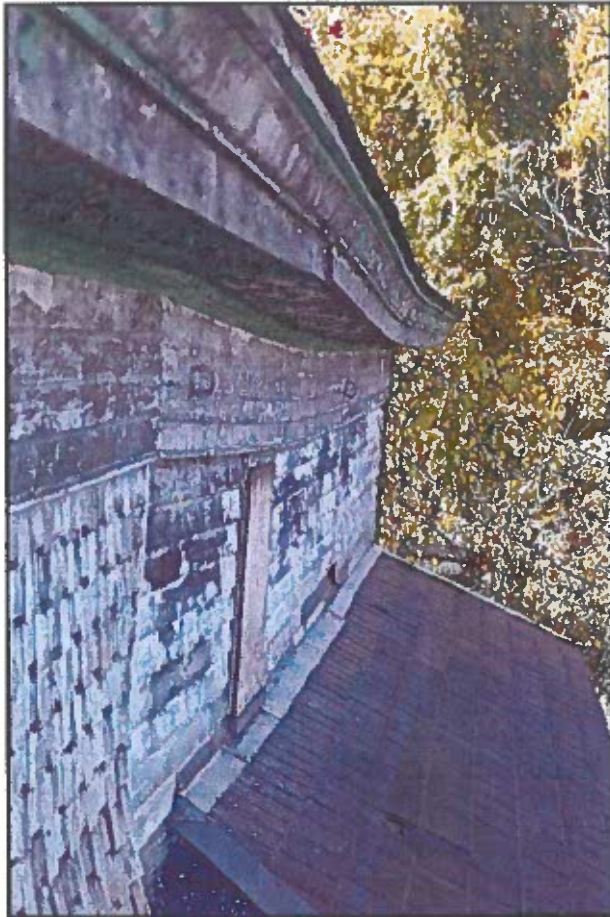
**Photo 69:** North facade of ell barn at loft level showing substantial sag in roof cornice and wall below. The sag does not extend into the first floor below indicating it may have been stabilized when the first floor was rebuilt c. 1930s.

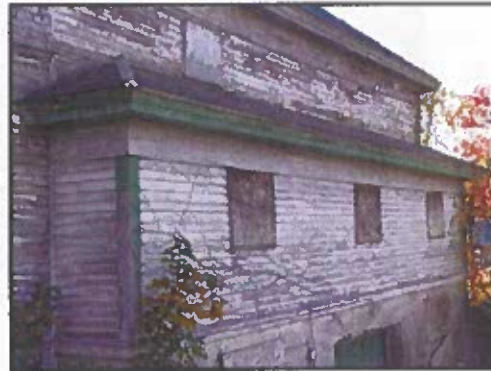
**Photo 70:** Overview of north ell facade showing the c. 1930s extension of the first floor. The extension does not exhibit sag of the loft wall above. However, as a precaution, the condition of sagging of the loft wall should be evaluated by a structural engineer when the basement ceiling is evaluated.

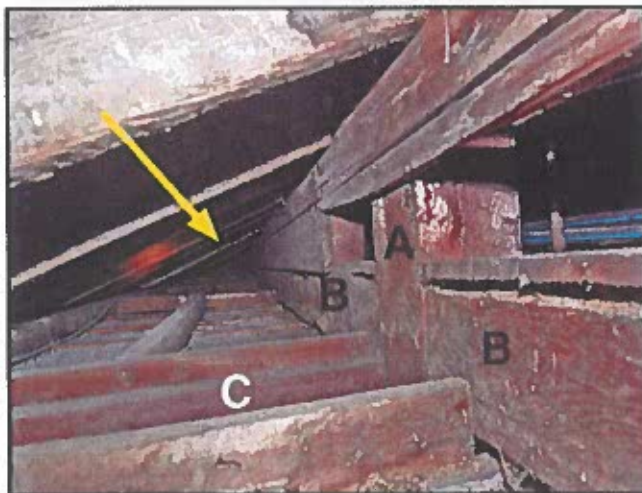
**Photo 71:** View of junction of ell loft wall framing with roof of first floor extension. Elements marked A, B, and C are the same elements marked in photo 72. The arrow indicates where the camera was positioned for photo 72.

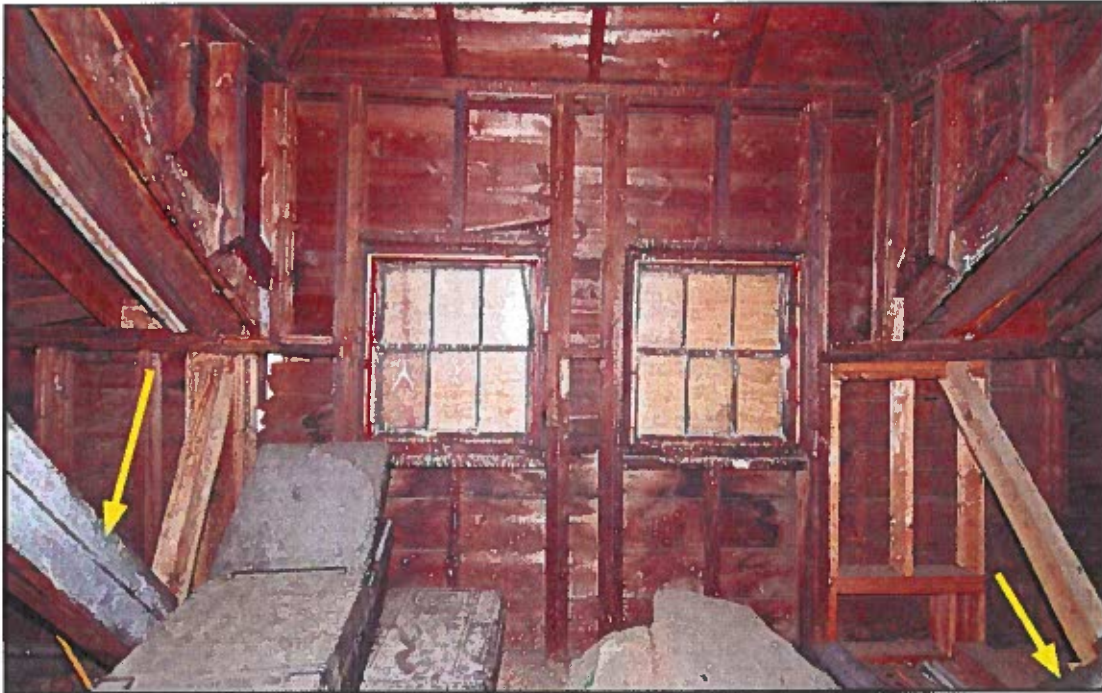
**Photo 73:** Interior of dormer # 4 at east wall of main barn showing past repairs to stabilize framing rotted by former roof leaks. The ends of the upper truss rafter chords (arrows) appear to be rotted completely off where they were originally joined to the floor beams forming bottom truss chords.

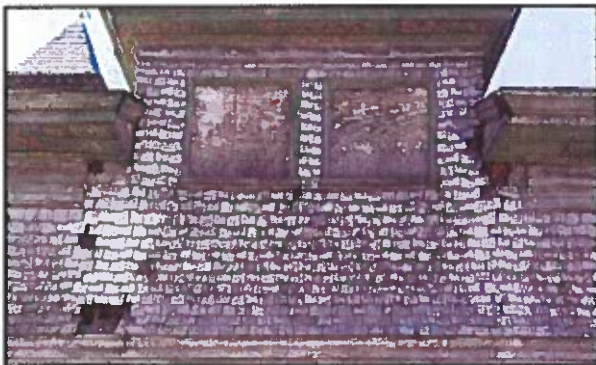
**Photo 74:** Exterior view of east wall at Dormer #4. Rotted truss rafter end was observed thru hole in shingles at belt course.

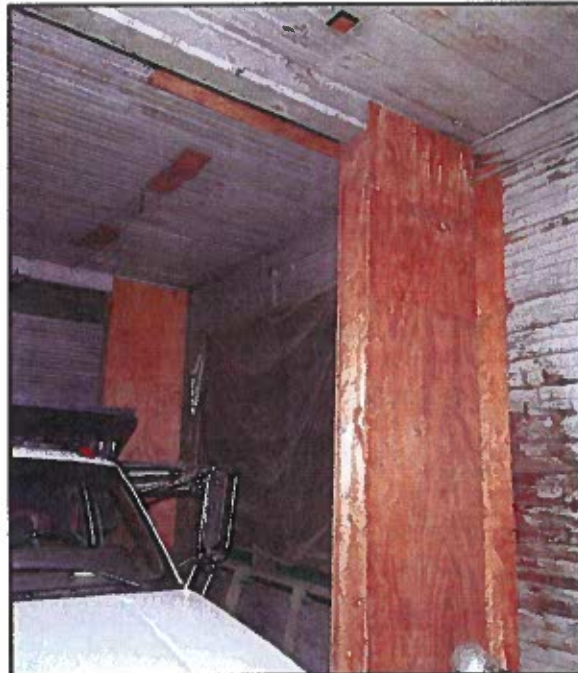
**Photo 75:** Past repair to stabilize rotted ceiling beam end and wall framing at first floor below dormer #4. The long term adequacy of the stabilization repairs should be evaluated by a structural engineer.

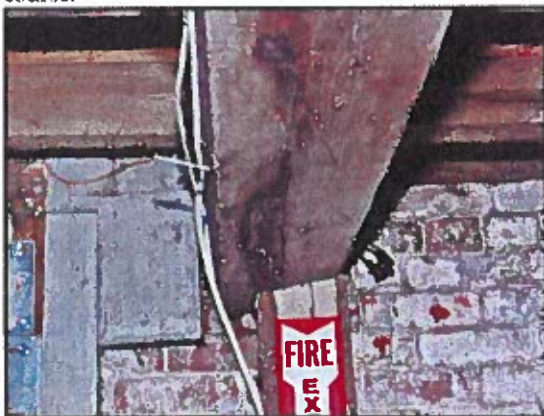
**Photo 76:** Twisted beam in basement directly below repairs shown in photo 75.

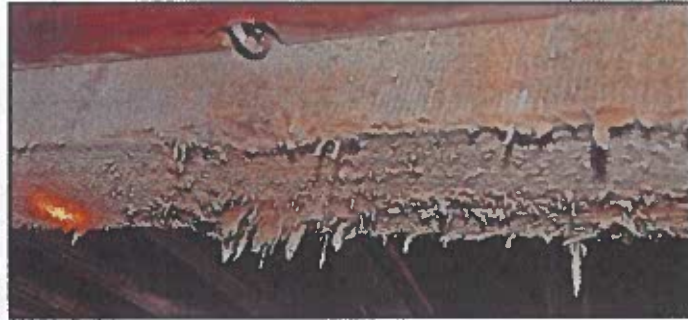
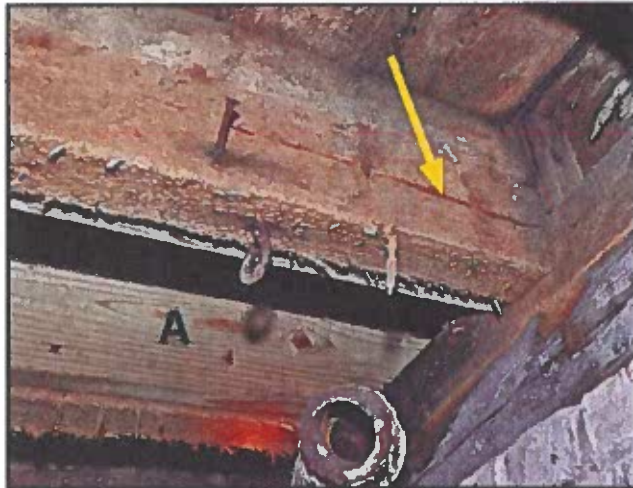
**Photo 78:** Ceiling joist in main barn basement with stress crack (arrow) at wall bearing. This and most other joists have been reinforced with sister joists ("B") to reduce the stress, probably after the cracks were observed.

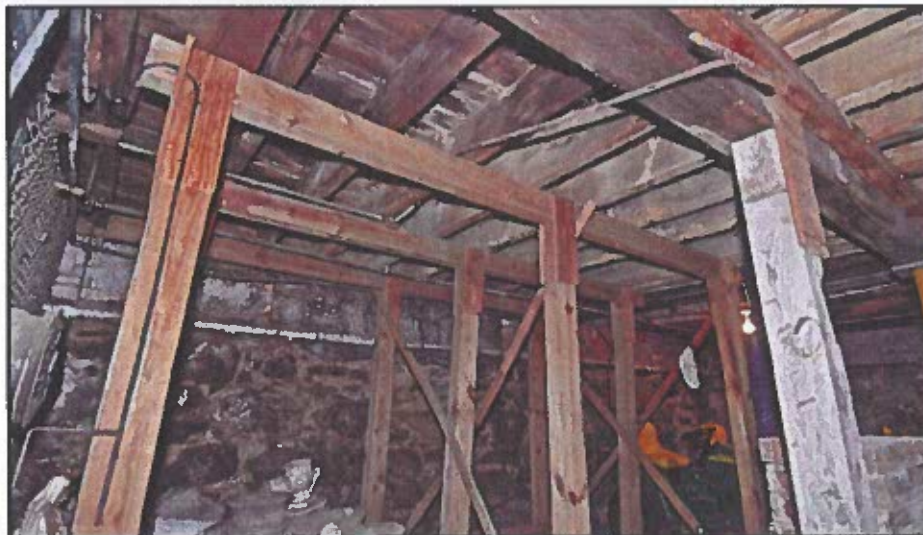
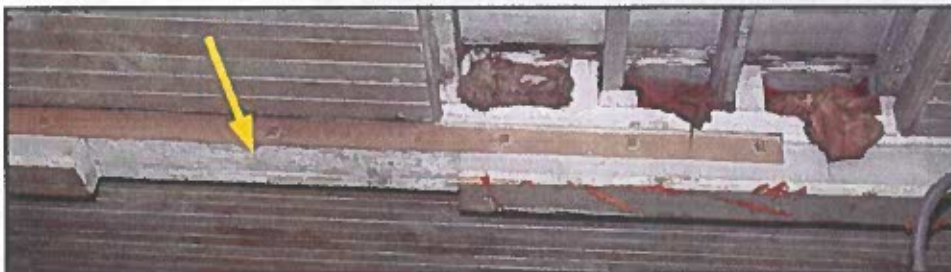
**Photo 80:** Bottom chord of roof truss with section cut out (arrow). The impact of this cut on the loading capacity of the loft floor should be evaluated by a structural engineer.

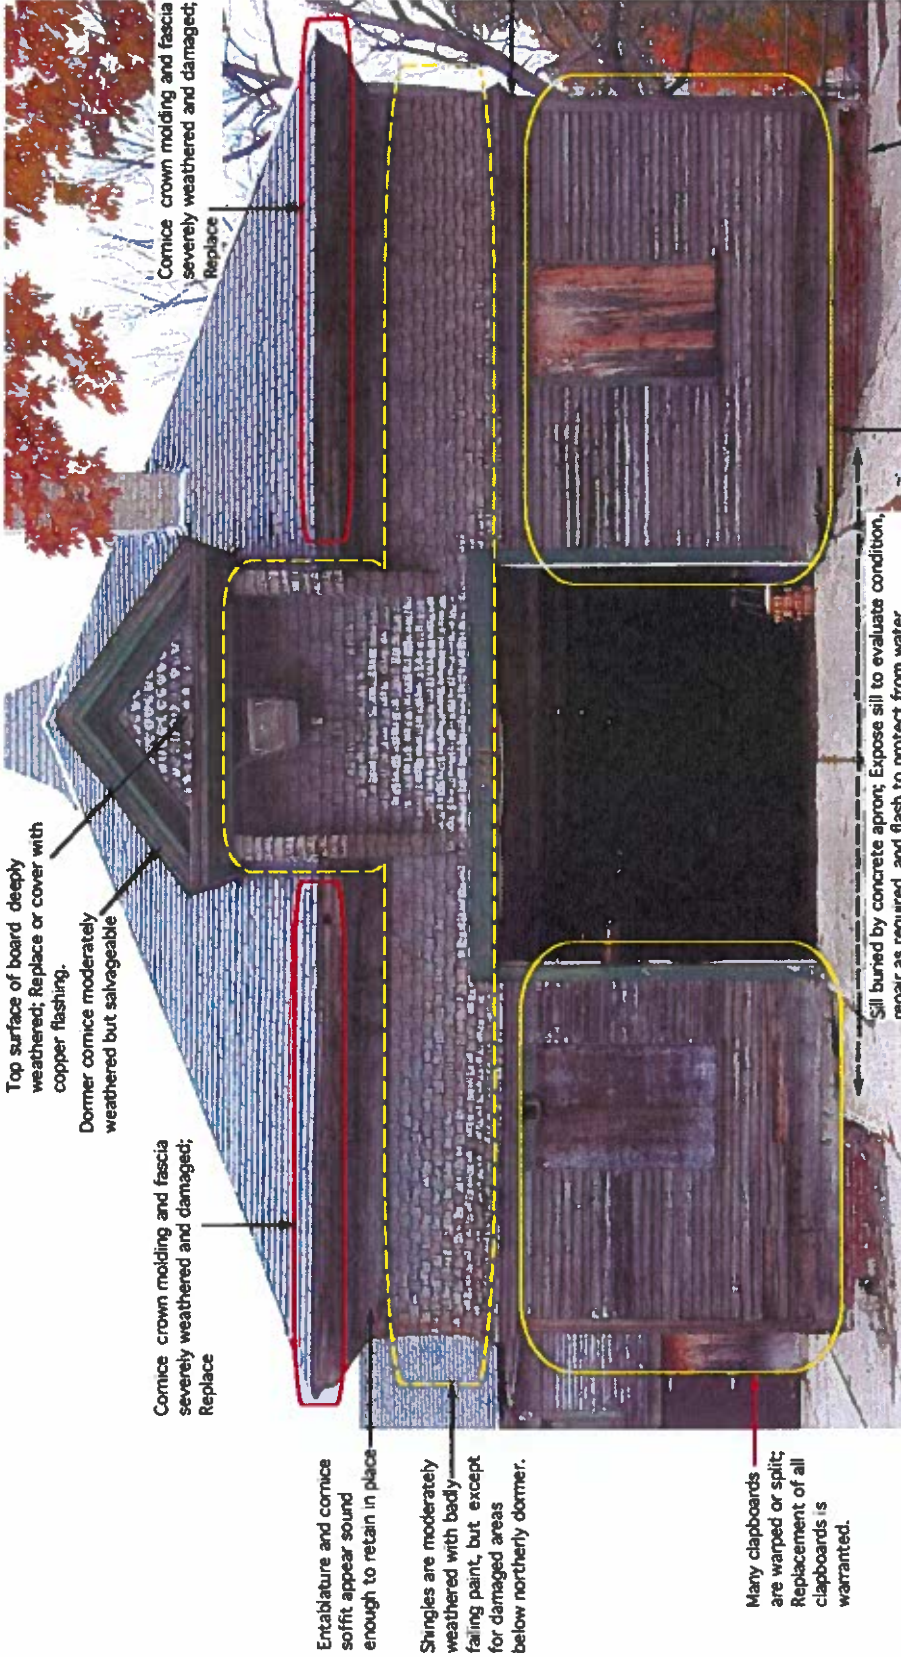
Top surface of board deeply weathered; Replace or cover with copper flashing.

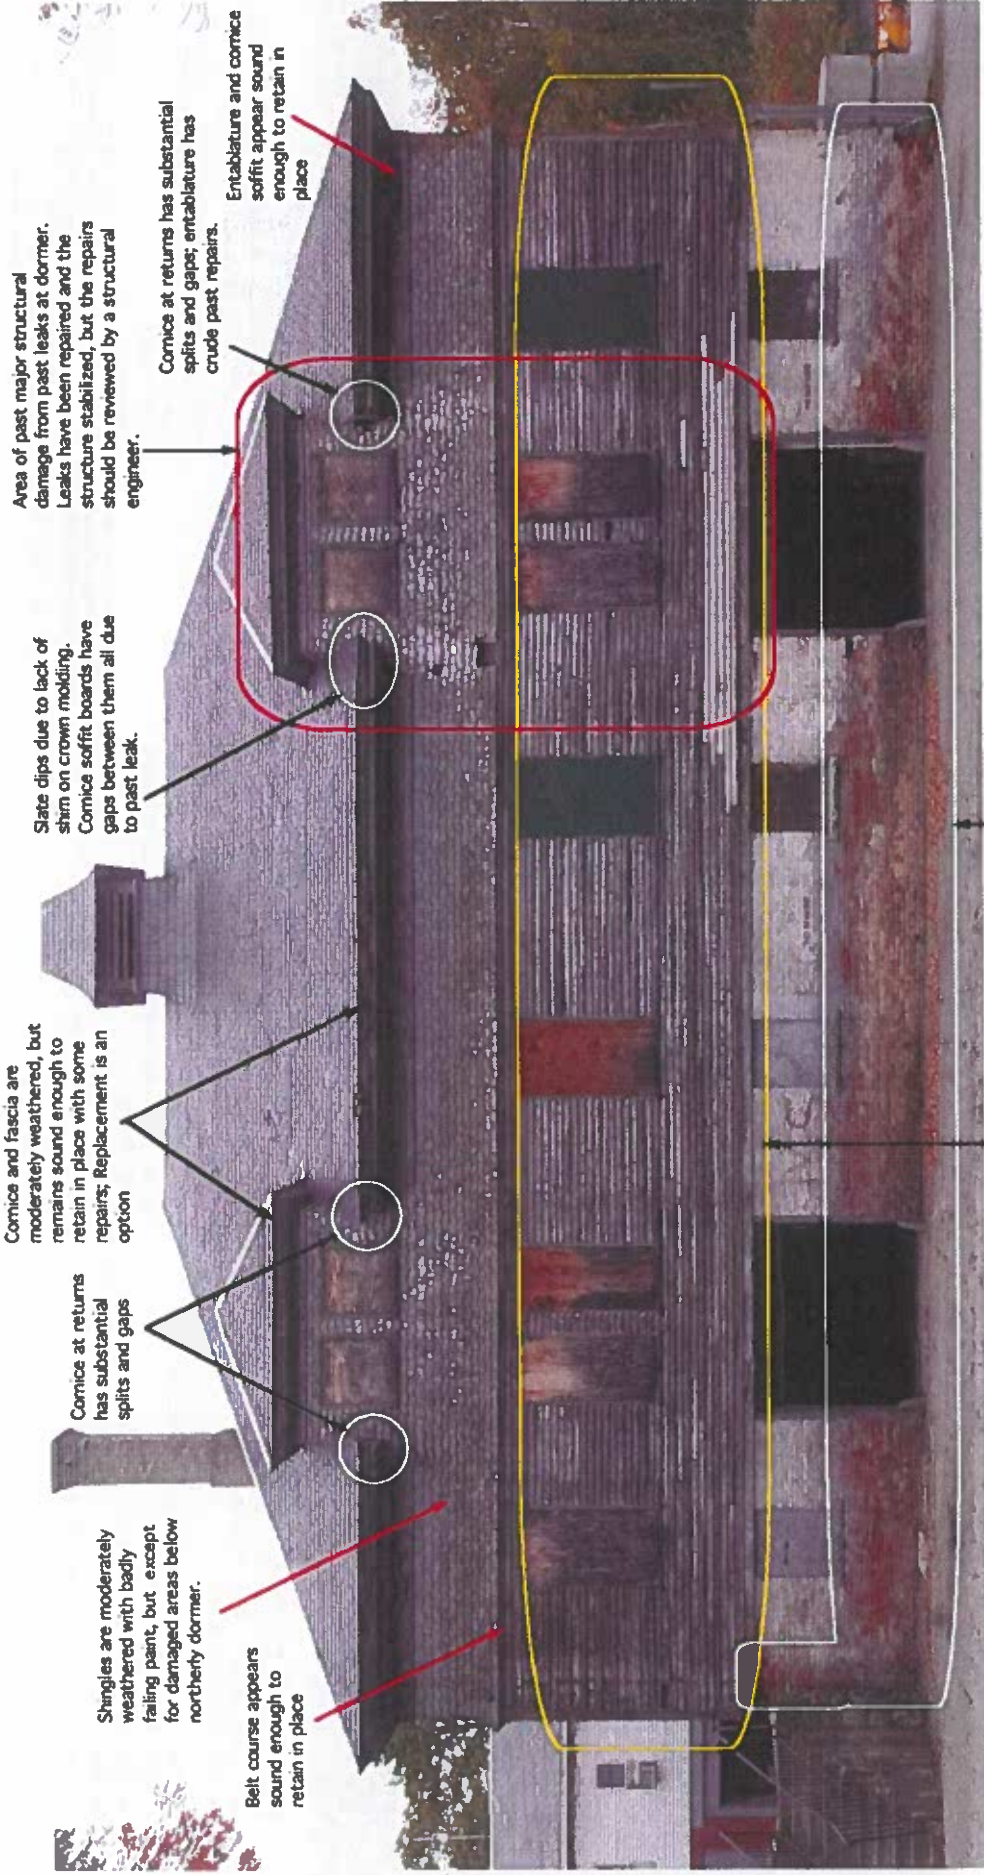
Area of past major structural damage from past leaks at dormer. Leaks have been repaired and the structure stabilized, but the repairs should be reviewed by a structural engineer.

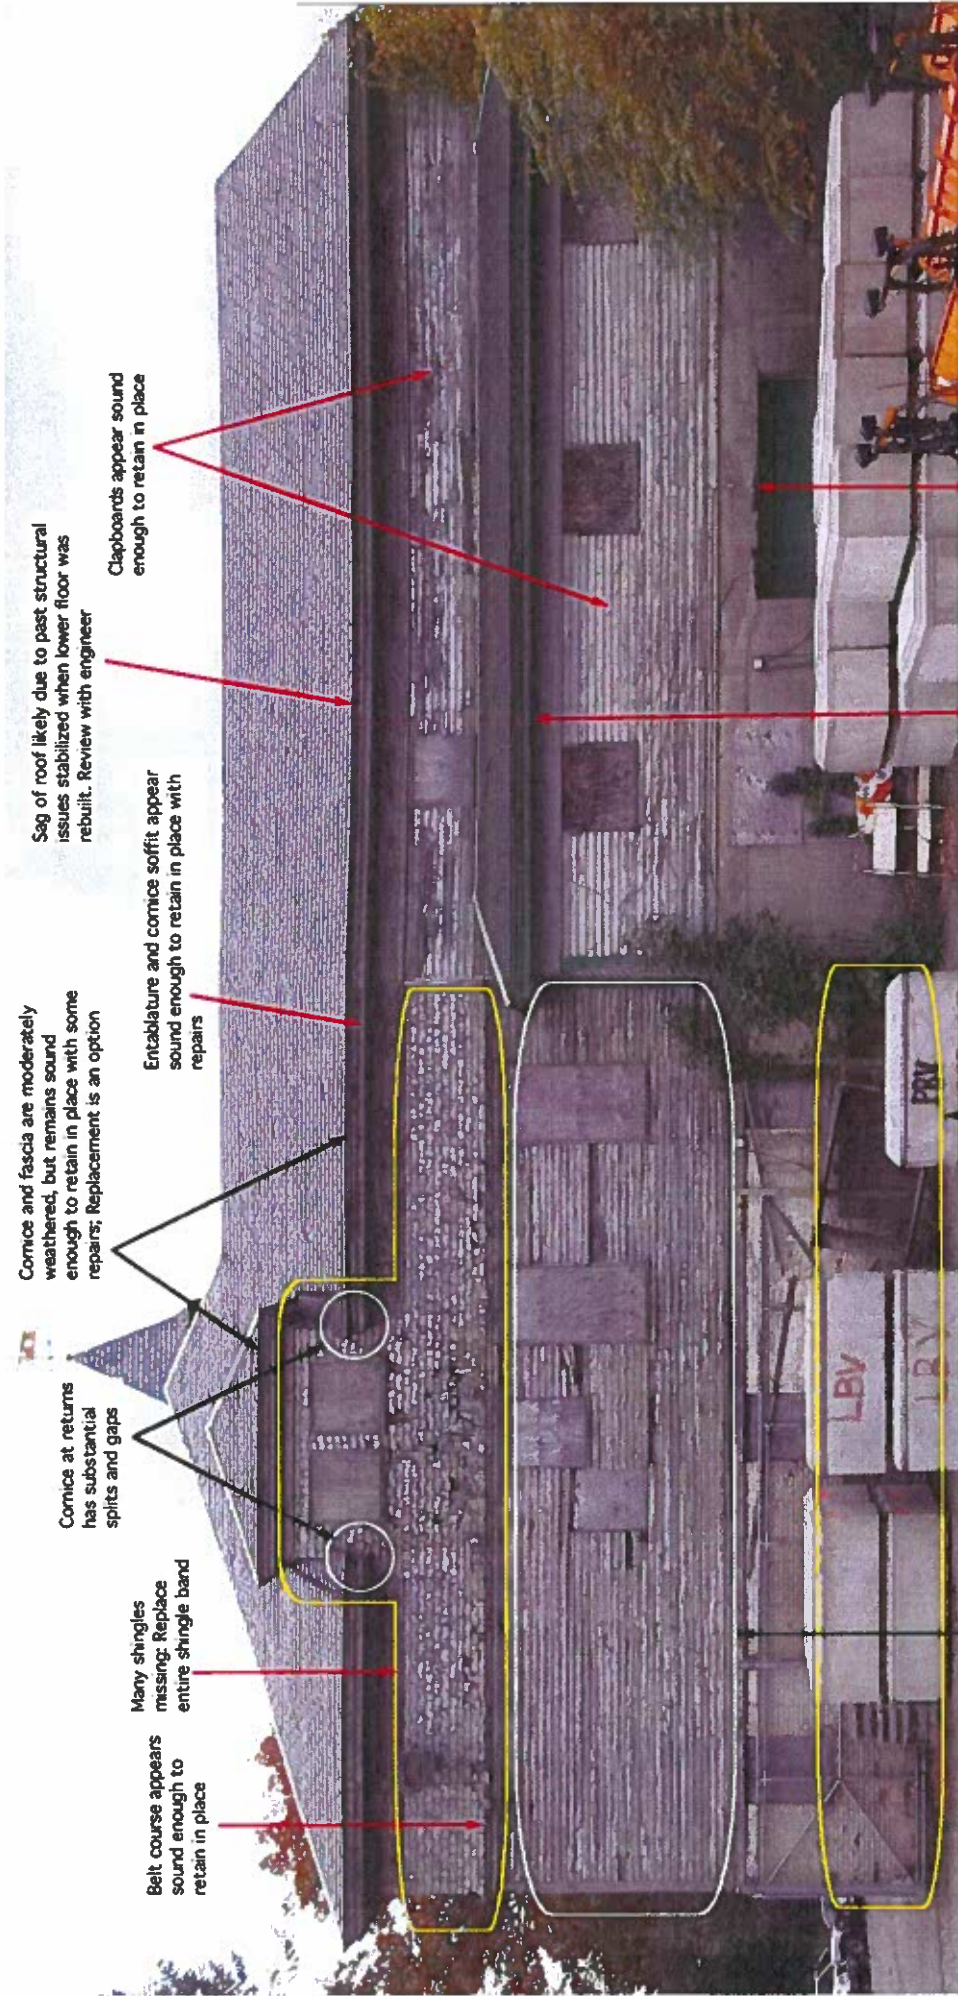
Comice and fascia are moderately weathered, but remains sound enough to retain in place with some repairs; Replacement is an option

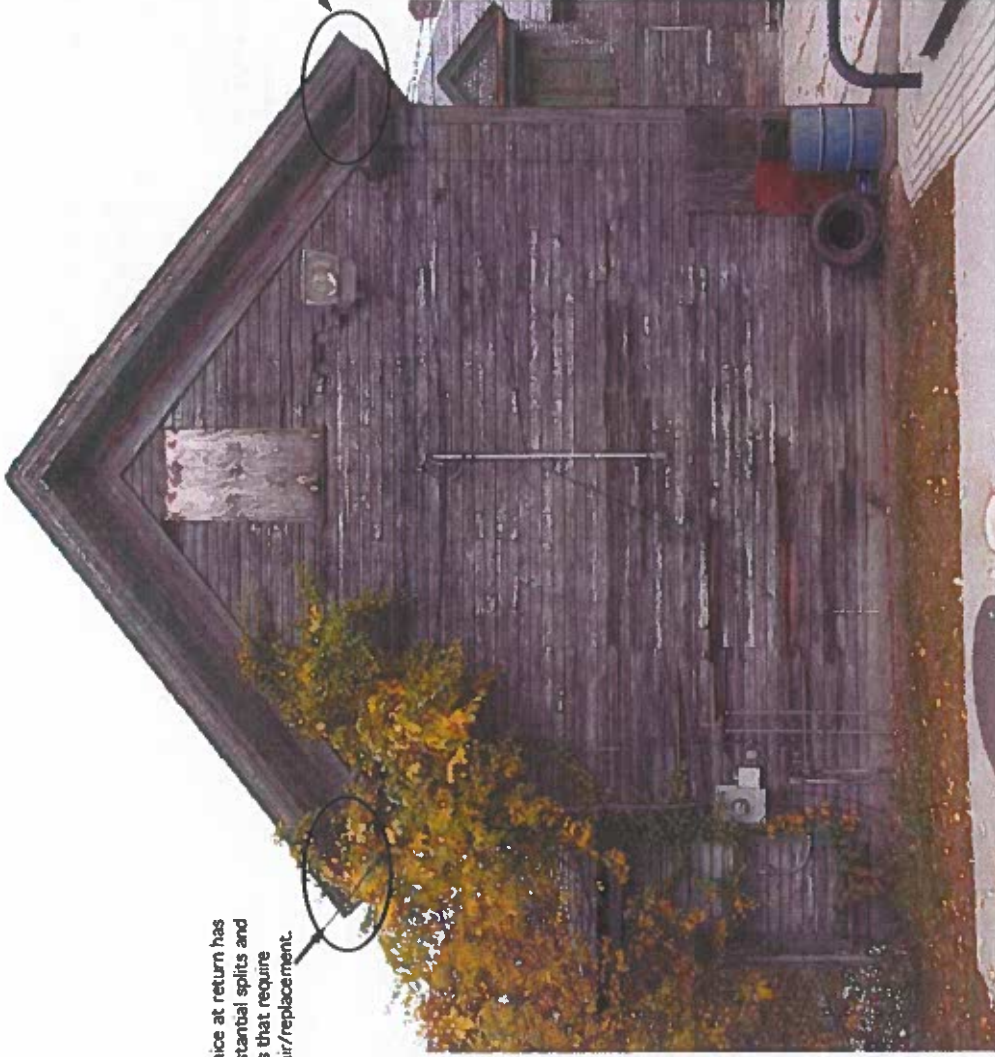
Cornice at return has substantial splits and gaps that require repair/replacement.
