## HOPE CEMETERY COMMISSION MEETING

Monday May 8, 2023 – 4:00 P.M.  
Parks, Recreation & Cemetery Administrative Office  
Meeting Room A  
50 Officer Manny Familia Way Worcester, MA 01605

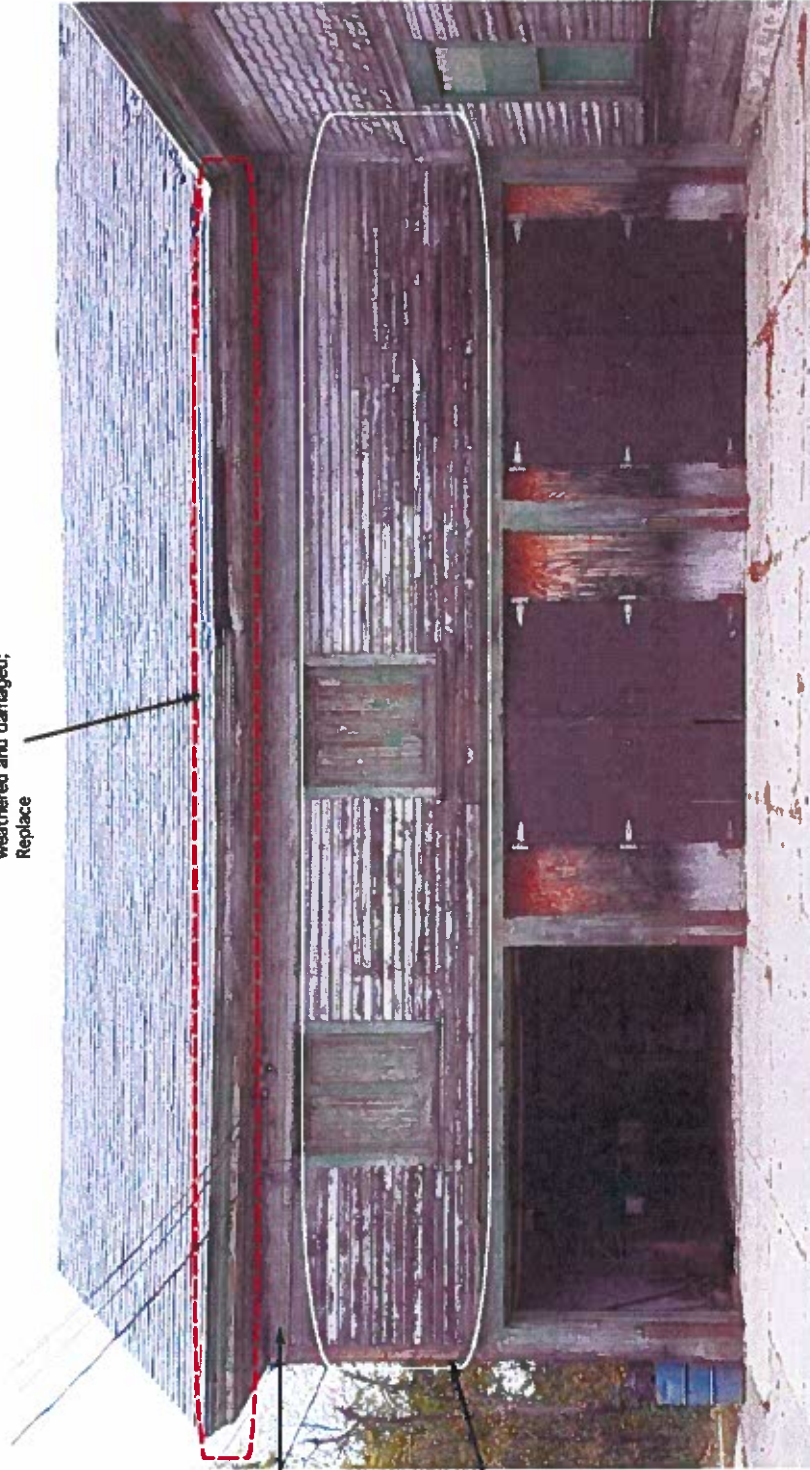
Entablature and cornice  
soffit appear sound  
enough to retain in  
place

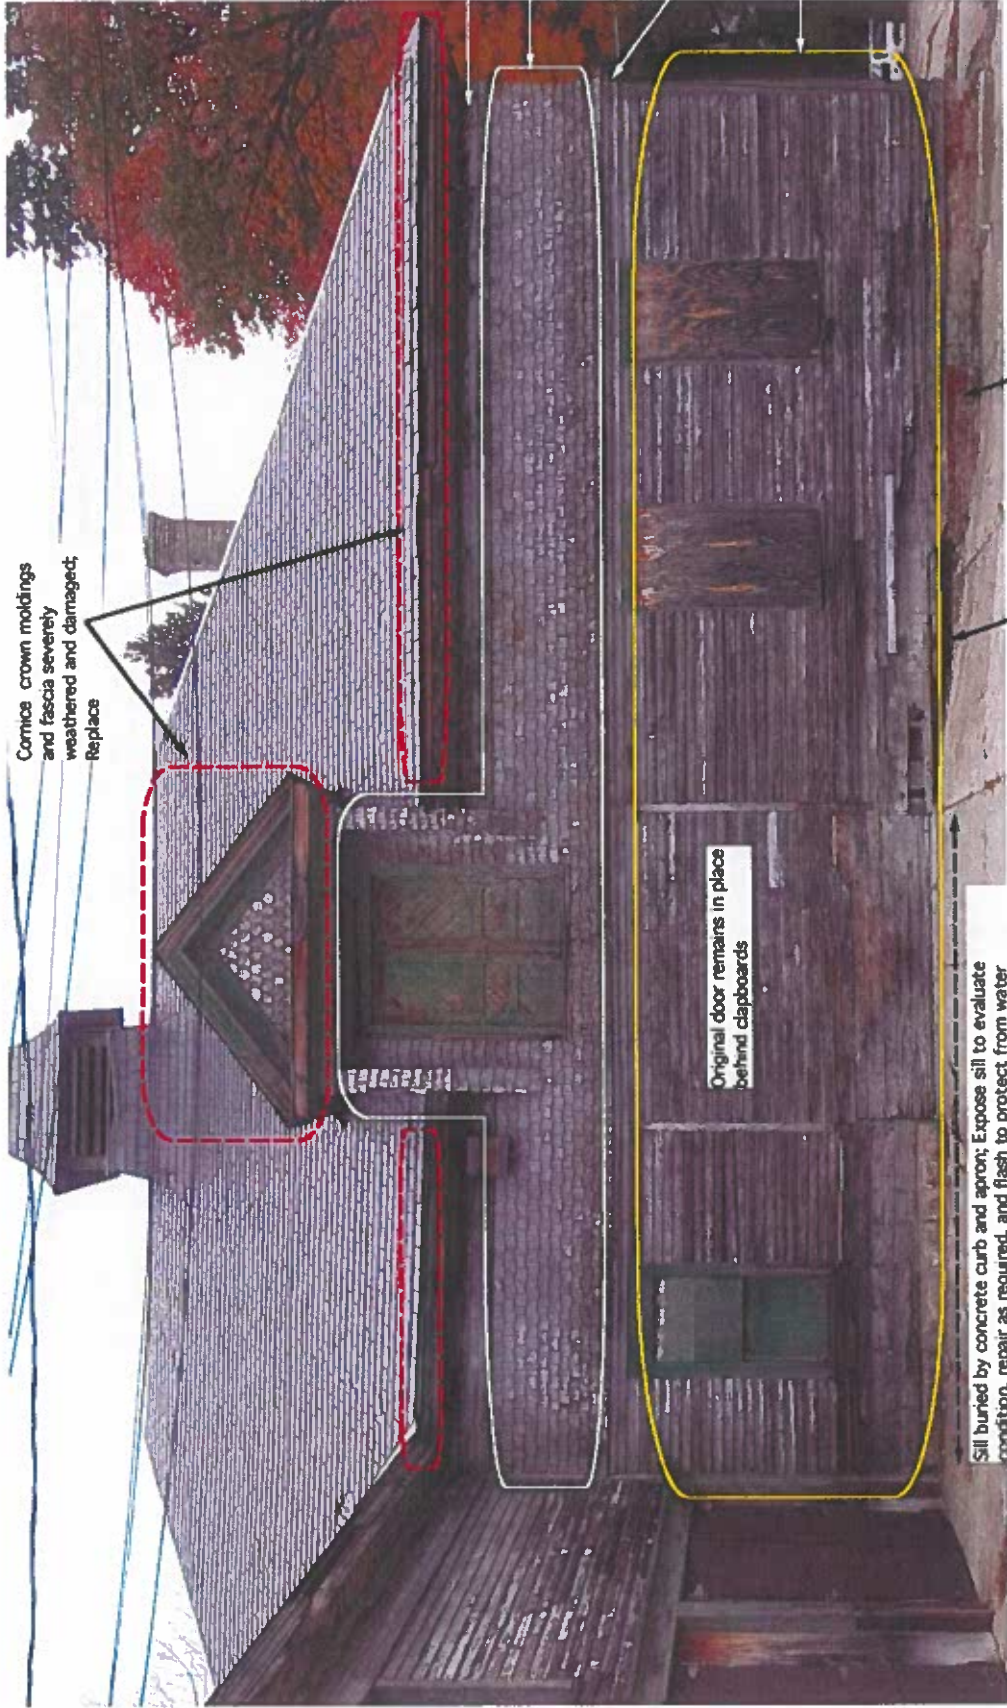
Cornice crown moldings and fascia severely weathered and damaged; Replace

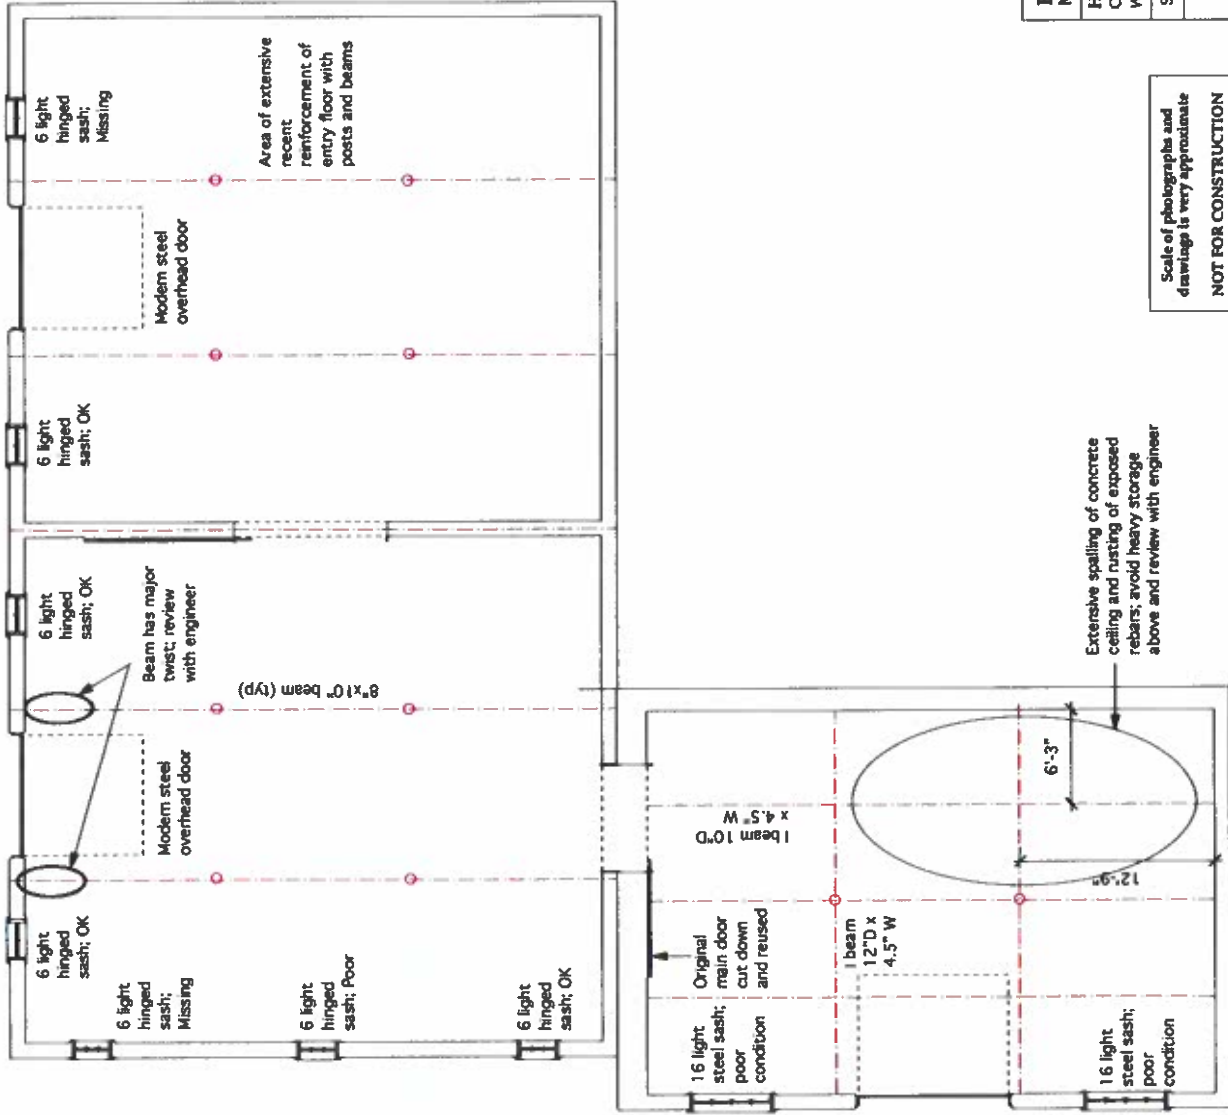
C. 1930 wood overhead door in poor condition; concrete lintel above door spalled with rusting rebar

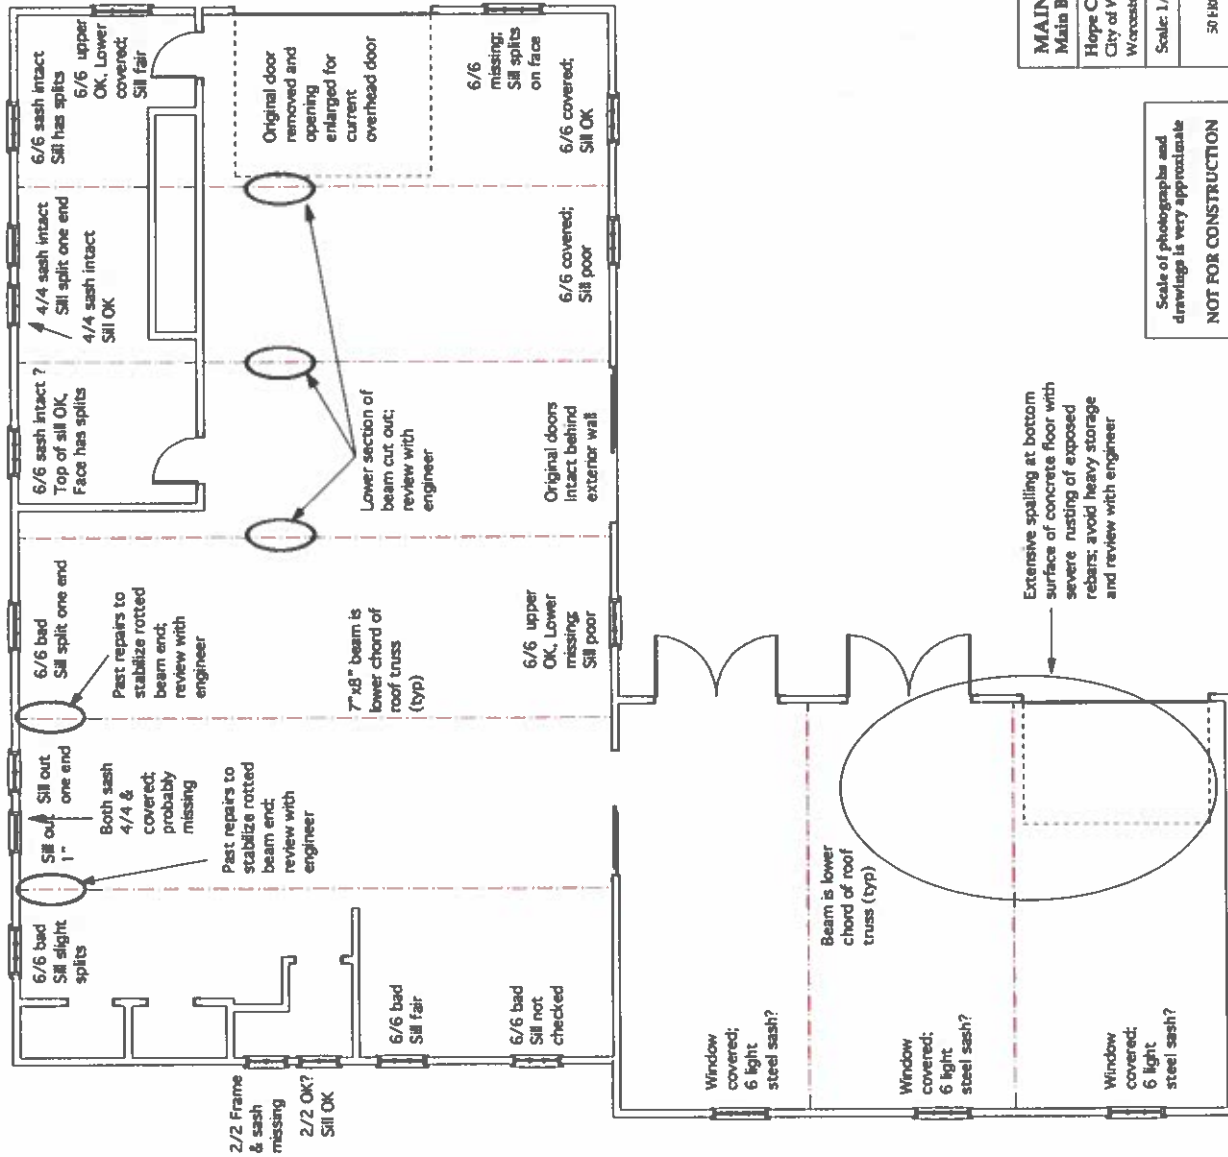
**MAIN FLOOR PLAN** Sheet # 8  
 Main Barn and EII Barn  
 Hope Cemetery Barn Condition Study  
 City of Worcester  
 Worcester, MA  
 Scale: 1/4" = 1'  
 Date: February 10, 2017  
 HNC&ROSE  
 50 FRONT STREET, BEVERLY, MA 01915 • 978-922-4950

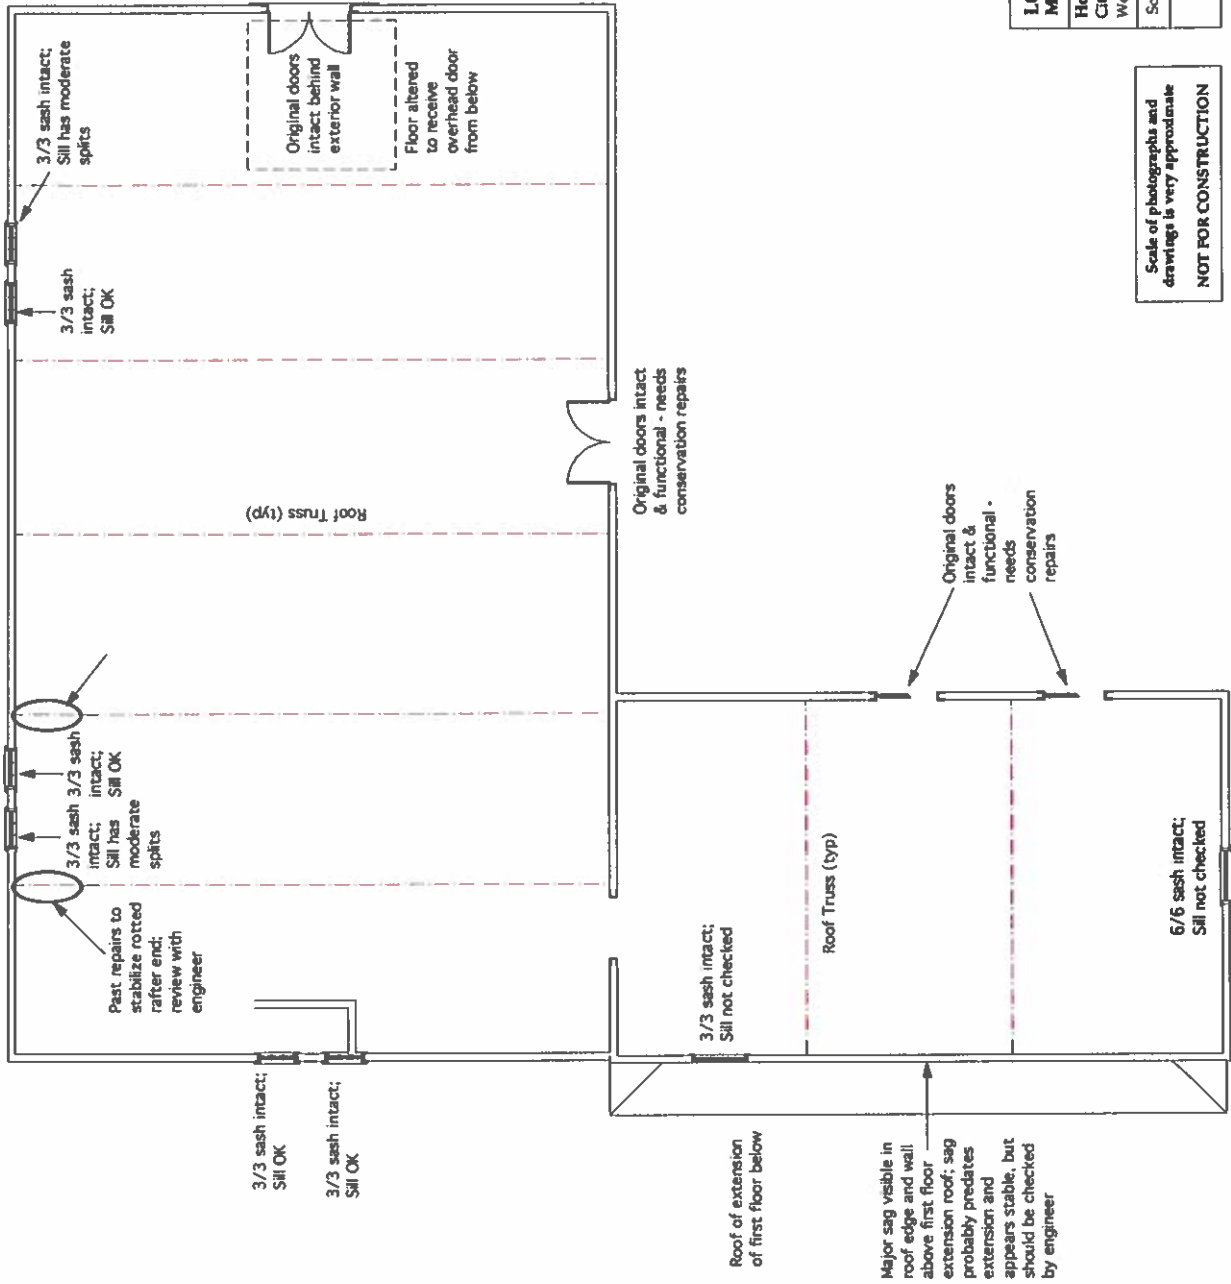
<b>LOFT FLOOR PLAN</b>	<b>Sheet # 9</b>
Main Barn and Ell Barn	
Hope Cemetery Barn Condition Study	
City of Worcester Worcester, MA	
Scale: 1/4" = 1'	Date: February 10, 2007
HINCHE/ROSE 50 HICOM STREET, BEVERLY, MA 01915 • 978-922-4950

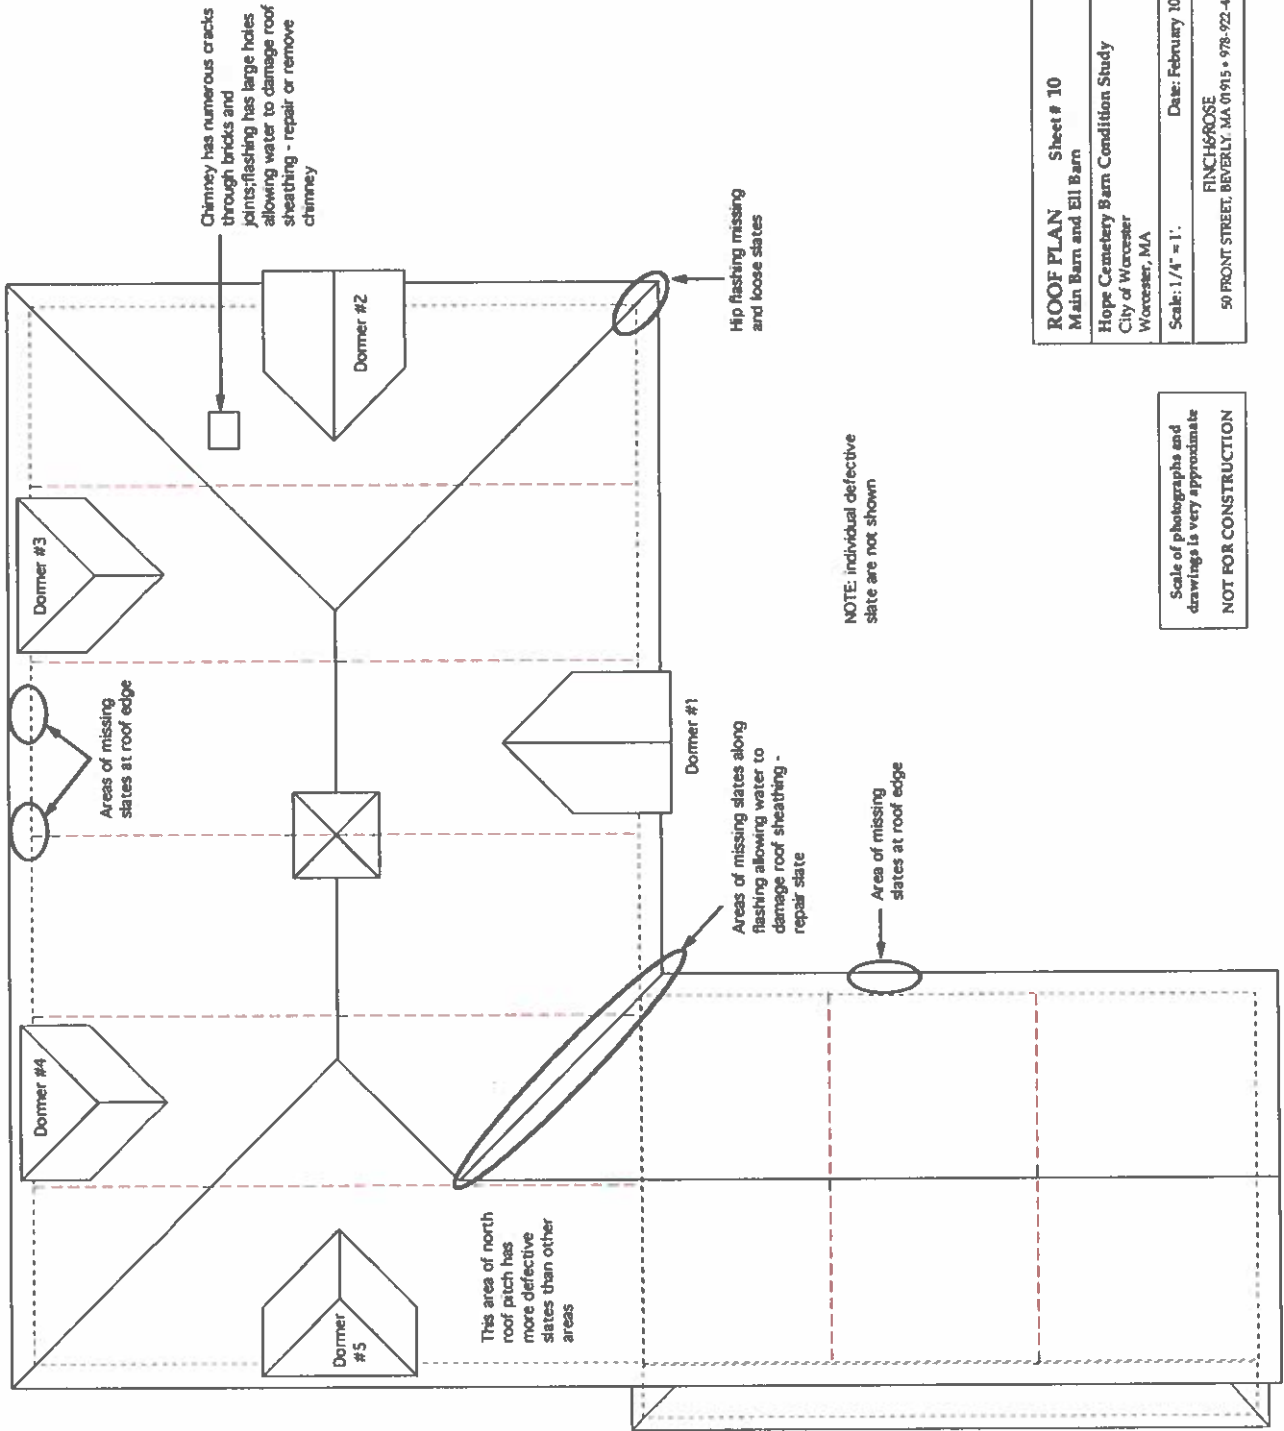
<b>ROOF PLAN</b>	<b>Sheet # 10</b>
Main Barn and Ell Barn	
Hope Cemetery Barn Condition Study	
City of Worcester Worcester, MA	
Scale: 1/4" = 1'	Date: February 10, 2007
FINCH/ROSE	
50 FRONT STREET, BEVERLY, MA 01915 • 978-922-4950
