CONDOMINIUM RESERVE STUDY

Denholm Building

**484 Main Street
Worcester, Massachusetts**

**Subject: Condominium Reserve Study & MEP/LS Report
Denholm Building
484 Main Street, Worcester, Massachusetts
EBI Project #1319000663**

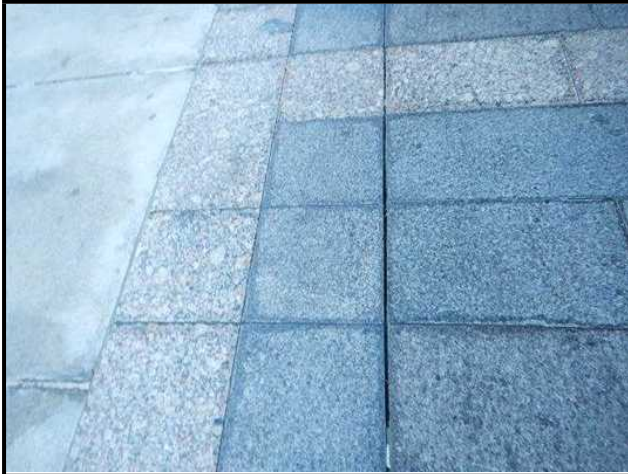
Minor moisture infiltration through the sidewalk paver and stone slabs was observed and reported. Critical Repairs are recommended to reseat the stone slab joints and/or stone paver mortar joints. Based on the observed condition and expected useful life, Capital Needs are recommended for sidewalk repairs during the analysis term.

Washed out mortar at granite pavers	Cracked stone sidewalk at front of building

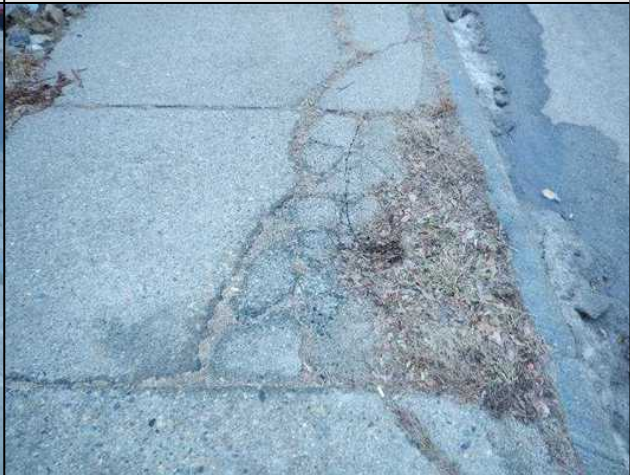
Sidewalk along remote parking lot	Deteriorated sidewalk at remote parking lot

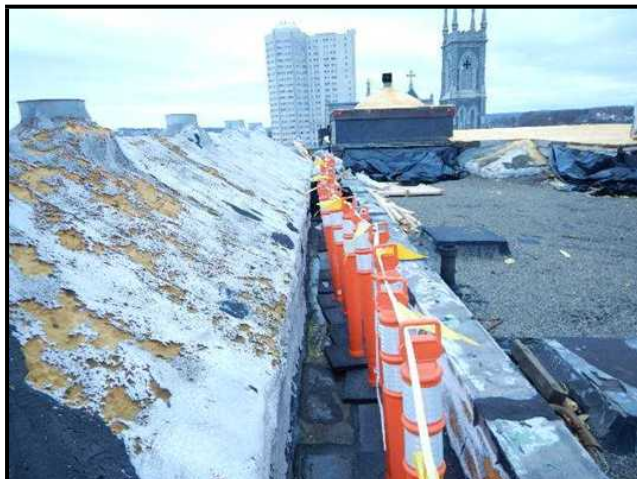
Polyurethane foam roofing showing erosion

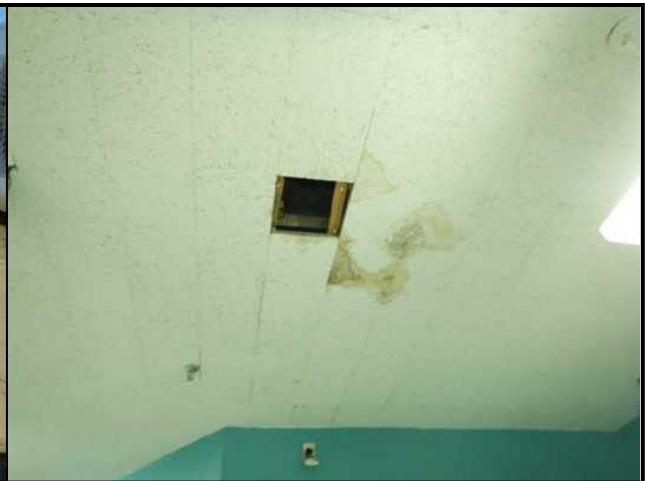
4th floor tenant space roof leak

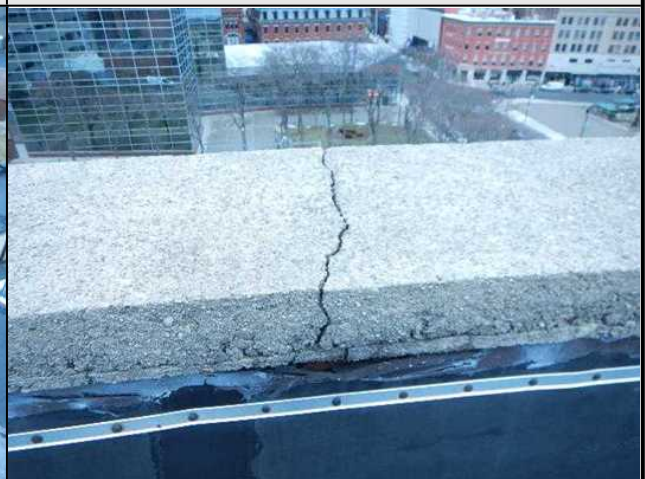
Roof section A/B parapet wall cracked coping

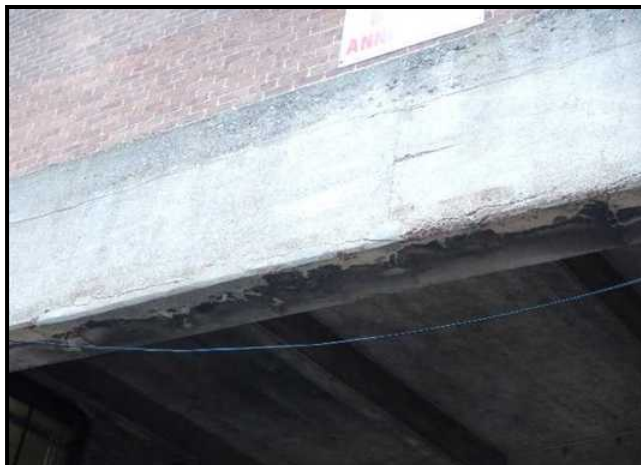
Bottom beam at alleyway bridge southern side showing minor cracking

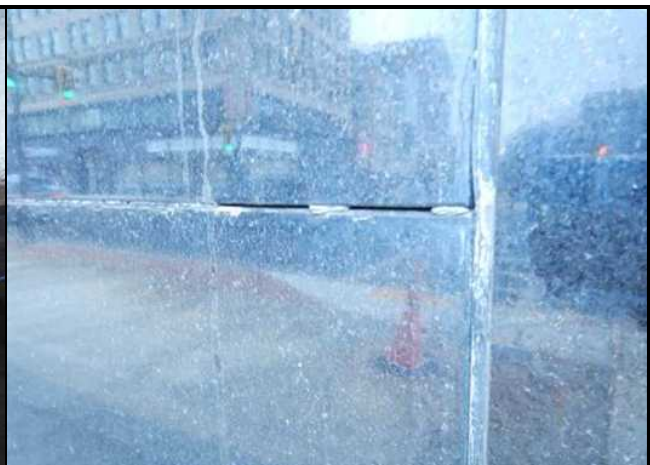
Missing mortar at front of building granite cladding

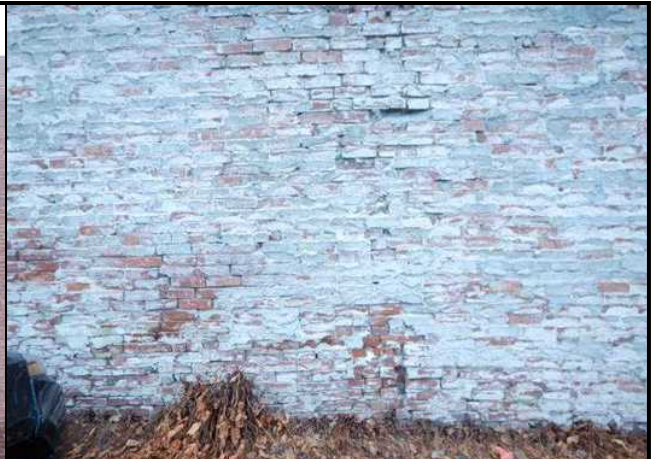
Brick mortar deterioration at southern mural facade

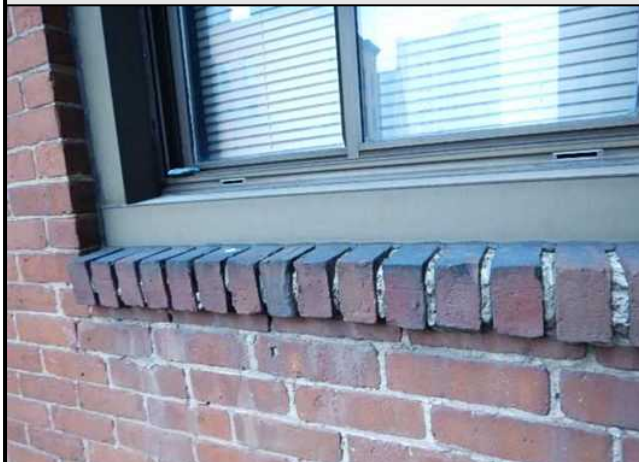
Washed out mortar joints at window sill along northern side

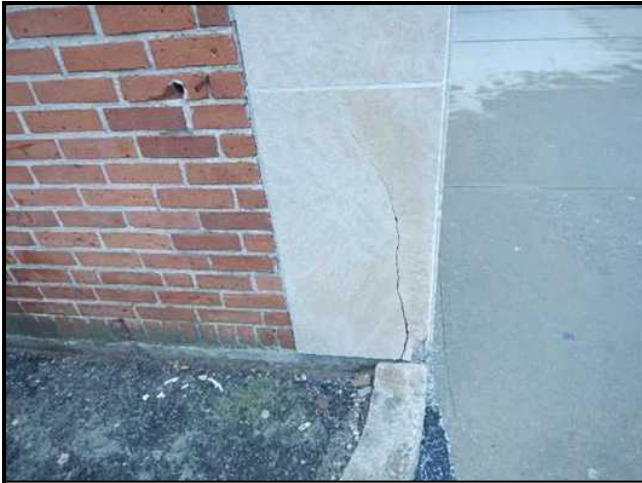
Cracking noted at rear stone facade	Base boiler chimney skirt deterioration

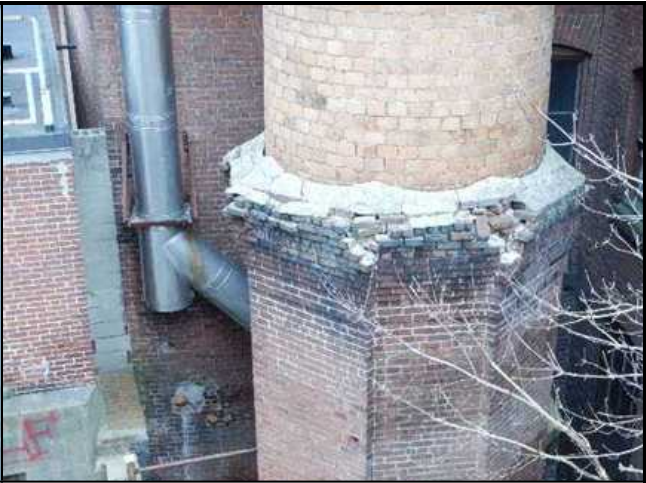
The boiler chimney stack was observed to be in fair to poor condition. The top of the stack exhibited cracking and the base smaller brick skirt is deteriorating. Based on the observed condition, Non-Critical Repairs are recommended for the removal of the masonry boiler chimney.

4.2	Facades	Remove masonry boiler chimney	1	\$4,500.00	20.0%	\$5,400.00	allowance	\$5,400.00			The boiler chimney stack was observed to be in fair to poor condition. The top of the stack exhibited cracking and the base smaller brick skirt is deteriorating.

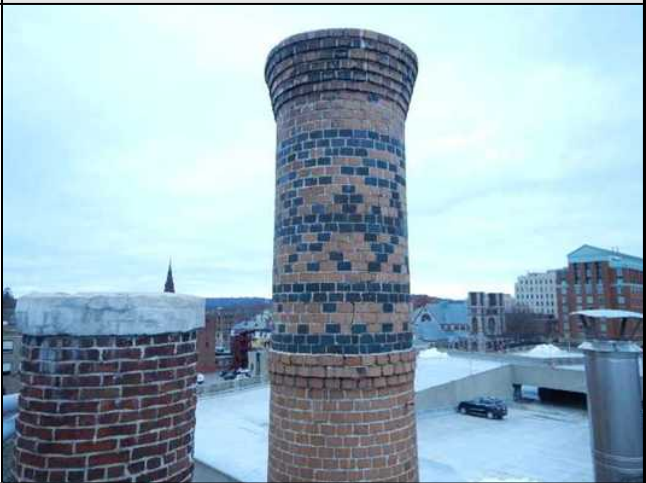
Façade cracking at interior of northern stairwell	Cracking masonry boiler stack at top

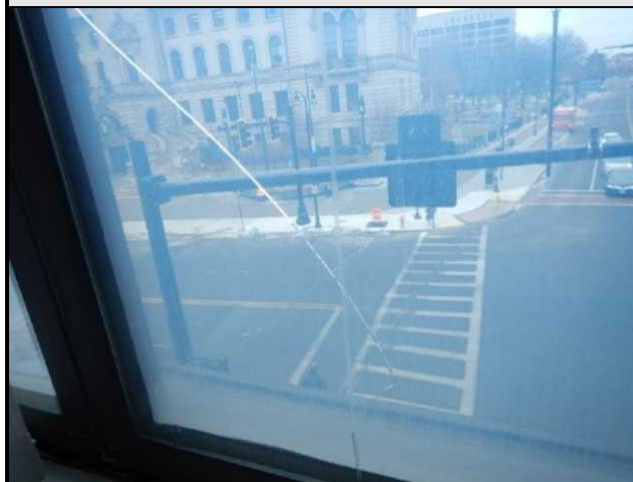
Cracked pane along eastern side of building

4.3	Windows and Doors	Commercial window replacement	14	\$826.50	20.0%	\$991.80	each		✓	\$13,885.20	Ten fogged windows and four cracked insulated panes were observed.

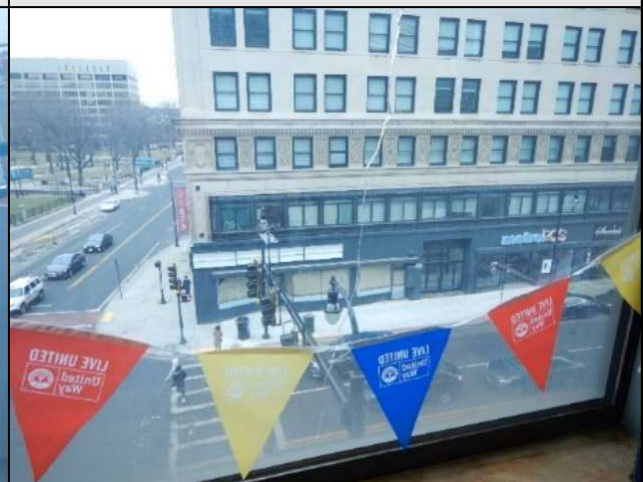
Cracked pane along eastern side of building

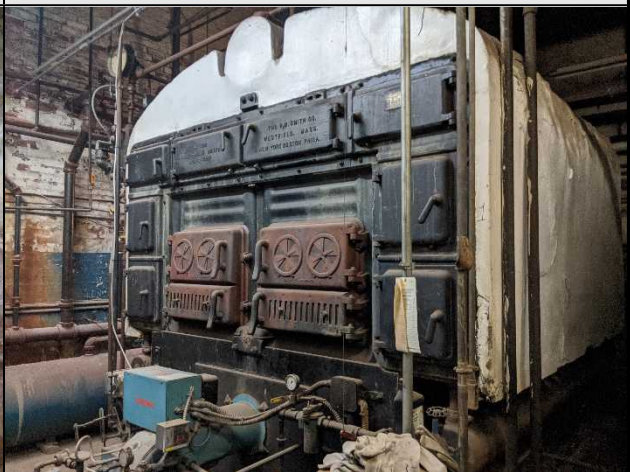
Inoperable Oil-fired boiler

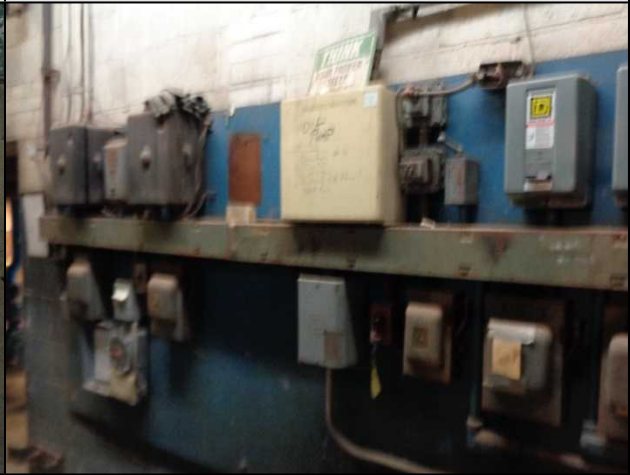
Emergency Generator	Disconnects with hot spots

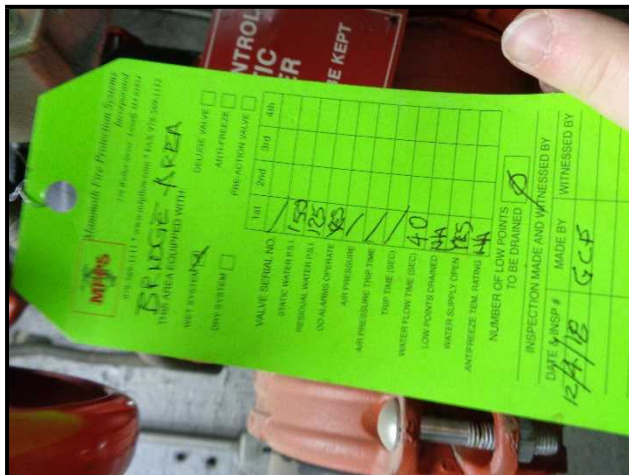
Expired Wet Sprinkler System Inspection
