NWMCC INSPECTION REPORT

Start date/time: 20200624 12:43		Weather: Dry - No precipitation during survey		Surveyed by: B.GROM		Certificate number: 1234		Pipe segment ref.: SM14609	
Owner:		Customer:		Pre-cleaning: No Pre-Cleaning		Date cleaned:		Project name: WEST05-65	
City: WORCESTER ,MA		Street: GARRISON AVE		Location code: Easement/Right of way		Pipe use: Sanitary Sewage Pipe		Drainage area: Not Controlled	
Upstream MH No: SS06394		Downstream MH No: SS06395		Direction: U		Total length: 37.300 ft.		Length surveyed: 37.300 ft.	
Purpose: Maintenance Related		Pipe joint length:		Height: 8 in.		Material: Vitrified Clay Pipe		LateralsCounter: 	
						Additional info:

Inspection Report

Date 6/4/2019	P/O. No.	Weather Dry	Surveyor's Name BRIAN GROM	Pipe Segment Reference SM11769	Section No. 1
Certificate No. U-0218030700746	Survey Customer	System Owner	Date Cleaned 6/4/2019	Pre-Cleaning No Pre-Cleaning	Sewer Category

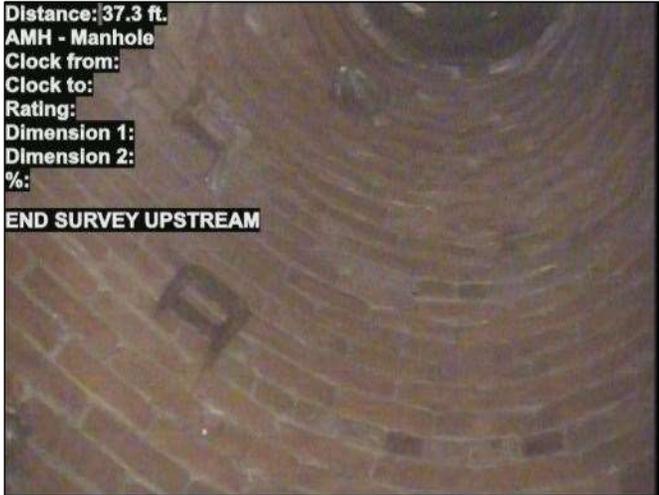
Photo: **SS06394-SS06395-20200624-124326-124800.JPG**

At: **37.3 ft. AMH - Manhole**

Joint: **No END SURVEY UPSTREAM**

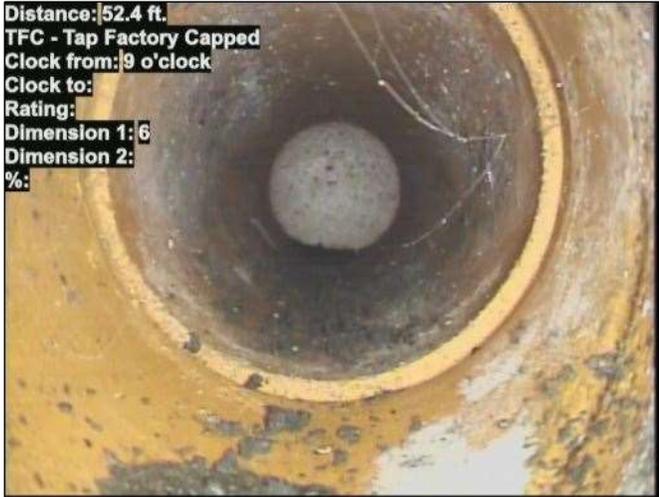
Photo: SS06798-SS06395-20200624-133846-134357.JPG
At: 52.4 ft. 9/. TFC - Tap Factory Capped
Joint: Yes

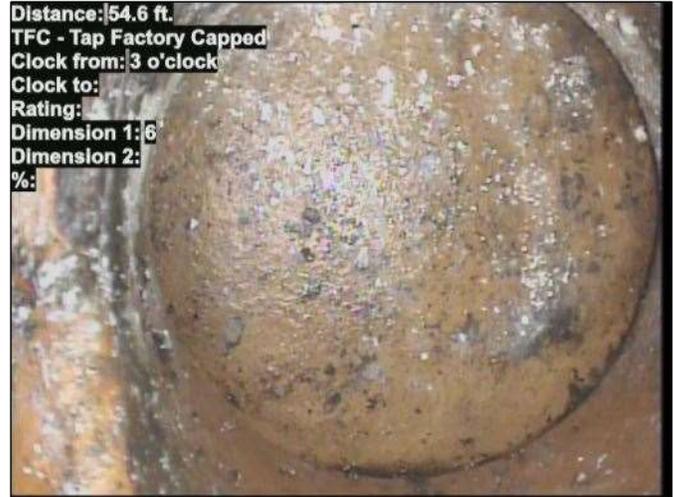
Photo: SS06798-SS06395-20200624-133846-134418.JPG
At: 54.6 ft. 3/. TFC - Tap Factory Capped
Joint: Yes

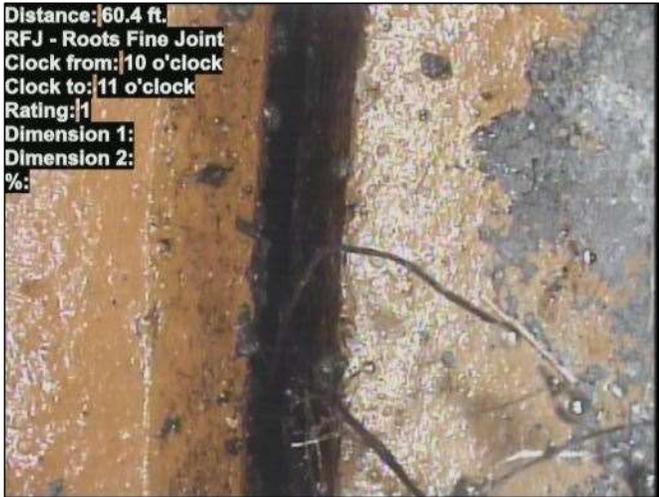
Photo: SS06798-SS06395-20200624-133846-134454.JPG
At: 60.4 ft. RFJ - Roots Fine Joint
10/11
Joint: Yes

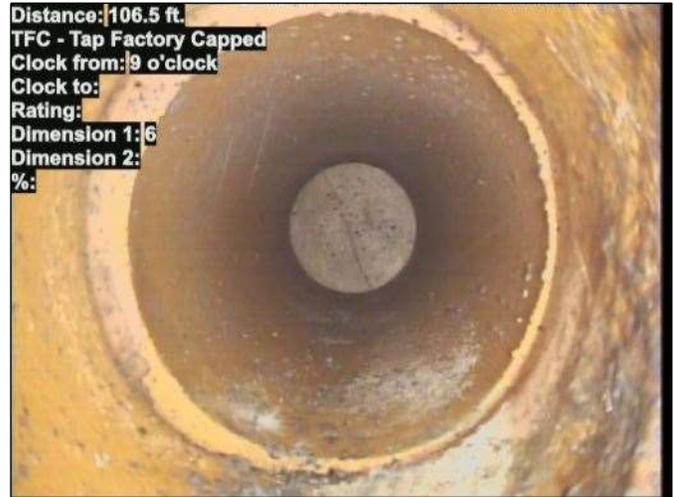
Photo: SS06798-SS06395-20200624-133846-135858.JPG
At: 106.5 ft. 9/. TFC - Tap Factory Capped
Joint: Yes

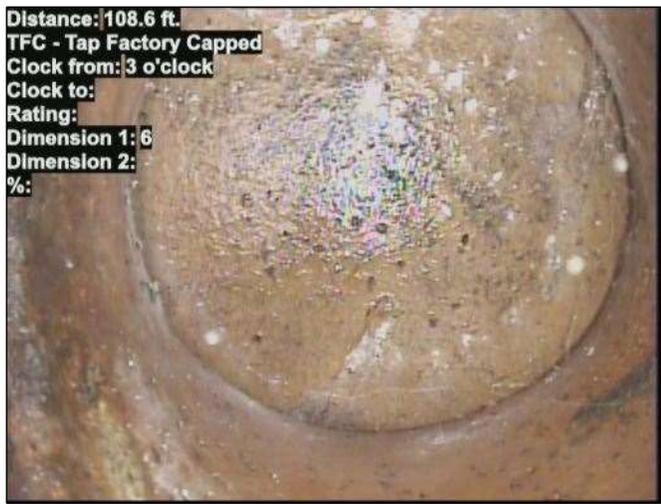
Distance: 108.6 ft.
TFC - Tap Factory Capped
Clock from: 3 o'clock
Clock to:
Rating:
Dimension 1: 6
Dimension 2:
%:

Photo: SS06798-SS06395-20200624-133846-135923.JPG
At: 108.6 ft. 3/. TFC - Tap Factory Capped
Joint: Yes

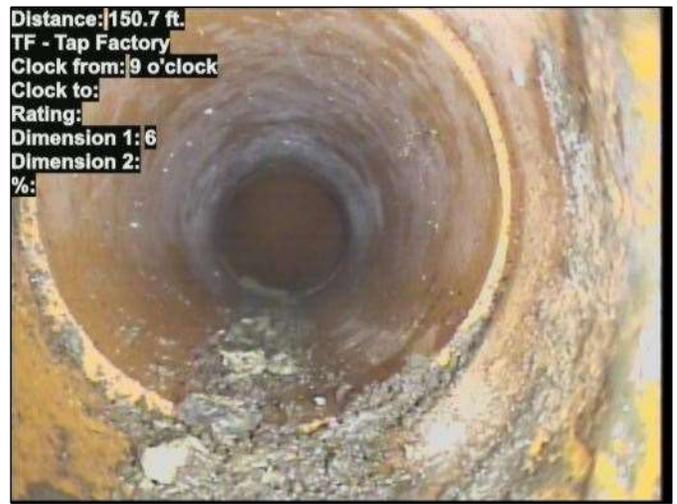
Distance: 150.7 ft.
TF - Tap Factory
Clock from: 9 o'clock
Clock to:
Rating:
Dimension 1: 6
Dimension 2:
%:

Photo: SS06798-SS06395-20200624-133846-140257.JPG
At: 150.7 ft. 9/. TF - Tap Factory
Joint: Yes

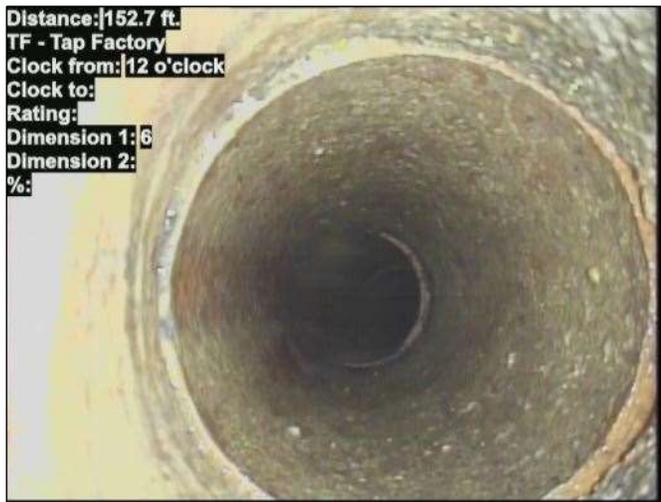
Distance: 152.7 ft.
TF - Tap Factory
Clock from: 12 o'clock
Clock to:
Rating:
Dimension 1: 6
Dimension 2:
%:

Photo: SS06798-SS06395-20200624-133846-140330.JPG
At: 152.7 ft. 12/. TF - Tap Factory
Joint: Yes

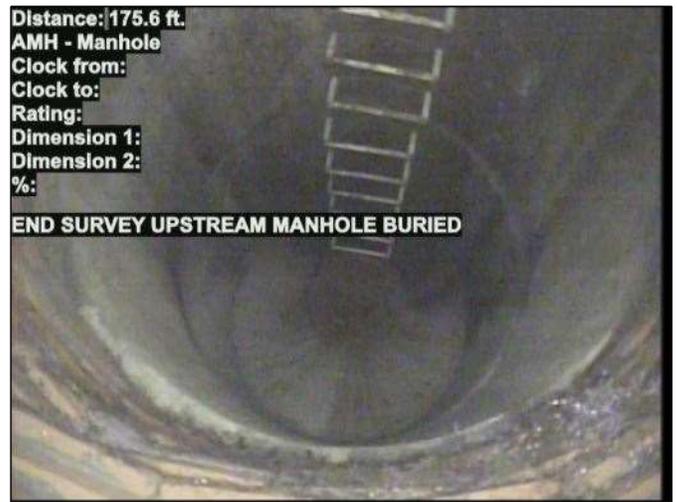
Distance: 175.6 ft.
AMH - Manhole
Clock from:
Clock to:
Rating:
Dimension 1:
Dimension 2:
%:

Photo: SS06798-SS06395-20200624-133846-140536.JPG
At: 175.6 ft. AMH - Manhole
Joint: No END SURVEY UPSTREAM MANHOLE BURIED

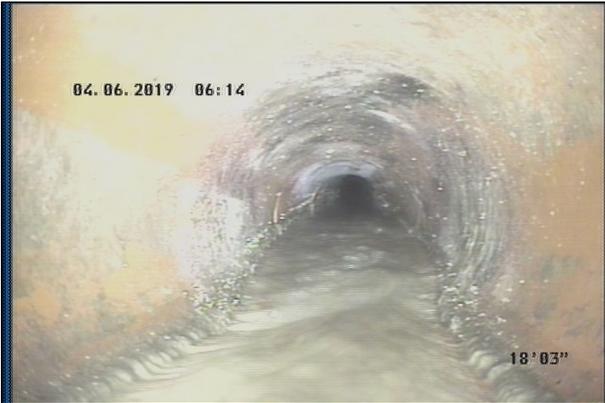
Photo:
SS14204-SS02754_04062019_DAGS_18.2139_072242_A.JPG
18.21FT, Deposits Attached Grease, 5 %of cross sectional area, from 04 to 08 o'clock, , within 8 inches of joint: YES, Start

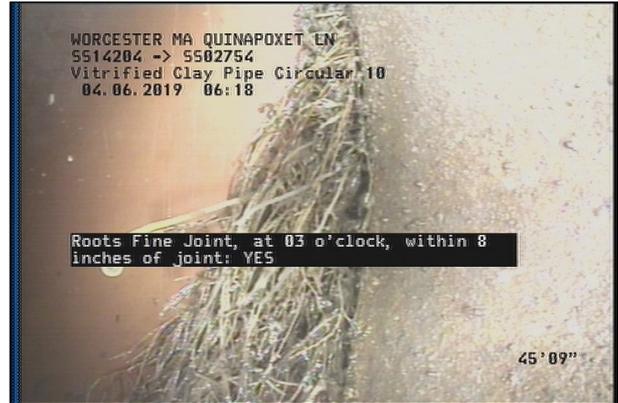
Photo:
SS14204-SS02754_04062019_RFJ_45.735_072624_A.JPG
45.74FT, Roots Fine Joint, at 03 o'clock, within 8 inches of joint: YES

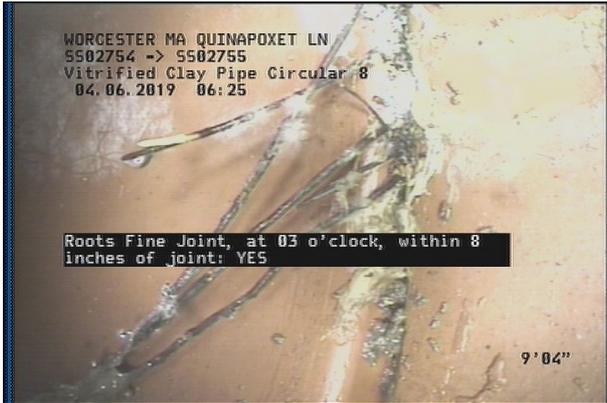
Photo:
SS02754-SS02755_04062019_RFJ_9.3071_073400_A.JPG
9.31FT, Roots Fine Joint, at 03 o'clock, within 8 inches of joint: YES

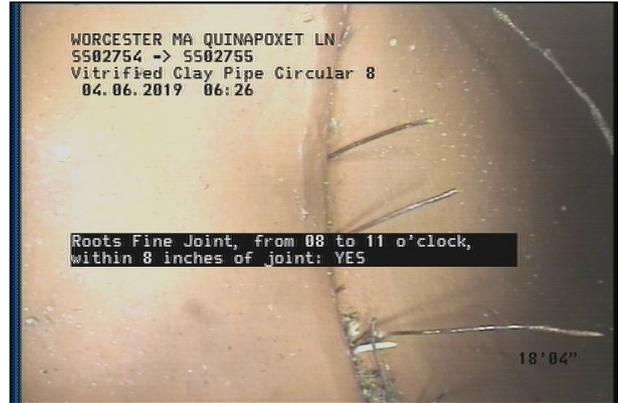
Photo:
SS02754-SS02755_04062019_RFJ_18.314_073510_A.JPG
18.31FT, Roots Fine Joint, from 08 to 11 o'clock, within 8 inches of joint: YES

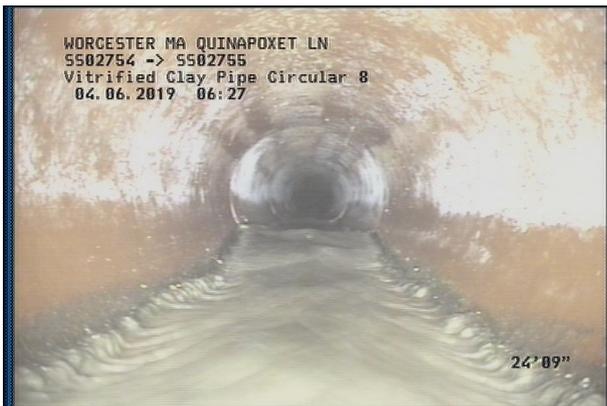
Photo:
SS02754-SS02755_04062019_DAGS_24.7189_073603_A.JPG
24.72FT, Deposits Attached Grease, 5 %of cross sectional area, from 04 to 08 o'clock, , within 8 inches of joint: YES, Start

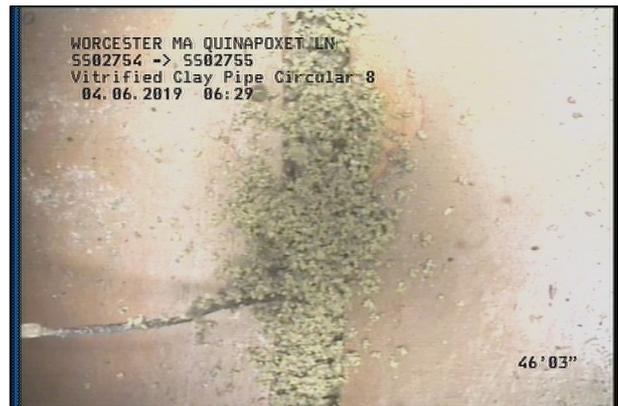
Photo:
SS02754-SS02755_04062019_RFJ_46.2354_073805_A.JPG
46.24FT, Roots Fine Joint, at 02 o'clock, within 8 inches of joint: YES

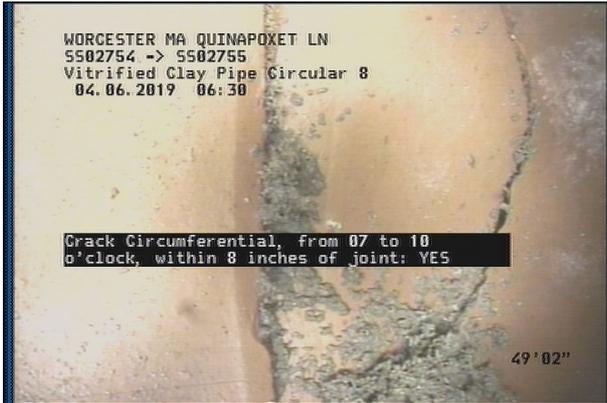
Photo:
SS02754-SS02755_04062019_CC_49.1376_073905_A.JPG
49.14FT, Crack Circumferential, from 07 to 10 o'clock, within 8 inches of joint: YES

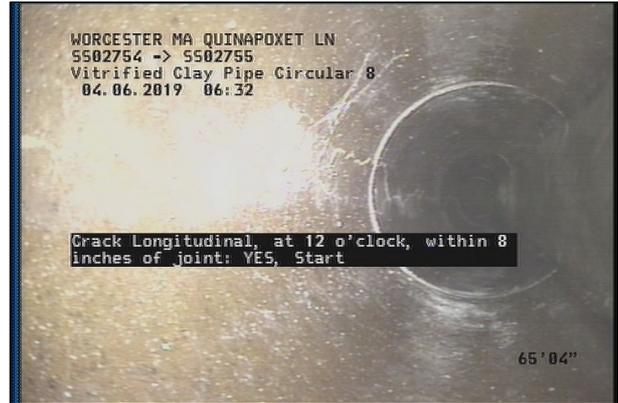
Photo:
SS02754-SS02755_04062019_CL_65.35_074050_A.JPG
65.35FT, Crack Longitudinal, at 12 o'clock, within 8 inches of joint: YES, Start

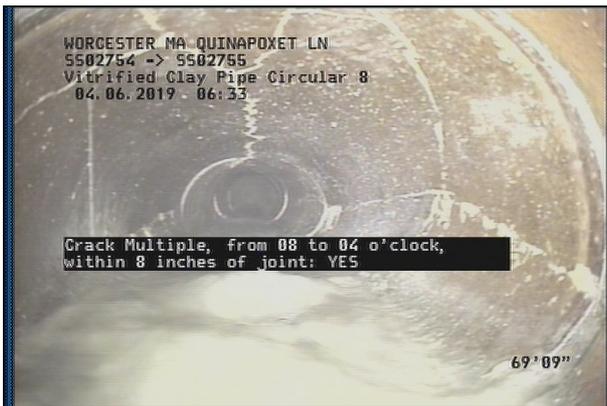
Photo:
SS02754-SS02755_04062019_CM_69.7534_074142_A.JPG
69.75FT, Crack Multiple, from 08 to 04 o'clock, within 8 inches of joint: YES

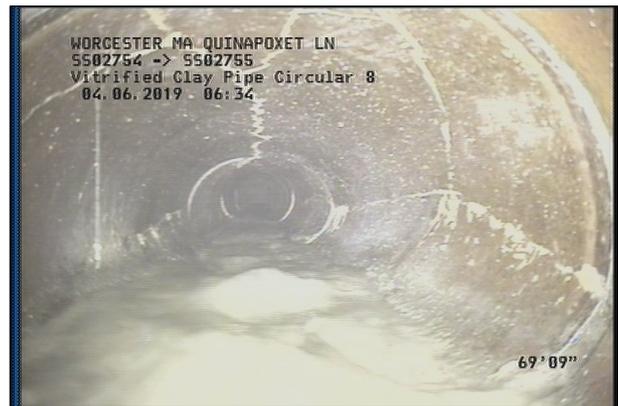
Photo:
SS02754-SS02755_04062019_DV_69.7534_074215_A.JPG
69.75FT, Deformed Vertical, 5 %

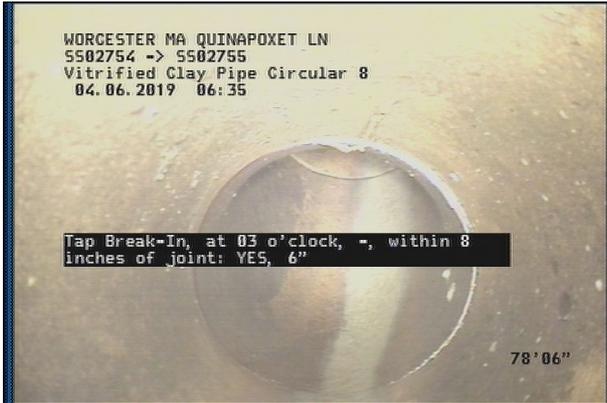
Photo:
SS02754-SS02755_04062019_TB_78.4601_074334_A.JPG
78.46FT, Tap Break-In, at 03 o'clock, -, within 8 inches of joint:
YES, 6"

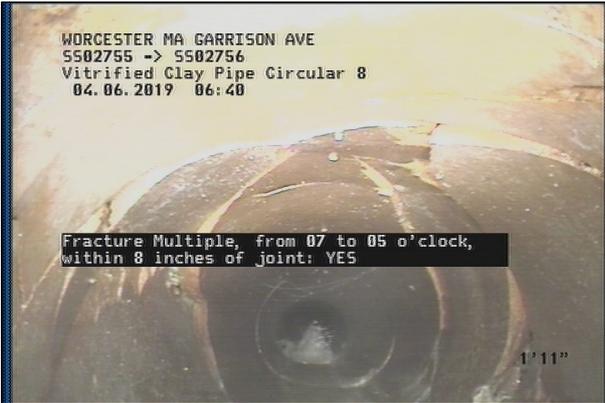
Photo:
SS02755-SS02756_04062019_FM_1.9015_074831_A.JPG
1.9FT, Fracture Multiple, from 07 to 05 o'clock, within 8 inches of joint: YES

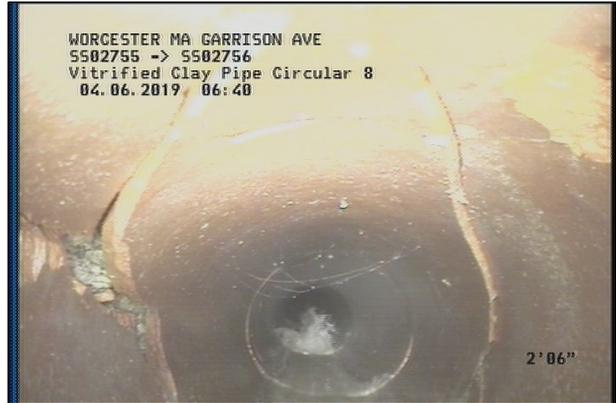
Photo:
SS02755-SS02756_04062019_FM_1.9015_074841_B.JPG
1.9FT, Fracture Multiple, from 07 to 05 o'clock, within 8 inches of joint: YES

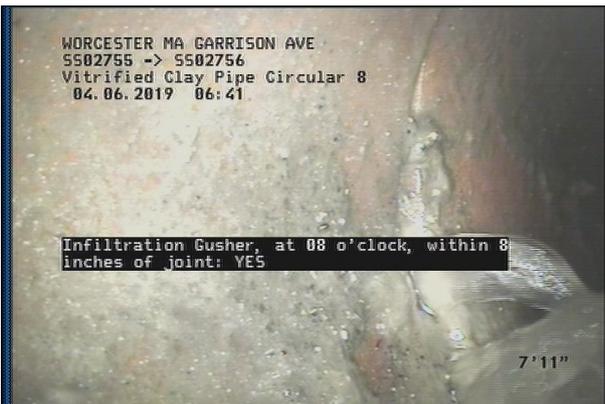
Photo:
SS02755-SS02756_04062019_IG_7.9061_074928_A.JPG
7.91FT, Infiltration Gusher, at 08 o'clock, within 8 inches of joint: YES

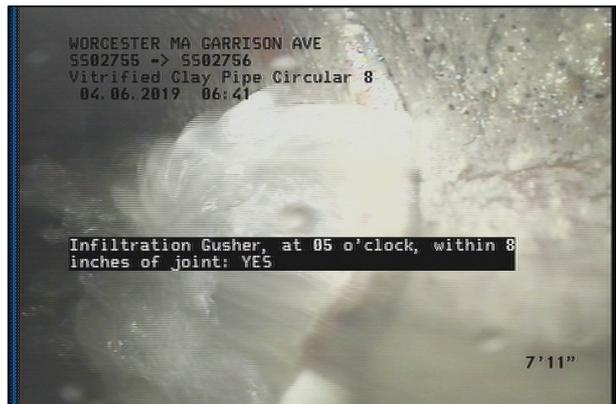
Photo:
SS02755-SS02756_04062019_IG_7.9061_074951_A.JPG
7.91FT, Infiltration Gusher, at 05 o'clock, within 8 inches of joint: YES

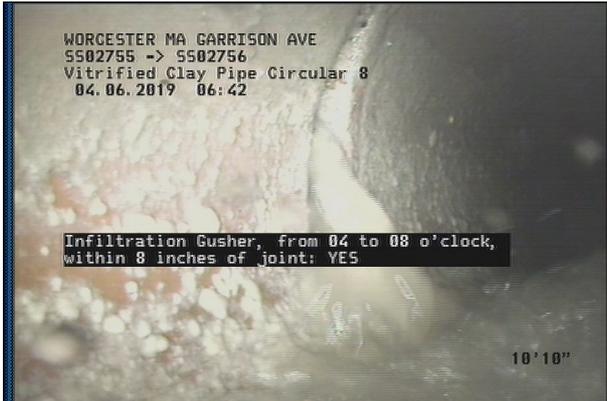
Photo:
SS02755-SS02756_04062019_IG_10.8083_075036_A.JPG
10.81FT, Infiltration Gusher, from 04 to 08 o'clock, within 8 inches of joint: YES

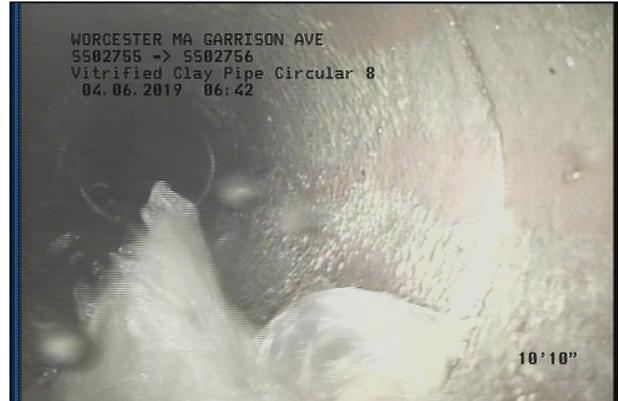
Photo:
SS02755-SS02756_04062019_IG_10.8083_075042_B.JPG
10.81FT, Infiltration Gusher, from 04 to 08 o'clock, within 8 inches of joint: YES

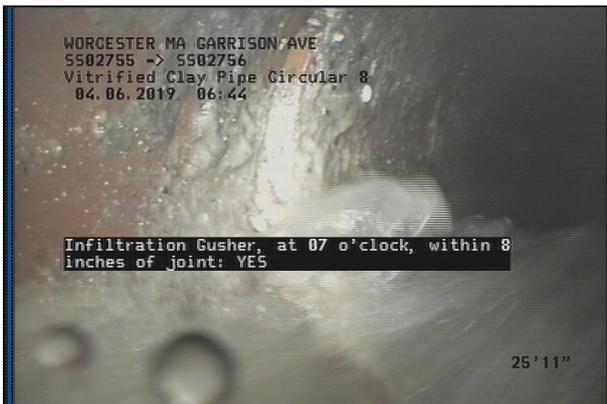
Photo:
SS02755-SS02756_04062019_IG_25.9198_075232_A.JPG
25.92FT, Infiltration Gusher, at 07 o'clock, within 8 inches of joint: YES

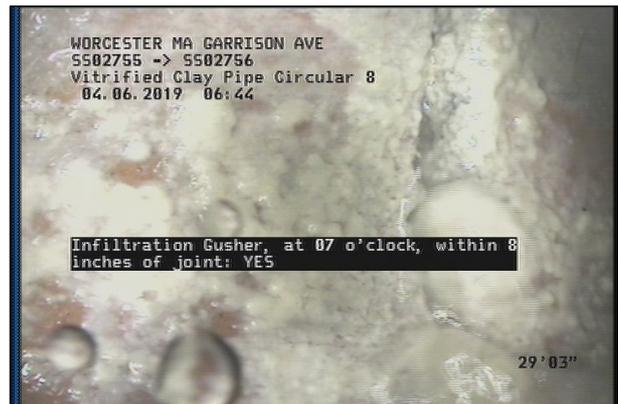
Photo:
SS02755-SS02756_04062019_IG_29.2224_075307_A.JPG
29.22FT, Infiltration Gusher, at 07 o'clock, within 8 inches of joint: YES

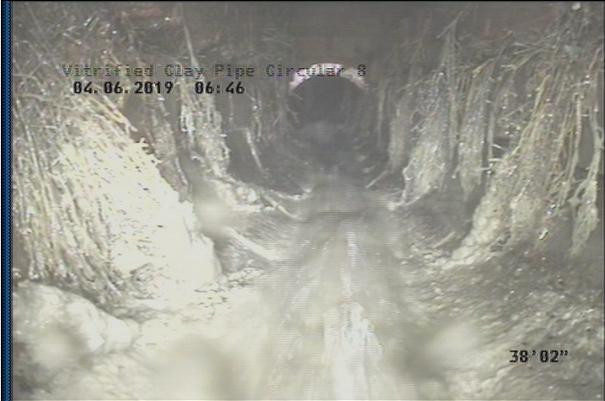
Photo:
SS02755-SS02756_04062019_MGO_38.1292_075412_A.JPG
38.13FT, General Observation

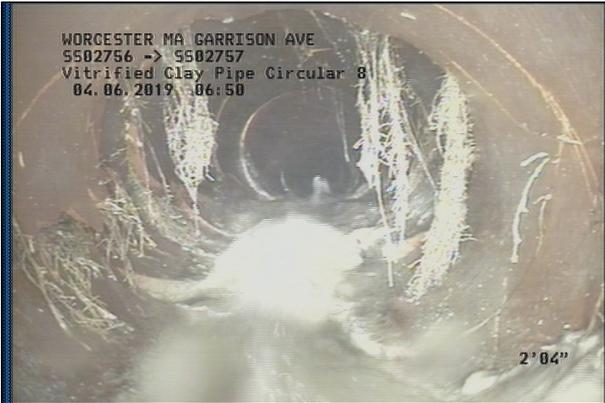
1:165 Position	Observation	
0.00	Upstream Manhole, Survey Begins	
0.00	Water Level, 5 %of cross sectional area	
2.30	Fracture Multiple, from 07 to 05 o'clock, within 8 inches of joint: YES

Photo:
SS02756-SS02757_04062019_FM_2.3018_075832_A.JPG
2.3FT, Fracture Multiple, from 07 to 05 o'clock, within 8 inches of joint: YES

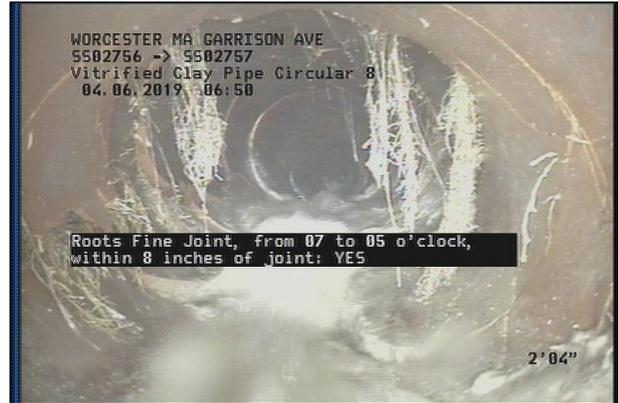
Photo:
SS02756-SS02757_04062019_RFJ_2.3018_075857_A.JPG
2.3FT, Roots Fine Joint, from 07 to 05 o'clock, within 8 inches of joint: YES

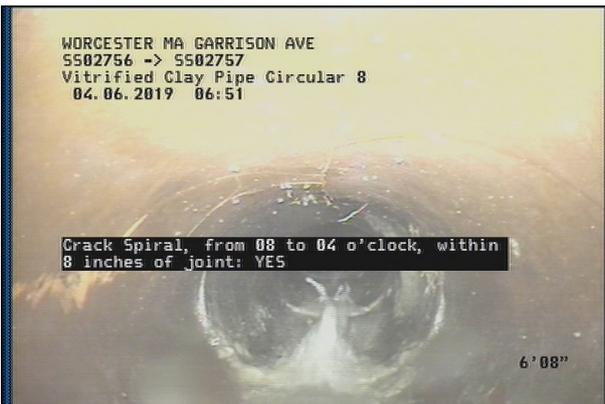
Photo:
SS02756-SS02757_04062019_CS_6.7051_075948_A.JPG
6.71FT, Crack Spiral, from 08 to 04 o'clock, within 8 inches of joint: YES

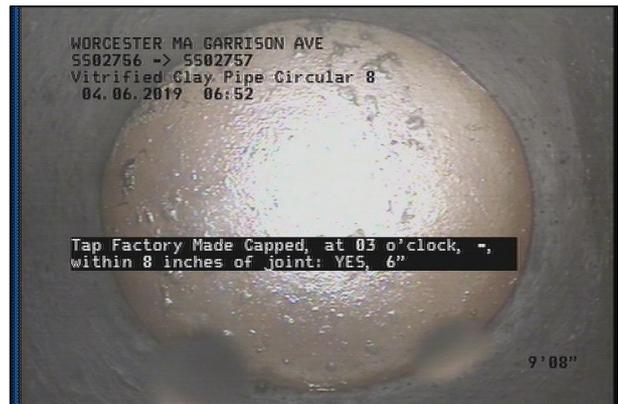
Photo:
SS02756-SS02757_04062019_TFC_9.7074_080032_A.JPG
9.71FT, Tap Factory Made Capped, at 03 o'clock, -, within 8 inches of joint: YES, 6"

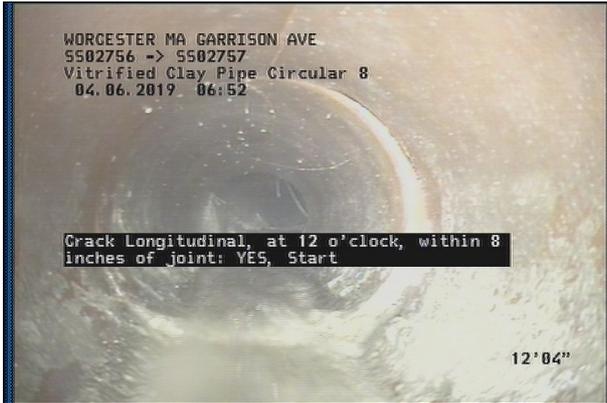
Photo:
SS02756-SS02757_04062019_CL_12.3094_080107_A.JPG
12.31FT, Crack Longitudinal, at 12 o'clock, within 8 inches of joint: YES, Start

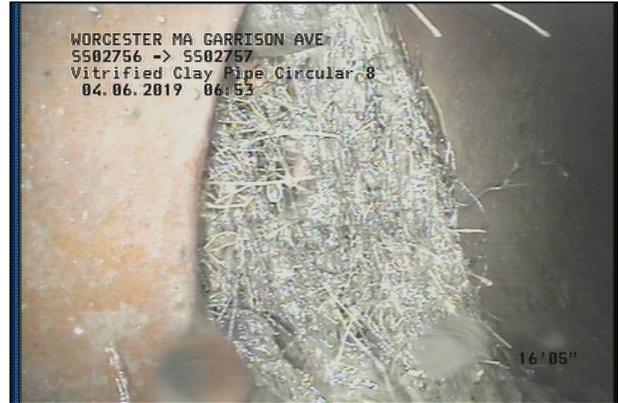
Photo:
SS02756-SS02757_04062019_RMJ_16.4126_080153_A.JPG
16.41FT, Roots Medium Joint, from 08 to 09 o'clock, 5 %, within 8 inches of joint: YESR

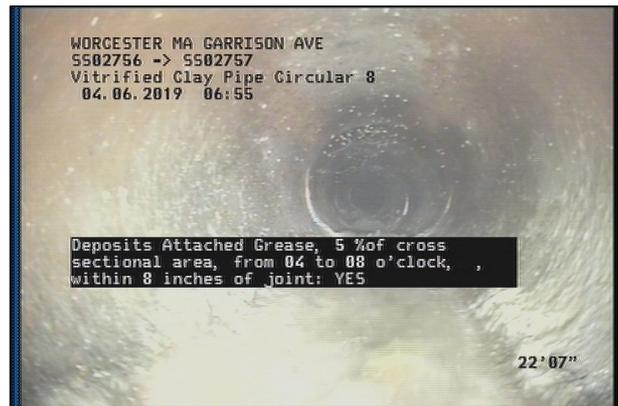
Photo:
SS02756-SS02757_04062019_DAGS_22.6173_080319_A.JPG
22.62FT, Deposits Attached Grease, 5 %of cross sectional area, from 04 to 08 o'clock, , within 8 inches of joint: YES

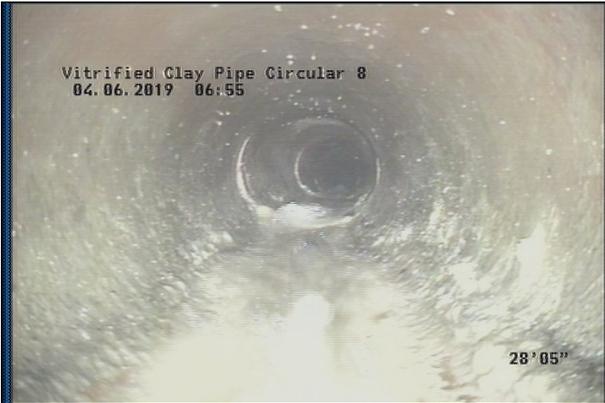
Photo:
SS02756-SS02757_04062019_DAGS_28.4218_080410_A.JPG
28.42FT, Deposits Attached Grease, 5 %of cross sectional area, from 04 to 08 o'clock, , within 8 inches of joint: YES, Start

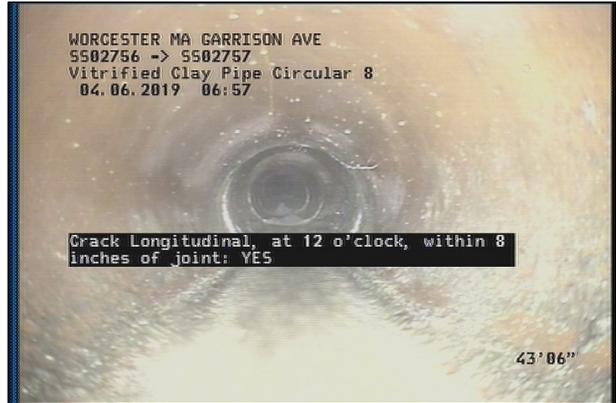
Photo:
SS02756-SS02757_04062019_CL_43.5333_080554_A.JPG
43.53FT, Crack Longitudinal, at 12 o'clock, within 8 inches of joint: YES

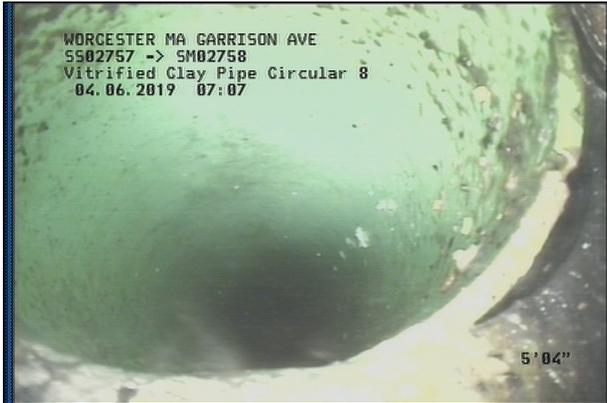
Photo:
SS02757-SM02758_04062019_TB_5.3041_081521_A.JPG
5.3FT, Tap Break-In, at 03 o'clock, -, within 8 inches of joint:
YES, 6"

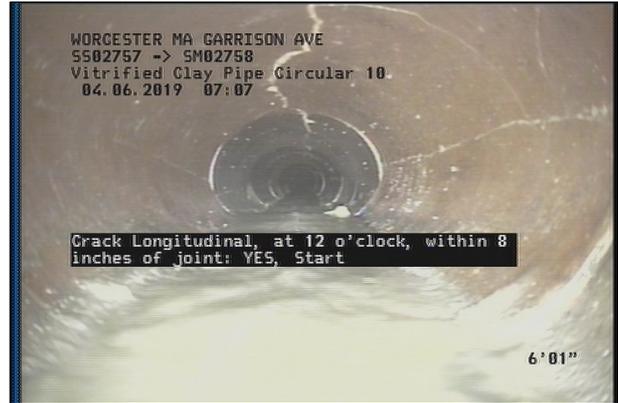
Photo:
SS02757-SM02758_04062019_CL_6.1047_081601_A.JPG
6.1FT, Crack Longitudinal, at 12 o'clock, within 8 inches of
joint: YES, Start

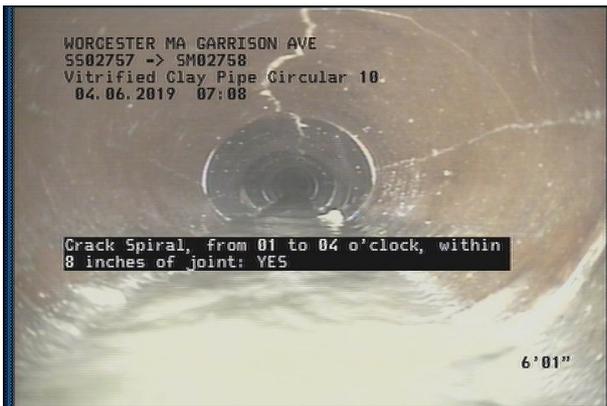
Photo:
SS02757-SM02758_04062019_CS_6.1047_081619_A.JPG
6.1FT, Crack Spiral, from 01 to 04 o'clock, within 8 inches of
joint: YES

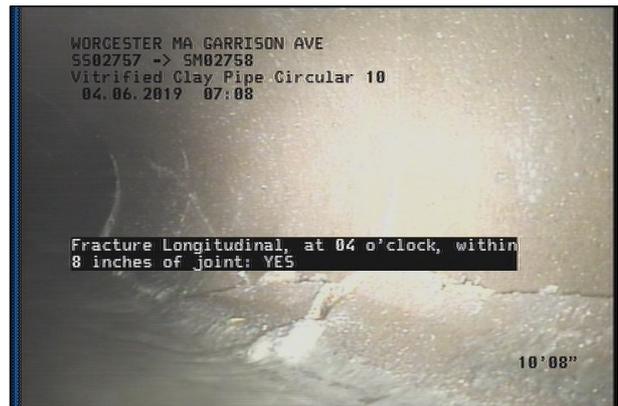
Photo:
SS02757-SM02758_04062019_FL_10.7082_081659_A.JPG
10.71FT, Fracture Longitudinal, at 04 o'clock, within 8 inches
of joint: YES

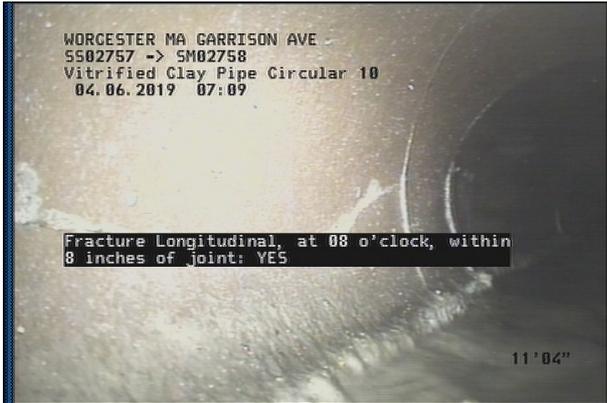
Photo:
SS02757-SM02758_04062019_FL_11.3087_081717_A.JPG
11.31FT, Fracture Longitudinal, at 08 o'clock, within 8 inches of joint: YES

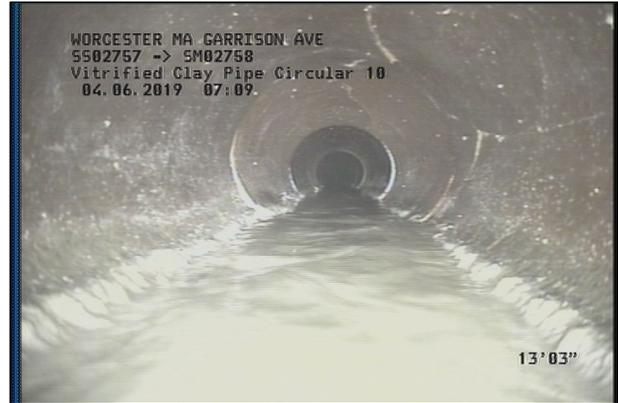
Photo:
SS02757-SM02758_04062019_DAGS_13.2101_081743_A.JPG
G
13.21FT, Deposits Attached Grease, 5 % of cross sectional area, from 04 to 08 o'clock, , within 8 inches of joint: YES, Start

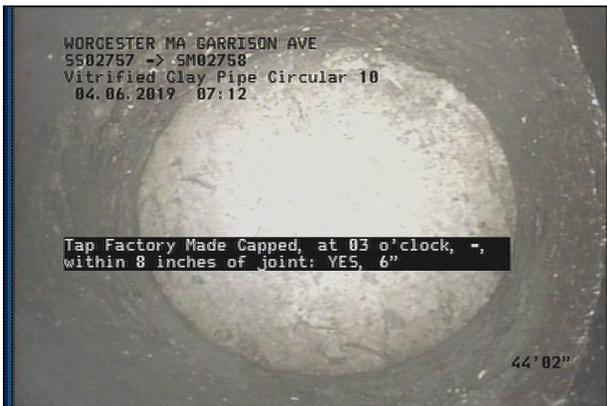
Photo:
SS02757-SM02758_04062019_TFC_44.1338_082036_A.JPG
44.13FT, Tap Factory Made Capped, at 03 o'clock, -, within 8 inches of joint: YES, 6"

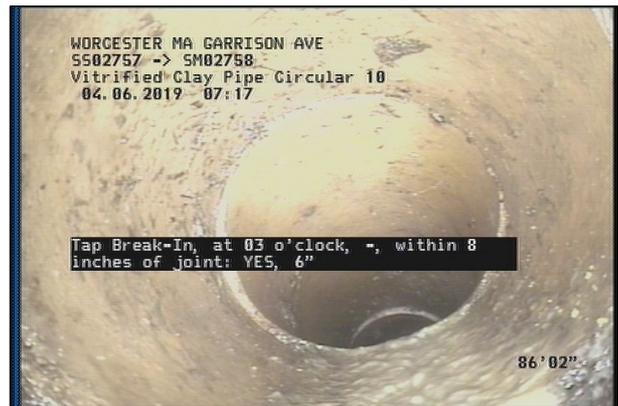
Photo:
SS02757-SM02758_04062019_TB_86.166_082513_A.JPG
86.17FT, Tap Break-In, at 03 o'clock, -, within 8 inches of joint: YES, 6"

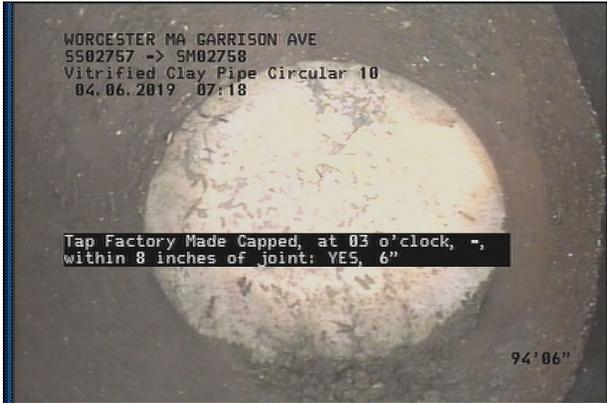
Photo:
SS02757-SM02758_04062019_TFC_94.4723_082626_A.JPG
94.47FT, Tap Factory Made Capped, at 03 o'clock, -, within 8 inches of joint: YES, 6"

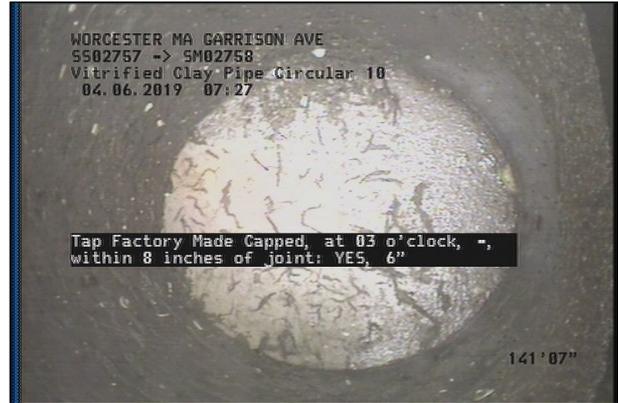
Photo:
SS02757-SM02758_04062019_TFC_141.6084_083557_A.JPG
141.61FT, Tap Factory Made Capped, at 03 o'clock, -, within 8 inches of joint: YES, 6"

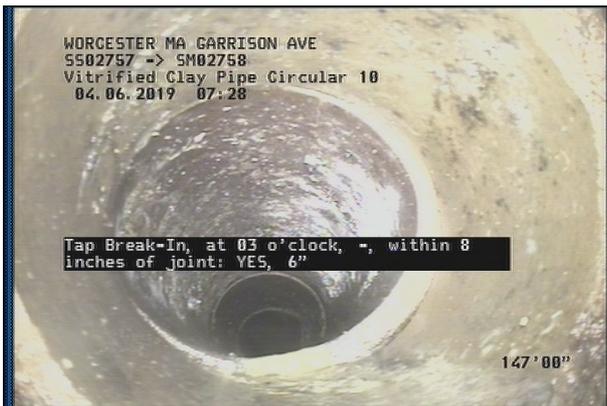
Photo:
SS02757-SM02758_04062019_TB_147.0126_083643_A.JPG
147.01FT, Tap Break-In, at 03 o'clock, -, within 8 inches of joint: YES, 6"

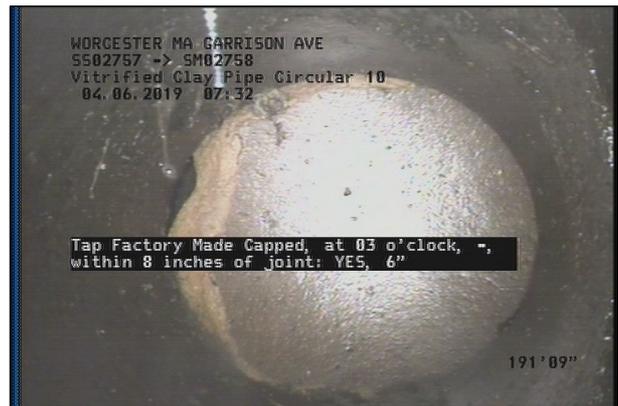
Photo:
SS02757-SM02758_04062019_TFC_191.7468_084059_A.JPG
191.75FT, Tap Factory Made Capped, at 03 o'clock, -, within 8 inches of joint: YES, 6"

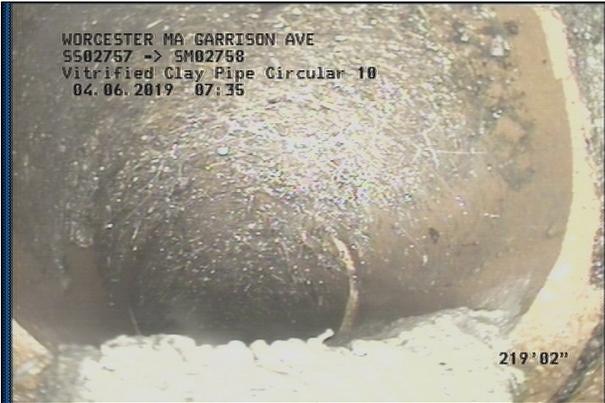
Photo:
SS02757-SM02758_04062019_TB_219.1678_084352_A.JPG
219.17FT, Tap Break-In, at 03 o'clock, -, within 8 inches of joint: YES, 6"

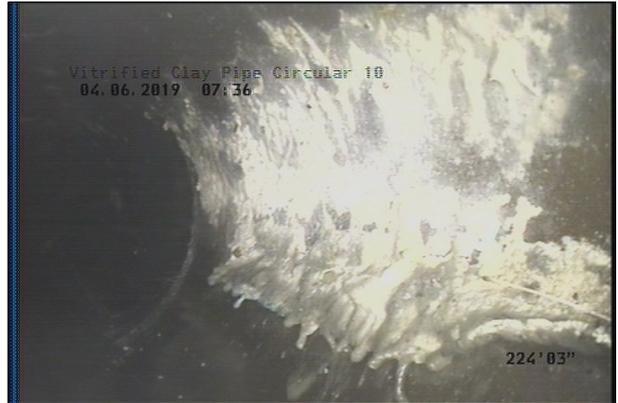
Photo:
SS02757-SM02758_04062019_DAGS_224.2717_084445_A.JPG
G
224.27FT, Deposits Attached Grease, 5 %of cross sectional area, from 02 to 05 o'clock, , within 8 inches of joint: YES

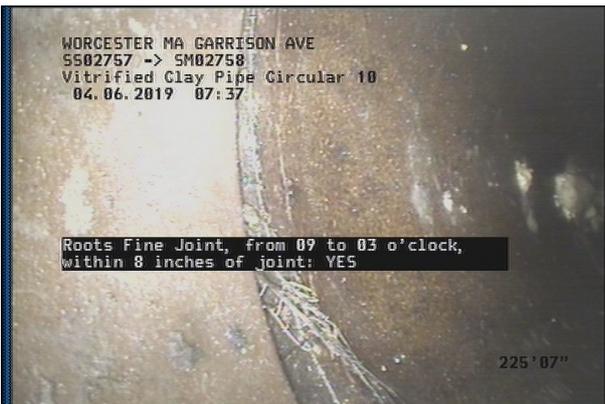
Photo:
SS02757-SM02758_04062019_RFJ_225.5727_084517_A.JPG
225.57FT, Roots Fine Joint, from 09 to 03 o'clock, within 8 inches of joint: YES

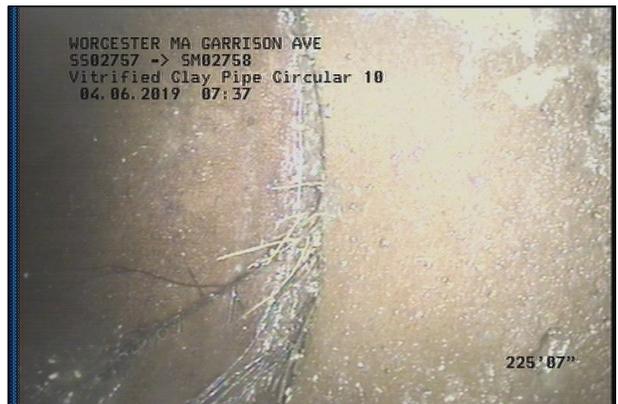
Photo:
SS02757-SM02758_04062019_RFJ_225.5727_084523_B.JPG
225.57FT, Roots Fine Joint, from 09 to 03 o'clock, within 8 inches of joint: YES

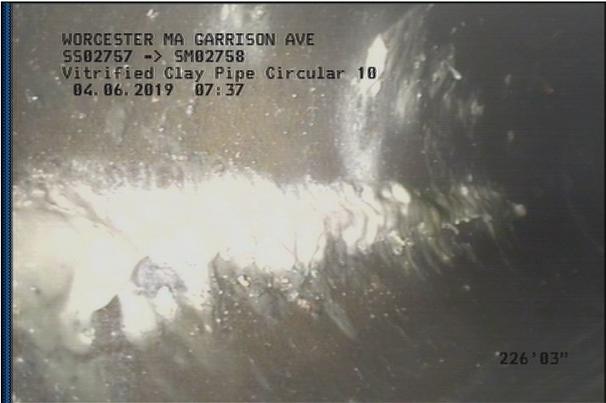
Photo:
SS02757-SM02758_04062019_DAGS_226.2733_084548_A.JPG
G
226.27FT, Deposits Attached Grease, 5 %of cross sectional area, at 09 o'clock, , within 8 inches of joint: YES

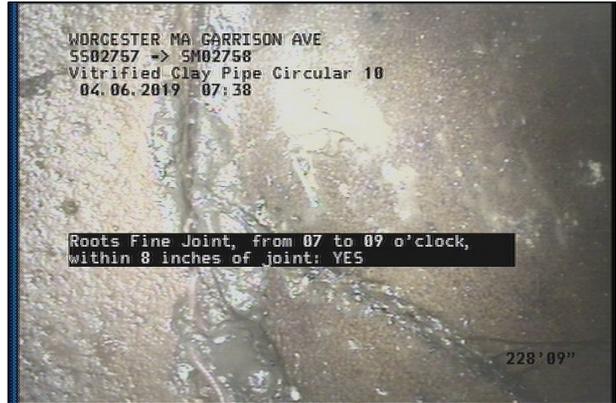
Photo:
SS02757-SM02758_04062019_RFJ_228.7752_084626_A.JPG
228.78FT, Roots Fine Joint, from 07 to 09 o'clock, within 8 inches of joint: YES

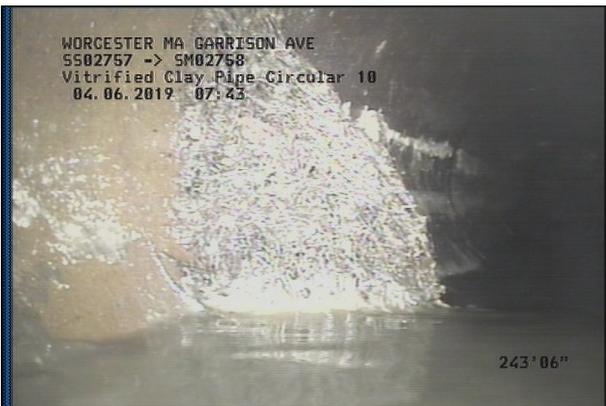
Photo:
SS02757-SM02758_04062019_RMJ_243.4865_085127_A.JPG
243.49FT, Roots Medium Joint, from 07 to 09 o'clock, 15 %, within 8 inches of joint: YESR

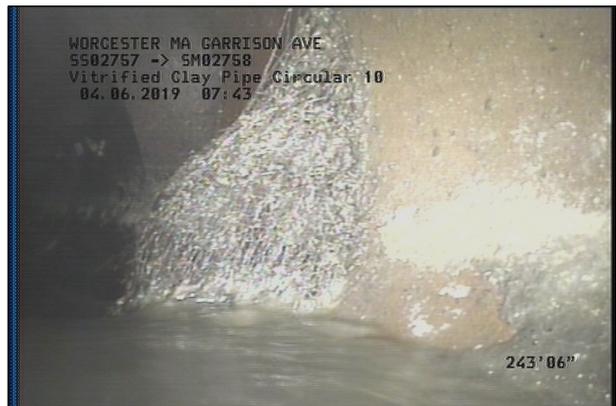
Photo:
SS02757-SM02758_04062019_RMJ_243.4865_085156_A.JPG
243.49FT, Roots Medium Joint, from 03 to 05 o'clock, 15 %, within 8 inches of joint: YESR

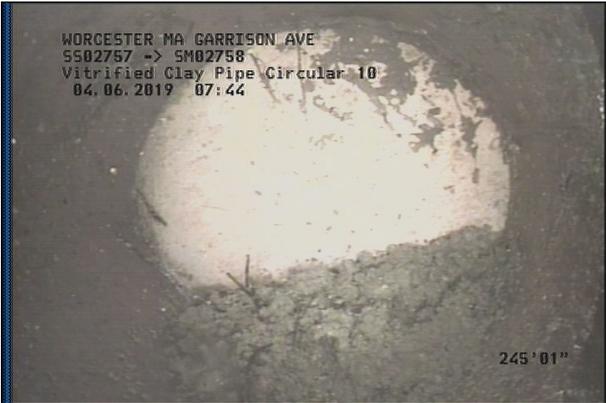
Photo:
SS02757-SM02758_04062019_TFC_245.0877_085235_A.JPG
245.09FT, Tap Factory Made Capped, at 03 o'clock, -, within 8 inches of joint: YES, 6"

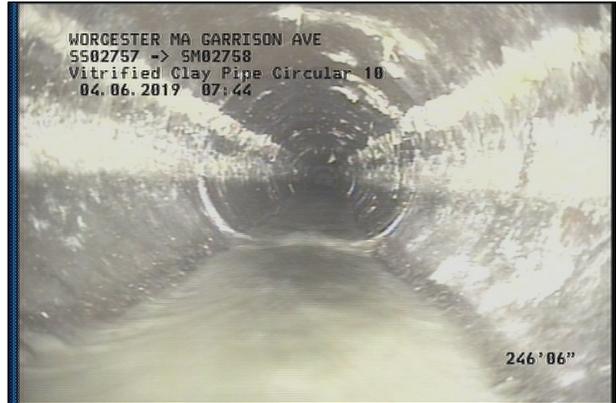
Photo:
SS02757-SM02758_04062019_DAGS_246.4887_085308_A.JPG
246.49FT, Deposits Attached Grease, 5 %of cross sectional area, from 09 to 03 o'clock, , within 8 inches of joint: YES, Start

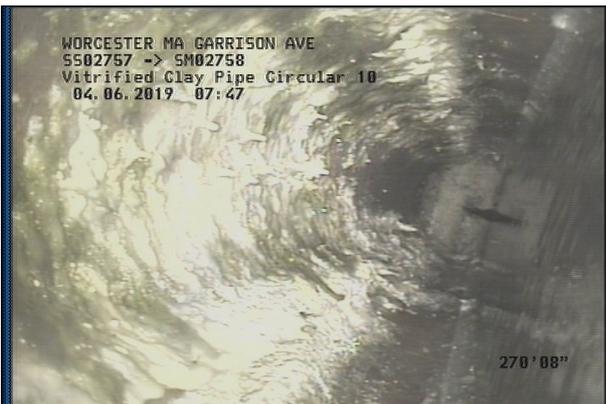
Photo:
SS02757-SM02758_04062019_DAGS_270.7073_085549_A.JPG
270.71FT, Deposits Attached Grease, 20 %of cross sectional area, from 09 to 03 o'clock, , within 8 inches of joint: YES, Start

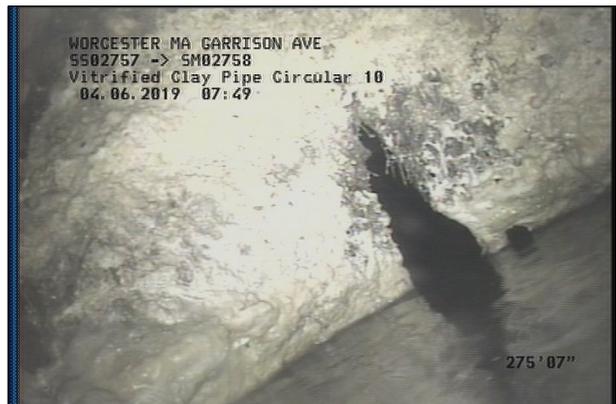
Photo:
SS02757-SM02758_04062019_OBZ_275.6111_085740_A.JPG
275.61FT, Obstacles Other, 90 %of cross sectional area, from 07 to 05 o'clock

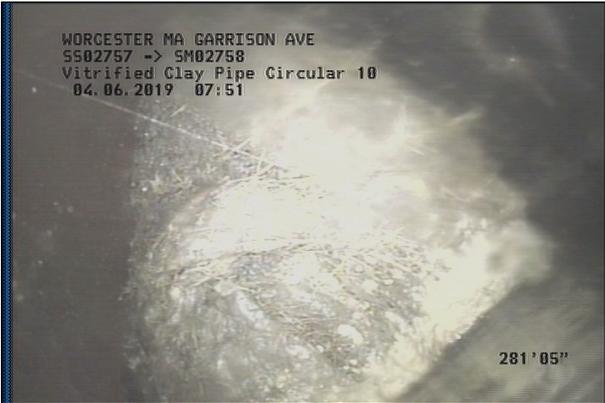
Photo:
SS02757-SM02758_04062019_RBB_281.4155_085924_A.JPG
281.42FT, Roots Ball Barrell, from 07 to 10 o'clock, 85 %
