# Inspection Report

Date <b>6/4/2019</b>	P/O. No.	Weather <b>Dry</b>	Surveyor's Name <b>BRIAN GROM</b>	Pipe Segment Reference <b>SM00463</b>	Section No. <b>6</b>
Certificate No. <b>U-0218030700746</b>	Survey Customer	System Owner	Date Cleaned <b>6/4/2019</b>	Pre-Cleaning <b>No Pre-Cleaning</b>	Sewer Category

Street <b>123 GARRISON AVE</b>	Use of Sewer <b>Sanitary</b>	Upstream MH <b>SS02758</b>
City <b>WORCESTER MA</b>	Drainage Area	Dowstream MH <b>SS02759</b>
Loc. details	Flow Control <b>Not Controlled</b>	Dir. of Survey <b>Downstream</b>
Location Code <b>Easement/Right of way</b>	Length surveyed <b>156.12 ft</b>	Section Length <b>156.12 ft</b>

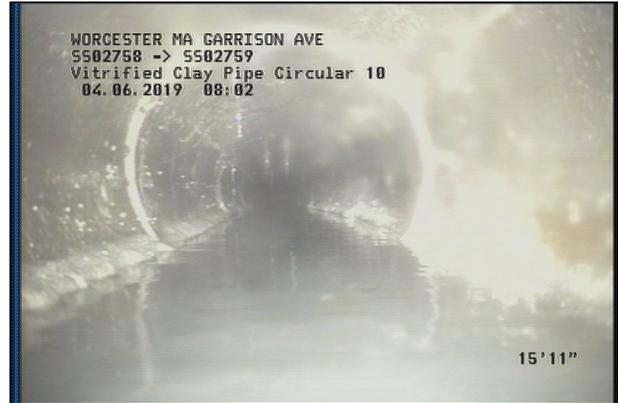
Photo:  
SS02758-SS02759\_04062019\_RFJ\_2.2017\_090839\_A.JPG  
2.2FT, Roots Fine Joint, from 09 to 03 o'clock, within 8 inches of joint: YES

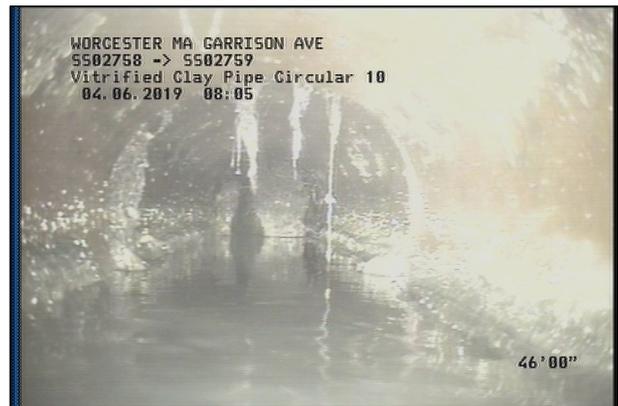
Photo:  
SS02758-SS02759\_04062019\_DAGS\_43.3332\_091300\_A.JPG  
43.33FT, Deposits Attached Grease, 95 %of cross sectional area, from 12 to 12 o'clock, , within 8 inches of joint: YES

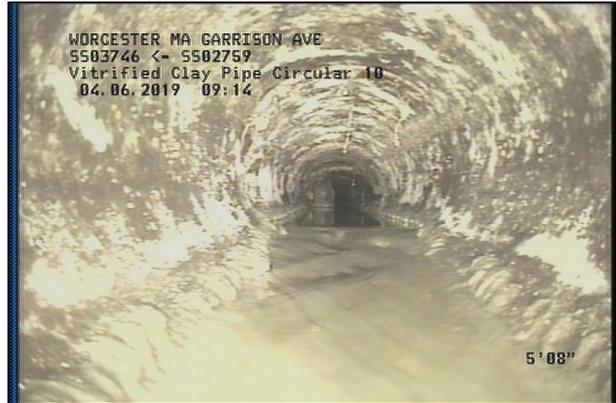
Photo:  
SS02759-SS03746\_04062019\_DAGS\_5.7044\_102209\_A.JPG  
5.7FT, Deposits Attached Grease, 5 %of cross sectional area, from 04 to 08 o'clock, , within 8 inches of joint: YES, Start

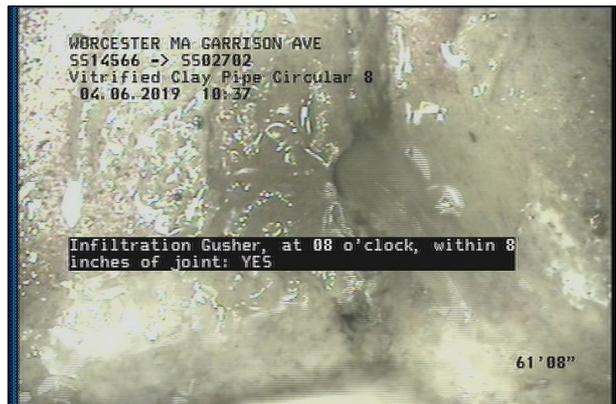
61.65 Infiltration Gusher, at 08 o'clock, within 8 inches of joint: YES

Photo:  
SS14566-SS02702\_04062019\_IG\_61.6472\_114551\_A.JPG  
61.65FT, Infiltration Gusher, at 08 o'clock, within 8 inches of joint: YES

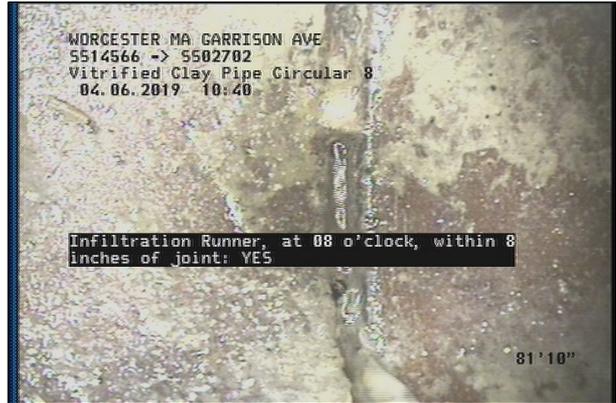
81.86 Infiltration Runner, at 08 o'clock, within 8 inches of joint: YES

Photo:  
SS14566-SS02702\_04062019\_IR\_81.8627\_114848\_A.JPG  
81.86FT, Infiltration Runner, at 08 o'clock, within 8 inches of joint: YES

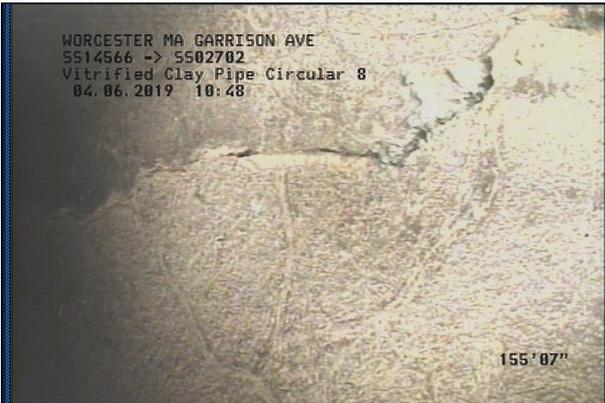
155.62 Fracture Longitudinal, at 12 o'clock, within 8 inches of joint: YES

Photo:  
SS14566-SS02702\_04062019\_FL\_155.6192\_115612\_A.JPG  
155.62FT, Fracture Longitudinal, at 12 o'clock, within 8 inches of joint: YES

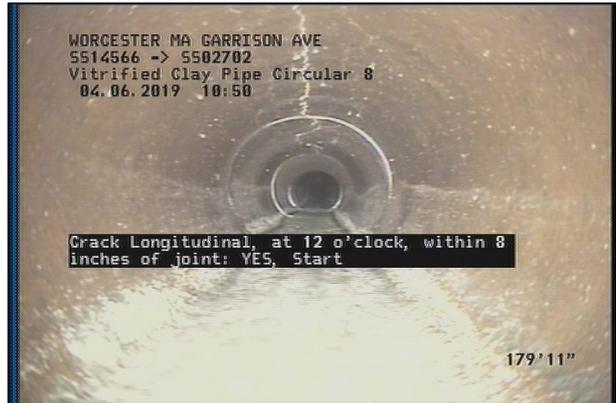
179.94 **S2** Crack Longitudinal, at 12 o'clock, within 8 inches of joint: YES, Start

Photo:  
SS14566-SS02702\_04062019\_CL\_179.9378\_115821\_A.JPG  
179.94FT, Crack Longitudinal, at 12 o'clock, within 8 inches of joint: YES, Start

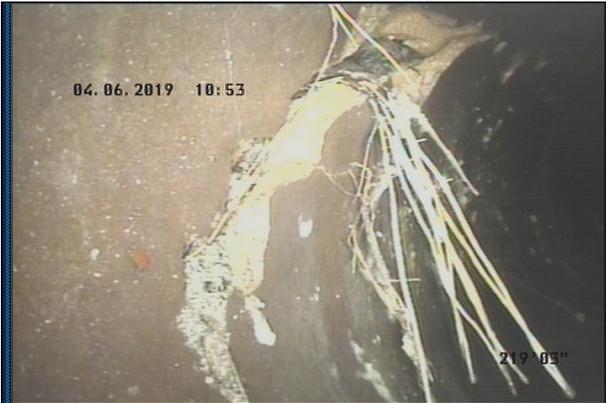
219.27 Broken Soil Visible, from 08 to 10 o'clock, within 8 inches of joint: YES

Photo:  
SS14566-SS02702\_04062019\_BSV\_219.2679\_120154\_A.JPG  
219.27FT, Broken Soil Visible, from 08 to 10 o'clock, within 8 inches of joint: YES

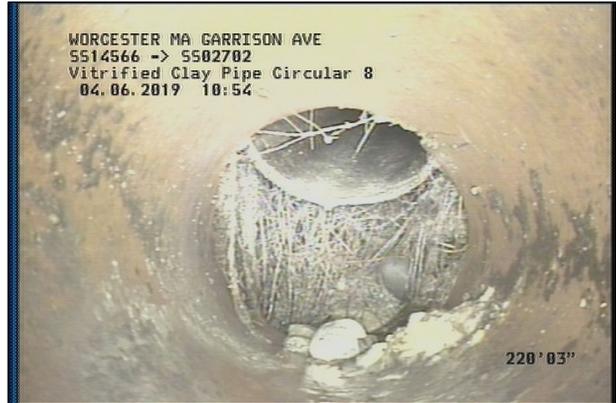
1:540	Position	Observation
	<u>220.27</u>	Tap Break-In Defective, at 03 o'clock, -, , within 8 inches of joint: YES, 6" / ROOTS AND LATERAL ISNT LINED UP WITH CONNECTION
	<u>220.27</u>	Broken Soil Visible, at 05 o'clock, within 8 inches of joint: YES
	<u>220.77</u>	<b>F2</b> Crack Longitudinal, at 12 o'clock, within 8 inches of joint: YES, Finish
	<u>220.77</u>	<b>F1</b> Deposits Attached Grease, 5 %of cross sectional area, from 10 to 02 o'clock, , within 8 inches of joint: YES, Finish
	<u>234.38</u>	Roots Fine Joint, from 10 to 02 o'clock, within 8 inches of joint: YES
	<u>244.19</u>	<b>S3</b> Crack Longitudinal, at 12 o'clock, within 8 inches of joint: YES, Start
	<u>267.81</u>	Roots Fine Joint, from 02 to 05 o'clock, within 8 inches of joint: YES
	<u>270.71</u>	<b>F3</b> Crack Longitudinal, at 12 o'clock, within 8 inches of joint: YES, Finish
	<u>270.81</u>	General Observation / ROOTS IN MANHOLE

Photo:  
SS14566-SS02702\_04062019\_TBD\_220.2687\_120250\_A.JPG  
220.27FT, Tap Break-In Defective, at 03 o'clock, -, , within 8 inches of joint: YES, 6"

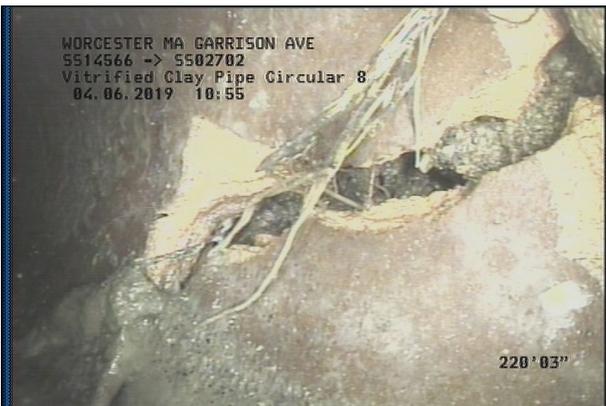
Photo:  
SS14566-SS02702\_04062019\_BSV\_220.2687\_120336\_A.JPG  
220.27FT, Broken Soil Visible, at 05 o'clock, within 8 inches of joint: YES

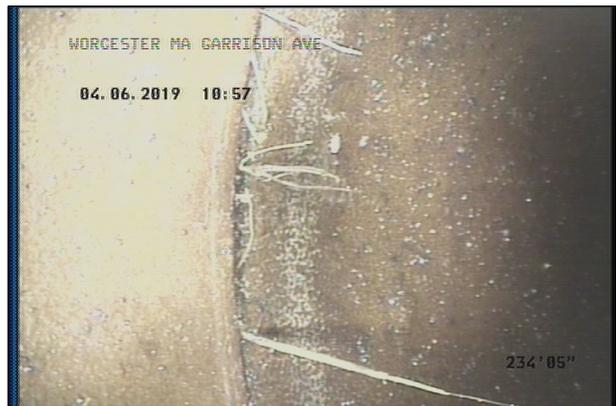
Photo:  
SS14566-SS02702\_04062019\_RFJ\_234.3795\_120525\_A.JPG  
234.38FT, Roots Fine Joint, from 10 to 02 o'clock, within 8 inches of joint: YES

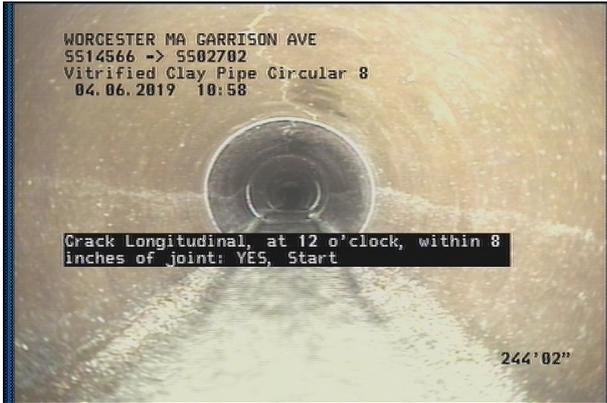
Photo:  
SS14566-SS02702\_04062019\_CL\_244.187\_120632\_A.JPG  
244.19FT, Crack Longitudinal, at 12 o'clock, within 8 inches of joint: YES, Start

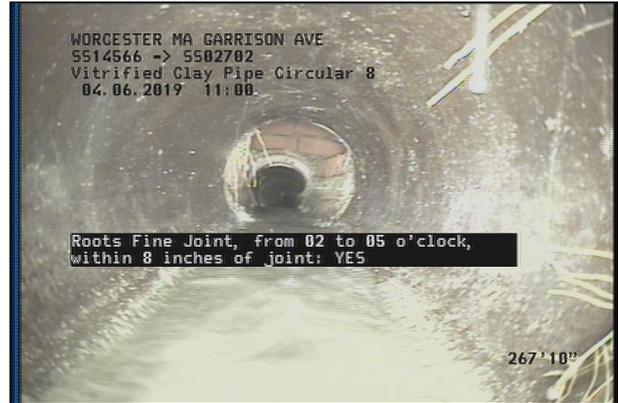
Photo:  
SS14566-SS02702\_04062019\_RFJ\_267.8051\_120815\_A.JPG  
267.81FT, Roots Fine Joint, from 02 to 05 o'clock, within 8 inches of joint: YES

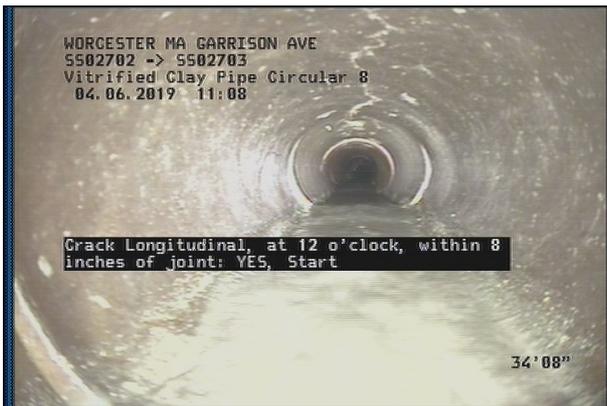
34.53 S2	Crack Longitudinal, at 12 o'clock, within 8 inches of joint: YES, Start	24.62 FT

Photo:  
SS02702-SS02703\_04062019\_CL\_34.5264\_121631\_A.JPG  
34.53FT, Crack Longitudinal, at 12 o'clock, within 8 inches of joint: YES, Start

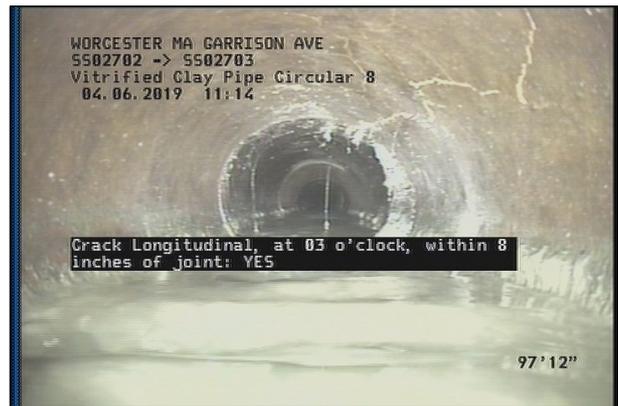
76.46	Material Change, Vitrified clay pipe	56.14 FT
97.98	Crack Longitudinal, at 03 o'clock, within 8 inches of joint: YES	
99.98	Roots Fine Joint, from 01 to 04 o'clock, within 8 inches of joint: YES

Photo:  
SS02702-SS02703\_04062019\_CL\_97.975\_122310\_A.JPG  
97.98FT, Crack Longitudinal, at 03 o'clock, within 8 inches of joint: YES

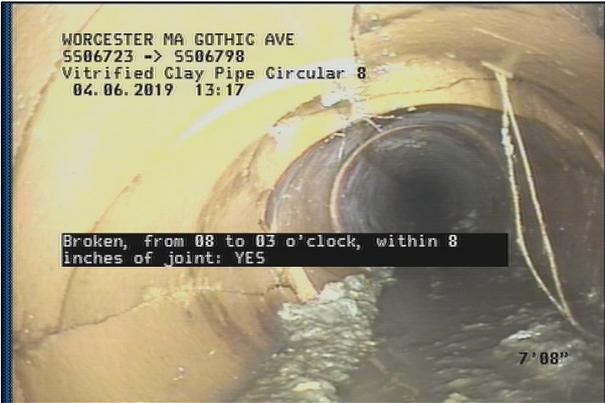
Photo:  
SS06723-SS06798\_04062019\_B\_7.7059\_142607\_A.JPG  
7.71FT, Broken, from 08 to 03 o'clock, within 8 inches of joint:  
YES

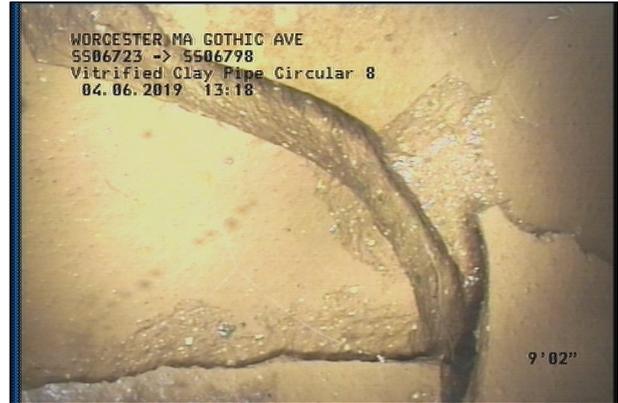
Photo:  
SS06723-SS06798\_04062019\_B\_7.7059\_142618\_B.JPG  
7.71FT, Broken, from 08 to 03 o'clock, within 8 inches of joint:  
YES

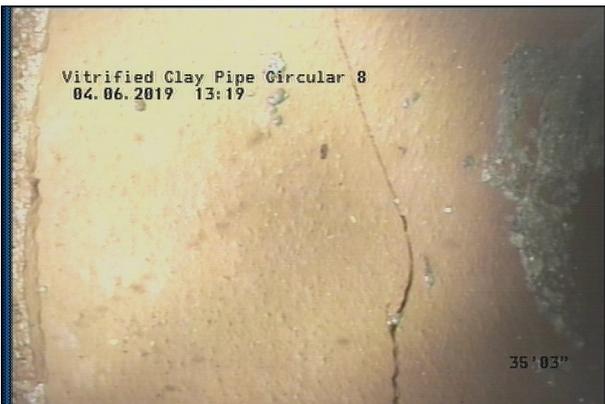
Photo:  
SS06723-SS06798\_04062019\_CC\_35.227\_142804\_A.JPG  
35.23FT, Crack Circumferential, from 07 to 10 o'clock, within 8 inches of joint: YES

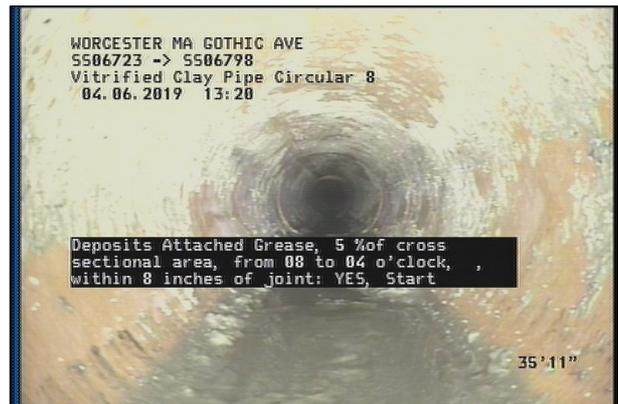
Photo:  
SS06723-SS06798\_04062019\_DAGS\_35.9275\_142824\_A.JPG  
35.93FT, Deposits Attached Grease, 5 %of cross sectional area, from 08 to 04 o'clock, , within 8 inches of joint: YES, Start

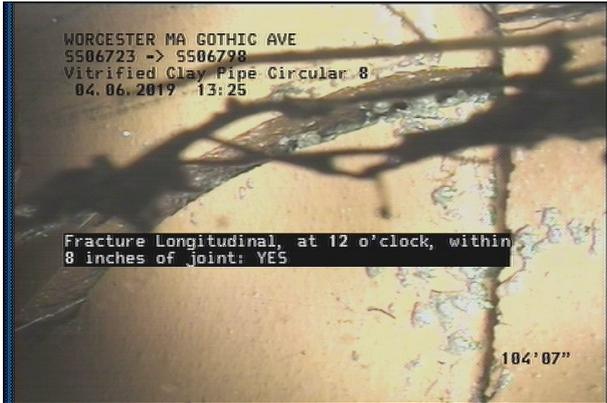
Photo:  
SS06723-SS06798\_04062019\_FL\_104.5801\_143349\_A.JPG  
104.58FT, Fracture Longitudinal, at 12 o'clock, within 8 inches of joint: YES

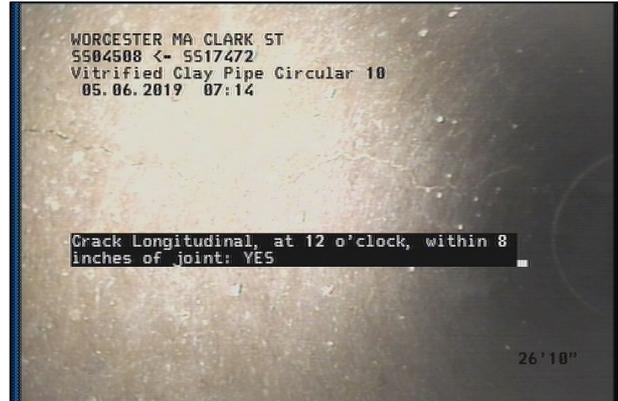
Photo:  
SS17472-SS04508\_05062019\_CL\_26.8205\_082310\_A.JPG  
26.82FT, Crack Longitudinal, at 12 o'clock, within 8 inches of joint: YES

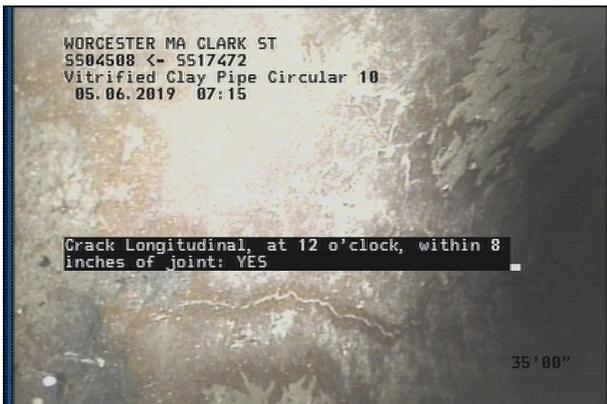
Photo:  
SS17472-SS04508\_05062019\_CL\_34.7266\_082407\_A.JPG  
34.73FT, Crack Longitudinal, at 12 o'clock, within 8 inches of joint: YES

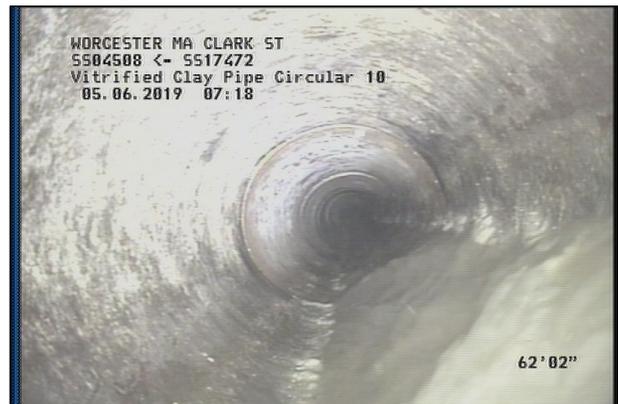
Photo:  
SS17472-SS04508\_05062019\_DAE\_62.1476\_082614\_A.JPG  
62.15FT, Deposits Attached Encrustation, 5 %of cross sectional area, from 08 to 04 o'clock, , within 8 inches of joint: YES, Start

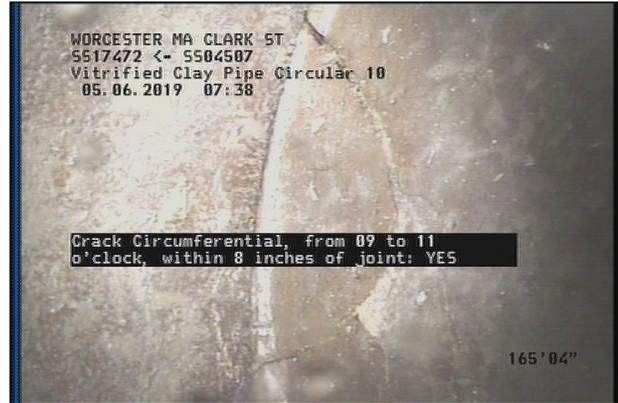
Photo:  
SS04507-SS17472\_05062019\_CC\_165.3266\_084707\_A.JPG  
165.33FT, Crack Circumferential, from 09 to 11 o'clock, within 8 inches of joint: YES

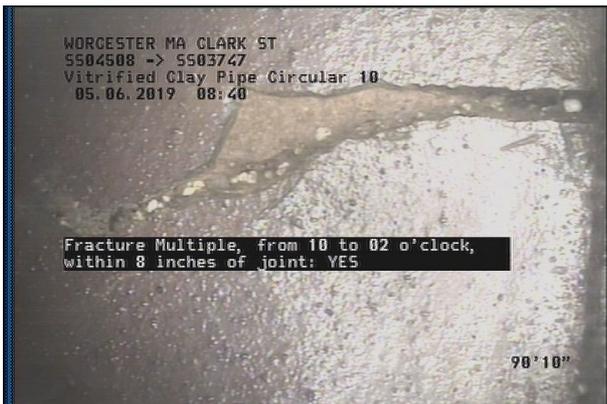
Photo:  
SS04508-SS03747\_05062019\_FM\_90.8696\_094838\_A.JPG  
90.87FT, Fracture Multiple, from 10 to 02 o'clock, within 8 inches of joint: YES

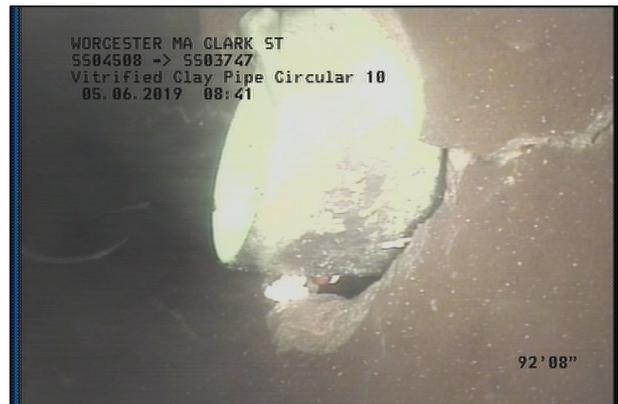
Photo:  
SS04508-SS03747\_05062019\_TBI\_92.671\_094912\_A.JPG  
92.67FT, Tap Break-In Intruding, at 12 o'clock, -, -, within 8 inches of joint: YES, 6", 1"

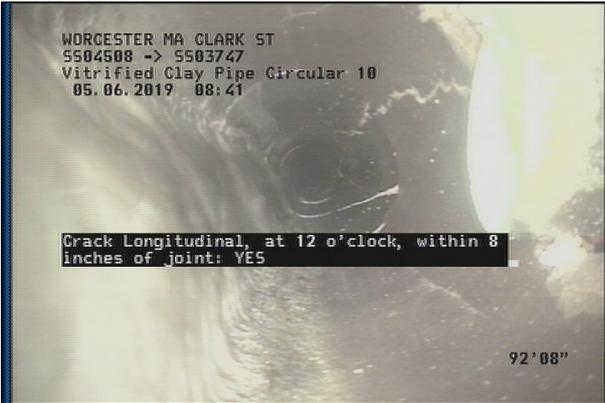
Photo:  
SS04508-SS03747\_05062019\_CL\_92.671\_094929\_A.JPG  
92.67FT, Crack Longitudinal, at 12 o'clock, within 8 inches of joint: YES

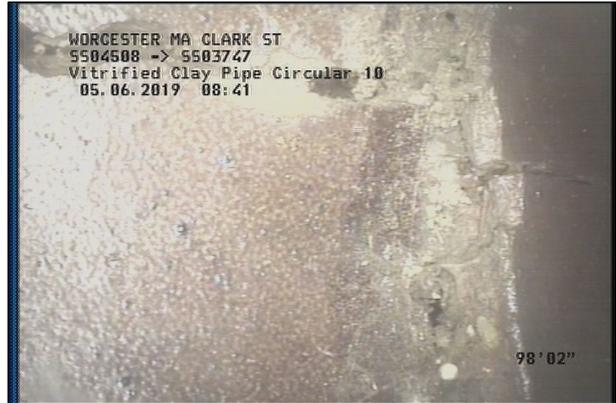
Photo:  
SS04508-SS03747\_05062019\_FL\_98.1752\_095005\_A.JPG  
98.18FT, Fracture Longitudinal, at 12 o'clock, within 8 inches of joint: YES

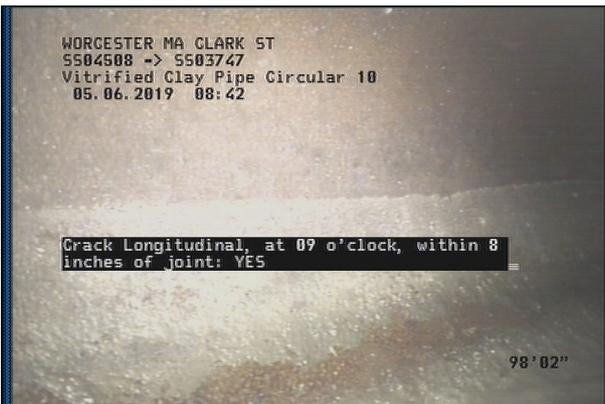
Photo:  
SS04508-SS03747\_05062019\_CL\_98.1752\_095027\_A.JPG  
98.18FT, Crack Longitudinal, at 09 o'clock, within 8 inches of joint: YES

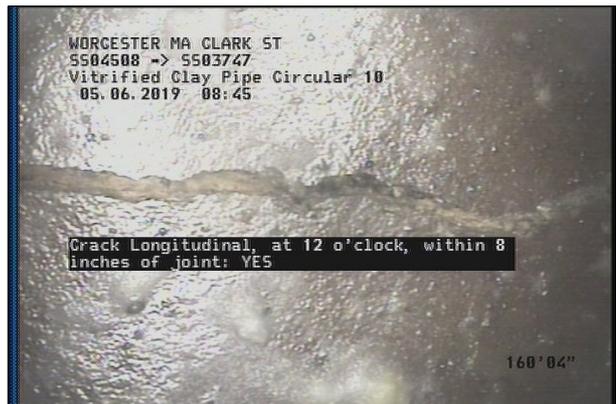
Photo:  
SS04508-SS03747\_05062019\_CL\_160.3228\_095339\_A.JPG  
151.07FT, Crack Longitudinal, at 12 o'clock, within 8 inches of joint: YES

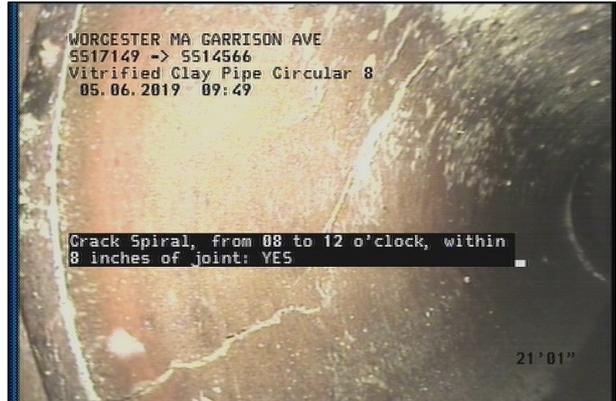
Photo:  
SS17149-SS14566\_05062019\_CS\_21.1162\_105717\_A.JPG  
21.12FT, Crack Spiral, from 08 to 12 o'clock, within 8 inches of joint: YES

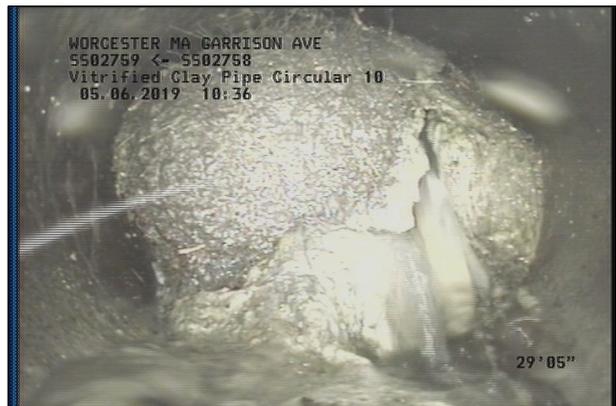
Photo:  
SS02758-SS02759\_05062019\_RBB\_29.4225\_114457\_A.JPG  
29.42FT, Roots Ball Barrell, from 12 to 12 o'clock, 95 %
