APPENDIX A
TELEVISION INSPECTION LOGS

Main Inspections Pipe Run with Images

Project name: WEST05-65	Mainline ID: SM00768	City: WORCESTER MA	Street: ASH ST
Start date/time: 20190510-121424	Direction: D	Weather: 1	Location code:
Shape: C	Material: VCP	Height: 12 in.	Width:

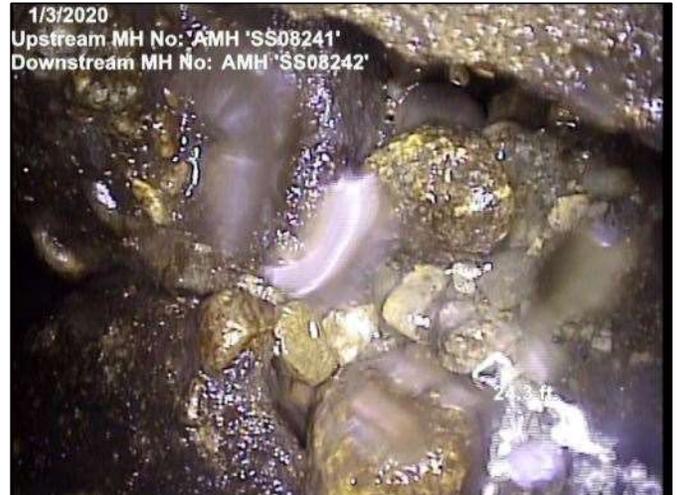
Photo: **SS08241-SS08242-20200103-083233-083604.JPG**
At: **15.8 ft. 6/. BSV - Broken Soil Visible**
Joint: **No**

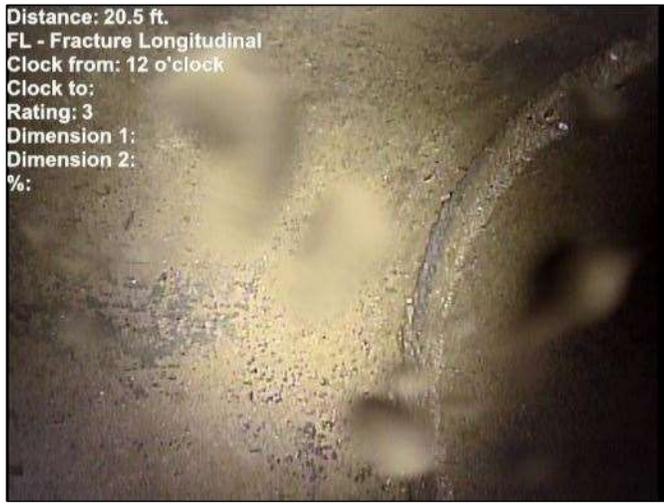
Photo: **SS08241-SS08242-20200103-083233-083700_1.JPG**
At: **20.5 ft. 12/. FL - Fracture Longitudinal**
Joint: **No**

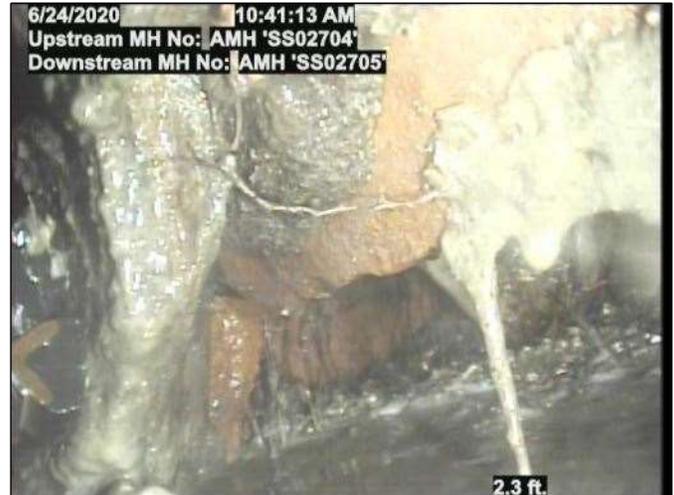
Photo: SS02704-SS02705-20200624-103910-104041_3.JPG
At: 1.8 ft. 7/9 BSV - Broken Soil Visible
Joint: Yes

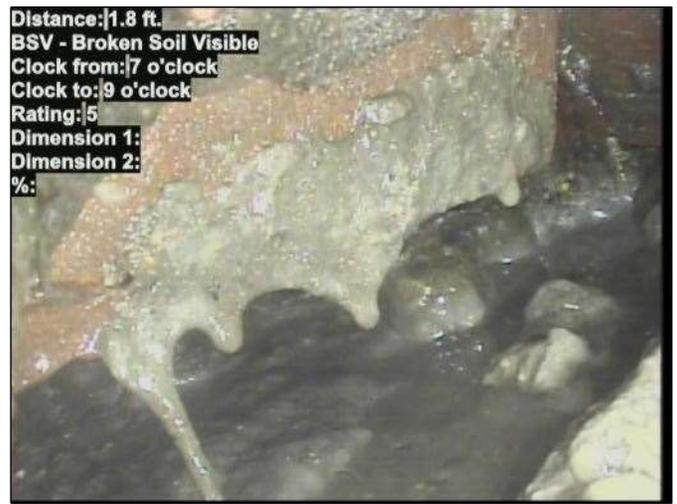
Distance:|1.8 ft.
BSV - Broken Soil Visible
Clock from:|7 o'clock
Clock to:|9 o'clock
Rating:|5
Dimension 1:
Dimension 2:
%:

Photo: SS02704-SS02705-20200624-103910-104041_1.JPG
At: 1.8 ft. 7/9 BSV - Broken Soil Visible
Joint: Yes
