ROAD SAFETY AUDIT

Chandler Street Corridor

City of Worcester

August 4, 2020

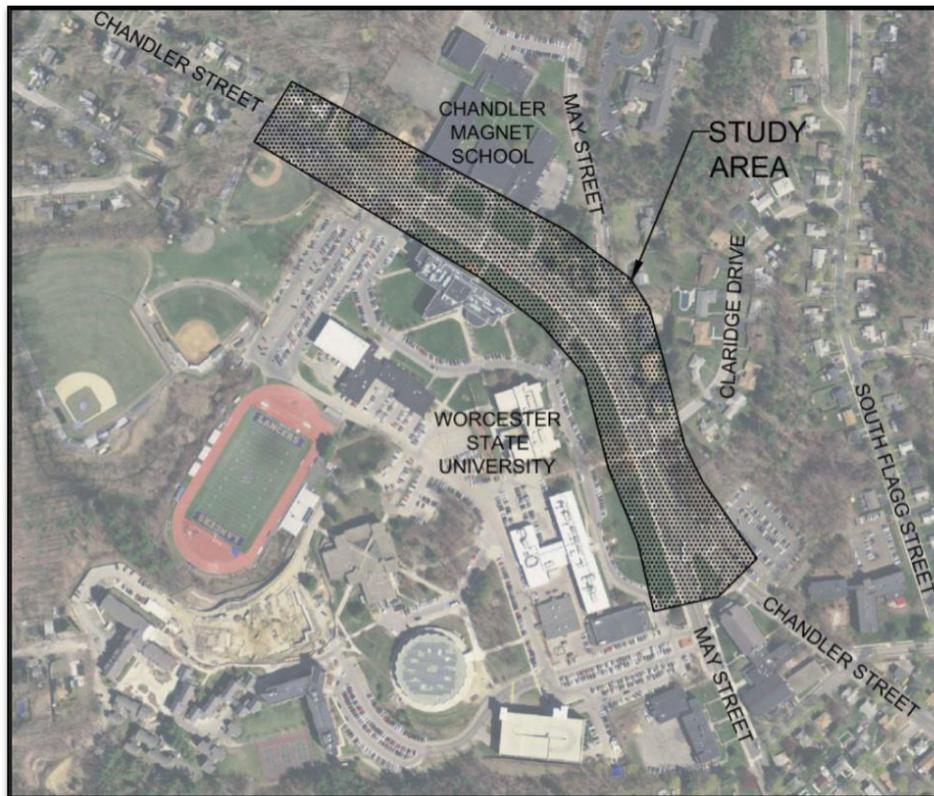
The southern intersection is a Y-type intersection with May Street being stop-controlled. Chandler Street southbound traffic splits into two lanes at Claridge Drive, with each lane providing uninterrupted flow through to May Street or Chandler Street. These lanes are not formally channelized and instead are designated through line striping as shown in the aerial image below.

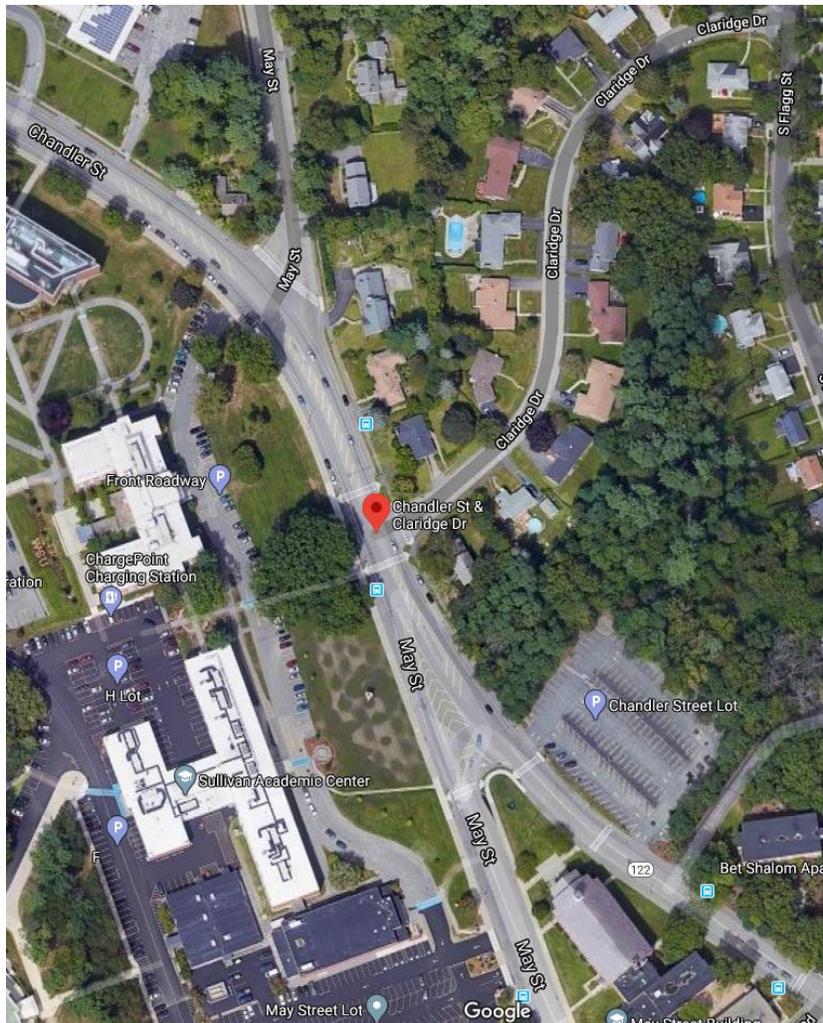
Claridge Drive Intersection

The intersection of Claridge Drive is a T-type intersection with Claridge Drive having the stop controlled approach. There is a marked crosswalk across Claridge Drive and two marked crosswalks across Chandler Street on either side.
