Re: Pre-Demolition Hazardous Materials Building Survey
Denholm Building
484-500 Main Street
Worcester, Massachusetts

Hazardous Materials Survey
Denholm Building
484-500 Main Street, Worcester, MA
Site Visit Photographs

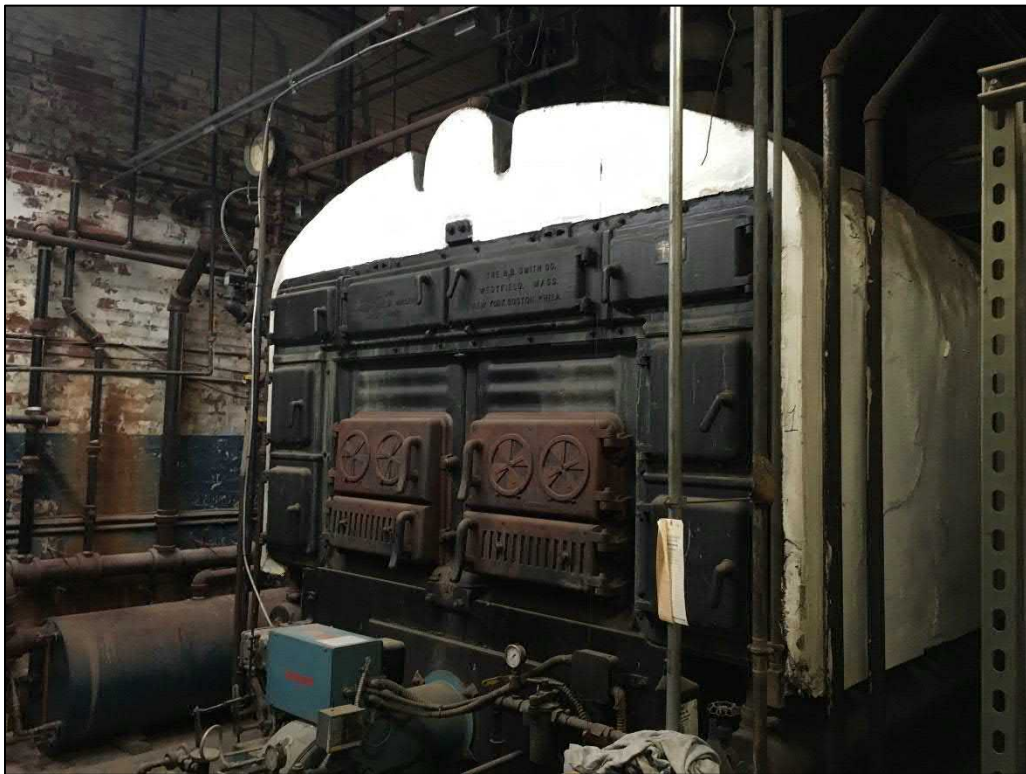
One of two steam boilers on-site; boiler jacket 40% asbestos

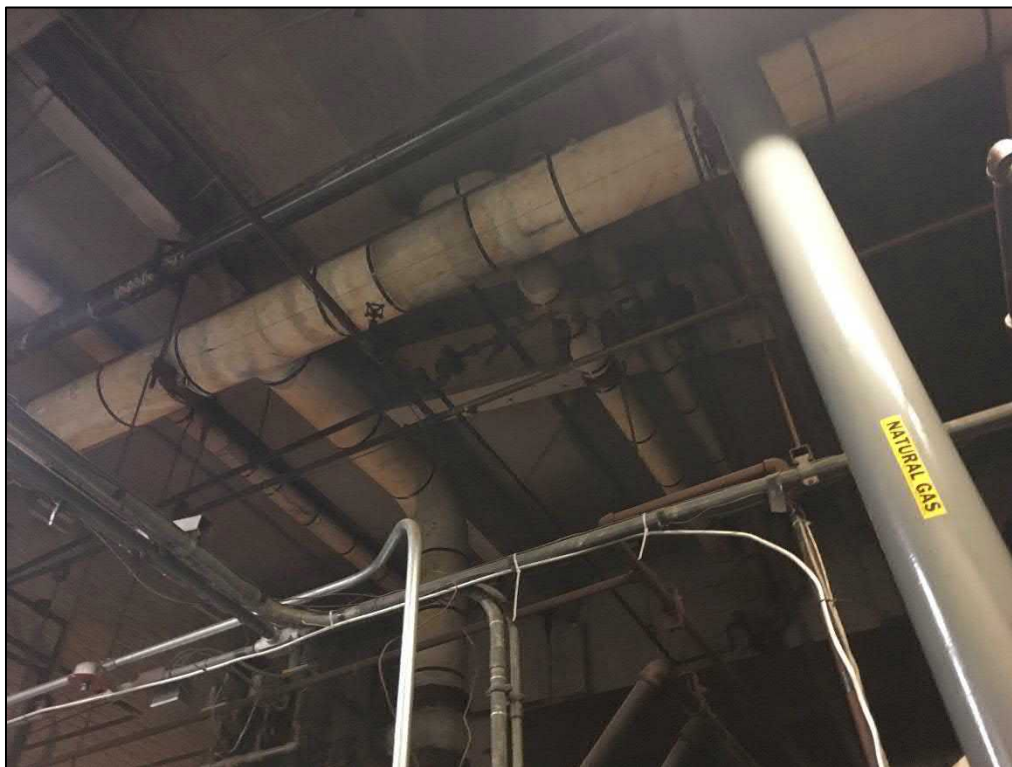
- TSI materials (boiler insulation, pipe insulation, pipe elbows and tees); 35-70% asbestos; located throughout building; extent/quantity of material is unknown.

TSI on piping above boilers

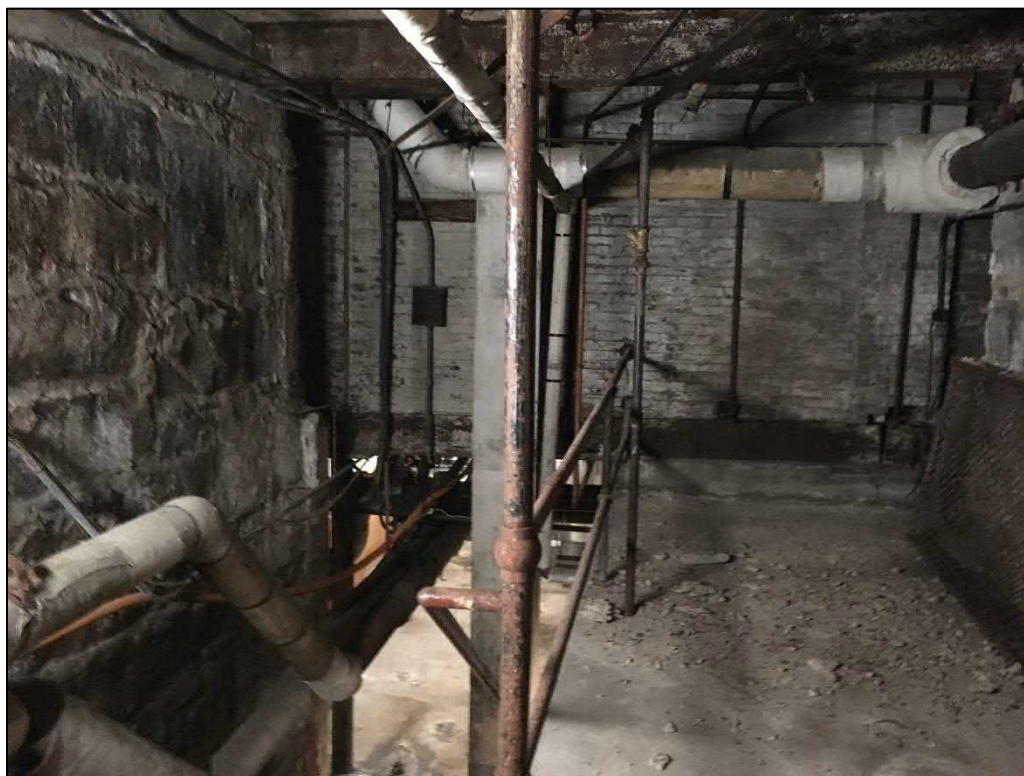
TSI on piping at ceiling and along walls; 35-70% asbestos

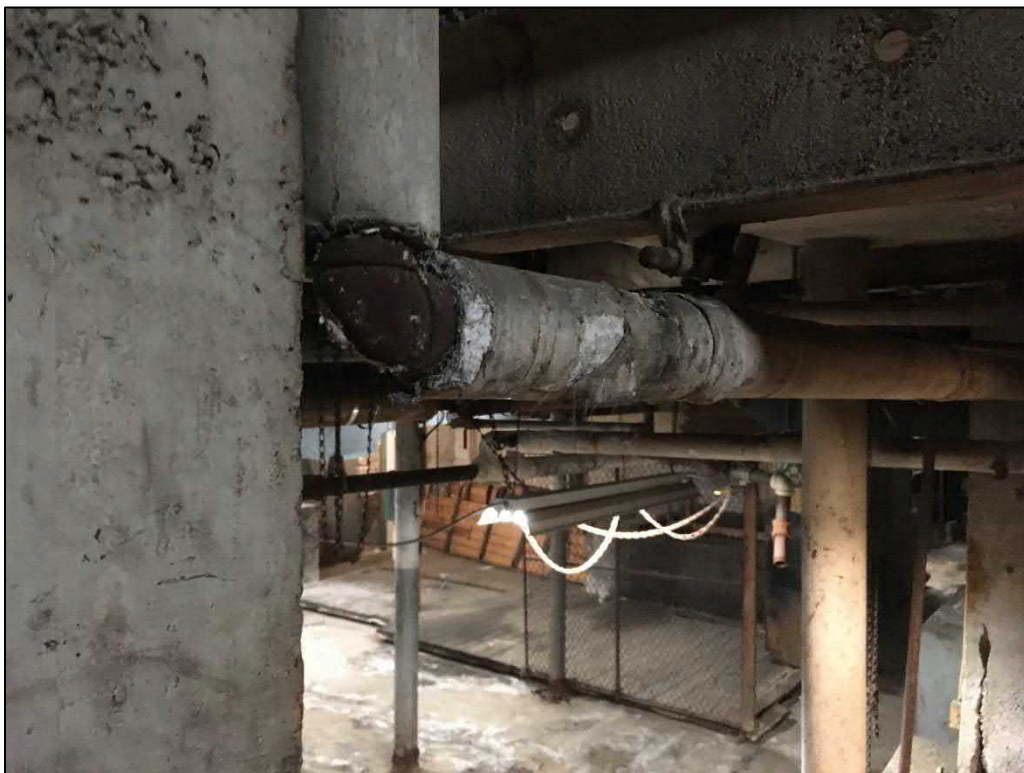
TSI along ceiling; 35-70% asbestos

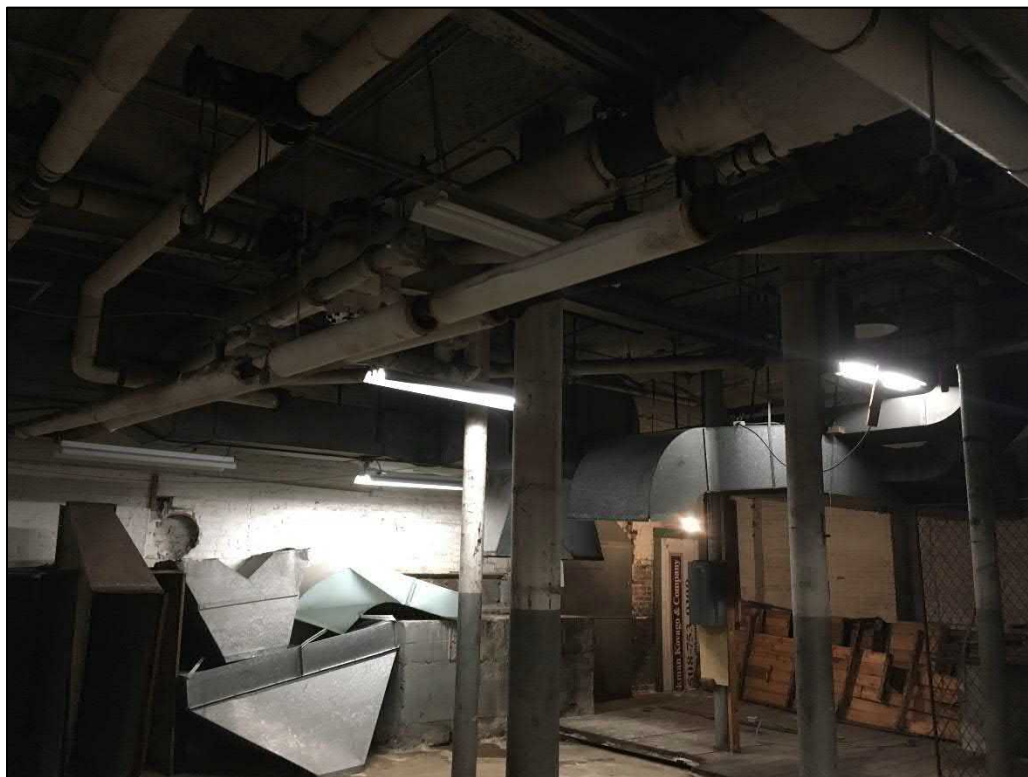
TSI along ceiling; 35-70% asbestos

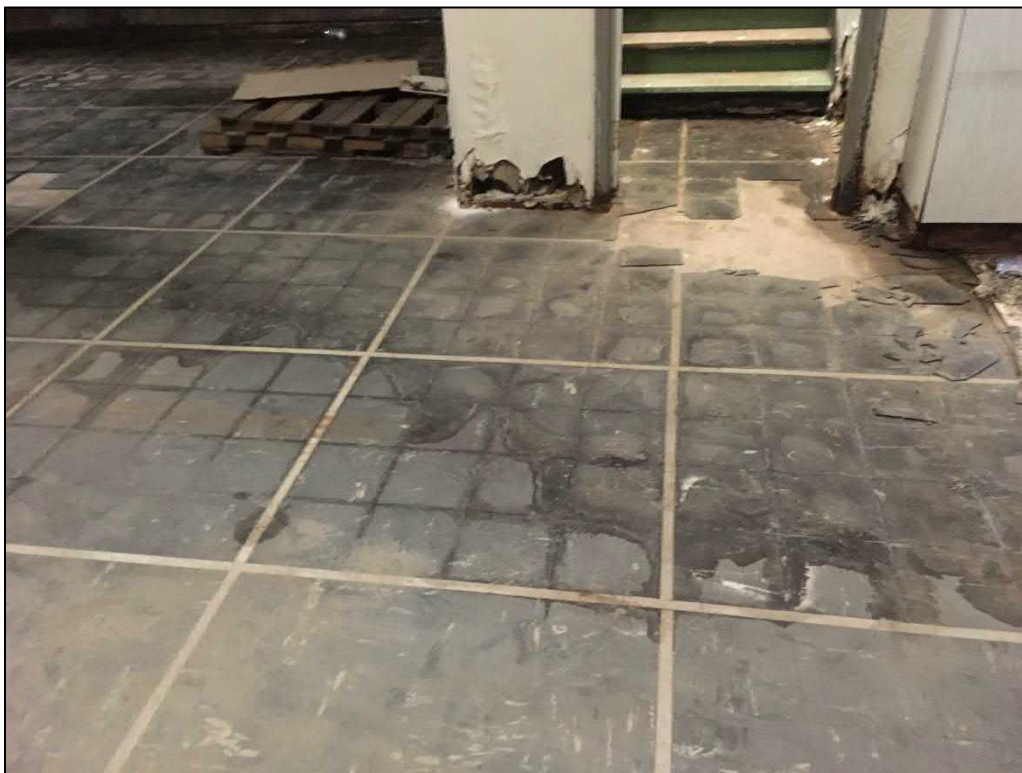
Black 9"x9" floor tiles in basement; 3% asbestos

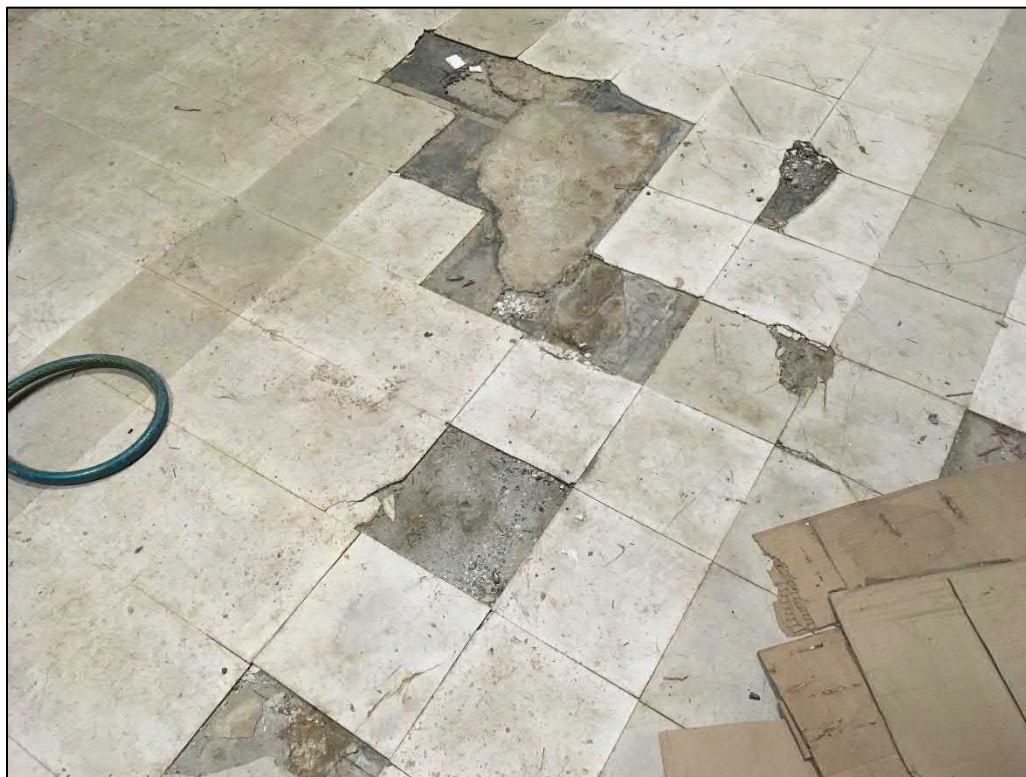
Beige 12"x12" tiles w. mastic (8% asbestos) over black 9"x9" tiles (3% asbestos) over gray leveler (10% asbestos)

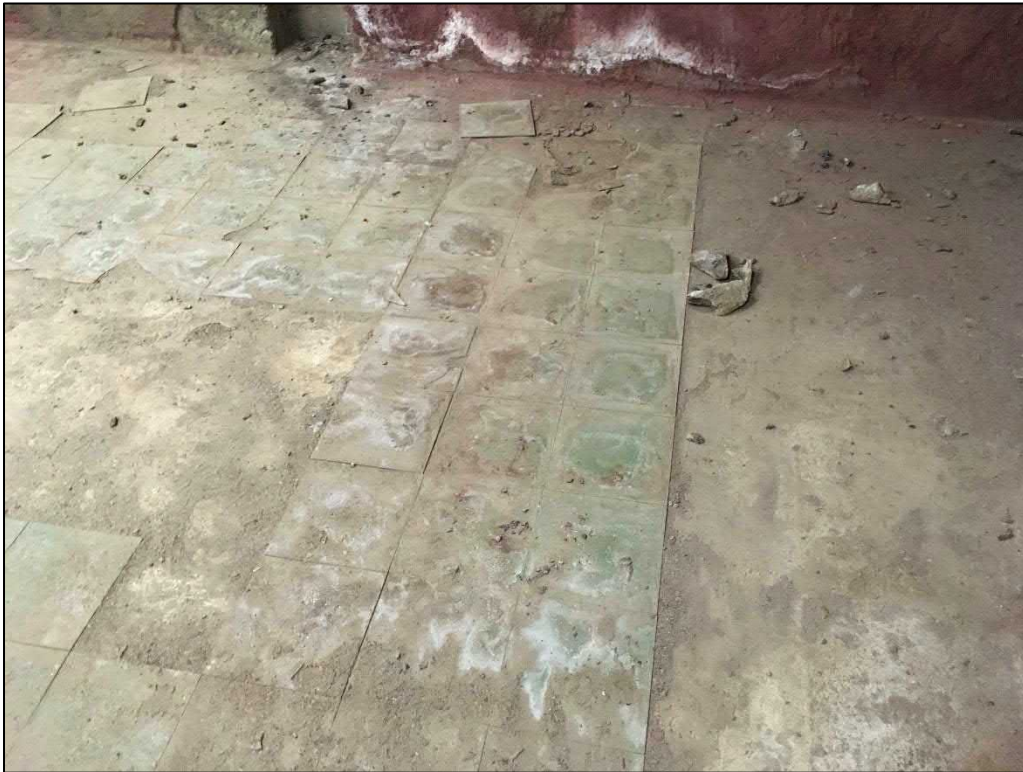
Green 9"x9" floor tiles in basement; 3% asbestos

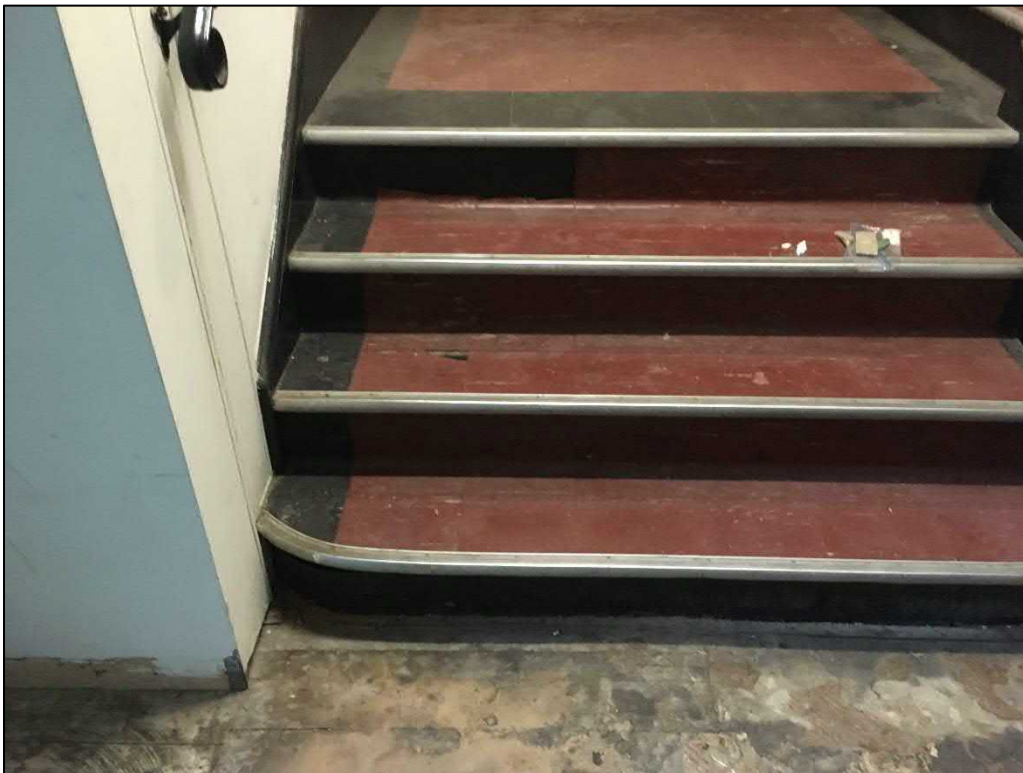
Black & red floor tiles in south stairwell; 5% asbestos

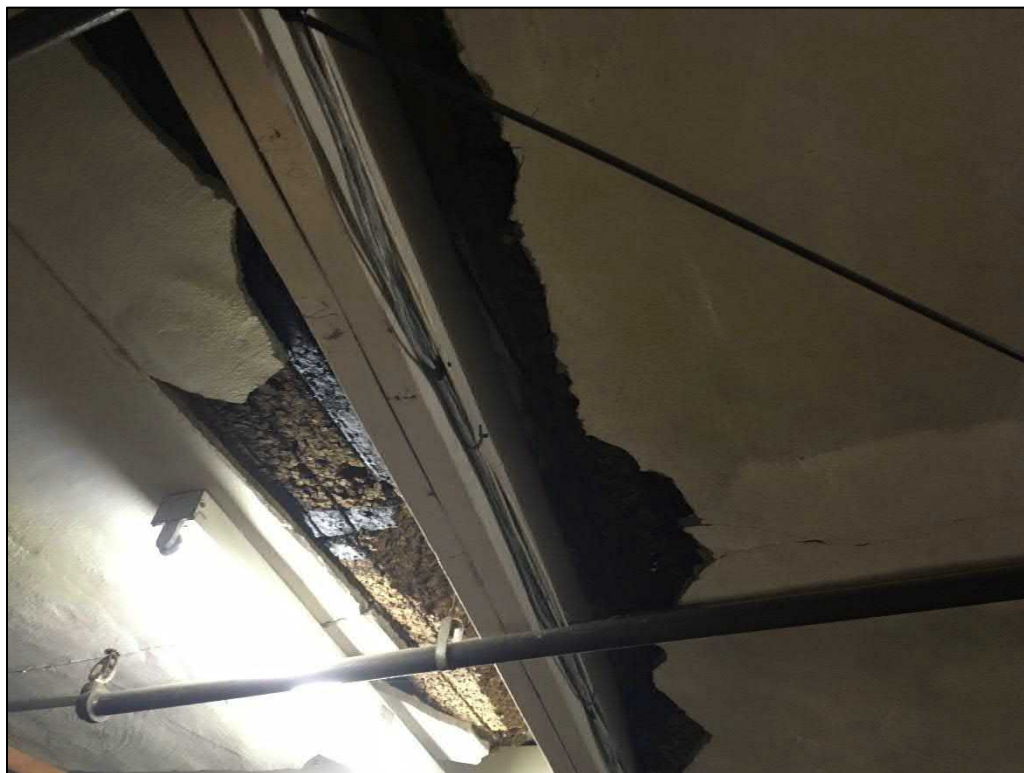
- White ceiling paint in the 1st floor attic / mechanical area; 51.6 mg/kg.
- Black coating on cork ceiling and walls; 2nd floor storage room in western part of building; 64.4 mg/kg.

Black coating on cork ceiling, second floor storage room; PCBs 64.4 mg/kg

Materials containing PCBs at concentrations greater than 50 mg/kg are considered to be a PCB Bulk Product Waste and should be disposed of according to TSCA regulations. Additional assessment of materials / strata surrounding the materials containing PCBs >50 ppm would be required per TSCA regulations. Building materials with concentrations greater than 1 mg/kg but less than 50 mg/kg are considered to be Federally Excluded PCB Product if the total PCB concentration in the original material has not been modified by subsequent activities. Building materials containing PCBs at concentrations less than 1 mg/kg are not regulated and can be managed as general construction waste.

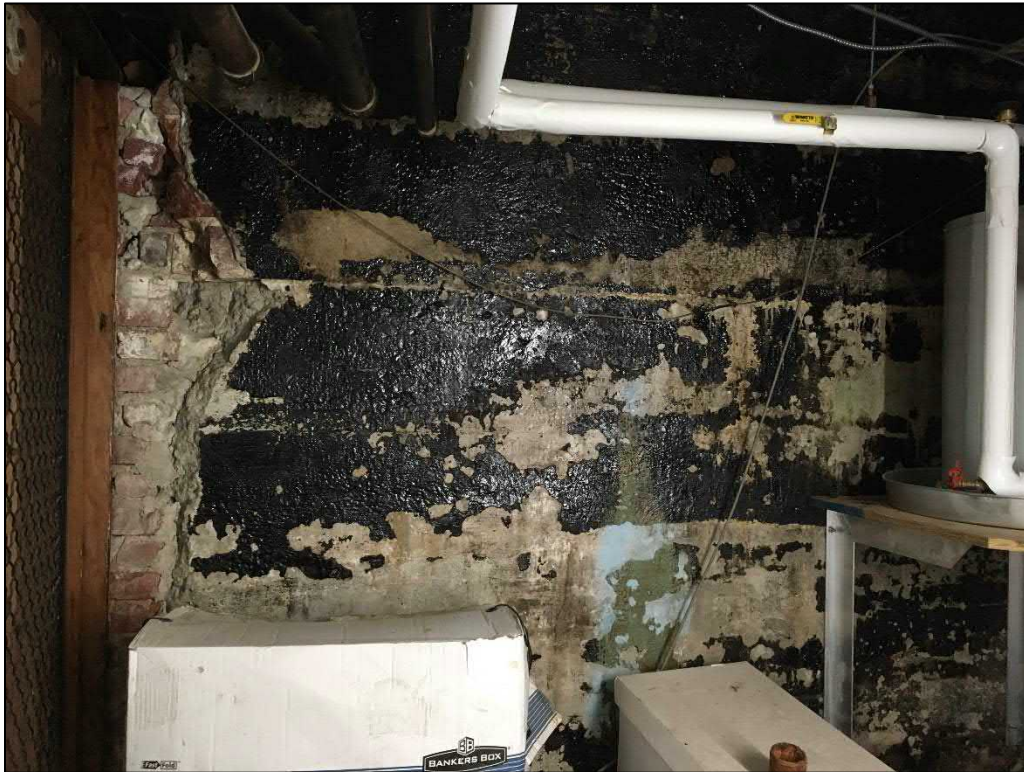
Black coating on walls, second floor storage room; PCBs 64.4 mg/kg

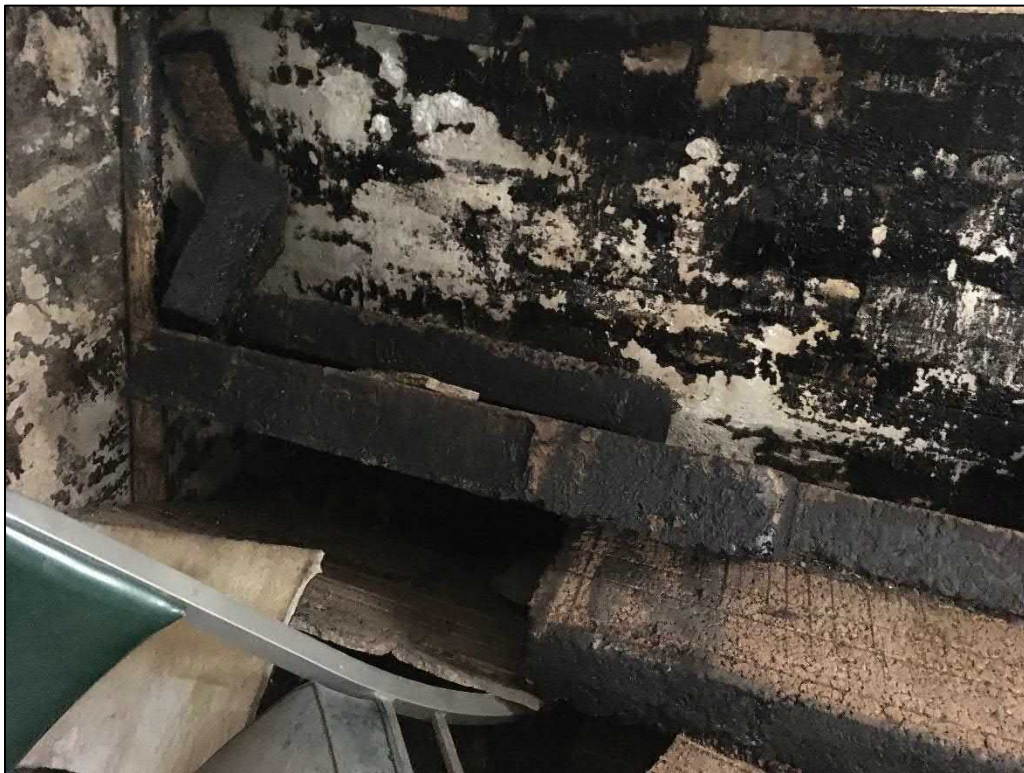
Black coating on cork wallboard, second floor storage room; PCBs 64.4 mg/kg

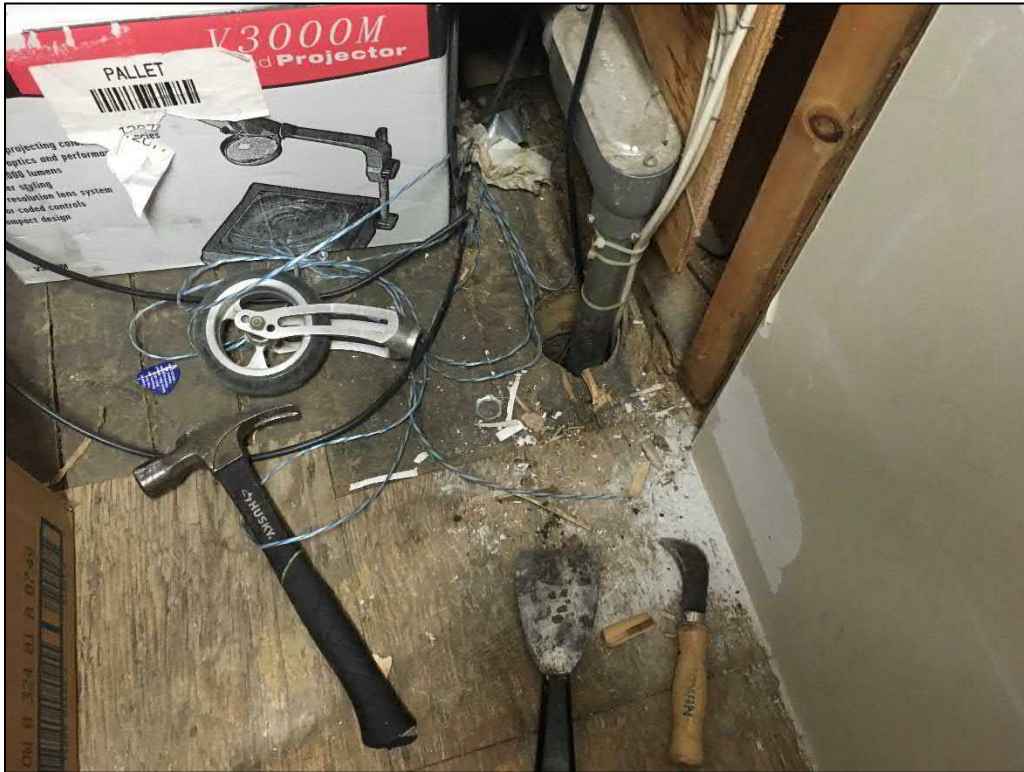
Paper layer identified beneath wood floor (3rd & 4th floors); 40% asbestos

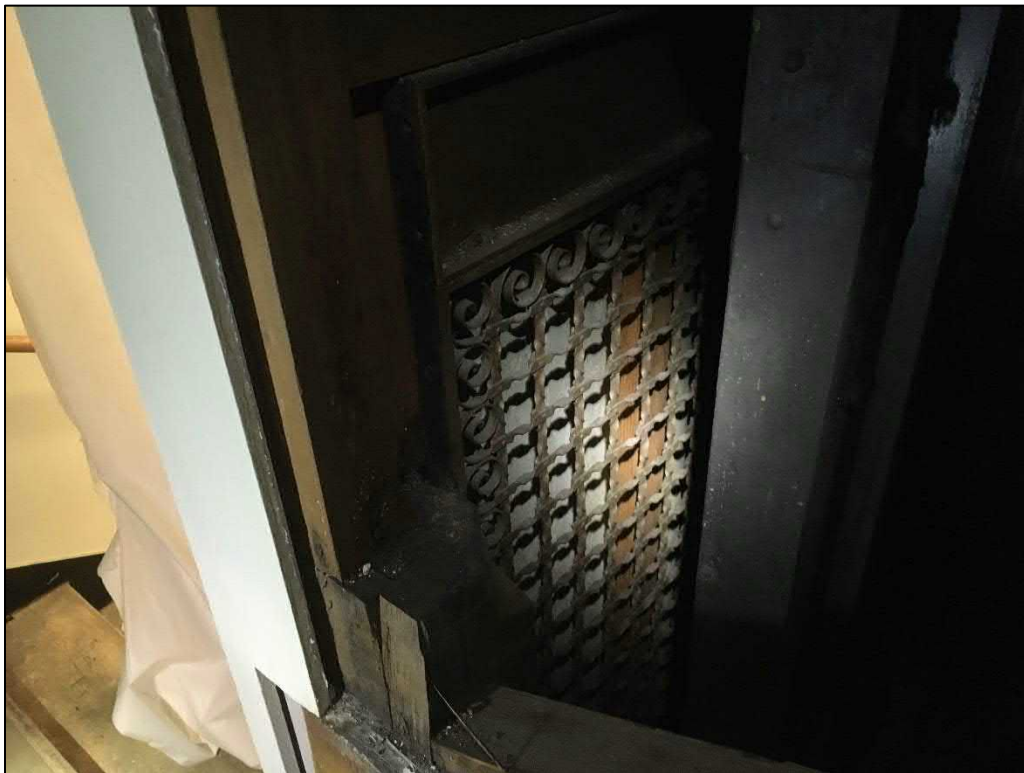
As noted, BETA observed one out-of-service freight elevator in the site structure that was reportedly cable-driven. BETA observed multiple gray panels inside of the elevator shaft that appeared to potentially contain transite, a type of asbestos; however, the panels were not physically accessible for sampling. These panels should be assumed to contain asbestos. BETA observed multiple fire doors throughout the building and on most levels. Fire doors may contain asbestos within their metal or wood exterior; however, the interiors of the fire doors were not accessible for sampling without destructive sampling techniques. These doors should be assumed to contain asbestos.

Possible transite panel in freight elevator shaft

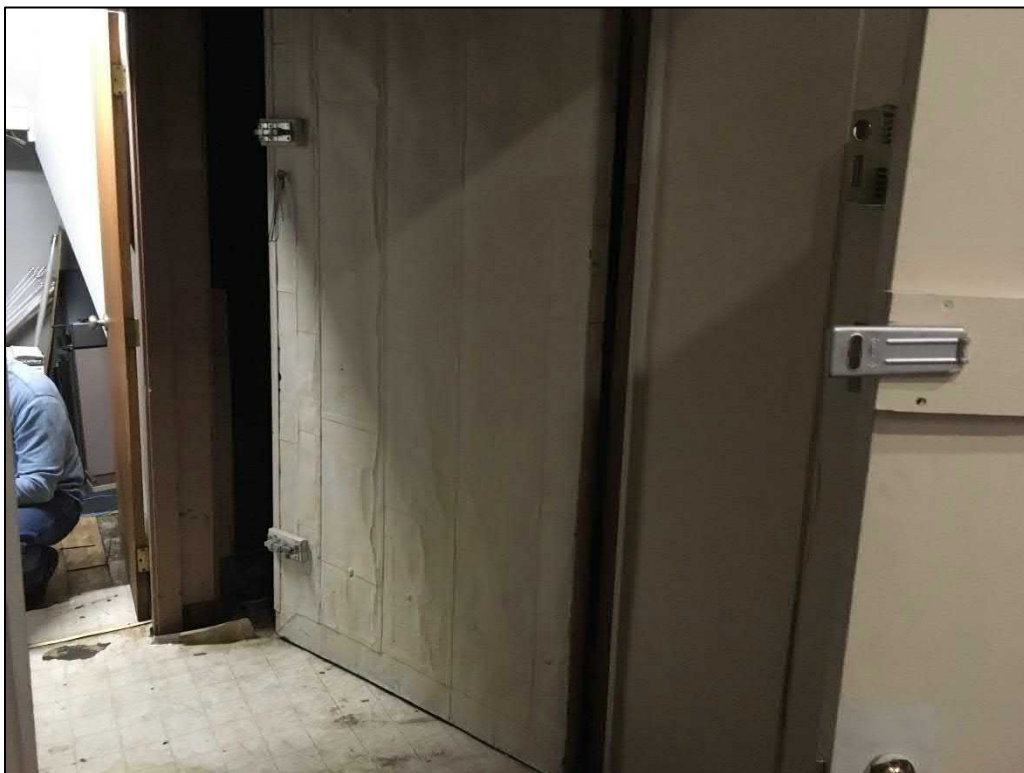
Fire door (possible asbestos inside)

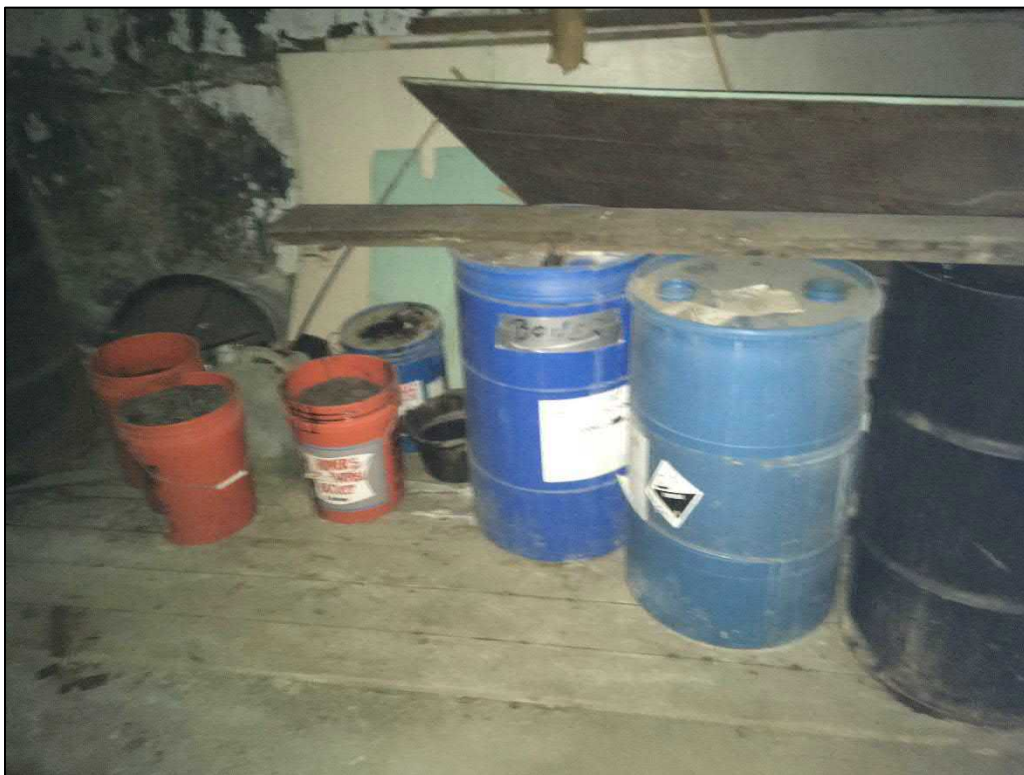
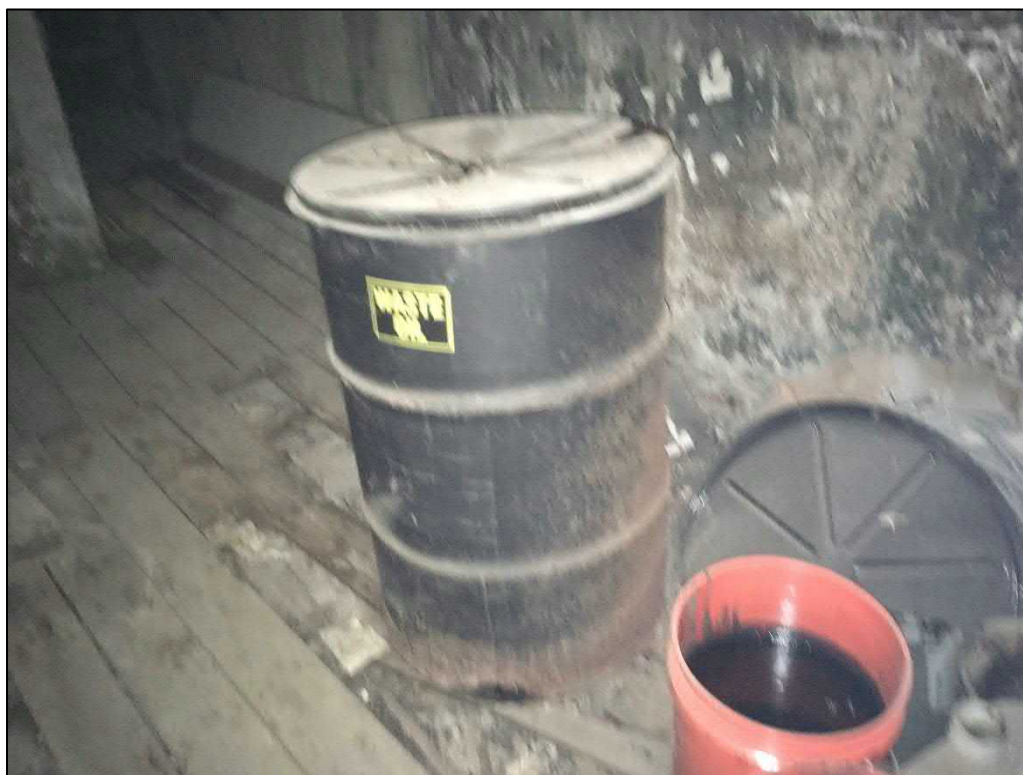
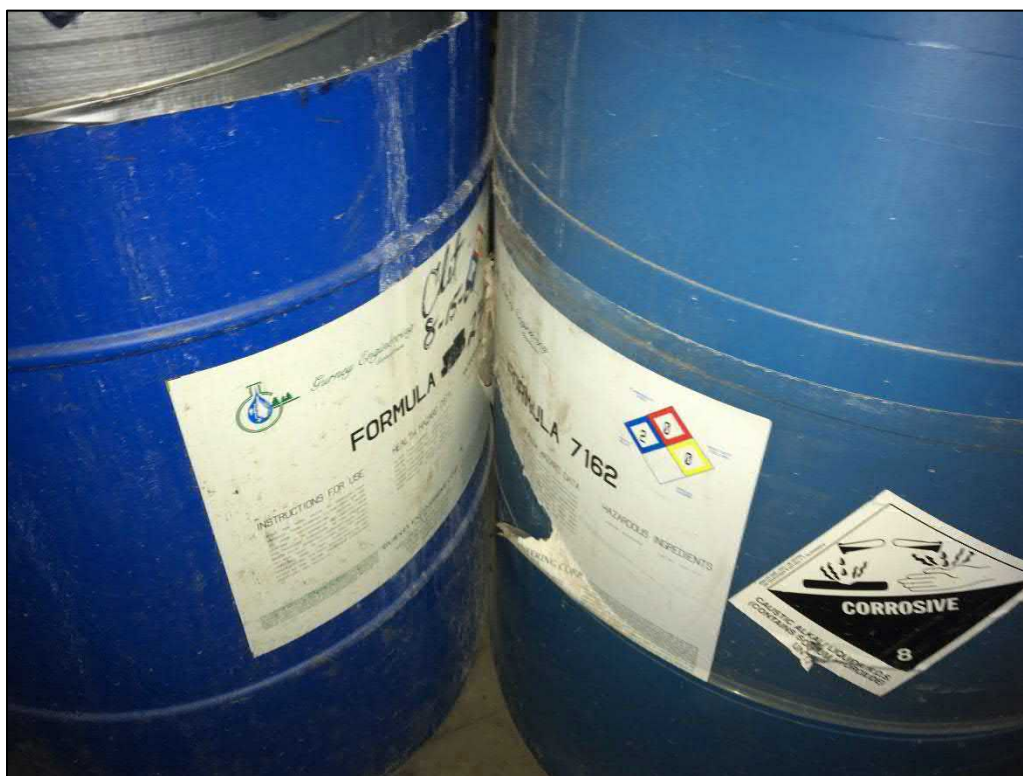
- (4) 55-gallon drums of waste oil (boiler room);
- (2) 55-gallon drums of corrosive liquid (boiler room);
- (5) 5-gallon buckets of waste oil (boiler room);
- (Approx. 20) 5-gallon buckets of various waste oils and/or other liquids (near generator room); and,
- (2) 55-gallon drums of hydraulic fluid (basement level near out-of-service freight elevator).

OHMs in boiler room

Containers of oils and/or other hazardous materials must be disposed of properly prior to site redevelopment. Potential PCB and mercury sources were observed at the site. Lighting ballasts must be recycled / disposed of in accordance with MassDEP's *Policy for Disposal of Lighting Ballasts*, dated January 16, 1992. Fluorescent tubes and bulbs, along with thermostats must be recycled / disposed of in accordance with MassDEP's *Universal Waste Rule*, dated October 17, 1997. Non-PCB and potential / assumed PCB containing light ballasts can be readily separated / managed during demolition activities.

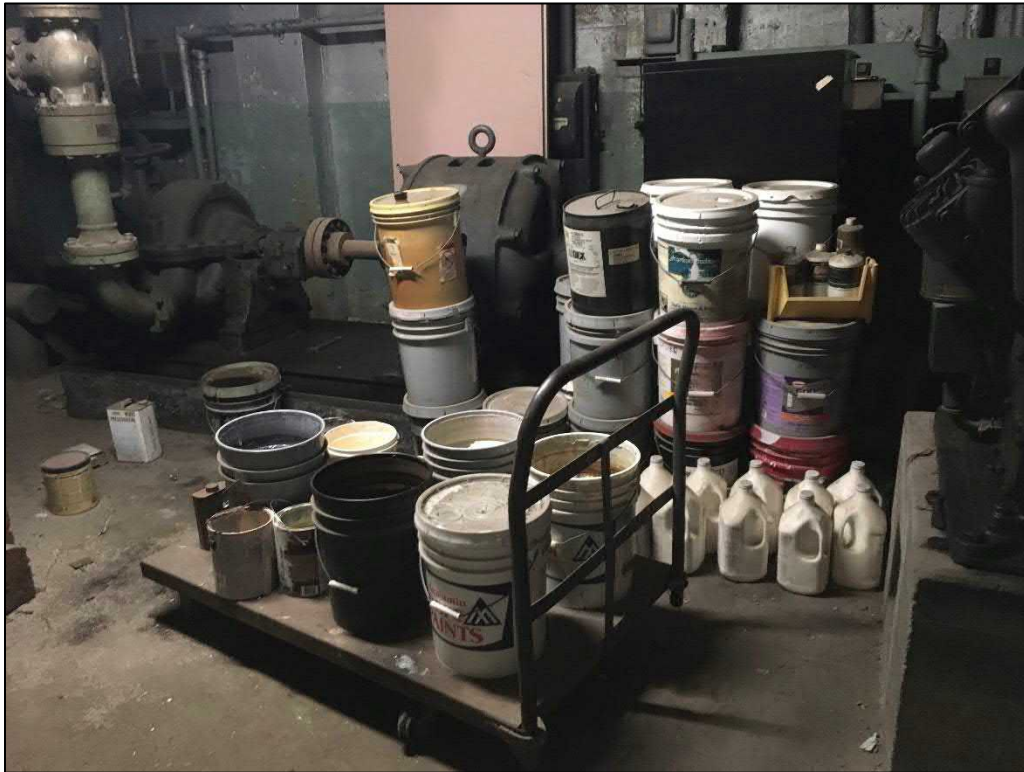
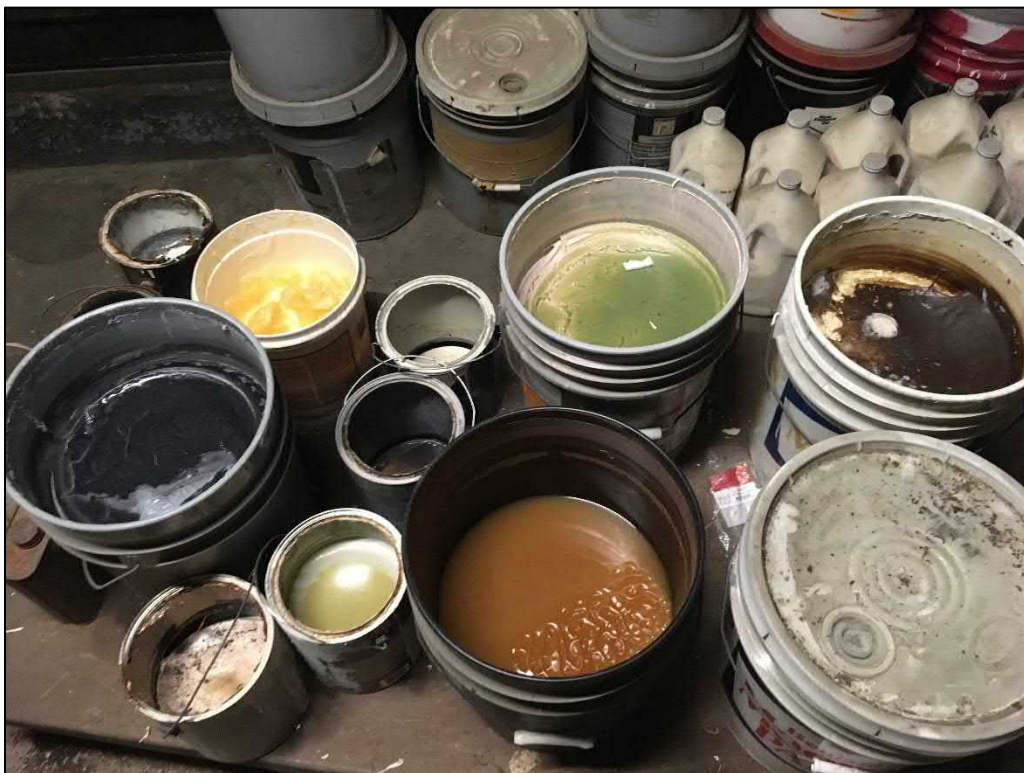
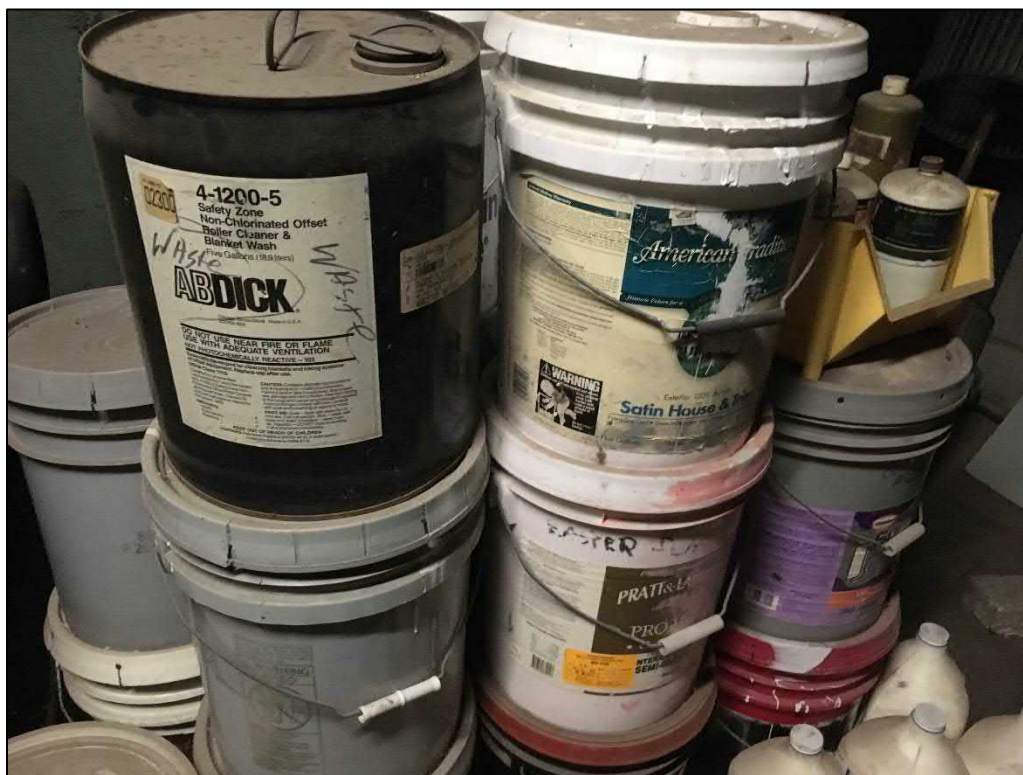
OHMs near generator room

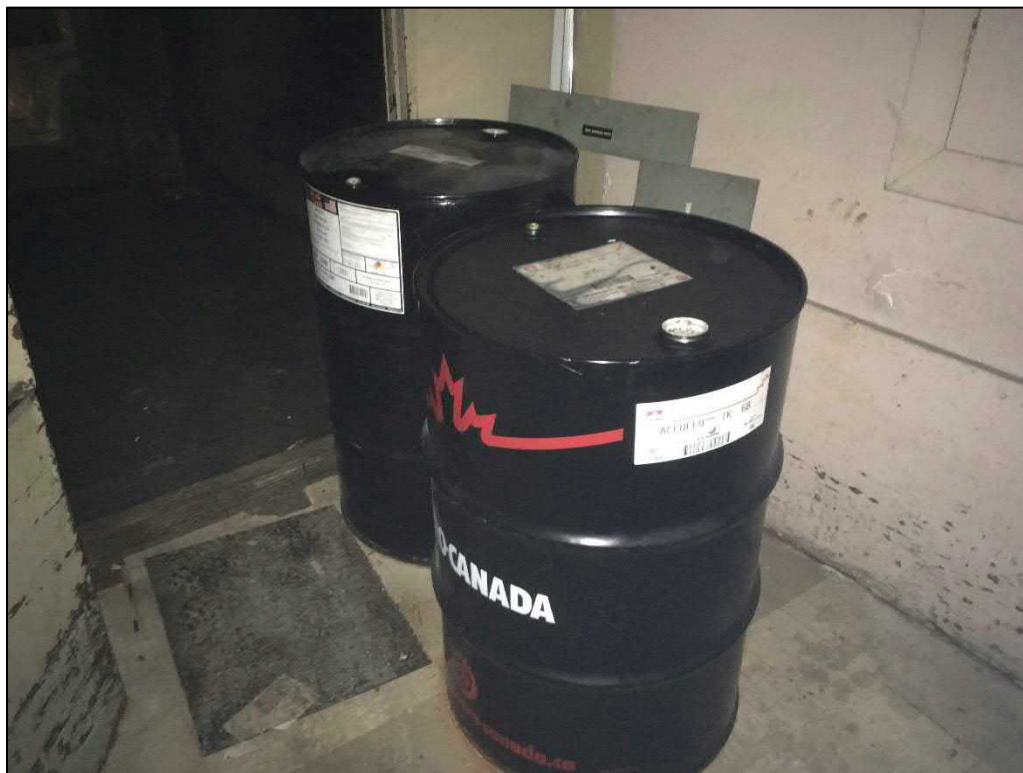
OHMs near freight elevator shaft
