WORCESTER CONSERVATION COMMISSION

# Fitzgerald Brook

Conservation Property Baseline Assessment

July 2024

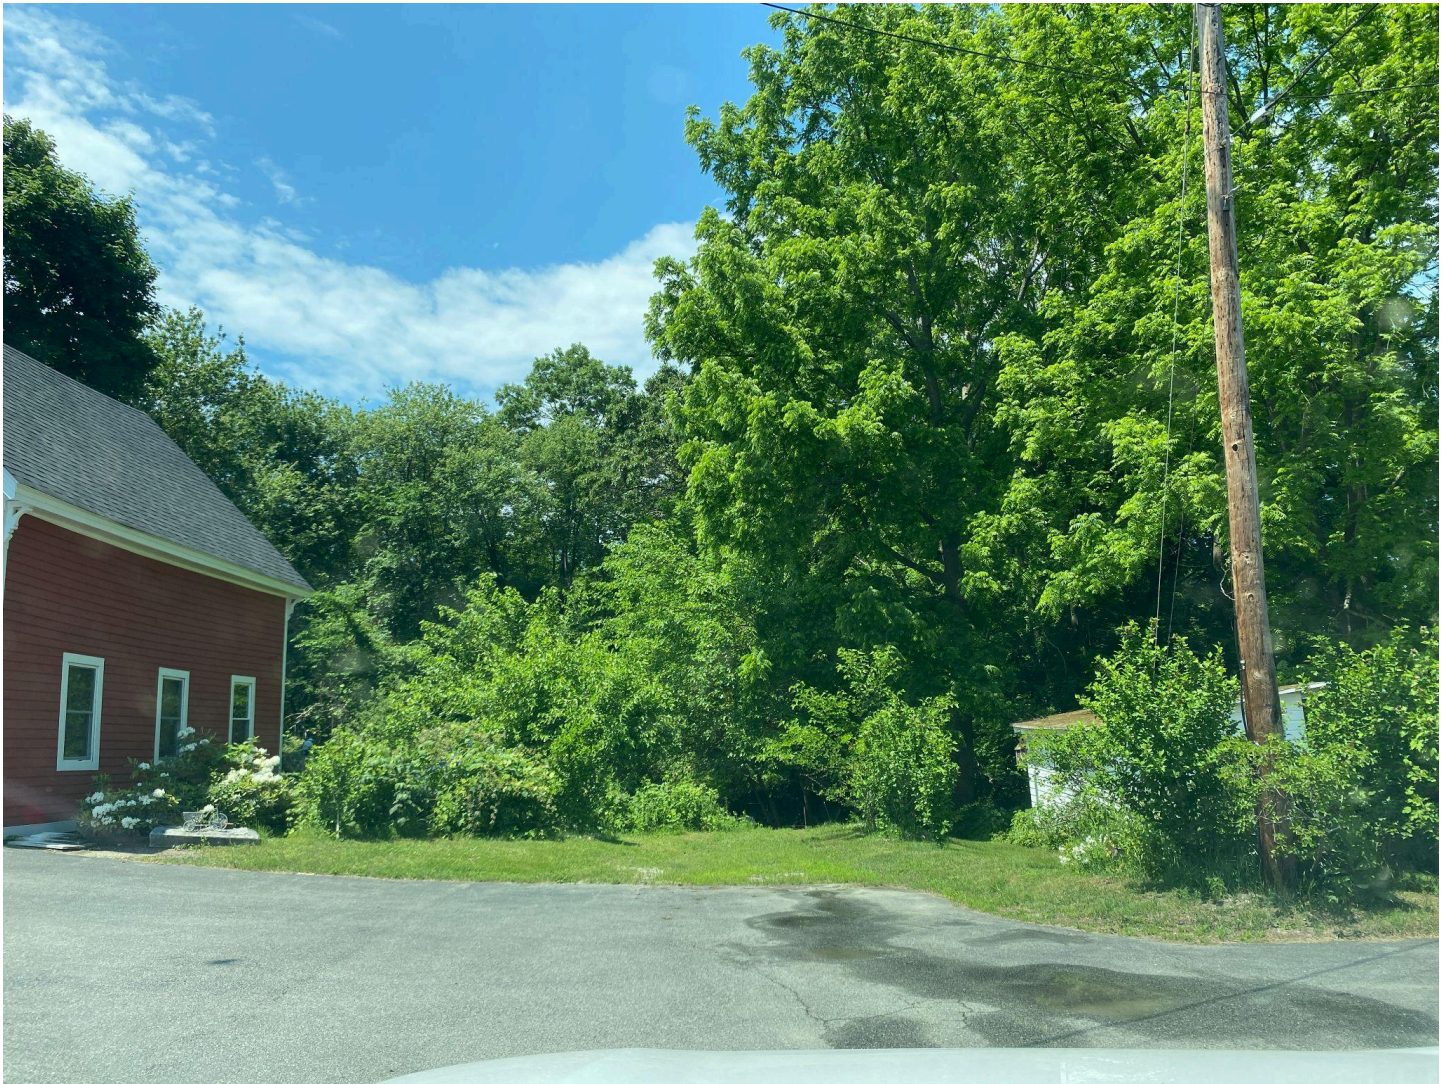
**Photo 1**

**Comments:** Anna Street meets the Fitzgerald Brook property at a dead end by 88 and 90 Locust Street. There is no signage indicating a conservation property boundary and no access to the property.

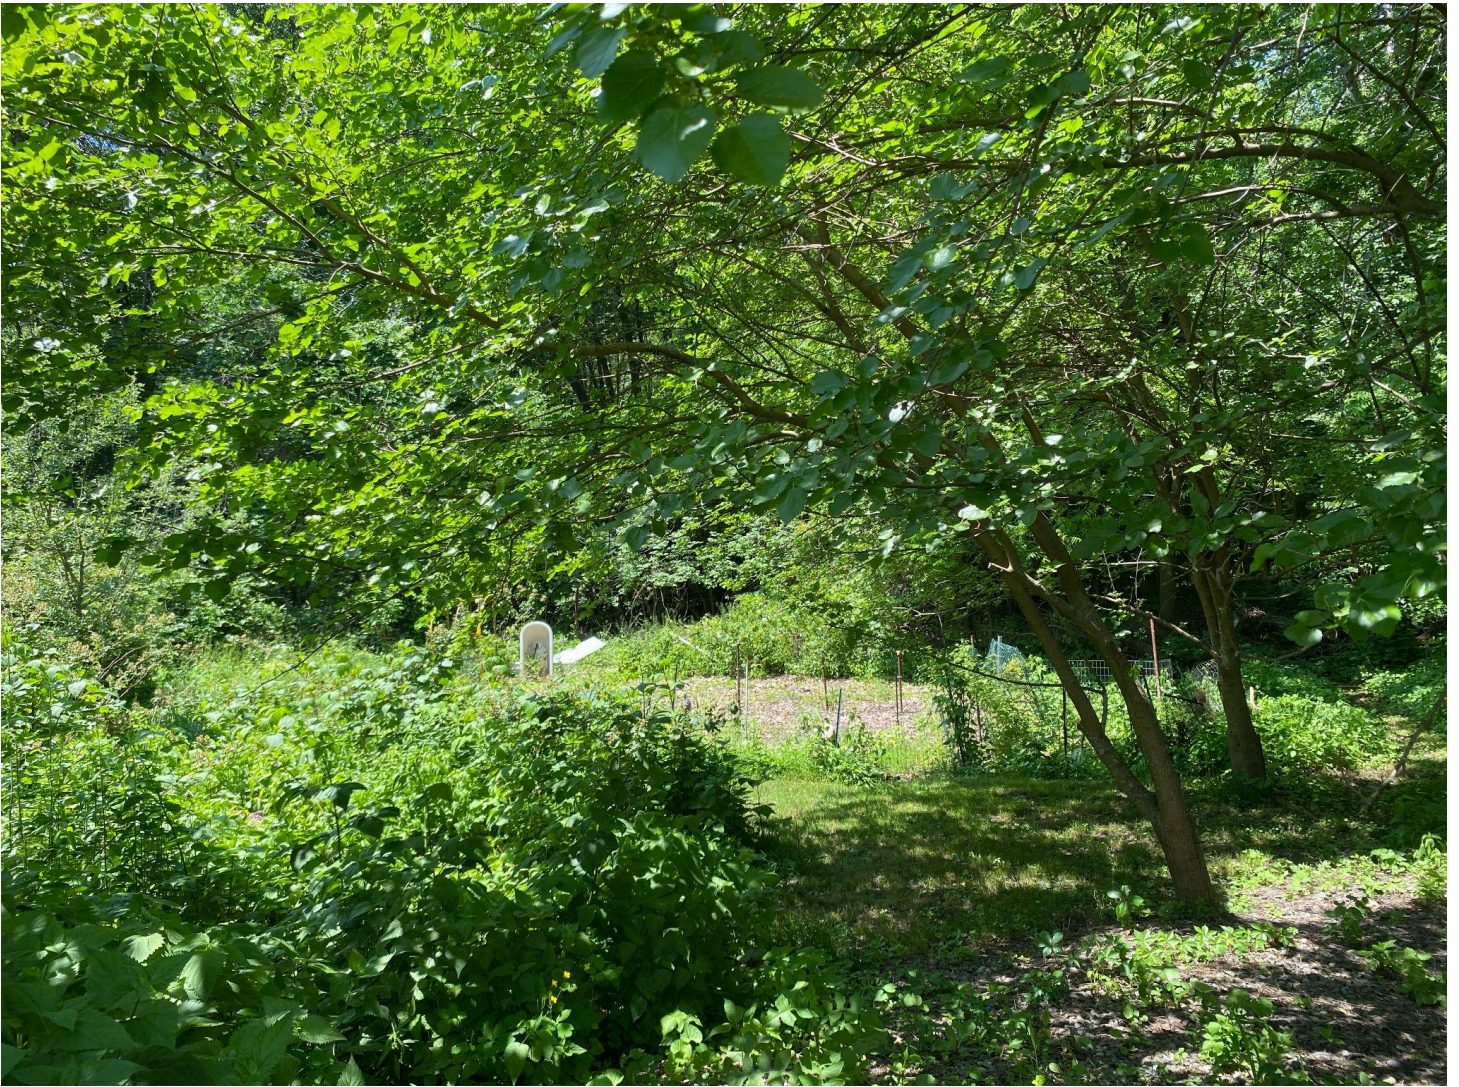
**Photo 2**

**Comments:** Garden and yard waste dumping on conservation property behind 88 and 90 Locust Street.

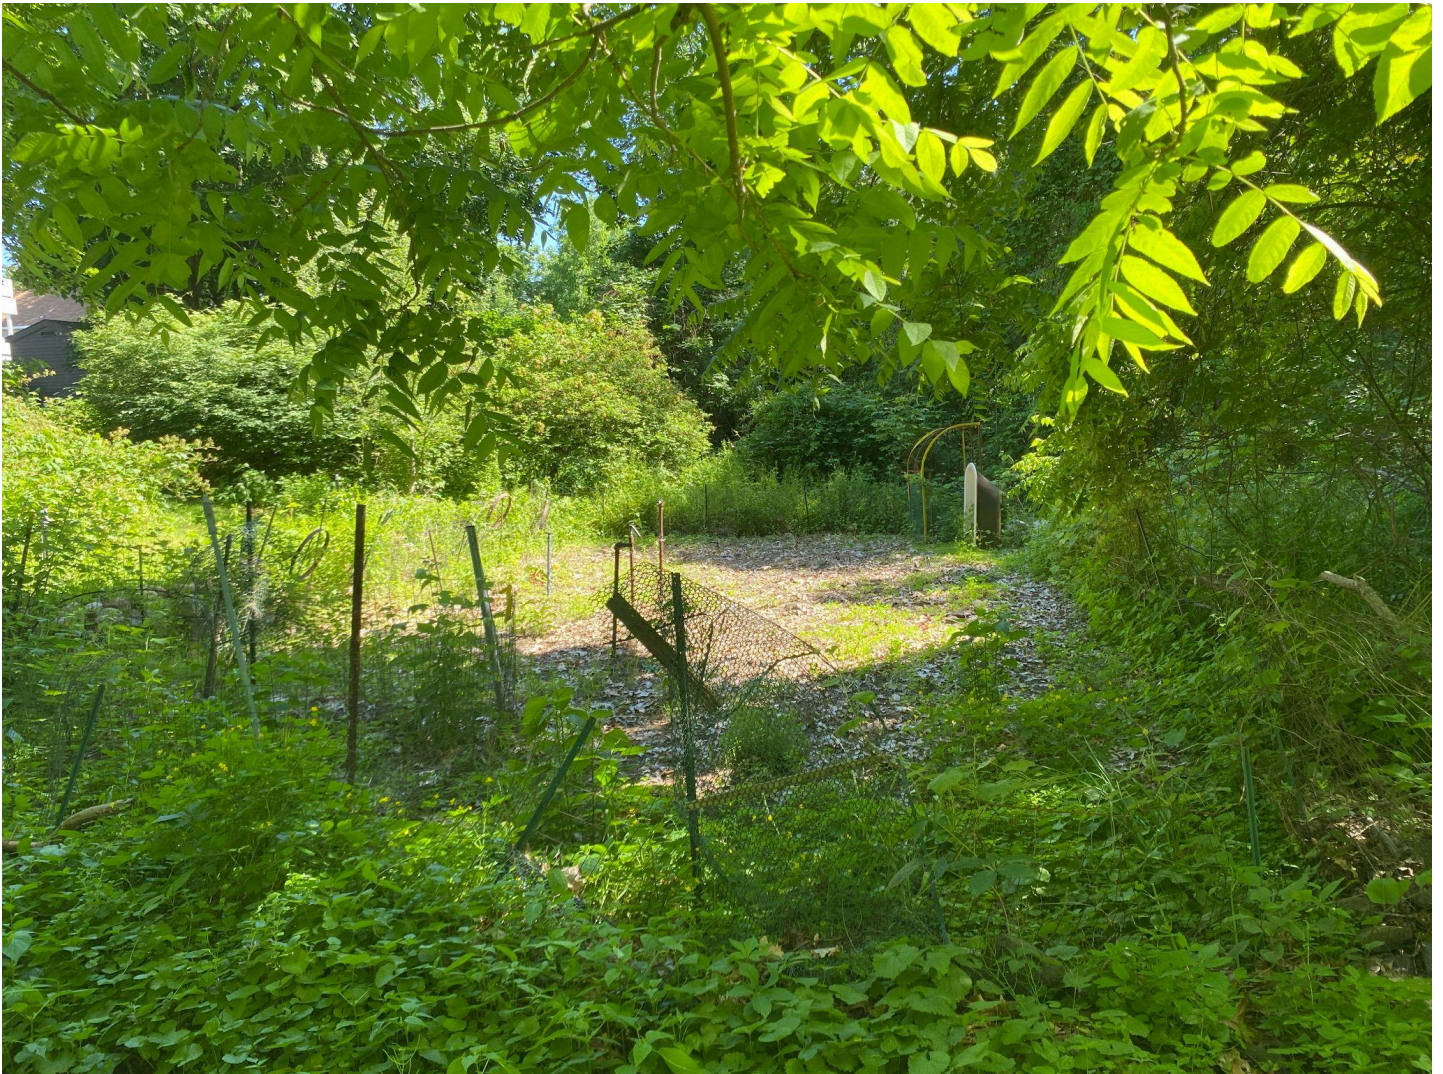
**Photo 3**

**Comments:** Additional view of garden on conservation property behind 88 and 90 Locust Street.

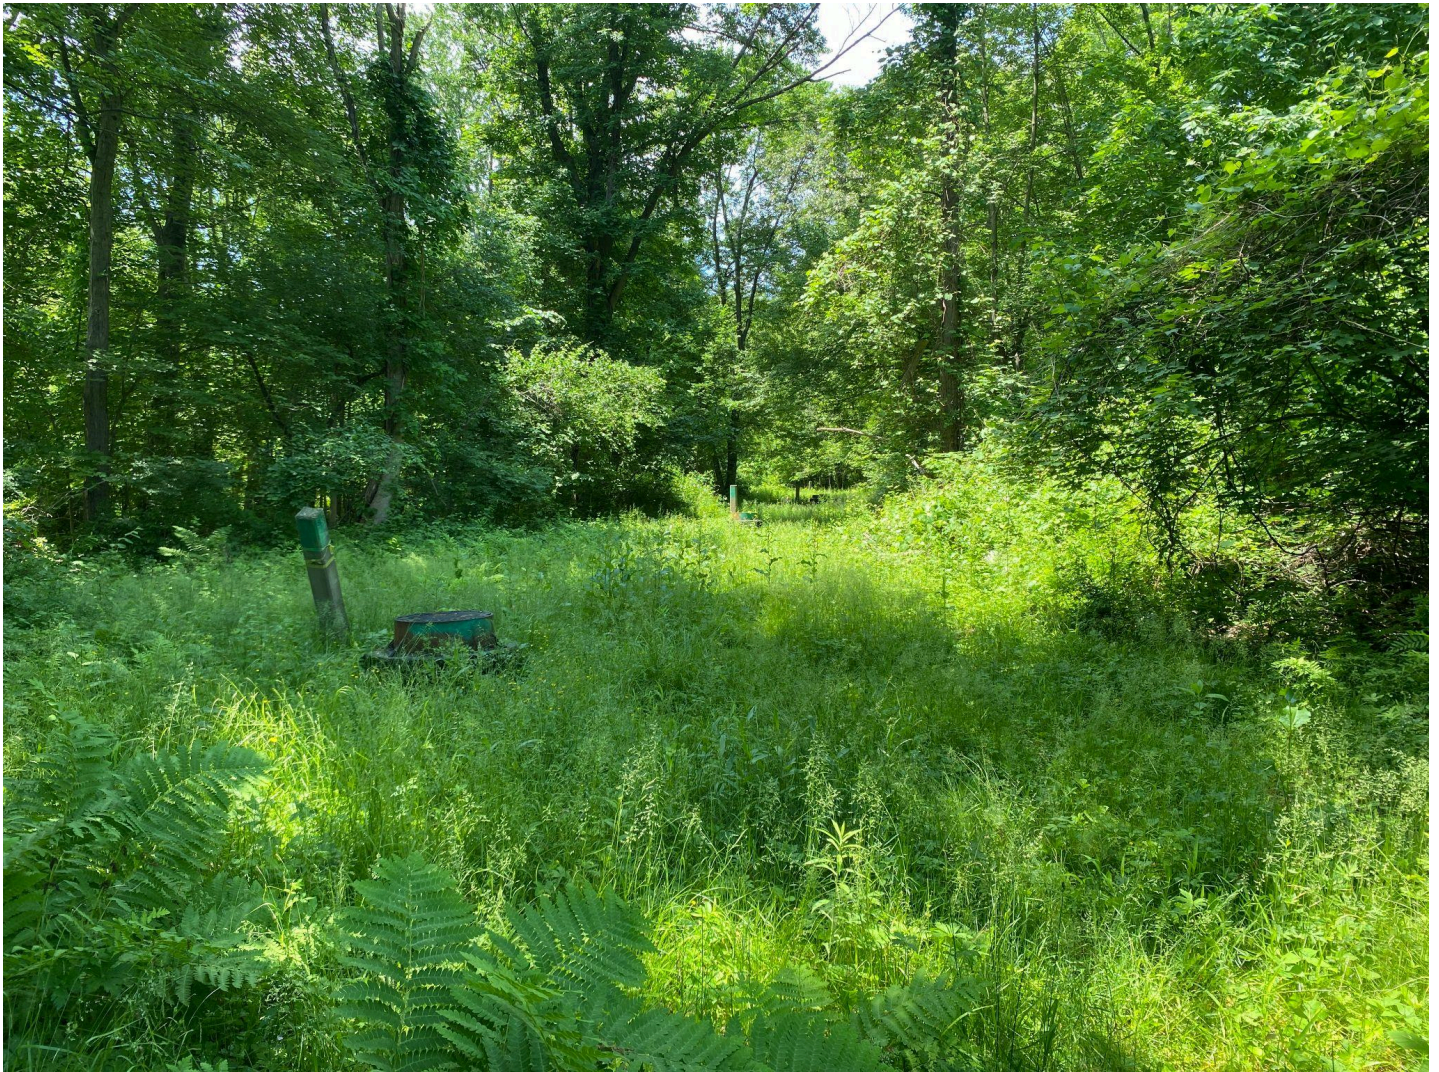
**Photo 4**

**Comments:** A utility easement extends through the Fitzgerald Brook property from the Alvarado Avenue cul-de-sac to a railroad berm at the western property boundary. The easement is covered with low growth vegetation, with a series of raised manholes

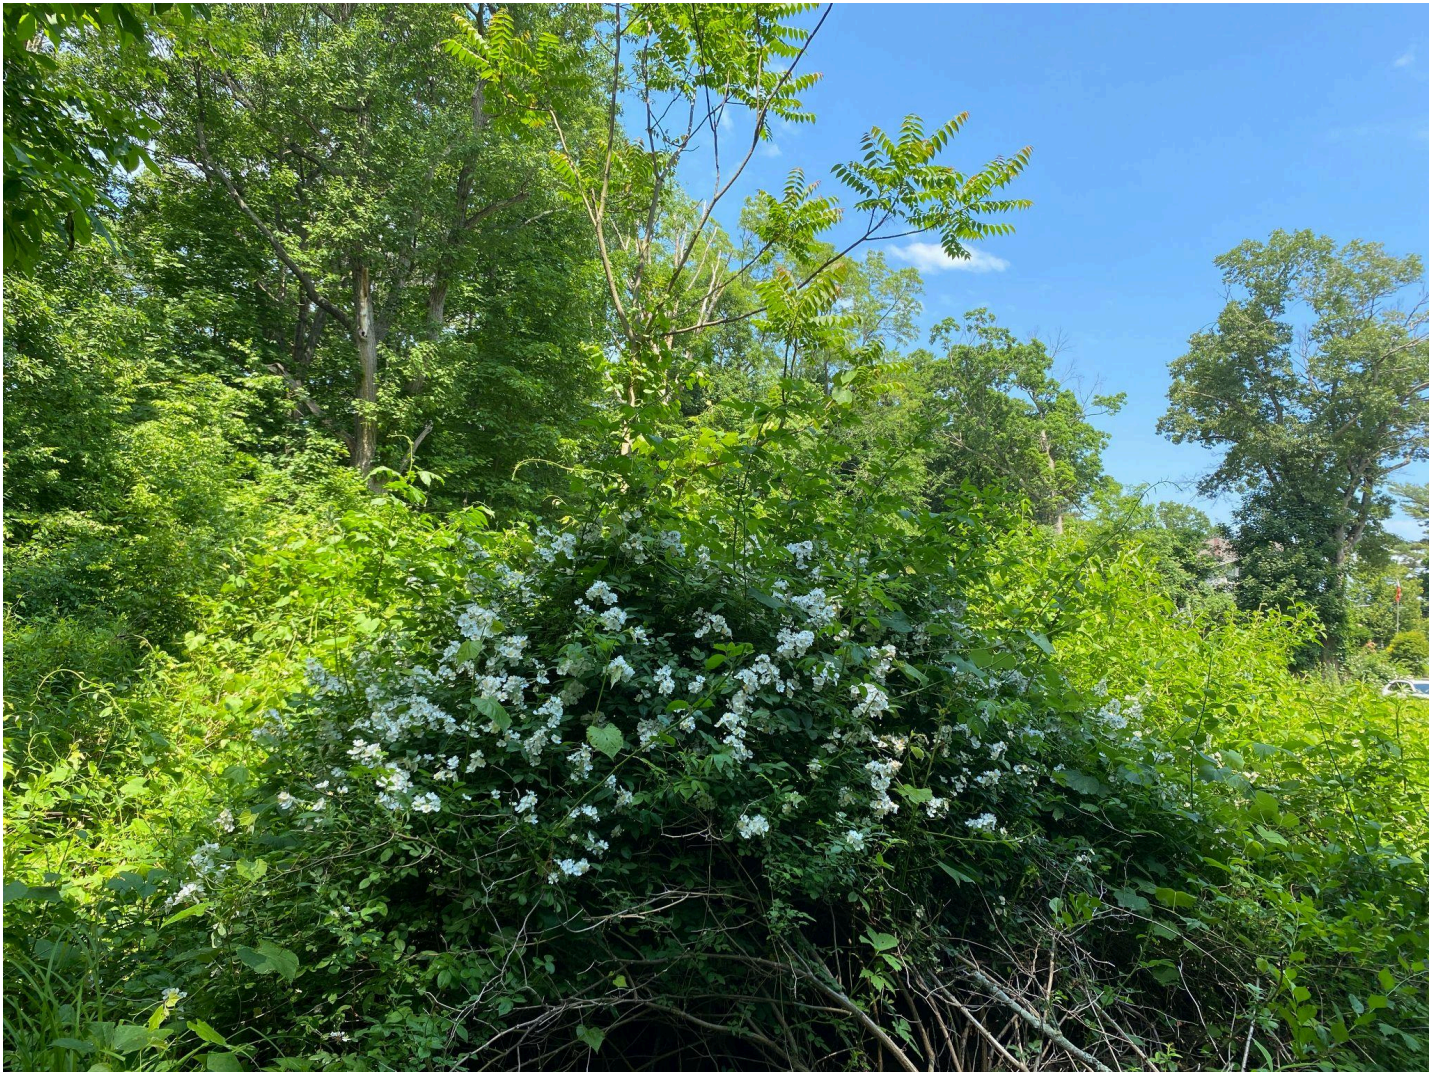
**Photo 5**

**Comments:** Invasive plants growing along the utility easement, including Japanese knotweed (*Reynoutria japonica*), tree-of-heaven (*Ailanthus altissima*), multiflora rose (*Rosa multiflora*), and burning bush (*Euonymus alatus*).

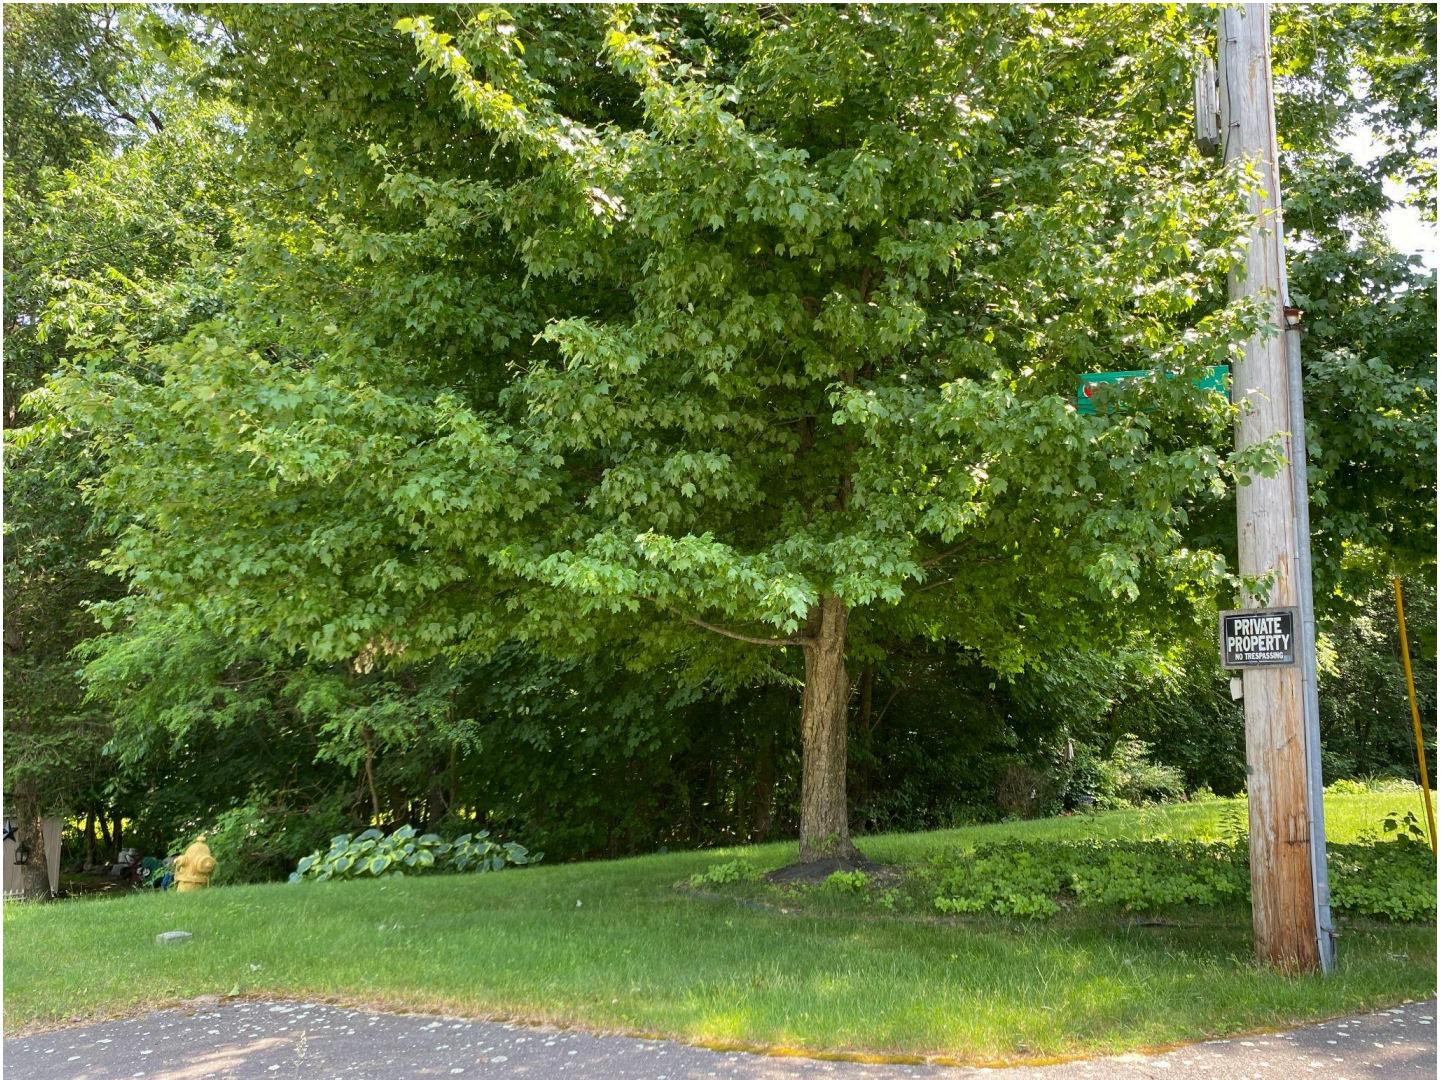
**Photo 6**

**Comments:** Locust Street dead ends Fitzgerald Brook parcel. There is no signage to indicate a conservation property boundary and no access to the property.

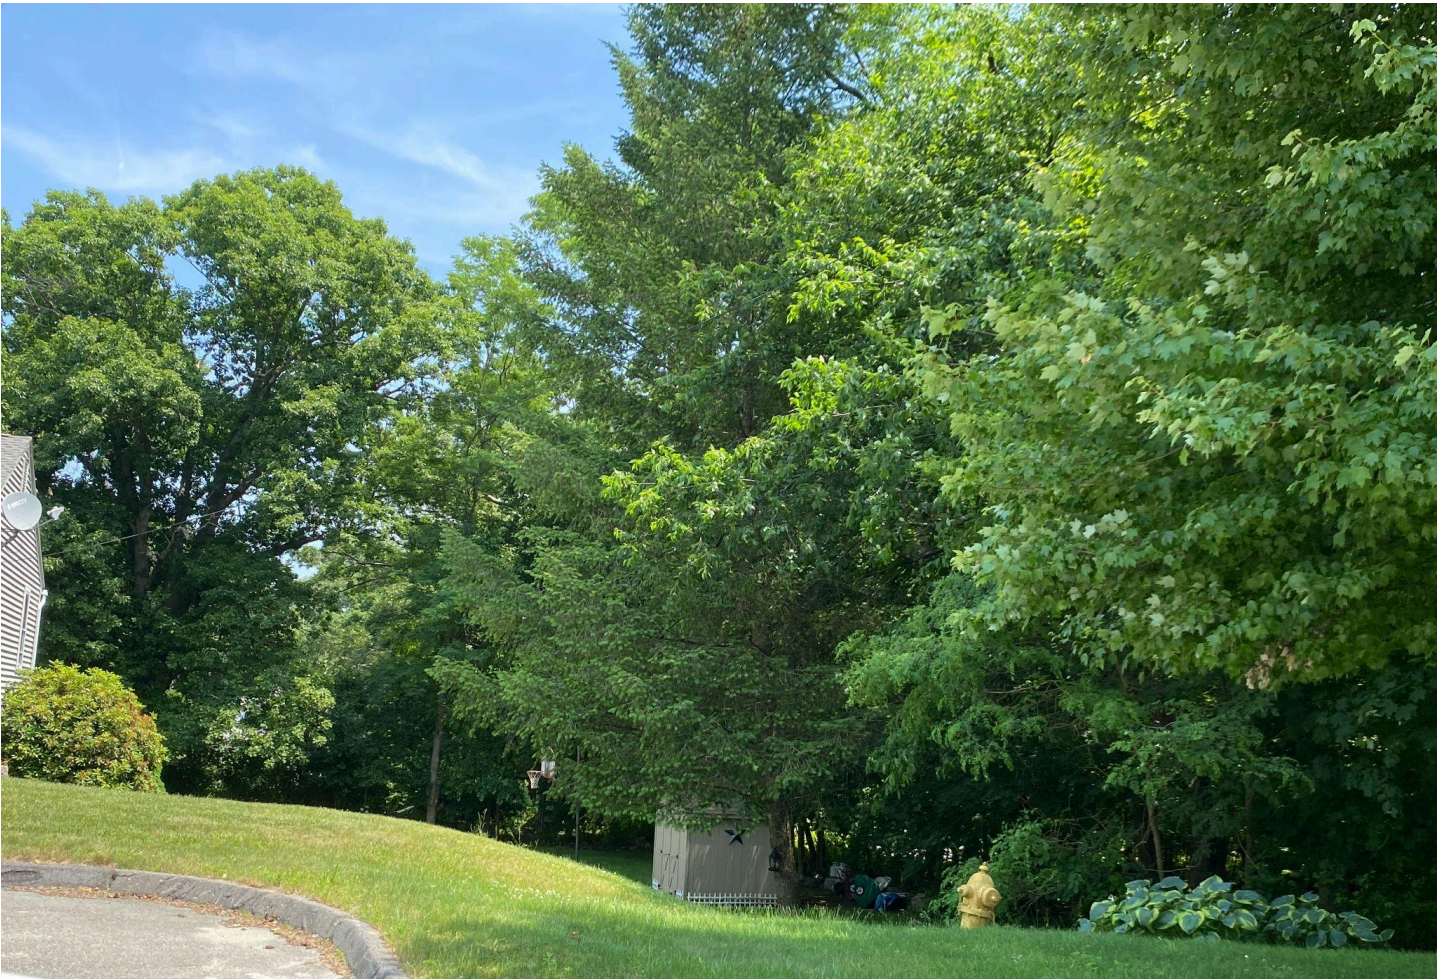
**Photo 7**

**Comments:** Possible encroachment along the southern boundary of 111 Locust Street where the abutting yard extends onto conservation property. There is a shed potentially within the boundary of the Fitzgerald Brook property.

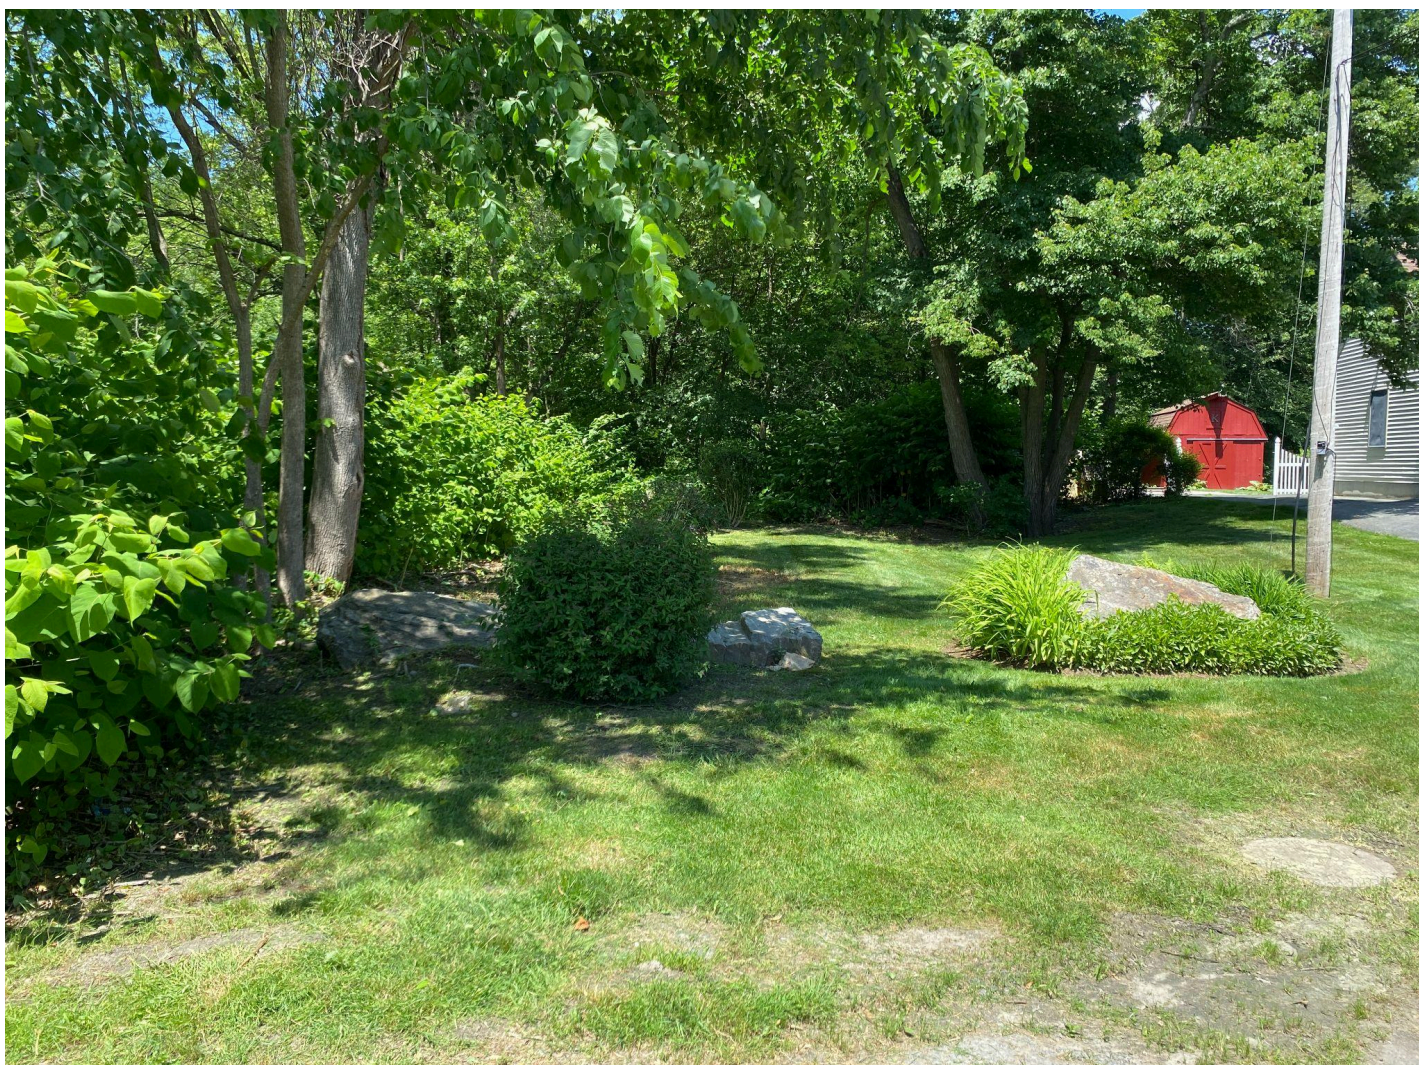
**Photo 8**

**Comments:** Dallas Street dead ends at the Fitzgerald Brook parcel. There is no signage to indicate a conservation property boundary and no property access.

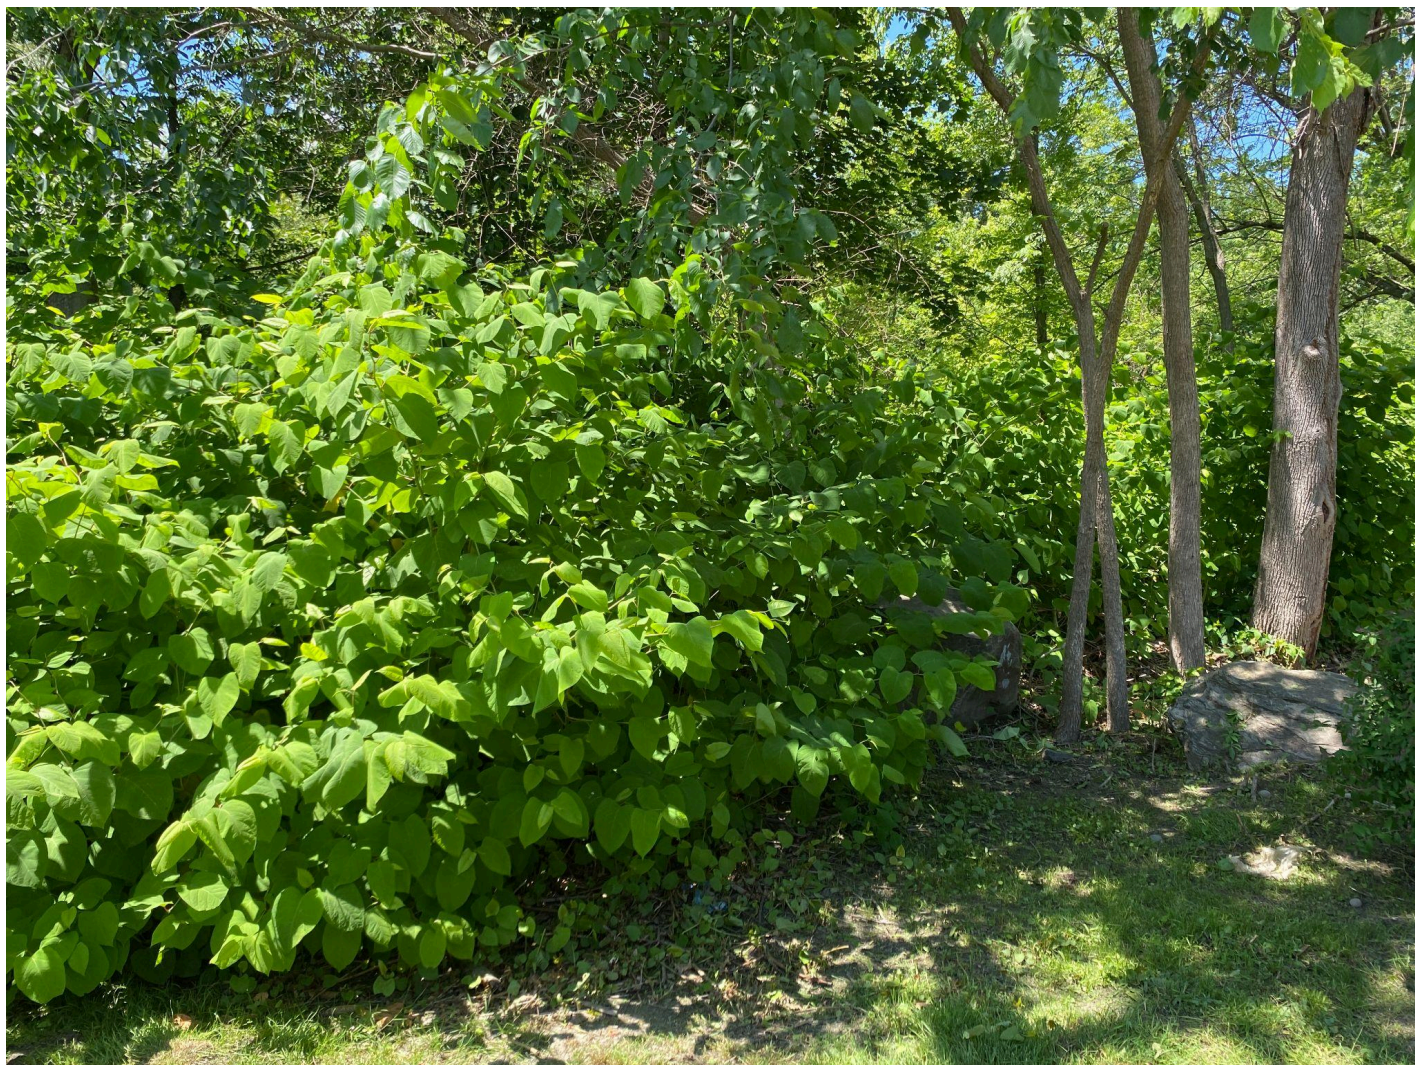
**Photo 9**

**Comments:** A patch of Japanese knotweed at the end of Dallas Street.

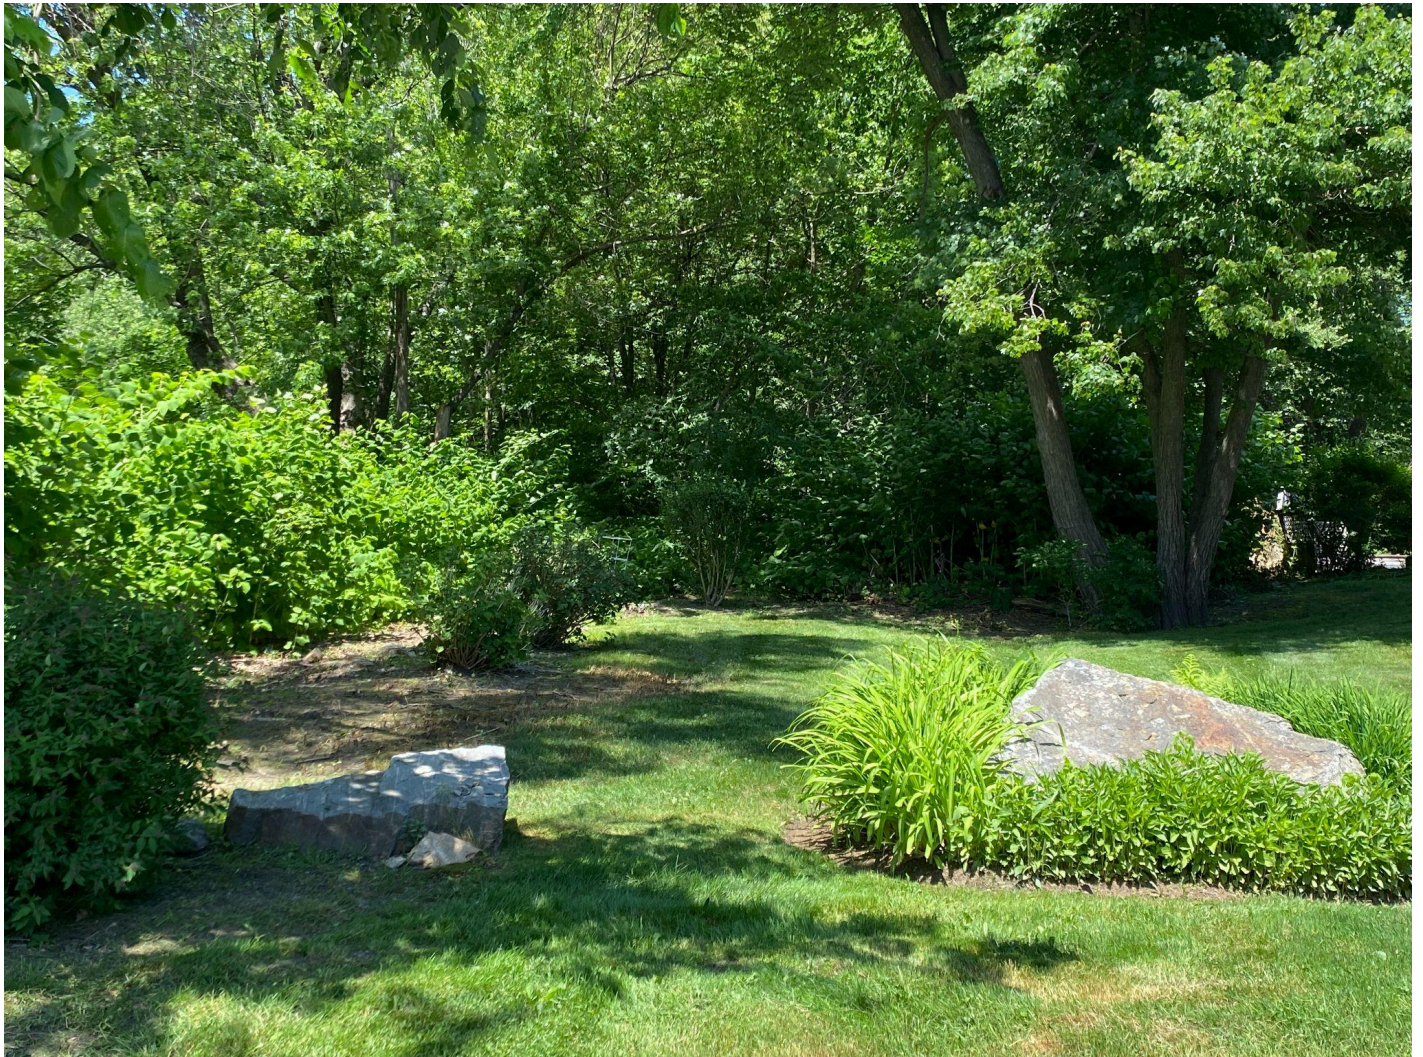
**Photo 10**

**Comments:** A portion of conservation property adjacent to 56 Nonquit Street's driveway off the end of Dallas Street has been mowed and landscaped.

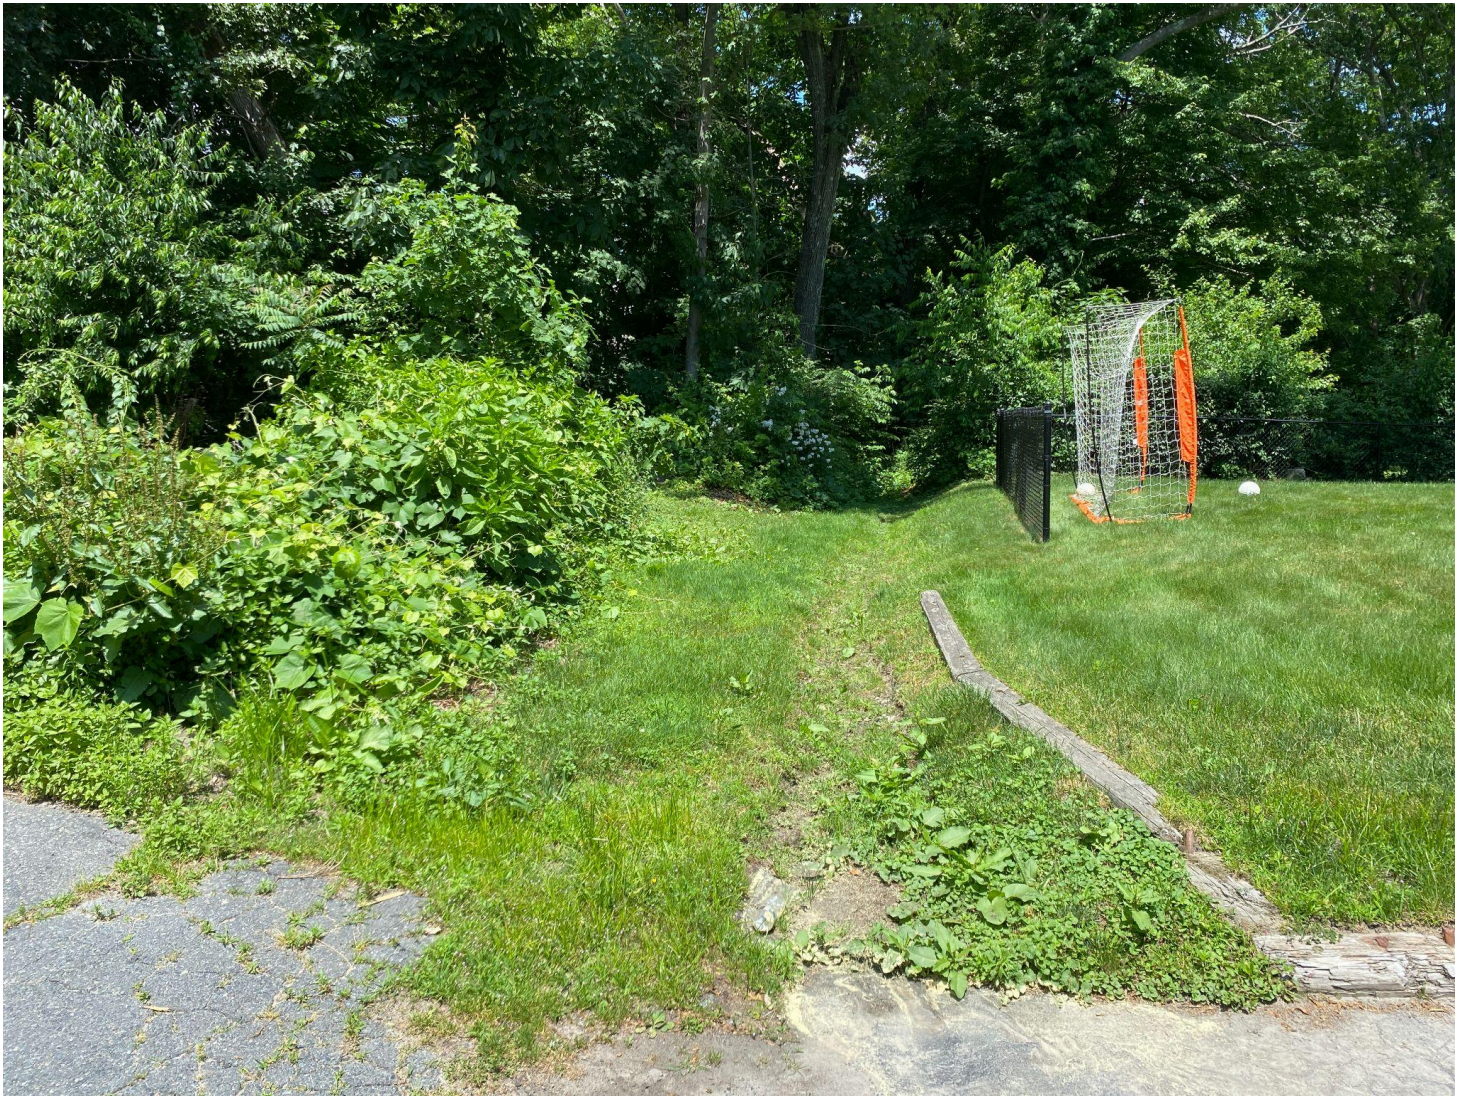
**Photo 11**

**Comments:** Palisade Street dead ends at the Fitzgerald Brook parcel. There is no signage to indicate a conservation property boundary and no clear access to the property.

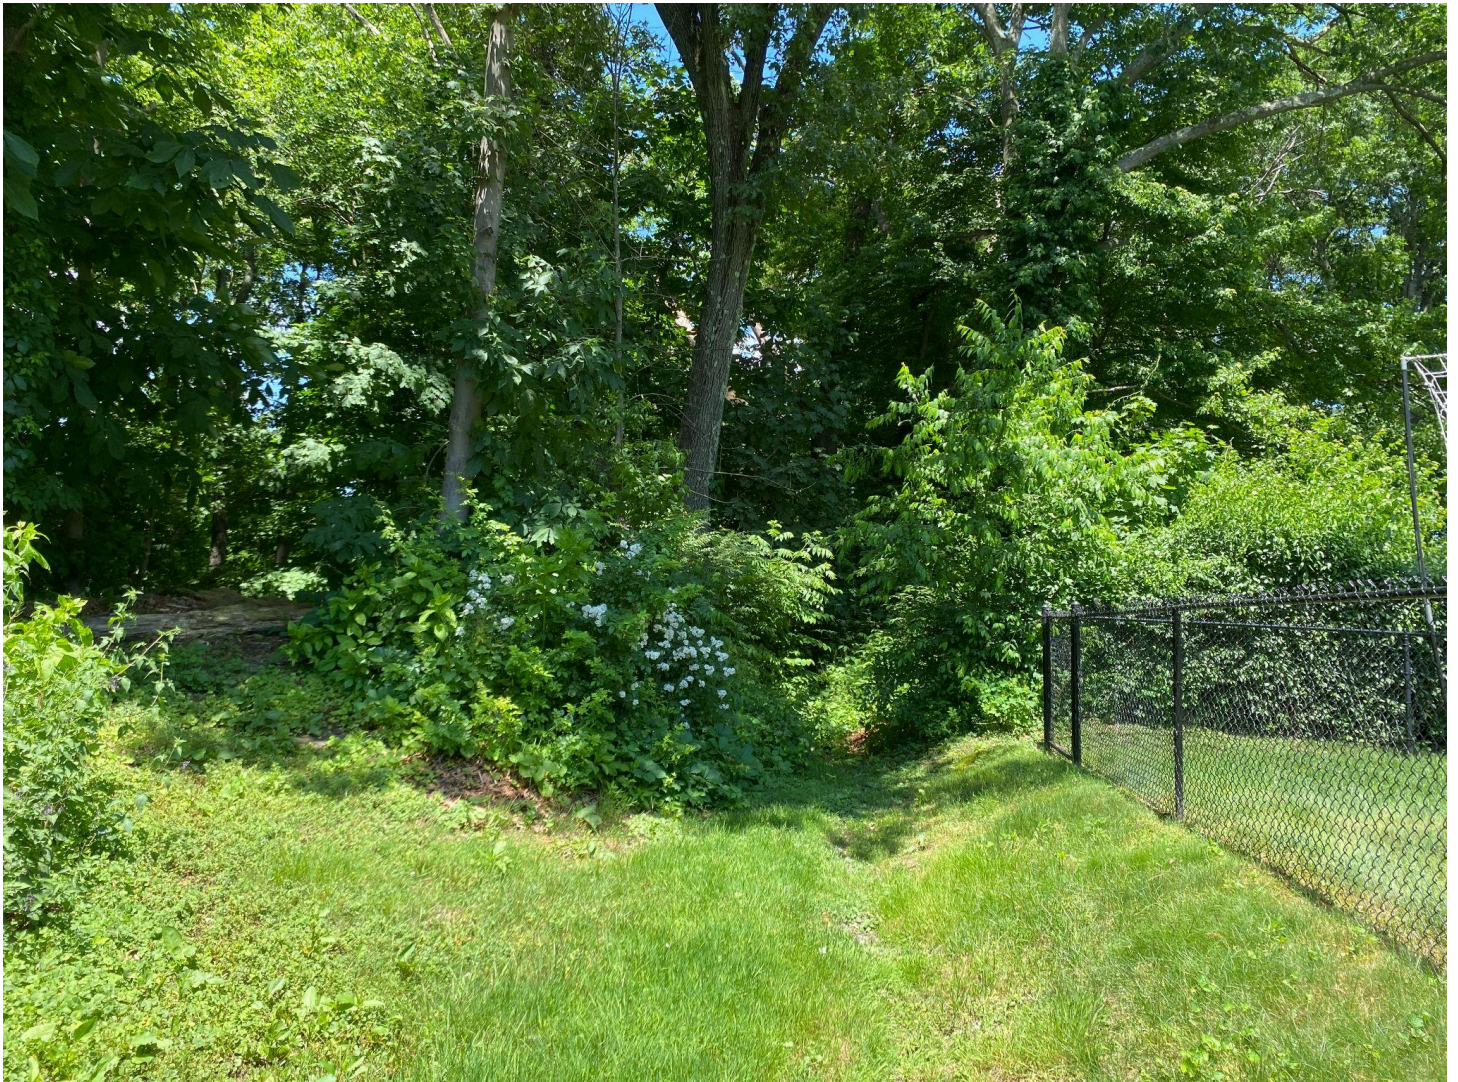
**Photo 12**

**Comments:** Possibly a narrow drainage path from the end of Palisade Street.

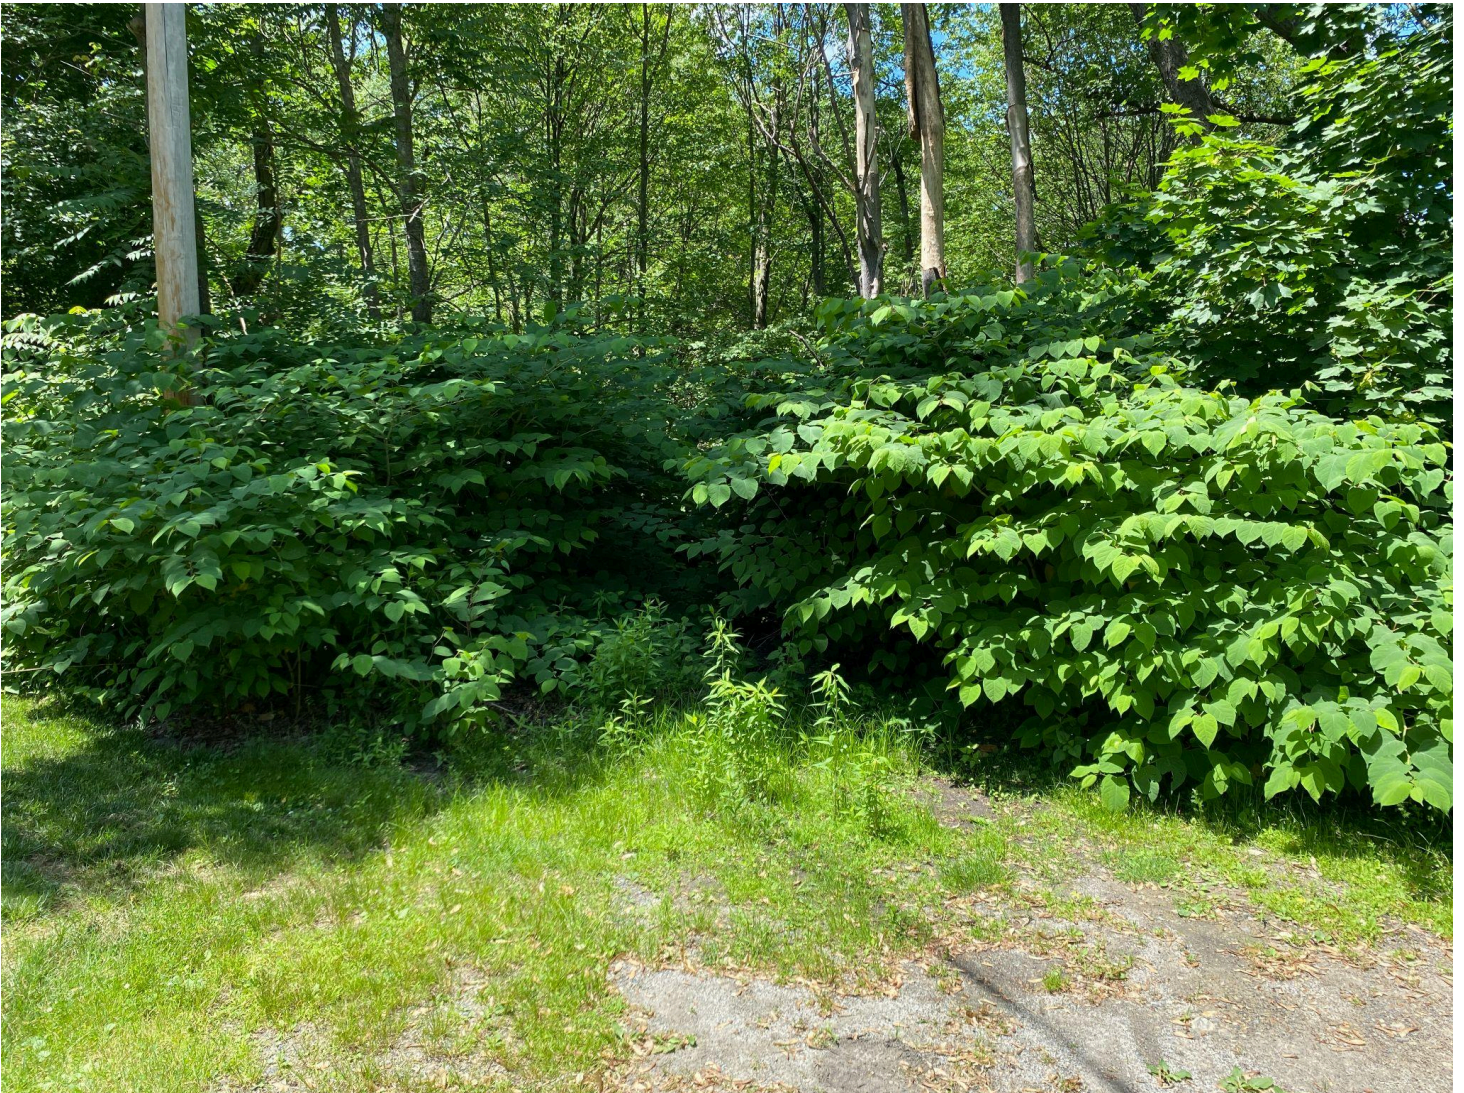
**Photo 13**

**Comments:** Touraine Street dead ends at the Fitzgerald Brook property. There is no signage to indicate a conservation property boundary and no clear access to the property.

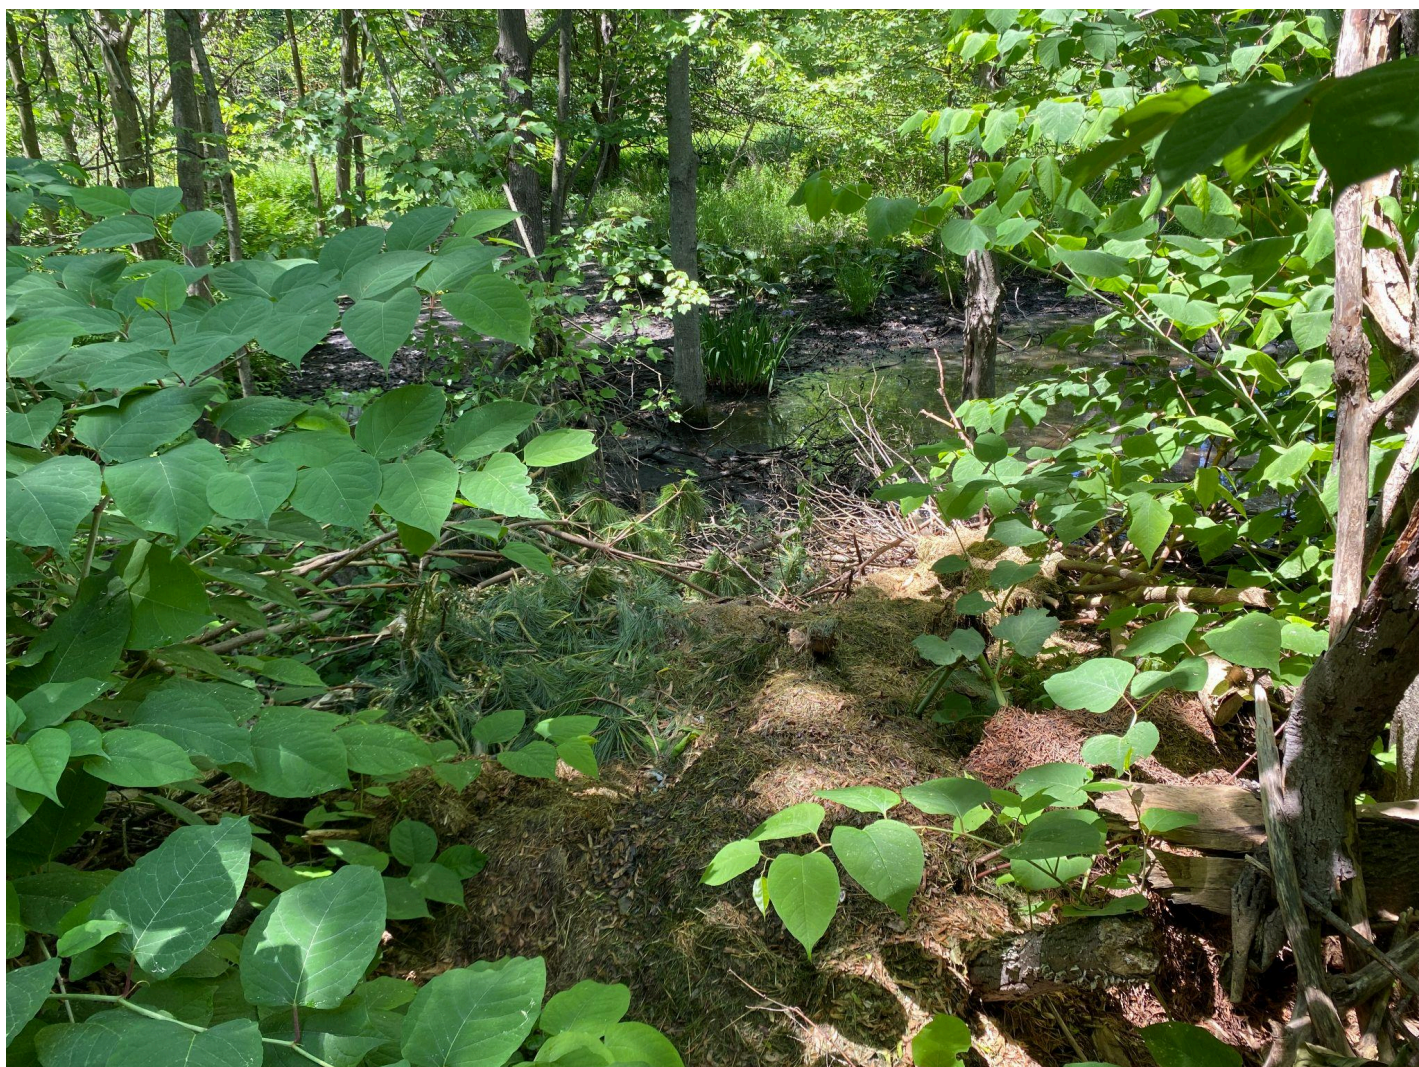
**Photo 14**

**Comments:** Yard waste dumping and Japanese knotweed at the end of Touraine Street.
