WORCESTER CONSERVATION COMMISSION

# Fitzgerald Brook

Conservation Property Baseline Assessment

July 2024

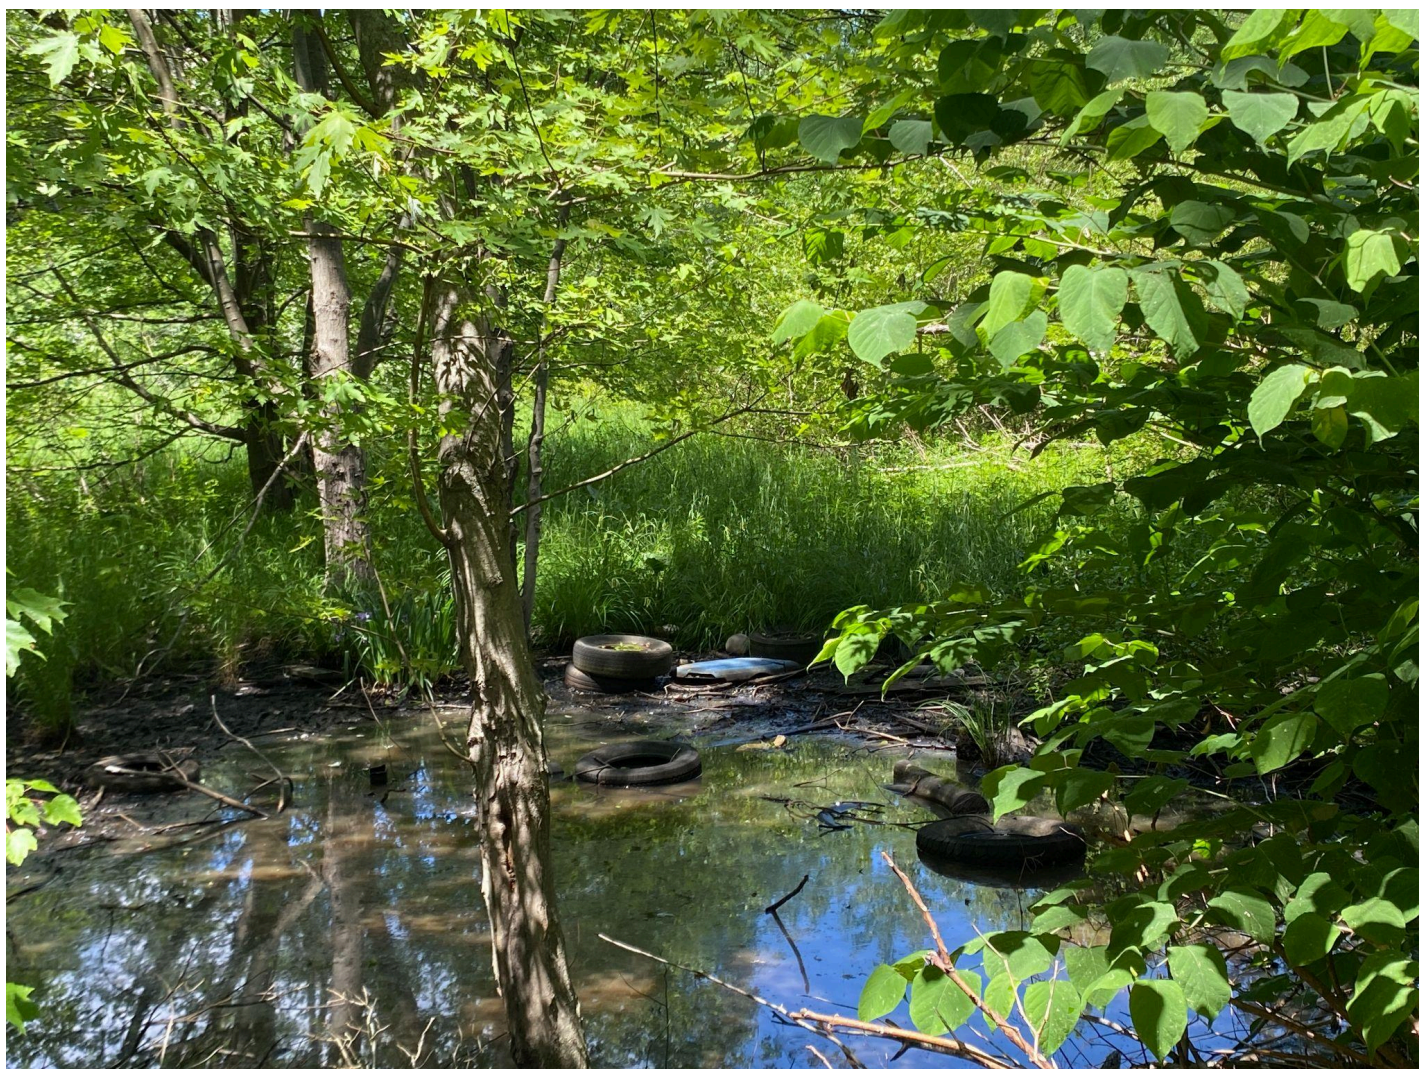
**Photo 15**

**Comments:** Tires and plastic waste dumped in a wetland area near Touraine Street.

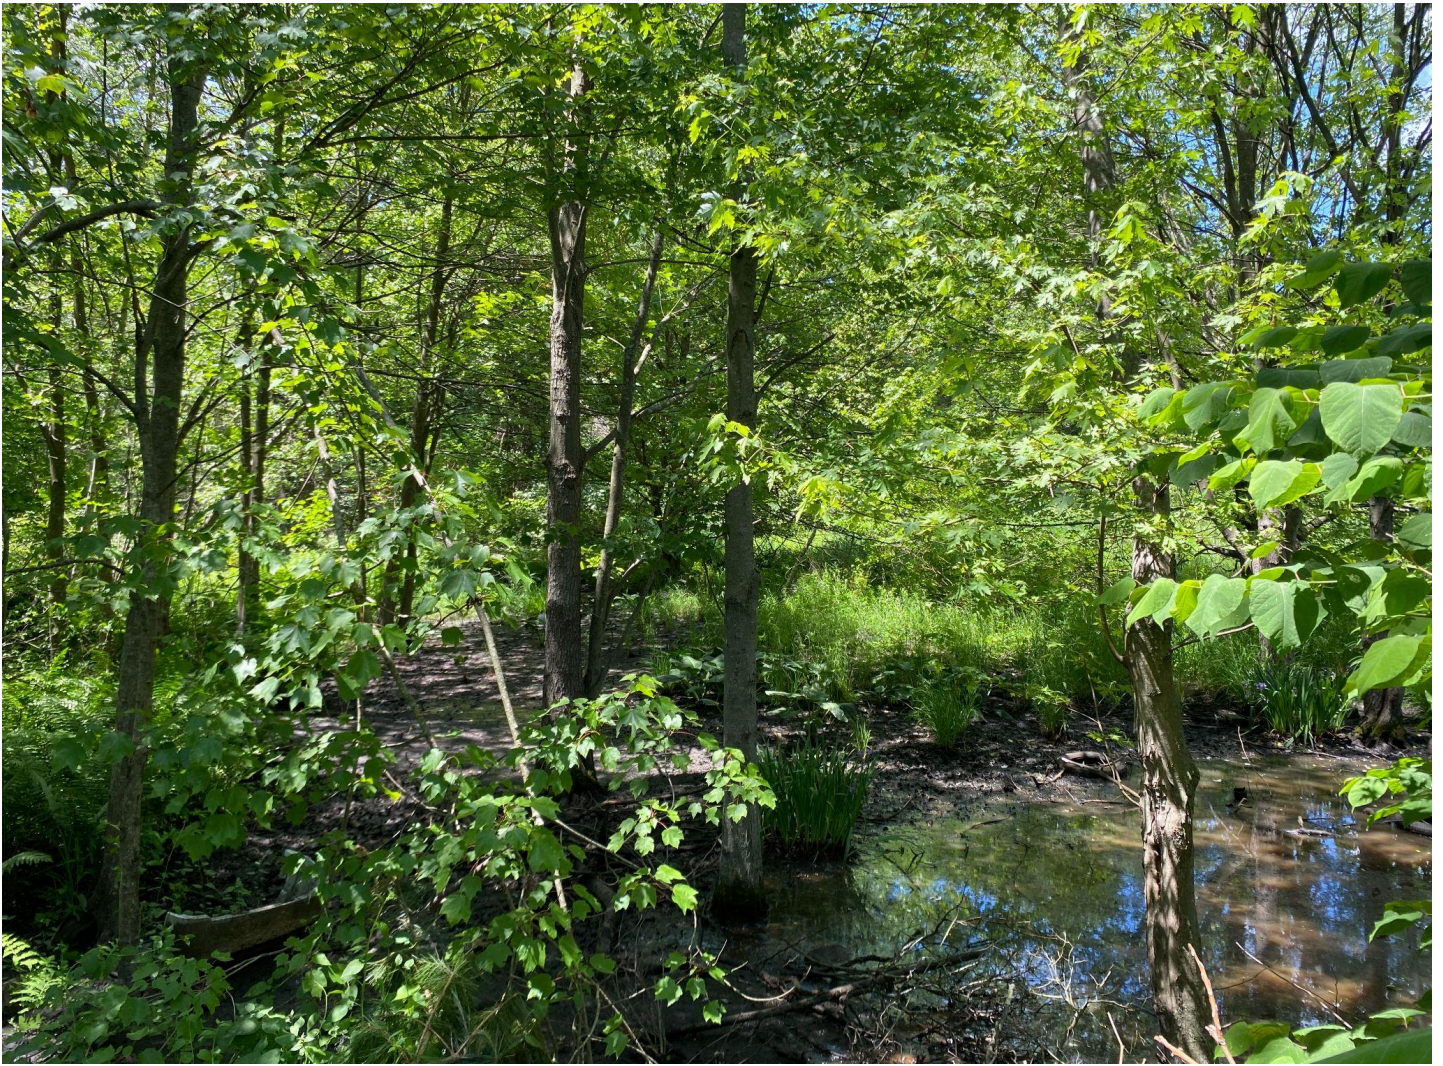
**Photo 16**

**Comments:** Wetland area near the end of Touraine Street.

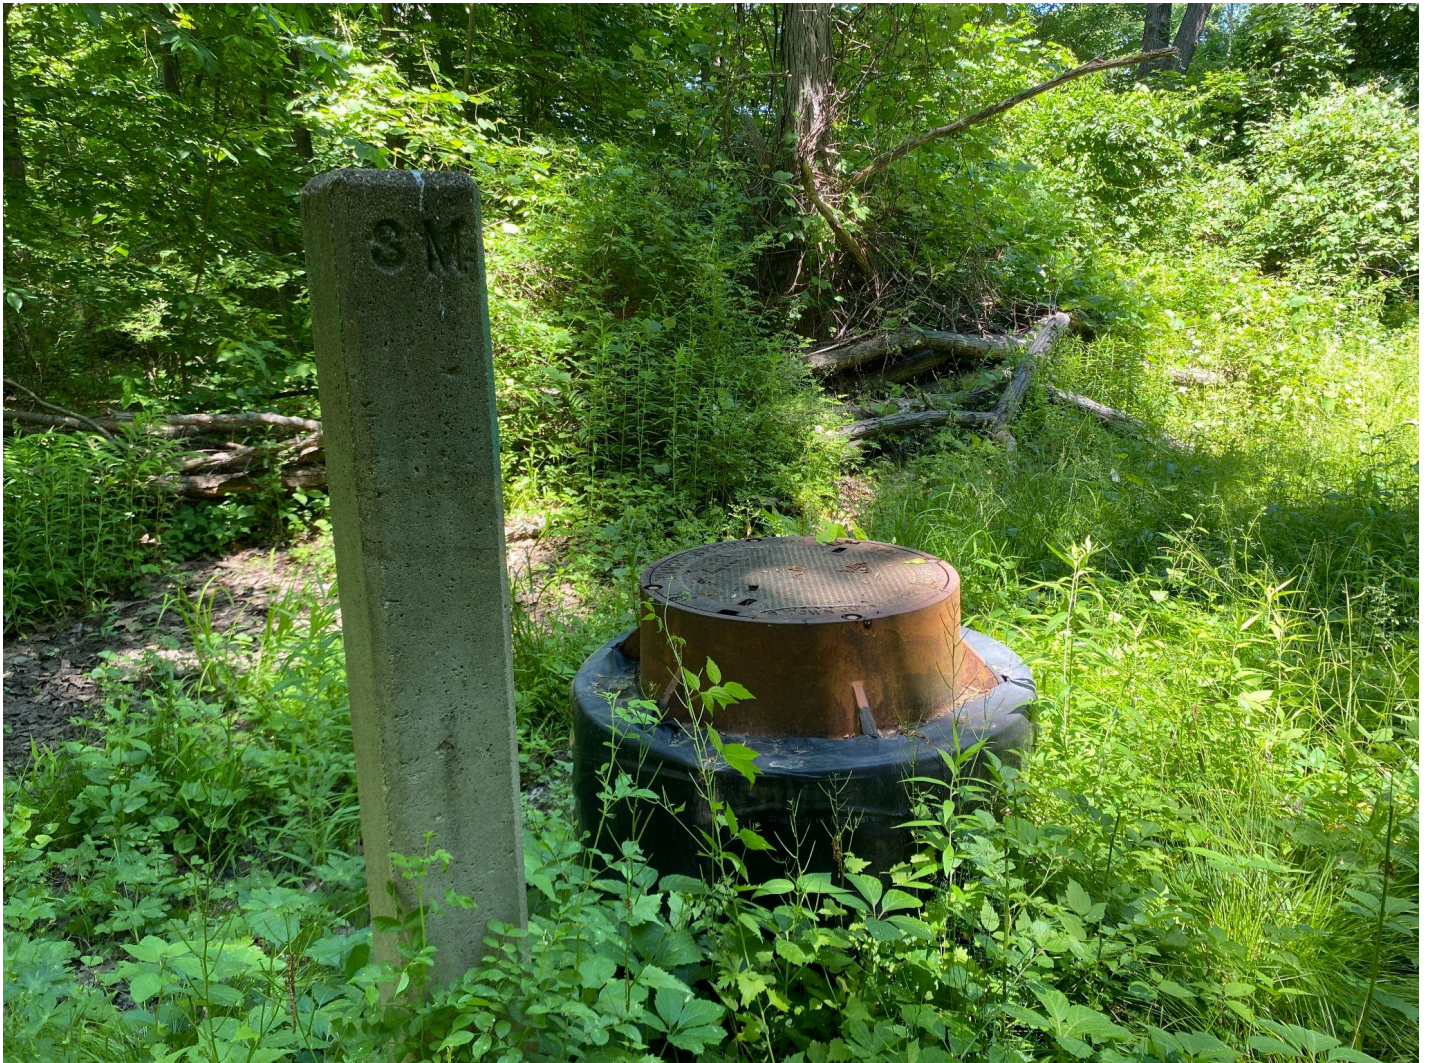
**Photo 17**

**Comments:** Recently raised manhole and cement posts labeled SM on a subsurface utility easement and wide, overgrown path extending from Alvarado Avenue to the railroad berm on the western boundary.

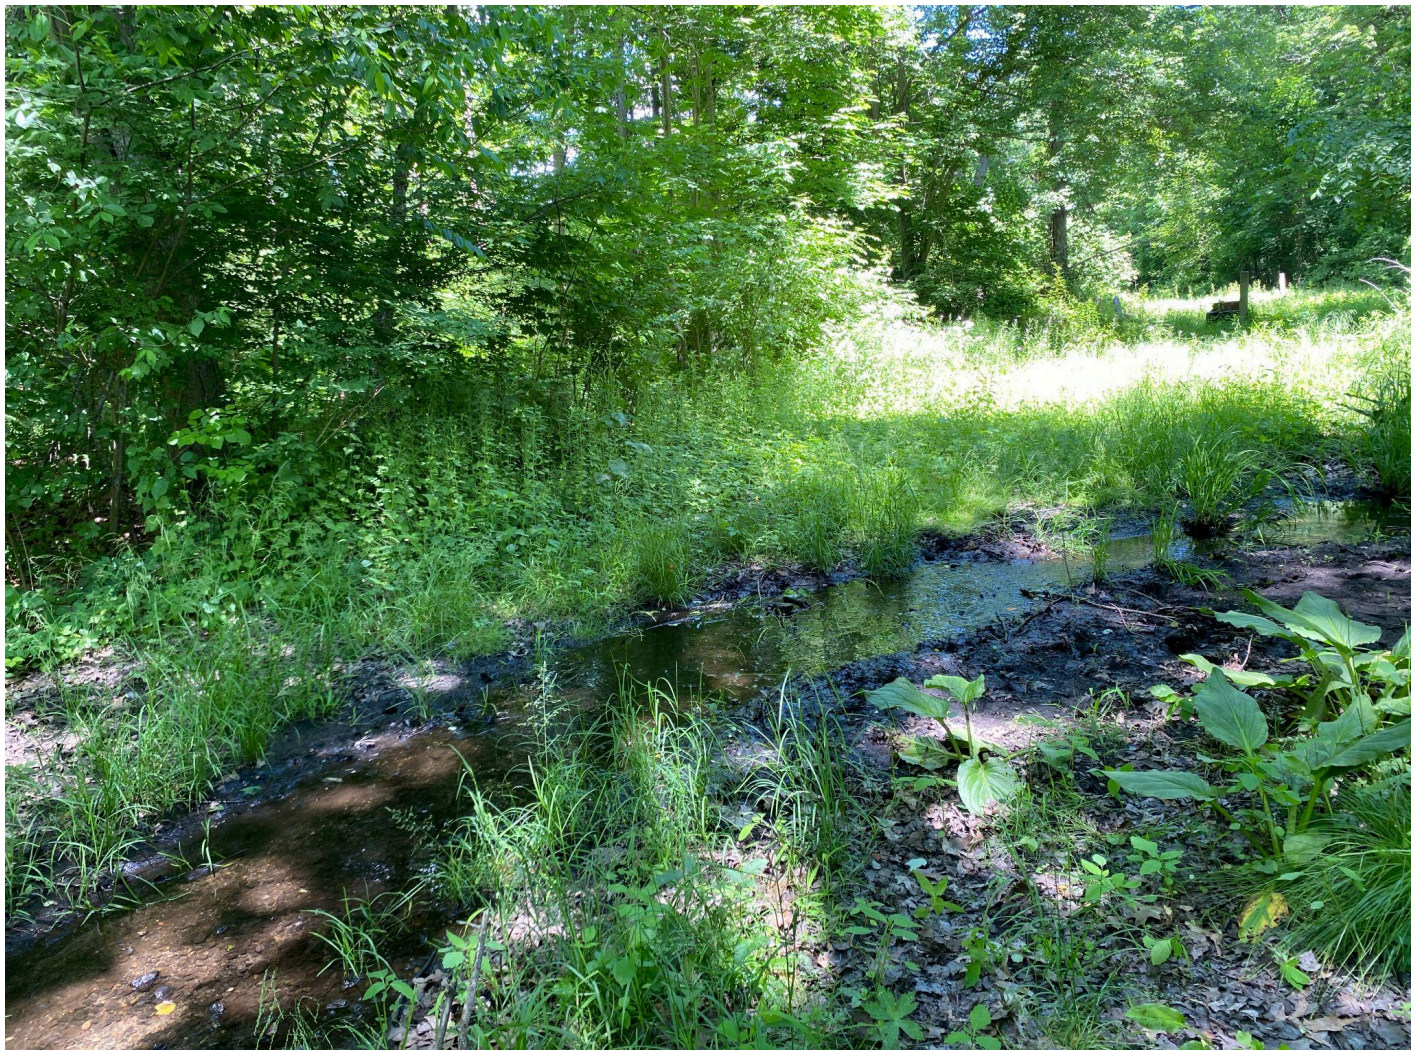
**Photo 18**

**Comments:** A small stream crosses the faint path along the underground utility line that leads from Alvarado Avenue.

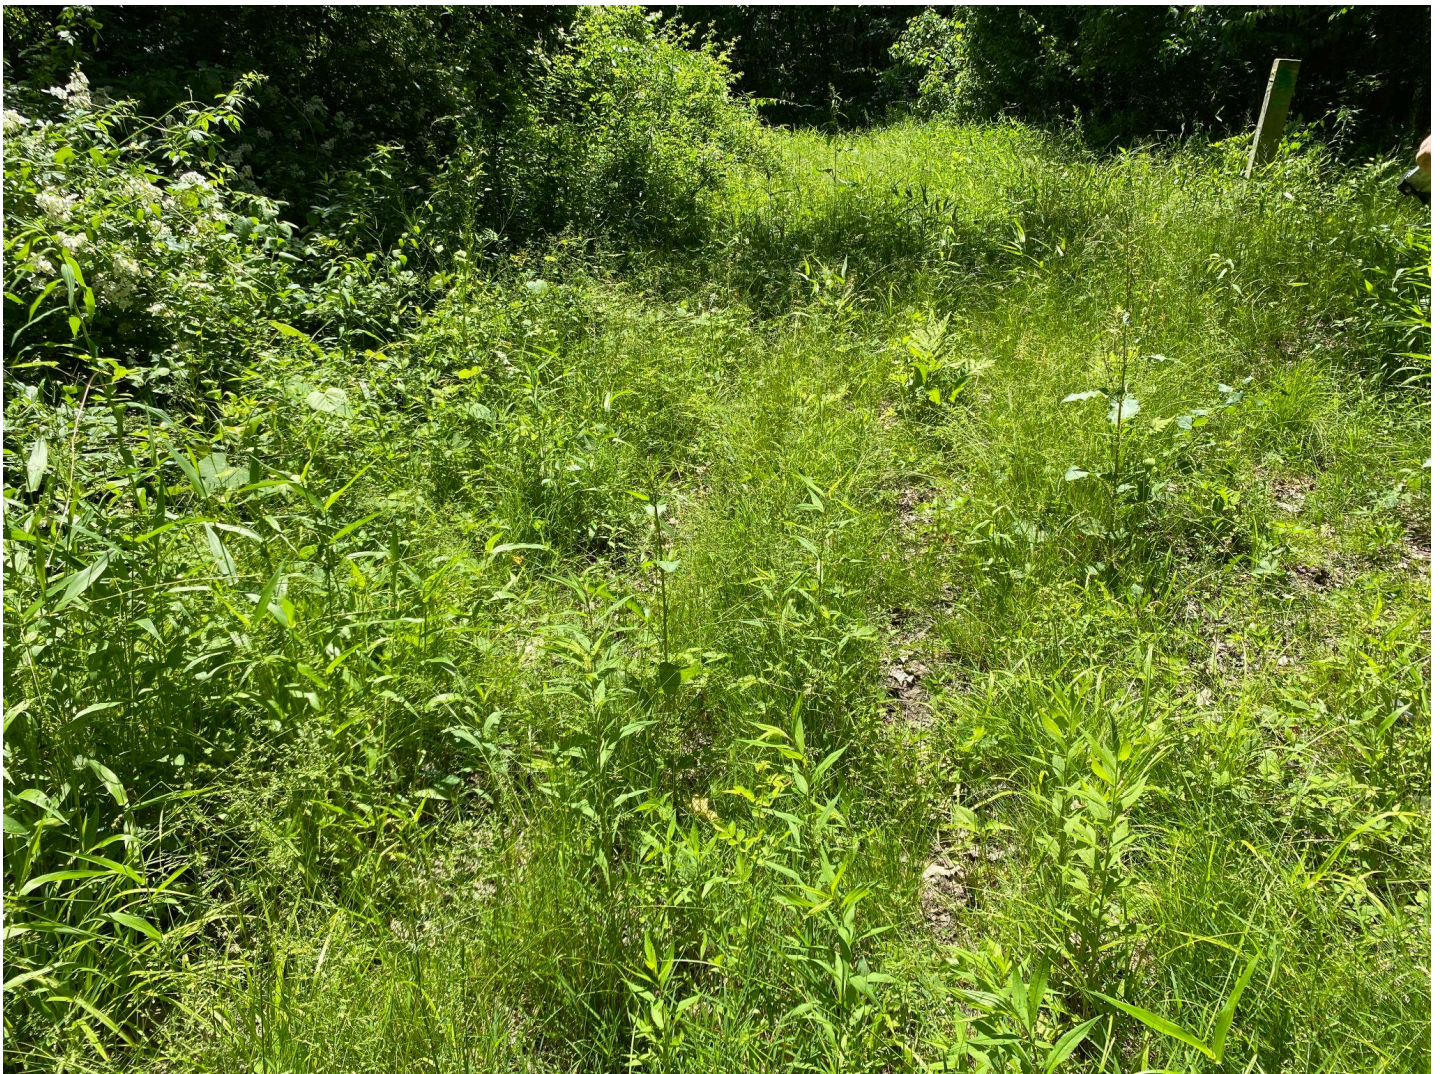
**Photo 19**

**Comments:** Faint tire tracks may indicate occasional use by ATVs along the underground utility line.

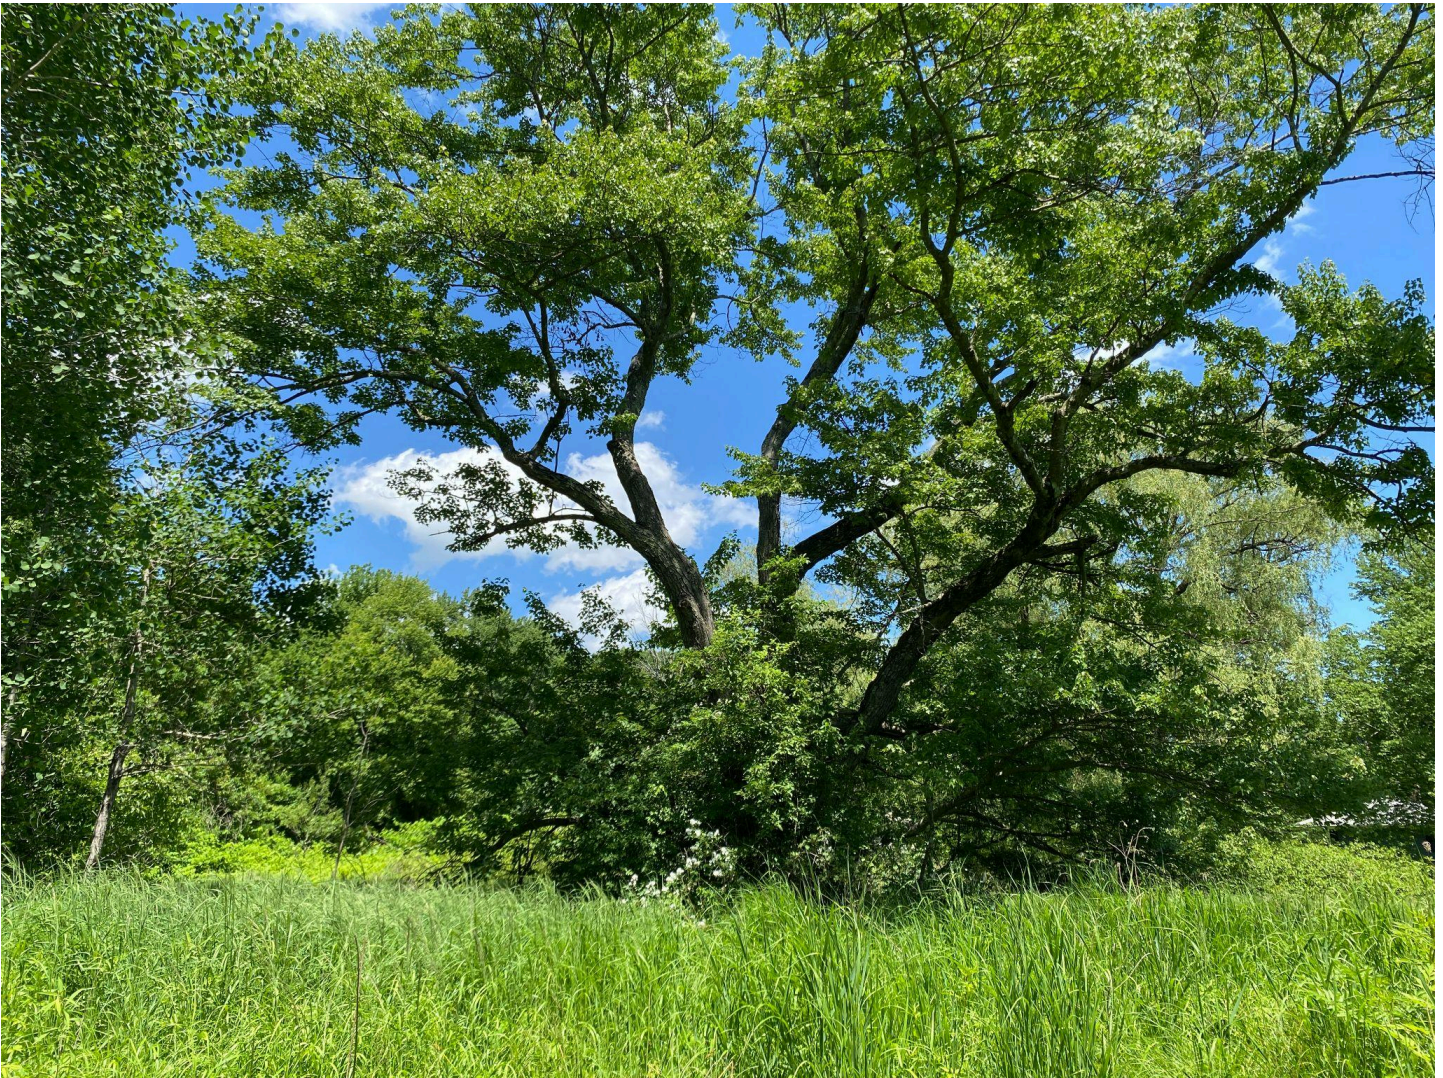
**Photo 20**

**Comments:** Open meadow area which appears to be periodically wet. Wetland species such as shrub willows (*Salix* spp.), rushes (*Juncus* spp.), and skunk cabbage (*Symplocarpus foetidus*) are present.

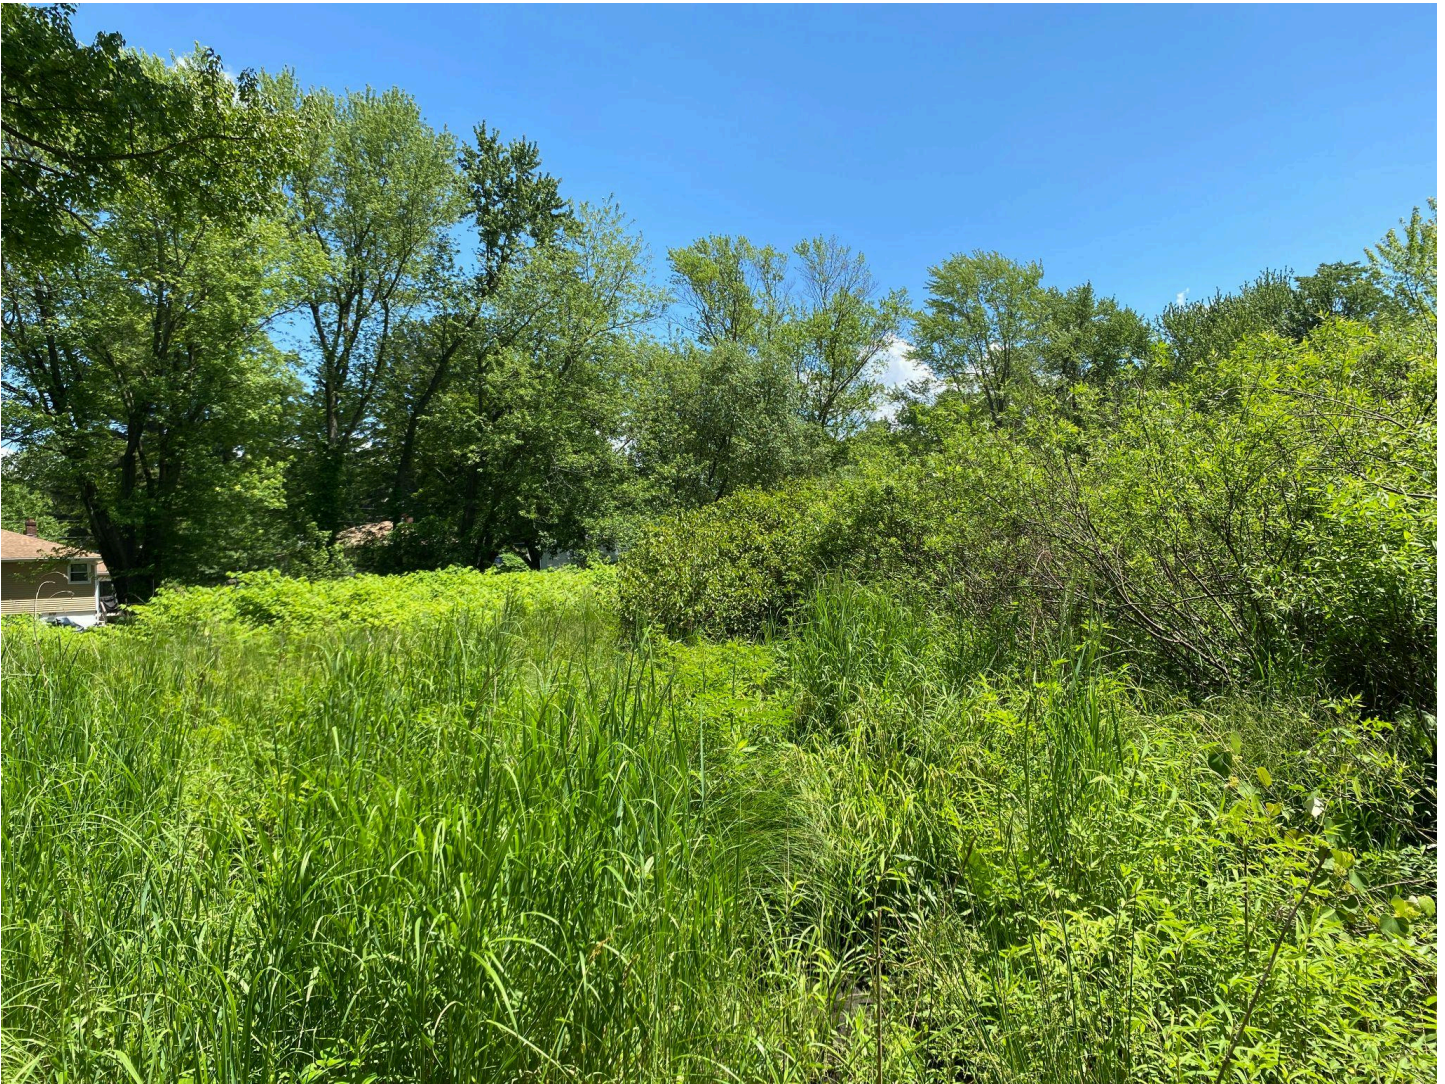
**Photo 21**

**Comments:** Open meadow area which appears to be periodically wet. Wetland species such as shrub willows (*Salix* spp.), rushes (*Juncus* spp.), and skunk cabbage (*Symplocarpus foetidus*) are present.

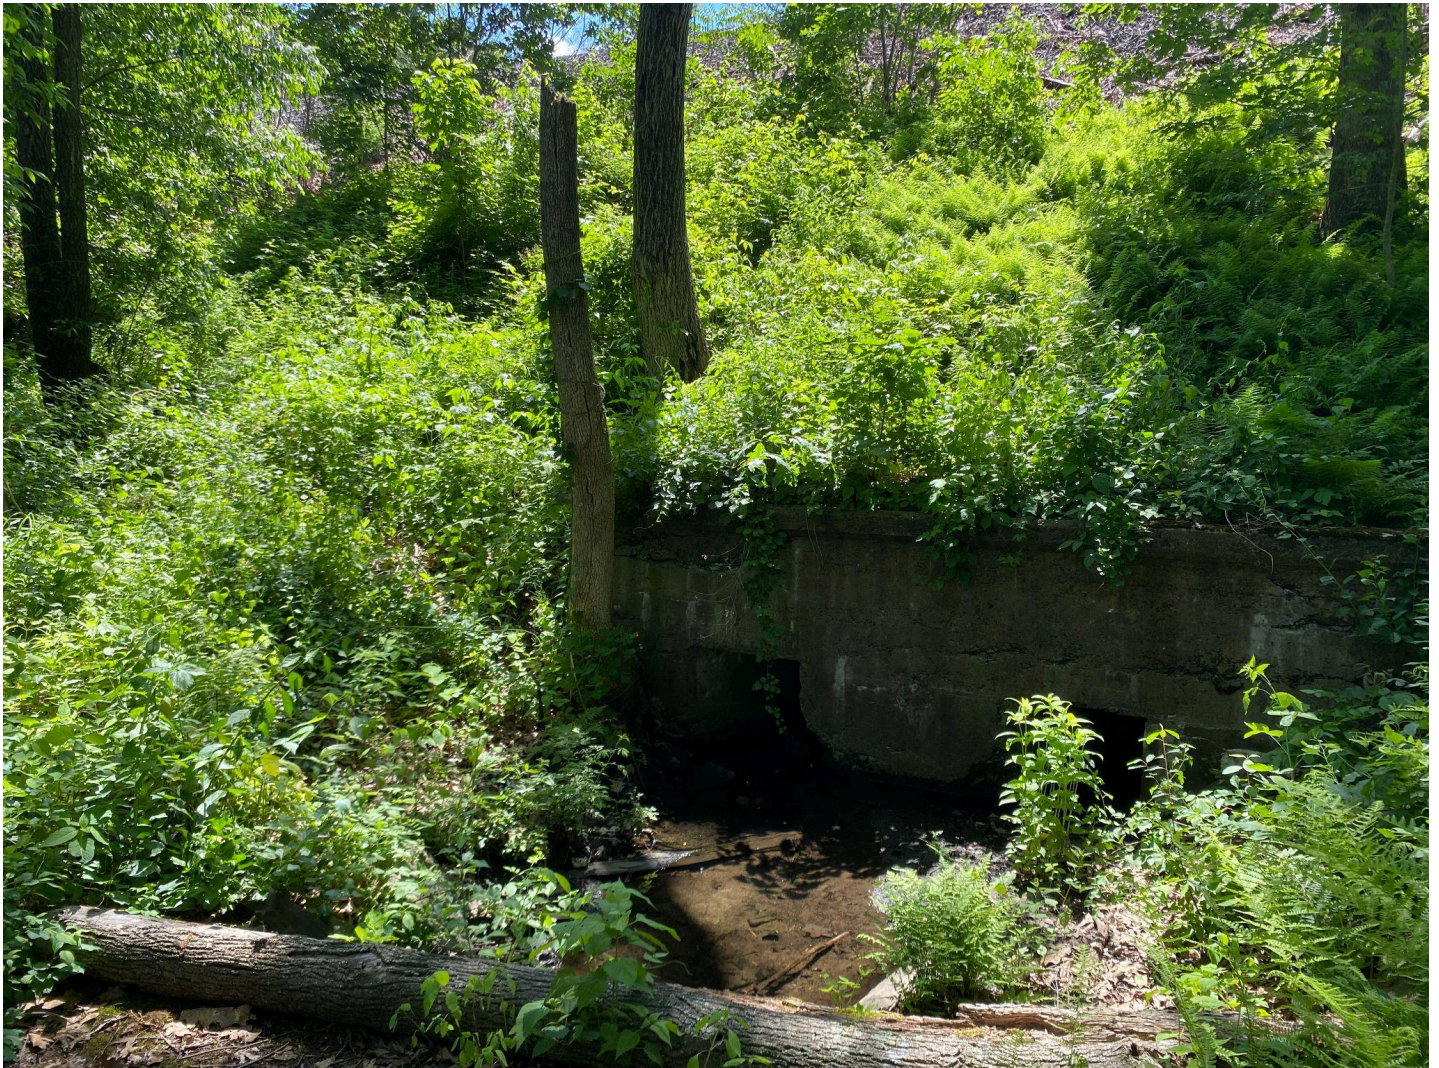
**Photo 22**

**Comments:** A cement culvert goes under the railroad.

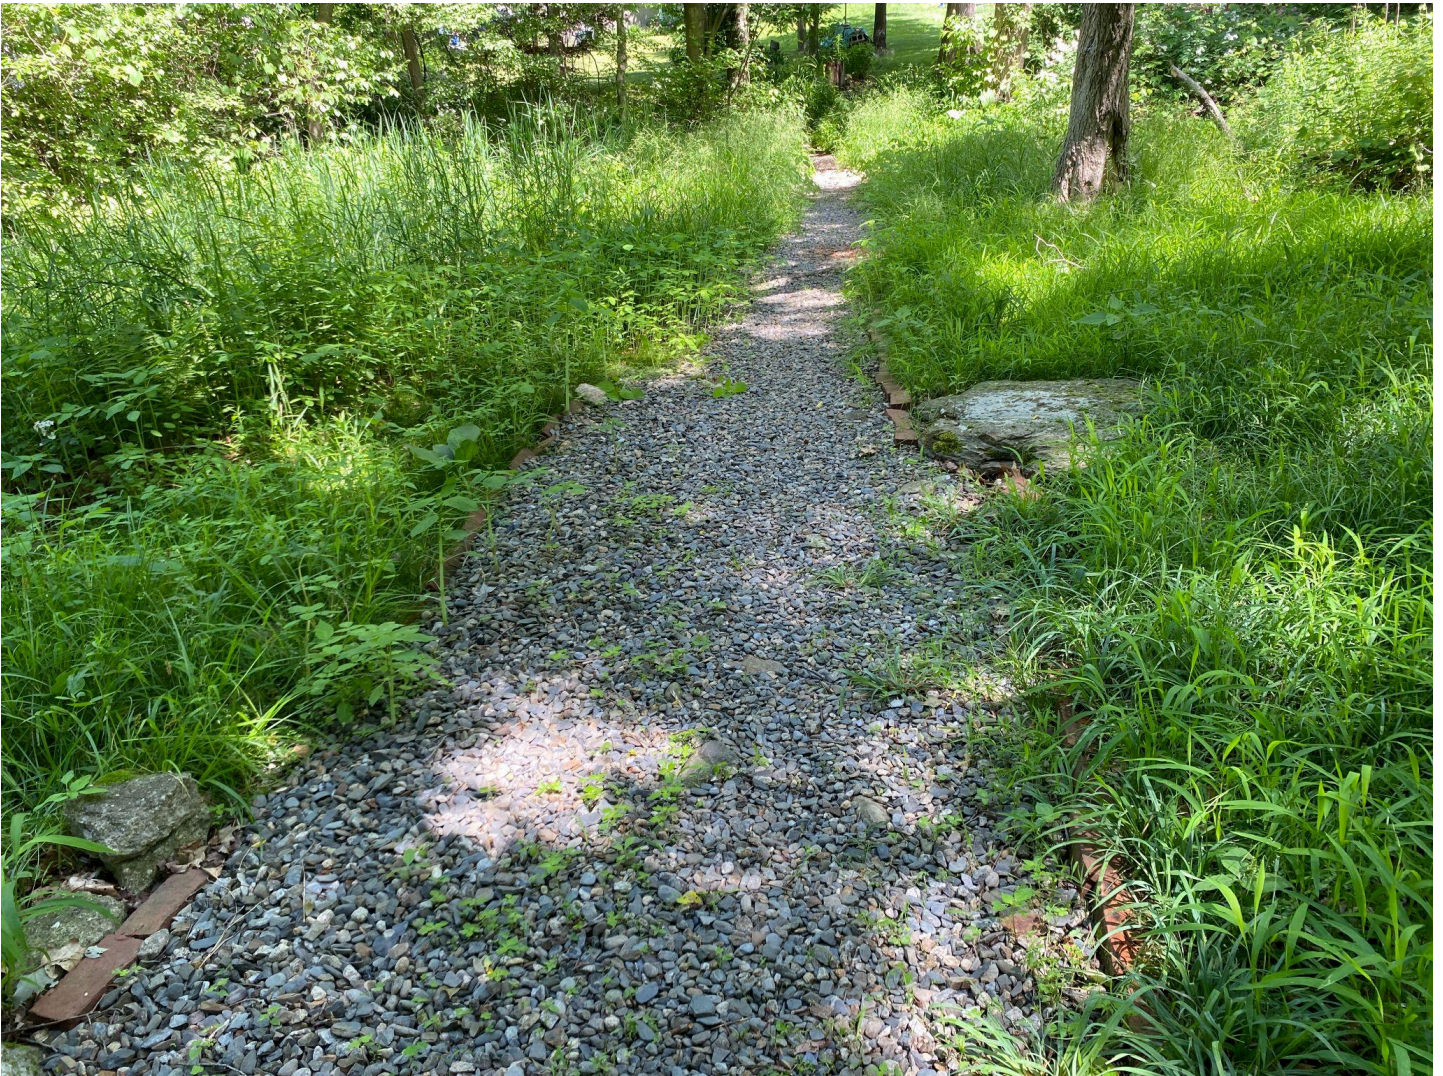
**Photo 23**

**Comments:** Gravel path on conservation property behind 24 Dallas Street.

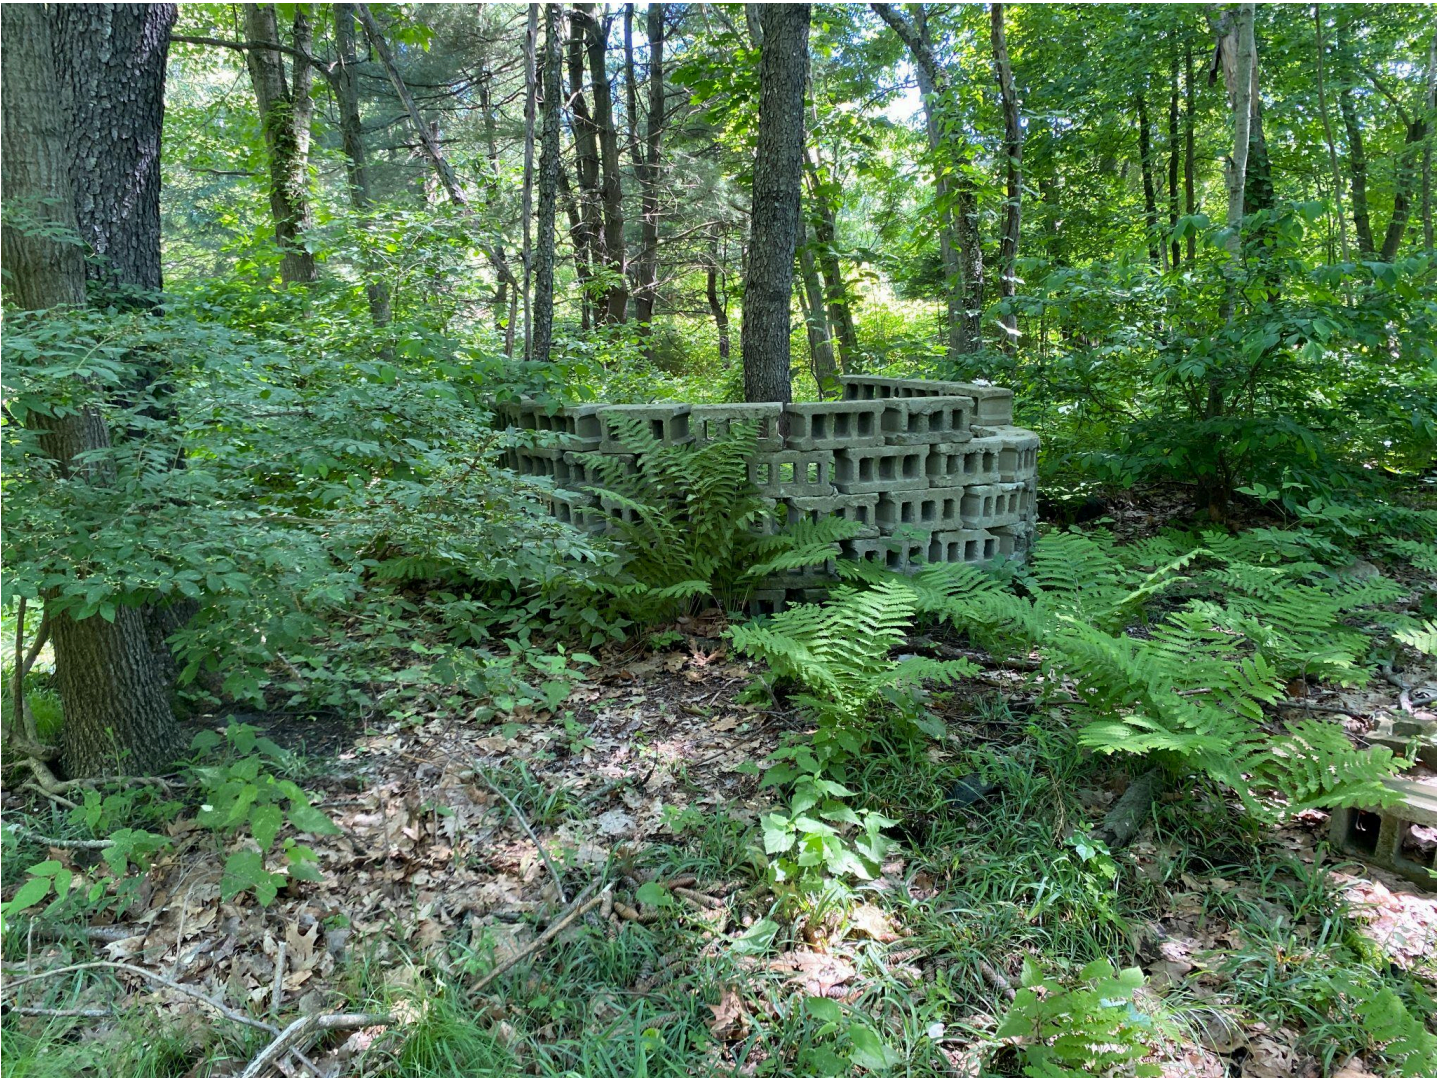
**Photo 24**

**Comments:** Stacked cinder blocks on conservation property behind 24 Dallas Street.

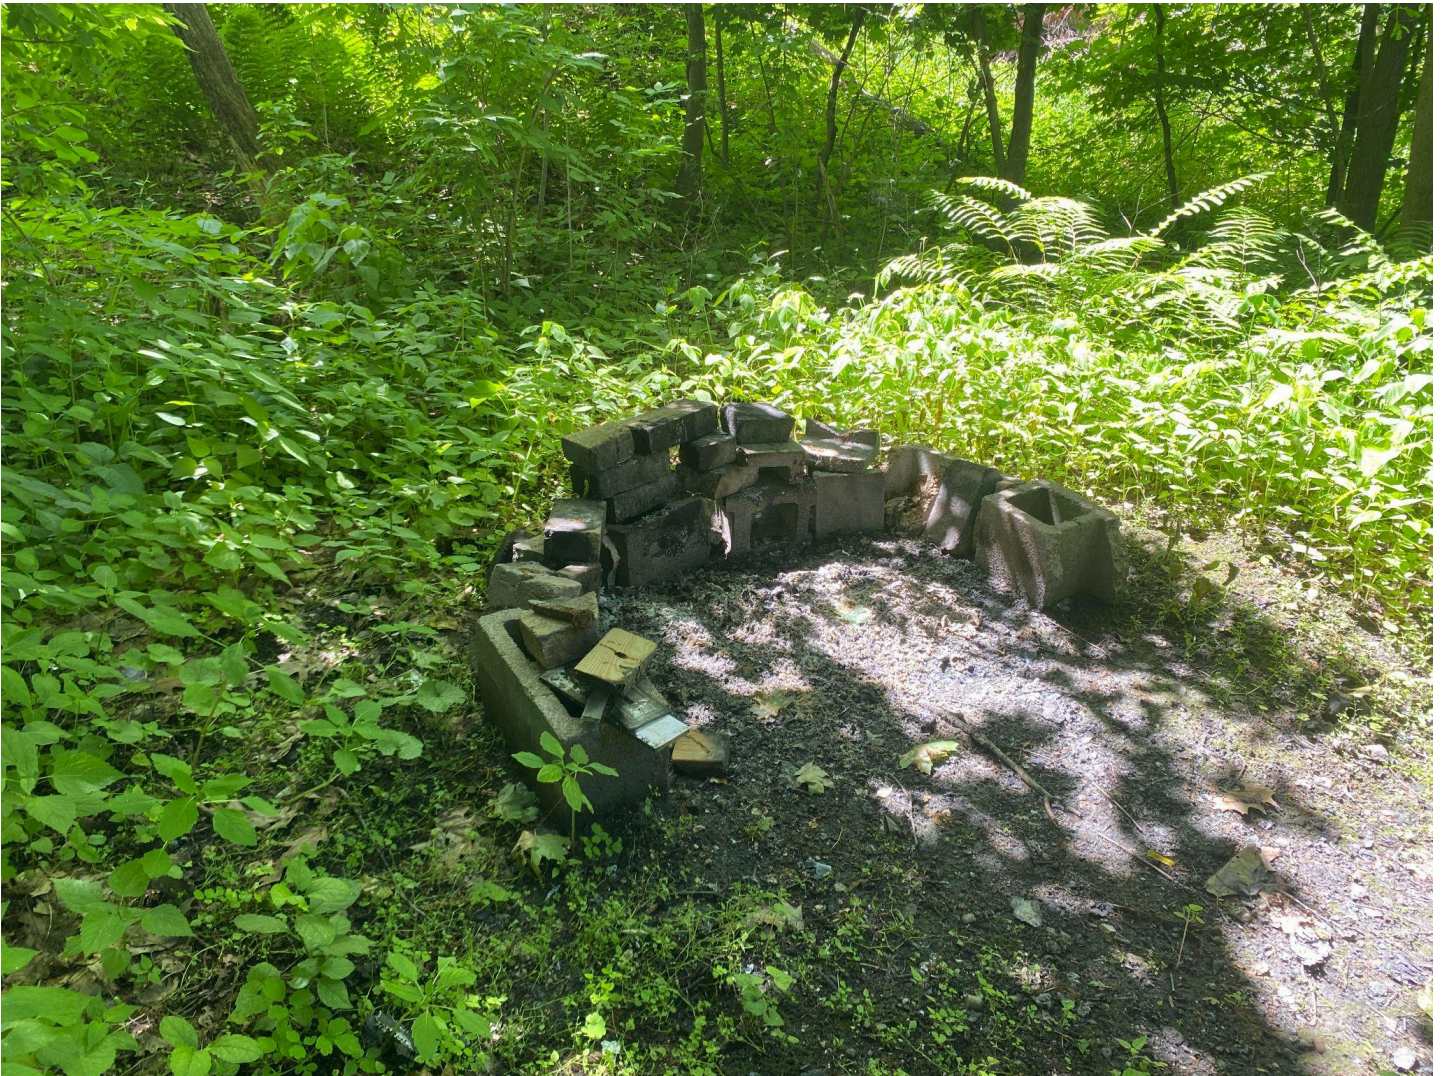
**Photo 25**

**Comments:** Cinder block fire pit along rough path behind Dallas Street.

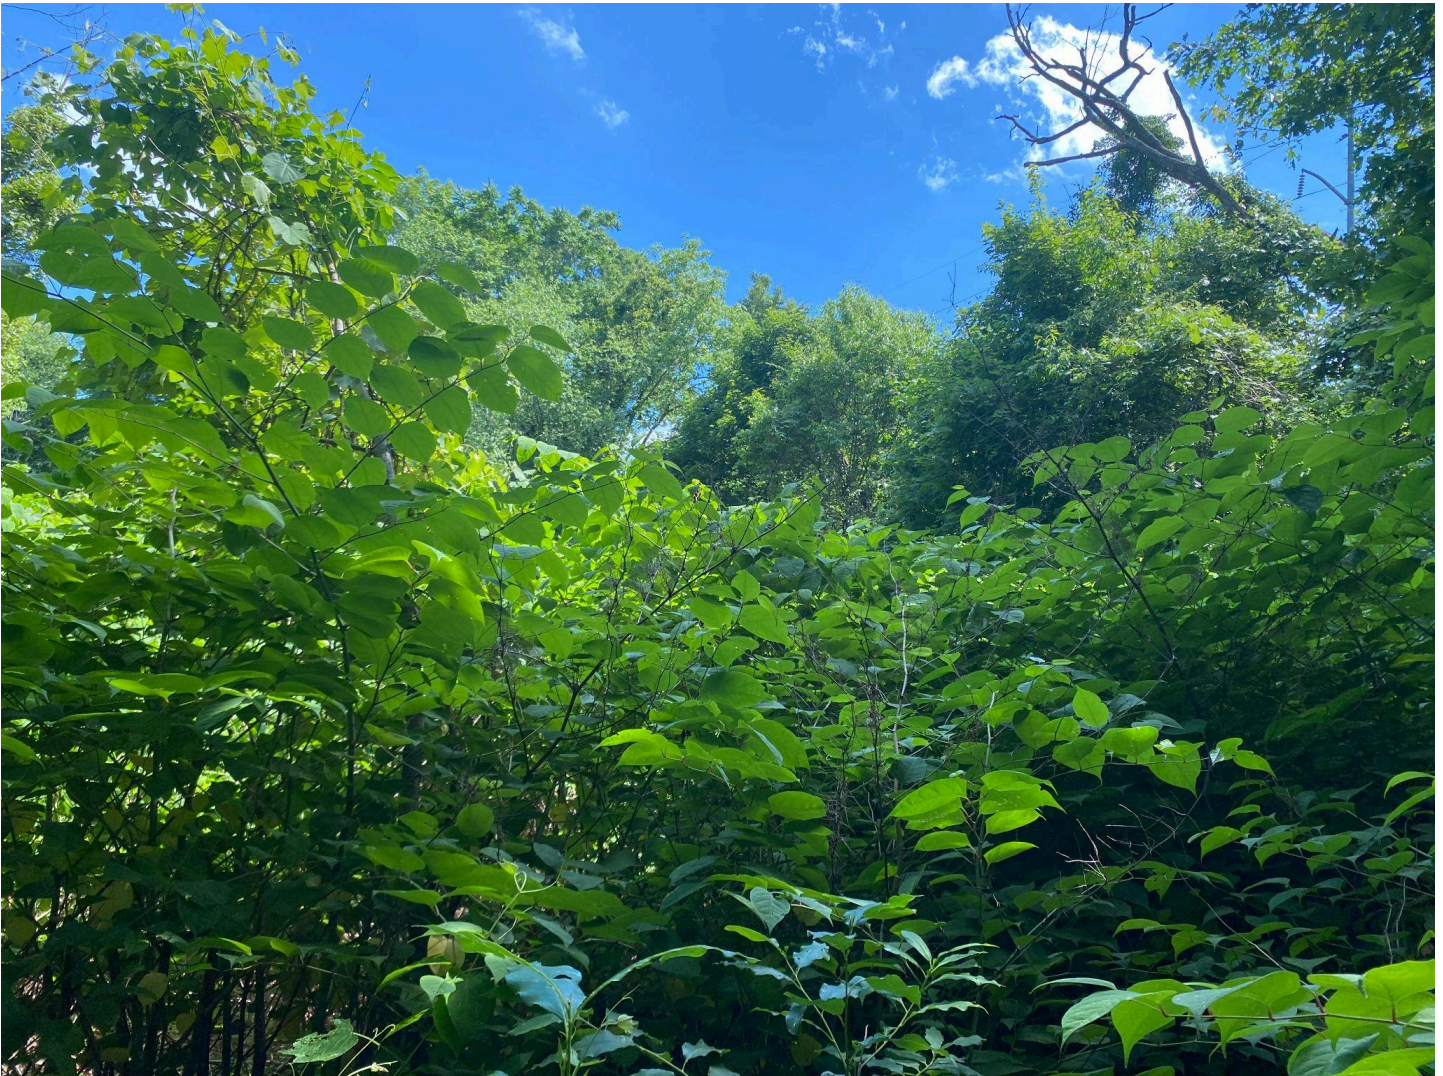
**Photo 26**

**Comments:** A large area of open canopy behind Dallas Street is filled with Japanese knotweed.

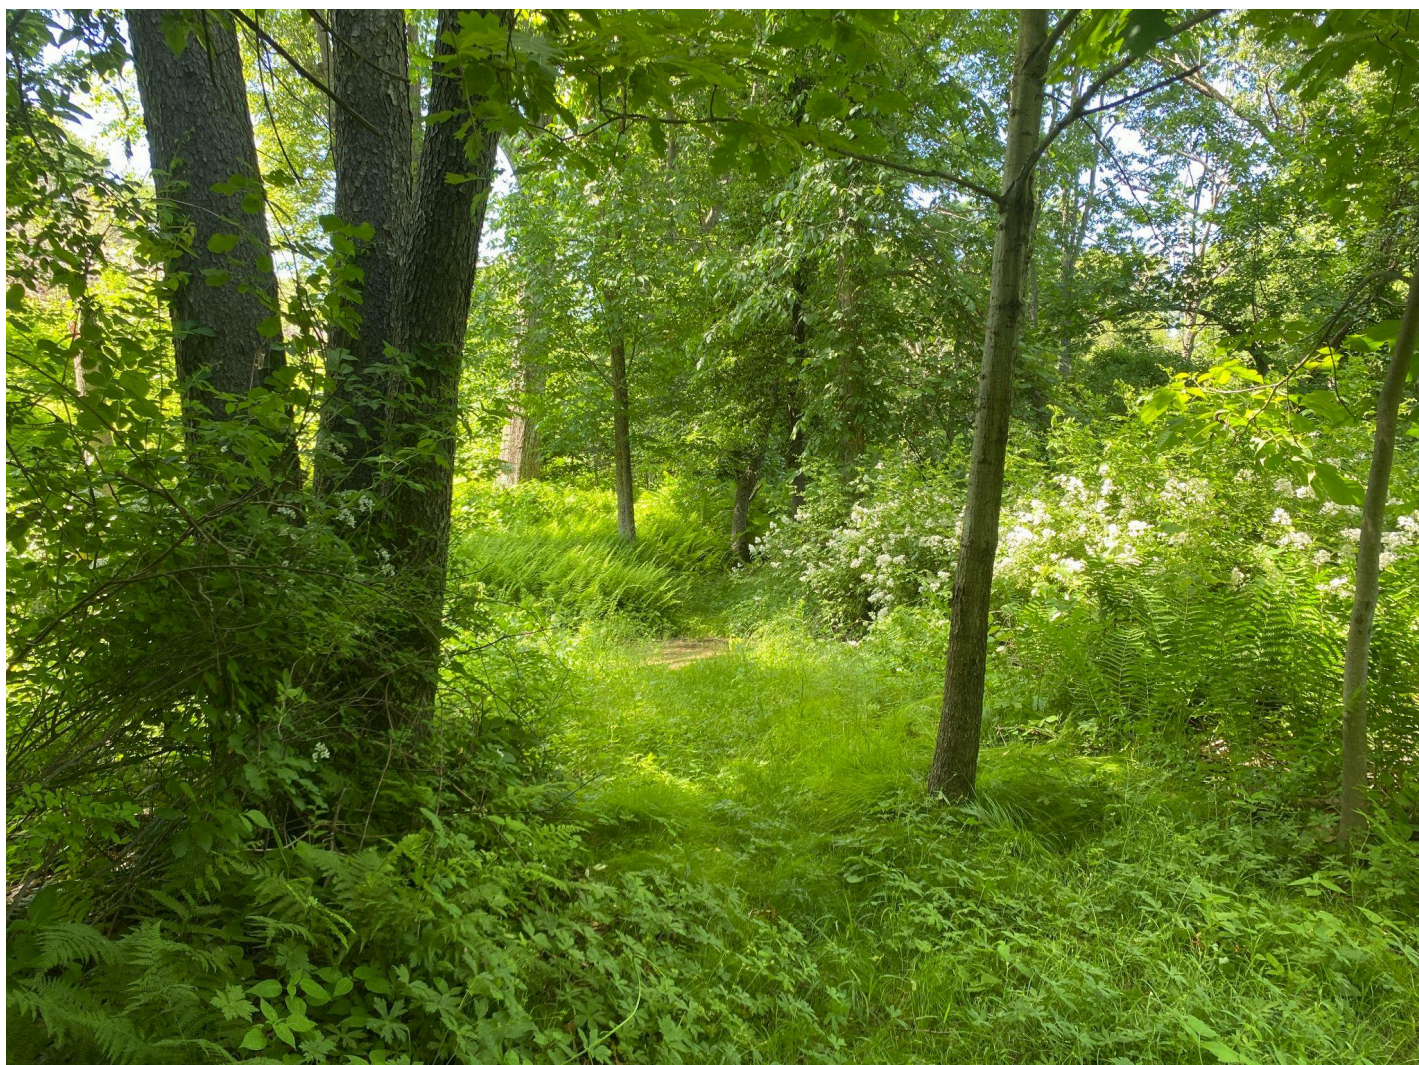
**Photo 27**

**Comments:** The path that started at the end of Alvarado Avenue along a utility easement continues behind Dallas Street homes. It is smaller but more frequently traveled here.

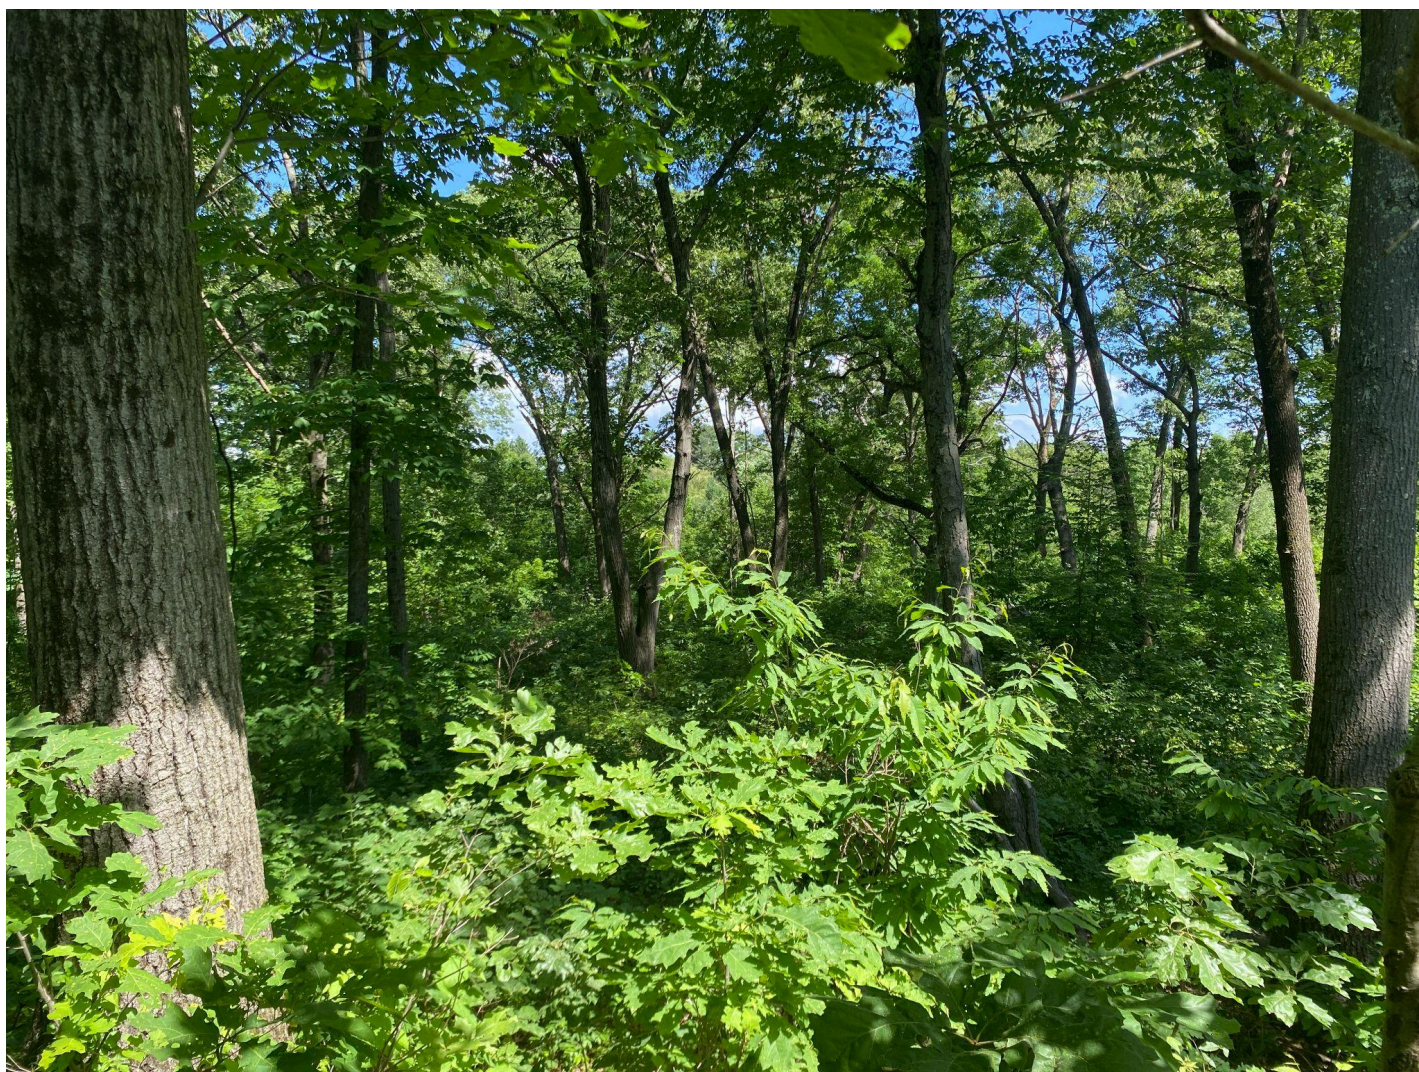
**Photo 28**

**Comments:** An area of more open forest with many small American chestnut (*Castanea dentata*) saplings.
