WORCESTER CONSERVATION COMMISSION

# Fitzgerald Brook

Conservation Property Baseline Assessment

July 2024

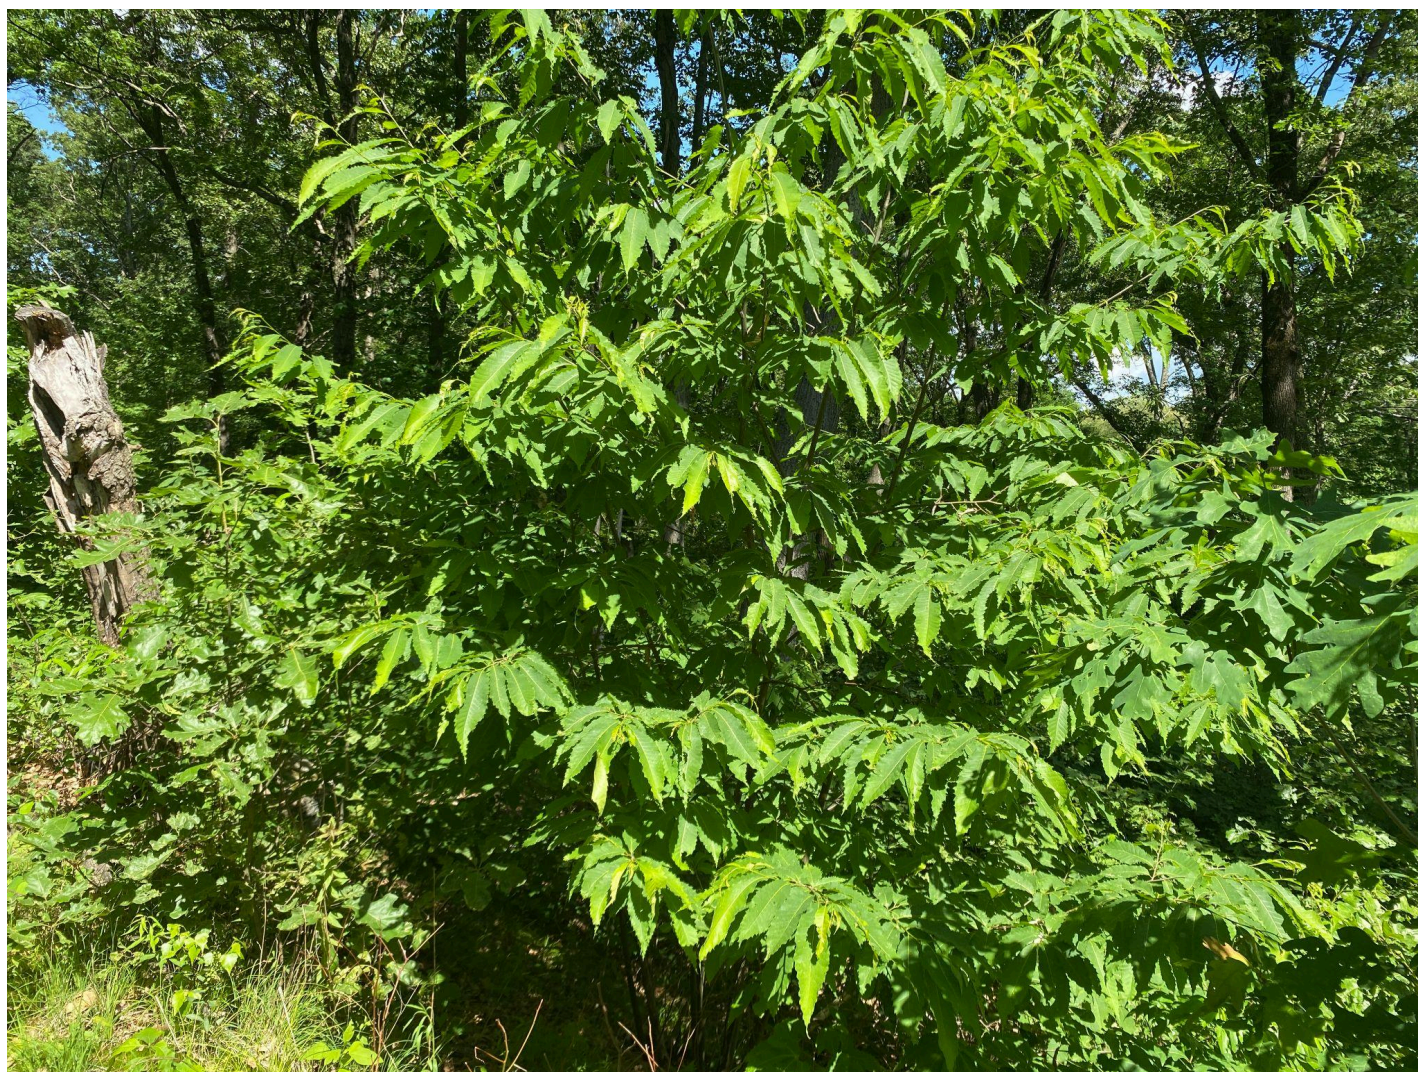
**Photo 29**

**Comments:** An area of more open forest with many small American chestnut (*Castanea dentata*) saplings.

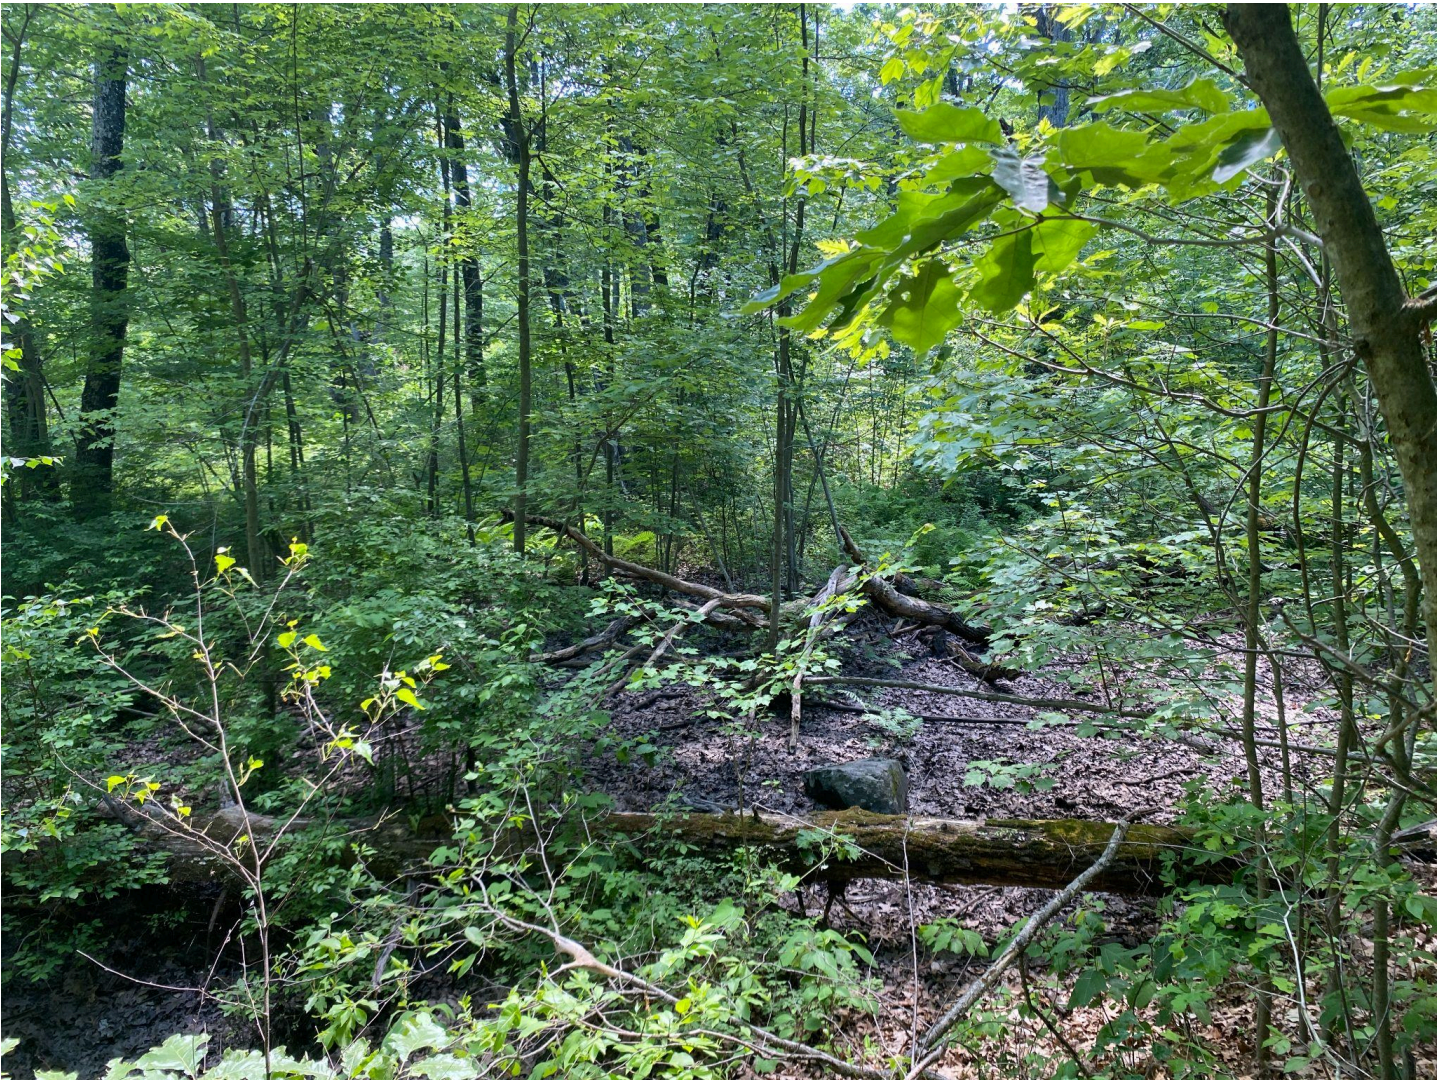
**Photo 30**

**Comments:** Periodically wet area that could potentially be a vernal pool.

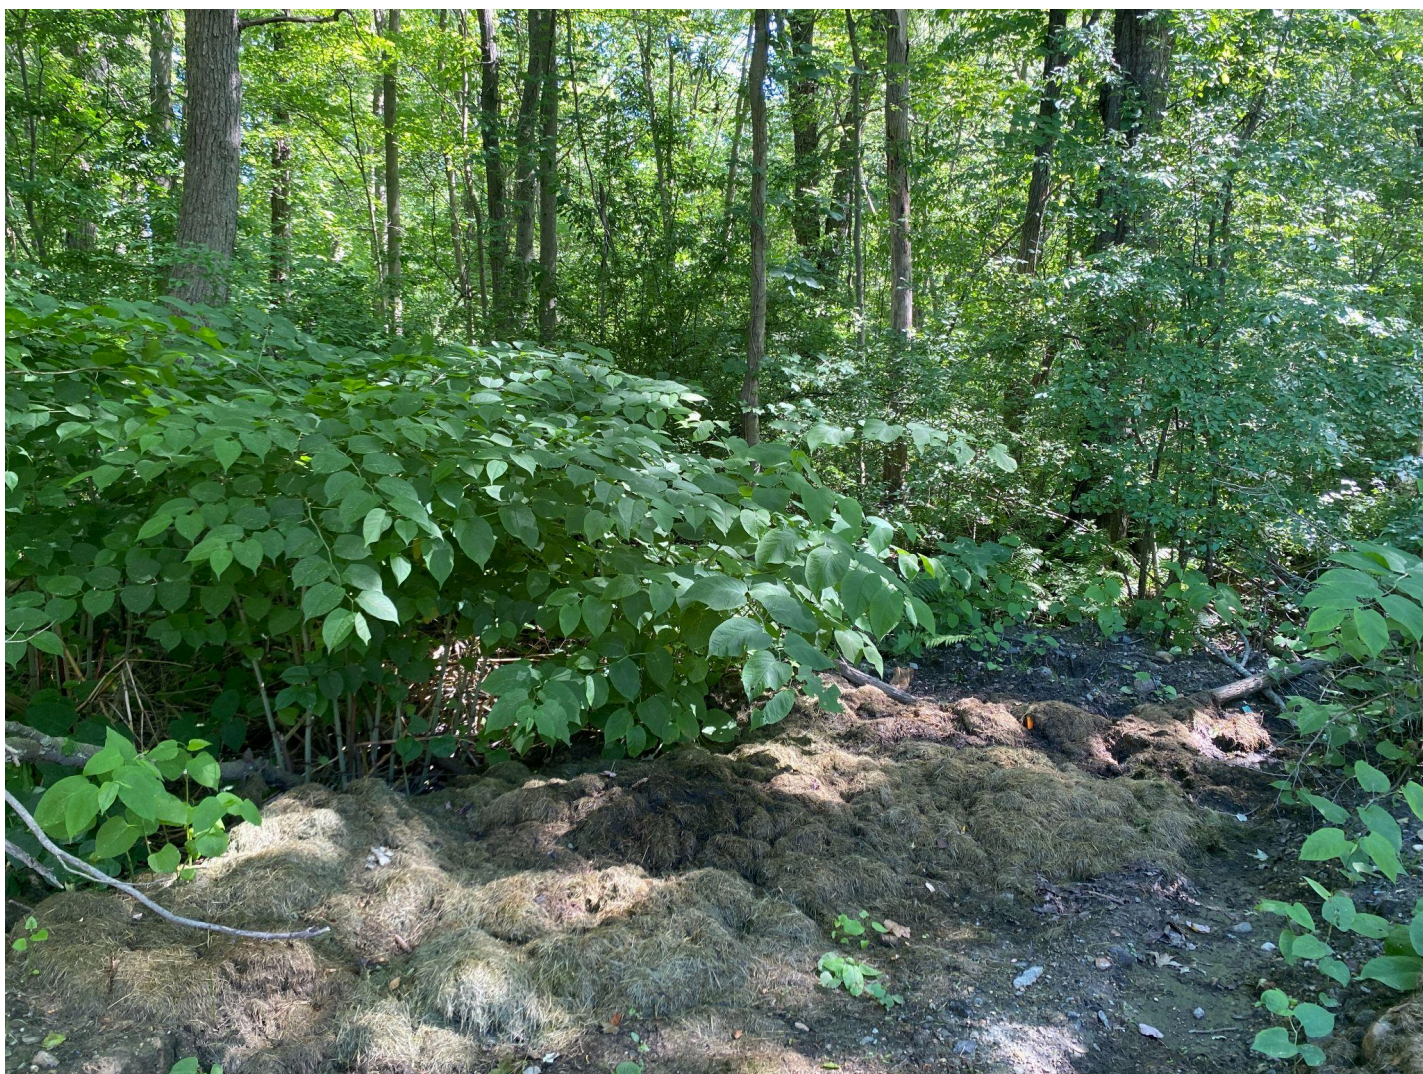
**Photo 31**

**Comments:** Yard waste dumping and Japanese knotweed behind the apartment complex at 80 Locust Street.

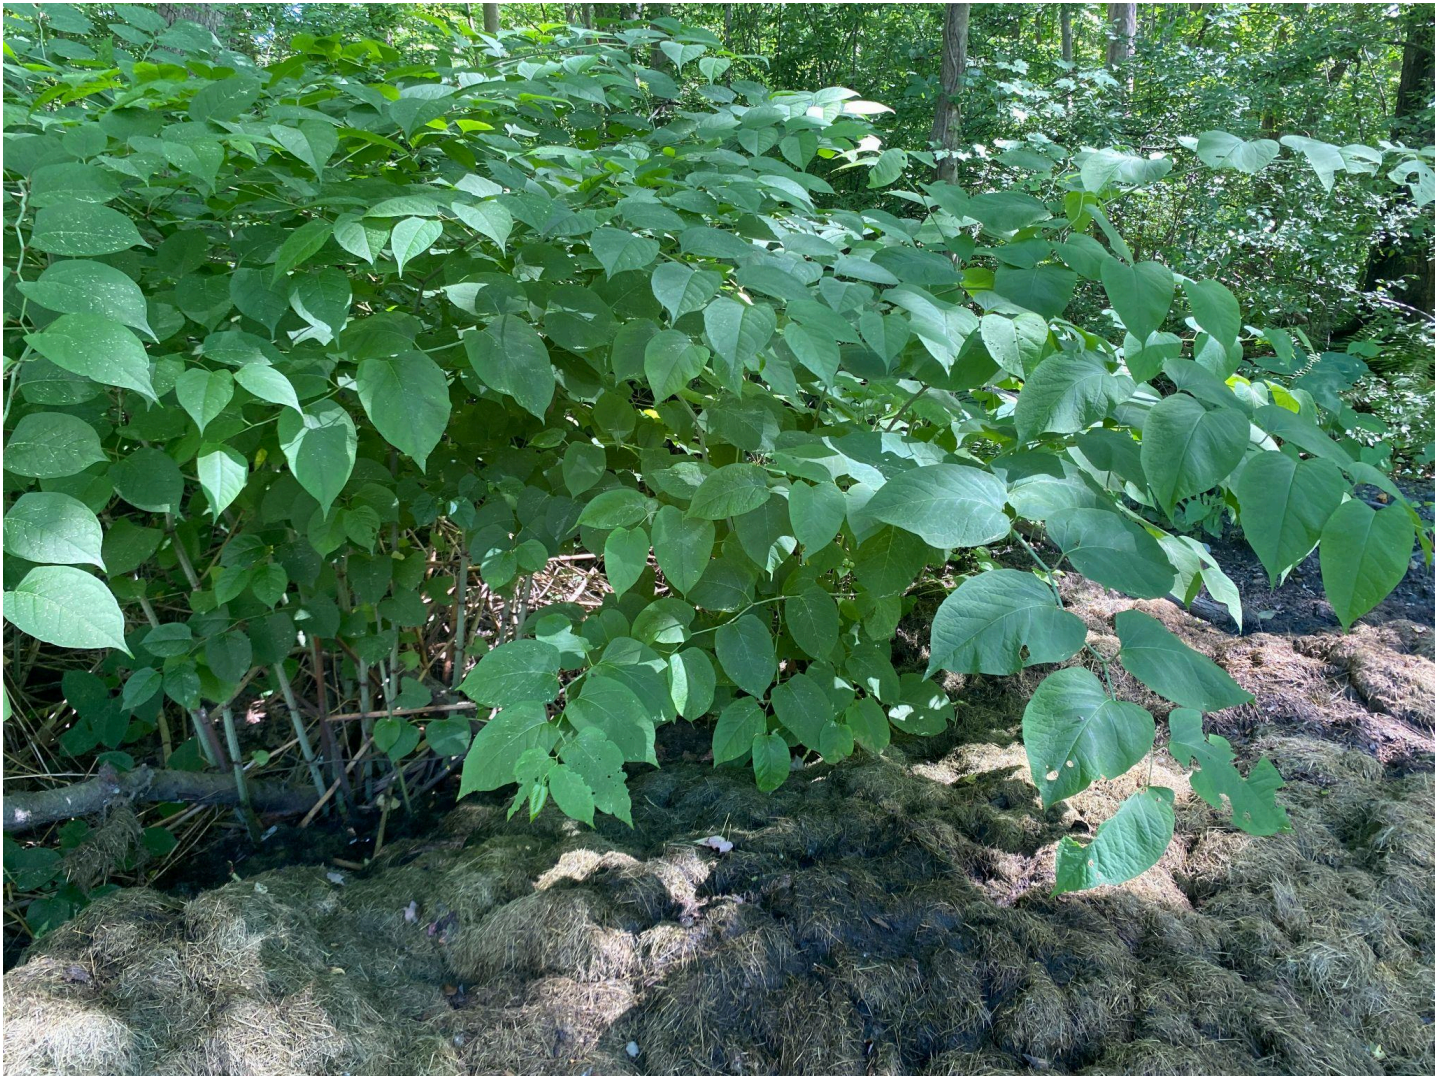
**Photo 32**

**Comments:** Japanese knotweed behind the apartment complex at 80 Locust Street.

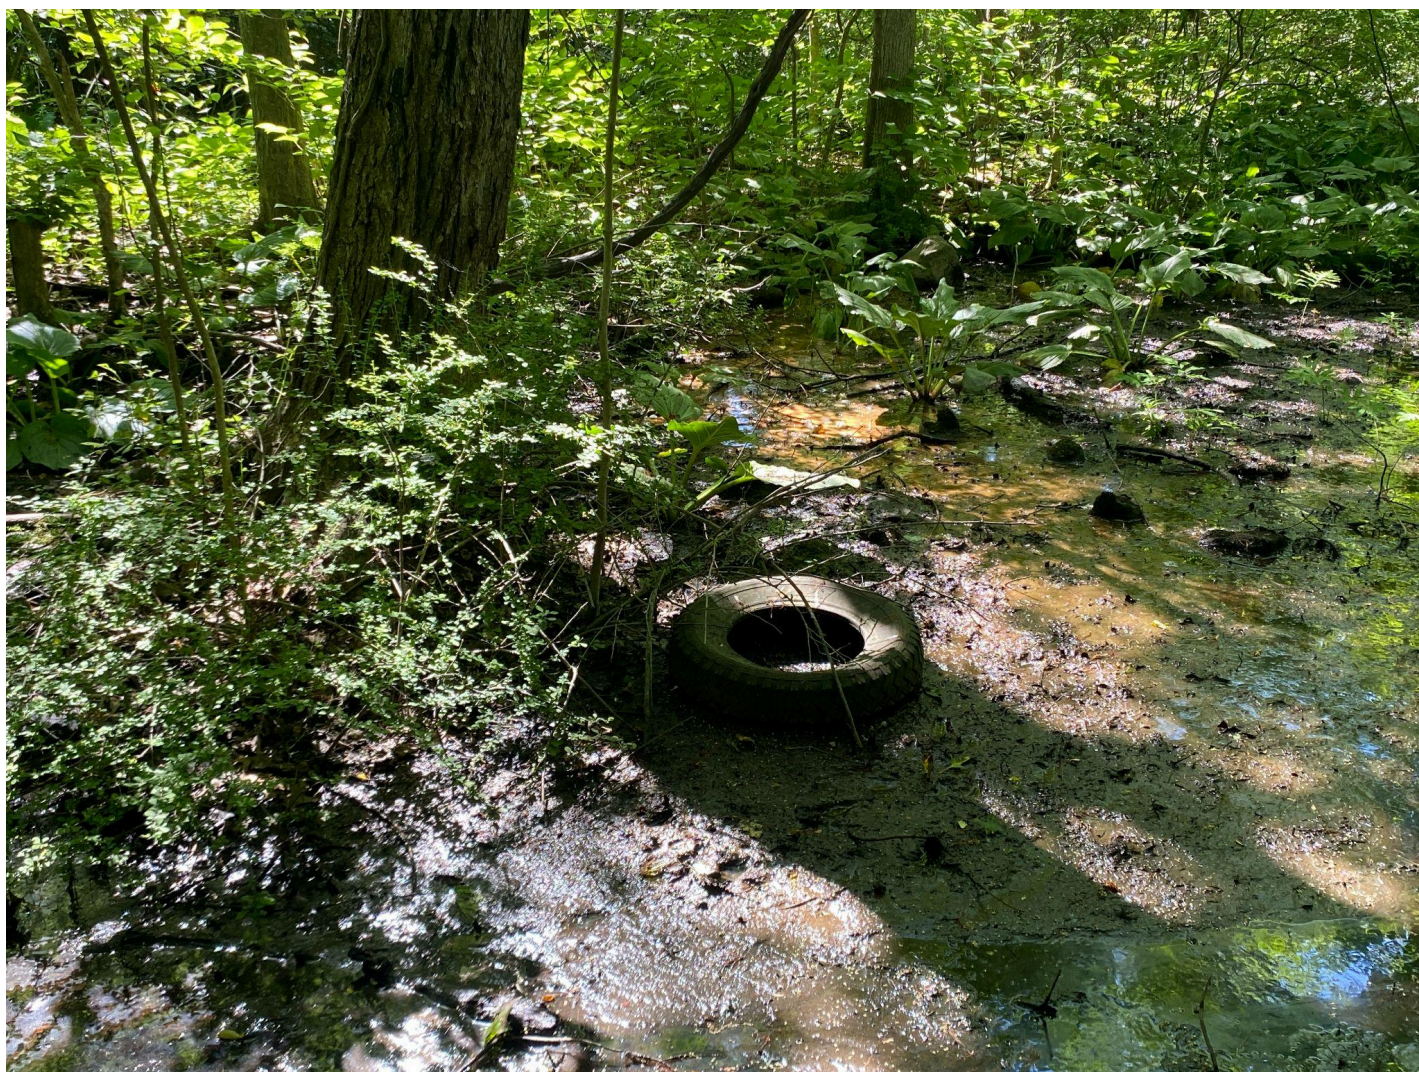
**Photo 33**

**Comments:** Tires and a car engine dumped behind 88-94 Locust Street.

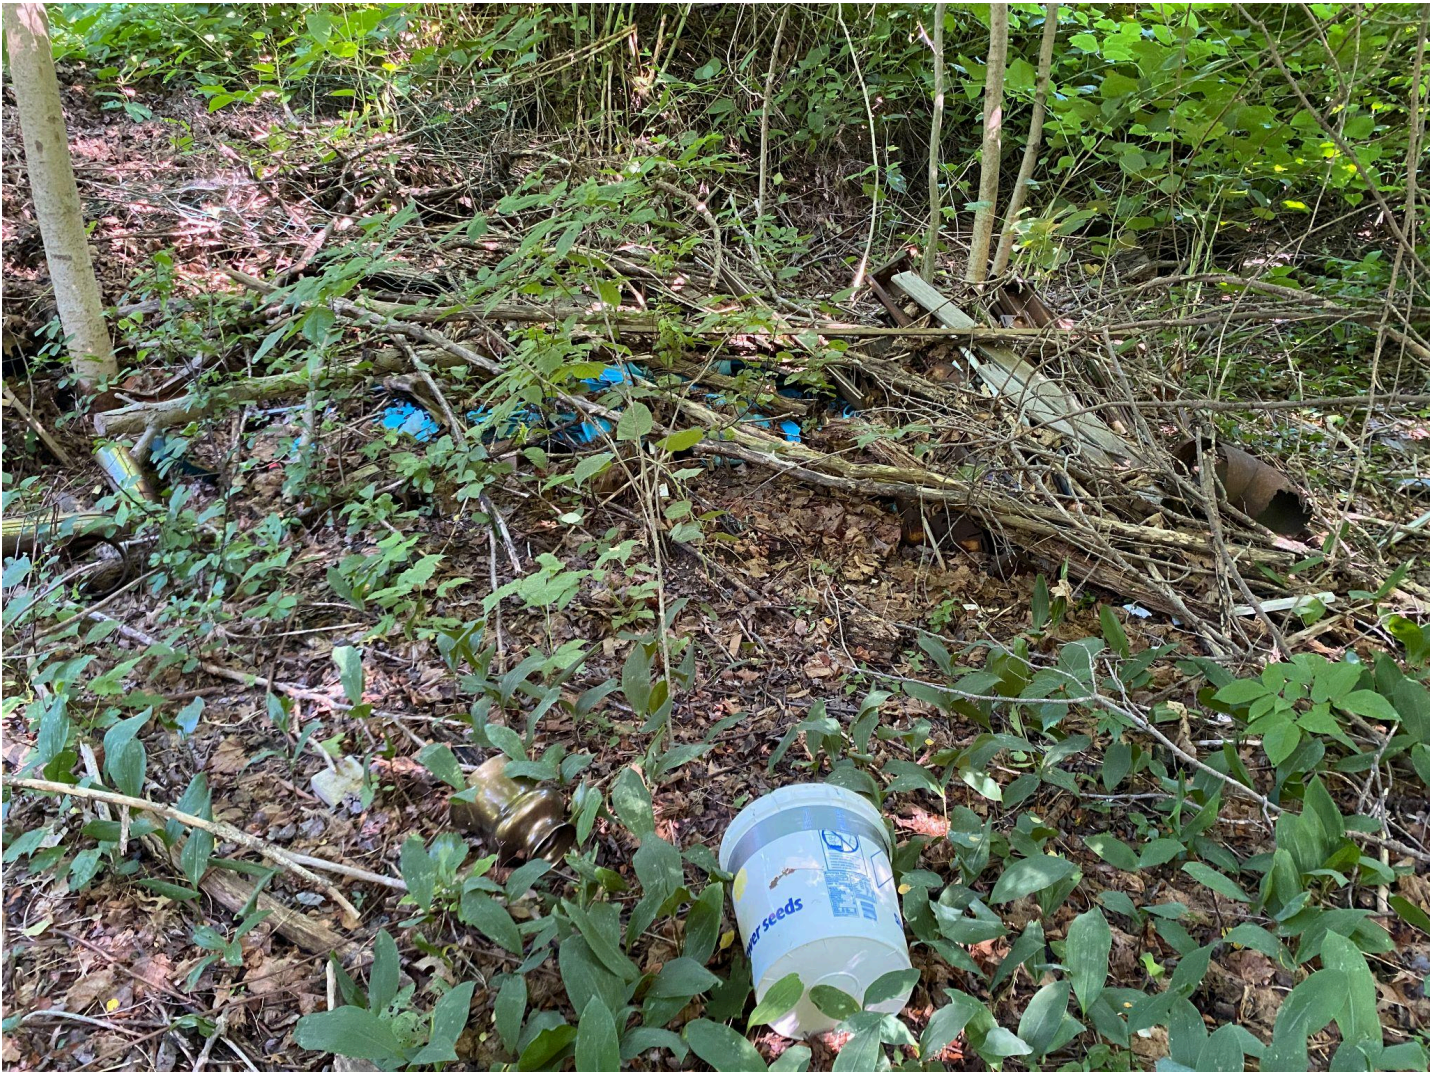
**Photo 34**

**Comments:** Dumping of yard waste, scrap metal, wood, and plastic along the boundary with 94 Locust Street.

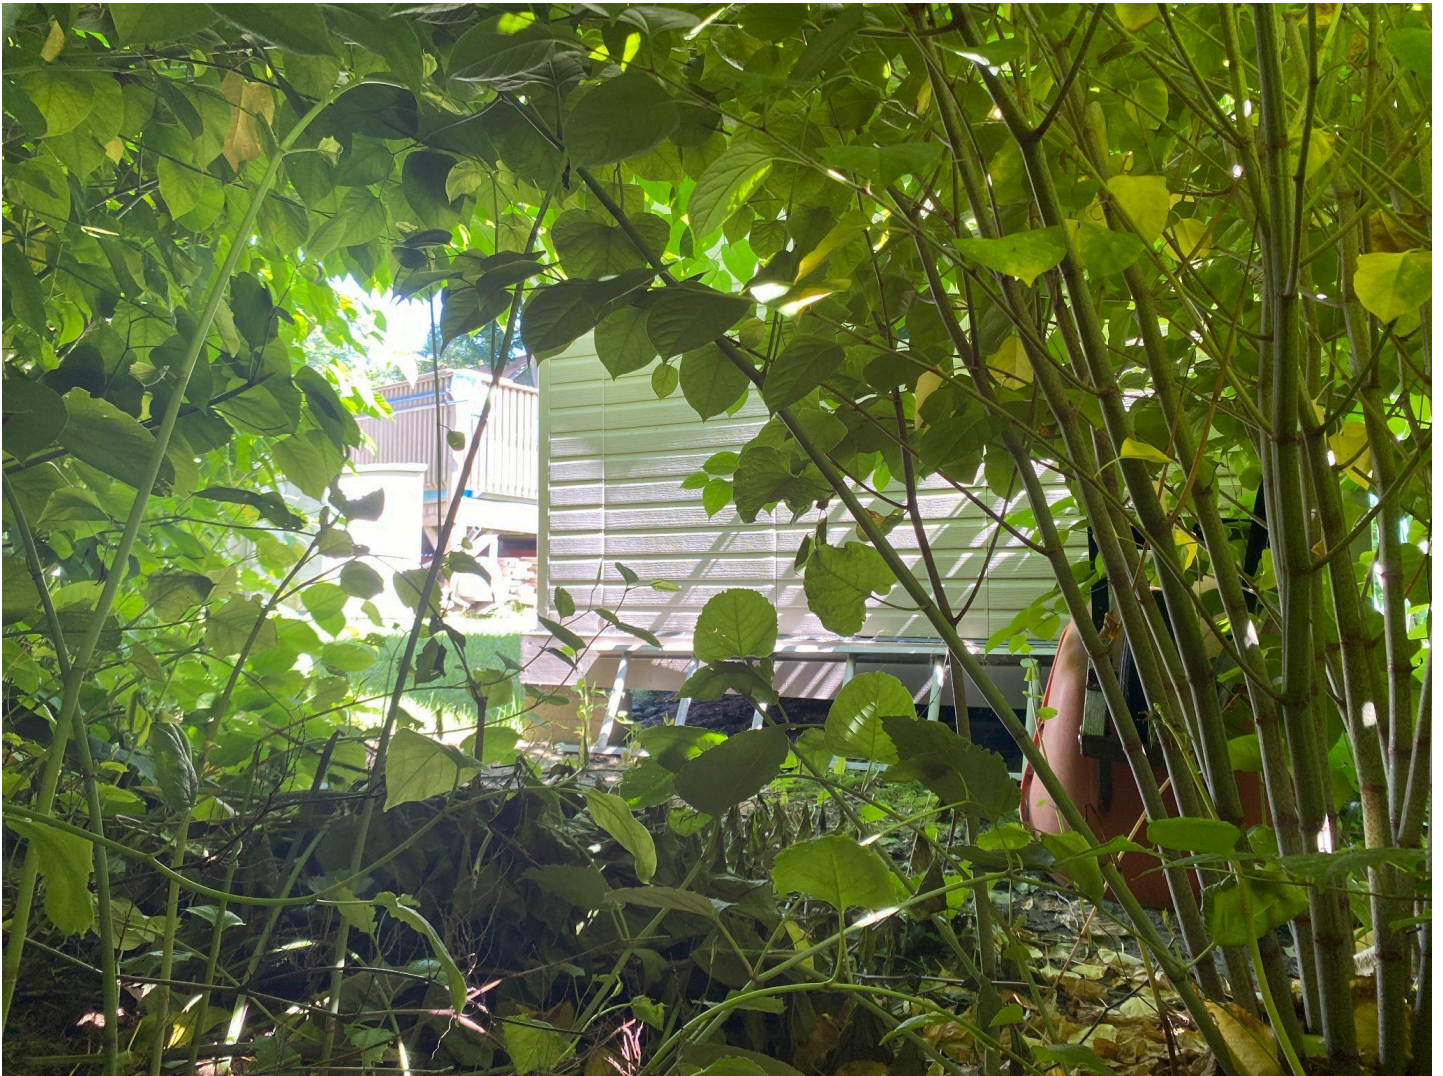
**Photo 35**

**Comments:** Japanese knotweed along the boundary with 94 Locust Avenue. A shed may be partially on conservation property.
