Perkins Farm

Conservation Property Baseline Assessment

July 2024

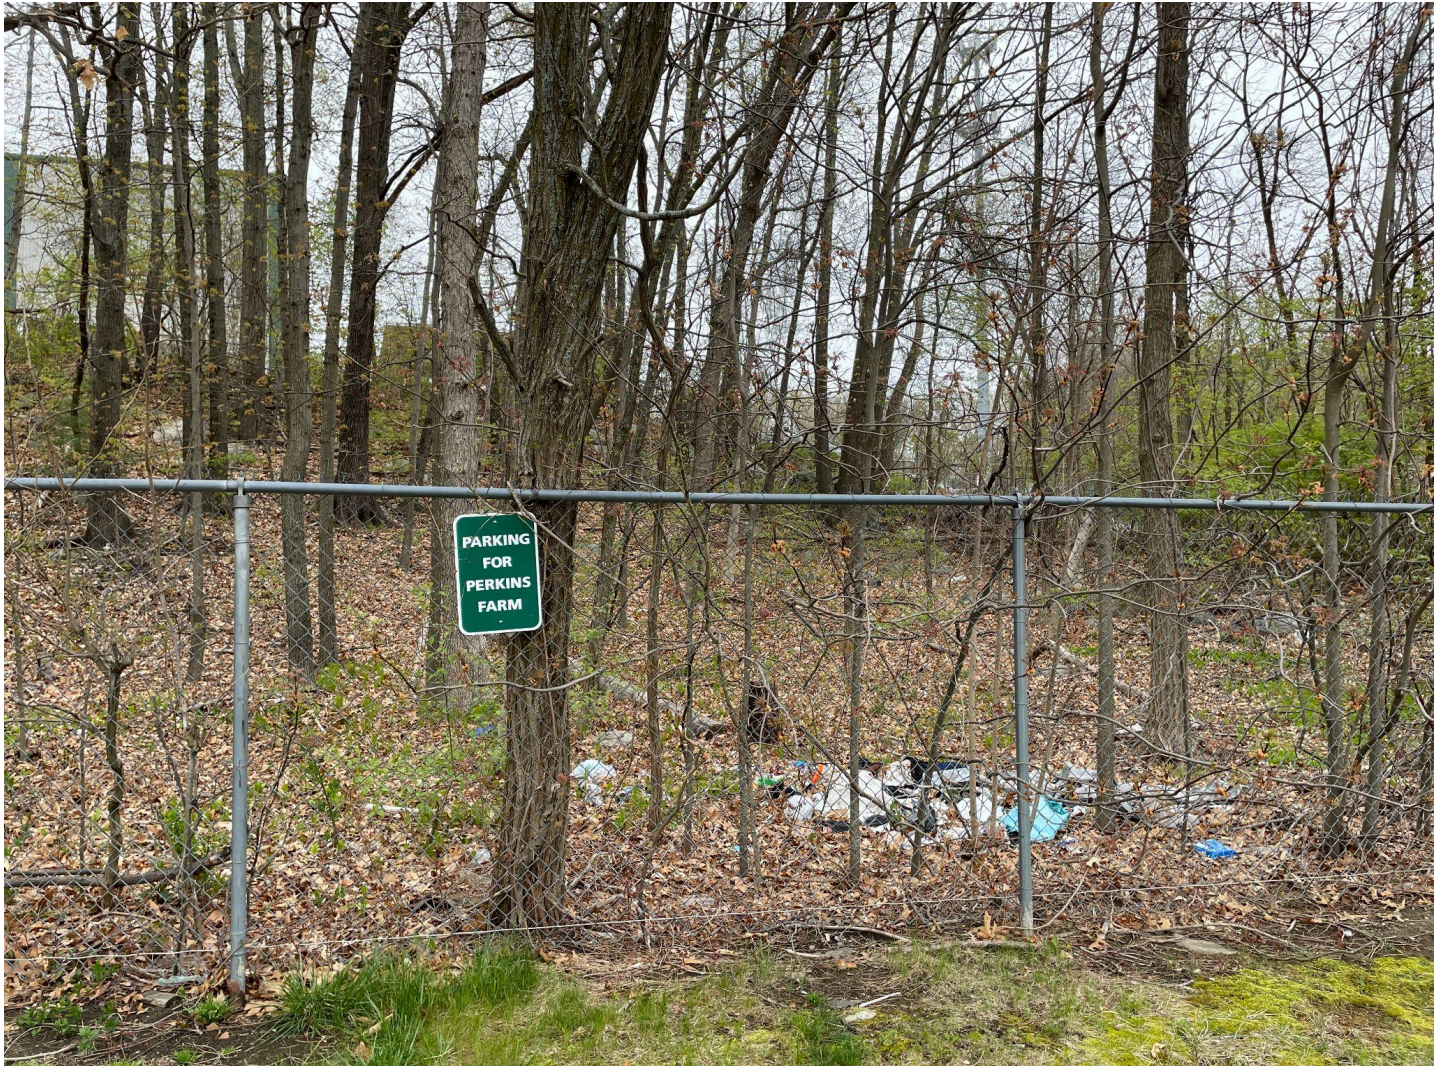
Photo 1

Comments: Dumping or storage of mostly domestic waste on the conservation land, directly adjacent to the Stop and Shop parking lot. The debris piles are highly visible from the allotted parking spaces for Perkins Farm visitors. No liquid containers or liquid materials were observed.

- d. Post signage which specifically prohibits dumping at key locations where dumping appears to be an issue.
5. Repair signage
 - a. Restore or replace Jolma Road sign.

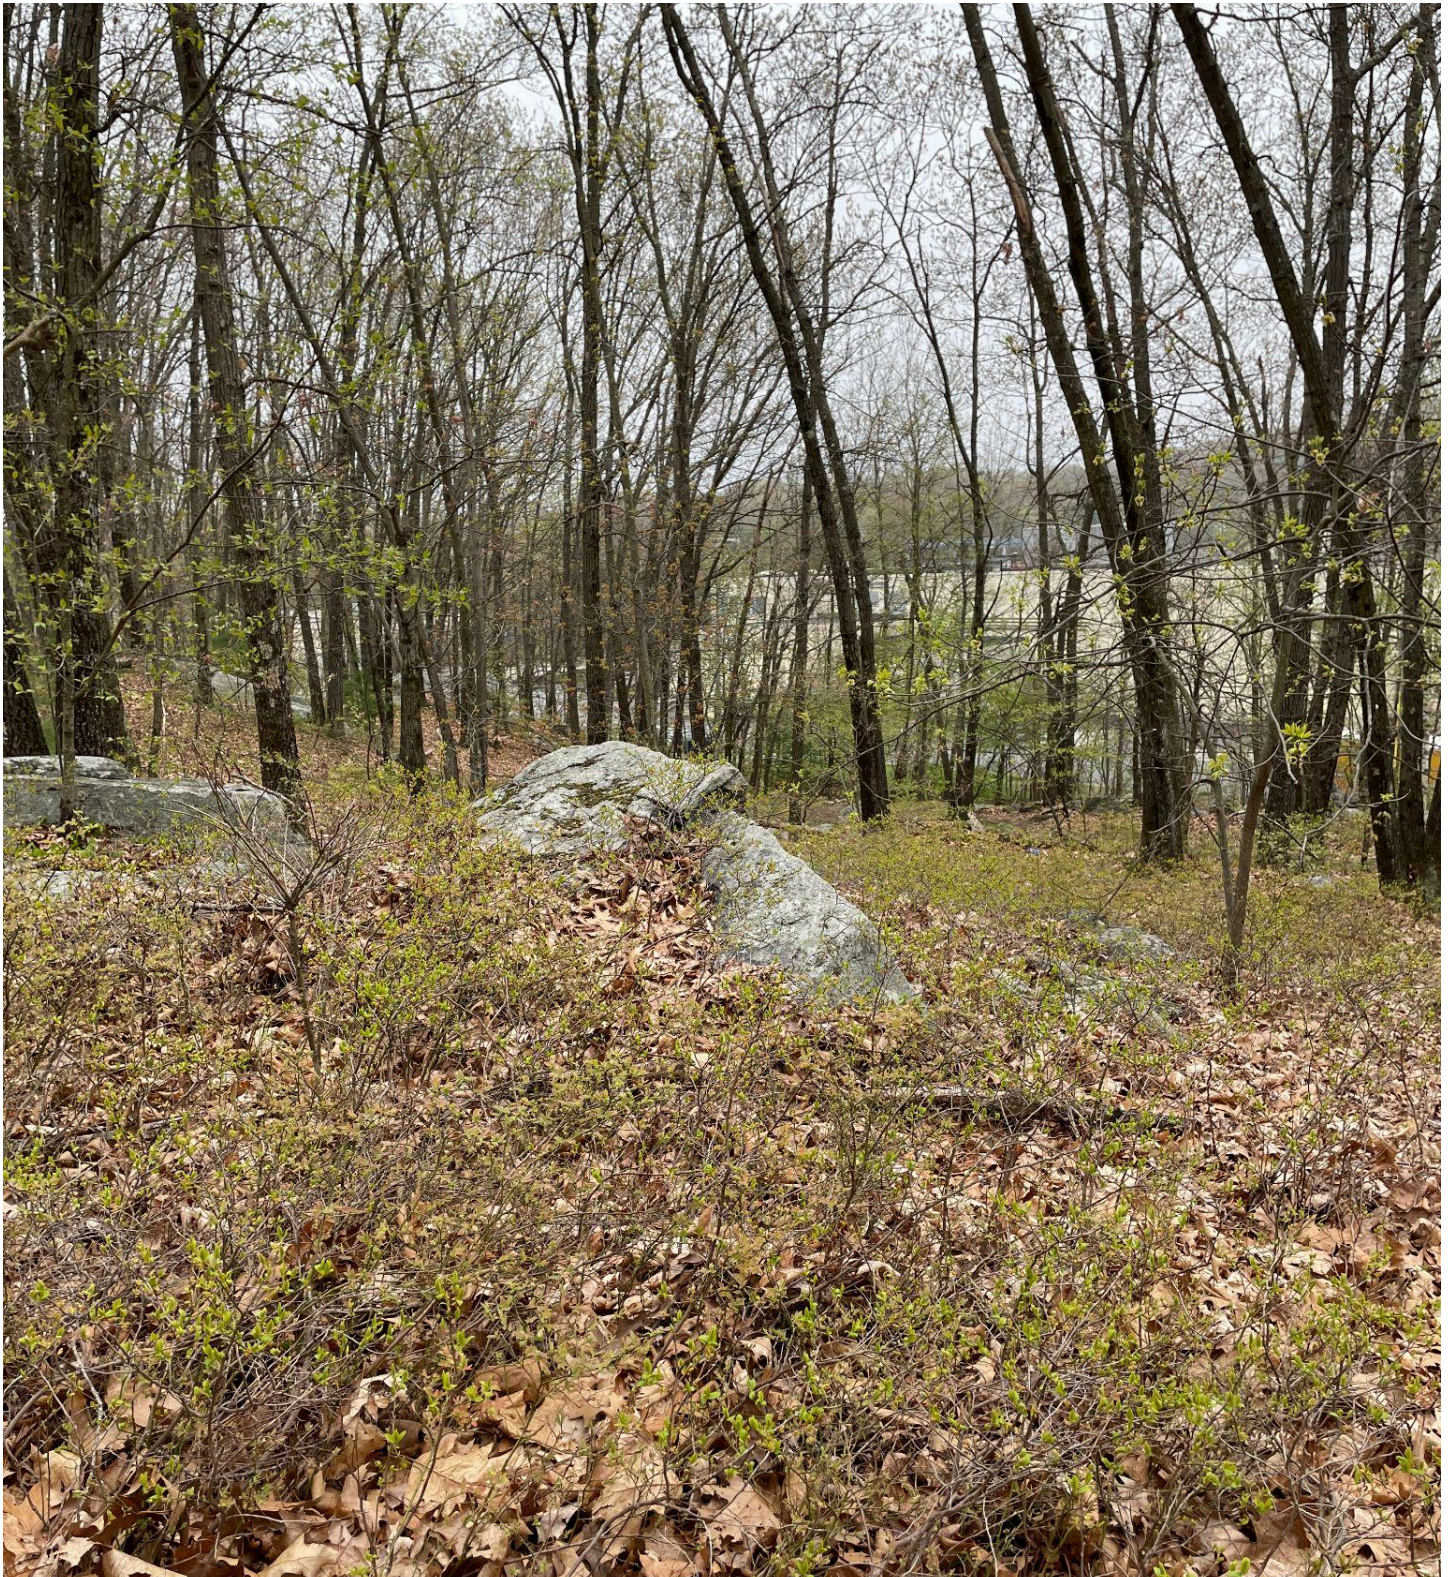
Photo 2

Comments: Glacial erratic along Birch Trail. Marked on existing trail maps.

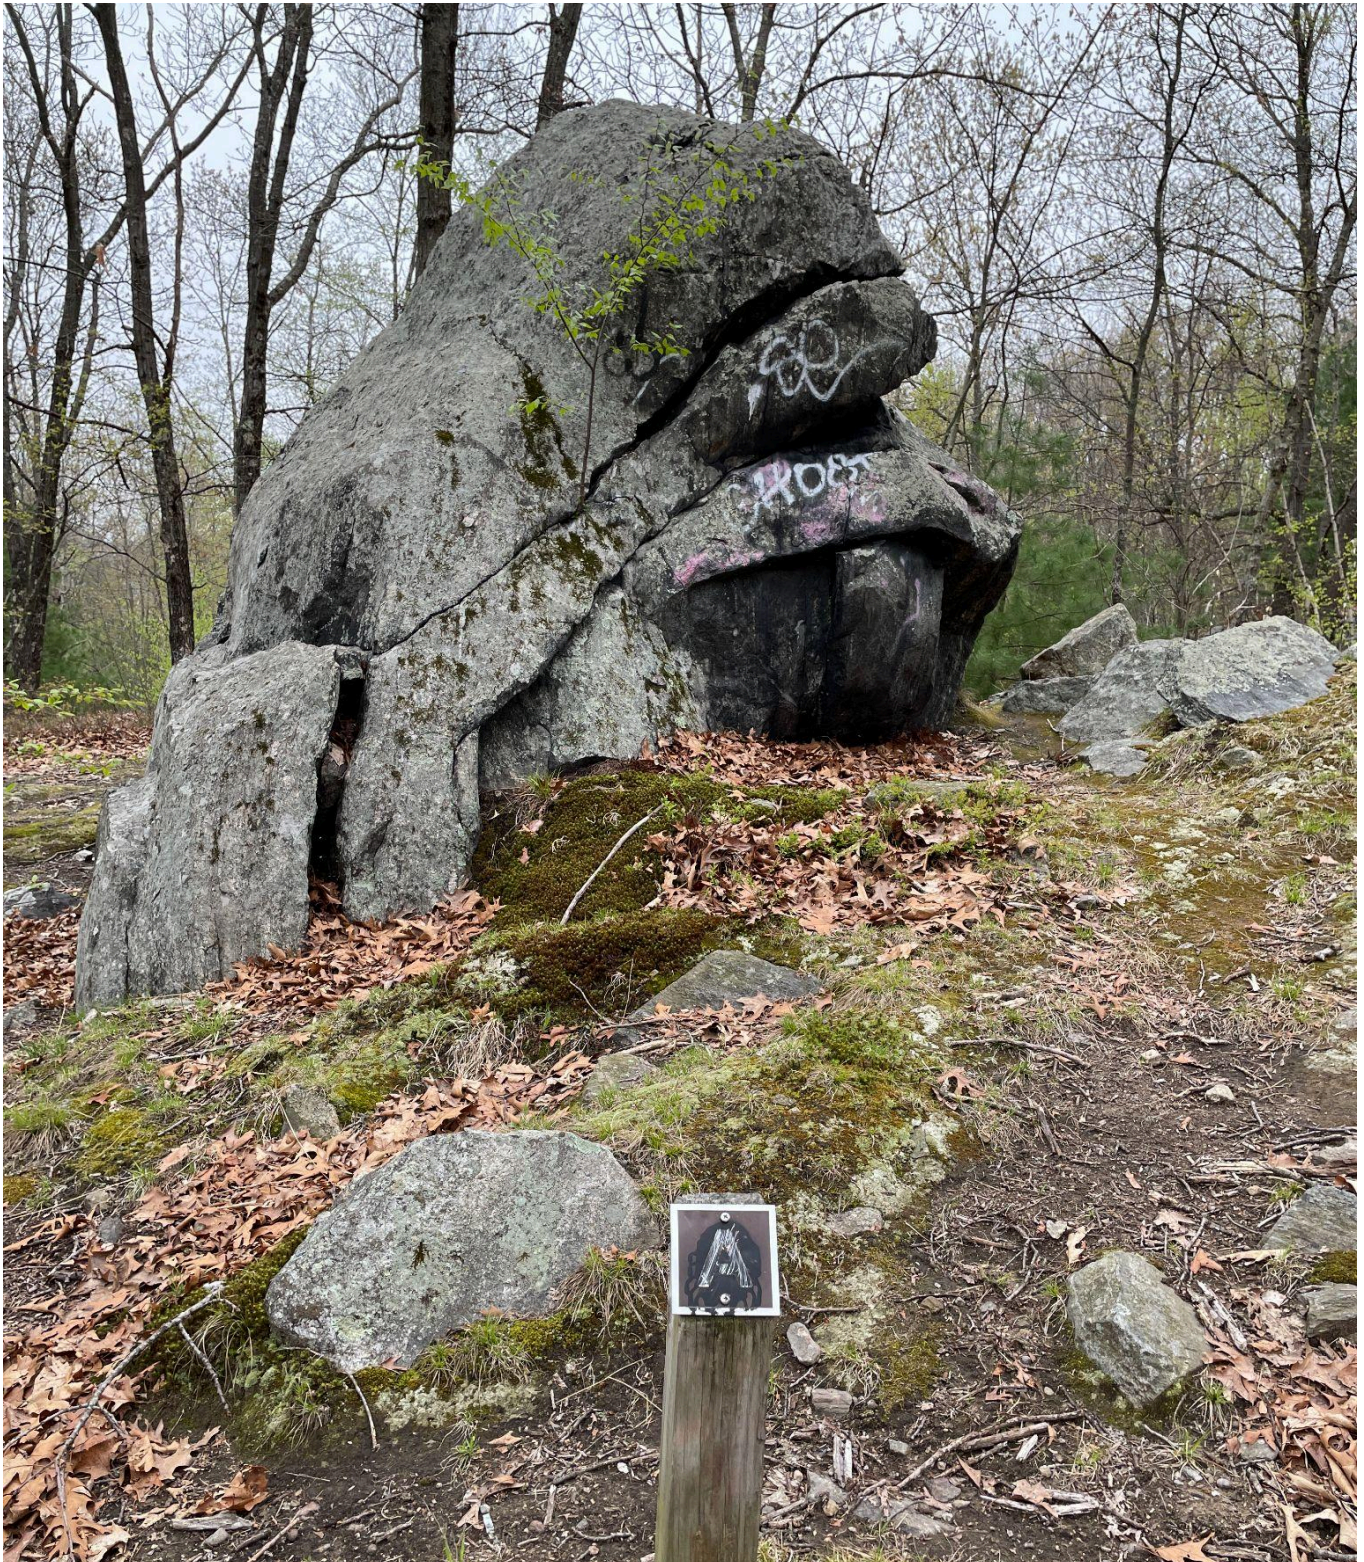
Photo 3

Comments: Glacial erratic along Birch Trail. Marked on existing trail maps. Stone defaced with graffiti and marker "A" damaged.

- e. Replace marker M and clean marker A.
6. Monitor forest stands on a regular basis, ideally annually.
 - a. Consider whether regeneration is occurring to replace canopy trees as they fall.

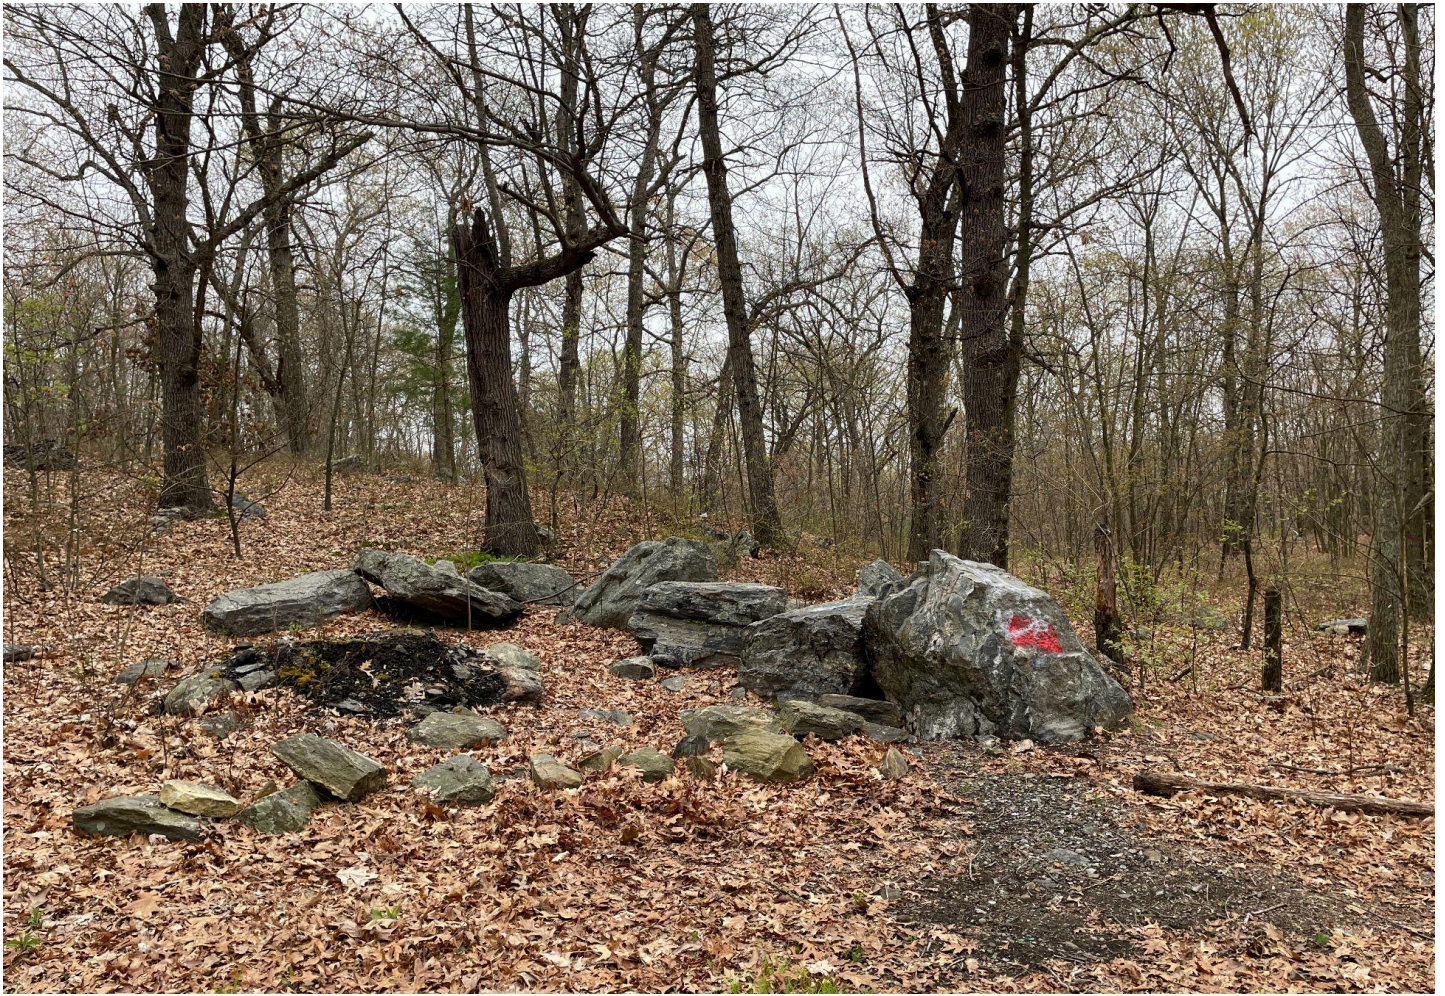
Photo 4

Comments: Grouping of stones at Trail Intersection 1 which appear to be a cluster of small glacial erratics with a mound in the center covered in old ashes. Area has been further delineated by a line of intentionally placed smaller rocks along the trail edge. Possibly a cultural feature, or may simply be a site used by people to host campfires.

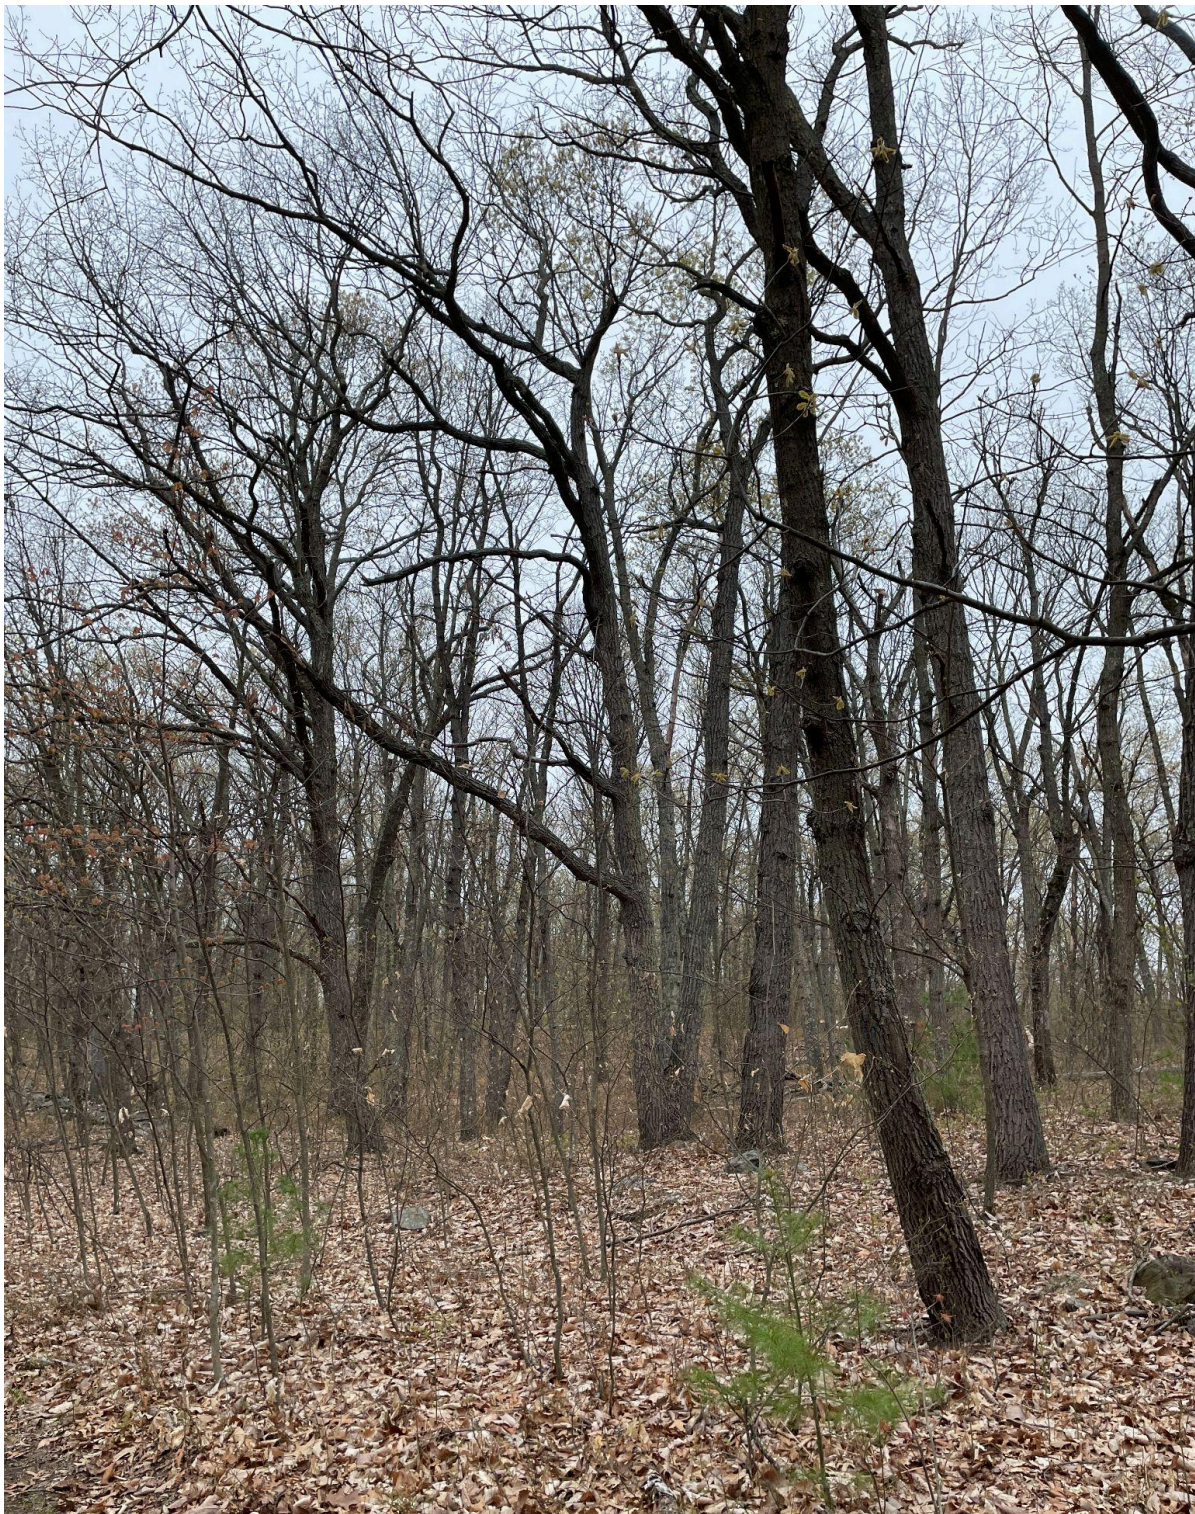
Photo 5

Comments: Chestnut oak (*Quercus montana*) stand. The marked area has an overstory of nearly pure chestnut oak, but chestnut oak continues to be a dominant canopy species beyond the delineated area although mixed with other oak species.

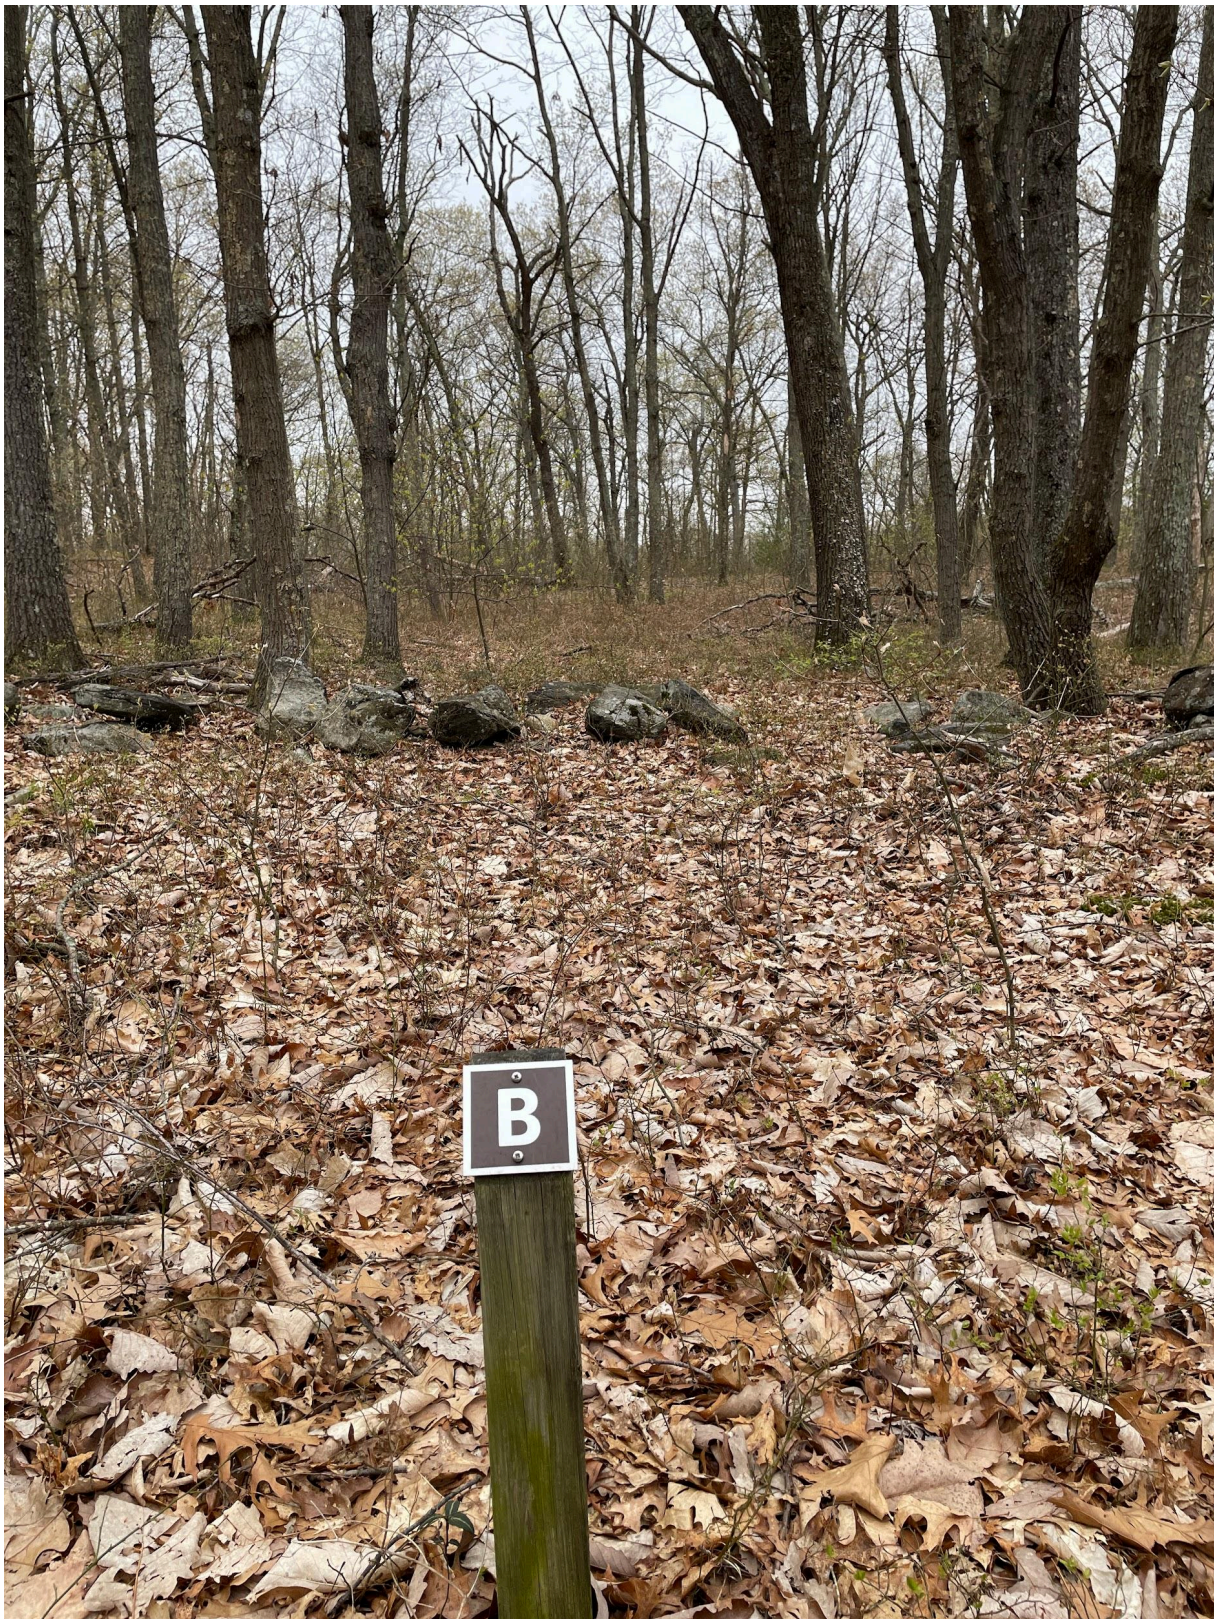
Photo 6

Comments: Campfire ring at Trail Intersection 2.

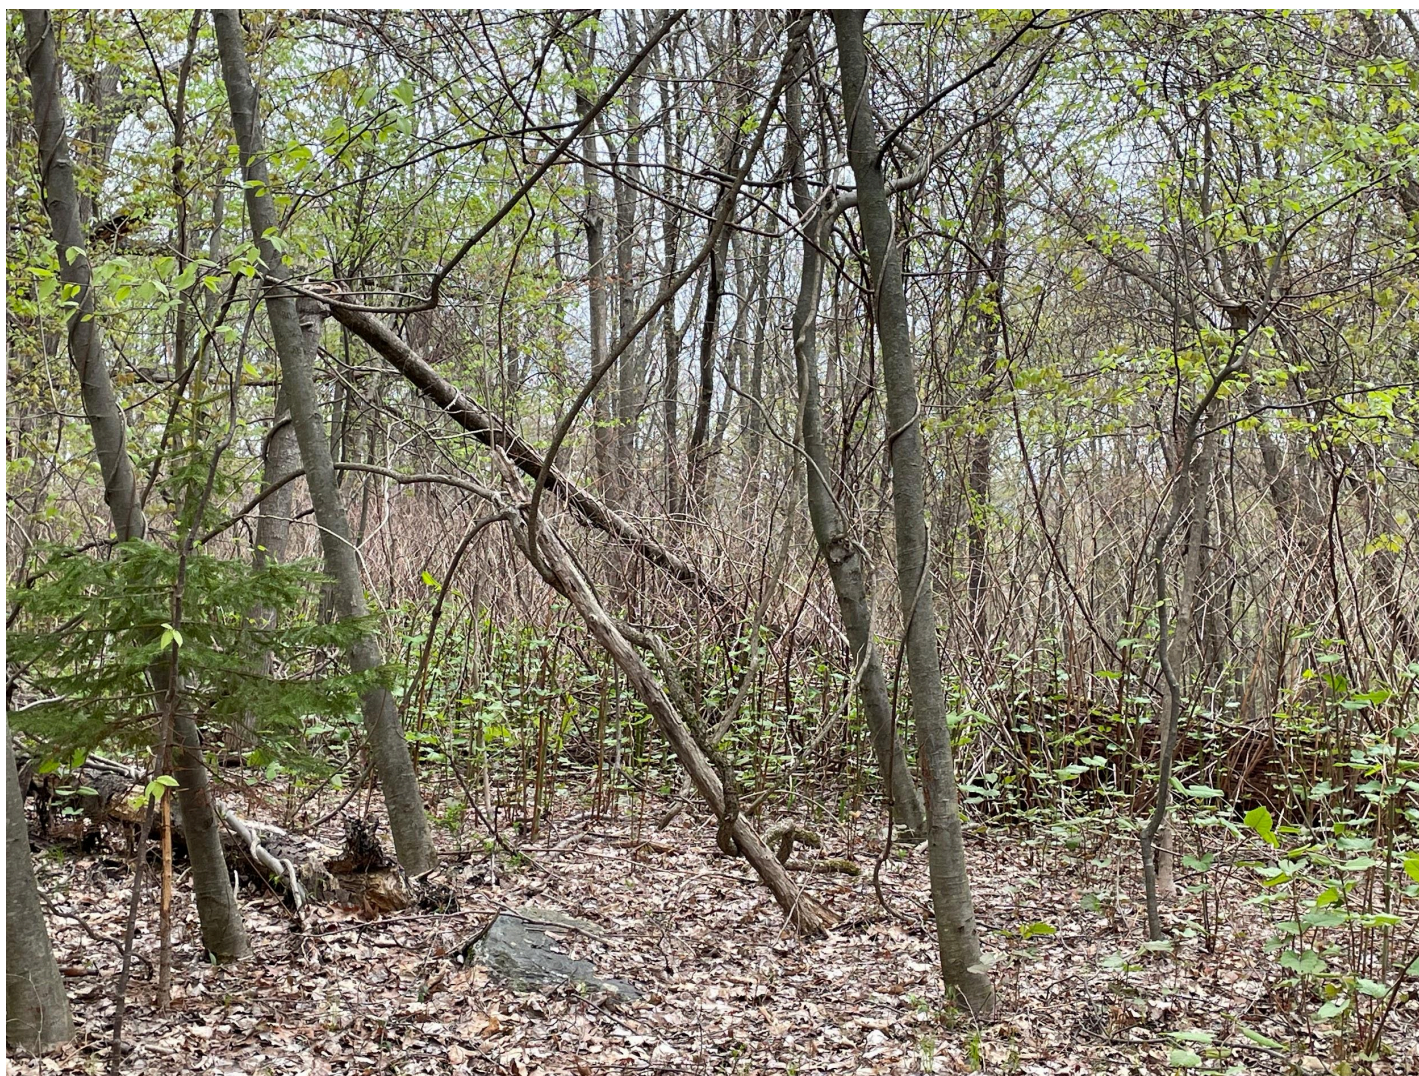
Photo 7

Comments: Japanese knotweed (*Reynoutria japonica*) is invading the conservation property along Cellar Hole Trail behind 64 Orton St Ext. The Japanese knotweed is densest along the edge of conservation property and is spreading inward toward the intermittent stream and vernal pool complex.

1. Manage the Japanese knotweed infestation along the boundary with 64 Orton Street Extension.
 - a. Prevent further spread and protect vernal pool habitat using appropriate chemical, cultural, manual, and mechanical methods.

- b. Reduce spread on conservation property.
 - c. Work with the abutter to manage infestation outside the conservation property boundary.
 - d. Management will need to be ongoing on an annual basis.

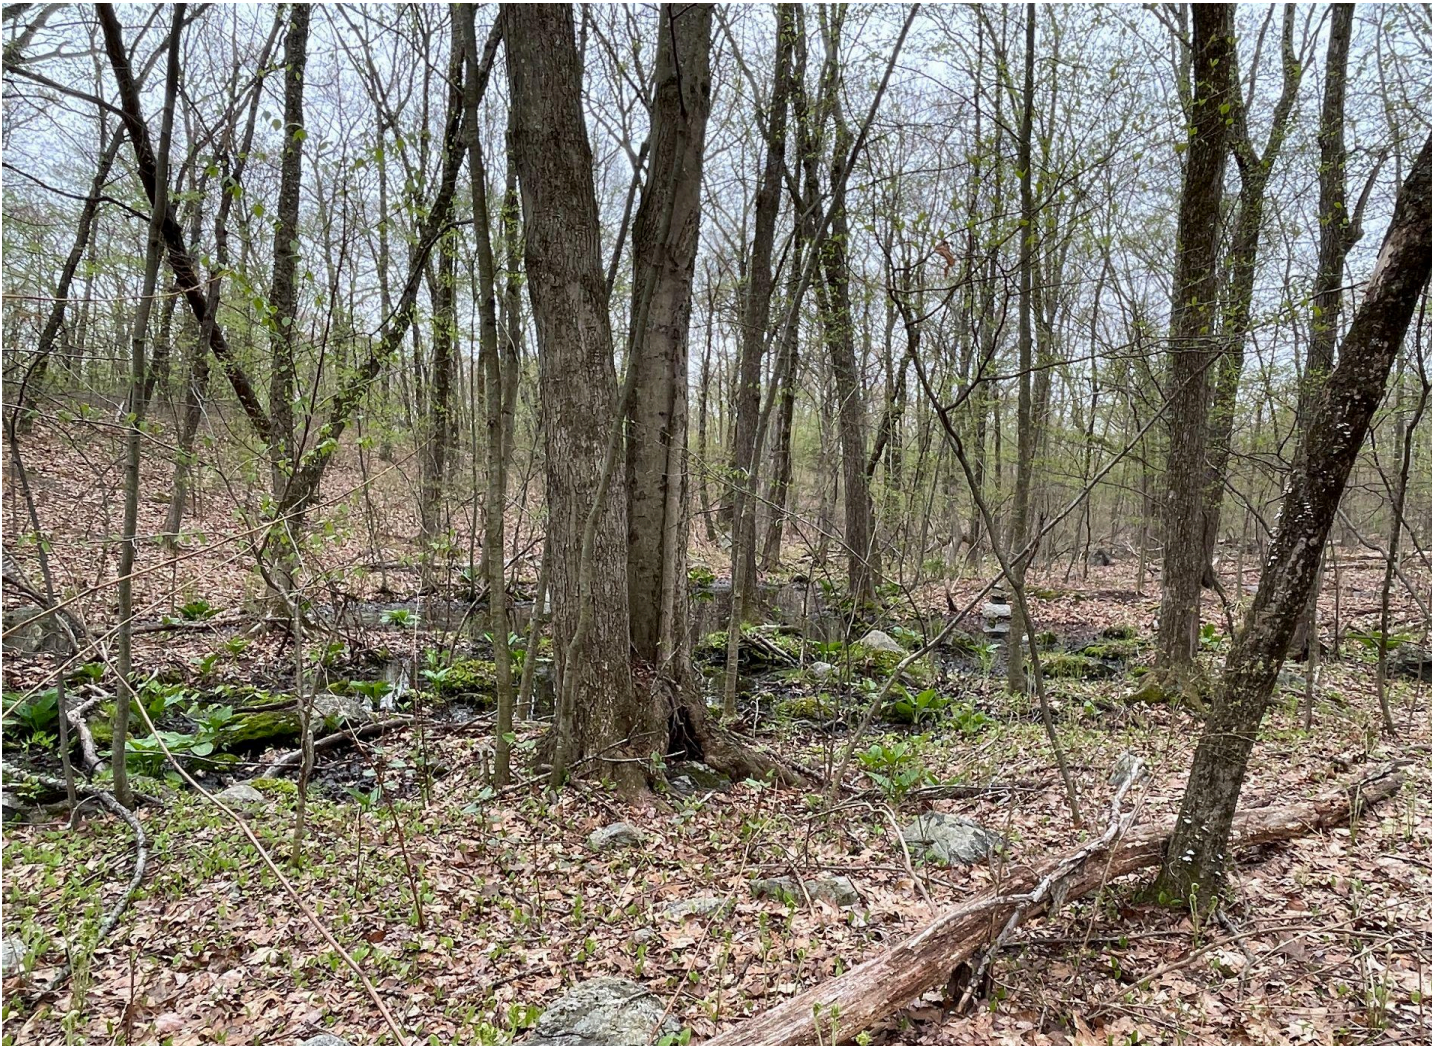
Photo 8

Comments: Aquatic habitat that is mapped as a certified vernal pool (CVP) fed by intermittent spring on a slope. The CVPs outflow when water is highest. The native vegetation in this area is threatened by encroaching Japanese knotweed.

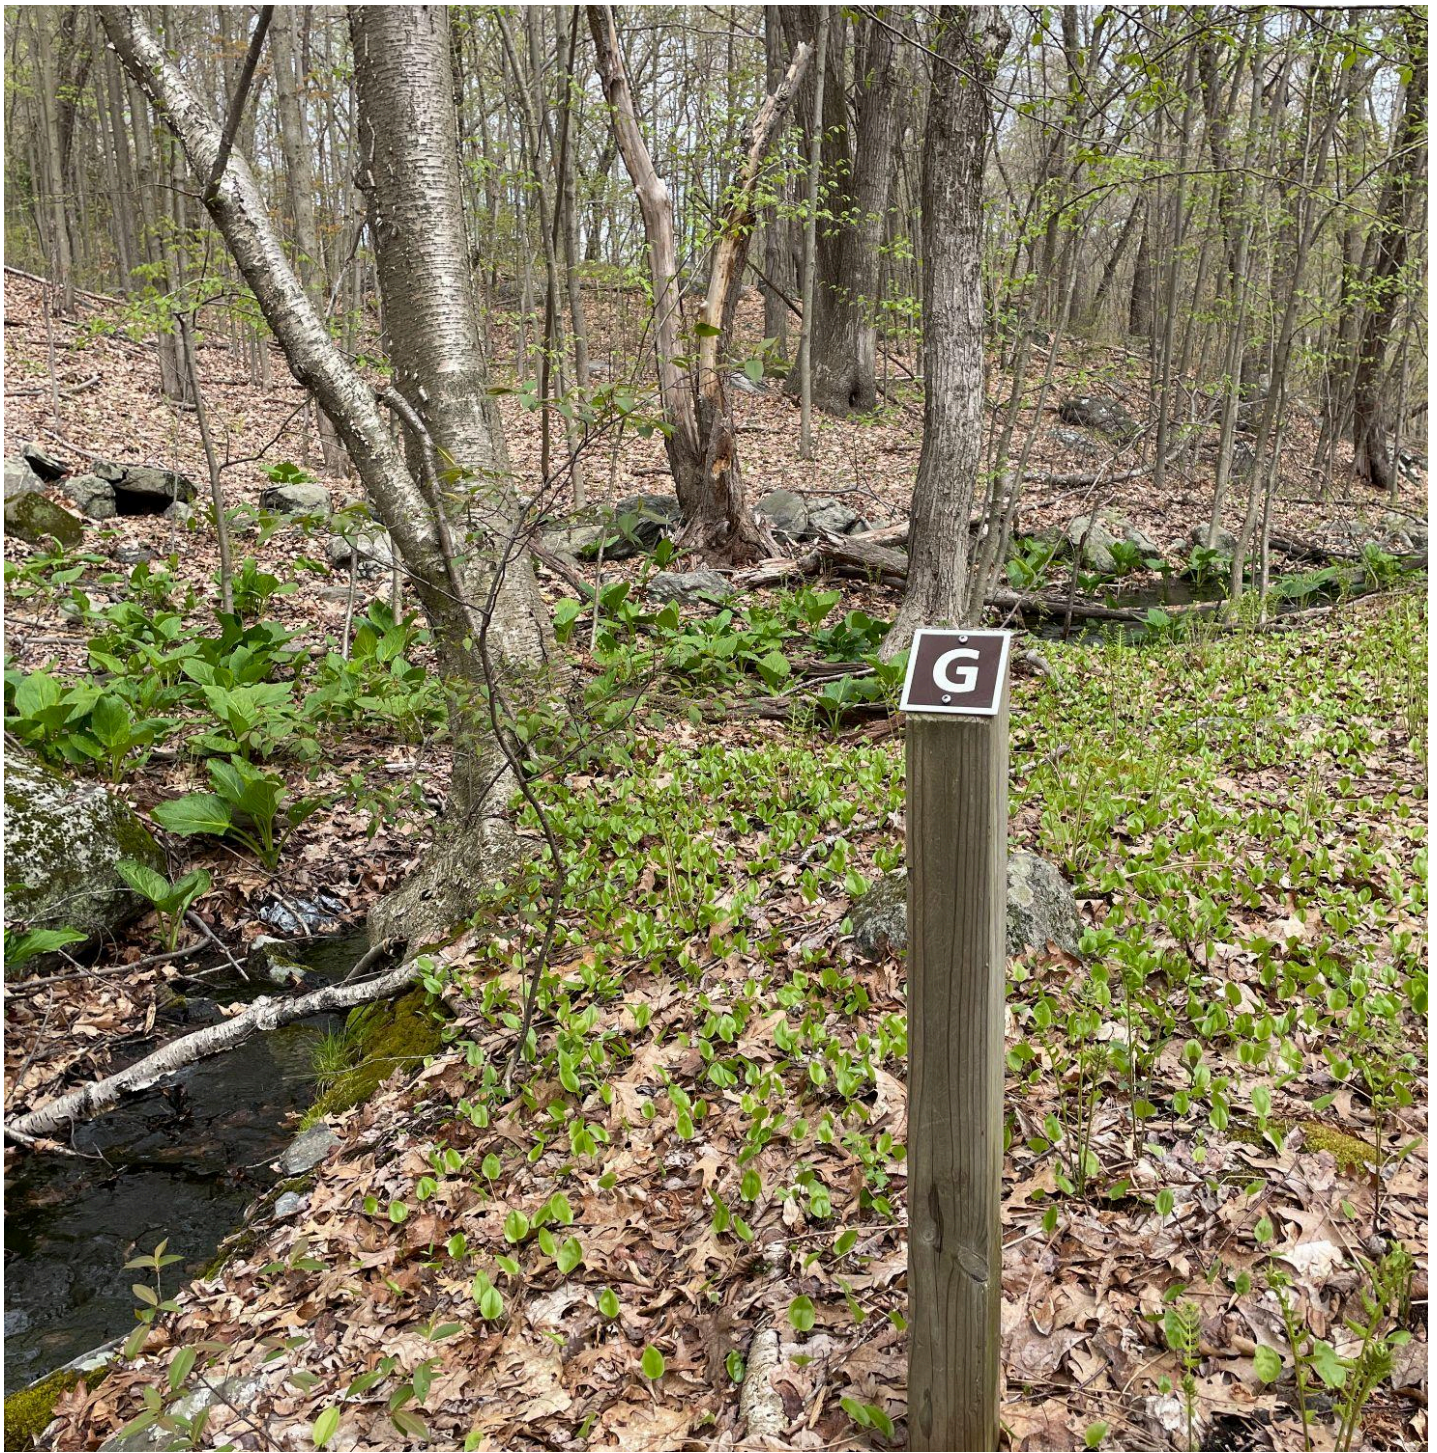
Photo 9

Comments: Spring. Currently free from Japanese knotweed. Marked on trail map.

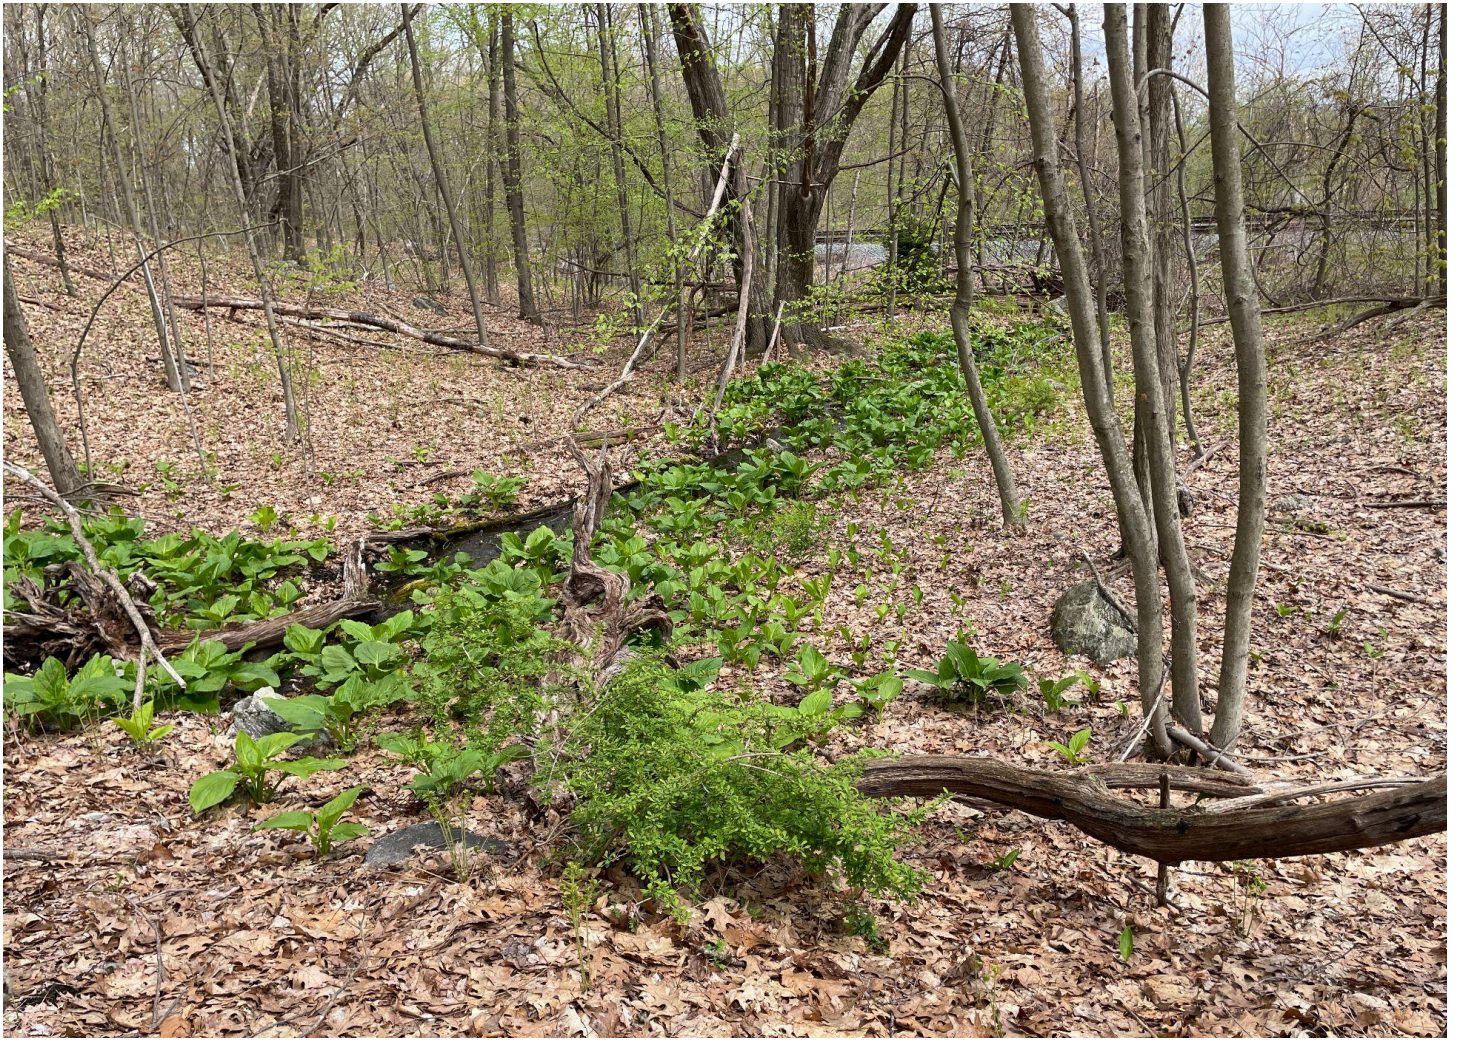
Photo 10

Comments: Japanese barberry (*Berberis thunbergii*) growing along spring outflow. The infestation is currently minor but has the potential to spread quickly.

2. Manage/eliminate Japanese barberry along spring outflow.
 - a. Manual or mechanical removal.
 - b. Monitor and continue to pull new individuals for 10+ years to ensure the seed bank is depleted.

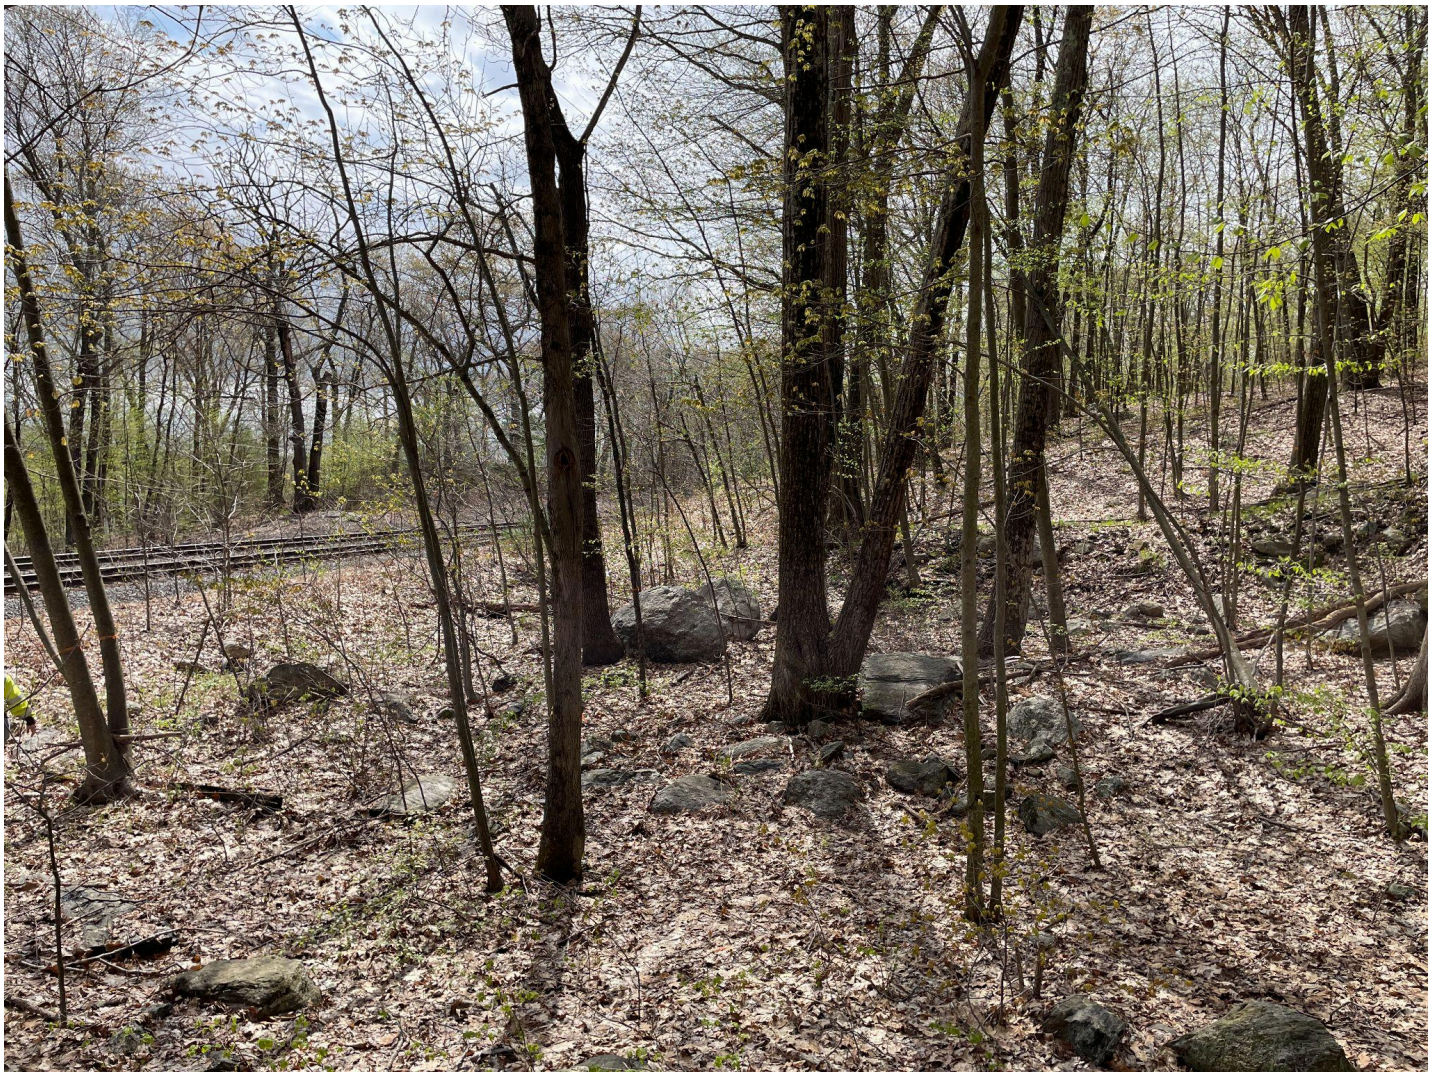
Photo 11

Comments: Foundation pits along railroad tracks. A few sprigs of Japanese knotweed, Oriental bittersweet (*Celastris orbiculatus*), and garlic mustard (*Alliaria petiolata*) are present in the foundations.

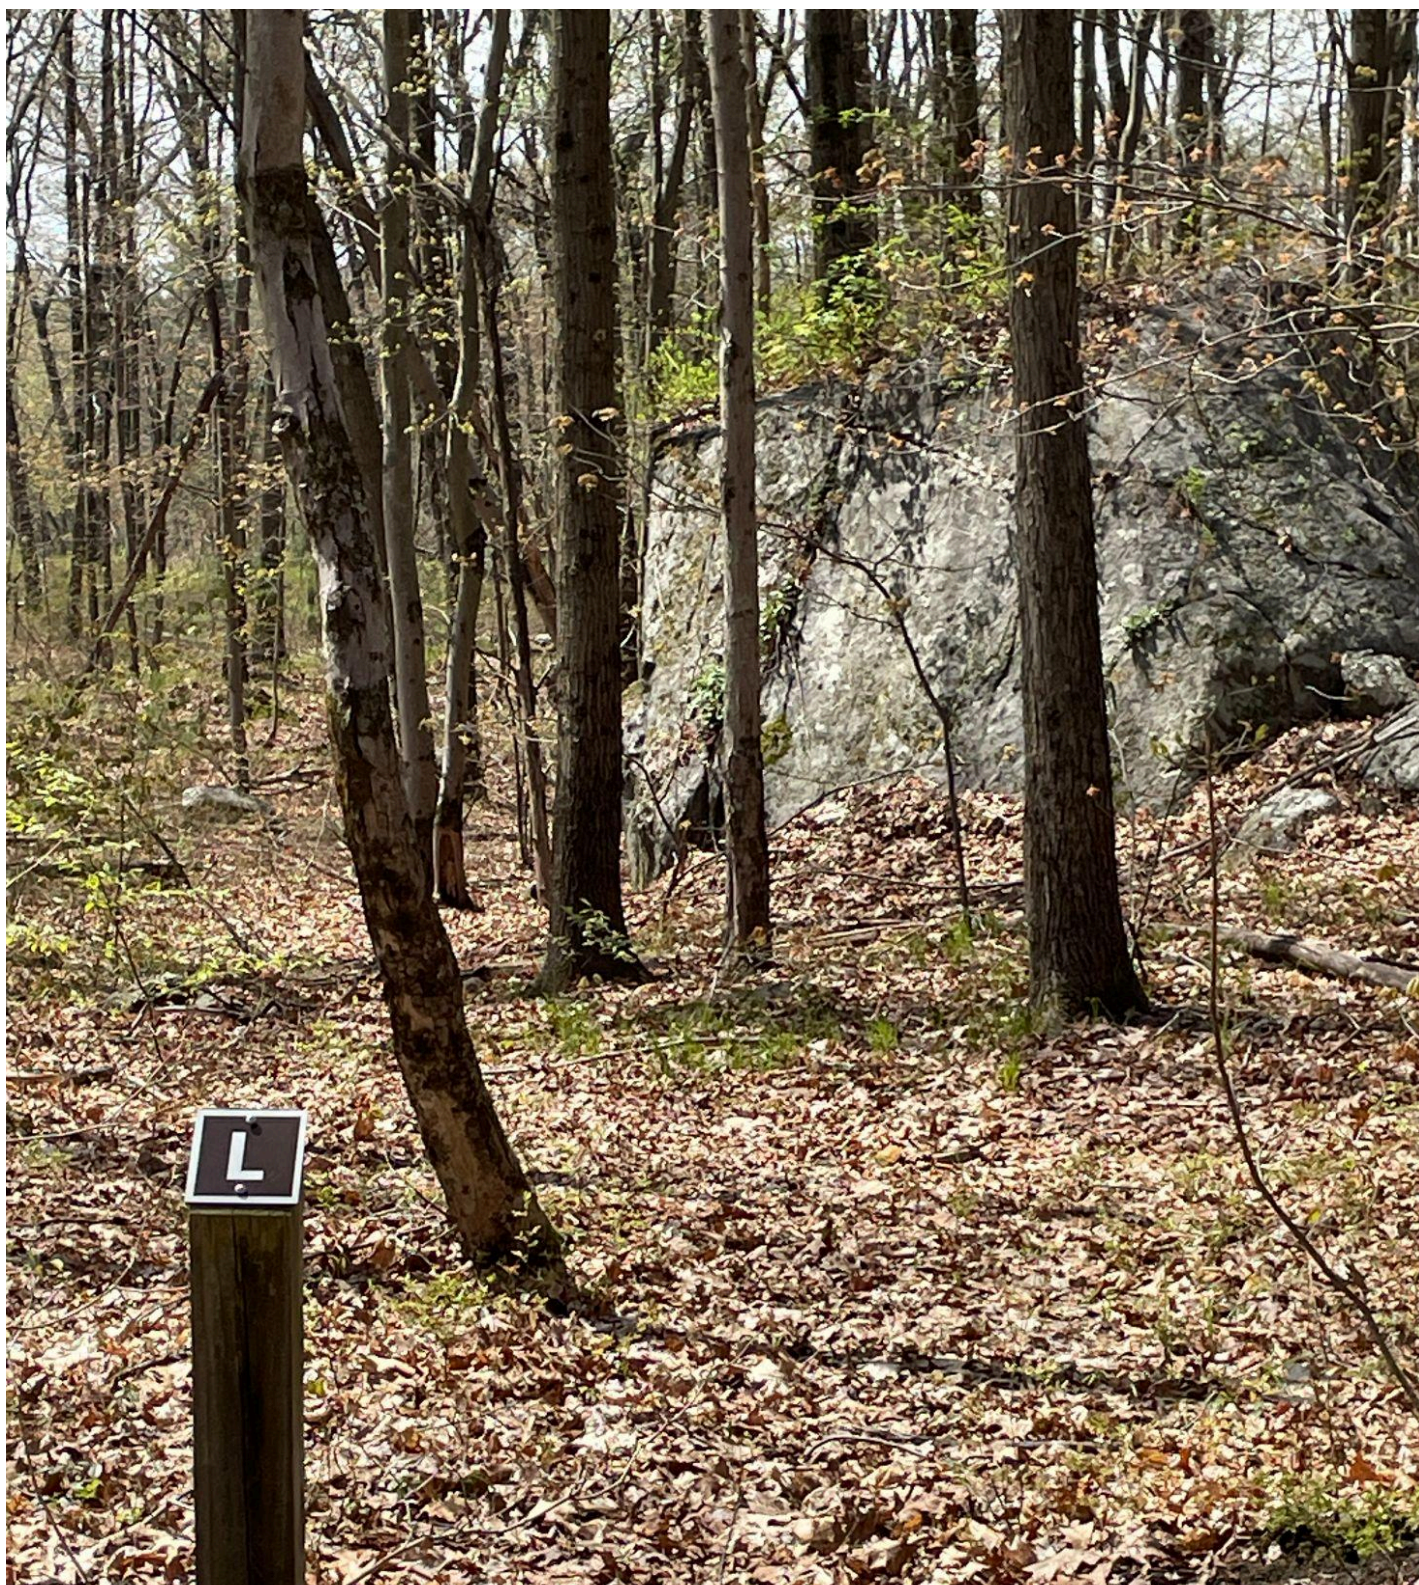
Photo 12

Comments: Glacial erratic. Marked on trail map.
