Perkins Farm

Conservation Property Baseline Assessment

July 2024

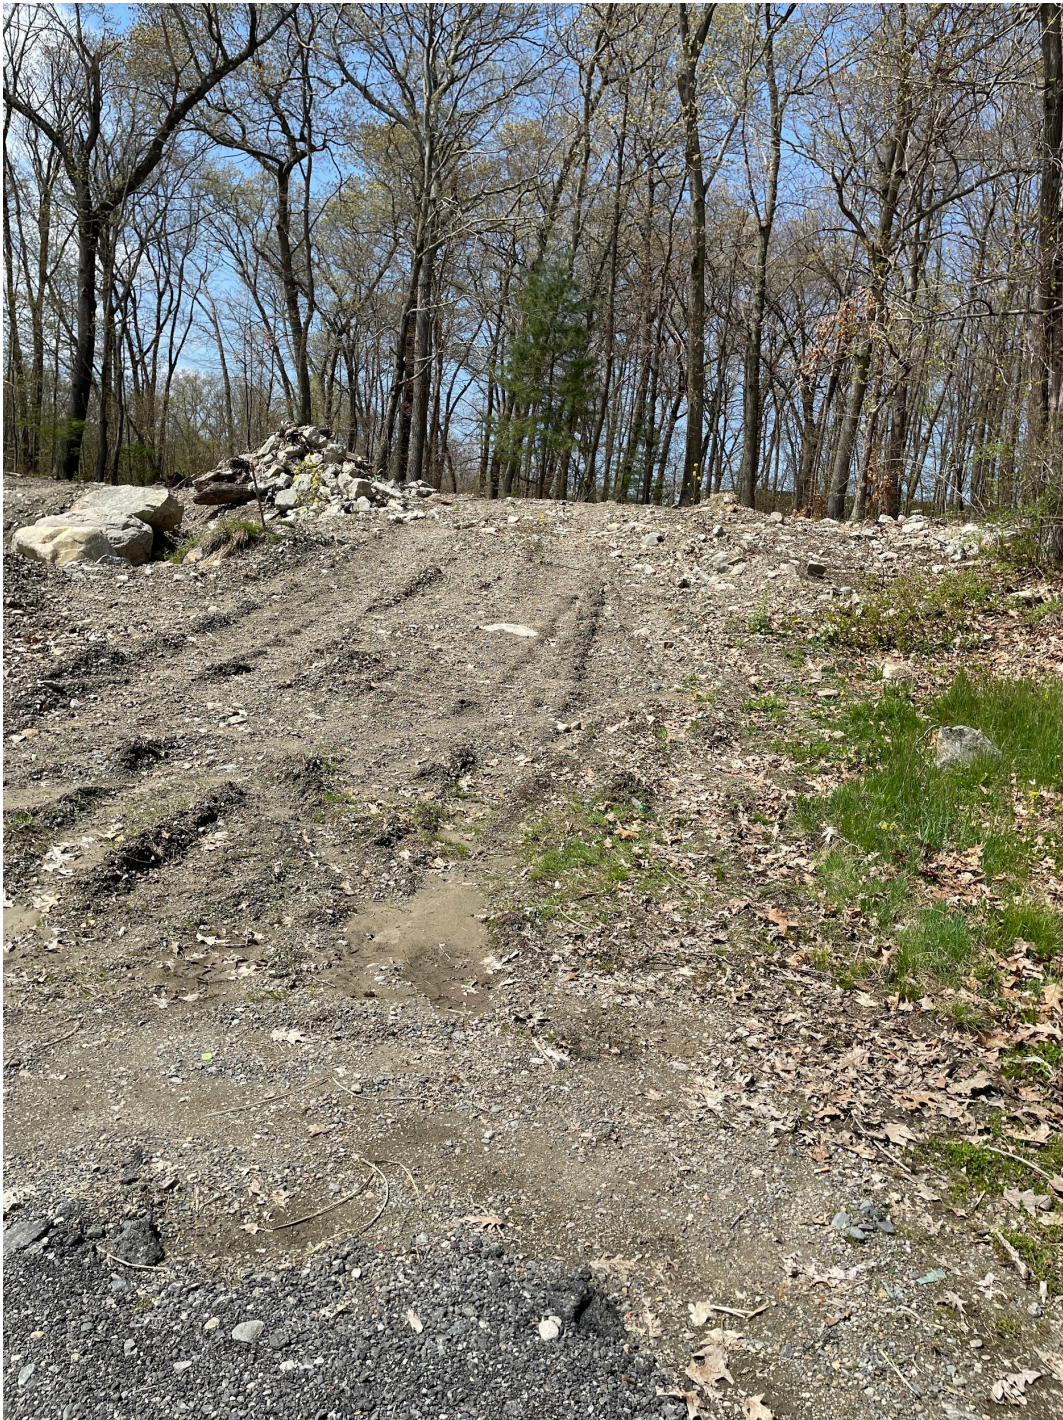
Photo 13

Comments: Significant encroachment along the boundary with 15 Waban Avenue. Within the conservation land, an approximately 75 feet long by 50 feet wide drive was cleared, grubbed and graded, perhaps for construction access. This will take significant effort to restore and will benefit from future monitoring for invasive plants brought in with construction materials. During the inspection, a small pickup truck dropped a load of soil at the edge of the property. No liquid waste was observed.

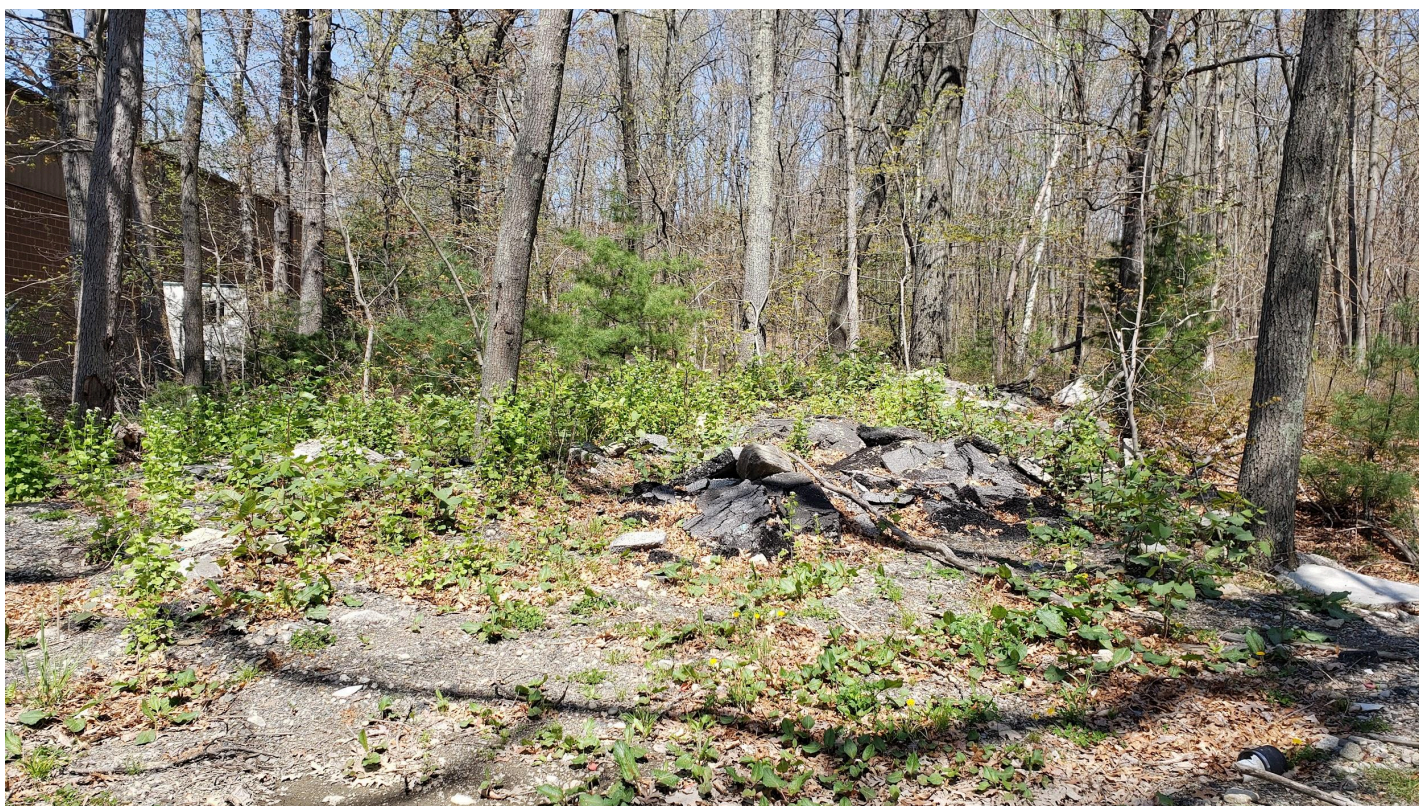
Photo 14

Comments: Significant dumping of construction, demolition, and/or industrial material, including soil, asphalt, concrete, tires and containers that may contain liquids at the boundary between the conservation land and the abutting properties at 24 Jolma Road, 9 Brandt Avenue, and 1035 Grafton Street. Invasive plants had encroached and were spreading into the adjacent woodlands, including garlic mustard and Japanese knotweed. The ground in this area is unstable, suggesting buried debris and unsafe walking areas.

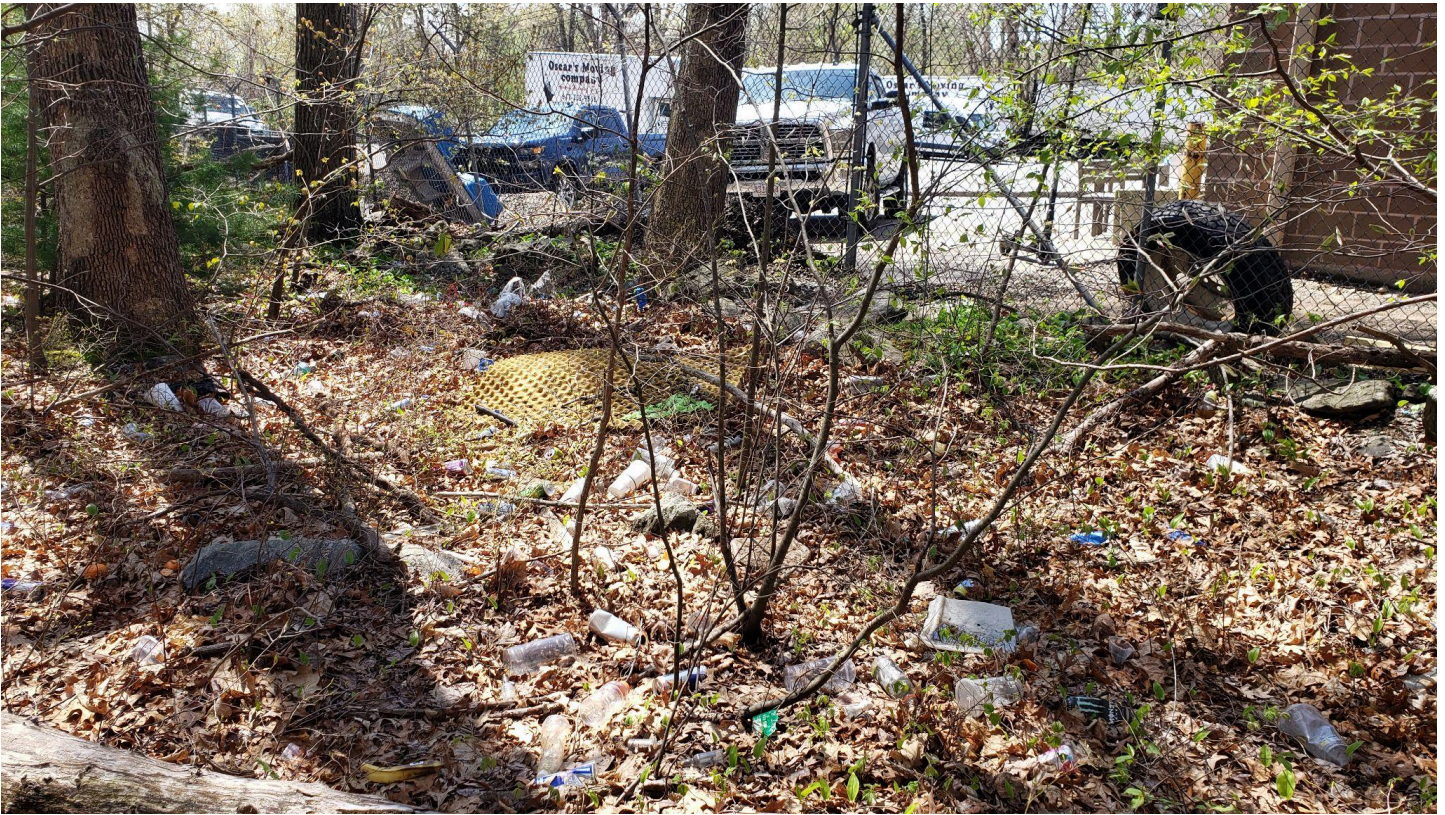
Photo 15

Comments: Dumping of trash and debris behind fence by abutter at 24 Jolma Rd. Mostly recyclable drink cans and bottles. Some containers may have liquids of an unknown nature within.

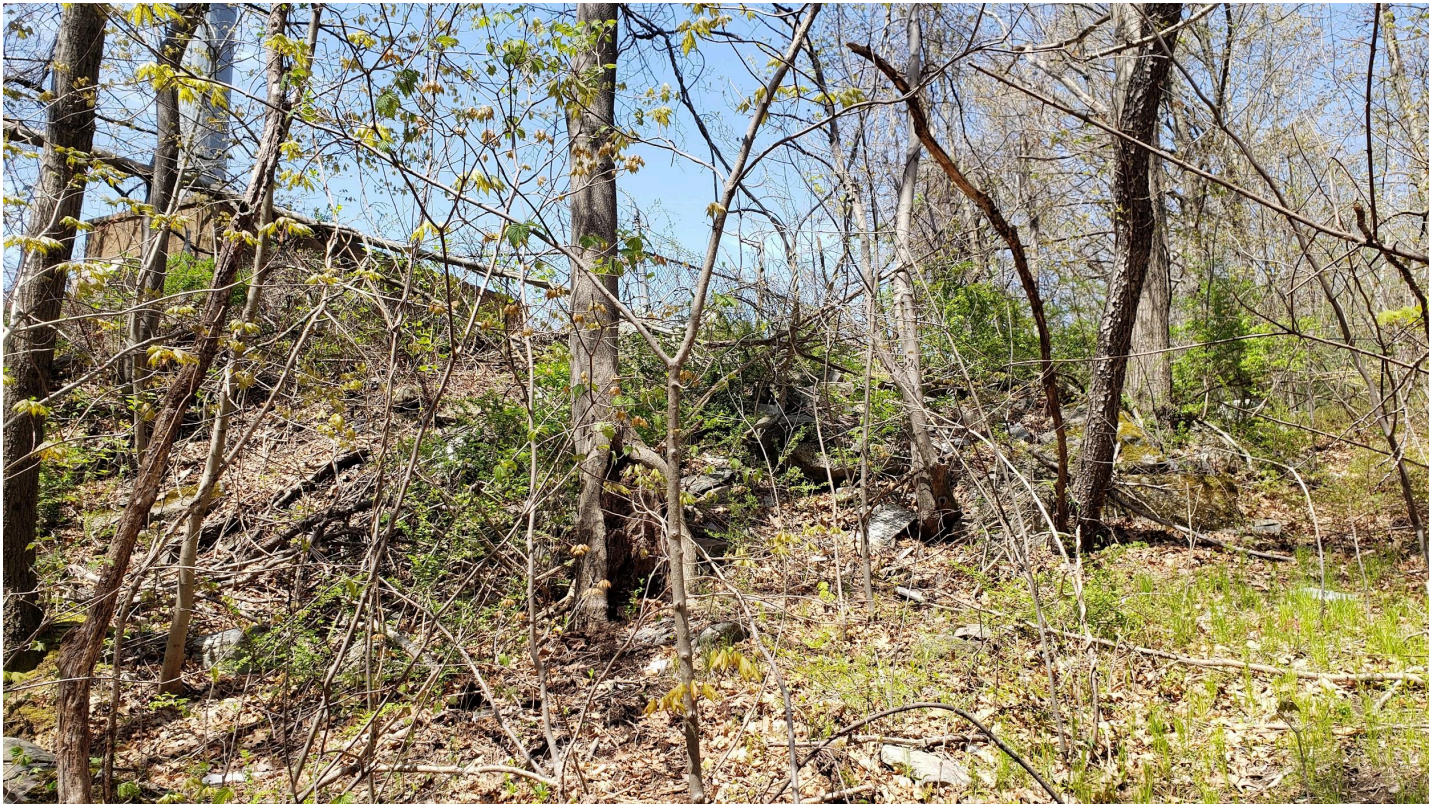
Photo 16

Comments: Japanese barberry and multiflora rose (*Rosa multiflora*) on the graded slope up to 39 Jolma.

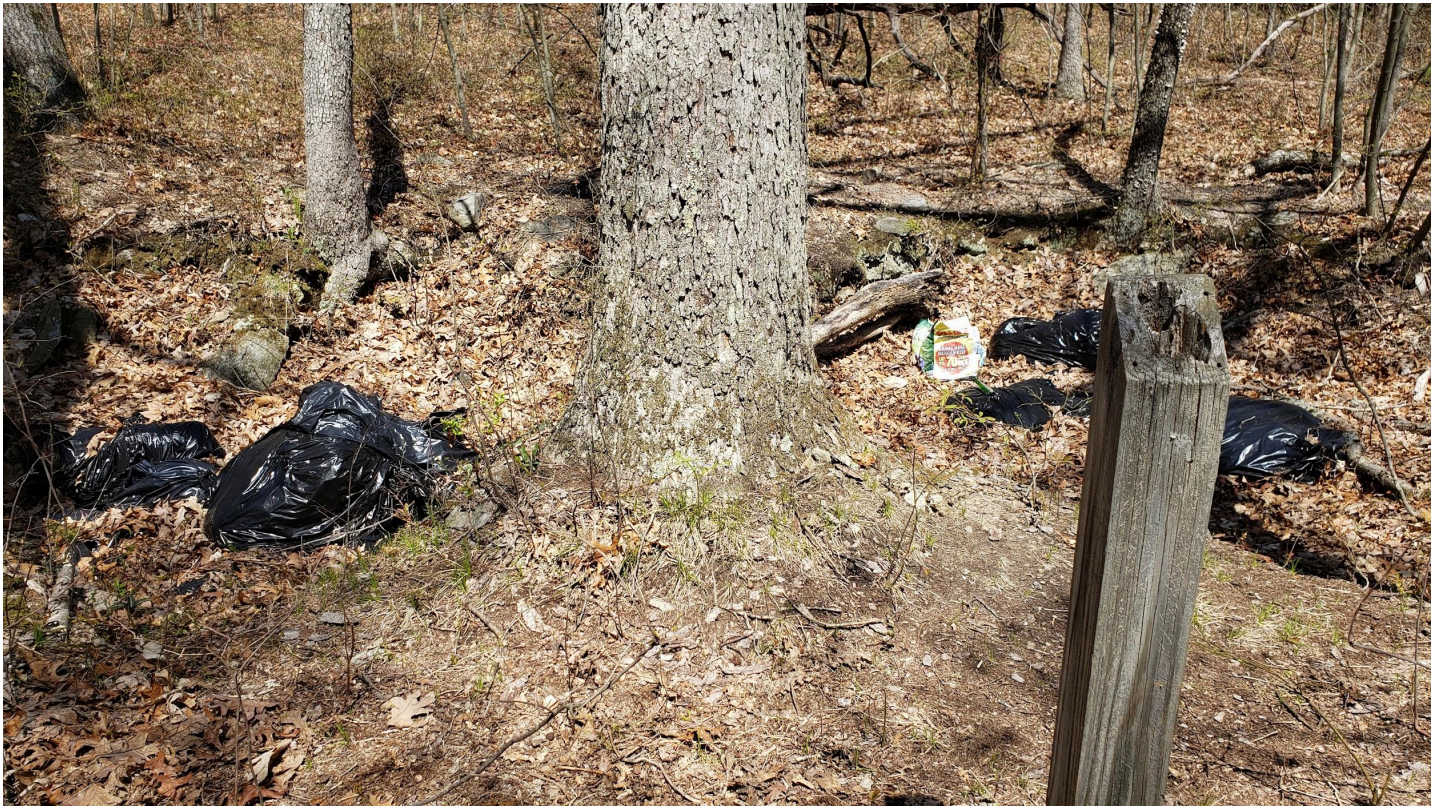
Photo 17

Comments: The “M” Point of Interest marker is missing. There are many black plastic garbage bags in pits that could be historic cellars, but also may have been dug more recently for waste dumping or test pits.

- e. Replace marker M and clean marker A.
6. Monitor forest stands on a regular basis, ideally annually.
 - a. Consider whether regeneration is occurring to replace canopy trees as they fall.

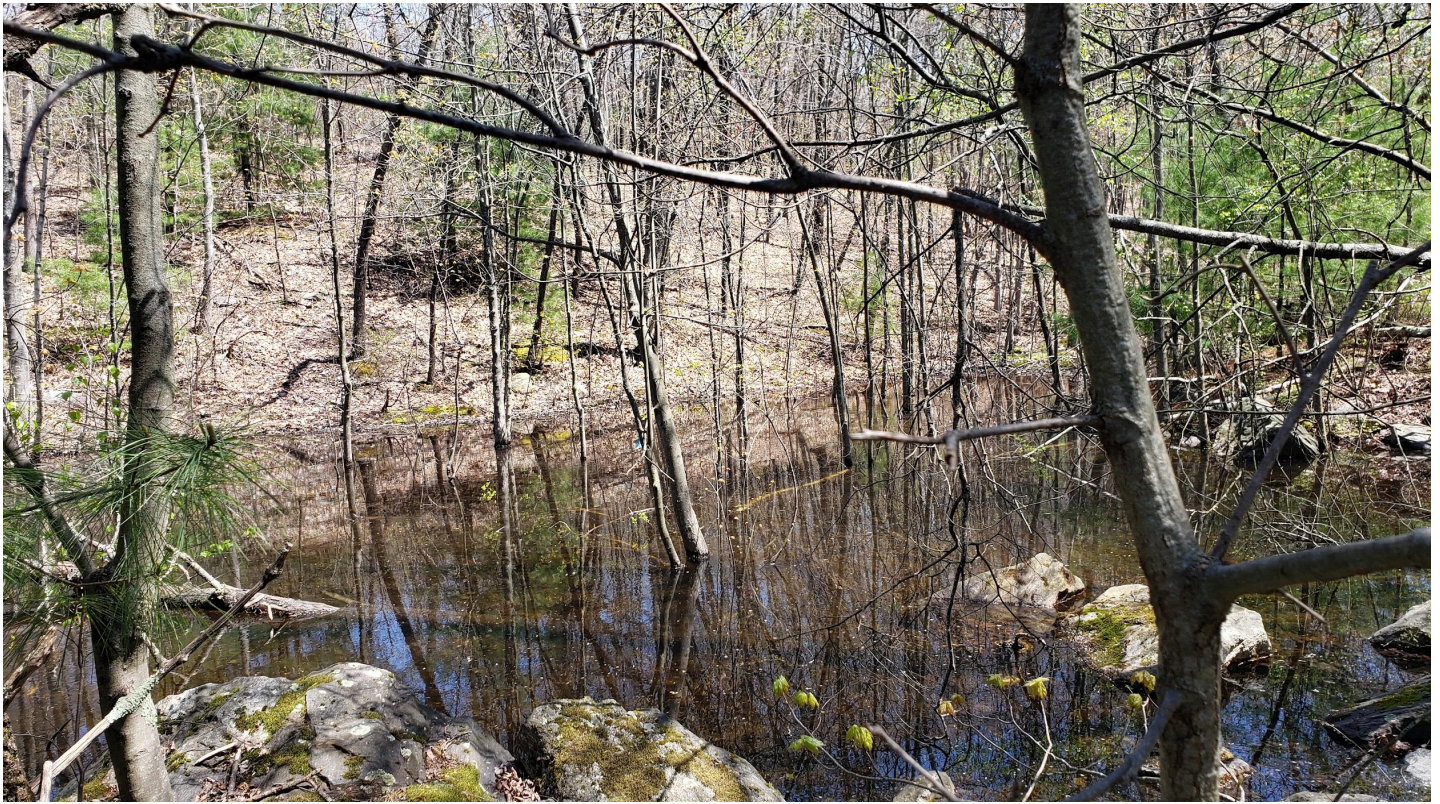
Photo 18

Comments: The aquatic habitat is situated at the western property boundary of Perkins Farm adjacent to Stop and Shop. It appears to be fed by springs, runoff or both from slopes along its eastern edge. It is separated from the Stop and Shop property by an insignificant berm on its western edge. No outlet was observed, but water is either overtopping the berm/bank or seeping through subsurface soils and collecting in the lower elevation Stop and Shop property. There is pollen visible on the pond surface, but some areas showed pond scum that might be a function of low levels of oxygen distribution in the pond.

- b. Look for new or worsening invasive infestations.
 - c. Look for signs and symptoms of tree pests or diseases.
7. Consider evaluating aquatic habitat behind Stop and Shop to confirm if it meets the criteria to be classified as a certified vernal pool.

- a. Conduct necessary field work and assessments to prove whether or not it qualifies for certification. These initial evaluations can be conducted by citizen scientists.

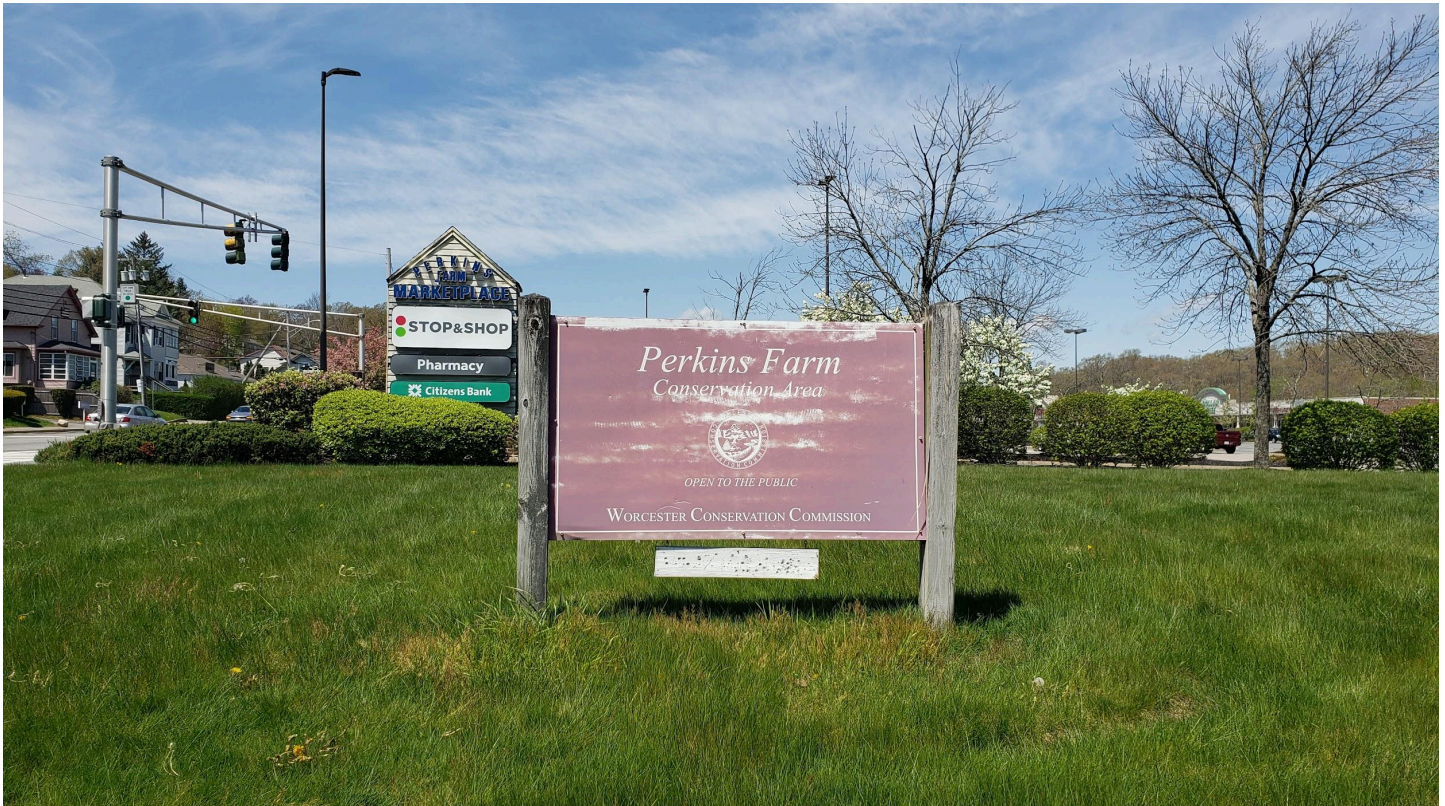
Photo 19

Comments: The entry sign at the start of Jolma Road is somewhat faded and worn.

- d. Post signage which specifically prohibits dumping at key locations where dumping appears to be an issue.
5. Repair signage
 - a. Restore or replace Jolma Road sign.

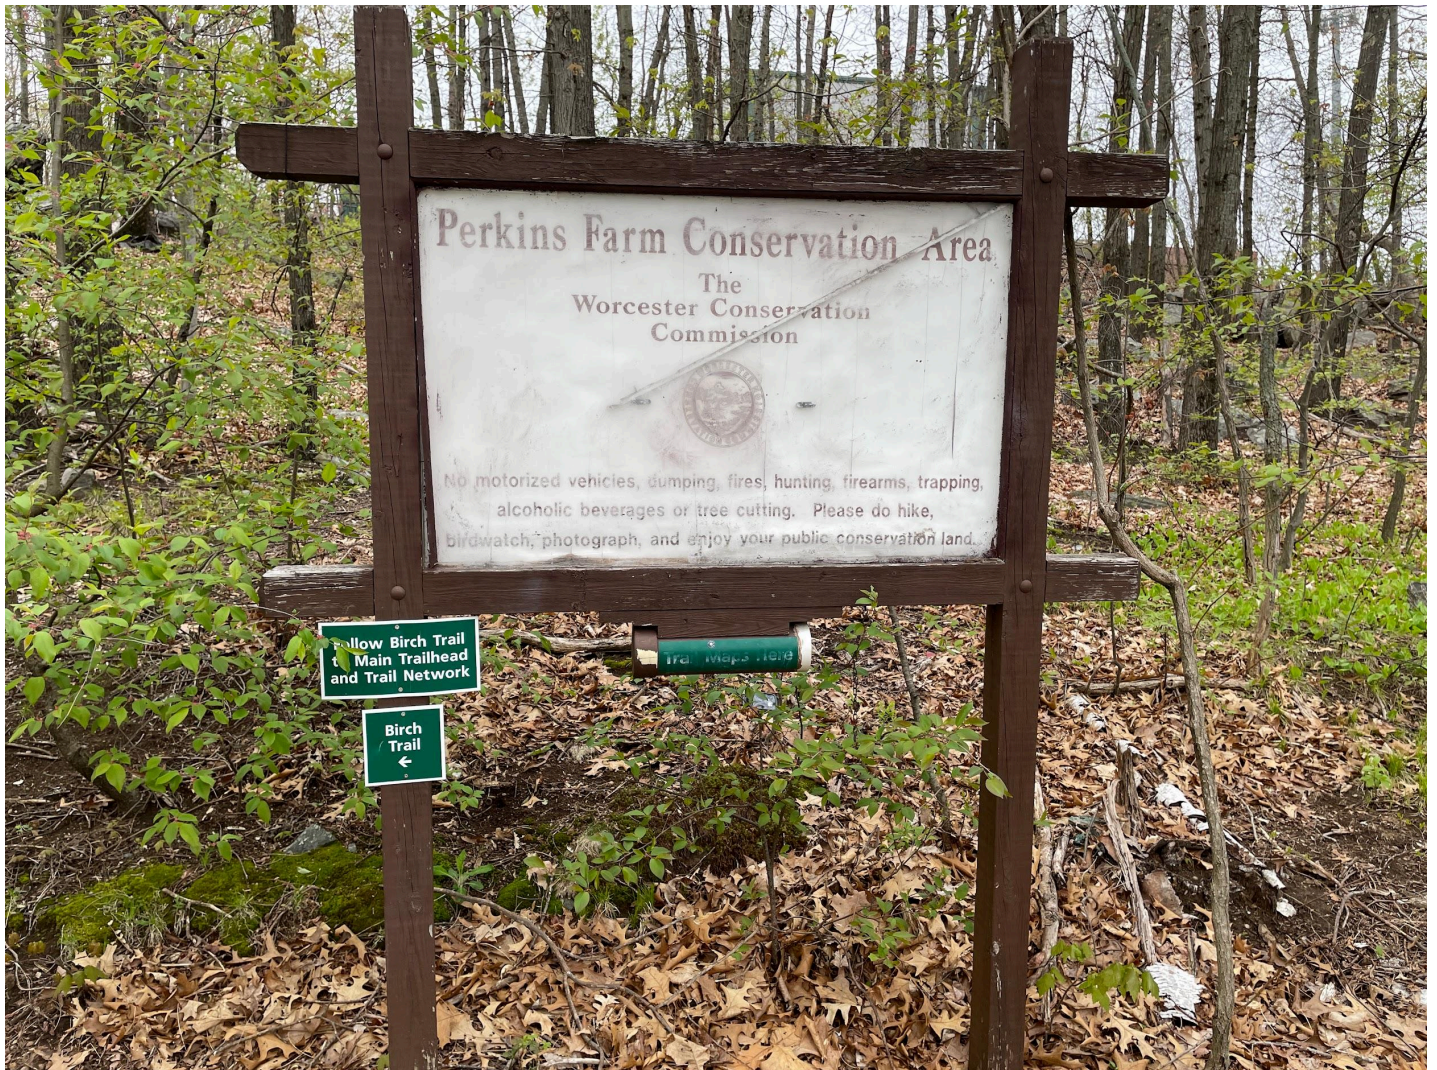
Photo 20

Comments: The sign at the start of Birch Trail from the parking area is in need of minor fixes and refreshing. No trail maps were available at the time of the assessment.

- b. Restore Birch Trail sign and ensure trail map(s) are available.
 - c. Where signs and markers attached to trees can be salvaged, back hardware out of trees to allow more room for tree growth.

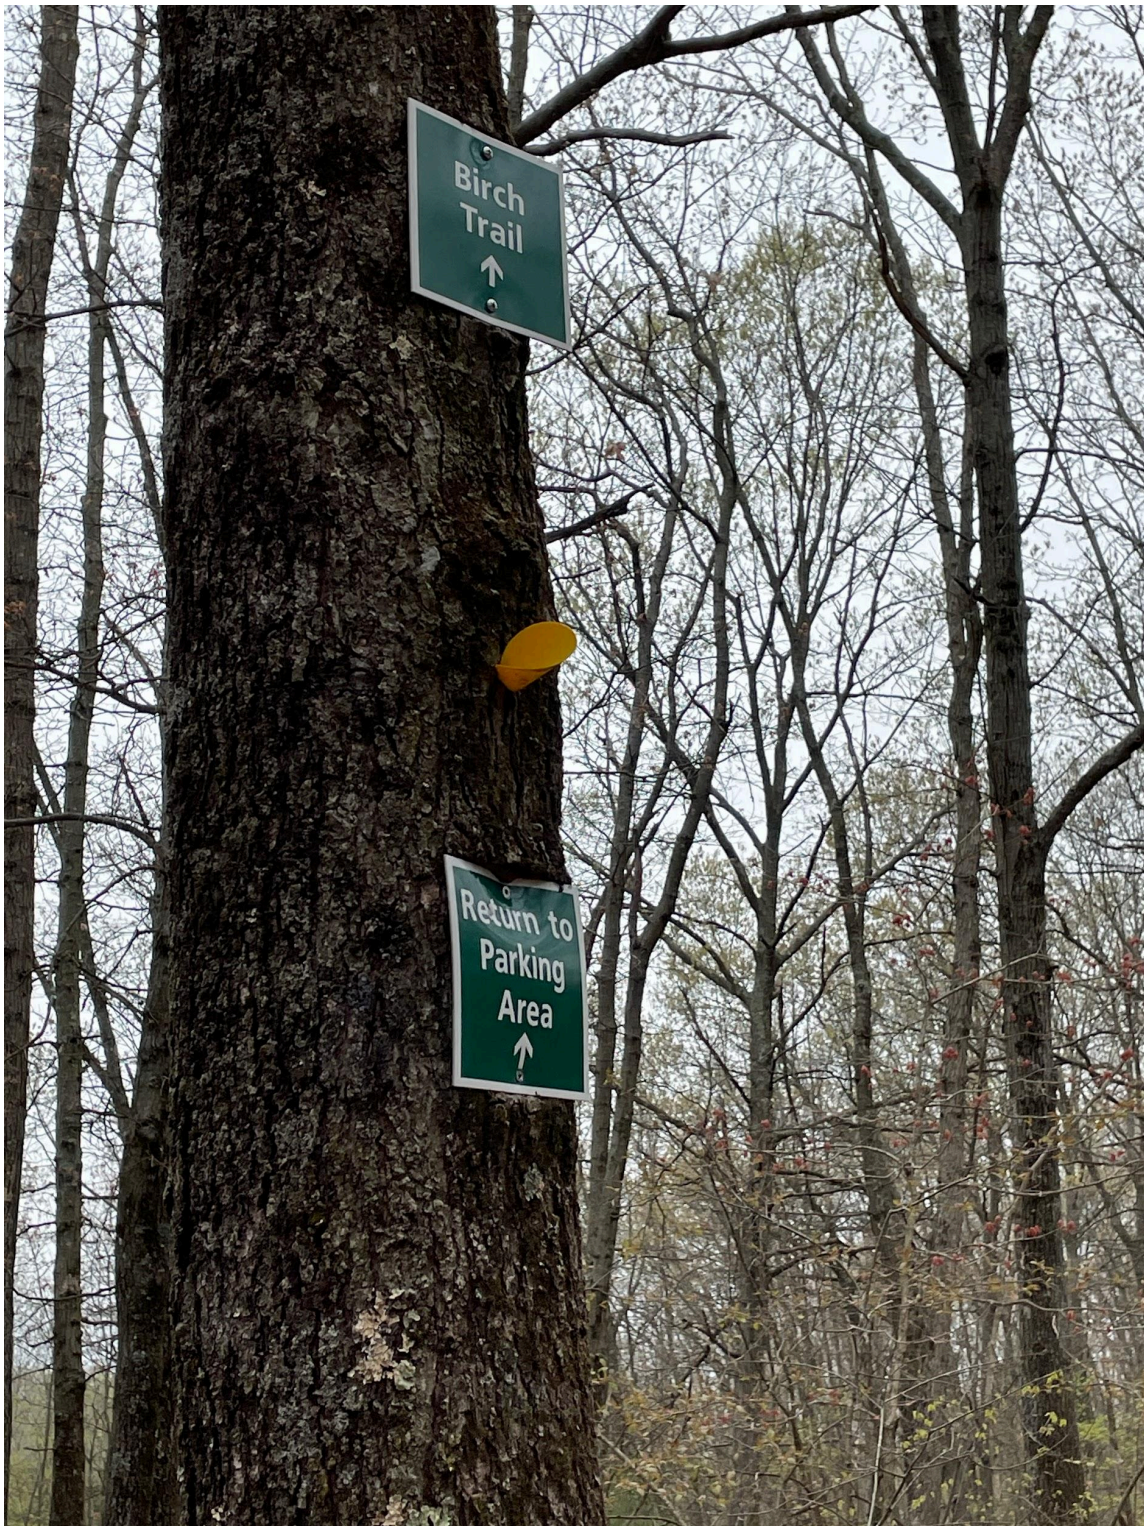
Photo 21

Comments: Trails are marked with signs naming each trail and blue or yellow circular discs to indicate whether the walker is traveling toward or away from the parking area. Many of the markers and signs need to be backed out of the trees or replaced as they are being engulfed as the trees grow.

- d. Where signs and markers attached to trees are heavily damaged, replace them. Ensure new attaching hardware leaves plenty of space for tree trunk growth without engulfing the signage.

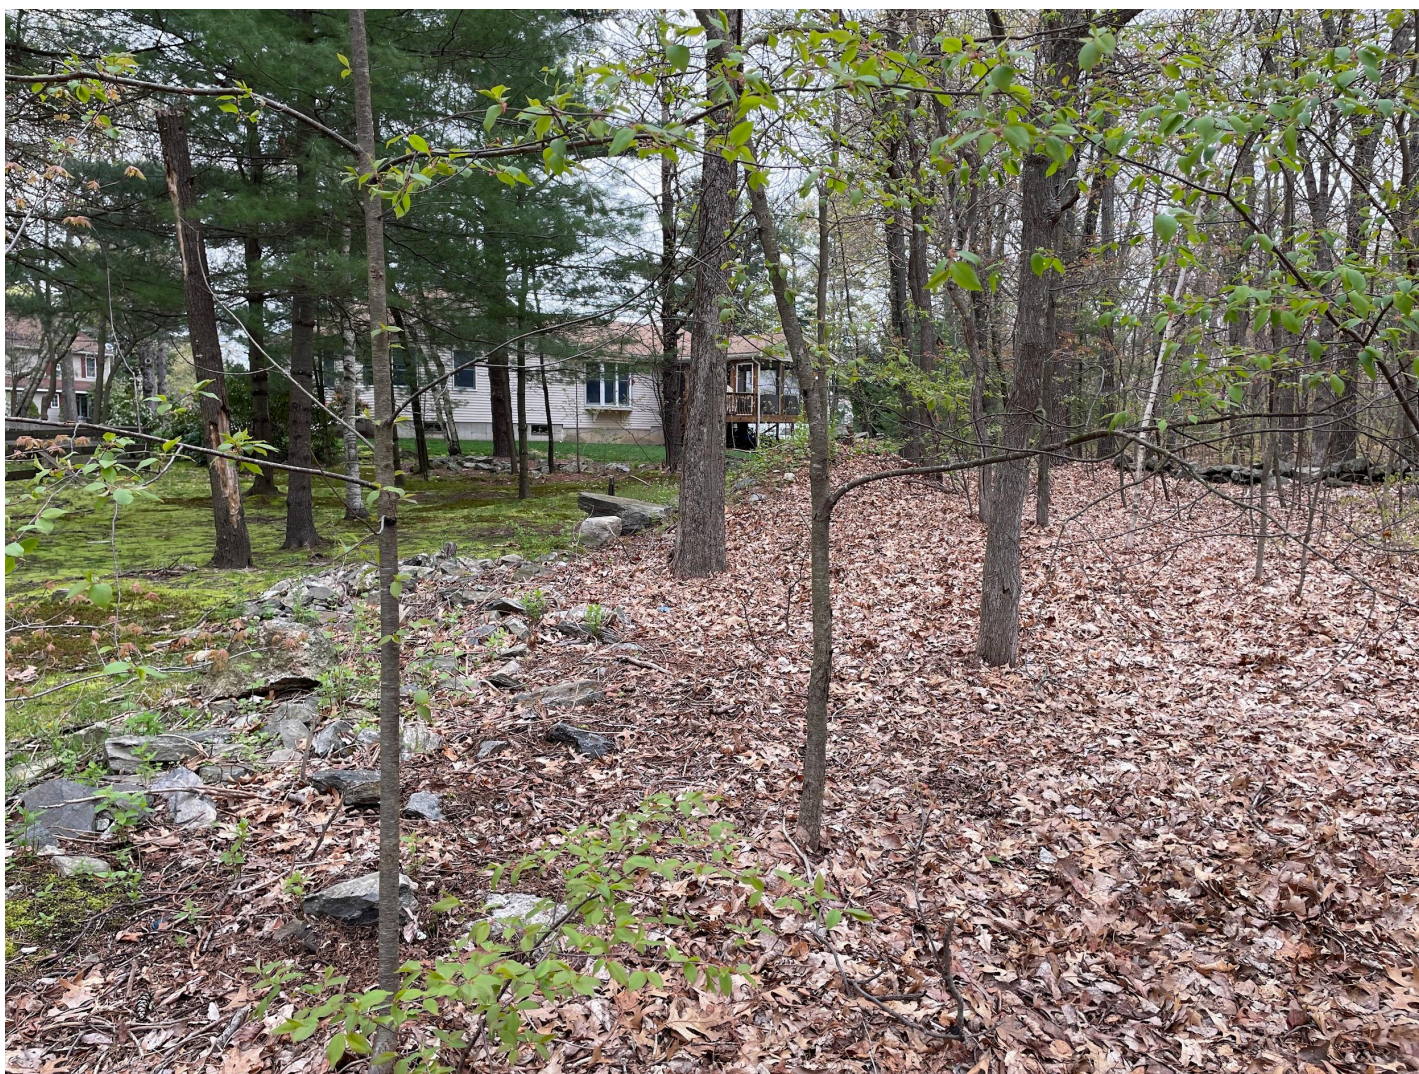
Photo 22

Comments: Some garlic mustard was observed along the edge of the residential properties on the northwestern side of Perkins Farm. The plant is not yet well established.

3. Manage Japanese knotweed and garlic mustard infestation along the boundary with 24 Jolma Road, 9 Brandt Avenue, and 1035 Grafton Street.
 - a. Use appropriate chemical, cultural, manual, and mechanical methods to reduce the extent of current infestation and prevent further spread.

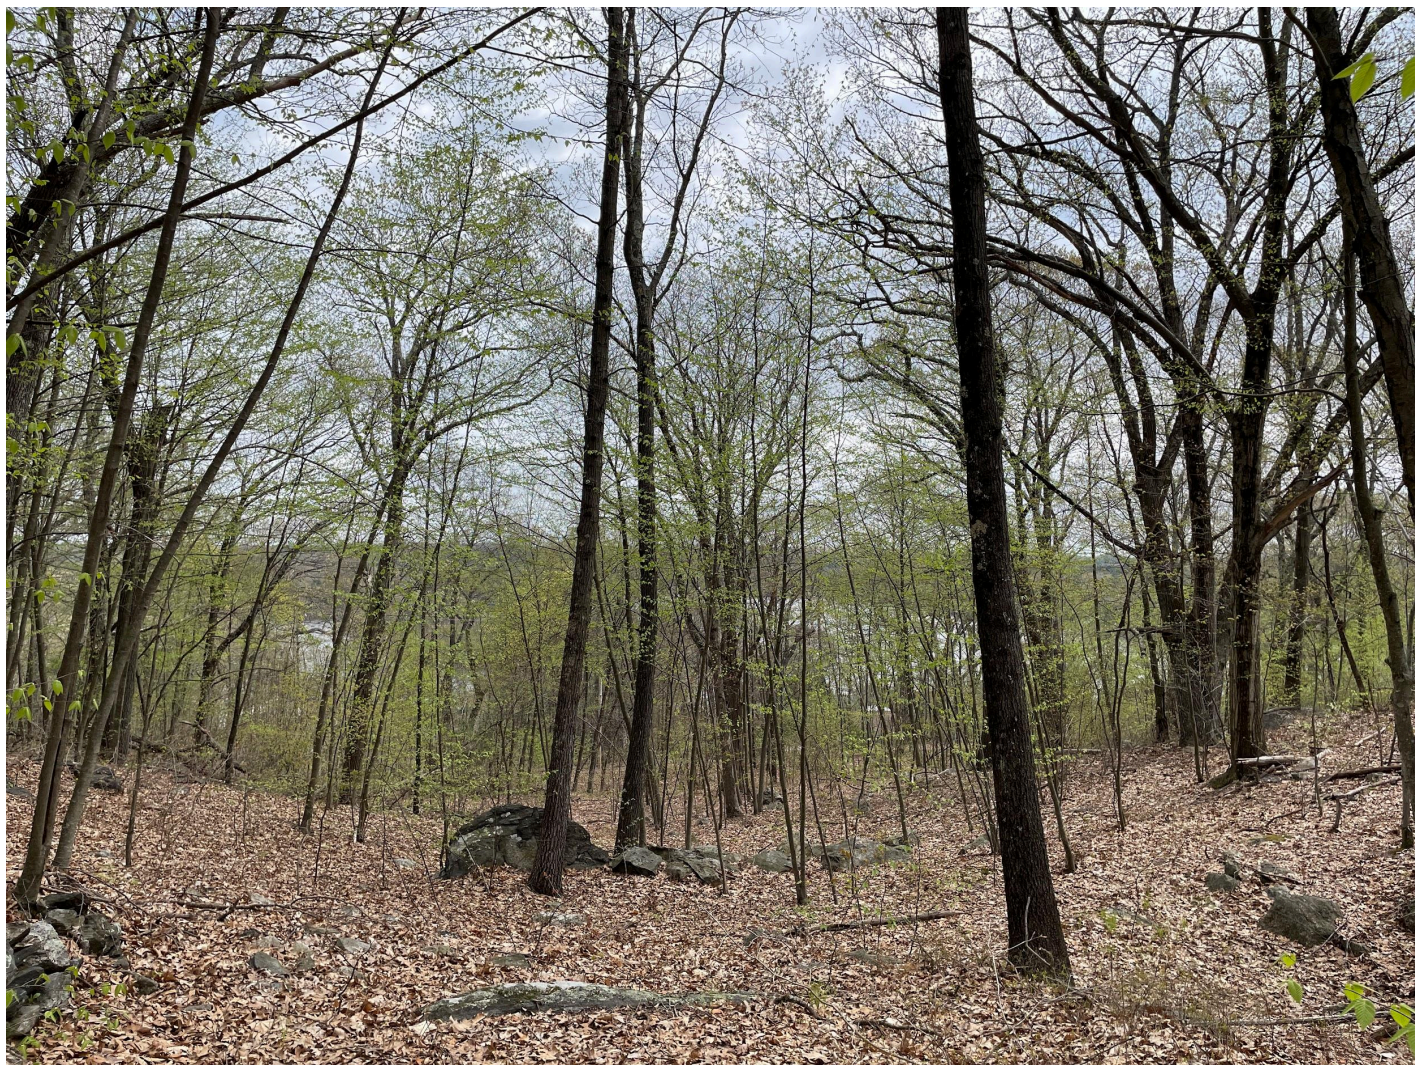
Photo 23

Comments: The view of Lake Quinsigamond is heavily obscured by vegetation during the growing season but is likely to open up and provide a view when leaves fall.

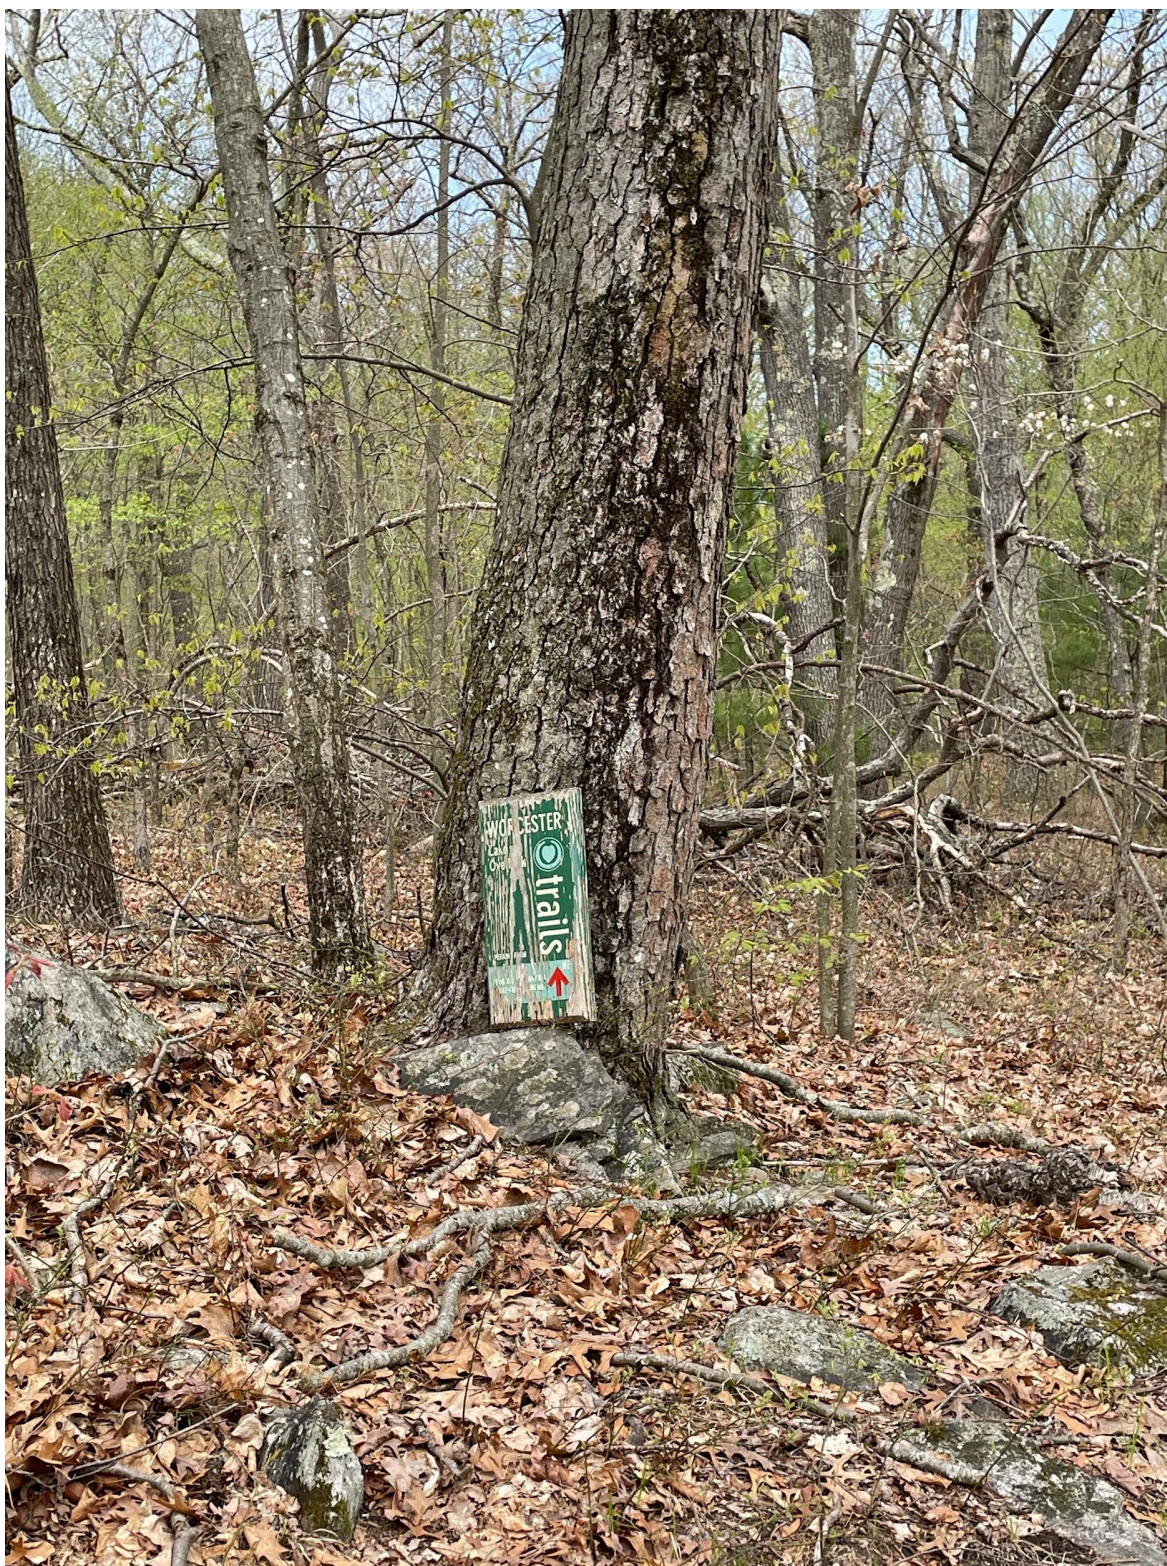
Photo 24

Comments: One of the older wooden signs near point of interest J has fallen and is propped against a tree. The sign is worn and losing its paint.

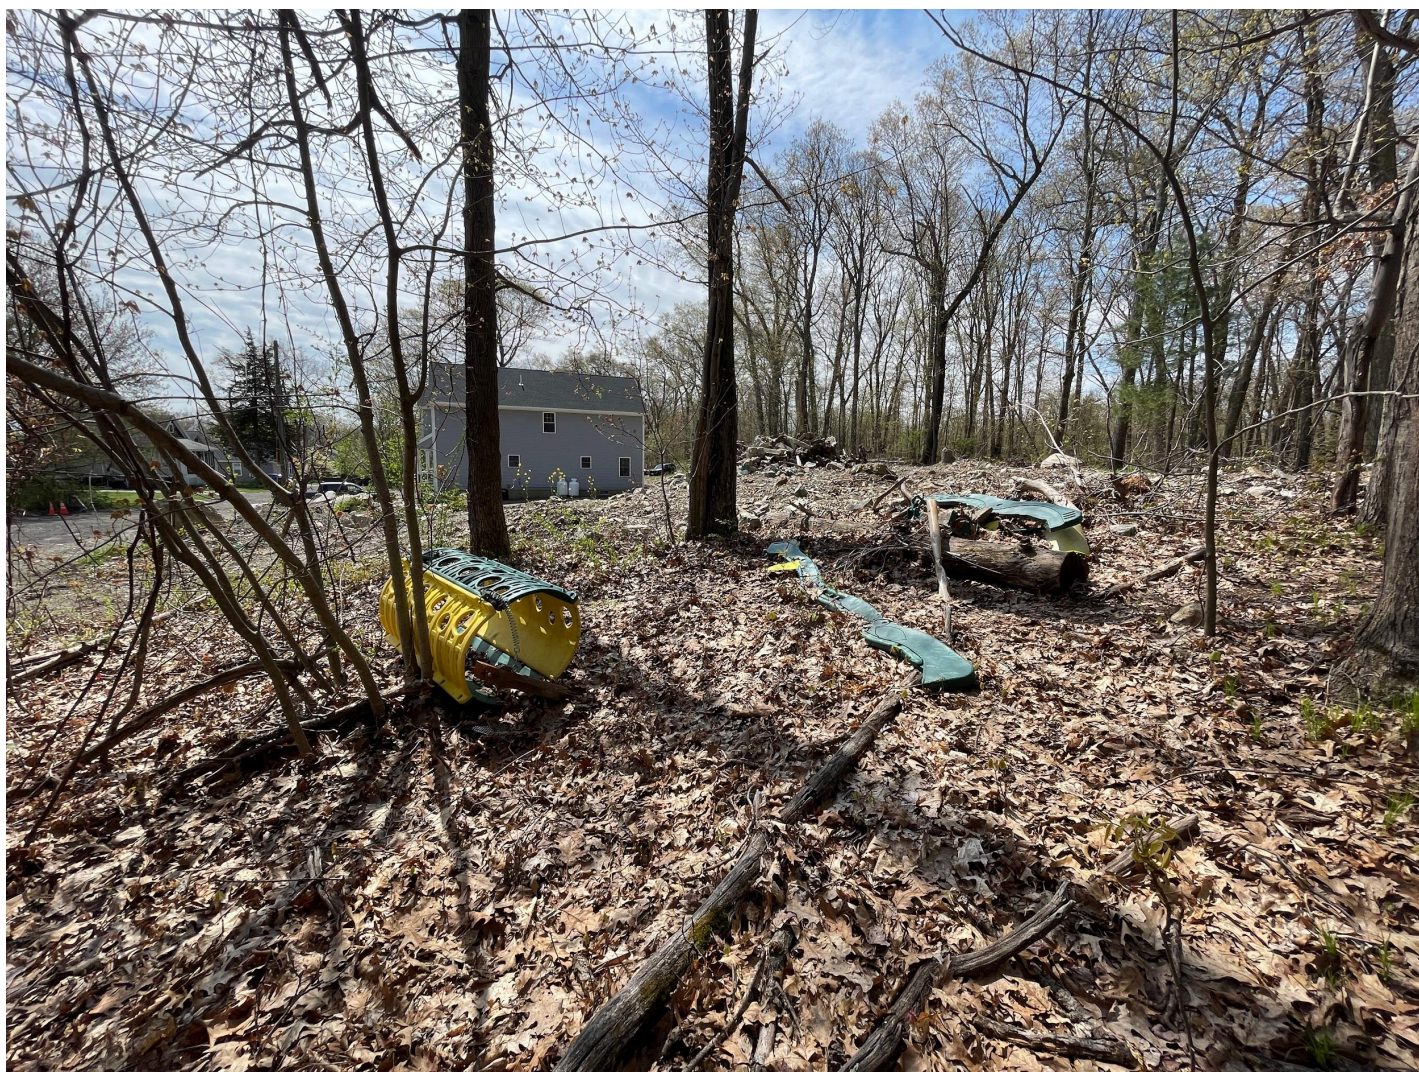
Photo 25

Comments: A playset has been discarded behind the encroachment at the end of Waban Avenue.
