# *CONDOMINIUM RESERVE STUDY*

## **Denholm Building**

**484 Main Street  
Worcester, Massachusetts**

**Subject: Condominium Reserve Study & MEP/LS Report  
Denholm Building  
484 Main Street, Worcester, Massachusetts  
EBI Project #1319000663**

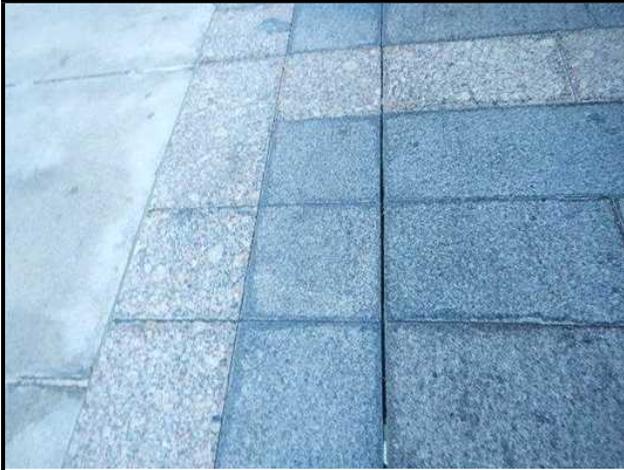
Minor moisture infiltration through the sidewalk paver and stone slabs was observed and reported. Critical Repairs are recommended to reseal the stone slab joints and/or stone paver mortar joints. Based on the observed condition and expected useful life, Capital Needs are recommended for sidewalk repairs during the analysis term.

Washed out mortar at granite pavers	Cracked stone sidewalk at front of building

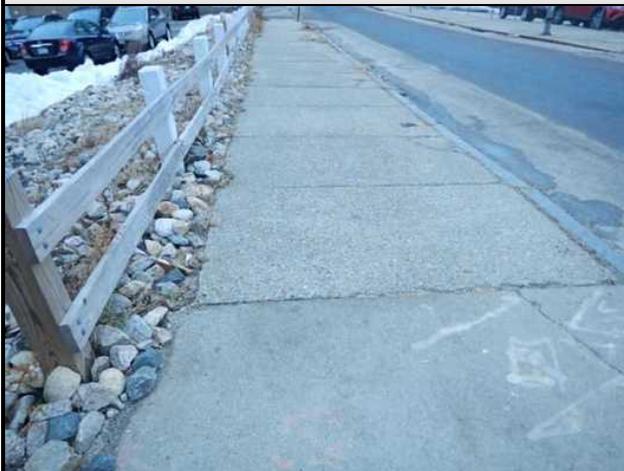
Sidewalk along remote parking lot	Deteriorated sidewalk at remote parking lot

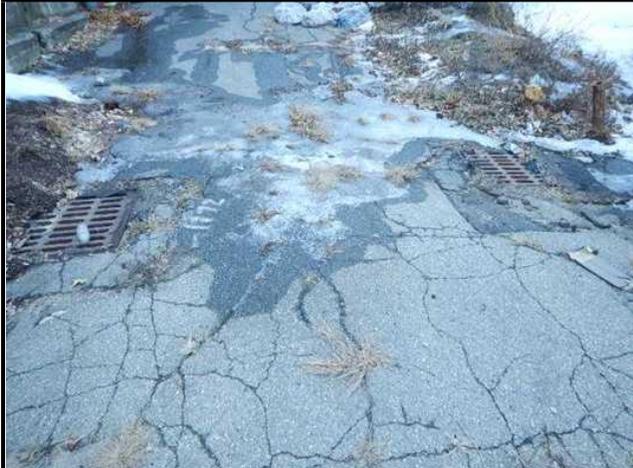
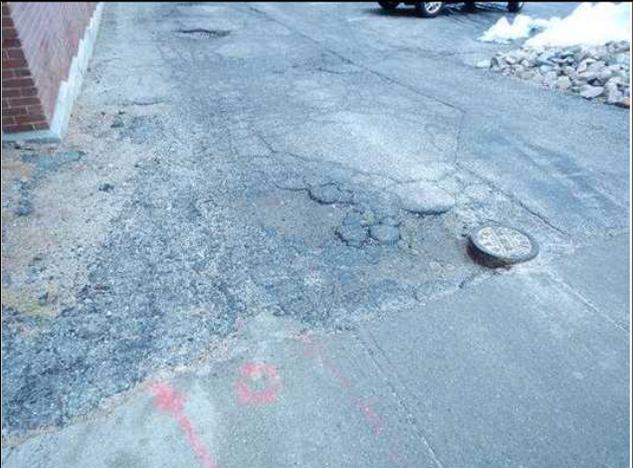
observed conditions, Critical Repairs are recommended to repave the remote parking lot entrance drive. Based on the observed condition and expected useful life, Capital Needs are recommended for periodic asphalt milling and overlay, striping, crack filling and sealcoating during the analysis term. The alleyway paving is in fair condition and appears to be a municipal owned property and repairs are not recommended.

Remote parking lot asphalt paving at southeastern corner	Entrance drive to remote parking lot

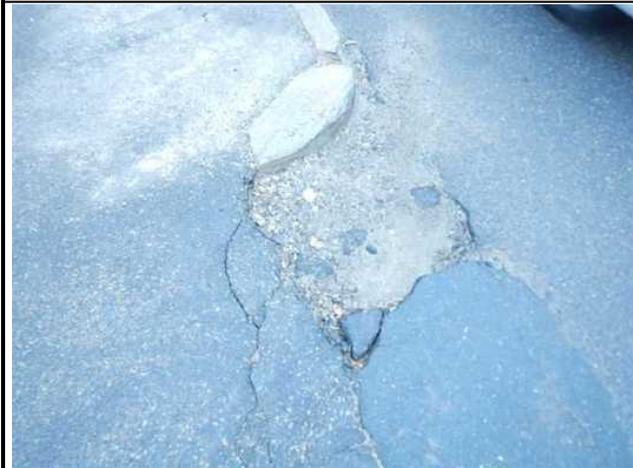
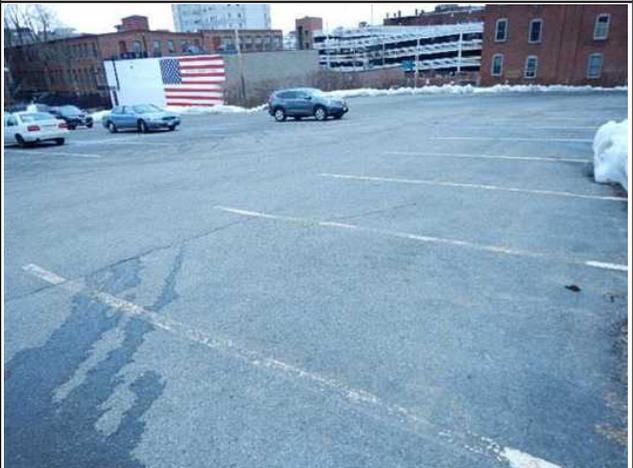
Pothole at remote parking lot	Faded striping at remote parking lot

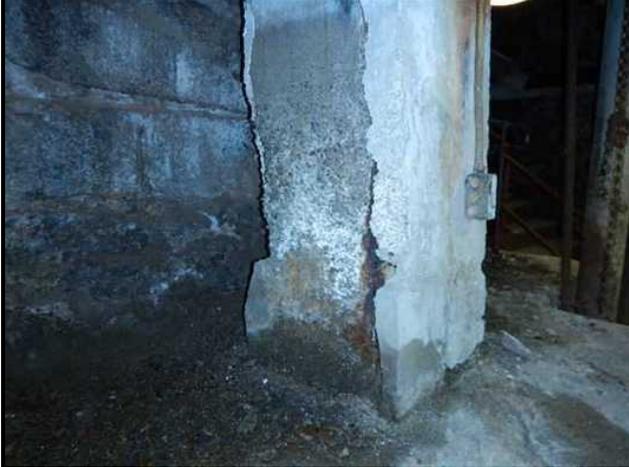
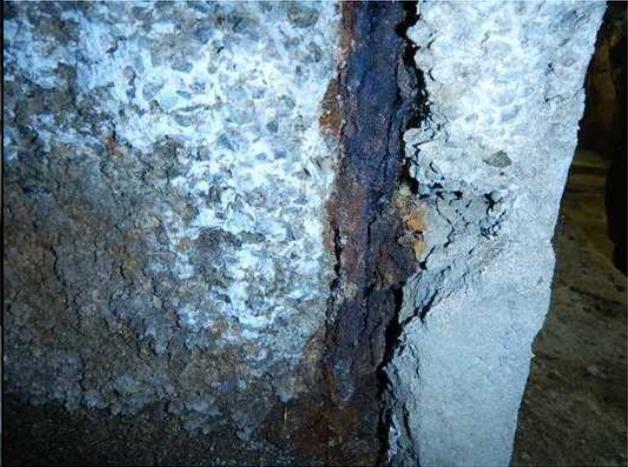
Concrete encased column at rear of basement	Corrosion evident at concrete encased column at rear of basement

2.4	Amenities	None			20.0%						
2.5	Utilities	None			20.0%						
<b>3.0</b>	<b>STRUCTURE</b>										
3.1	Substructure	None			20.0%						
3.2	Superstructure	Clean and repair basement column	1	\$1,500.00	20.0%	\$1,800.00	each		✓	\$1,800.00	Clean and recast concrete around base of column at rear of basement.
<b>4.0</b>	<b>BUILDING ENVELOPE</b>

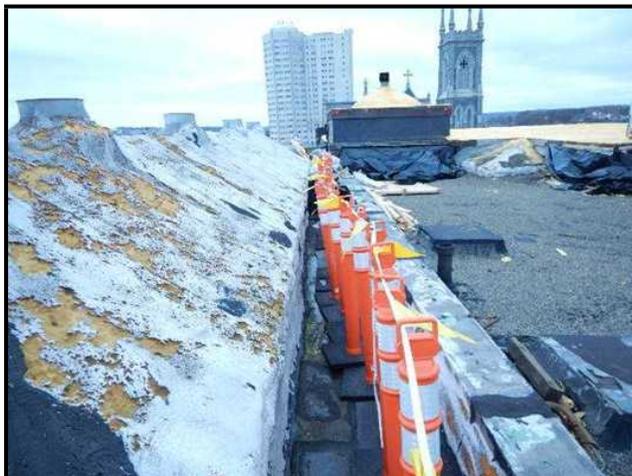
Polyurethane foam roofing showing erosion

4.1	Roof	Repair two roof leaks roof sections A and B	2	\$1,300.00	20.0%	\$1,560.00	\$3,120.00				Complete roof repairs at section A and B.
4.1	Roof area C	EPDM 60 mil roof replacement - mid rise	7,015	\$9.64	20.0%	\$11.57	per square foot		✓	\$81,170.57	Replace built-up and foam roof section C.

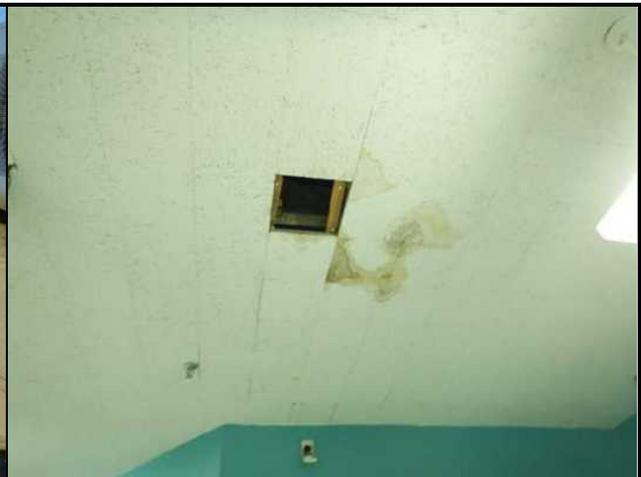
4<sup>th</sup> floor tenant space roof leak

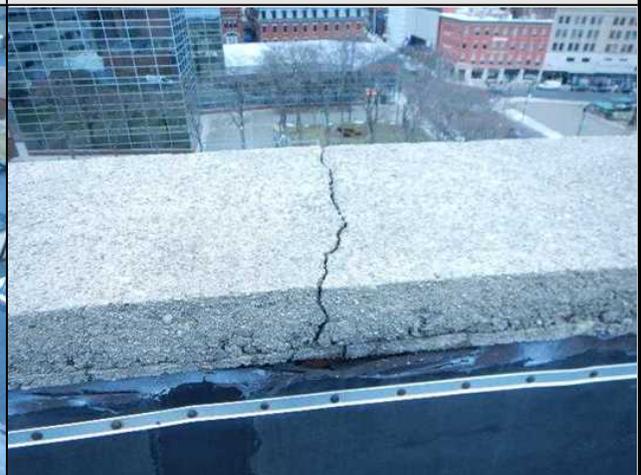
Roof section A/B parapet wall cracked coping

4.1	Roof	Complete roofing installation Section E	1		20.0%		action item				Complete roofing installation delayed due to weather.
4.1	Roof	Rework parapet walls and flashings	1	\$5,000.00	20.0%	\$6,000.00	lump sum				Repair worn parapet walls and flashings.

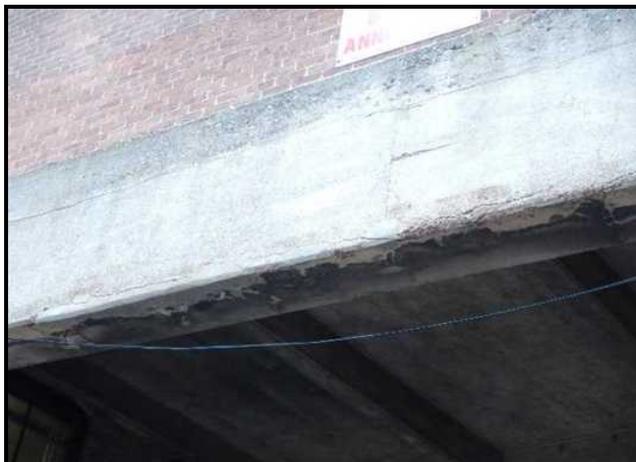
Bottom beam at alleyway bridge southern side showing minor cracking

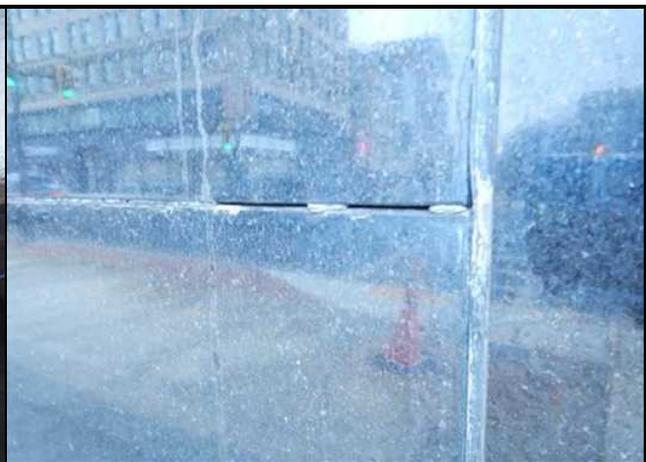
Missing mortar at front of building granite cladding

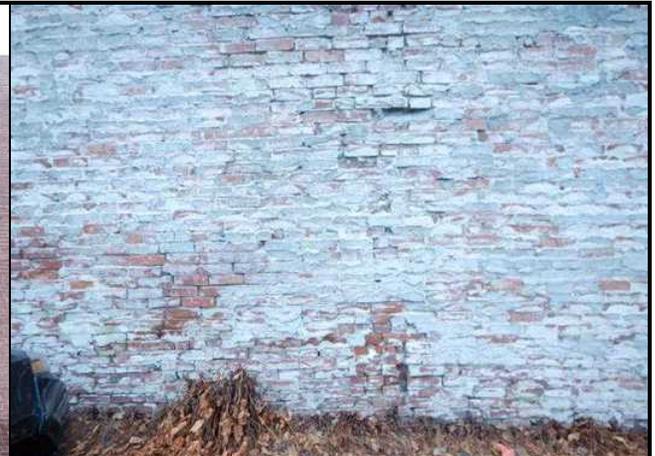
Brick mortar deterioration at southern mural facade

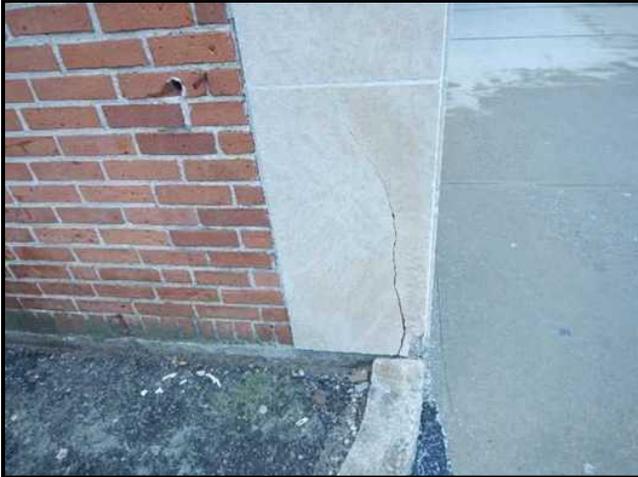
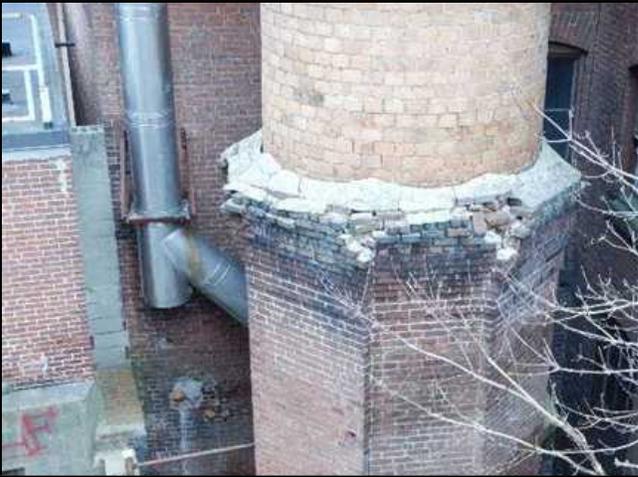
The boiler chimney stack was observed to be in fair to poor condition. The top of the stack exhibited cracking and the base smaller brick skirt is deteriorating. Based on the observed condition, Non-Critical Repairs are recommended for the removal of the masonry boiler chimney.

Cracking noted at rear stone facade	Base boiler chimney skirt deterioration

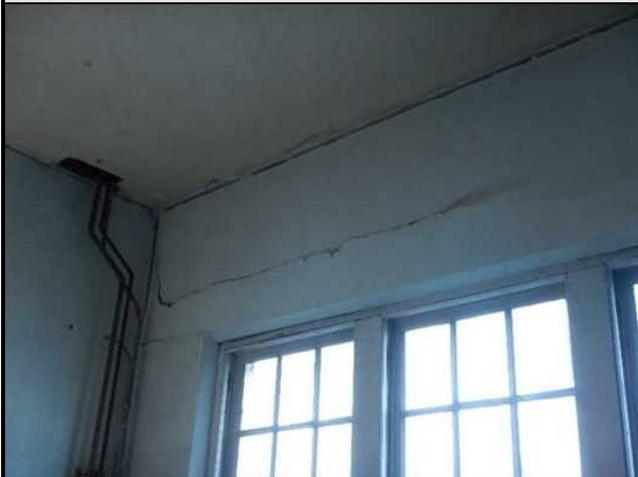
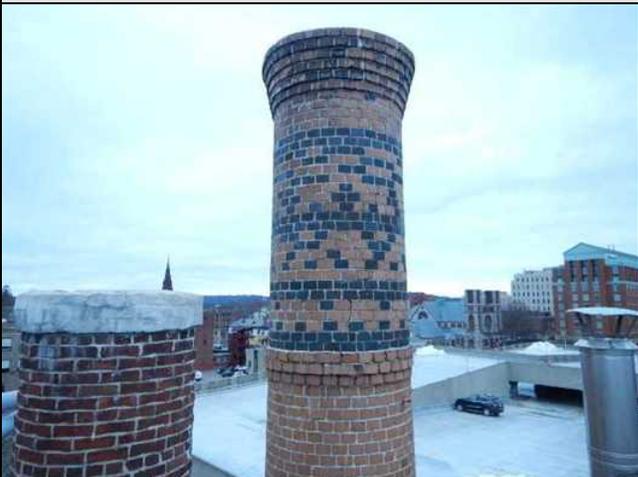
Façade cracking at interior of northern stairwell	Cracking masonry boiler stack at top

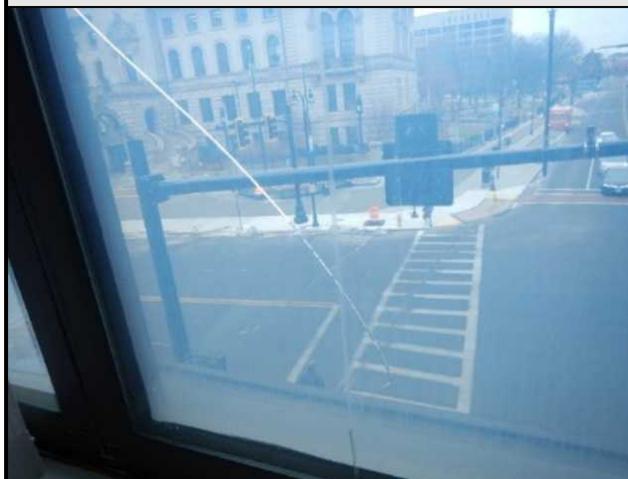
Cracked pane along eastern side of building

4.3	Windows and Doors	Commercial window replacement	14	\$826.50	20.0%	\$991.80	each		✓	\$13,885.20	Ten fogged windows and four cracked insulated panes were observed.

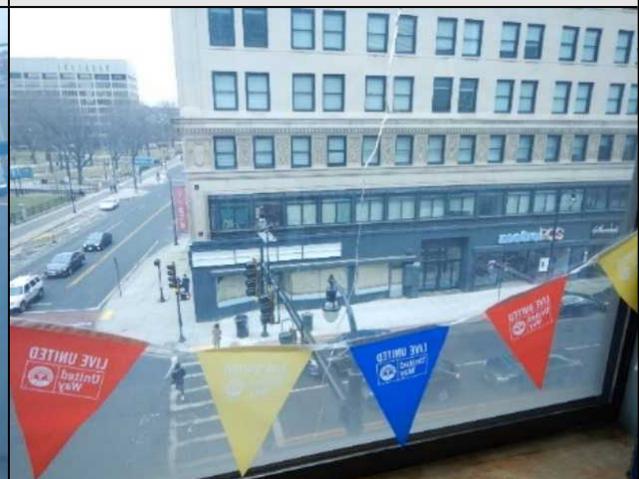
Cracked pane along eastern side of building

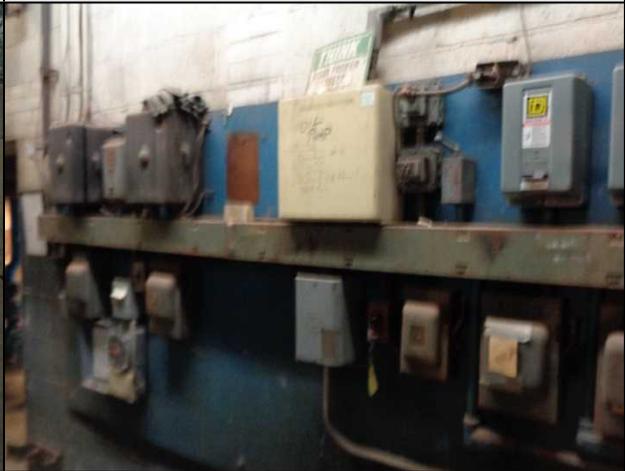
The emergency generator is approximately 40 years old and appears to be in fair to poor condition. Generators of this size and type have an average expected useful life of approximately 25 to 30 years, depending on their maintenance and amount of regular testing and usage, but can be extended with refurbishment/overhaul of the unit. The emergency generator was not operated during our on-site assessment. According to maintenance personnel, the generator is exercised at regular intervals during the year and was last tested. Based on its reported age, current condition, and expected useful life, Short Term Repairs are recommended for replacement of the emergency generator.

Emergency Generator	Disconnects with hot spots

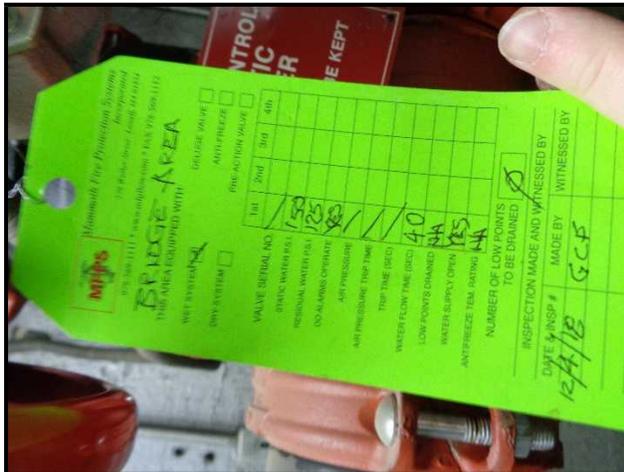
Expired Wet Sprinkler System Inspection
