Re: Pre-Demolition Hazardous Materials Building Survey
Denholm Building
484-500 Main Street
Worcester, Massachusetts

BETA Group, Inc. (BETA) has completed a Pre-Demolition Hazardous Materials Building Survey for the Denholm Building located at 484-500 Main Street in Worcester, Massachusetts (the site). BETA understands that demolition activities are being considered for the existing site structure.

Hazardous Materials Survey
Denholm Building
484-500 Main Street, Worcester, MA
Site Visit Photographs

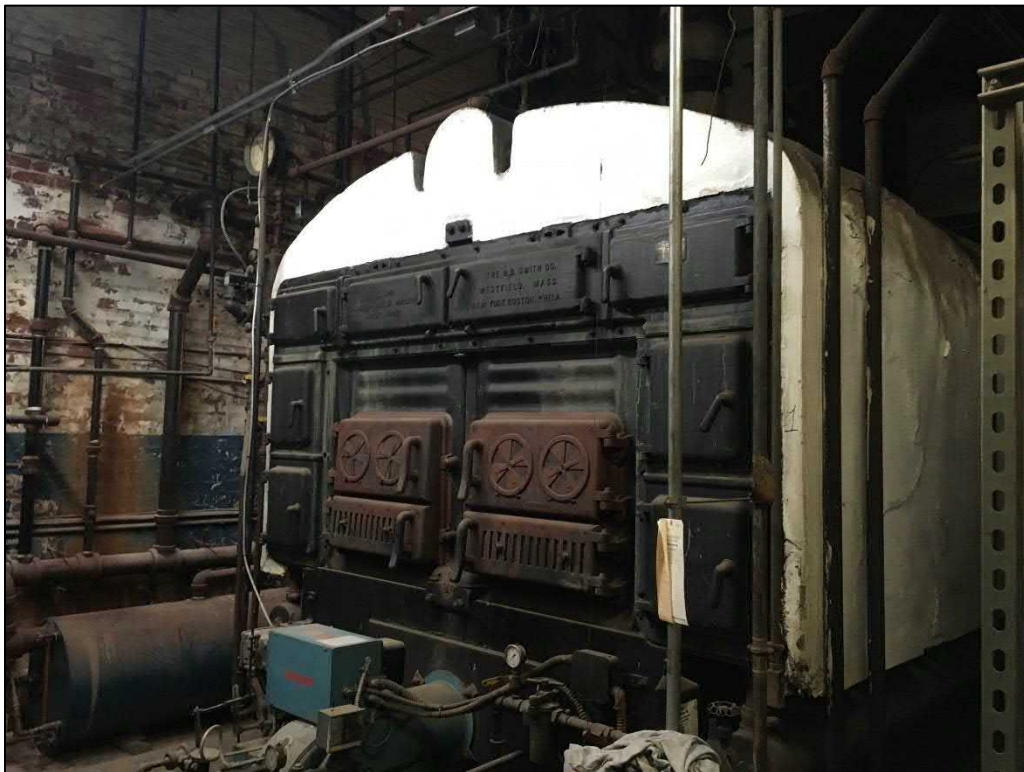
One of two steam boilers on-site; boiler jacket 40% asbestos

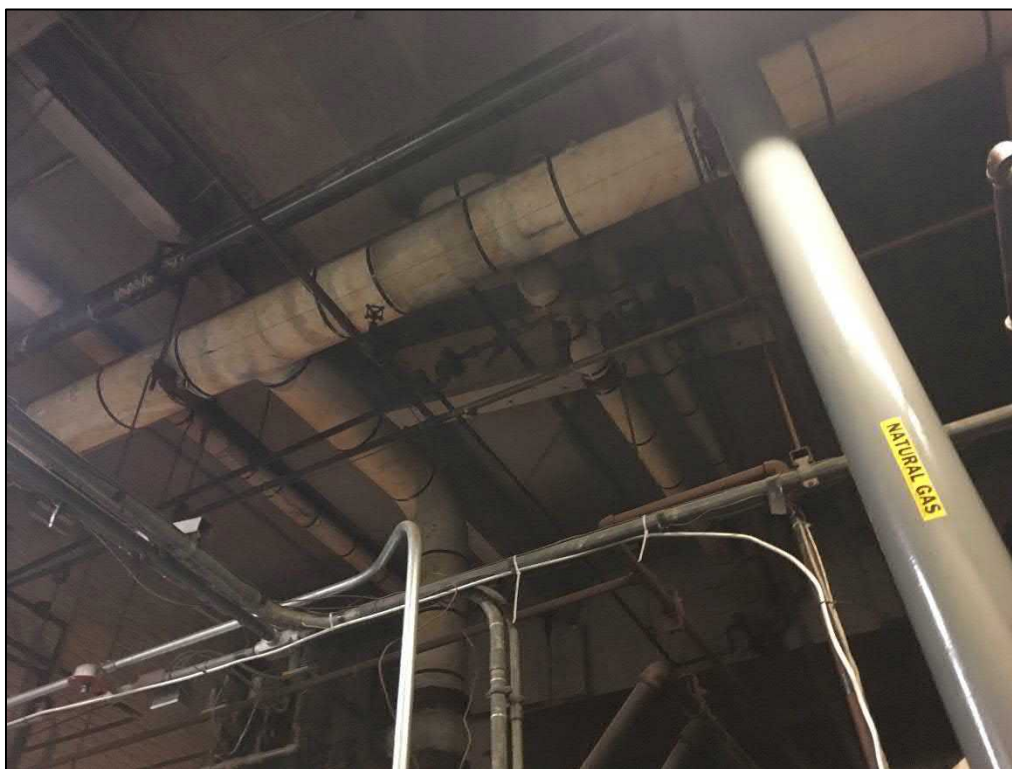
TSI on piping above boilers

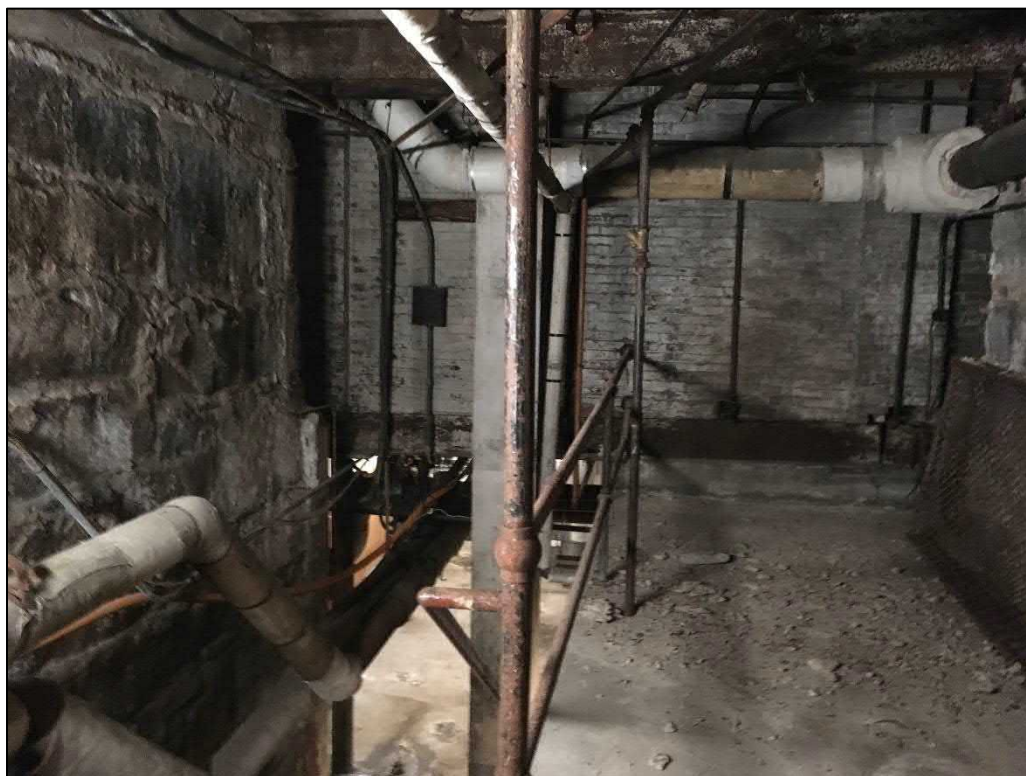
TSI on piping at ceiling and along walls; 35-70% asbestos

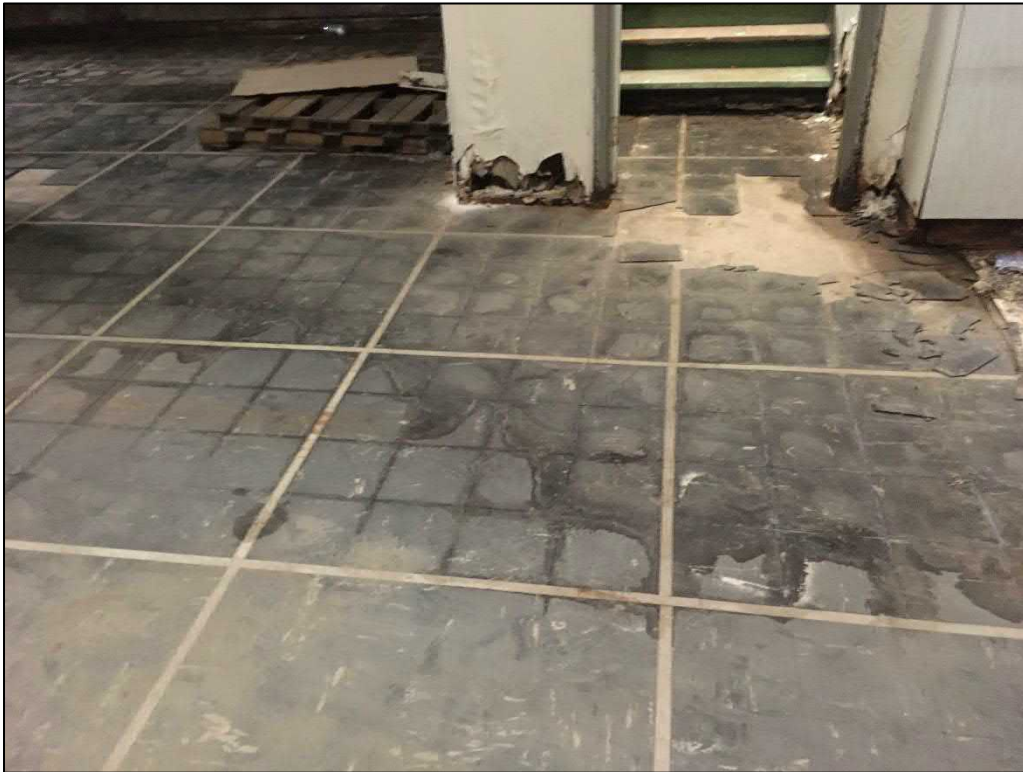
Black 9"x9" floor tiles in basement; 3% asbestos

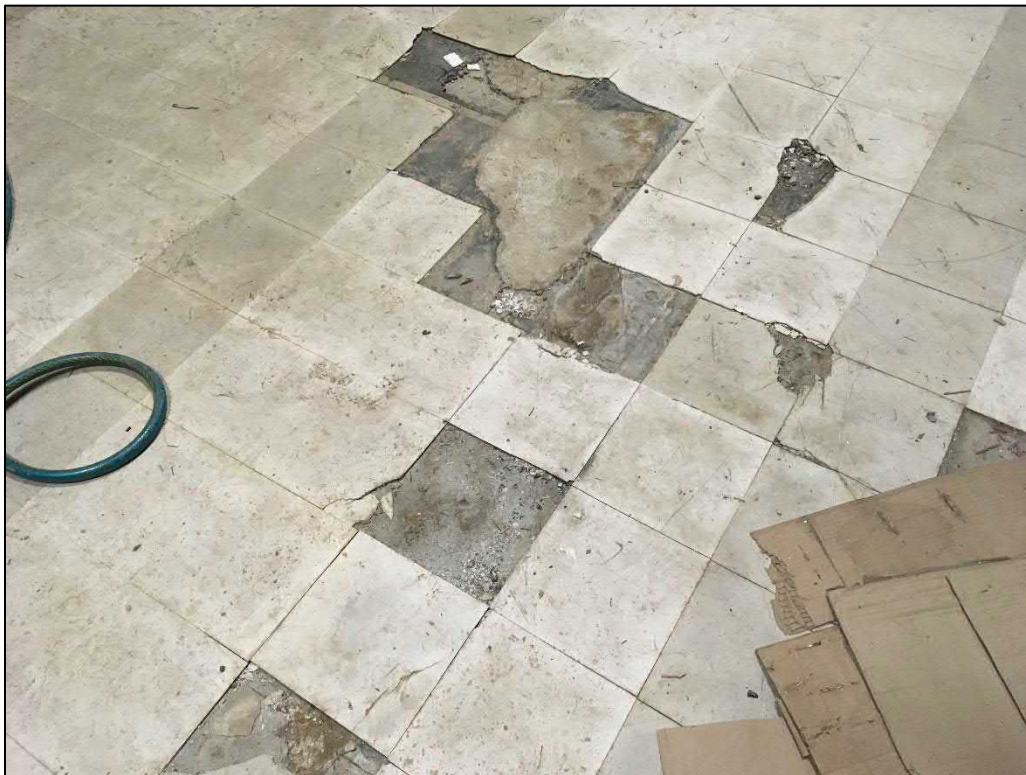
Beige 12"x12" tiles w. mastic (8% asbestos) over black 9"x9" tiles (3% asbestos) over gray leveler (10% asbestos)

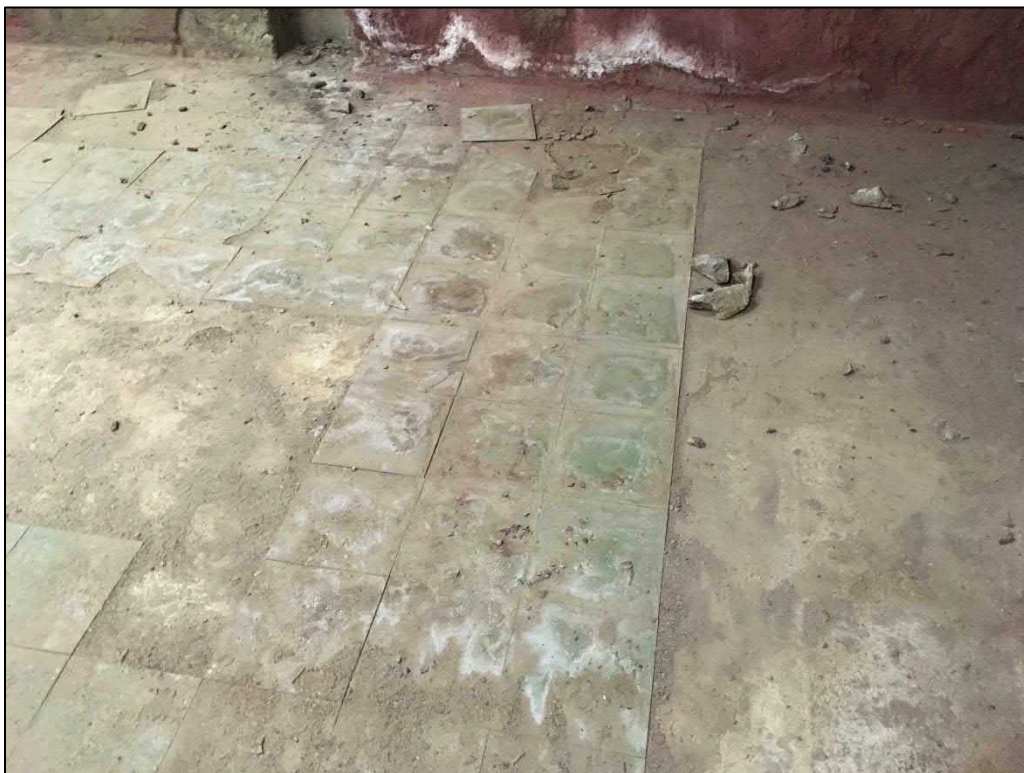
Green 9"x9" floor tiles in basement; 3% asbestos

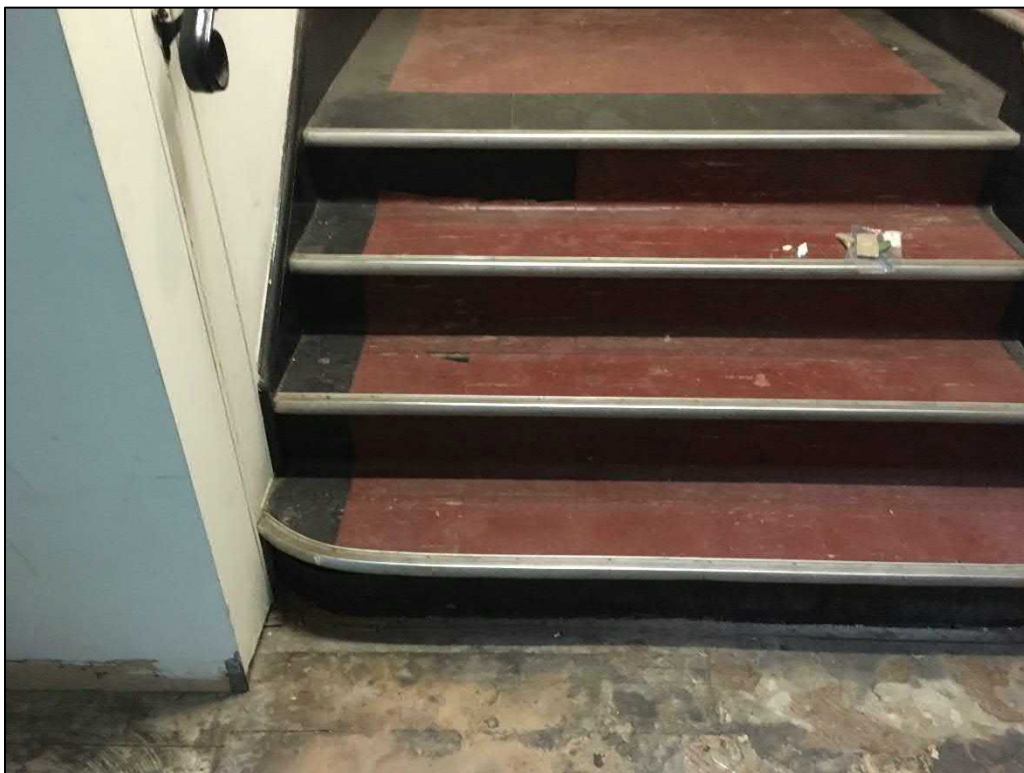
Black & red floor tiles in south stairwell; 5% asbestos

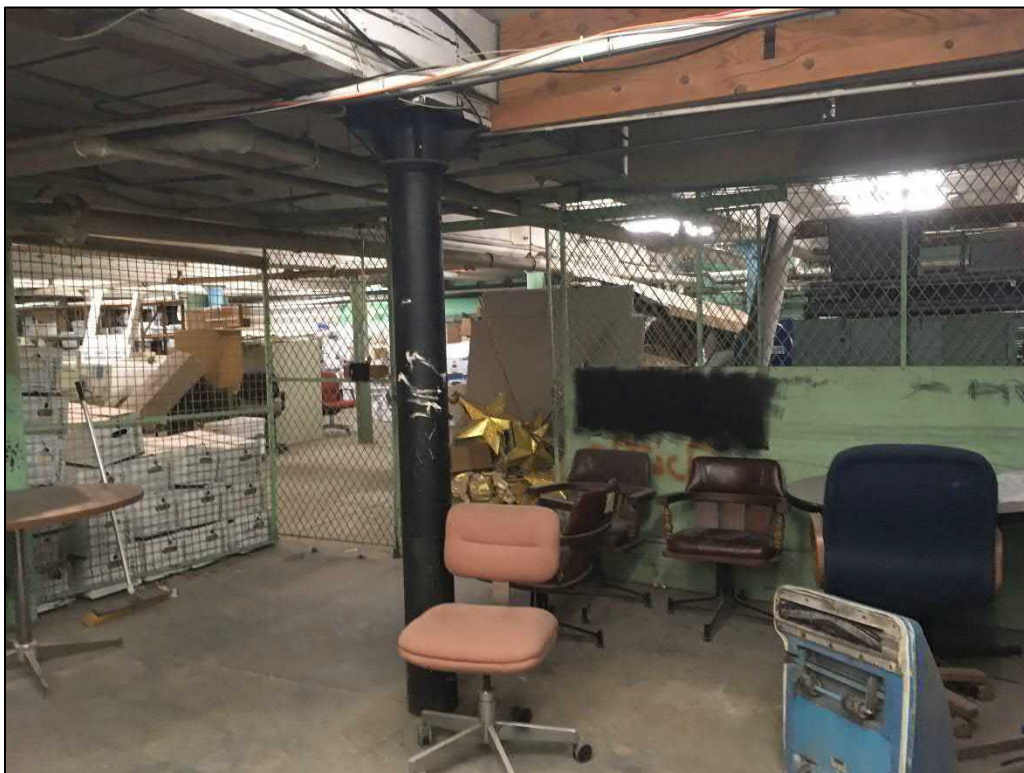
Second floor storage room, west side of building with cork roof & walls

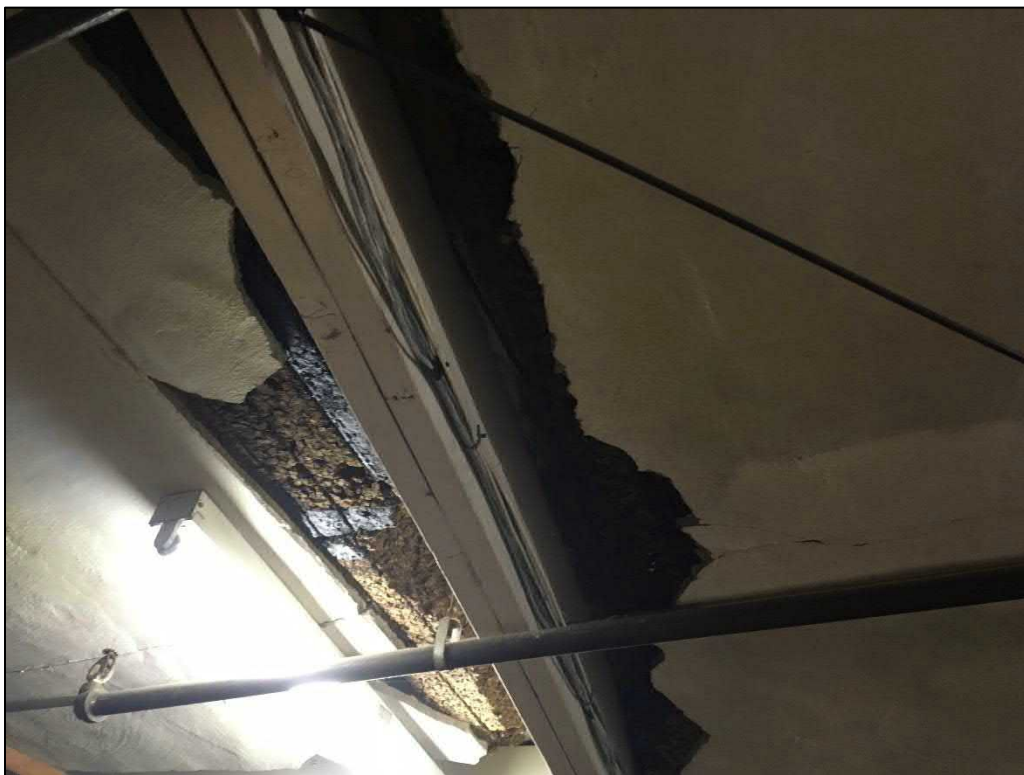
- White ceiling paint in the 1st floor attic / mechanical area; 51.6 mg/kg.
- Black coating on cork ceiling and walls; 2nd floor storage room in western part of building; 64.4 mg/kg.

Black coating on cork ceiling, second floor storage room; PCBs 64.4 mg/kg

Materials containing PCBs at concentrations greater than 50 mg/kg are considered to be a PCB Bulk Product Waste and should be disposed of according to TSCA regulations. Additional assessment of materials / strata surrounding the materials containing PCBs >50 ppm would be required per TSCA regulations. Building materials with concentrations greater than 1 mg/kg but less than 50 mg/kg are considered to be Federally Excluded PCB Product if the total PCB concentration in the original material has not been modified by subsequent activities. Building materials containing PCBs at concentrations less than 1 mg/kg are not regulated and can be managed as general construction waste.

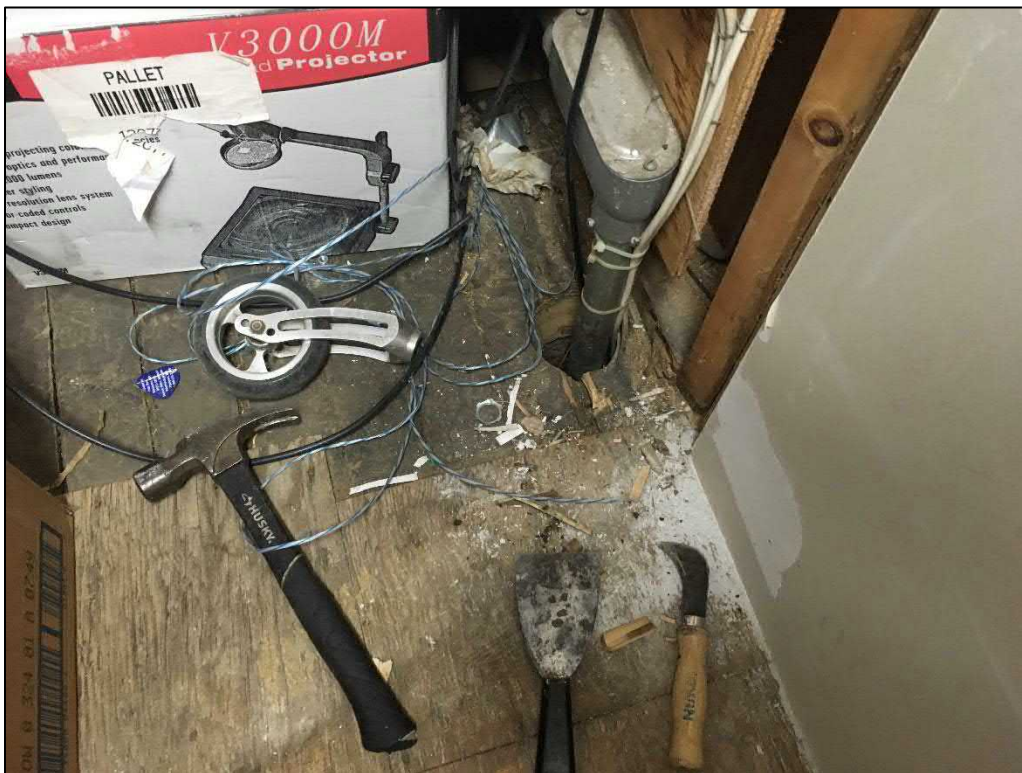
Paper layer identified beneath wood floor (3rd & 4th floors); 40% asbestos

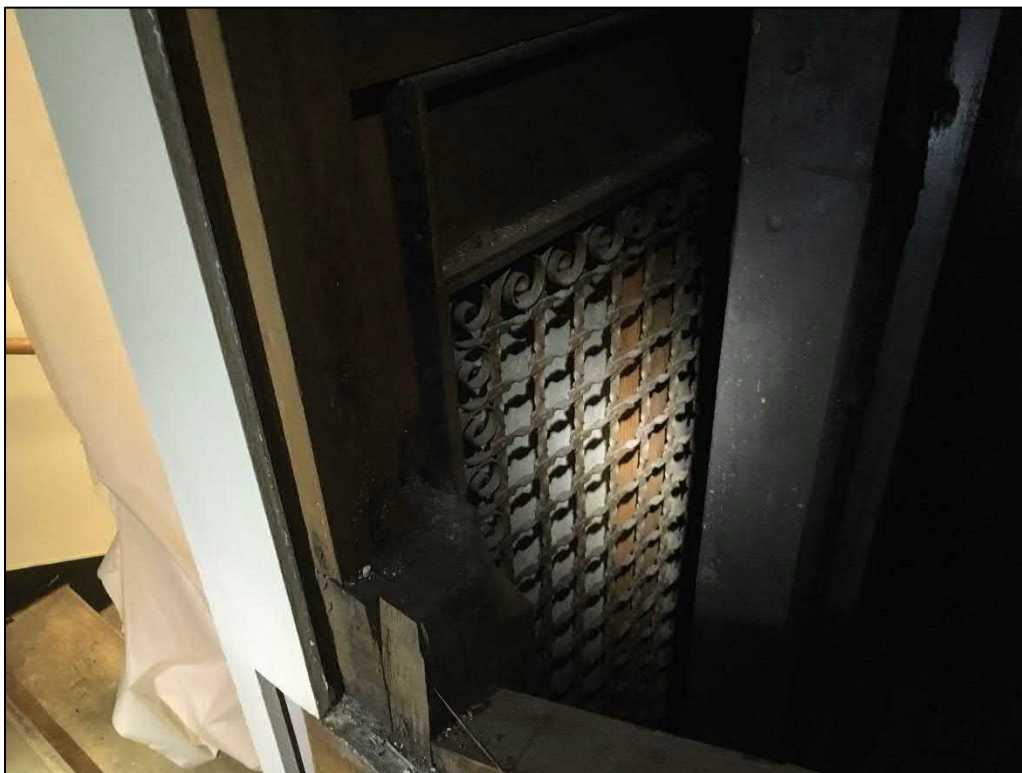
As noted, BETA observed one out-of-service freight elevator in the site structure that was reportedly cable-driven. BETA observed multiple gray panels inside of the elevator shaft that appeared to potentially contain transite, a type of asbestos; however, the panels were not physically accessible for sampling. These panels should be assumed to contain asbestos. BETA observed multiple fire doors throughout the building and on most levels. Fire doors may contain asbestos within their metal or wood exterior; however, the interiors of the fire doors were not accessible for sampling without destructive sampling techniques. These doors should be assumed to contain asbestos.

Possible transite panel in freight elevator shaft

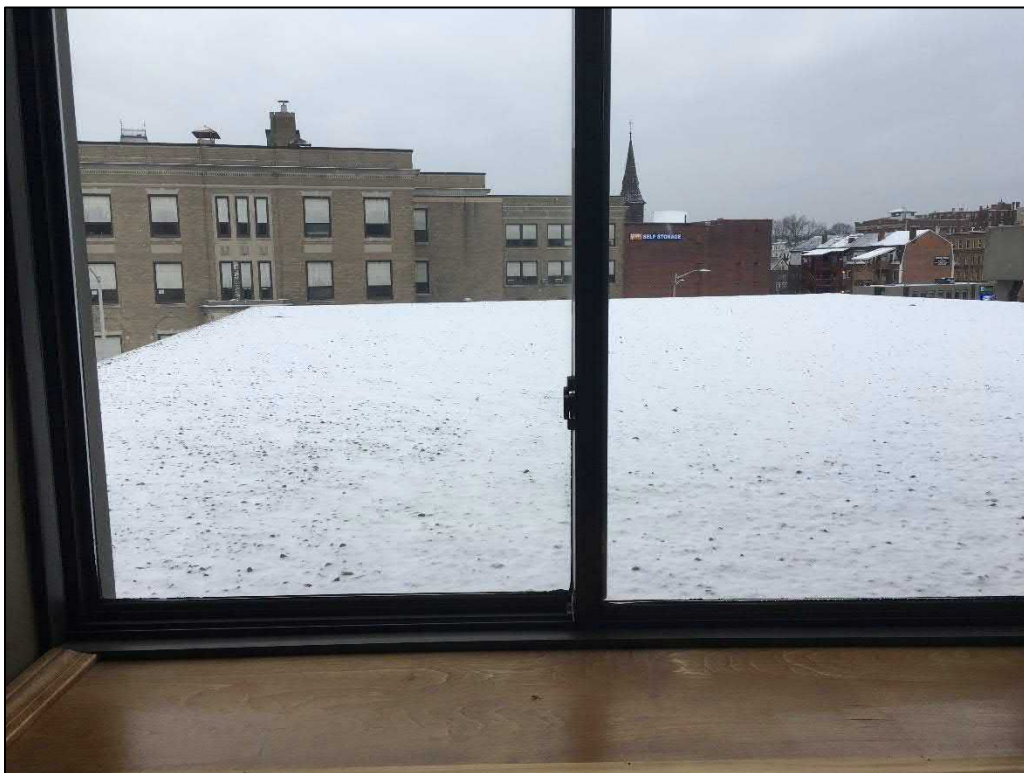
Portion of roof not recently replaced

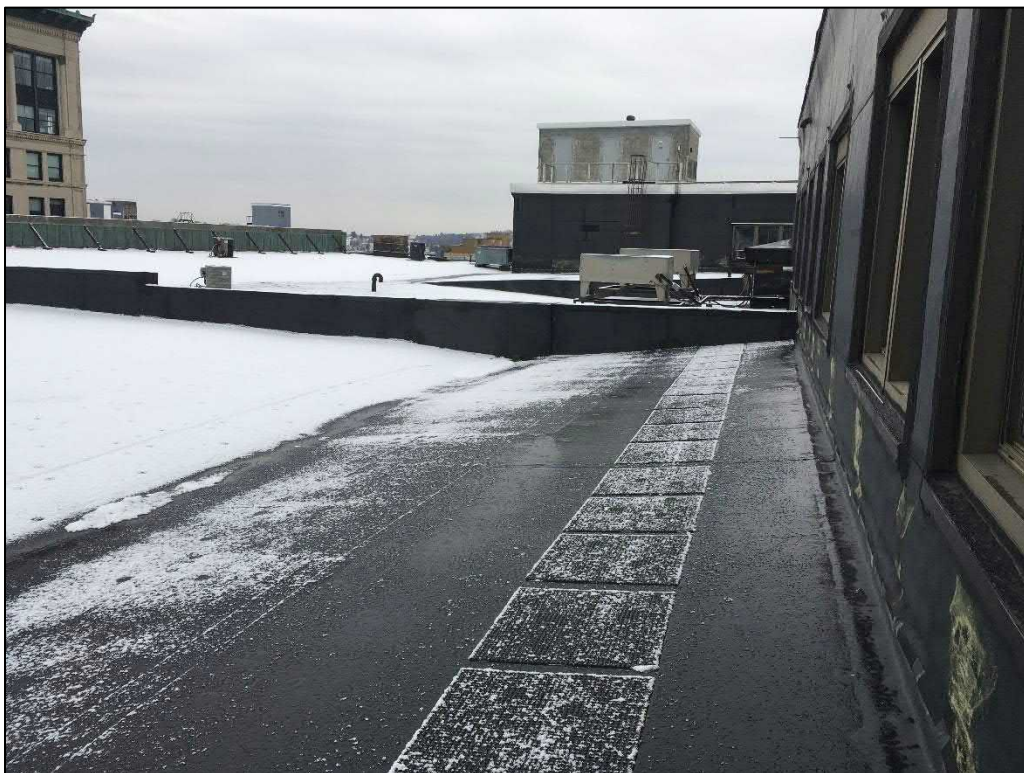
Portion of roof replaced in 2020

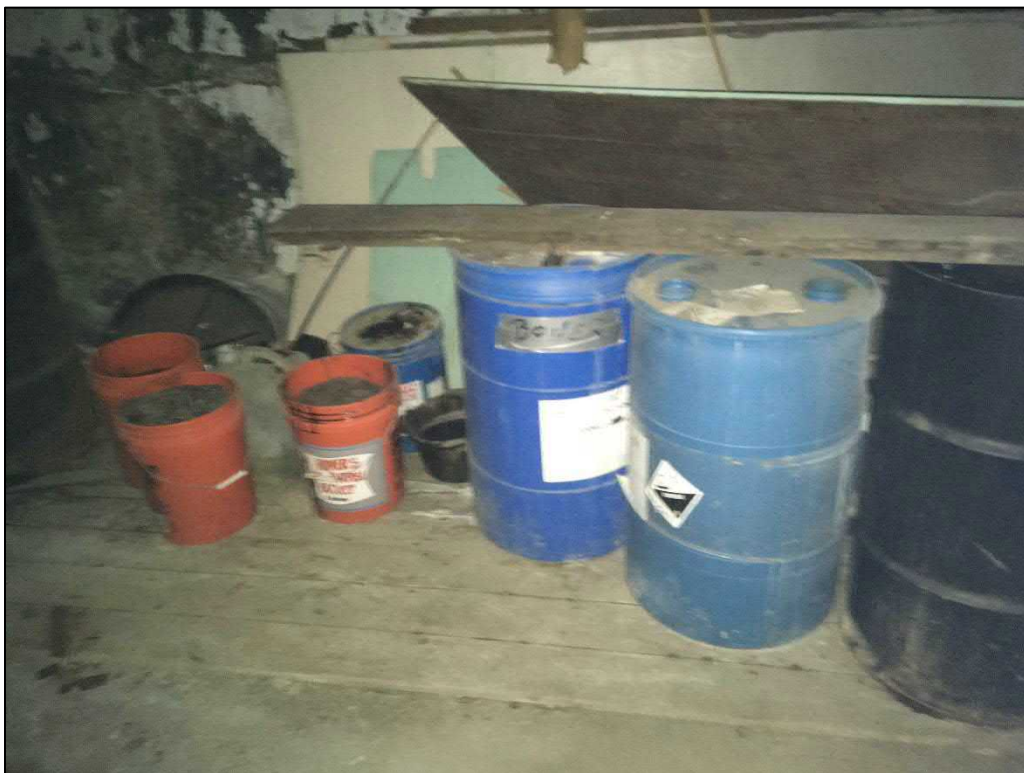
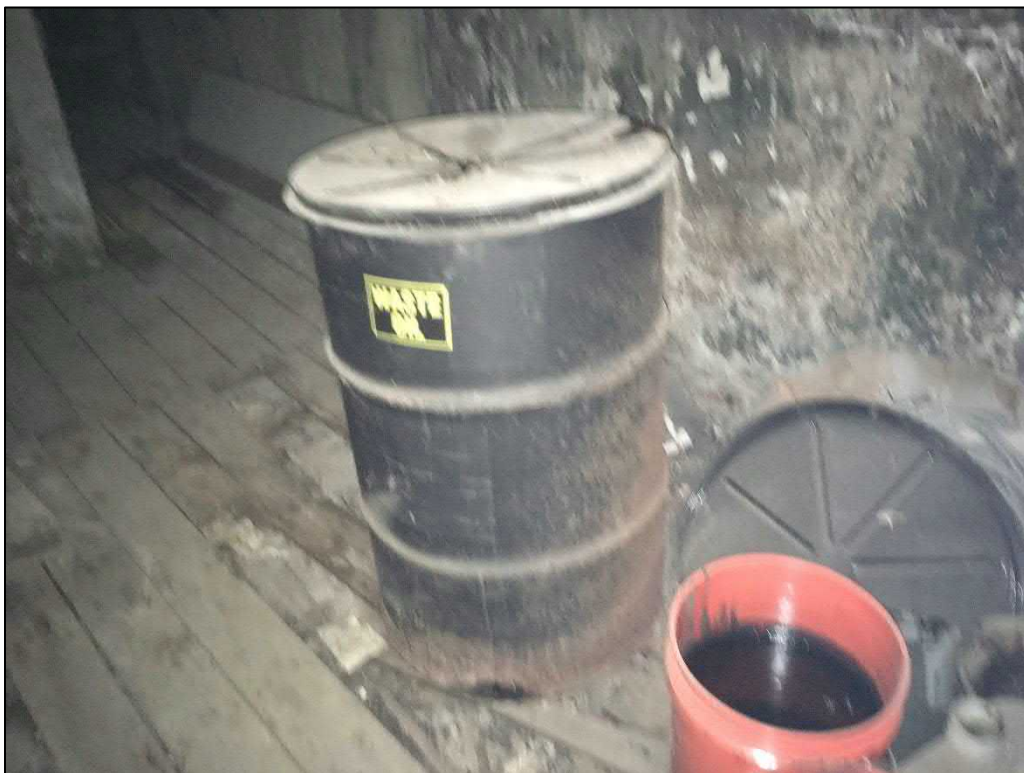
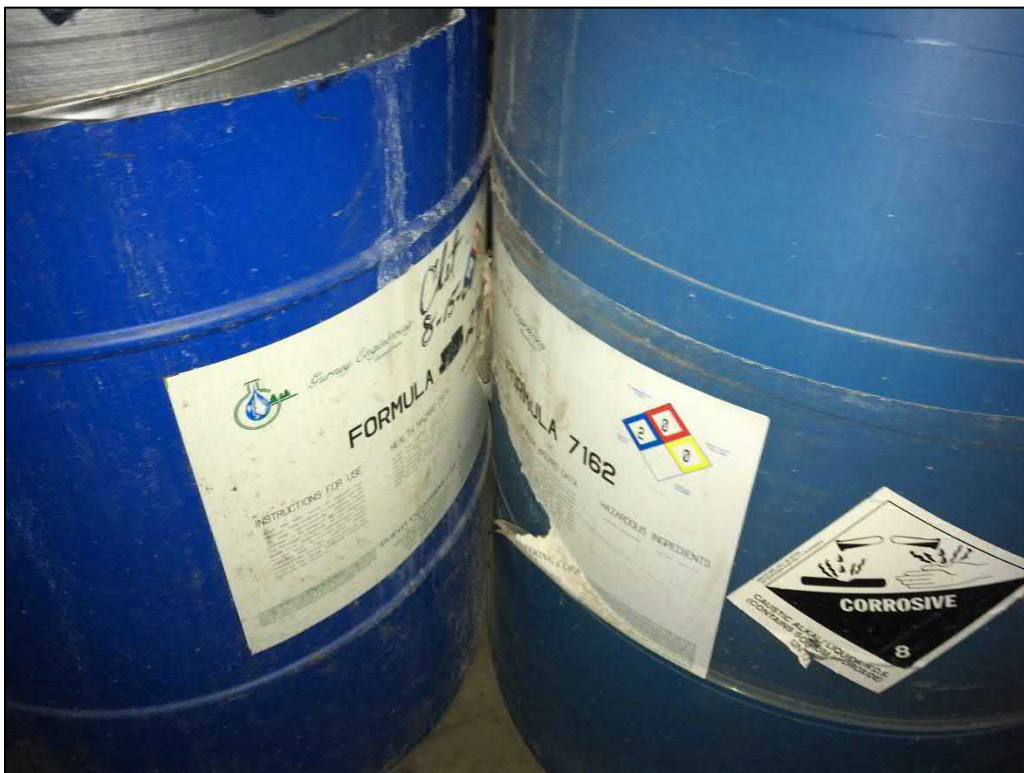
- (4) 55-gallon drums of waste oil (boiler room);
- (2) 55-gallon drums of corrosive liquid (boiler room);
- (5) 5-gallon buckets of waste oil (boiler room);
- (Approx. 20) 5-gallon buckets of various waste oils and/or other liquids (near generator room); and,
- (2) 55-gallon drums of hydraulic fluid (basement level near out-of-service freight elevator).

OHMs in boiler room

Containers of oils and/or other hazardous materials must be disposed of properly prior to site redevelopment. Potential PCB and mercury sources were observed at the site. Lighting ballasts must be recycled / disposed of in accordance with MassDEP's *Policy for Disposal of Lighting Ballasts*, dated January 16, 1992. Fluorescent tubes and bulbs, along with thermostats must be recycled / disposed of in accordance with MassDEP's *Universal Waste Rule*, dated October 17, 1997. Non-PCB and potential / assumed PCB containing light ballasts can be readily separated / managed during demolition activities.

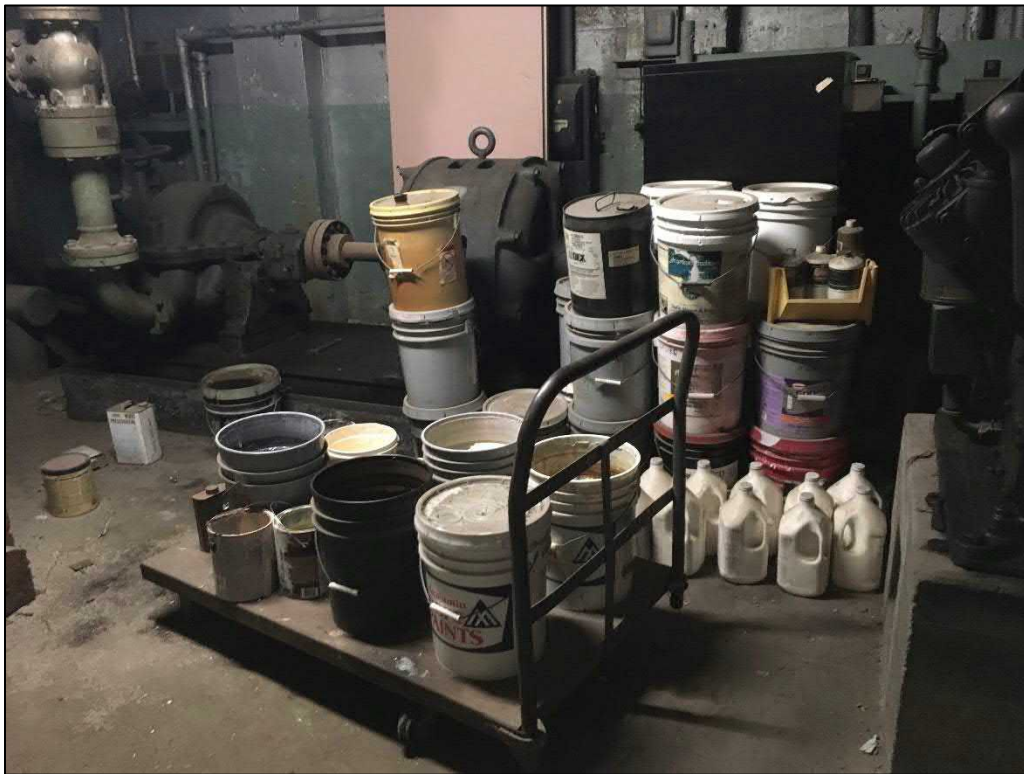
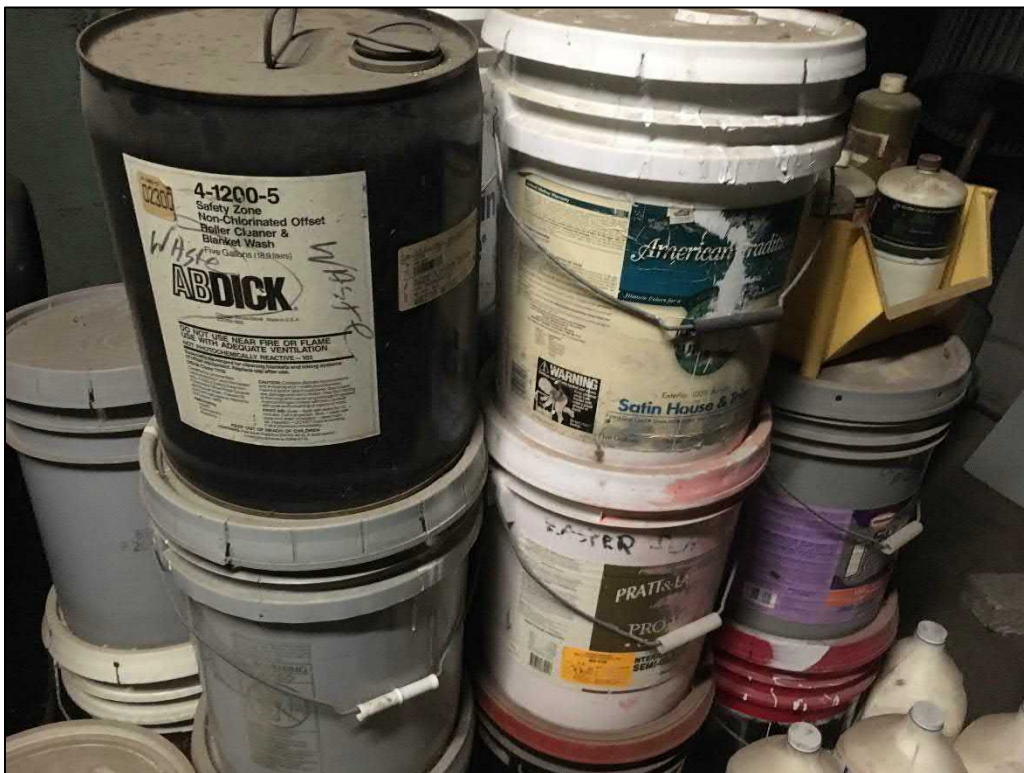
OHMs near generator room

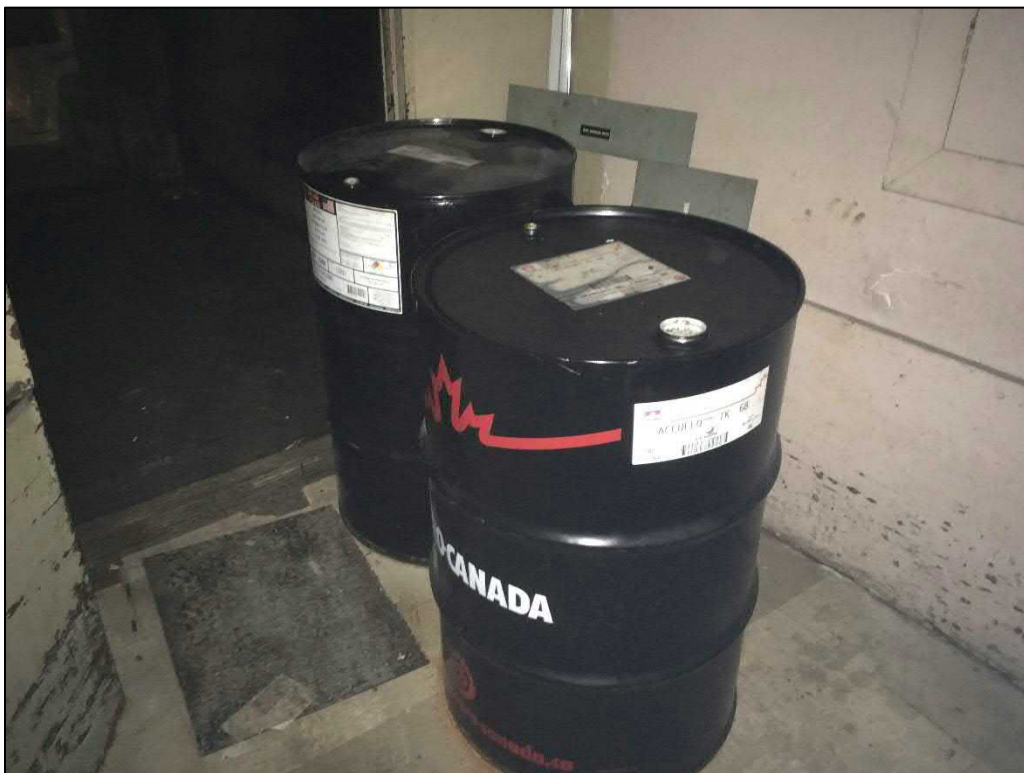
OHMs near freight elevator shaft
