Memorandum

Date:	August 3, 2022	Project#:	225426
To:	Nault Architects		
From:	Jeremy Souza, P.E. – Code Red Consultants		
Re:	Arnold C. Weller, Jr. Academic Center 61 Sever St, Worcester, MA		
Cc:	David A. Carrillo – Code Red Consultants Dan Picciano, P.E., CFPS – Code Red Consultants

Code Red Consultants (CRC) has been retained by Nault Architects to perform an evaluation on the existing fire alarm and fire protection systems located within the existing building located at 61 Sever Street in Worcester, MA. The intent of this evaluation is to outline the existing conditions of the fire alarm and fire sprinkler systems as well as their capabilities to support the proposed new occupants and their desired usage. This evaluation does not include any NFPA 25 or NFPA 72 functionality testing and/or inspections. It is assumed all existing systems are regularly inspected, tested, and maintained in accordance with the requirements of the Massachusetts Comprehensive Fire Safety Code (527 CMR 1.00), referencing NFPA 25 and NFPA 72.

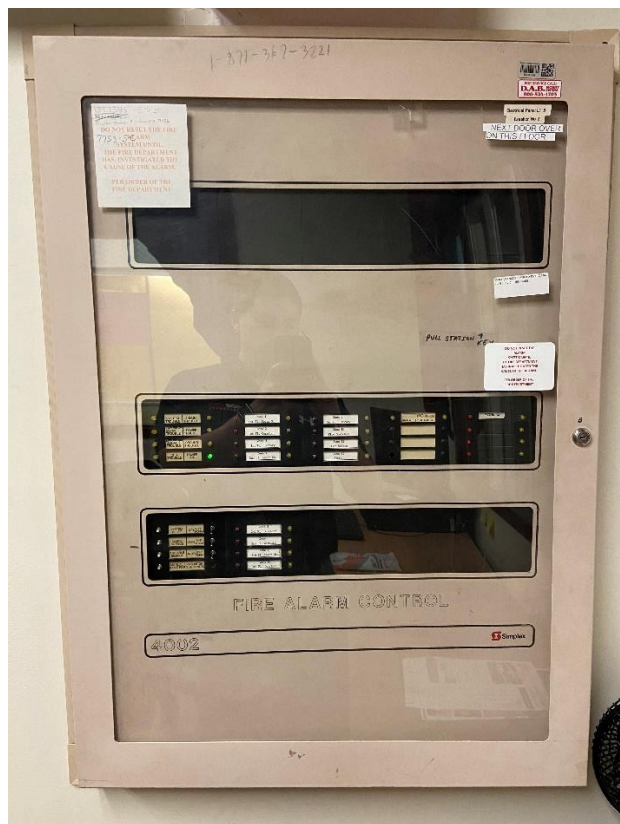
61 Sever Street is equipped with a conventional zoned fire alarm system which is controlled and monitored by a Simplex 4002 Fire Alarm Control Unit (FACU). The existing FACU is located on the Second Floor within the reception office. A remote annunciator panel is provided on the exterior of the building outside of the main entrance. Mounted above the FACU is a Notification Appliance Circuit (NAC) extender panel and a Starlink communicator, which transmits all signals to a Central Station. The existing fire alarm system is believed to have been installed during the 1987 renovation project.

FIGURE 1: MAIN FIRE ALARM CONTROL UNIT (FACU)

The existing conventional Simplex 4002 FACU was formally discontinued for new installations by Simplex in 1998, and parts supplies were discontinued in 2017 (See Appendix A.) If this panel fails (via mechanical damage, failed components, power surge, etc.), the panel would need to be replaced on an emergency basis. It is recommended to replace the existing FACU with a new, addressable FACU in accordance with the following:

- The new Fire Alarm System should comply with NFPA 72, 780 CMR, and 527 CMR 1.00 requirements.
- New FACU wiring should minimally be Class B and installed in accordance with NFPA 70 and NFPA 72.

- New FACU should be located at the same location of the existing FACU or coordinated with the project's architect, owners, and Worcester Fire.
- New FACU should be provided with a means to transmit signals off-premises. A dual path communicator is recommended.

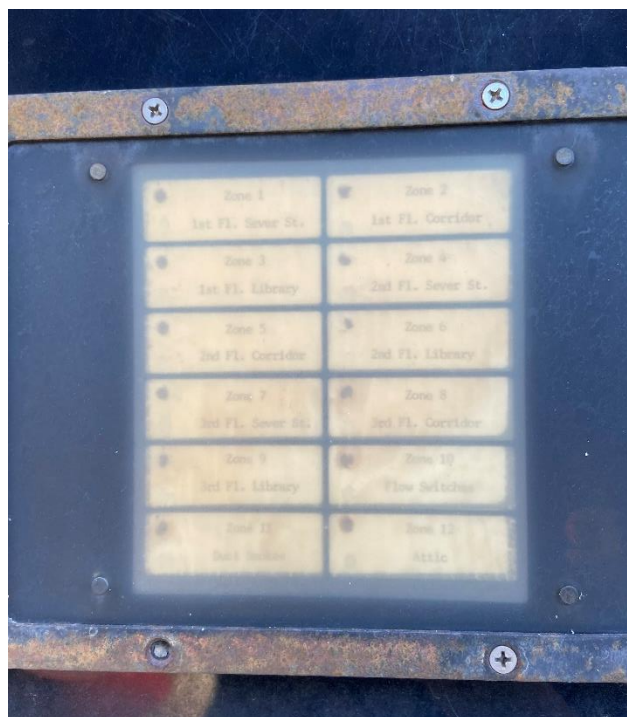
FIGURE 2: REMOTE ANNUNCIATOR PANEL

- New FACU should be provided with a remote annunciator with control functions that same as the main FACU, located near the main entrance of the building.

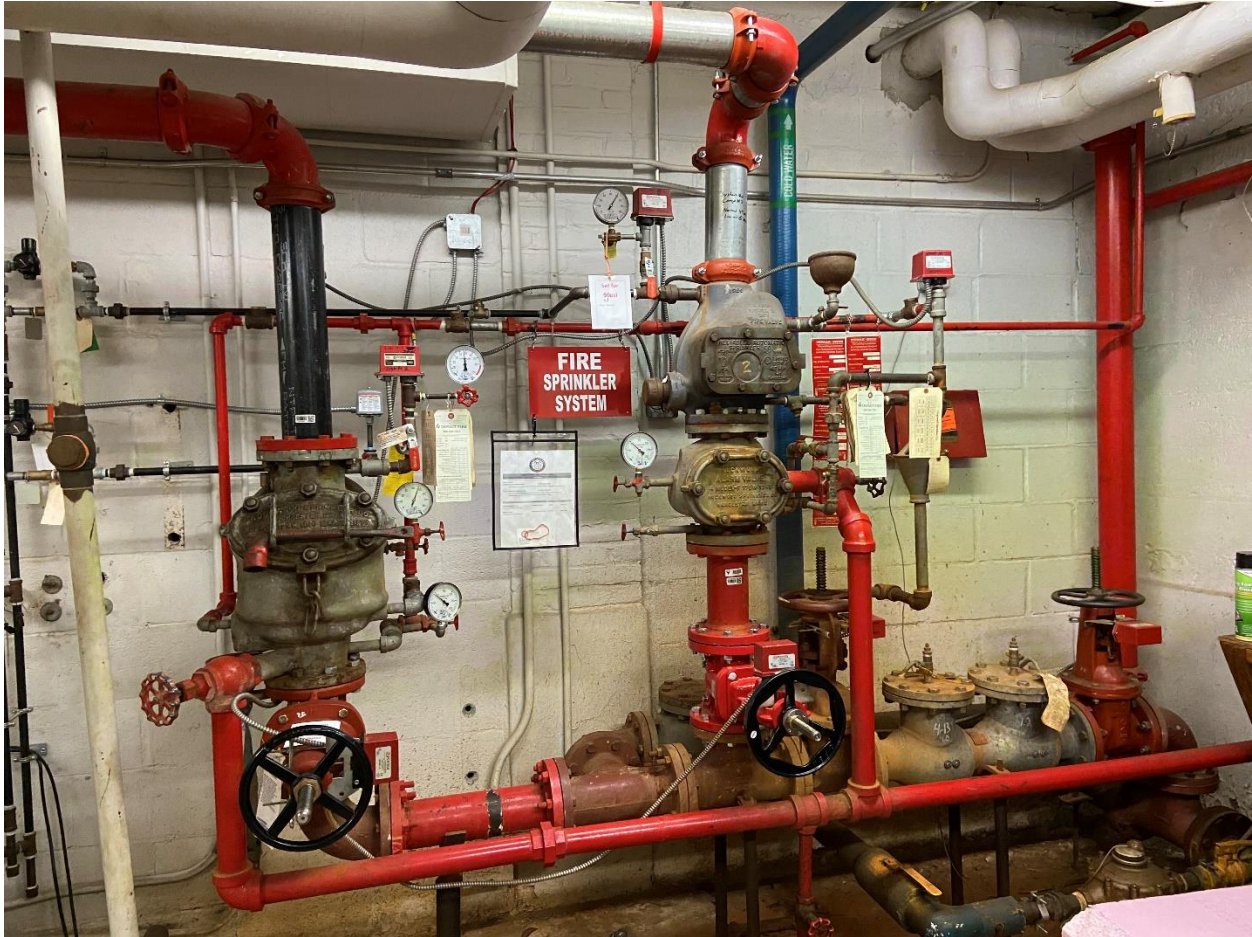
FIGURE 3: SPRINKLER SYSTEM RISERS

The first dry pipe valve, on the left in Figure 3 above, is a 4-inch valve, which appears to be original to the building. While a manufacturing date was not noted in the casting for the valve body, the valve shows patent dates of 1919 and 1927. The air system pressure for this valve was shown as 47 psi at the time of the inspection, which is substantially higher than generally seen for dry pipe systems (15 to 25 psi is generally the expected range). As original operating and maintenance instructions for the valve are not available, this pressure cannot be verified.

The second dry pipe valve is “stacked” above a wet pipe alarm check valve. The wet pipe valve, a Rockwood Model F, has a casting date of 1960, and is the same manufacturer as the dry pipe valve. The dry pipe valve, a 4-inch Reliable Model D, has a casting date of 1993. Similar to the first dry pipe valve, the air pressure in this system was noted as 50 psi

Based on this “stacked” valve arrangement, as well as the as-built FP drawings, it is believed that the building was originally provided with a wet-pipe system, which was converted to a dry-pipe system.

The system design data placards located at both system risers indicates that both systems have been hydraulically calculated to a density/area of 0.115 gpm/sqft over a remote area of 1950 sqft. This density is not typical; the expected densities would be 0.10 gpm/sqft for Light Hazard and 0.15 gpm/sqft for Ordinary Hazard, Group 1. It is not known why this density was chosen.

- Given the ongoing systemic corrosion problems, the existing fire protection systems and all associated components down stream of the incoming water supply flange should be replaced with new.

- Provide a new backflow preventer between the system risers and the incoming water supply. Backflow should be sized based on hydraulic calculations.
- It is our understanding that the City Archivist has indicated that non-water based fire protection be utilized for the archive areas in order to minimize water damage. Should a clean agent system, such as FM-200, Inergen, or similar systems, be utilized in this area, a water-based fire protection system is still required as to comply with the "fully sprinklered" requirements of 780 CMR and MGL Chapter 148. It is our recommendation that a single- or double-interlock preaction system be provided within the archive areas to minimize accidental water discharge. Should a preaction system be utilized, the following would be required:

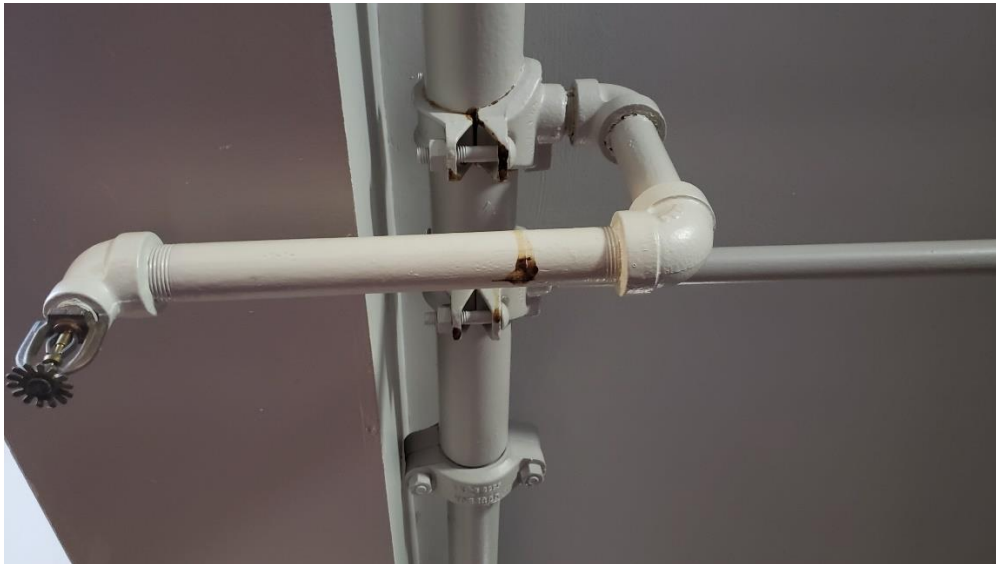
During the site survey, it was noted that the wet pipe sprinkler system within the building had been converted to a dry pipe system. From discussions with Nault Architects and with facilities staff on site, it is our understanding that the wet system had been plagued with small leaks and that the corrective action was to convert the system to a dry sprinkler system. Dry sprinkler systems require the ability to remove all trapped water should the system activate^a, while wet pipe systems only require full drainage for maintenance operations (sections of pipe with less than 5 gallons of water do not require drains). Numerous locations throughout the building showed areas where water would be trapped during an activation. Individual pendent-style sprinkler drops and low piping segments without auxiliary drains were noted throughout the building. These locations will retain water after an activation, which will remain in the piping system and contribute to corrosion within the piping. Figure 4 shows a typical return bend which cannot be drained and will trap water.

FIGURE 4: PIPING SEGMENT TRAPPING WATER (TYPICAL)

- Dry pipe sprinkler systems should be installed as to allow full drainage of the piping
 - A nitrogen generator to prevent internal pipe corrosion should be provided for all new dry pipe systems

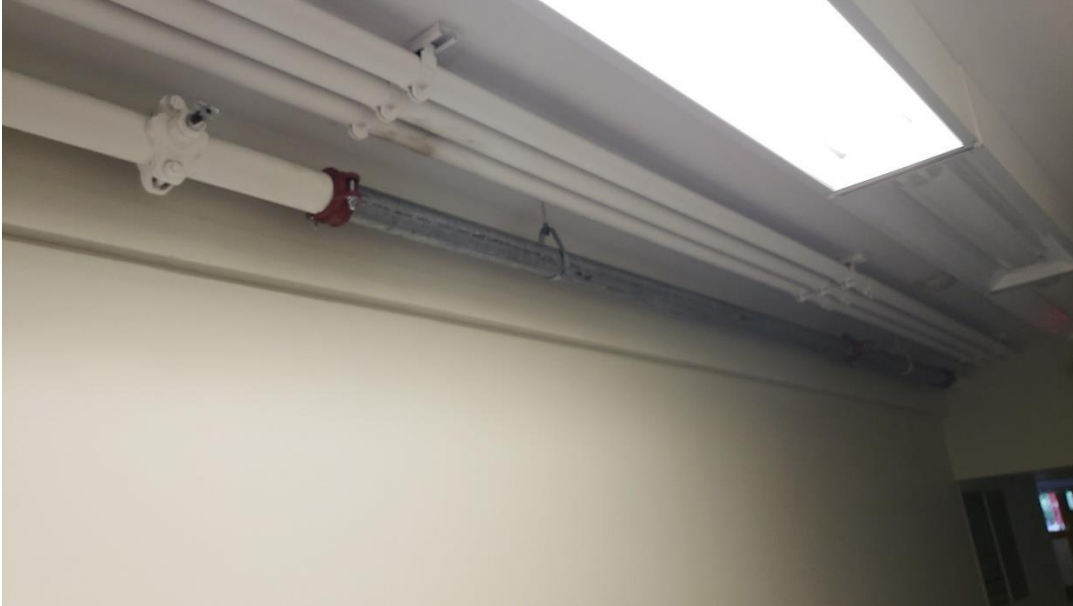
It was additionally noted that repairs to the piping had taken place in the past. The pipe material appears generally to be Schedule 10 and Schedule 40 black steel pipe. In certain locations, it was noted that piping sections had been replaced with galvanized pipe. Typically, dry sprinkler systems utilize galvanized pipe (which is more resistant to corrosion) or Schedule 40 (which has a thicker wall than Schedule 10) pipe. Figure 5 below shows one of these repairs.

FIGURE 5: REPAIR WITH GALVANIZED PIPE

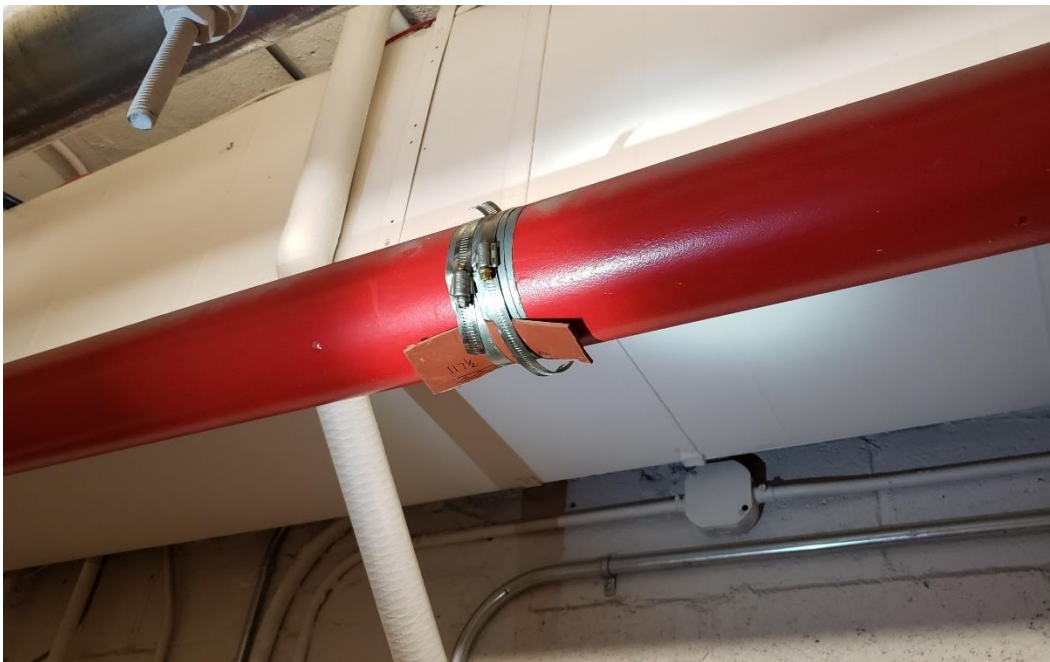
FIGURE 6: CARDBOARD AND HOSE CLAMPS USED TO REPAIR LEAK

In discussions on site with facilities staff, it was noted that the compressors for the dry pipe systems operate at least three or four times per day to recharge the air within the sprinkler system. This indicates the presence of significant leaks within the system. Facilities staff additionally indicated that there are locations where leaking air can be heard behind or inside walls, however this was not able to be verified in the field. Evidence of numerous, small, ongoing leaks were noted throughout the building. Corrosion (primarily rust) was noted at joints and fittings in most locations in the building. These locations are particularly identifiable in areas where the sprinkler piping is painted white. Rust-colored spots were noted on piping, as identifiable in Figure 4 beneath the mechanical tee, as well as in Figure 8 below. It is particularly notable that the corrosion has continued beneath the paint, indicating that the corrosion is being driven from inside the piping. This is commonly caused by trapped water within the otherwise air-filled pipe, which creates an environment that increases the rate of corrosion.

In our opinion, should the current piping configuration (dry pipe system with significant trapped water) be maintained, the corrosion within the existing piping system will continue and will lead to more substantial piping failures.

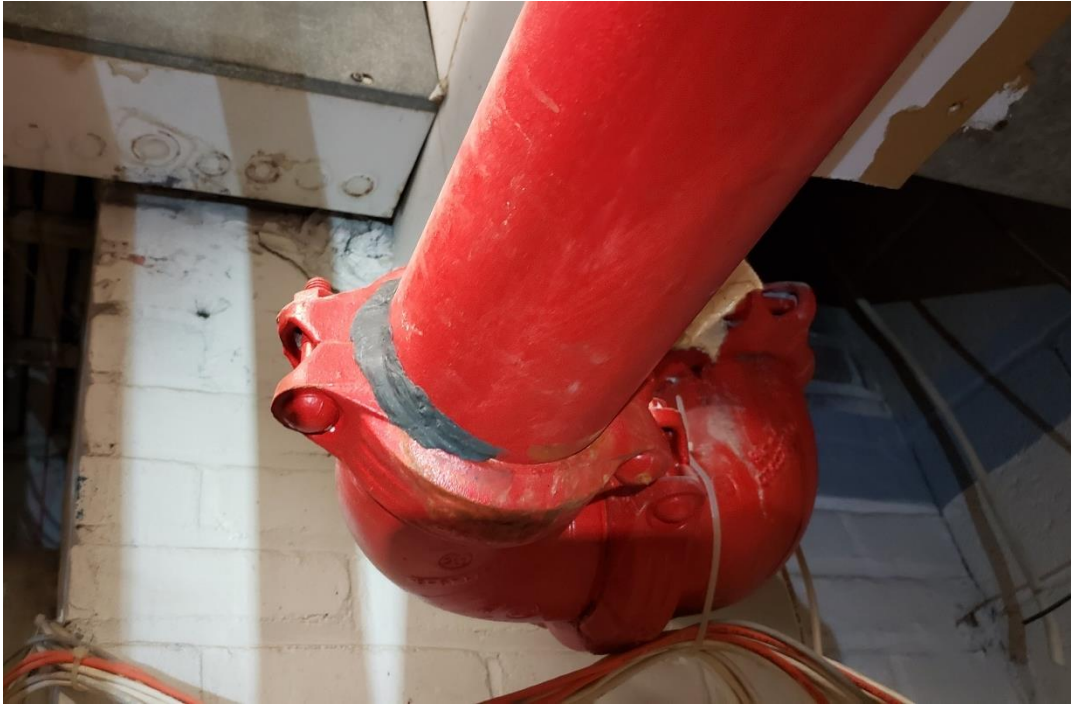
FIGURE 7: EPOXY ON GROOVE-LOCK COUPLING TO REPAIR LEAK

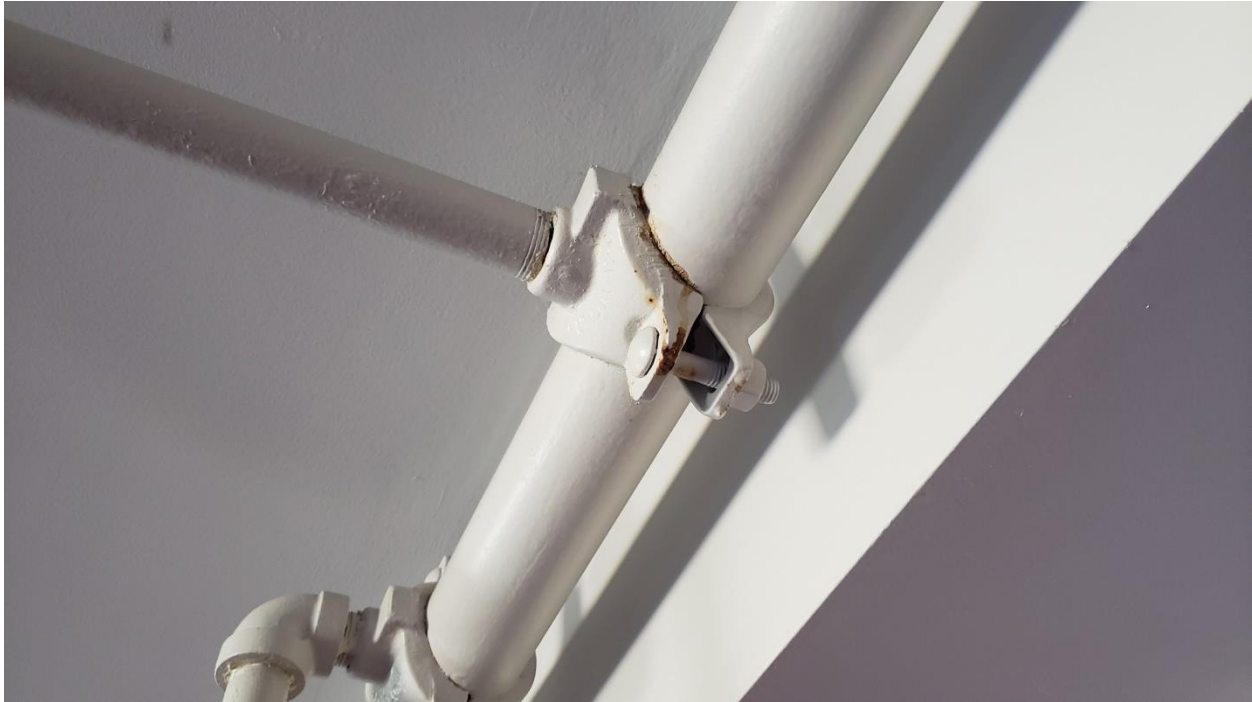
FIGURE 8: CORROSION AT MECHANICAL TEE
