PINE HILL RESERVOIR DAM
PHASE I
INSPECTION / EVALUATION REPORT

Dam Name: Pine Hill Reservoir Dam
State Dam ID#: 3-14-134-6
NID ID#: MA 00623
Owner: City of Worcester
Owner Type: Municipal
Town: Holden, Massachusetts
Consultant: CDM Smith Inc.
Date of Inspection: April 11, 2012

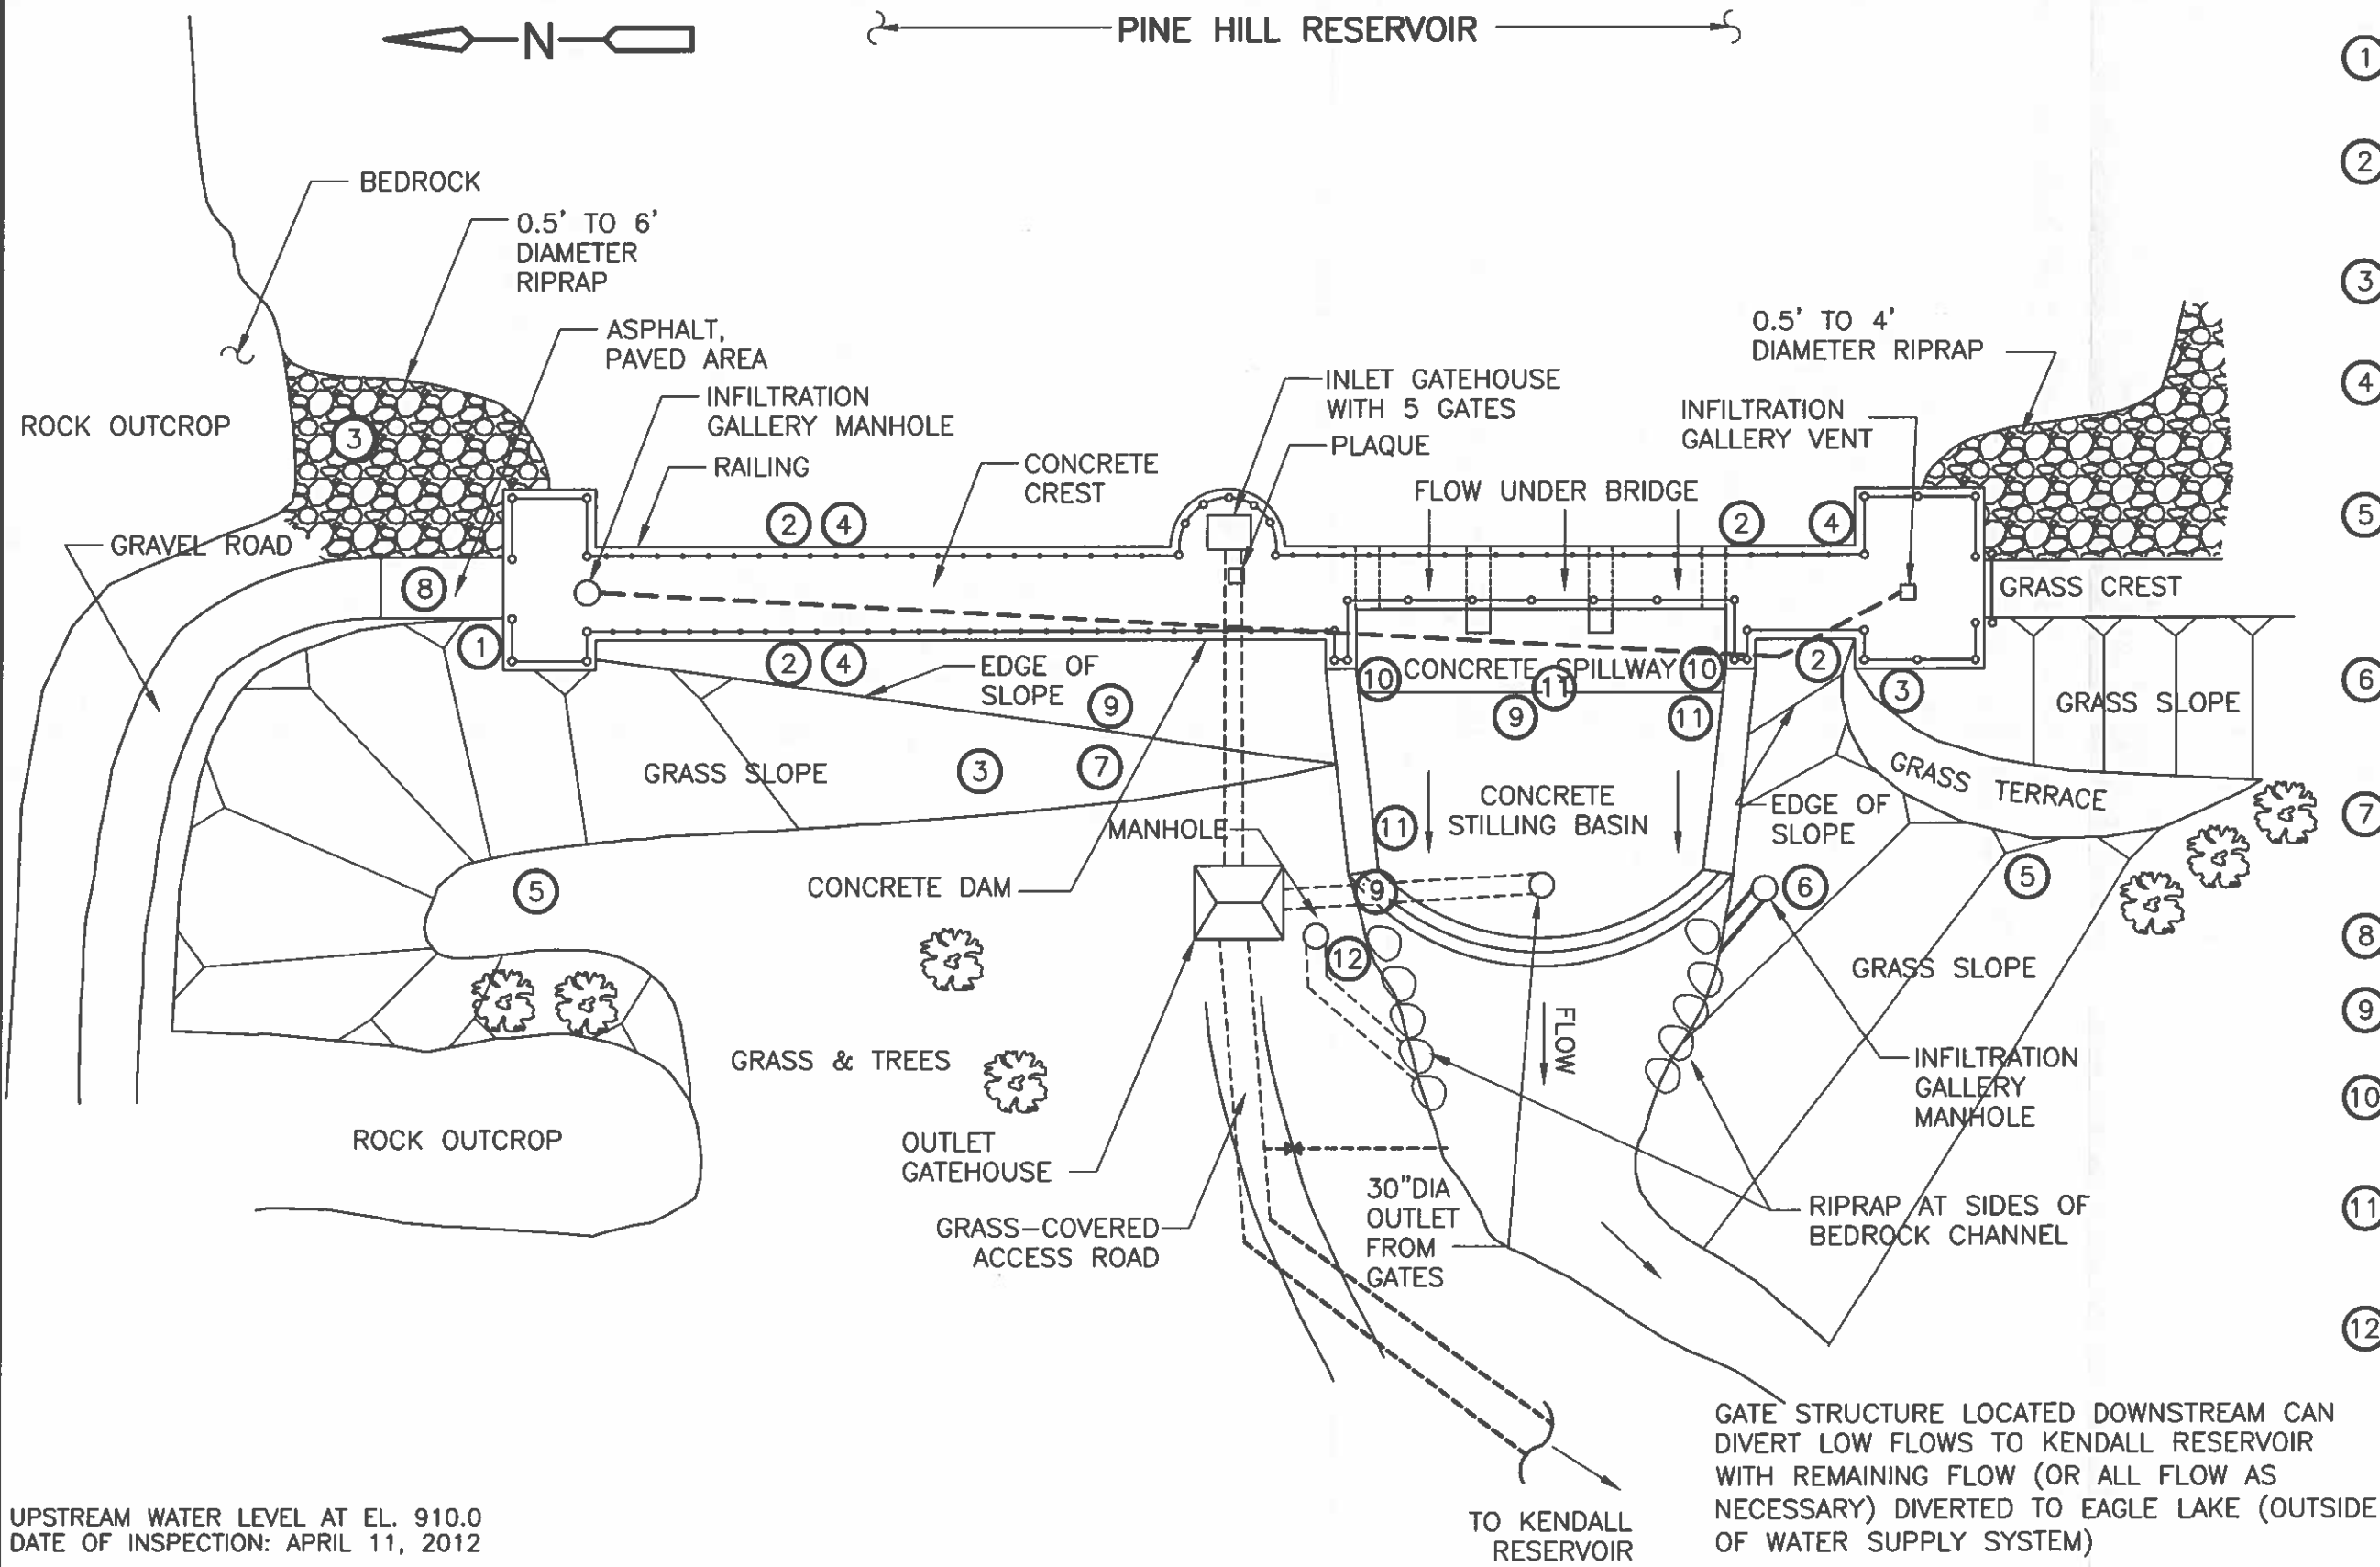
- ① BROKEN GUARDRAIL.
- ② SHOTCRETE SLOUGHING FROM SOME CONCRETE SURFACES.
- ③ SOME BRUSH, BUSHES, AND VINES.
- ④ SOME CONCRETE CRACKING WITH MINERAL DEPOSITION.
- ⑤ A FEW EROSION RILLS ON GRASS-COVERED SLOPE.
- ⑥ WATER FLOWS OUT OF TOP OF INFILTRATION GALLERY MANHOLE INSTEAD OF 8\" DIA. DRAIN PIPE.
- ⑦ 40'x20' DEPRESSION/SATURATED SPOT NEAR FACE OF DAM.
- ⑧ RUTS AND CRACKS IN ASPHALT ON CREST.
- ⑨ EXPOSED REBAR.
- ⑩ CONCRETE FILLET MISSING FROM SPILLWAY.
- ⑪ CONCRETE SPALLING AND EFFLORESCENCE.
- ⑫ SEEPAGE OCCURRING IN EMBANKMENT D/S OF RIGHT TRAINING WALL.

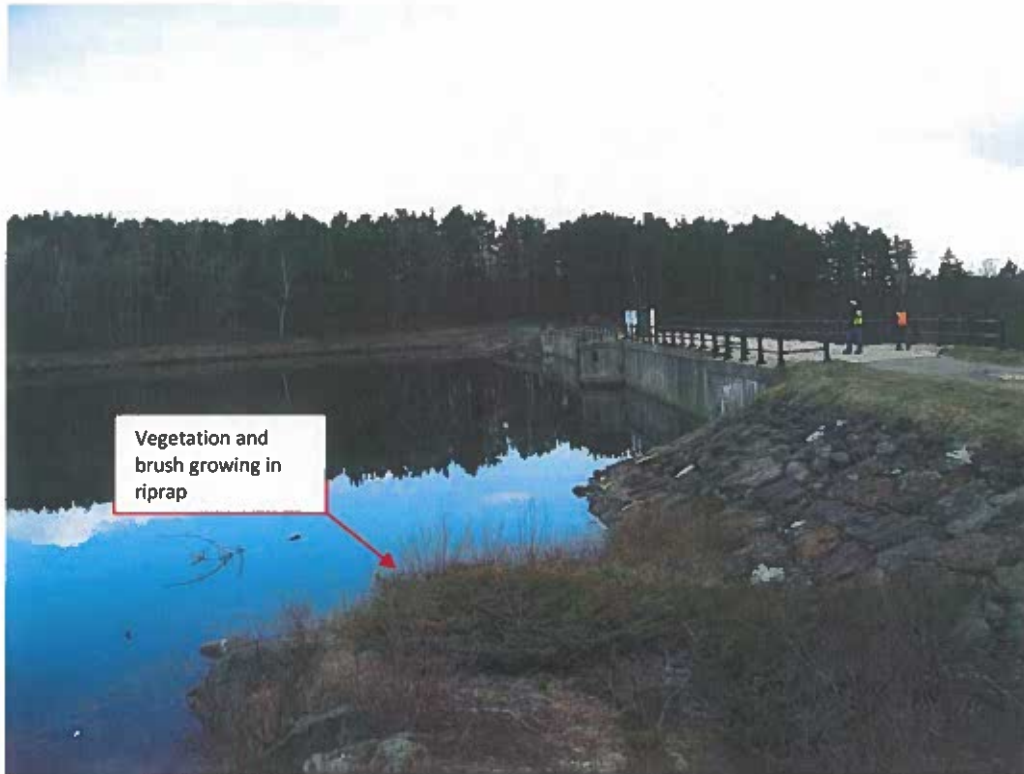
The riprap on the upstream slopes of the earth embankments is in good condition. Removal of some vegetation and brush is needed along the right embankment (Photos 1 and 4). The upstream portions of the concrete dam have some cracking and spalling of the shotcrete coating which has allowed some vegetation to root in its surface (Photo 20). Mineral deposits were noted below many of these cracks.

Photo No. 1: Overview of dam and upstream face from right abutment. Note vegetation and brush growing in upstream slope riprap.

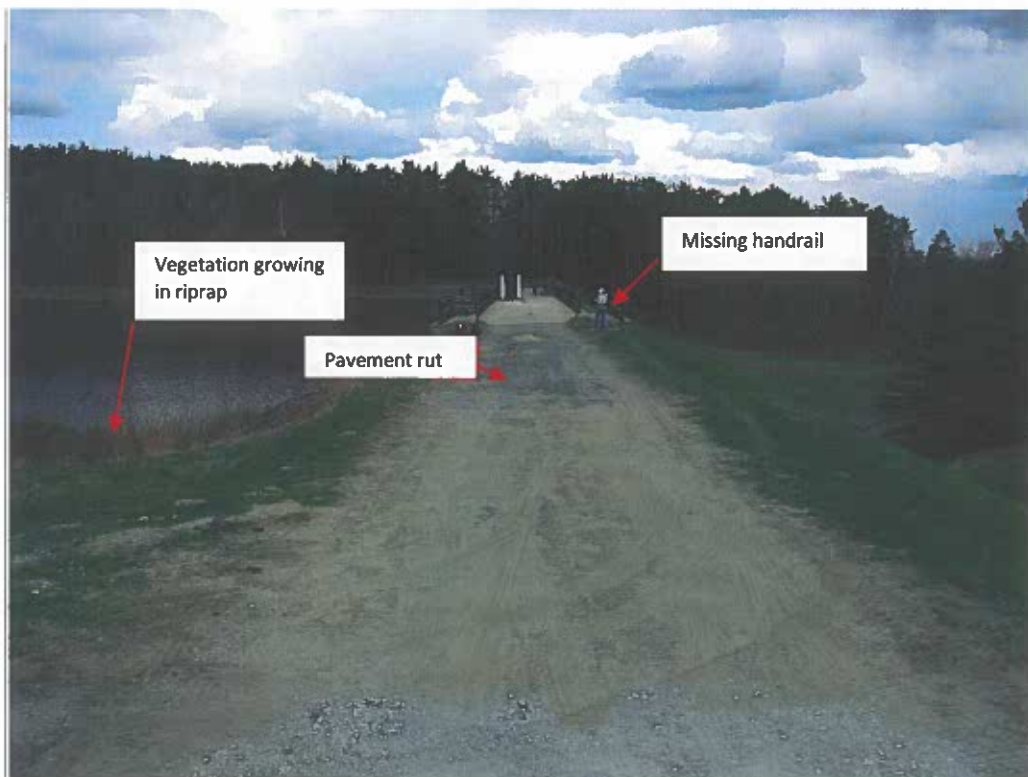
covered with an asphalt access road that has severe deterioration with ruts and cracks and is in need of repair (Photos 4 and 22).

Photo No. 4: Overview of crest from right abutment.

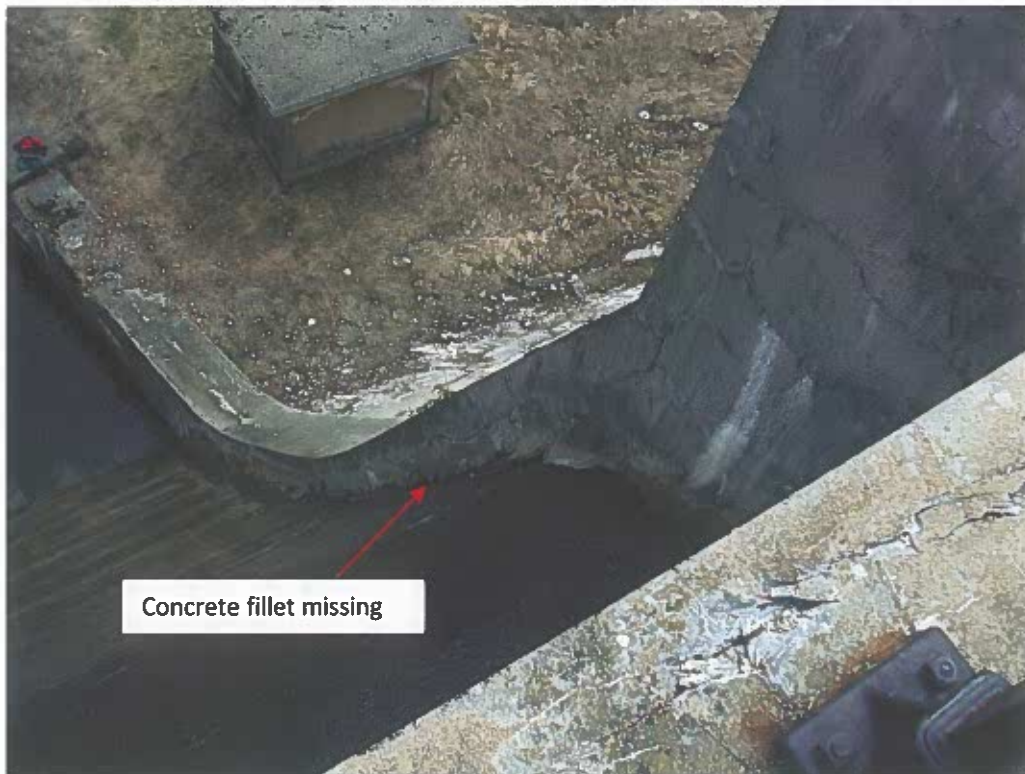
Concrete fillet missing

**Photo No. 8: Overview of right downstream spillway training wall.
Note part of concrete fillet is missing and cracks and efflorescence are present.**

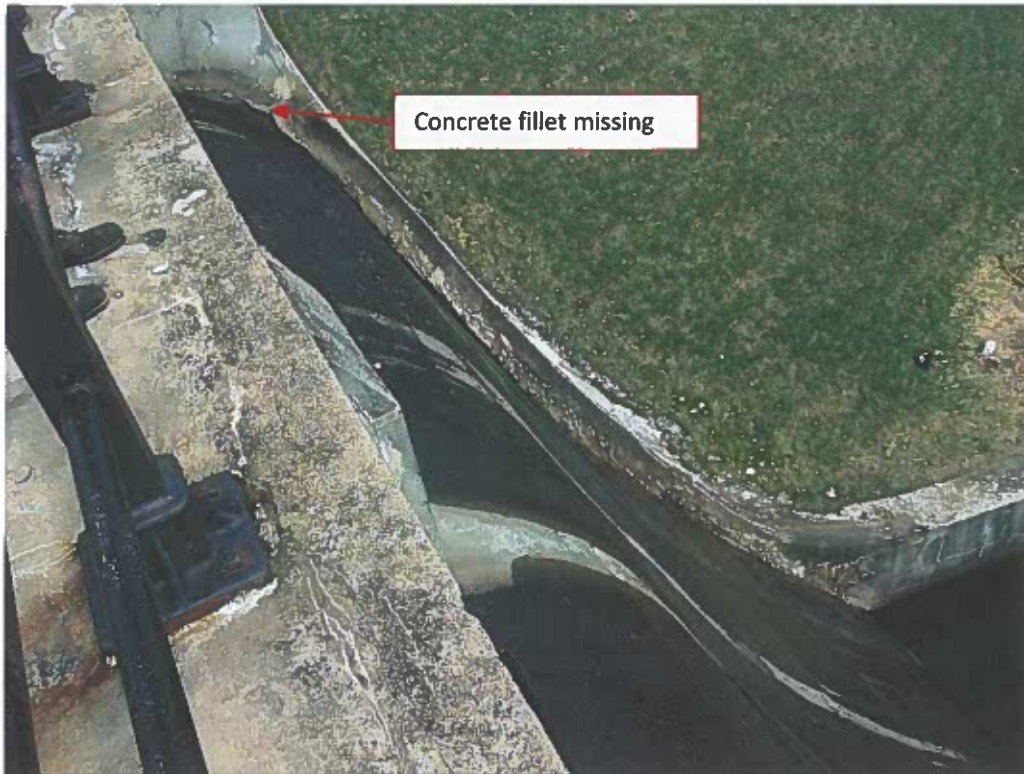
Photo No. 9: Overview of left downstream spillway training wall. Note part of concrete fillet is missing and cracking and efflorescence are present on the wall.

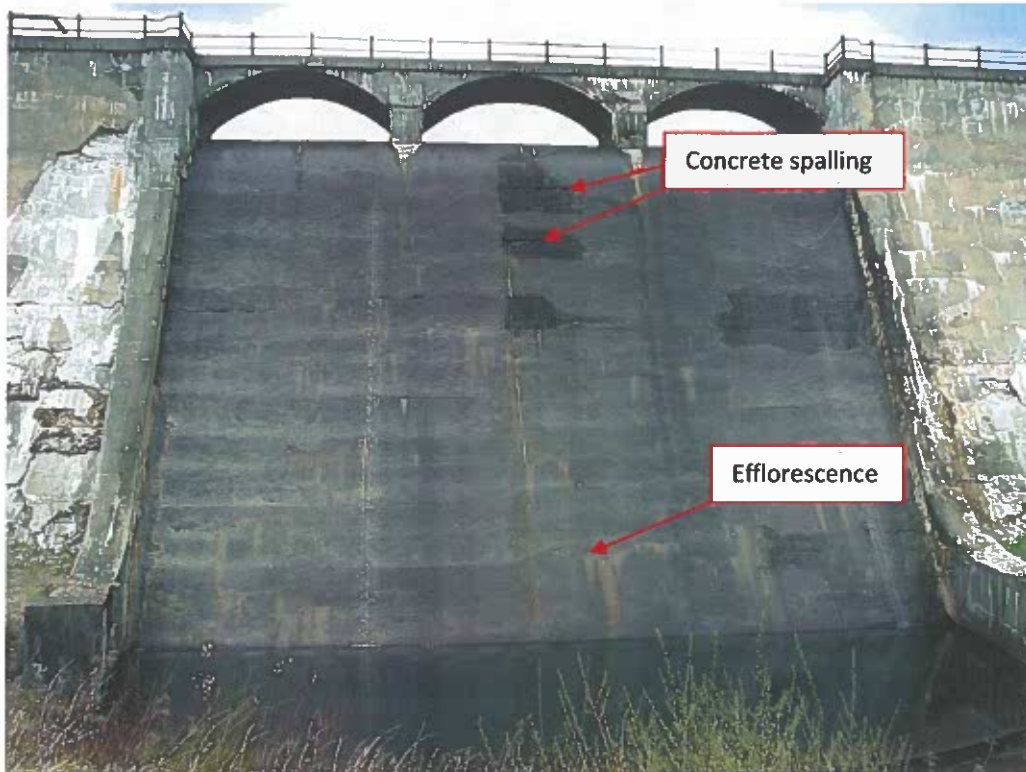
Photo No. 11: Overview of spillway weir from downstream. Note spalled sections of concrete and efflorescence on spillway weir.

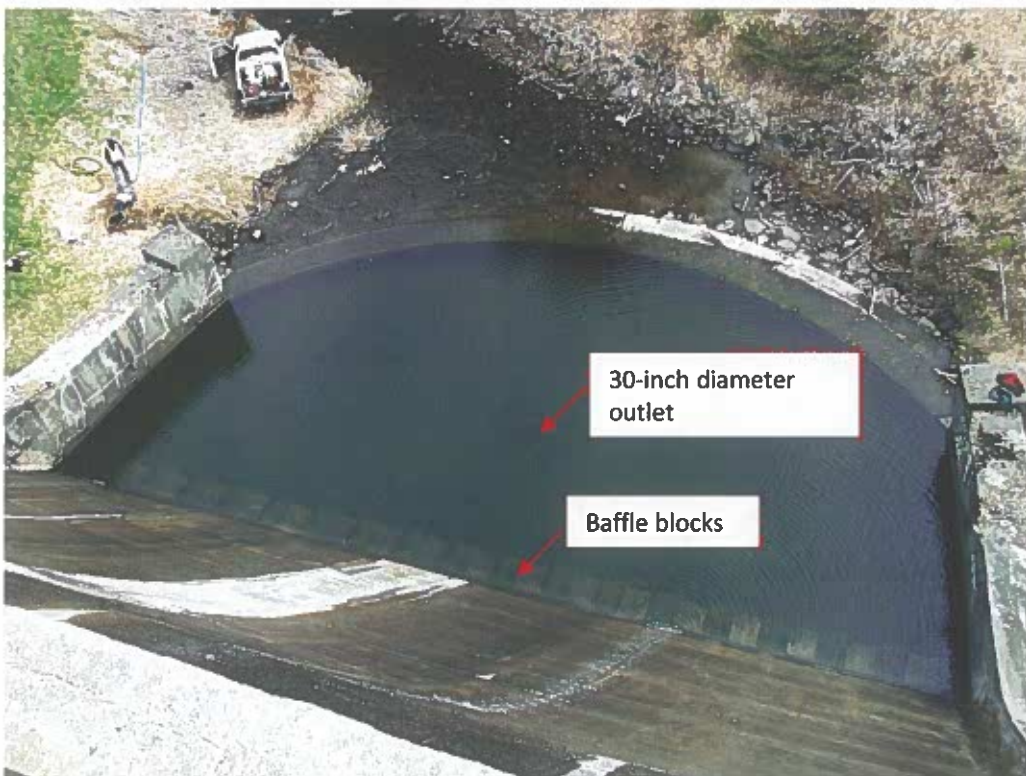
Photo No. 12: Overview of stilling basin looking downstream from the crest. Note variation in elevation of the top of the downstream basin overflow weir.

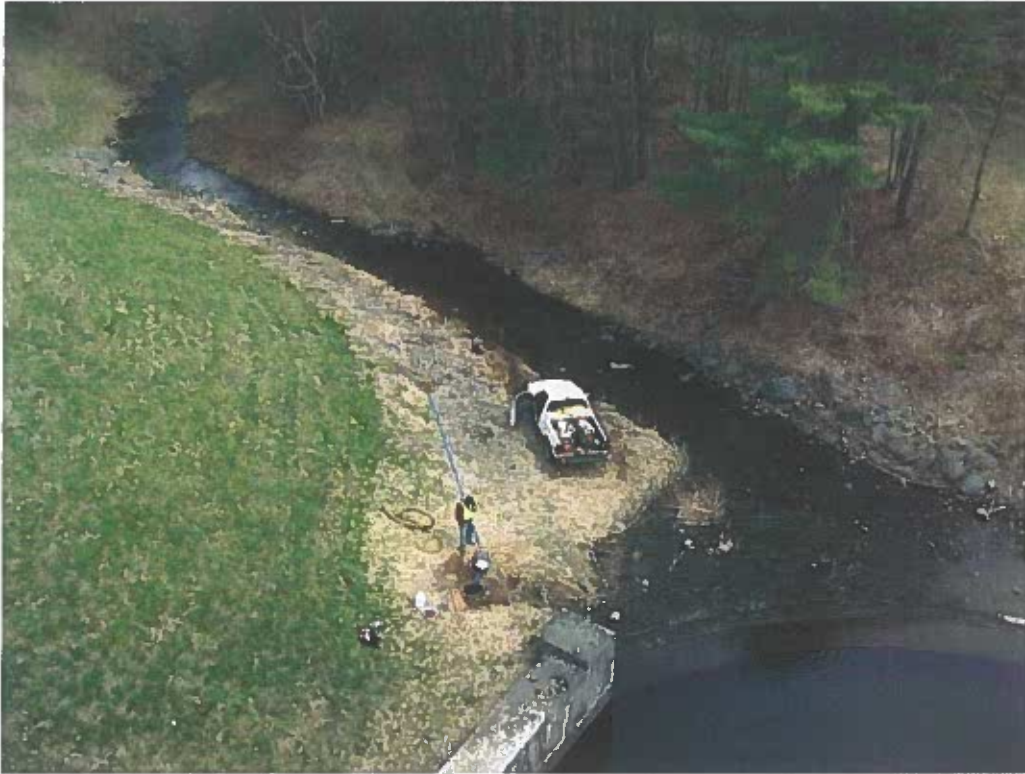
Photo No. 13: Overview of downstream channel from the crest. Note trees along channel.

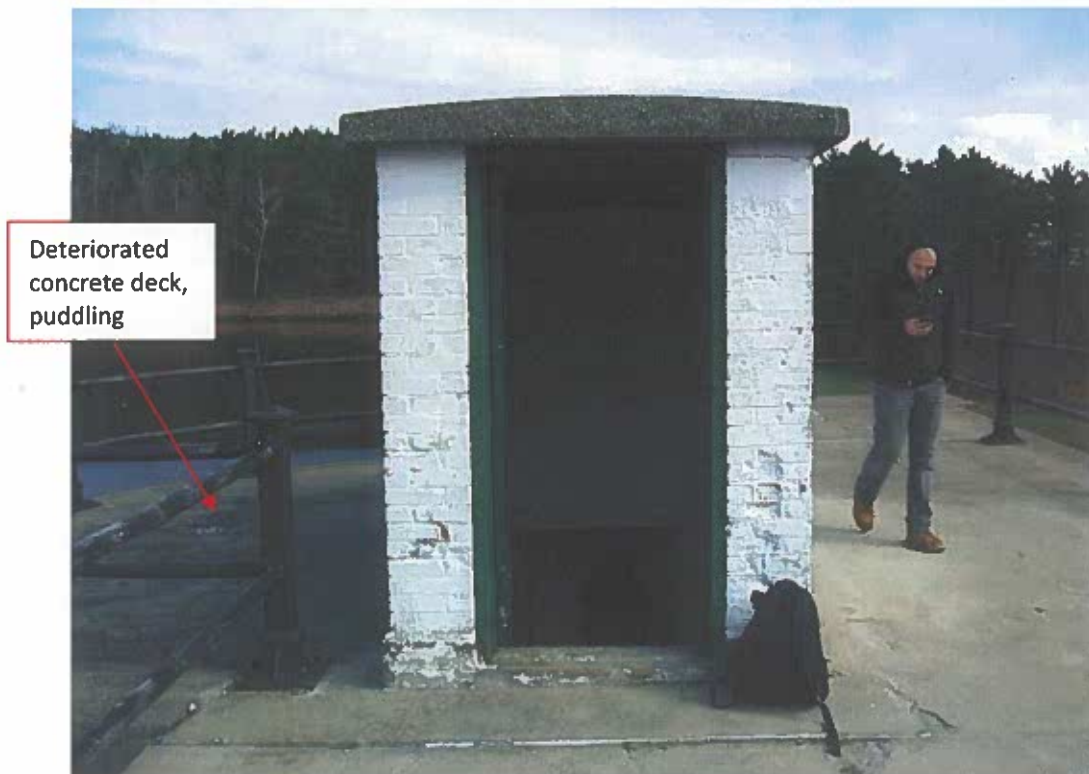
The concrete dam crest is generally in fair condition. Cracking and spalling is exhibited along the length of the concrete crest, and a small amount of vegetation is taking root (Photos 14, 21 and 23). Moss and vegetation are also growing in joints along the concrete dam crest. In addition, there are longitudinal cracks along the steel pipe railing on the concrete crest (Photo 60). The crest of the left earth embankment is covered with maintained grass about 4 to 8 inches tall. The crest of the right earth embankment is

Photo No. 14: Overview of upper gatehouse exterior. Note cracking, spalling, and puddling along concrete deck.

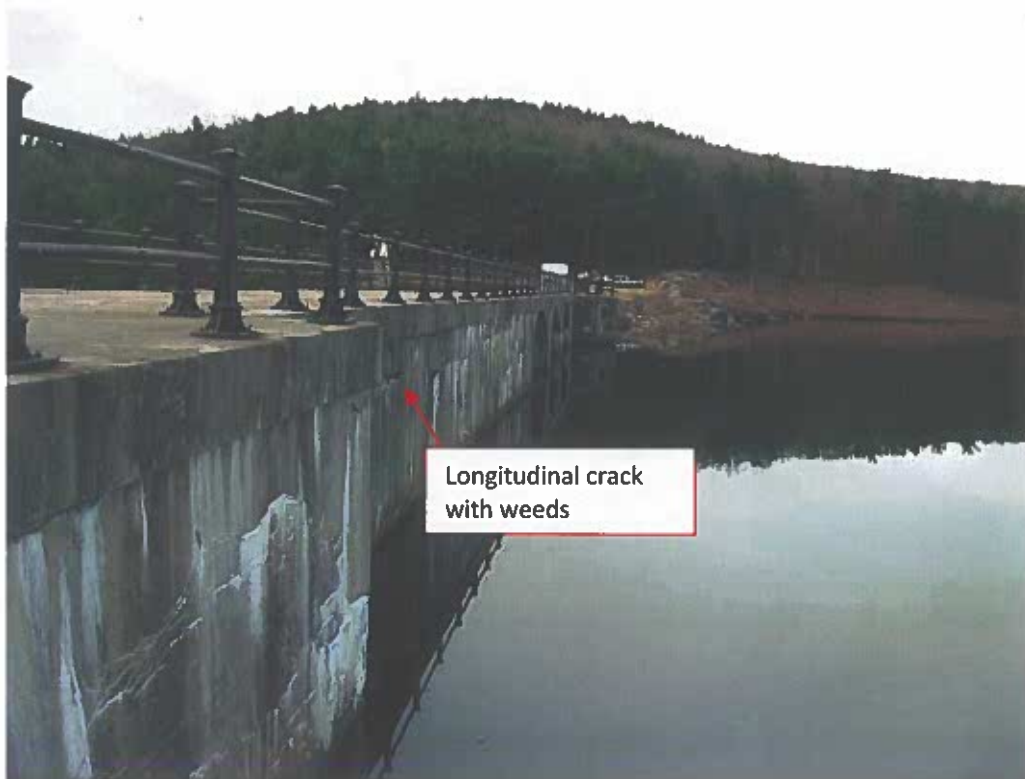
Photo No. 20: Cracks and efflorescence on upstream face of dam. Note that some weeds are growing in the cracks.

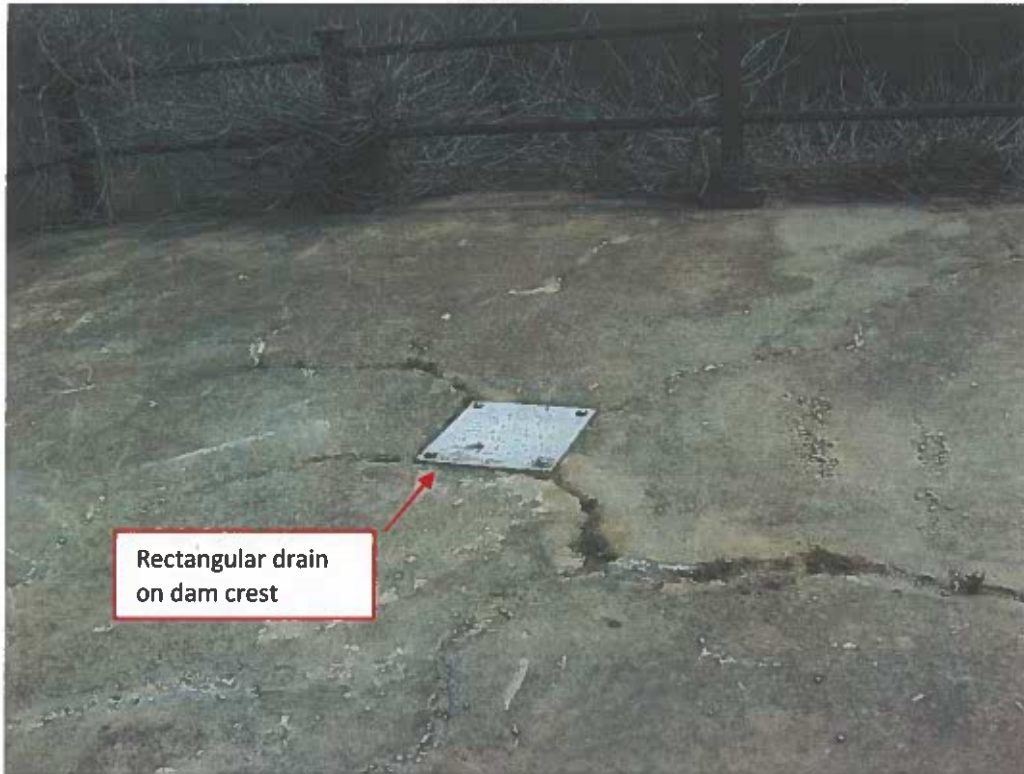
Photo No. 21: Cracks on crest near left embankment. Note minor weeds and moss growing in the cracks. Rectangular drain leads directly to left-most inspection gallery drainage well.

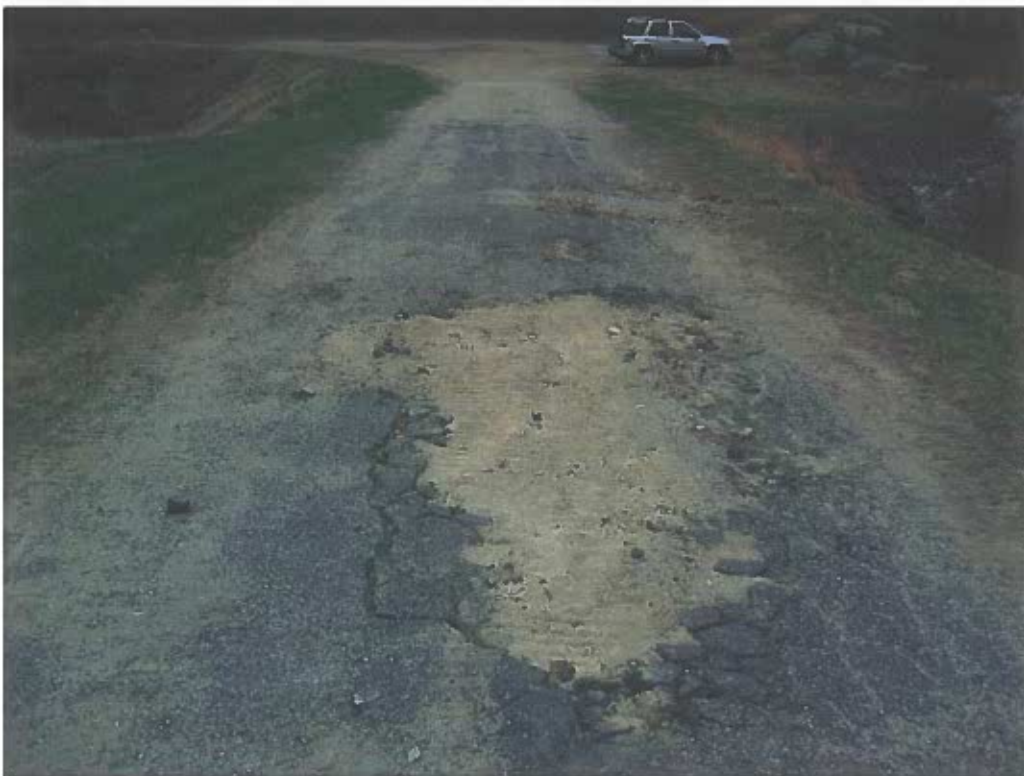
Photo No. 22: Pavement eroded, rutted, and cracked on right crest (looking towards right abutment).

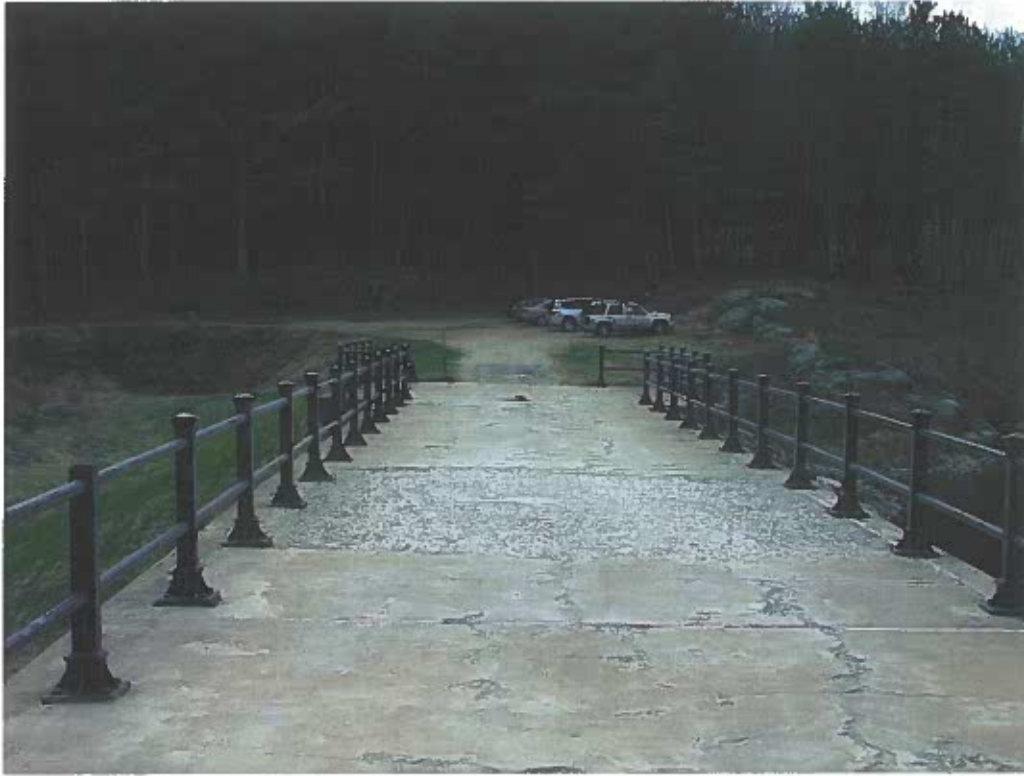
Photo No. 23: Concrete spalled and cracked on right crest (looking towards right abutment).

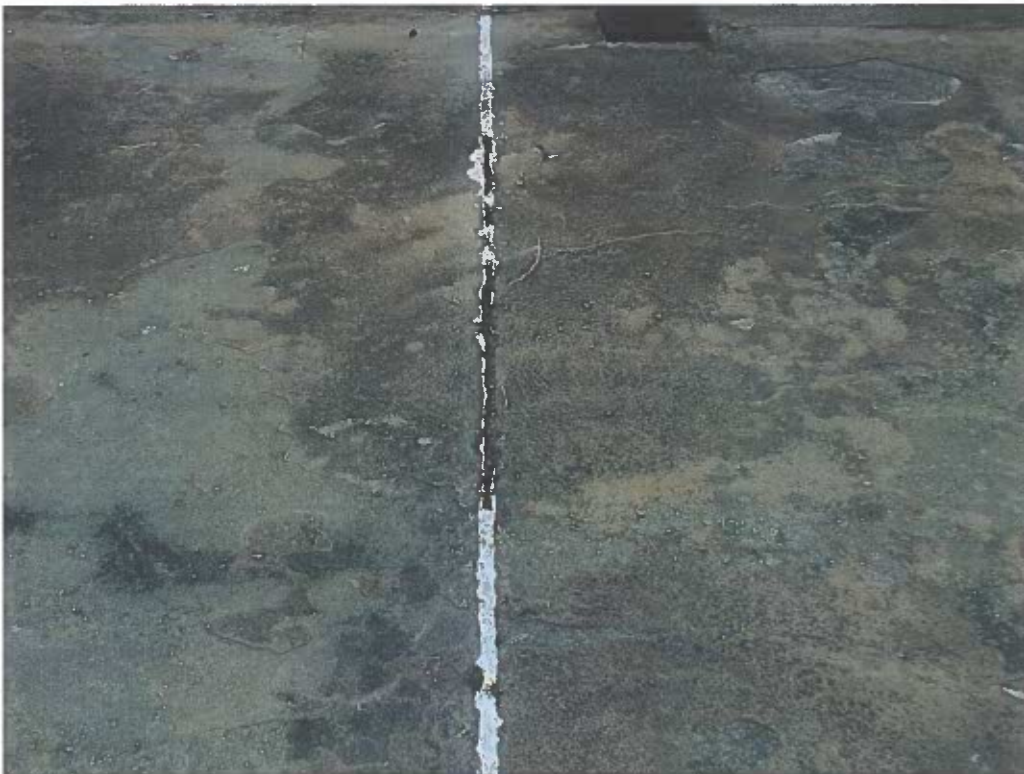
Photo No. 24: Moss and vegetation growing in expansion joints along dam crest.

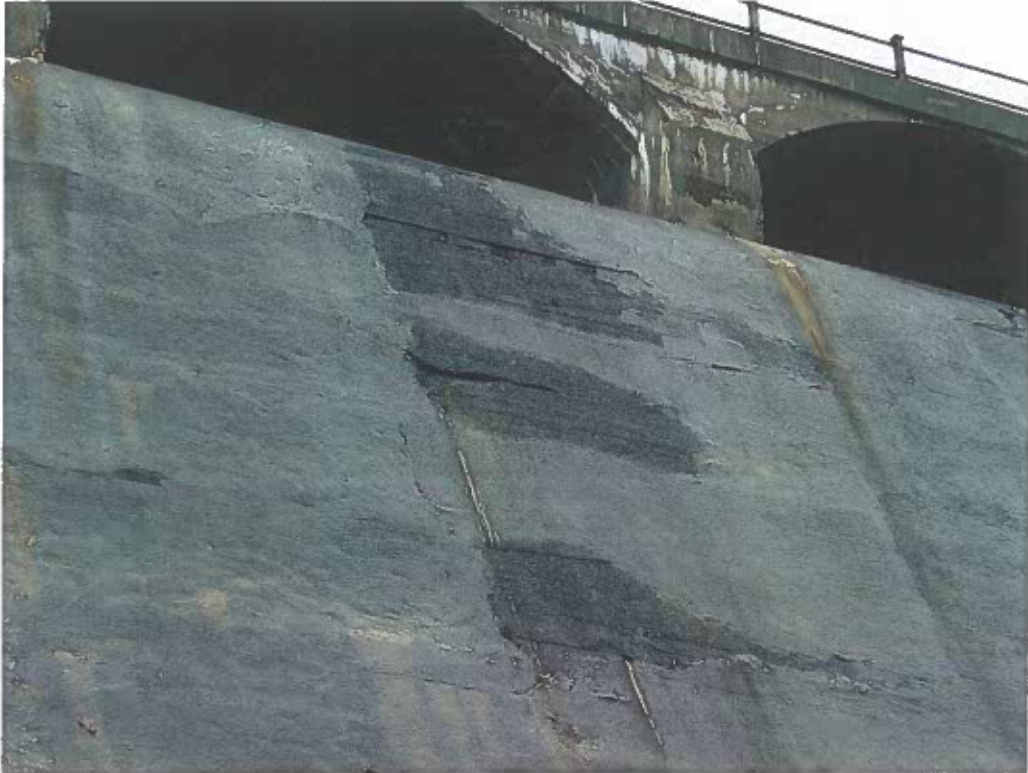
Photo No. 25: Cracks/spalling and efflorescence on the spillway surface (view from downstream).

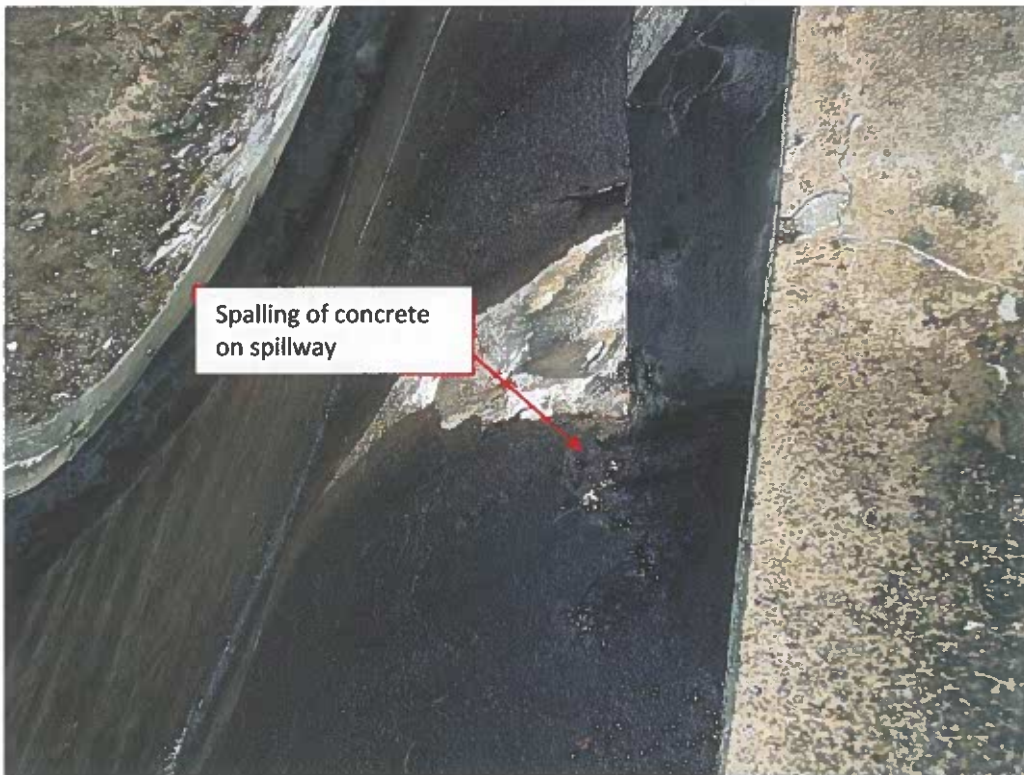
Photo No. 26: Spalling on the spillway surface (view from the crest).

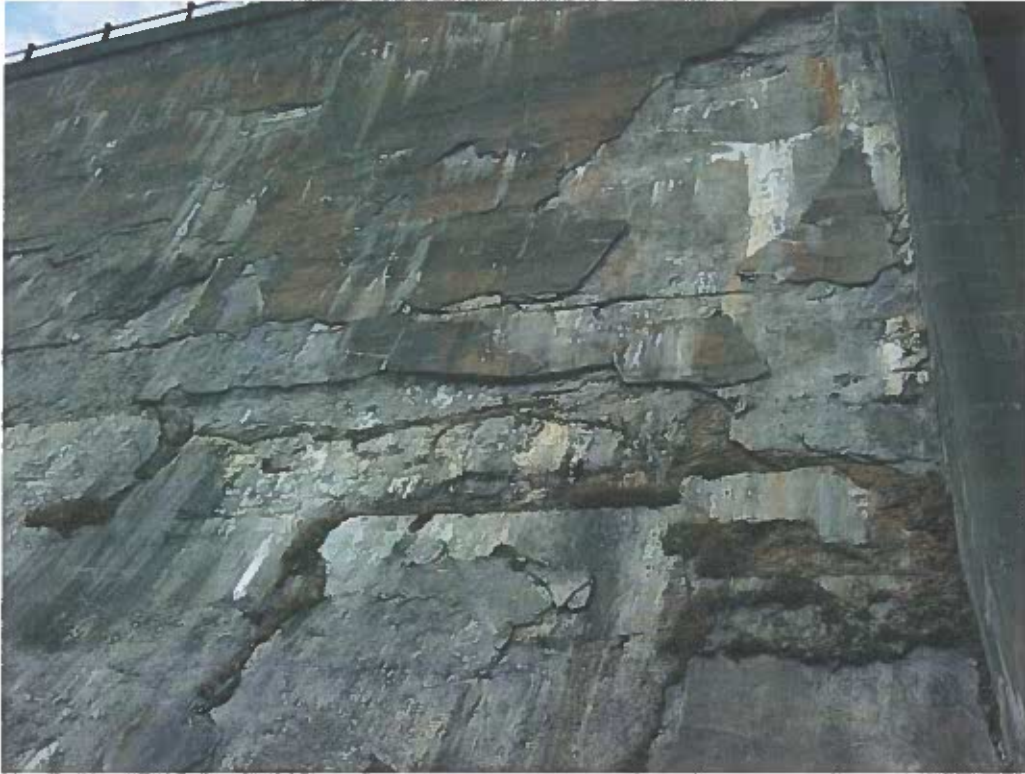
Photo No. 27: A large piece of shotcrete spalled next to the right training wall on the right downstream face. Note weeds growing in the cracks.

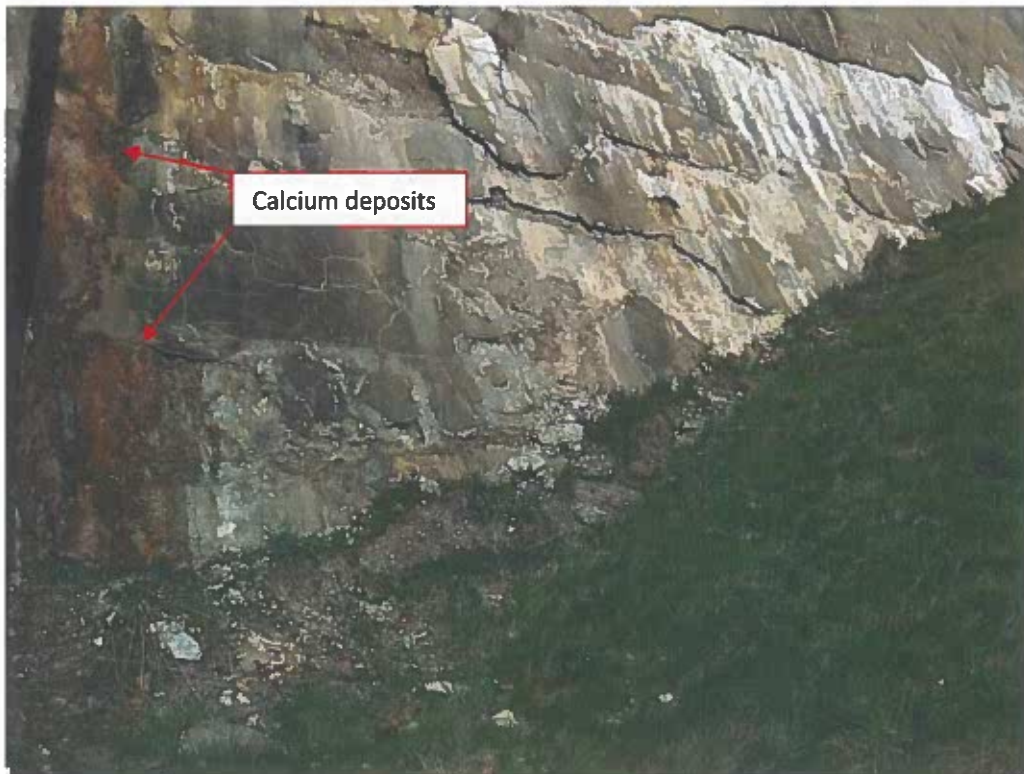
The grass-covered downstream slopes of the earth embankment are covered with maintained grass about 4 to 12 inches tall (Photos 6 and 7). Some tractor ruts and bare spots (Photo 59) were found (Item 5 on Figure 5) parallel to the slope on the left downstream face. An area approximately 20-feet-wide by 40-feet-long (Photo 58) at the base of the dam, right of the gate house, was observed to exhibit tire ruts or depressions in the soft, damp ground, and was previously observed to have a saturated soil area in the October 9, 2009 Phase I inspection report (Item 7 on Figure 5). Much of the shotcrete surface on the downstream face of the concrete dam is cracked, spalled and delaminated. Some vegetation has taken root in the cracks (Photos 27, 28, 29, 30, 34, 35, and 36). Mineral deposits were noted below many of the spalled areas. One area has exposed wire mesh reinforcement from the shotcrete application performed between 1981 and 1982 (Photo 30). Calcium deposits were noted along the left concrete downstream face along with wet areas (Photos 28, 29, and 31).

Photo No. 28: Spalling of shotcrete left of the spillway (downstream face). Note calcium deposits forming to the left of the left training wall.

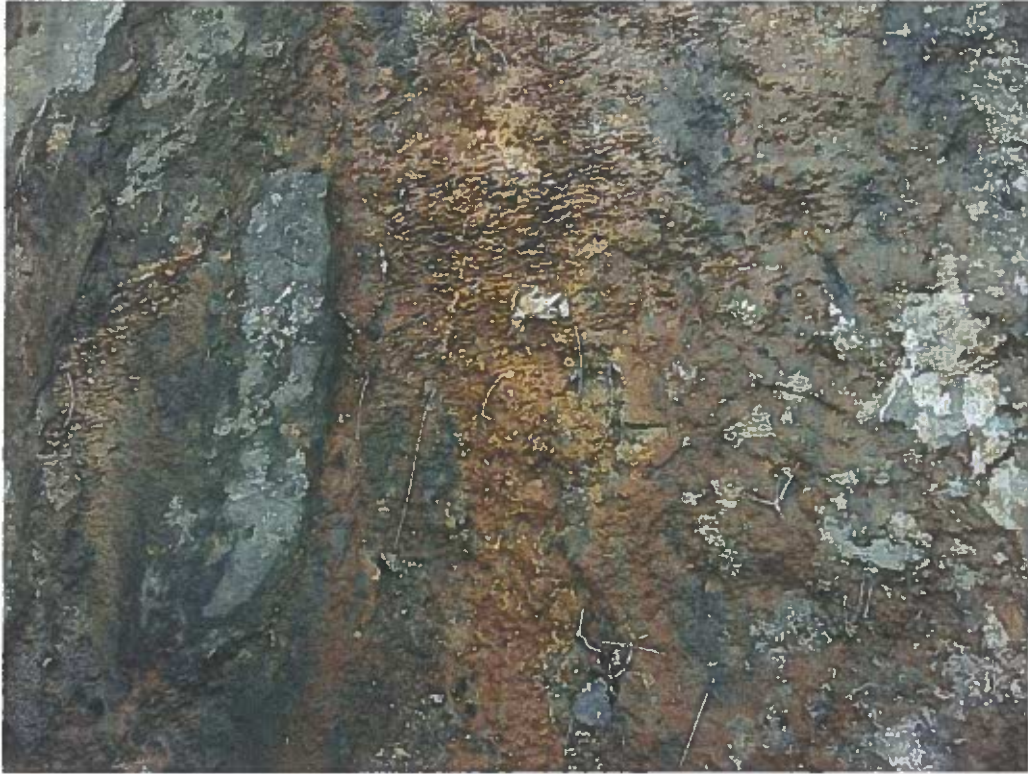
Photo No. 29: Calcium deposits forming to the left of the left training wall.

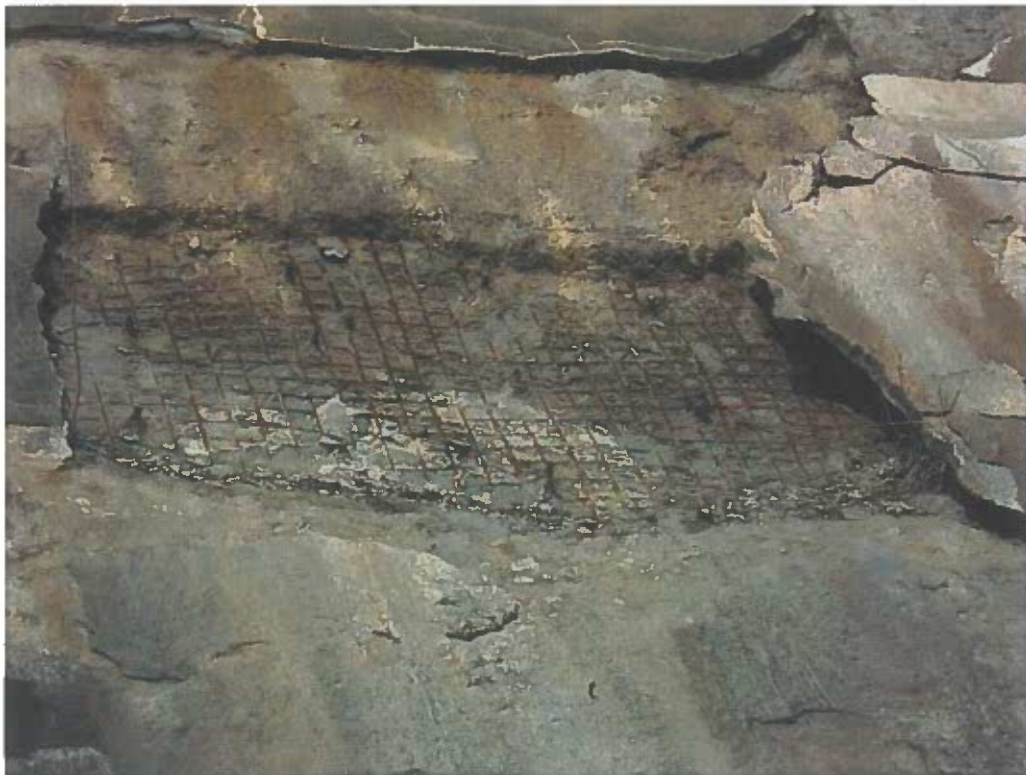
Photo No. 30: A large section of shotcrete spalled exposing wire mesh on the downstream face of dam next to left training wall.

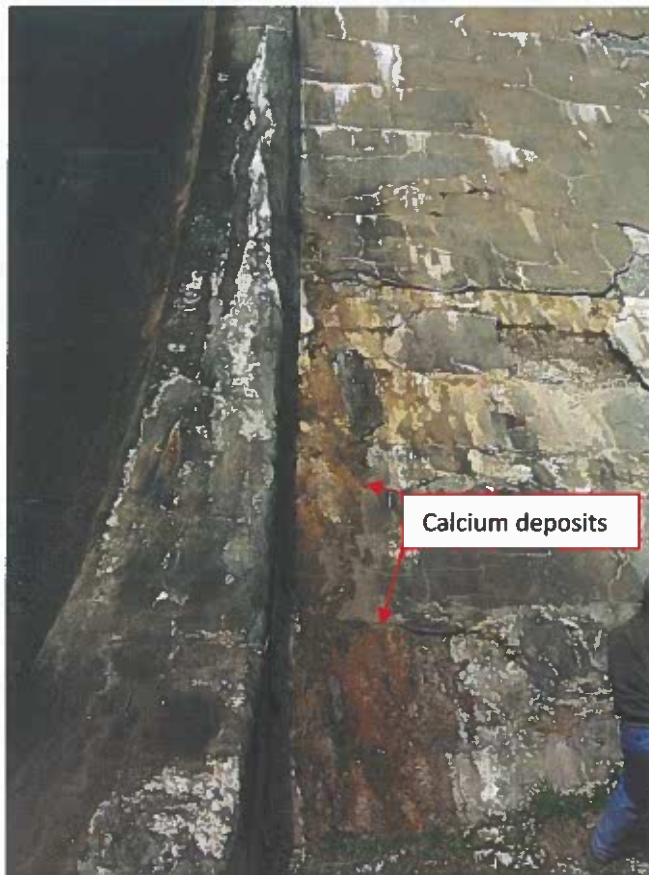
Photo No. 31: Efflorescence and spalling of concrete at toe of left training wall. Note calcium deposits on left downstream face.

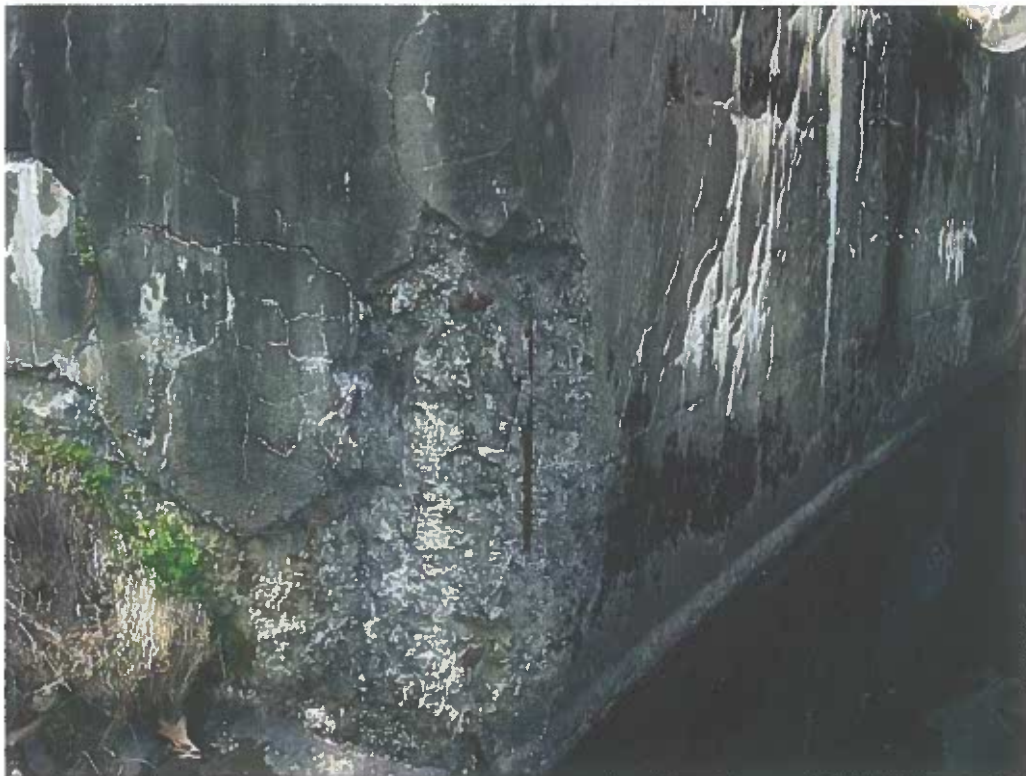
Photo No. 32: Concrete spalling and exposed rebar at the end of the right training wall.

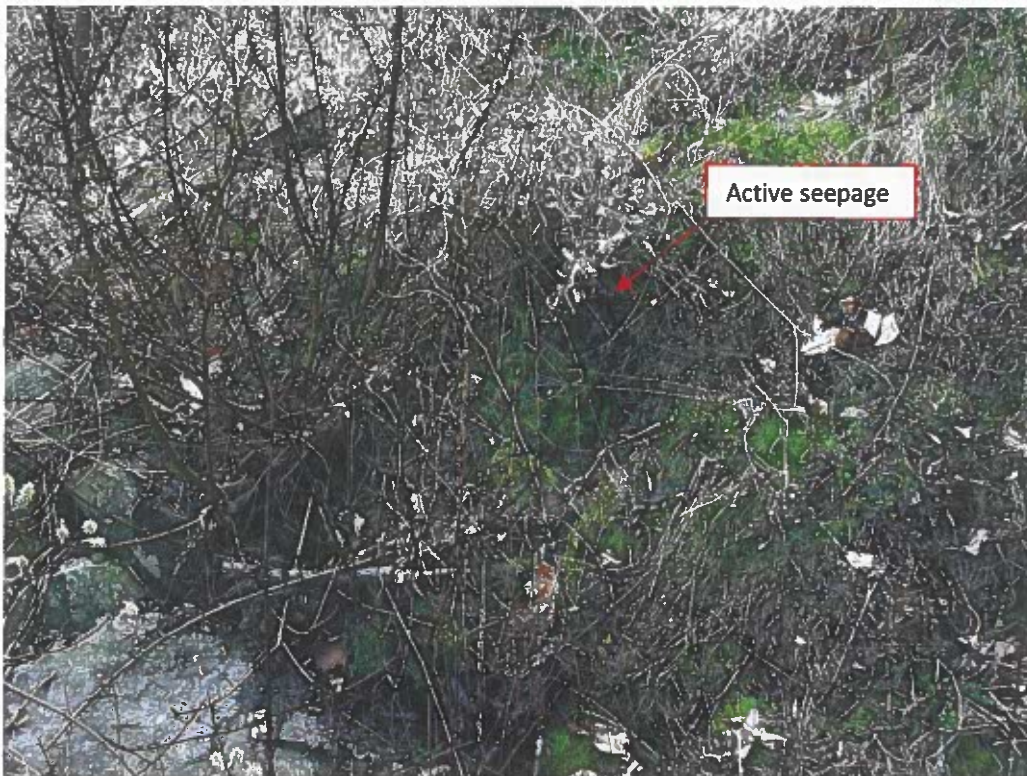
Photo No. 33: Seepage occurring in embankment directly downstream from right training wall.
