PINE HILL RESERVOIR DAM
PHASE I
INSPECTION / EVALUATION REPORT

Dam Name: Pine Hill Reservoir Dam
State Dam ID#: 3-14-134-6
NID ID#: MA 00623
Owner: City of Worcester
Owner Type: Municipal
Town: Holden, Massachusetts
Consultant: CDM Smith Inc.
Date of Inspection: April 11, 2012

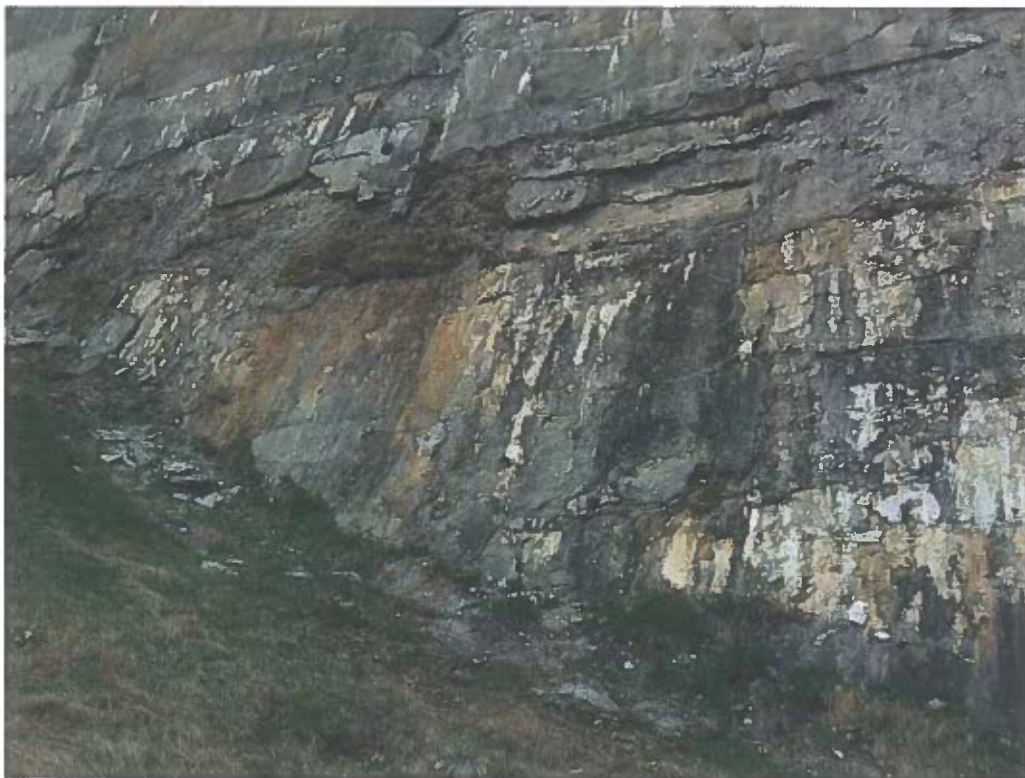
Photo No. 34: Efflorescence, cracking, spalling and weeds growing in the cracks on the downstream face of the dam to right of spillway.

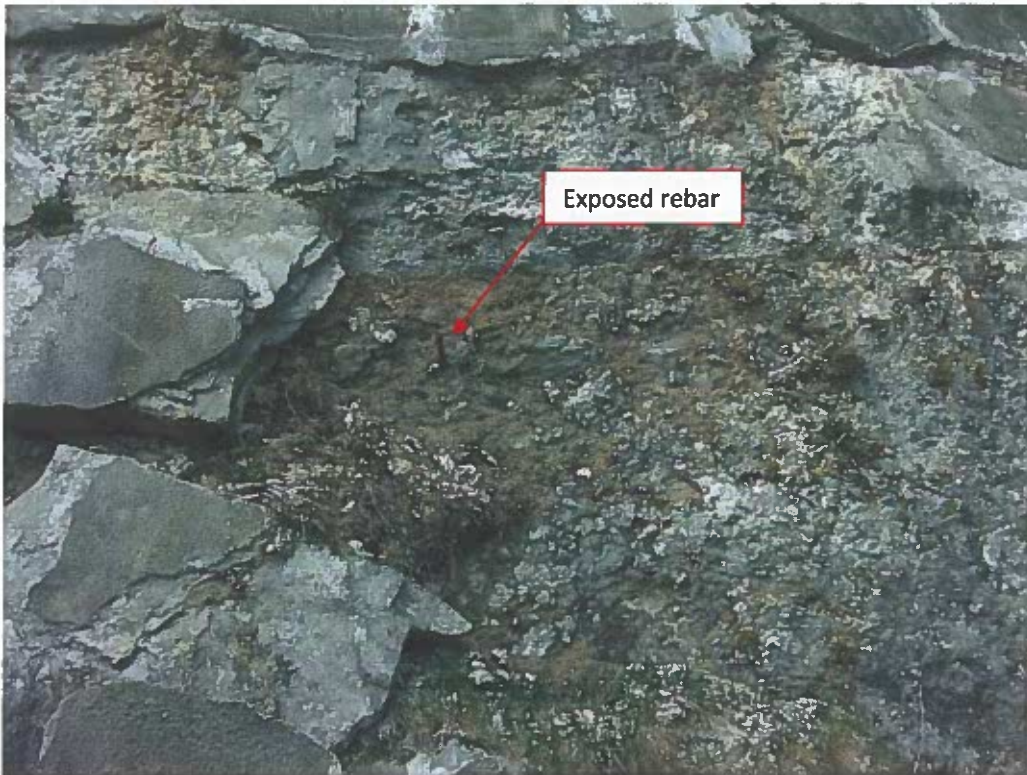
Photo No. 35: Exposed rebar intended to provide anchorage for shotcrete on the downstream face of the dam to right of spillway.

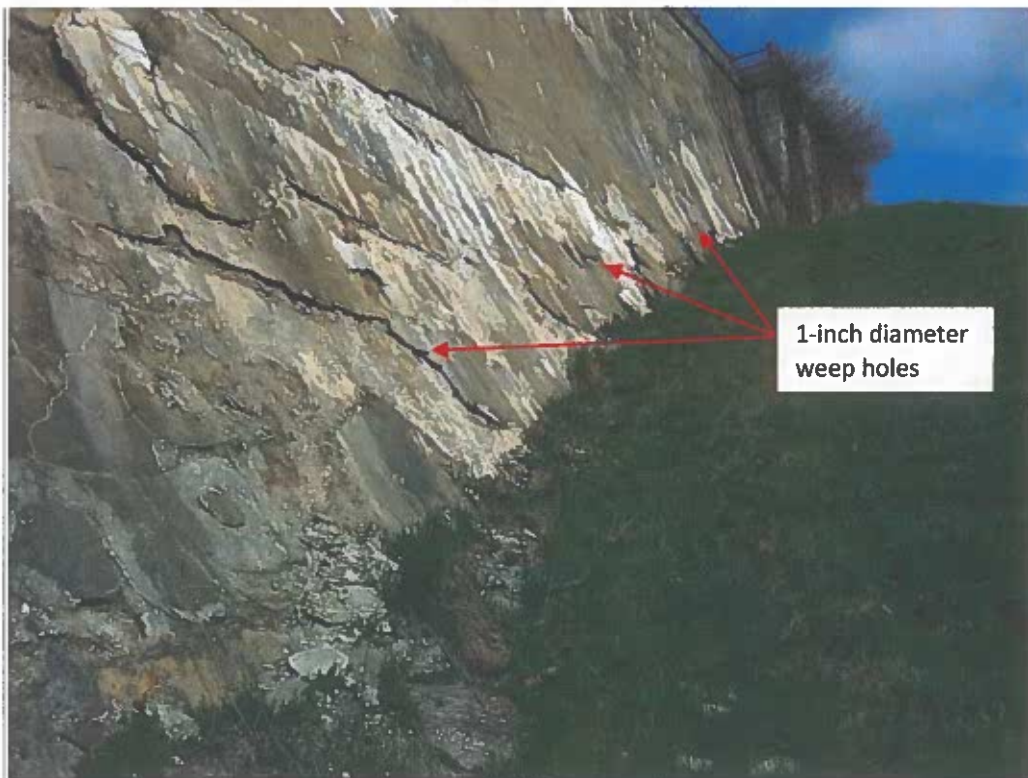
Several 1-inch diameter PVC pipes were observed on the downstream face of the concrete dam (Photo 36). These pipes were installed in the dam during the installation of shotcrete. A 9.5-inch deep weephole was observed on the downstream face of right dam section.

Photo No. 36: PVC weep holes on the downstream face of the dam to left of spillway. Weep holes were installed when dam face was sandblasted and shotcrete-covered in 1981 to 1982.

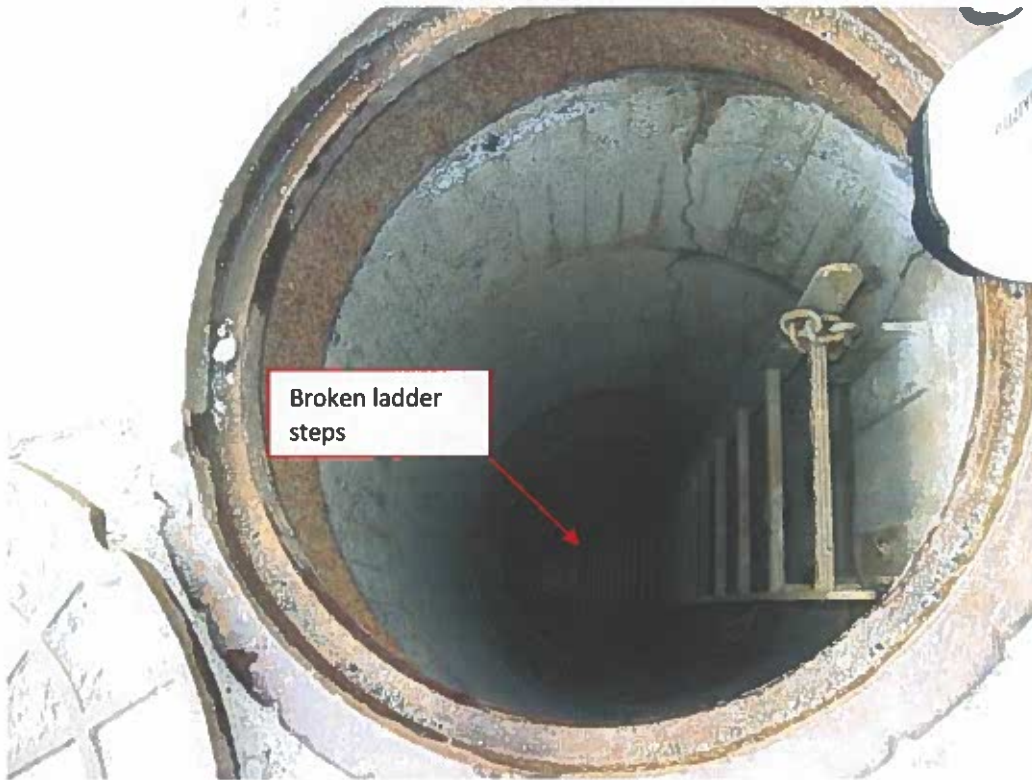
Photo No. 37: Entrance to the inspection gallery on dam crest. Note the broken ladder steps.

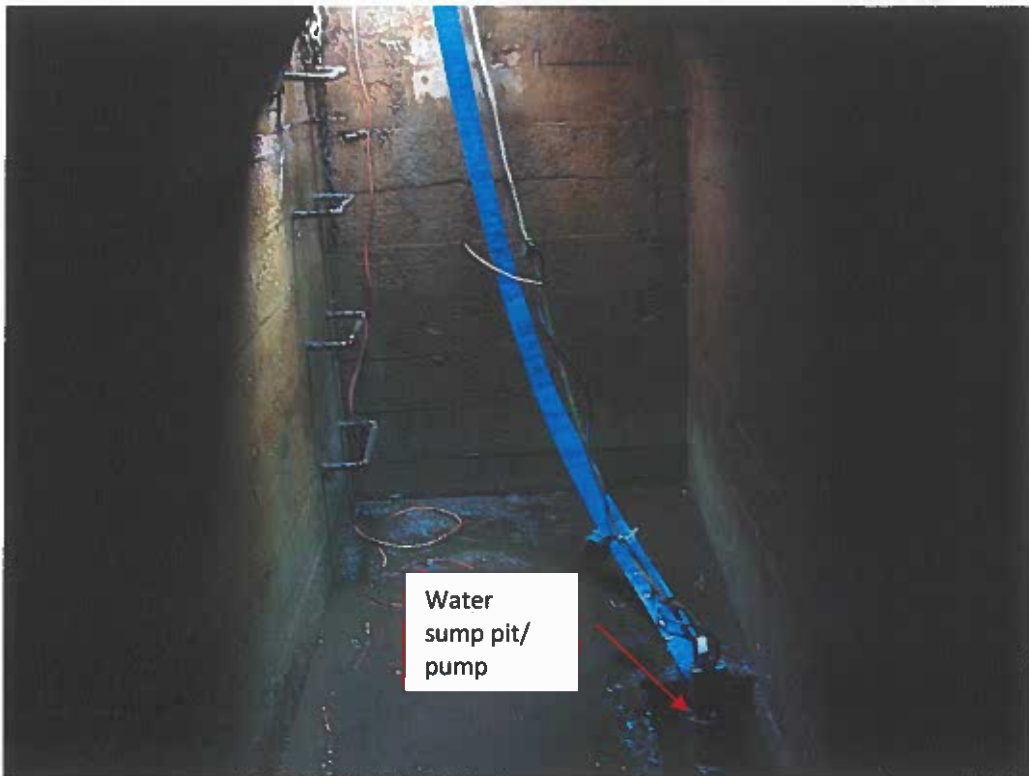
The seepage infiltration gallery (Photos 39, 40, 41, 42, 43, 44, 45, 46, 47, 48, 49, 50, 51, 52 and 53) was pumped out prior to the April 11, 2012 inspection. It has been reported that the 8-inch diameter cast iron outlet drain has been blocked since the 1960's, causing the seepage water to flow out of the top of the infiltration gallery access manhole downstream of the dam (Photo 54).

Photo No. 39: Overview of inspection gallery interior at downstream end of perpendicular "T" (looking downstream toward lower manhole entrance). Note water needs to be pumped from the gallery prior to entrance.

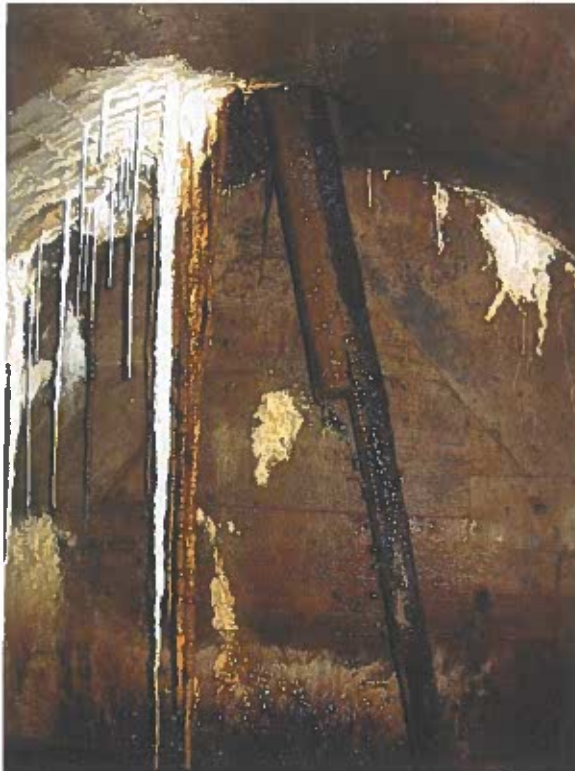
Photo No. 53: Two 2"x4" wood lumber pieces apparently inserted inside left-most drainage well at left end of gallery.

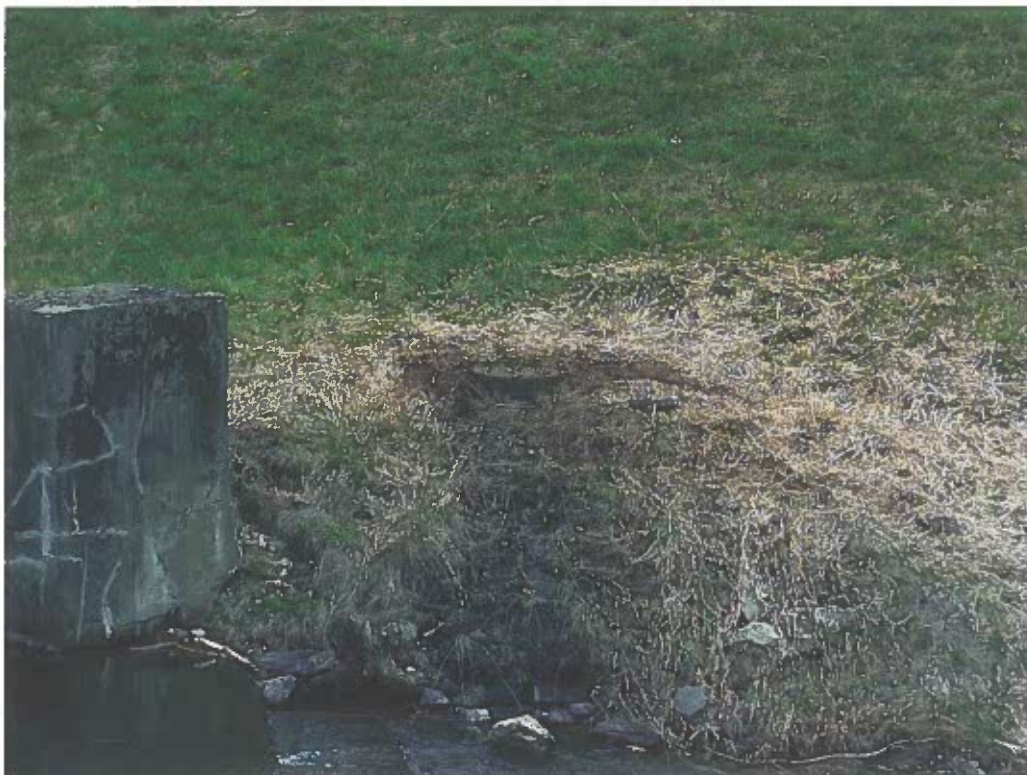
Photo No. 54: Downstream manhole access to drainage gallery. Note that water draining from the top of the drainage gallery manhole is causing erosion of the downstream bank.

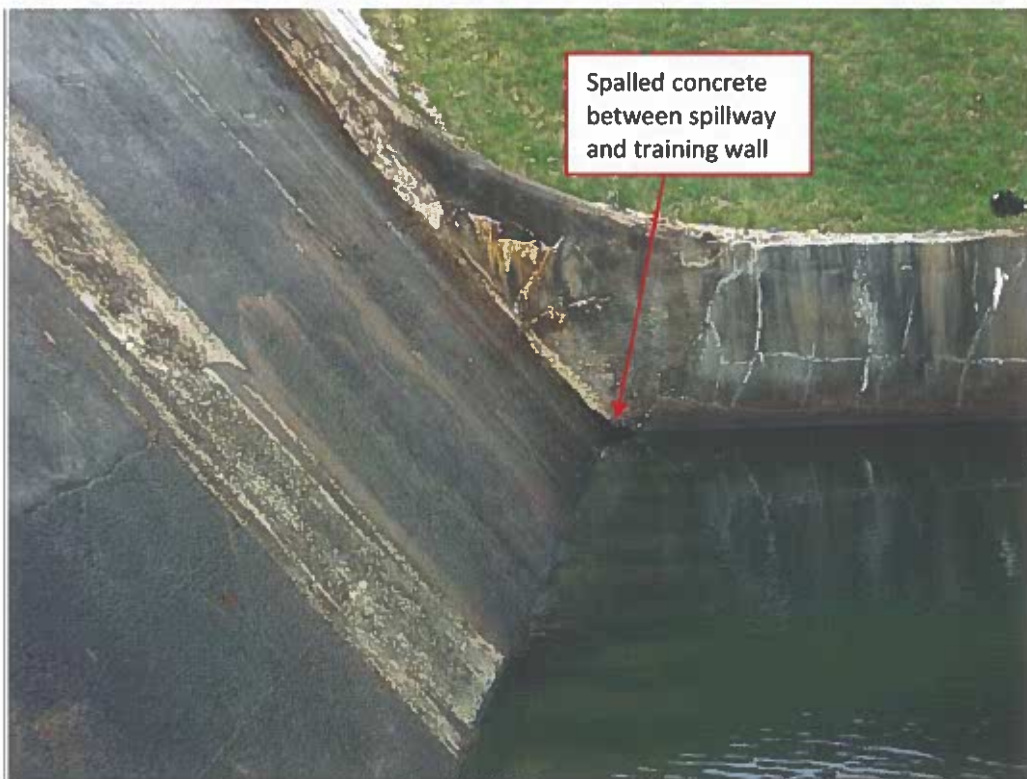
Photo No. 56: Concrete spalled between spillway and training wall at stilling basin. Cracking, spalling, and efflorescence on left training wall.

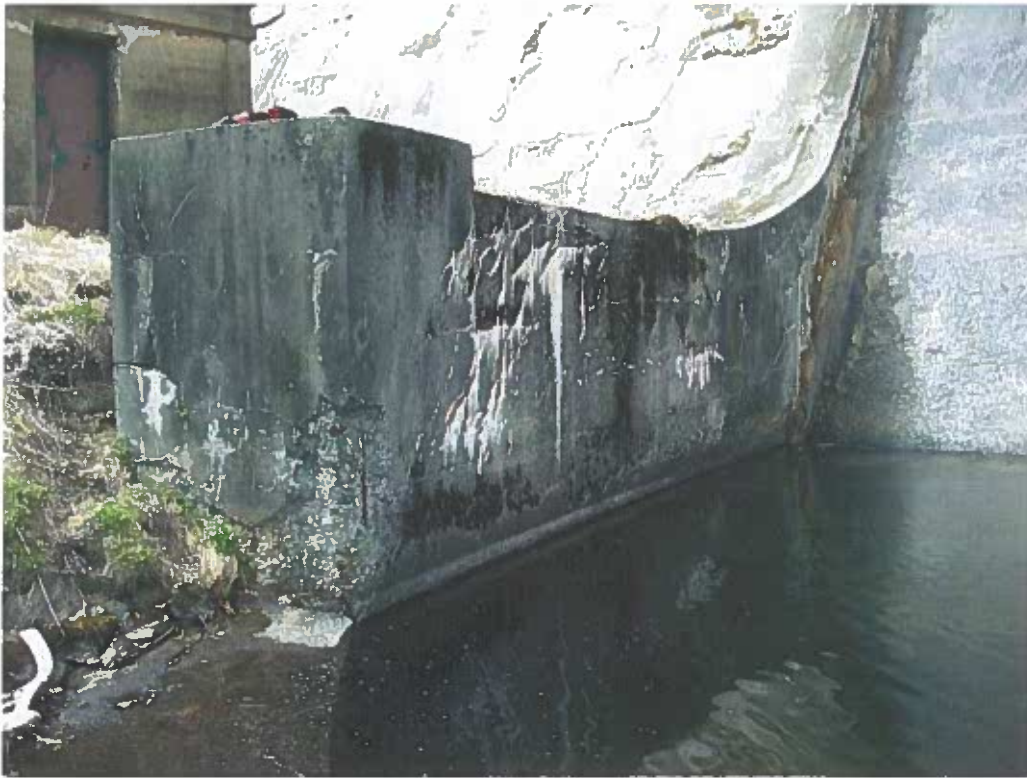
Photo No. 57: Cracking, spalling, and efflorescence on right training wall at stilling basin.

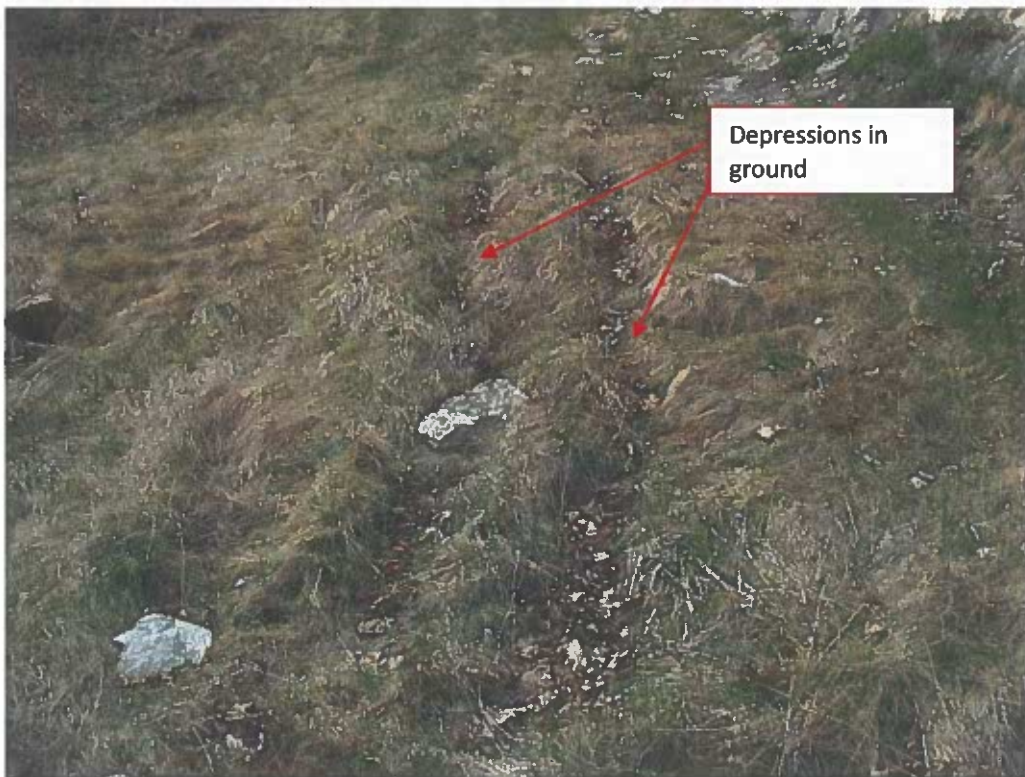
Photo No. 58: Tire ruts on soft, damp ground on right slope between dam face and outlet gatehouse.

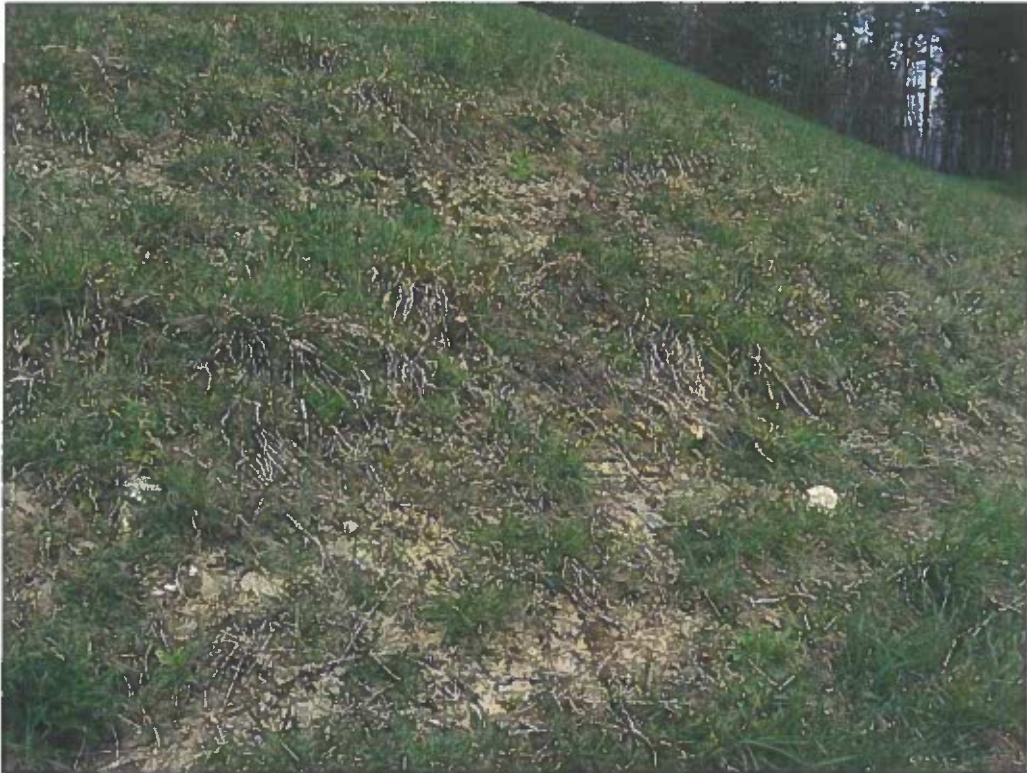
The grass-covered downstream slopes of the earth embankment are covered with maintained grass about 4 to 12 inches tall (Photos 6 and 7). Some tractor ruts and bare spots (Photo 59) were found (Item 5 on Figure 5) parallel to the slope on the left downstream face. An area approximately 20-feet-wide by 40-feet-long (Photo 58) at the base of the dam, right of the gate house, was observed to exhibit tire ruts or depressions in the soft, damp ground, and was previously observed to have a saturated soil area in the October 9, 2009 Phase I inspection report (Item 7 on Figure 5). Much of the shotcrete surface on the downstream face of the concrete dam is cracked, spalled and delaminated. Some vegetation has taken root in the cracks (Photos 27, 28, 29, 30, 34, 35, and 36). Mineral deposits were noted below many of the spalled areas. One area has exposed wire mesh reinforcement from the shotcrete application performed between 1981 and 1982 (Photo 30). Calcium deposits were noted along the left concrete downstream face along with wet areas (Photos 28, 29, and 31).

Photo No. 59: Tractor ruts and bare spots on left embankment downstream slope from mowing.

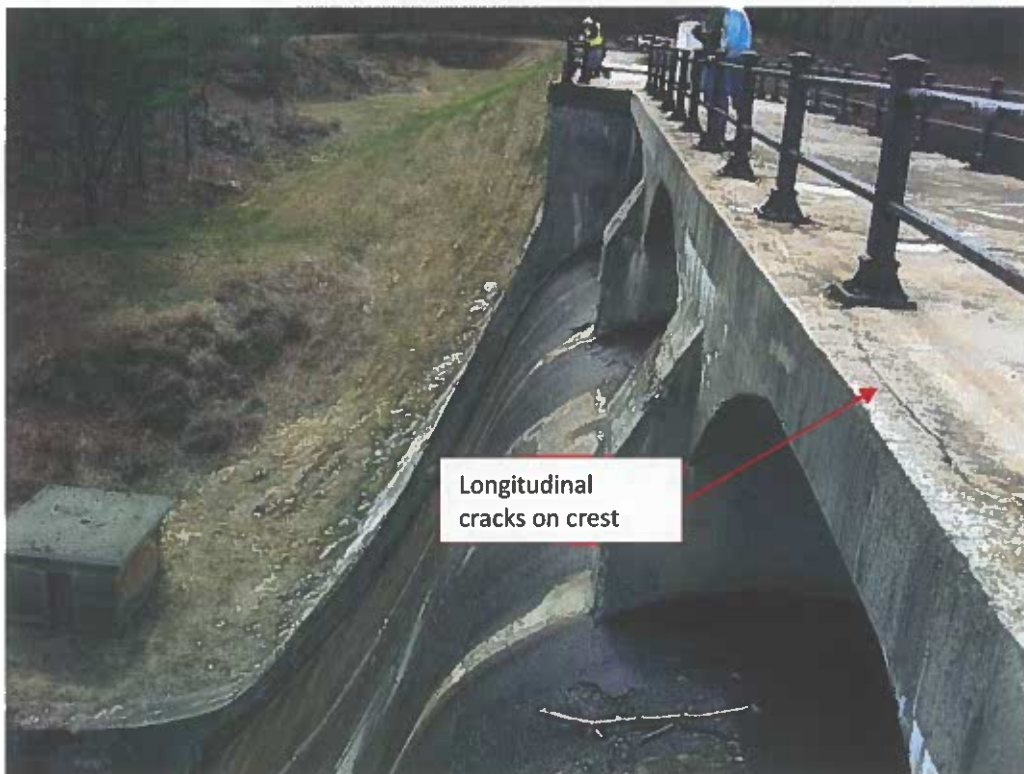
Photo No. 60: Longitudinal cracks along railing. Spalling, cracking, and efflorescence on concrete arch bridge over spillway. Weeds growing in cracks.

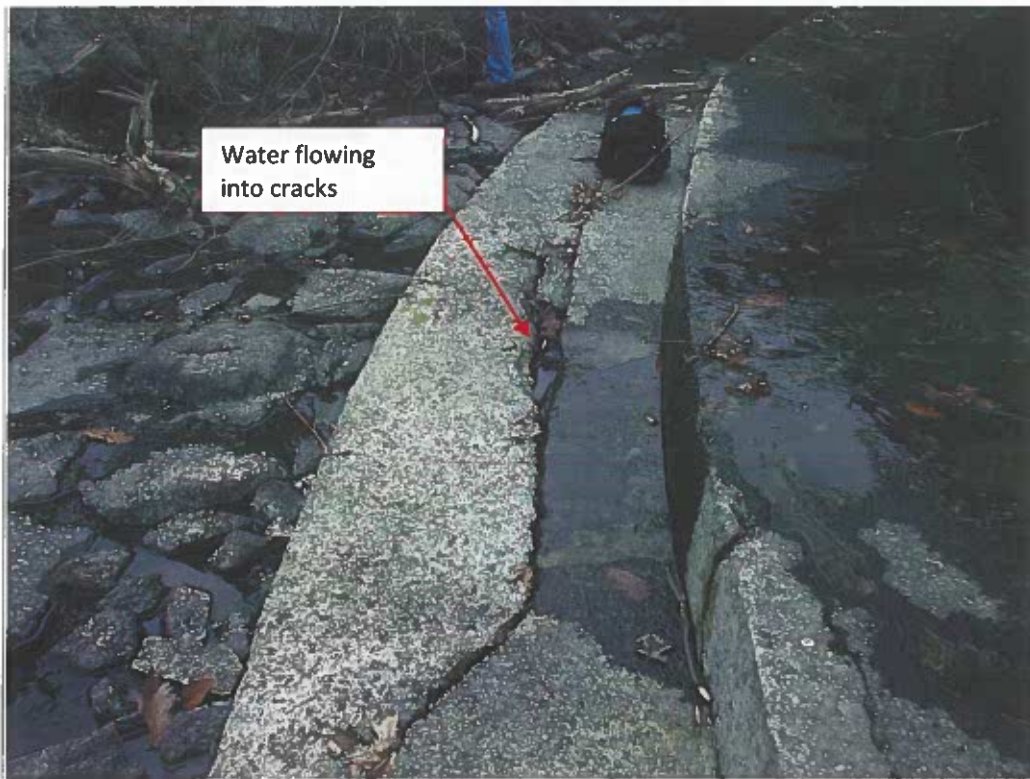
Photo No. 61: Longitudinal cracks along stilling basin weir stone steps. Note water is flowing into cracks.

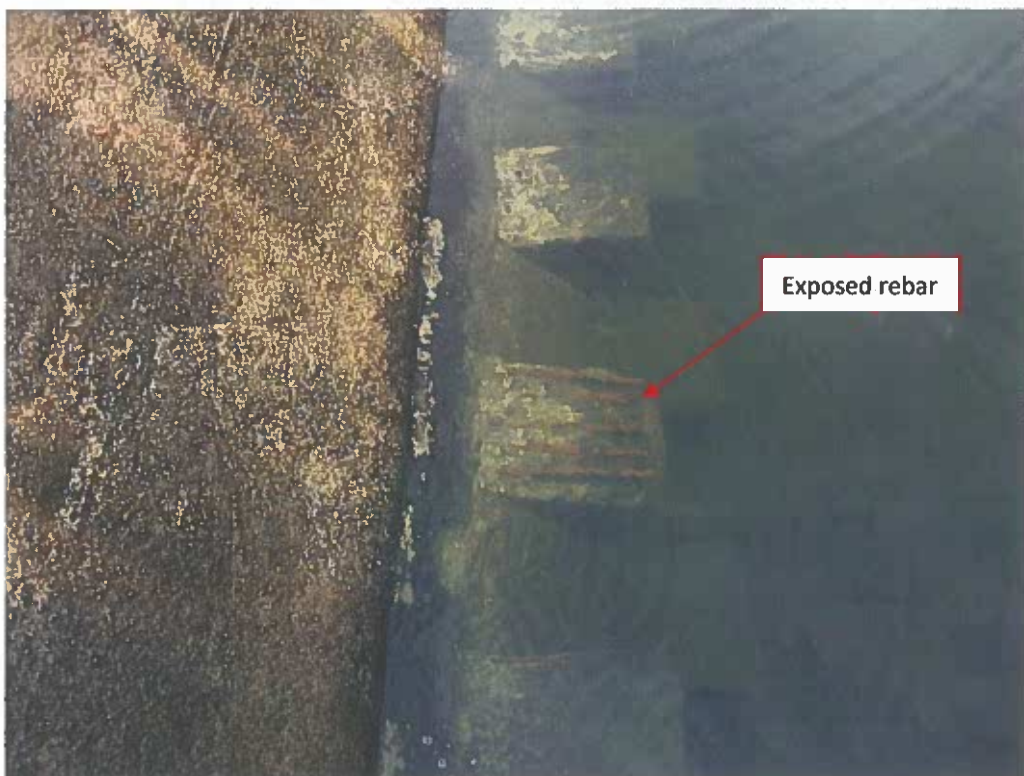
Photo No. 62: Exposed rebar on baffle blocks in stilling basin.
