PINE HILL RESERVOIR DAM
PHASE I
INSPECTION / EVALUATION REPORT

Dam Name: Pine Hill Reservoir Dam
State Dam ID#: 3-14-134-6
NID ID#: MA 00623
Owner: City of Worcester
Owner Type: Municipal
Town: Holden, Massachusetts
Consultant: CDM
Date of Inspection: October 9, 2009

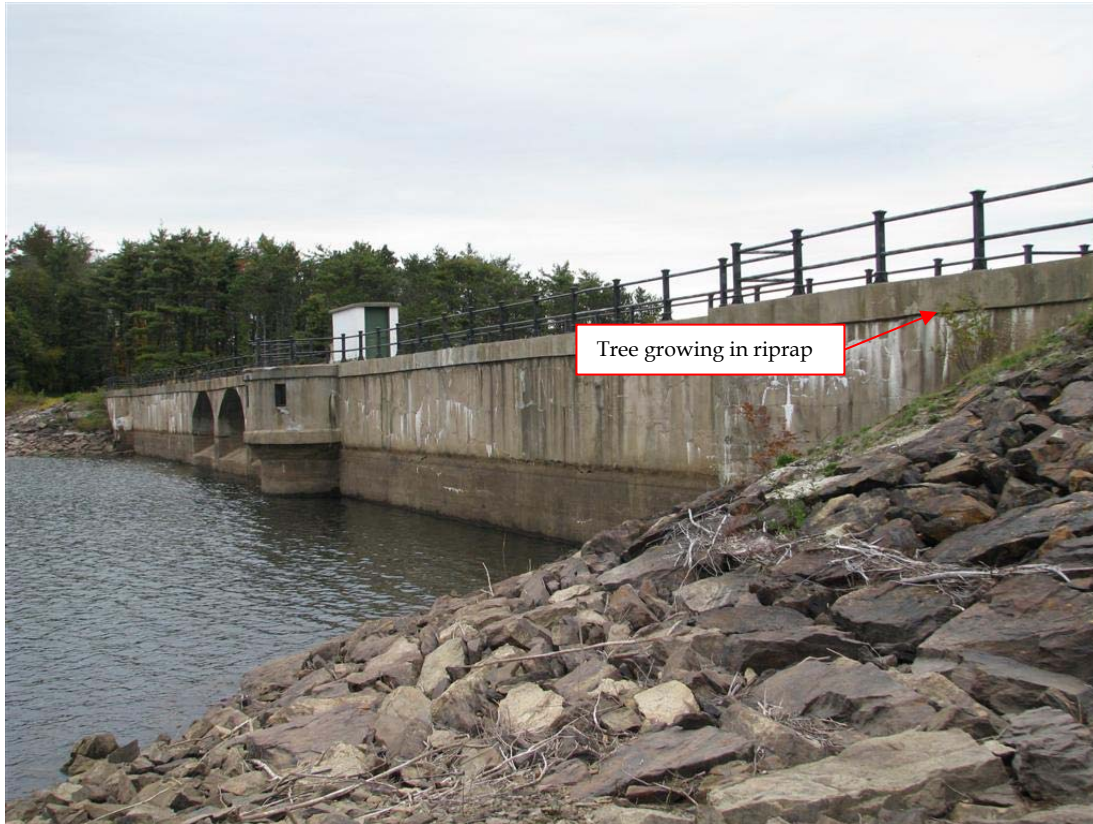
The riprap on the upstream slopes is in good condition but removal of some small trees and brush is needed along the embankment and at the contact with the concrete dam and spillway (Photos 1 and 3). The upstream portions of the concrete dam have some cracking and spalling of the shotcrete coating which has allowed some vegetation to root in its surface (Photo 17). Mineral deposits were noted below many of these cracks.

Photo No. 1: Overview of dam and upstream face from right abutment. Note brush on riprap near concrete dam contact.

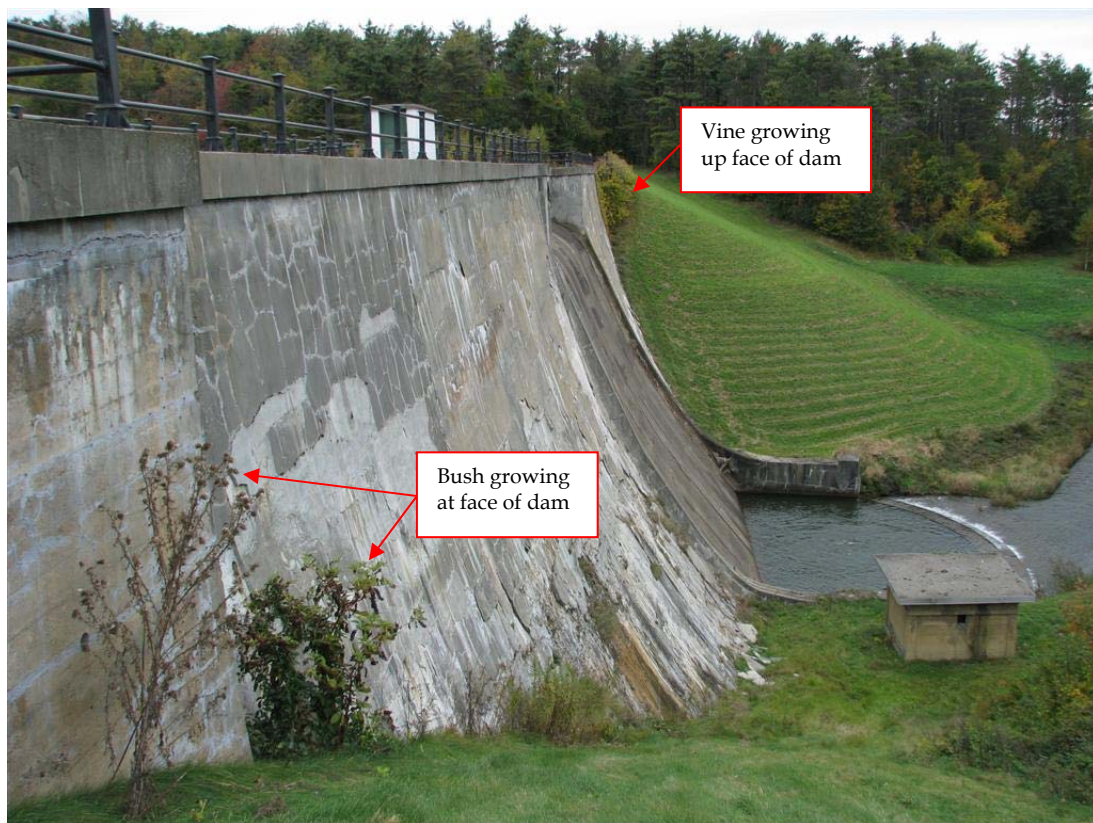
The grass-covered downstream slopes of the earth portions of the embankment are covered with grass and milkweed about 6 to 15 inches tall (Photos 2, 6 and 7). Some tractor ruts and bare spots (Photos 2, 13 and 34) were found (Item 5 on Figure 5) parallel to the slope on the left downstream face. A saturated soil area approximately 20-feet-wide by 40-feet-long (Photo 33) at the base of the dam right of the gate house was observed (Item 7 on Figure 5). The shotcrete coating on the downstream faces of the concrete dam is cracked and spalled in numerous areas and has allowed some vegetation to take root (Photos 21, 22, 24, 26, 27 and 28). Mineral deposits were noted below many of these spalled areas. One area has exposed reinforcement wire mesh from the 1987 shotcrete application (Photo 26).

Photo No. 2: Overview of dam and downstream face from right embankment.

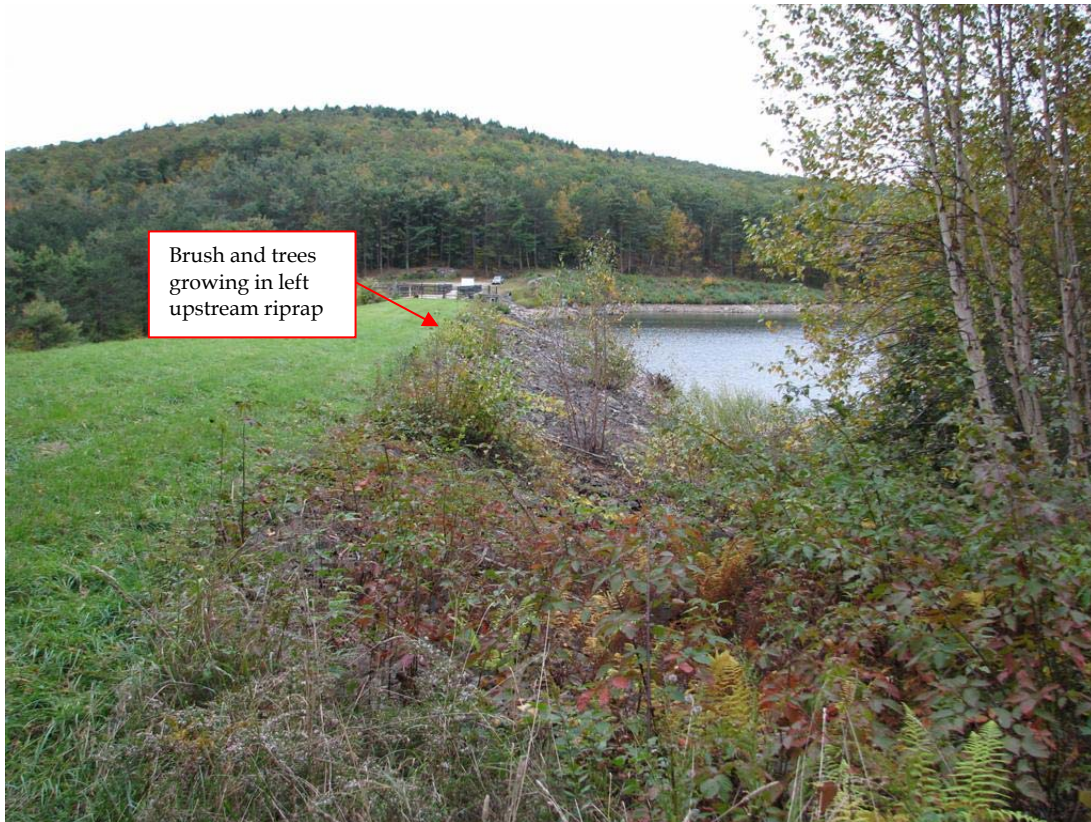
Abutment contacts with embankments are generally in good condition except there were lines of trees observed on the left abutment (Photo 3). It is riprap-lined on the upstream faces and ties into bedrock on the right embankment.

Photo No. 3: Overview of upstream face and crest from left abutment.

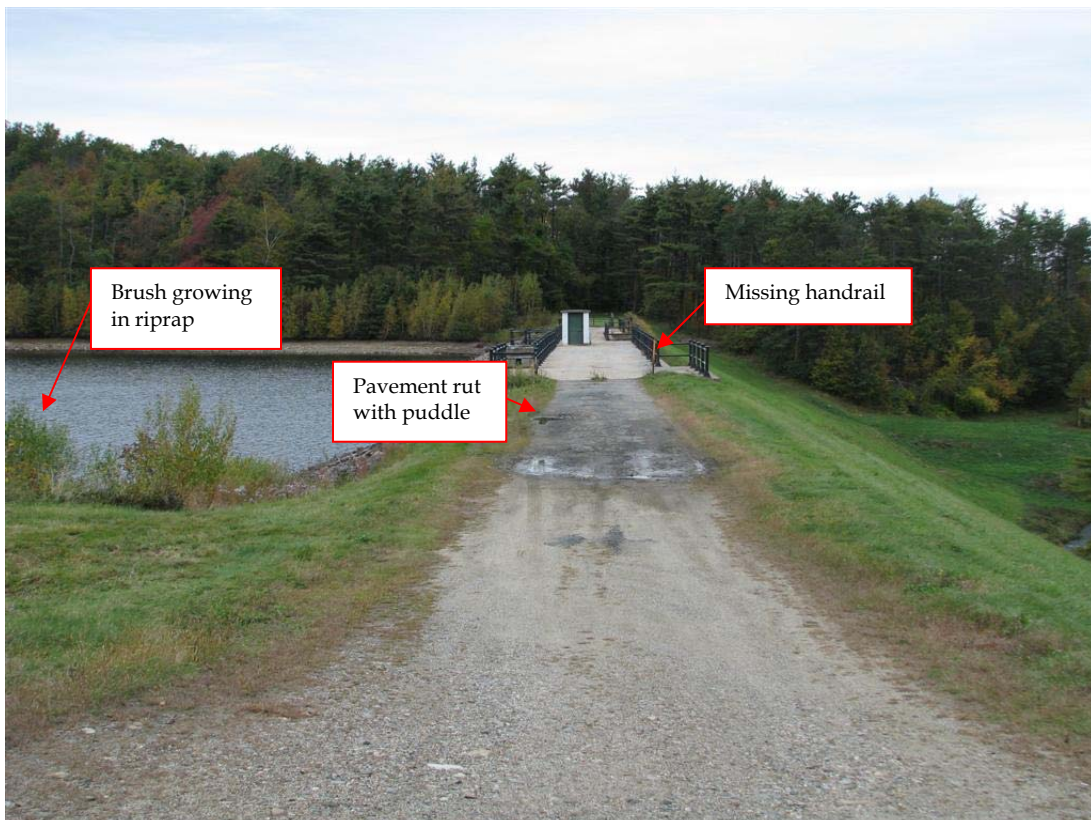
The concrete dam crest also has cracking and spalling, and a small amount of vegetation taking root (Photos 4, 18 and 19). The crest of the left embankment is covered with grass about 6 to 12 inches tall. The crest of the right embankment is

covered with an asphalt access road that has severe deterioration with ruts and cracks and is in need of repair. On the right embankment crest, the asphalt access road had cracking, rutting, and the edges were eroded (Photo 4).

Photo No. 4: Overview of crest from right abutment.

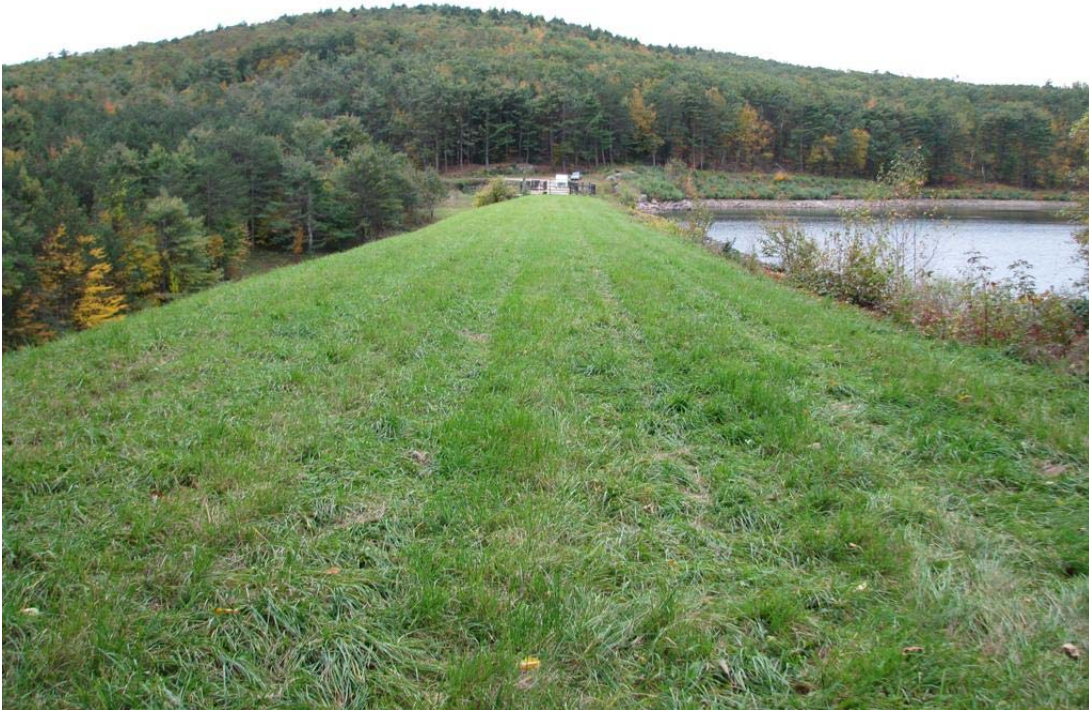
Photo No. 5: Overview of crest from left abutment.

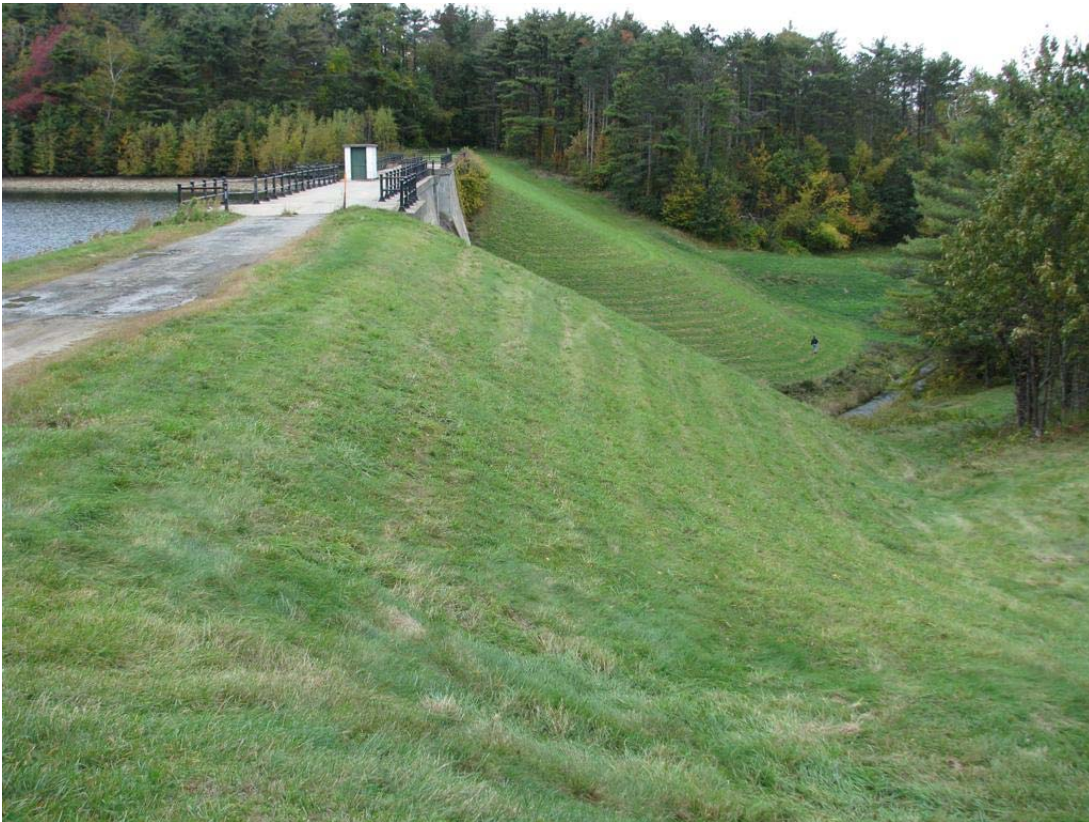
Photo No. 6: Overview of downstream slope from right abutment.

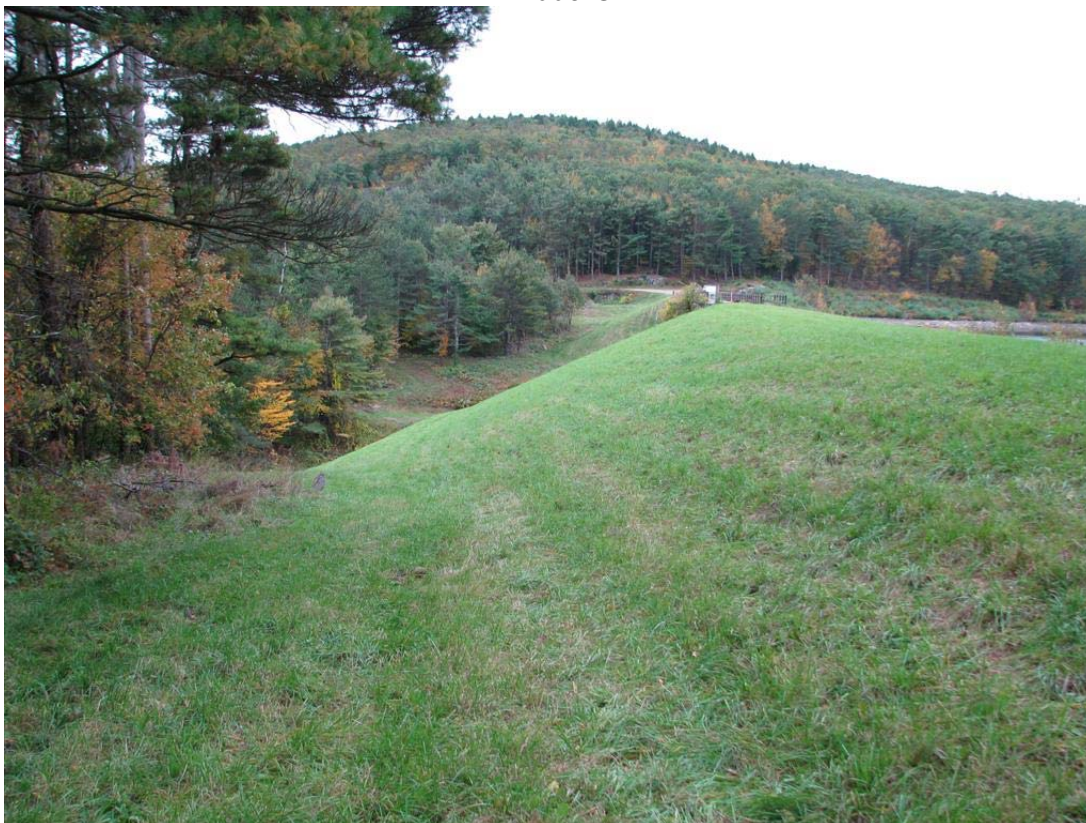
Photo No. 7: Overview of downstream slope from left abutment.

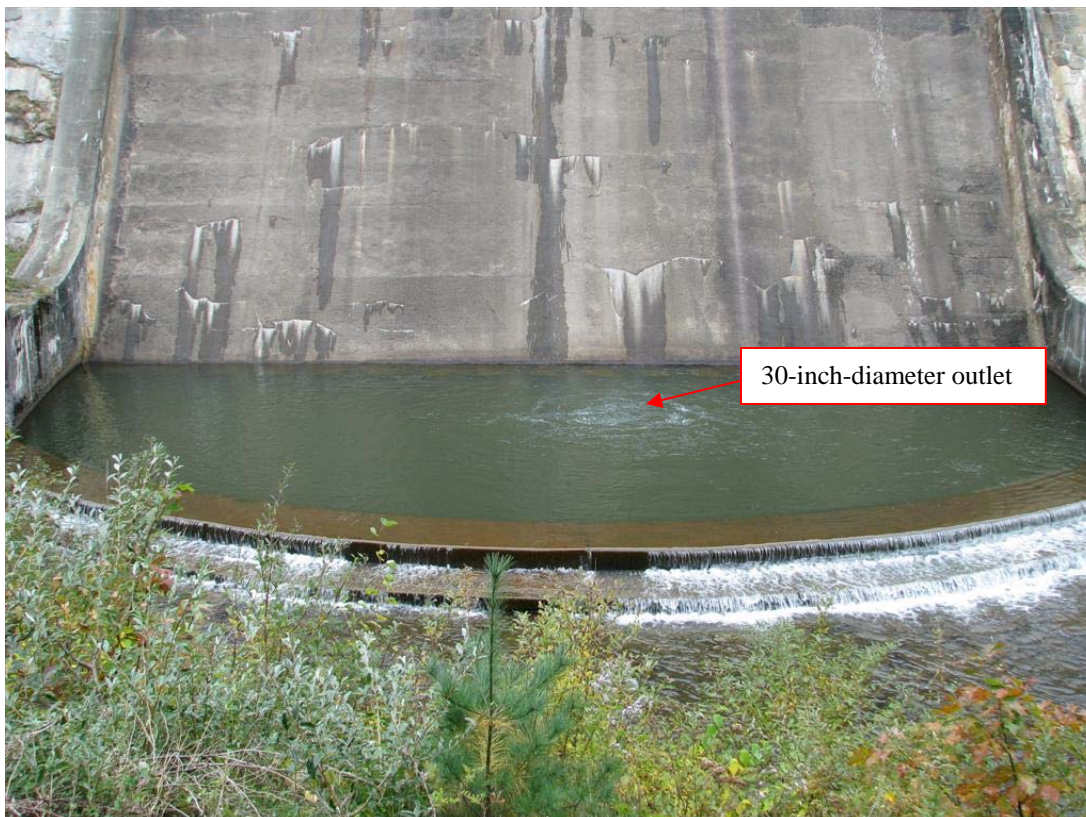
In general the condition of the spillway is similar to the condition reported during the last inspection with some additional deterioration of the face of the concrete. Water was about 5 feet below the concrete ogee spillway crest at the time of inspection. Some cracking and spalling of the spillway slab, and training walls was evident (Photos 8, 9, 10, 11, 12, 20, 31, 32, and 35).

Photo No. 8: Overview of spillway.

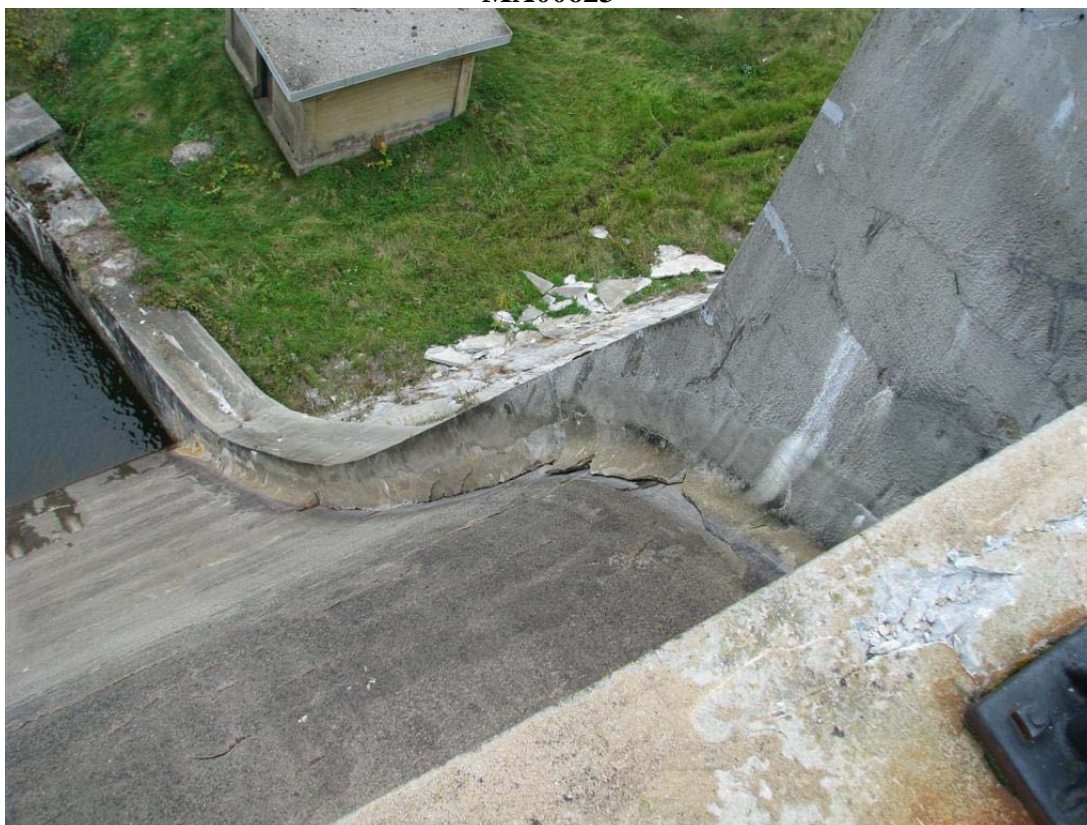
**Photo No. 9: Overview of right downstream spillway training wall.
Note part of concrete fillet is missing.**

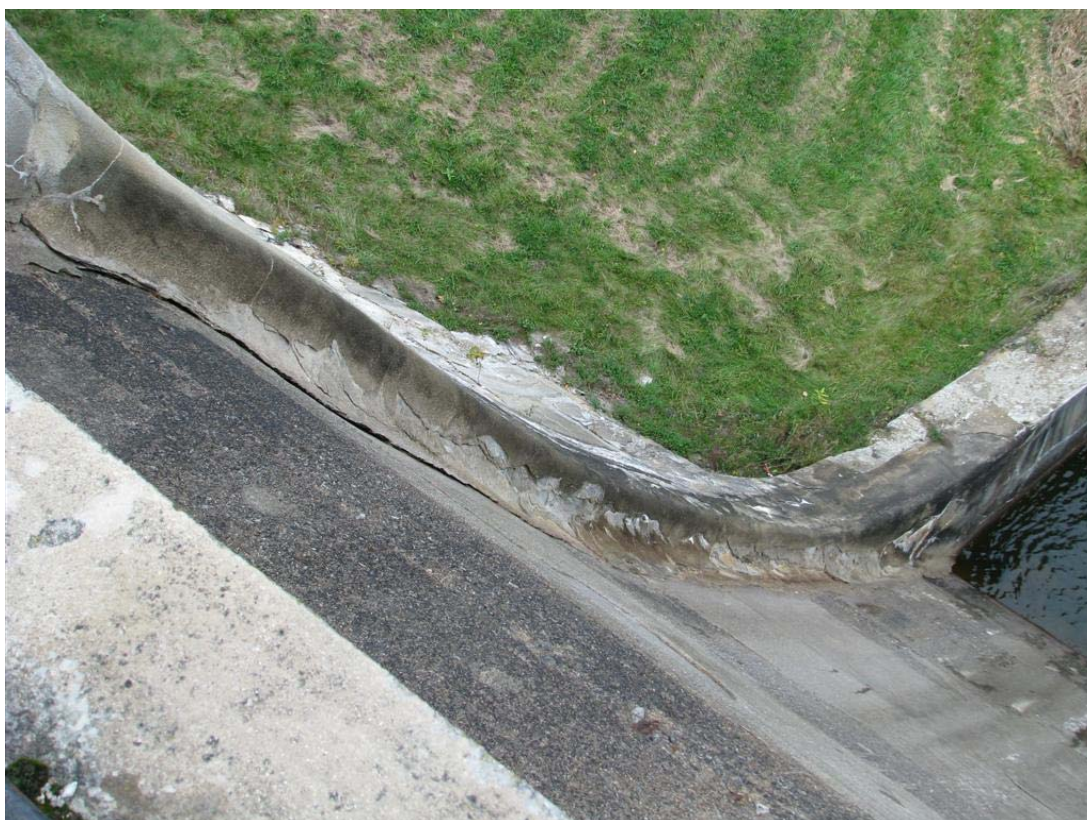
Photo No. 10: Overview of left downstream spillway training wall.

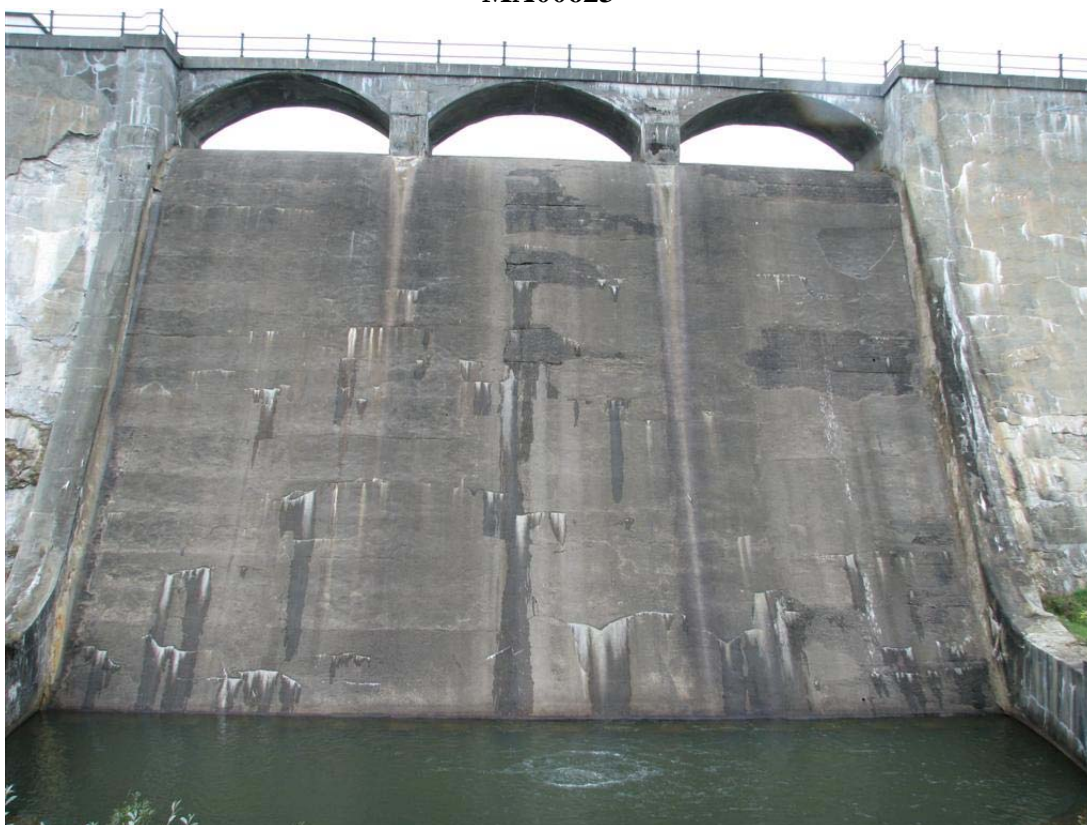
Photo No. 11: Overview of spillway weir.

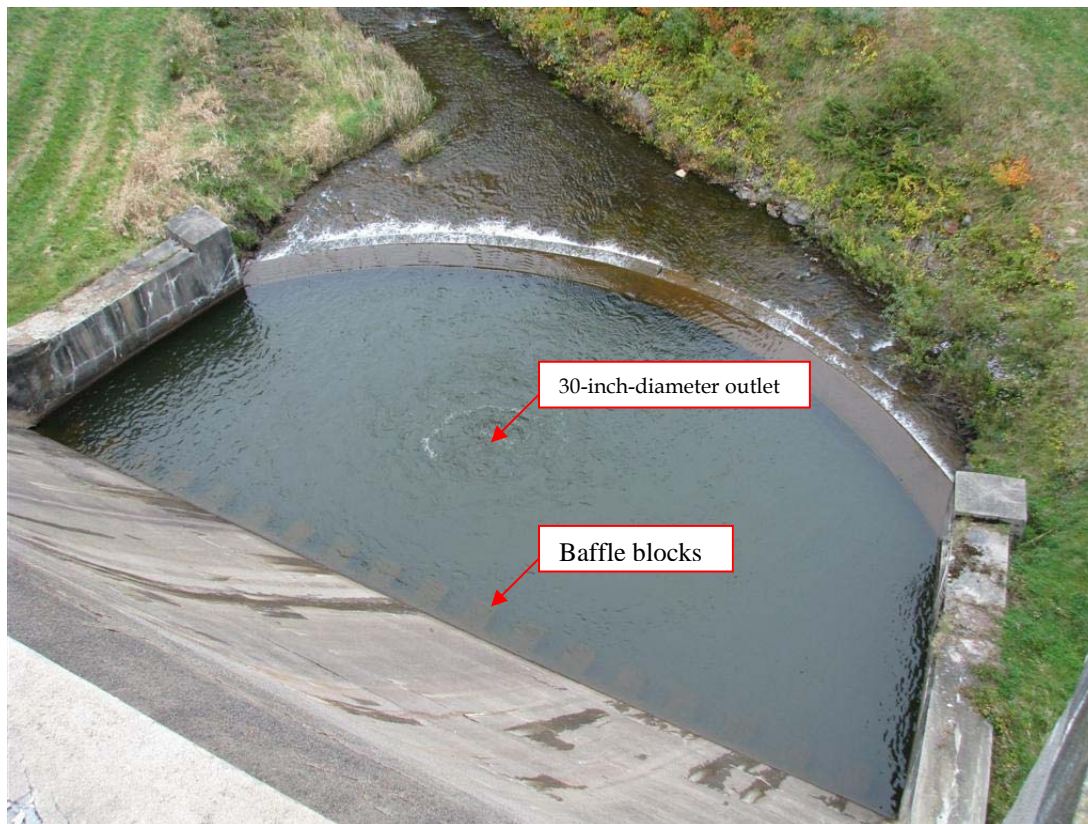
Photo No. 12: Overview of stilling basin. Need to label the arrow.

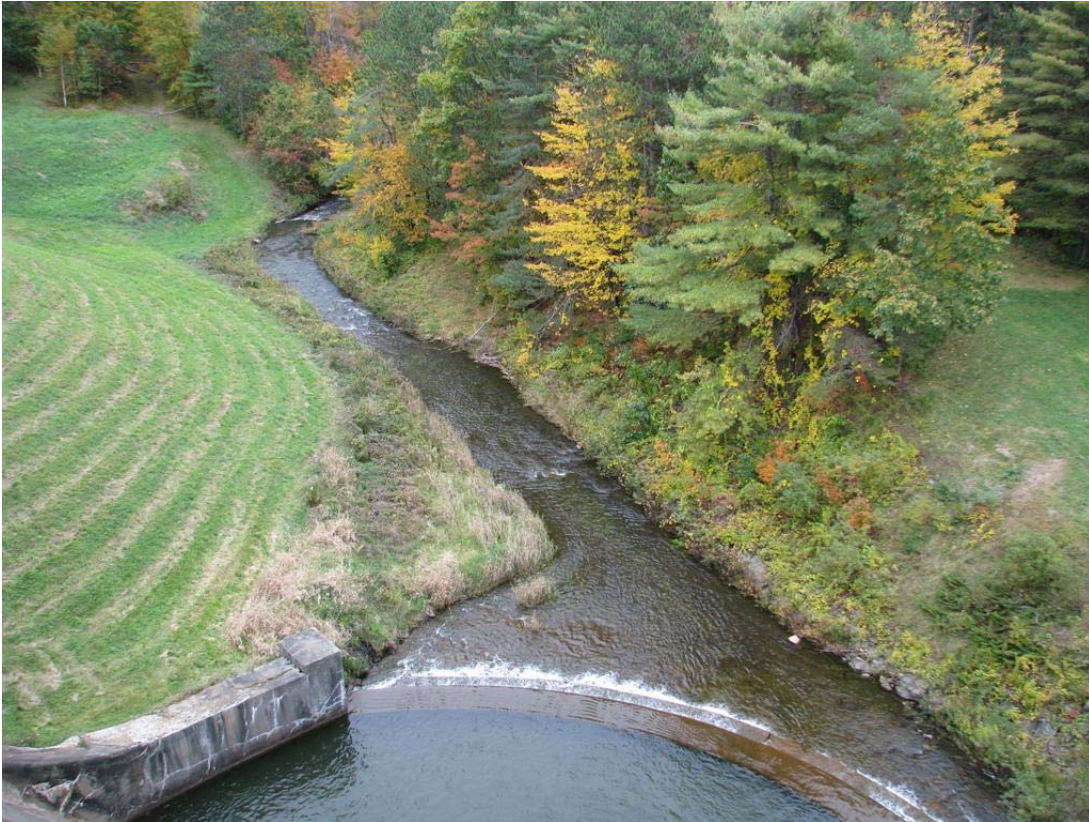
Photo No. 13: Overview of downstream channel (Note trees along channel).

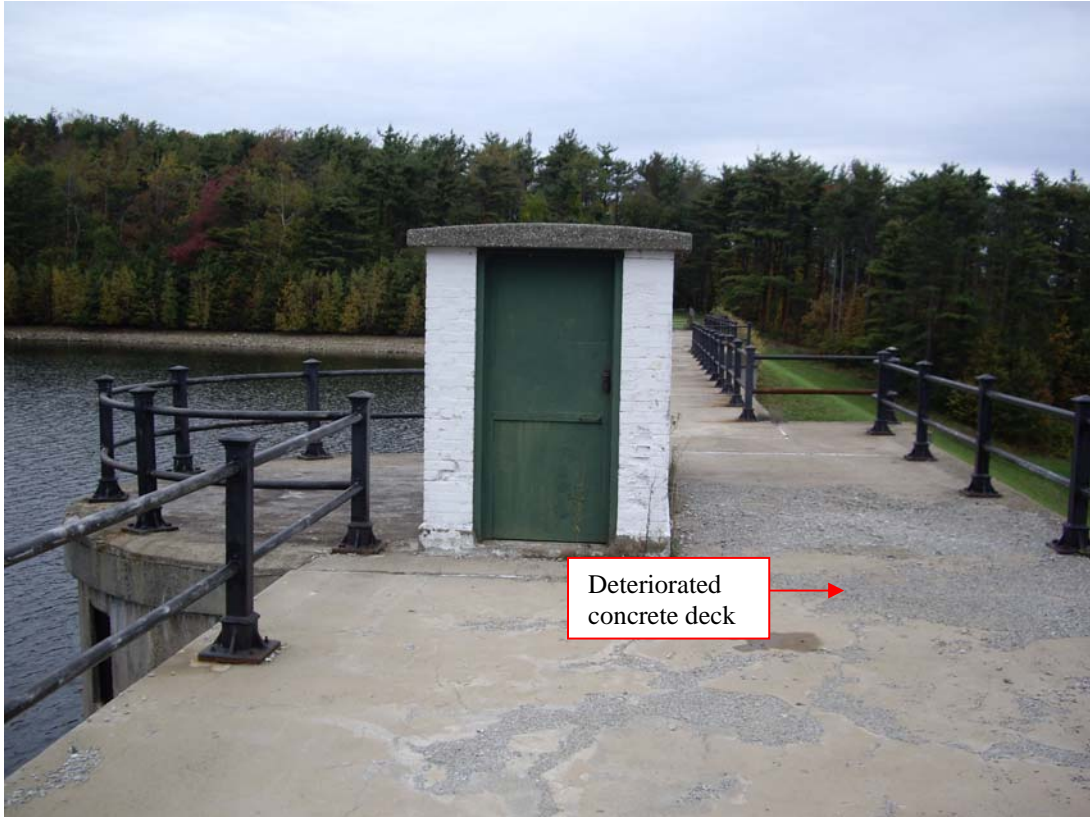
Deteriorated
concrete deck

Photo No. 14: Overview of gatehouse exterior.

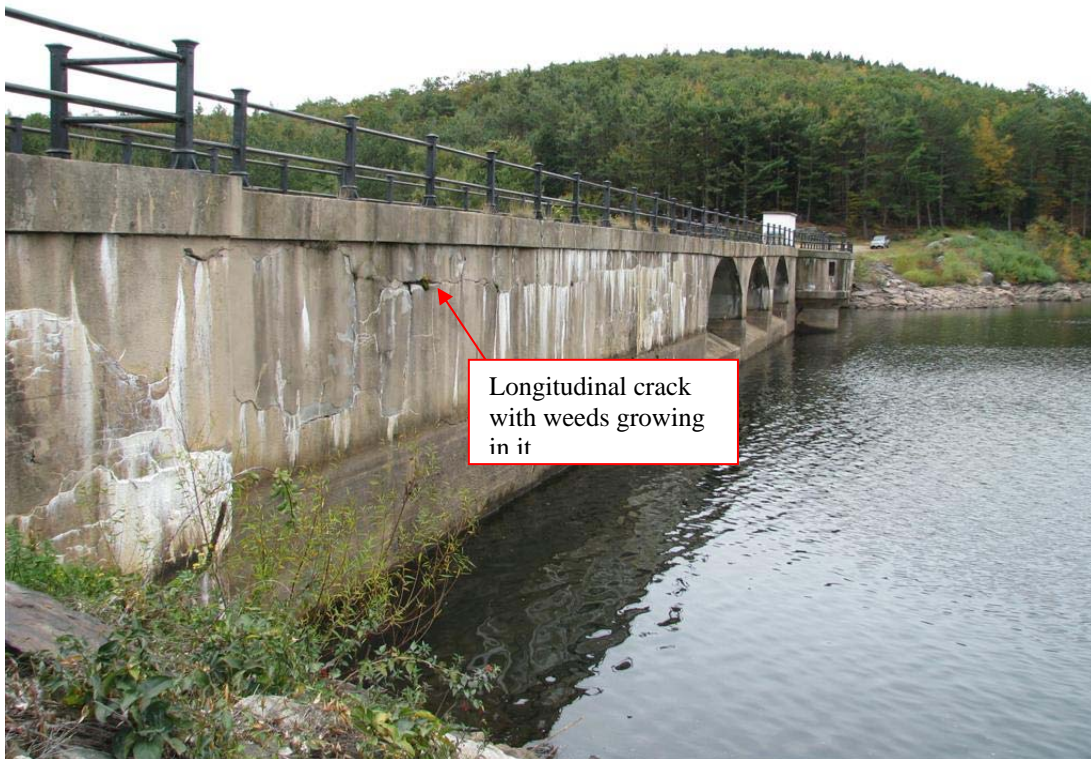
Photo No. 17: Cracks and efflorescence on upstream face of dam. Note that some weeds are growing in the cracks.

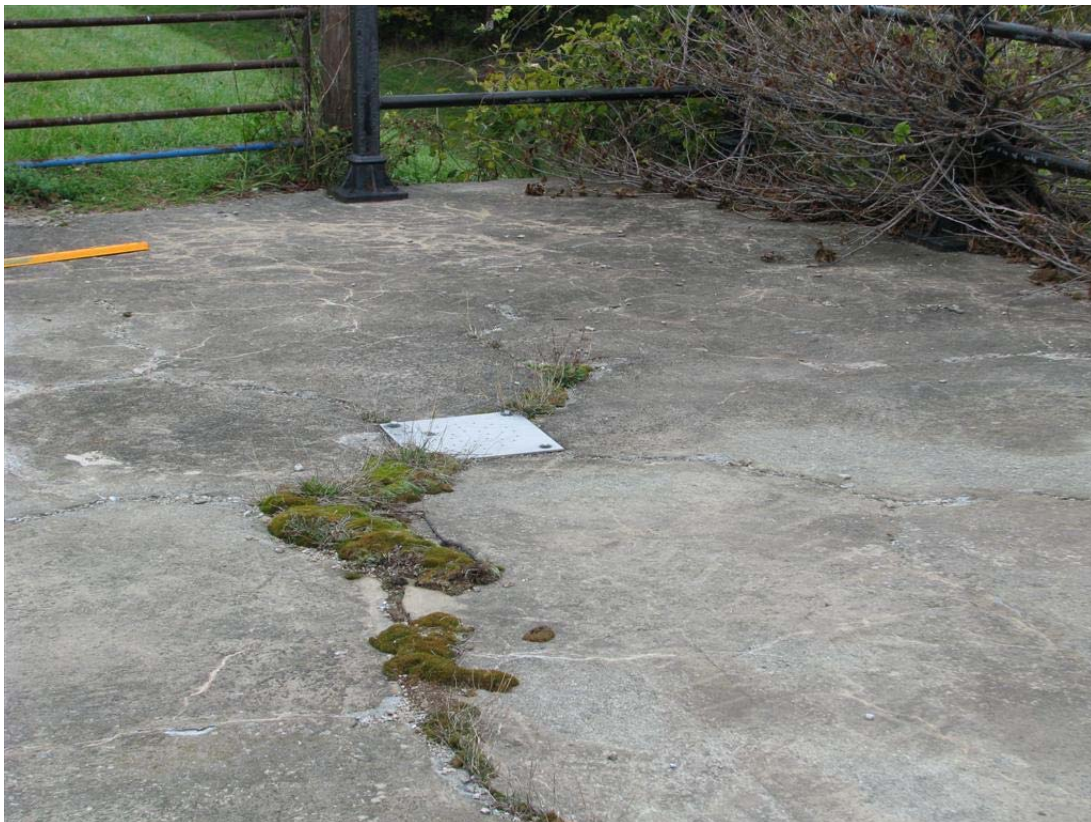
Photo No.18: Crack on crest near left embankment. Note weeds and moss growing in the crack.

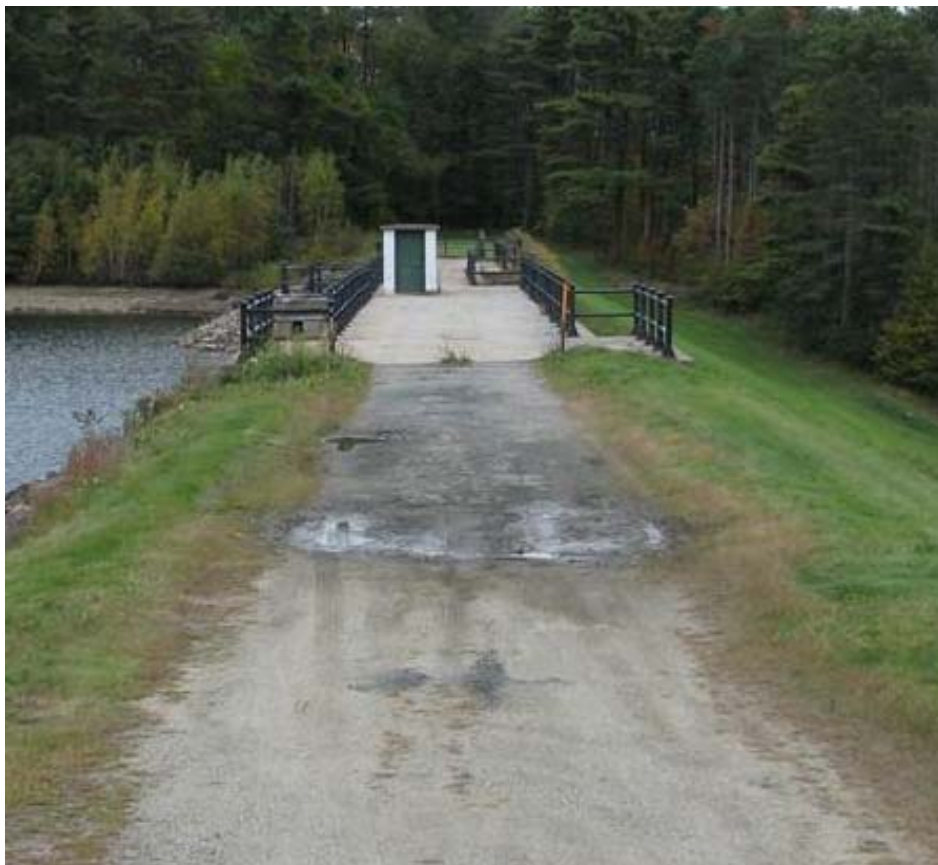
Photo No. 19: Pavement eroded, rutted, and cracked on right crest.

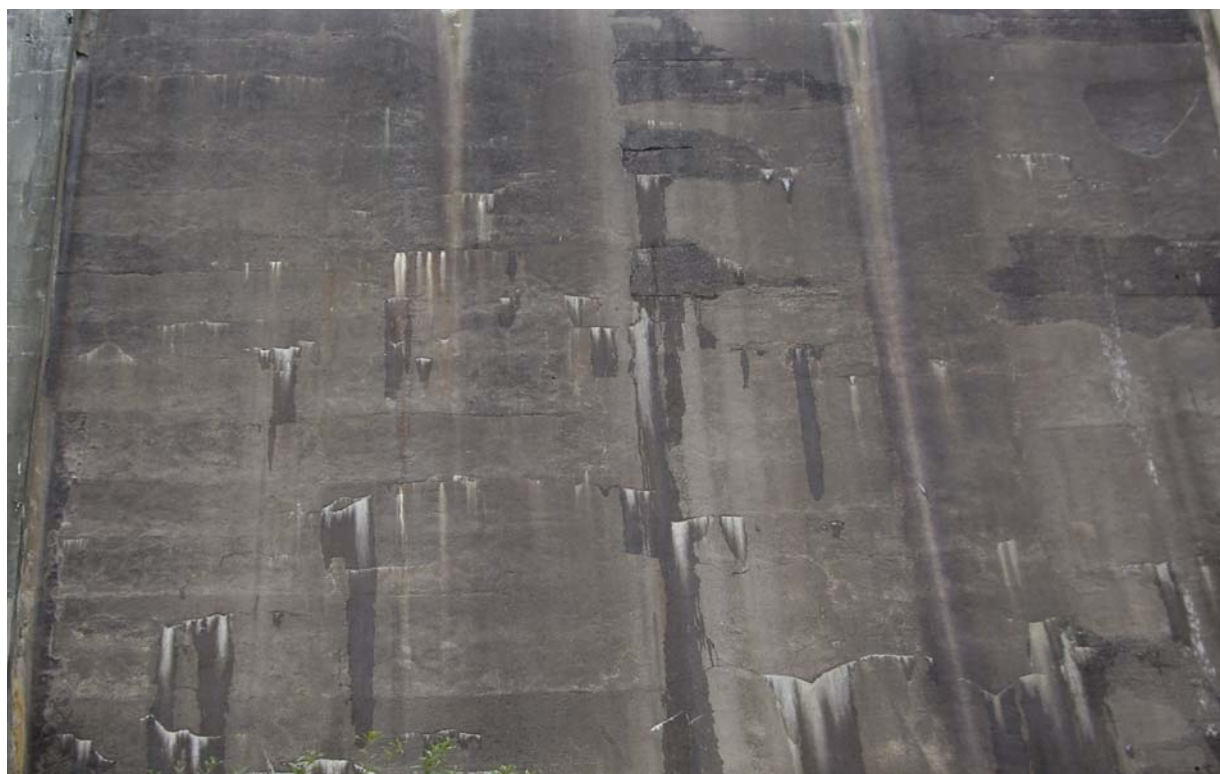
Photo No. 20: Cracks and efflorescence on the spillway surface (View from downstream).

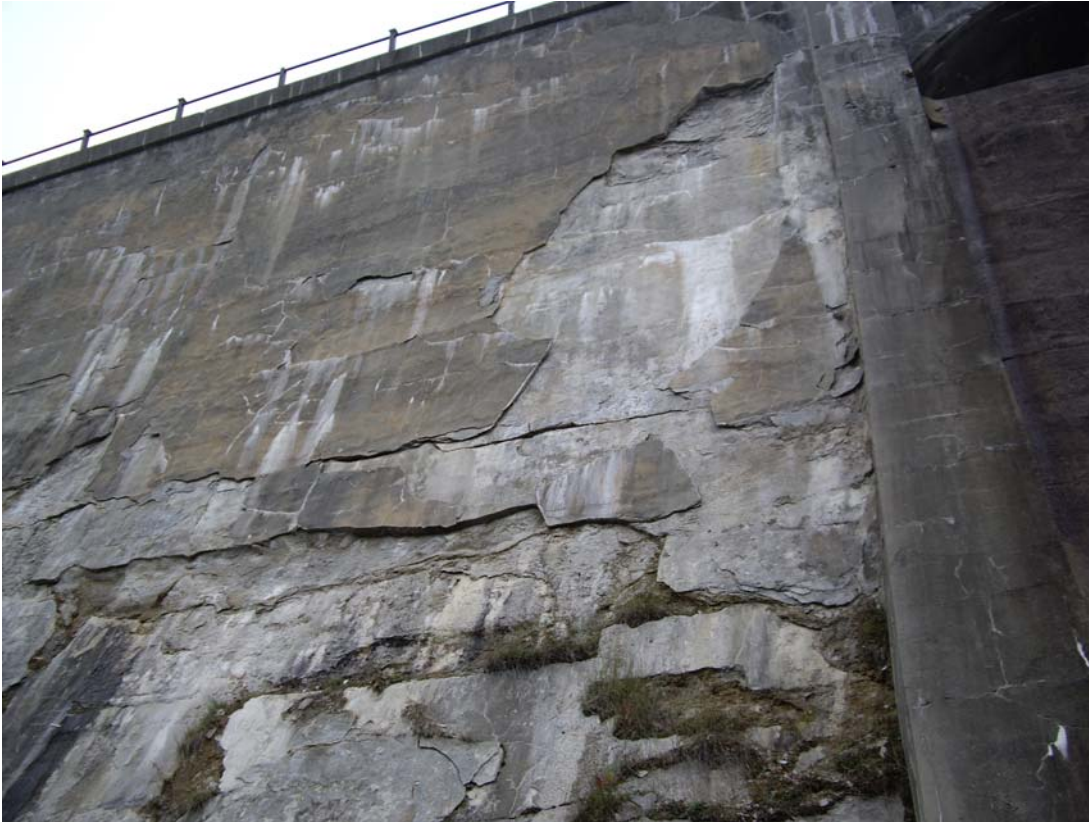
Photo No. 21: A large piece of shotcrete spalled next to the right training wall. Note weeds growing in the cracks.

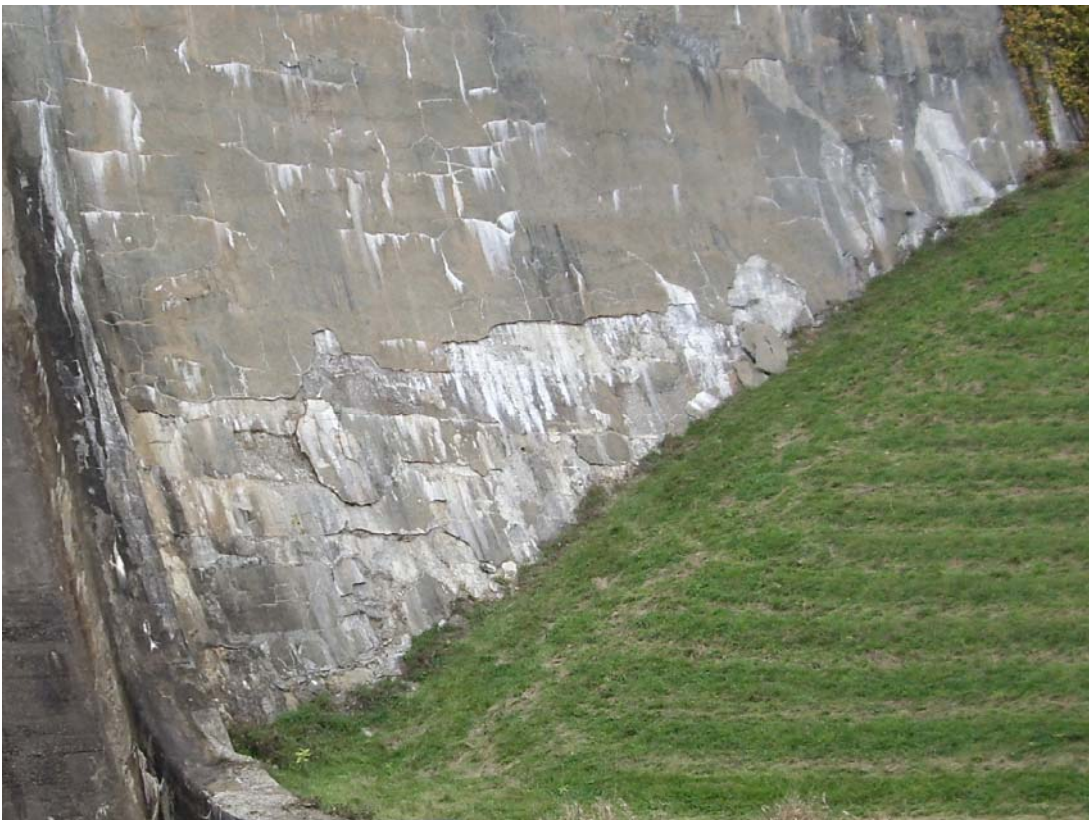
Photo No. 22: Spalling of shotcrete left of the spillway (downstream face).

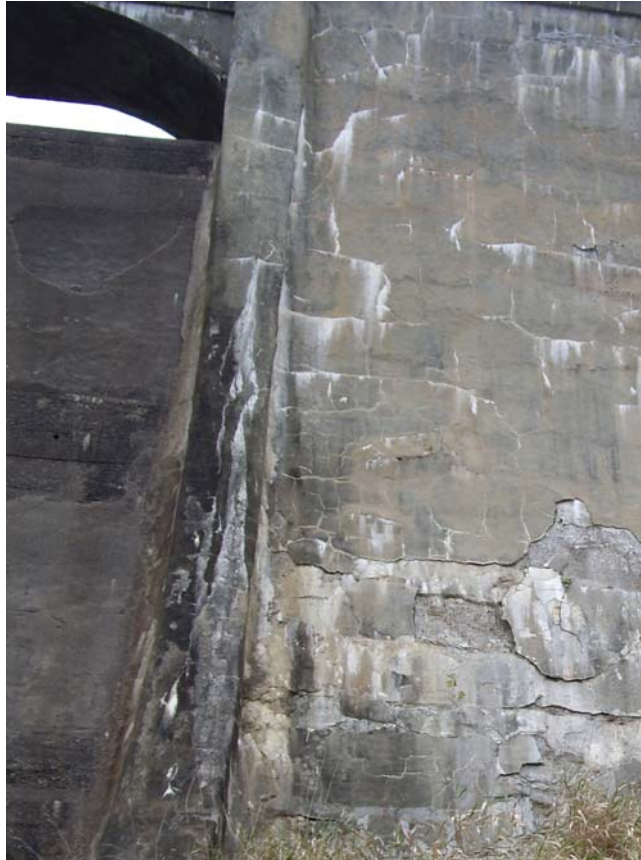
Photo No. 23: Efflorescence and spalling of concrete at toe of left training wall.

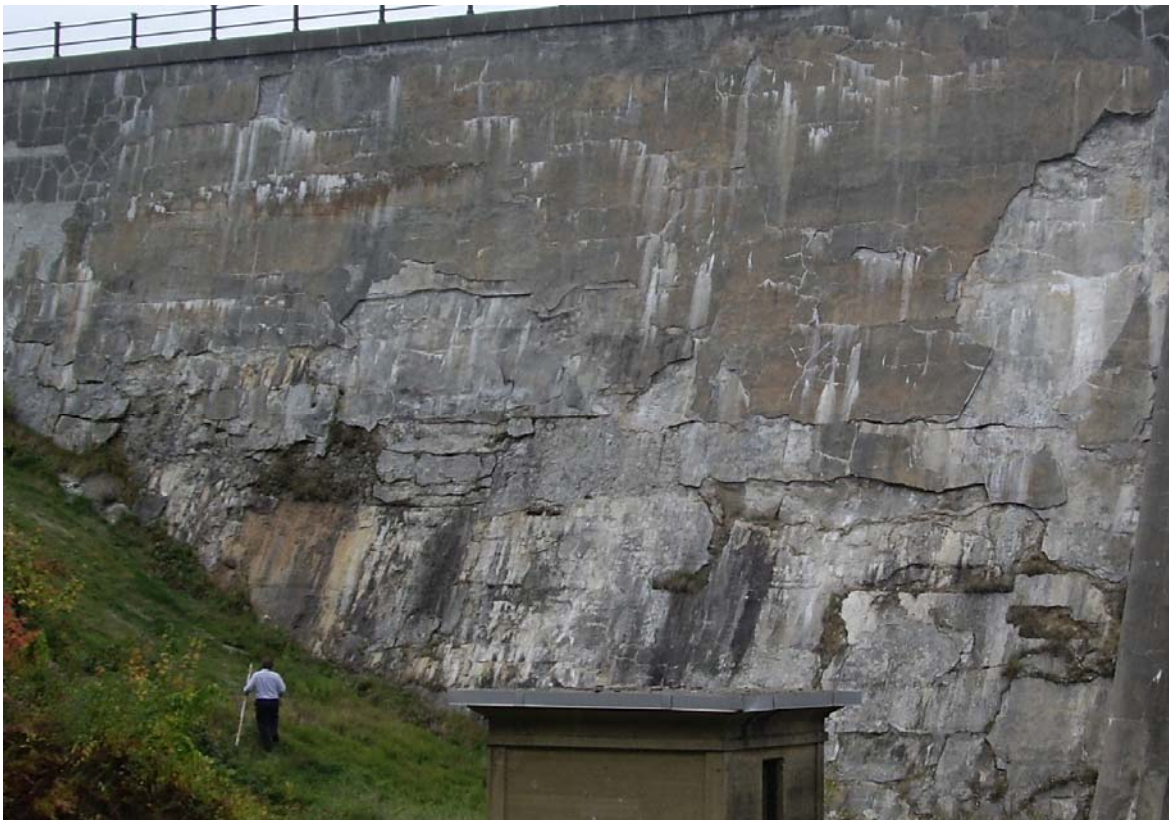
Photo No. 24: Large areas of spalling on downstream face of the dam to the right of the spillway.

Weeds growing in some cracks.

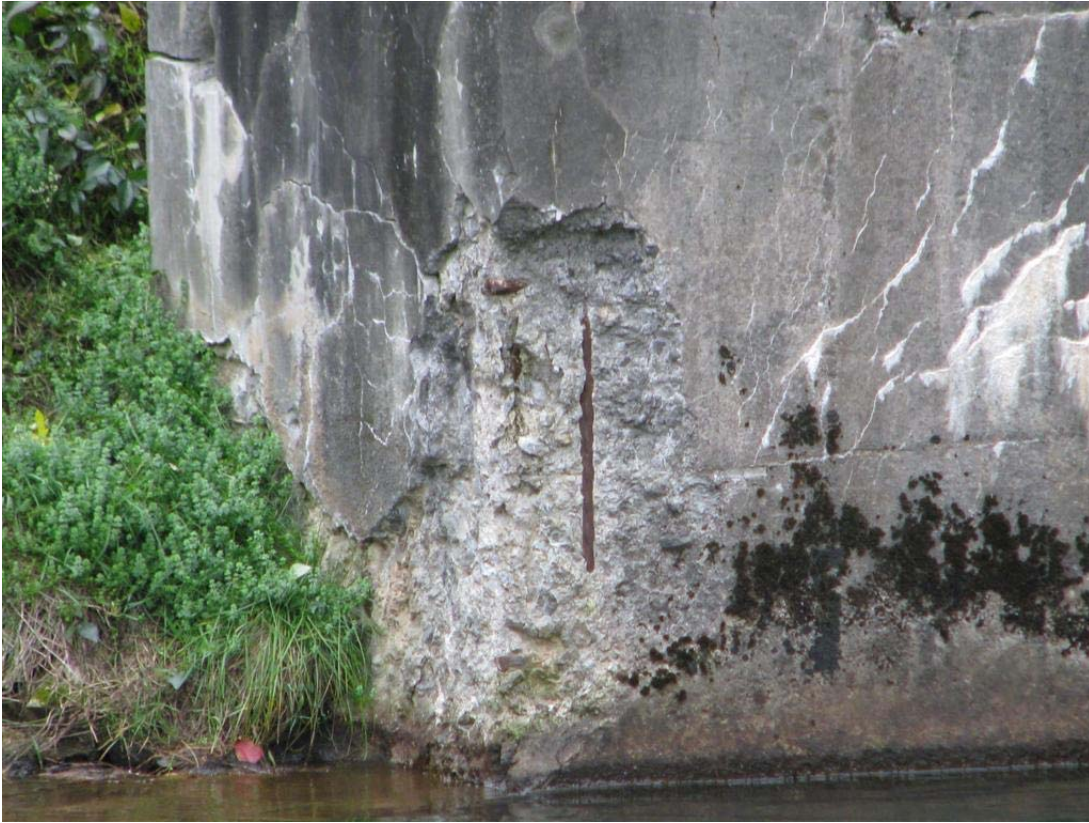
Photo No. 25: Exposed rebar at the end of the right training wall.

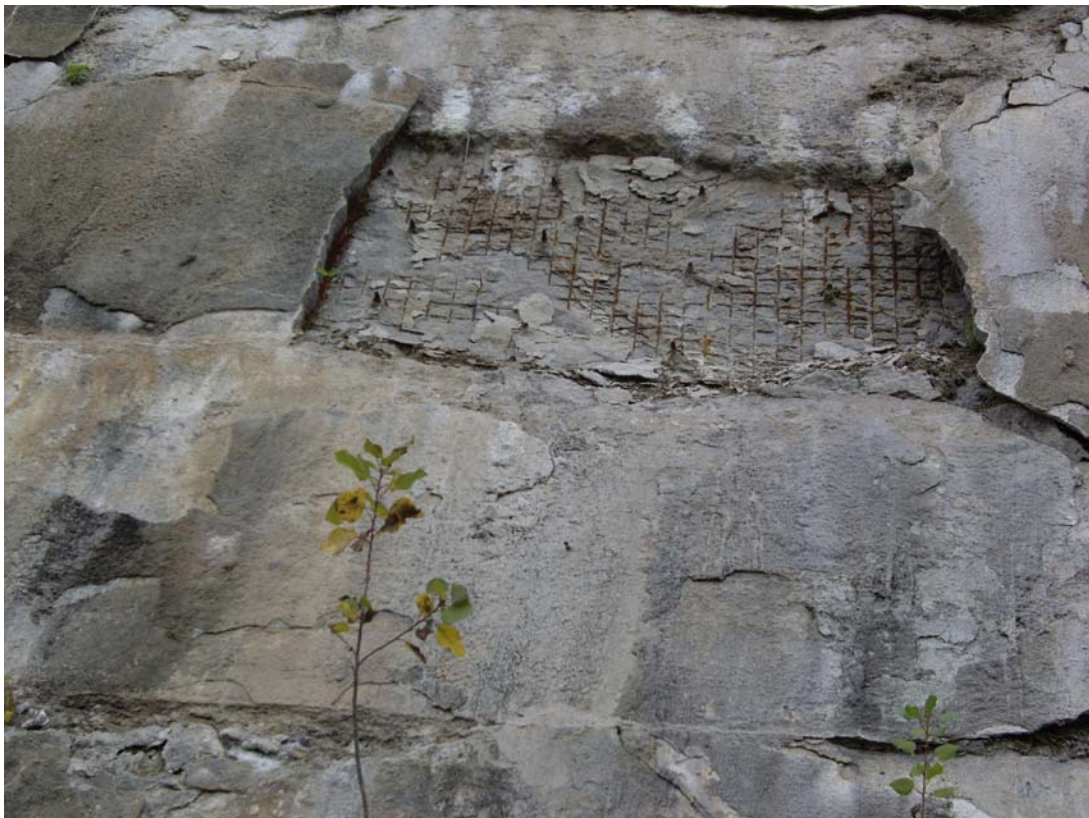
Photo No. 26: A large piece of shotcrete spalled exposing wire mesh in downstream face of dam next to left training wall. Weeds growing in cracks.

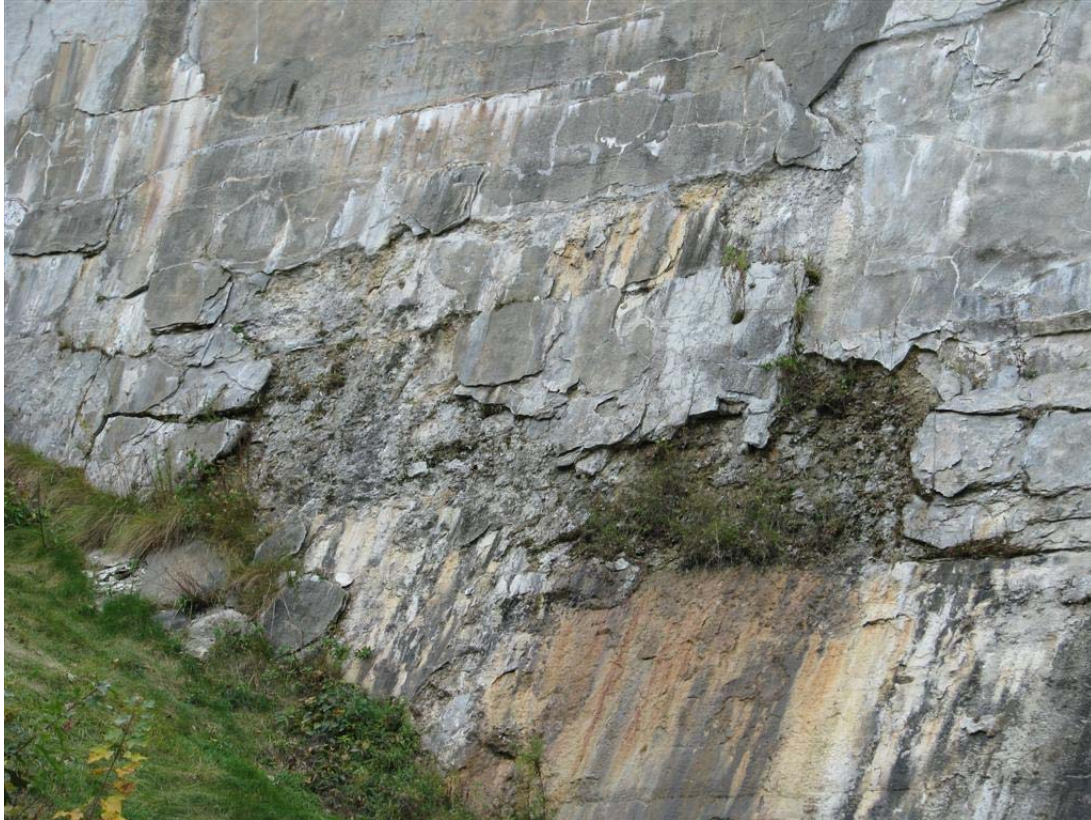
Photo No. 27: Efflorescence, cracking, spalling and weeds growing in the cracks on the downstream face of the dam to right of spillway.
