PINE HILL RESERVOIR DAM
PHASE I
INSPECTION / EVALUATION REPORT

Dam Name: Pine Hill Reservoir Dam
State Dam ID#: 3-14-134-6
NID ID#: MA 00623
Owner: City of Worcester
Owner Type: Municipal
Town: Holden, Massachusetts
Consultant: CDM
Date of Inspection: October 9, 2009

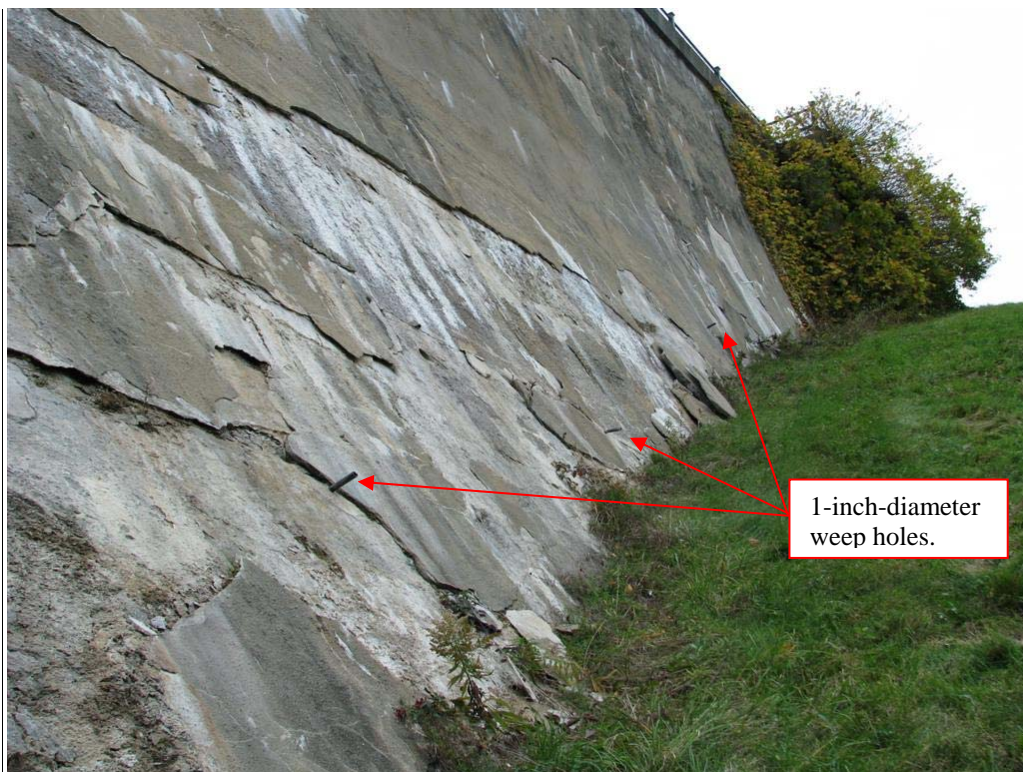
A 1-inch-diameter PVC pipes were observed on downstream face of the concrete dam (Photo 28). These pipes were installed in the dam during the installation of shotcrete. A 9.5-inch-deep weephole was observed on downstream face of right dam section.

Photo No. 28: PVC weep holes on the downstream face of the dam to left of spillway. weep holes were installed when dam face was sandblasted and shotcrete-covered in 1987.

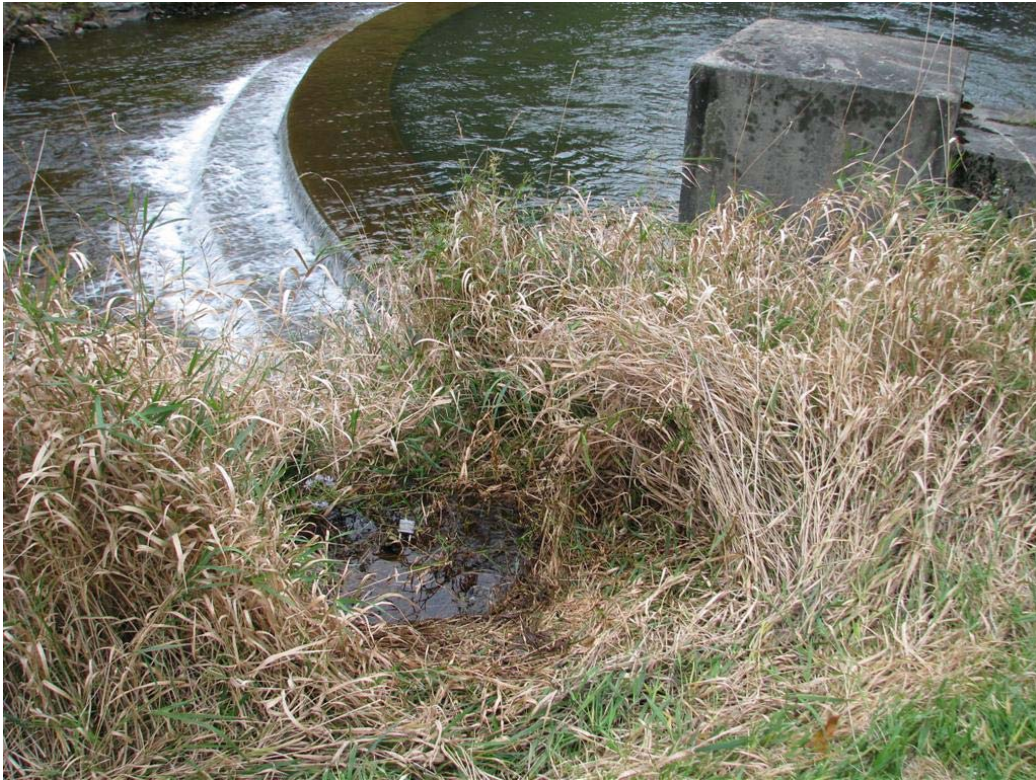
The lower manhole cover to the seepage infiltration gallery (Photo 29) was locked during the October 9, 2009 inspection and water was flowing out of the cover. The flow was estimated to be 10 to 15 gpm. It has been reported that the 8-inch-diameter cast iron outlet drain has been blocked since the 1960's causing the seepage water flow out of the top of the infiltration gallery access manhole (Photo 29).

Photo No. 29: Entrance to the gallery under the dam. Note the manhole cover is locked and water is flowing out of holes in cover.

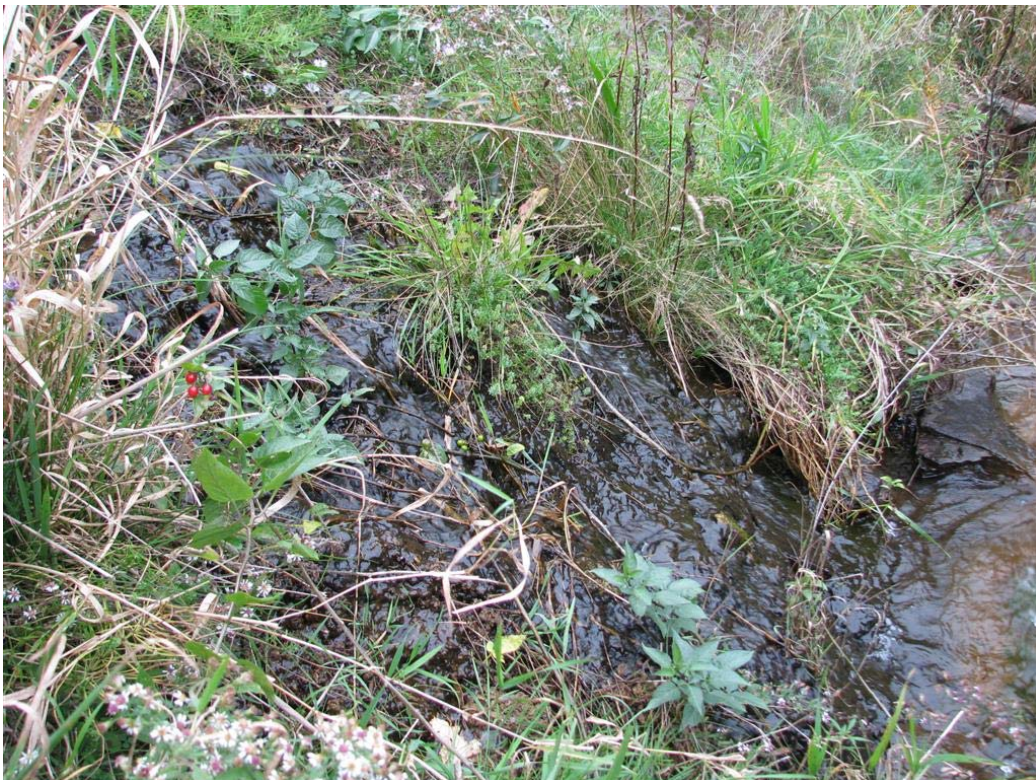
Photo No. 30: Outlet from drainage gallery clogged and overgrown. Water overflowing from manhole cover above.

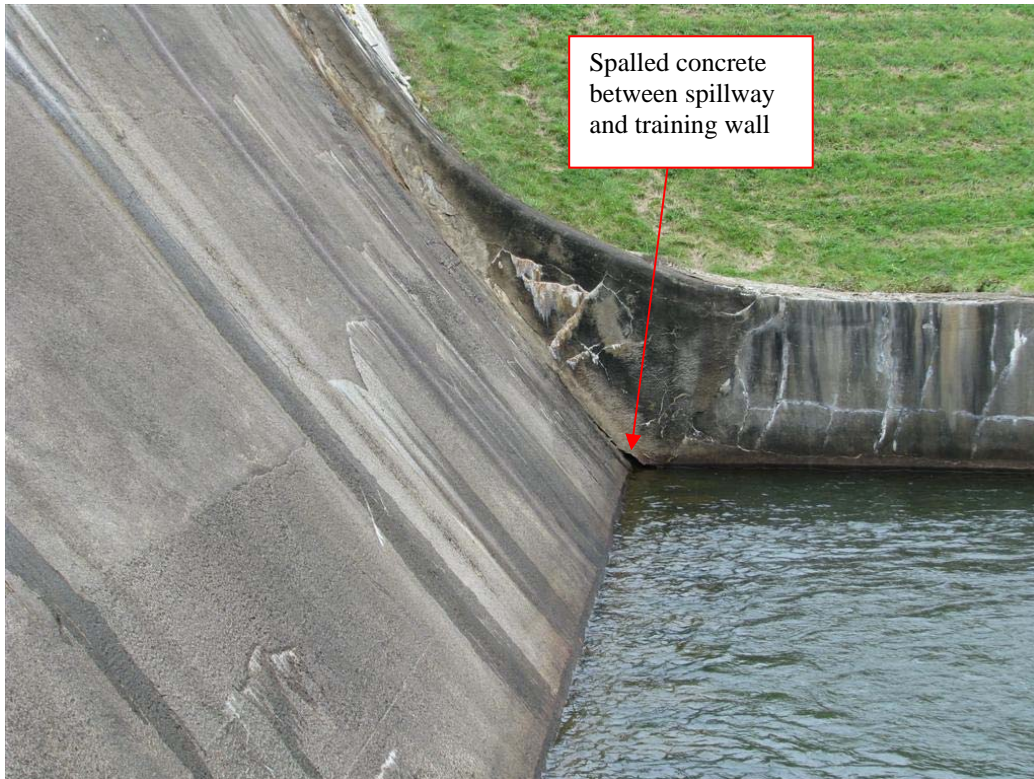
In general the condition of the spillway is similar to the condition reported during the last inspection with some additional deterioration of the face of the concrete. Water was about 5 feet below the concrete ogee spillway crest at the time of inspection. Some cracking and spalling of the spillway slab, and training walls was evident (Photos 8, 9, 10, 11, 12, 20, 31, 32, and 35).

Photo No. 31: Concrete spalled between spillway and training wall at stilling basin. Cracking, spalling, and efflorescence on left training wall.

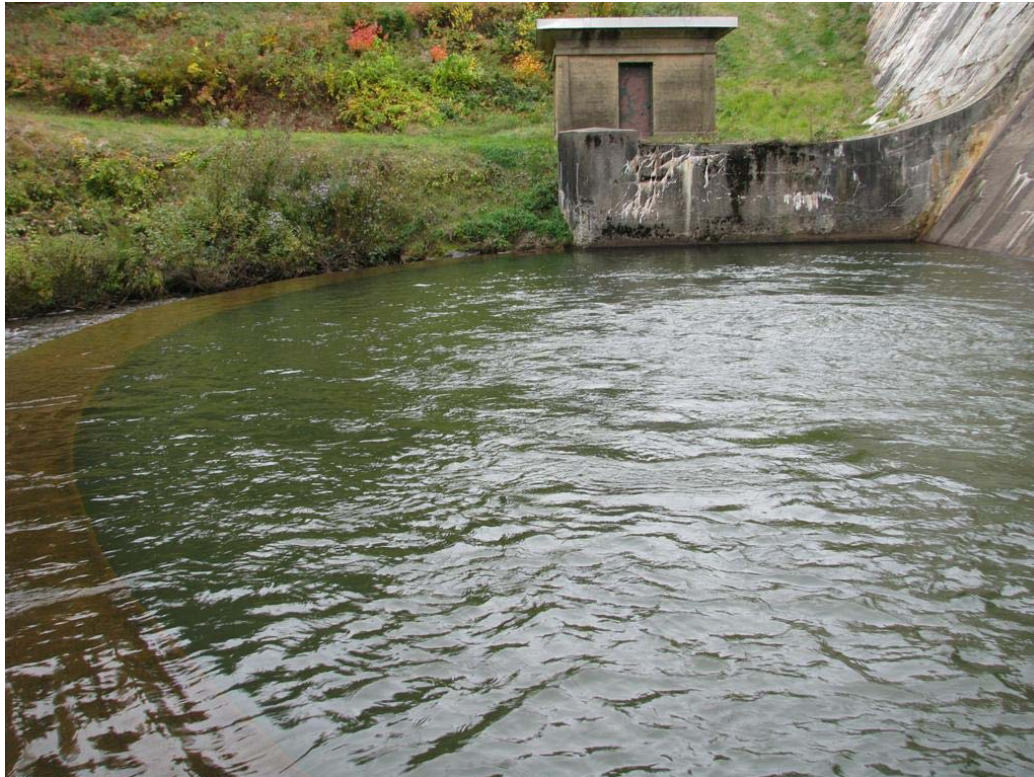
Photo No. 32: Cracking, spalling, and efflorescence on right training wall at stilling basin.

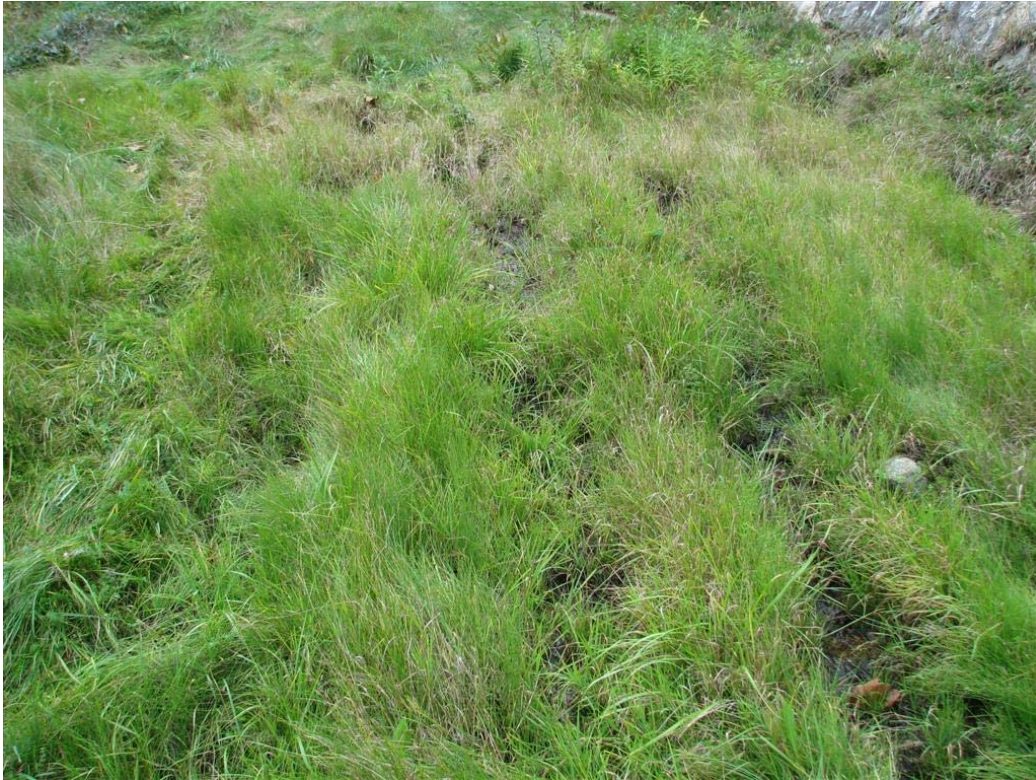
Possible seepage was noted on the right downstream slope near the gate house during the October 9, 2009 inspection. Efflorescence was also observed below cracks and spalled shotcrete areas on the face of the dam. Based on CDM's experience with similar concrete dams and the fact that a formal stability analyses has not previously been performed, a seepage and stability analysis of this structure should now be performed along with the previously described hydrologic and hydraulic analyses. These conclusions are further supported by findings in previous Phase I reports.

Photo No. 33: Wet area on right slope between dam face and outlet gatehouse.

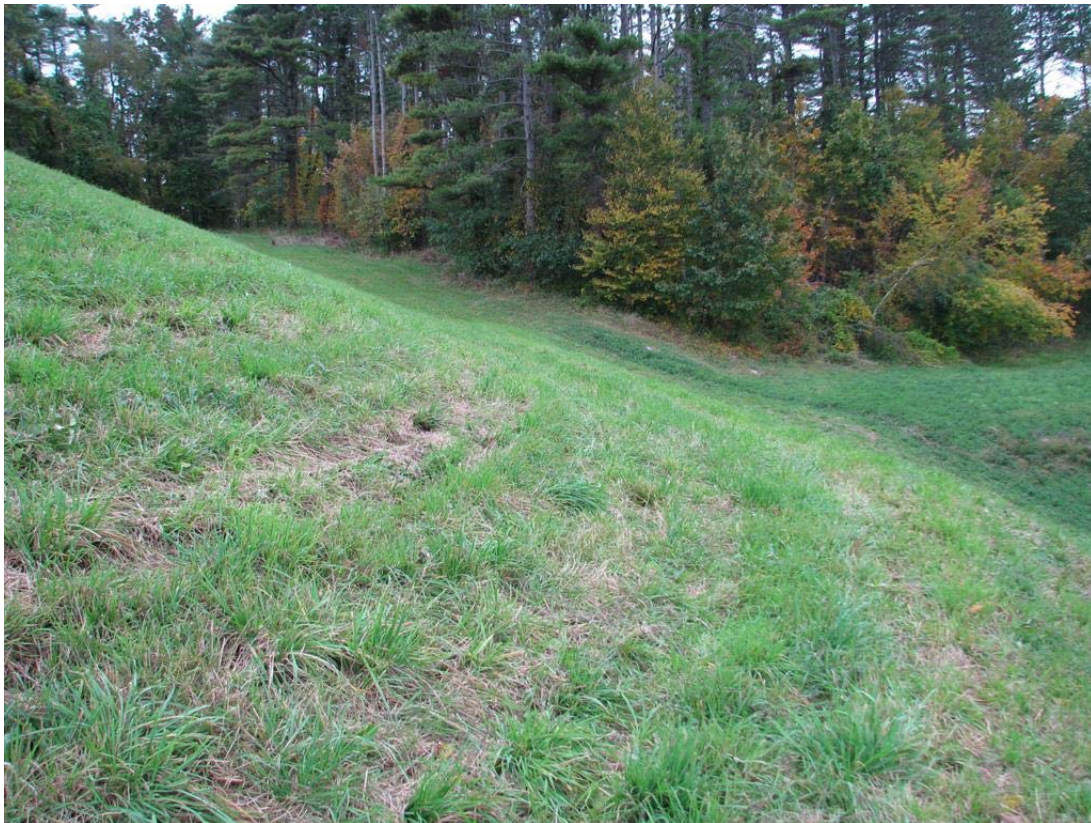
The grass-covered downstream slopes of the earth portions of the embankment are covered with grass and milkweed about 6 to 15 inches tall (Photos 2, 6 and 7). Some tractor ruts and bare spots (Photos 2, 13 and 34) were found (Item 5 on Figure 5) parallel to the slope on the left downstream face. A saturated soil area approximately 20-feet-wide by 40-feet-long (Photo 33) at the base of the dam right of the gate house was observed (Item 7 on Figure 5). The shotcrete coating on the downstream faces of the concrete dam is cracked and spalled in numerous areas and has allowed some vegetation to take root (Photos 21, 22, 24, 26, 27 and 28). Mineral deposits were noted below many of these spalled areas. One area has exposed reinforcement wire mesh from the 1987 shotcrete application (Photo 26).

Photo No. 34: Tractor ruts and bare spots on left embankment downstream slope from mowing.

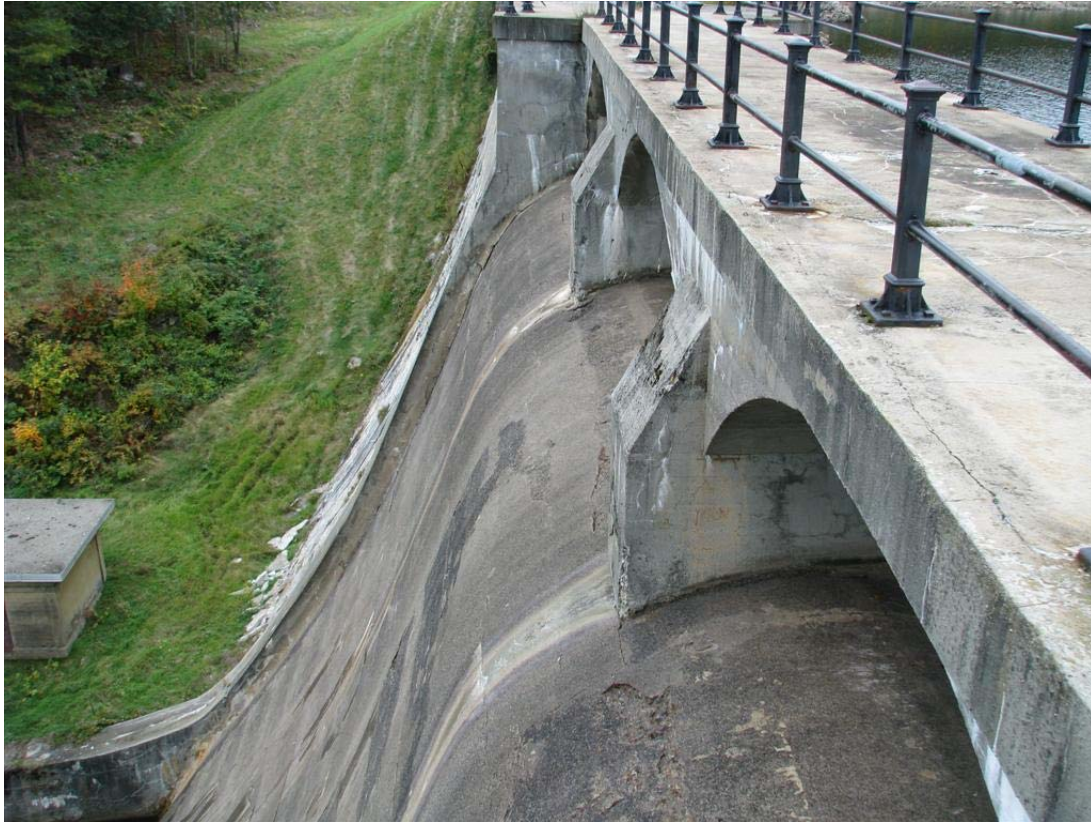
Photo No. 35: Longitudinal cracks along railing. Spalling, cracking, and efflorescence on concrete arch bridge over spillway. Weeds growing in cracks.
