PINE HILL RESERVOIR DAM
PHASE I
INSPECTION / EVALUATION REPORT

Dam Name: Pine Hill Reservoir Dam
State Dam ID#: 3-14-134-6
NID ID#: MA 00623
Owner: City of Worcester
Owner Type: Municipal
Town: Holden, Massachusetts
Consultant: CDM Smith Inc.
Date of Inspection: September 24, 2015

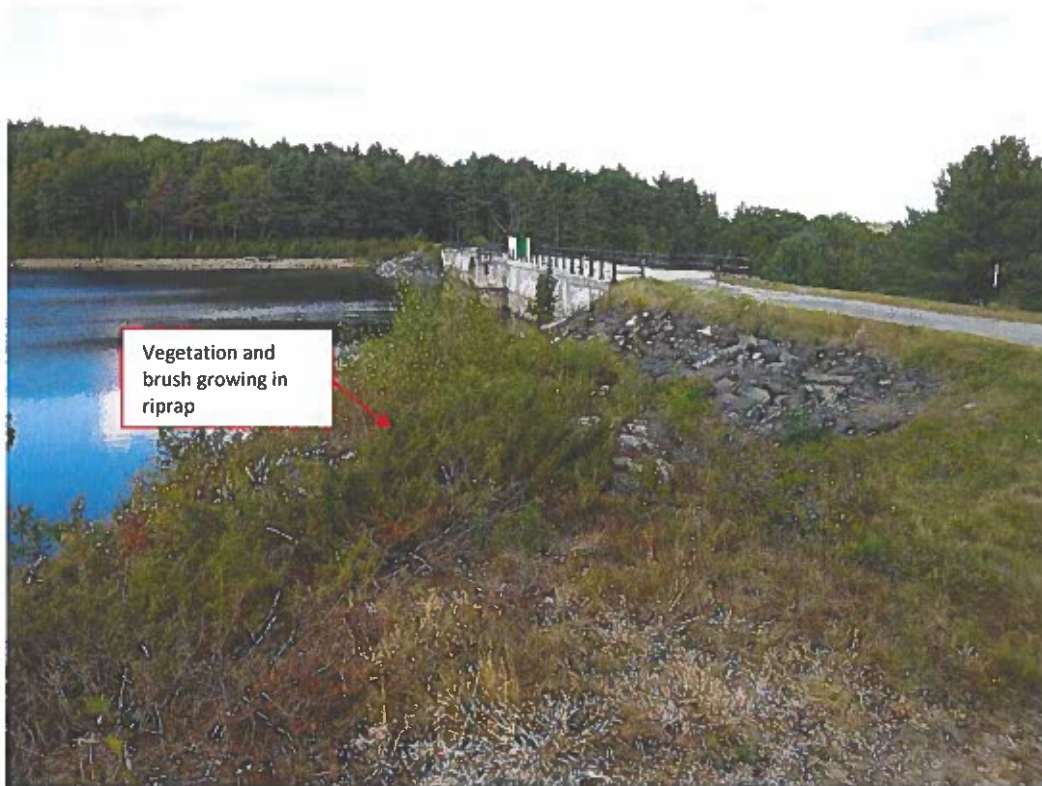
The riprap on the upstream slopes of the earth embankments is in good condition. Removal of some vegetation and brush is needed along the right embankment (Photo 1). The upstream portions of the concrete dam have some cracking and spalling of the shotcrete coating which has allowed some vegetation to root in its surface (Photo 18). Mineral deposits were noted below many of these cracks.

Photo No. 1: Overview of dam and upstream face from right abutment. Note vegetation and brush growing in upstream slope riprap.

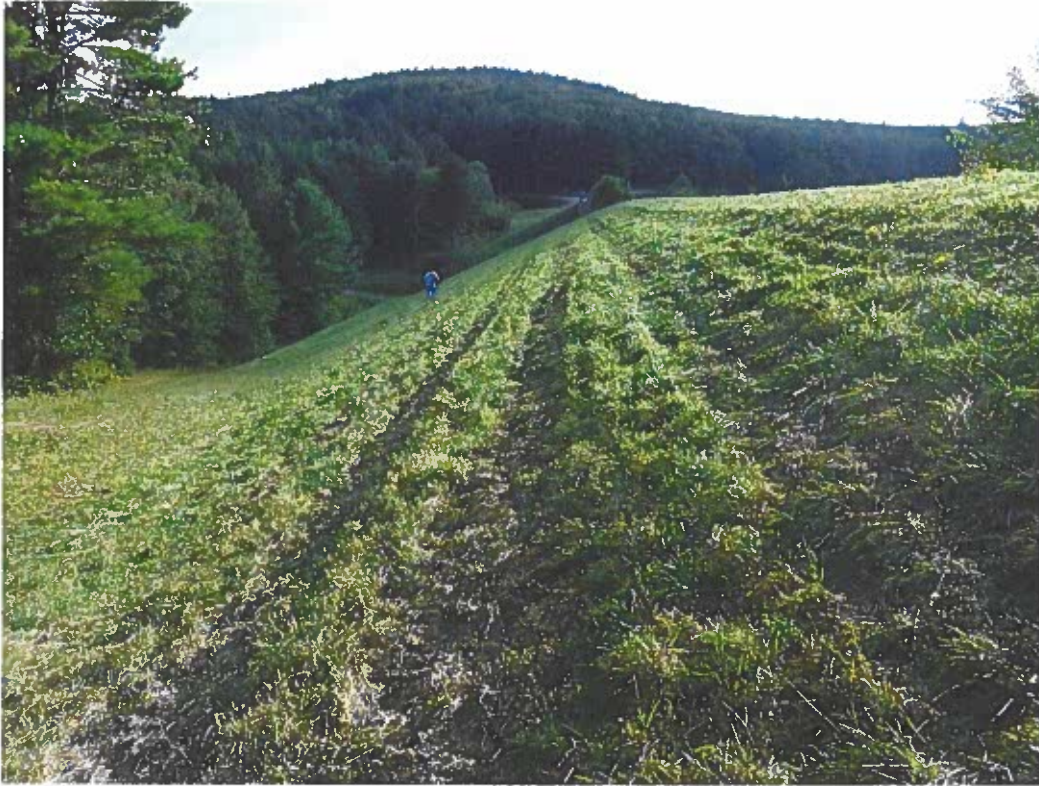
The grass-covered downstream slopes of the earth embankment are covered with maintained grass about 4 to 5 inches tall (Photos 6 and 7). Some tractor ruts and bare spots (Photo 37) were found parallel to the slope on the left downstream face. The area approximately 20-feet-wide by 40-feet-long at the base of the dam, right of the gate house, previously observed in 2012 as soft, damp ground, was much drier and firm during this inspection (Photo 14). Much of the shotcrete surface on the downstream face of the concrete dam is cracked, spalled and delaminated. Some vegetation has taken root in the cracks (Photos 29 and 30). Mineral deposits were noted below many of the spalled areas. One area has exposed wire mesh reinforcement from the shotcrete application performed between 1981 and 1982 (Photos 25 and 26). Calcium deposits were noted along the left concrete downstream face along with damp areas (Photo 27).

Photo No. 7: Overview of downstream slope from left abutment. Note ruts in grass due to mowing equipment.

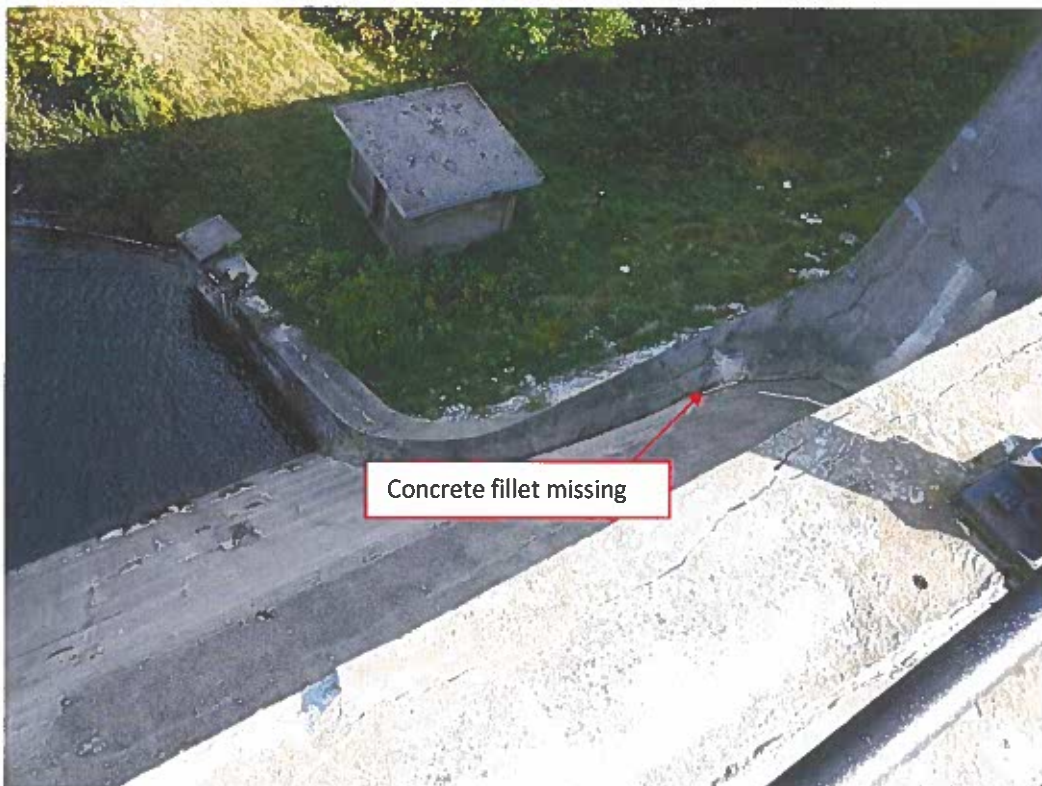
Photo No. 8: Overview of right downstream spillway training wall. Note part of concrete fillet is missing and cracks and efflorescence are present.

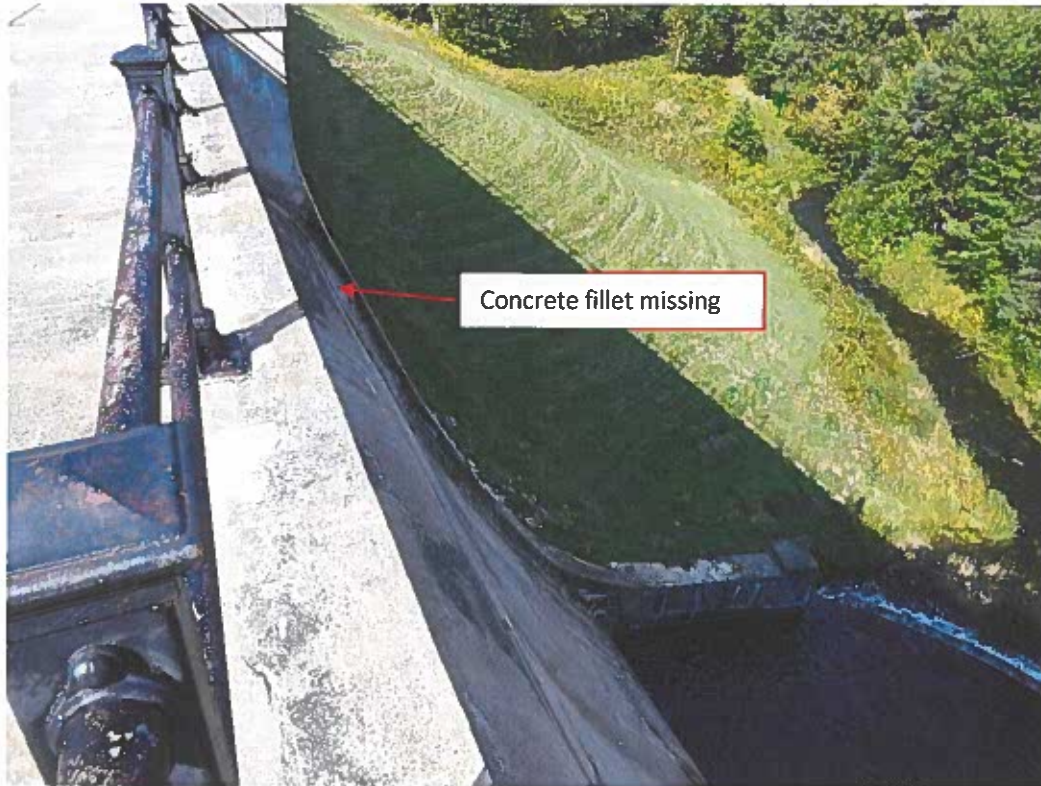
Photo No. 9: Overview of left downstream spillway training wall. Note part of concrete fillet is missing and cracking and efflorescence are present on the wall.

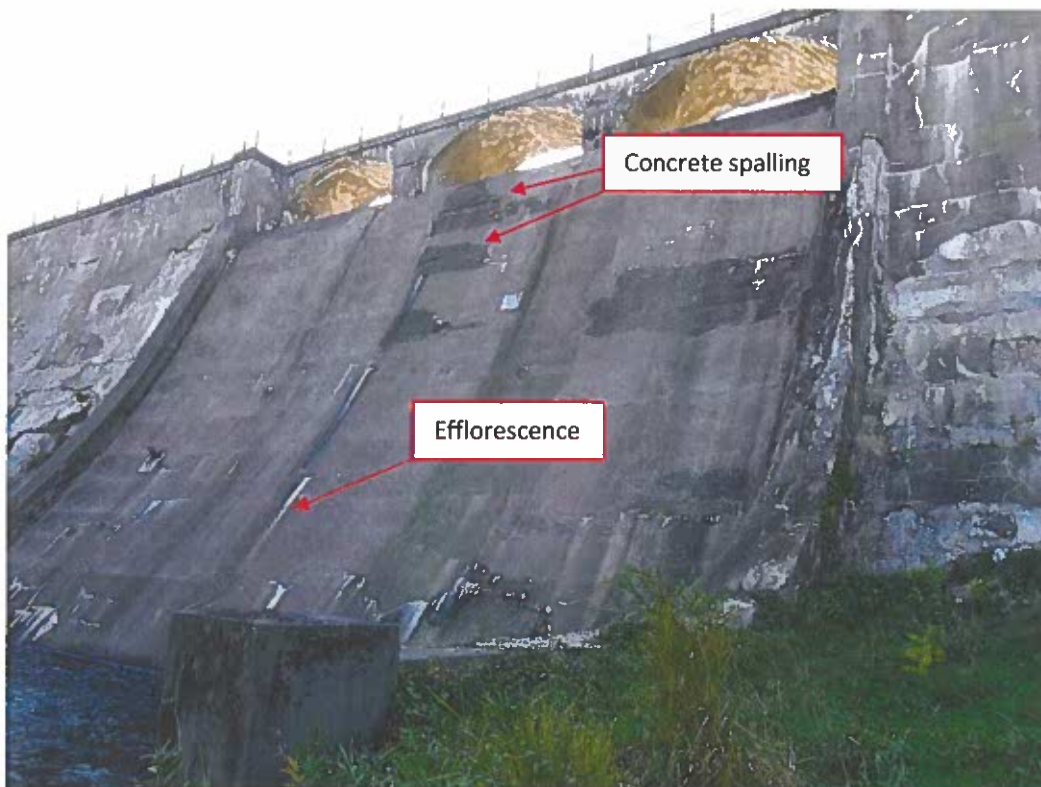
Photo No. 10: Overview of spillway from downstream. Note spalled sections of concrete and efflorescence on spillway weir.

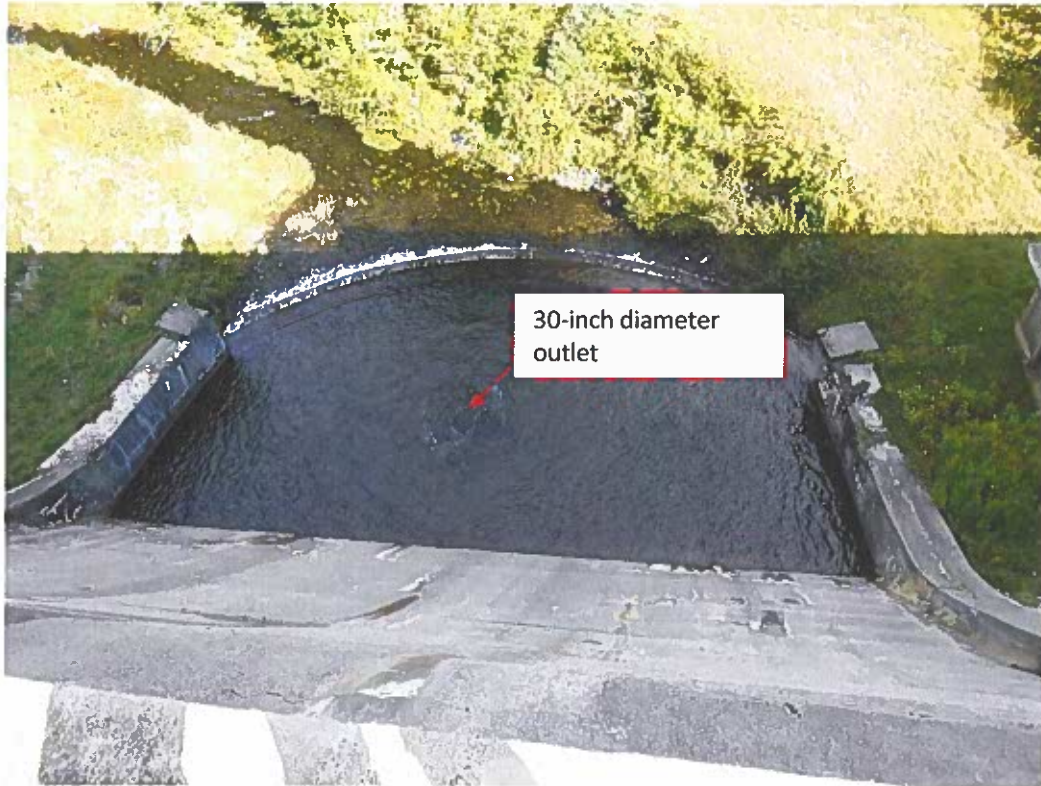
Photo No. 11: Overview of stilling basin looking downstream from the crest. Note variation in elevation of the top of the downstream basin overflow weir. Also note trees along channel.

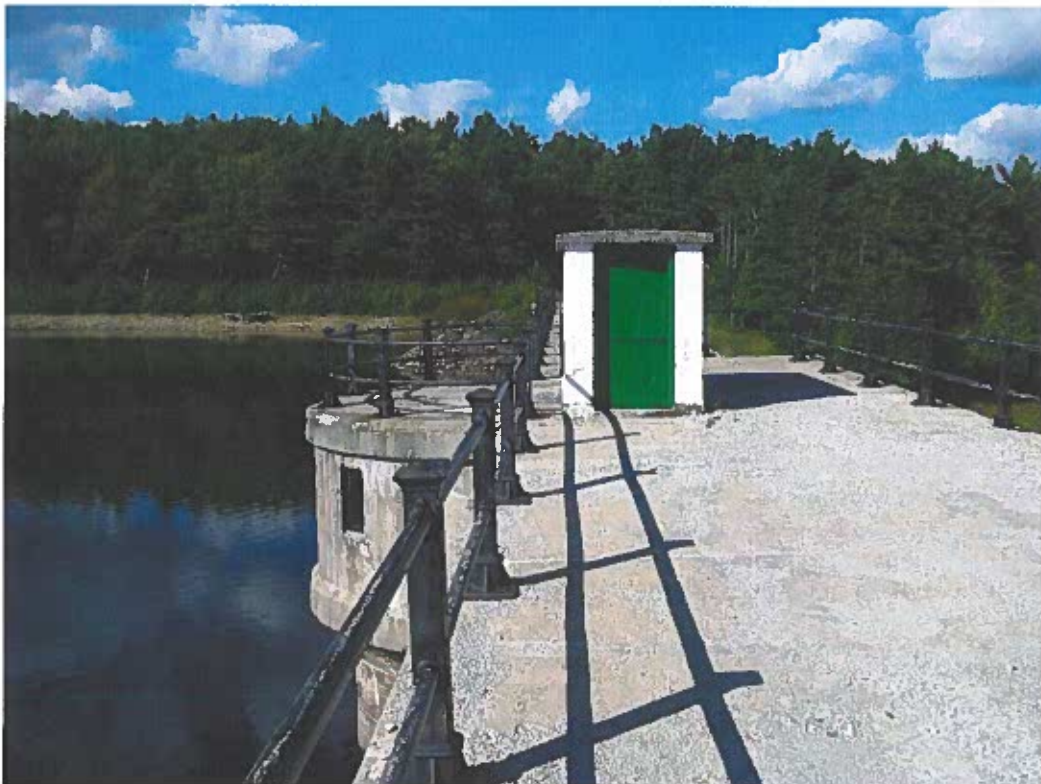
The concrete dam crest is generally in fair condition. Cracking and spalling is exhibited along the length of the concrete crest, and a small amount of vegetation is taking root (Photos 12, 19 and 21). Moss and vegetation are also growing in joints along the concrete dam crest. In addition, there are longitudinal cracks along the steel pipe railing on the concrete crest (Photo 38). The crest of the left earth embankment is covered with maintained grass about 4 to 5 inches tall. The crest of the right earth embankment is

Photo No. 12: Overview of upper gatehouse exterior. Note cracking, spalling, and puddling along concrete deck.

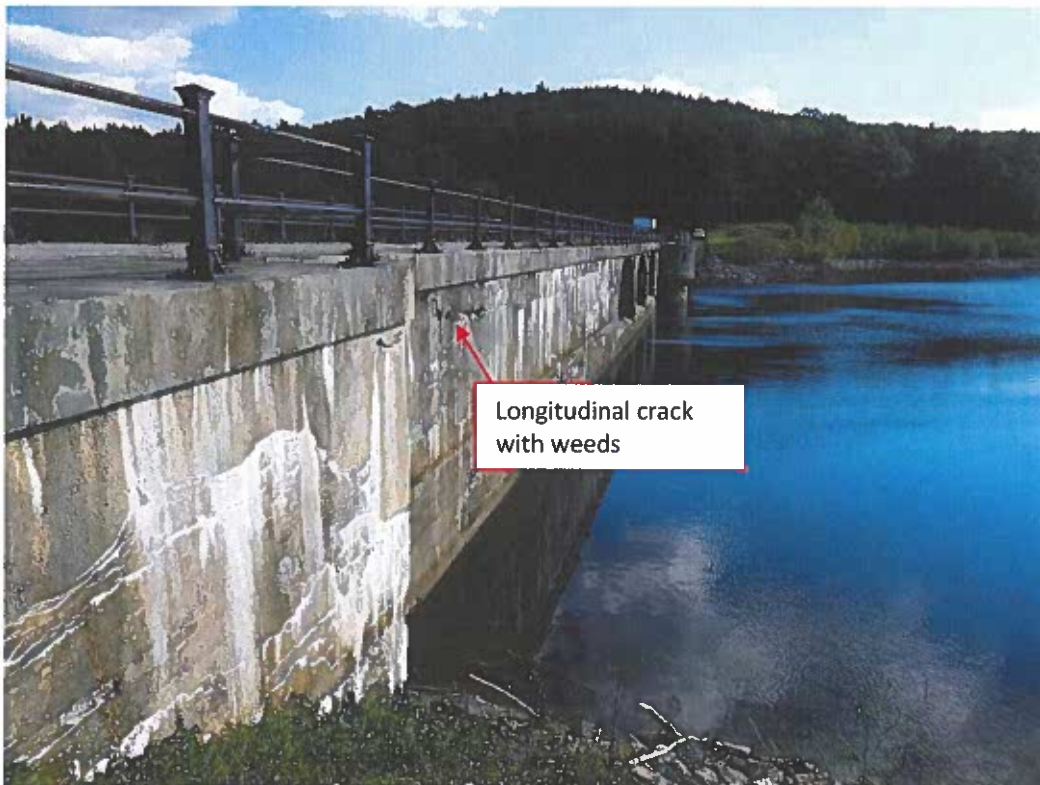
Photo No. 18: Cracks and efflorescence on upstream face of dam. Note that some weeds are growing in the cracks.

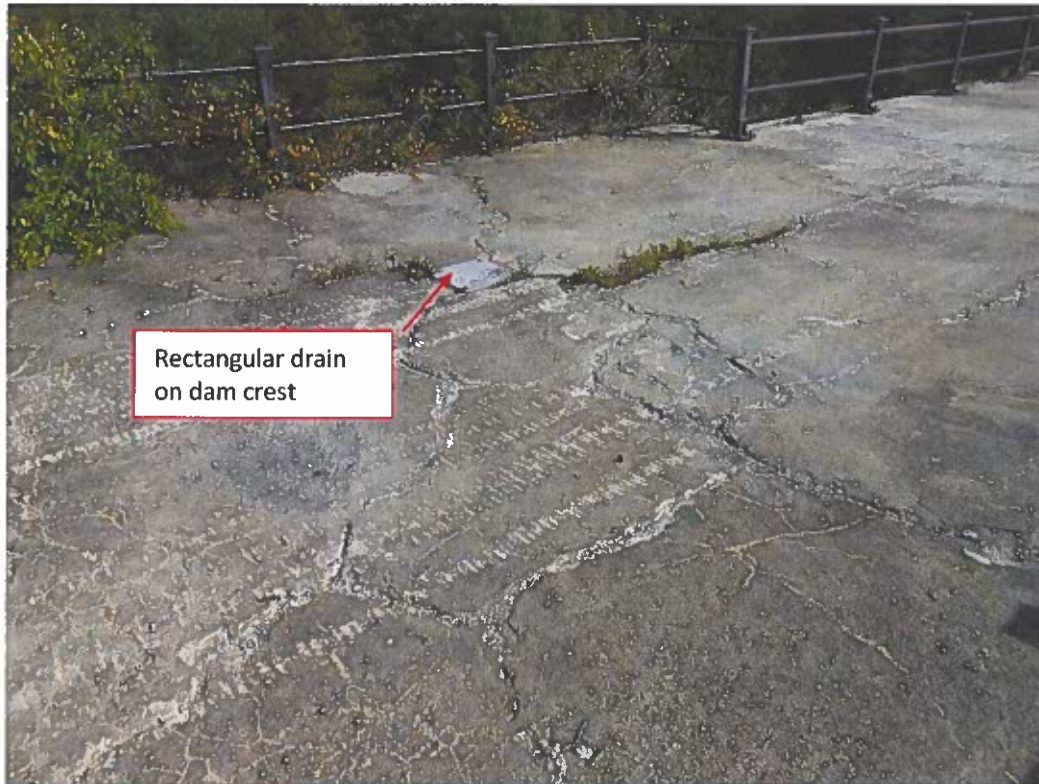
Photo No. 19: Cracks on crest near left embankment. Note minor weeds and moss growing in the cracks. Rectangular drain leads directly to left-most inspection gallery drainage well.

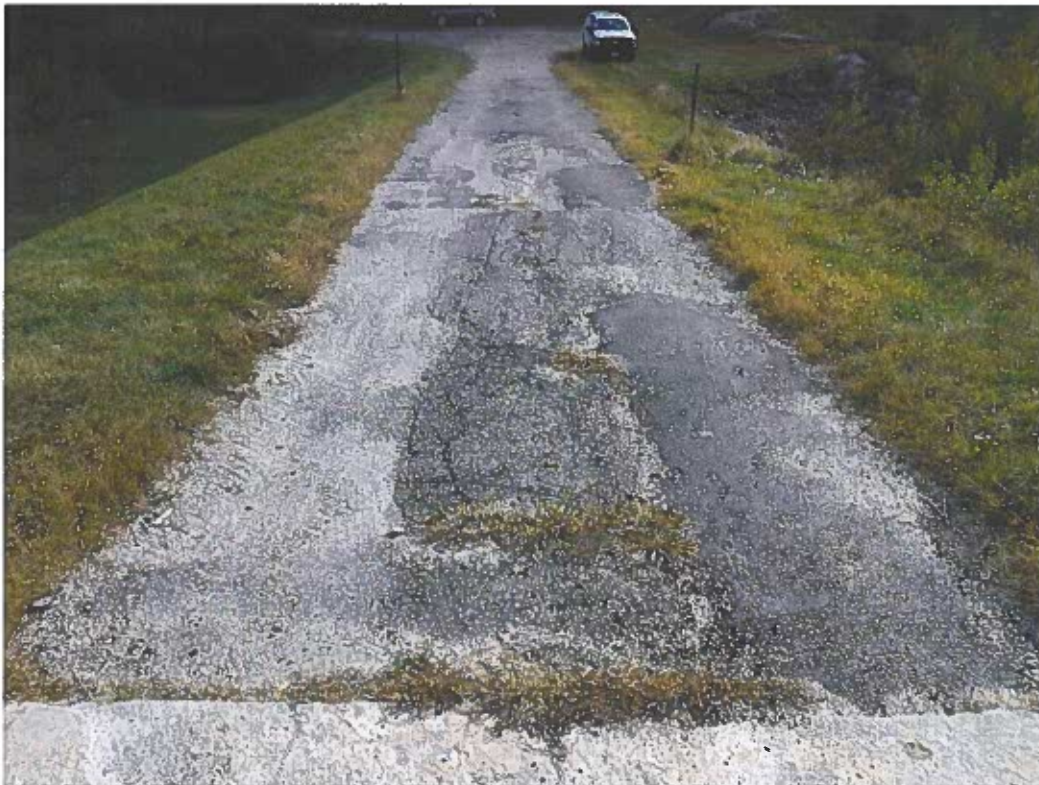
covered with an asphalt access road that has severe deterioration with ruts and cracks and is in need of repair (Photos 4 and 20).

Photo No. 20: Pavement eroded, rutted, and cracked on right crest (looking towards right abutment).

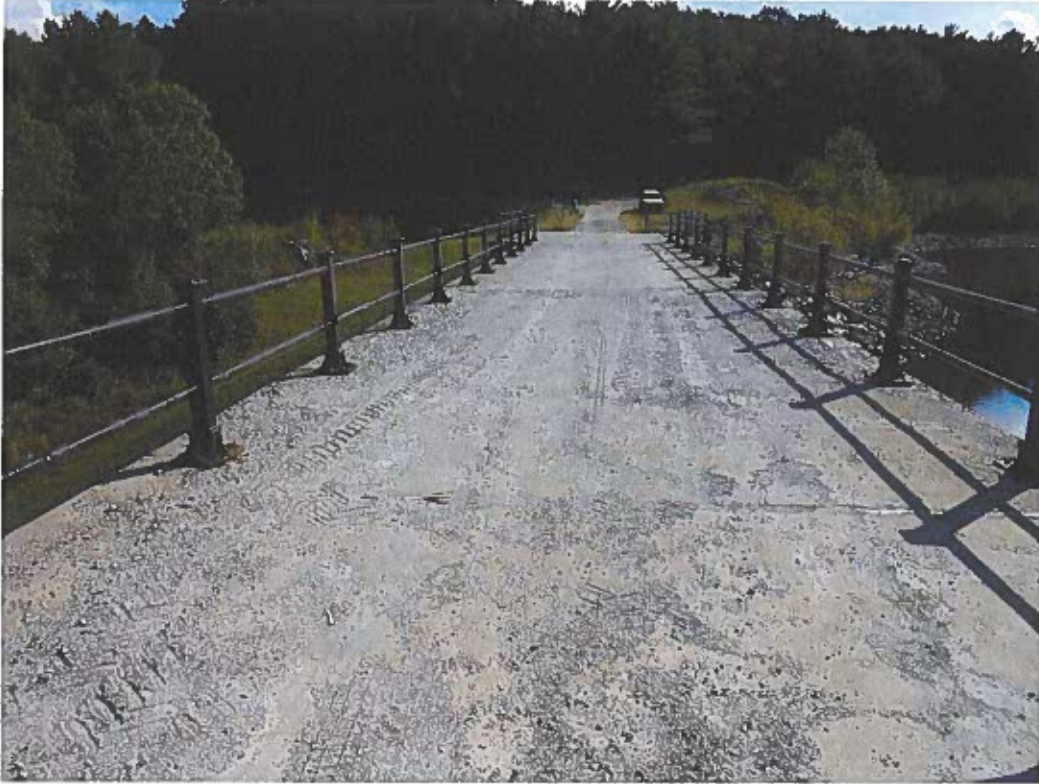
Photo No. 21: Concrete spalled and cracked on right crest (looking towards right abutment).

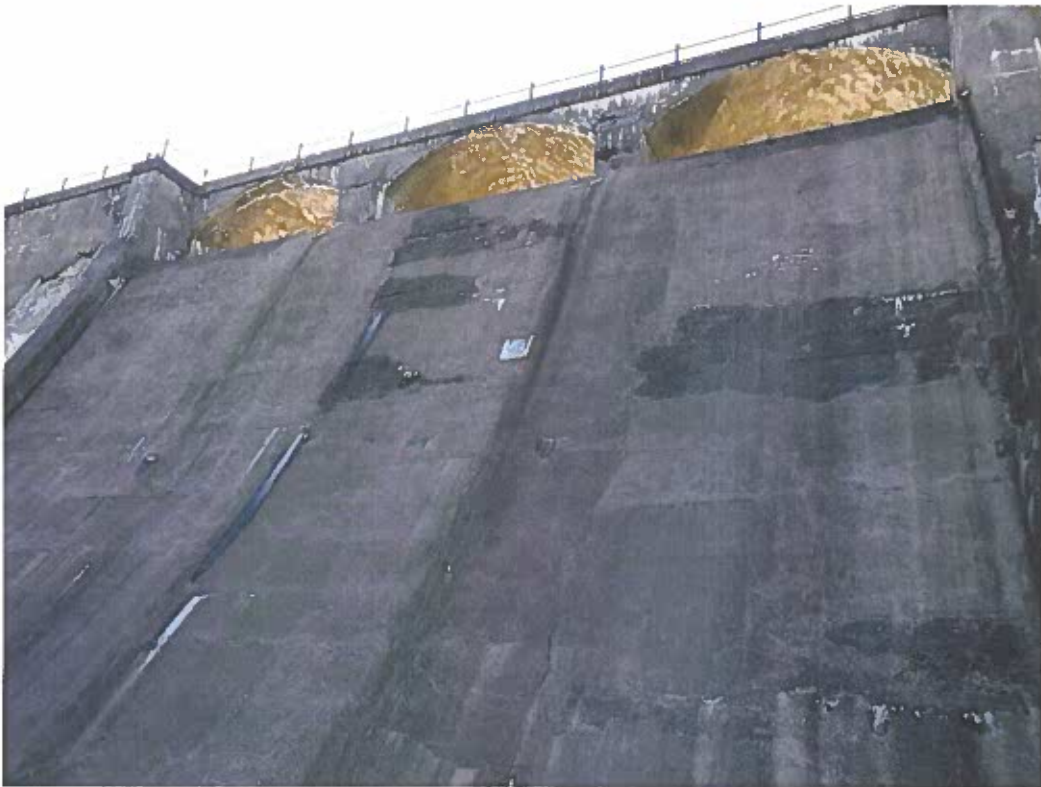
Photo No. 22: Cracks/spalling and efflorescence on the spillway surface (view from downstream).

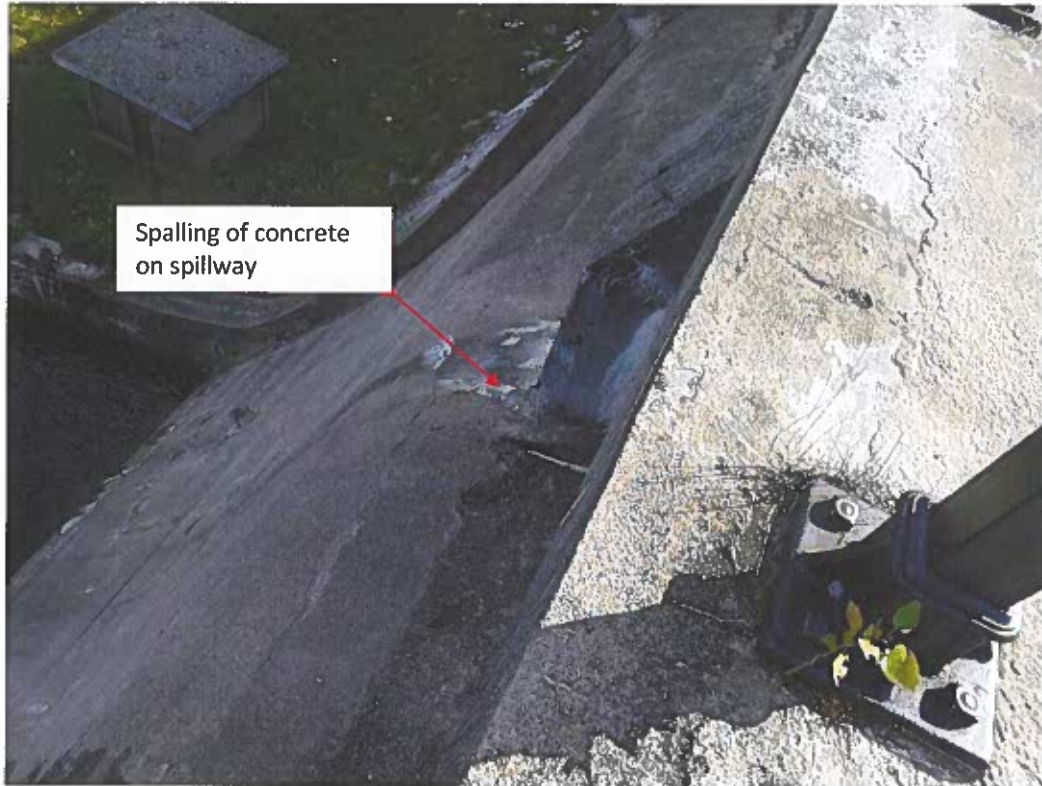
Photo No. 23: Spalling on the spillway surface (view from the crest).

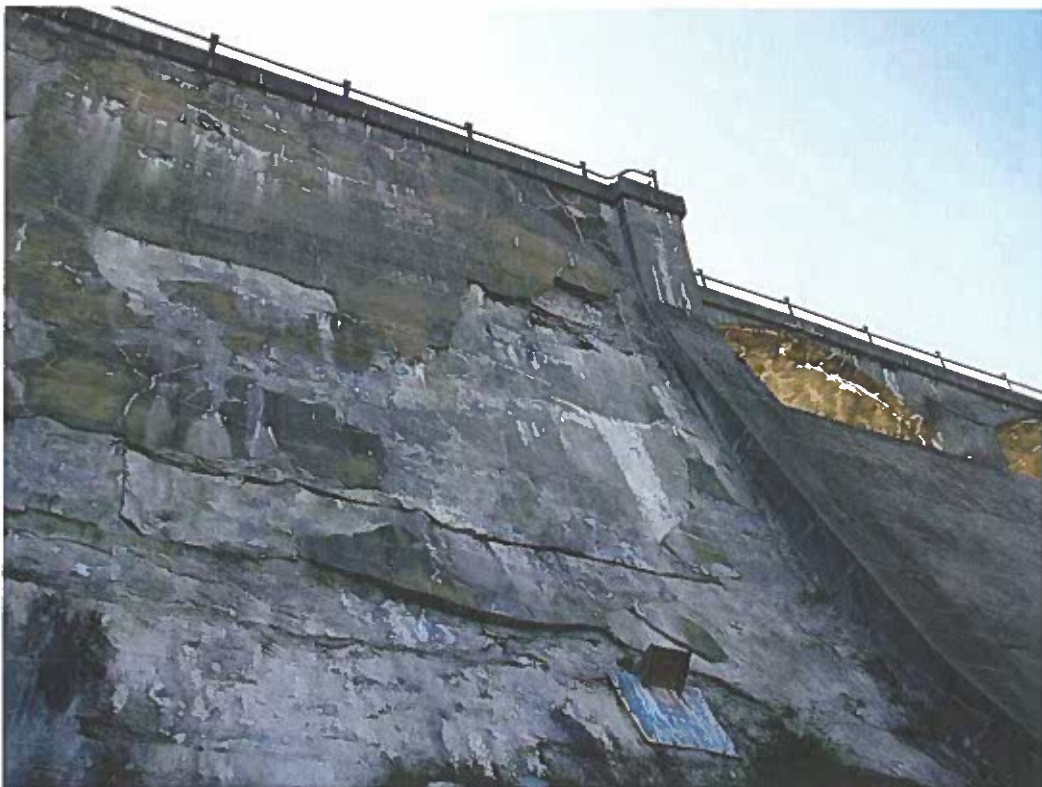
Photo No. 24: A large piece of shotcrete spalled next to the right training wall on the right downstream face. Note weeds growing in the cracks.

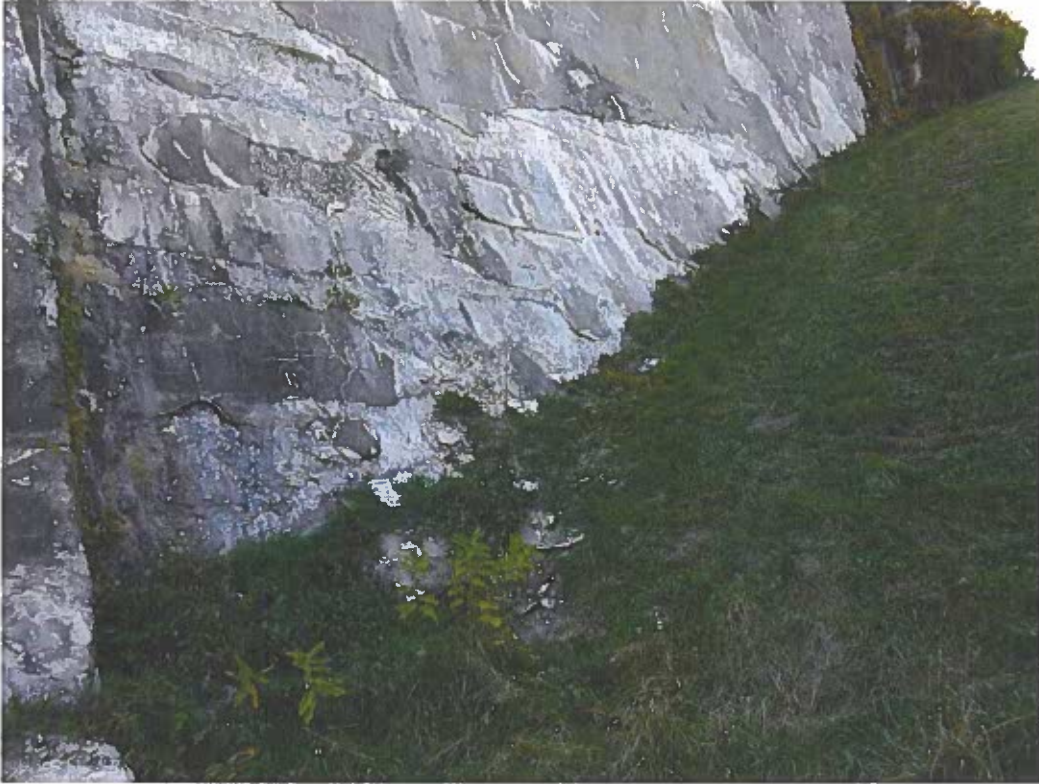
Photo No. 25: Spalling of shotcrete left of the spillway (downstream face). Note calcium deposits forming to the left of the left training wall.

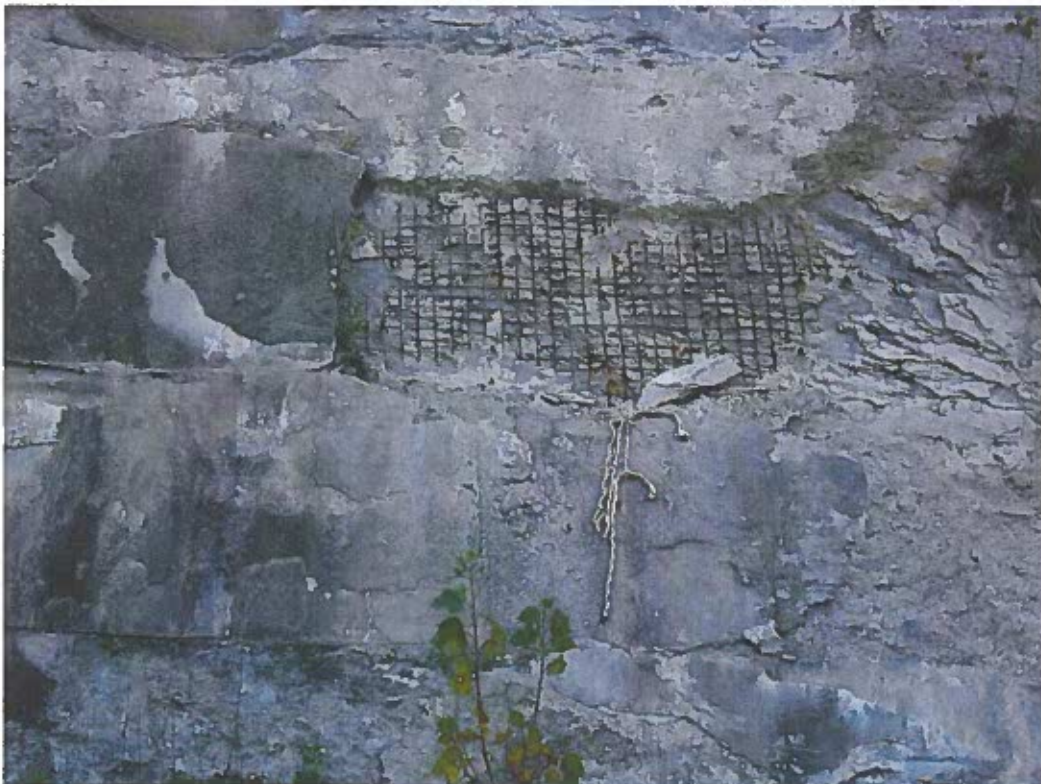
Photo No. 26: A large section of shotcrete spalled exposing wire mesh on the downstream face of dam next to left training wall.

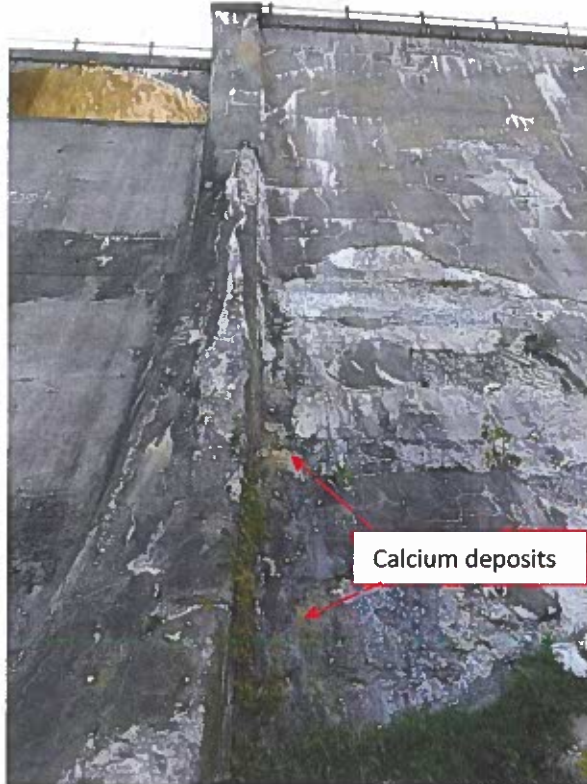
Photo No. 27: Efflorescence and spalling of concrete at toe of left training wall. Note calcium deposits on left downstream face.

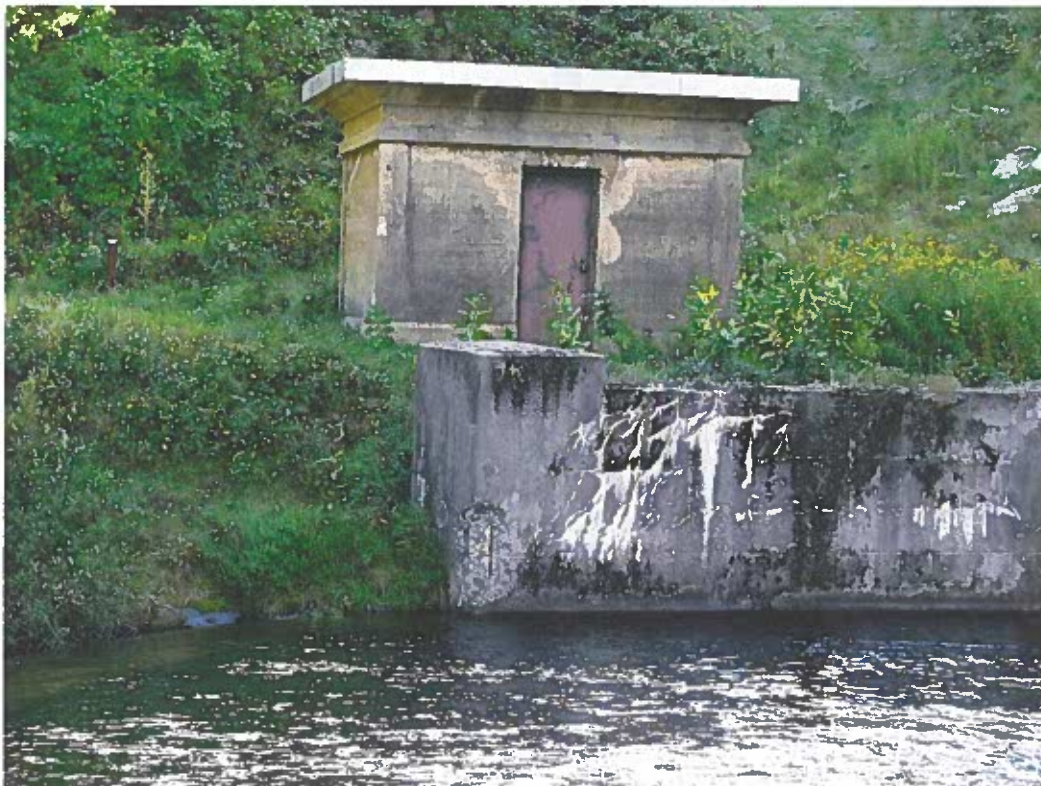
Photo No. 28: Concrete spalling and exposed rebar at the end of the right training wall.

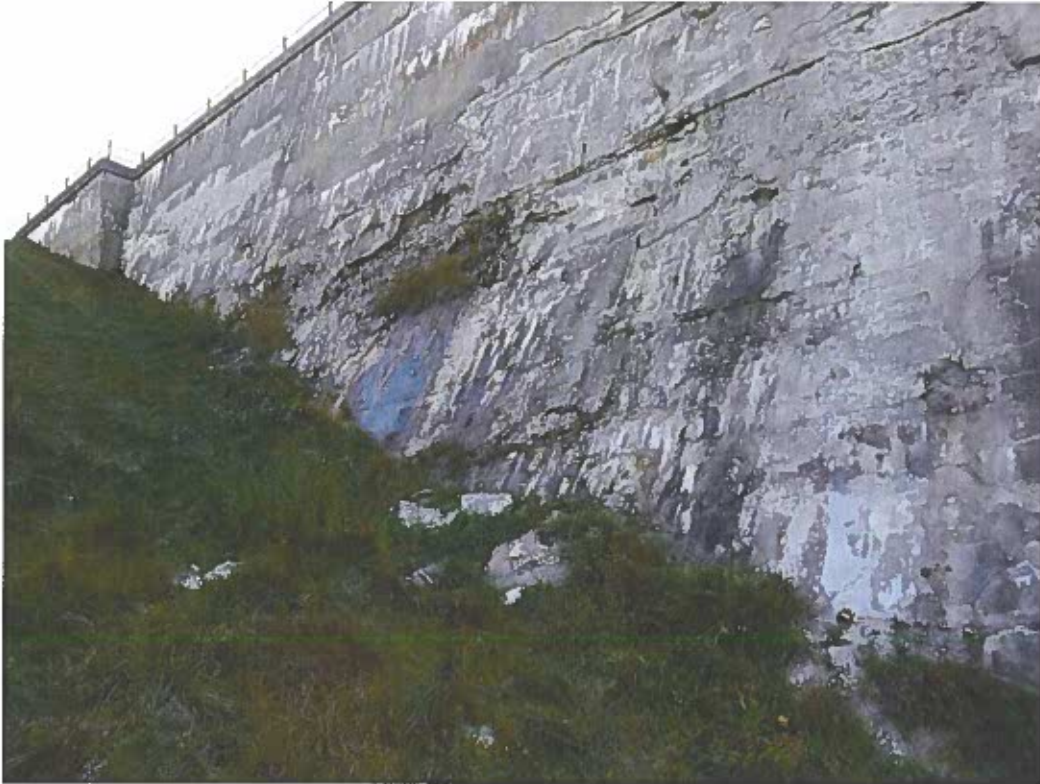
Photo No. 29: Efflorescence, cracking, spalling and weeds growing in the cracks on the downstream face of the dam to right of spillway.

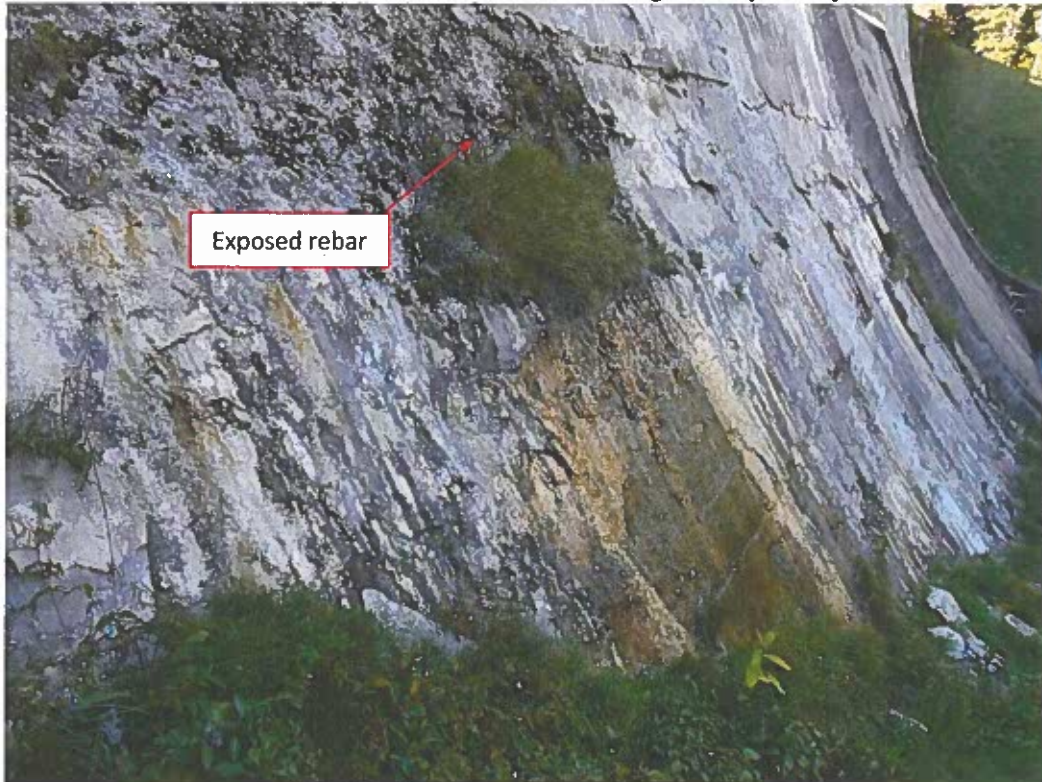
Photo No. 30: Exposed rebar intended to provide anchorage for shotcrete on the downstream face of the dam to right of spillway.

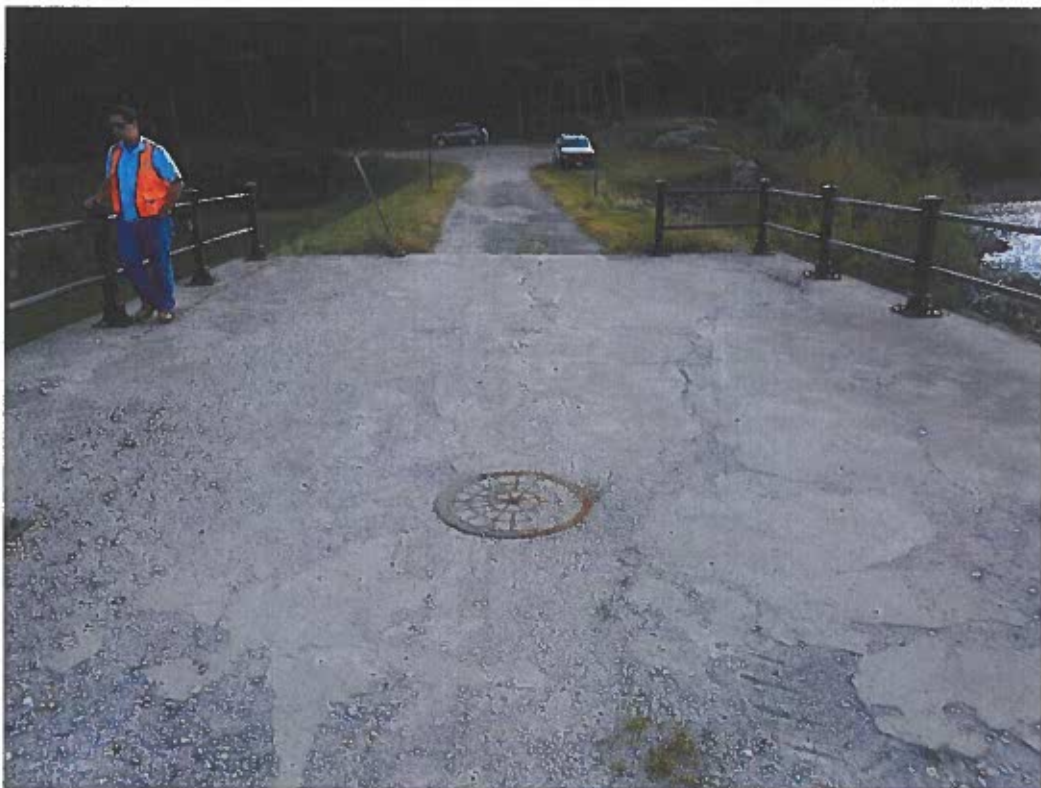
10. Broken steps on access ladder in right access manhole to drainage gallery.

Photo No. 32: Entrance to the inspection gallery on dam crest. Note the broken ladder steps.

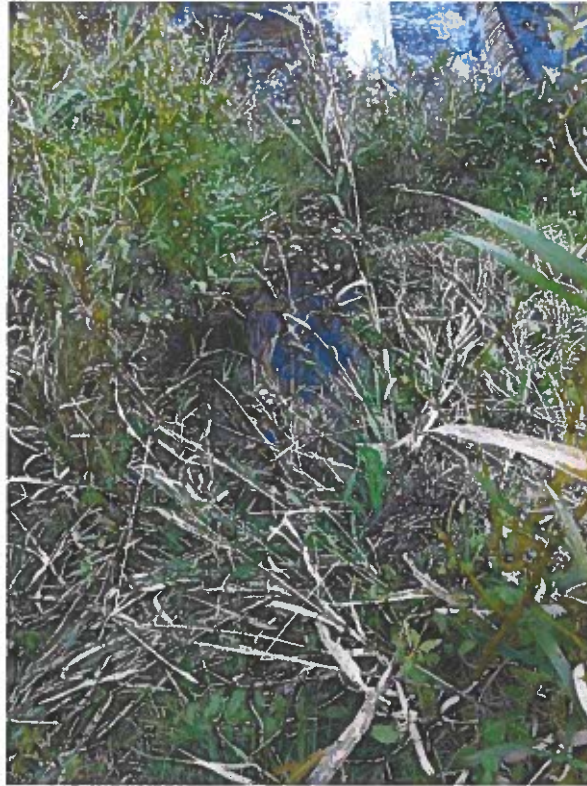
The seepage infiltration gallery was not observed during this inspection. A detailed structural inspection was performed in September 2014 as part of the field investigation for the preliminary rehabilitation design of the dam. It has been reported that the 8-inch diameter cast iron outlet drain has been blocked since the 1960's, causing the seepage water to flow out of the top of the infiltration gallery access manhole downstream of the dam (Photos 33 and 34).

Photo No. 33: Manhole entrance to the inspection gallery under the dam. Water is flowing out of entrance.

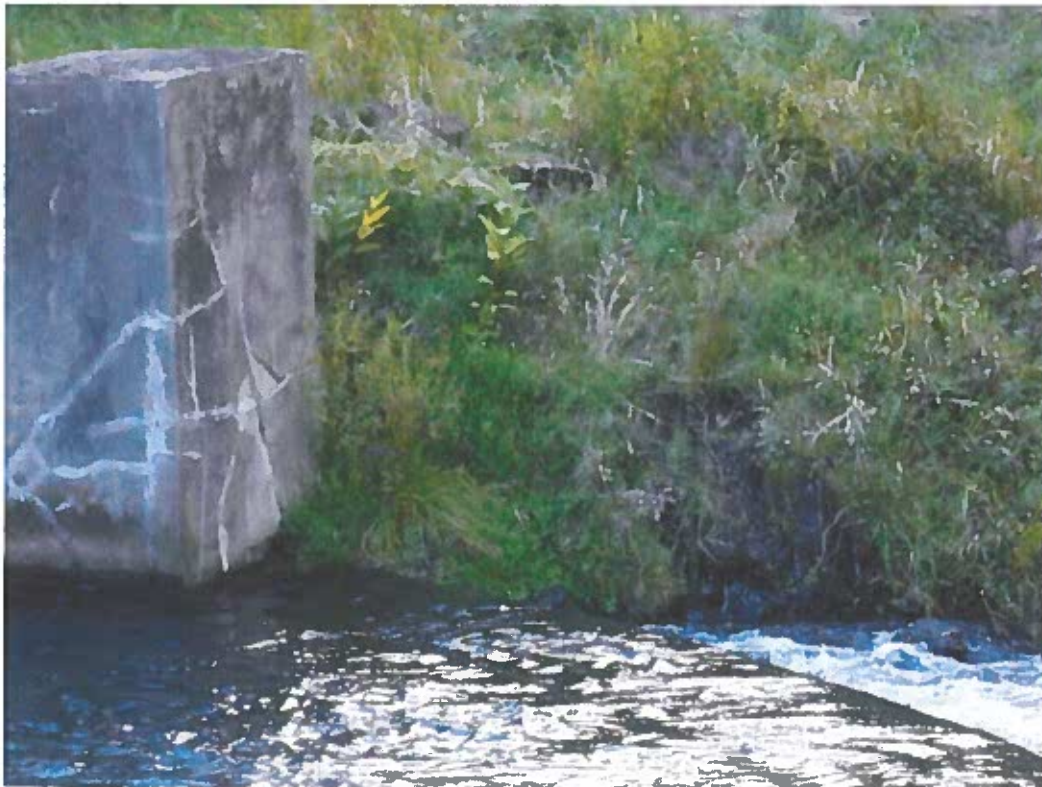
Photo No. 34: Downstream manhole access to drainage gallery. Note that water draining from the top of the drainage gallery manhole is causing erosion of the downstream bank.

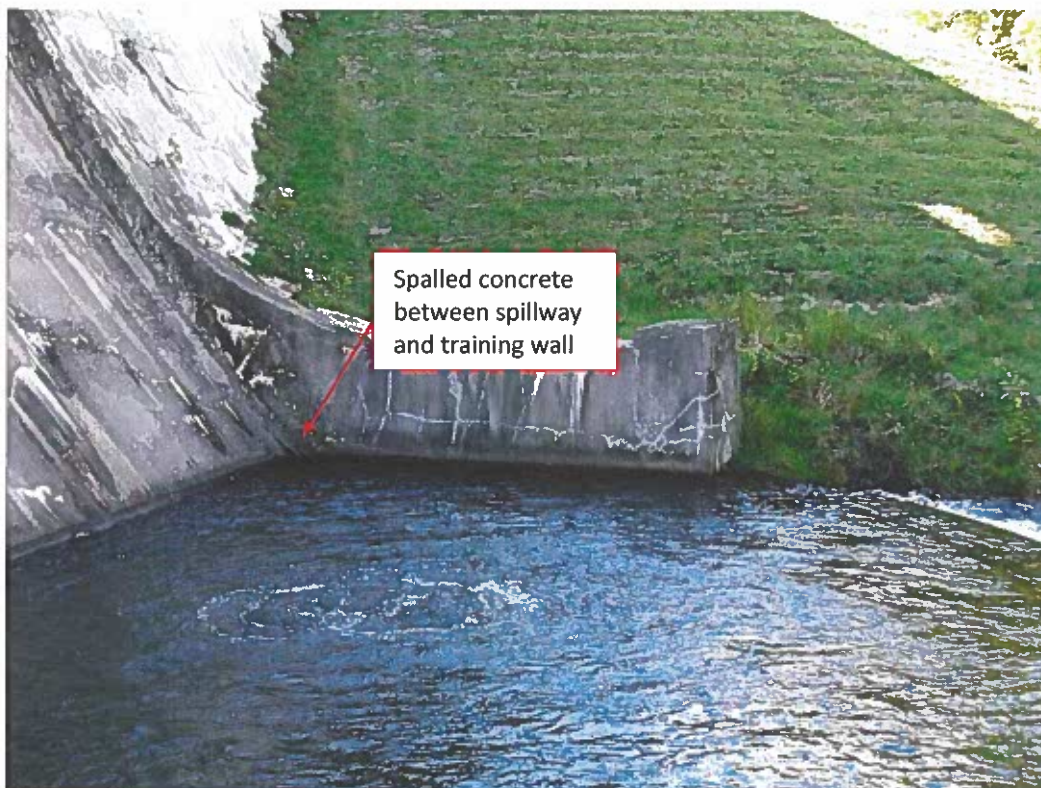
Photo No. 36: Concrete spalled between spillway and training wall at stilling basin. Cracking, spalling, and efflorescence on left training wall.

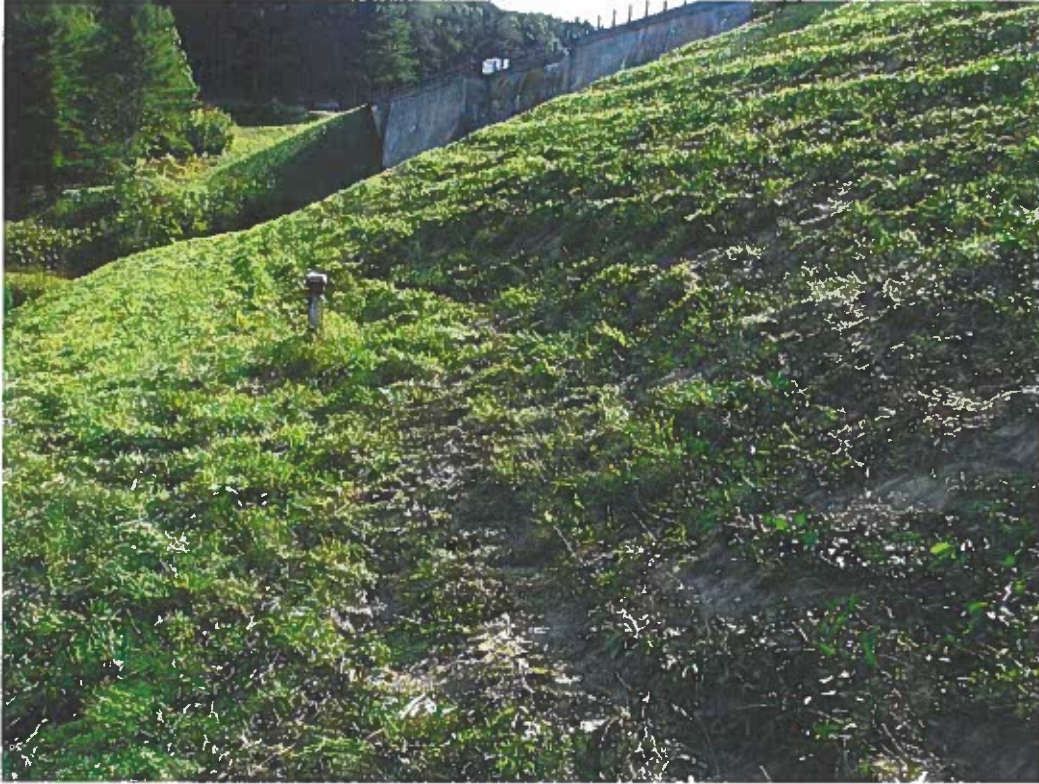
Photo No. 37: Tractor ruts and bare spots on left embankment downstream slope from mowing. Eroded zone remnant from monitoring well installation.

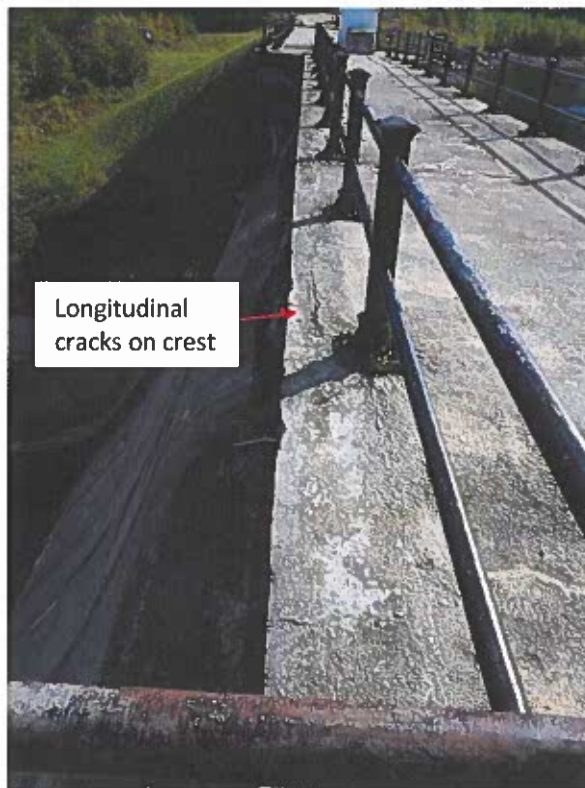
Photo No. 38: Longitudinal cracks along railing. Spalling, cracking, and efflorescence on concrete arch bridge over spillway. Weeds growing in cracks.

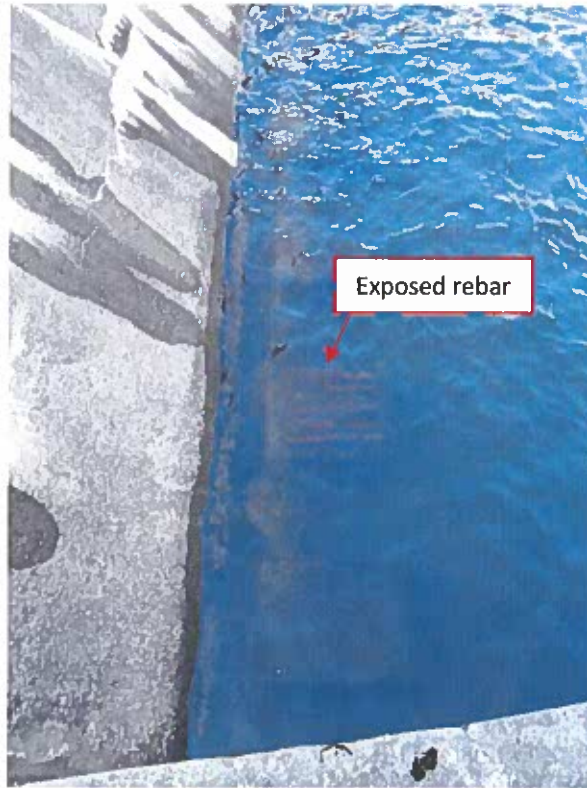
basin was flowing. Exposed rebar was observed on the top face of the baffle blocks at the base of the spillway (Photo 39).

Photo No. 39: Exposed rebar on baffle blocks in stilling basin.
