# **Pine Hill Reservoir Dam (State Dam ID# 3-14-134-6) Underwater Inspection and Acoustic Imaging**

**November 2014**

**Project:** Pine Hill Reservoir Dam Underwater Inspection

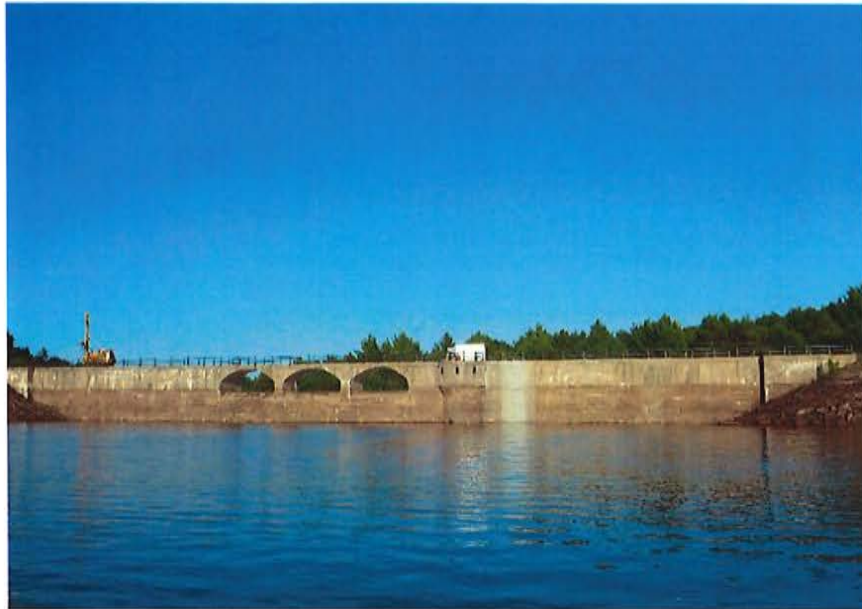
**Photograph 1. Overall View of the West Elevation,  
Looking East.**

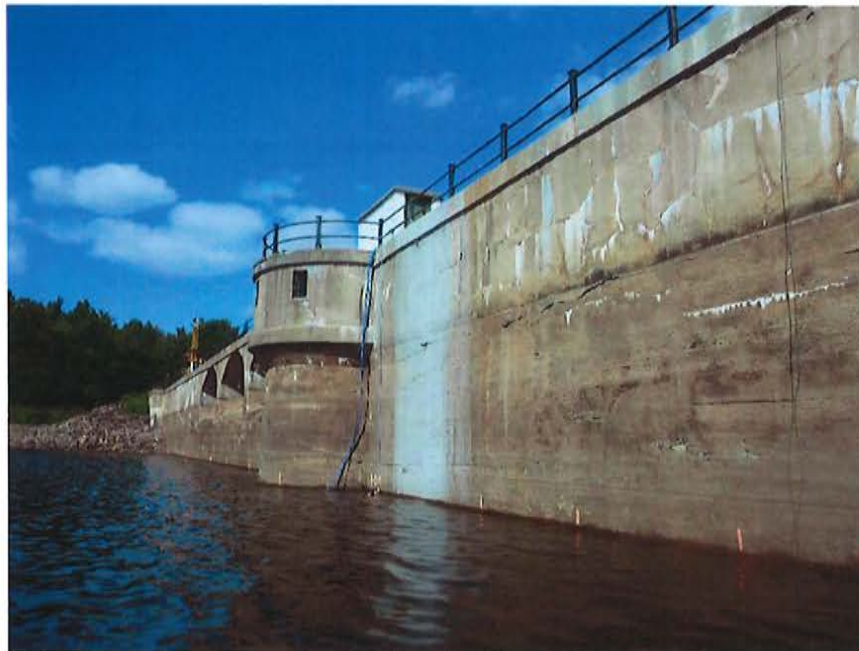
**Photograph 2. Overall of the West Elevation, Looking  
Northeast.**

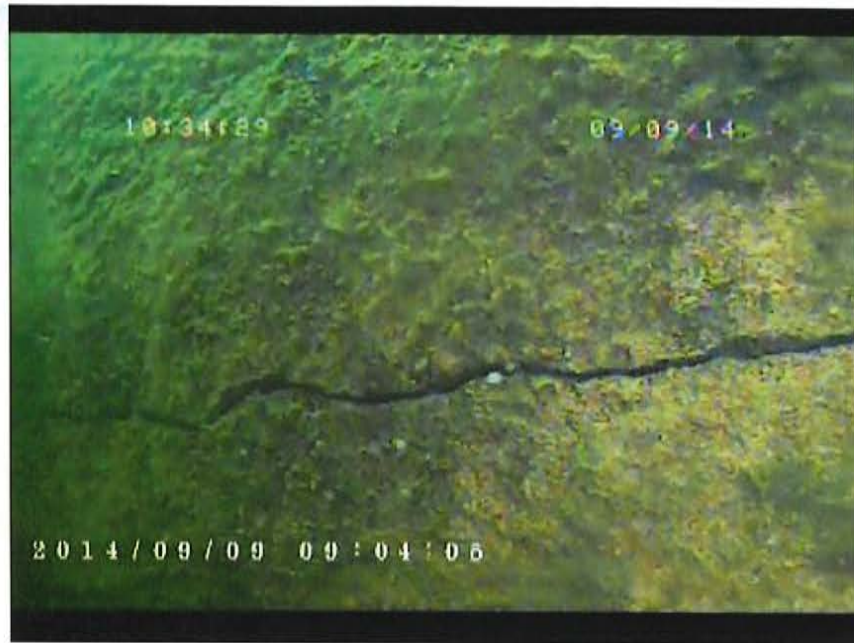
Approximately 80-lf of horizontal cracks and 4-lf of vertical cracks up to 1/8-inch wide were observed, typically located 1-2 feet below the water line and 10-12 feet below the waterline.

**Photograph 3. Typical Horizontal Crack (Station 1 + 80 shown).**

Typically, crack repairs are completed on concrete structures to limit water intrusion and corrosion of embedded reinforcing steel. However, the dam is a mass-concrete structure with minimal to no reinforcing steel, and due to the age of the observed cracks, water infiltration has already occurred. Therefore, sealing the cracks and open construction joints is not warranted at this time.

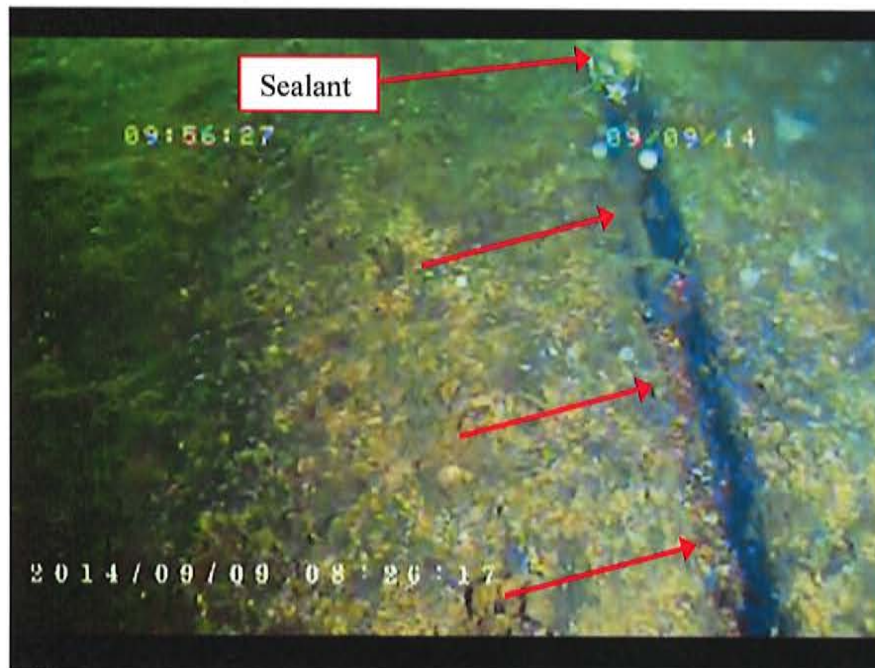
Minor corner spalling and honeycombing was typically observed around the edges of the construction joints, and failed joint sealant was observed in four construction joints, with joint openings up to 3 inches wide and up to 5 inches of penetration.

**Photograph 4. Typical Open Construction Joint (Station 1 + 28 Shown. Note Sealant Intact at Top)**

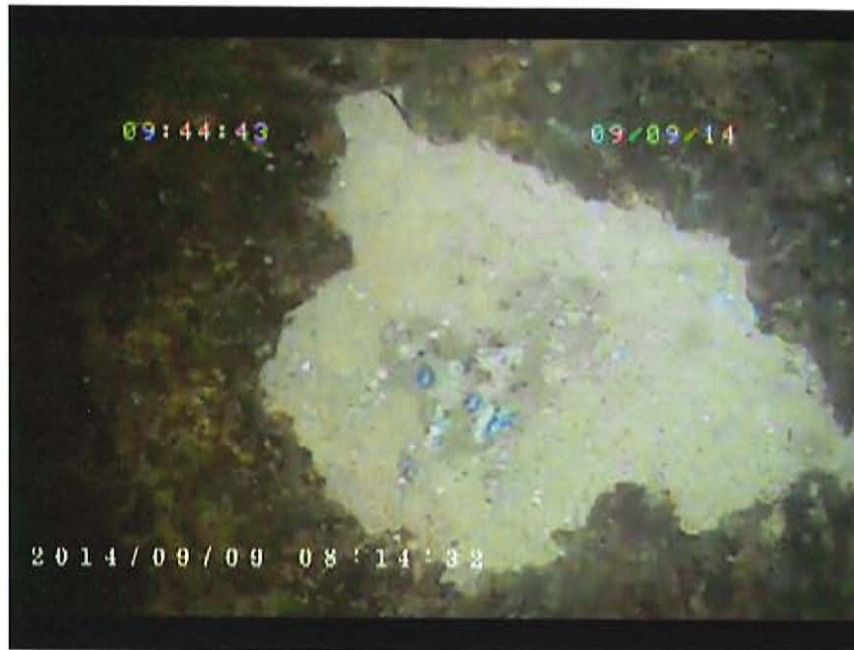
**Photograph 5.** Typical Concrete Condition with 1/8" to 1/4" Soft Concrete (Station 1 + 15 Shown)

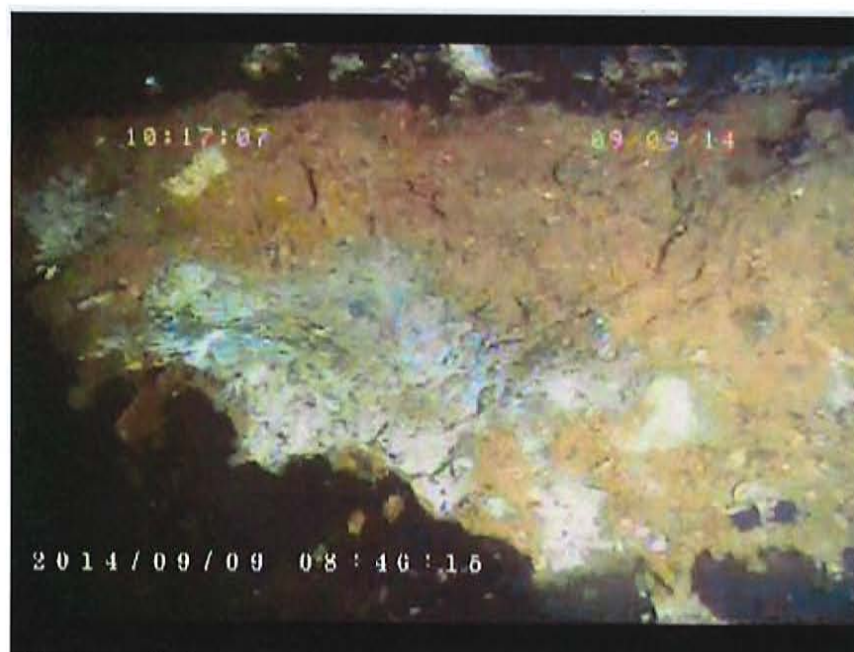
The concrete was generally in satisfactory condition, with minor scaling and soft concrete typically 1/8" to 1/4" deep on the surface. Approximately 125-sf of surface concrete degradation was observed, typically with 2-4 inches of soft concrete that could be removed easily by light chipping with a hammer. The areas of concrete degradation were typically located adjacent to construction joints and appear to be due to poor concrete consolidation during original construction. Two small open voids were observed, one located on the dam and one on the gate house. The void on the gatehouse exhibited exposed reinforcing steel; however, no significant section loss was observed in the reinforcing.

**Photograph 6.** Concrete Degradation With 2-3" of Soft Concrete (Station 1 + 50 shown).

Recommended repairs include repairing the areas of deteriorated concrete and voids to maintain the integrity of the structure; however, the repairs can be completed on a low-priority basis. Repairs would consist of removal of soft and deteriorated concrete down to sound concrete, forming around the limits of the repair area, and placement of new concrete. All concrete repair work can be completed underwater by using a form-and-pump method with a marine grade concrete or a polymer-modified mortar such as Octocrete U. Concrete repairs may also be completed in the dry using temporary cofferdams, however this approach is far more expensive and generally used where more critical structural repairs are required; therefore this repair method is not warranted for this project. Additionally, the leaking intake valve should be investigated to determine the cause and the issue resolved on a low-priority basis.

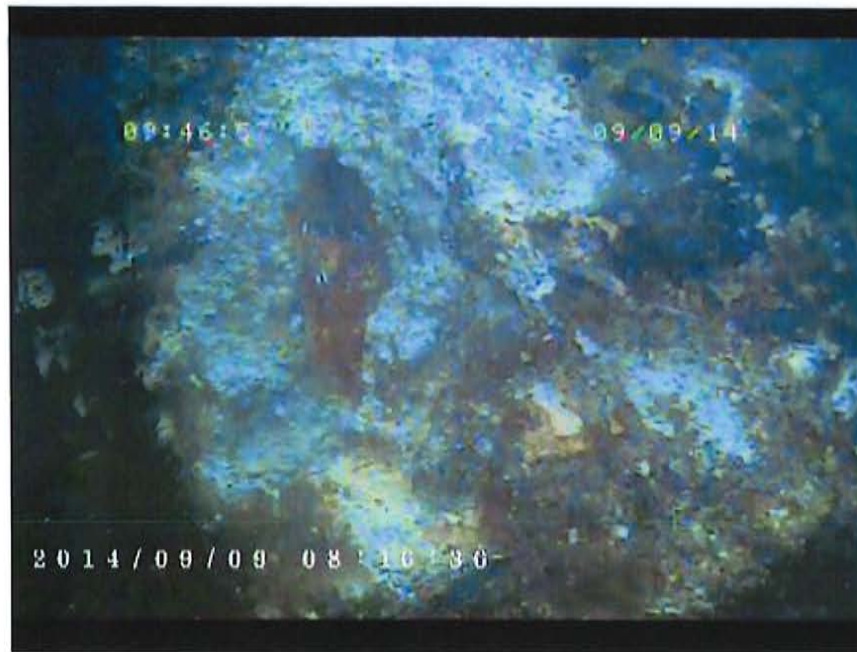
**Photograph 7. Spall with Exposed Reinforcing Steel at Gate House (Station 1 + 22).**

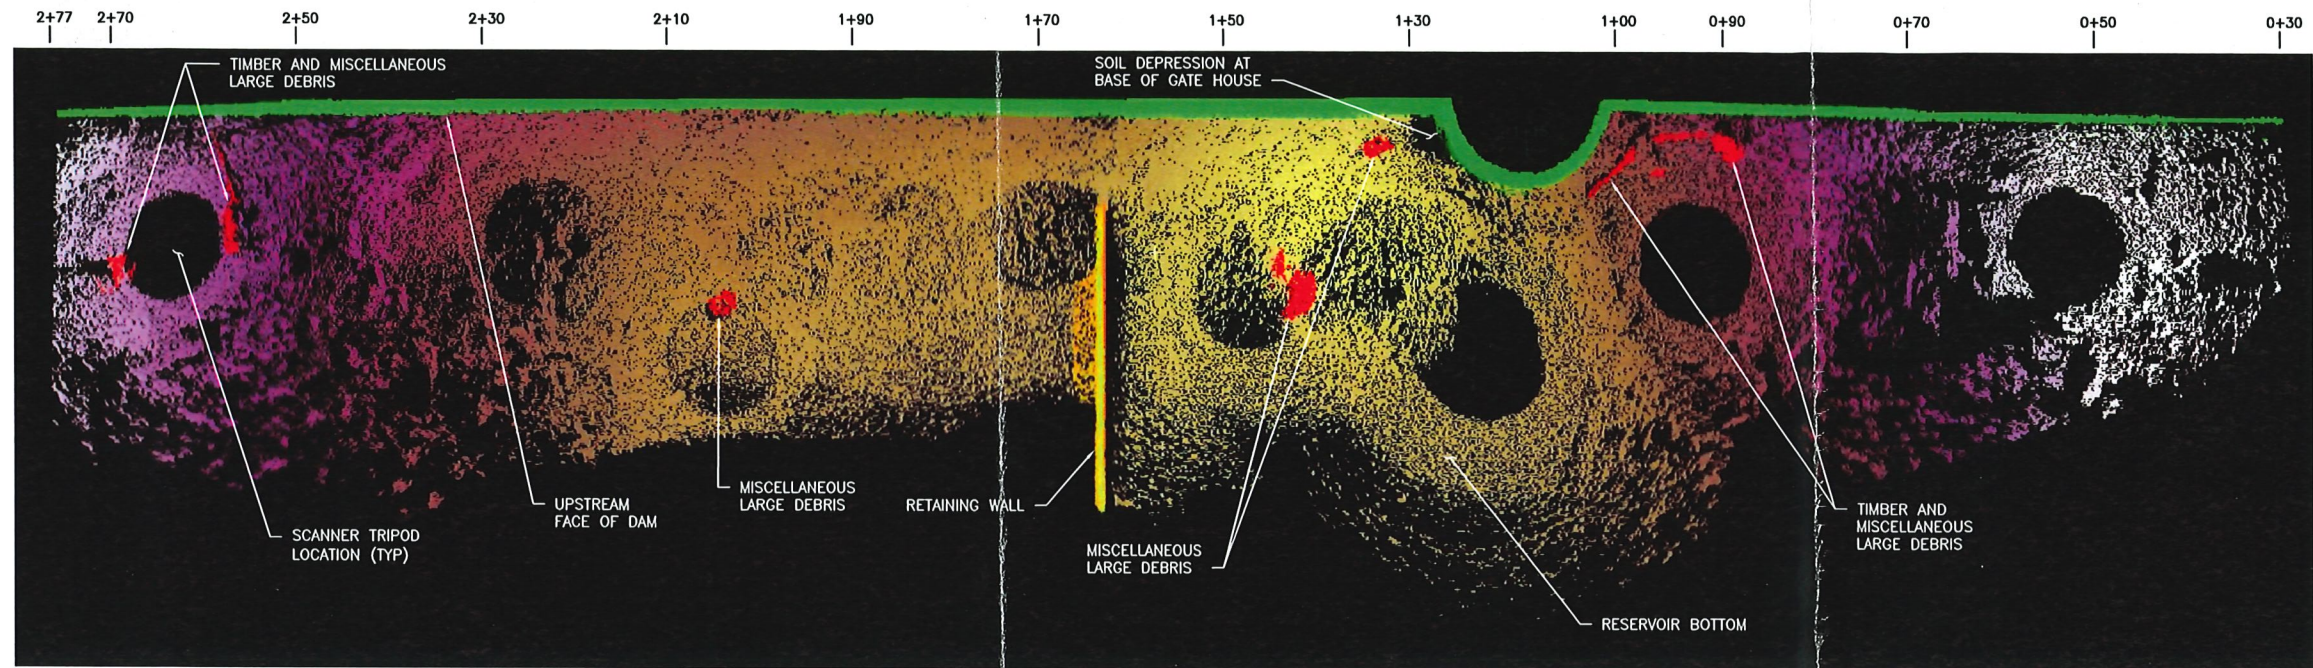
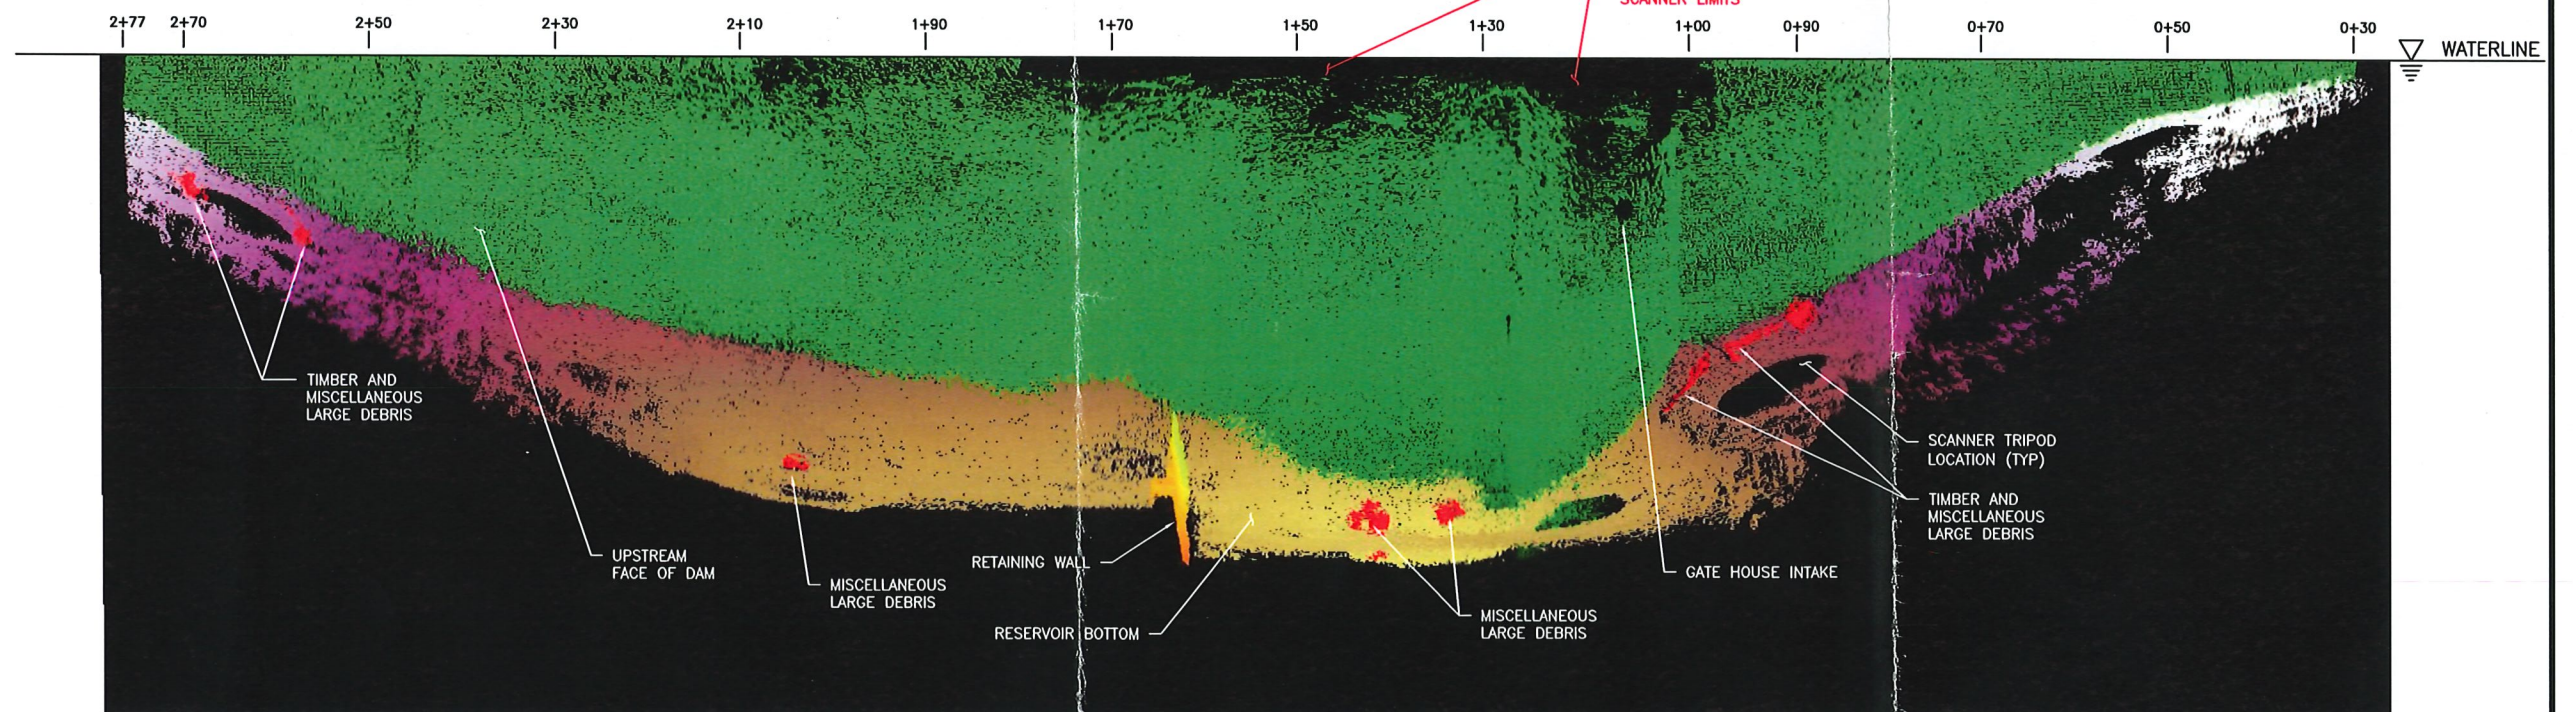
STATE DAM ID# 3-14-134-6 HOLDEN, MA FIG. NO.  
PINE HILL RESERVOIR DAM  
ACOUSTIC IMAGING  
B1

A retaining wall was detected in the 3-D acoustic imaging, located at station 1+65 approximately 10 feet from the face of the dam. The retaining wall appears to have originally been installed to retain the northern slope; however, the imaging indicates that the bottom contours have changed such that the wall is no longer required for slope stability.

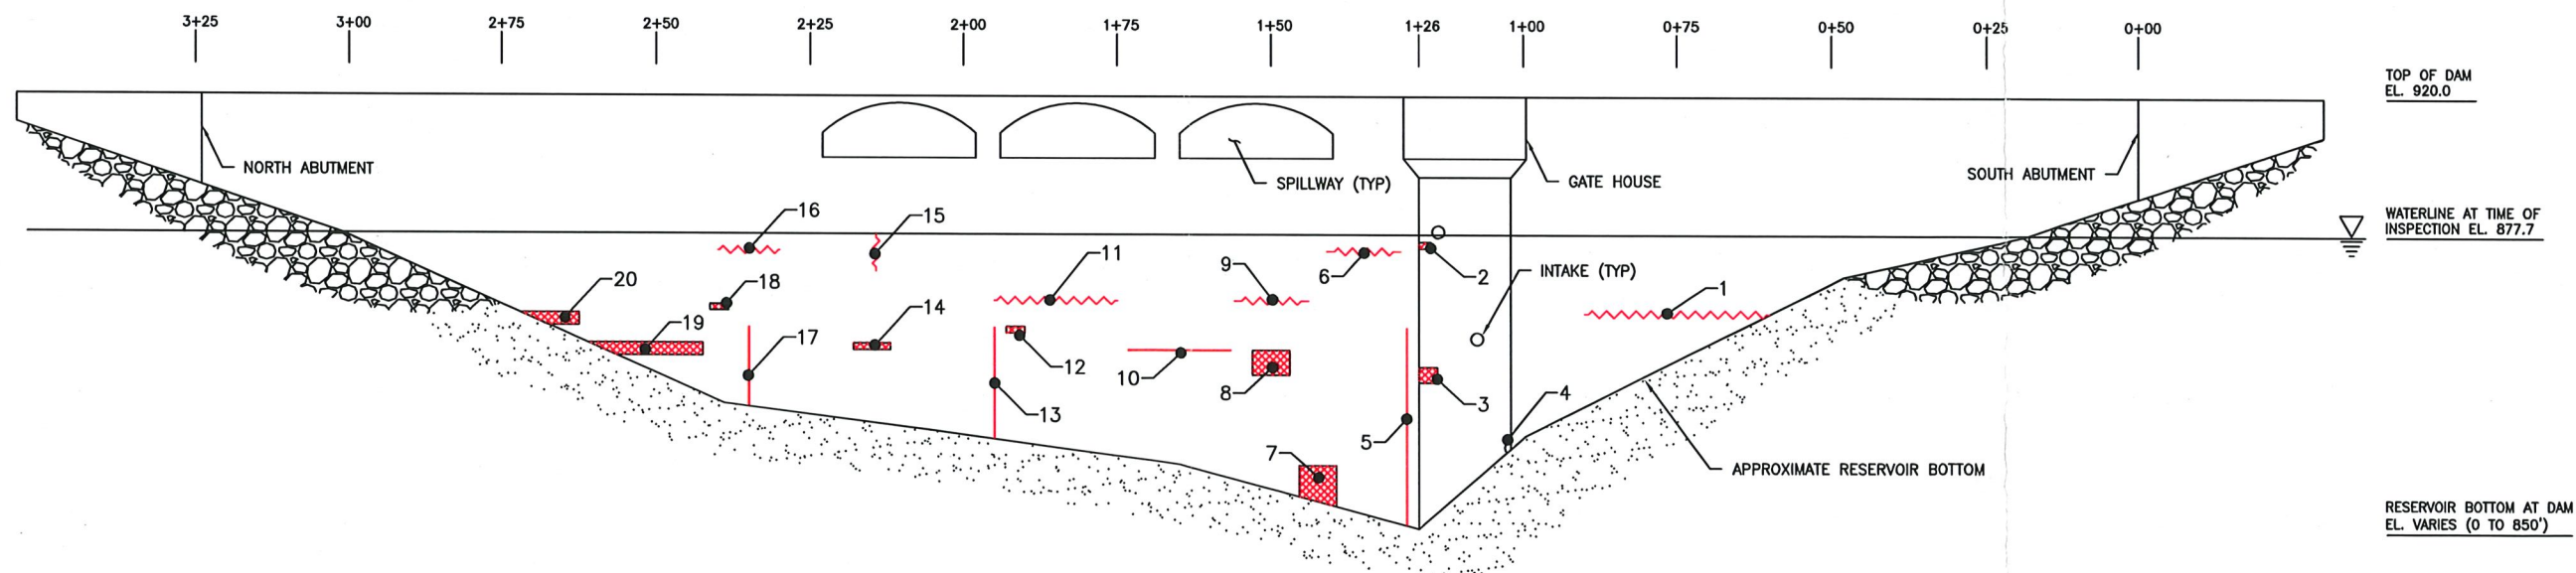
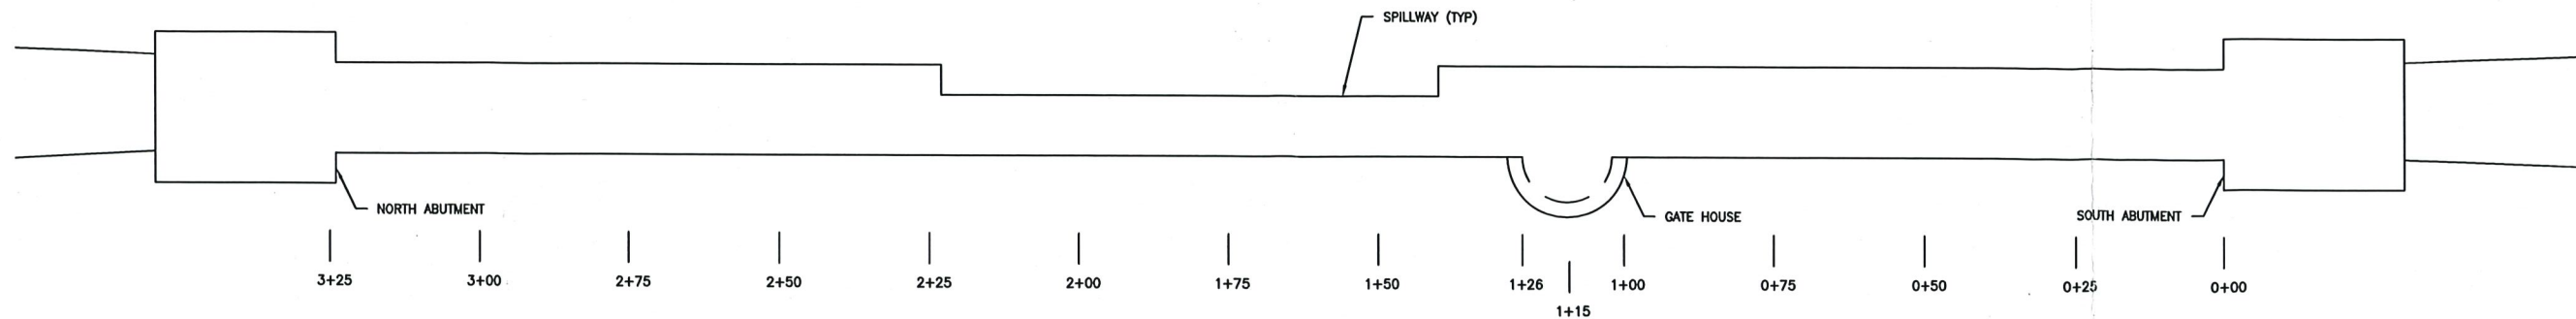
STATE DAM ID# 3-14-134-6 HOLDEN, MA FIG. NO.  
**PINE HILL RESERVOIR DAM  
UNDERWATER INSPECTION** D1

TABLE D-1: SUMMARY OF OBSERVED DEFECTS									
Defect ID#	Defect Type	Defect Center	Distance Below Top of Dam (ft)	Length (ft)	Height (ft)	Crack Width (in)	Depth (in)	Comments	Photo (See Exhibit A)
1	Horizontal Crack	0+70	35	30	1/8	1/8			
2	Concrete Void	1+22	24	4	1		2	1 exposed bar	Photo No. 7
3	Surface Degradation	1+22	45	4	2.5		2		
4	Leaking Intake Valve	1+10	52					Intake not completely sealed	
5	Open Constr. Joint	1+28	50	30		3/4	3	Failed sealant	Photo No. 4
6	Horizontal Crack	1+33	25	12		1/8			
7	Surface Degradation	1+40	60	6	6		1		
8	Surface Degradation	1+50	43	6	4		4		Photo No. 6
9	Horizontal Crack	1+50	33	12		1/16			
10	Open Constr. Joint	1+65	41	15		3	5	Failed sealant	
11	Horizontal Crack	1+85	33	20		1/8			Photo No. 3
12	Surface Degradation	1+90	38	3	1		4		
13	Open Constr. Joint	1+95	45	20		2	3	Failed sealant	
14	Surface Degradation	2+15	40	6	1		4		
15	Vertical Crack	2+15	25	4		1/8		Continues above waterline

16	Horizontal Crack	2+35	25	10		1/16			
17	Open Constr. Joint	2+35	23	15		1		Failed sealant	
18	Concrete Void	2+40	33	2	1		3		
19	Surface Degradation	2+52	40	15	2		2		
20	Surface Degradation	2+60	35	8	2		1	Prior Repair
