# **Pine Hill Reservoir Dam**

## **Phase I Inspection / Evaluation Report**

**Consultant: Pare Corporation**

**Date of Inspection: June 15, 2022**

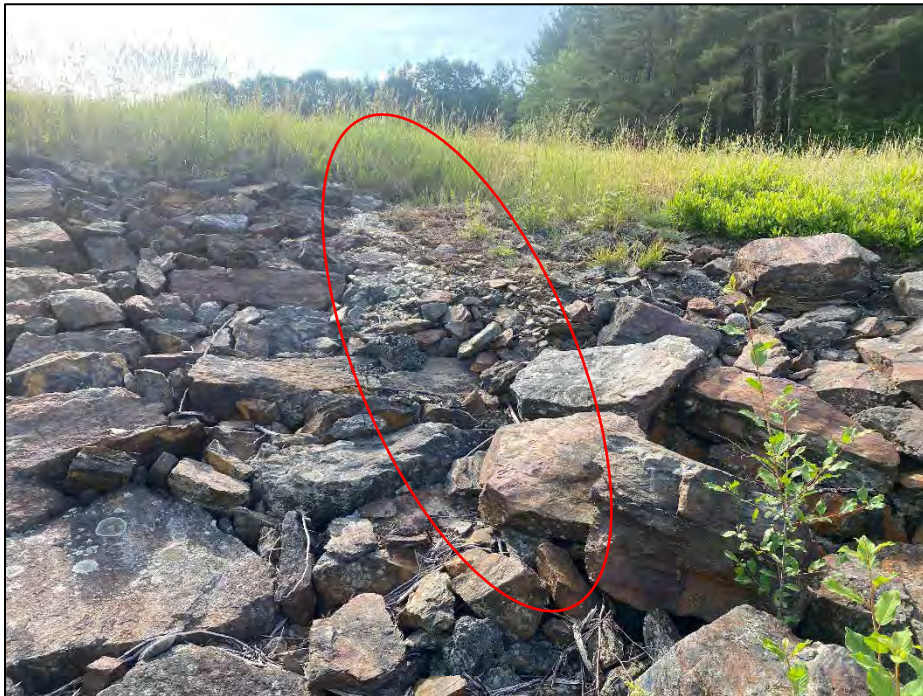
- An area of displaced stones and an erosion path was present near STA 0+90 at bend in the riprap.
  - A 6 inch wide by 7 inch deep erosion channel was present near STA 0+90 on the upstream shoulder, leading to the top of the riprap. The intersection of the vegetated slope and the riprap was depressed and was able to be probed to 18-inches deep. Eroded soil from this area was observed on the surface of the riprap within this area.

Photo No. 2.: Area of erosion and soil movement at the bend of the upstream riprap near STA 0+90.

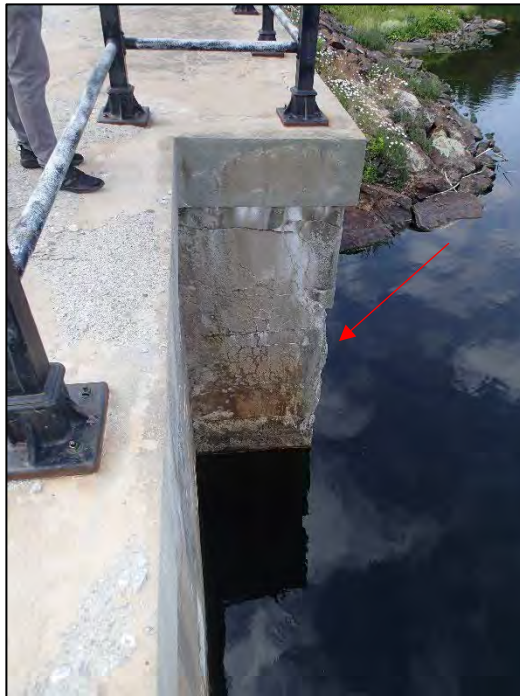
Photo No. 5.: Spalled and cracked concrete on the upstream face near STA 2+00.

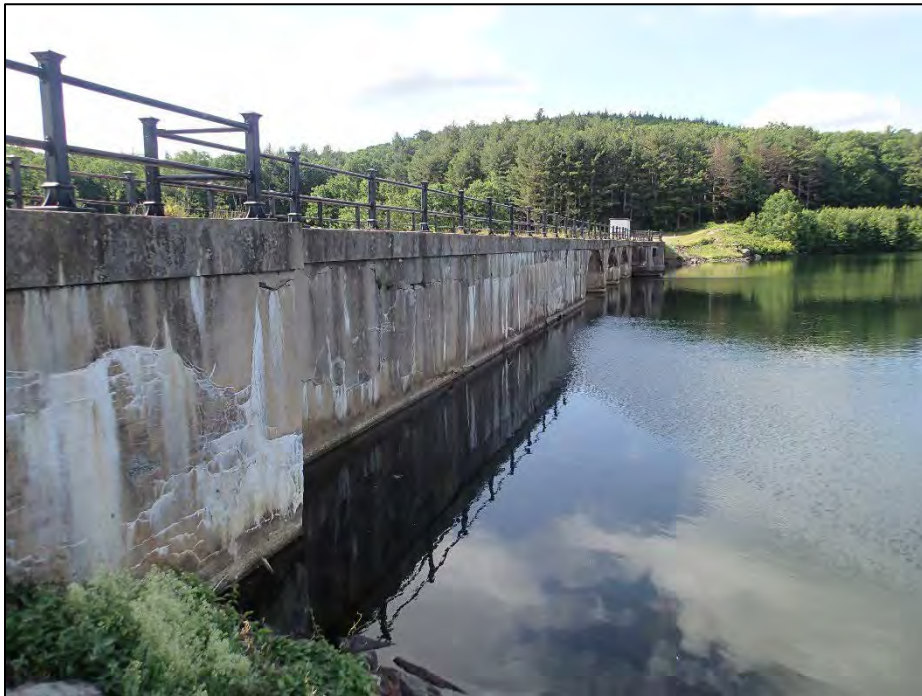
- A gap between the cap and the upstream wall was observed throughout. The cap was up to 0.25 inches wide.
  - Throughout the upstream face, efflorescent staining, spalling, and map cracking were observed throughout

Photo No. 6.: Upstream face from near STA 5+50 looking right. Note cracking and efflorescent staining throughout.

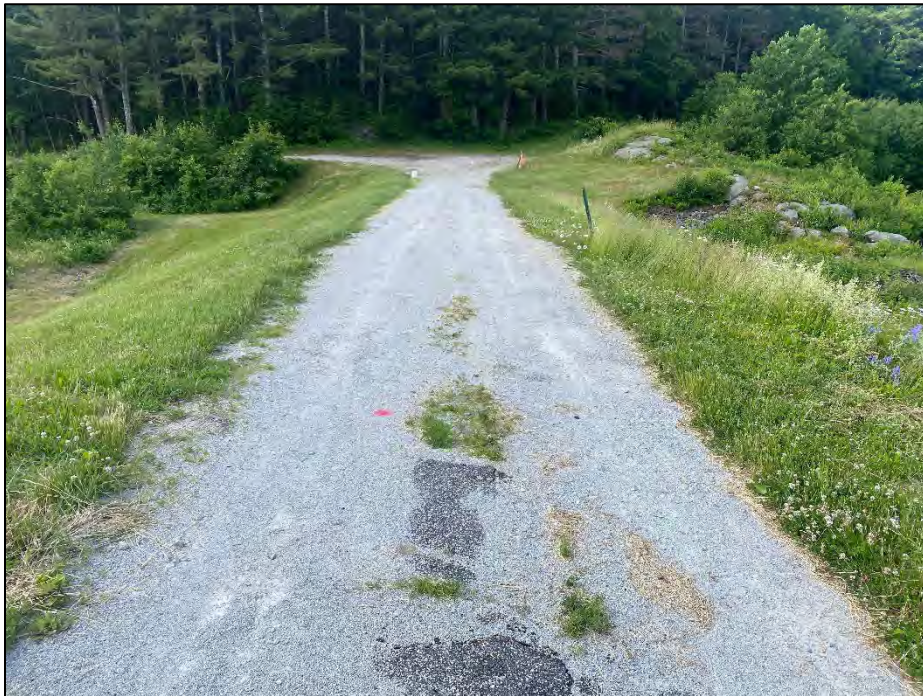
- The following was noted on the crest between the right abutment and STA 1+75.
  - The surface of the crest consists of gravel and asphalt. The asphalt was significantly deteriorated due to vehicles.

Photo No. 10.: Crest from STA 1+75 looking right. Note deterioration of the asphalt.

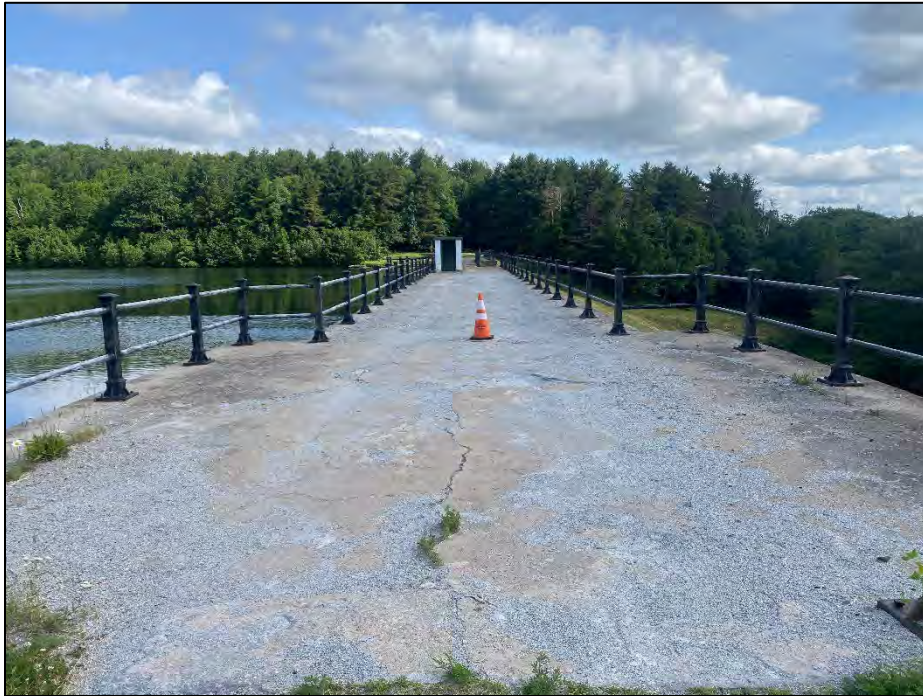
- The following was noted on the concrete section of the crest.
  - The surface of the crest was observed to have multiple cracks and deterioration. The surface had vegetation developing within the cracks.

Photo No. 11.: Crest from STA 1+75 looking left. Note deterioration and cracking of the concrete.

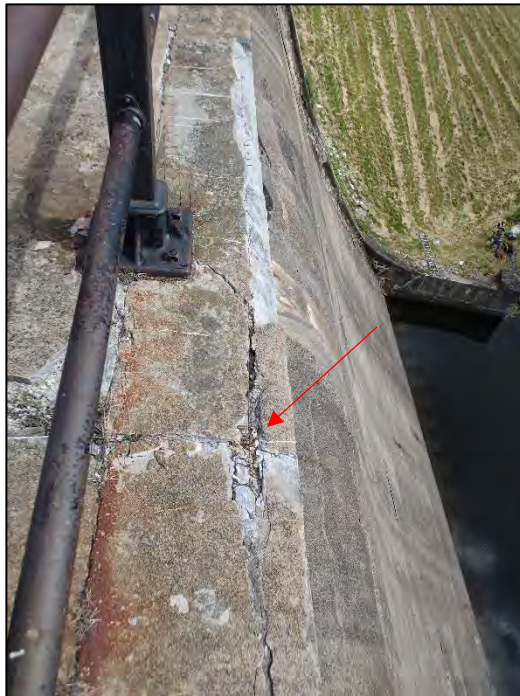
- On the downstream edge of the crest, between STA 3+25 to STA 3+40, a longitudinal crack with spalling and delamination was observed. The crack was measured up to 2 inches wide. Pieces of concrete has fallen off the edge of the crest.
- The following was observed between STA 5+50 and the left abutment:
  - The crest appeared to have a well-maintained grass cover.
  - No unusual alignment or settlement noted
  - A 3 to 4 inch diameter burrow (turtle nest) was observed at the upstream side of the dam crest near Sta. 7+15
  - The left abutment contact appeared good with no signs of movement.

Photo No. 13.: Crack on the downstream edge of the crest. Note missing concrete and exposed steel mesh.

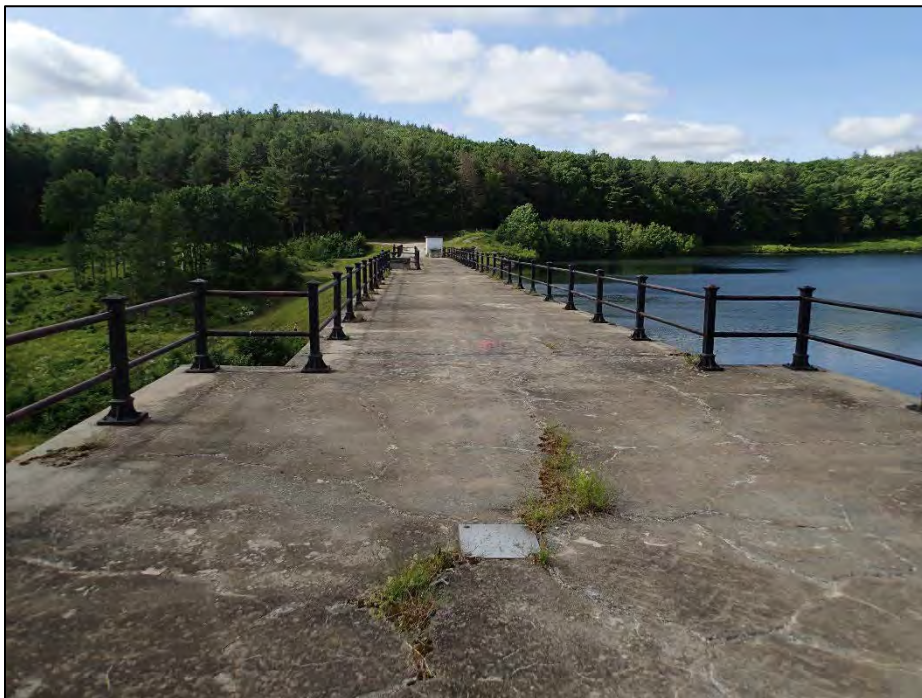
Photo No. 14.: Crest from STA 5+50 looking right. Note cracking and developing vegetation within cracks.

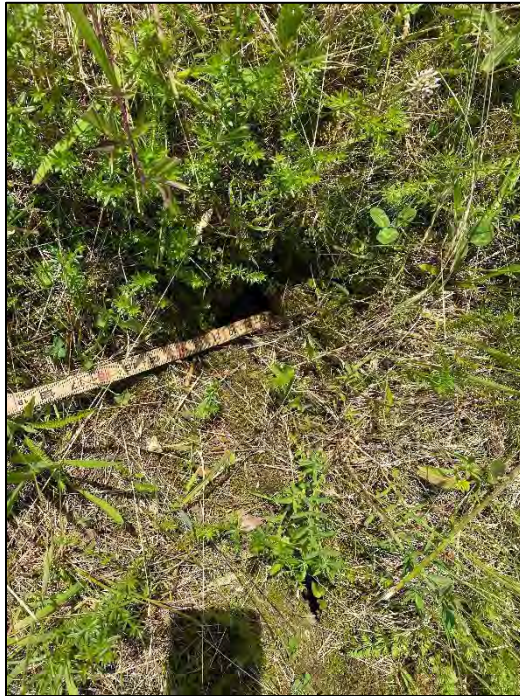
Photo No. 17.: Typical animal burrow observed on the downstream slope.

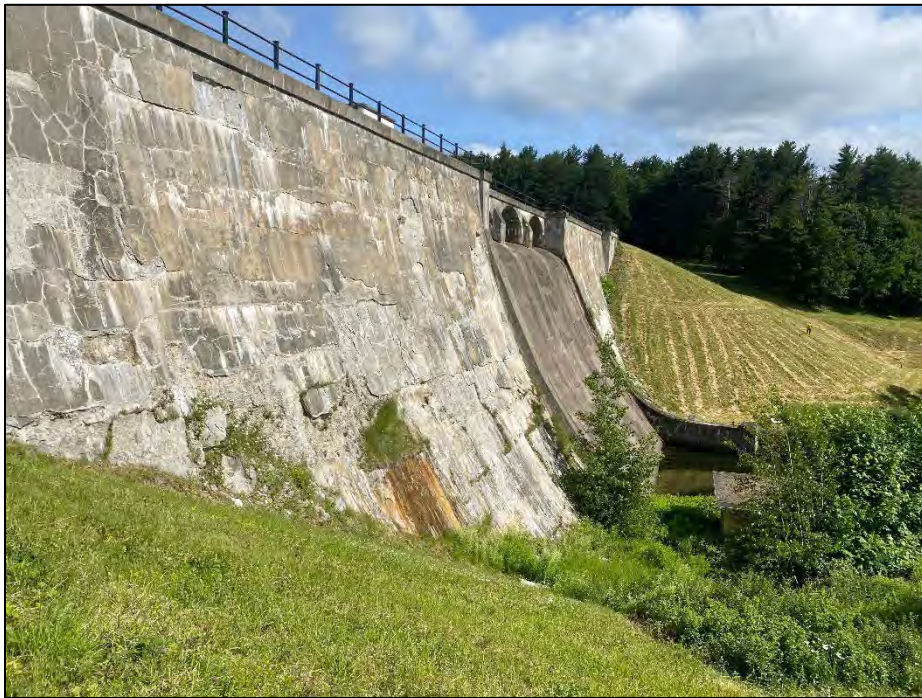
Photo No. 19.: Downstream face from the right end looking left. Note delamination, spalls, and vegetation developing on the wall.

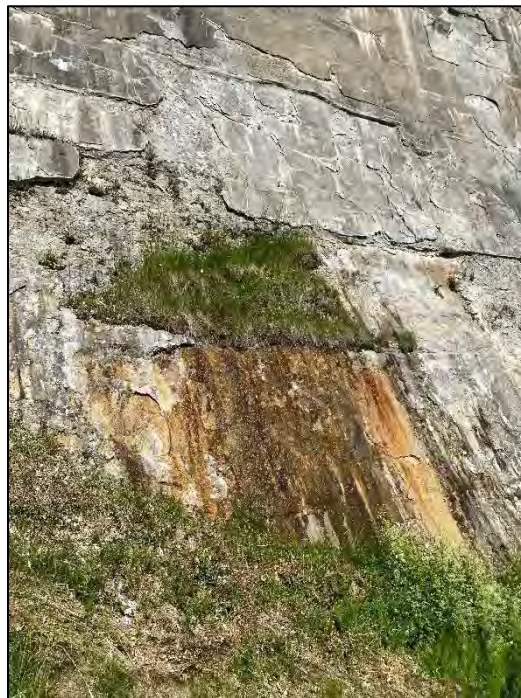
Photo No. 20.: Seepage area approximately 60 feet from the right side of the spillway. Note vegetation developing immediately above the seepage and iron oxide staining.

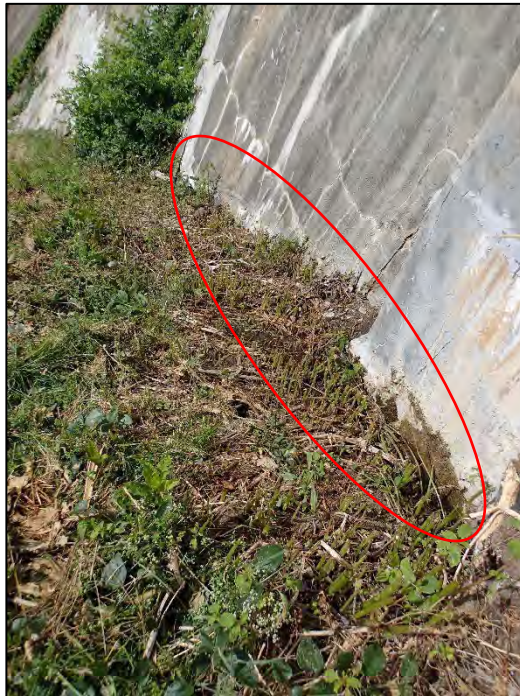
Photo No. 22.: Seepage where the downstream face meets the embankment slope near STA 5+15.

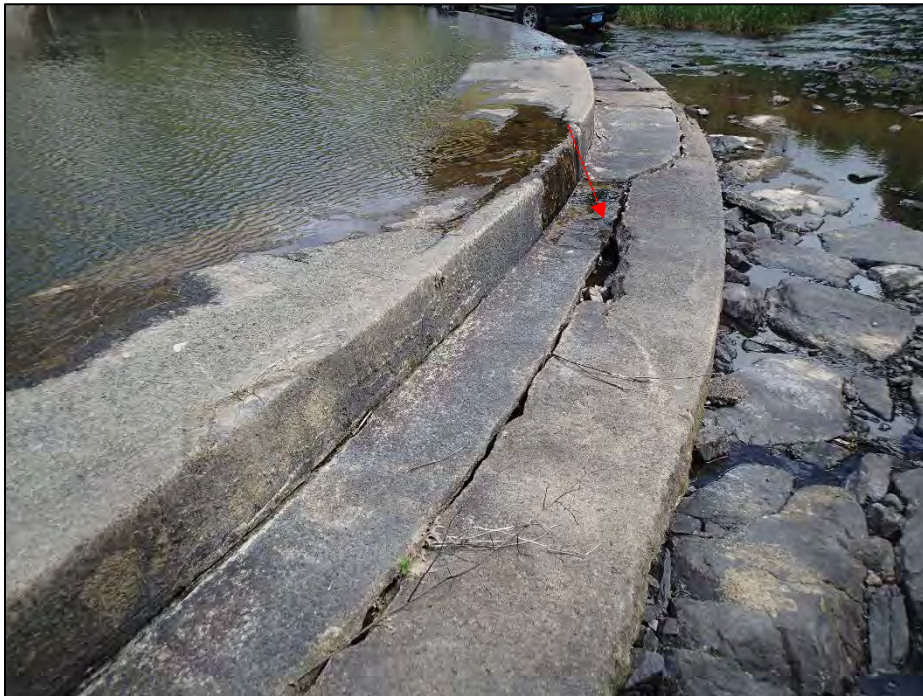
Photo No. 28.: End sill of the spillway with settled cracks and water penetrating the cracks.

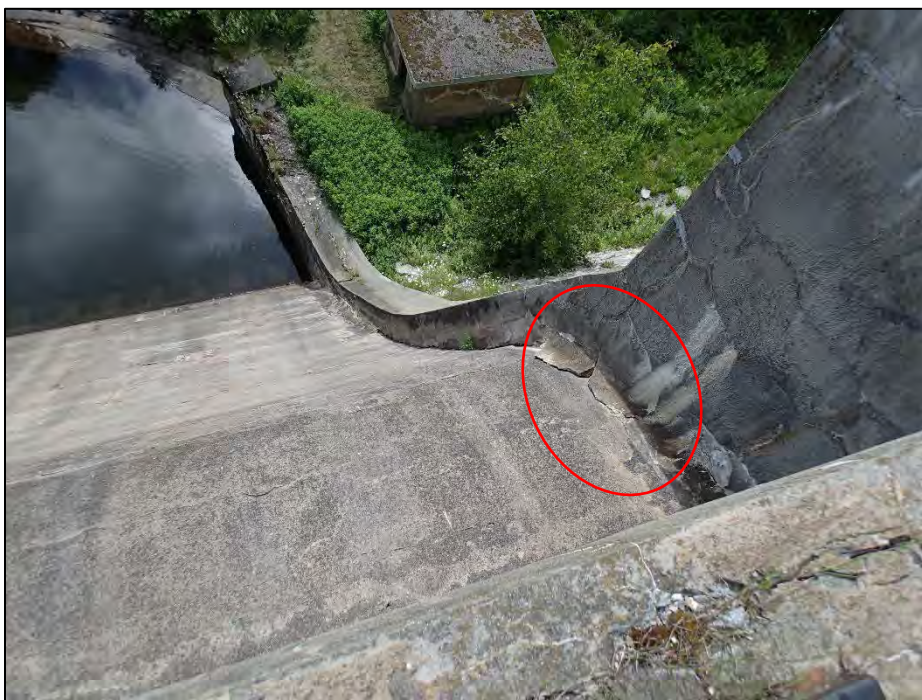
Photo No. 29.: Right training wall and spillway. Note delamination and cracking of concrete at the intersection of the two.

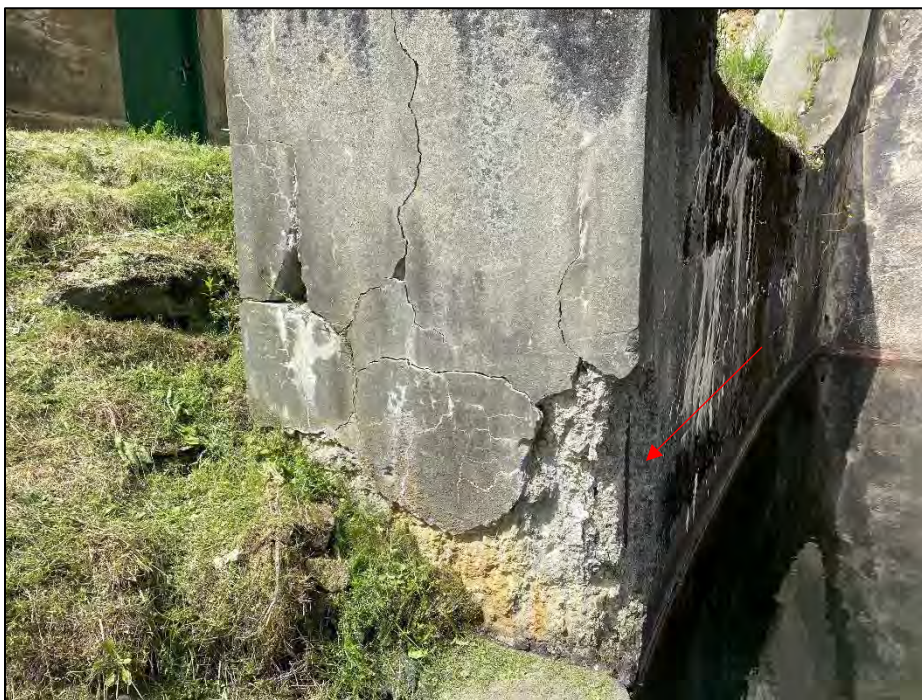
Photo No. 30.: End of the right training wall with exposed rebar and delamination.

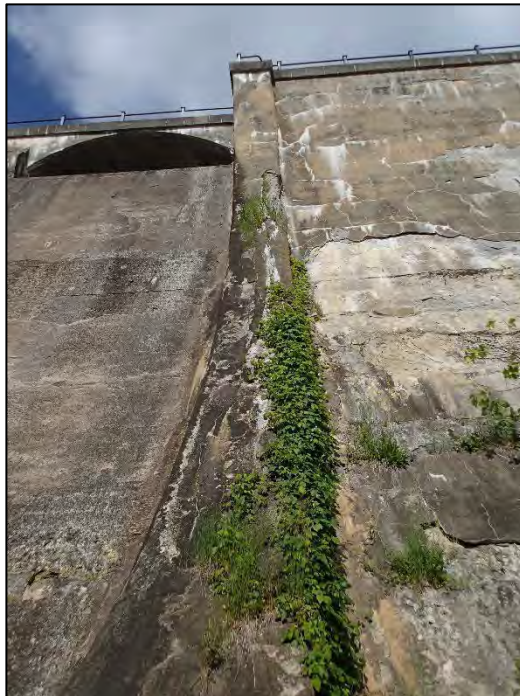
Photo No. 31.: Left training wall of the spillway. Note developing vegetation and cracking.

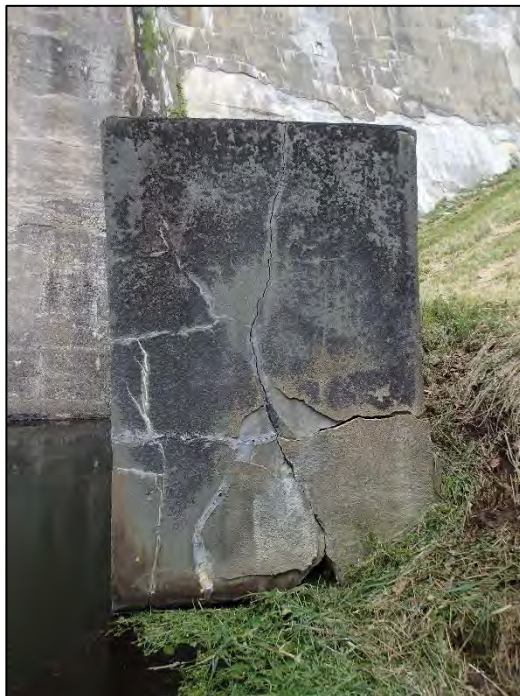
Photo No. 32.: Downstream end of the left training wall. Note cracking and potential misalignment.

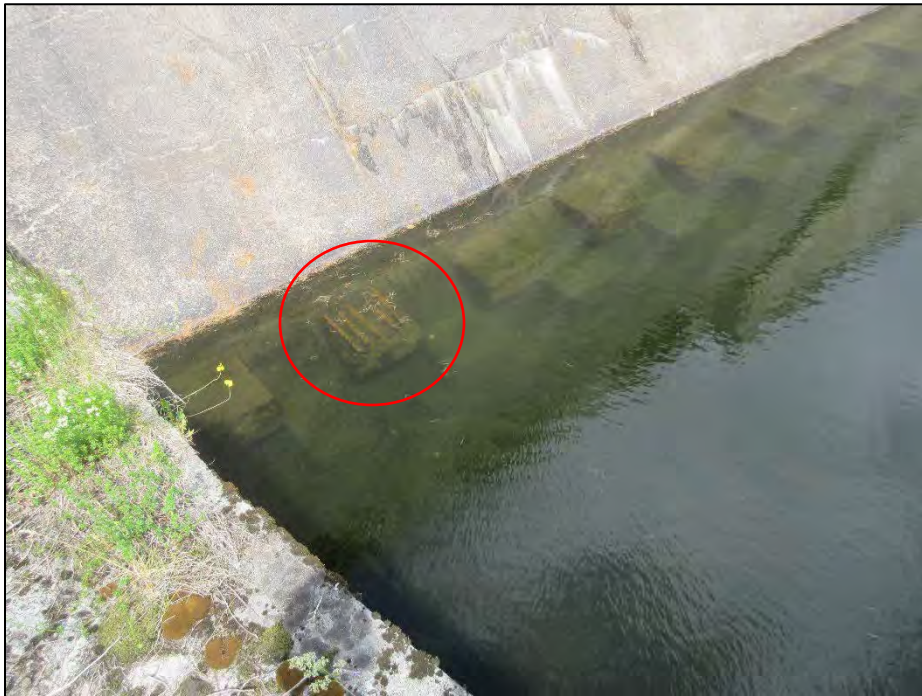
Photo No. 34.: Baffle block with exposed rebar in the top row of the baffle blocks.

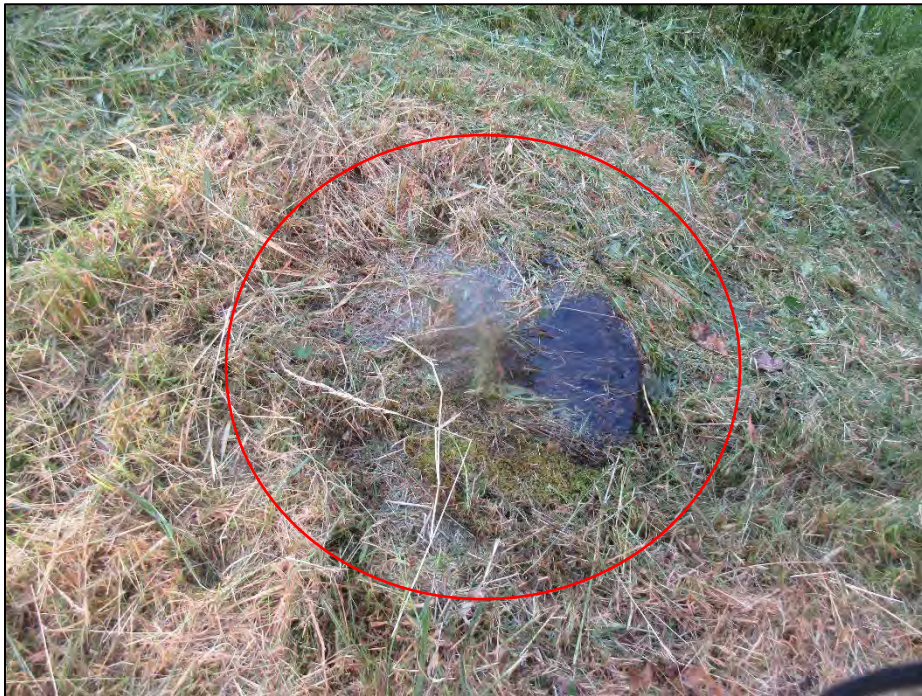
Photo No. 40.: Manhole to the seepage gallery in the downstream area to the left of the spillway. Note the seepage gallery is filled with water and leaking from the manhole.

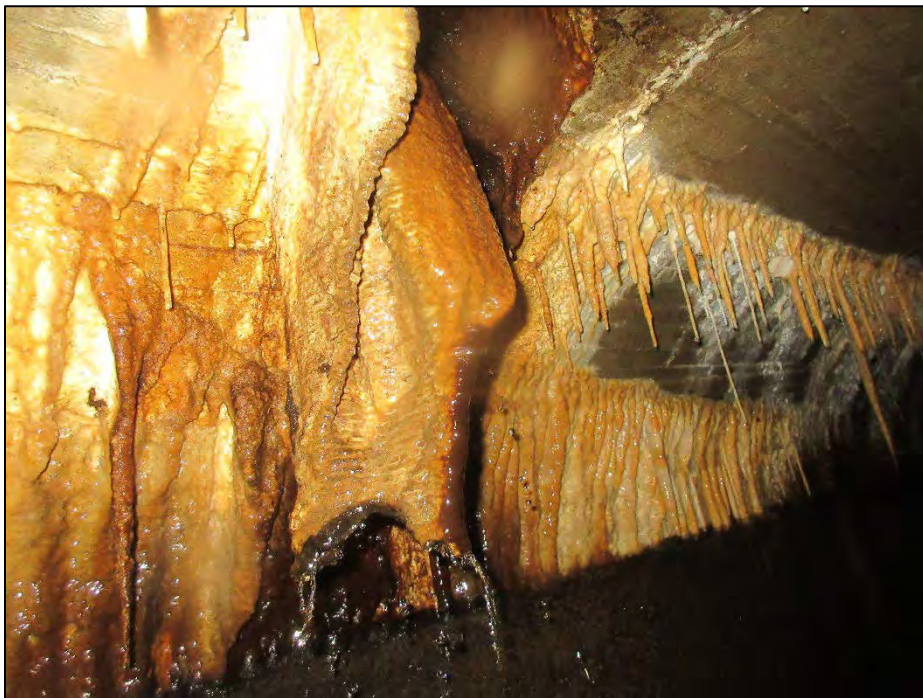
Photo No. 44.: Seepage gallery drain with iron oxide staining, flow, and calcification.
