APPENDIX C
MANHOLE INSPECTION LOGS

MANHOLE INSPECTION LOG

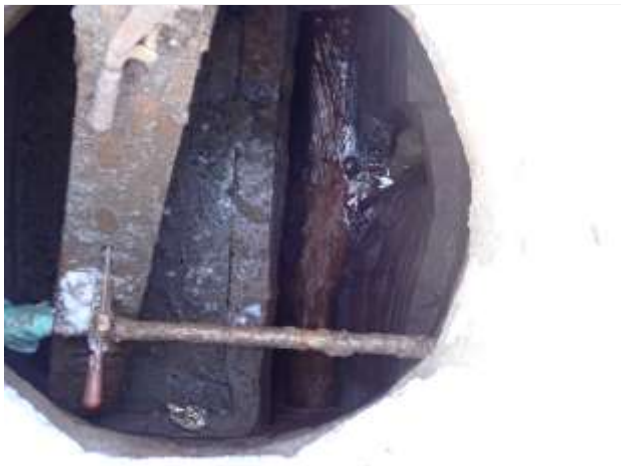
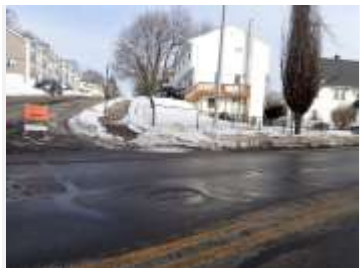
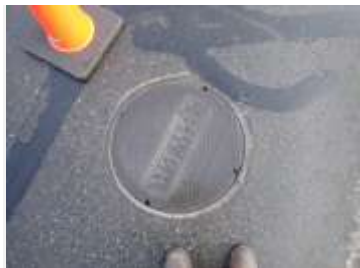
MINOR CRACK IN COVER

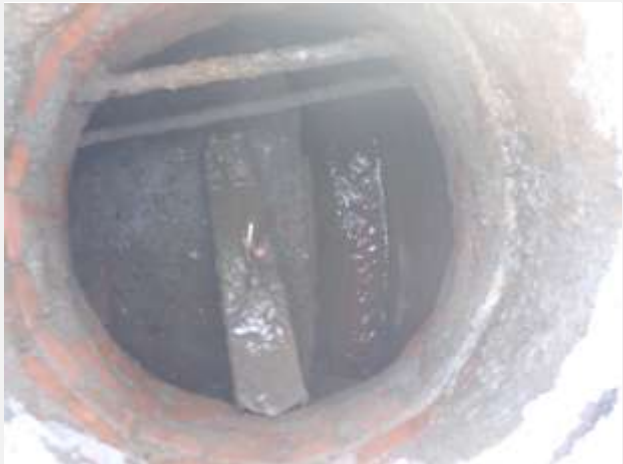
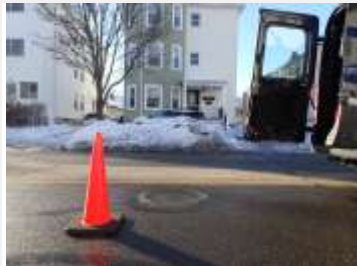
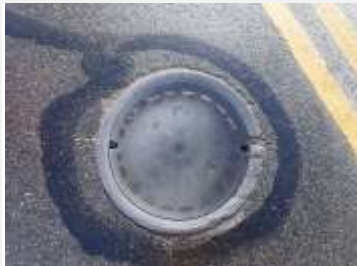
TWO CROSSBORES THAT COULD BE MAKESHIFT STEPS, MINOR CRACK IN COVER

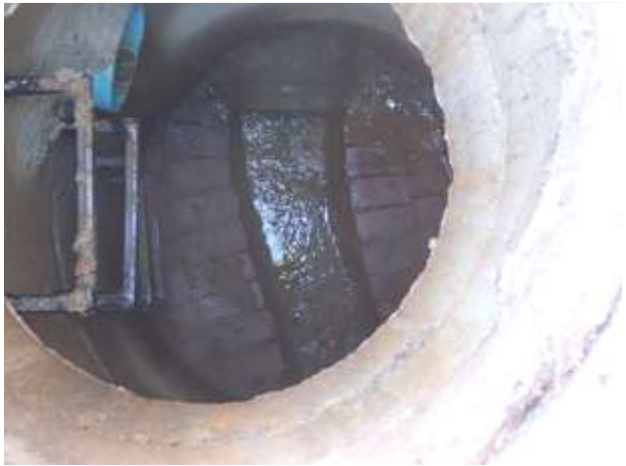
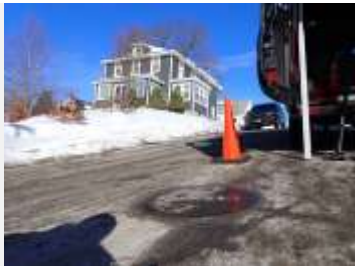
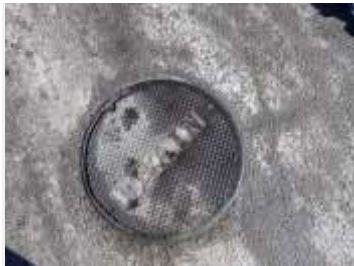
INFILTRATION AT 1200 INCOMING

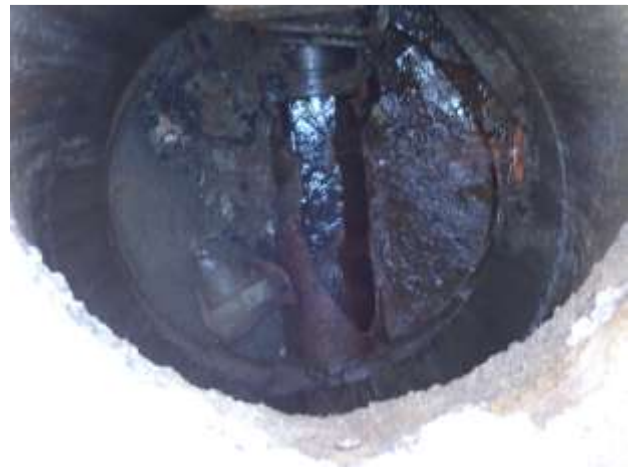
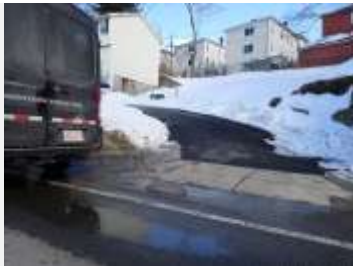
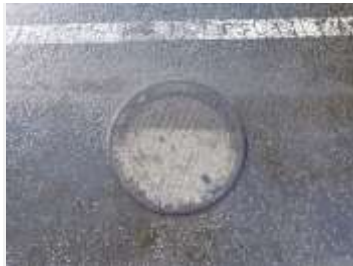
DEBRIS ON BENCH, INFILTRATION THROUGH 0300 CONNECTION

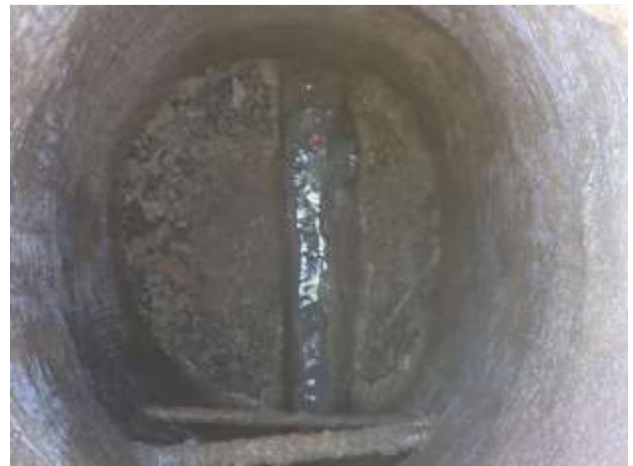
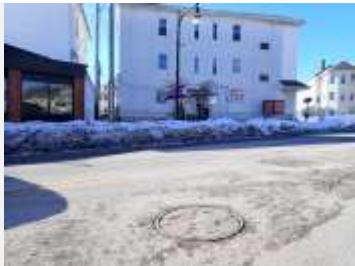
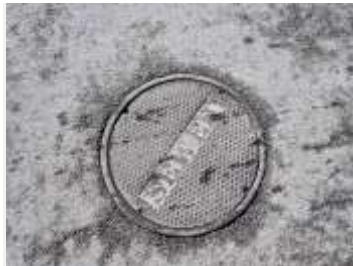
THREE CROSSBORES THAT COULD BE MAKESHIFT STEPS, INFILTRATION STAINING ON WALLS

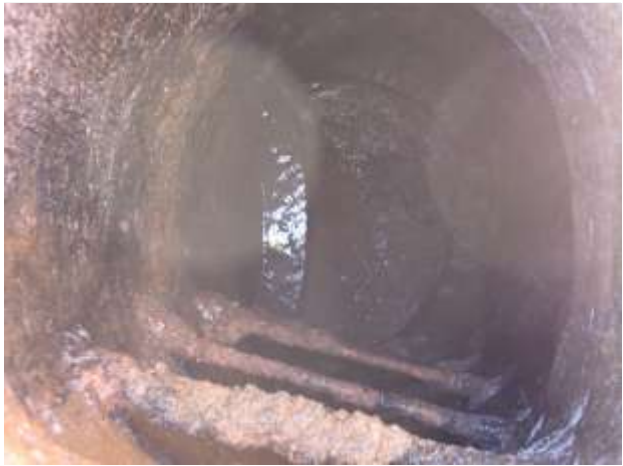
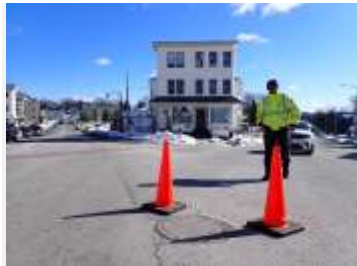
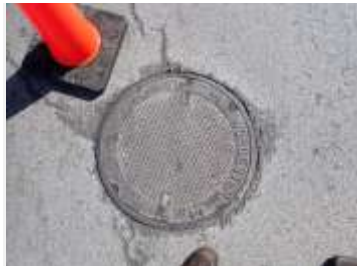
SEVEN CROSSBORES THAT COULD BE MAKESHIFT STEPS, INFILTRATION STAINING ON WALLS

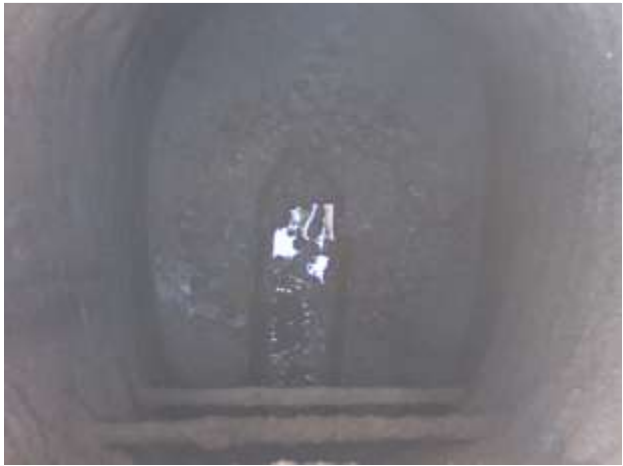
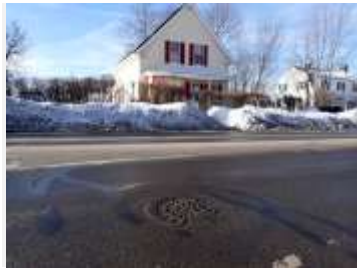
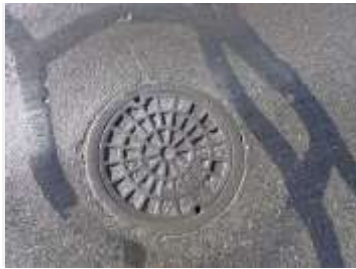
CLEANING RECOMMENDED, THREE CROSSBORES THAT COULD BE MAKESHIFT STEPS

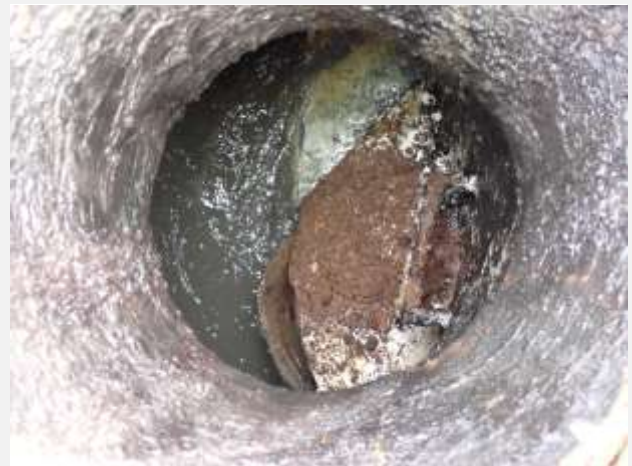
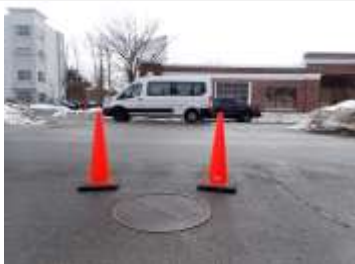
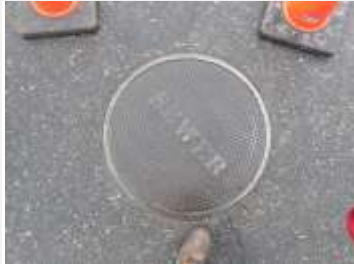
APPEARS TO BE GREASE BUILDUP IN CHANNELS, SOME KIND OF SEDIMENT BUILDUP ON WALLS AND CHIMNEY, RUSTING IN CHIMNEY
