# APPENDIX A

## TELEVISION INSPECTION REPORTS AND VIDEOS

## Inspection Report

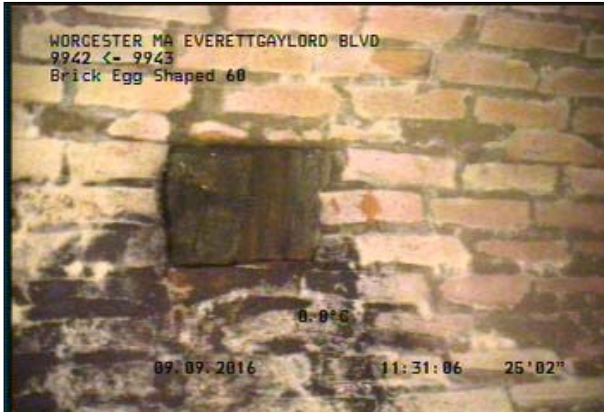
Photo: 9943\_9942\_26102016\_14572626\_\_\_\_.jpg  
25.19FT, Tap Break-In, at 02 o'clock, -, within 8 inches of joint:  
NO, 6"

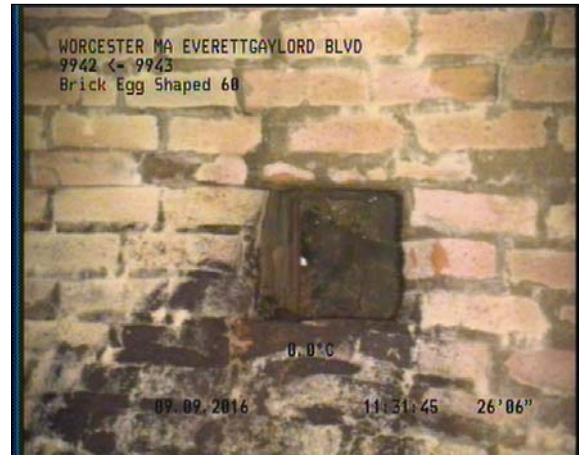
Photo: 9943-9942\_09092016\_TB\_26.494\_113343\_A.JPG  
26.49FT, Tap Break-In, at 11 o'clock, -, within 8 inches of joint:  
NO, 6"

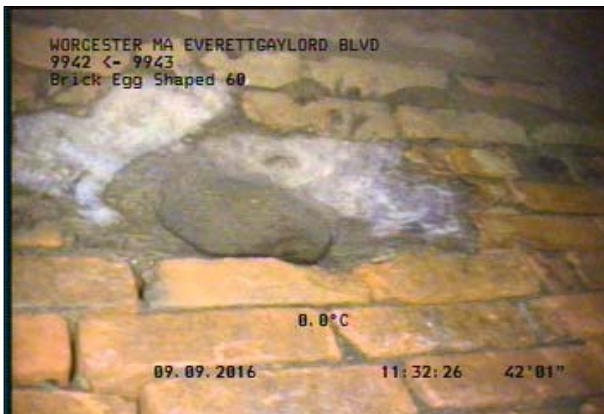
Photo: 9943\_9942\_26102016\_14573434\_\_\_\_.jpg  
42.09FT, Tap Break-In, at 10 o'clock, -, within 8 inches of joint:  
NO, 6"

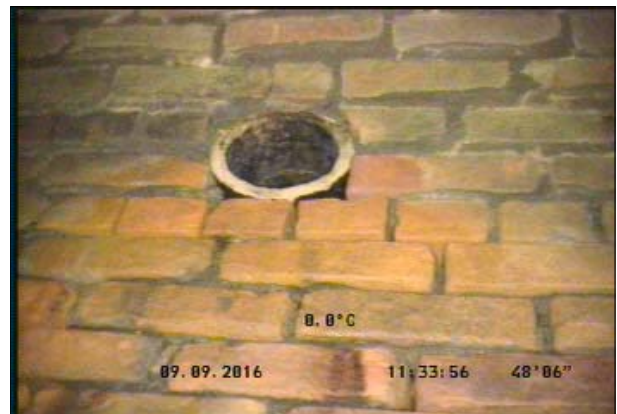
Photo: 9943\_9942\_26102016\_14575050\_\_\_\_.jpg  
48.49FT, Tap Break-In, at 02 o'clock, -, within 8 inches of joint:  
NO, 6"

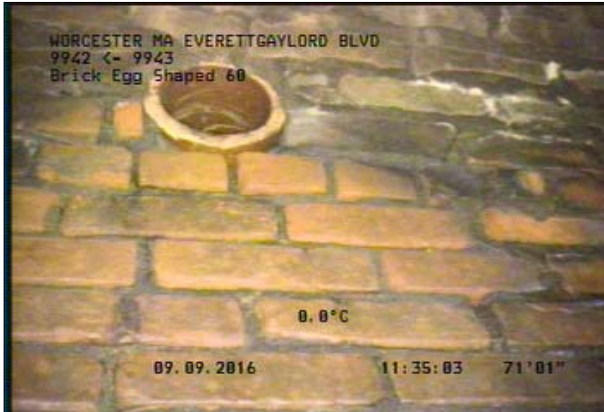
Photo: 9943\_9942\_26102016\_14575959\_\_\_\_.jpg  
71.08FT, Tap Break-In, at 10 o'clock, -, within 8 inches of joint:  
NO, 6"

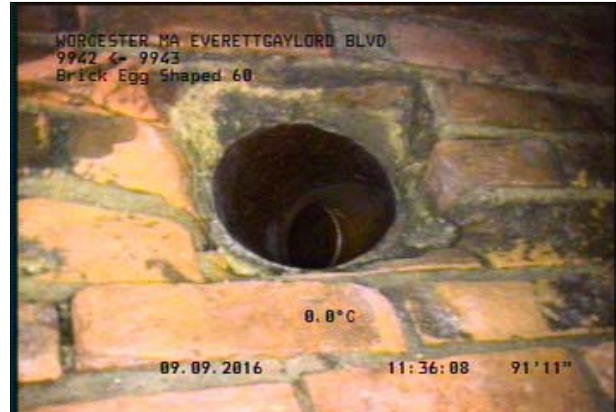
Photo: 9943\_9942\_26102016\_14581818\_\_\_\_.jpg  
91.88FT, Tap Break-In, at 09 o'clock, -, within 8 inches of joint:  
NO, 6", 6"

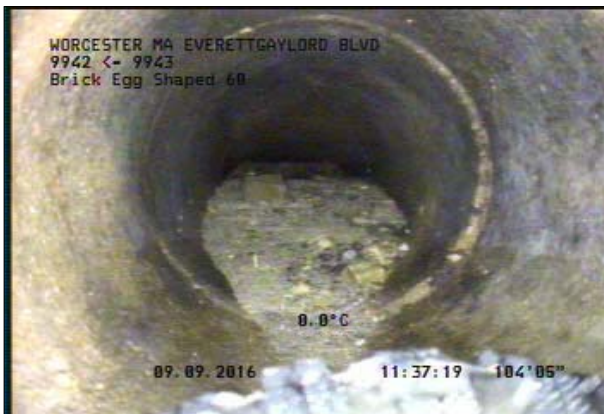
Photo: 9943\_9942\_26102016\_14584646\_\_\_\_.jpg  
104.38FT, Tap Break-In, at 09 o'clock, -, within 8 inches of  
joint: NO, 6"

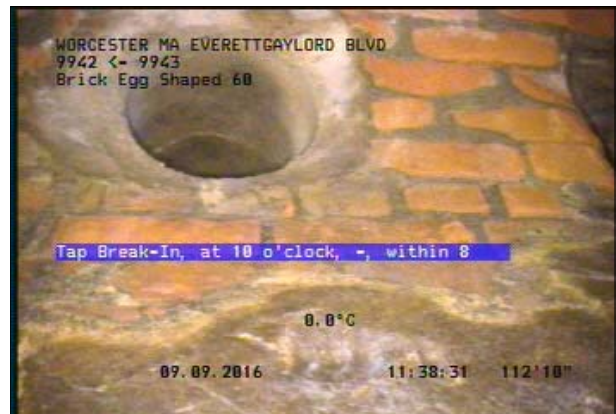
Photo: 9943\_9942\_26102016\_14591010\_\_\_\_.jpg  
112.87FT, Tap Break-In, at 10 o'clock, -, within 8 inches of  
joint: NO, 6"

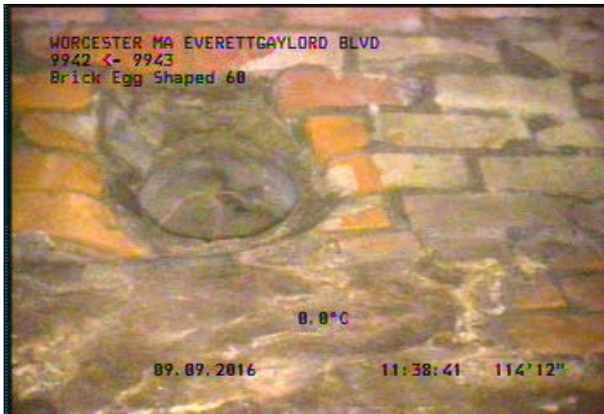
Photo: 9943\_9942\_26102016\_14591818\_\_\_\_.jpg  
114.97FT, Tap Break-In, at 11 o'clock, -, within 8 inches of joint: NO, 6"

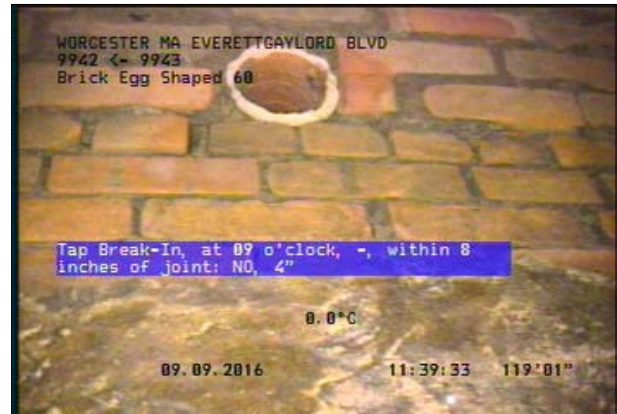
Photo: 9943\_9942\_26102016\_14592626\_\_\_\_.jpg  
119.07FT, Tap Break-In, at 09 o'clock, -, within 8 inches of joint: NO, 4"

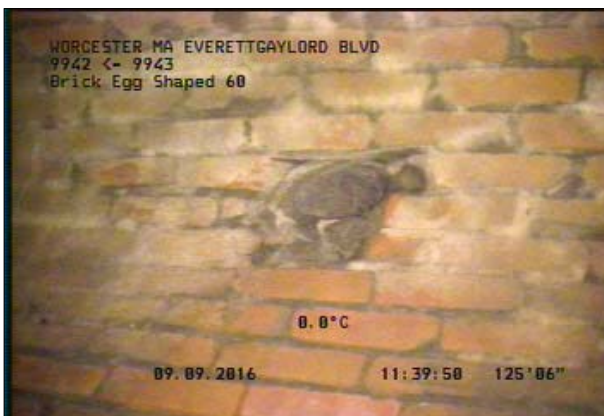
Photo: 9943\_9942\_26102016\_14593434\_\_\_\_.jpg  
125.47FT, Tap Break-In, at 01 o'clock, -, within 8 inches of joint: NO, 6"

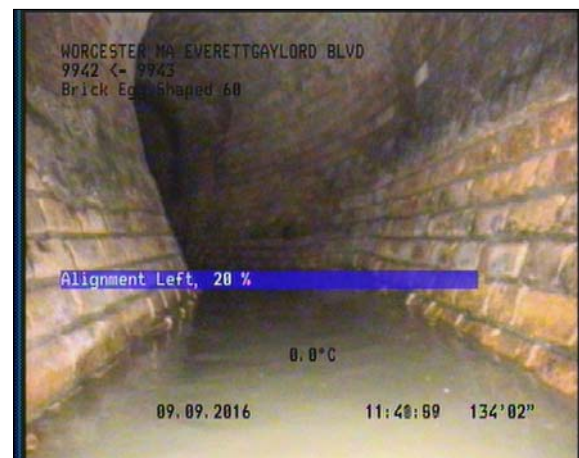
Photo: 9943-9942\_09092016\_LL\_134.1699\_114259\_A.JPG  
134.17FT, Alignment Left, 20 %

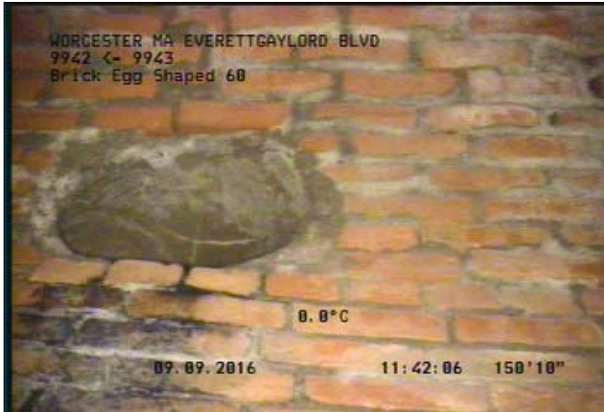
Photo: 9943\_9942\_26102016\_15042424\_\_\_\_.jpg  
150.87FT, Tap Break-In, at 02 o'clock, -, within 8 inches of joint: NO, 6"

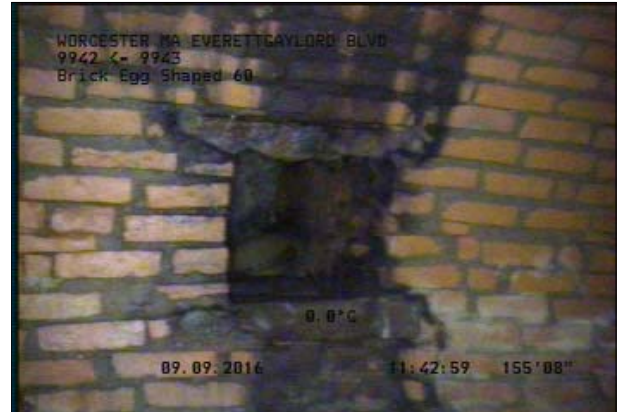
Photo: 9943\_9942\_26102016\_15050707\_\_\_\_.jpg  
155.66FT, Tap Break-In, at 11 o'clock, -, within 8 inches of joint: NO, 6"

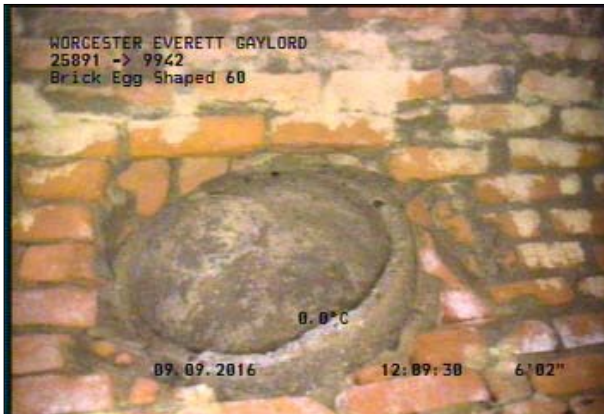
Photo: 25891\_9942\_26102016\_15121515\_\_\_\_.jpg  
6.2FT, Tap Break-In, at 02 o'clock, -, within 8 inches of joint:  
NO, 6"

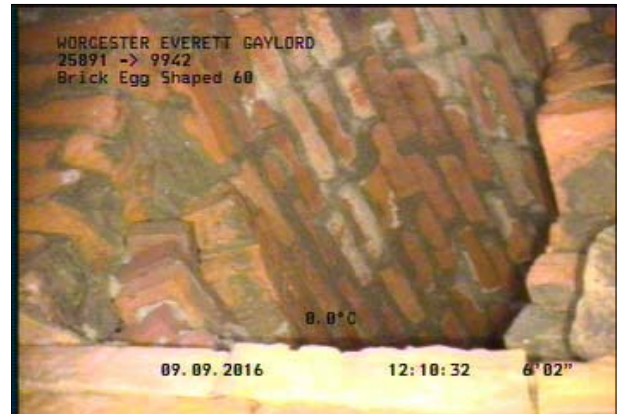
Photo: 25891\_9942\_26102016\_15123131\_\_\_\_.jpg  
6.2FT, Tap Break-In, at 10 o'clock, -, within 8 inches of joint:  
NO, 6"

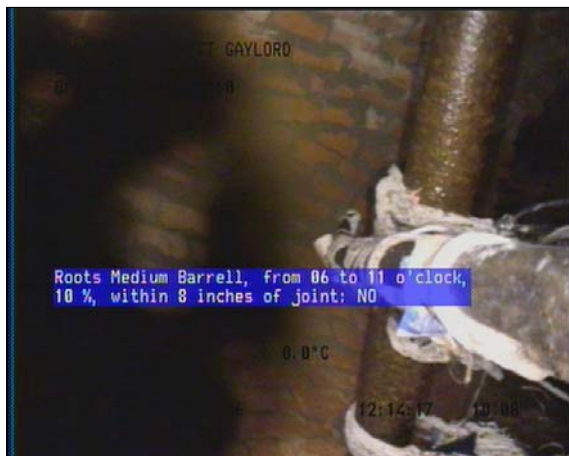
Photo: 25891-9942\_09092016\_RMB\_10.6976\_121616\_A.JPG  
10.7FT, Roots Medium Barrell, from 06 to 11 o'clock, 10 %, within 8 inches of joint: NO

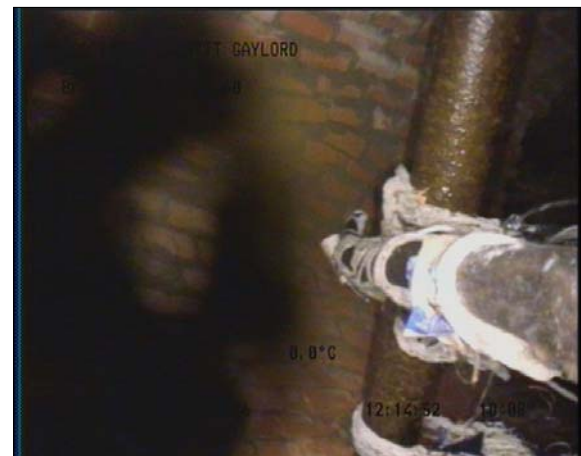
Photo: 25891-9942\_09092016\_OBM\_10.6976\_121650\_A.JPG  
10.7FT, Obstacles Pipe Material, 10 % of cross sectional area, from 10 to 02 o'clock

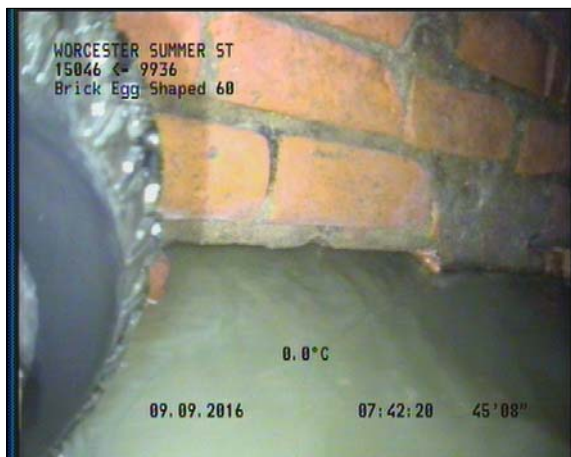
| 1:300 | Position | Observation | | |
|---|---|---|---|---|
| | | 45.69 | Missing Brick, at 08 o'clock | |

Photo: 9936-15046\_09092016\_MB\_45.6897\_074417\_A.JPG  
45.69FT, Missing Brick, at 08 o'clock

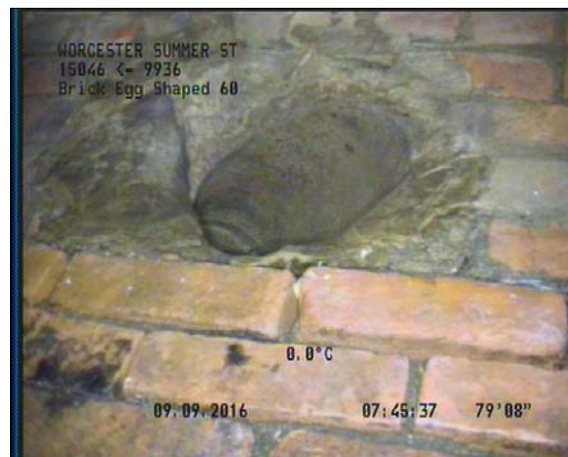
Photo: 9936-15046\_09092016\_TB\_79.6821\_074733\_A.JPG  
79.68FT, Tap Break-In, at 03 o'clock, -, within 8 inches of joint:  
NO, 6"

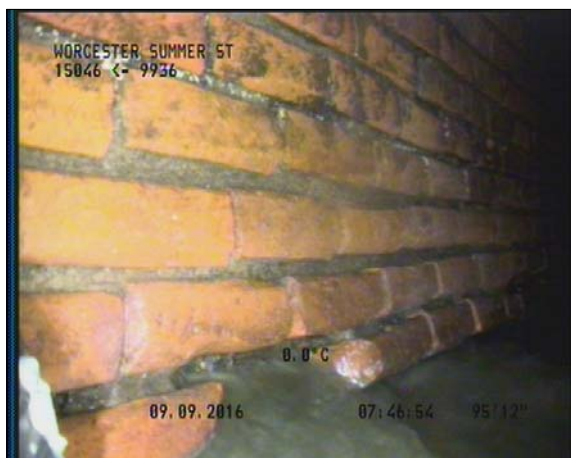
| 1:300 | Position | Observation | | |
|---|---|---|---|---|
| | | 95.98 | Displaced Brick, at 08 o'clock | |

Photo: 9936-15046\_09092016\_DB\_95.9784\_074852\_A.JPG  
95.98FT, Displaced Brick, at 08 o'clock

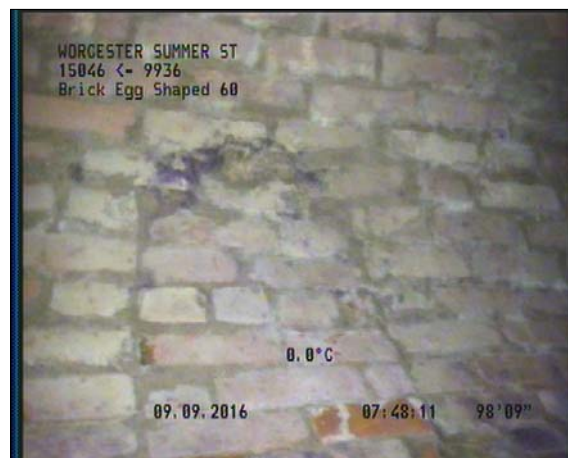
Photo: 9936-15046\_09092016\_TBC\_98.7778\_075010\_A.JPG  
98.78FT, Tap Break-In Capped, at 09 o'clock, -, within 8 inches  
of joint: NO, 6"

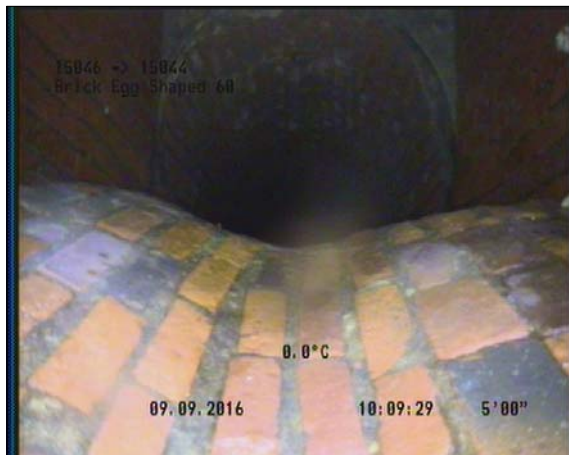
| 1:105 | Position | Observation | |
|---|---|---|---|
| | <div><div>5.00</div></div> | Alignment Up, 25 % | |

Photo: 15046-15044\_09092016\_LU\_4.9989\_101128\_A.JPG  
5FT, Alignment Up, 25 %

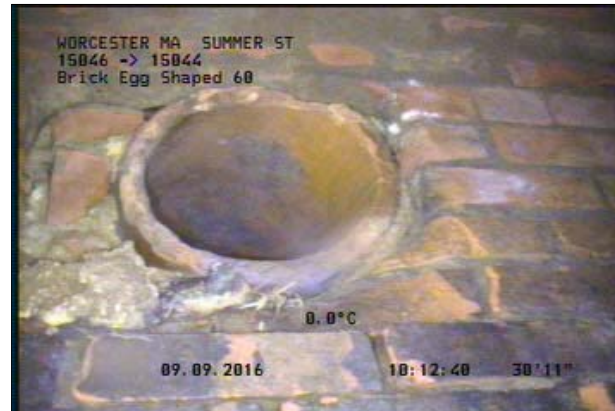
Photo: 9942\_12746\_26102016\_13195454\_\_\_\_.jpg  
30.89FT, Tap Break-In, at 09 o'clock, -, within 8 inches of joint:  
NO, 6"

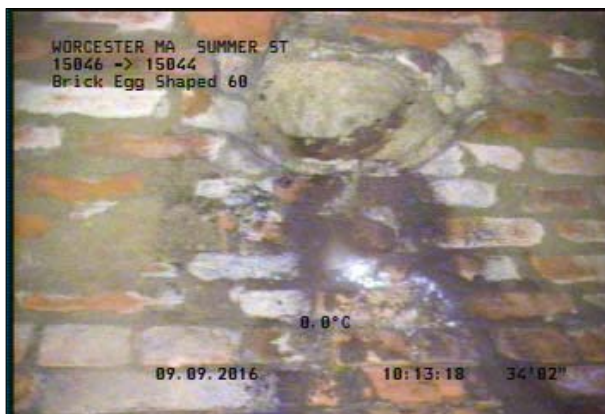
Photo: 15046\_15044\_26102016\_13284848\_\_\_\_.jpg  
34.19FT, Tap Break-In, at 03 o'clock, -, within 8 inches of joint:  
NO, 6"

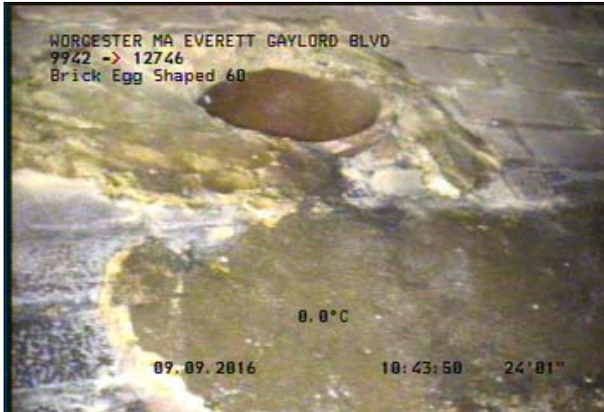
Photo: 9942\_12746\_26102016\_13400000\_\_\_\_.jpg  
24.09FT, Tap Break-In Intruding, at 10 o'clock, -, -, within 8 inches of joint: NO, 1", 6"

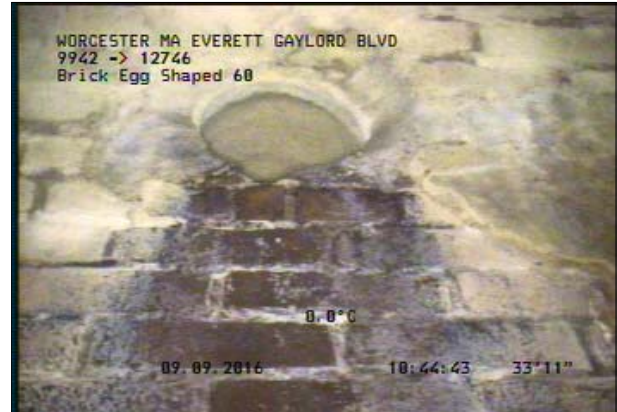
Photo: 9942\_12746\_26102016\_13401414\_\_\_\_.jpg  
33.89FT, Tap Break-In, at 10 o'clock, -, within 8 inches of joint: NO, 6"

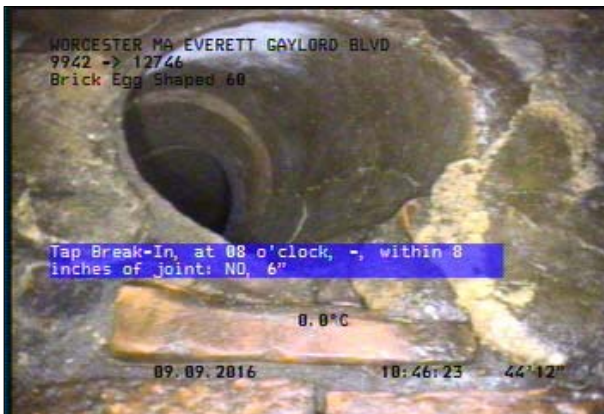
Photo: 9942\_12746\_26102016\_13403030\_\_\_\_.jpg  
44.99FT, Tap Break-In, at 08 o'clock, -, within 8 inches of joint: NO, 6"

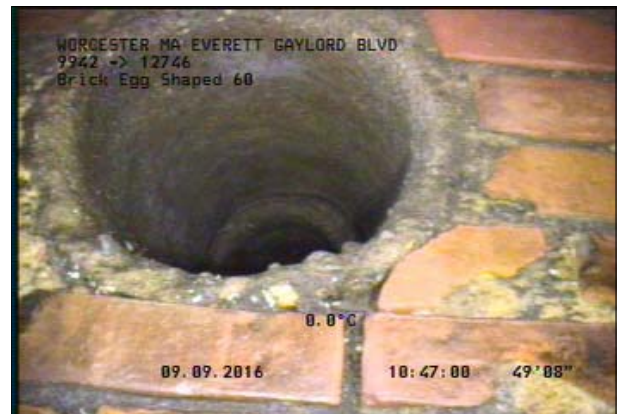
Photo: 9942\_12746\_26102016\_13411616\_\_\_\_.jpg  
49.69FT, Tap Break-In, at 03 o'clock, -, within 8 inches of joint: NO, 6"

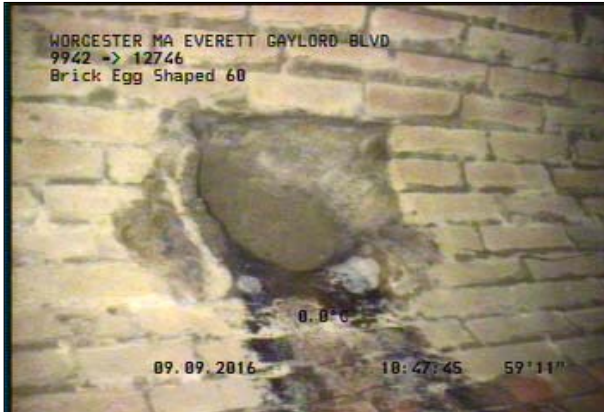
Photo: 9942\_12746\_26102016\_13414242\_\_\_\_.jpg  
59.89FT, Tap Break-In, at 10 o'clock, -, within 8 inches of joint:  
NO, 6"

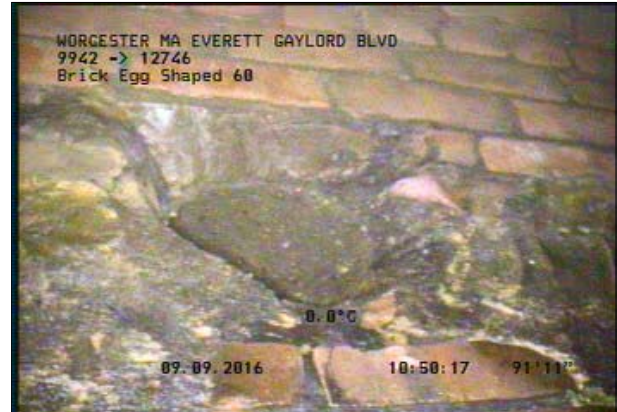
Photo: 9942\_12746\_26102016\_13415858\_\_\_\_.jpg  
91.88FT, Tap Break-In, at 09 o'clock, -, within 8 inches of joint:  
NO, 6"

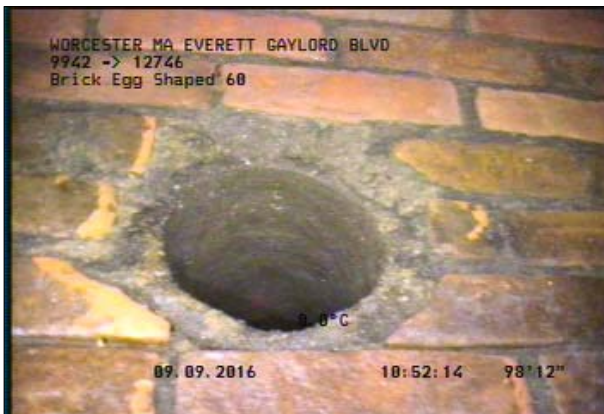
Photo: 9942\_12746\_26102016\_14464444\_\_\_\_.jpg  
96.88FT, Tap Break-In, at 03 o'clock, -, within 8 inches of joint:  
NO, 6"

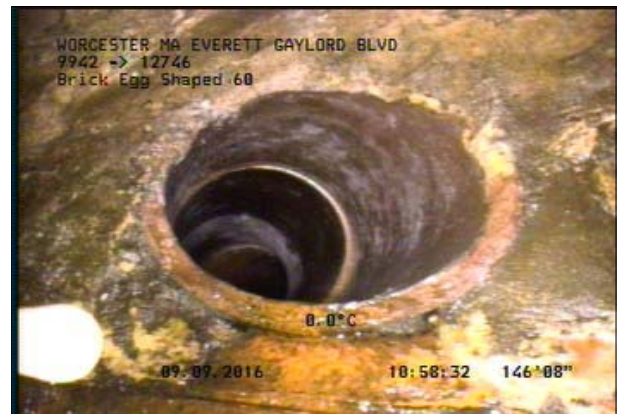
Photo: 9942\_12746\_26102016\_14472020\_\_\_\_.jpg  
146.77FT, Tap Break-In, at 09 o'clock, -, within 8 inches of joint:  
NO, 6"

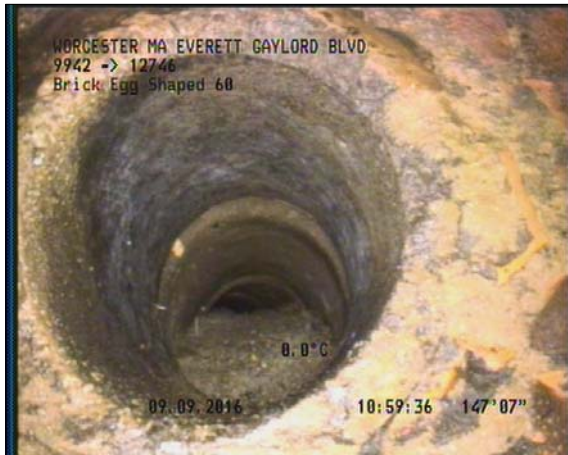
Photo: 9942-12746\_09092016\_TB\_147.5668\_110136\_A.JPG  
147.57FT, Tap Break-In, at 03 o'clock, -, within 8 inches of joint: NO, 6"

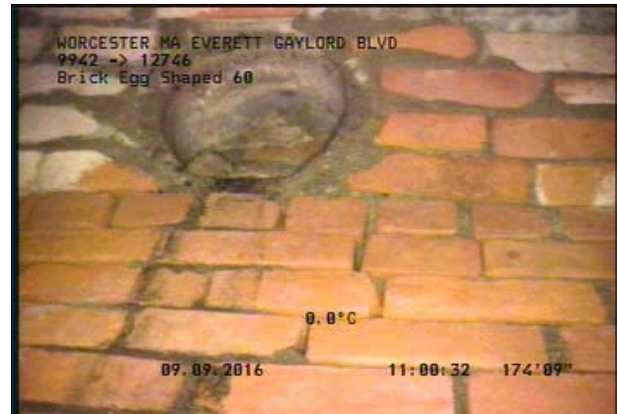
Photo: 9942\_12746\_26102016\_14492020\_\_\_\_.jpg  
174.76FT, Tap Break-In, at 03 o'clock, -, within 8 inches of joint: NO, 6"

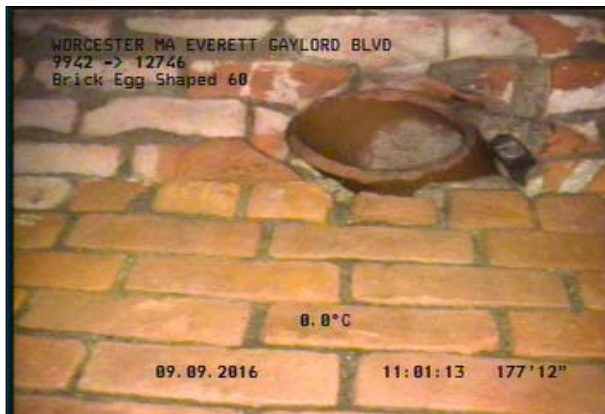
Photo: 9942\_12746\_26102016\_14493939\_\_\_\_.jpg  
177.96FT, Tap Break-In, at 03 o'clock, -, within 8 inches of joint: NO, 6"

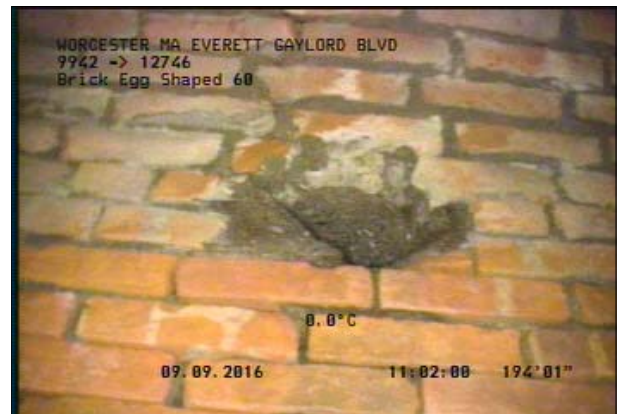
Photo: 9942\_12746\_26102016\_14494646\_\_\_\_.jpg  
194.16FT, Tap Break-In, at 09 o'clock, -, within 8 inches of joint: NO, 6"

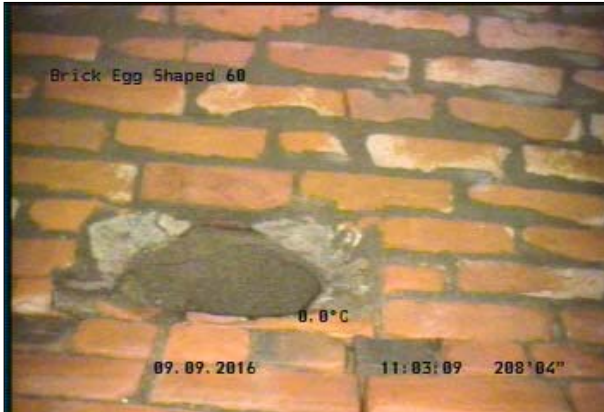
Photo: 9942\_12746\_26102016\_14501818\_\_\_\_.jpg  
208.35FT, Tap Break-In, at 03 o'clock, -, within 8 inches of joint: NO, 6"

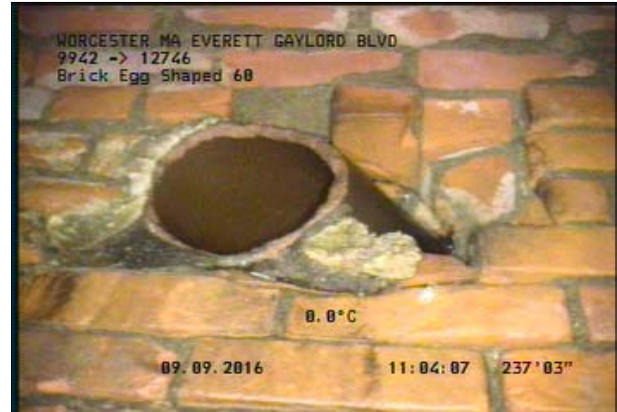
Photo: 9942\_12746\_26102016\_14502525\_\_\_\_.jpg  
237.25FT, Tap Break-In Intruding, at 03 o'clock, -, -, within 8 inches of joint: NO, 2", 6"

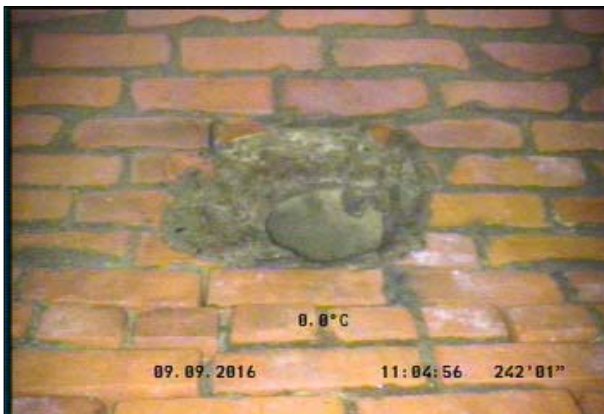
Photo: 9942\_12746\_26102016\_14504242\_\_\_\_.jpg  
242.05FT, Tap Break-In, at 10 o'clock, -, within 8 inches of joint: NO, 6"

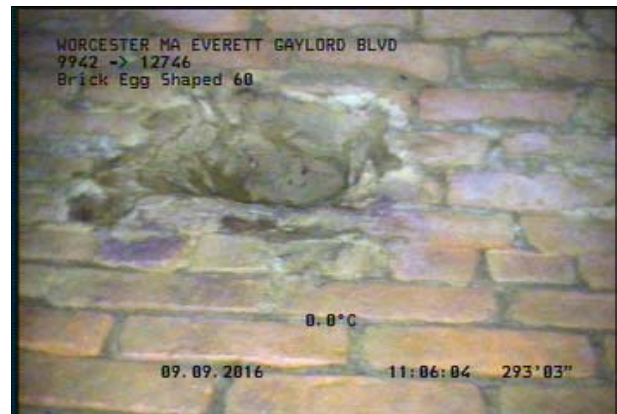
Photo: 9942\_12746\_26102016\_14504949\_\_\_\_.jpg  
293.23FT, Tap Break-In, at 03 o'clock, -, within 8 inches of joint: NO, 6"

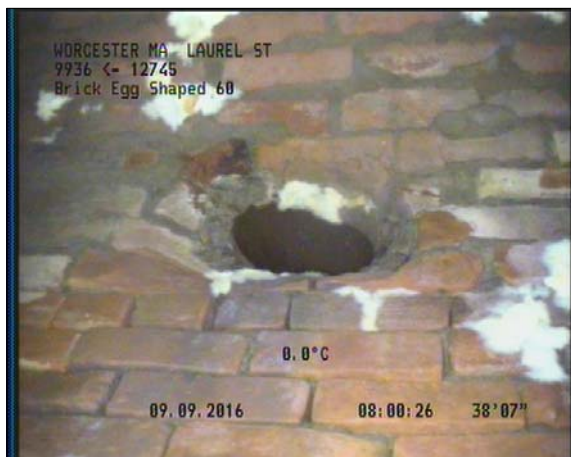
Photo: 12745-9936\_09092016\_TB\_38.5913\_080225\_A.JPG  
38.59FT, Tap Break-In, at 10 o'clock, -, within 8 inches of joint: NO, 6"

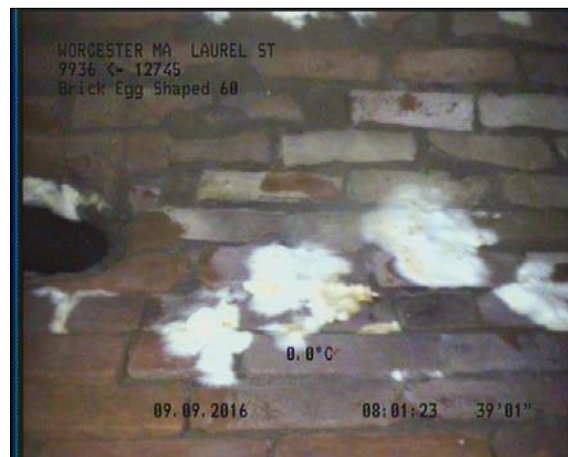
Photo: 12745-9936\_09092016\_DAGS\_39.0912\_080321\_A.JPG  
39.09FT, Deposits Attached Grease, 5 %of cross sectional area, from 09 to 12 o'clock, , within 8 inches of joint: NO

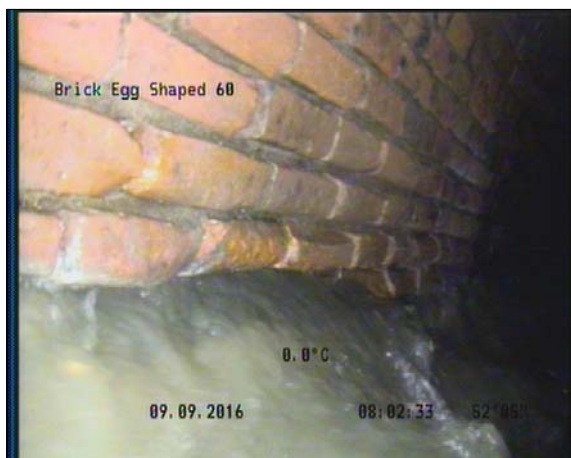
| 1:450 | Position | Observation | | | | | |
|---|---|---|---|---|---|---|---|
| | 52.39 | Missing Brick, at 08 o'clock | | | | | |

Photo: 12745-9936\_09092016\_MB\_52.3882\_080431\_A.JPG  
52.39FT, Missing Brick, at 08 o'clock

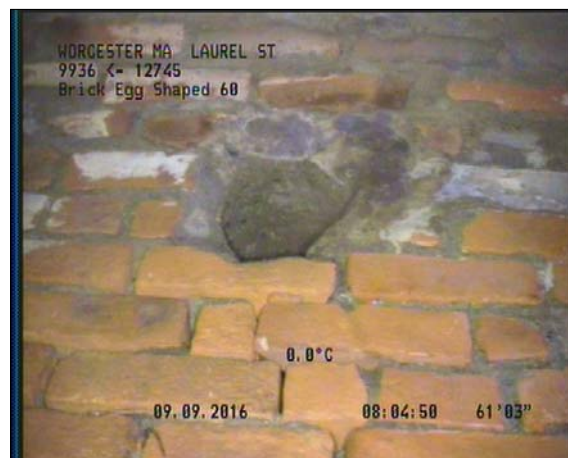
Photo: 12745-9936\_09092016\_TB\_61.2862\_080648\_A.JPG  
61.29FT, Tap Break-In, at 03 o'clock, -, within 8 inches of joint: NO, 6"

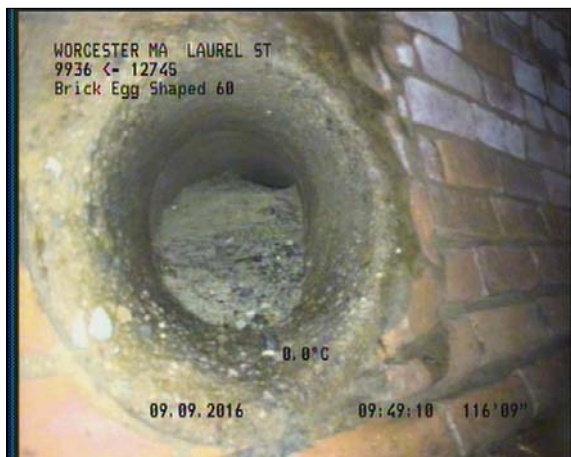
Photo: 12745-9936\_09092016\_TB\_116.7738\_095109\_A.JPG  
116.77FT, Tap Break-In, at 09 o'clock, -, within 8 inches of joint: NO, 6"

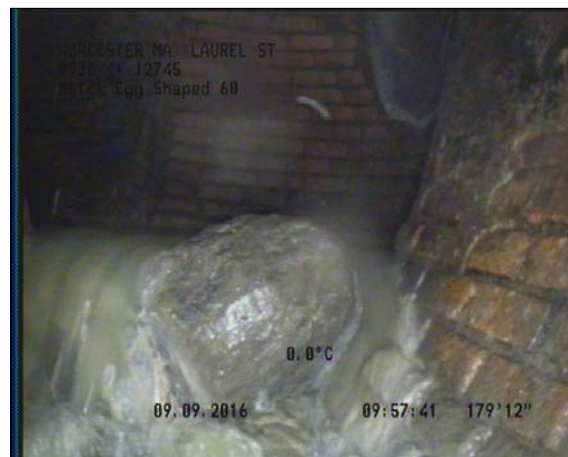
Photo:  
12745-9936\_09092016\_MGO\_179.9596\_095941\_A.JPG  
179.96FT, General Observation
