# APPENDIX A

## TELEVISION INSPECTION REPORTS AND VIDEOS

Project Name: <b>WS WORCESTER WI</b>	Project Number:	Date:
---	-----------------	-------

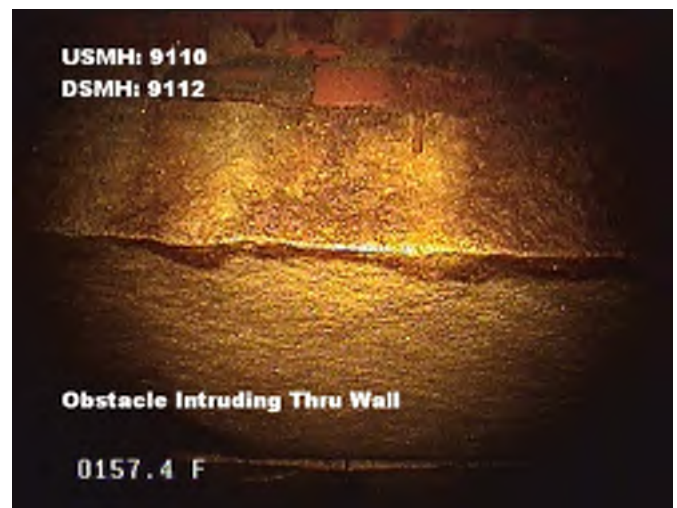
Distance: 152.1 ft. Grade: 2  
Condition: Obstacle Intruding Thru Wall  
Remarks: N/A

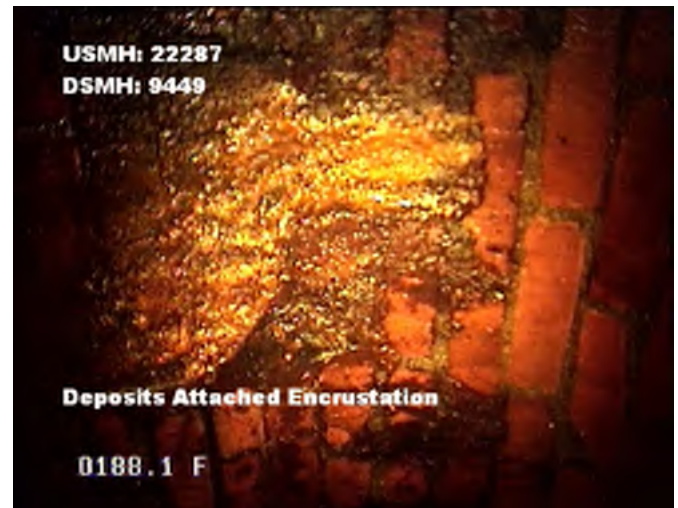
Distance: 170.4 ft. Grade: 2  
Condition: Deposits Attached Encrustation  
Remarks: N/A

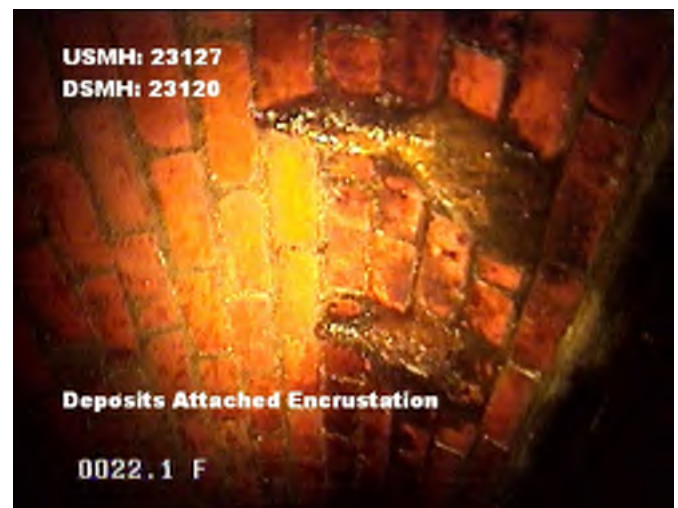
Distance: 7.0 ft. Grade: 2  
Condition: Deposits Attached Encrustation  
Remarks: N/A

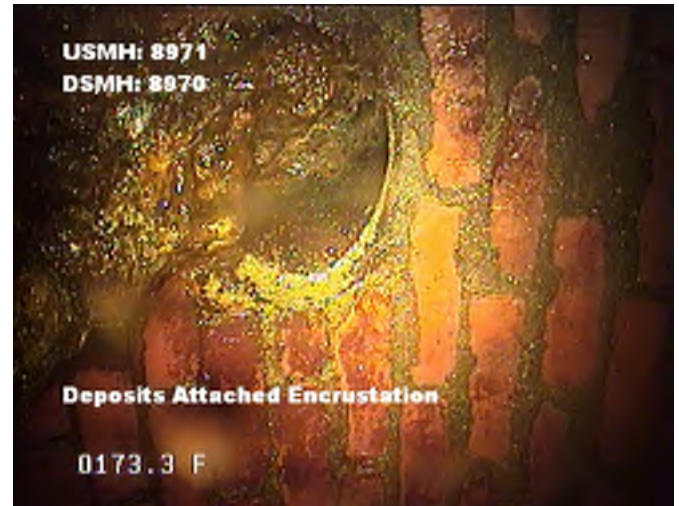
Distance: 173.3 ft. Grade: 2  
Condition: Deposits Attached Encrustation  
Remarks: N/A
