**HAZARDOUS MATERIALS SURVEY  
128 PROVIDENCE STREET  
WORCESTER, MASSACHUSETTS**

February 28, 2019

**Wilcox & Barton, Inc. Project No: WORC0006**

Wilcox & Barton, Inc. has completed a hazardous materials survey of the Former St. Vincent Hospital Nurses' Wing building at 128 Providence Street in Worcester, Massachusetts. The work was performed on behalf of the City of Worcester.

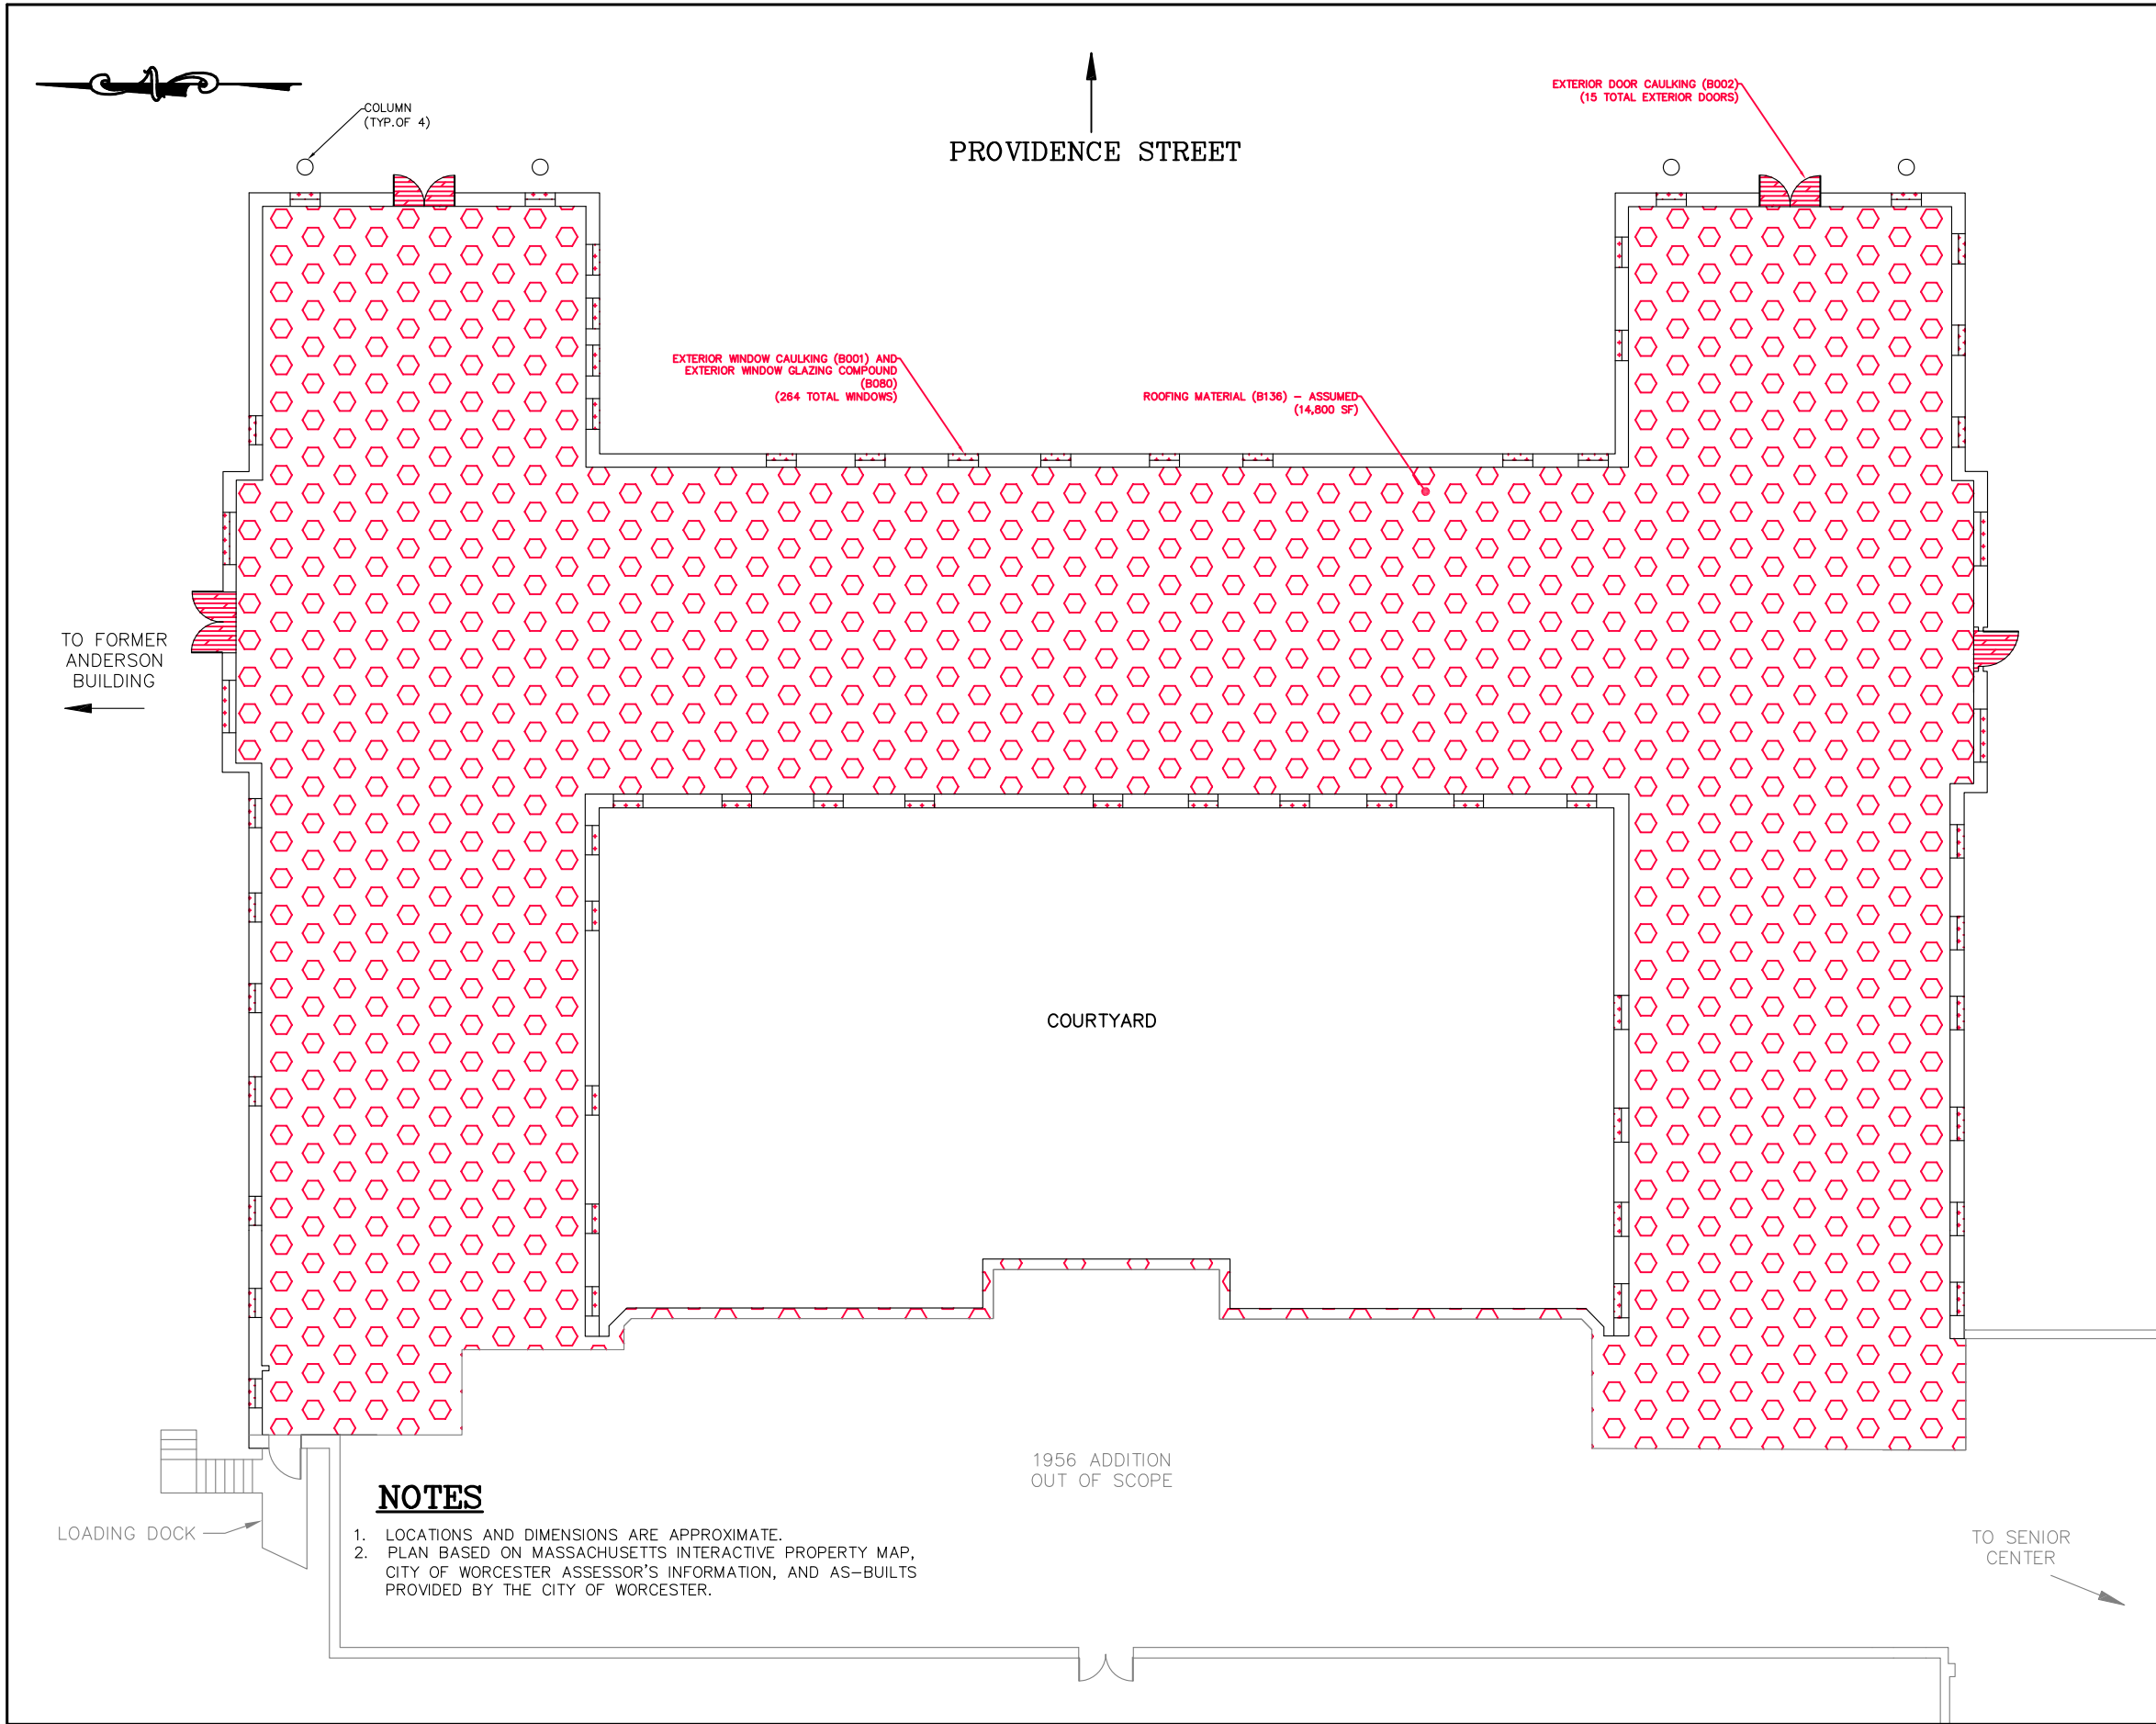
| LOCATION<br>Former St. Vincent Hospital Nurses' Wing<br>128 Providence Street<br>Worcester, Massachusetts | | DRAWING NUMBER<br><b>FIGURE 3A</b> |

- EXTERIOR WINDOW CAULKING (B001) AND EXTERIOR WINDOW GLAZING COMPOUND (B080) (264 TOTAL WINDOWS)
- EXTERIOR DOOR CAULKING (B002) (15 TOTAL EXTERIOR DOORS)
- ROOFING MATERIAL (B136) – ASSUMED (14,800 SF)
