Cascades East

Conservation Property Baseline Assessment

July 2024

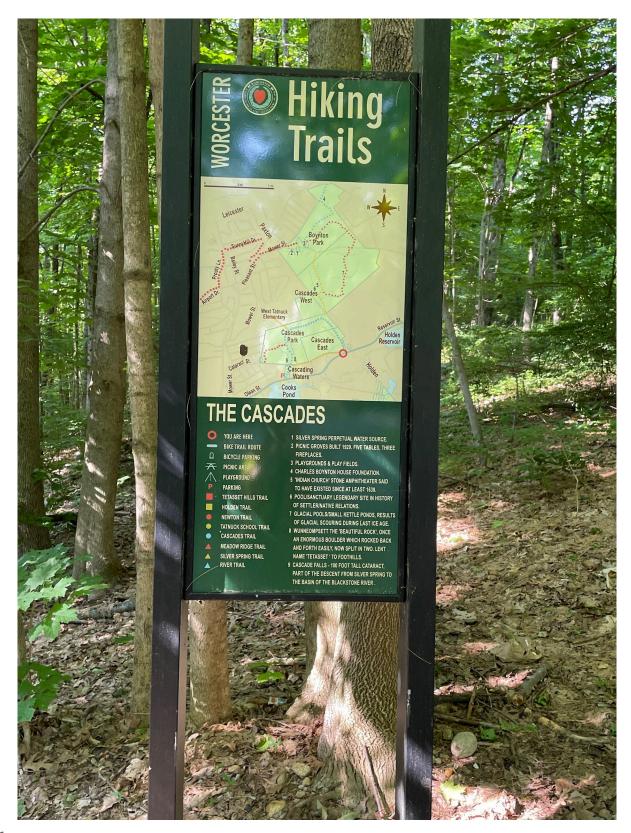
Polygon ID: 53279 **Type:** Sign/Marking

Comments: Well-maintained hiking trail map at parking area off Olean Street.

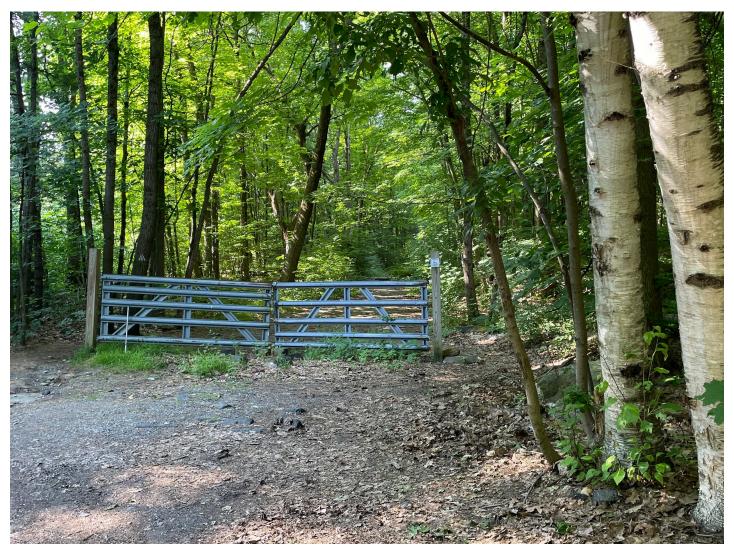
Photo 2
Polygon ID: 53279
Type: Sign/Marking

Comments: A metal gate blocks vehicle access to the gravel portion of Cascade Street from the Olean parking area.

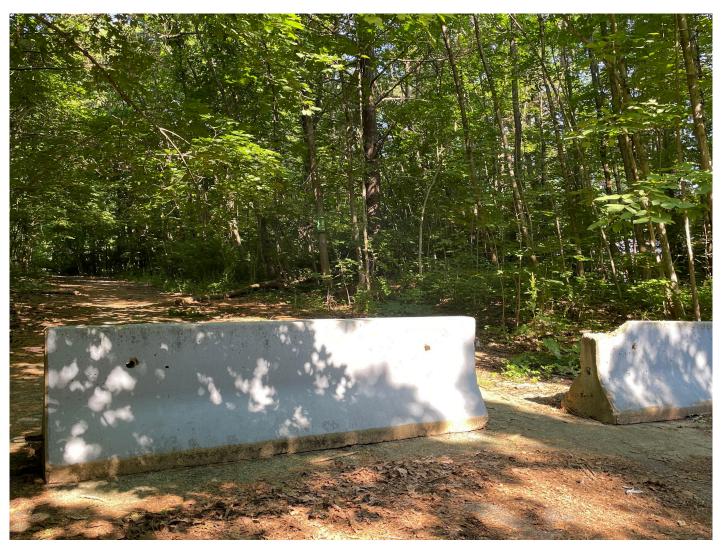
Photo 3
Polygon ID: 53279
Type: Sign/Marking

Comments: Concrete barriers prevent vehicle access to the trail leading into Cascades East from the Olean parking area.

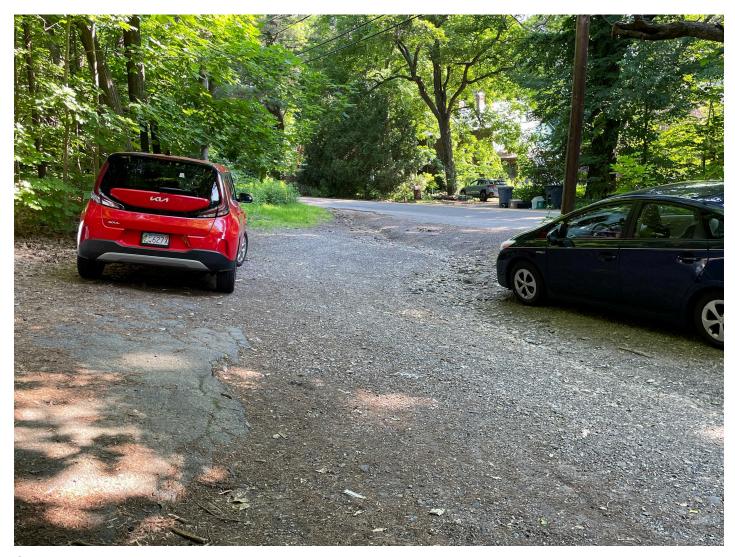
Photo 4

Polygon ID: 53279 **Type:** Sign/Marking

Comments: The Olean Street parking area has multiple potholes and eroded areas but was in use at the time of the

assessment.

- 4. Repair the Olean Street parking area.
 - a. Fill in potholes and areas of erosion in the parking lot to provide a better surface for parking of vehicles.

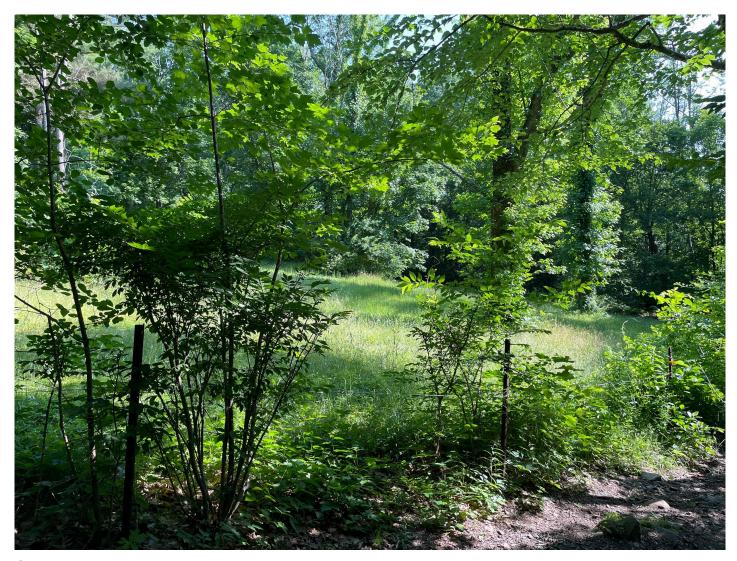
Polygon ID: 53292

Comments: To the northern side of the trail from the Olean parking area is a privately owned meadow providing birch

habitat.

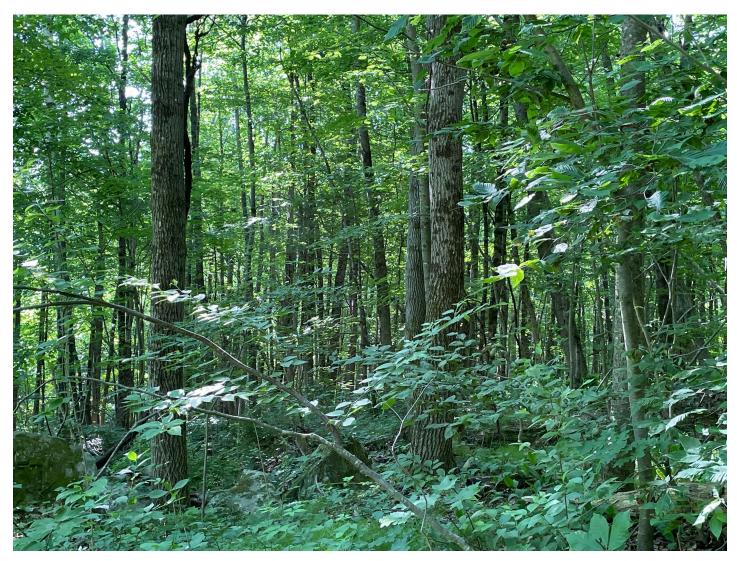
Polygon ID: 53292

Comments: To the southern side of the trail from the Olean parking area is mid-successional deciduous forest.

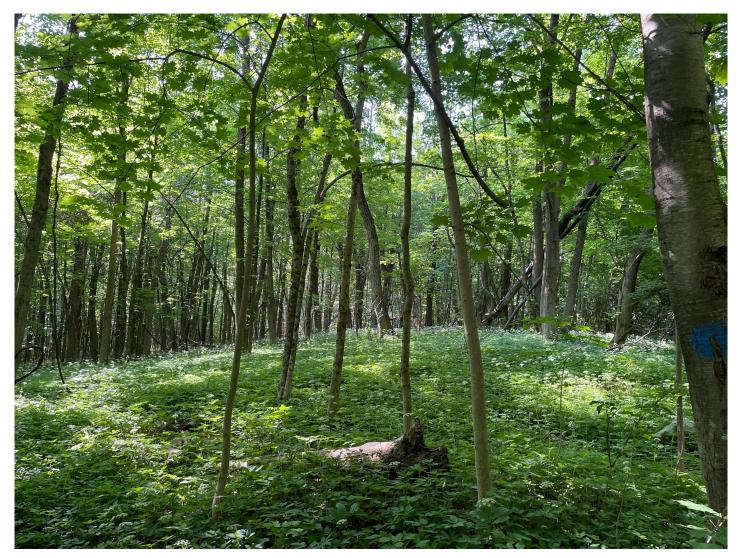
Polygon ID: 53282 **Type:** Invasive Species

Comments: A patch of ground elder (*Aegopodium podagraria*) and evidence of past soil disturbance.

- 1. Manage ground elder and Japanese knotweed invasive species infestations around the bottle and can dump clean-up area.
 - a. Develop a management strategy specific to the species and scope of the infestations.

- b. Carry out management tasks and reseed cleared areas with native species from a reputable and knowledgeable source.
 - c. Monitor invasive species management areas several times annually to identify resprouting undesirable species and adjust management accordingly.

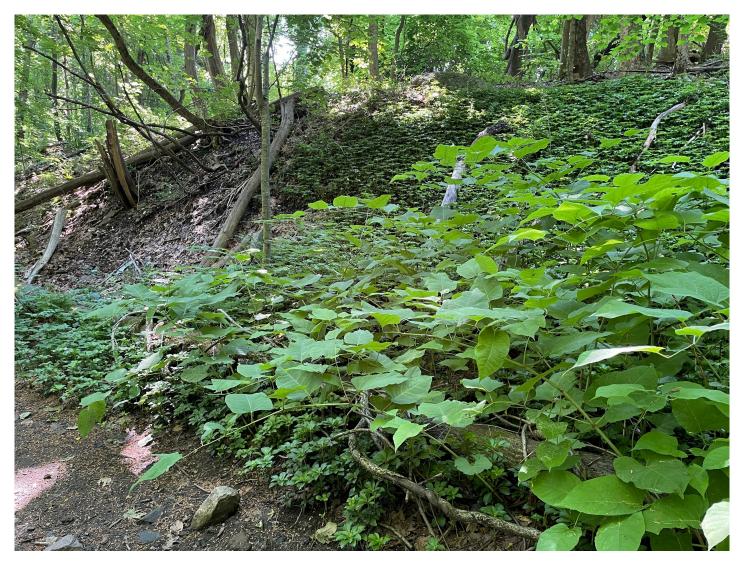
Polygon ID: 53286 **Type:** Invasive Species

Comments: A patch of Japanese knotweed (*Reynoutria japonica*) and pachysandra (*Pachysandra* spp.) lie along the western boundary of the Cascades East parcel. There appears to have been soil disturbance in the area in the past.

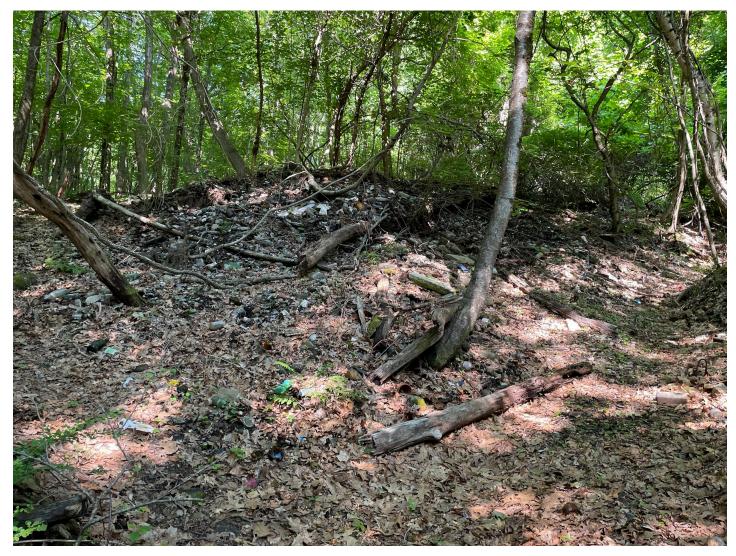
Polygon ID: 53293 Type: Hazard

Comments: Area labeled as "clean-up area" on trail maps appears to be an old dump filled with broken glass, wood, and metal debris. Signs of excavation may be related to clean-up efforts.

- 3. Continue clean-up of the bottle and can dump. Past clean up efforts may have resulted in invasive species infestations.
 - a. Consider posting signage to warn hikers of the hazards around the dump area (broken glass, sharp metal, etc.)

- b. Minimize soil disturbance wherever possible to reduce suitable habitat for invasive species.
 - c. Ensure that any new soil brought into the site is clean and free from invasive propagules. Japanese knotweed, in particular, is known to be present in many commercially available soils.

- d. Replant or reseed disturbed areas after clean-up with native plants purchased from a knowledgeable and reputable source to limit suitable habitat for invasive species to take root.

- e. Monitor cleared areas annually to look for invasive species that may have been brought in or encouraged by the soil disturbance.
 - f. Many of these tasks could potentially be done, wholly or in part, by volunteers or conservation stewards to provide educational opportunities.

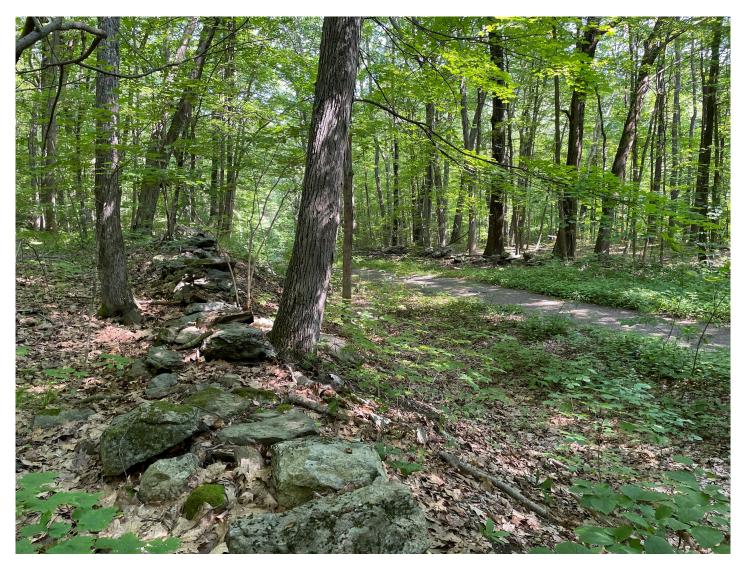
Photo 10 Polygon ID: 53296 Type: Cultural Feature

Comments: The eastern boundary of Cascades East runs along the gravel Cataract Street trail and includes an old

stone wall.

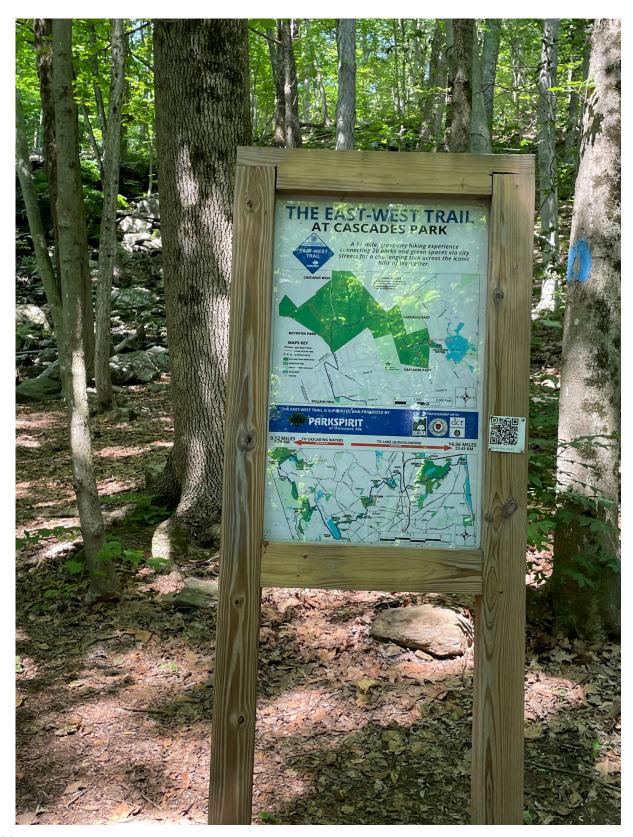
Polygon ID: 53298 Type: Waterway

Comments: Trail map for the East-West Trail off site at the neighboring Cascades Park.

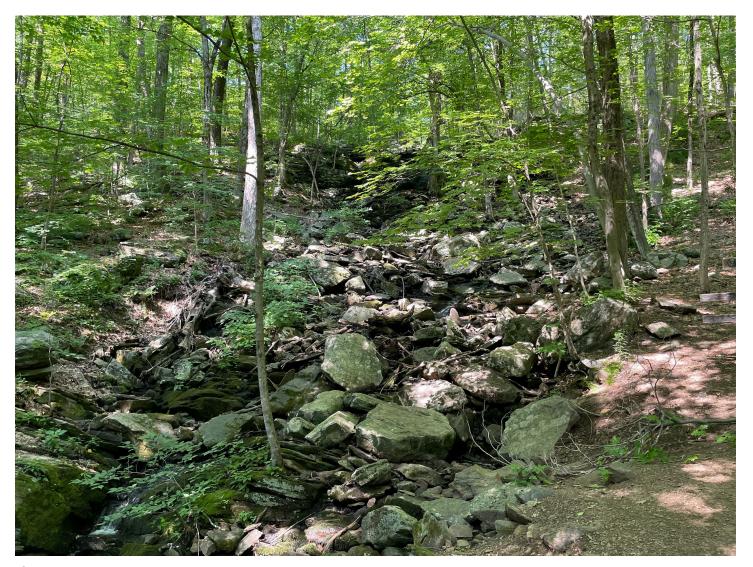
Photo 12 Polygon ID: 53298 Type: Waterway

Comments: The cascades of Cascades Park, visible from Cataract Street.

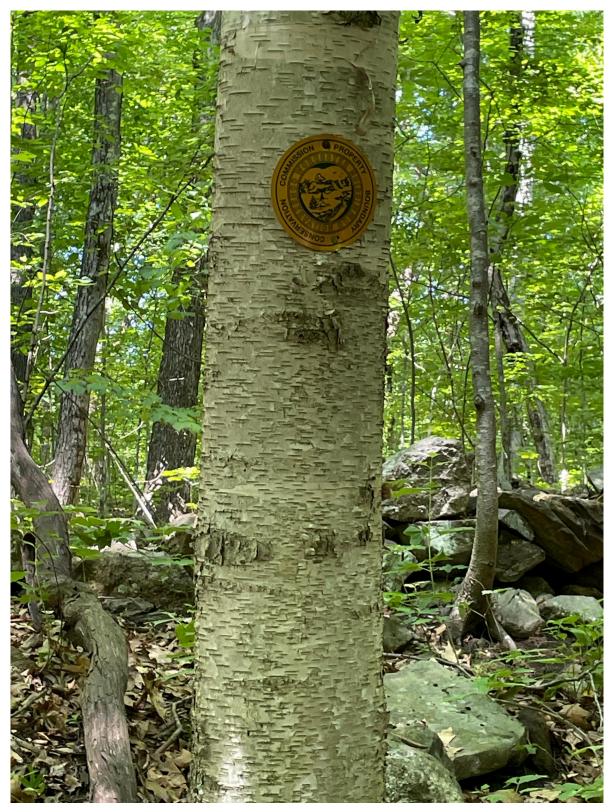
Photo 13
Polygon ID: 53294
Type: Sign/Marking

Comments: Boundary marker for the Cascades East conservation property along Cataract Street.

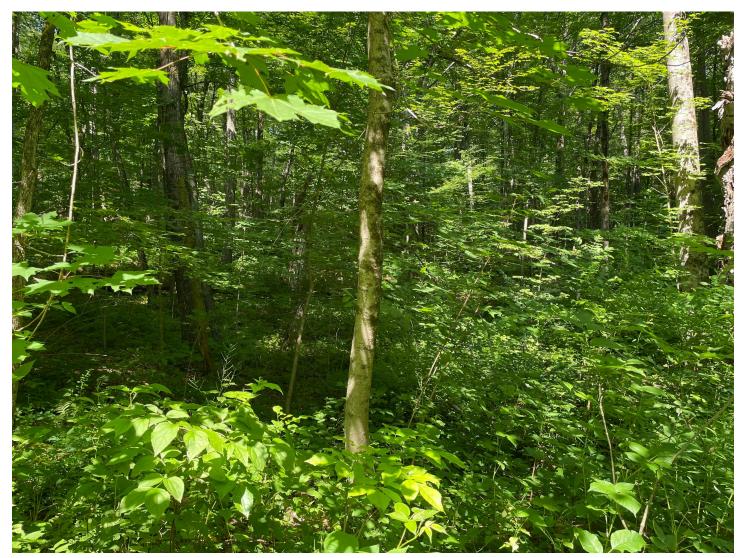
Photo 14
Polygon ID: 53297
Type: Waterway

Comments: Forest in the area is dense and multi-aged with signs of intermittent streams that may flood across Cataract Street when high.

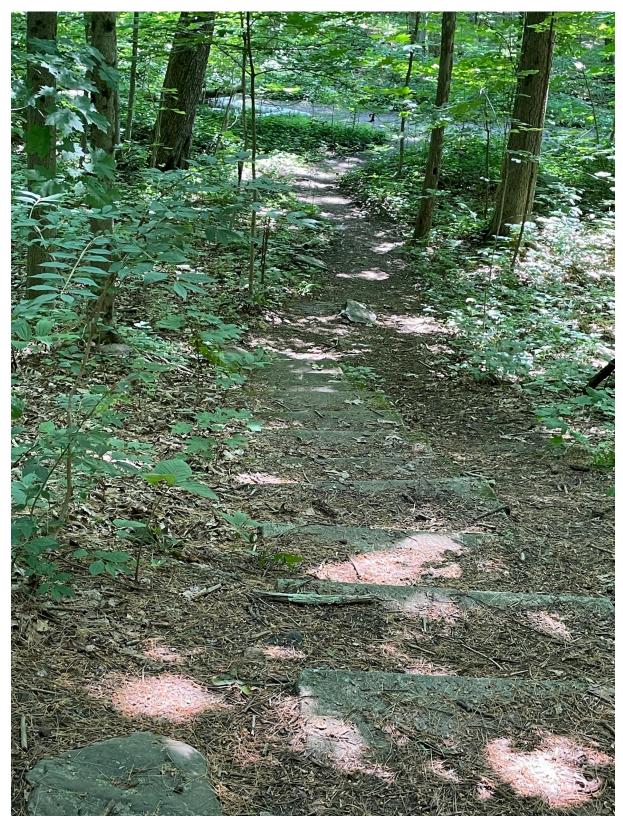
Photo 15
Polygon ID: 53299
Type: Cultural Feature

Comments: Stone steps to a small, unmapped trail may be related to a former homestead on the site.

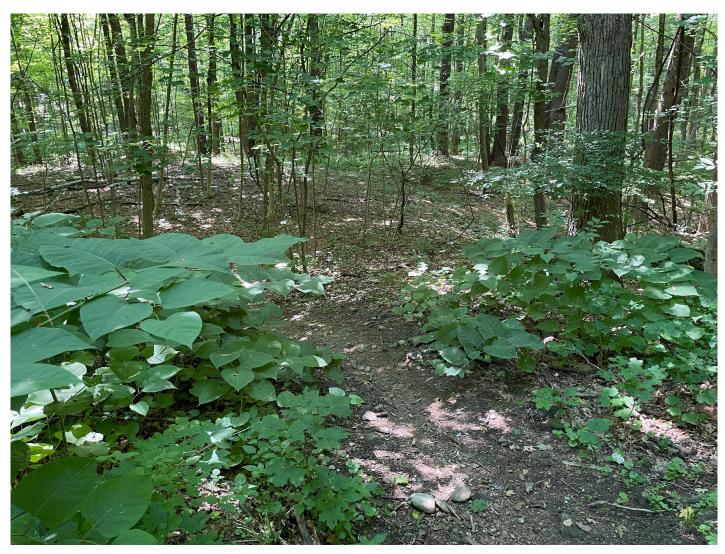
Photo 16 Polygon ID: 53295

Comments: A small patch of Japanese knotweed is present near the top of the stone stairs.

- 2. Manage or eradicate Japanese knotweed patch at the top of the stone stairs.
 - a. Due to the small size of the infested area, it may be possible to eradicate this infestation.

- b. Chemical methods will likely be needed to manage Japanese knotweed, as it is very difficult and inadvisable to attempt manual or mechanical removal alone since it can easily resprout or spread from any scraps left behind.

- c. Monitor the area several times annually after invasive removal to look for resprouting and continue to treat as needed to control and ultimately eradicate the infestation.
