WORCESTER CYANOBACTERIA MONITORING COLLABORATIVE

Coes Pond - October 2021

Coes Pond - September 2021

Coes Pond

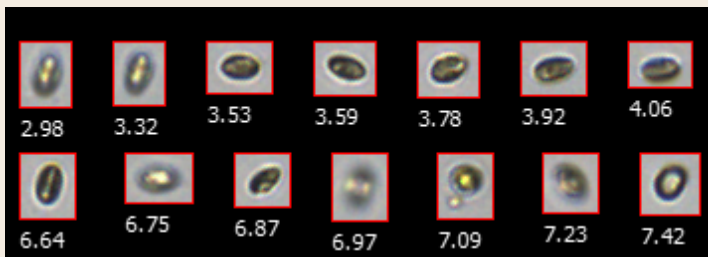
The particle density at Coes Pond was 186 particles/ml in October, down from 2,319 particles/ml in September, according to the FlowCam. While the sample did include some cyanobacteria particles, including *Woronichinia* and *Aphanizomenon*, there were few compared to last month's sample. The sample was dominated by smaller particles, including cryptomonads.

Cryptomonad Cryophytes

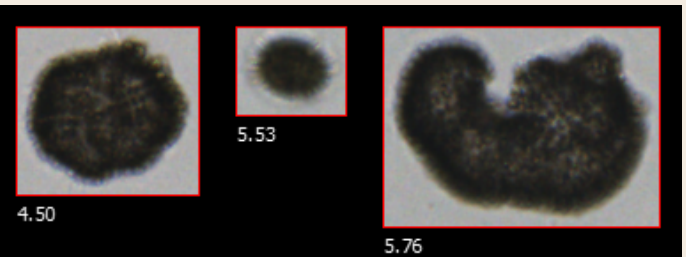
Woronichinia cyanobacteria

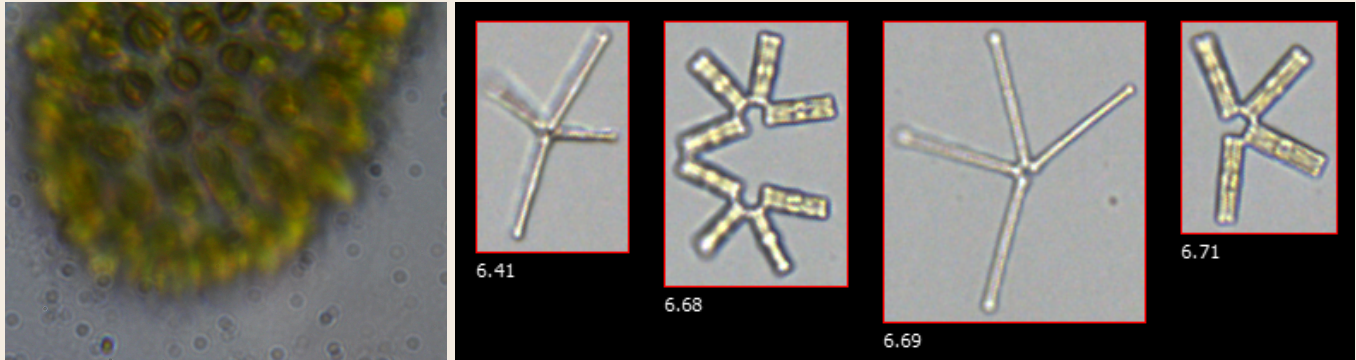
Possibly *Synura* golden algae

Flowcam Images of *Tabellaria* and *Asterionella* Diatoms

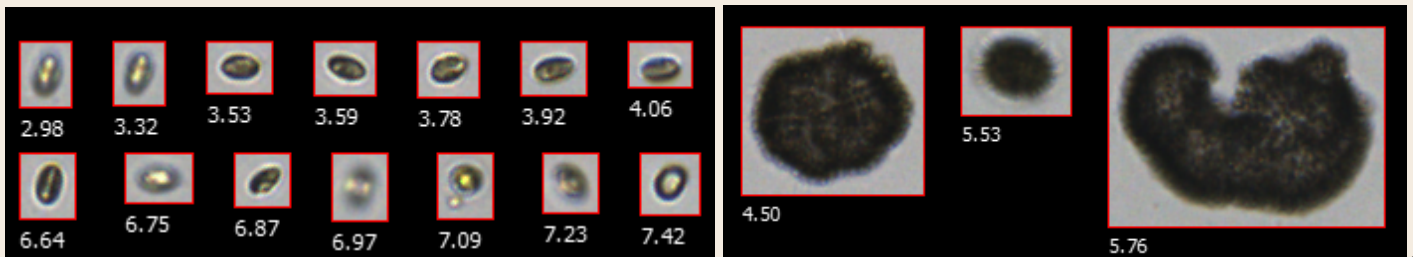
The particle density at Coes Pond was 2319 particles/ml in September, according to the FlowCam, which was higher than it was in August. Unlike in August, however, there were very few cyanobacteria cells, and only three images of *Woronichinia* were obtained. The sample contained many diatoms, including from the genera *Tabellaria* and *Asterionella*, as well as *Cryptomonads*. The sample diversity was similar to that of Coes Reservoir, which flows into Coes Pond.

Cryptomonad Cryophytes

Woronichinia cyanobacteria

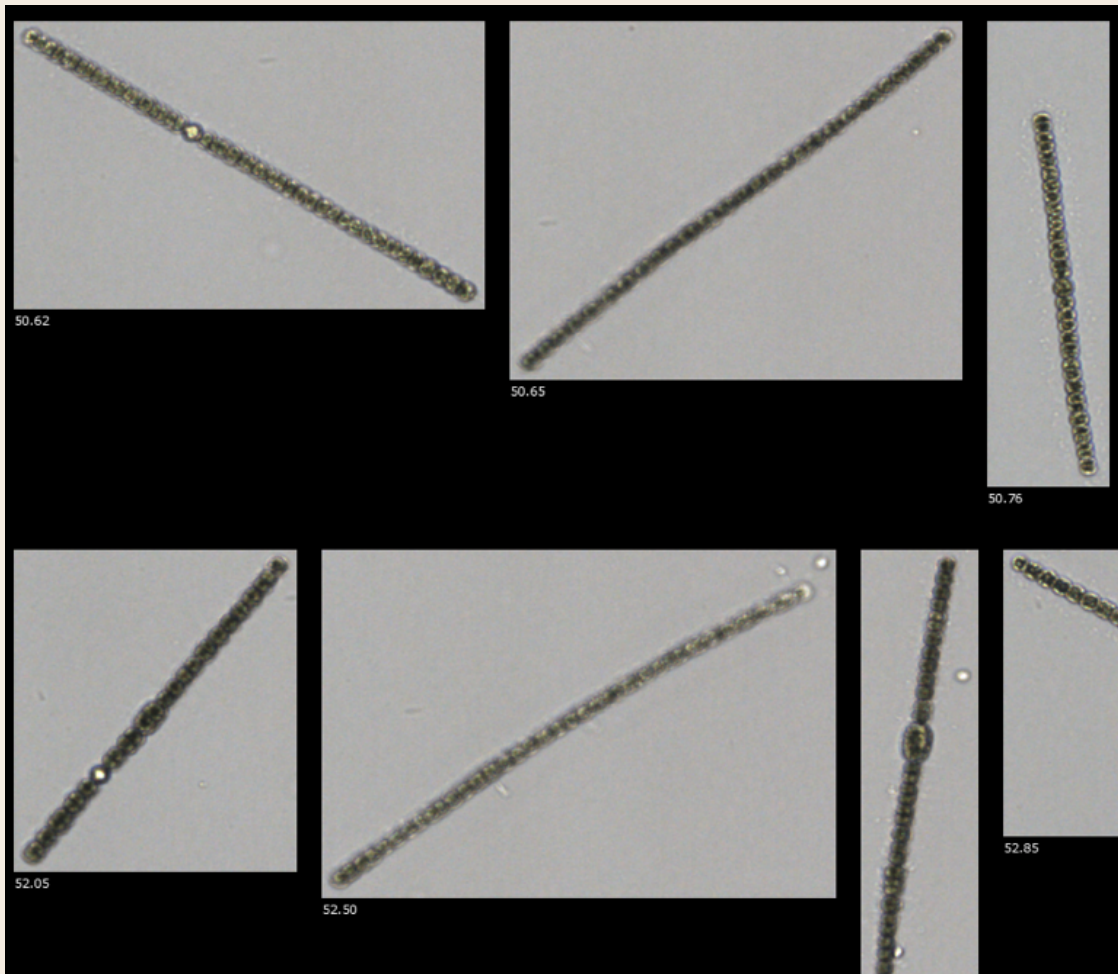
The particle density at Coes Pond was 609 particles/ml in August, according to the FlowCam, which was much lower than it was in July. The sample was dominated by the cyanobacteria *Dolichospermum*. Unfortunately, we do not have fluorometry data for this pond this month, so we are unsure if it is at risk for a bloom.

Dolichospermum Cyanobacteria

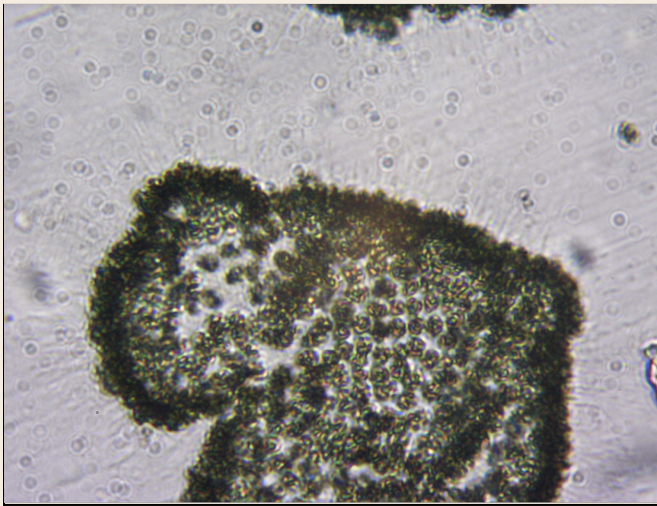
Woronichinia - 400x

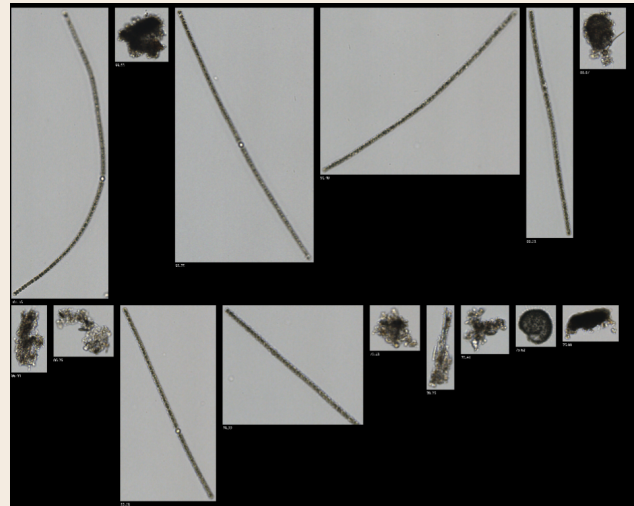
The FlowCam, an advanced microscopy technology, was run for all organisms in the water sample including green algae, golden algae, cyanobacteria, diatoms, and debris. The pond was not sampled in June, but results as 2,610 particles/ml in July. The figure provides a snapshot of some of the images that were seen by the camera at this lake.

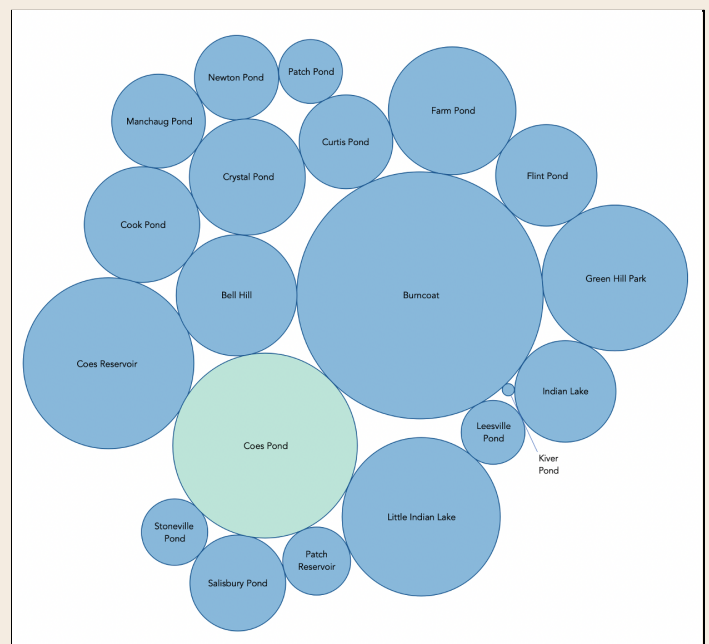
Using the fluorometer to find phycocyanin levels, the following graph represents the relative cyanobacteria pigment in each pond. Coes Pond was not sampled this June, and now is equal to about 35 Absorbance Units (Au) in the month of July. A pond becomes at risk for a bloom when the level is above 50 Au.

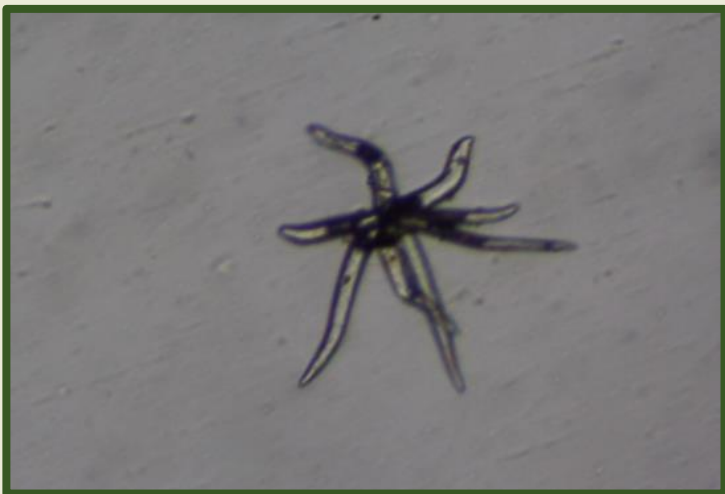
Trichome (100x)

Trichomes are fine hair – like outgrowths that occur on many plant and algal species. These are likely from aquatic macrophytes.

Underneath the microscope this month, volunteers found a trichome, and no types of cyanobacteria. Next month, fluorometry will be used on samples Coes Pond to better determine the threat of cyanobacteria.
