WORCESTER CYANOBACTERIA MONITORING COLLABORATIVE

Coes Reservoir - October 2021

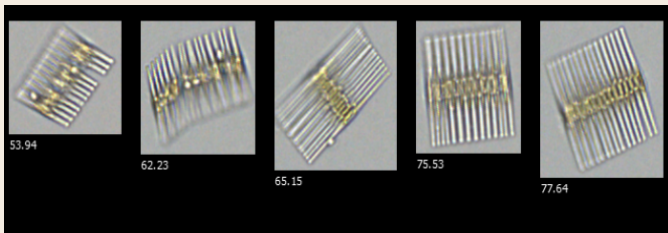
Tabellaria Diatoms

The particle density at Coes Reservoir was 238 particles/ml in October, according to the FlowCam, which was lower than what was observed in September. The sample was again dominated by diatoms, such as *Asterionella*, *Fragilaria*, and small circular diatoms. There were only a few images of cyanobacteria, including *Woronichinia*. The diversity this month was therefore similar to last month's, however, the density of cells was much lower.

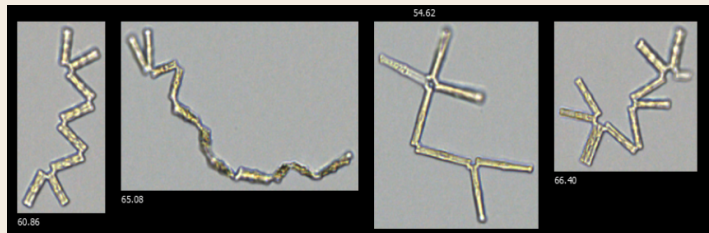
Fragilaria Diatoms

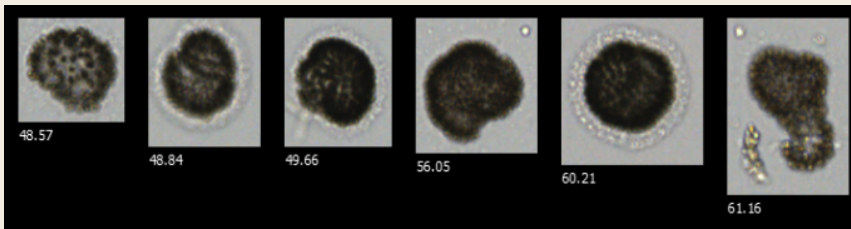
Woronichinia Cyanobacteria

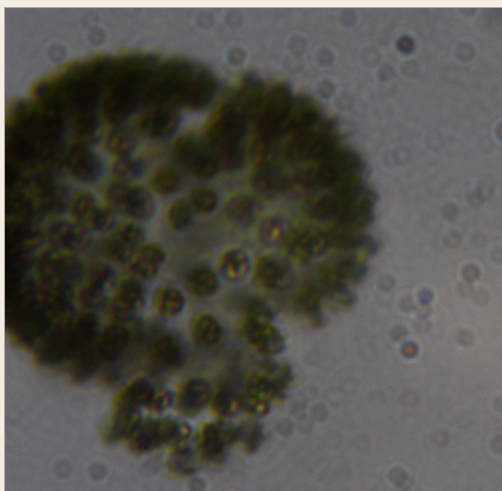
Woronichinia Cyanobacteria

The particle density at Coes Reservoir was 3793 particles/ml in September, according to the FlowCam, which was more than what was observed in August. The sample was dominated by diatoms, such as Asterionella, Fragilaria, and small circular diatoms. There were only a few images of cyanobacteria, including Woronichinia. Since the last sampling event, there was a copper sulfate treatment performed at the lake, which may be responsible for the reduced density of cyanobacteria.

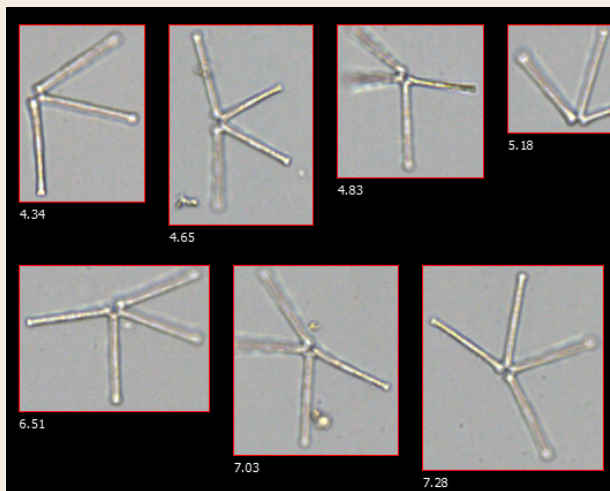
Flowcam Images of Asterionella Diatoms

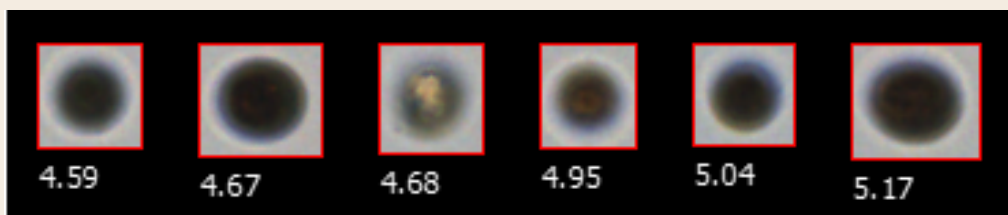
Circular Diatoms

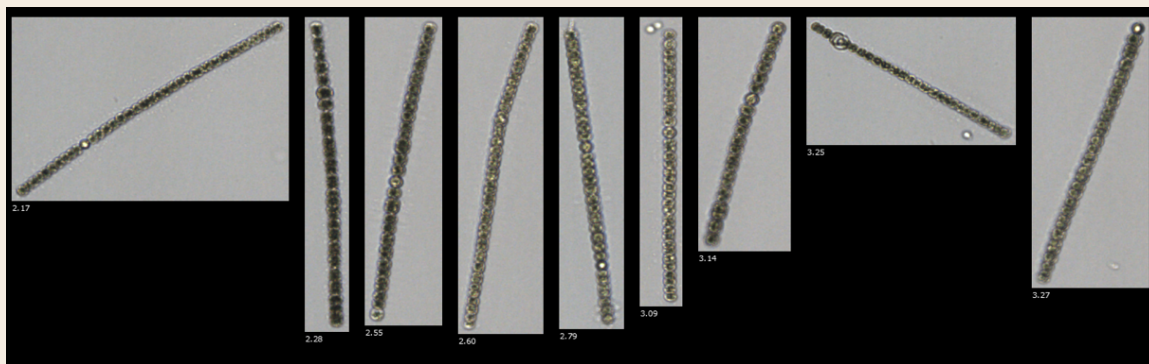
Dolichospermum Cyanobacteria

The particle density at Coes Reservoir was 631 particles/ml in August, according to the FlowCam, which was less than what was observed in July. The sample was dominated by the cyanobacteria *Dolichospermum*, as well as some green algae from the genera of *Oocystis* and *Sphaerocystis*. Follow-up samples are now being taken at Coes Reservoir to determine if there is a threat of a cyanobacteria bloom.

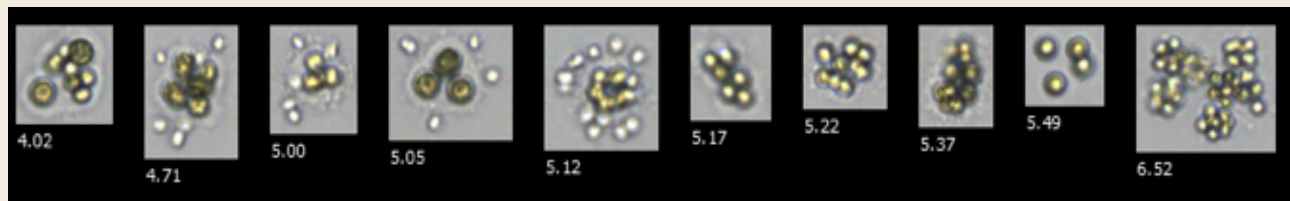
Oocystis/Sphaerocystis green algae

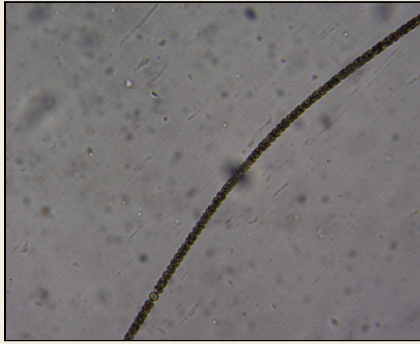
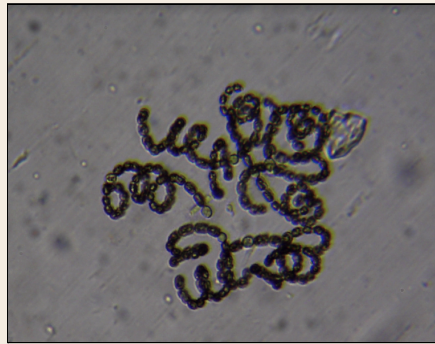
Dolichospermum - 100x

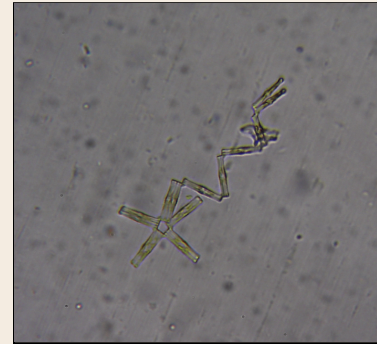
Tabellaria - 100x

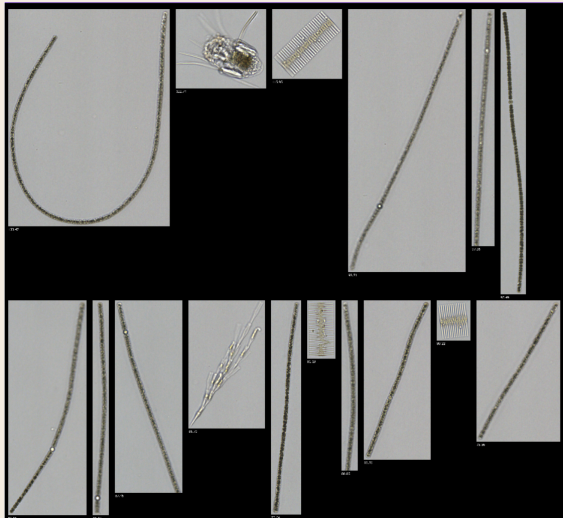
The FlowCam, an advanced microscopy technology, was run for all organisms in the water sample including green algae, golden algae, cyanobacteria, diatoms, and debris. The particle density at Coes Reservoir was 1202 particles/ml in June, and increased to 1891 particles/ml in July. The figure provides a snapshot of some of the images that were seen by the camera at this lake.

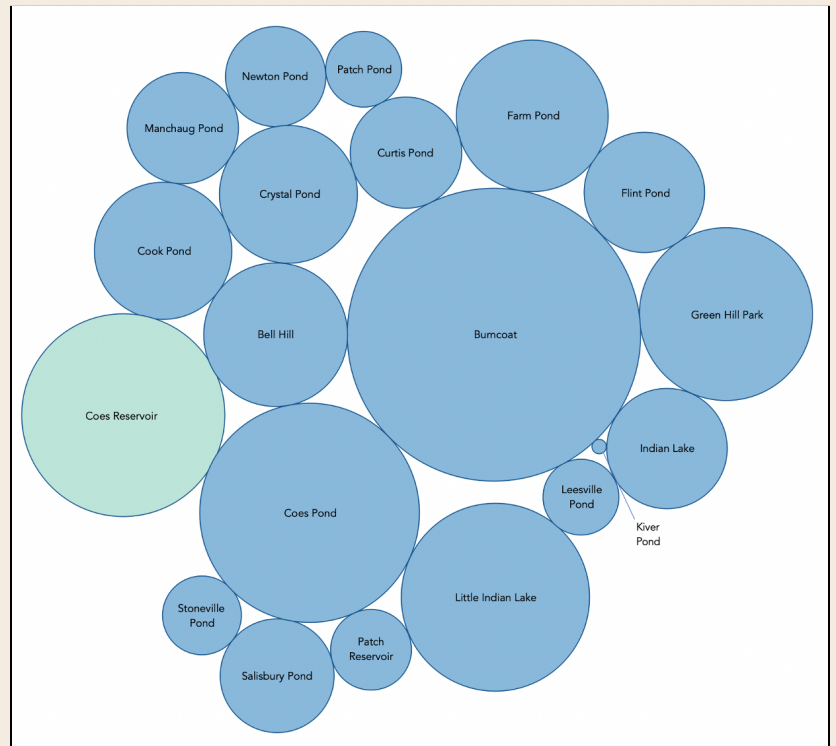
Using the fluorometer to find phycocyanin levels, the following graph represents the relative cyanobacteria pigment in each pond. Coes Reservoir rose from an undetectable level in the month of June to about 30 Absorbance Units (Au) in the month of July. A pond becomes at risk for a bloom when levels rise above 50 Au.

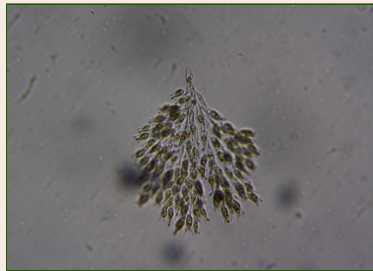
Dinobryon - 100x

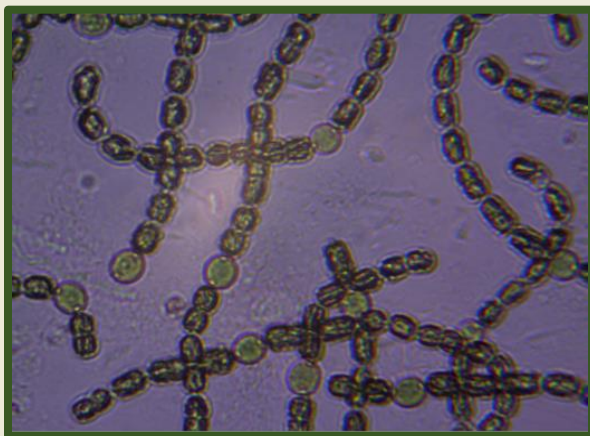
Dolichospermum
cyanobacteria (400x)

Underneath the microscopes, a small colony of Dolichospermum cyanobacteria was found by volunteers, as well as what we believe to be a green algae. These are commonly seen in Coes Reservoir, based on past years' timeline shown below. Since the sample was taken, the City has contracted a microscopic cell count, and levels of cyanobacteria have been determined to be low, and not a threat to humans or pets.

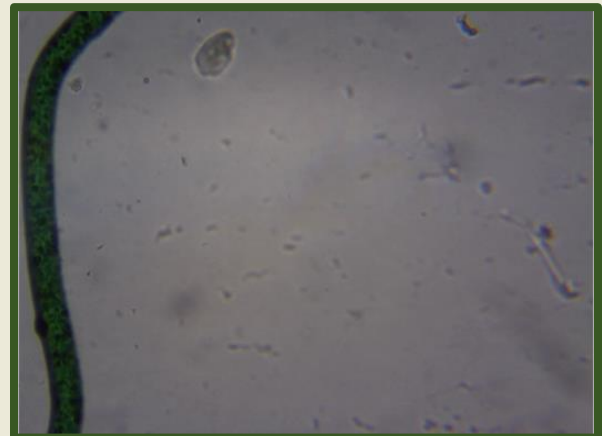
Unidentified (100x)

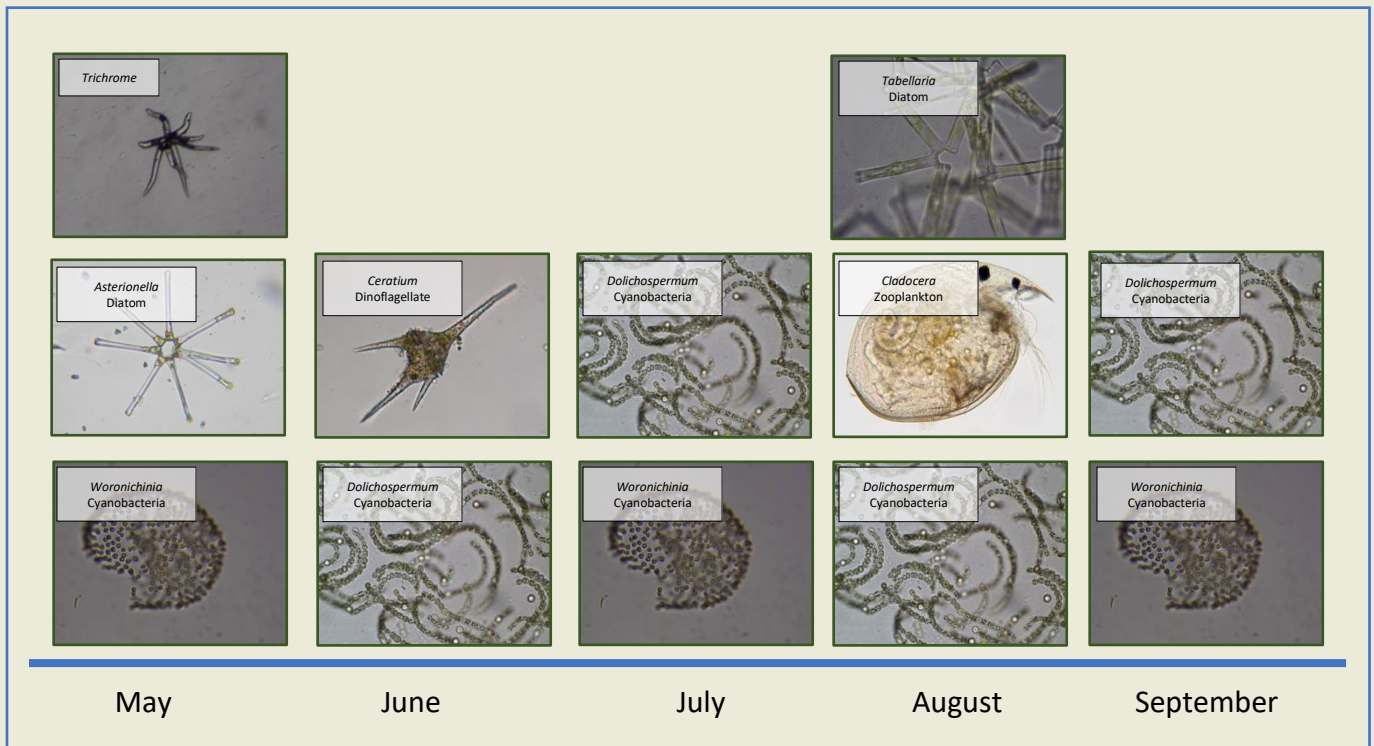
The timeline below shows the organisms that have been found in Coes Reservoir in past years.
