Patch Reservoir

2022 Water Quality Report

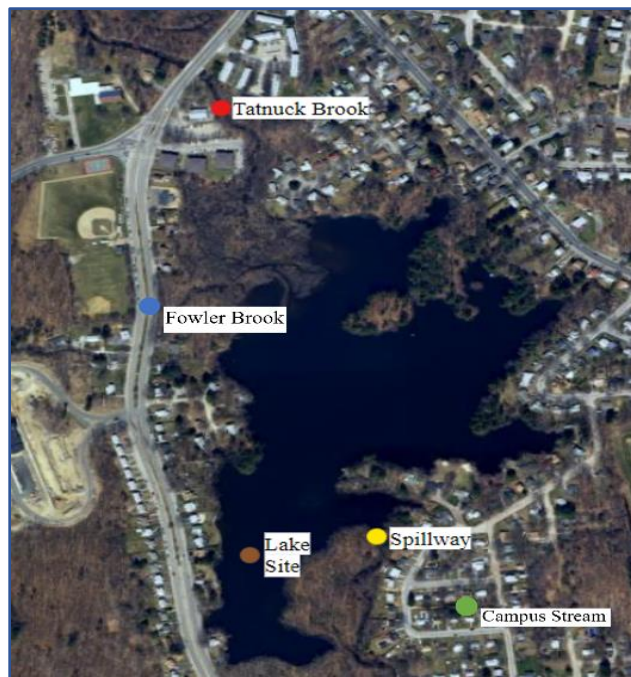
Figure 2 - Patch Reservoir map and approximate sampling locations.

In 2022, Patch Reservoir was visited twice monthly from May through October and sampled at three locations: the major aboveground tributary, Tatnuck Brook; the deepest part of the reservoir (the southern end of which is approximately 13 feet deep); and the outlet at the spillway located in the southern part of the reservoir (see Figure 2). At the in-lake locations, probe measurements and water samples were collected one 1 foot below the surface of the water (“surface”), and two 2 feet off of the bottom of the lake (“bottom”). Parameters evaluated included: Secchi transparency, temperature, dissolved oxygen (DO), pH, total phosphorus (TP), and total dissolved phosphorus (TDP). Samples analyzed for total suspended solids (TSS), ammonia (NH₃), and nitrate (NO₃) were collected on a monthly basis. Altogether, there were 12 sampling events. For 5 of these events, there was no rainfall 24 hours prior to data collection. However, on 7-Jul, there were 1.47 inches of rain in the 24 hours prior to sampling, on 23-

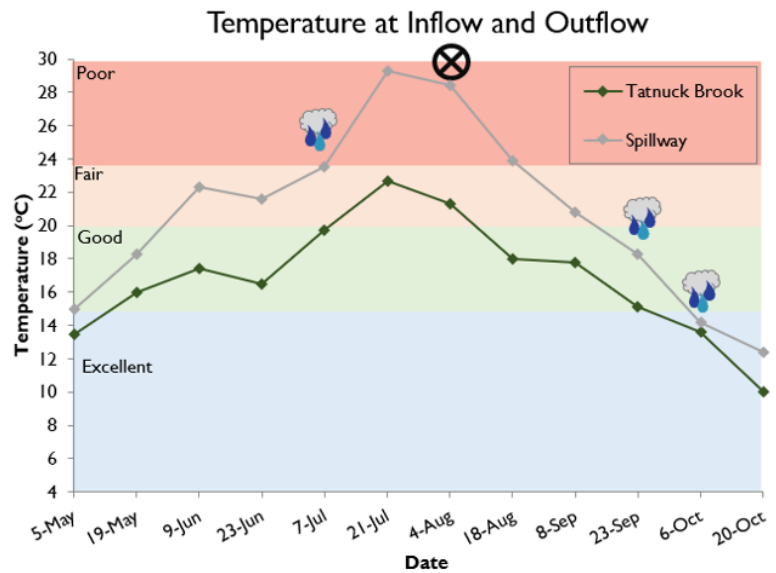
Tributaries at Patch Reservoir. At Patch Reservoir, the major natural tributary is Tatnuck Brook, which enters the pond from the north. The major outlet of the reservoir is the spillway, located on the southern end of the impoundment. Tatnuck Brook is considered to be a Coldwater Fish Resource (CFR), which means that it is a stream that can hold reproducing cold water fish such as trout. Tatnuck Brook, therefore, has higher standards for temperature than many local urban waterbodies. Over the 2022 sampling season, the brook had a maximum temperature of 22.7°C degrees on 21-Jul and was in what is considered the "Fair" temperature range for 2 of the 12 sampling events though mostly it fell into the "Good" or "Excellent" categories (see Figure 10). As water from Tatnuck Brook enters Patch Reservoir, it slows down and is more exposed to the sun and air, warming it up, especially within the small marsh environment where the brook enters the reservoir. On average, the water leaving the Patch Reservoir spillway was 3.9 degrees higher than the water that enters the reservoir. This resulted in four of the sampling events in the summer months to have temperature readings in the "Poor" category for a CFR. These high temperatures may be stressful for cold-water fish species.

Figure 10 – Water temperature at the Patch Reservoir spillway was on average 3.9 degrees higher than when it entered the impoundment.

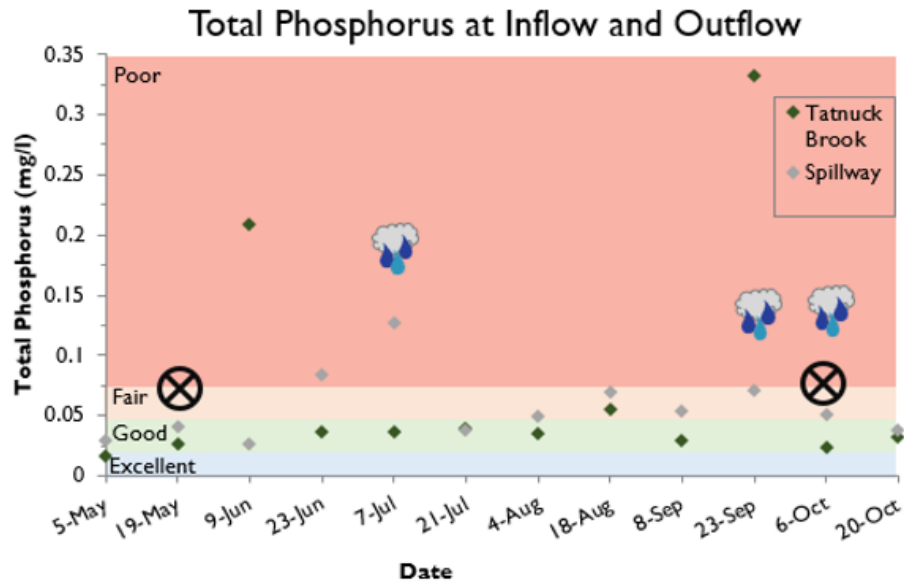
TP concentrations in Tatnuck Brook were widely variable, ranging between 0.016 and 0.333 although most results were in the range considered “Good” (see *Figure 12*). Two results were considerably higher than the rest, 0.209 mg/l on 9-Jun, and 0.333 mg/l on 23-Sep. Concentrations at the spillway were less predictable and generally higher, ranging between 0.029 mg/l and 0.127 mg/l, with most results in the categories considered “Fair” and “Poor”.

Figure 12 – Total phosphorus at Tatnuck Brook ranged between the “Excellent” and “Poor” categories between the “Good” and “Poor” categories at the Spillway..

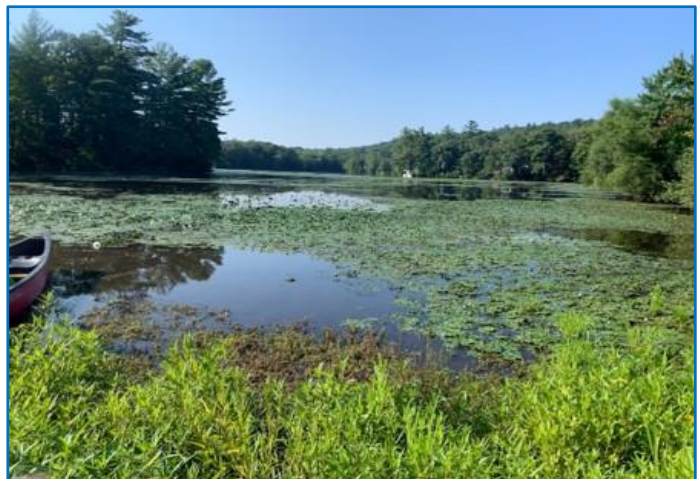
Figure 13 – Invasive Water Chestnut in the northern portion of Patch Reservoir.

Previously, the invasive aquatic plant, Water Chestnut, which is found primarily in the northern portion of the reservoir, was managed by volunteer hand-pulls organized by the Friends of Patch Reservoir. Unfortunately, the size of the infestation and geography of the reservoir makes it difficult to eradicate all plants with this method. Since 2019, the contact herbicide Imazomox (trade name Clearcast) has been applied each year to Patch Reservoir. A different spraying technique was utilized in July of 2022 and was found to be the most effective treatment of Patch since 2019. Unfortunately, the reproductive strategy of the Water Chestnut means that it will need to continue to be managed for many years before the infestation is eradicated. In 2018, a chemical was applied to treat the Fanwort and Milfoil. This treatment was effective for several years, but now both plants are starting to re-invade Patch.

In 2022, Flumioxazin (trade name: Clearcast) and Flumiguard SC were applied to Patch 12-Jul and 28-Jul of 2022. The post-treatment survey by Solitude concluded that the treatment was successful in reducing the density of Water Chestnut, but two small patches remained. While invasive aquatic plants have historically been an issue at Patch Reservoir, the adaptable management plan has been effective at controlling species such as Water Chestnut from taking over. Managing the Water Chestnut population at Patch is a long-term project with no potential end date determined.

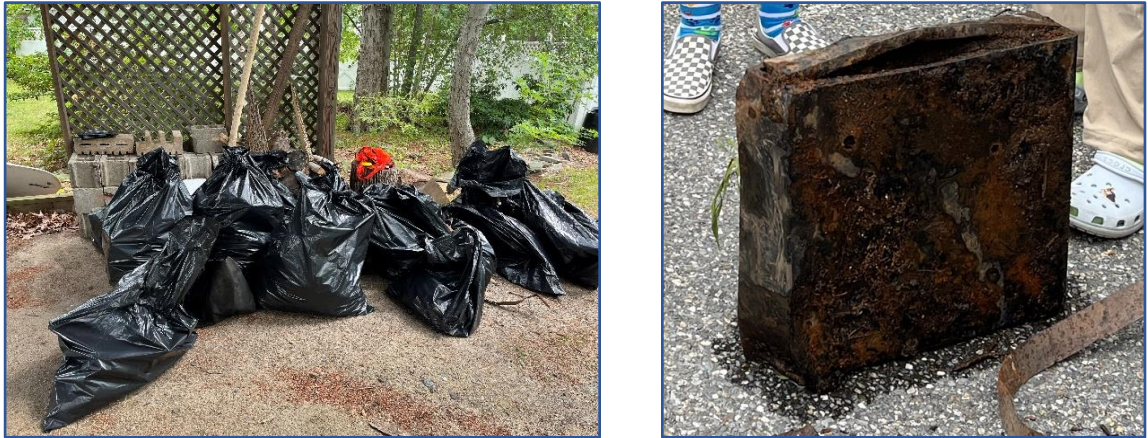
Figure 15 – Litter collected throughout the sampling season and during the “Zap the Blackstone” clean-up event on 27-Aug 2022.

Litter at Patch Reservoir. Litter was collected throughout the sampling season whenever it was present during a sampling event. Litter was also collected from the Tatnuck Brook upstream of Patch Reservoir during the Blackstone Zap 50 event on 27-Aug 2022. This clean-up event spanned the Blackstone Watershed and was led around Patch Reservoir by the Friends of Patch Reservoir. Together, at least 10 bags of trash were collected; items included rubber ducks and many golf balls. Several items were too large or heavy to be thrown into a garbage bag, such as a basketball hoop and two cash register boxes.

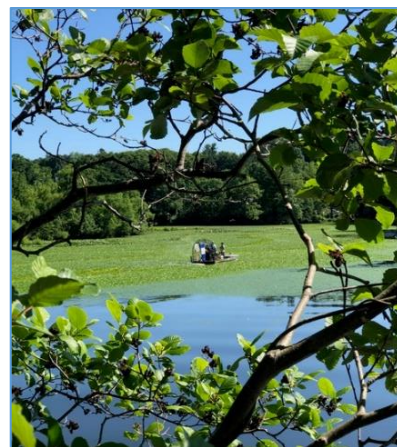
Figure 16 - Contractors applying the herbicide Clearcast to Invasive Water Chestnut at Patch Reservoir.

Invasive Aquatic Plant Management. In 2023 the community group, Friends of Patch Reservoir, with help from the Lakes and Ponds Program, will continue to administer the invasive aquatic plant management plan similar to how it was enacted in 2022. Herbicide use will continue, as patches of fanwort and milfoil began to resurface in 2022. As the management goals are currently not being met, they will be updated to better serve the community. Currently, there is no official protocol for alerting the public to the occurrence
