Evaluation of “Crosswalk and Lighted Crosswalk System”

14 Richards Street
September 18, 2023

Petitioner: Brian Underwood request installation of flashing crosswalk lights in the vicinity of Goddard School of Science & Technology, 14 Richards St.
9z CC June 8, 2021

Prepared by: Todd M. Kirrane., Assistant Director

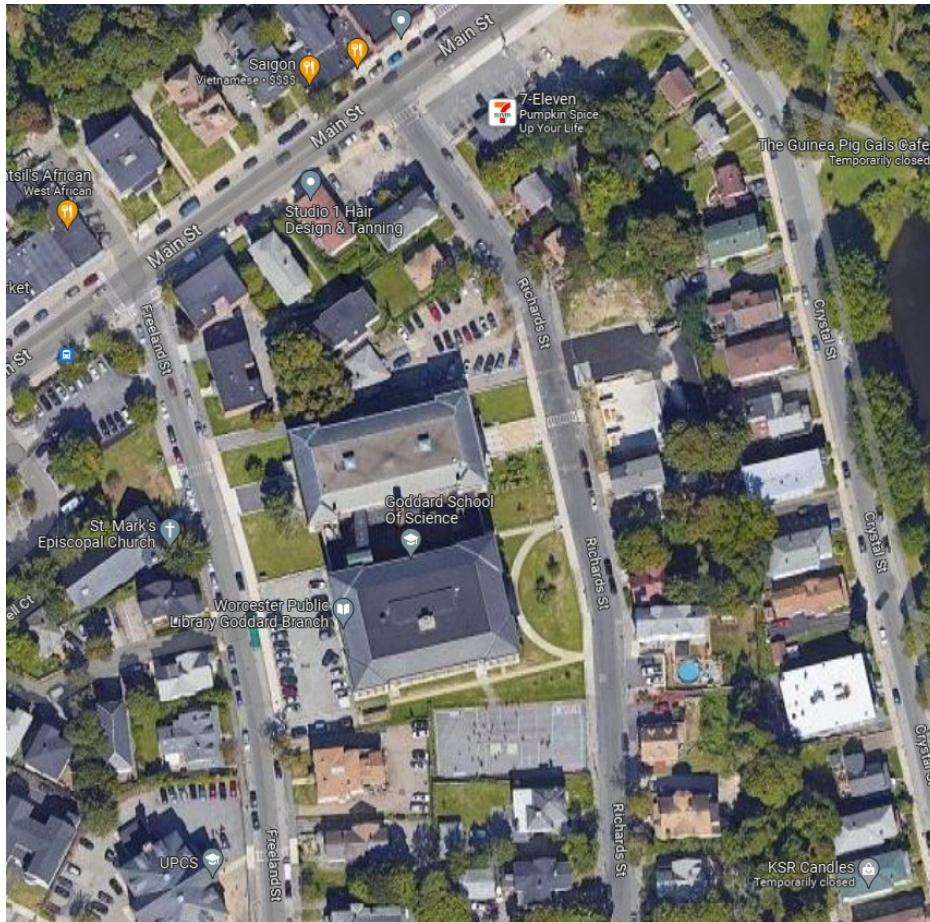
IMAGE 1: AERIAL VIEW OF LOCATION

Richards Street is classified by the Massachusetts Department of Transportation (MassDOT) as a Local Road under City Jurisdiction. The roadway is approximately 30 feet curb to curb, generally runs in an east-west direction in this segment and provides a local connection between Cambridge Street and Main Street and the Goddard School, a Worcester public elementary school . The road includes two-way motor vehicle operations with 1 general purpose travel lane in each direction. On Street parking is permitted on both sides of the street within the study area. The statutory (unposted) speed limit is 30 mph during non-school hours and posted 20 mph during school hours. In addition to the school, land use along this section is single and multi-family residential. There are continuous 7-foot sidewalks along both sides of the street. The ramps at the crosswalk were recently constructed as part of an abutting private property project.

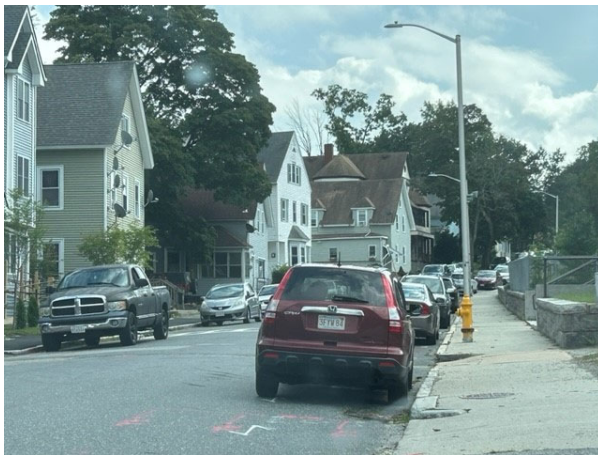
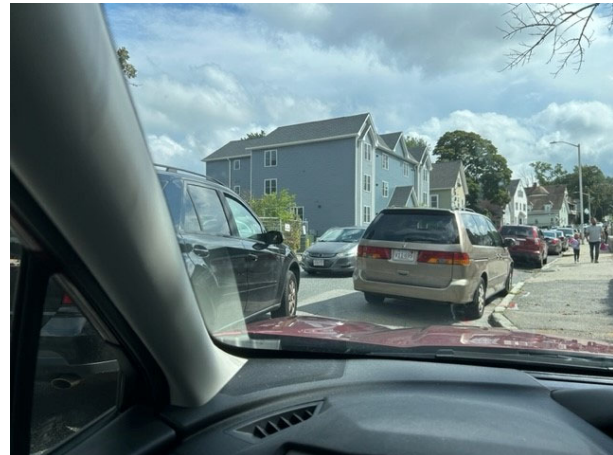
- Dismissal Observations: Similar to arrival, parents begin arriving for dismissal as early as 30 minutes before school is over. Those arriving by motor vehicle, the vast majority, park along both sides of the street and right up to the crosswalk. Many either sat in their vehicle or waited on the sidewalk and socialized with other parents or guardians. Because of this by the time dismissal took place the roadway was significantly narrowed to only 1 vehicle width. Under normal conditions this would be manageable as a 'yield street' where cars could pull off into the parking lane to allow others to pass. However, with the curbside at 100% capacity and some vehicles standing in driveways, the roadway became impassable and at one point a trades van that was traveling eastbound toward Cambridge Street had to back down the street over 400 feet back to Main Street. Additionally, those trying to crosswalk the street were not visible to motor vehicles until they stepped into the pathway of the vehicle.

Images from Dismissal from the west of the crosswalk location

In order to prioritize the safety and access of pedestrians, especially school age pedestrians, we need to improve the visibility of pedestrians attempting to cross the street to motor vehicles on the roadway. This should begin with ordaining a NO PARKING ANYTIME/TOW AWAY ZONE 20 feet from the crosswalks on both sides of the street with considerations for hardening these zones as part of recommendation # 3.

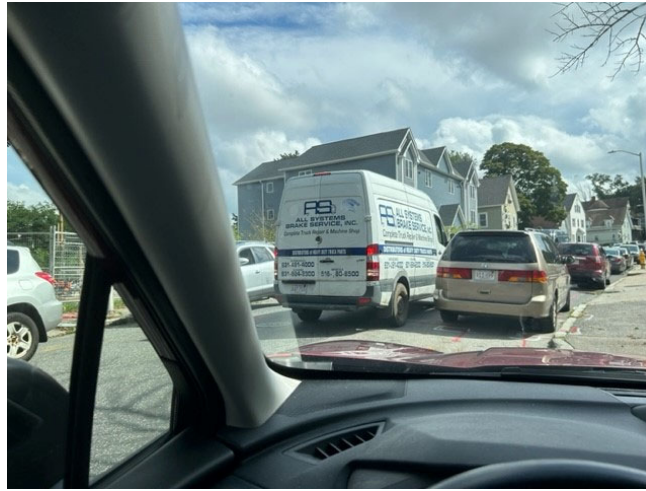
Image of the van that had to back down the street because it could not pass

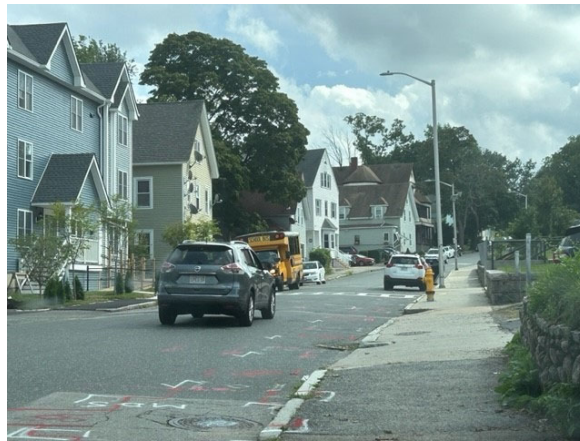
Image of the street following dismissal. Only vehicle left unrelated to the school was the white car behind the school bus
