## WORCESTER CYANOBACTERIA MONITORING COLLABORATIVE

# Patch Reservoir - September 2021

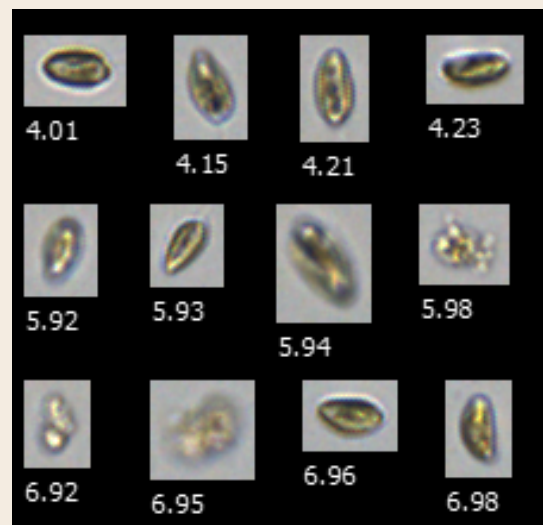
The particle density at Patch Reservoir was 1902 particles/ml in September, according to the FlowCam, which was higher than it was in August. Contrary to the previous month, however, there were few to no cyanobacteria cells present. Instead, the sample was dominated by Cryptomonads, which are not known to cause toxin blooms in our lakes.

Flowcam Image of *Cryptomonads*

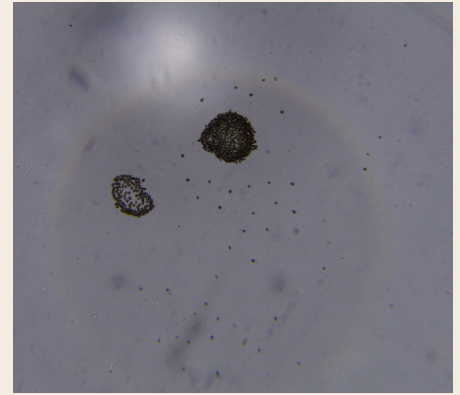
*Woronichinia* Cyanobacteria

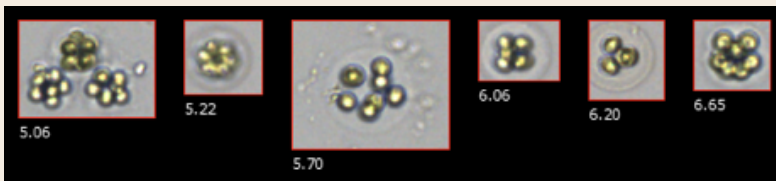
Green Algae

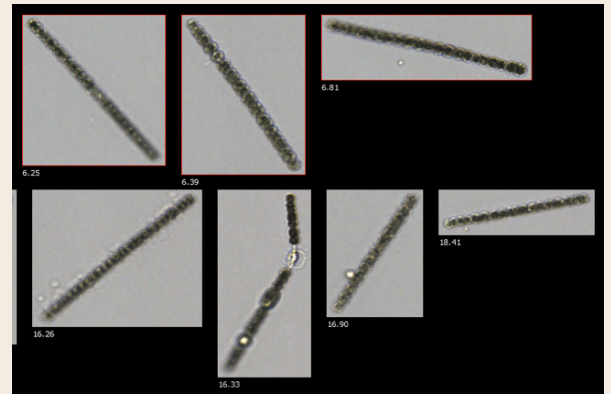
The particle density at Patch Reservoir was 621 particles/ml in August, according to the FlowCam, which was much lower than it was in July. The sample was dominated by the cyanobacteria *Dolichospermum*, and our fluorimetry data suggest that there may be conditions for a bloom there.

*Dolichospermum* Cyanobacteria

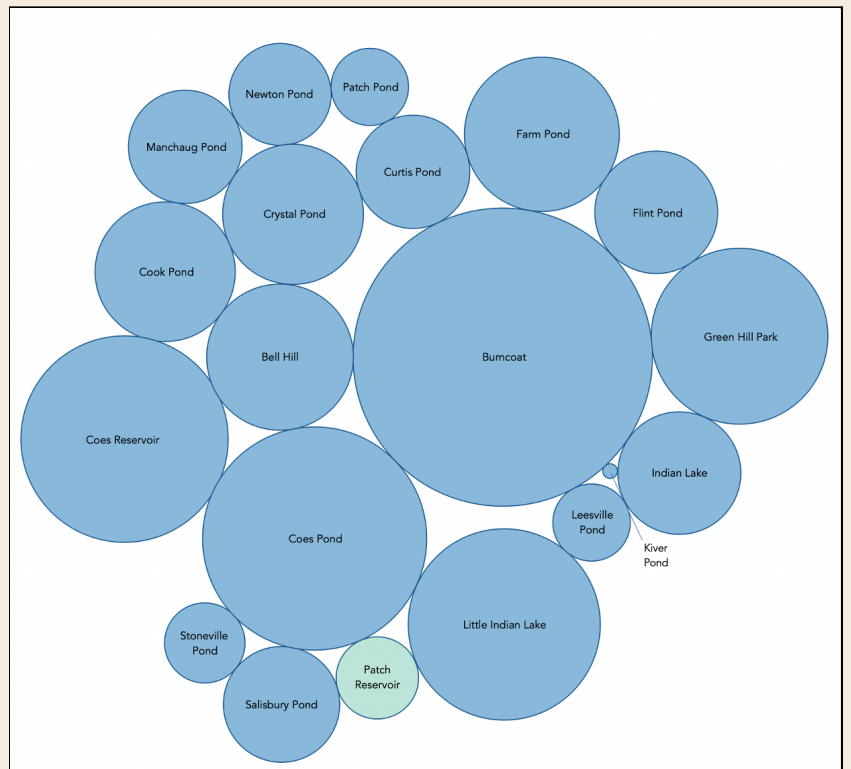
Using the fluorometer to find phycocyanin levels, the following graph represents the relative cyanobacteria pigment in each pond. Patch Reservoir has remained at undetectable limits in the months of June and July. A pond becomes at risk for a bloom when levels rise above 50 Au.

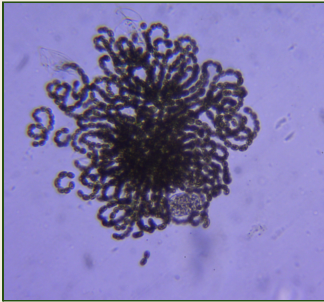
Dolichospermum - 100x

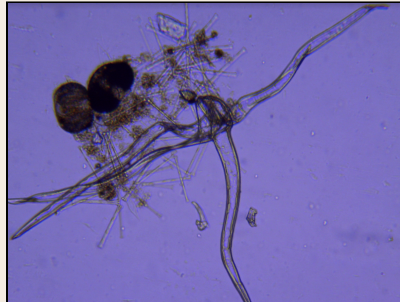
Asterionella, Pollen, Trichome - 100x

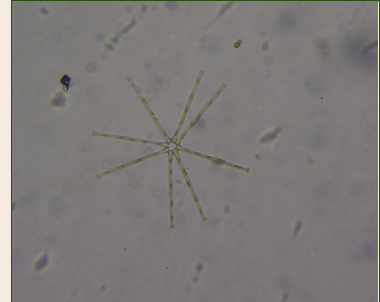
Asterionella - 100x

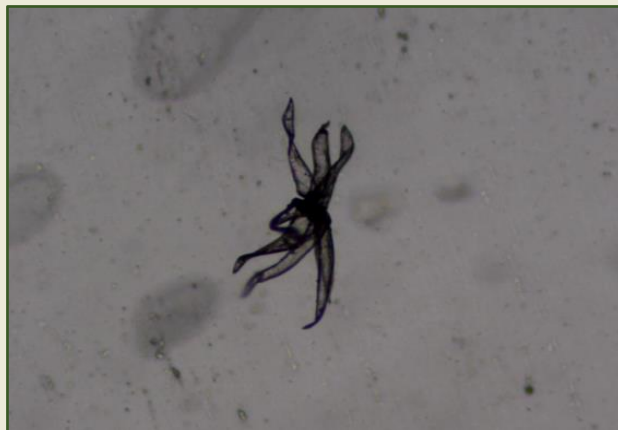
Trichome (100x)

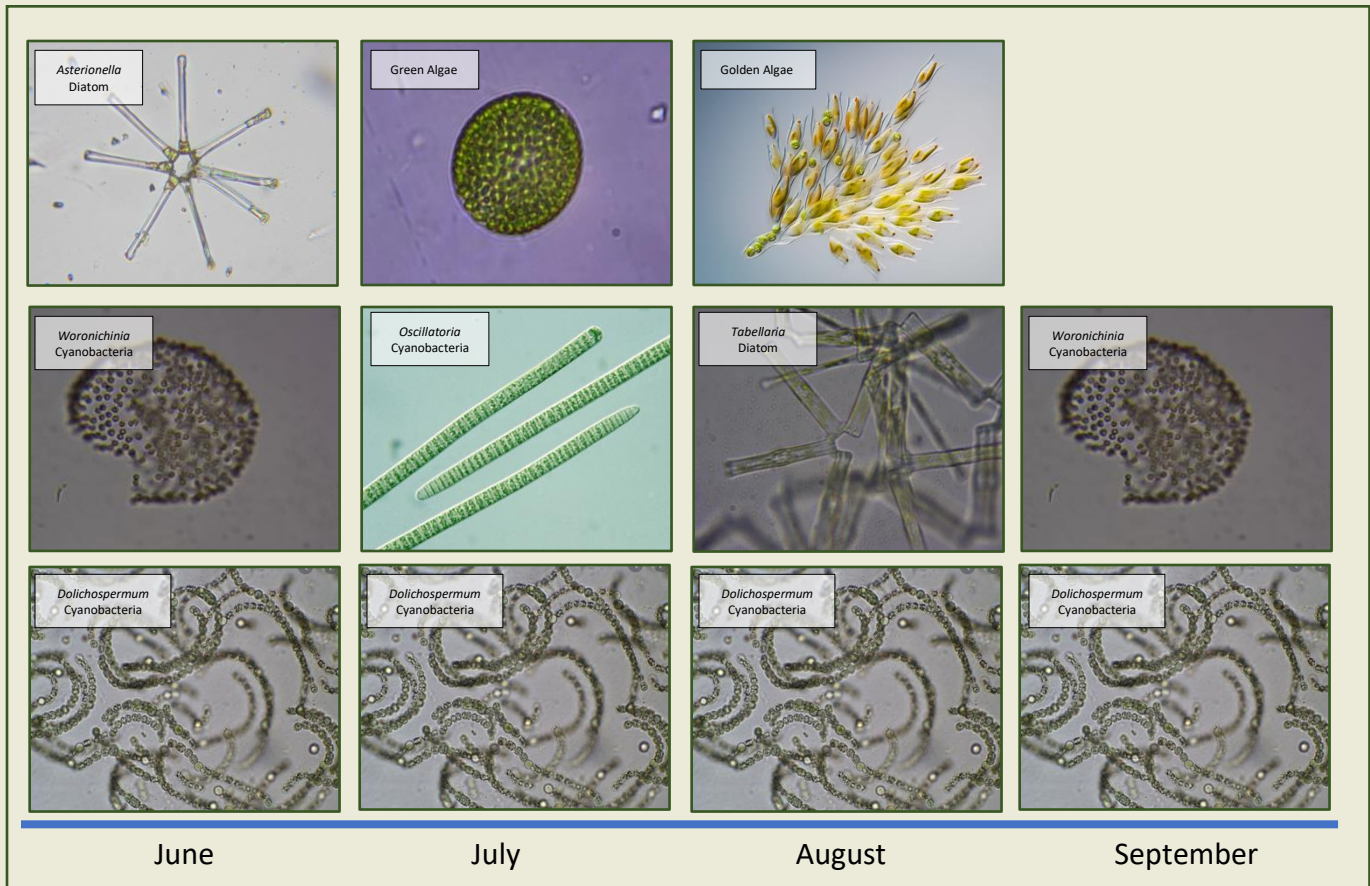
The timeline below shows the organisms that have been found in Patch Reservoir in past years.
