**BIGELOW MEMORIAL CONSERVATION ASSESSMENT  
WORCESTER, MASSACHUSETTS**

**Timothy Bigelow Memorial**

**Focus of this assessment: Marble monument and slate headstones**

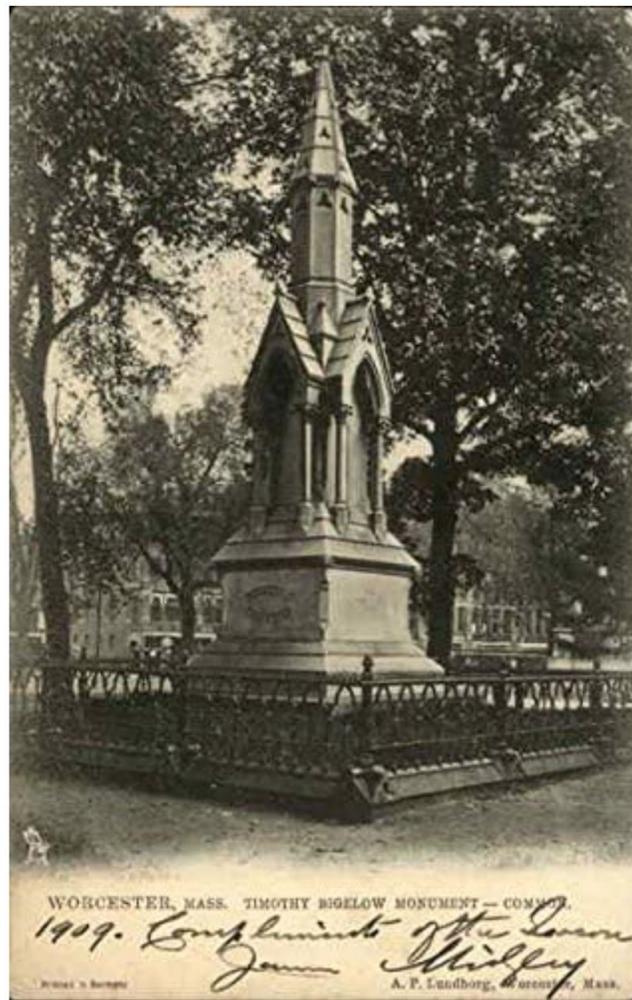
**Historic photo:**

Historic 1909 postcard photo.  
Note the design of the top spire has a different design than today, and the earlier fence design, construction, and size.

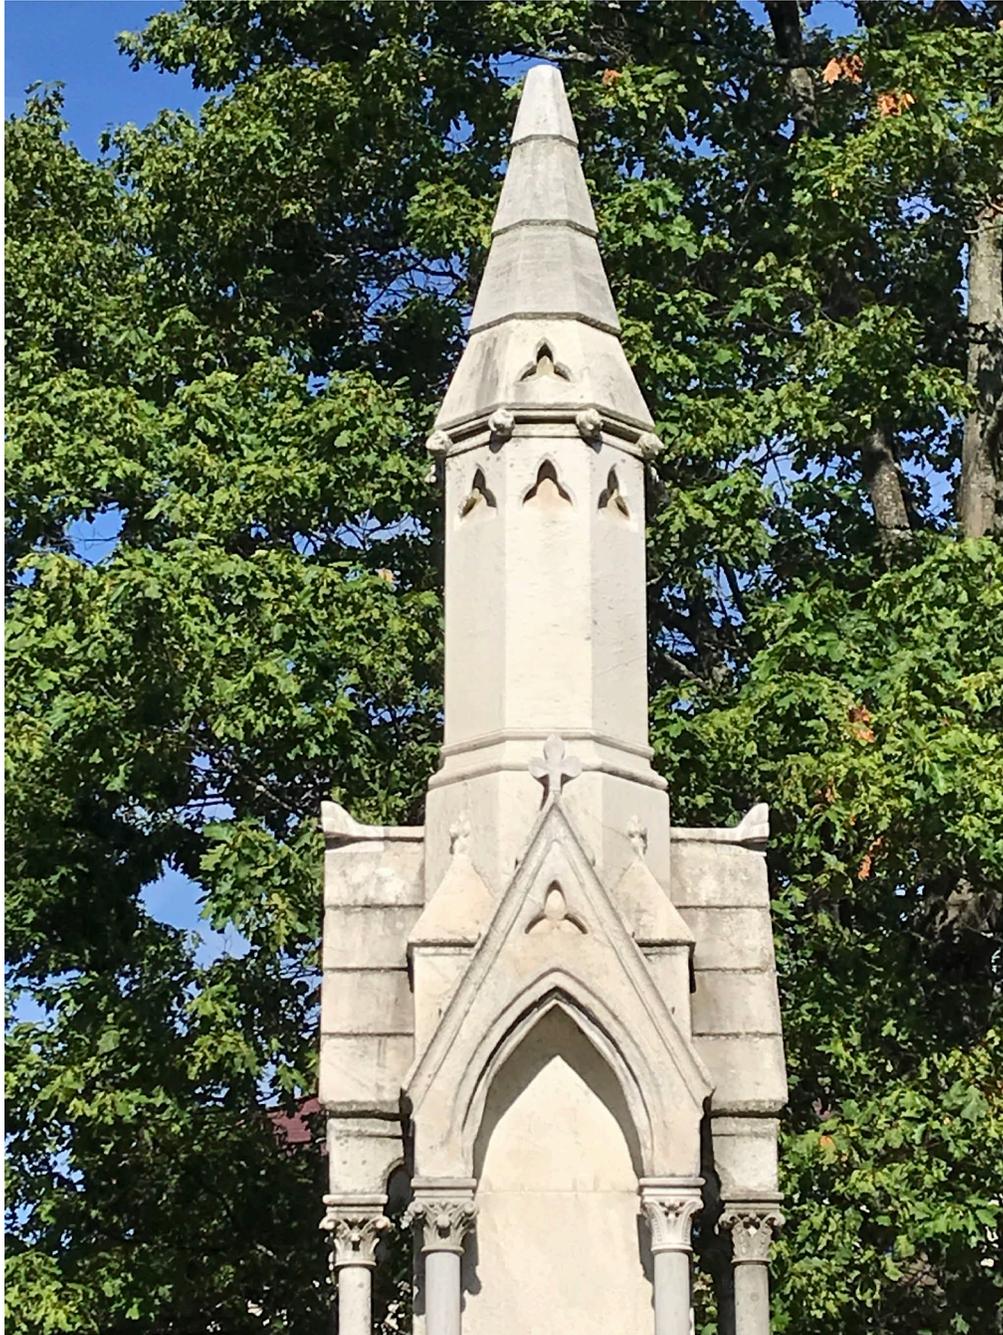
Timothy Bigelow Memorial: detail of the second gothic-style spire. The original spire was replaced sometime after the monument's first installation in 1861. The reason for the replacement is unknown.

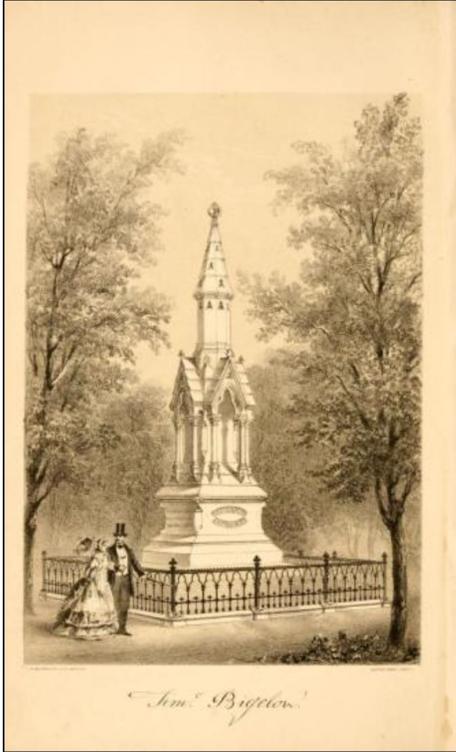
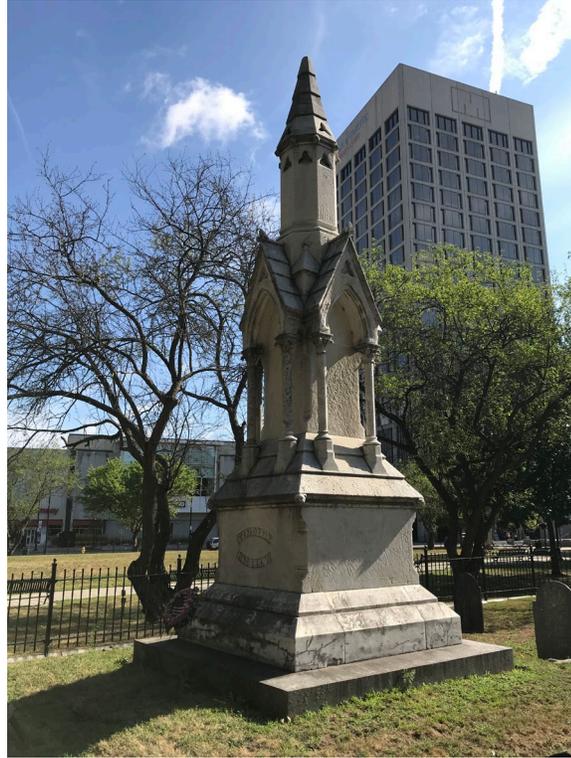
**Left:** earlier pre-1909 image showing original and taller spire. **Right:** current spire.

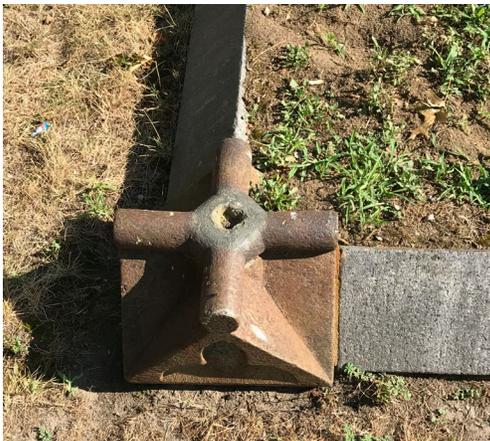
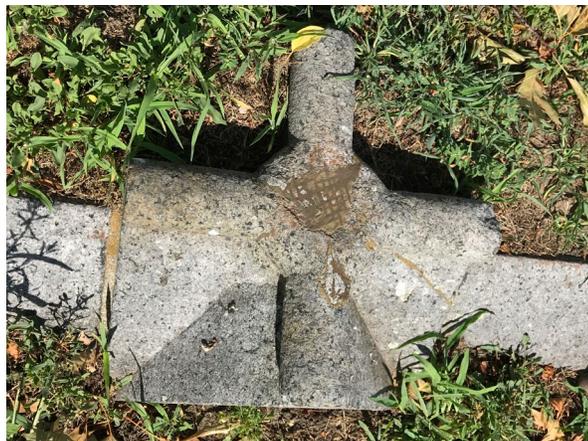
There is a granite coping surrounding the memorial in a square shape approximately 5.5 feet from the monument. The coping contains 16 stones in a cross shape every 5.4 feet with shallow holes in the middle, a number of them with iron staining. Instead of being locations for flags, recent research indicates these are the attachment locations for the previous painted iron fence (see 1909 postcard image). Some of the holes have been filled with various fill material to prevent water pooling.

**Cross-shaped granite stones:** used to set the painted iron posts of the original fence.

1. Photograph conditions before treatment in high resolution digital JPEG files each image labeled with monument name, date, brief description, and "BT" (indicating before treatment).
2. Gently wash all surfaces of the granite with Professional's Edge Nilodor Urine Digester to reduce biological growth, or use Biocide D/2, sold by Biological Solutions, Inc.
3. Wash again with Orvus™ (sodium lauryl sulfate) water, followed by water rinse.  
**Note that municipal water may be used to wash the granite.**

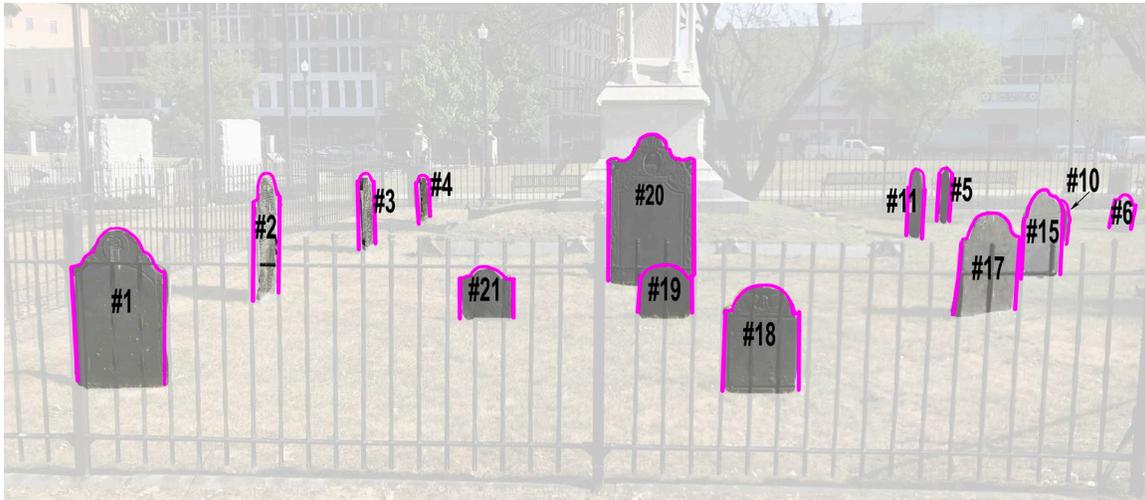
The small cemetery surrounding the Bigelow Monument has 21 slate headstones dating to the 18<sup>th</sup> century (see diagram below with headstone numbers.). The stones are worn and have some weathering. All of stones have surface soil and biological growth, with some lichen (a slow growth bio-matter composed of a fungi and algae).

Headstones facing north, starting in southwest corner and numbering clockwise around the monument.

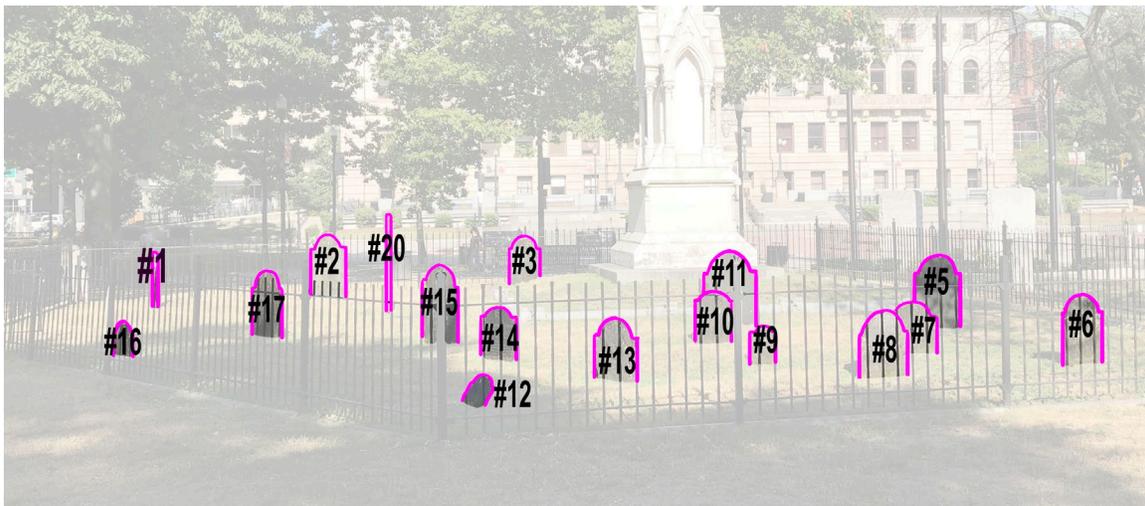
Headstones facing west. Headstone #12 will be straightened.

One of the smaller of the headstones (#12) is tilted backward, and there appears to be a previous attempt at straightening it (there is a small amount of stone rubble on the forward side). Another headstone (#19) appears to have been previously re-set into concrete. All the headstones should be very gently cleaned with distilled water and the small leaning stone returned to its upright position.

7. Straighten and re-set headstone #12 by removing 4 inches of grass around headstone and reserve. Remove current small stones that have not effectively supported the headstone. Gently dig downward and remove soil surrounding the headstone 8 to 12" downward, or until the bottom edge of the headstone is visible. Reserve the earth using a short 2" x4" piece of wood to support the headstone upright. Fill the lower half portion of the void with clean crushed washed stone with 1/2" wide pebbles. The angle of the stone should closely match the surrounding headstones (not necessary directly upright). Fill the remaining void with crushed washed pea stone leaving 2" to return the previously removed earth and grass.
8. Photograph all headstones front and back after treatment in high-resolution JPEG digital format and label each image as "AT" for after treatment.
9. Prepare written report.

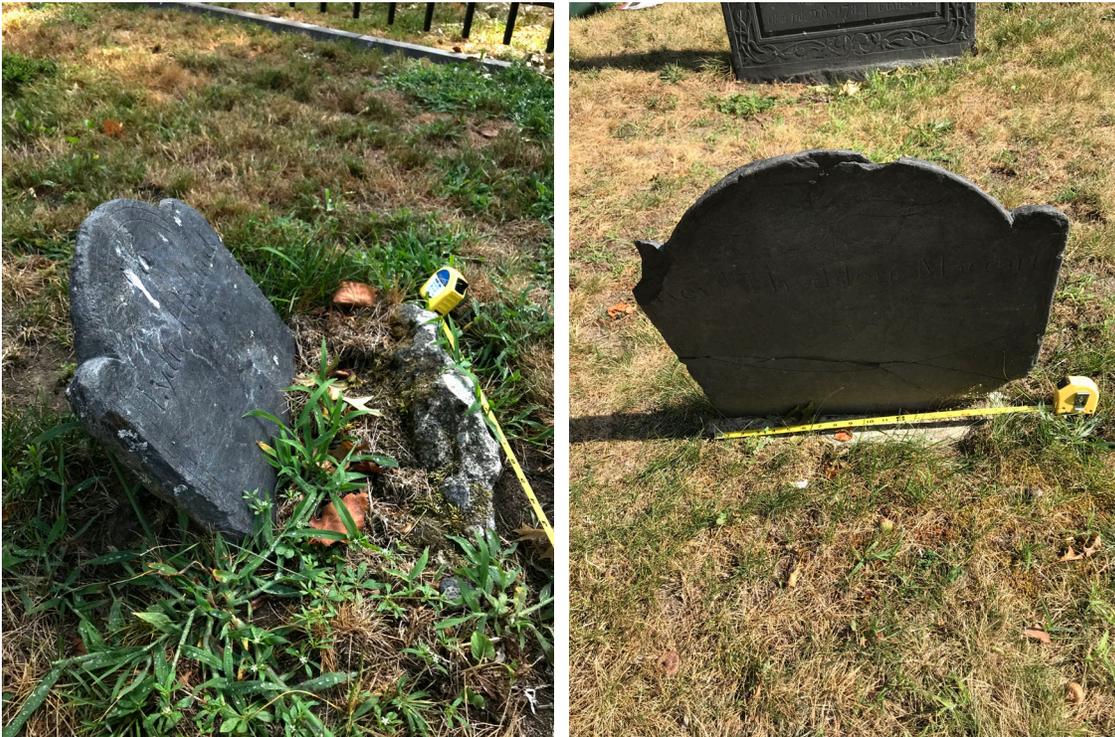
**Left:** Headstone #12 tilted back. Bird droppings on the surface, some past attempt at straightened with small chunks of stone.

**Right:** Headstone #19 with concrete reinforcement indicating that the headstone was previously straightened. Concrete is visible under tape measure. Leave this headstone as is.

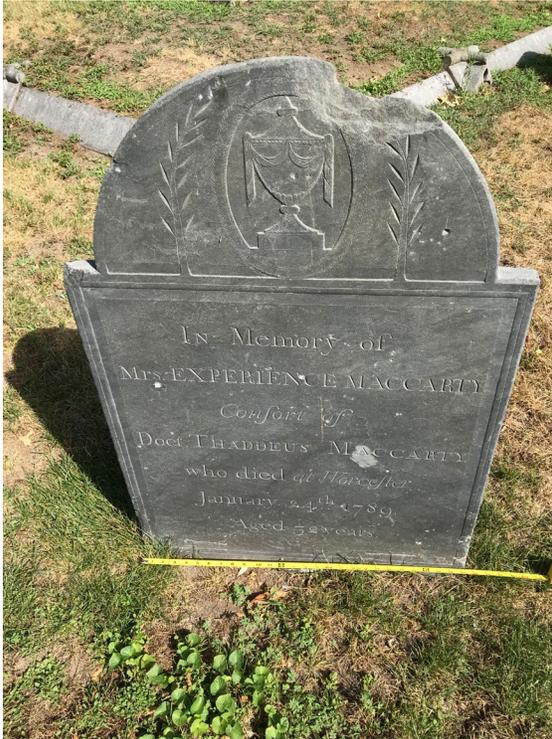
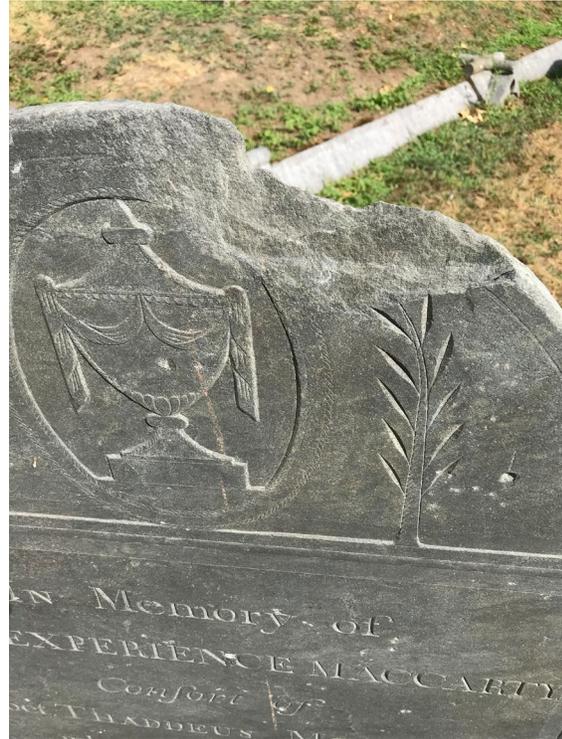
**Left:** Headstone #15, showing area of stone loss, most likely from an initial direct hit.  
**Right:** Headstone #15 detail of loss and showing some biological growth, requiring washing and stabilization. Stabilization can be carried out with Paraloid B-72 clear acrylic resin.

6. After drying, stabilize the upper loss area and broken edge of Headstone # 15 loss area using 7% Paraloid B-72 in acetone, applying only to damaged area with a soft natural bristle brush.

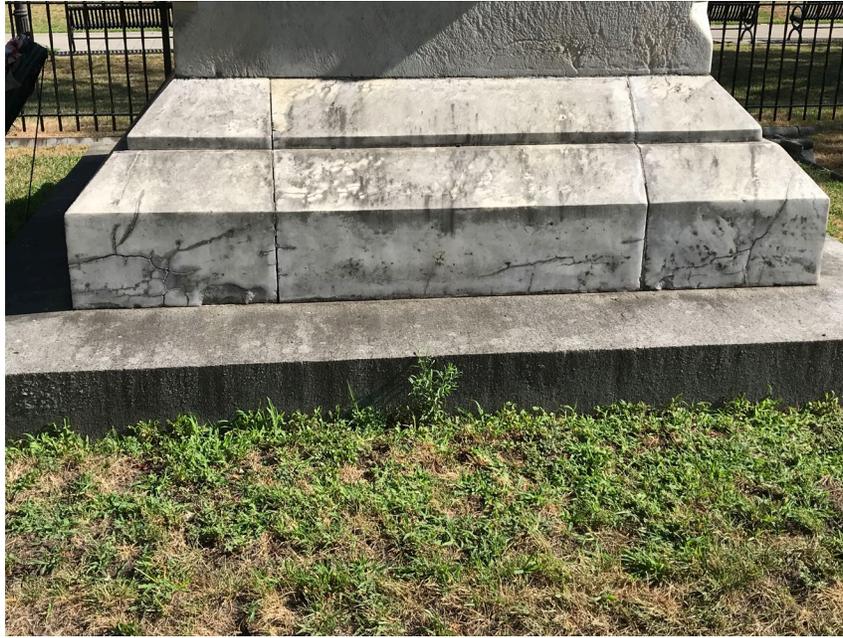
The multi-tiered marble memorial was unfortunately previously aggressively over-cleaned by sandblasting and the entire surface has lost much detail and has an uneven profile. This past damage has introduced areas for biological growth to form and has allowed water to infiltrate the marble matrix, causing damage upon freezing. The surface has a “sugared” appearance. The previous treatment has also caused cracking, particularly at the bottom courses of the stone.

**Cracks in marble:** north-facing view

3. Repeat the washing step with Orvus™ (sodium lauryl sulfate) and water, followed by repeated gentle water rinse.
4. Clean the horizontal cracks in the marble with a small brush and water. After drying, fill cracks less than 1/8" wide with grout made of dispersed hydrated lime manufactured by US Heritage Group ([usheritage.com](http://usheritage.com)) or Voidspan Technologies ([Voidspan.com](http://Voidspan.com)), Cathedral Stone's Jahn pre-mixed marble mortar, or approved equal. Prepare a sample fill no longer than 8". Once approved, fill all cracks with the hydrated lime grout. A plastic syringe is useful to apply the mortar.

5. For filling cracks and losses between 1/8" and 3/8", use fine cleaned marble dust mixed with St. Astier Natural Hydraulic Lime (available from [Limeworks.us](http://Limeworks.us)) or approved alternative. A small flexible steel spatula is useful for application.

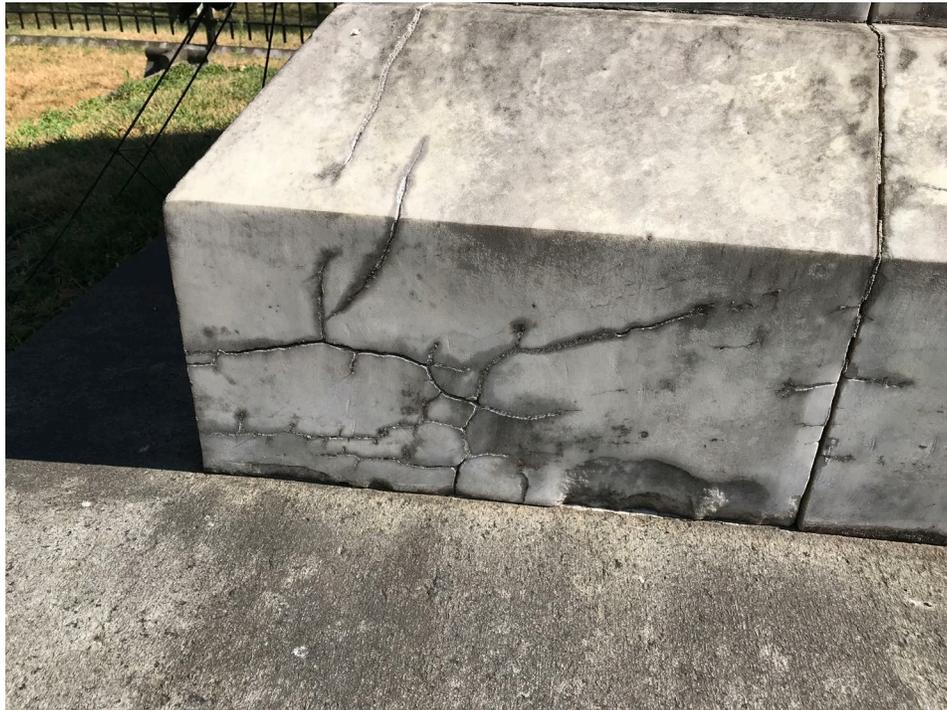
**Detail:** multiple intersecting cracks in marble on the southwest corner of the base

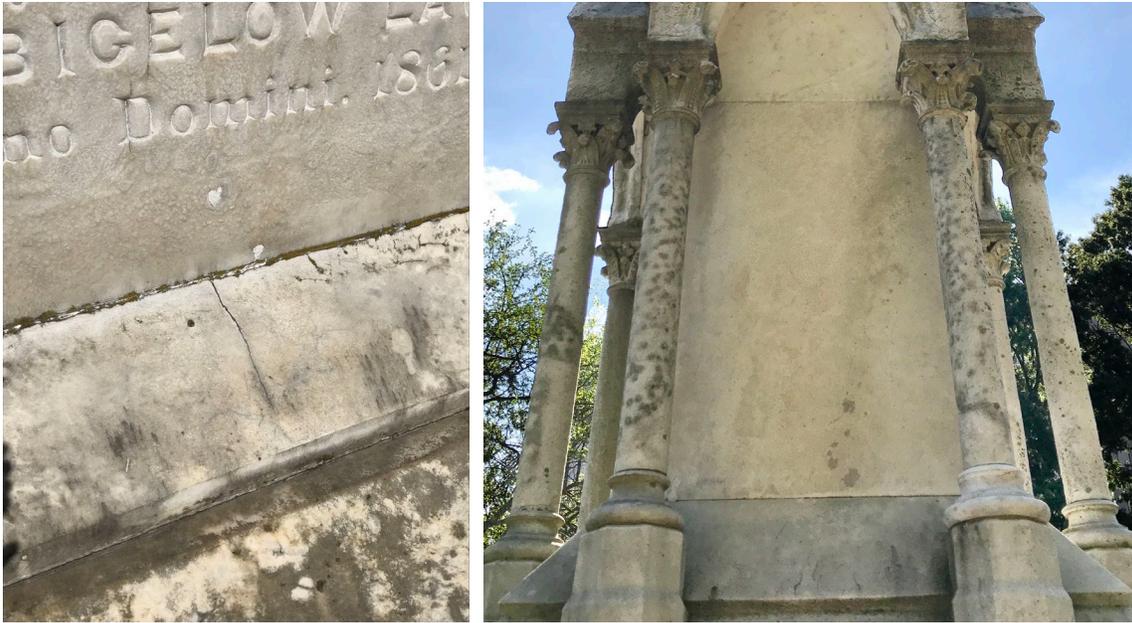
**Left:** crack, discoloration and bio-growth in marble base under the inscription

**Right:** discoloration from bio-growth on marble especially on columns

2. Gently wash all surfaces of the marble monument, first using just water, then with Professional's Edge Nilodor Urine Digester to reduce biological growth. Biocide D/2, sold by Biological Solutions, Inc. **Note that municipal water may be used to wash the monument but allow the water to run until it is clear.**
