**City of Worcester**

**ADA Self-Evaluation  
(as basis for Transition Plan)**

**Prepared by  
Institute for Human Centered Design  
August 1, 2014**

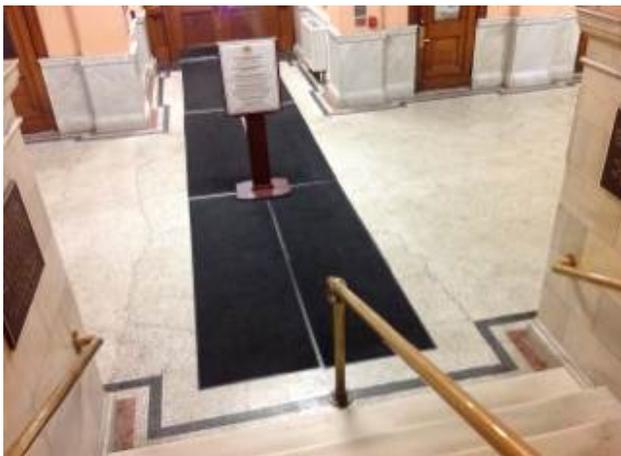
Photo 5

At all entrances as well as elevator lobbies, entry doors to offices, and circulation areas within the building, weather mats are not secure and can become tripping hazards to visitors and staff. (Photo 5)

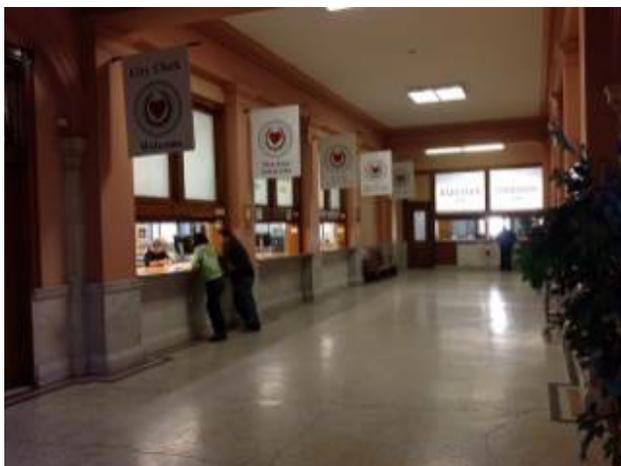
Photo 6

- Treasure & Collector of Taxes (room 203);
- Payroll Parking (room 204);
- City Clerk (room 206); (Photo 6)
- Election Commission (room 208);
- Division of Assessing (room 209).

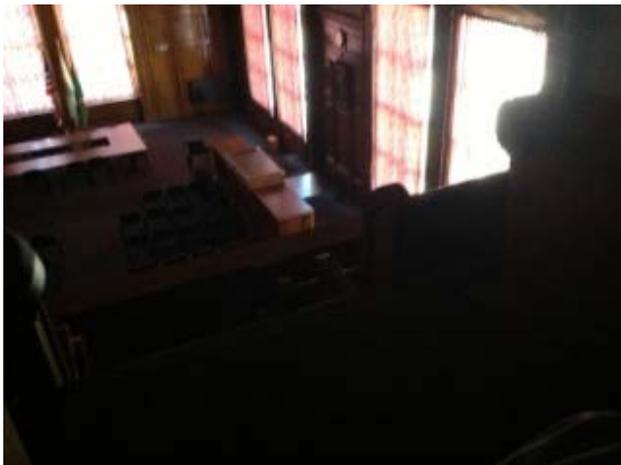
Photo 8

No reserved wheelchair spaces are identified within the tiered seating inside Esther Howland Chamber and Levi Lincoln Jr. Room on levels 3 and 4. Additionally, there does not appear to be any assistive listening or captioning equipment in any of these assembly areas and there is no signage notifying users of its availability.

Except for the signs identifying the toilet rooms on level 1, very little signage is provided at this facility and not all permanent rooms and spaces are properly identified with ADA-compliant signs. (Photos 8 & 9)

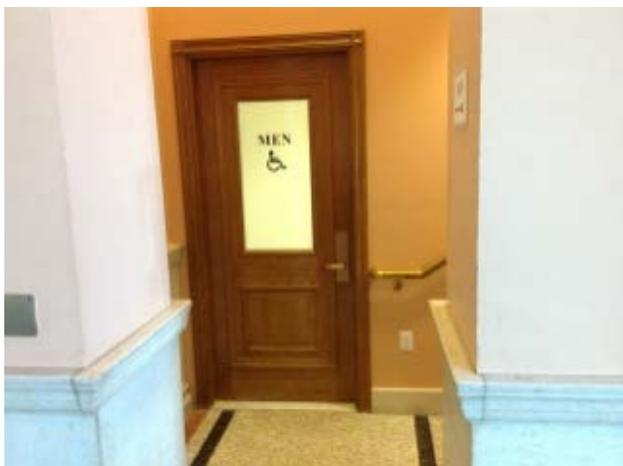
Photo 12

Except for the toilet rooms on level 1, all other toilet rooms are not identified with accessible signage. In addition to the designation signs, directional signs indicating the location of the accessible toilet rooms are also not provided at inaccessible toilet rooms. (Photo 12)

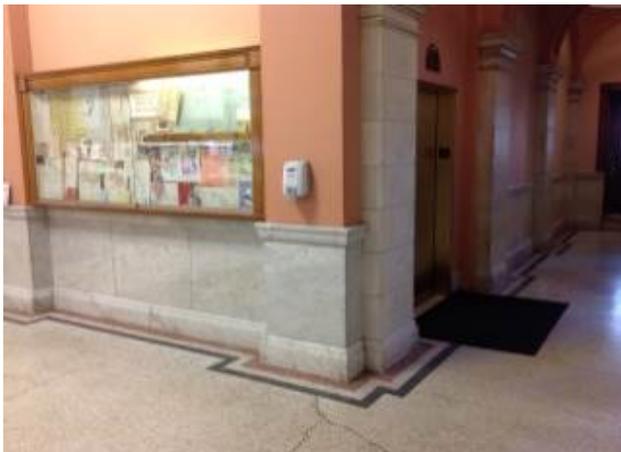
Photo 14

At City Hall, at least one hand sanitizer dispenser was found in the lobby on level 2. This dispenser provided for public use exceeds the maximum allowable height (50" AFF). (Photo 14)

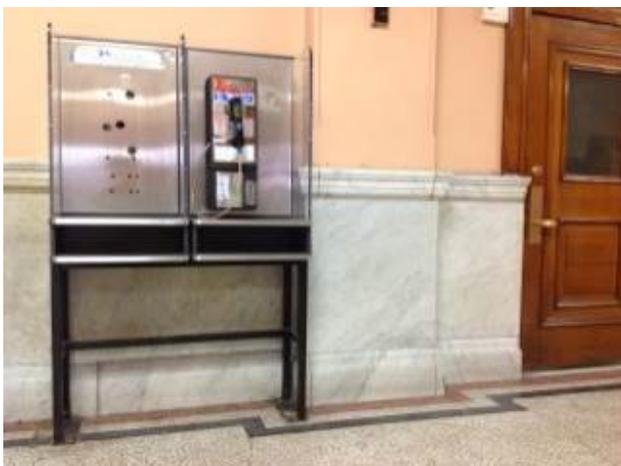
Photo 15

In the lobby on level 1, the public telephone offers no TTY capability. (Photo 15)

- Install a TTY device on telephone on level 1.

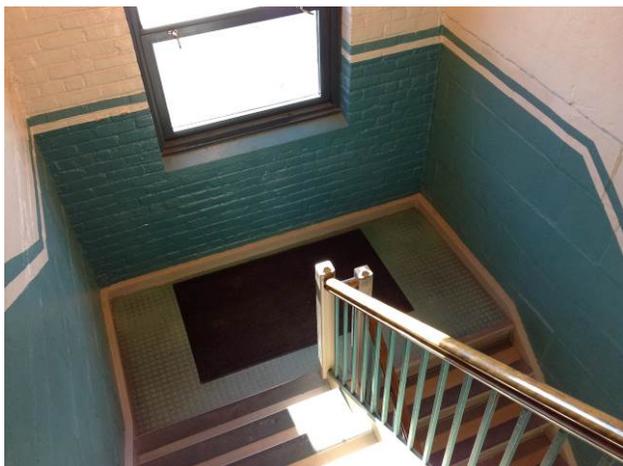
Photo 5

Within most flights of the egress stairways, several weather mats are not secure and can become tripping hazards to visitors and staff. (Photo 5)

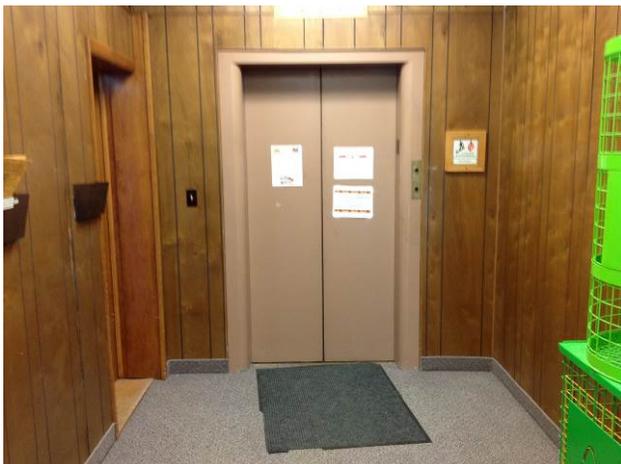
Photo 8

An elevator is located near the accessible entrance and connects the entry lobby on street level and levels 2 and 3. This elevator does not offer an accessible route to level 1, which can only be accessed via a stairway (see Stairways above). The elevator meets the minimum dimensional requirements for existing elevators under the MAAB (48" x 48", wall-to-wall and wall-to-floor); however, it does not meet the following requirements for accessible elevators:

- no intercom is provided inside the elevator cab;
- raised letters and Braille for buttons are not provided on the control panel;
- the top button of the control panel exceeds the maximum allowable height (58" AFF);
- on all floor levels, jamb signs are provided on only one side of the elevator hoistway entrances and exceed the maximum allowable height (63" AFF);
- on all floor levels, call buttons exceed the maximum allowable height (54-57" AFF). (Photo 8)

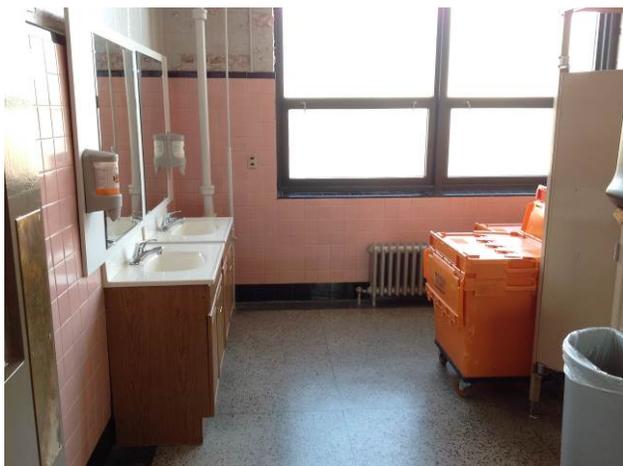
Photo 11

One set of multi-user toilet rooms (one for each gender) for staff and public use are located on levels 1 and 3 while two sets of multi-user toilet rooms are located on level 2. Although one set of multi-user toilet rooms have been recently renovated on the West side of the building on level 2, all other toilet rooms inaccessible with insufficient maneuvering spaces, inaccessible toilet stalls, urinals and lavatories, and missing alarms. (Photos 10 & 11)

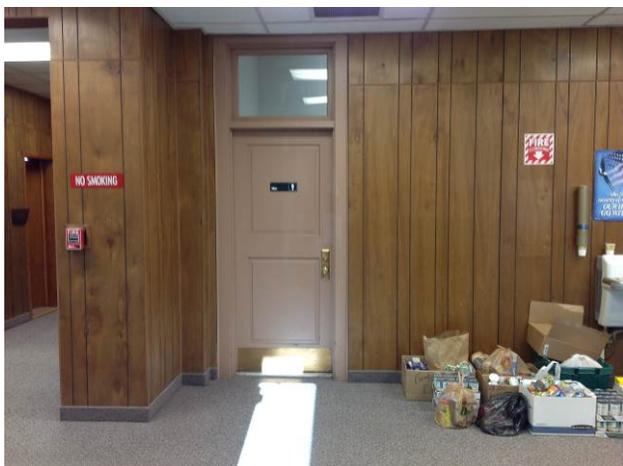
Photo 12

Except for the toilet rooms on level 3, all other toilet rooms (including the recently renovated ones) are not identified with accessible signage. (Photo 12)

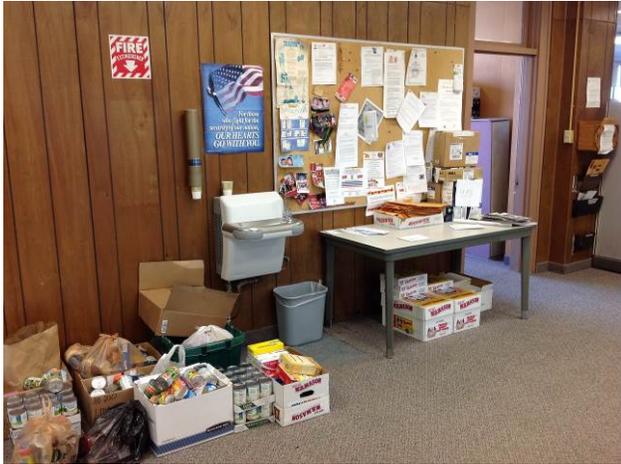
Photo 13

At least one drinking fountain is provided on each floor level. On level 2, the single, wall-mounted drinking fountain exceeds the maximum allowable height (38" AFF) and is obstructed by storage. (Photo 13)

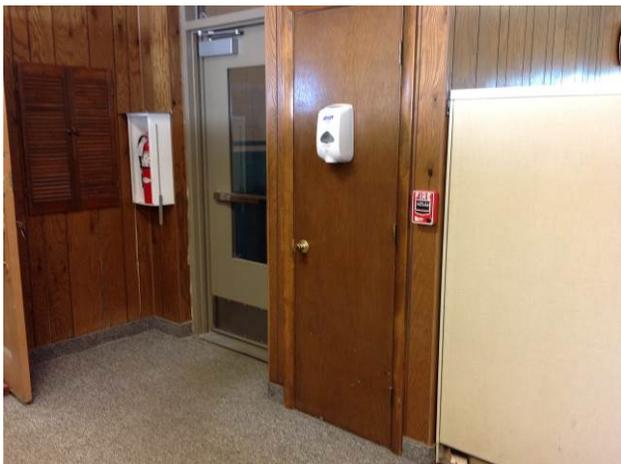
Photo 14

On level 3, a hand sanitizer dispenser mounted on the closet door near the egress stairway exceeds the maximum allowable height (54" AFF). (Photo 14)

- Lower hand sanitizer on level 3.

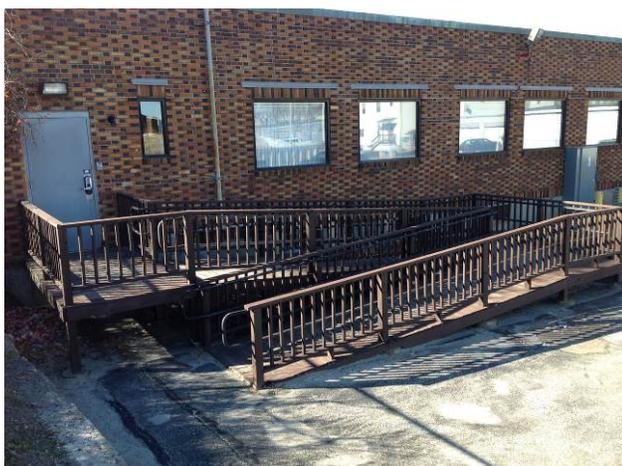
Photo 2

At the end of parking lot, a ramp connects the accessible entrance at the East side of the building. This ramp presents the following barriers to those using wheeled mobility devices:

- the transition between asphalt driveway and wooden ramp is not properly maintained and a one-inch lip is found at the bottom landing of the ramp; (Photos 2 & 3)
- the surface of the ramp appears to be slippery during wet conditions;
- the top run of the ramp exceeds the maximum allowable slope (9.2%).

- Improve the off-street parking designated as accessible by installing a sign that contain the designation “van accessible”, re-striping the parking space, and enlarging the access aisle to eight feet wide.
- Smooth the transition between asphalt driveway and wooden ramp;
- Add slip-resistant strips along the surface of the ramp;
- Remove, relocate, or install a barrier underneath the ceiling-mounted television screen near the main entrance;
- Implement a comprehensive signage plan to ensure that ADA-compliant signage is provided at all spaces that are open to the public;
- Relocate the flush valve of the accessible toilet stall in the Women’s toilet room.
- Relocate obstructions around drinking fountain.

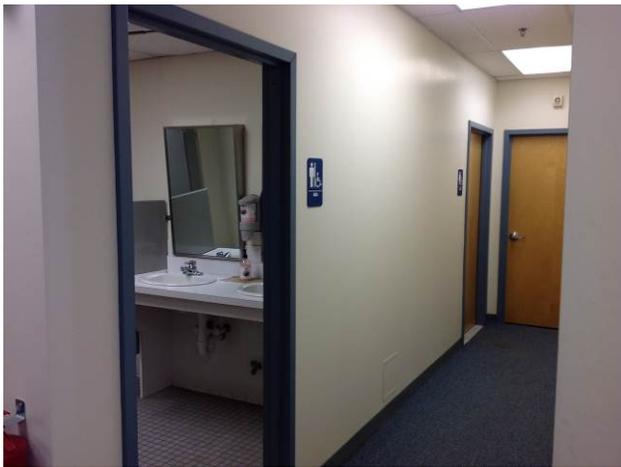
Photo 5

Except for the signs identifying the toilet rooms, very little signage is provided at this facility and not all permanent rooms and spaces are properly identified with ADA-compliant signs. (Photos 5 & 6)

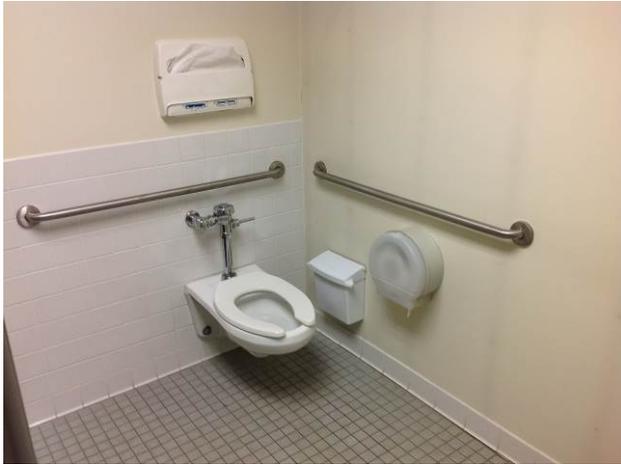
Photo 7

One set of multi-user toilet rooms (one for each gender) for staff and public use are located at the rear of the building. Inside the accessible toilet stall in the Women's toilet room, the flush valve is located on the incorrect side of the toilet. (Photo 7)

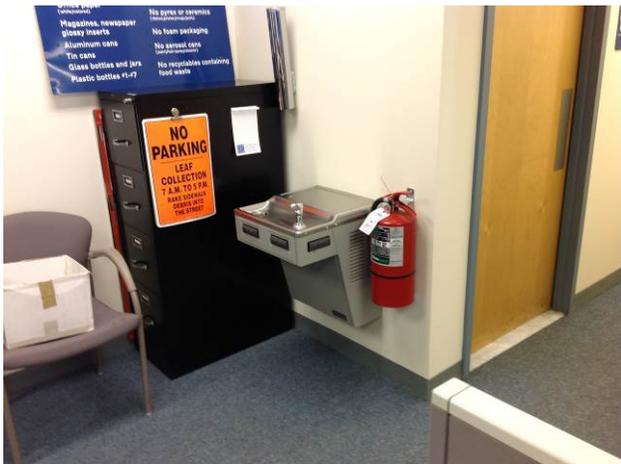
Photo 8

Near the toilet rooms, the single, wall-mounted drinking fountain is obstructed by furniture and a fire extinguisher. (Photo 8)

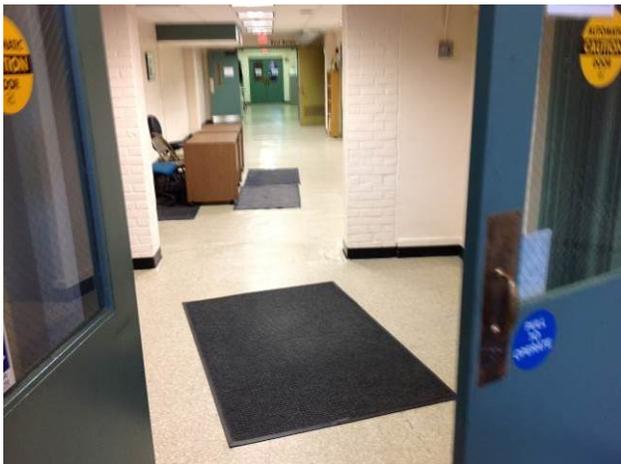
Photo 2

At all entrances as well as stairways and other circulation areas within the building, several weather mats are not secure and can become tripping hazards to visitors and staff. (Photo 2)

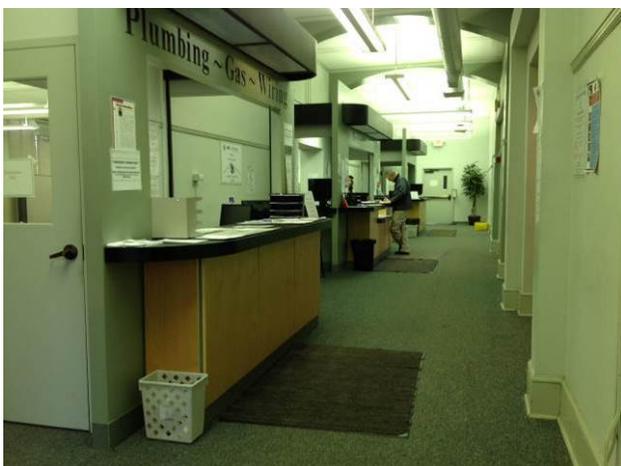
Photo 3

- Plumbing / Gas / Wiring (room 108); (Photo 3)
- Housing (room 106);
- Property Review Team (room 206).

- Replace all door knobs with levers on doors to offices that open to public;
- Replace or remove all thresholds on doors to offices that open to public;
- Ensure that counters for transactions with the public are accessible;
- Ensure that at least one of each type of computer station is accessible and unobstructed by storage and furniture at all times;
- Implement a comprehensive signage plan to ensure that ADA-compliant signage is provided at all spaces that are open to the public;
- Install an ADA-compliant sign at each inaccessible toilet room on levels 1 and 2 to indicate the location of the accessible toilet rooms on the basement level.

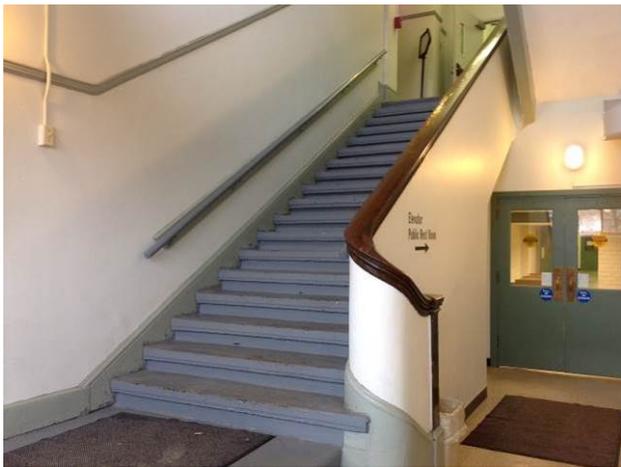
Photo 5

On opposite sides of the building, egress stairways offers vertical circulation to all floor levels. Another stairway connects the main entrance off of the staff parking lot to level 1. Neither stairway has compliant handrails. (Photo 5)

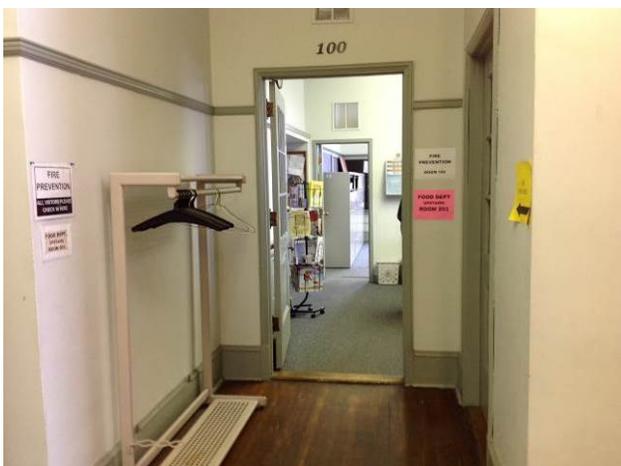
Photo 6

Except for the signs identifying the toilet rooms on the basement level, very little signage is provided at this facility and not all permanent rooms and spaces are properly identified with ADA-compliant signs. (Photo 6)

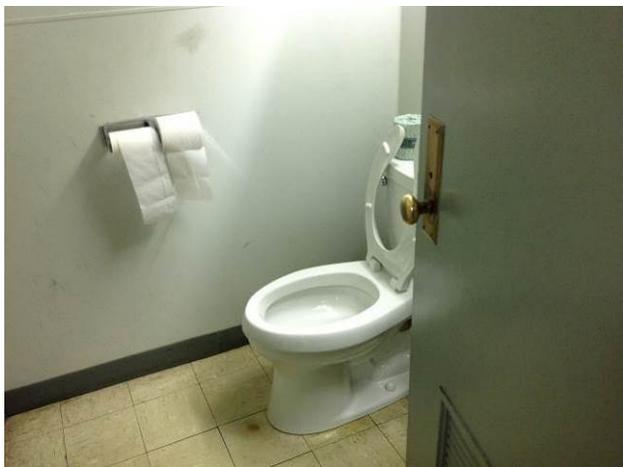
Photo 7

One set of multi-user toilet rooms (one for each gender) for staff and public use are located on the basement level while one set of single-user toilet rooms are located on levels 2 and 3. Although the multi-user toilet rooms on the basement level have been recently renovated, all single-user toilet rooms are inaccessible with insufficient maneuvering spaces, inaccessible plumbing fixtures, and missing alarms. (Photos 7 & 8)

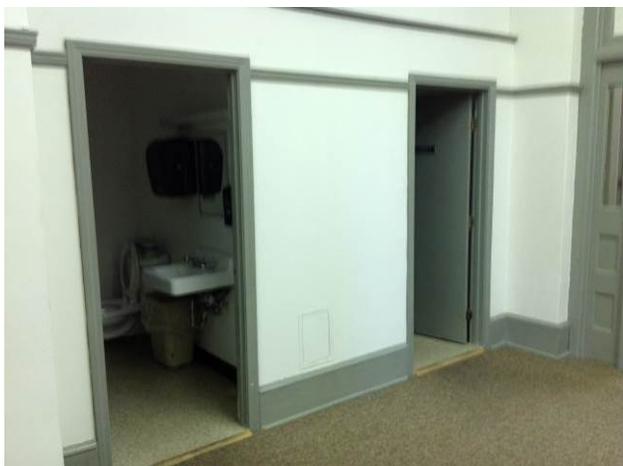
Photo 9

Except for the recently renovated toilet rooms on the basement level, all other toilet rooms are not identified with accessible signage despite being located within public areas. In addition to the designation sign, a directional sign indicating the location of the accessible multi-user toilet rooms on the basement level is also not provided. (Photo 9)

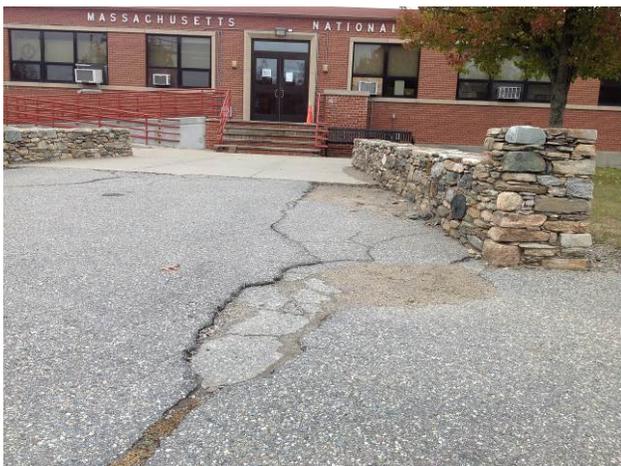
Photo 2

- the asphalt walkway between the parking lot and the building entrance has been poorly maintained, with heaving and cracking surfaces; (Photo 2)
- the exterior ramp leading to the building entrance exceeds the maximum allowable running slope on the top segment (9.4%);
- the exterior stairway leading to the building entrance has loose stone steps at top and bottom that create tripping hazards. (Photo 3)

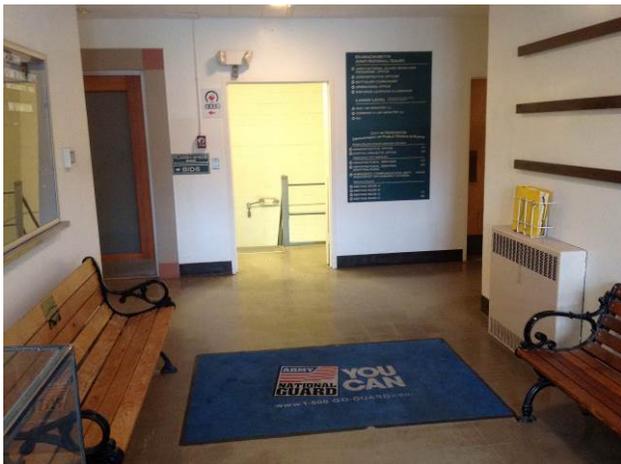
Photo 5

At the entry lobby, a weather mat is not secure and can become a tripping hazard to visitors and staff. (Photo 5)

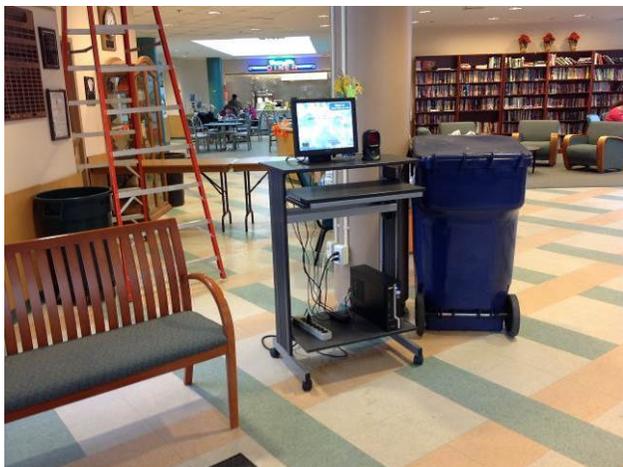
Photo 4

On level 1, several tables and desks are offered to the public for working or dining. Near the front entrance, a computer station for sign-in not only exceeds the maximum allowable height, but also does not have the required clear floor space for those using wheeled mobility devices. (Photo 4)

Replace the computer station for sign-in near the front entrance with an accessible desk no higher than 34” above the floor and with the required clear floor space underneath it. Confirm the total seating capacity of the diner and the function room on level 1 and ensure that 5% of the tables in each space are accessible.

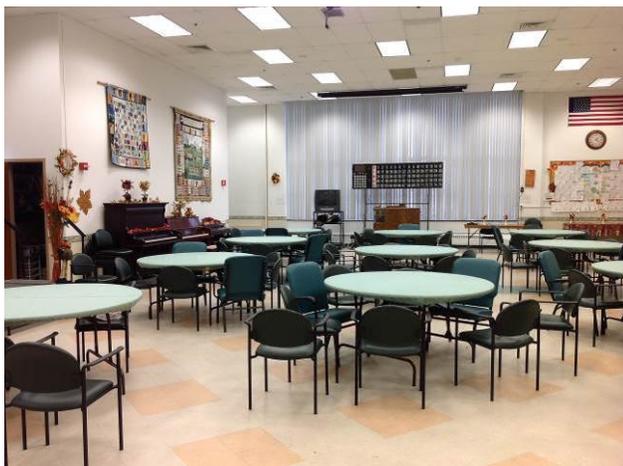
Photo 5

In each seating area of the diner and the function room on level 1, 5% of accessible tables were not found. (Photo 5)

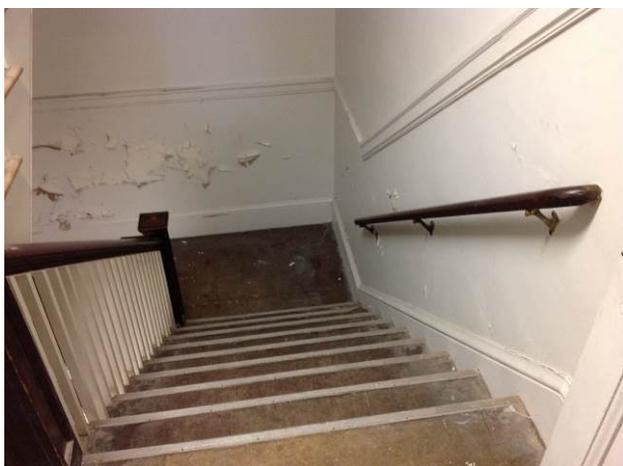
Photo 6

On opposite sides of the building, two egress stairways offer vertical circulation to all floor levels. Although the newer egress stairway on the South wing meets most requirements for accessible stairways, the older egress stairway on the North wing has non-compliant handrails and nosings. (Photo 6)

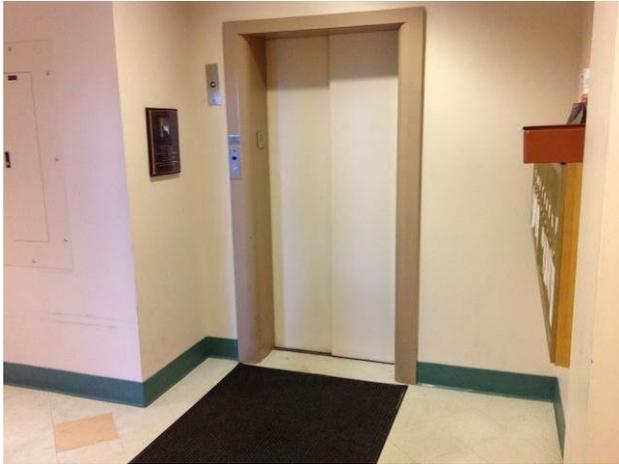
Photo 7

Although the newer elevator on the South wing is completely accessible, the older elevator at the center of the building does not meet the following requirements for accessible elevators:

- minimum dimensional requirements of the elevator cab of either 1991 or the current accessibility laws and regulations (44" x 72");
- raised letters and Braille for buttons are not provided on the control panel;
- on most floor levels, jamb signs on the elevator hoistway entrances do not provide the required tactile characters and braille;
- on all floor levels, call buttons exceed the maximum allowable height (54" AFF). (Photo 7)

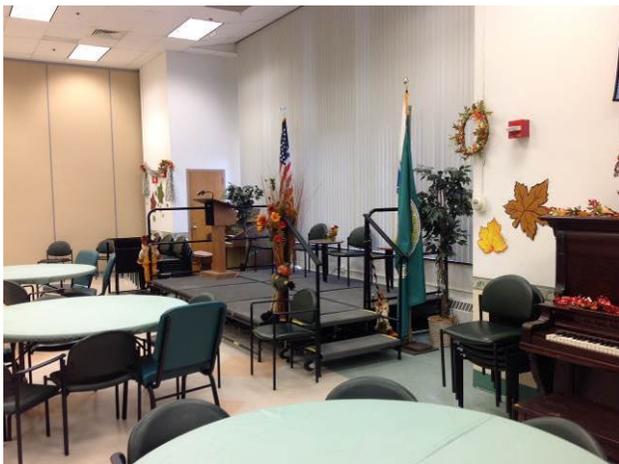
Photo 8

On level 1, at least two stages are found inside the function room. No accessible route is provided to either stage. (Photo 8)

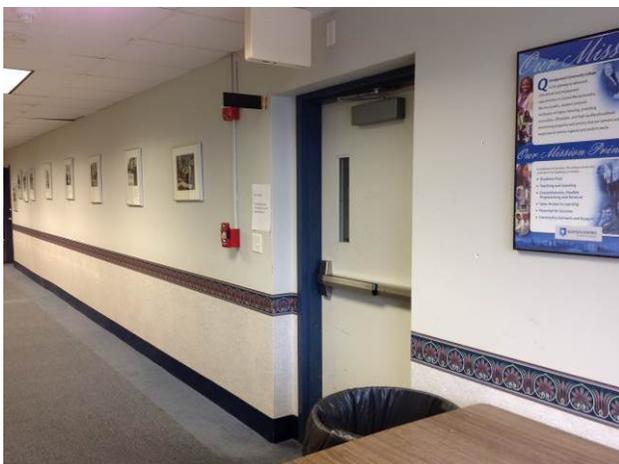
Photo 9

Although the designating signage in this facility is mostly accessible, the following permanent rooms and spaces are not properly identified with ADA-compliant signs:

- stairways; (Photo 9)
- elevators;
- function room on level 1;
- a few offices throughout the building.

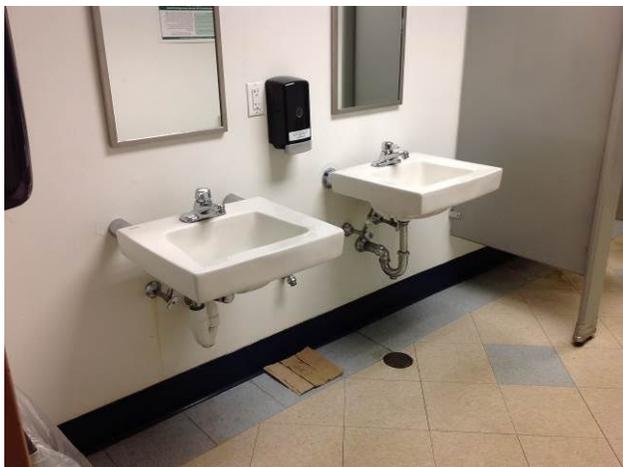
Photo 10

- lavatories with obstructed clear floor space and unprotected plumbing underneath; (Photo 10)
- mirrors above lavatories exceed the maximum allowable height (41" AFF).

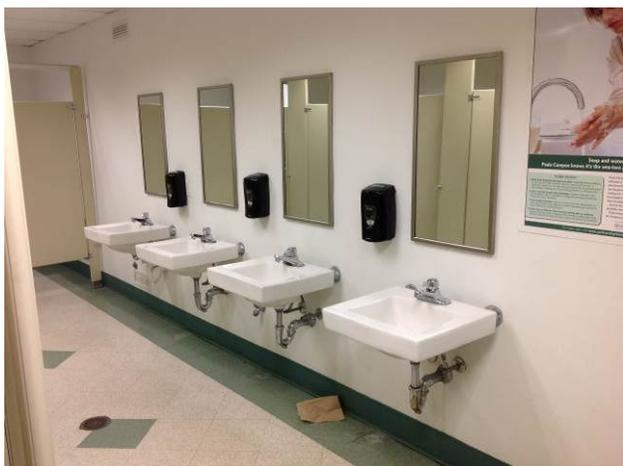
Photo 11

- lavatories with obstructed clear floor space and unprotected plumbing underneath; (Photo 11)
- mirrors above lavatories exceed the maximum allowable height (41" AFF);
- door to ambulatory stall inside Women's toilet rooms incorrectly swings into the stall. (Photo 12)

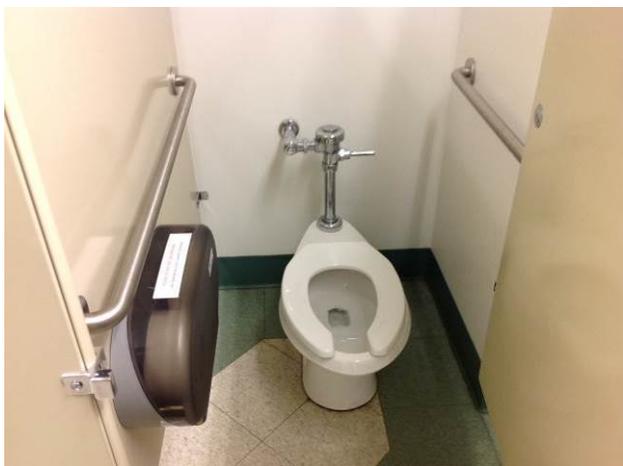
Photo 12

Signage identifying toilet rooms is compliant, except for the Women's toilet rooms on levels 2 and 3. Designation signs for such toilet rooms are incorrectly placed on the corridor instead of alongside the doors. (Photo 12)

- Reverse swing of door to ambulatory stall inside the Women's toilet room near the Diner on level 1;
- Adjust or replace the self-closing hinges of doors to accessible stalls - Multi-user toilet rooms (Men's & Women's) on levels 2 & 3;

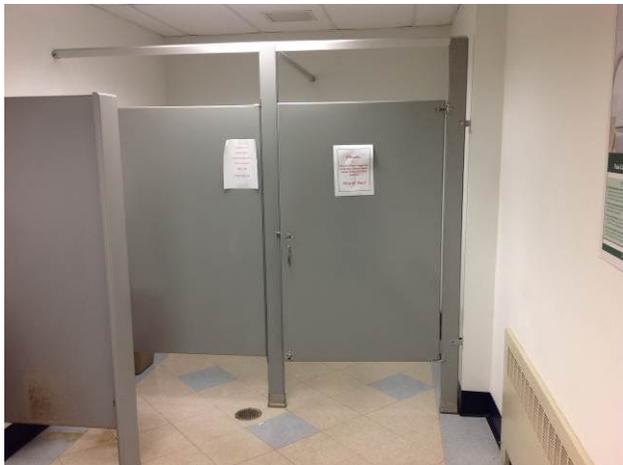
Photo 13

- lavatories with obstructed clear floor space and unprotected plumbing underneath;
- mirrors above lavatories exceed the maximum allowable height (41" AFF);
- malfunctioning self-closing hinge of door to accessible stalls; (Photo 13)
- non-compliant flush valves inside accessible toilet stall. (Photo 14)

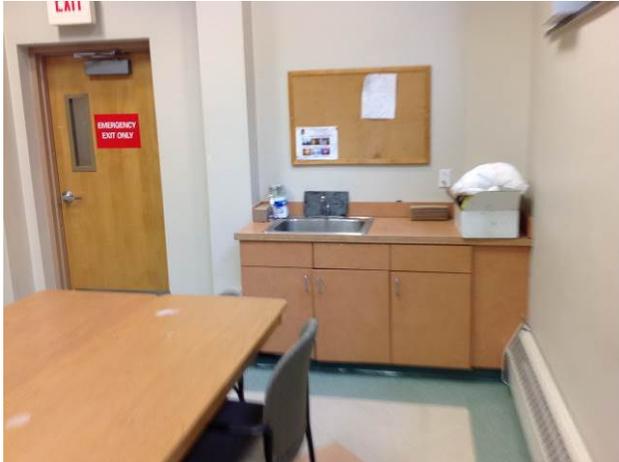
Photo 16

Inside the Craft Room on level 1, the kitchen for public use have been renovated but lacks clear floor space and an accessible sink, among other items. (Photo 16)

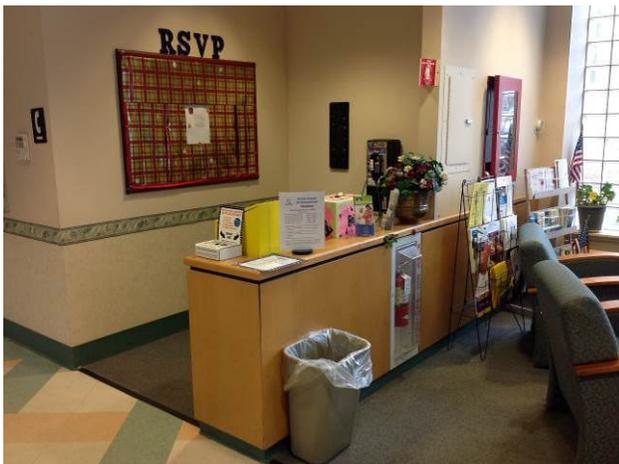
Photo 17

In the lobby on level 1, the public telephone offers no TTY capability. (Photo 17)

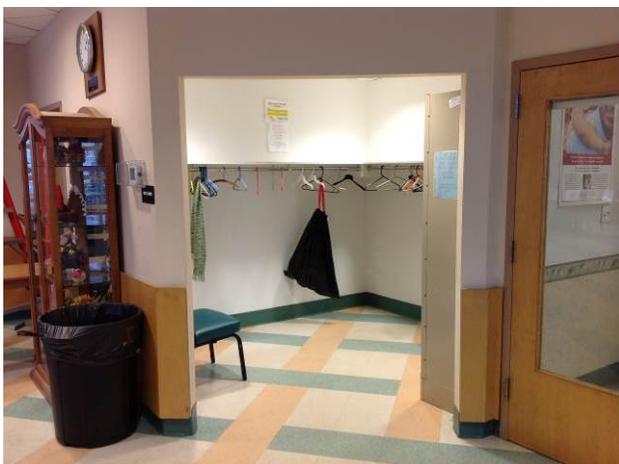
Photo 18

In the lobby on level 1, a coat room is located near the function room. No coat hangers are provided within the allowable reach ranges. (Photo 18)

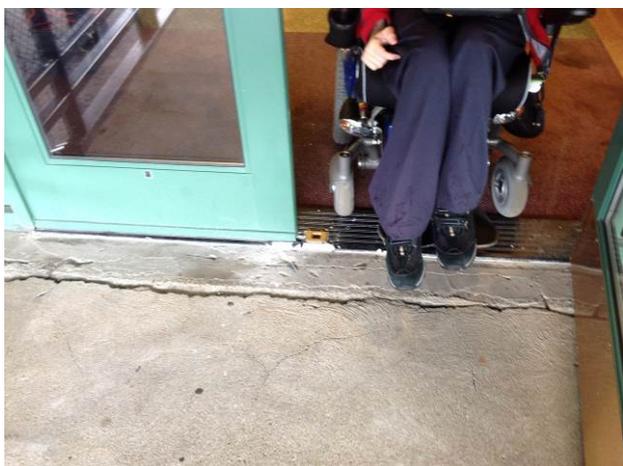
Photo 3

Additionally, at the entrance on level 2, the surface adjacent to the exterior doors is deteriorated and can also become tripping hazards to visitors and staff. (Photo 3)

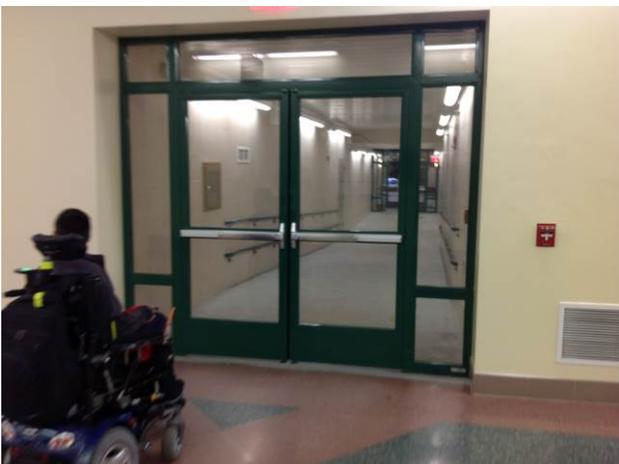
Photo 6

Although the designating signage in this facility is mostly accessible, the entrance to the garage from the train station on level 1 is not properly identified with ADA-compliant signs. (Photo 6)

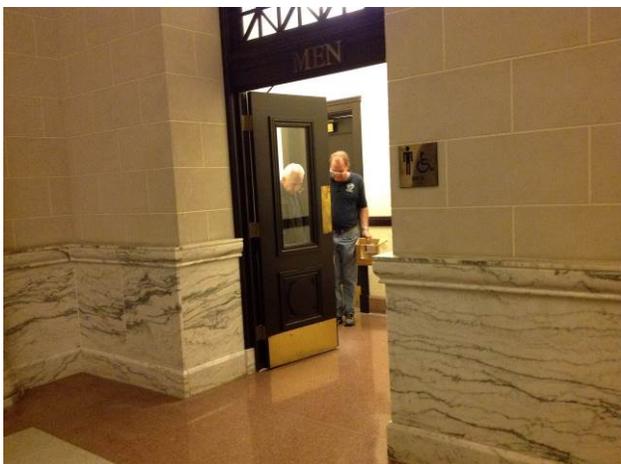
Photo 9

Signage identifying toilet rooms is compliant, except for the toilet rooms on level 1. Designation signs for such toilet rooms are incorrectly placed on the doorways to the grand hall instead of alongside the doors. (Photo 9)

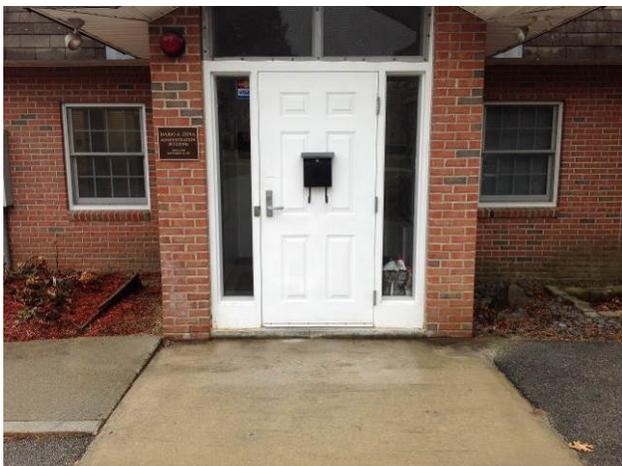
Photo 3

The public entrance is not accessible because it has one step up from the sidewalk (2.5”). (Photo 3)

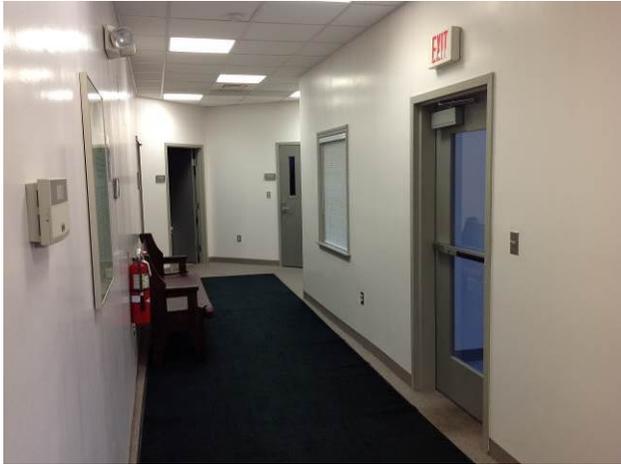
Photo 4

At the public entrance as well as circulation areas within the building, weather mats are not secure and can become tripping hazards to visitors and staff. (Photo 4)

Secure all weather mats with industrial-strength double-stick tape. Alternatively, replace them with recessed walk-off mats or grates at all entrances.

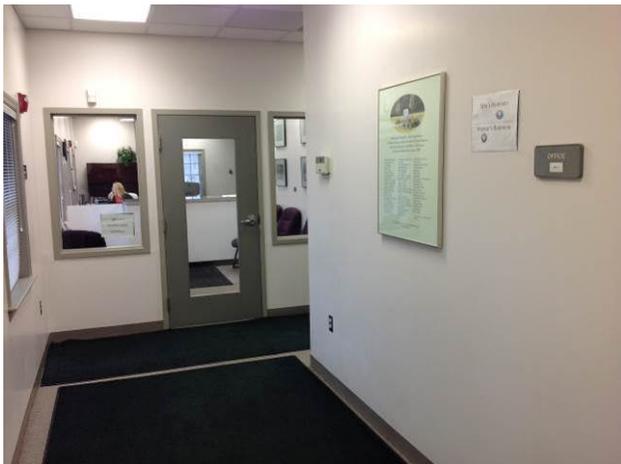
Photo 5

One counter for transactions with the public can be found inside the office. The counter is inaccessible because it exceeds the maximum allowable height for visitors using wheeled mobility devices or who are of short stature (42" AFF). (Photo 5)

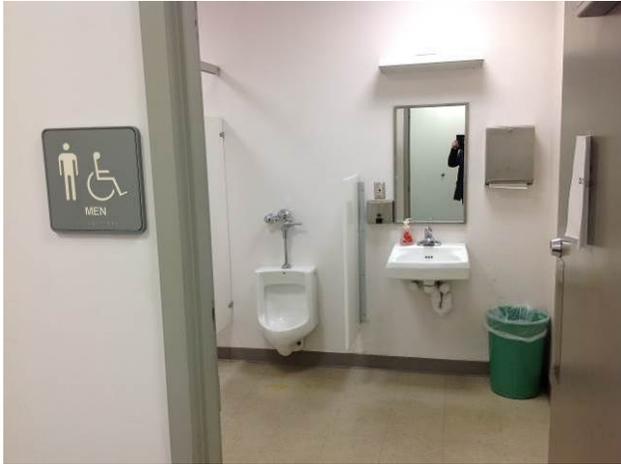
Photo 7

One set of multi-user toilet rooms (one for each gender) for staff and public use are located near the front entrance. In both toilet rooms, mirrors above lavatories exceed the maximum allowable height (41" AFF) and door to accessible stalls have malfunctioning self-closing hinges. (Photos 7 & 8)

In both toilet rooms, lower the mirrors above the accessible lavatories so that their reflective surface is no higher than 40" above the floor. Additionally, adjust or replace the self-closing hinges of doors to accessible stalls. In the Women's toilet room, modify the plumbing of the accessible toilet stall so that the flush valve is on the left side of the toilet.

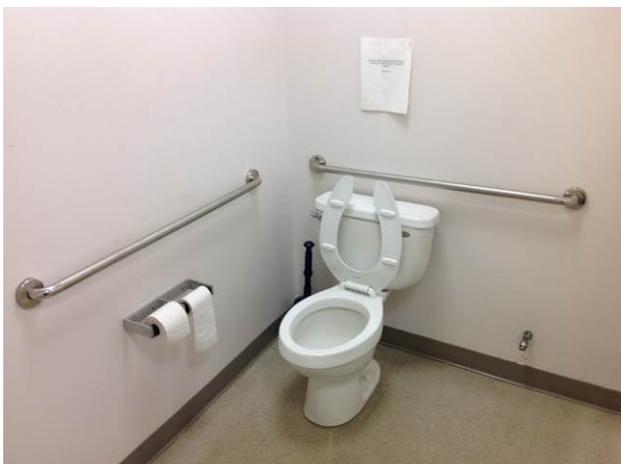
Photo 9

Inside the accessible toilet stall in the Men's toilet room, the flush valve is located on the incorrect side of the toilet. (Photo 9)

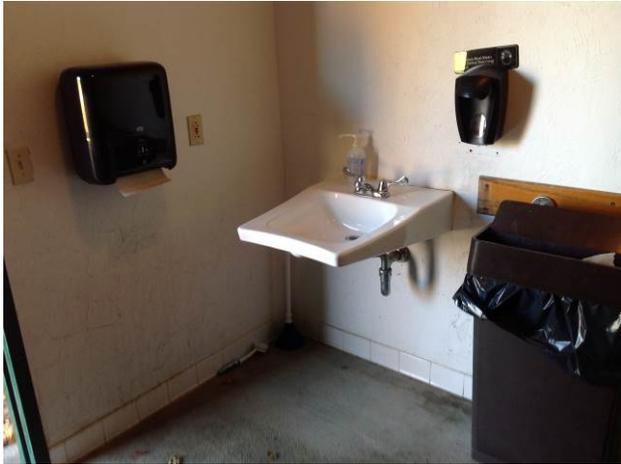
Photo 7

One set of multi-user toilet rooms (one for each gender) for staff and public use are located in the clubhouse and one set of single-user toilet rooms (one for each gender) for staff and public use are located in the Sand Wedge Shoppe building near Skyline Drive. All toilet rooms have lavatories with unprotected plumbing underneath. (Photos 7 & 8)

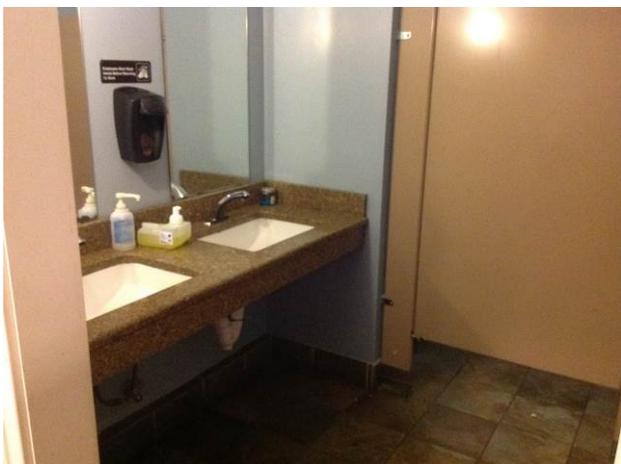
Photo 9

Additionally, inside both toilet rooms in the clubhouse, wall-mounted soap dispensers exceed the maximum allowable height (52" above the floor). (Photo 9)

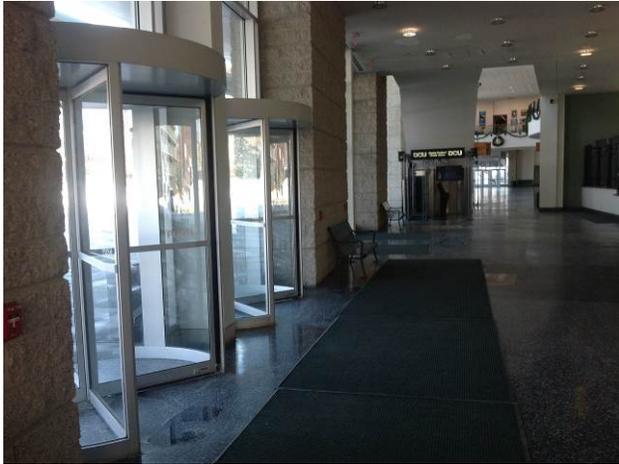
Photo 1

At most entrances, weather mats are not secure and can become tripping hazards to visitors and staff. (Photo 1)

Secure weather mats with industrial-strength double-stick tape or replace them with low-profile, ADA-compliant weather mats.

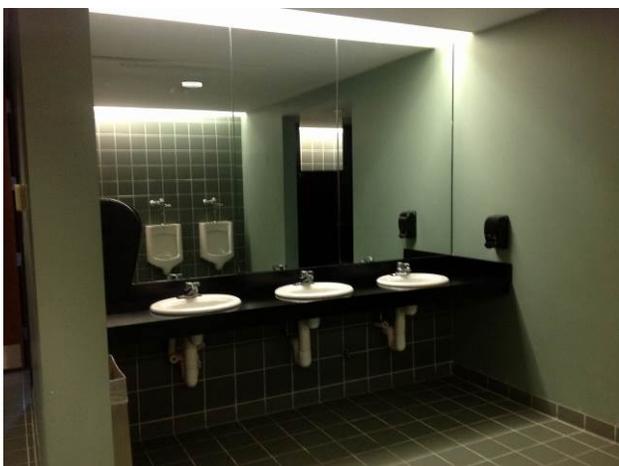
Photo 3

- lavatories exceed the maximum allowable height (35" above the floor) inside toilet rooms on level 3; (Photo 3)
- mirrors above lavatories exceed the maximum allowable height (42" above the floor) in the Men's and Women's toilet rooms inside exhibition halls on level 1;
- malfunctioning self-closing hinge of door to accessible stalls on all levels;
- flush valve on incorrect side of toilet in accessible toilet stall of Men's and Women's toilet rooms inside gallery on level 1 and Men's toilet room inside north exhibition hall on level 1.

- Lower the mirror above all accessible lavatories so that their reflective surface is no higher than 40" above the floor;
- Adjust or replace the self-closing hinges of doors to all accessible stalls;
- Replace the flush valve of toilet in accessible toilet stall of the Men's and Women's toilet rooms inside the gallery on level 1 and the Men's toilet room inside the north exhibition hall on level 1.

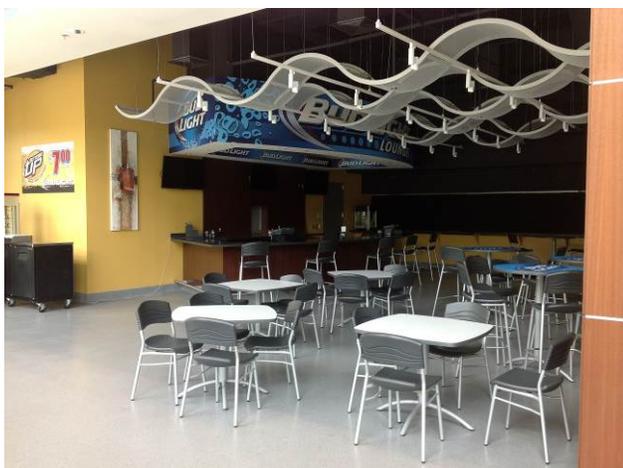
Photo 3

At least five tables are provided within the new bar along Foster Street. Although the tables meet the maximum allowable height, none provide the required knee clearance because they are not-ADA compliant. (Photo 3)

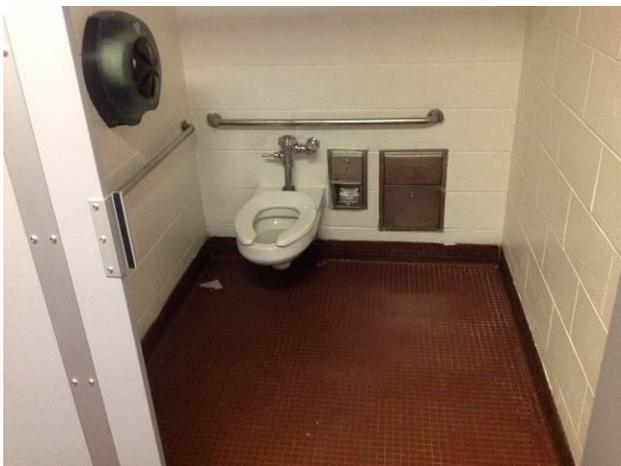
Photo 6

- door to accessible stall incorrectly swings into space inside Men's toilet room along Commercial Street; (Photo 6)
- flush valve is located on the incorrect side of toilet in the toilet room inside 'Shark Tank', Women's toilet room near 'Coors Light Cold Zone', and accessible toilet stall of Men's toilet room along Commercial Street.

- Replace flush valve of toilet - toilet room inside 'Shark Tank', Women's toilet room near 'Coors Light Cold Zone', and accessible toilet stall of Men's toilet room along Commercial Street.

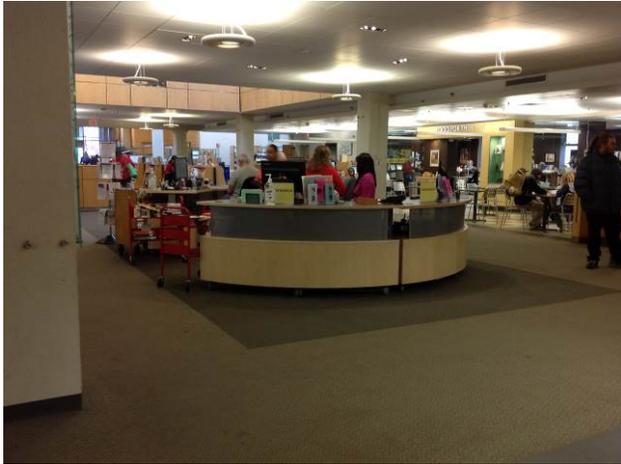
Photo 1

Circulation counters can be found on most levels. On level 1, the circulation counter near the accessible entrance is inaccessible because it exceeds the maximum allowable height (39" AFF). (Photo 1)

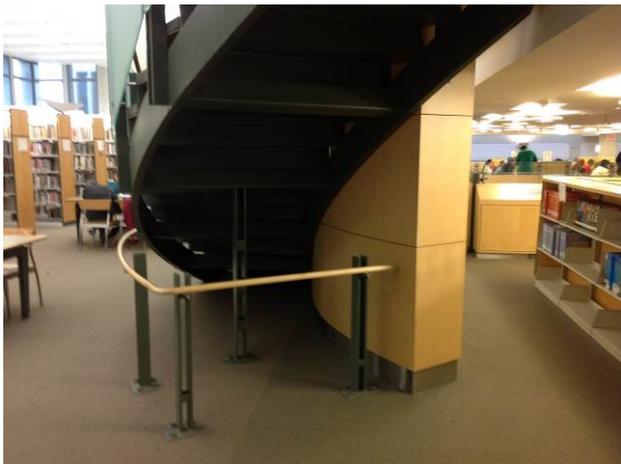
Photo 2

- partially unprotected underside of the stairway on level 2; (Photo 2)
- wall-mounted shelf adjacent to circulation counter on level 2;
- wall-mounted display adjacent to circulation counter on level 3. (Photo 3)

These protruding objects increase the likelihood of injuries among people with low or no vision or others who may be unobservant.

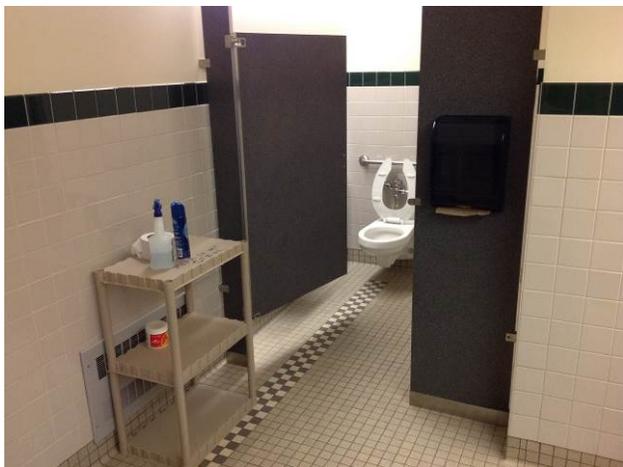
Photo 4

On level 4, inside the Men's toilet room, furniture obstructs the approach to the accessible stall and the doors to the accessible stall incorrectly swing into the stall. (Photo 4)

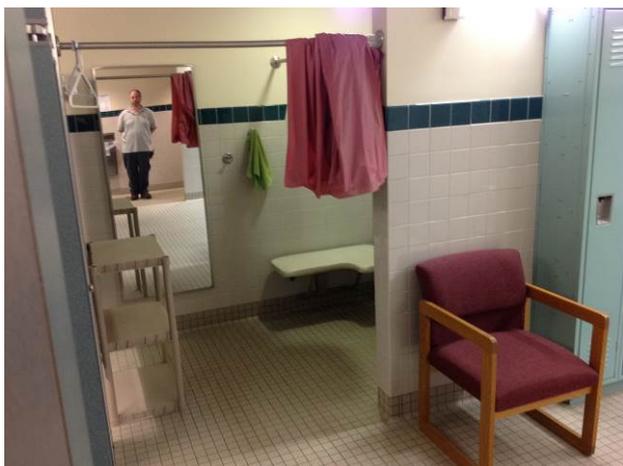
Photo 5

*NOTE: Both Men's and Women's locker rooms in the basement level are not fully accessible because ADA-compliant lockers are not provided, curtain rods create hazardous protruding objects, and doors to the accessible stall incorrectly swing into the stall. (Photo 5) Although these locker rooms are restricted to staff use only, the Americans with Disabilities Act prohibits discrimination in the workplace against disabled individuals and the library must be prepared to address a reasonable accommodation request by an employee with a disability.*

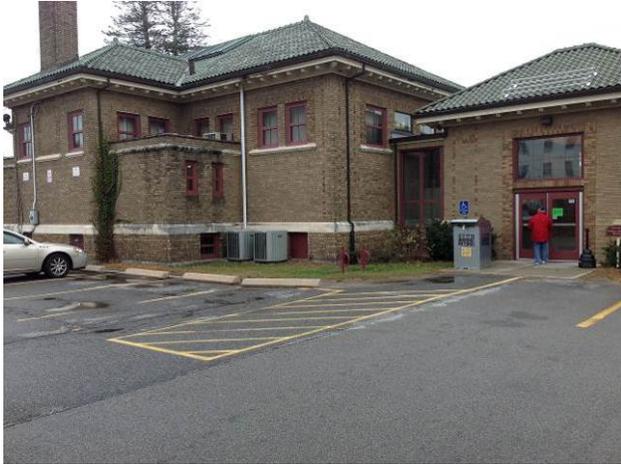
Photo 1

Off-street staff and public parking was identified in the parking lot at the rear of the building. Although one accessible parking space is provided near the accessible entrance, it does not meet the minimum requirements for access aisle and signage – signage is located on the building over 25 feet away. Additionally, based on the total number of parking spaces in the parking lot, an additional accessible parking space is required. (Photos 1 & 2)

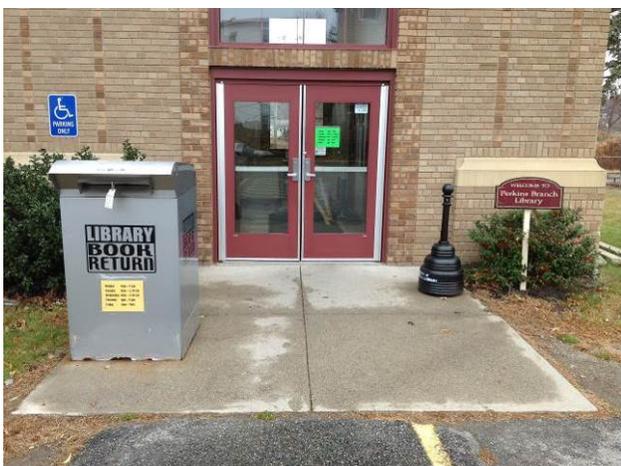
Photo 3

Near the accessible entrance, the transition between asphalt driveway and concrete landing creates a tripping hazard to those entering or exiting the library. Further, the drop box offered at this location does not have clear floor space for those who use wheeled mobility devices. (Photo 3)

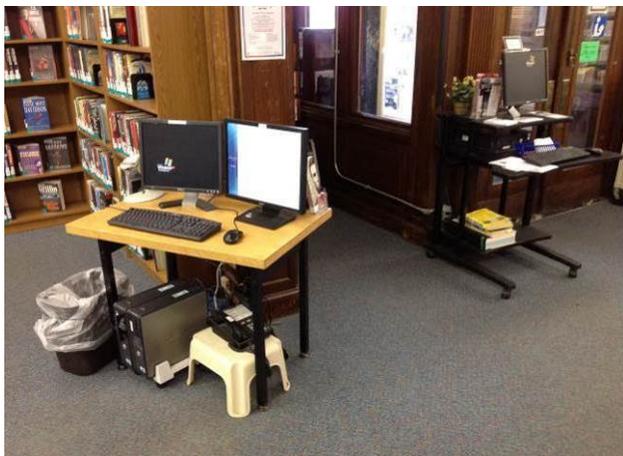
Photo 6

In the reading room on the upper level, none of the computer workstations provide the required knee and toe clearance. Workstations include the catalog station, queue/sign-up station, computer station with internet access, and computer station in children section. (Photo 6)

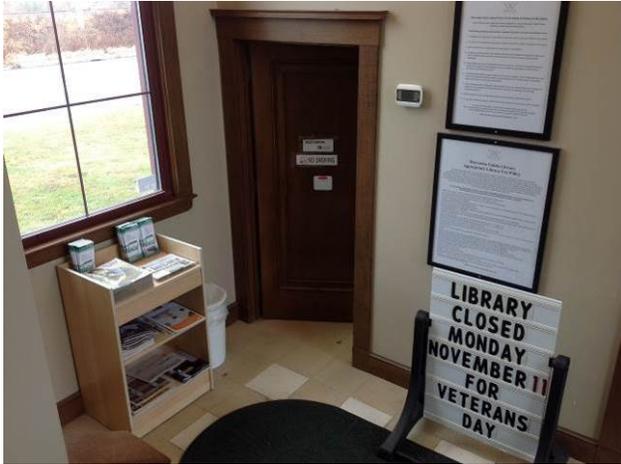
Photo 7

A few barriers can be found within the building. In the entry lobby, a storage shelf and trash can obstruct the approach to one of the single-user toilet rooms. (Photo 7)

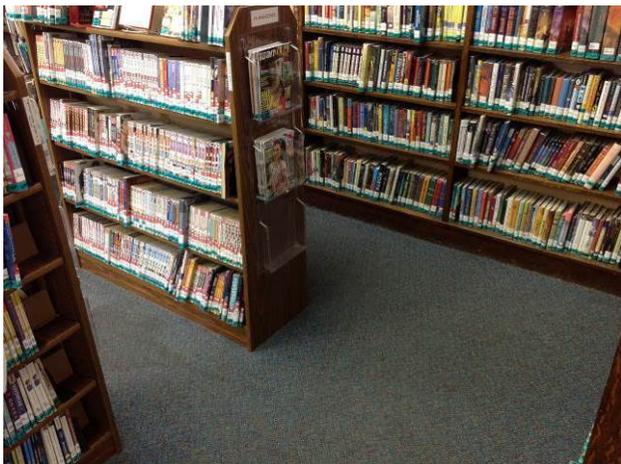
Photo 8

In the adult section of the reading room on the upper level, a floor-mounted chord creates a barrier to those using wheeled mobility devices as well as a tripping hazard to those not paying attention. In the children section, bookshelves at the rear obstruct the accessible route and circulation paths to less than 36" of width. (Photo 8)
