**City of Worcester**

**ADA Self-Evaluation  
(as basis for Transition Plan)**

**Prepared by  
Institute for Human Centered Design  
August 1, 2014**

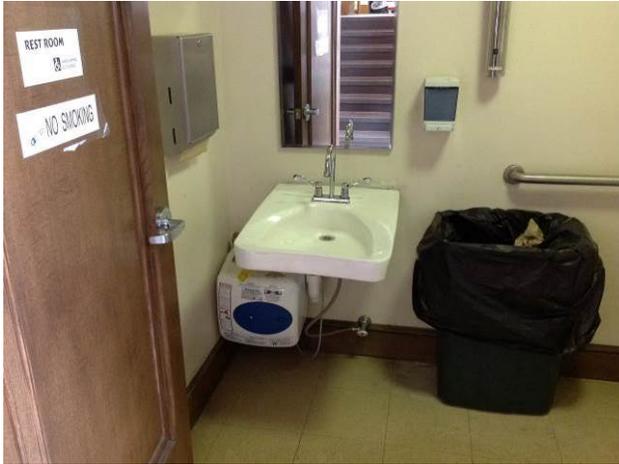
Photo 10

- the clear floor space underneath the lavatory is obstructed by instant hot water heater; (Photo 10)
- the approach to the toilet is obstructed by trash can; (Photo 11)
- the flush valve is located on the incorrect side of the toilet;
- the rear grab bar is obstructed by the toilet tank; (Photo 11)
- the side grab bar does not meet minimum height (30”) and is obstructed by toilet paper dispenser; (Photo 11)
- the baby changing station exceeds the maximum allowable (38”).

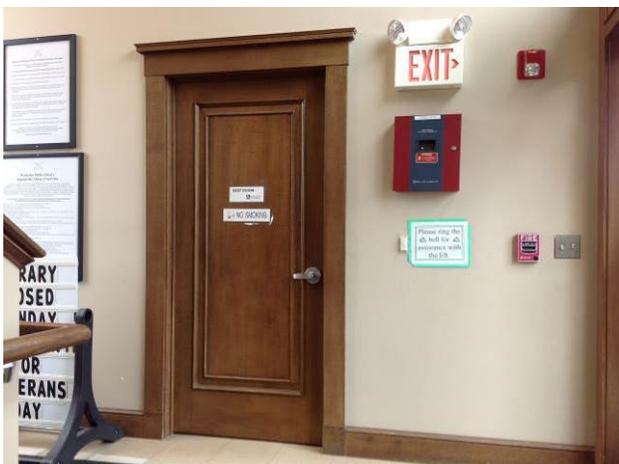
Photo 12

Toilet rooms are not identified with accessible signage. (Photo 12)

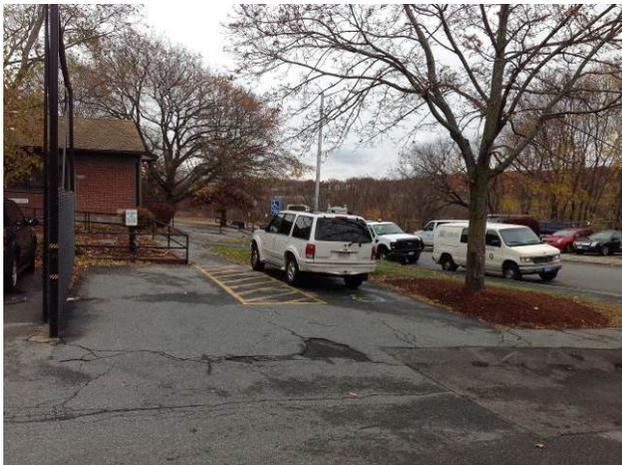
Photo 1

Off-street staff and public parking was identified in the small parking lot near the building. These parking spaces seem to be used by staff and public from the adjacent offices and are not exclusively used by the library occupants. Although one space is designated as accessible for public use, it does not meet the minimum requirements for access aisle and signage. Additionally, being located on a hillside, this parking space has excessive slopes that render it completely unusable by those arriving by vehicles. (Photo 1)

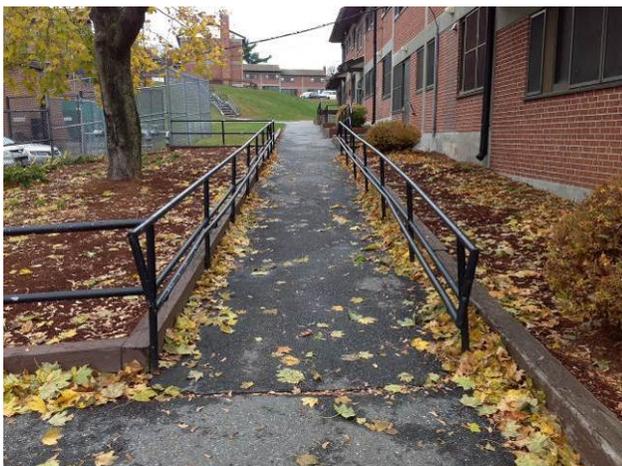
Photo 2

The long walkway between the sidewalk, the parking, and the entrance to the library (about 135 feet) is excessively steep and poorly maintained. Despite one segment of this walkway is served by a ramp, the entire walkway exceeds 5% slope and should be treated as an accessible ramp with railings on both sides. Further, the ramp has non-compliant and damaged railings as well as a slippery surface. Both the lowest and highest points of this exterior route are served by railings on only one side. (Photos 2 & 3)

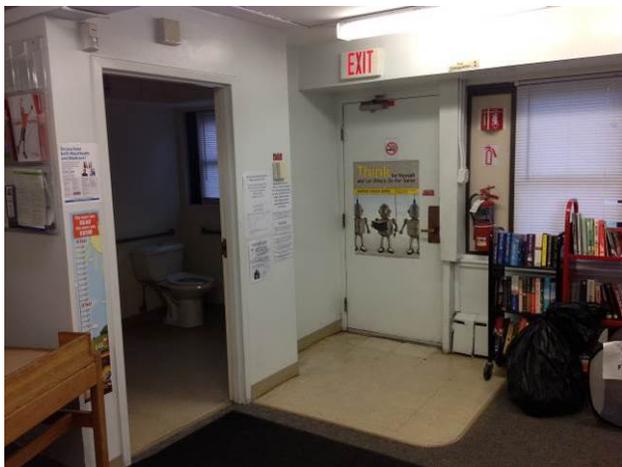
Photo 4

Near the entrance and toilet room, a weather mat is not secure and can become tripping hazards to visitors and staff. (Photo 4)

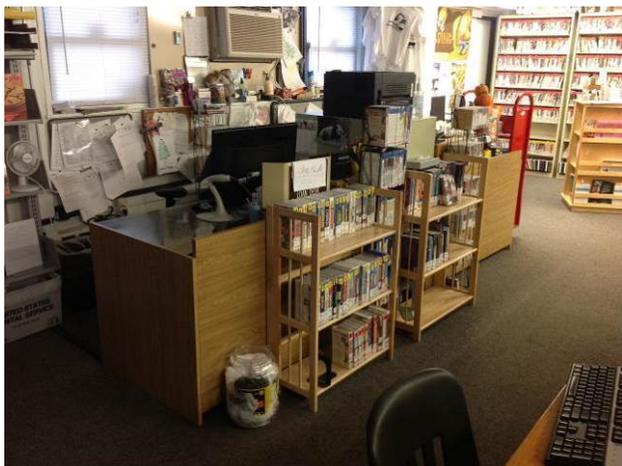
Photo 5

In the reading room, approach to the circulation counter is obstructed by the nearby bookshelves and storage. (Photo 5)

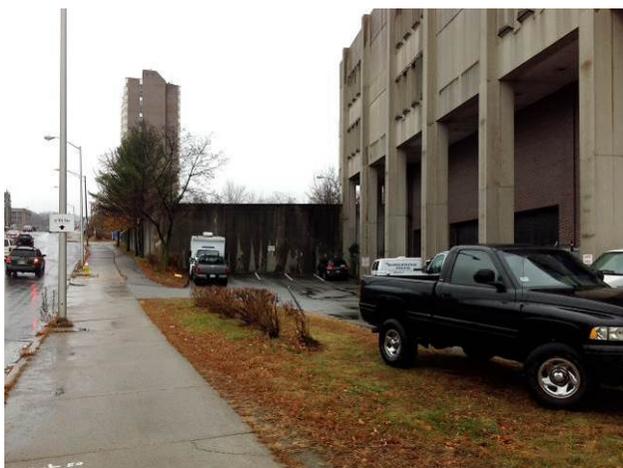
Photo 2

The exterior route between the bus stops, site entrances, the parking, and the entrance to the police station are not connected to an accessible route. The accessible entrance is approximately 875 feet from the bus stop on Goldsberry Street and can only be reached via a steep vehicular driveway within the busy parking lot. (Photo 2)

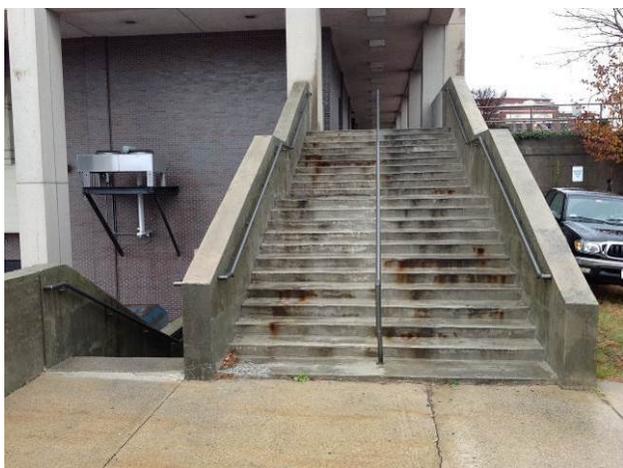
Photo 3

The accessible entrance is approximately 2,500 feet from the bus stop at the intersection of Major Taylor Boulevard and Belmont Street and can only be reached via two long flights of stairs on the southeast corner of the building. (Photo 3)

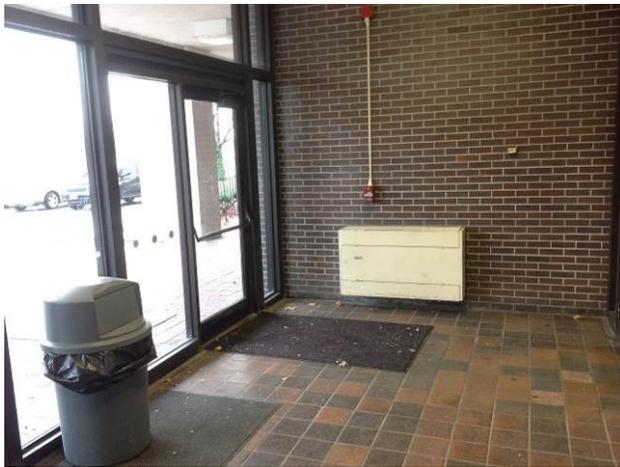
Photo 4

In the vestibule and lobby on level 1, weather mats are not secure and can become tripping hazards to visitors and staff. (Photo 4)

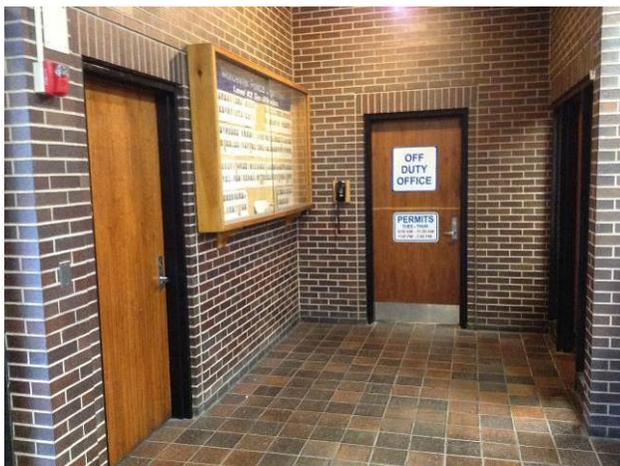
Photo 5

In the lobby on level 1, a wall-mounted display case is a hazardous protruding object that increases the possibility of injury to visitors and staff. (Photo 5)

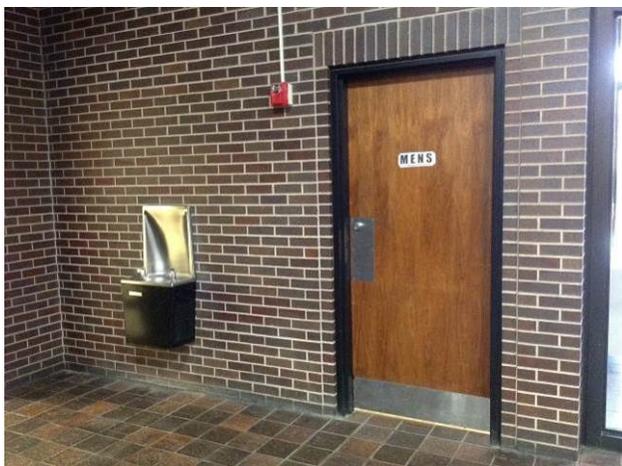
Photo 9

Toilet rooms for public use on level 1 are not identified with accessible signage. (Photo 9)

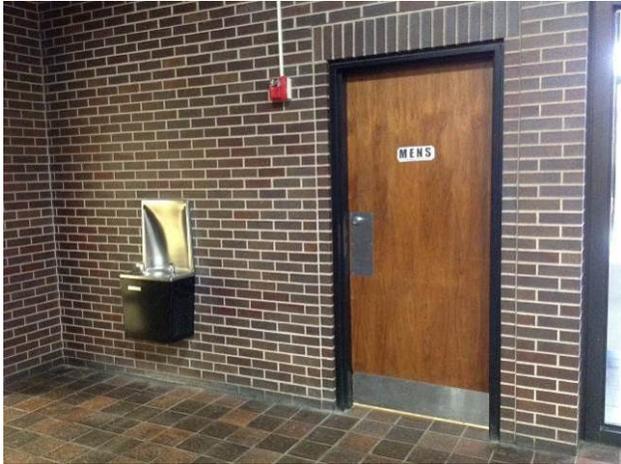
Photo 10

One wall-mounted drinking fountain is provided near the toilet rooms on level 1. Such fixture is not ADA-compliant. (Photo 10)

Replace the existing fixture in the lobby on level 1 with an accessible drinking fountain. In the meantime, provide an adjacent water cooler with cups for equivalent access at the inaccessible drinking fountain.

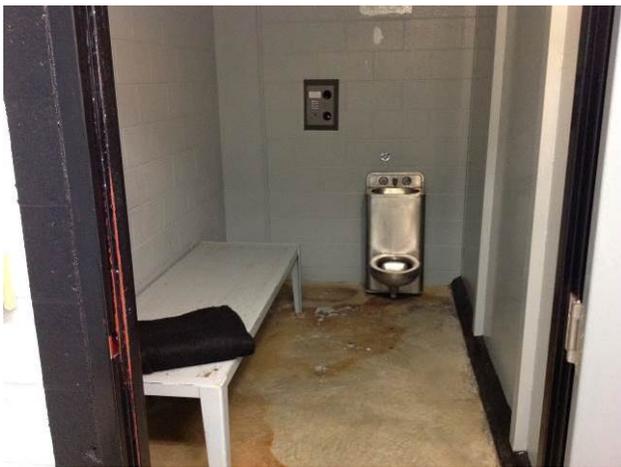
Photo 11

At the basement level, no accessible holding cells are provided. (Photos 11& 11)

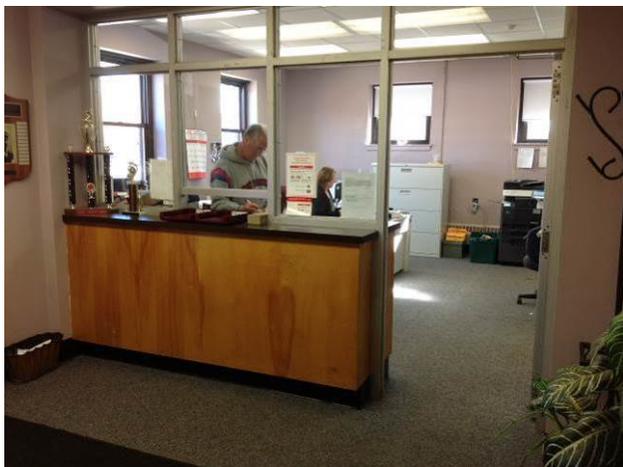
Photo 1

- in the reception, a weather mat is not secure and can become tripping hazards to visitors and staff;
- also in the reception, a counter for transactions with the public exceeds the maximum allowable height for visitors using wheeled mobility devices or who are of short stature (41" AFF); (Photo 1)
- a completely inaccessible single-user toilet room. (Photo 2)

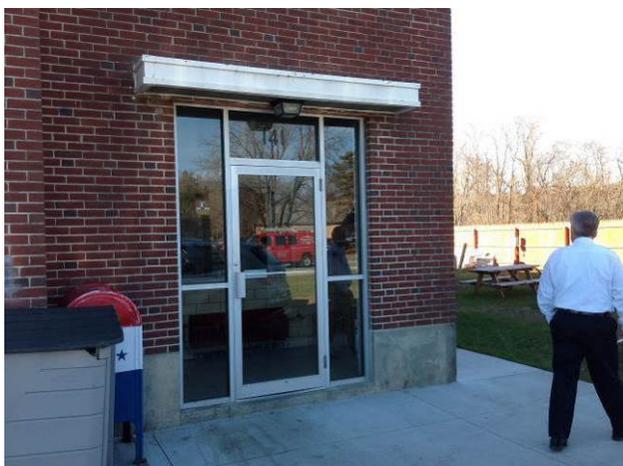
Photo 3

This two-story fire station has staff spaces beside and above the apparatus bay. This facility does not offer an at-grade entrance into the watch room (4" step) or toilet rooms for public use. (Photo 3)

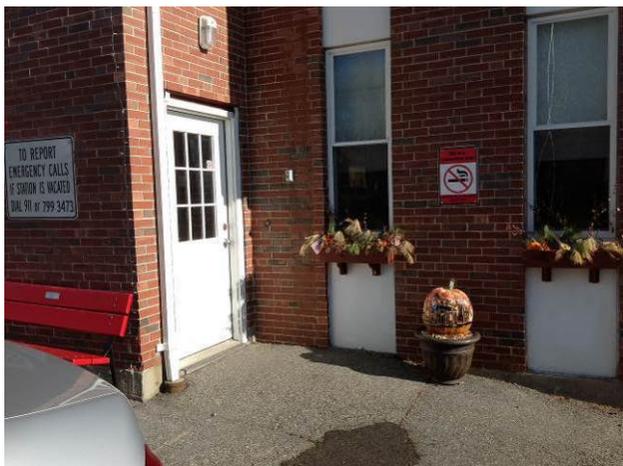
Photo 2

- approach to the entrance is often obstructed by staff vehicles; (Photo 2)
- the inaccessible entry door has a small step, a non-compliant door knob, and inadequate maneuvering clearances on the latch side of the door. (Photo 3)

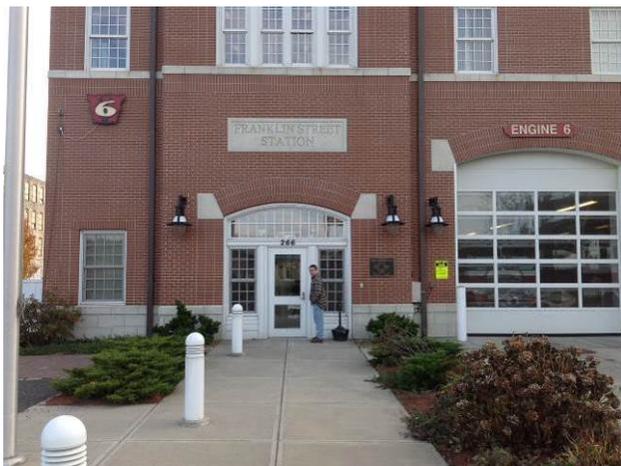
Photo 2

- at the front entrance, no clear floor space is provided underneath the doorbell; (Photo 2)
- in the parking lot, the van-designated parking space is obstructed by trash can and recycling bins; (Photo 3)
- a barbeque grille obstructs the accessible route between the accessible parking and the entrance; (Photo 3)
- in the watch room, the designation sign identifying the accessible toilet room is incorrectly located on the hinge side of the door.

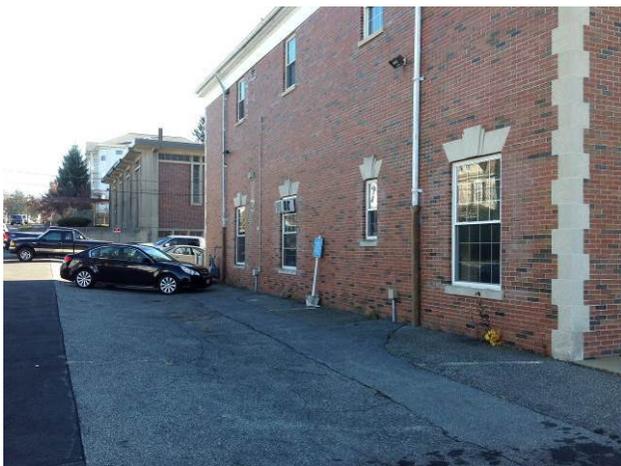
Photo 2

- the *ad hoc* parking space designated as accessible is not located on a level surface, does not have the required access aisle, and has a sign that needs maintenance; (Photo 2)
- near the at-grade entrance, the transition between asphalt driveway and concrete landing creates a tripping hazard to those entering or exiting the fire station; (Photo 3)
- at the at-grade entrance, a weather mat is not secure and can become tripping hazards to visitors and staff. (Photo 3)

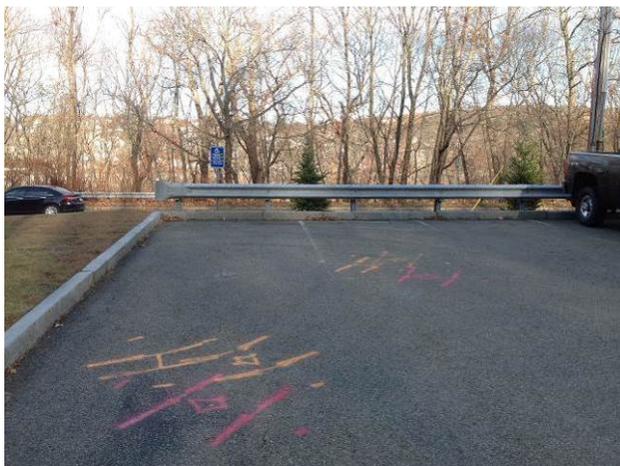
Photo 2

This two-story fire station, with staff spaces beside and above the apparatus bay, is located within a heavily wooded area along McKeon Road with no sidewalks for pedestrian access; therefore, this fire station can only be accessed via a steep vehicular driveway. (Photo 2)

- the space designated as accessible has markings that are not highly visible and is missing an identification sign for van-designated spaces; (Photo 2)
- near the at-grade entrance, the transition between the walkway and landing of the covered porch creates a tripping hazard to those entering or exiting the fire station.
- at the at-grade entrance, a weather mat is not secure and can become tripping hazards to visitors and staff;
- in the watch room, a service counter exceeds the maximum allowable height for visitors using wheeled mobility devices or who are of short stature (42" AFF); (Photo 3)
- the single-user toilet room near the watch room is completely inaccessible.

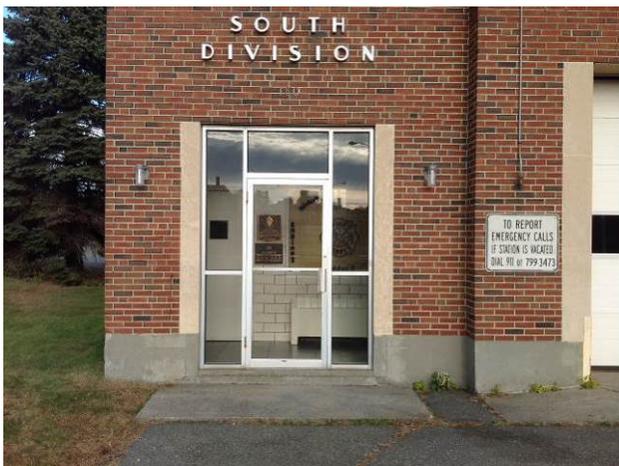
Photo 2

- although off-street parking for public use is offered at this facility, no accessible parking spaces are provided;
- an accessible route is not provided between the parking on the East side and entrance on the West side of the lot;
- near the at-grade entrance, the transition between asphalt driveway and concrete landing creates a tripping hazard to those entering or exiting the fire station. (Photo 2)
- the inaccessible entry door has a small step; (Photo 2)
- the multi-user toilet room near the watch room is completely inaccessible. (Photo 3)

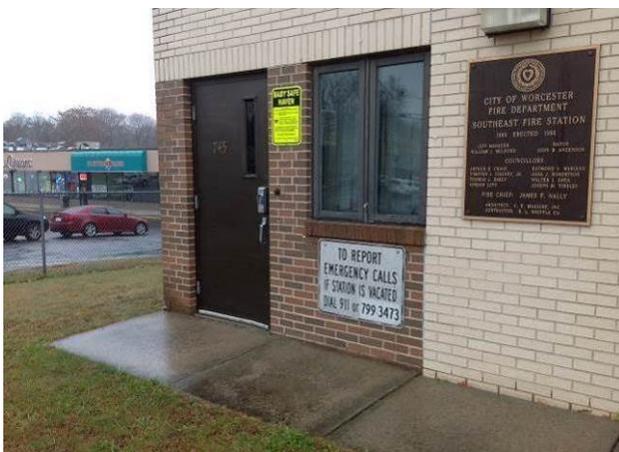
Photo 3

- Although two accessible parking spaces are provided, they exceed the maximum allowable slope (7%) and do not meet the minimum requirements for access aisle (42" wide) and signage;
- The concrete landing adjacent to the entry door exceeds the maximum allowable cross slope (3%);
- Although it may be generally used by those with mobility disabilities, the single-user toilet room near the watch room does not meet all accessibility requirements because the door hardware is not compliant, the mirror and soap dispenser exceed the maximum allowable heights (45" and 51" AFF, respectively), grab bars do not meet the minimum allowable height (30" AFF), and approach to the toilet is obstructed by the heating baseboard. (Photo 3)

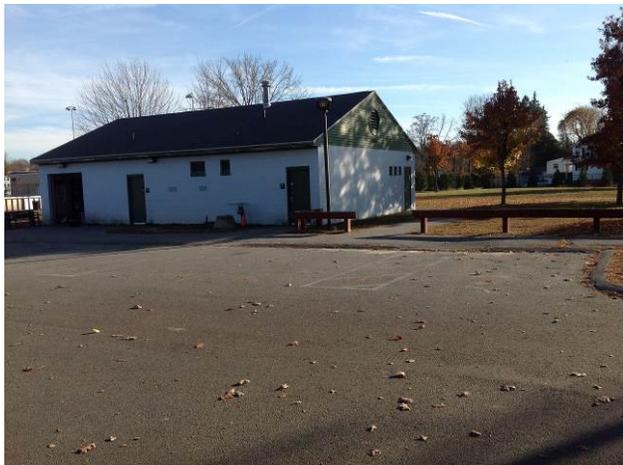
Photo 1

- Parking signs are not provided;
- Van-designated space is not provided;
- Stripping is worn out;
- Curb ramps adjacent to parking spaces are in poor condition.

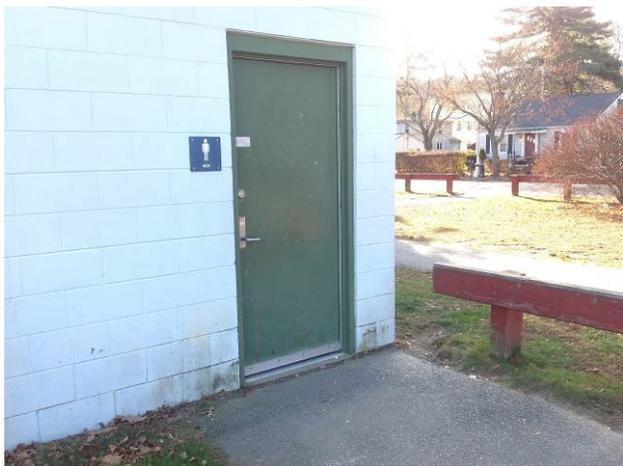
Photo 2

- ADA-compliant designating signs are not provided alongside doors;
- Deteriorated surface along doors thresholds of toilet rooms create barriers and tripping hazards;
- Toilets are too high (20" above floor);
- Self-closing hinges of door to accessible toilet stall are malfunctioning.

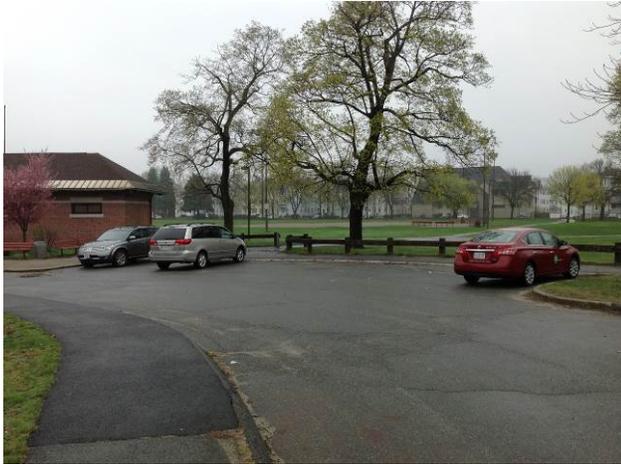
Photo 1

- Parking stripping is not provided;
- Accessible parking (including van-designated space) is not provided;
- Curb ramp between parking lot and building is in poor condition.

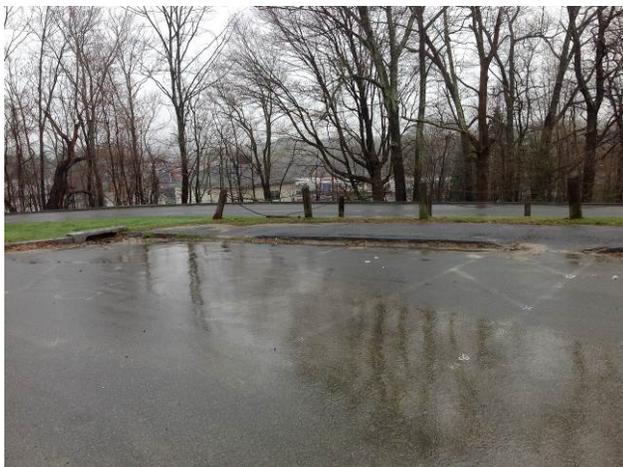
Photo 1

- Parking signs are not provided;
- Van-designated space is not provided;
- Stripping is worn out;
- Slopes of parking spaces at top of park are slightly excessive (2.5%);
- Slope of parking space near splash park is excessive (5.5%);
- Curb ramp between parking lot at top of park and buildings is in poor condition.

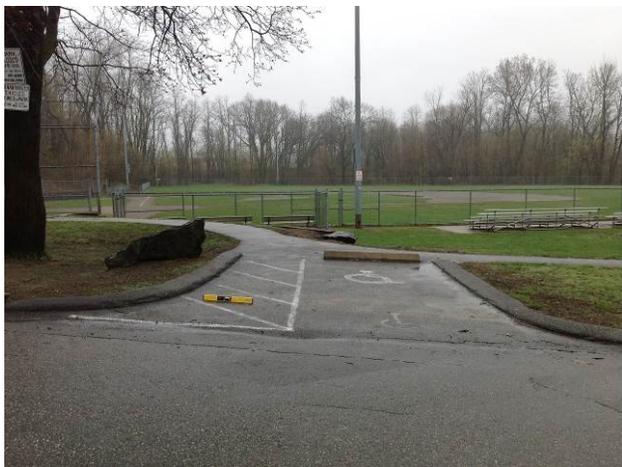
Photo 1

- Parking signs are not provided;
- Van-designated spaces are not provided;
- Slope of parking space at top of park is excessive (8%);
- Slope of parking space near playground is excessive (3.5%);
- Inadequate number of accessible parking spaces.

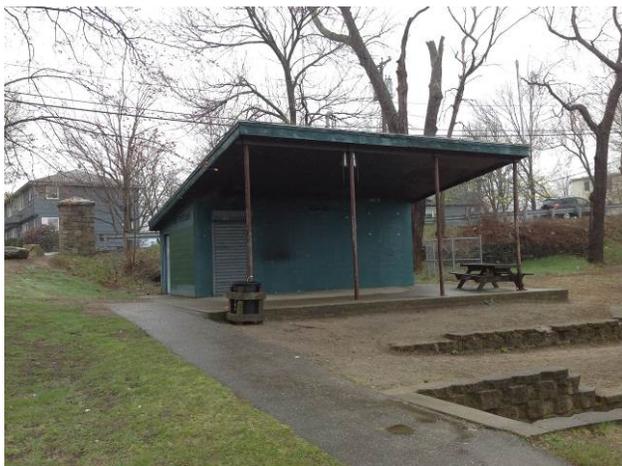
Photo 2

- ADA-compliant designating signs are not provided alongside doors;
- Toilet rooms are completely inaccessible;
- Portable toilet room is not located on an accessible route.

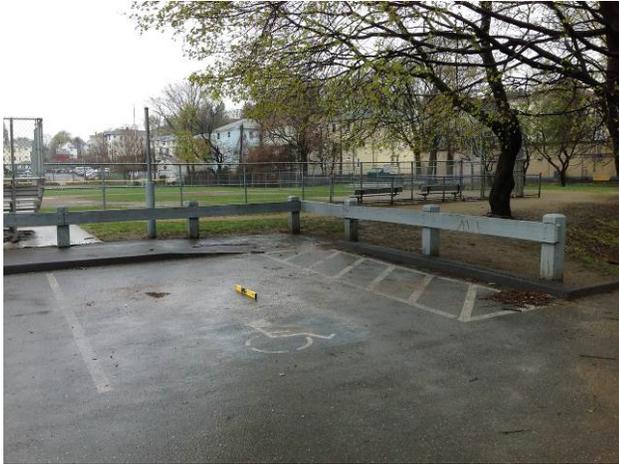
Photo 1

- Parking sign is not provided;
- Van-designated space is not provided;
- Access aisle is too narrow (4');
- Slopes are slightly excessive (2.5%);
- Curb ramp between parking lot and field is in poor condition.

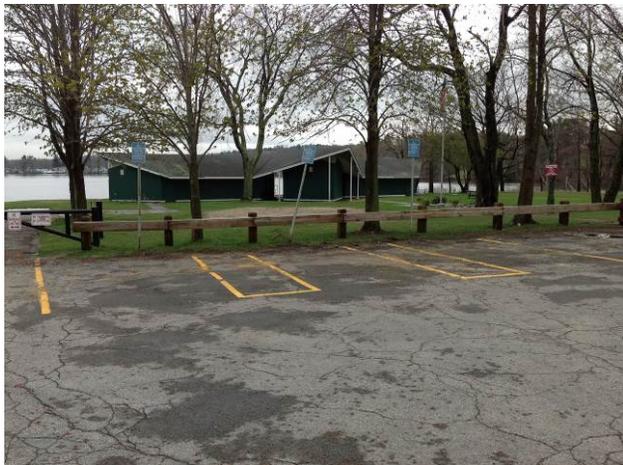
Photo 1

- Poor pedestrian access;
- Walkway between parking and building is in poor condition;
- An accessible route is not provided between the concrete walkway and the beach.
