# City of Worcester, Massachusetts

## Evaluation and Transition Plan (ADA) of Polling Places

Prepared by  
The Institute for Human Centered Design  
March 15, 2015

Part I: Executive Summary  
and Overview

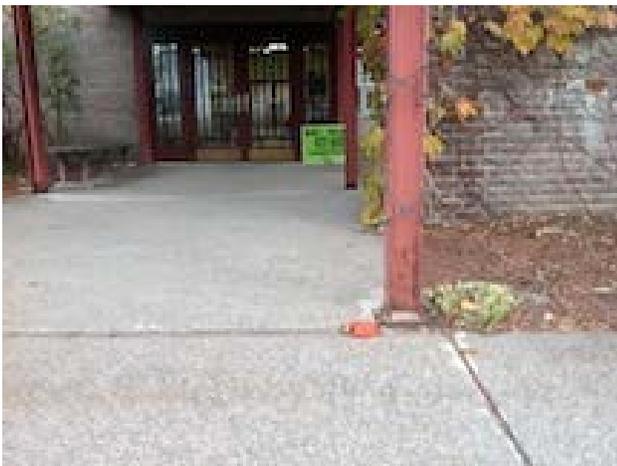
Photo 2

**Parking** There is a large parking lot with no marked accessible parking spaces; and, one marked accessible car parking space adjacent to facility walkway. This space is not accessible:

- There is no accessible route between parking and entrance because there are level changes over 1/2 inch between the access aisle and the walkway.
- There is no designated van-accessible space

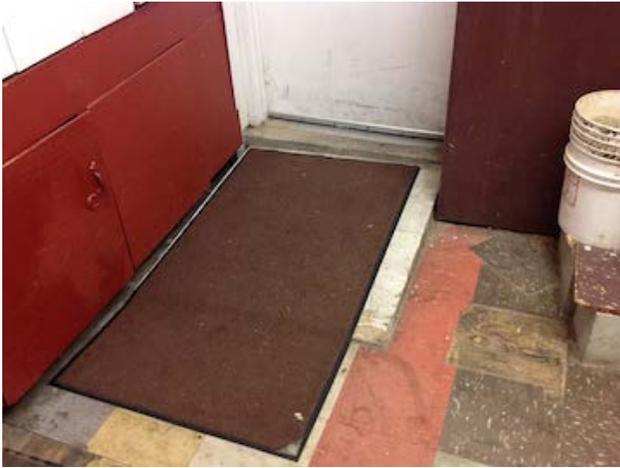
Photo 4

**Ramp** An *ad hoc* ramp is created at the interior of the designated accessible entrance, which consists of a rug over a step. (Photo 4)

- Ramp /rug is not secured
- Ramp / rug is not flush with the door threshold
- Ramp /rug does not have a level bottom landing connecting to an accessible route that is slip-resistant.

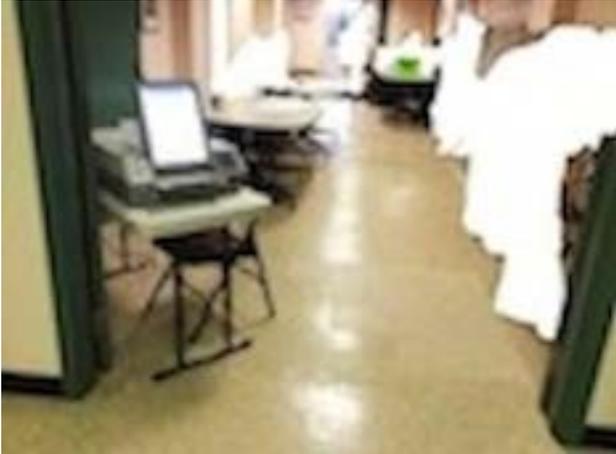
Photo 4

**Voting Area** The voting area is not set-up to enable voters to vote independently and cast a private ballot:

- AutoMARK table is not located along an accessible route located in the same area the other voting booths. (Photo 4)
- AutoMARK machine does not have privacy hood installed and is not set up in a way that ensures voter privacy. (Photo 6)

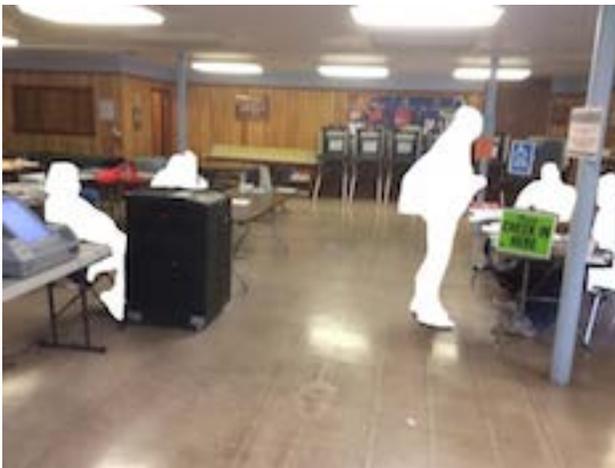
Photo 5

- The accessible lower table is too cluttered for use.
- The accessible voting booth is placed at the end of the table, over the table leg, which blocks the required knee clearance under the table.
- AutoMARK machine does not have privacy hood installed and is not set up in a way that ensures voter privacy. (Photo 5)
- AutoMARK table is not adjusted to provide adequate clear space for knee clearance (at least 27 inches from floor to underneath table surface).
- Headphones were at table but were not attached.
- A chair was not provided at or nearby the accessible voting features.

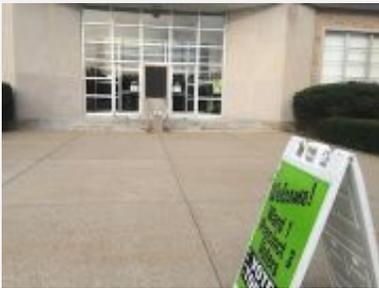
**ID** 6-189

mat at accessible entrance foyer unsecured- a potential tripping hazard.

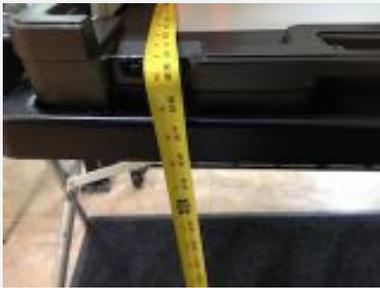
Unsecured mat at low table can pose tripping hazards.

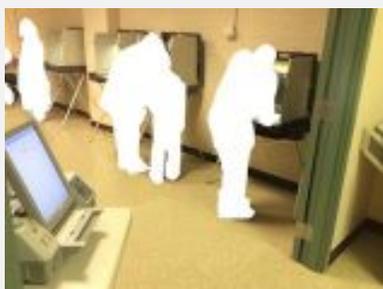
Machine positioned improperly, not set up for use.

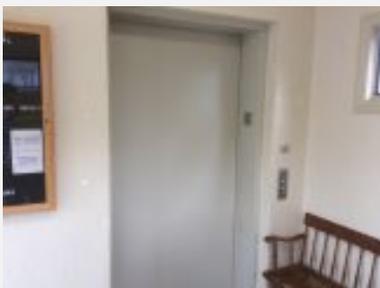
path from elevator to voting area.  
Trash can located within circ route- tripping hazard. Chairs also navigational hazard.
