WORCESTER CONSERVATION COMMISSION

God's Acre

Conservation Property Baseline Assessment

July 2024

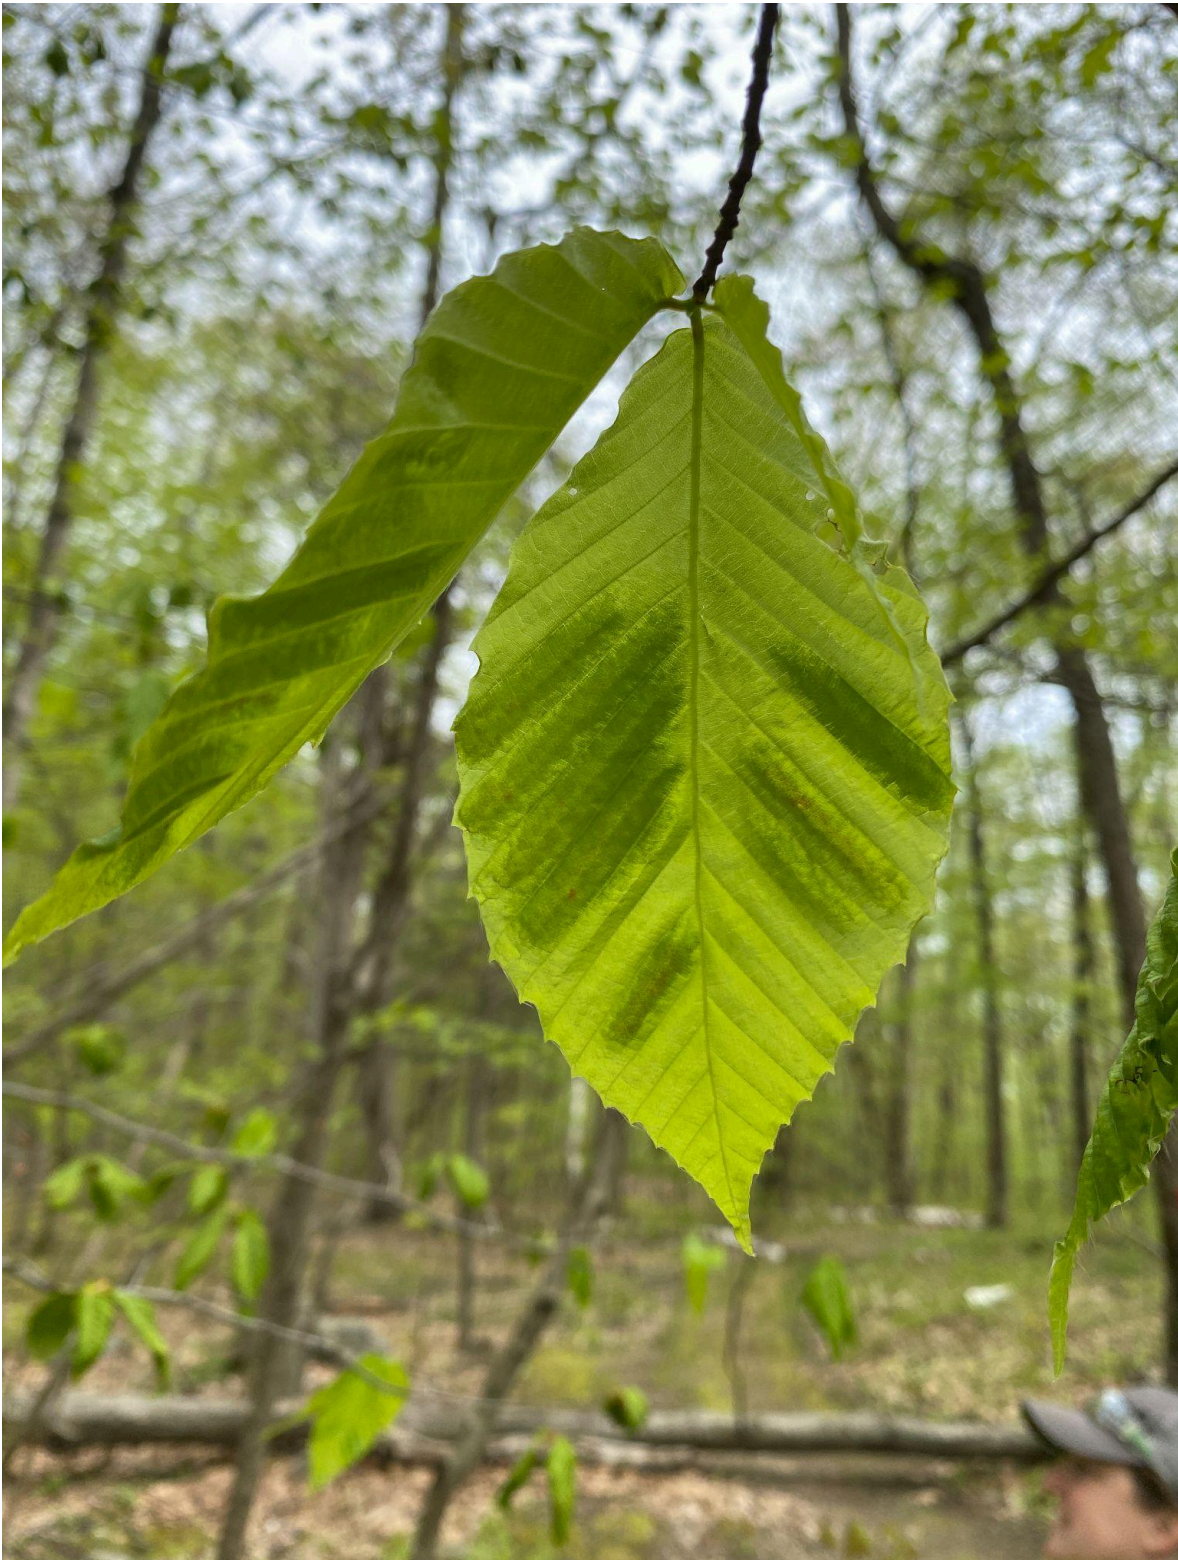
Photo 1

Comments: Beech leaf disease. Trees are showing signs throughout the entire property. Photo from near the parking area off of Swan Avenue.

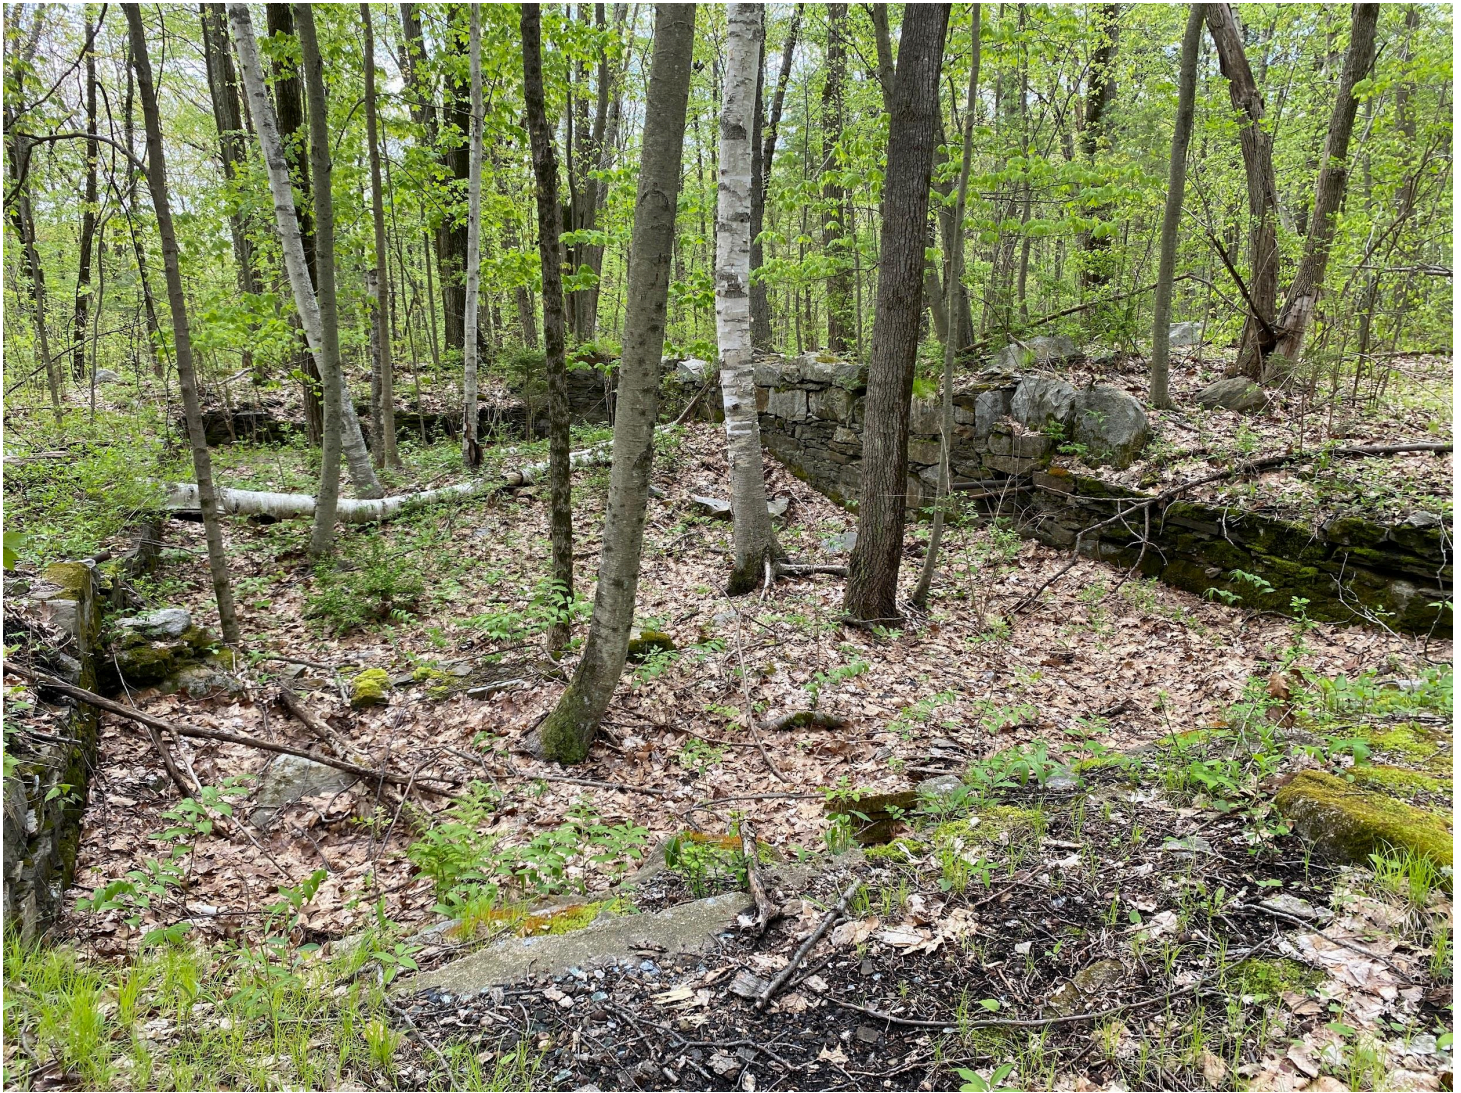
Photo 3

Comments: Foundation along the trail. Some sparse Japanese barberry (*Berberis thunbergii*) is sprouting in the area.

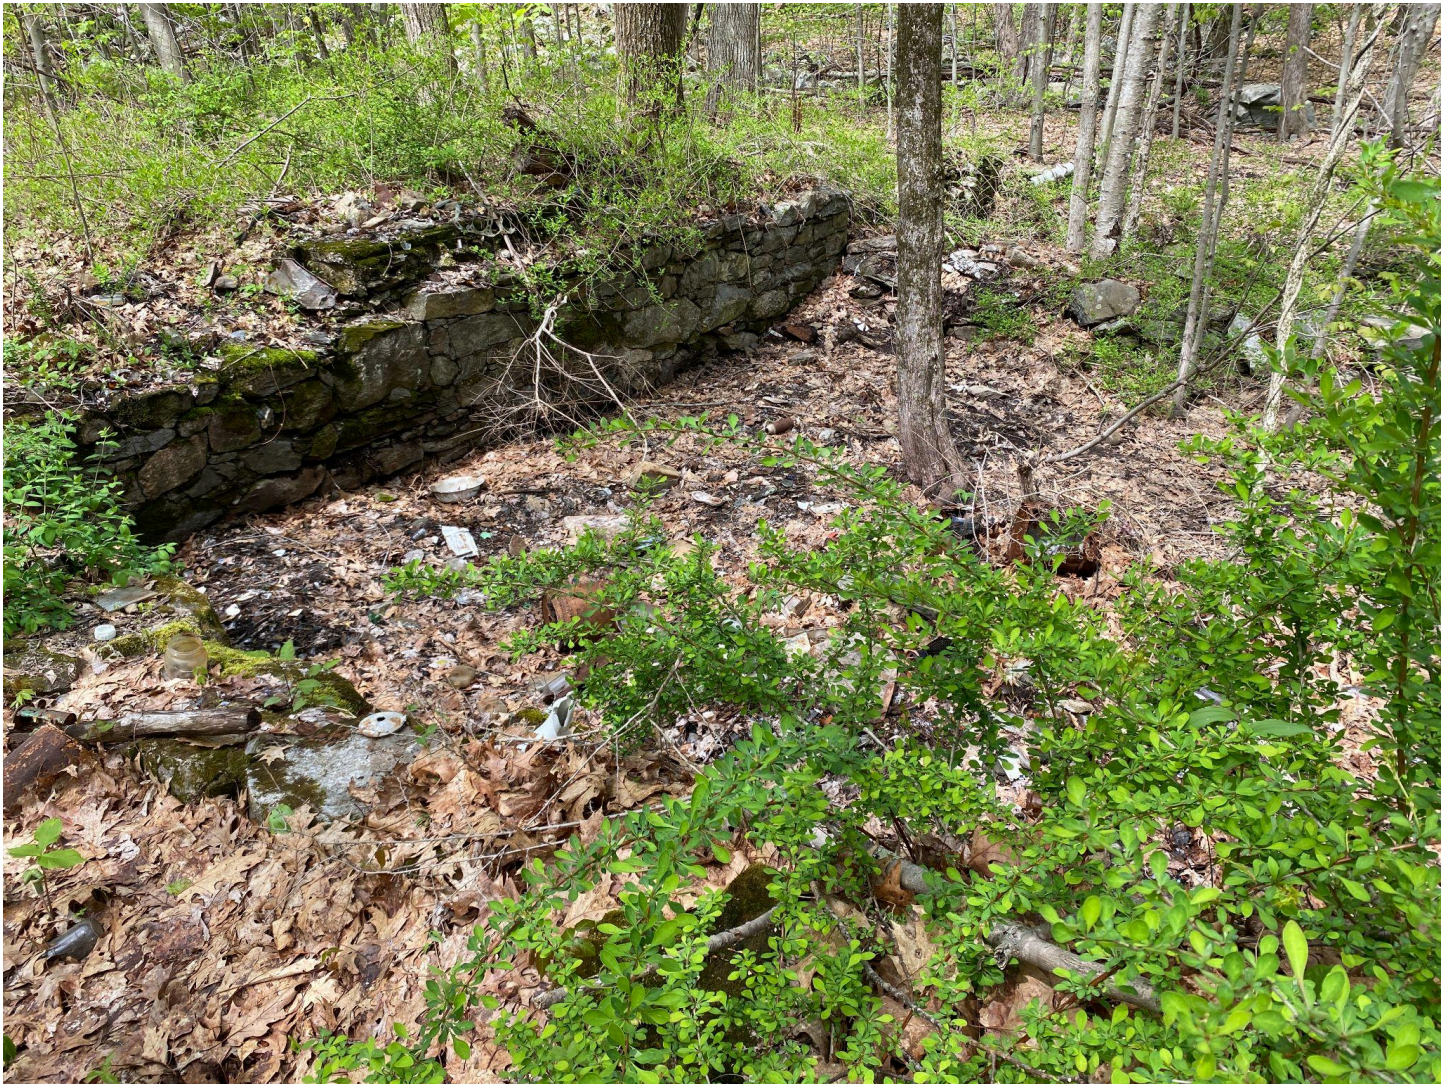
Photo 4

Comments: Foundation along the trail. Materials such as broken glass, metal, and other solid household trash have been dumped here. Invasive plants including Oriental bittersweet (*Celastrus orbiculatus*), burning bush (*Euonymus alatus*), non-native honeysuckle (*Lonicera* spp.), and Japanese barberry are growing in and around the foundation.

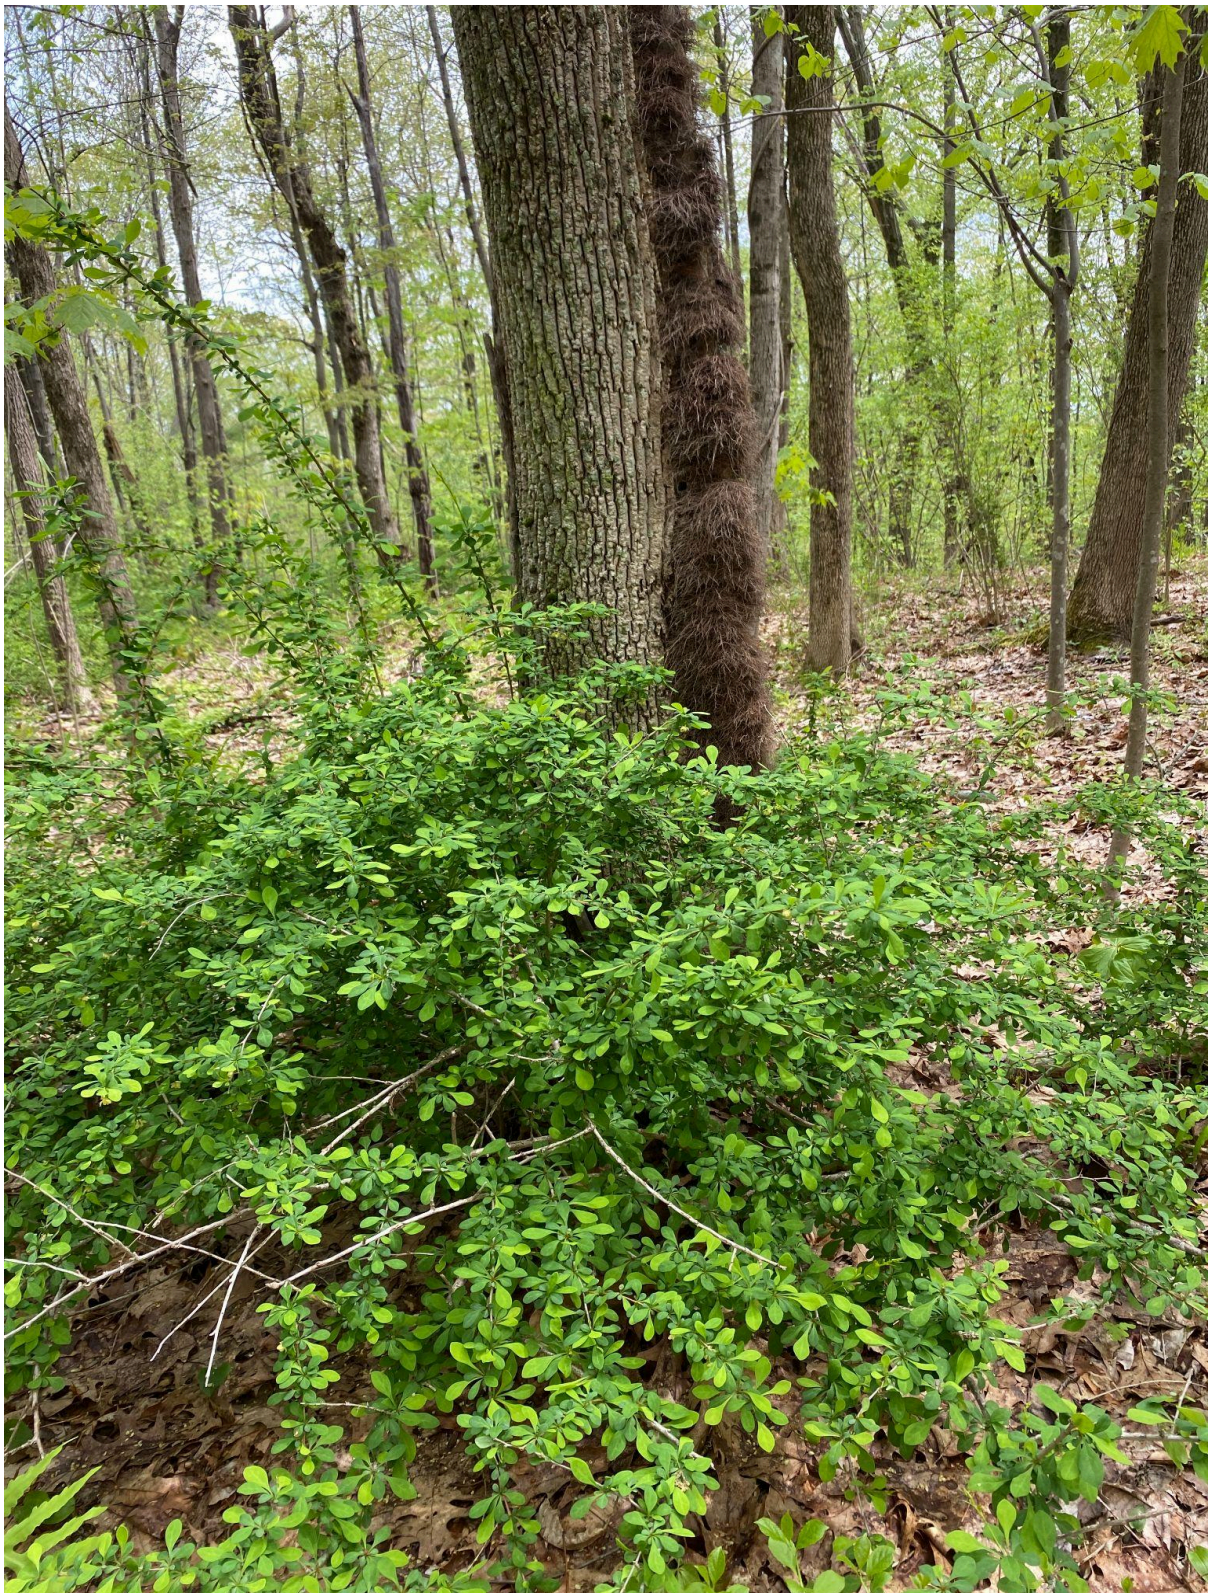
Photo 5

Comments: Japanese barberry growing near the foundations along the Red Trail.

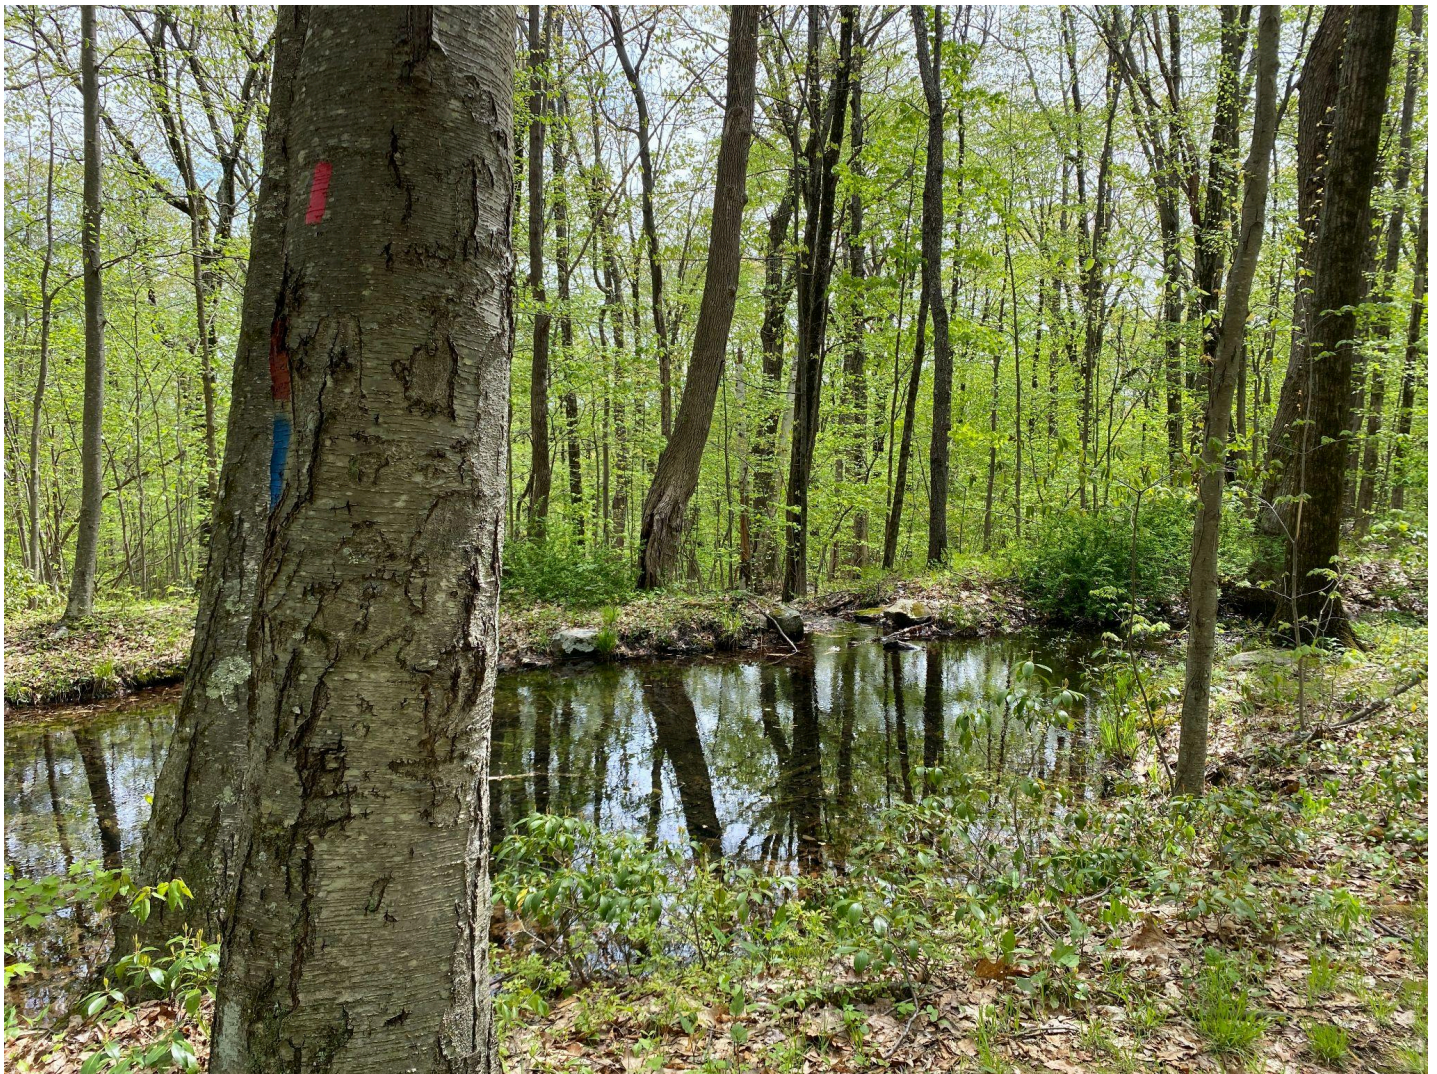
Photo 6

Comments: Artificial pond along path created by damming a small and potentially seasonal stream. Invasive plants such as Japanese barberry dominate the vegetation, potentially out-competing native plants.

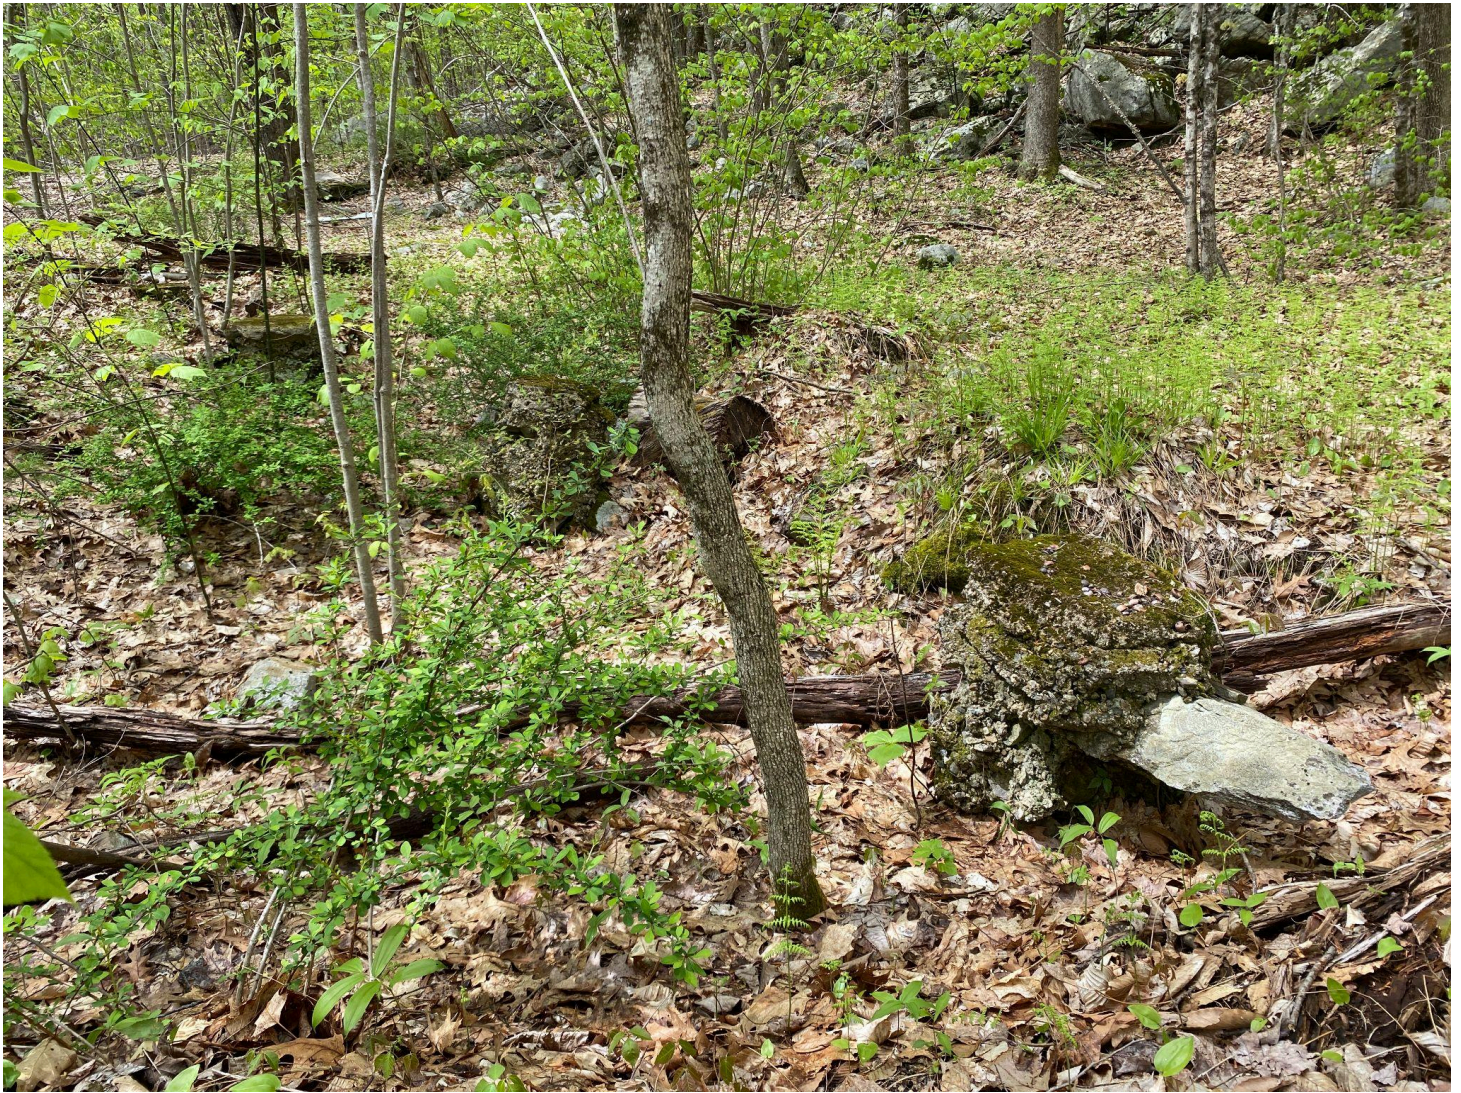
Photo 7

Comments: Cement footings may indicate another old structure.

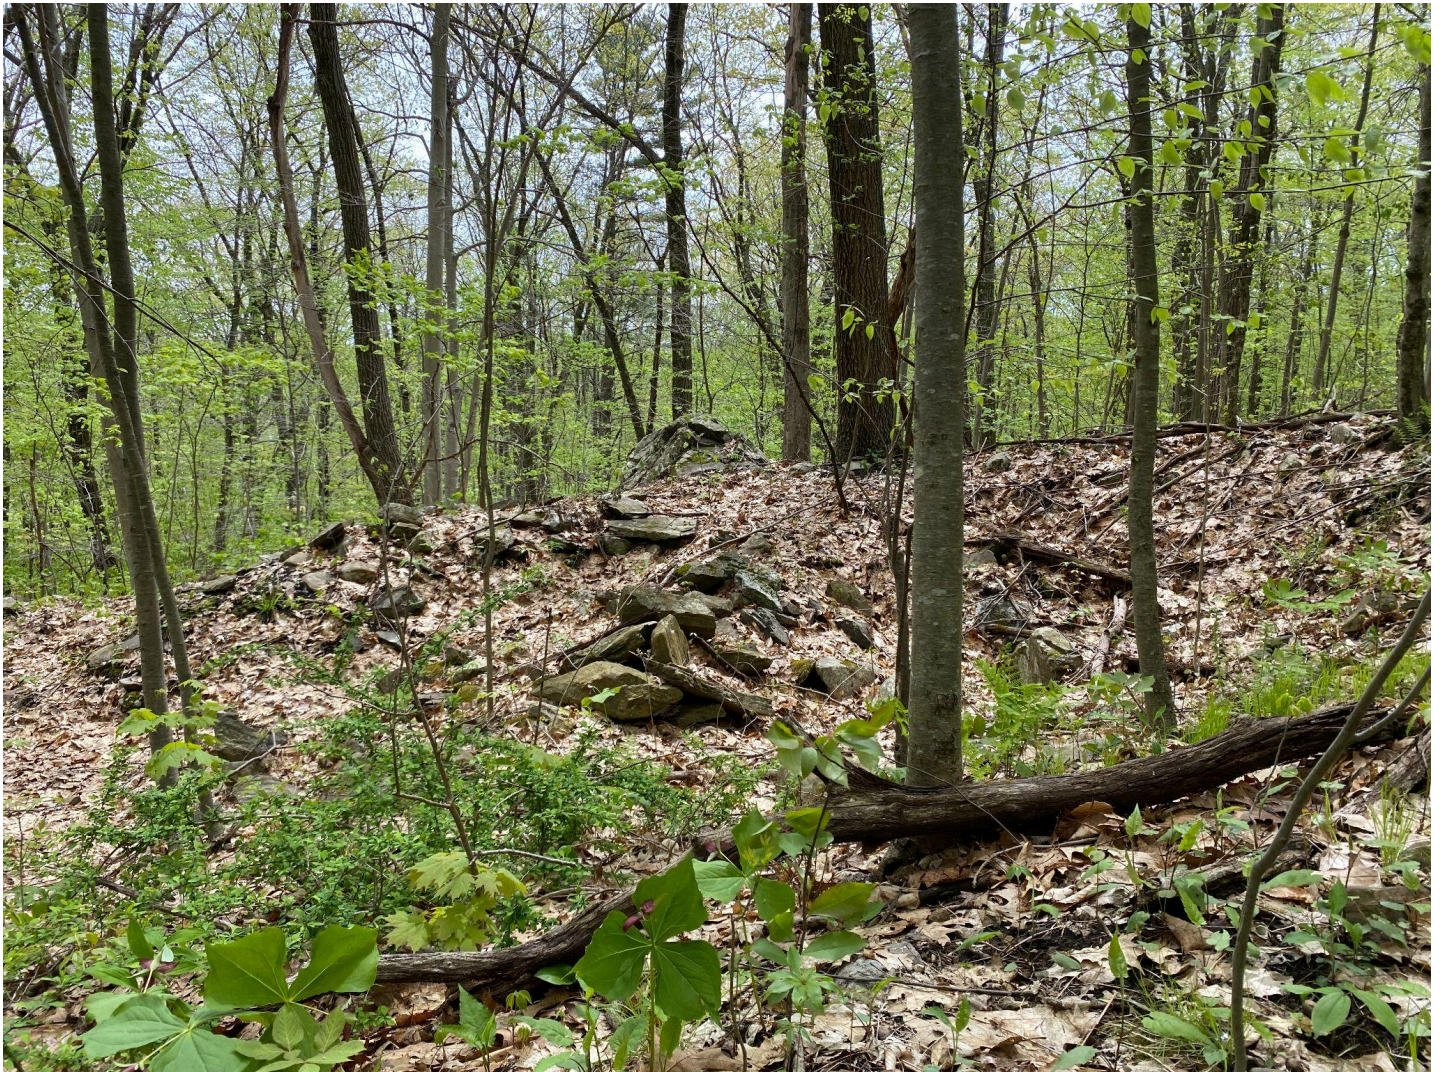
Photo 8

Comments: Building foundation.

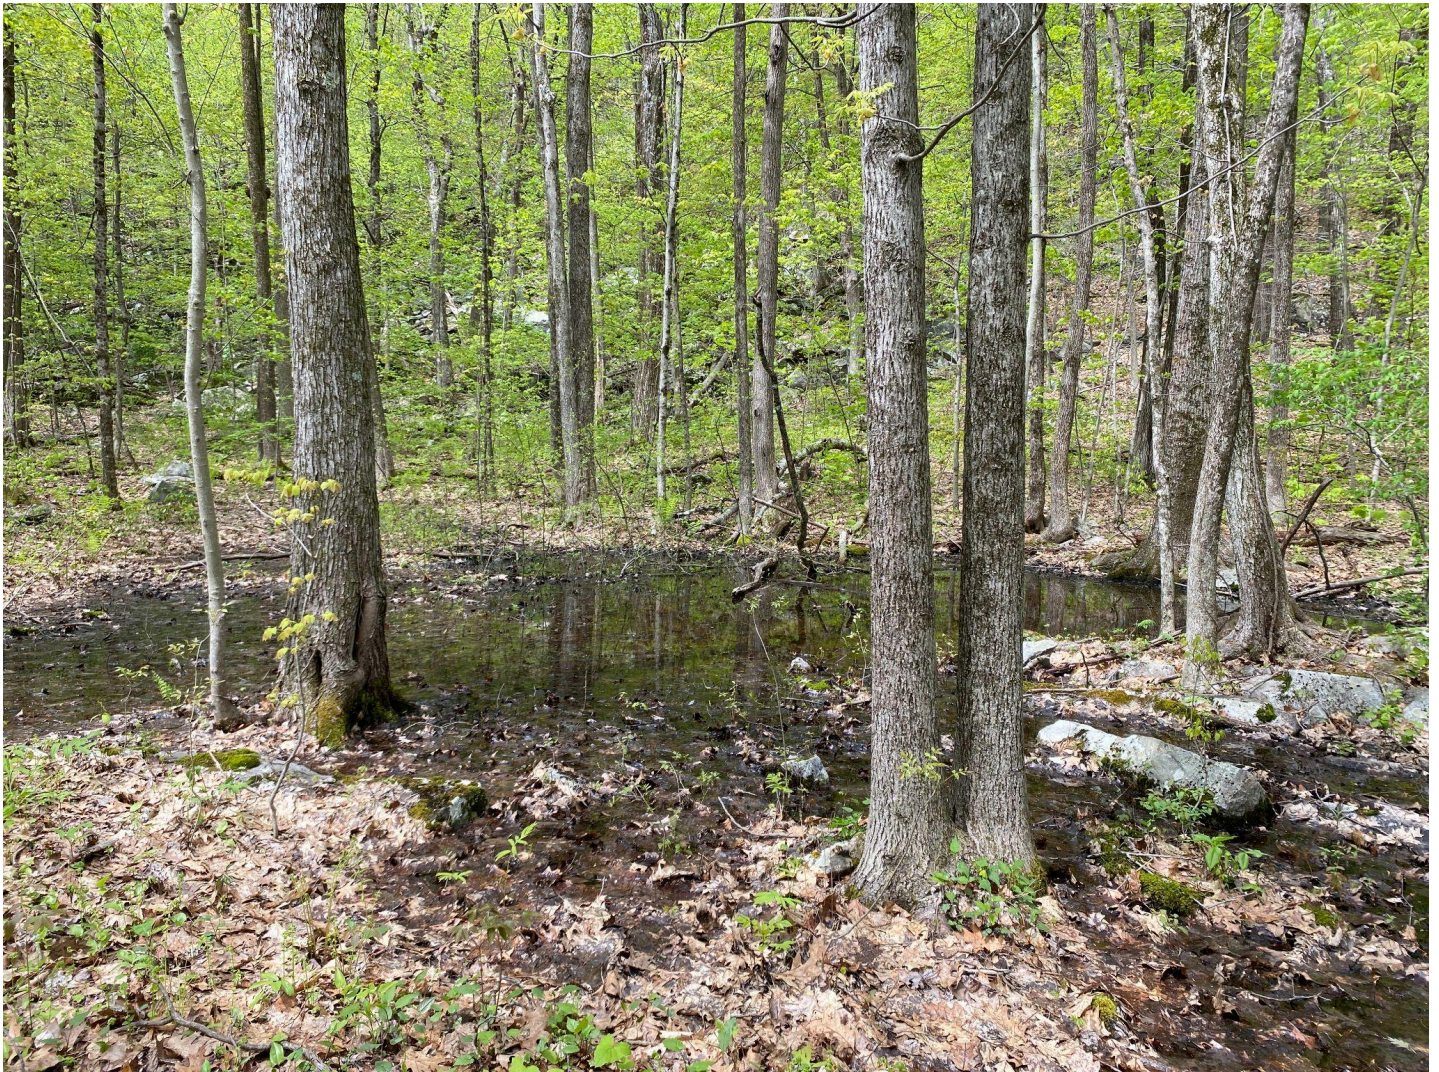
Photo 9

Comments: Possible vernal pool or other ephemeral aquatic habitat.

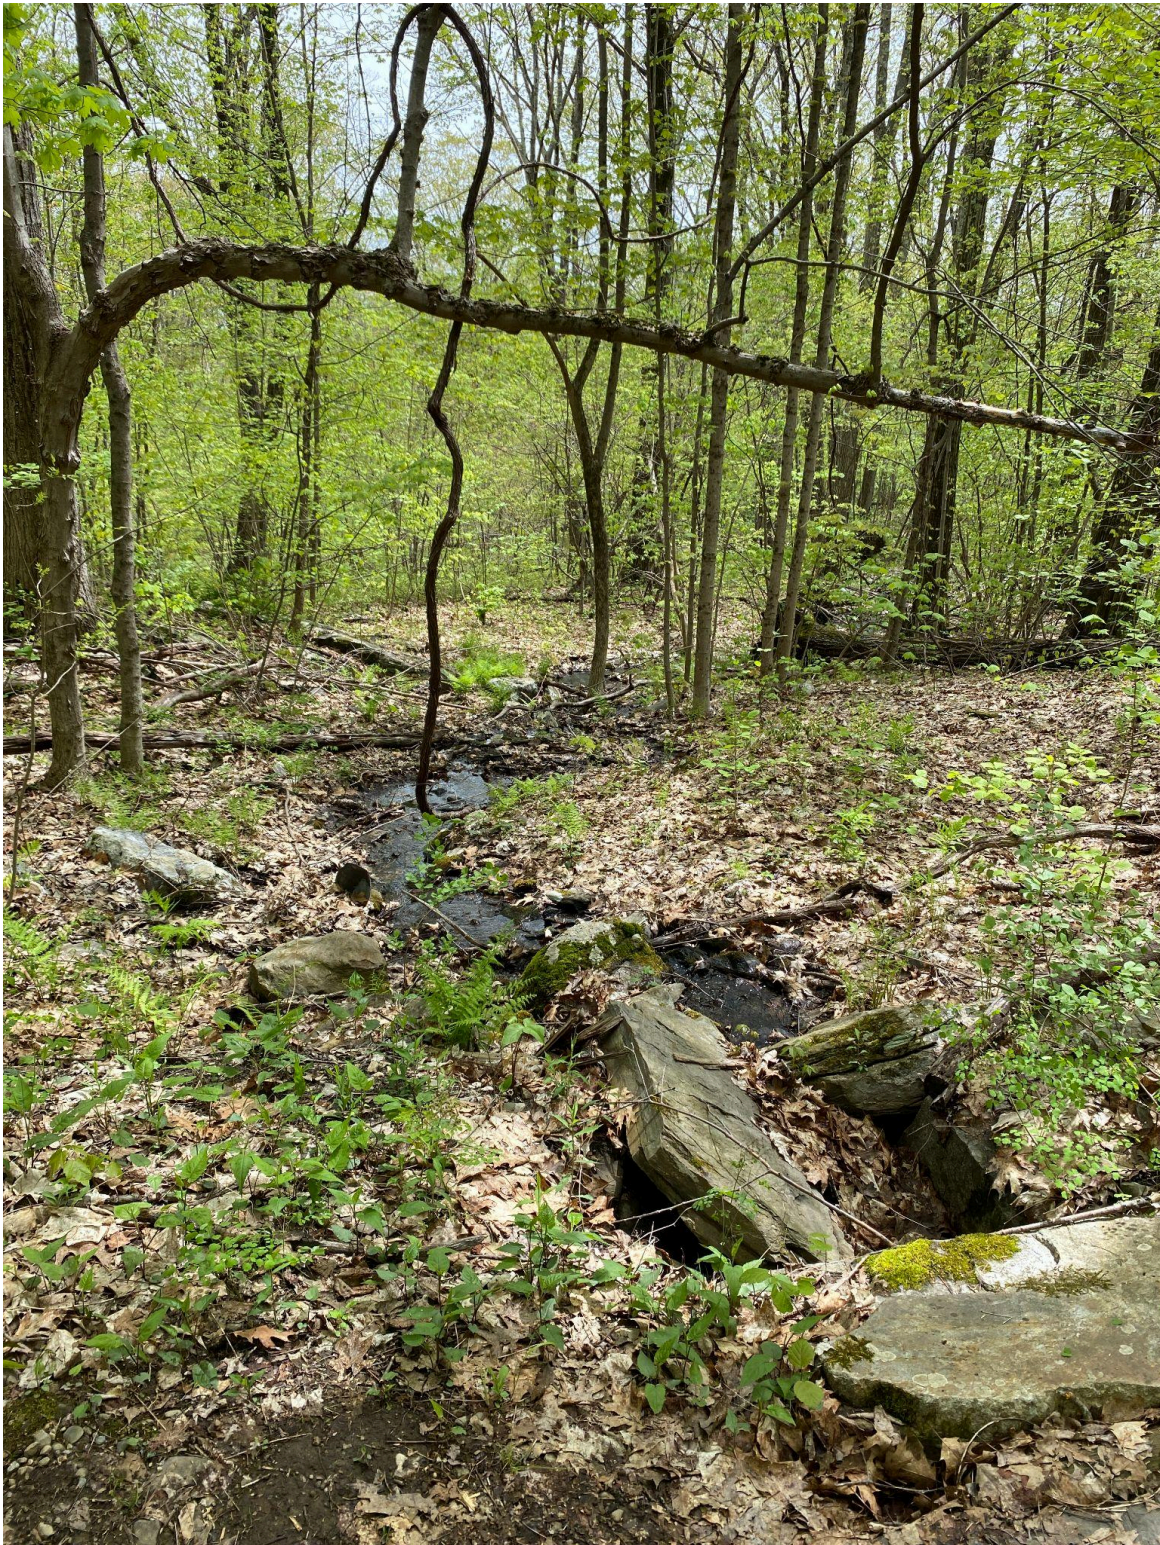
Photo 10

Comments: Intermittent stream flowing down the hill. Stream continues both above and below the delineated polygon.

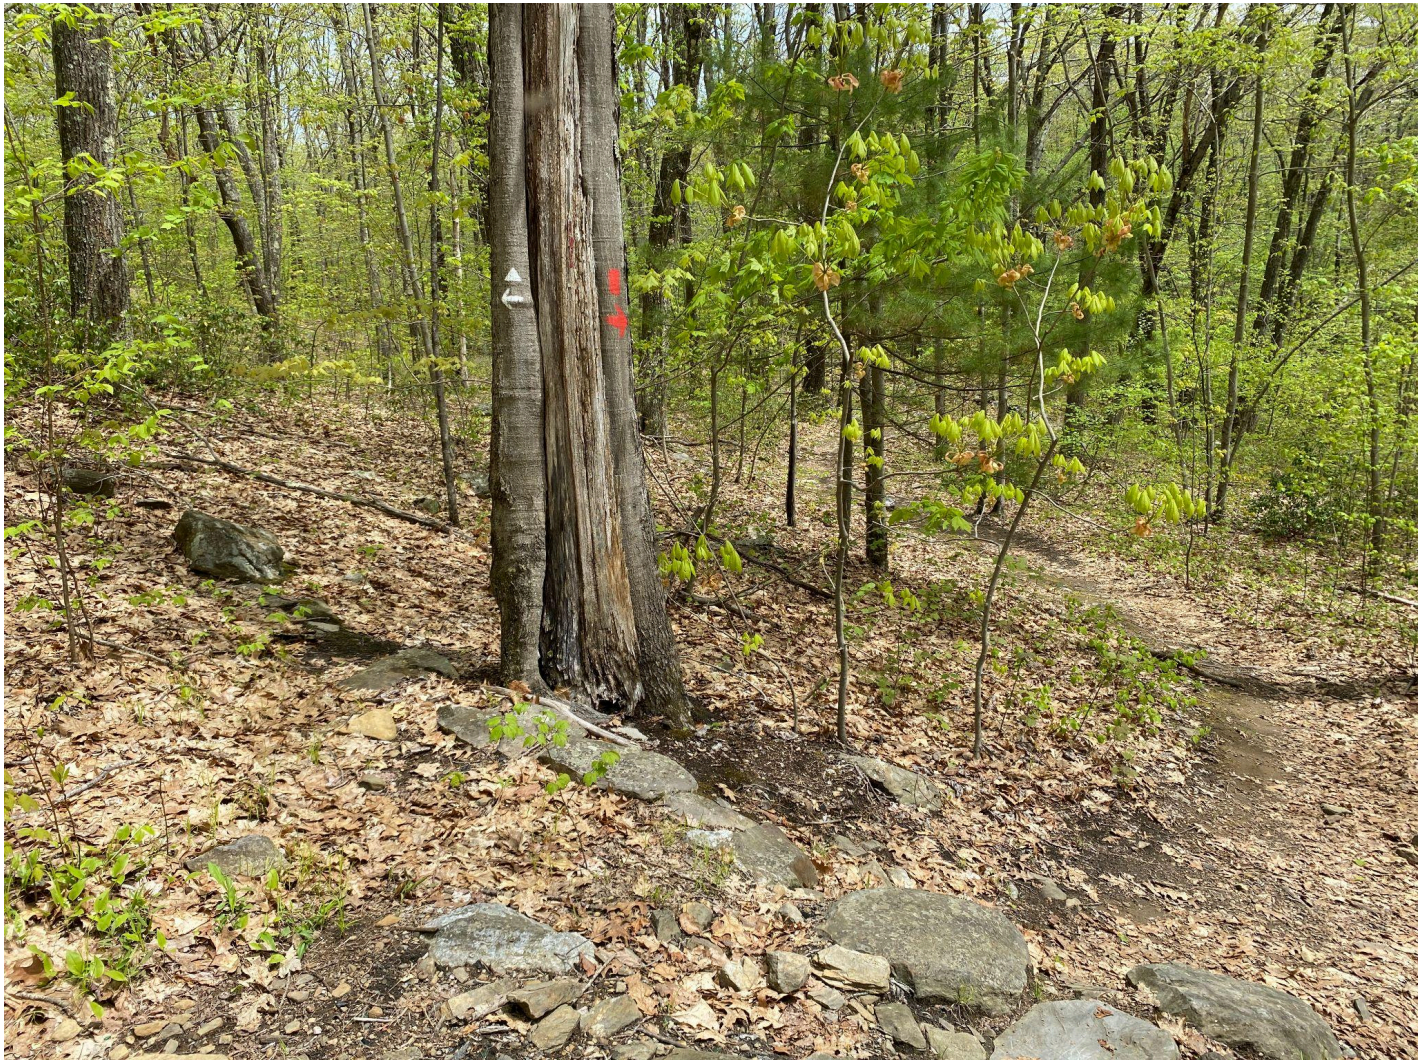
Photo 11

Comments: Trail marker at intersection of red trail and white triangle trail, looking northeast along red trail.

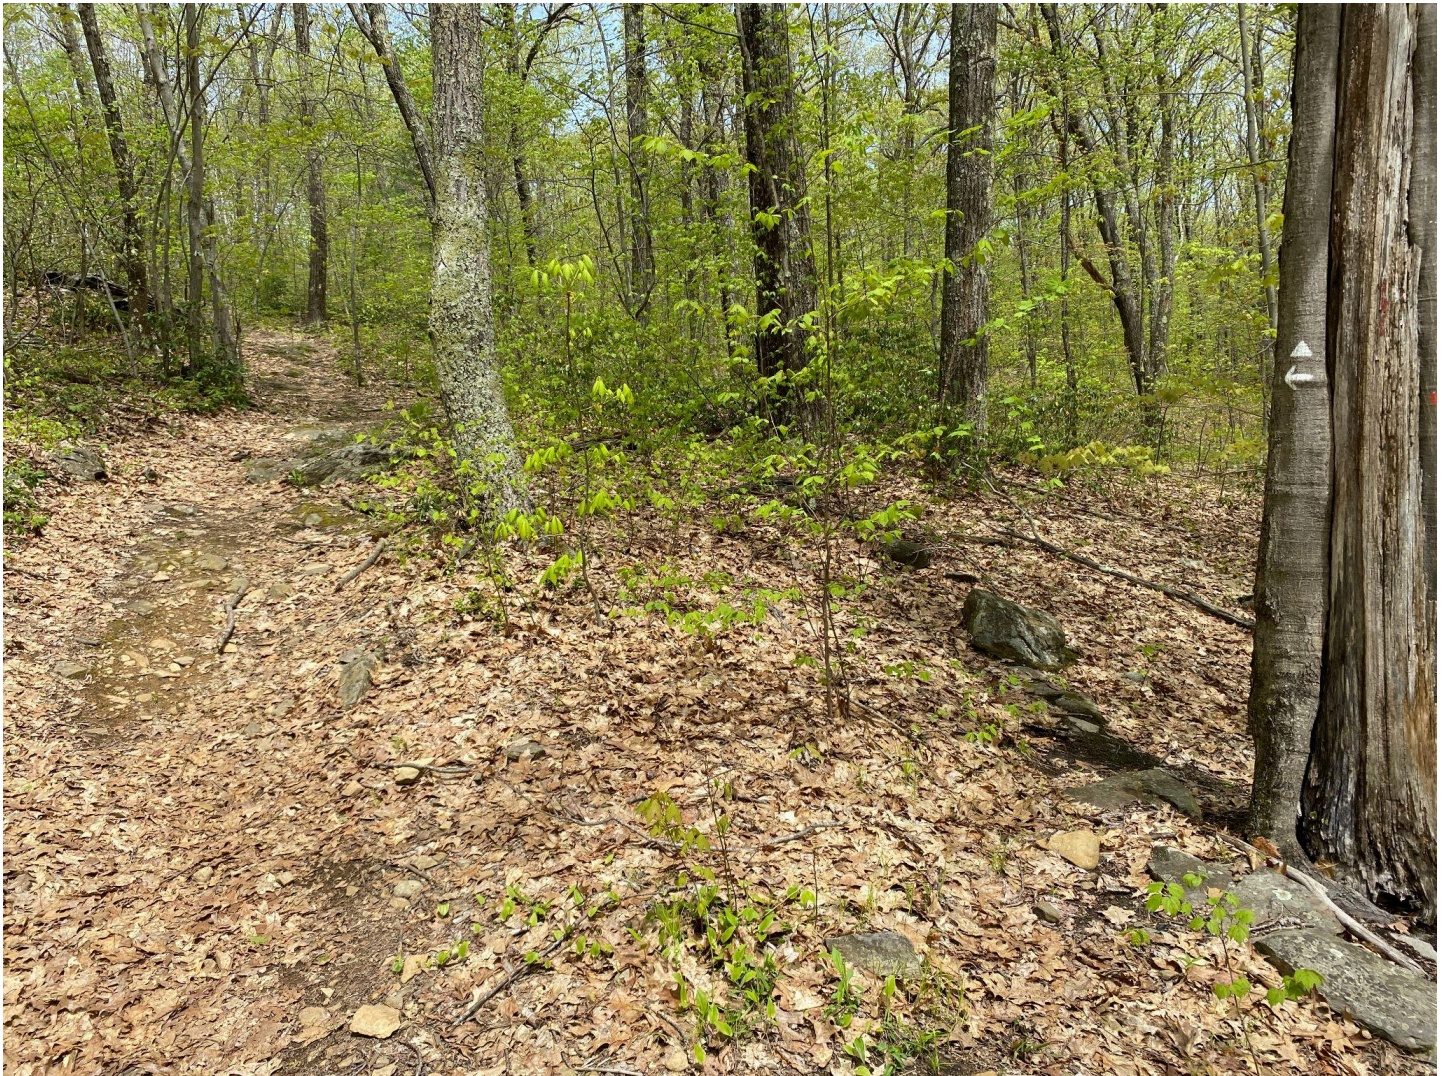
Photo 12

Comments: Same location as Photo 11 but looking northwest along white triangle trail.

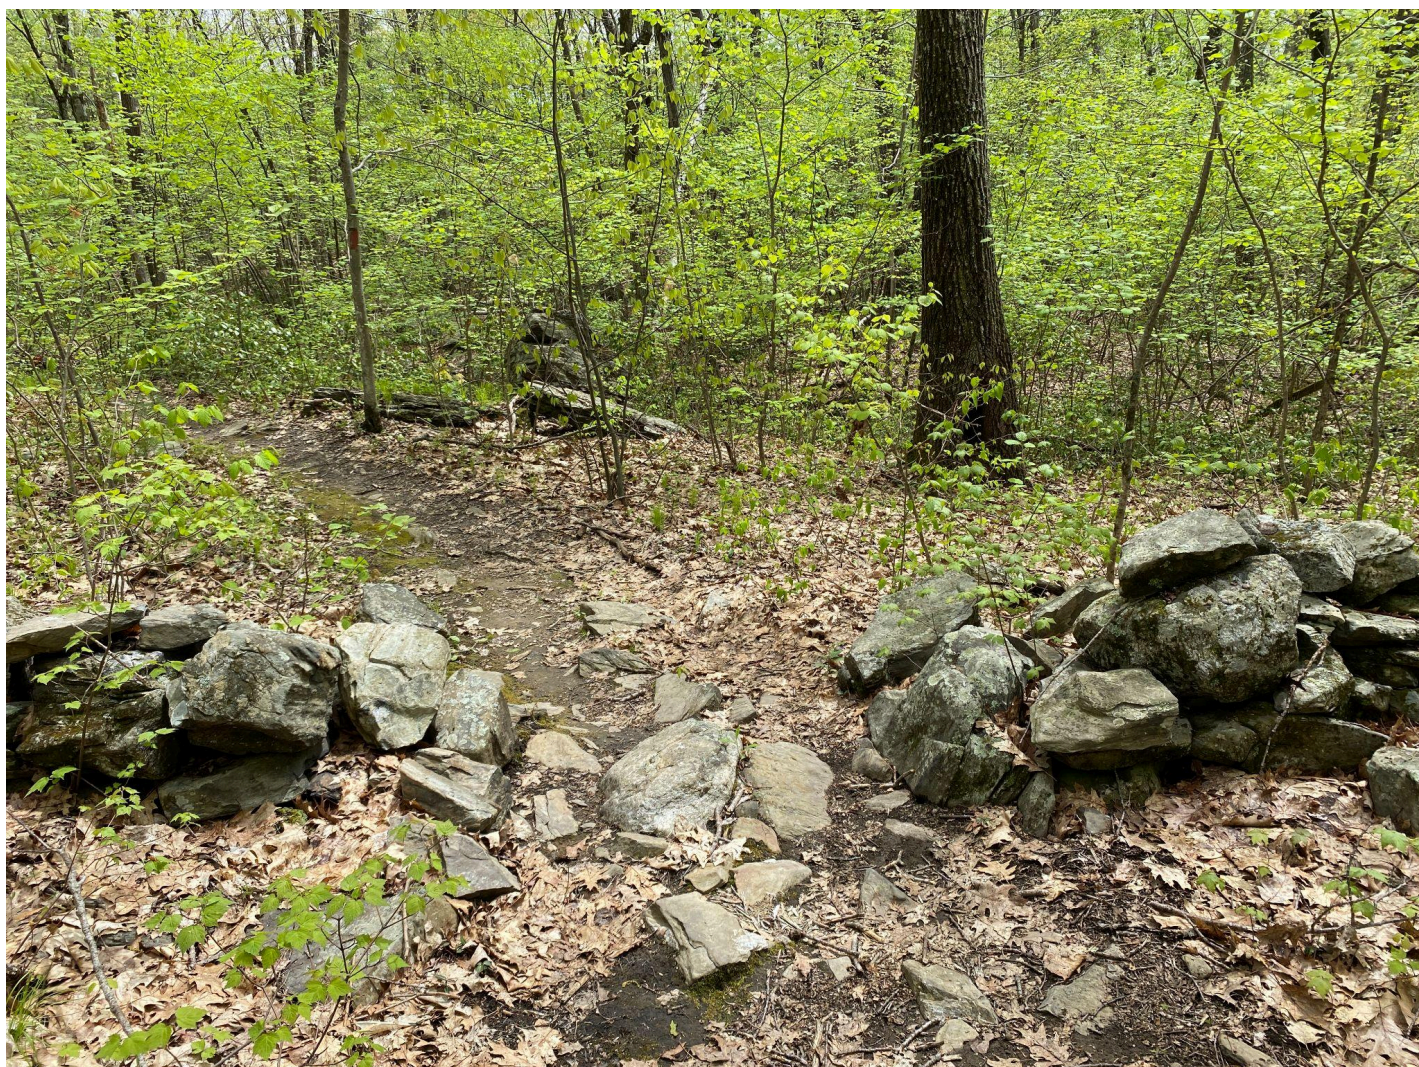
Photo 13

Comments: Stone wall crossing the path. Wall continues both north and south of the delineated polygon area.

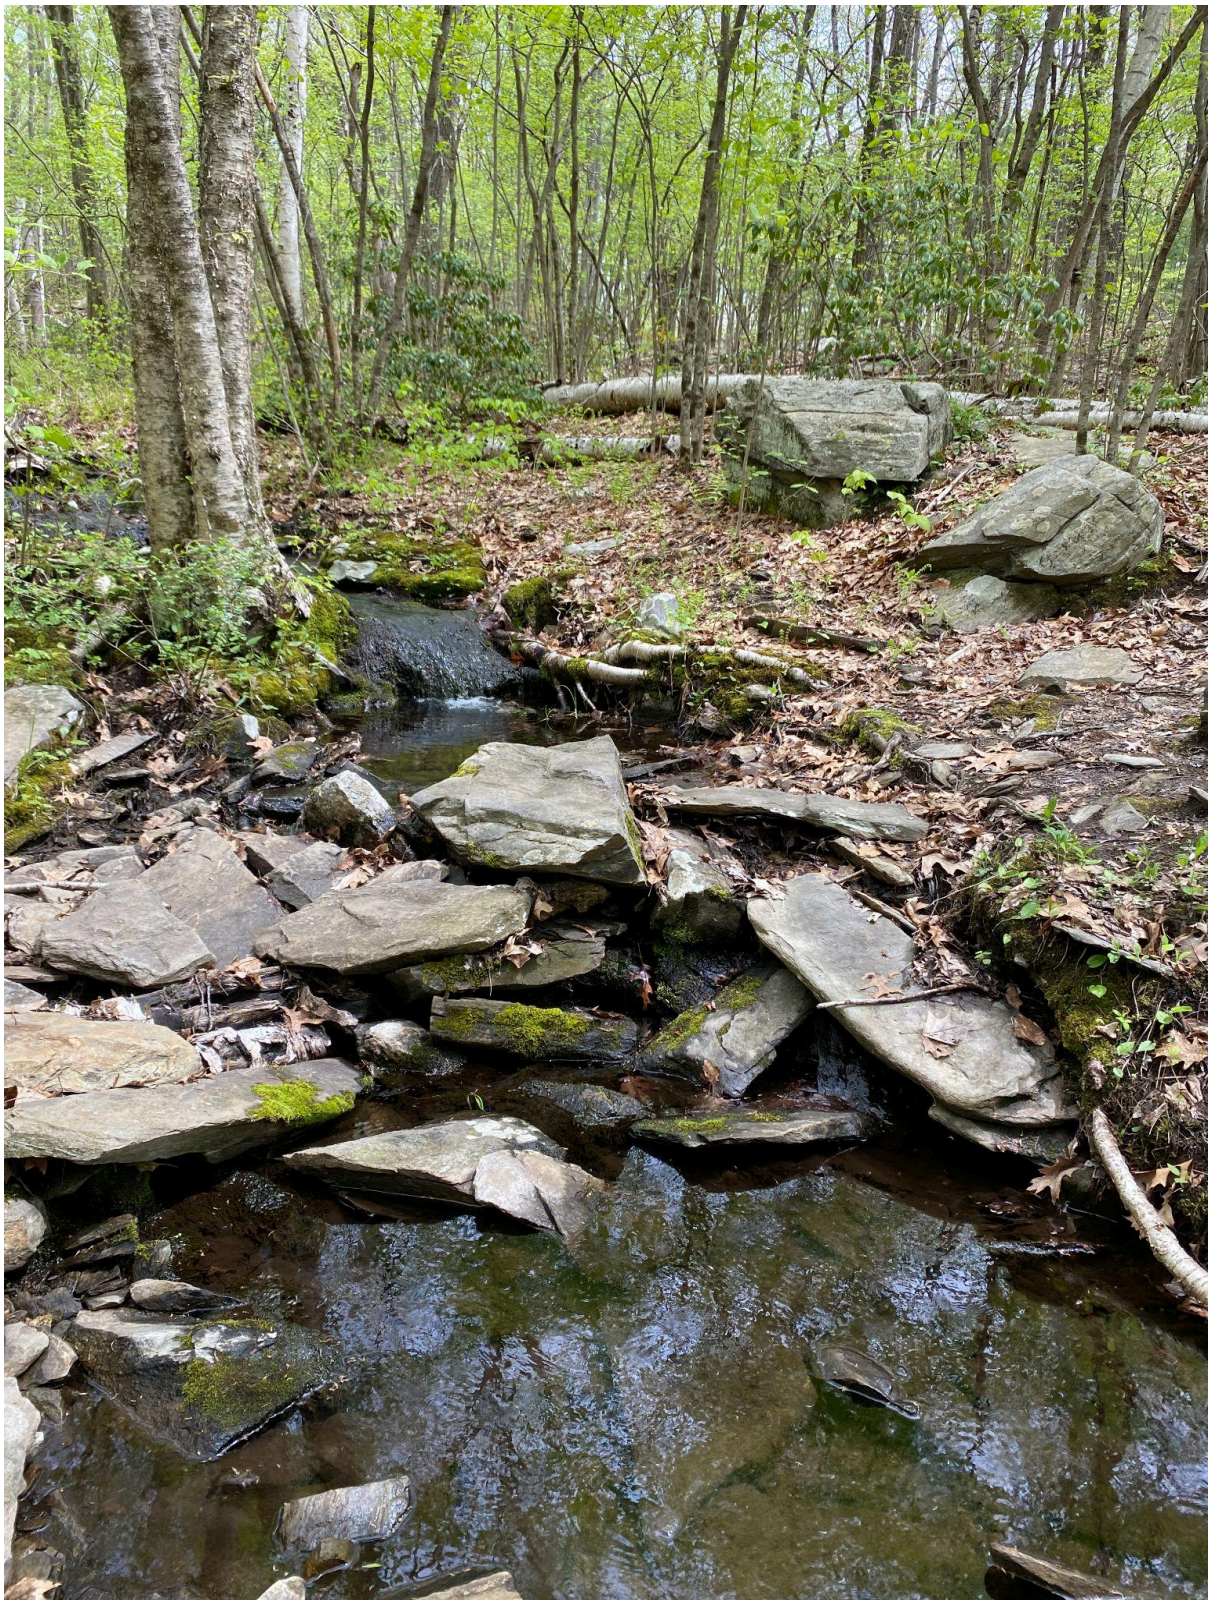
Photo 14

Comments: Stream crossing the path. Stream continues both north and south of the delineated polygon area.
