WORCESTER CONSERVATION COMMISSION

God's Acre

Conservation Property Baseline Assessment

July 2024

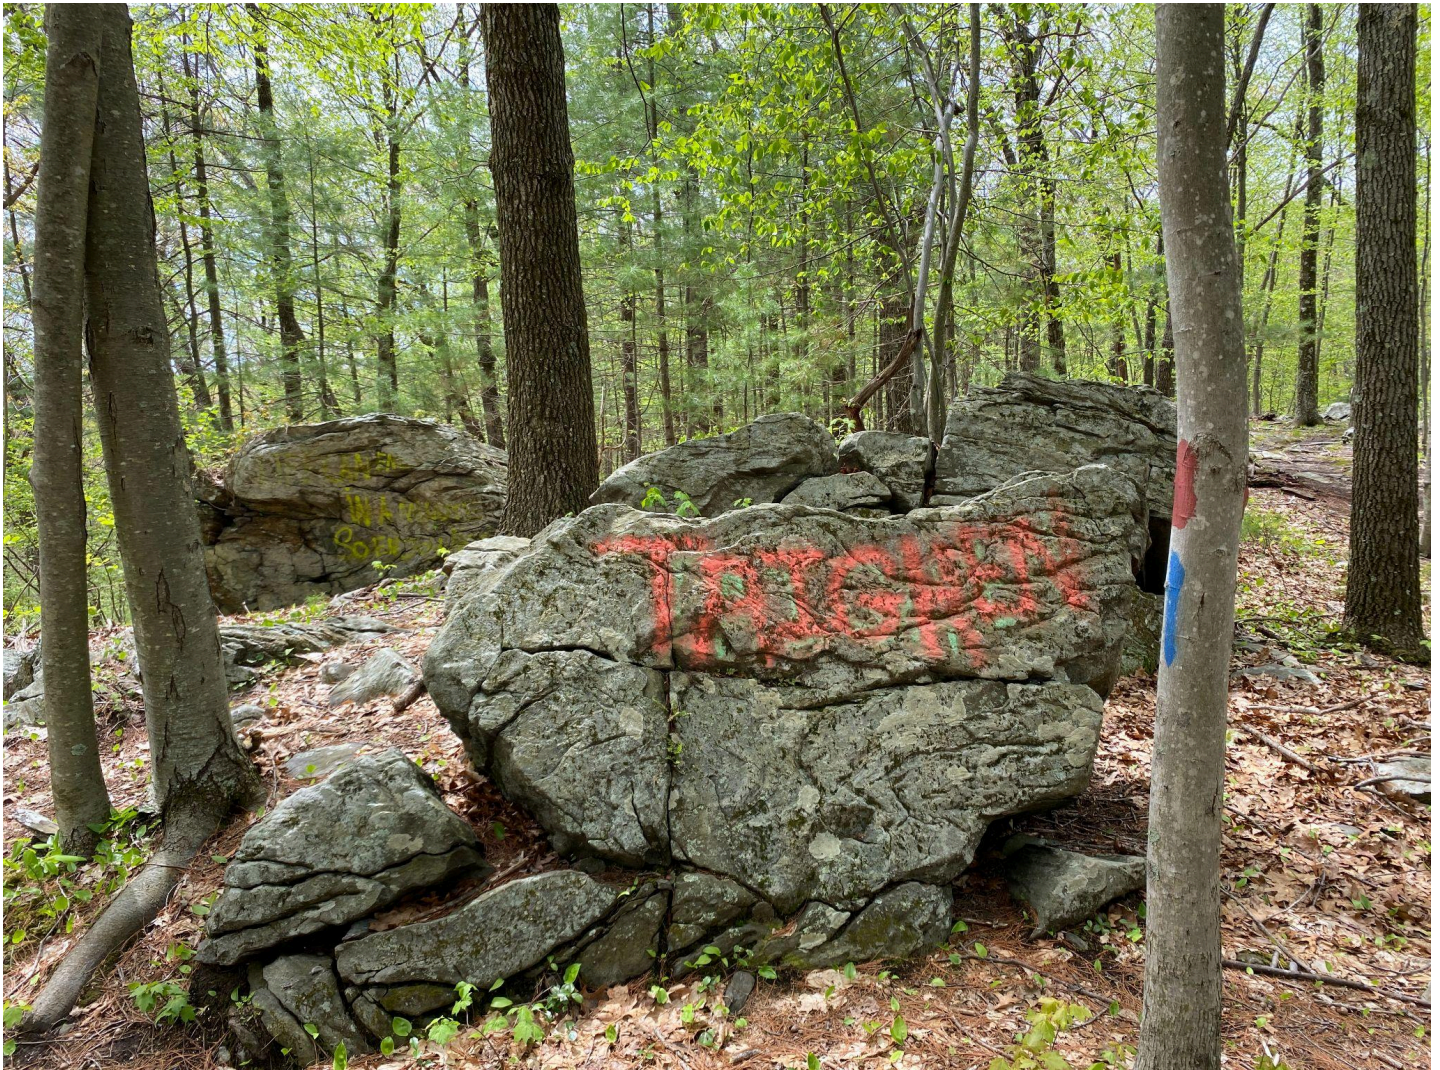
Photo 15

Comments: Graffiti on rocks at top of small rise.

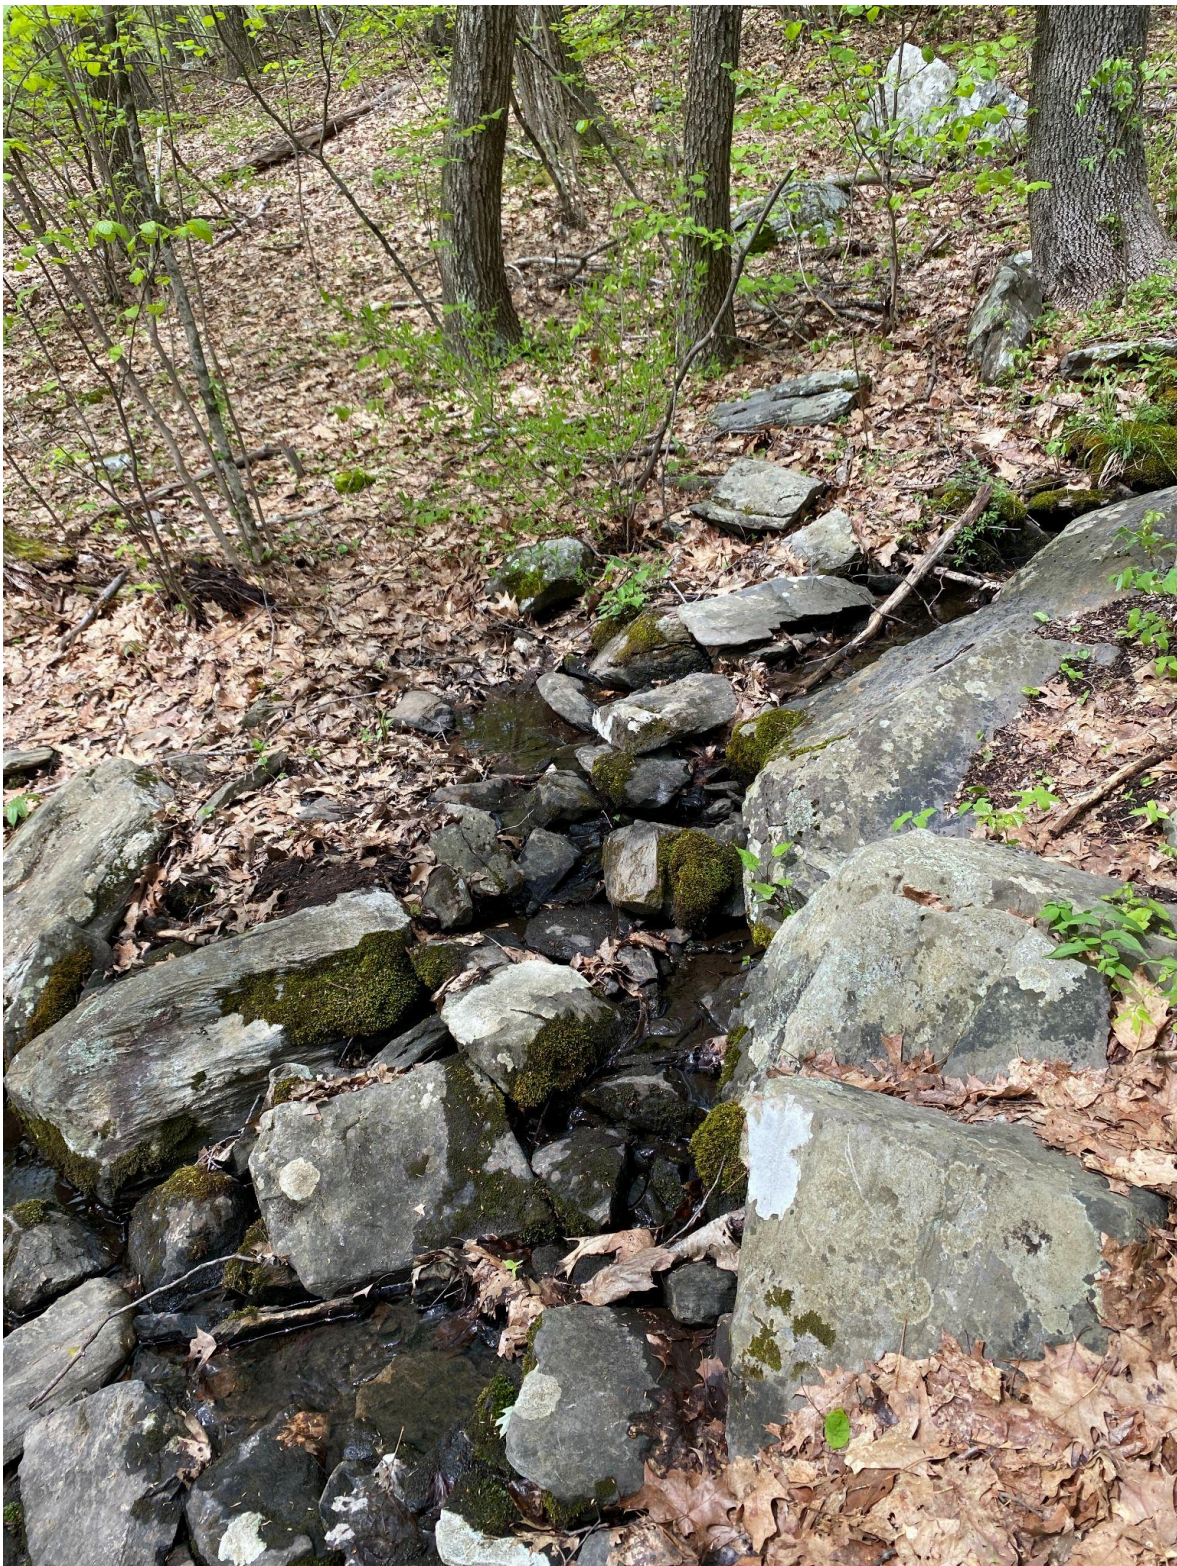
Photo 16

Comments: Stream crossing the path. Stream continues both northwest and southeast of the delineated polygon area.

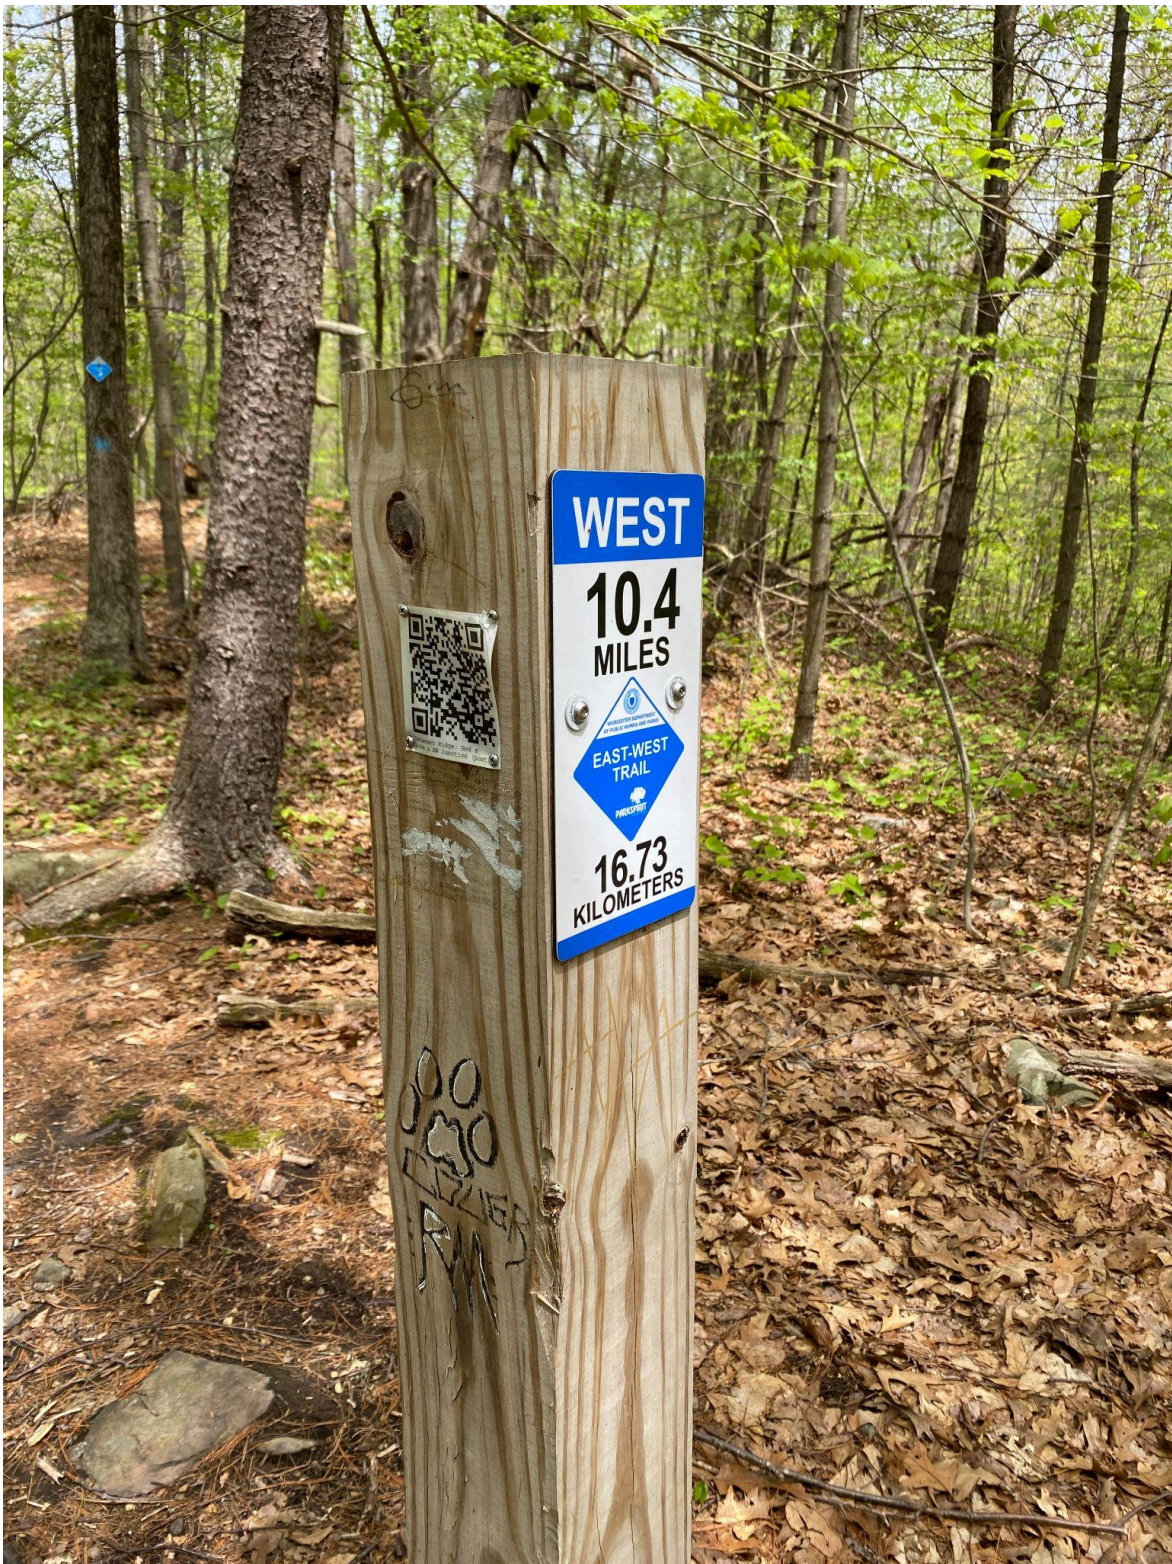
Photo 17

Comments: East / West Trail marker near the property boundary. There are no markers indicating the crossing into/out of the property.

There is no evidence of property boundary markers at the northern edge where the Red/Blue Trail enters the property. There are markers when leaving the property to indicate you are entering the Tetasset Ridge GWLT property.

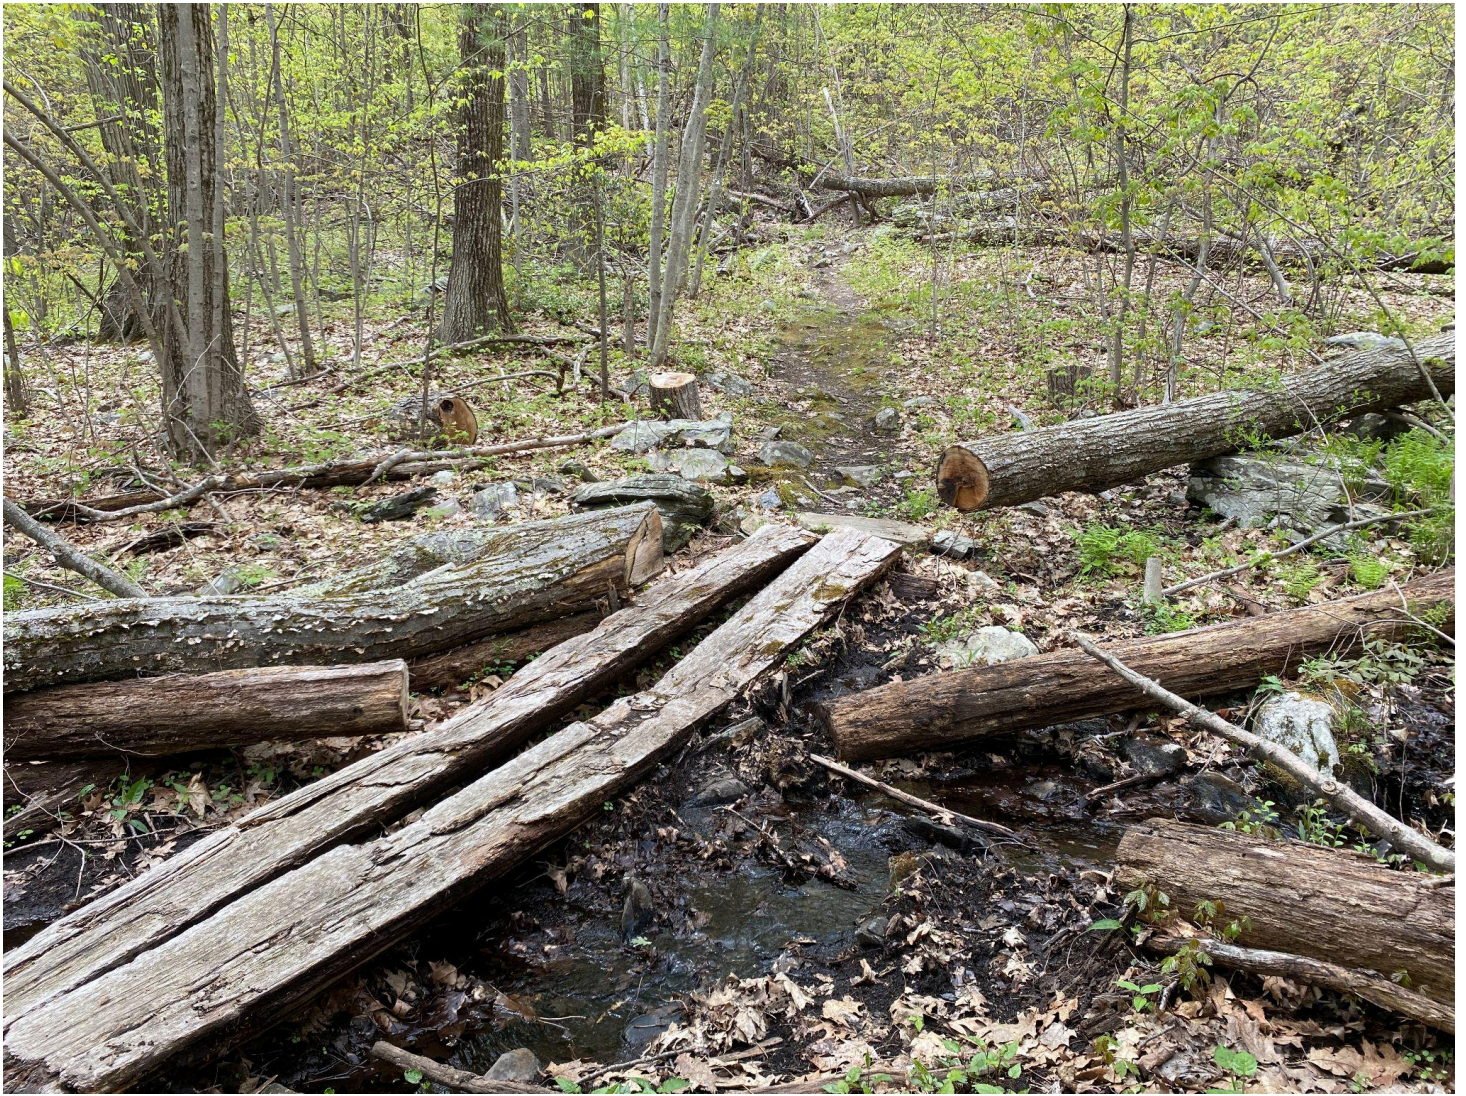
Photo 20

Comments: Stream with halved trees as a bridge. Bridge planks are rotten on the trail crossing.

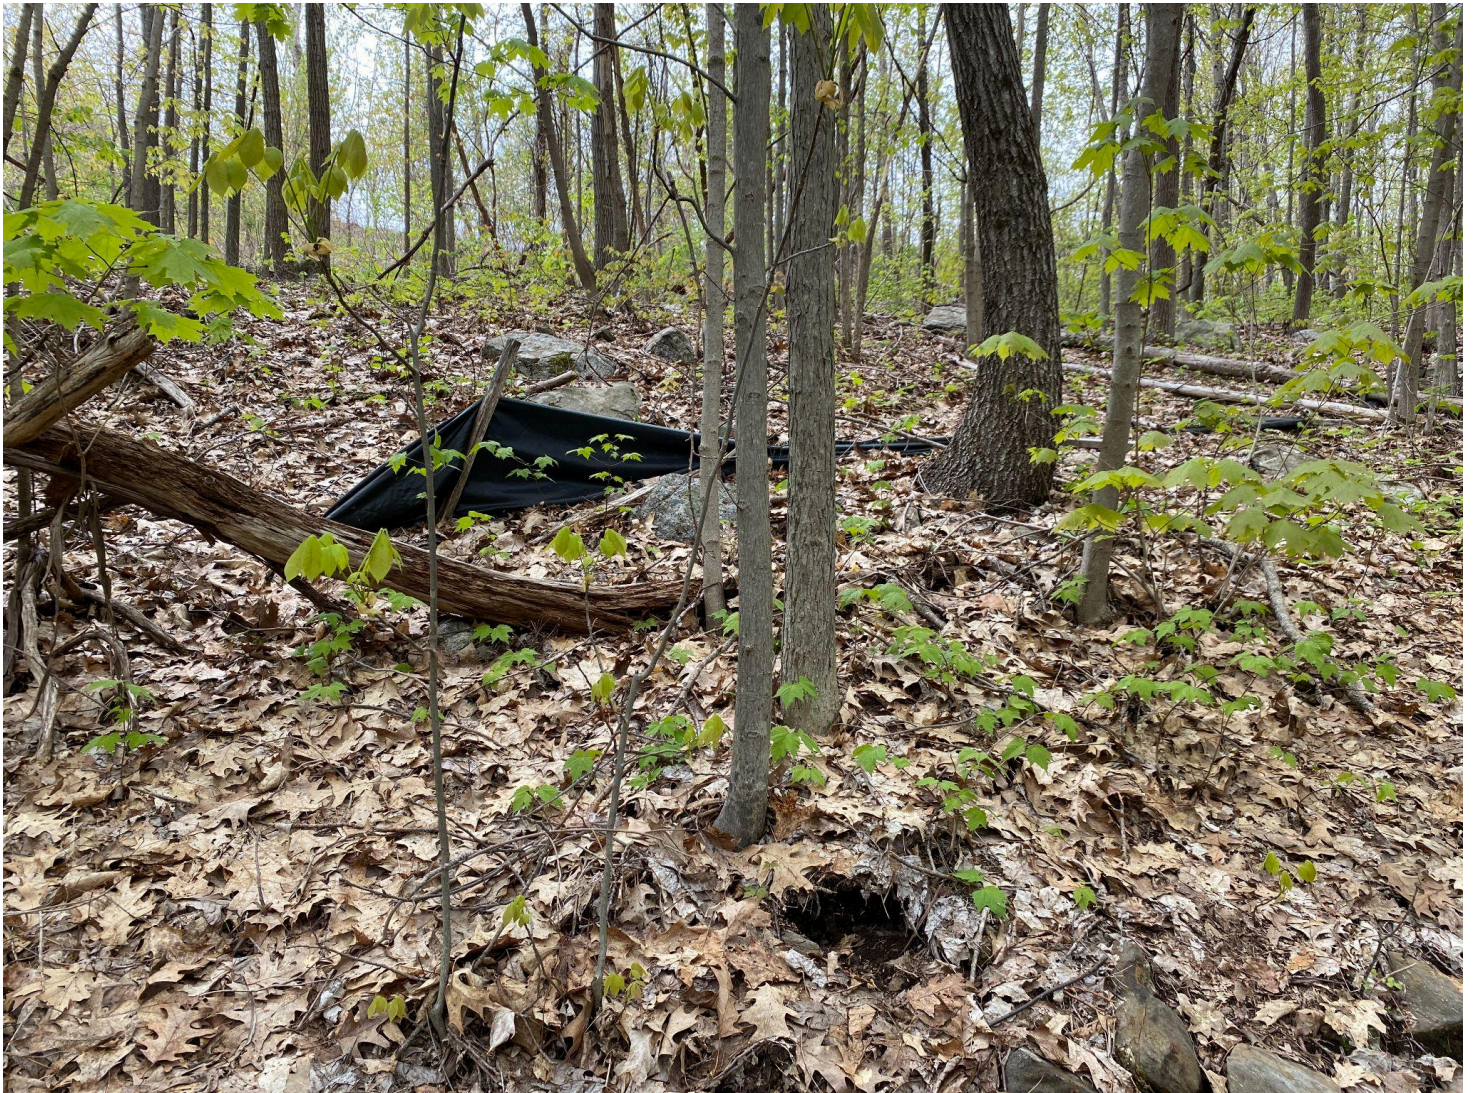
Photo 21

Comments: Erosion control fence leaning, but still managing erosion of the steep slope.

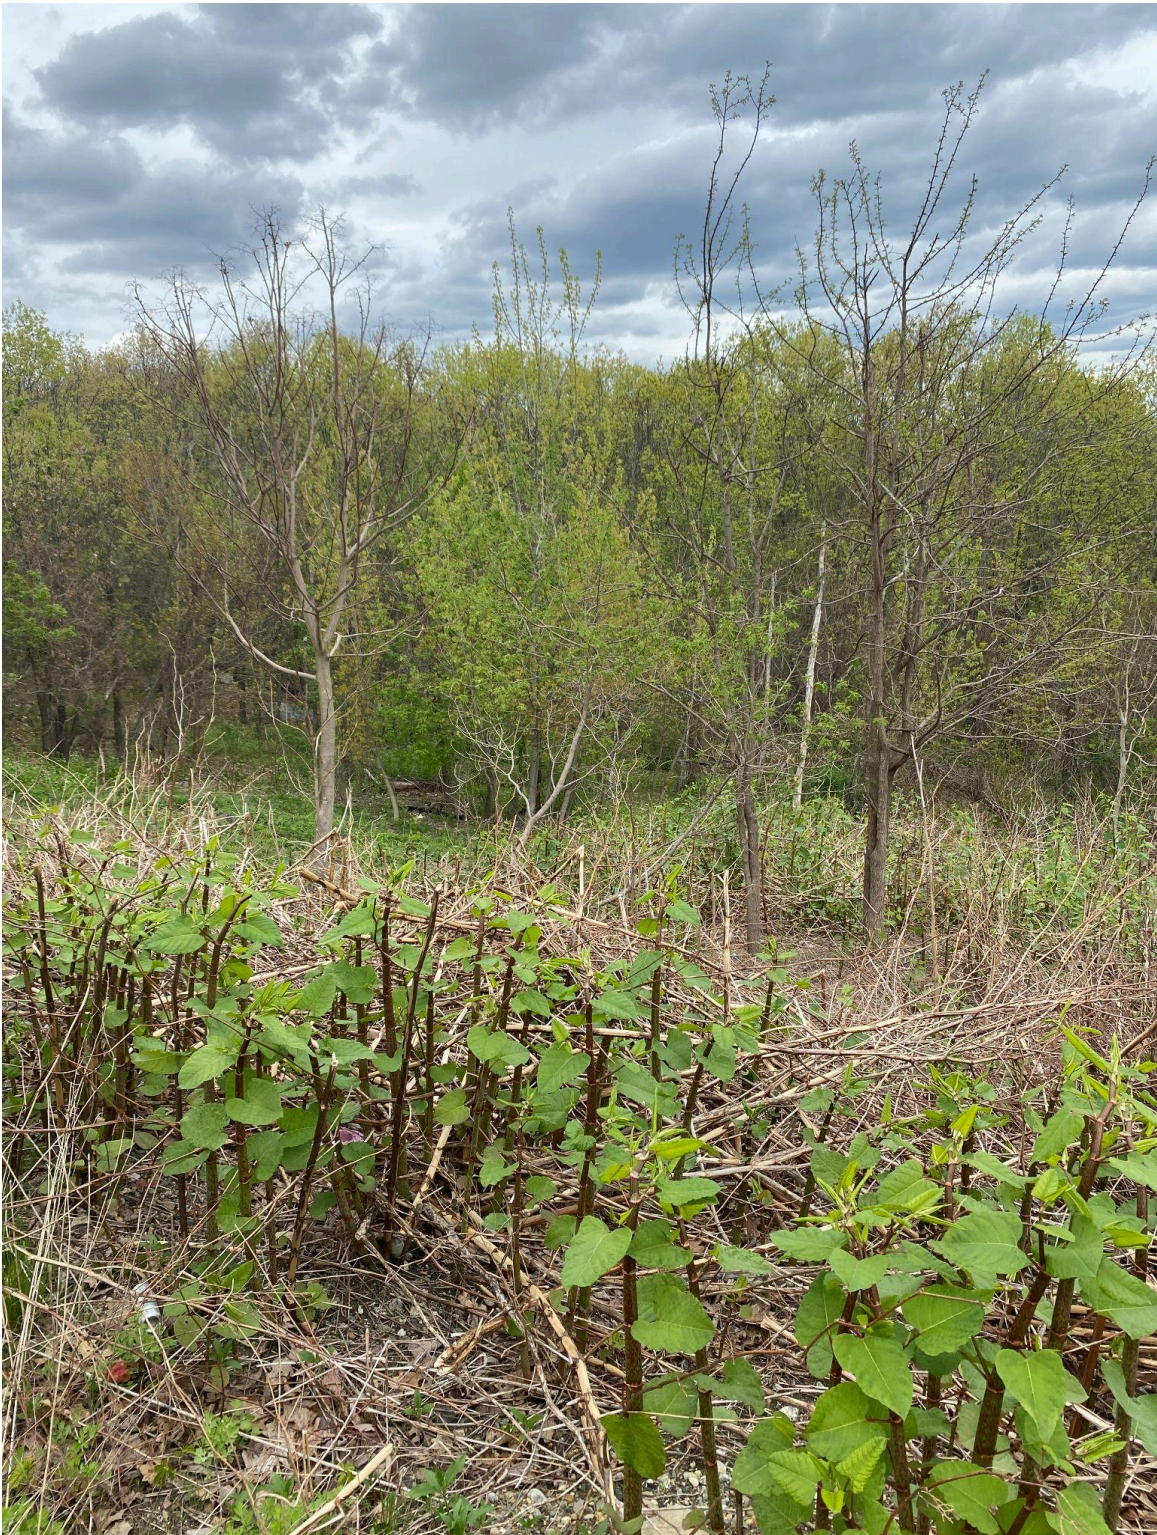
Photo 22

Comments: Japanese knotweed (*Reynoutria japonica*) located in adjacent property at 162 Goddard Memorial Drive. Not in the conservation area, but touching the border. Photo is view from adjacent property looking over knotweed and into conservation property.

- d. Along boundaries with other properties collaboration with private landowners may be required to manage invasive species adjacent to the God's Acre property and prevent reinfestation.

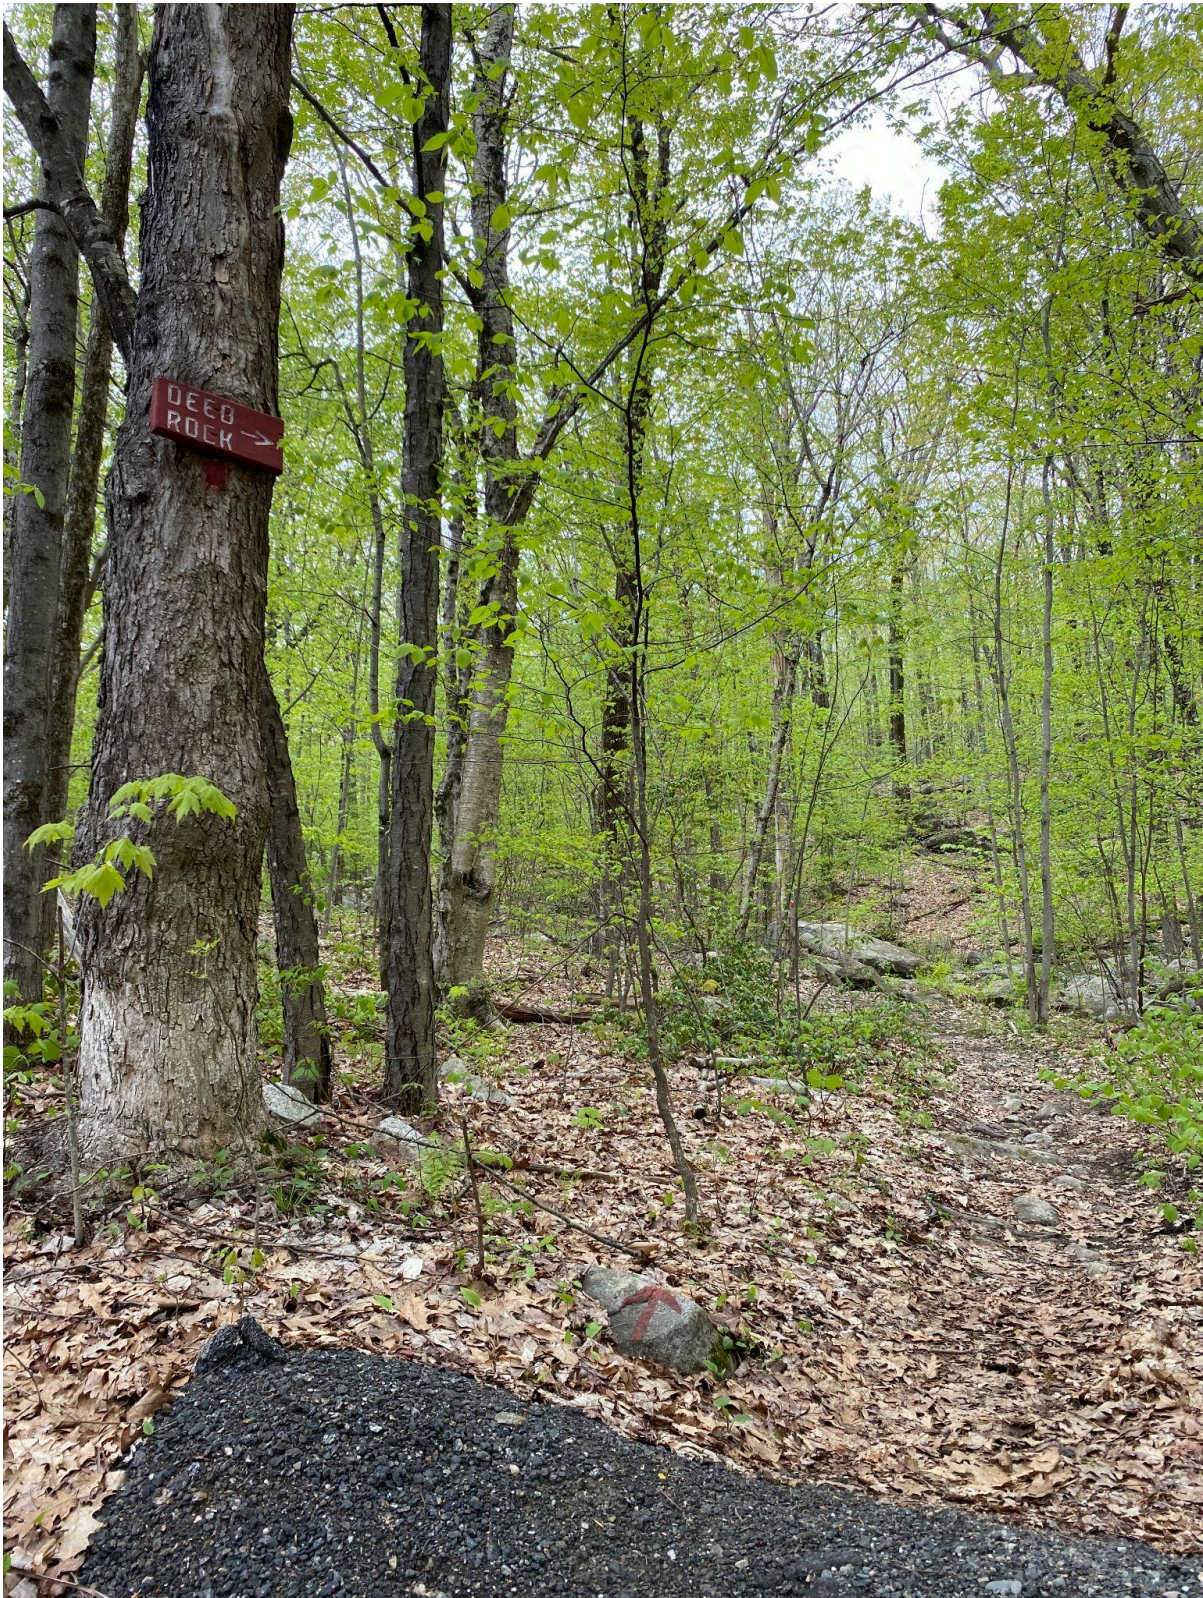
Photo 23

23-24	53117	Cultural Feature	(Photo 23) Sign marking a spur trail to Deed Rock. (Photo 24) Deed Rock, commissioned by Solomon Parsons in 1840 “deeding” the property to God.
No Photo	53109	Waterway	Seasonal (intermittent) stream, dry at the time of the assessment.
No Photo	53118	Other	Faint, unmarked trail or possible runoff channel between Worcester State University (WSU) satellite resident parking lot and home at 194 Swan Avenue.
25	53122	Other	Faint, unmarked trail or possible runoff channel between Worcester State University (WSU) satellite resident parking lot and home at 194 Swan Avenue.
No Photo	53103	Waterway	Small, possibly seasonal stream running underneath the trail.
26	53121	Other	Multiple large trees have fallen over the trail.

Comments: Sign marking a spur trail to Deed Rock.

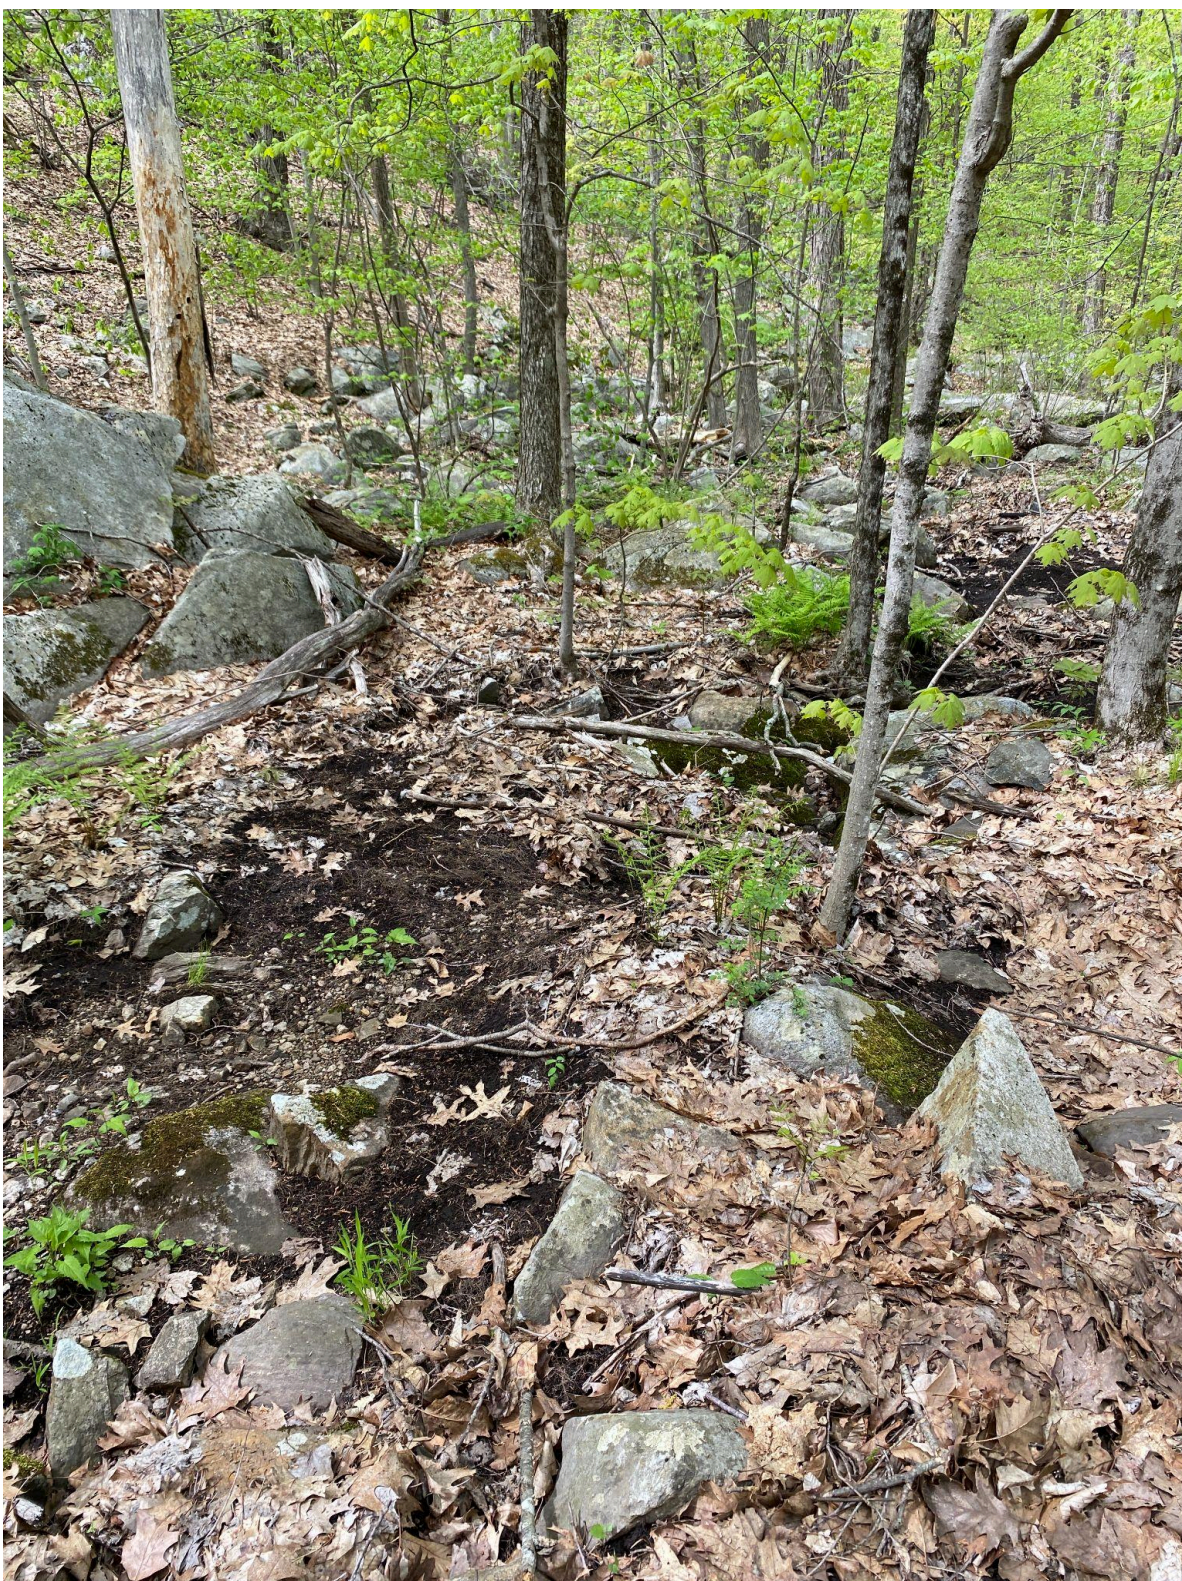
Photo 25

Comments: Faint, unmarked trail or possible runoff channel between Worcester State University (WSU) satellite resident parking lot and home at 194 Swan Avenue.

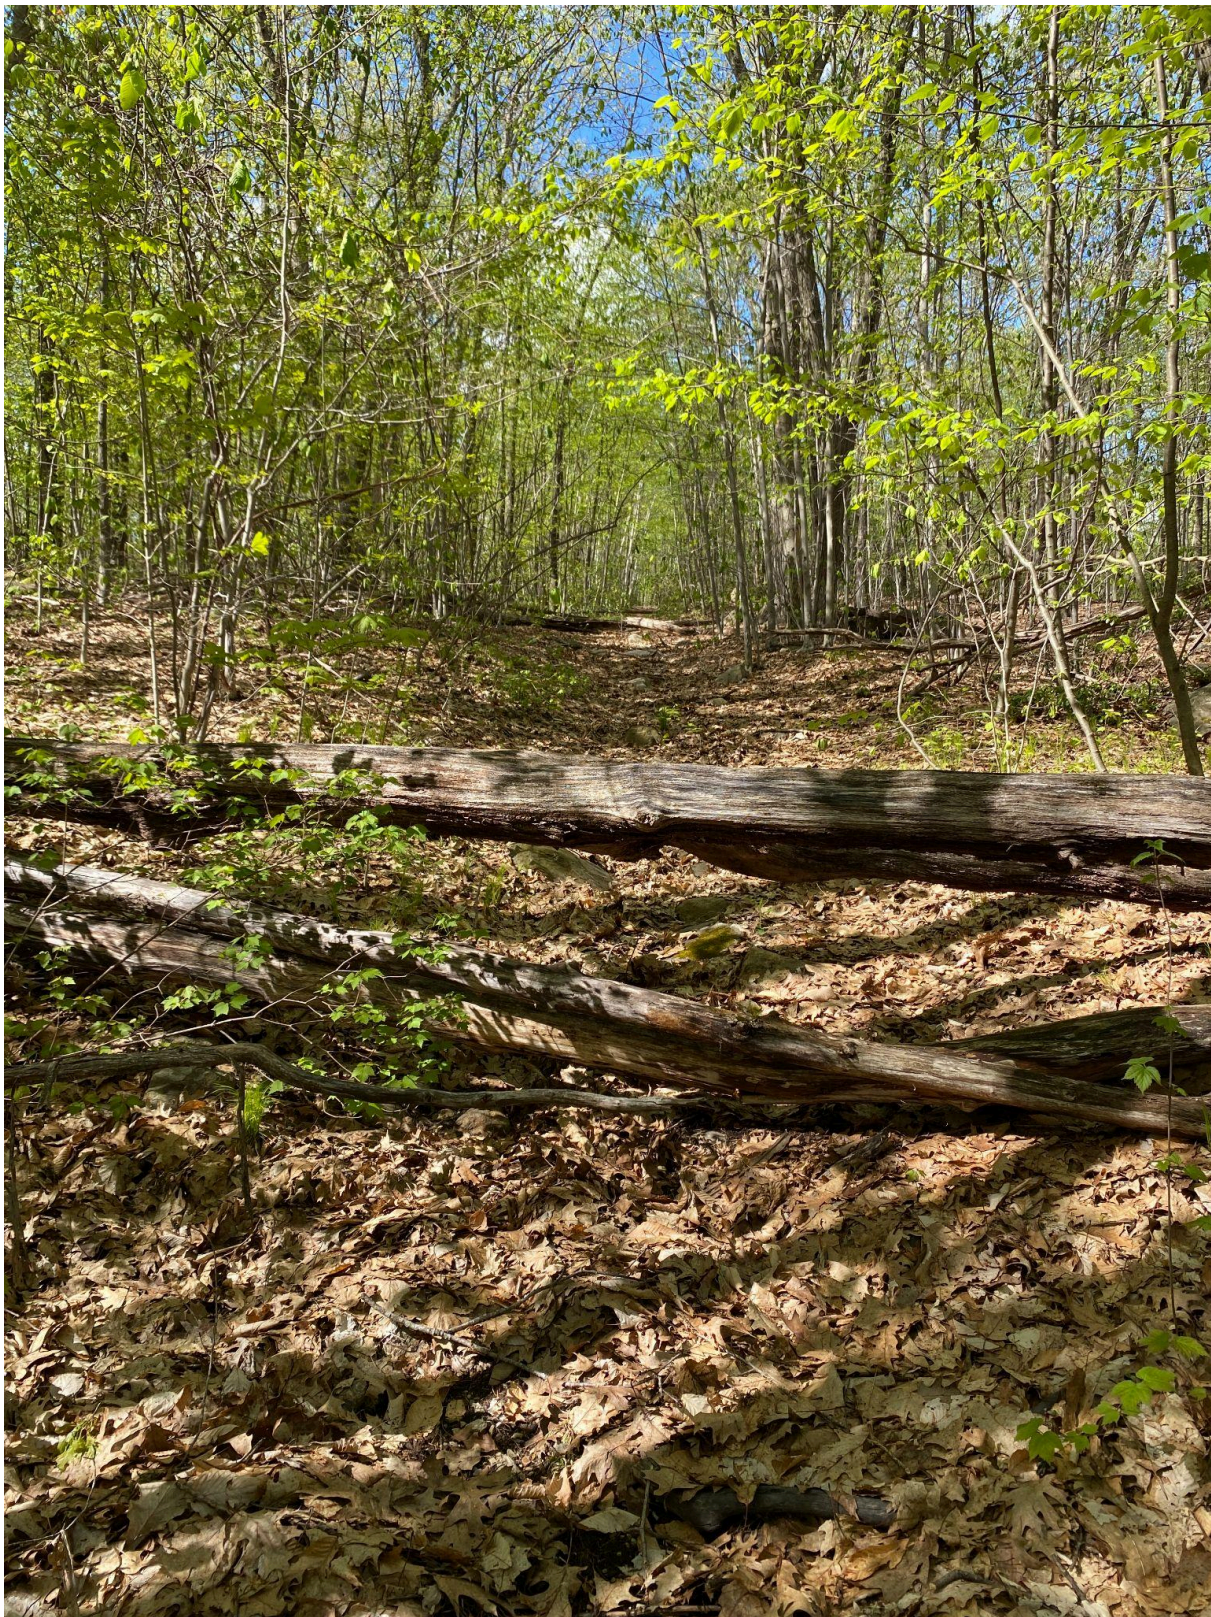
Photo 26

Comments: Multiple large trees have fallen over the trail.

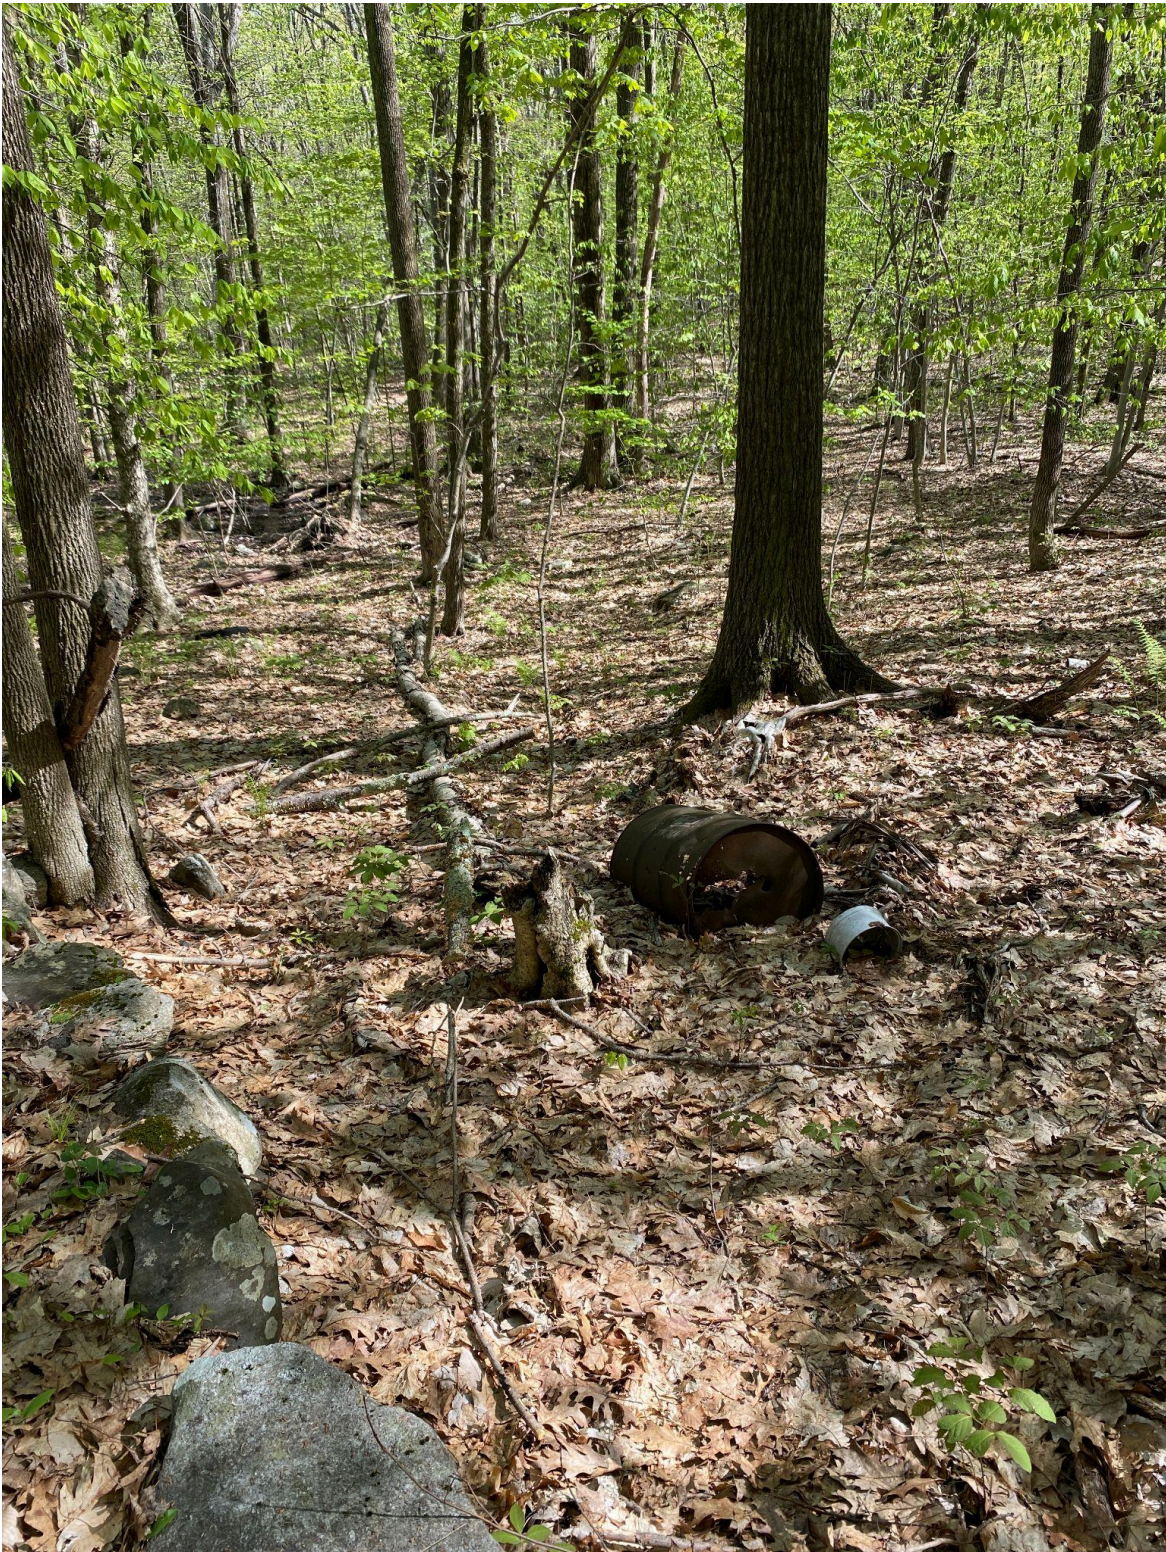
Photo 27

Comments: Metal drums, possibly once containing liquids, dumped at the end of the trail between 194 Swan Avenue and the WSU parking lot.

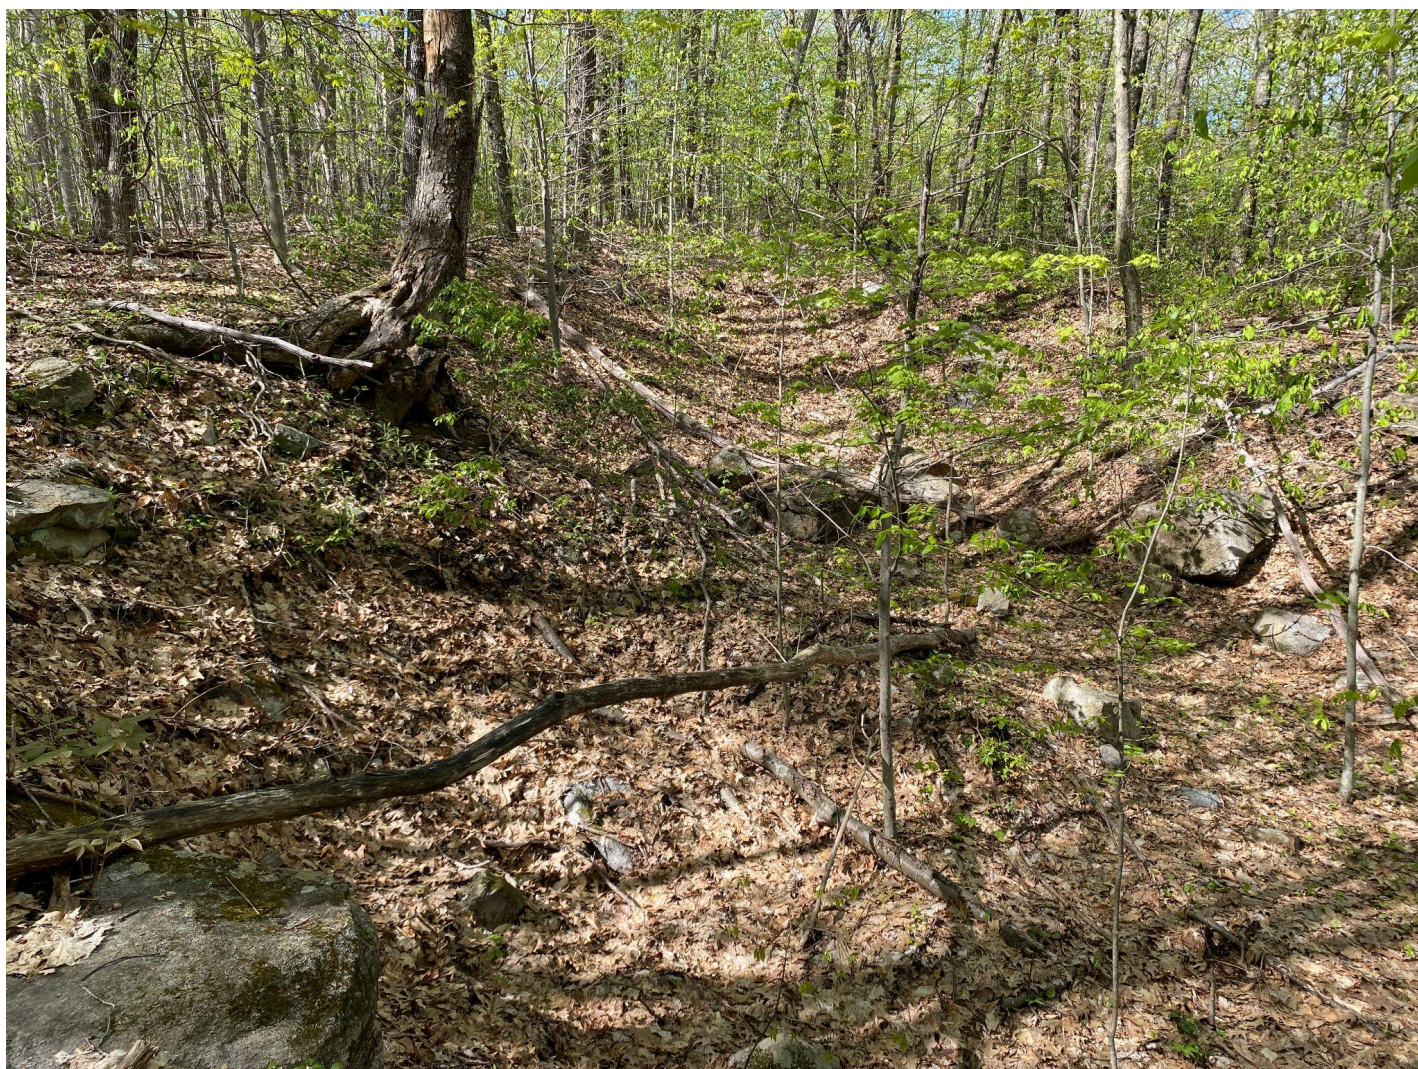
Photo 28

Comments: Large crater in woods, cause unknown.

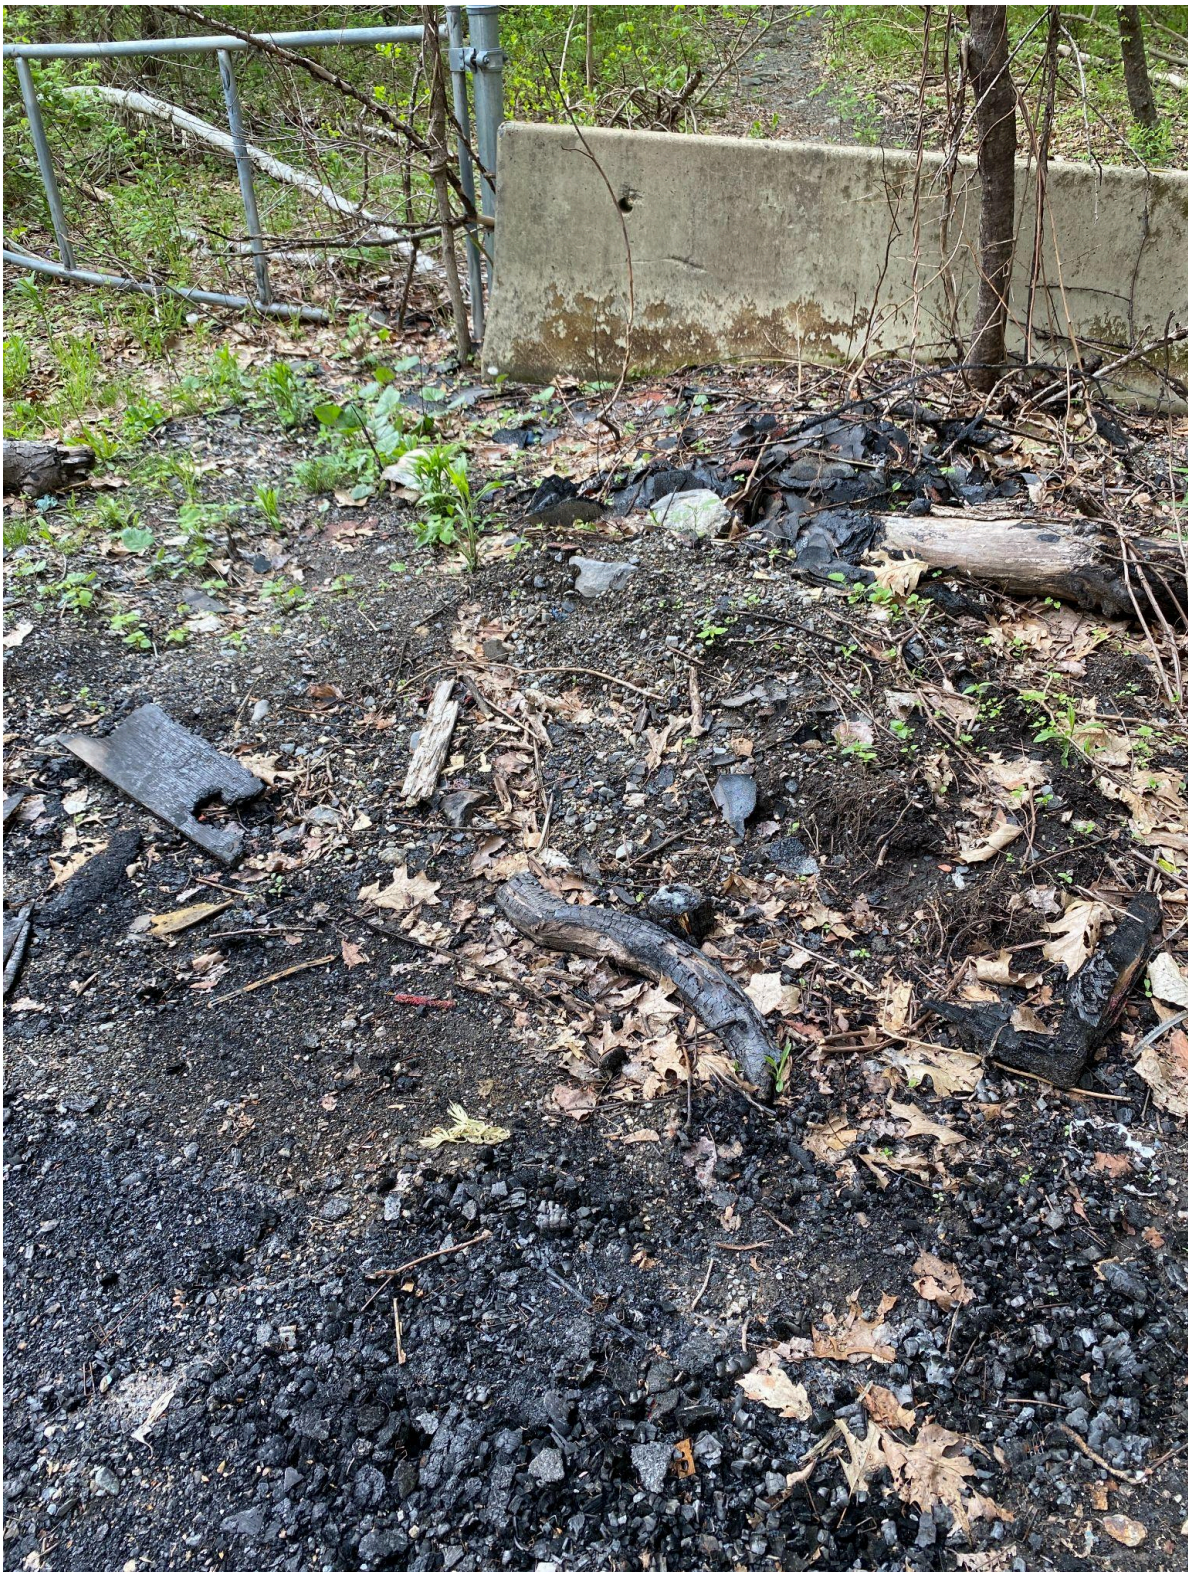
Photo 30

Comments: Signs of a campfire or burn pile. Roofing shingles dumped by gate from photo 29. Entrance to the trail portion of Paris Road at this end is overgrown and unmaintained.
