WORCESTER CONSERVATION COMMISSION

God's Acre

Conservation Property Baseline Assessment

July 2024

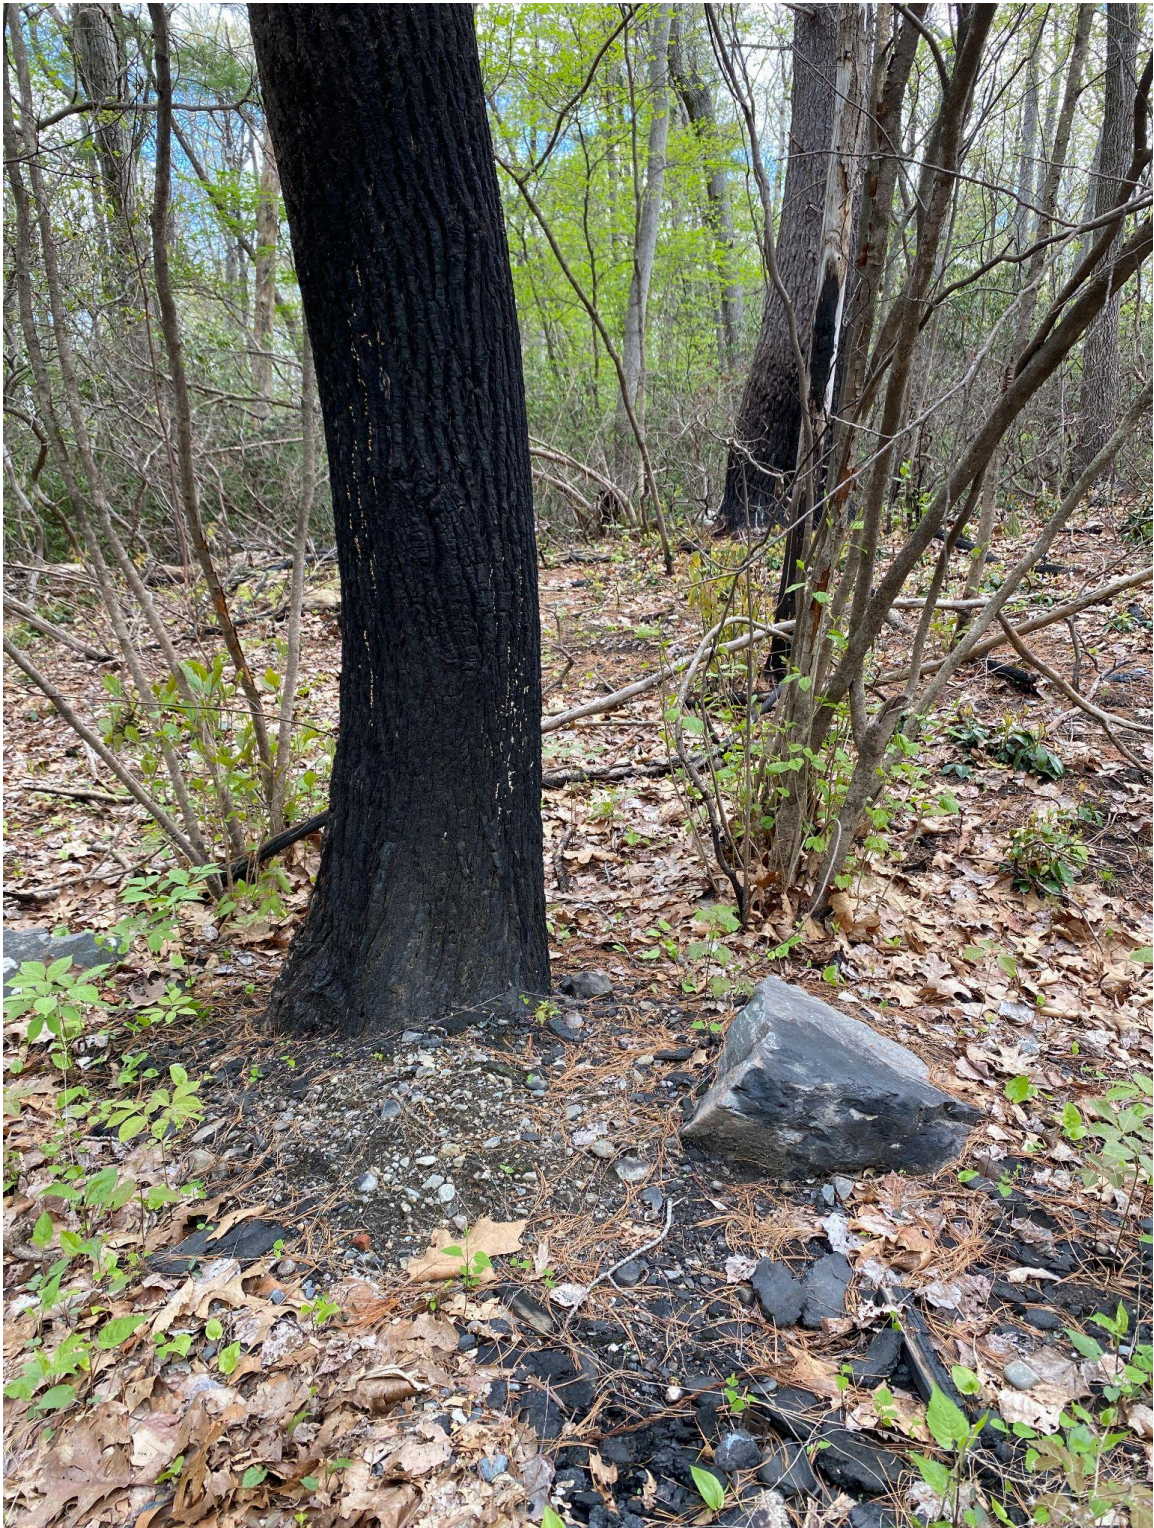
Photo 31

Comments: Burned trees along Swan Avenue. There were several trees burned in this way spaced out along the road.

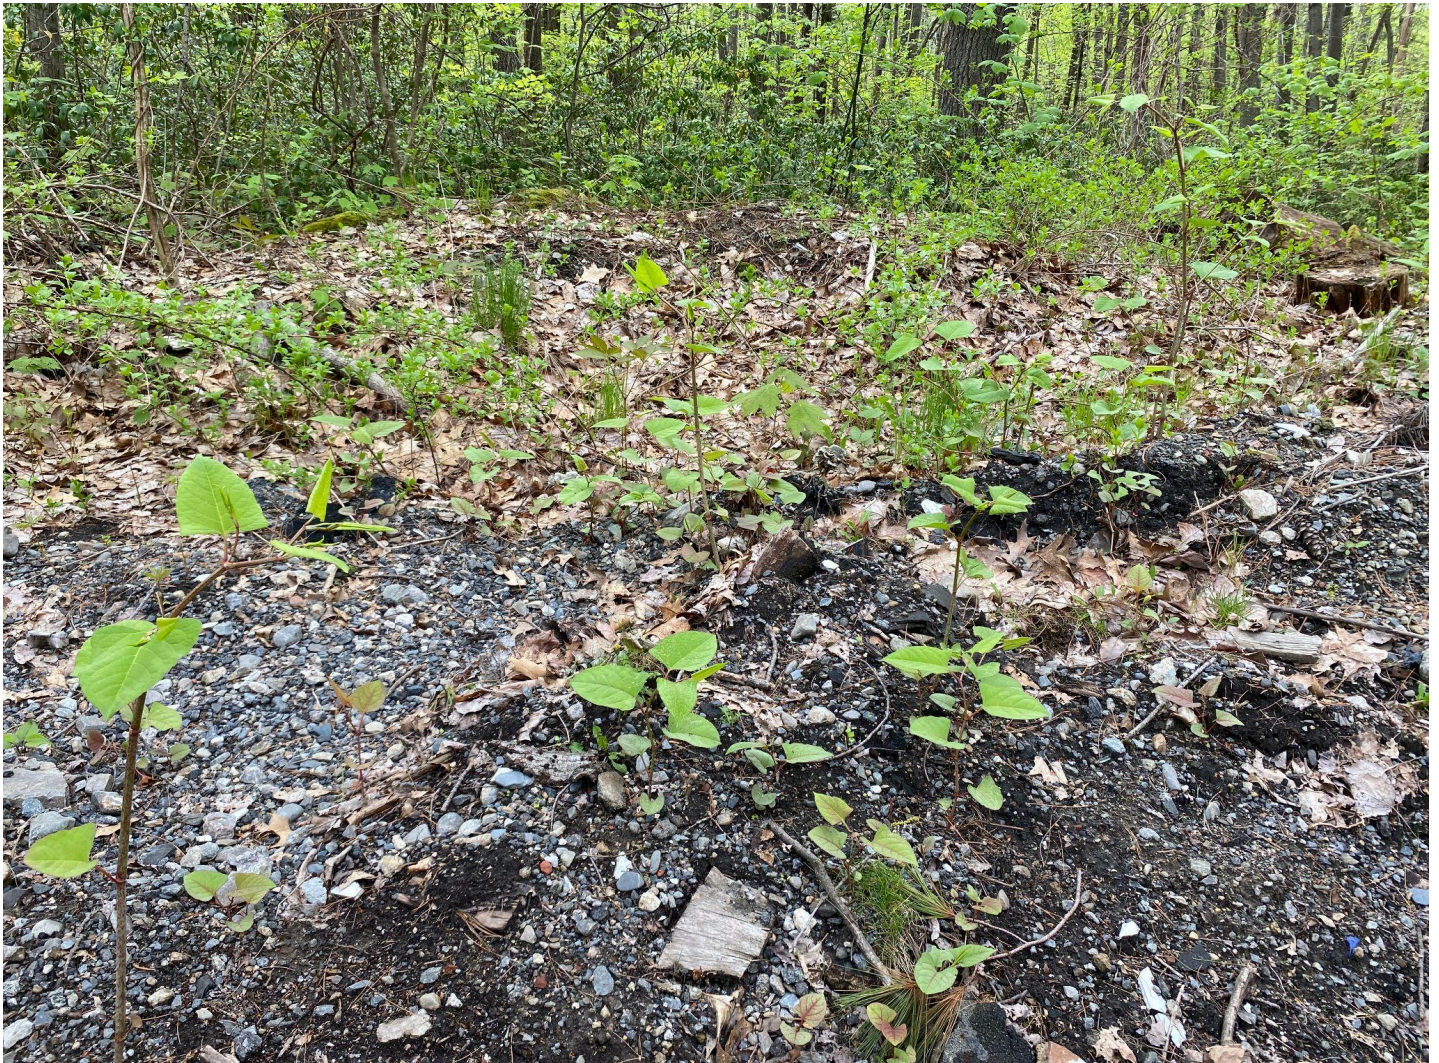
Photo 32

Comments: Invasive species including Japanese knotweed and Oriental bittersweet at dirt pull-off along Swan Avenue.

1. Manage or eliminate invasive species infestations where they have been identified within the property.
 - a. Many different invasive species were identified, including multiflora rose, Japanese knotweed, Oriental bittersweet, and Japanese barberry.

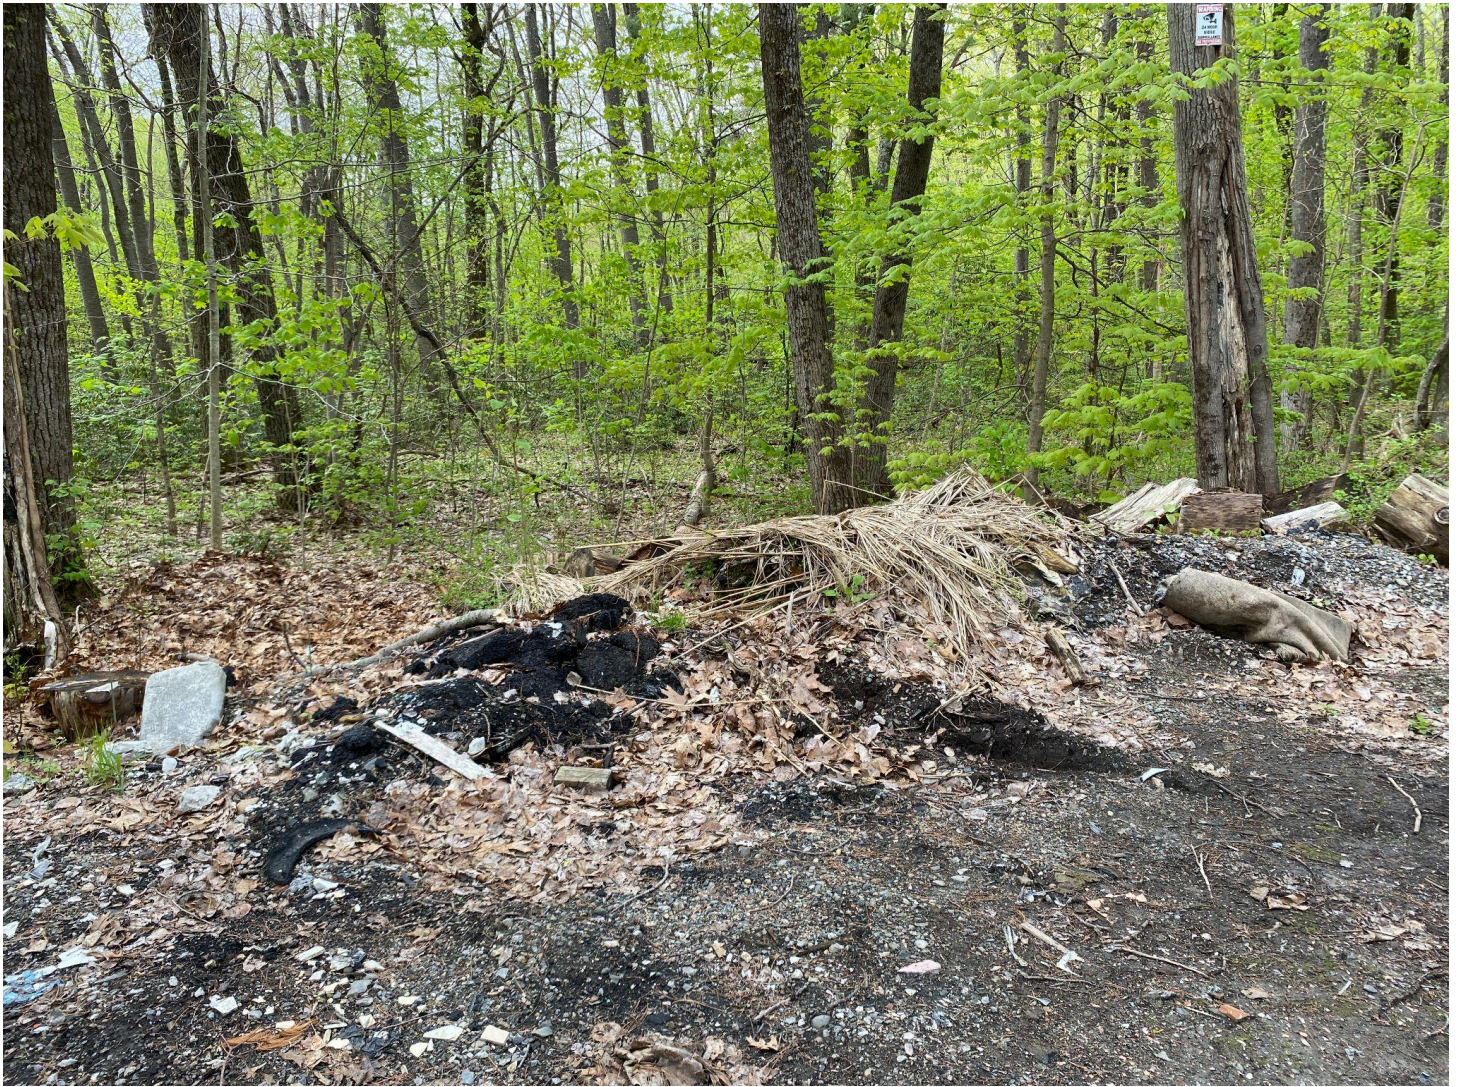
Photo 33

Comments: Household garbage including glass, plastic, fabric, and ceramics dumped at dirt pull-off along Swan Avenue.

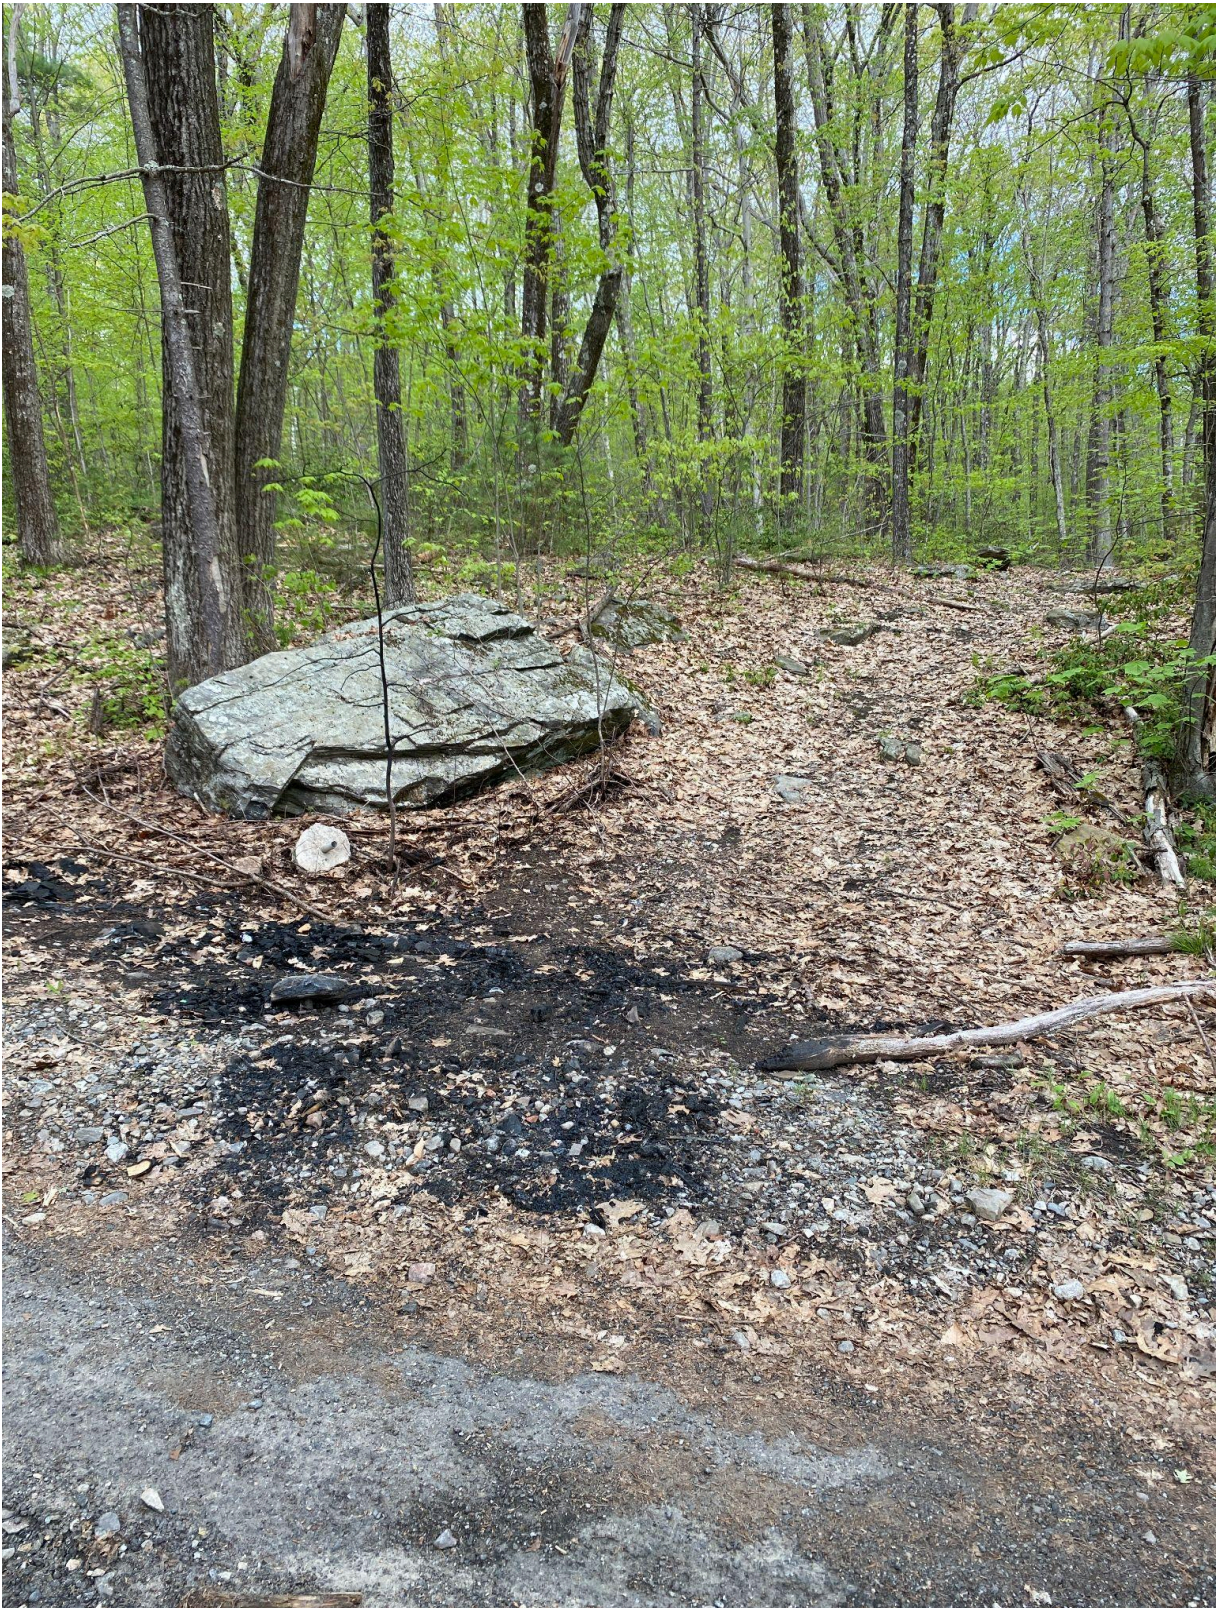
Photo 35

Comments: Unmarked trail into the woods and a burn pile.

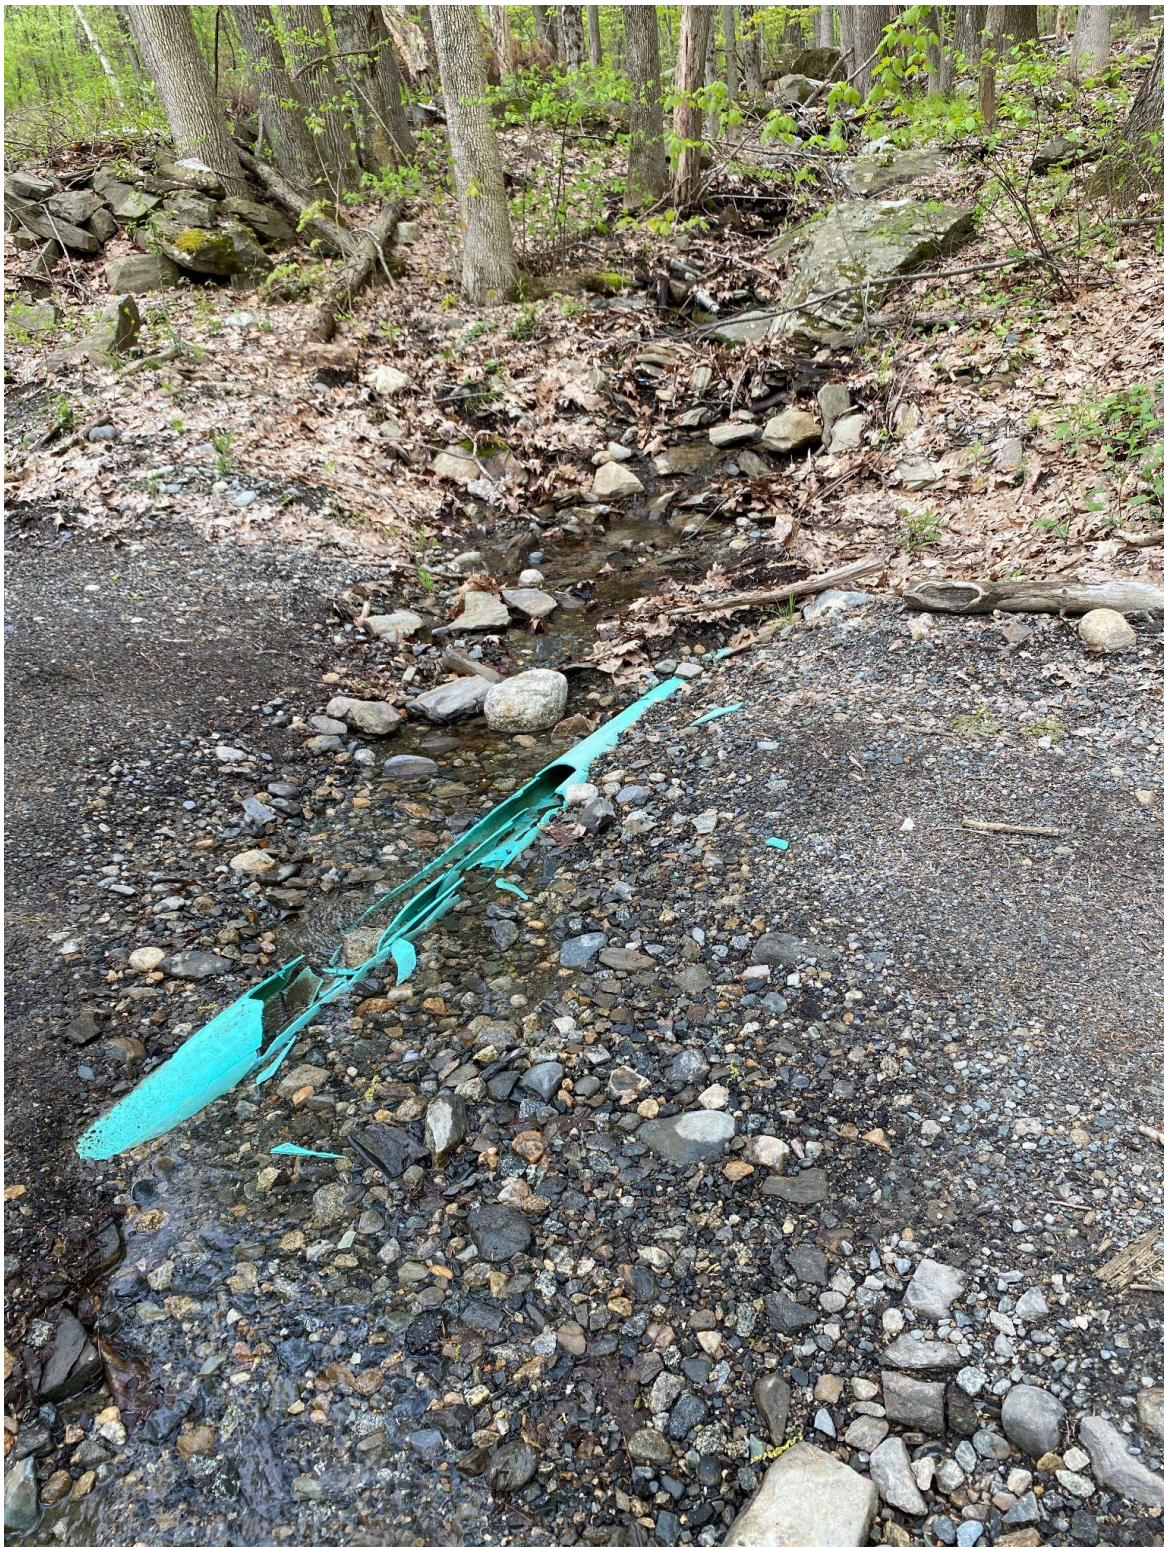
Photo 36

Comments: Culvert pipe underneath Swan Avenue has broken, resulting in the collapse of the road above the pipe. A stream now flows over Swan Avenue.

6. Continue to protect the on-site streams that are headwater tributaries to the Patch and Coes Reservoirs.
7. Improve access to God's Acre via Swan Avenue.
 - a. Fill potholes and eroded areas of the road.
 - b. Repair culvert pipe near 200 Swan Avenue to improve drainage, reroute stream under the road, and reduce further erosion.
 - c. Add drainage culverts or other drainage infrastructure to reduce road erosion during rainstorms.
 - d. Grade road and/or fill new potholes and erosion several times annually to keep the road in drivable condition.
 - e. Add signage at either end of Swan Avenue to indicate access to God's Acre and warn drivers of challenging road conditions.
 - f. Add signage along Swan Avenue to indicate locations where vehicles may be parked for access to God's Acre.

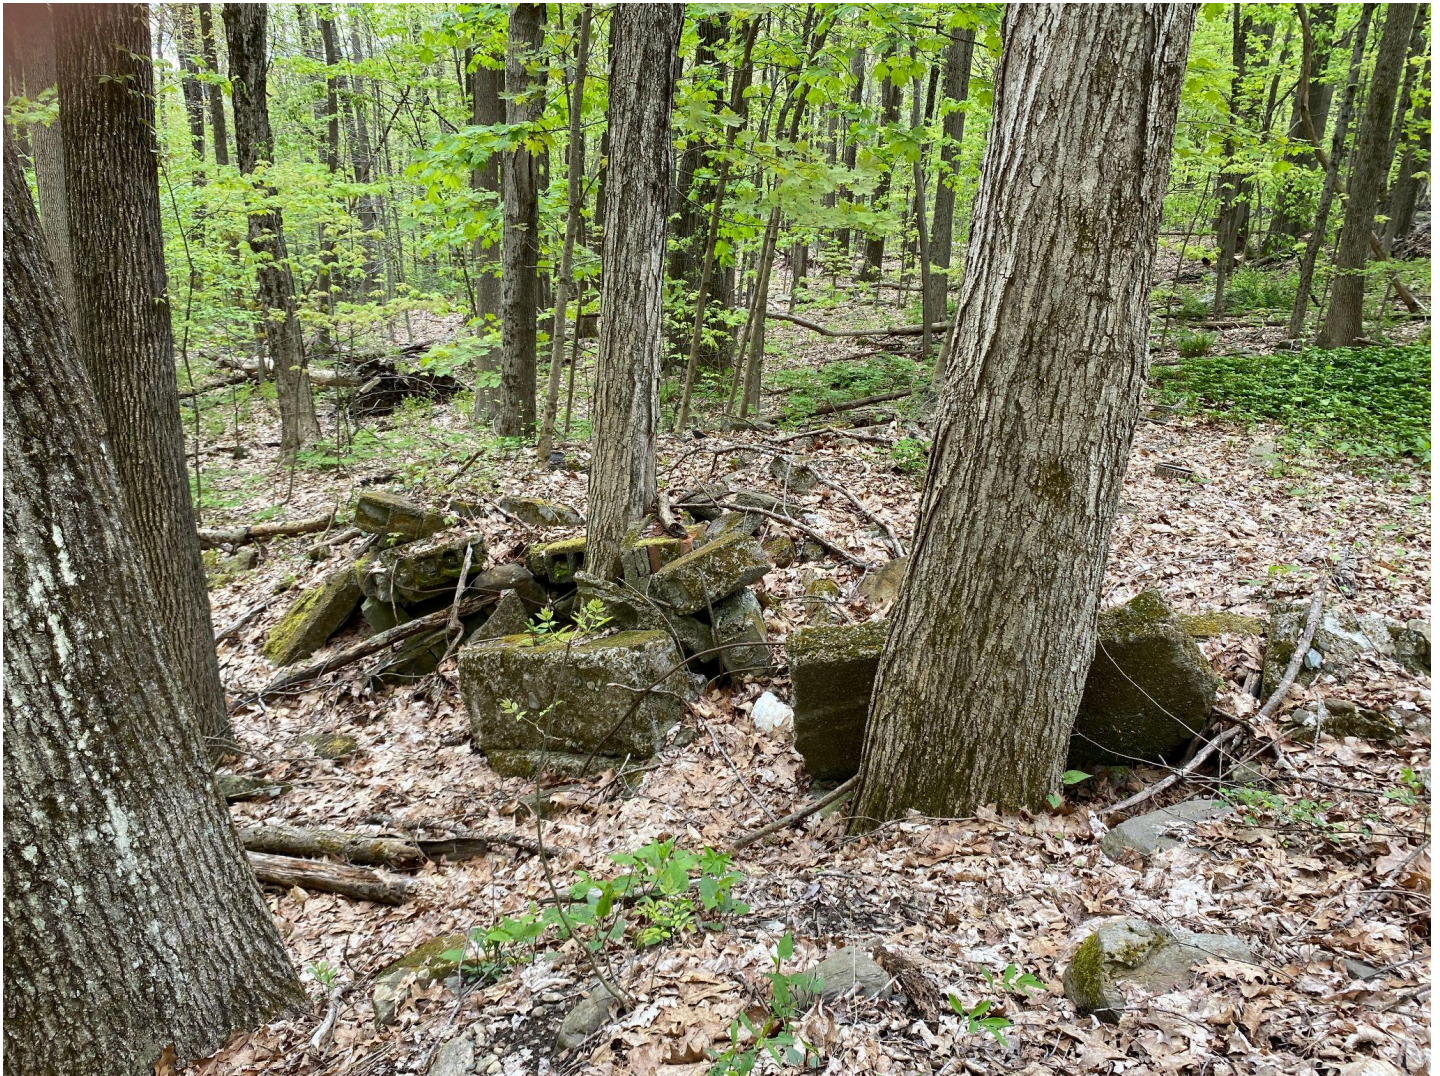
Photo 37

Comments: Pile of dumped cement blocks.

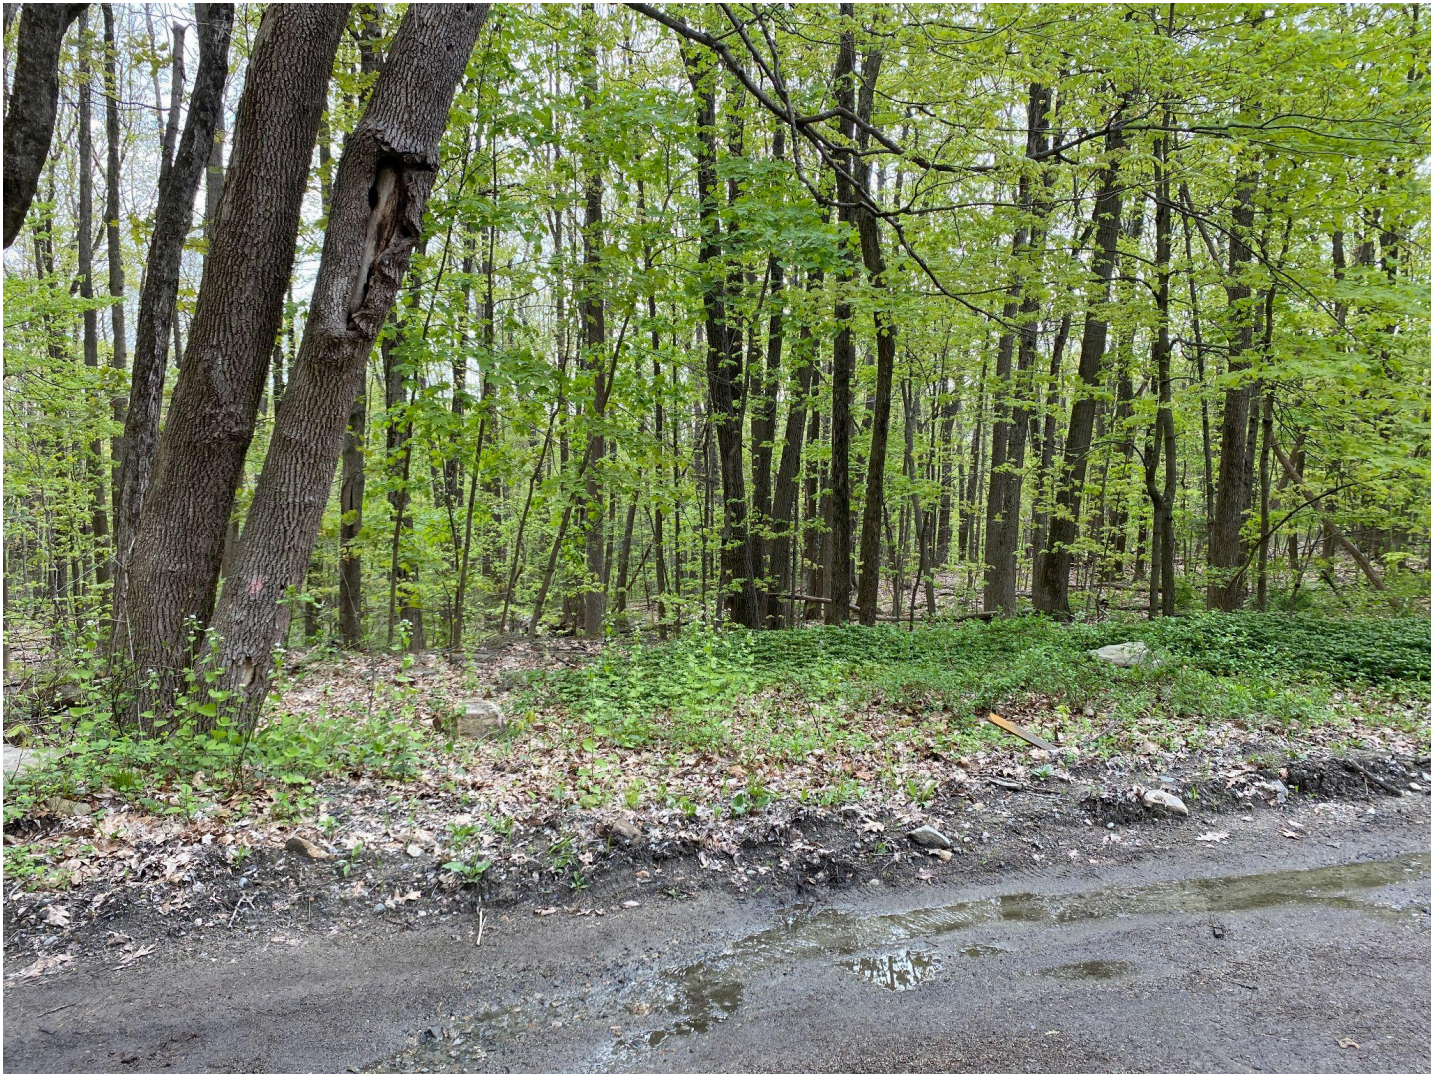
Photo 39

Comments: Invasive plants including Oriental bittersweet, Japanese barberry, multiflora rose (*Rosa multiflora*), and Japanese knotweed. Other introduced garden plants such as Pachysandra (*Pachysandra* spp.) and daylily (*Hemerocallis* spp.) are present as well.

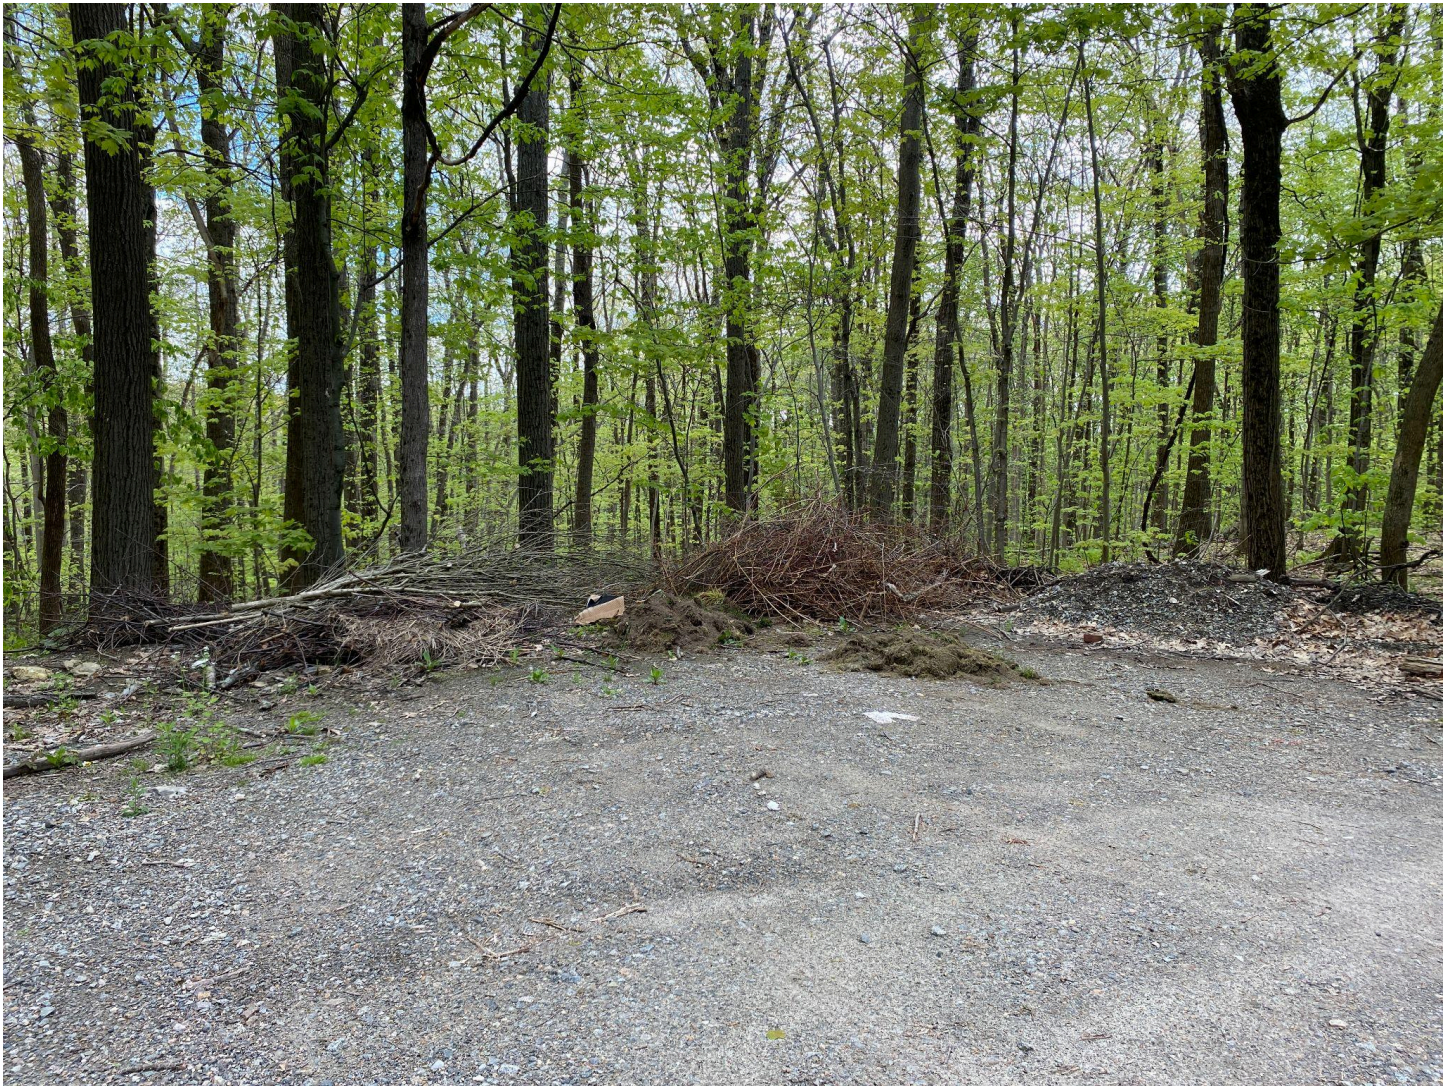
Photo 40

Comments: Dirt pull-off from Swan Avenue with evidence of abutter dumping of yard waste.

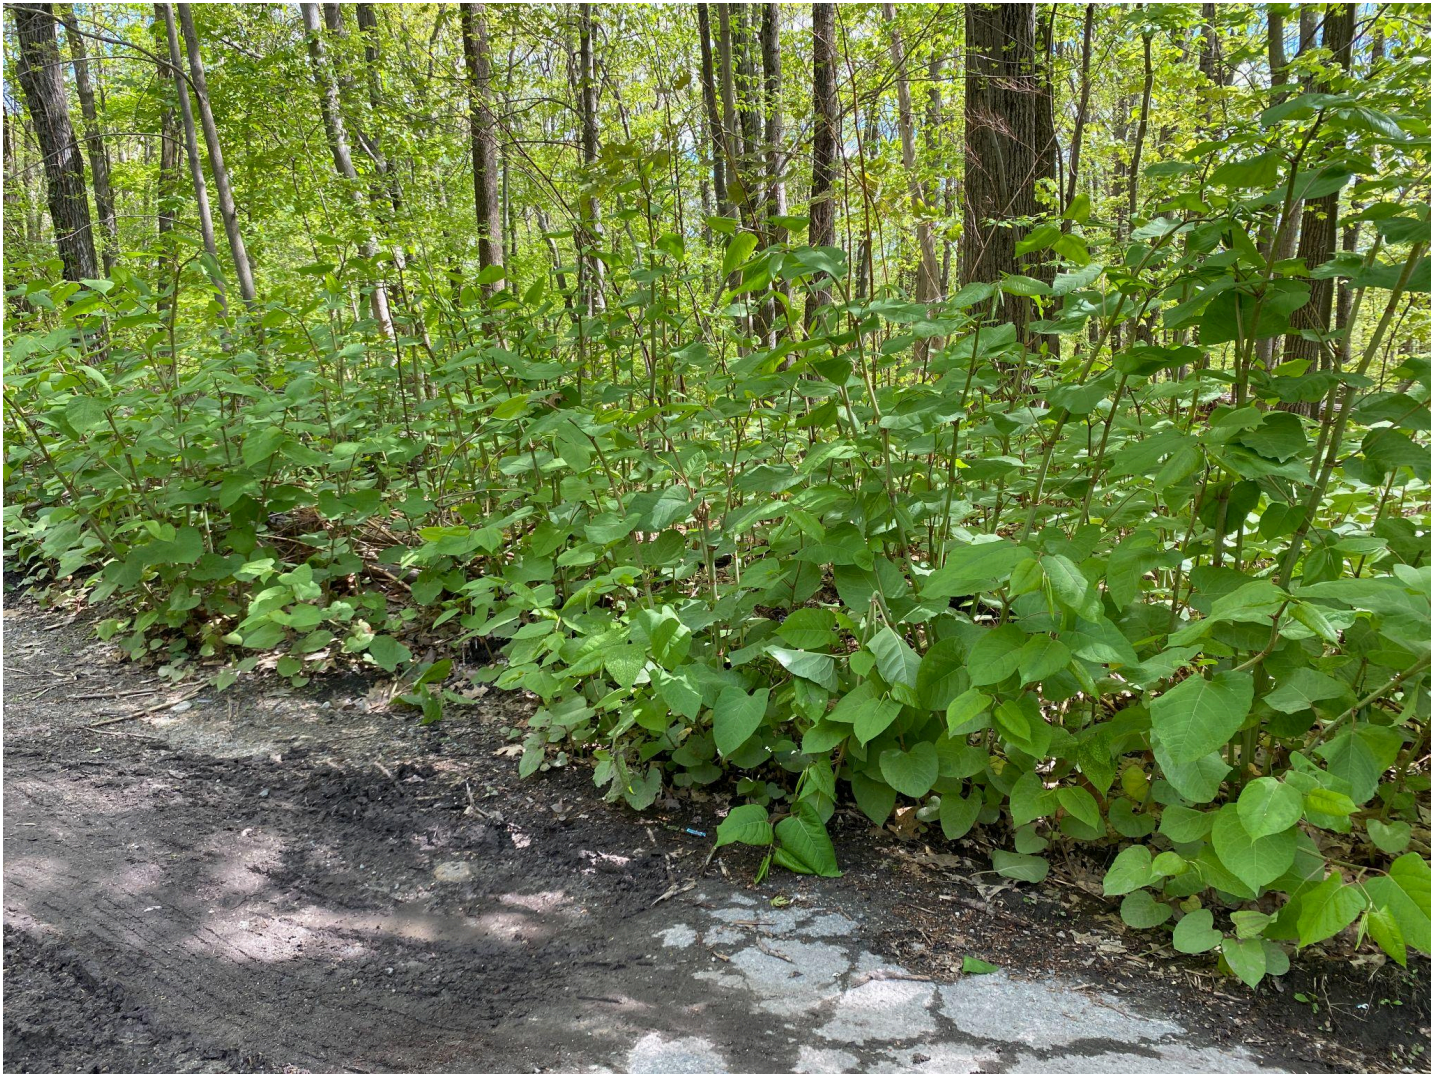
Photo 42

Comments: Japanese knotweed along the path.

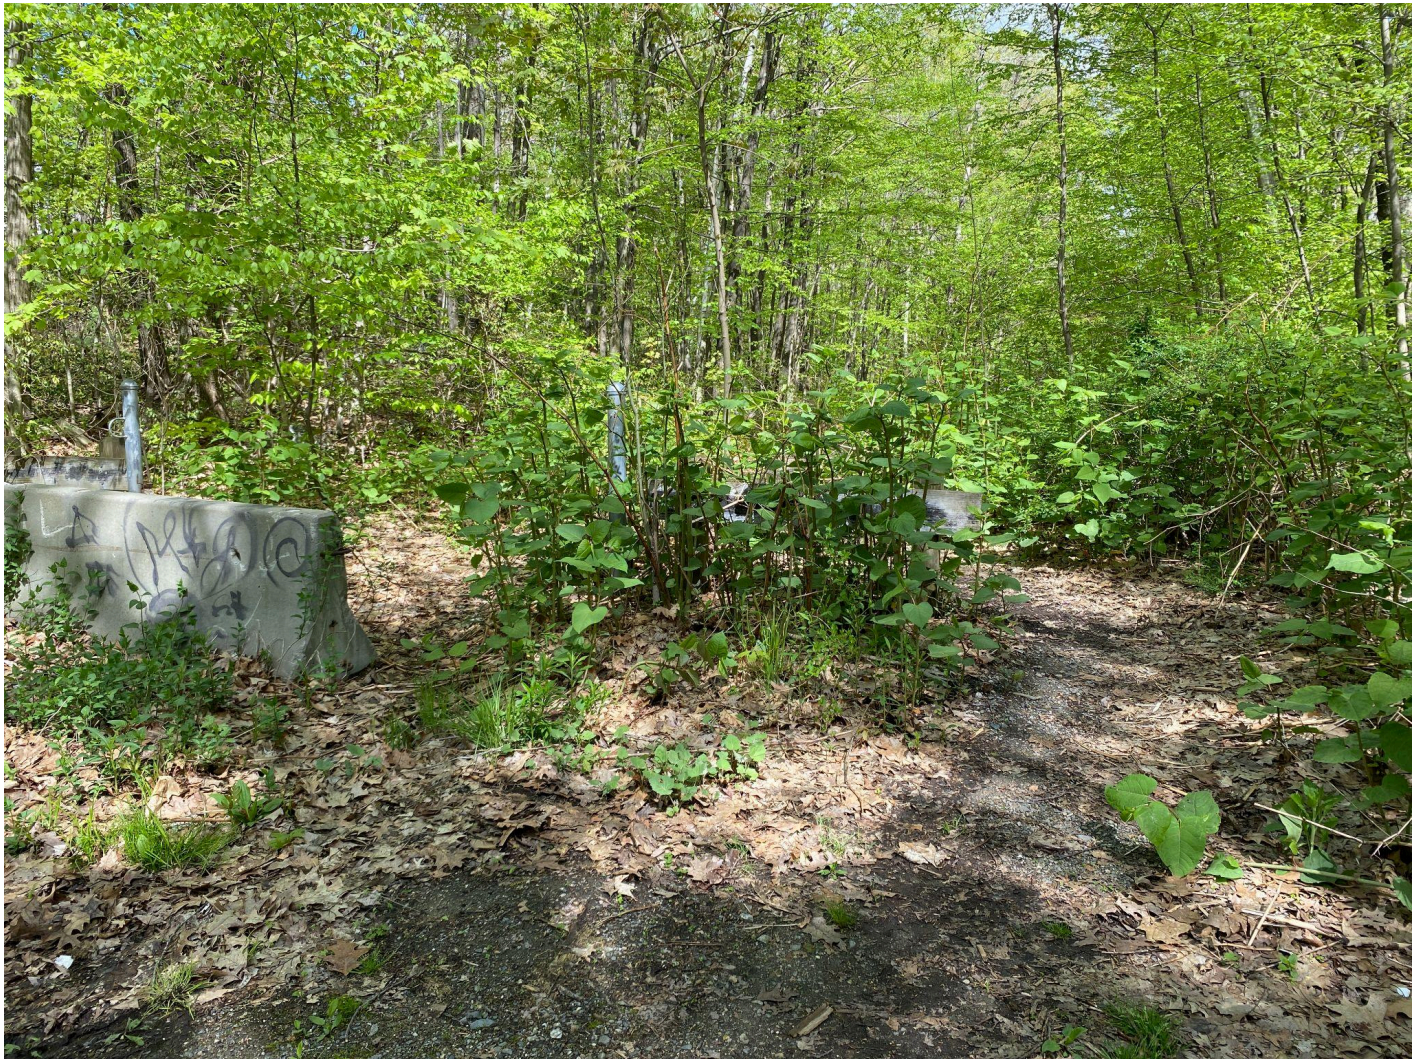
Photo 43

Photo ID	Polygon ID	Type	Comments
42, 44-45	53124	Invasive Species	(Photo 42) Japanese knotweed along the path. (Photo 44) Fallen tree blocking the path off the end of Paris Road. (Photo 45) Path created to circumvent the fallen tree.
43, 46-47	53127	Invasive Species	(Photo 43) Entrance to path at the end of Paris road. The road is blocked by a cement barricade but a foot path continues through to Swan drive. (Photo 46) Japanese knotweed grows from the entrance to the Paris Road footpath down the trail about 20 feet. (Photo 47) Evidence of a campfire or dumping of ashes in addition to roofing materials and yard waste dumped by the cement barrier.
48	53135	Invasive Species	Invasive plants along the west/east boundary between the WSU parking lot at 140 Goddard Memorial Drive and the God's Acre property including Japanese knotweed and multiflora rose.
49	53134	Other	Unmarked footpath that appears to end at a dense wall of fallen trees and shrubs.

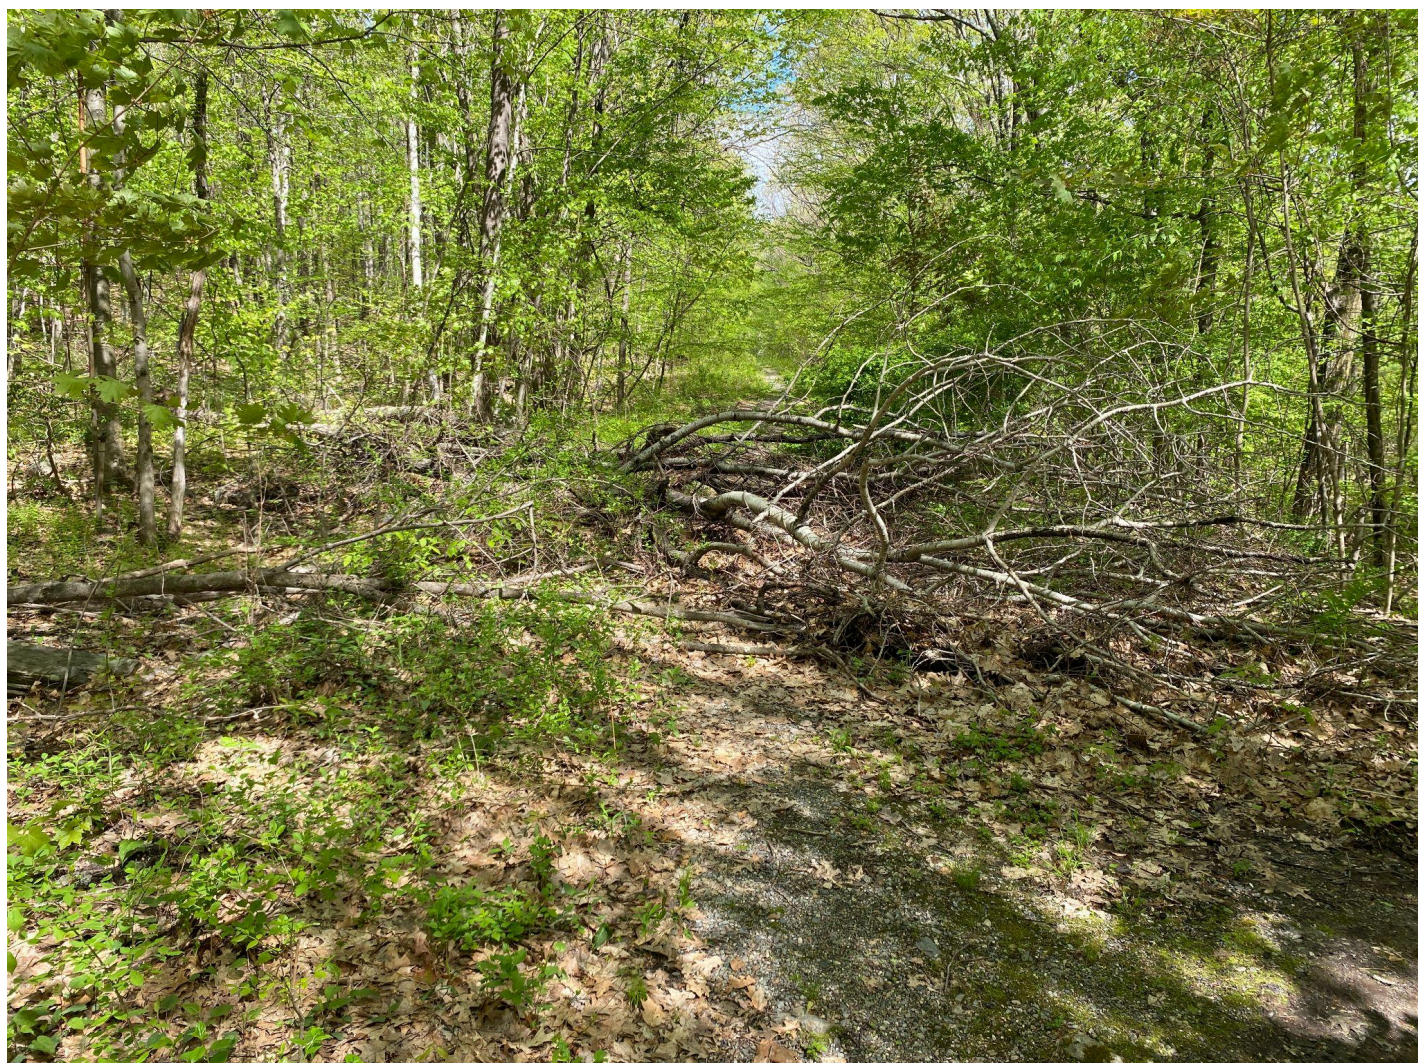
Photo 44

Comments: Fallen tree blocking the path off the end of Paris Road.

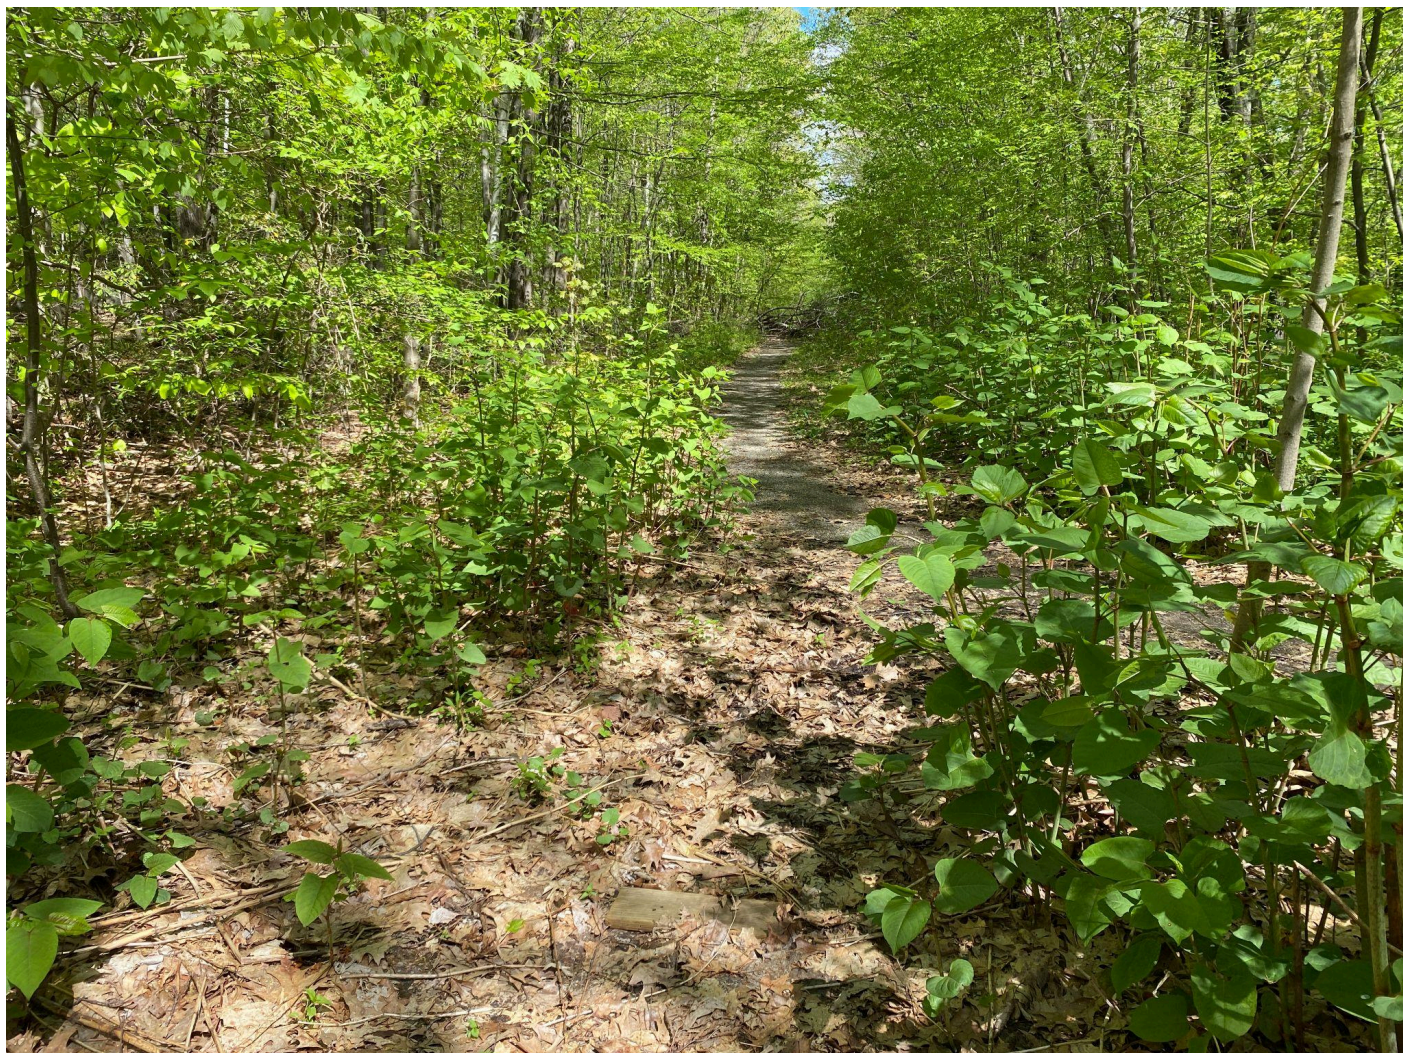
Photo 46

Comments: Japanese knotweed grows from the entrance to the Paris Road footpath down the trail about 20 feet.

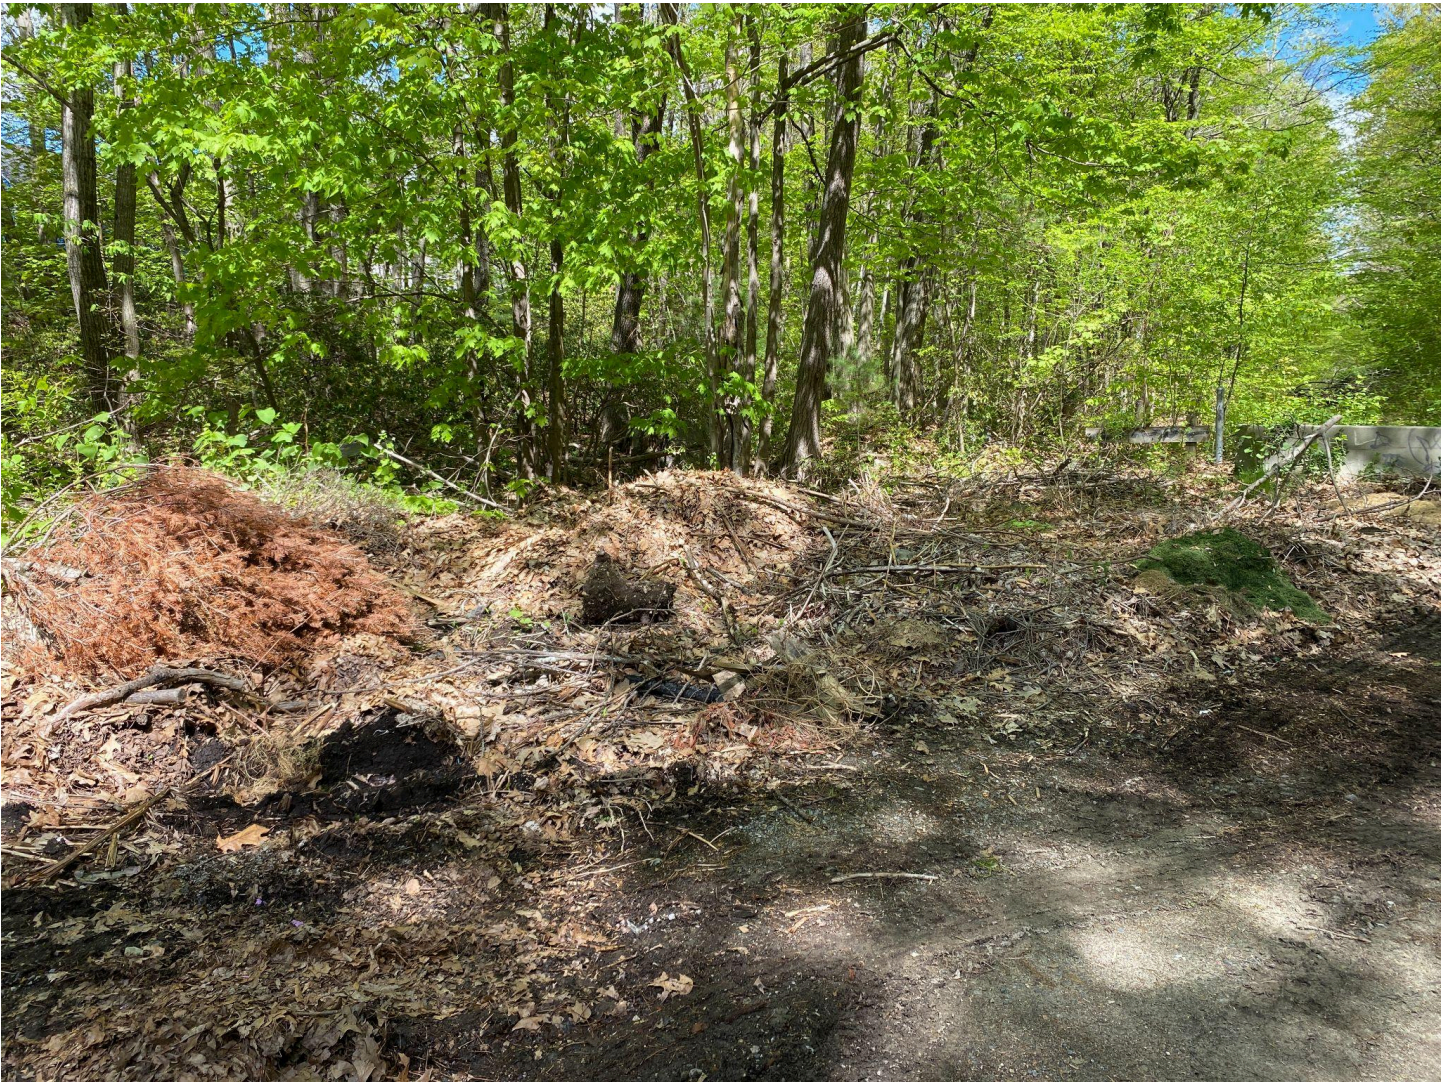
Photo 47

Comments: Evidence of a campfire or dumping of ashes in addition to roofing materials and yard waste dumped by the cement barrier.
