WORCESTER CONSERVATION COMMISSION

God's Acre

Conservation Property Baseline Assessment

July 2024

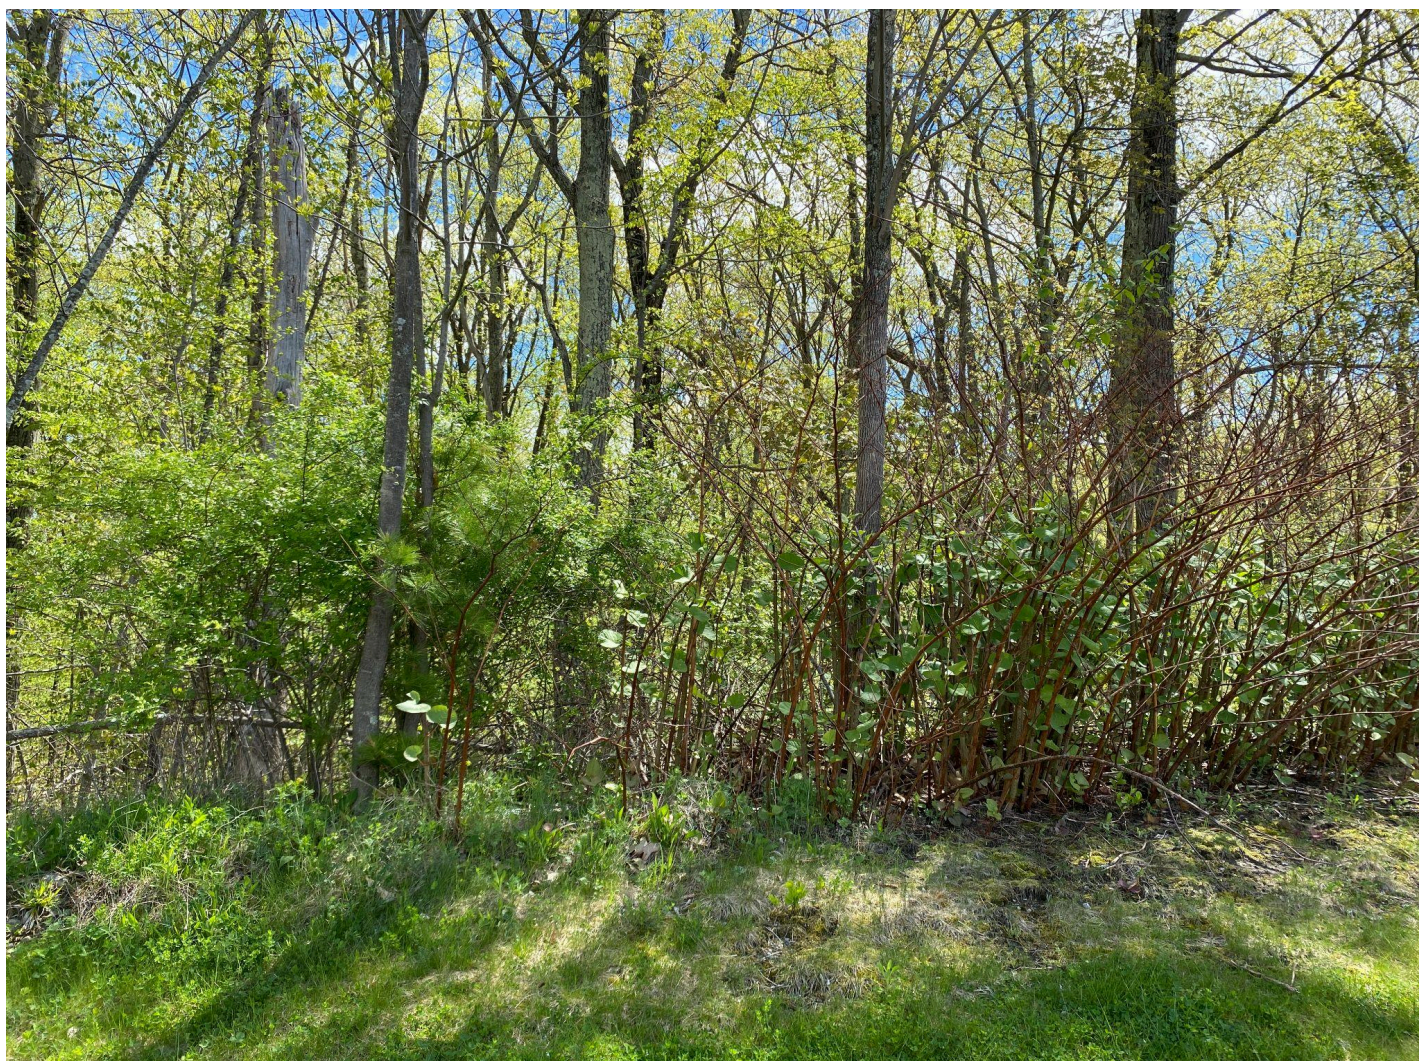
Photo 48

Comments: Invasive plants along the west/east boundary between the WSU parking lot at 140 Goddard Memorial Drive and the God's Acre property including Japanese knotweed and multiflora rose.

- d. Along boundaries with other properties collaboration with private landowners may be required to manage invasive species adjacent to the God's Acre property and prevent reinfestation.

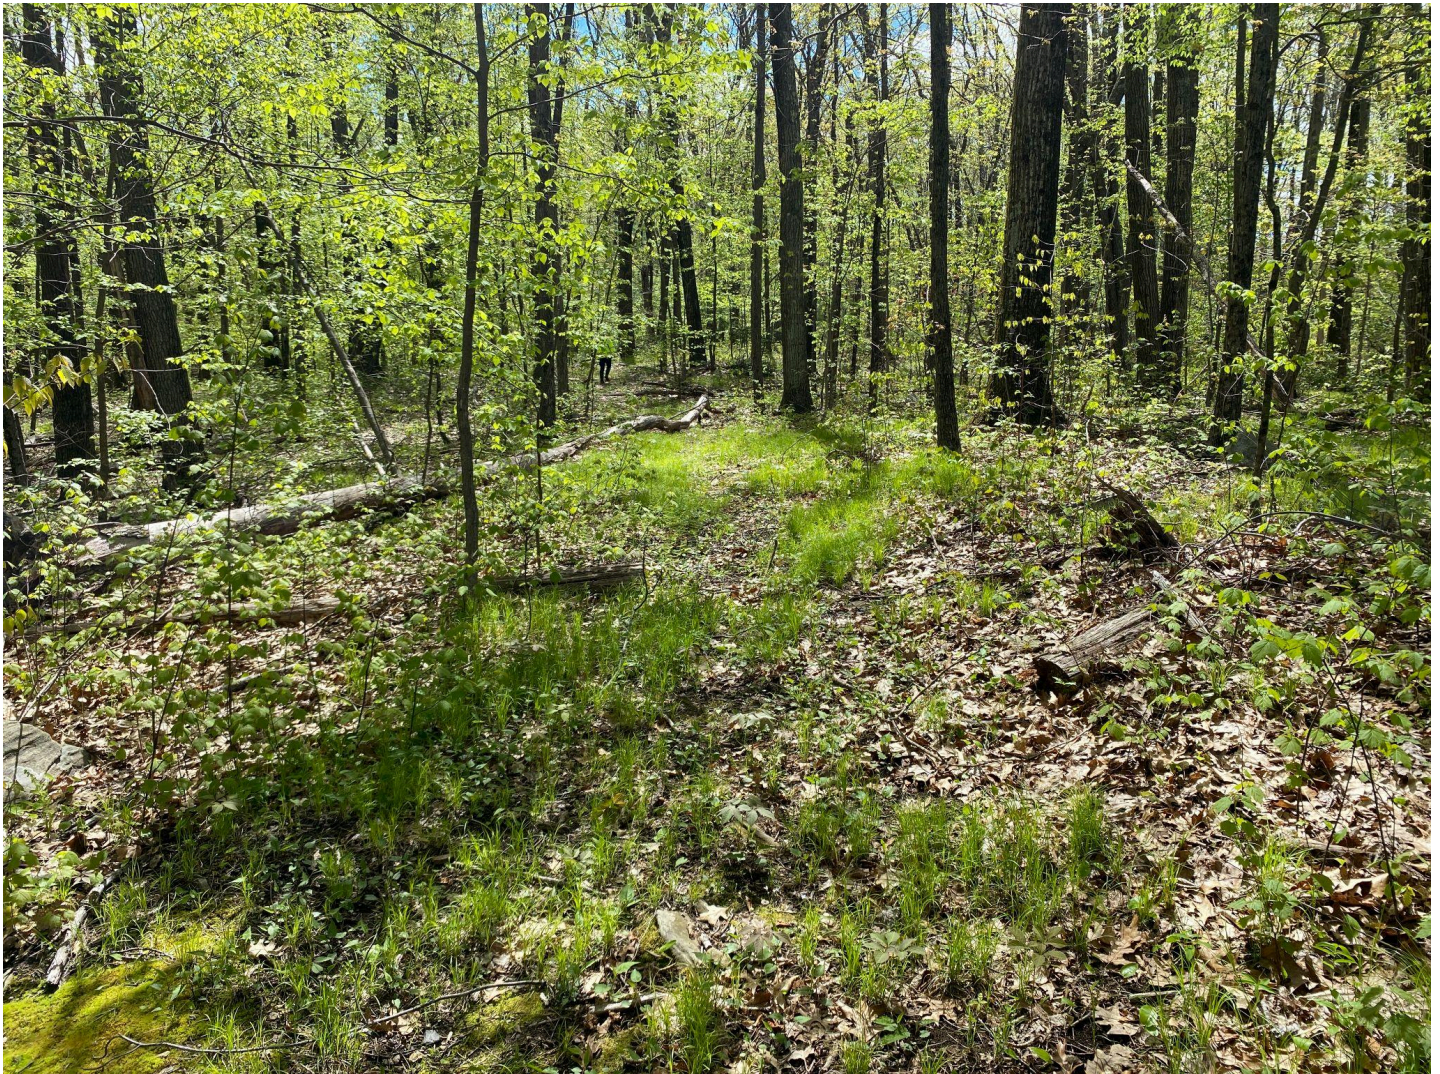
Photo 49

Comments: Unmarked footpath that appears to end at a dense wall of fallen trees and shrubs.

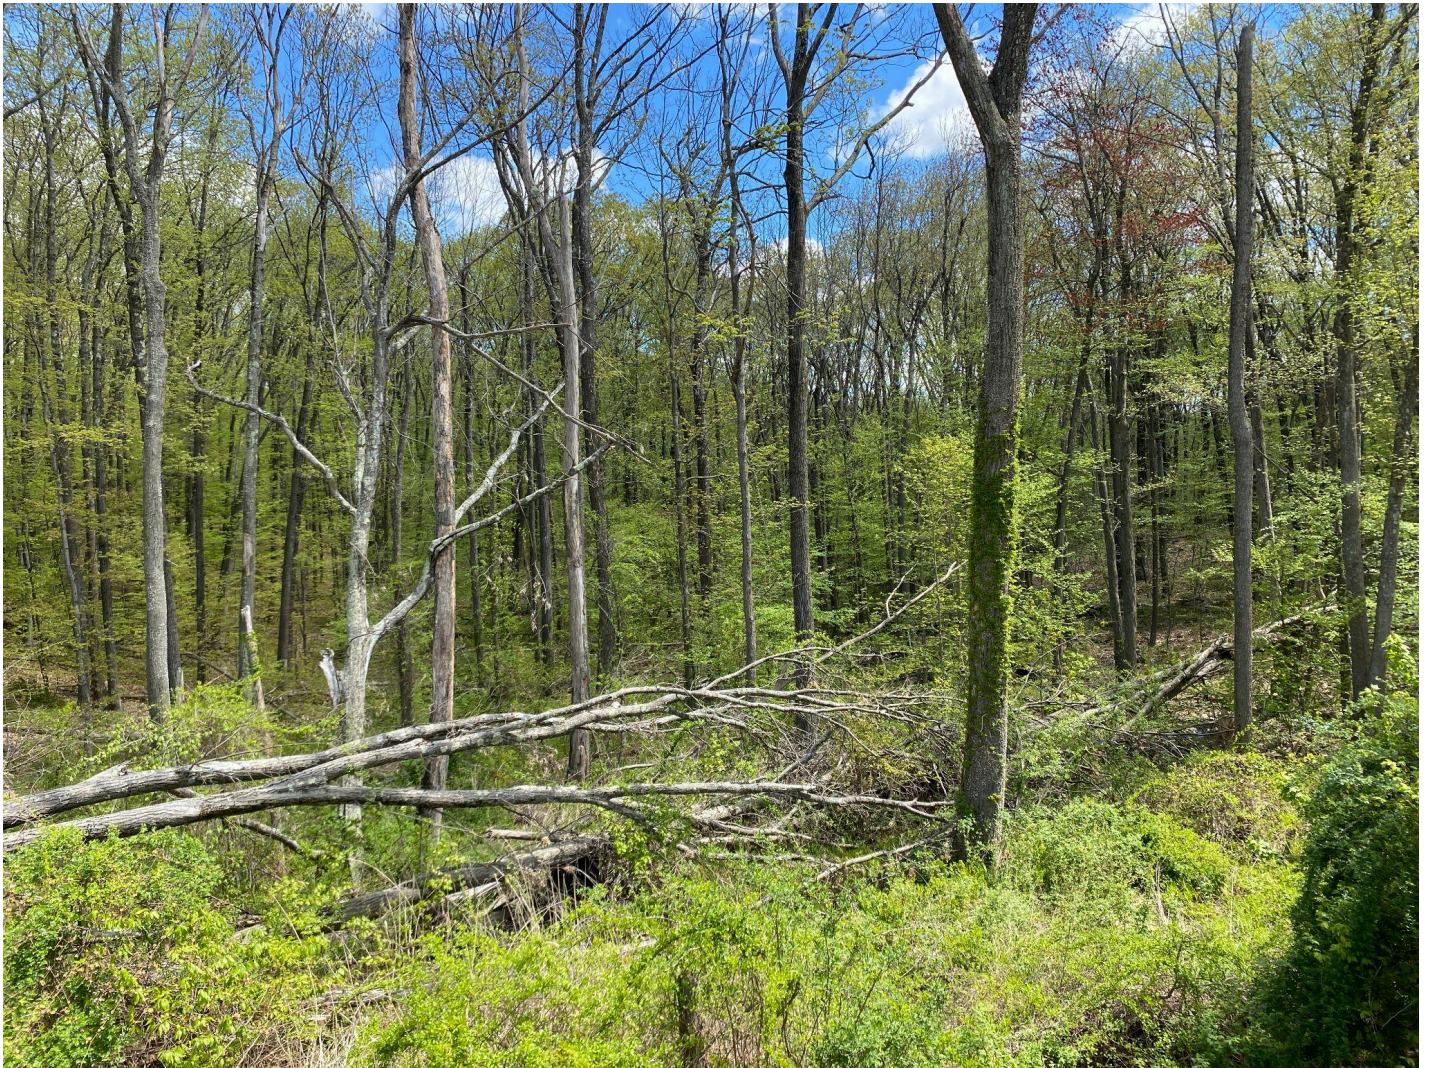
Photo 50

Comments: Area with large canopy gaps due to both standing and fallen dead oak and ash trees. Invasive species, including multiflora rose, are growing in the openings.
