WORCESTER CONSERVATION COMMISSION

Patch Pond and Reservoir

Conservation Property Baseline Assessment

July 2024

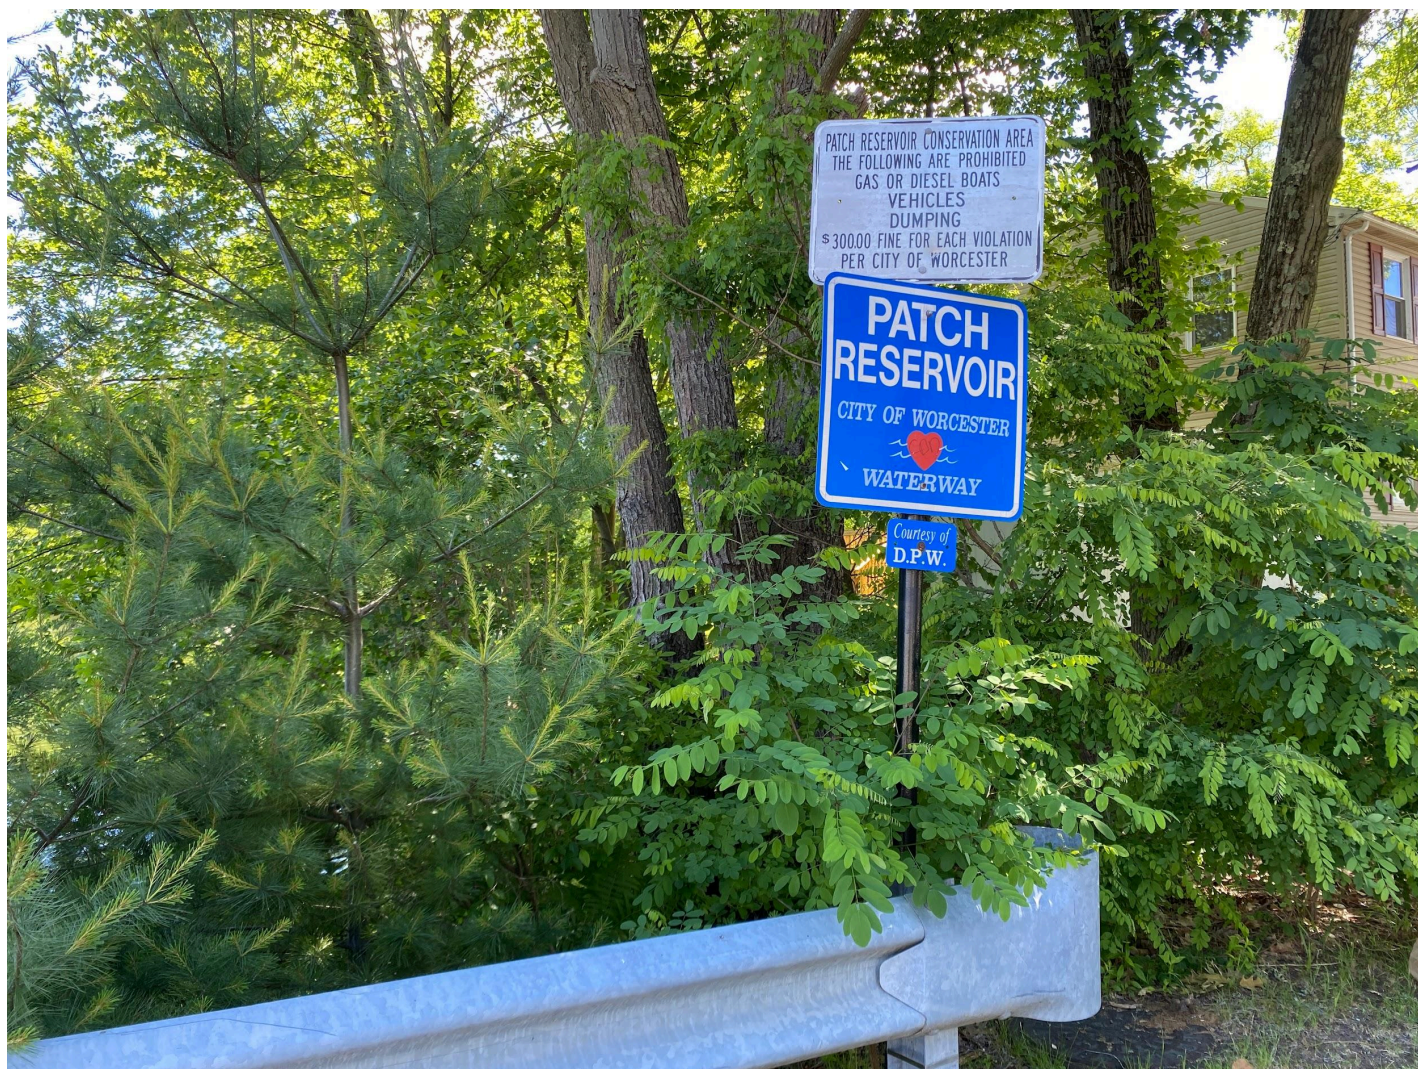
Photo 1

Comments: Sign identifying Patch Reservoir where the pond meets Mill Street. The sign indicates prohibited uses for the site, including gas or diesel boats, vehicles, and dumping. Sign is not especially close to trail entry to the property.

- d. Post signage which specifically prohibits dumping at key locations where dumping appears to be an issue.
5. Work with collaborators such as the Worcester Water Department to determine if the existing dam structure at the Patch Reservoir outflow is sufficient and repair/replace if necessary.

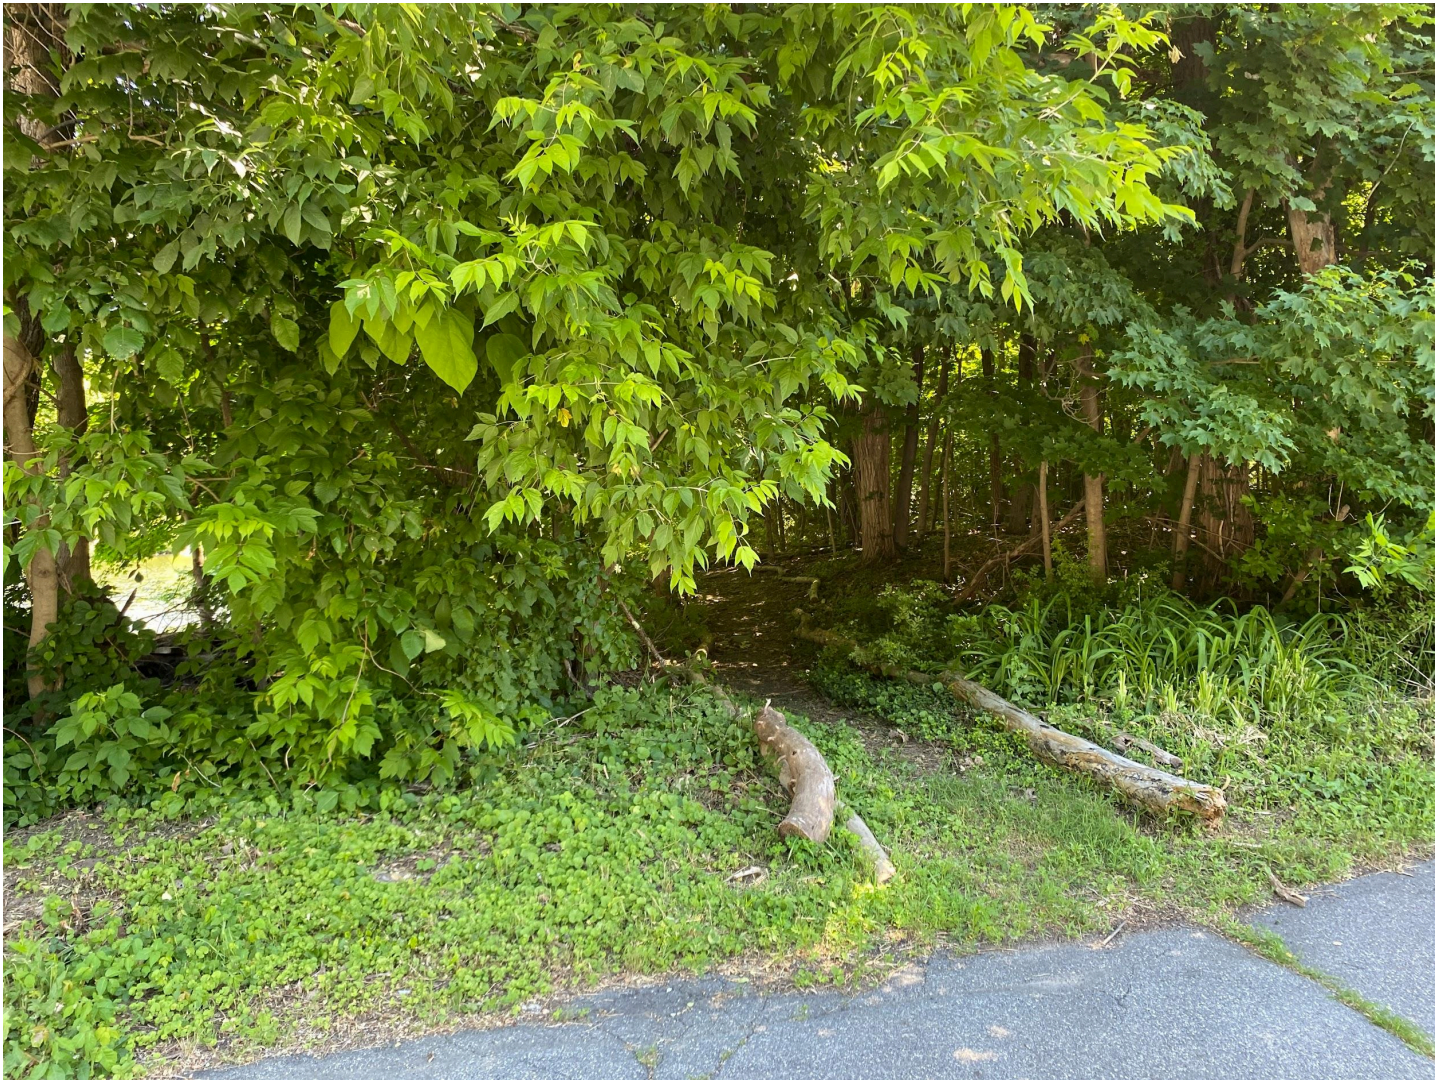
Photo 2

Comments: The northernmost trailhead off Mill Street has no signage.

- c. Post clear boundary signage along property boundaries to mark where the conservation property begins. Observations at the time of the property assessment did not reveal any clear boundary markers.

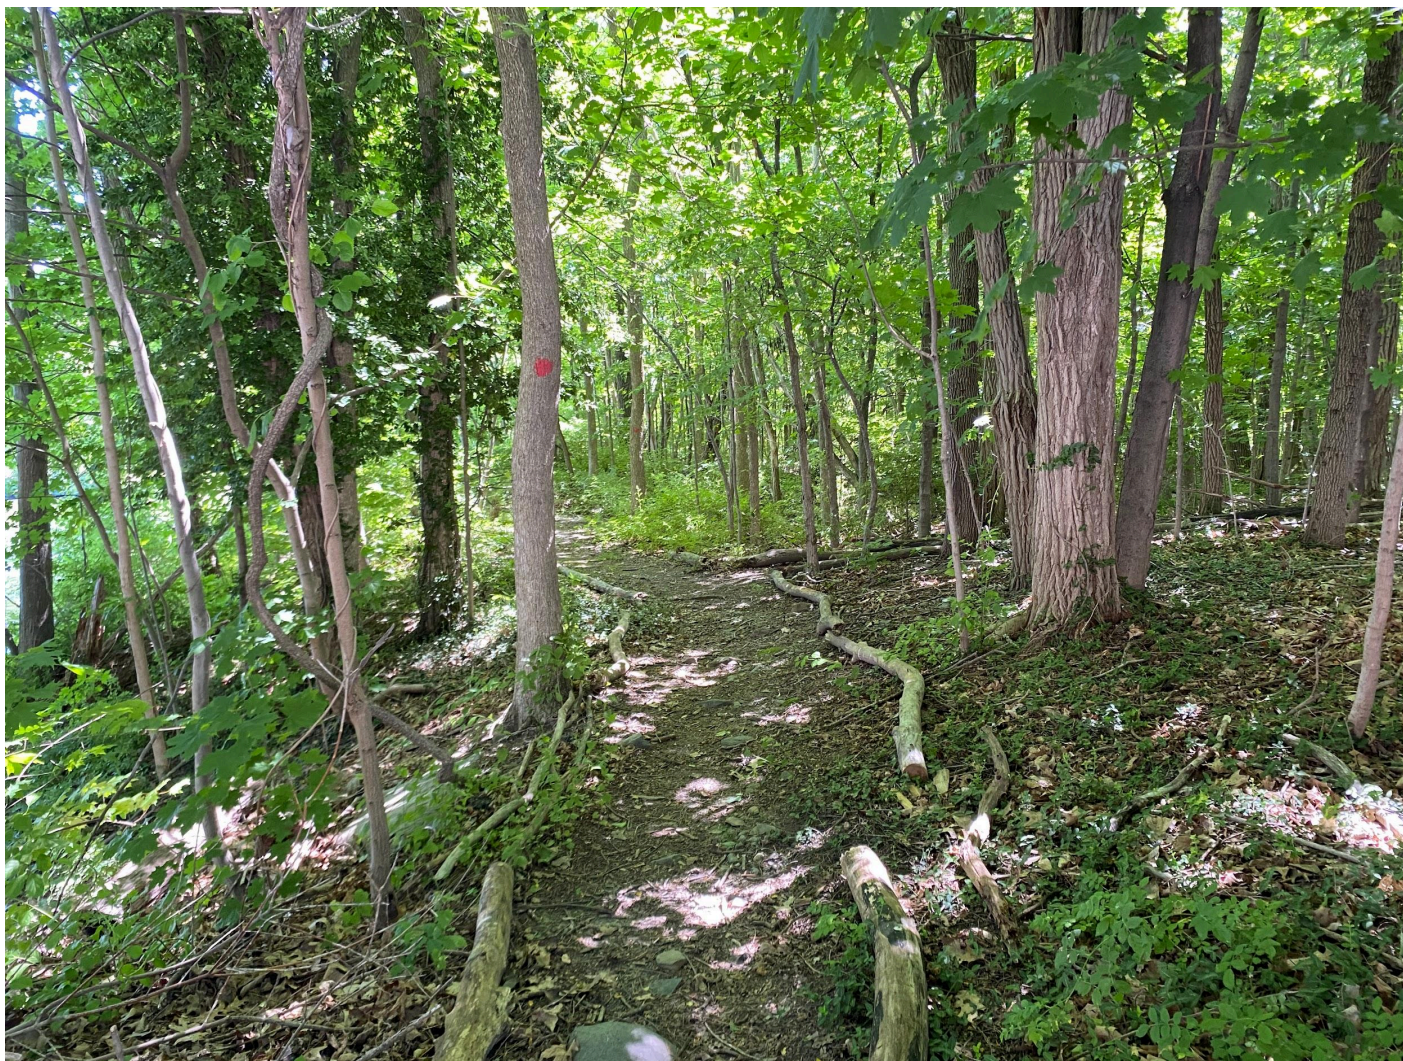
Photo 3

Comments: The trails in the property are marked with red and blue blazes.

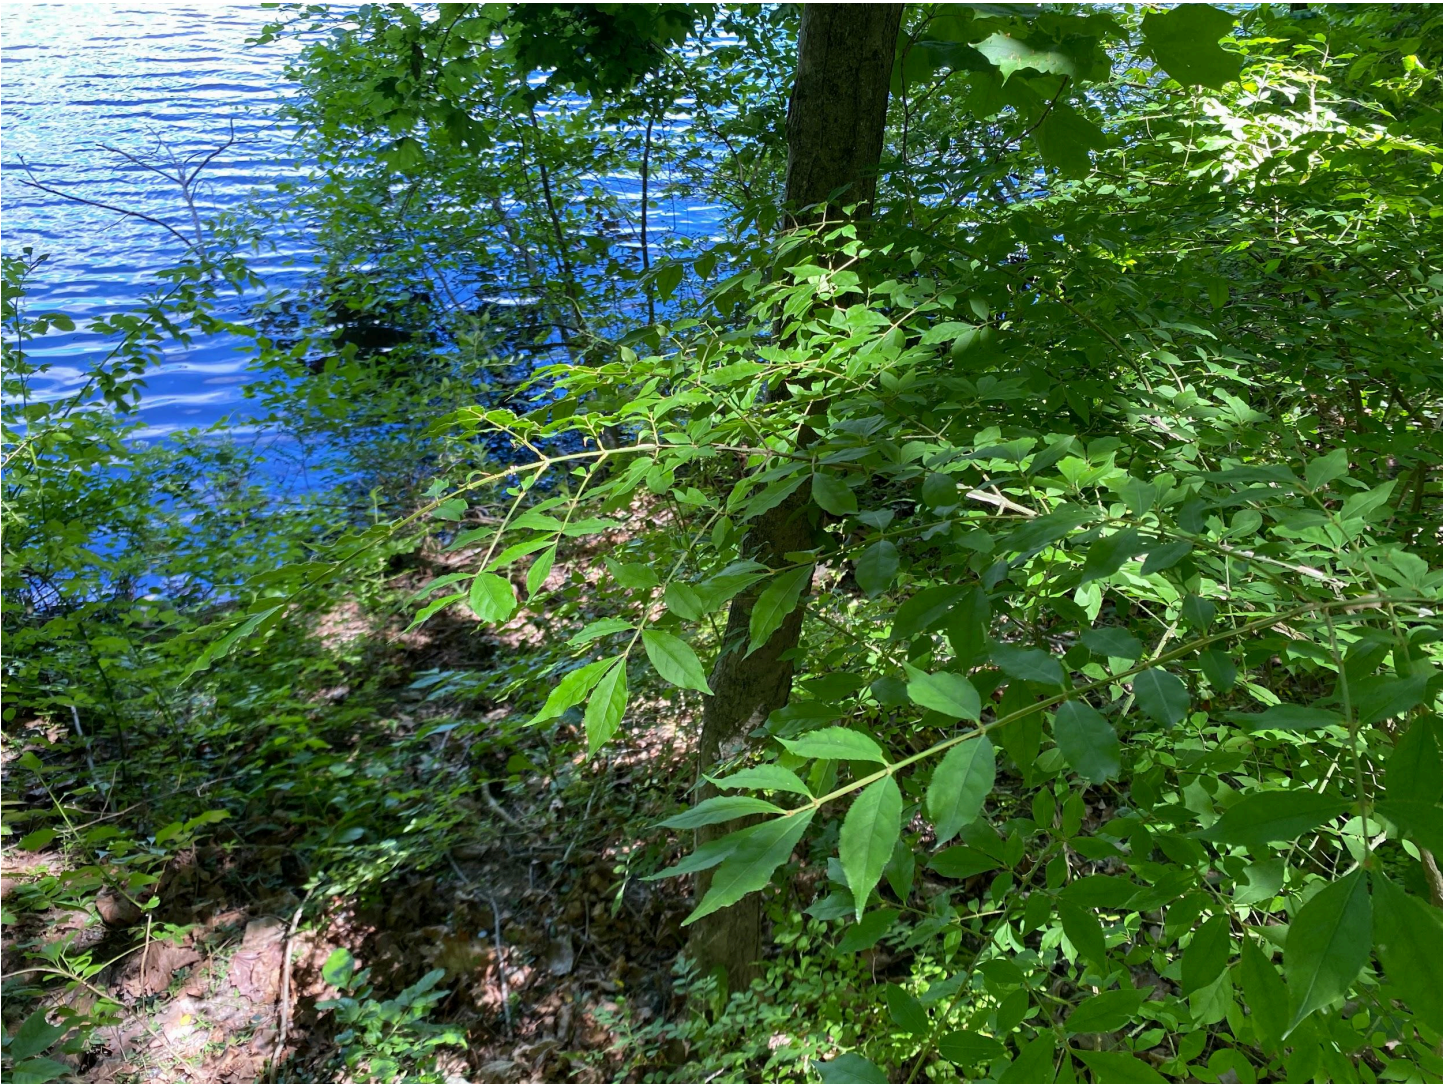
Photo 4

Comments: A variety of invasive species are present around the trailhead including burning bush (*Euonymus alatus*), multiflora rose (*Rosa multiflora*), and Oriental bittersweet (*Celastrus orbiculatus*). These invasives are widespread throughout the property.

2. Implement a management strategy for invasive shrubs, including Japanese barberry, Japanese knotweed, burning bush, invasive honeysuckle, and multiflora rose.

- a. Use a variety of management methods including herbicide treatment, manual and mechanical cutting/removal, and cultural practices (ex. Reseeding areas cleared of invasive species) to minimize the existing infested areas.

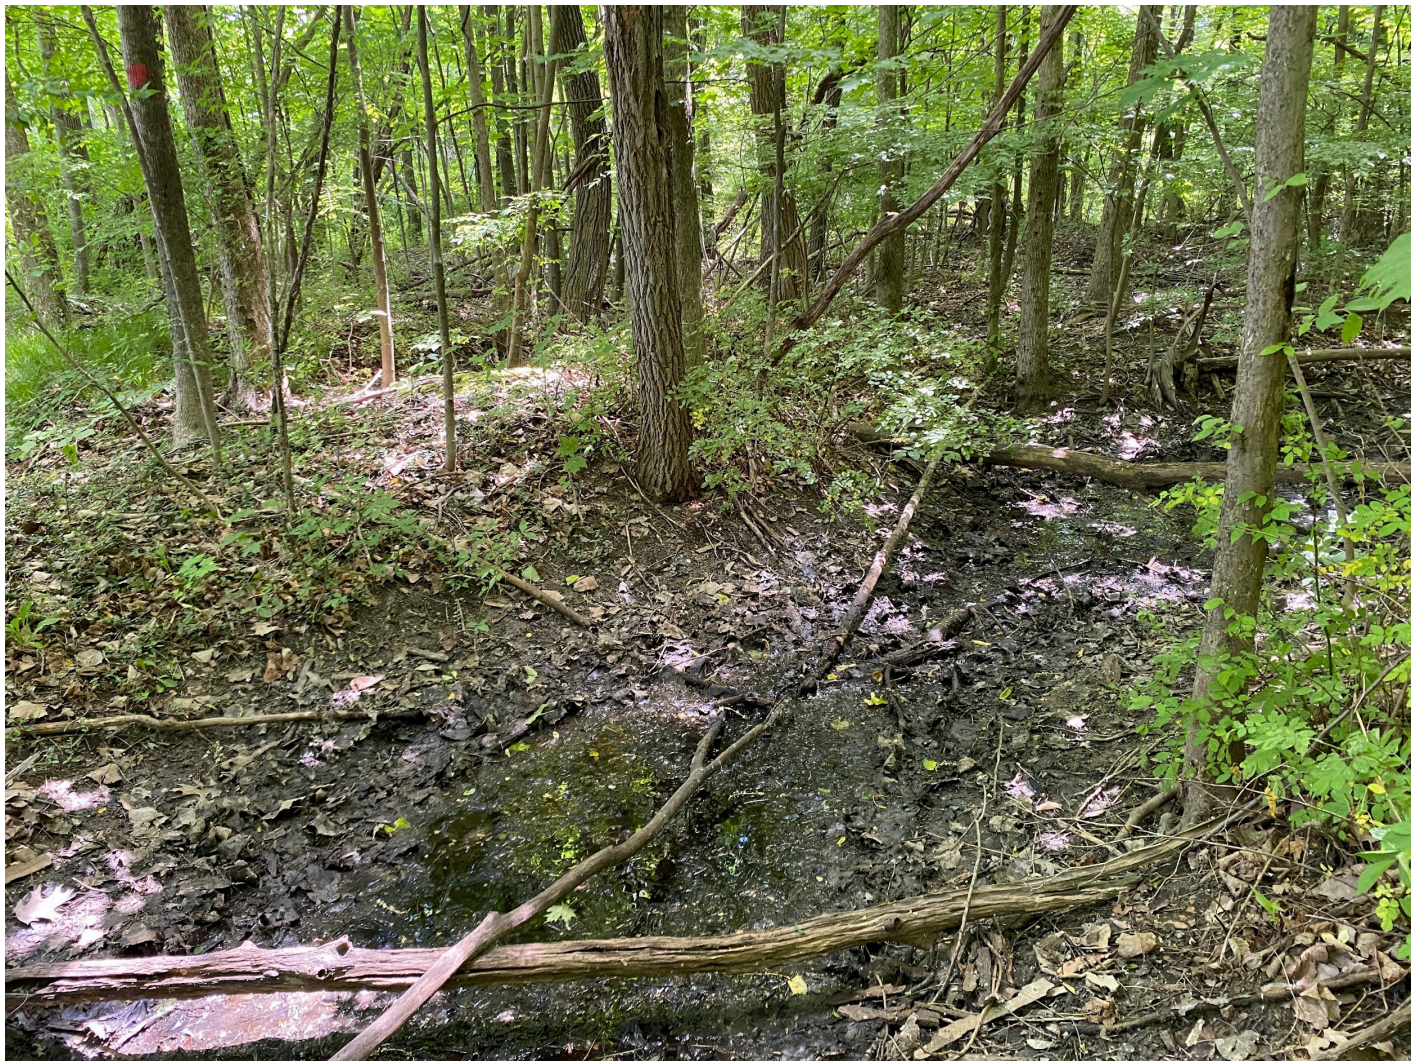
Photo 5

Comments: Several periodically wet patches along the red trail which may be vernal pools.

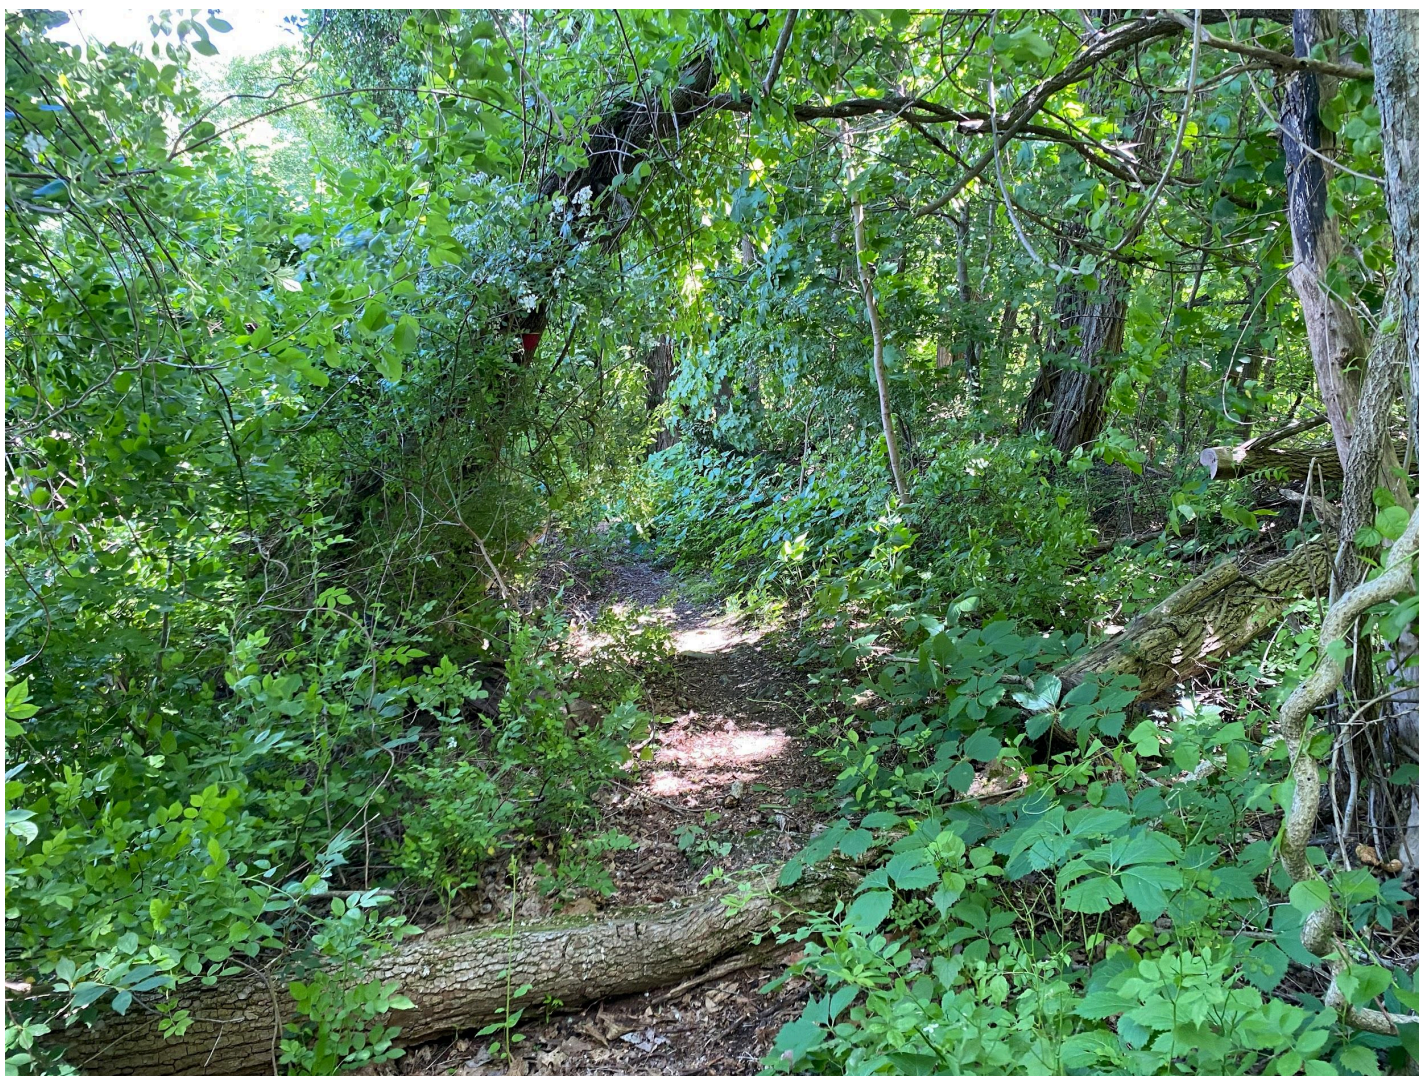
Photo 6

Comments: Heavy Oriental bittersweet infestation may cause hazards as it kills and pulls down overstory trees.

1. Implement a management strategy for Oriental bittersweet
 - a. Cutting large vines followed by a cut-stump treatment can be effective for established individuals.

- b. Do not attempt to remove vines from the canopy - this can further damage trees. Allow the vines to die on the tree and decay over time.
 - c. Significant monitoring and follow-up treatments will be needed to manage Oriental bittersweet at Patch Reservoir.

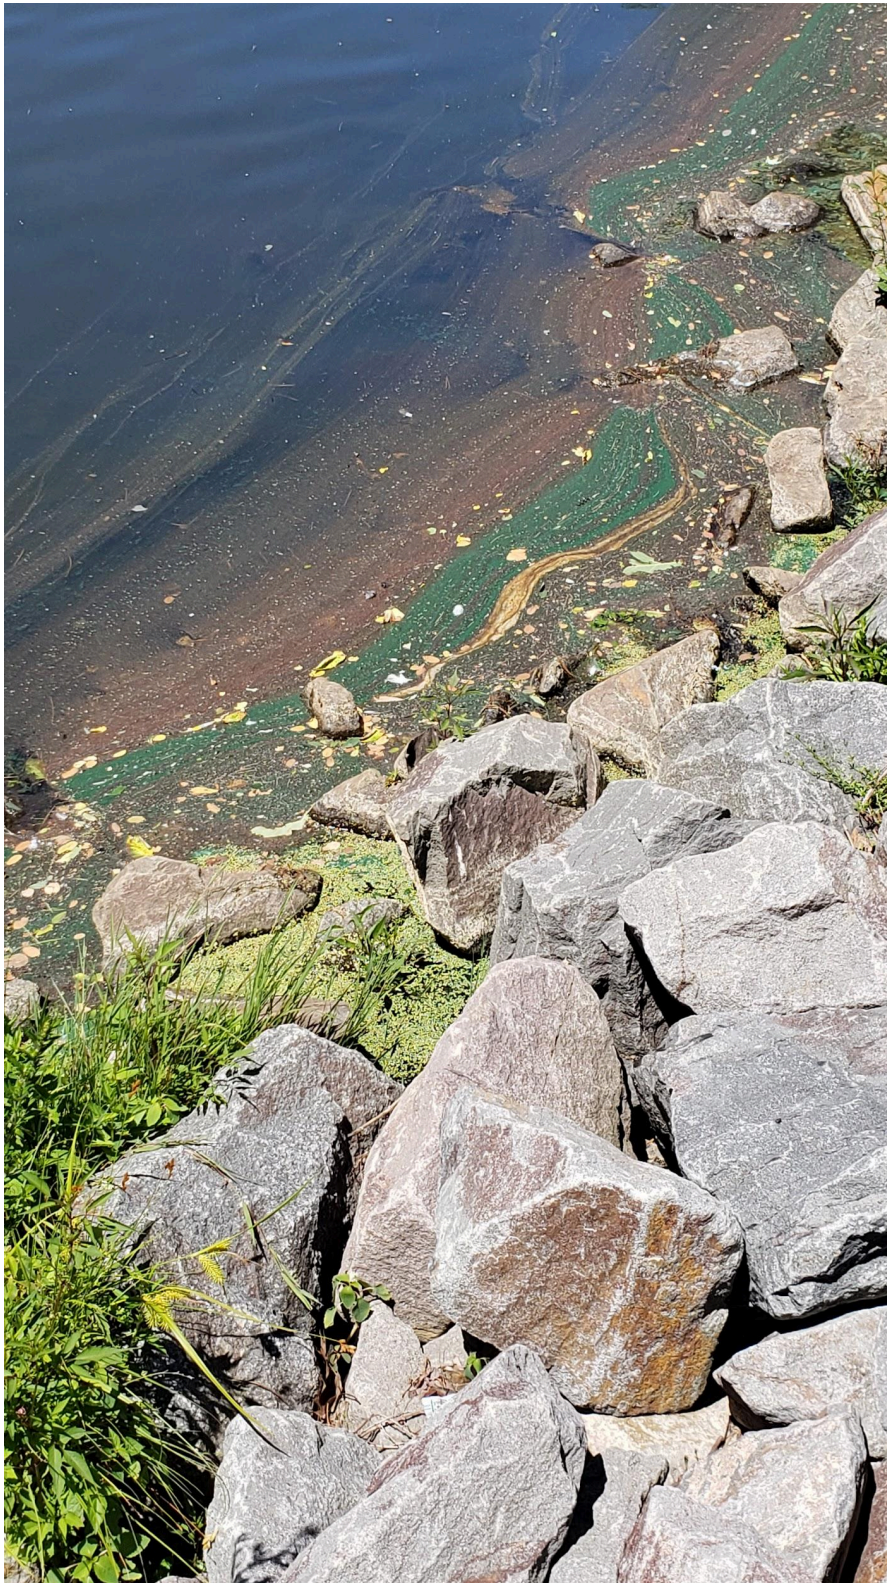
Photo 7

Around the shoreline of Patch Reservoir are many dead and declining trees of various species which corresponds well to the UTC canopy health results. The cause of shoreline tree decline is unclear, but it could be due to fluctuating water levels and saturated soils or to cyanobacterial blooms in the reservoir. Possible evidence of a cyanobacterial bloom was present during the June 28th visit as a dark emerald green scum around the edges of the reservoir.

Comments: A dark green scum, possibly cyanobacteria, was floating along reservoir edges during a late June visit.

6. Improve water quality and reduce sedimentation within the Reservoir and Pond.
 - a. Continue water quality monitoring efforts in collaboration with the Worcester Water Department, Worcester State University, and GWLT to identify challenges and opportunities for improvement.

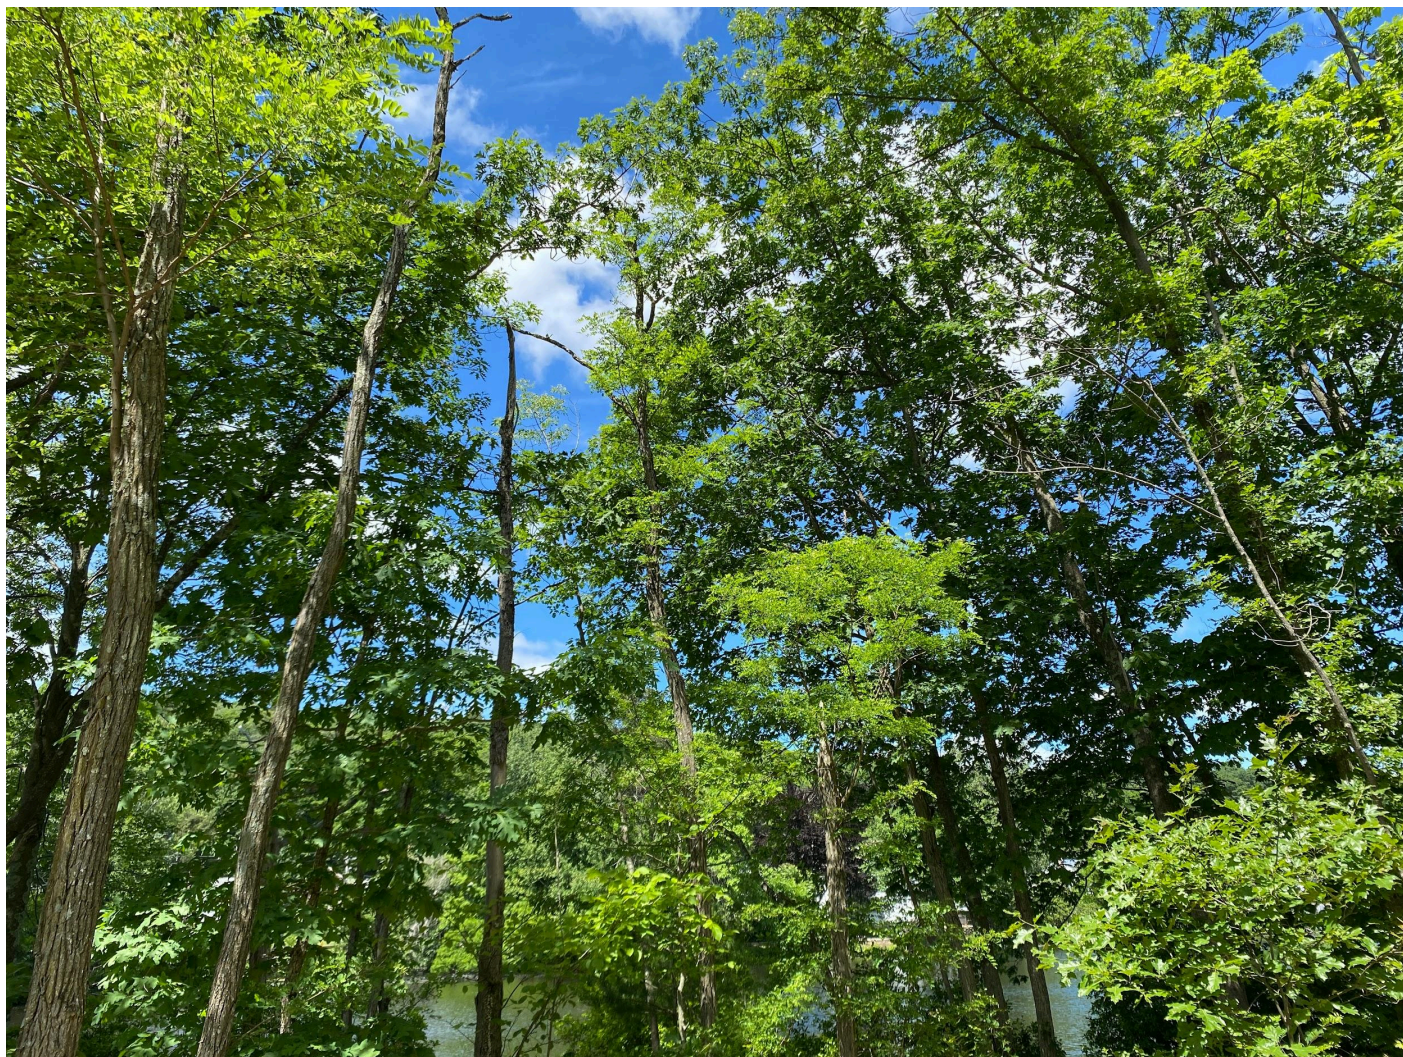
Photo 8

Comments: Trees in dead/dying condition are most common around the margins of the reservoir. The reason for dieback is unclear, although it may be related to saturated soils or harsher conditions on forest edges.

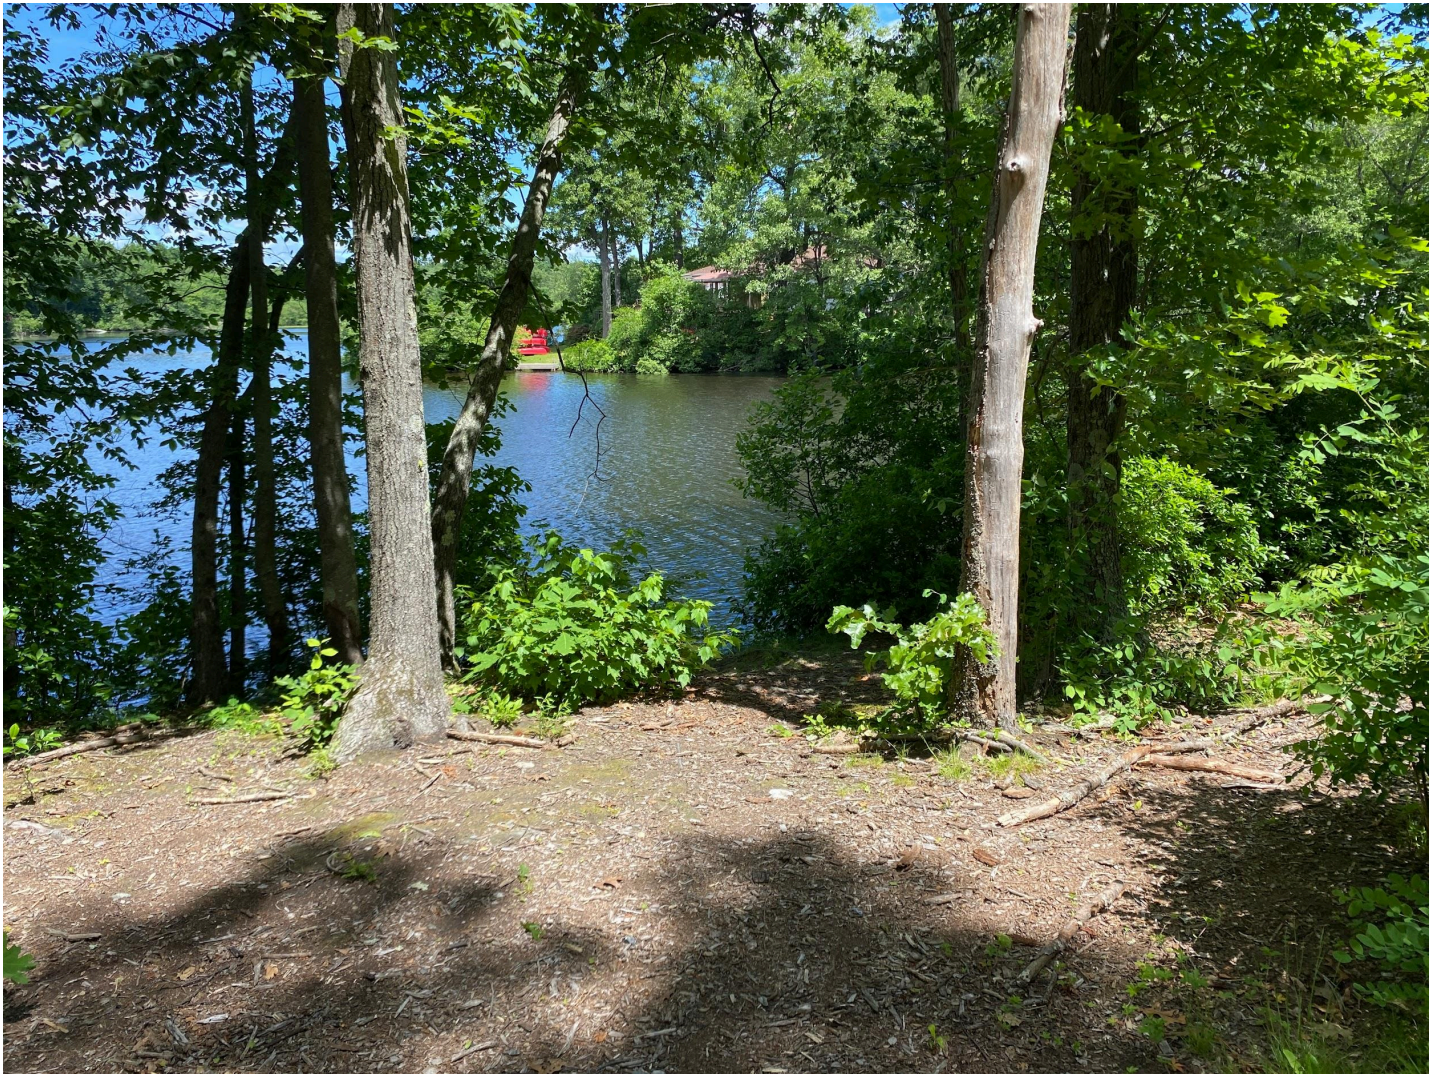
Photo 9

Comments: The blue trail appears to end at the shore with several lookout points over the reservoir. This end of the trail is somewhat overgrown.

- c. Monitor treated areas long-term to look for regrowth of invasive species from root or seed.
3. Maintain and improve trails.
 - a. Reestablish the blue loop trail or remove it from trail maps.

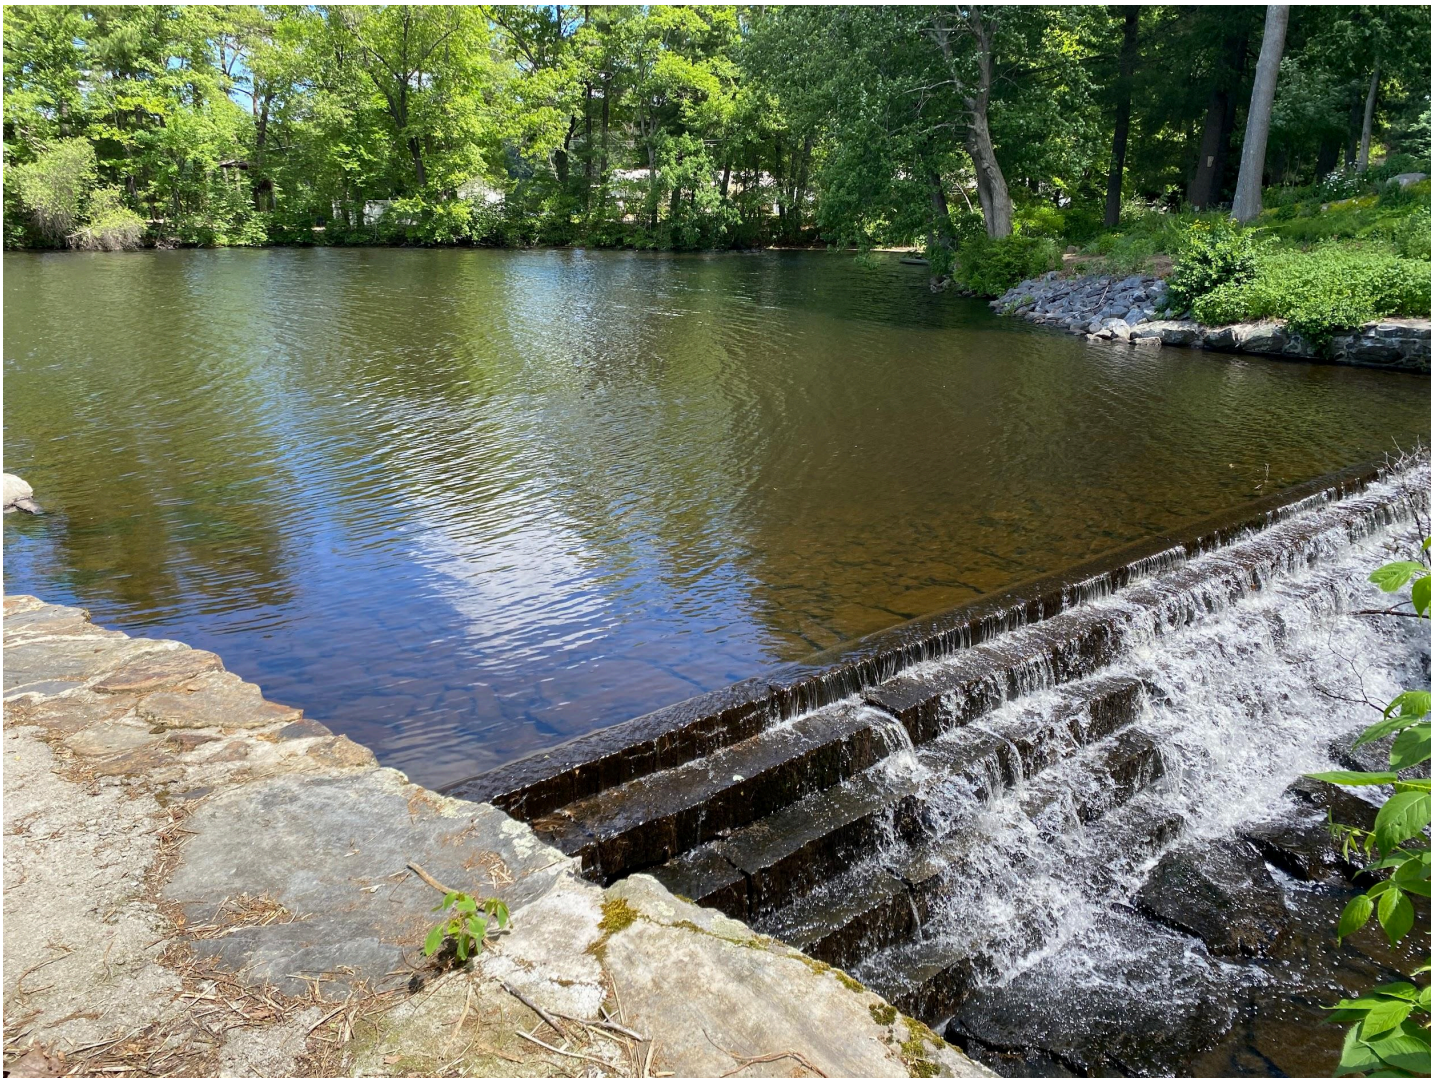
Photo 10

Comments: A dam at the end of the blue trail regulates water flow from the reservoir into Tatnuck Brook.

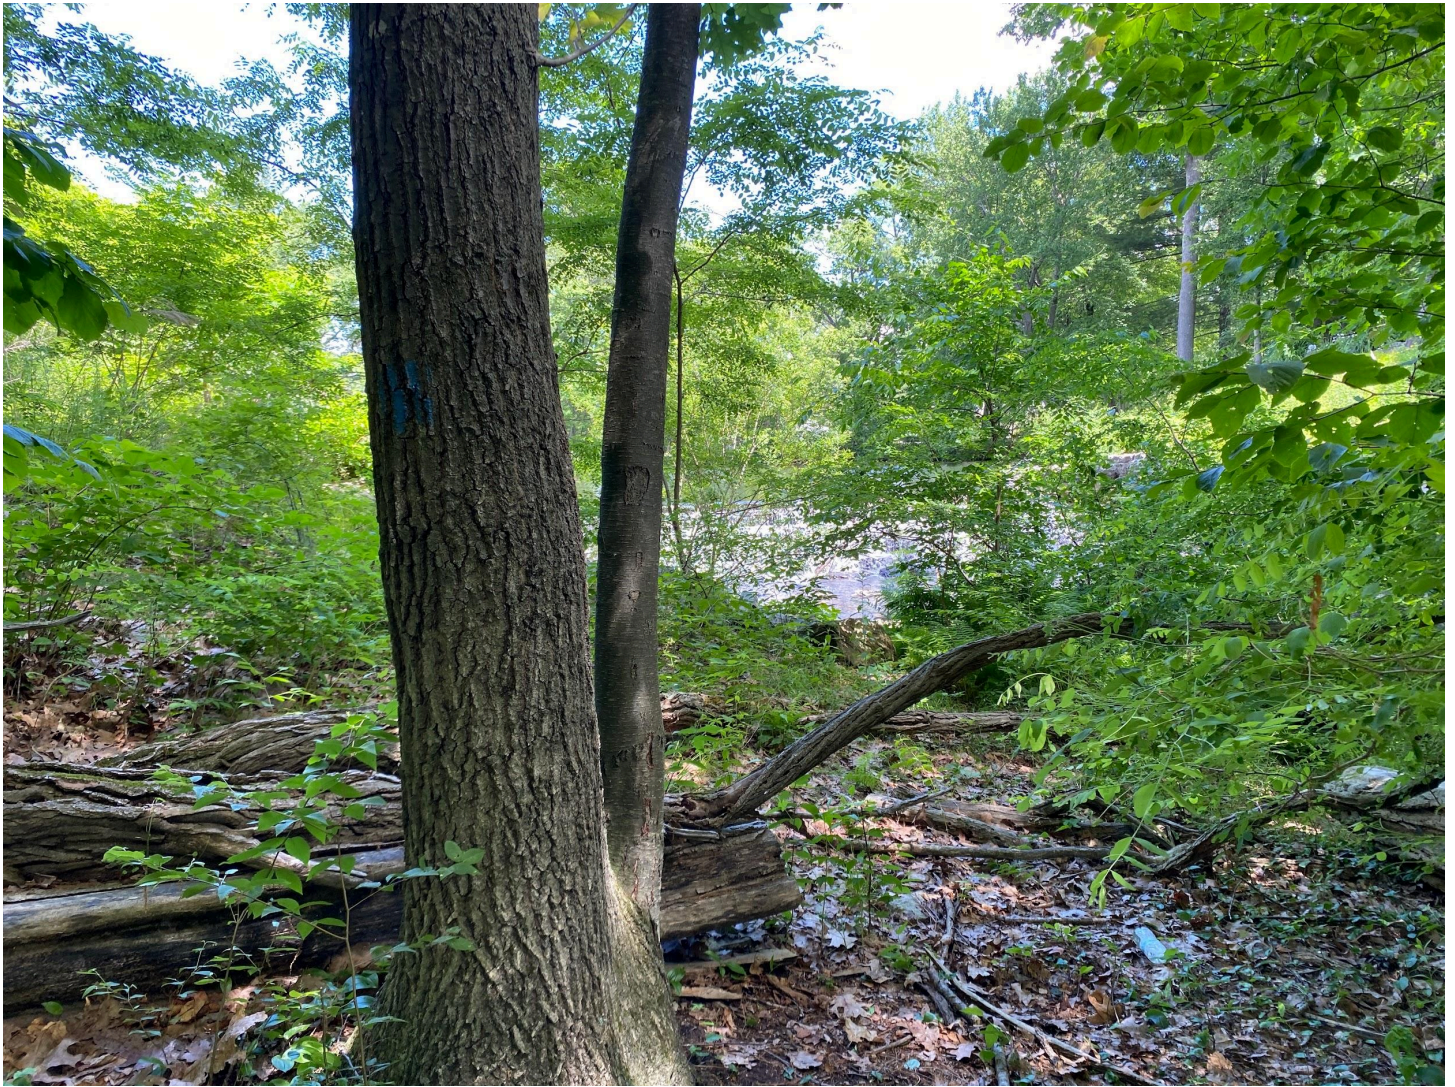
Photo 11

Comments: The blue loop trail is partially overgrown and difficult to spot, with faded blue blazes.

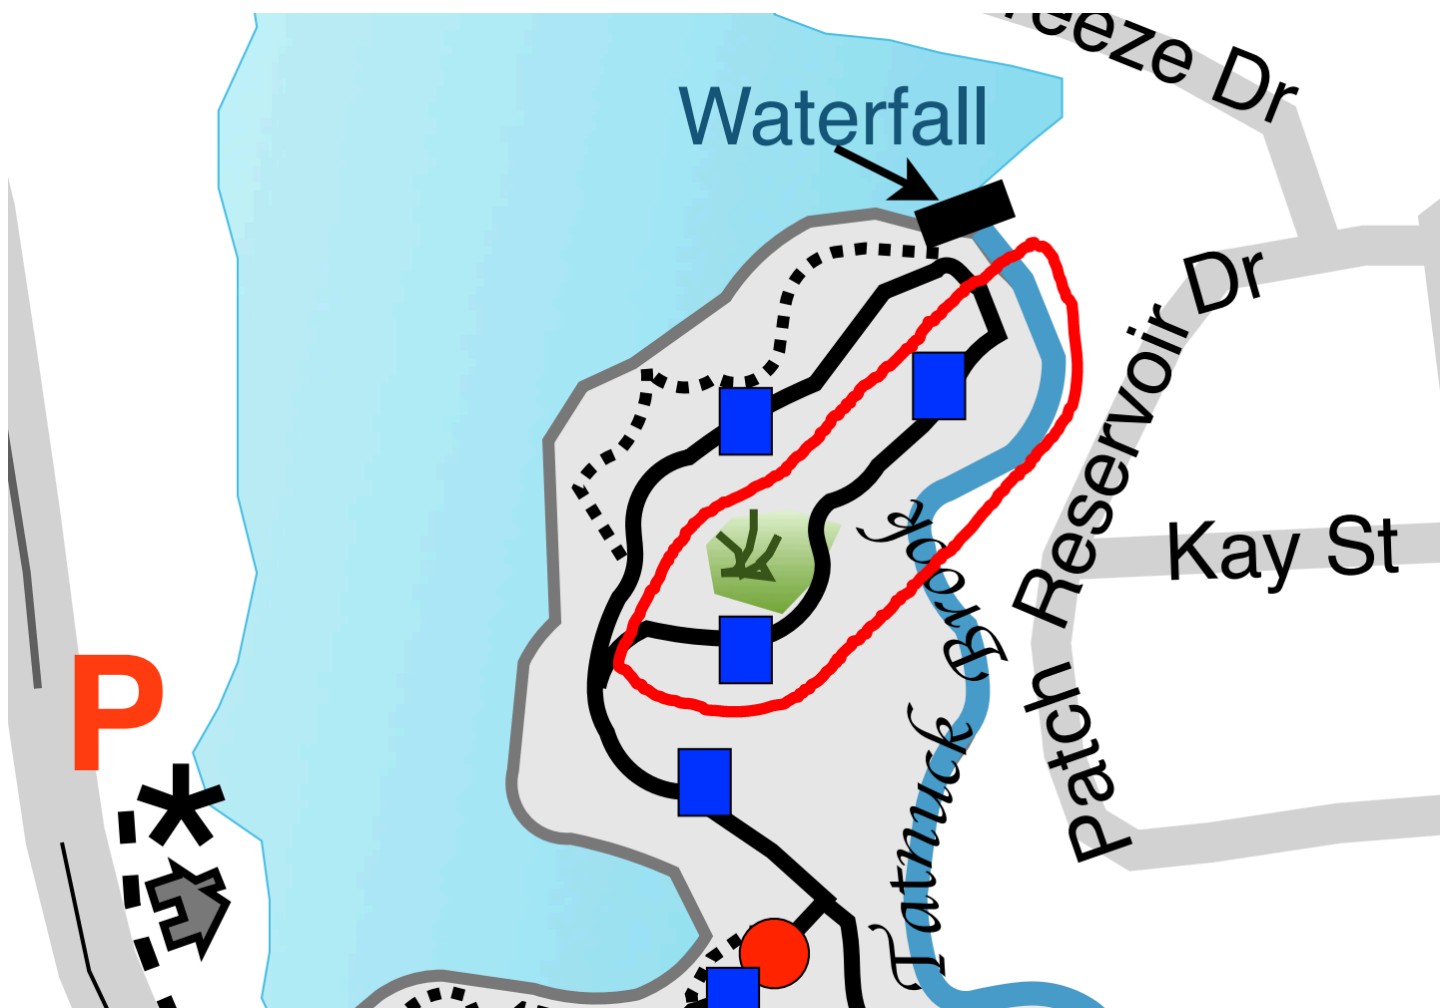
Photo 12

Comments: Image of the Hike Worcester map of Patch Reservoir trails indicating which portion of the blue loop trail is disused.

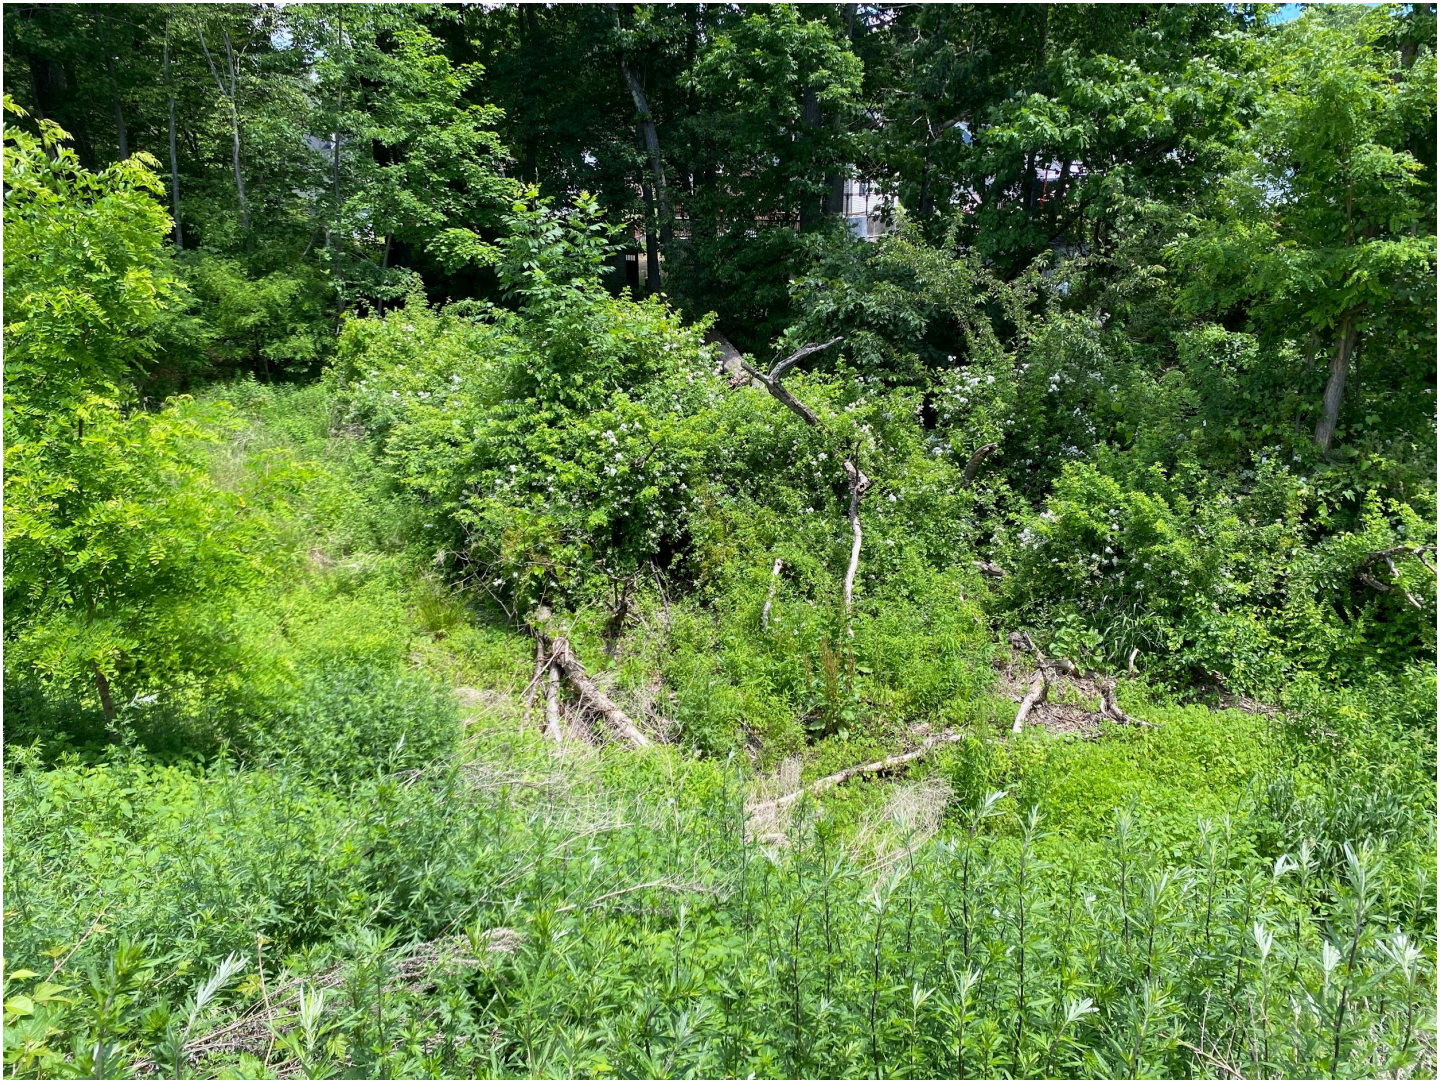
Photo 13

Comments: Where the raised southern reservoir border dips downward there is more multiflora rose and Oriental bittersweet.

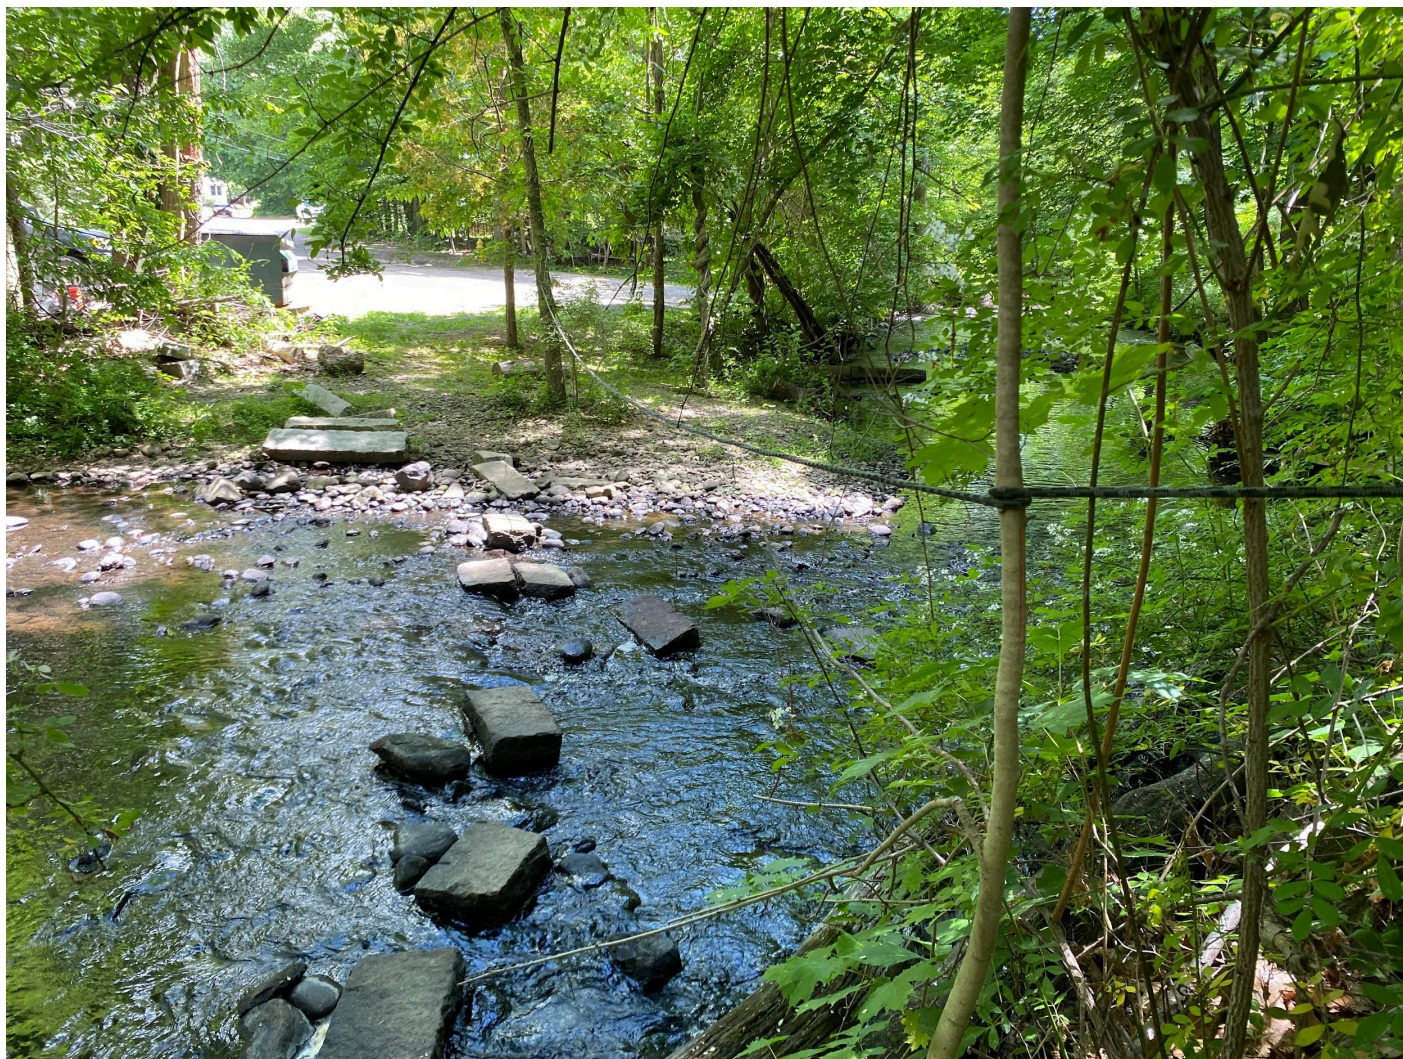
Photo 15

Comments: Access to the red trail from the end of Ada Street is aided by flat stones and a rope crossing Tatnuck Brook. These amenities may have been installed by property users rather than Worcester officials.

- b. Improve the Tatnuck Brook crossing from Ada Street.
 - c. Determine if trails can be rerouted or widened to lessen the necessity for handles attached to trees.
