WORCESTER CONSERVATION COMMISSION

Patch Pond and Reservoir

Conservation Property Baseline Assessment

July 2024

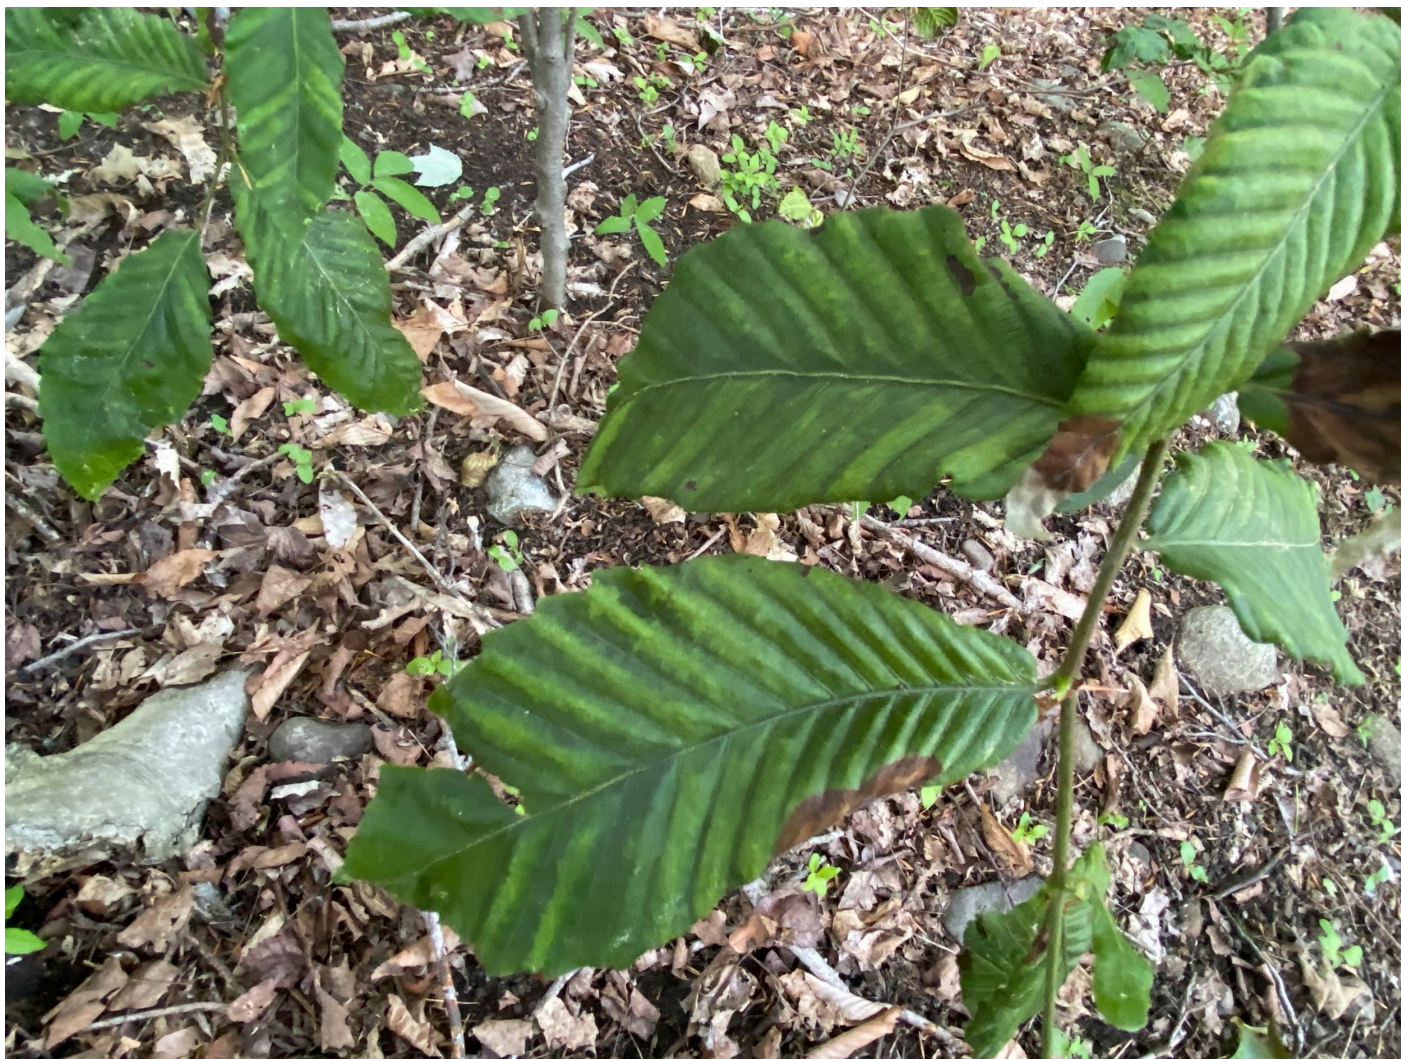
Photo 16

Comments: Beech leaf disease is affecting all American beech (*Fagus grandifolia*) on the property, which may explain patches of poor canopy health.

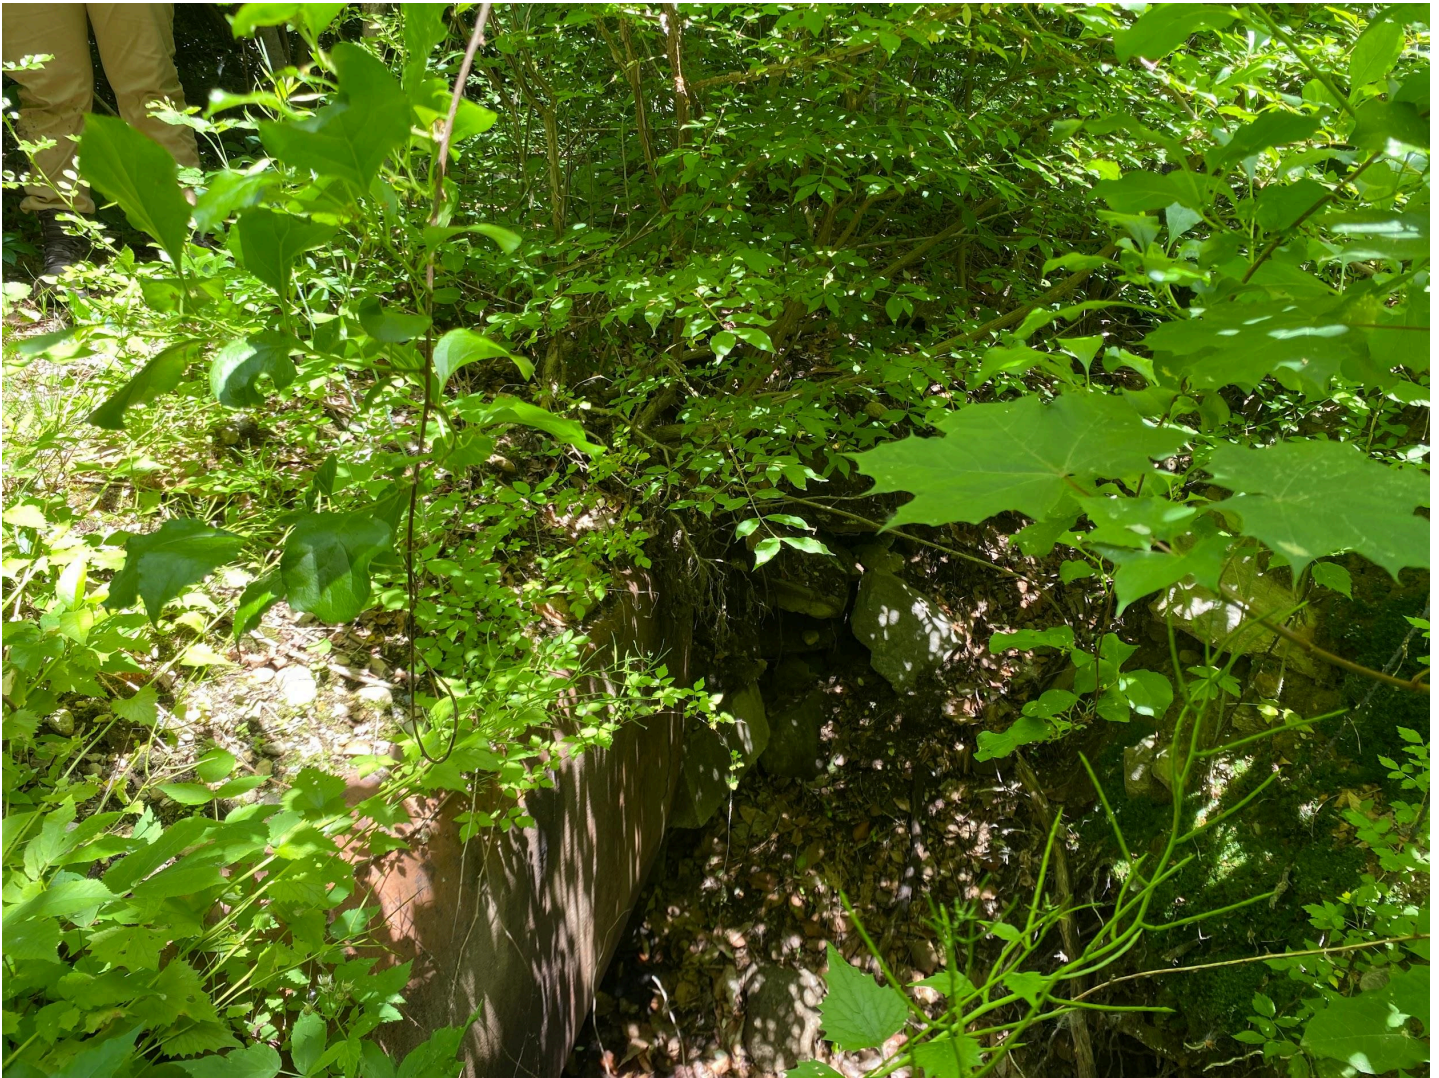
Photo 17

Comments: A dangerous drop-off to the southern side of the red trail, possibly caused by an uprooted tree, is not easily visible or marked. DRG added pink flagging as a temporary measure to identify the hazard.

- d. Reroute trail and/or improve visibility of the dropoff hazard along the red loop trail.
 - e. Manage Japanese knotweed infestations around the red loop trail to improve trail visibility.

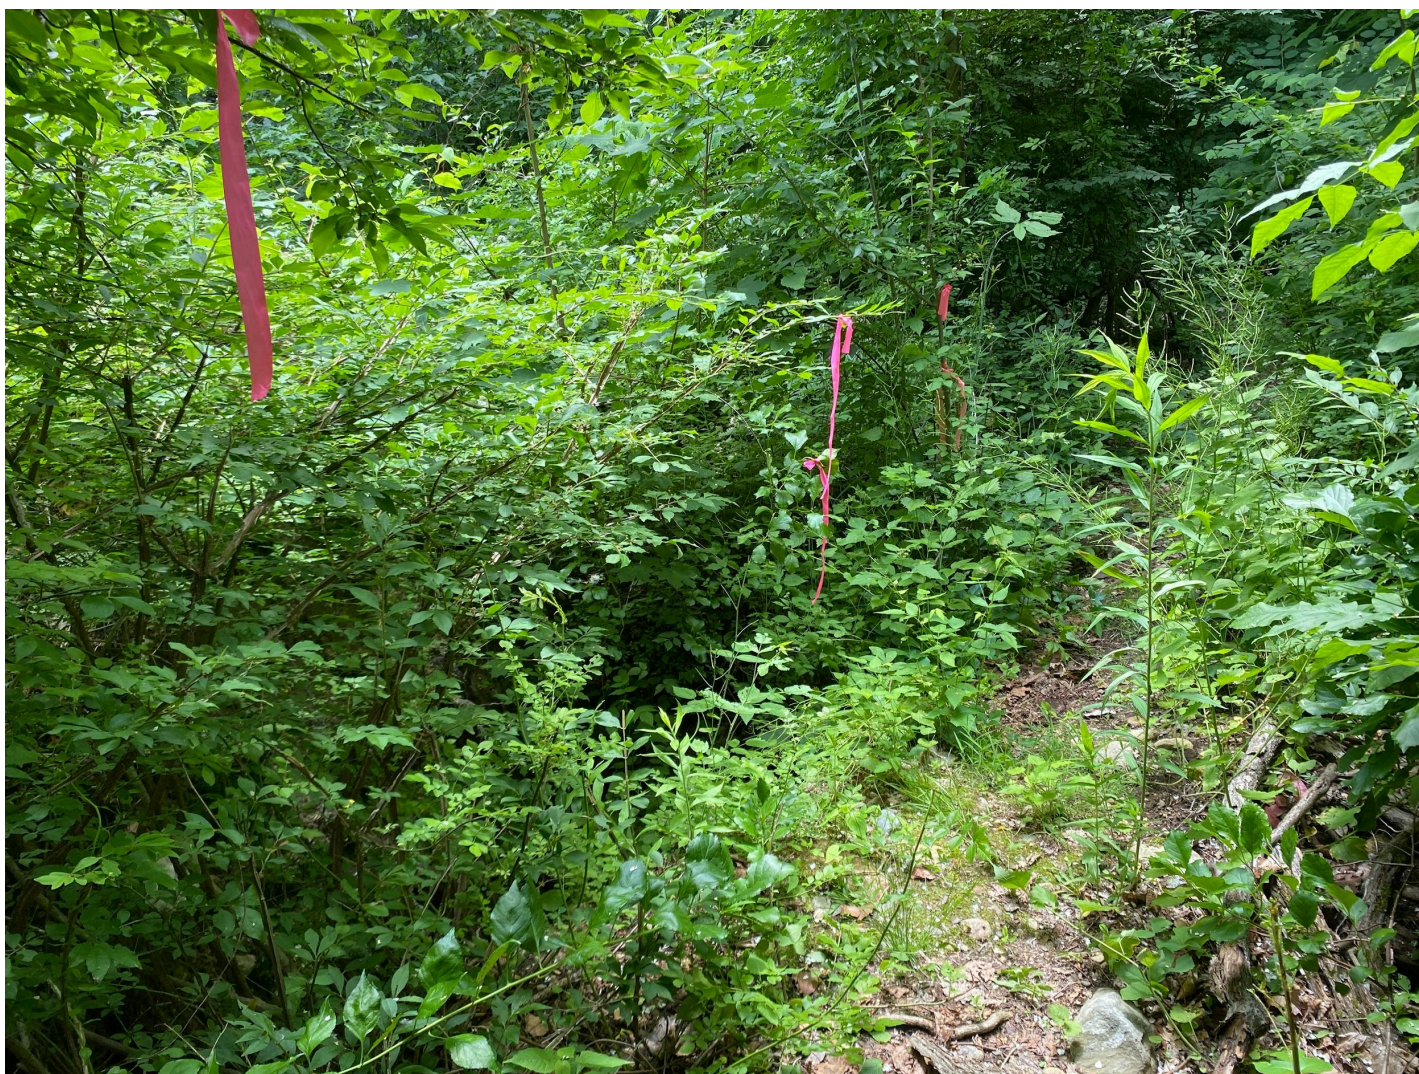
Photo 18

Comments: A dangerous drop-off to the southern side of the red trail, possibly caused by an uprooted tree, is not easily visible or marked. DRG added pink flagging as a temporary measure to identify the hazard.

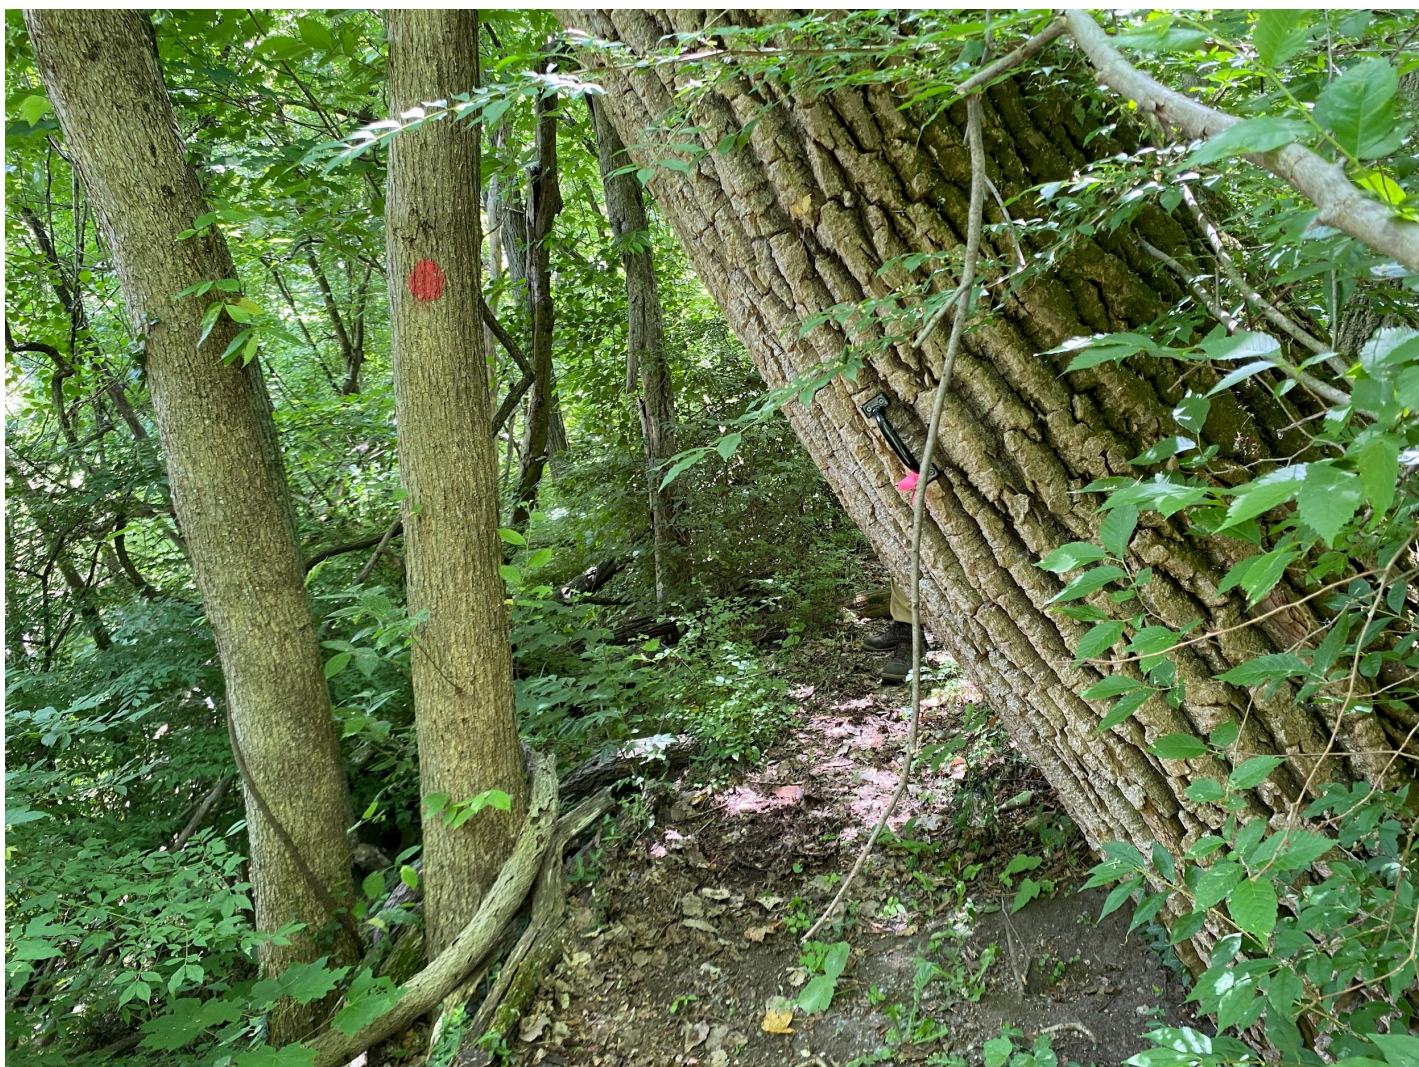
Photo 19

Comments: The trail slopes sharply on the southern side and a large, partially fallen cottonwood makes trail navigation difficult. Handles have been attached to the tree to aid hikers in navigating this portion of trail.

- b. Improve the Tatnuck Brook crossing from Ada Street.
 - c. Determine if trails can be rerouted or widened to lessen the necessity for handles attached to trees.

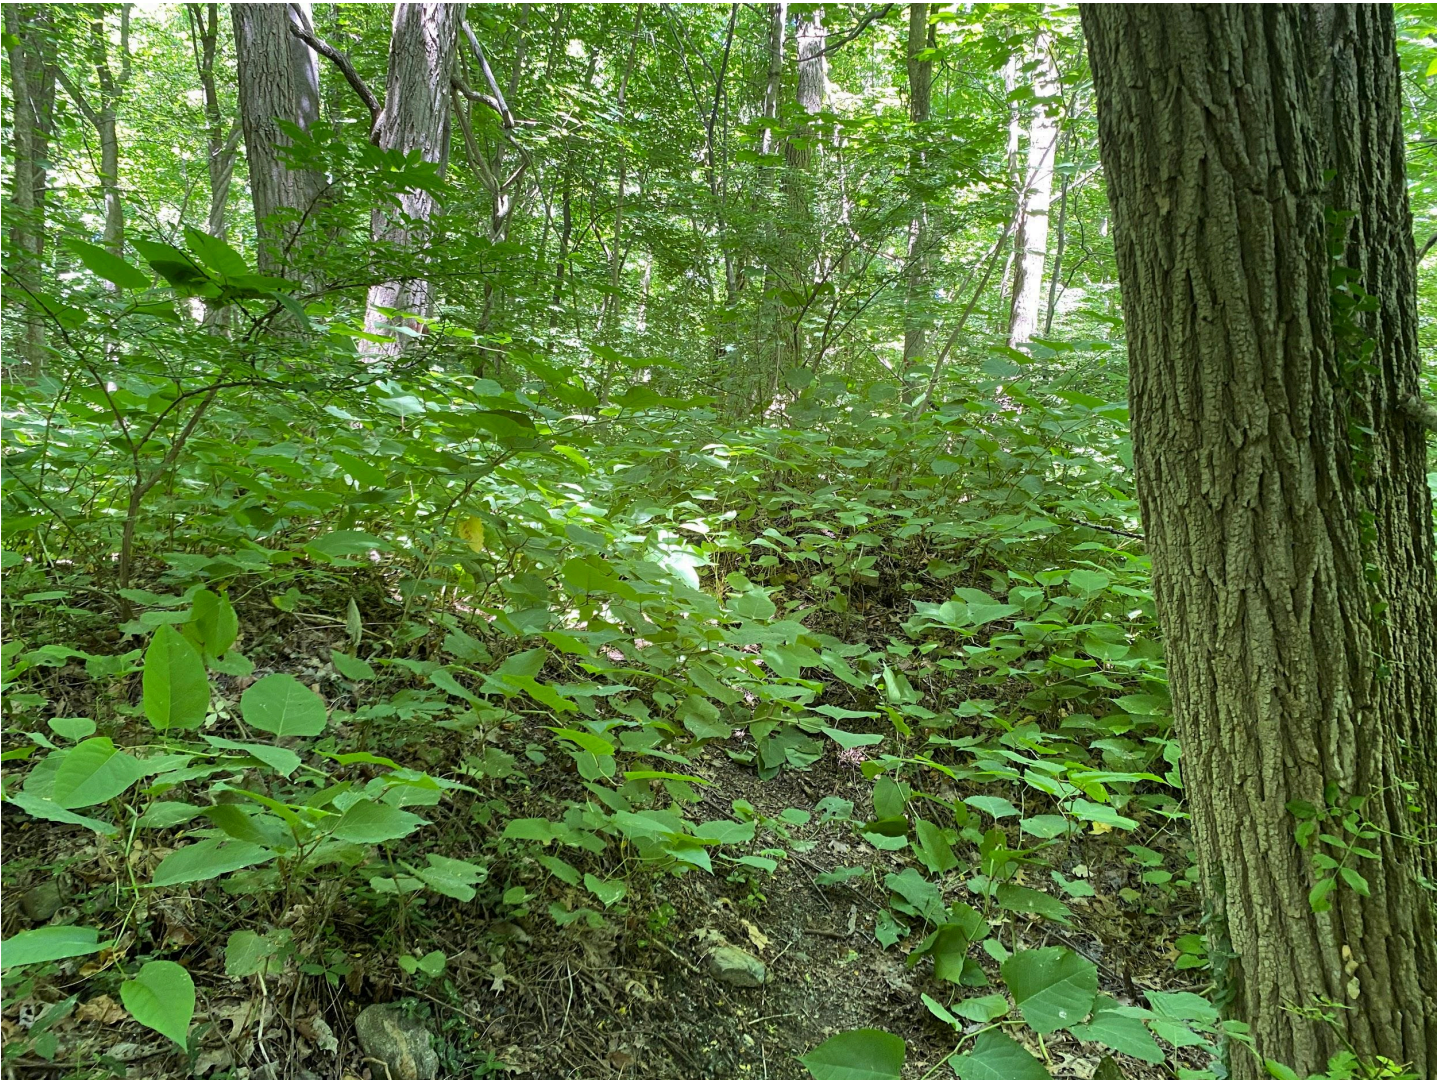
Photo 20

Comments: A portion of the trail is being overgrown with Japanese knotweed (*Reynoutria japonica*).

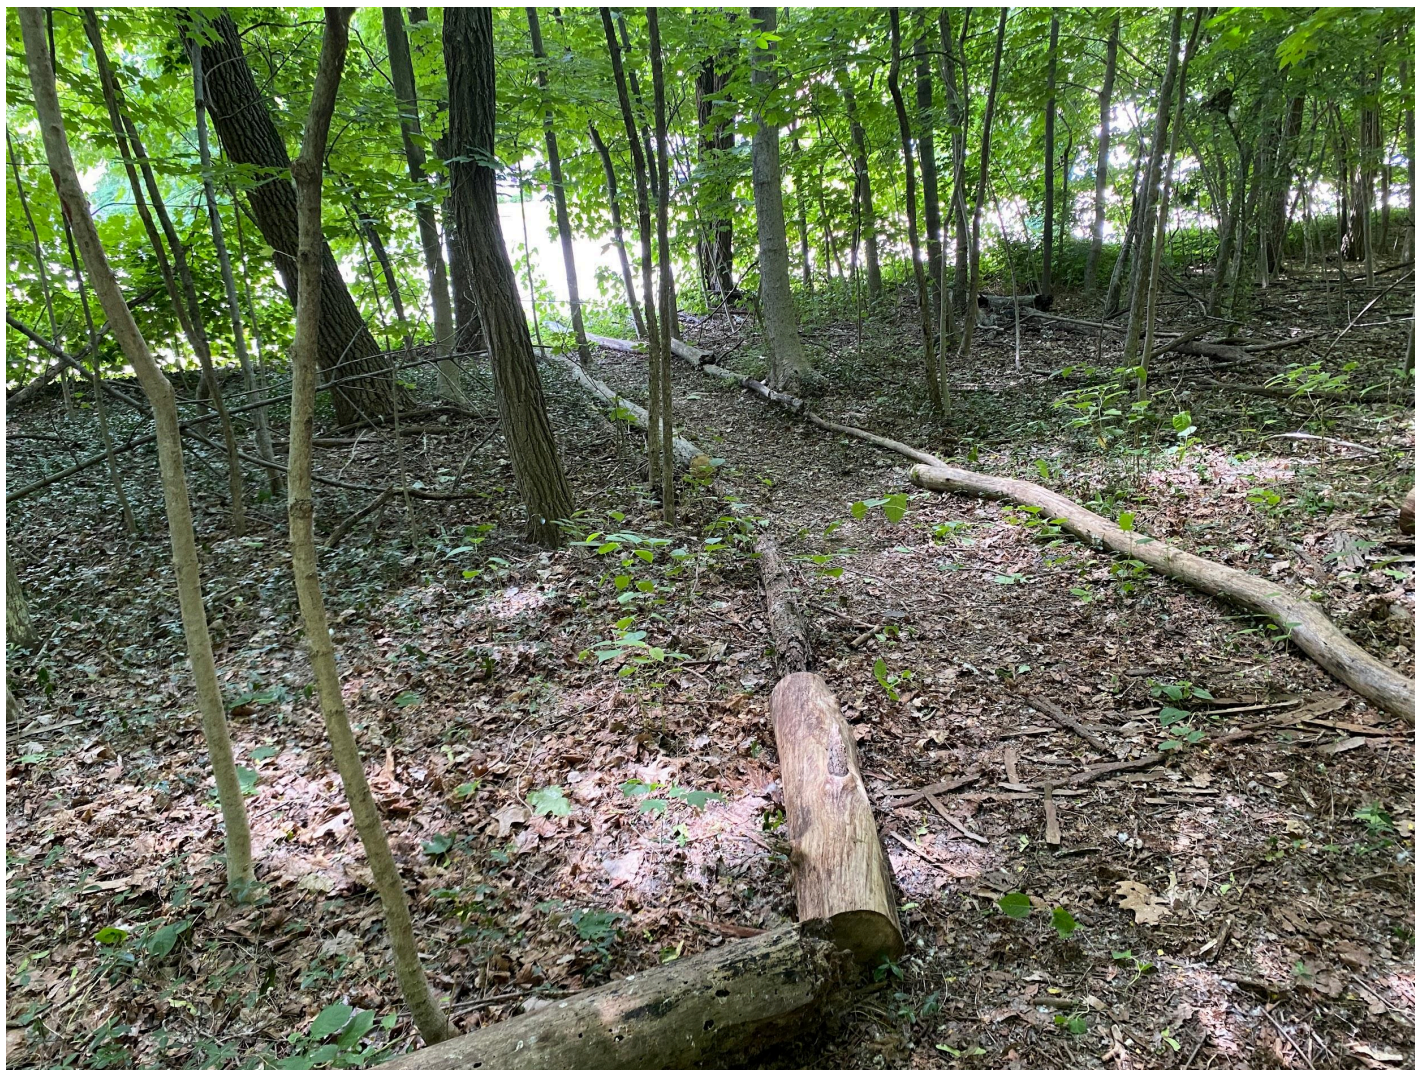
Photo 21

Comments: The trailhead across from Midgley Avenue is lined with fallen logs.

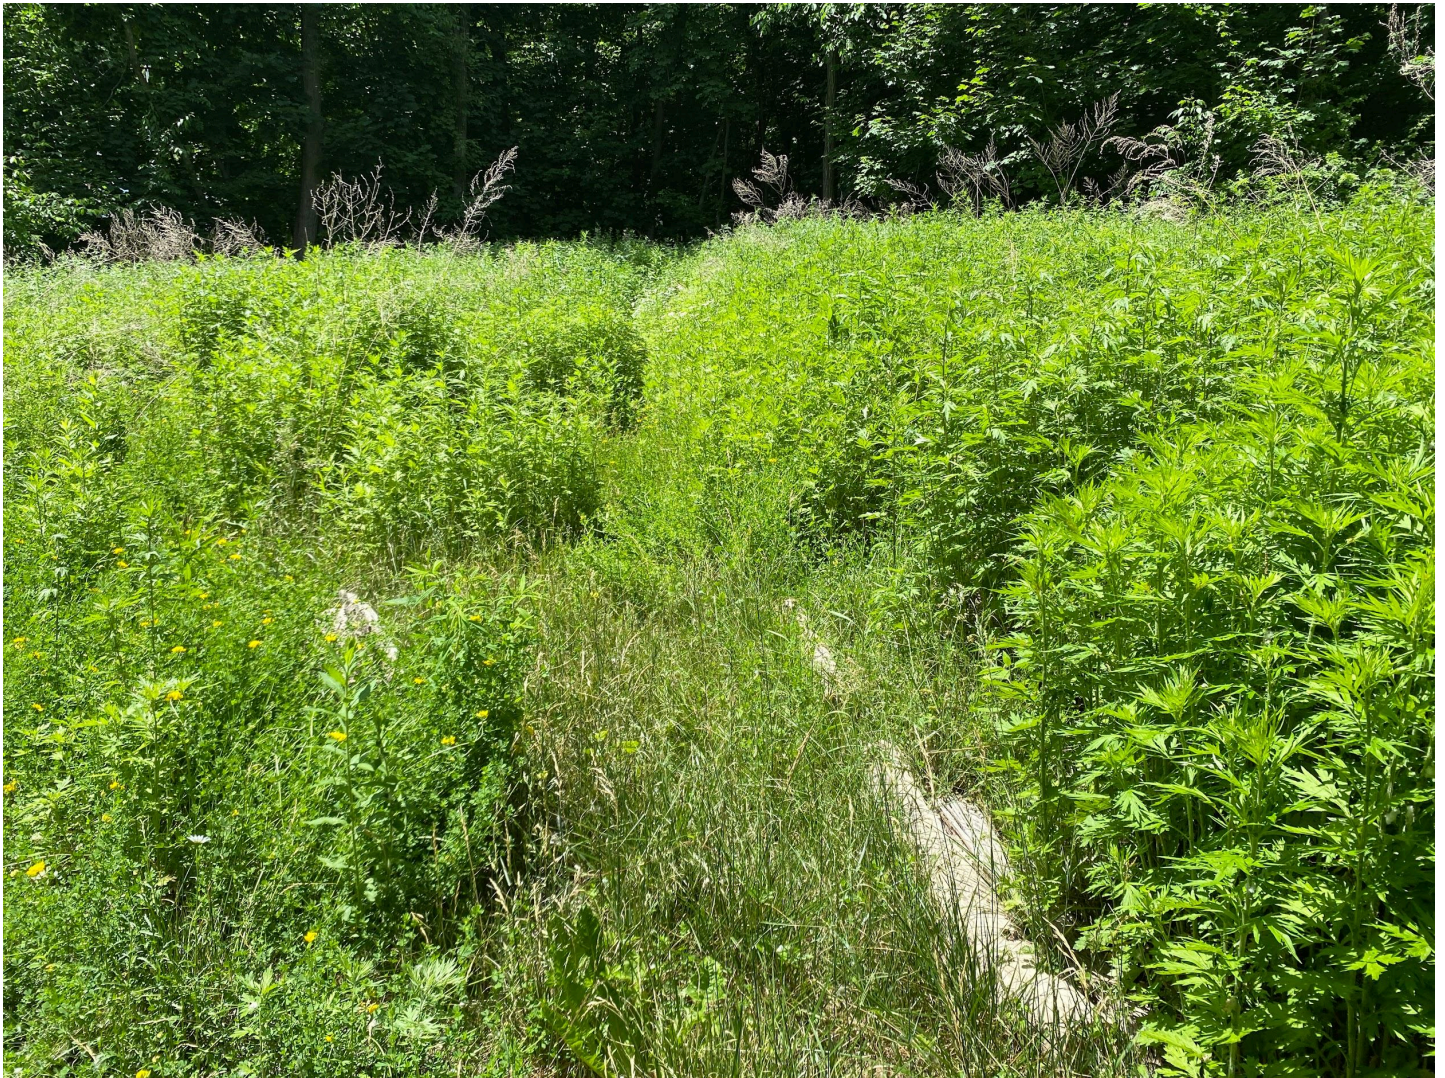
Photo 22

Comments: Where the access road crosses the red trail, the trail is heavily overgrown with meadow vegetation. No trail markings indicate how to return to the trail.

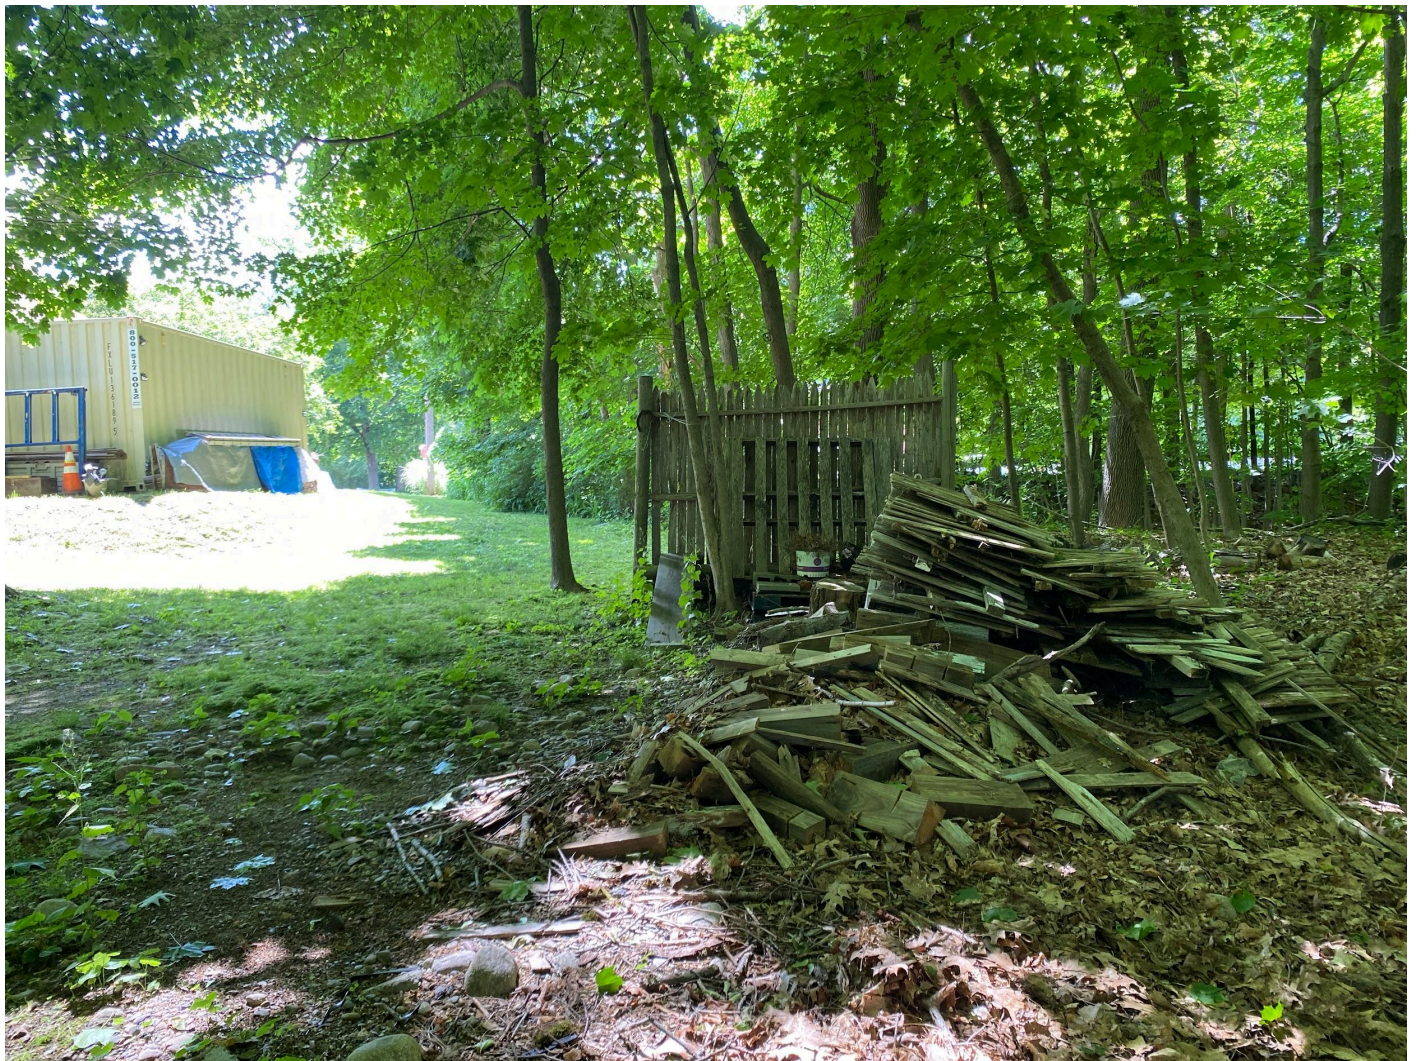
Photo 23

Comments: The yard of 518 Mill Street appears to extend into the reservoir property. There is a pile of dumped wood scraps.

4. Pursue options to mitigate current encroachment and prevent further encroachment around boundaries with 518 Mill Street and 15 Patch Reservoir Drive.

- a. Cease and desist and other legal measures to stop imminent and ongoing encroachment.
 - b. Consider more collaborative and outreach-based efforts to develop better relationships with abutters and educate about the harm that encroachment can cause to conservation property.

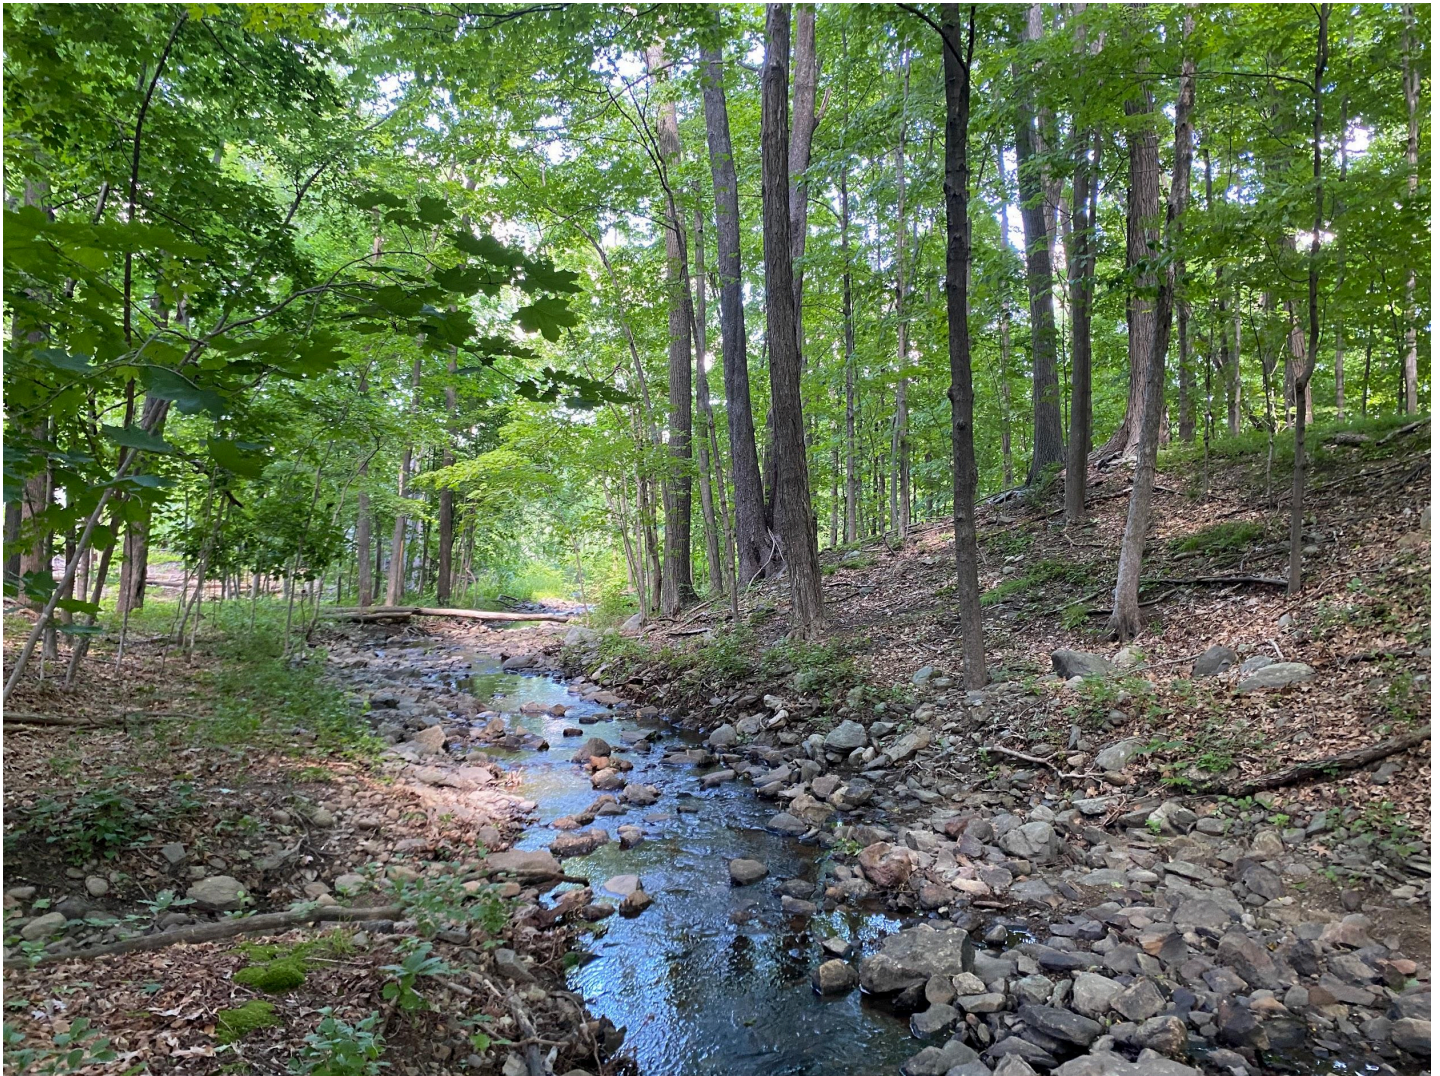
Photo 24

Comments: A stream runs through the northwestern portion of the reservoir property. There are no trails or access to this piece of the property.

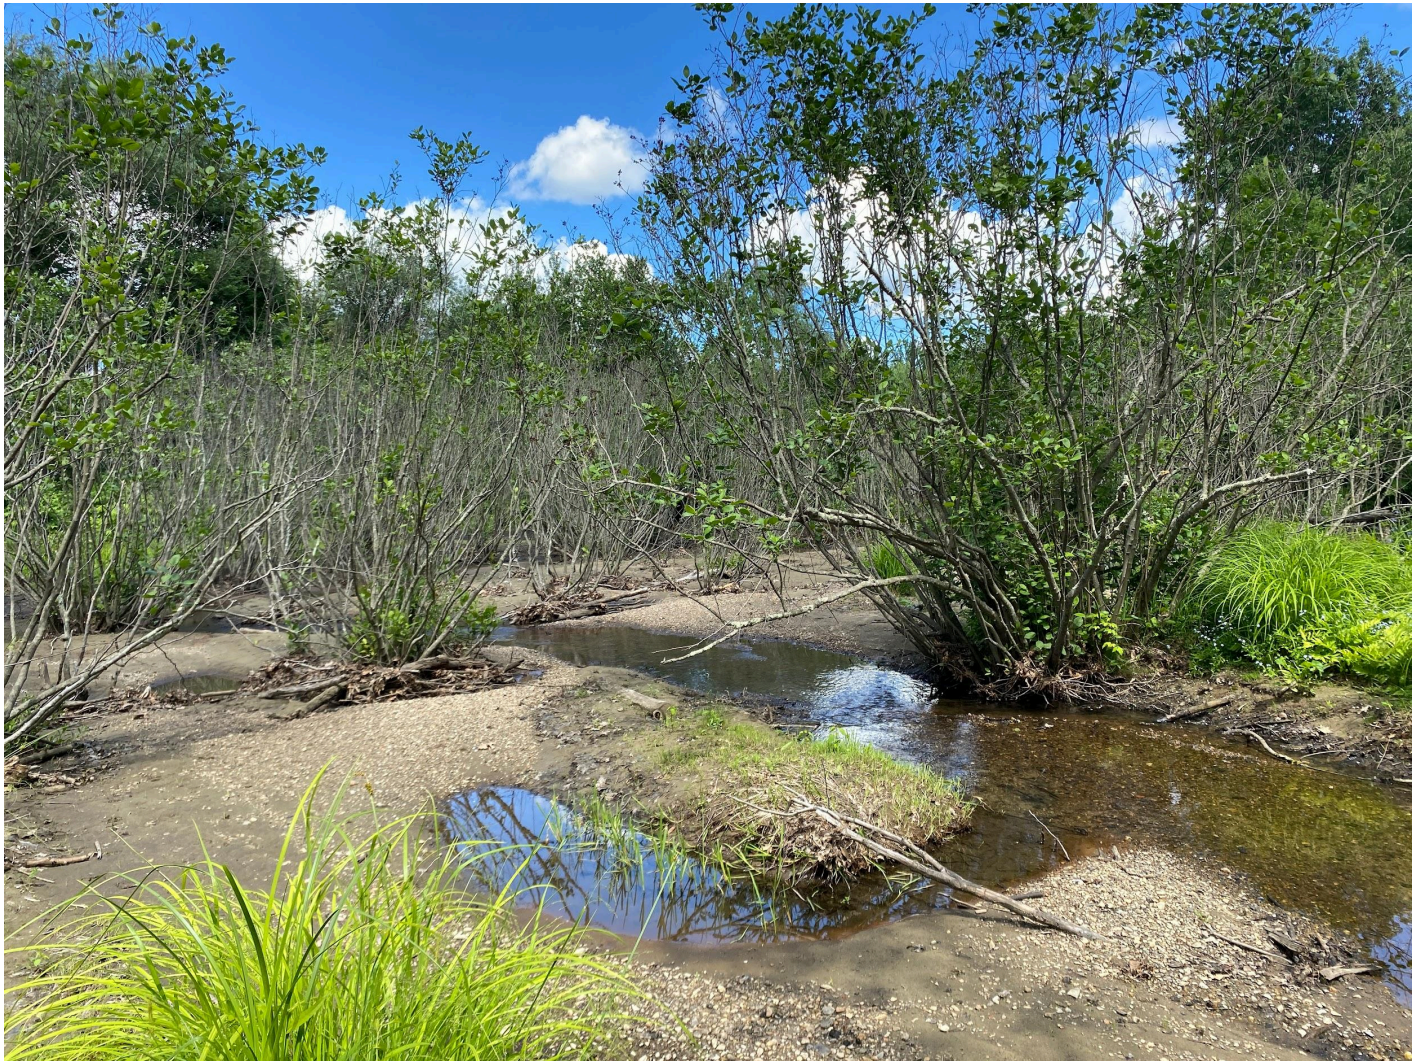
Photo 25

Comments: Tatnuck Brook flows into the reservoir through a wooded deciduous swamp.
