WORCESTER CONSERVATION COMMISSION

Wayside Conservation Area

Conservation Property Baseline Assessment

July 2024

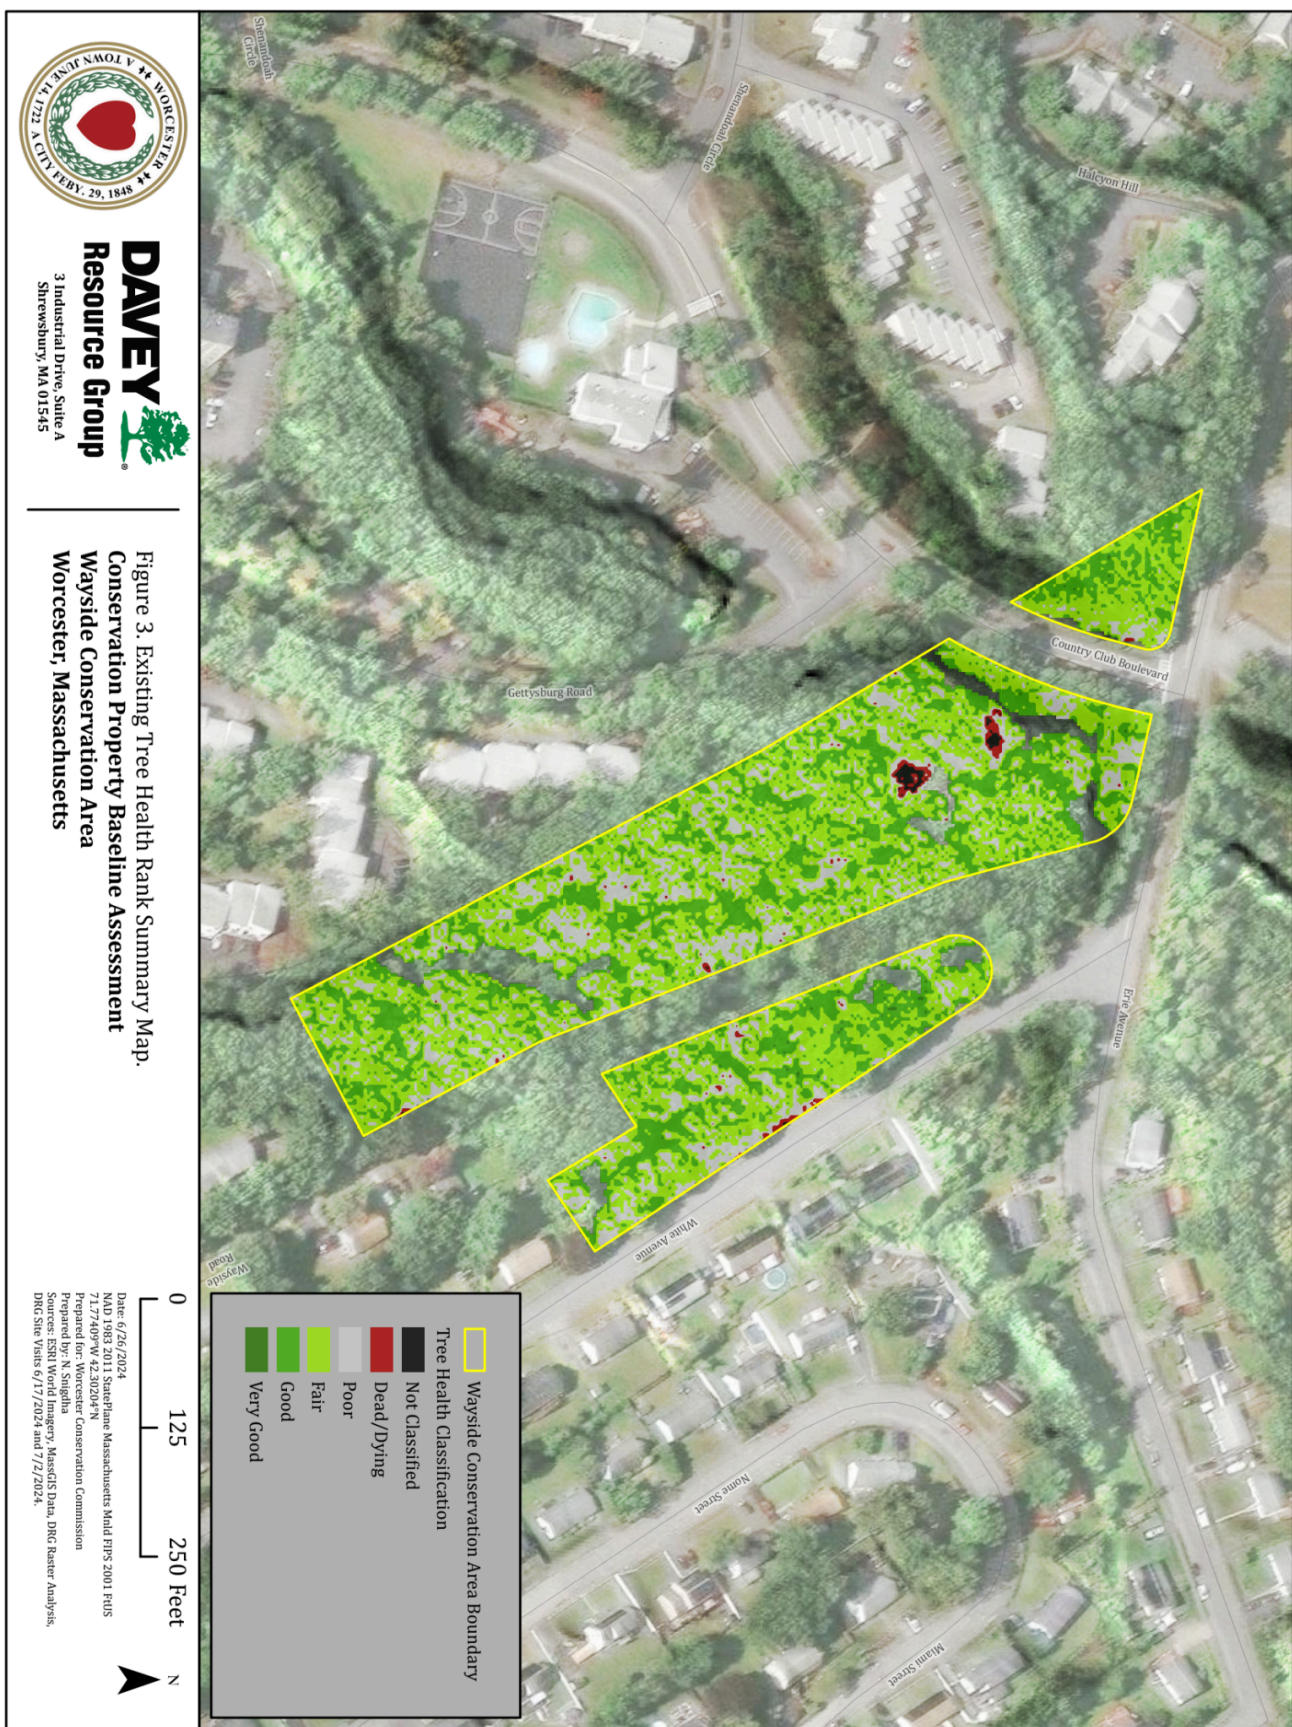
Map 3: Existing tree health rank summary map.

Patches of poor canopy health in the UTC assessment appear to correspond to wet areas of the property where tree roots are periodically submerged under water. Although most trees can tolerate occasional inundation, prolonged periods spent with roots underwater have the potential to cause suffocation and root dieback, leading to declines in overall tree health and even death. The high diversity in tree species observed at the property is likely to contribute to canopy persisting on the landscape even as precipitation regimes change due to climate change, as those better suited to wet conditions will be able to grow into the canopy as those less suited fail.

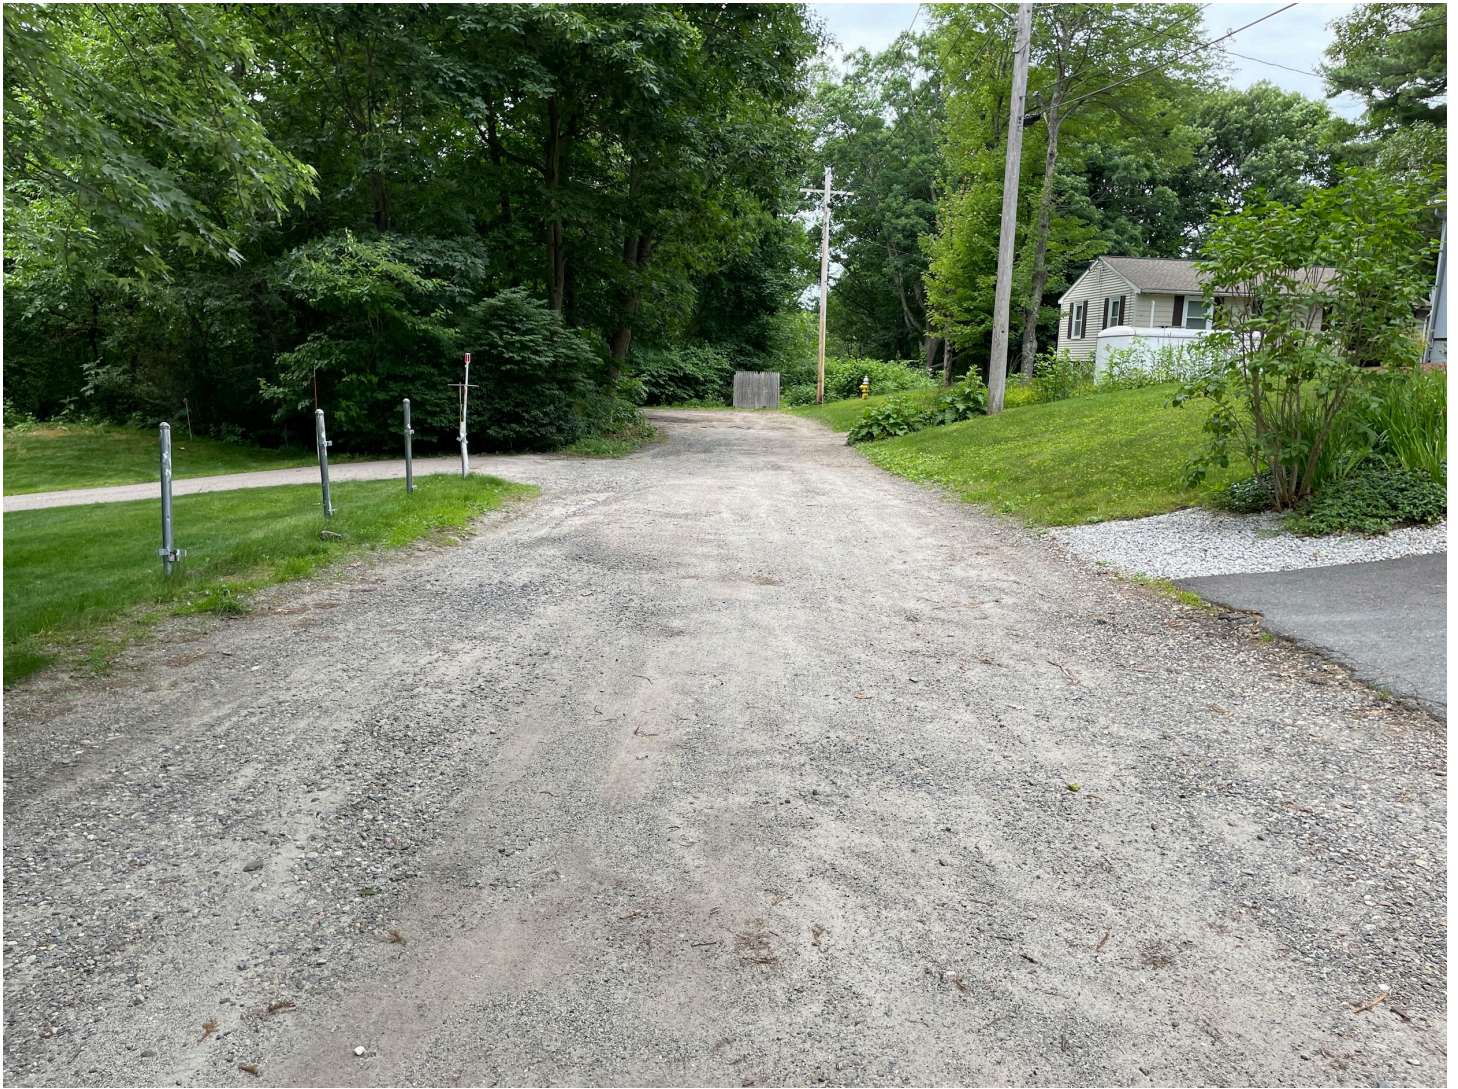
Photo 1

Comments: There is no signage indicating a conservation property or prohibited uses at the end of Wayside Road.

- b. Post signage to mark the boundary of the conservation property and signs prohibiting dumping at the Wayside Road and along White Avenue.
 - c. Work with abutting residents to provide/educate about alternative options for yard waste disposal and the damage it can cause when dumped in conservation land.

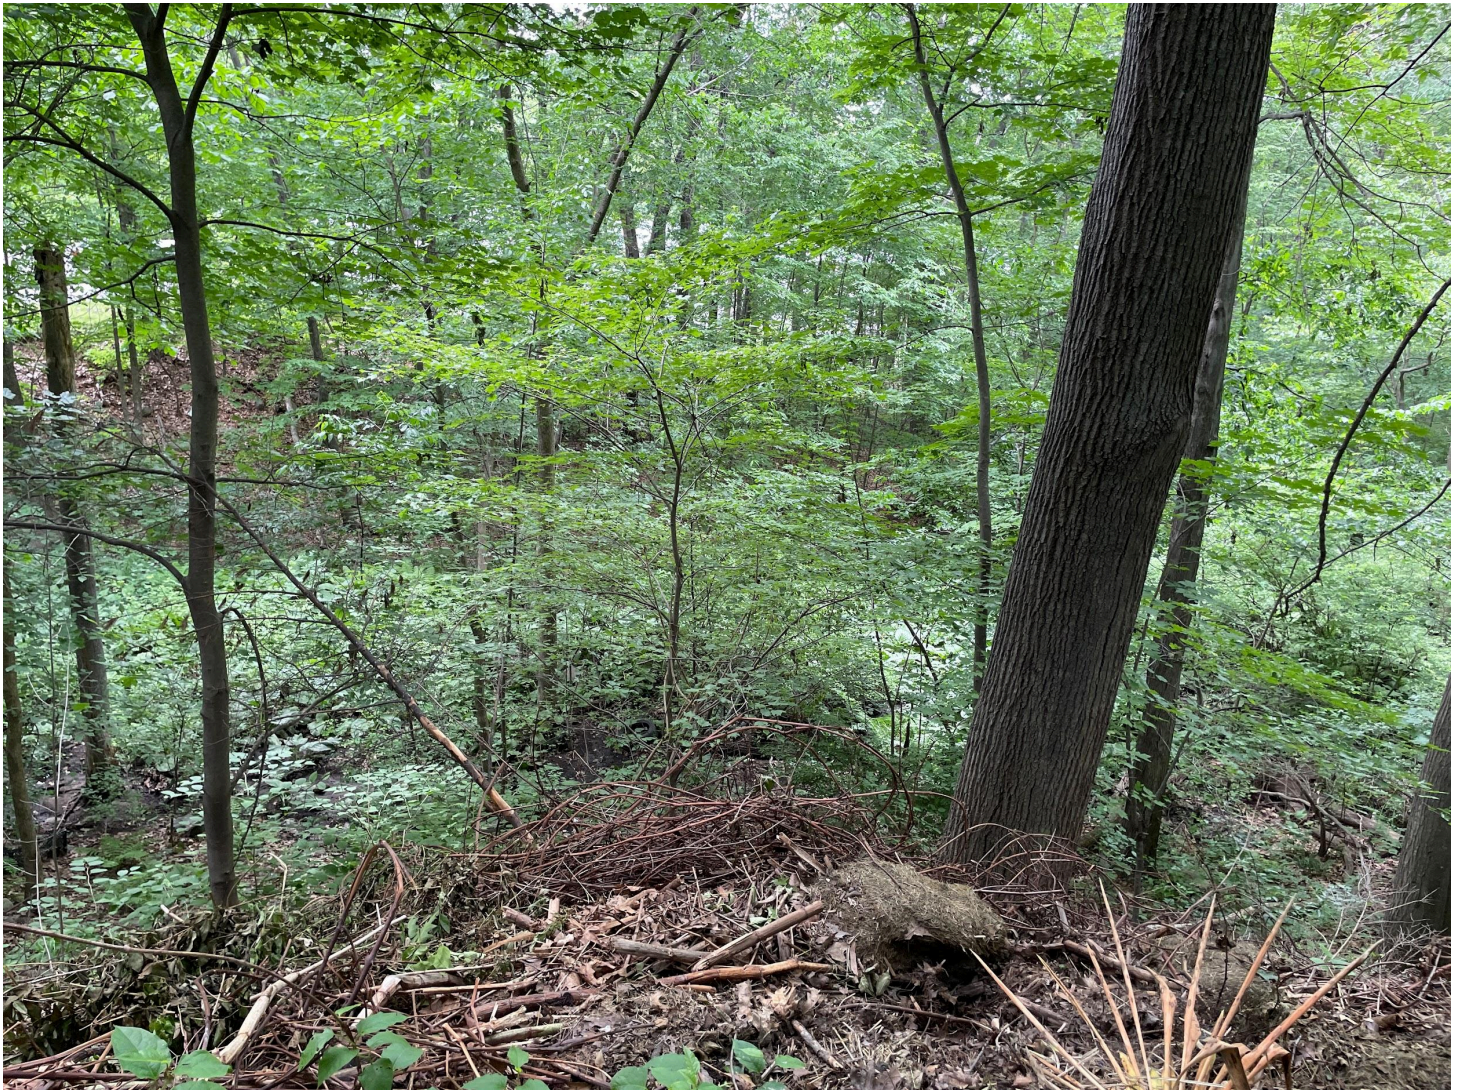
Photo 2

Comments: Large pile of dumped yard waste at the end of Wayside Road.

2. Take steps to reduce or eliminate yard waste dumping along property edges.
 - a. Remove existing yard waste piles and reseed the ground to stabilize the bank and reduce the likelihood of invasive species taking roots in the disturbed areas.

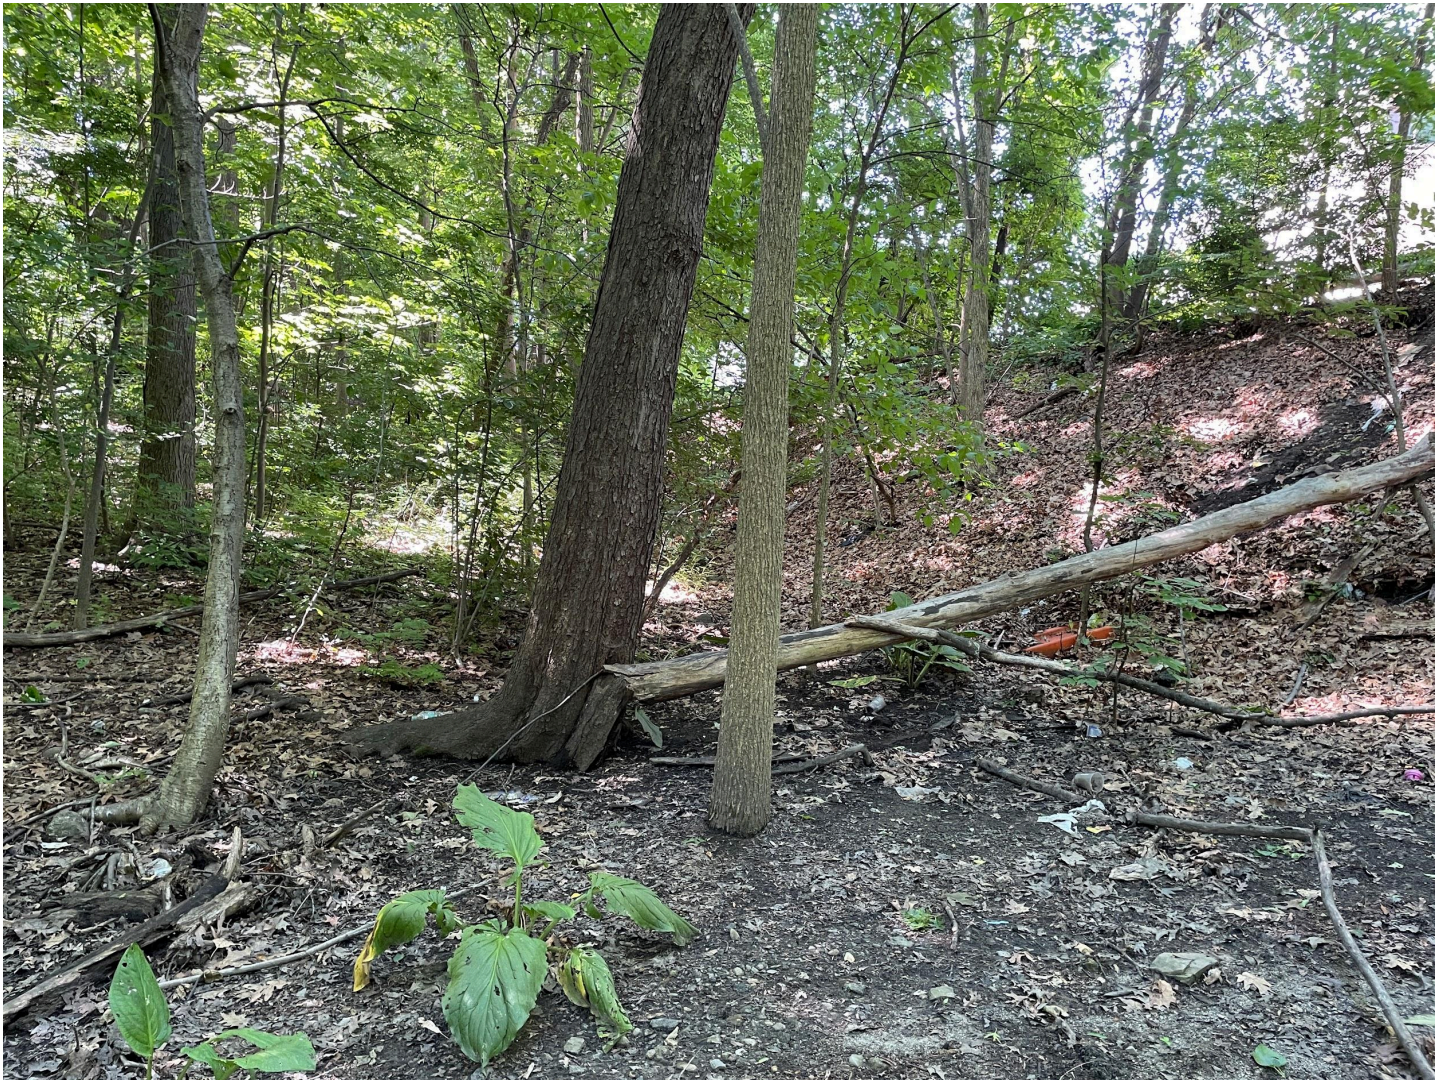
Photo 3

Comments: Stormwater contribution to Wayside from condos to the west. The wetland can be viewed from the end of Wayside Road.

- d. Track how changing precipitation patterns may be affecting tree canopy health.
4. Determine if the discharge from behind the condominium to the southwest portion of the conservation area is appropriate and if it requires approval or management.

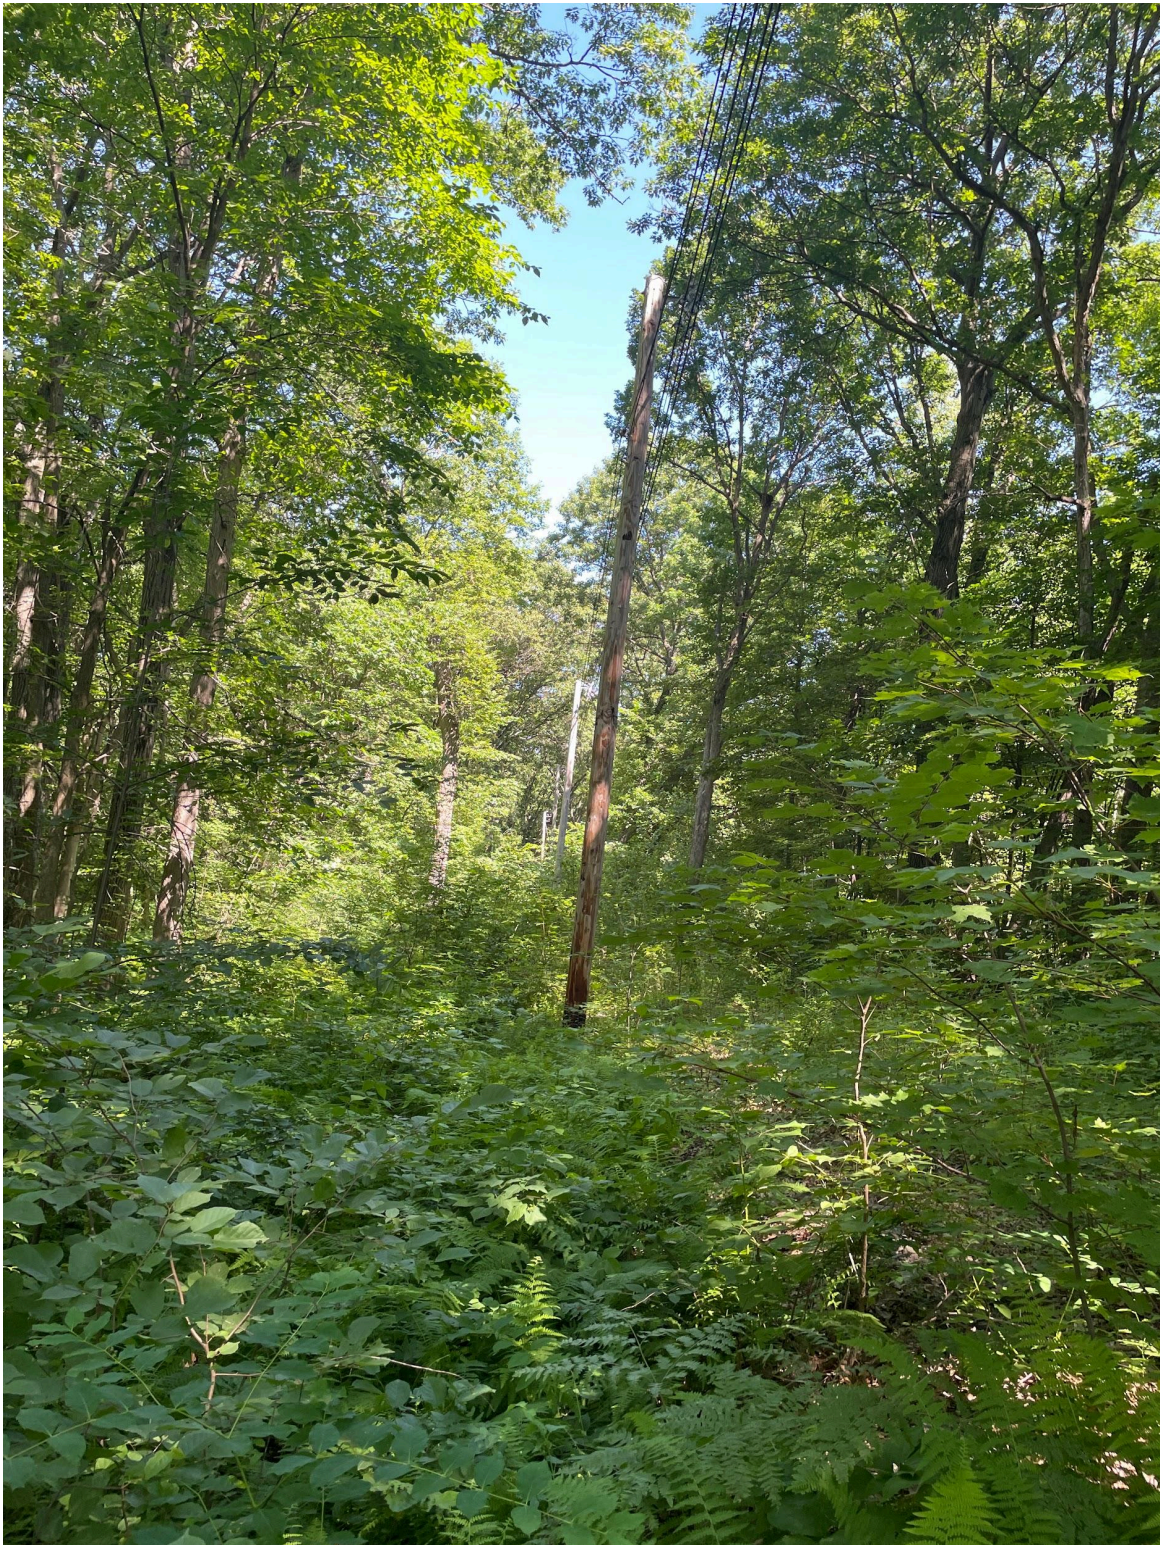
Photo 4

Comments: Overhead utility lines run between Wayside parcels along the route of the northern end of Wayside Road, which is a “paper road”.

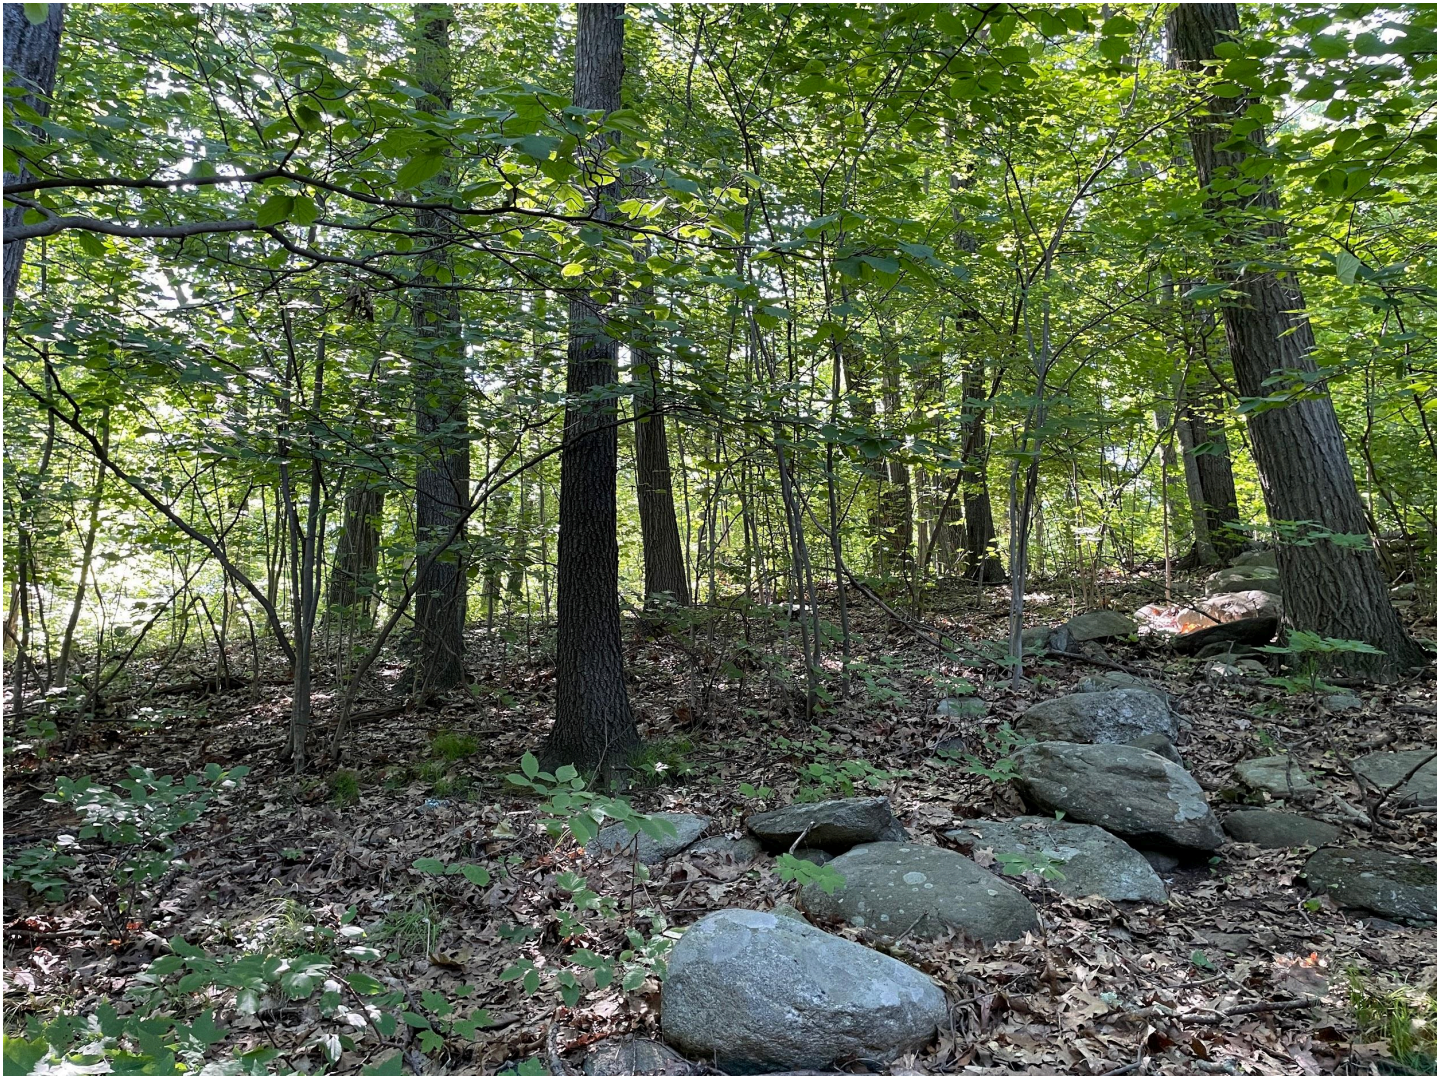
Photo 5

Comments: A wetland area is present in the interior of the property and seems to originate from outflow from culverts and natural springs.

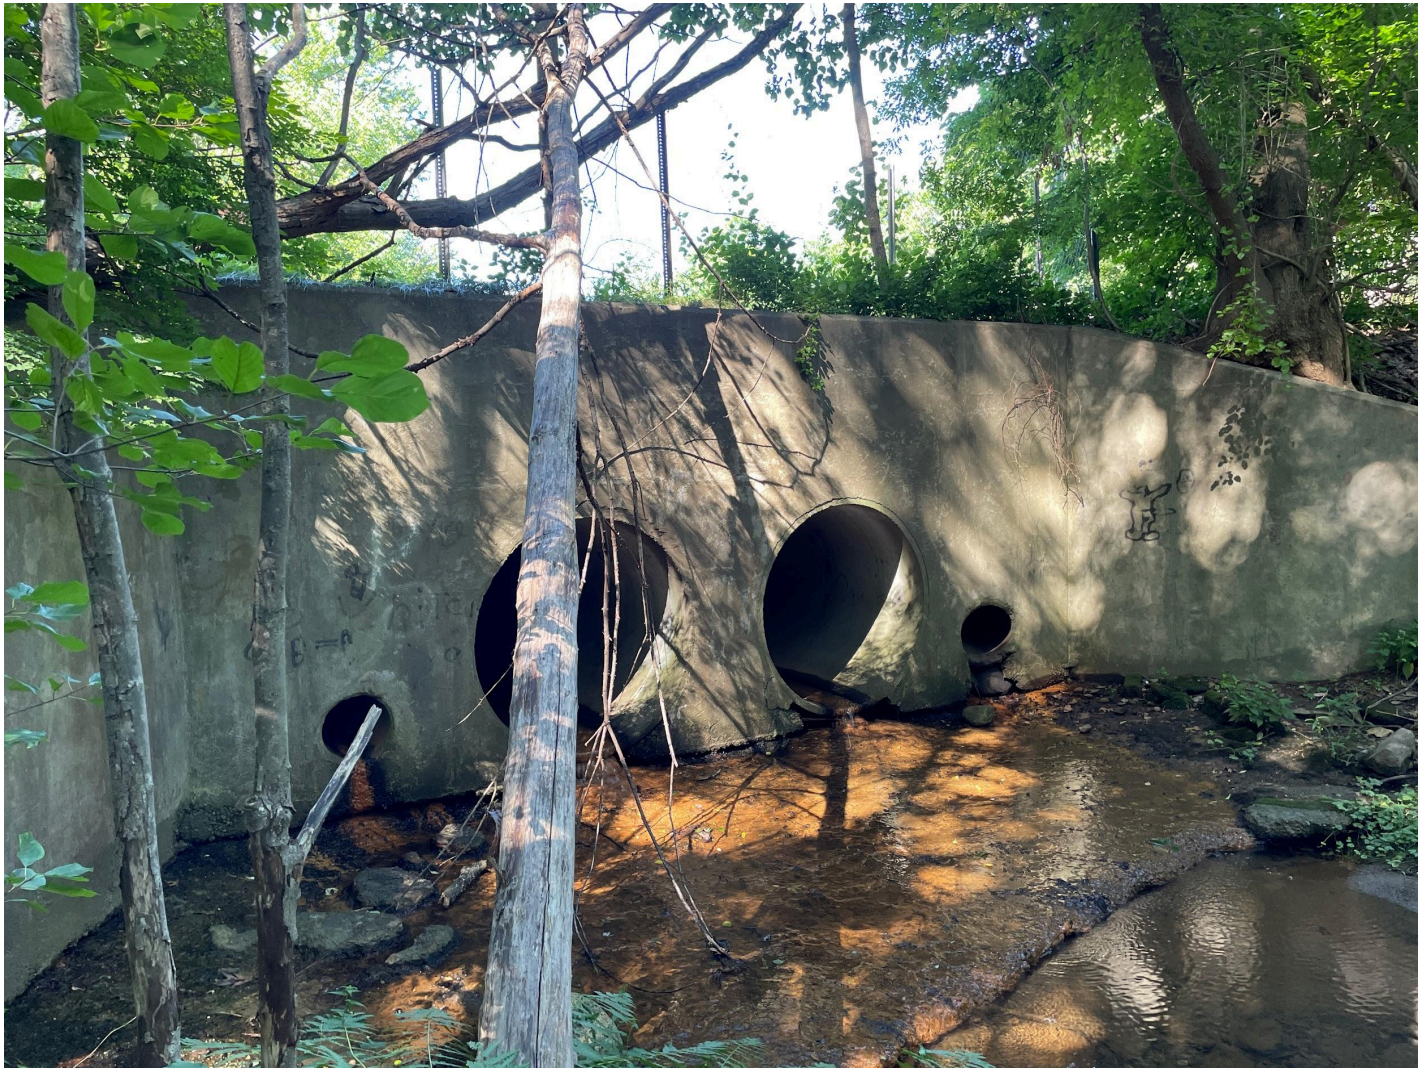
Photo 6

Comments: Streambed fed by large culvert which flows west to east along Country Club Boulevard, existing the property under Erie Avenue.

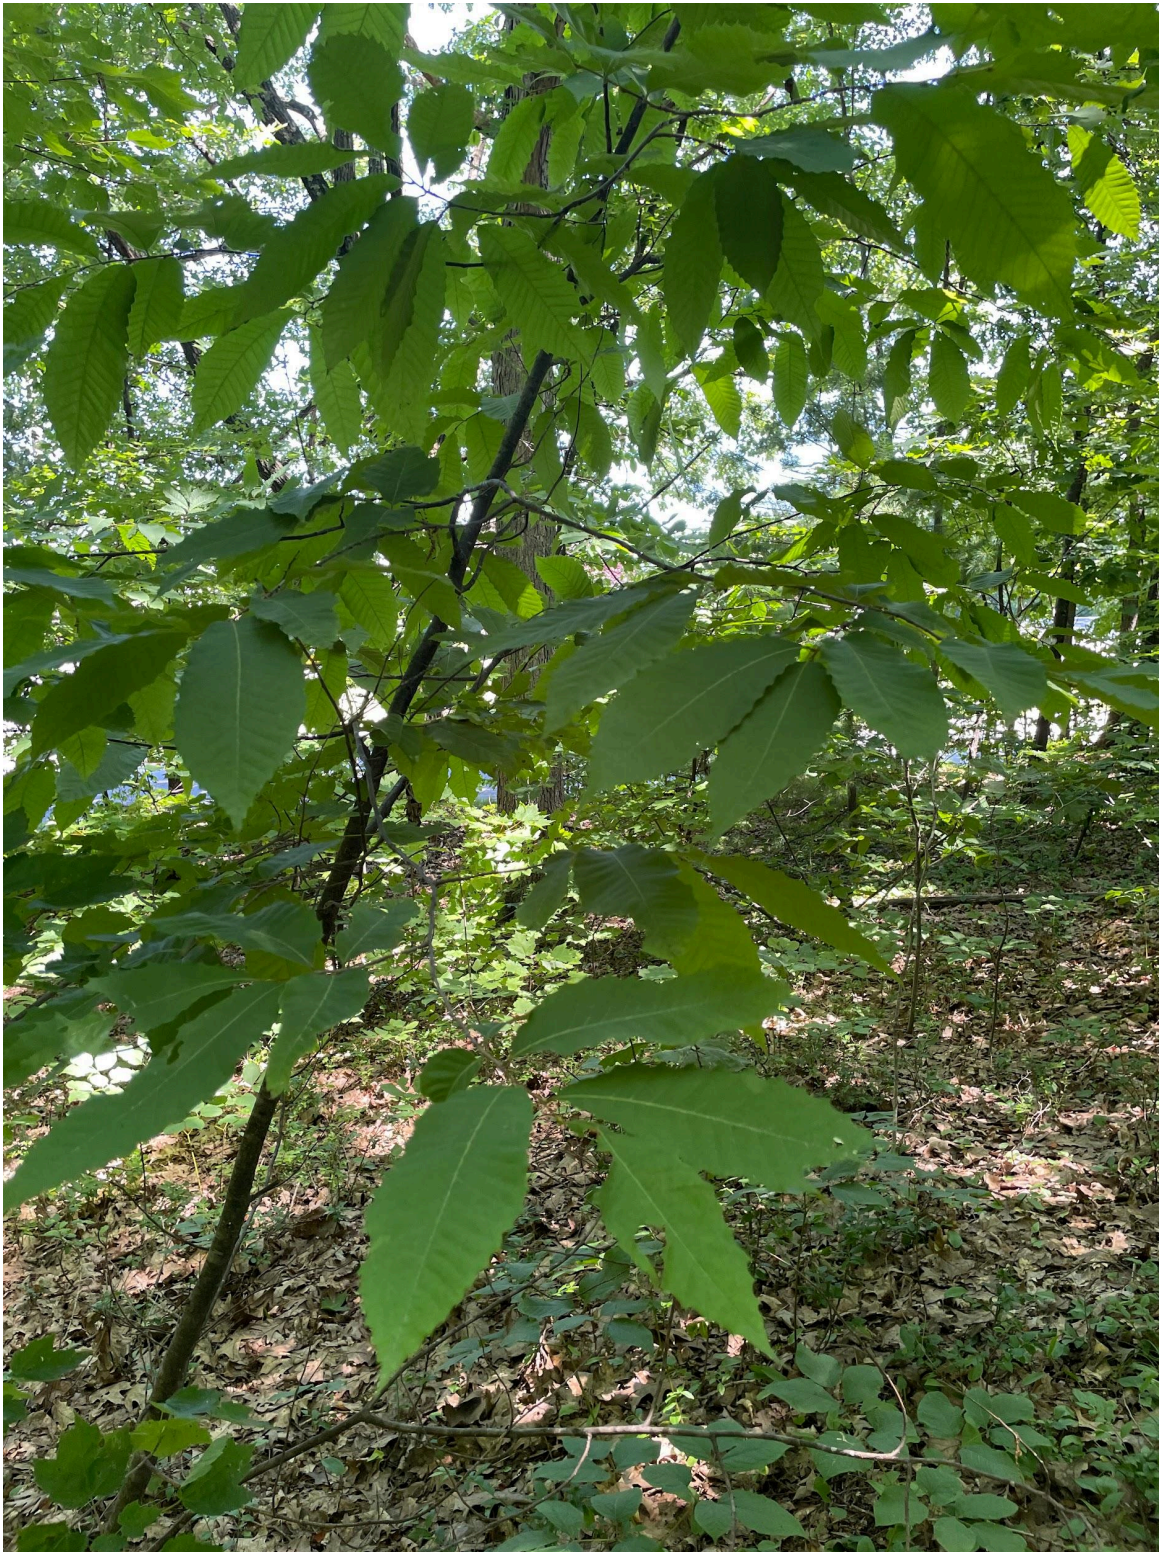
Photo 7

Comments: American chestnuts (*Castanea dentata*) of good size, up to 4 inches in diameter at breast height (DBH) and 20 feet tall, are present in the small triangle of land at the corner of Erie Avenue and Country Club Boulevard.

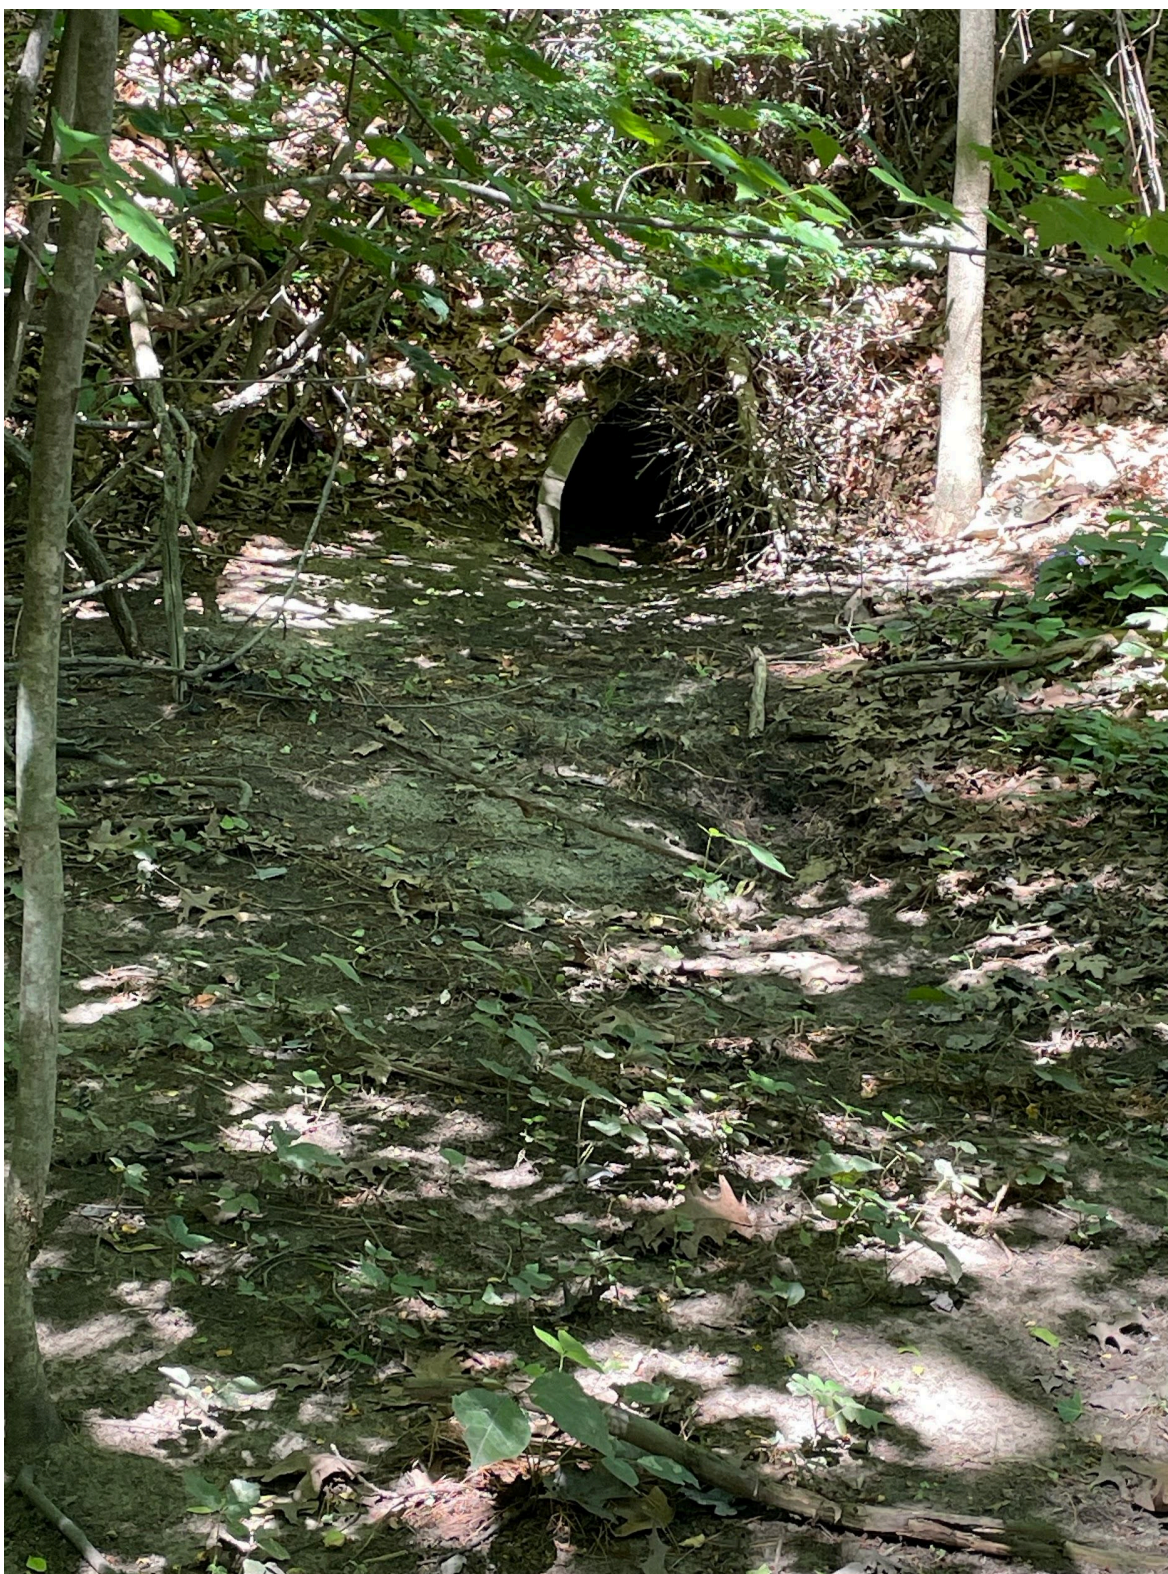
Photo 8

Comments: Lowland area with a drainage pipe for outflow but no clear inflow that appears to collect water. Some garbage has collected in the depression.

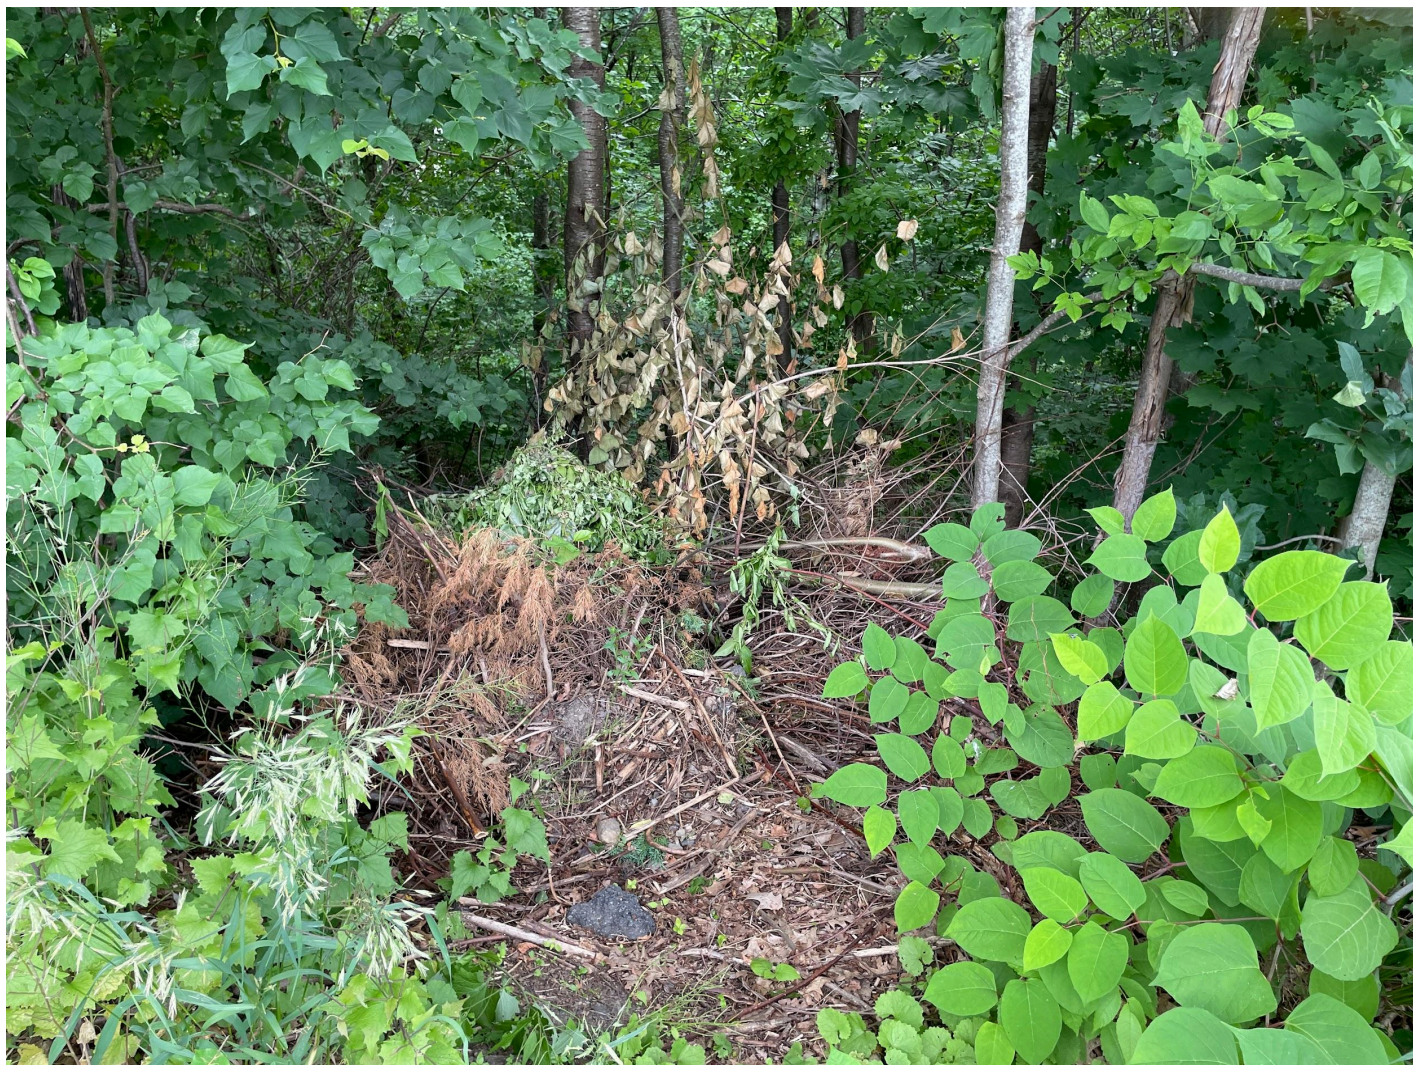
Photo 9

Comments: Yard waste dumping is very common along White Street. Some of the dump piles have additional refuse, including pallets, window screens, and construction debris.

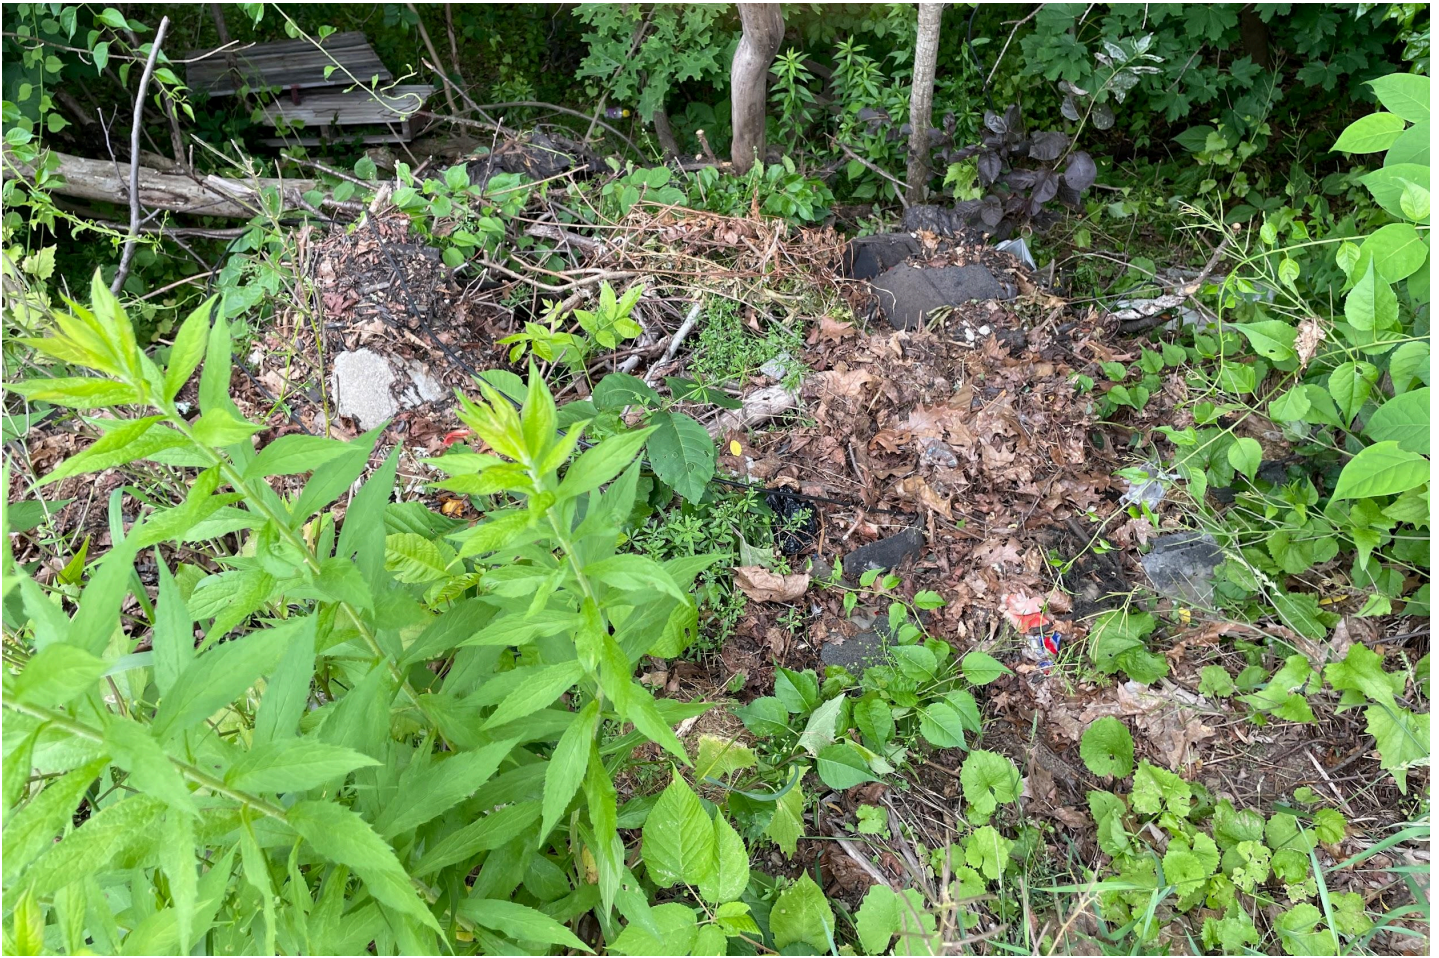
Photo 10

Comments: Yard waste dumping is very common along White Street. Some of the dump piles have additional refuse, including pallets, window screens, and construction debris.

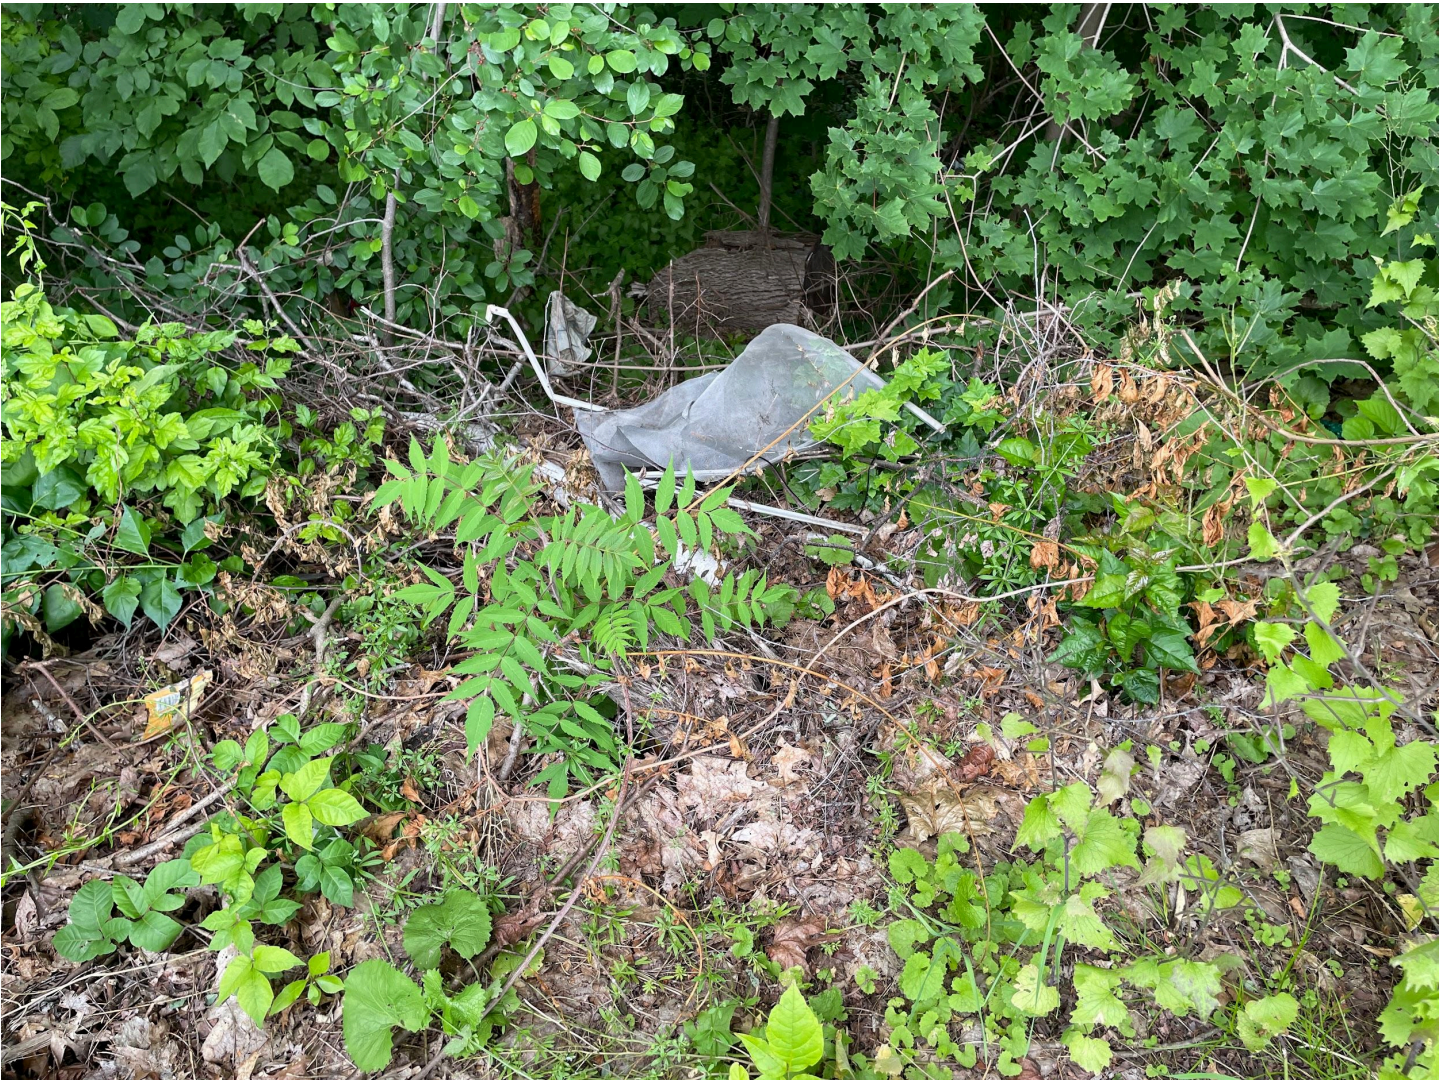
Photo 11

Comments: Yard waste dumping is very common along White Street. Some of the dump piles have additional refuse, including pallets, window screens, and construction debris.
