Subject: **Bid #: 8319-W5, Lincoln Square Improvements / DPWP**

**Date:** November 15, 2024  
**Project:** Lincoln Square Improvements  
City of Worcester Department of Public Works and Parks  
Parks, Recreation and Cemetery Division

Lahlaf Geotechnical Consulting, Inc. (LGCI) has completed a geotechnical study for the proposed Lincoln St. WWI Monument Renovation in Worcester, Massachusetts. This report contains the results of our explorations and our foundation design and construction recommendations.

**Geotechnical Report**  
**Proposed Lincoln St. WWI Monument Renovation**  
**Worcester, Massachusetts**  
**LGCI Project No. 2031**

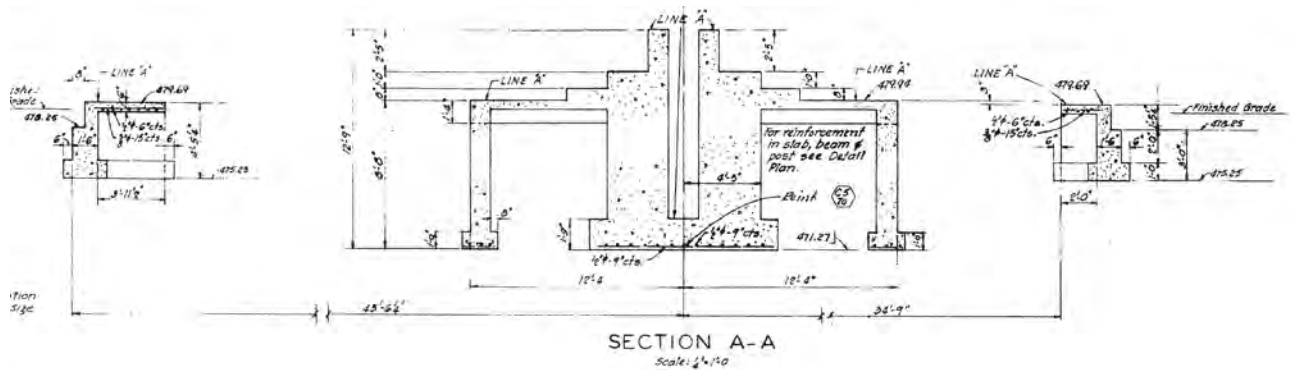
Cropped from the Monument Foundation Plans listed above

Based on the Monument Foundation Plans, the obelisk is supposed to be located within the center of the monument. However, the obelisk is located on the southern side of the monument, close to the knee-high wall. The Monument Foundation Plans indicate that the obelisk is supported on a concrete foundation extending to a depth of about 8.7 feet beneath the ground surface, and that the Whisper Wall and the knee-high wall are supported on concrete footings extending to a depth of about 4 feet beneath the ground surface as shown in the cross section below.

Based on the Tunnel Sections, the tunnel is about 37 feet wide and 21 feet high.

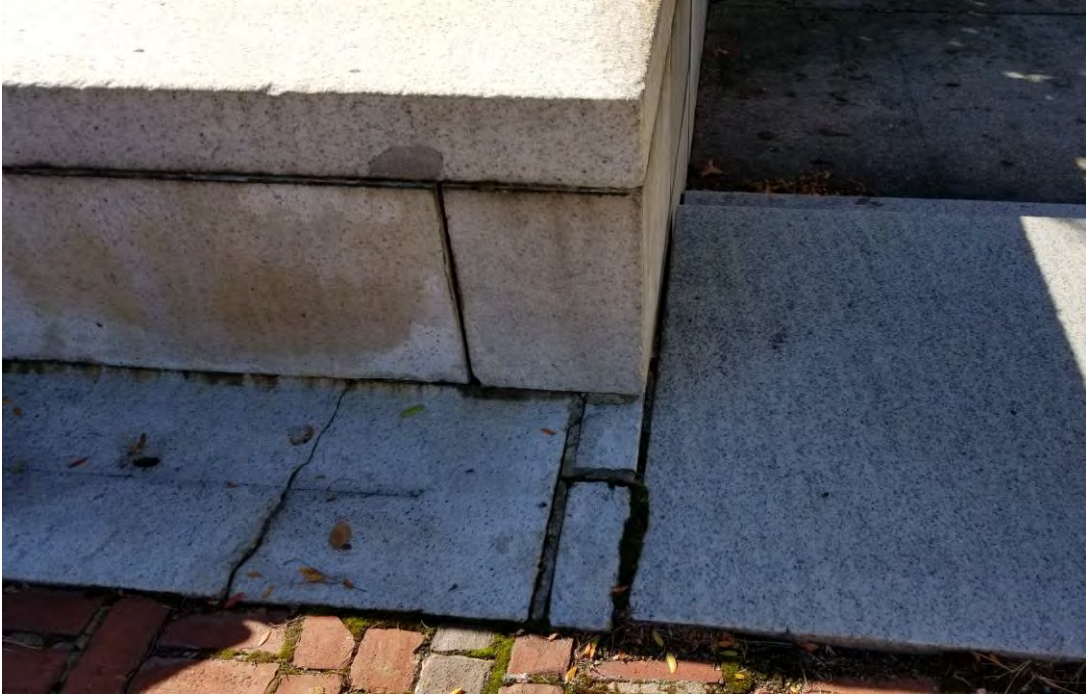
Photo No. 1: Crack in ground stone and displaced wall stones.

The monument is in a state of slight disrepair as evidenced by cracks in the wall, relative movement of stone blocks in the knee-high wall and Whisper Wall, and uneven ground. LGCI documented the condition of the existing monument with photographs included in Appendix C.

Settlement – We believe that the monument foundations were placed on fill that was not placed in compacted lifts. Furthermore, the fill appeared to contain traces of organic soil. Existing fill that was not placed with strict moisture, density, and gradation control presents risks of unpredictable settlement that generally result in poor performance of foundations.

Frost Heave – Our test pits indicated that the walls of the monument were set on what appears to be a concrete “leveling pad” cast on top of a concrete foundation. The “leveling pad” was only a few inches beneath the ground surface. In all three (3) test pits a seam of soil was observed between the “leveling pad” and the underlying concrete foundation. We believe that as water seeps in the soil seam and freezes, it causes an uplift movement of the wall. We believe that this repeated action has caused cracks to open in the walls and in the mortar between stone blocks. The movement was exacerbated by water entering the cracks and the separations between the stone blocks and freezing, causing further movement.

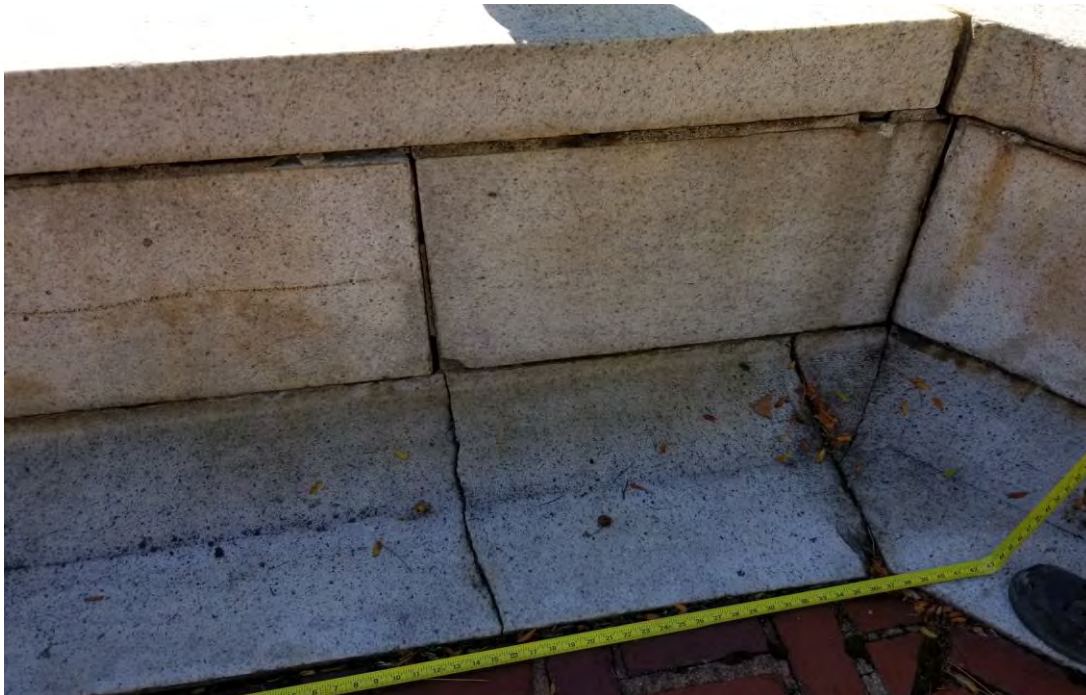
Photo No. 2: Crack in ground stone and displaced wall stones.

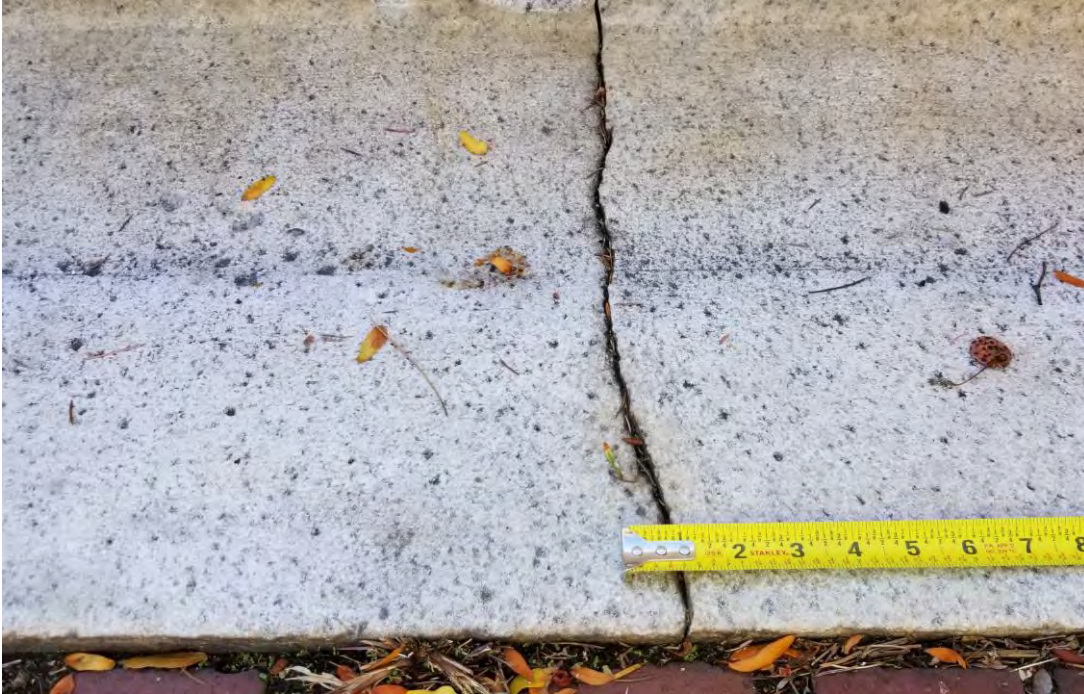
Photo No. 3: Crack in ground stone.

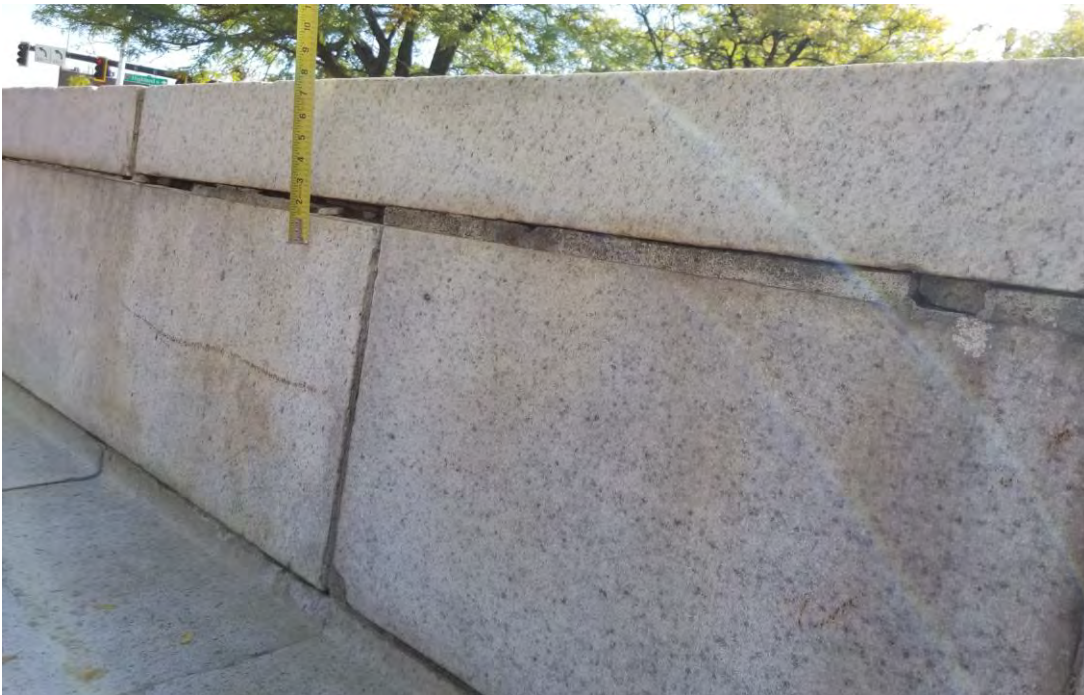
Photo No. 4: Displaced wall stone (knee high wall).

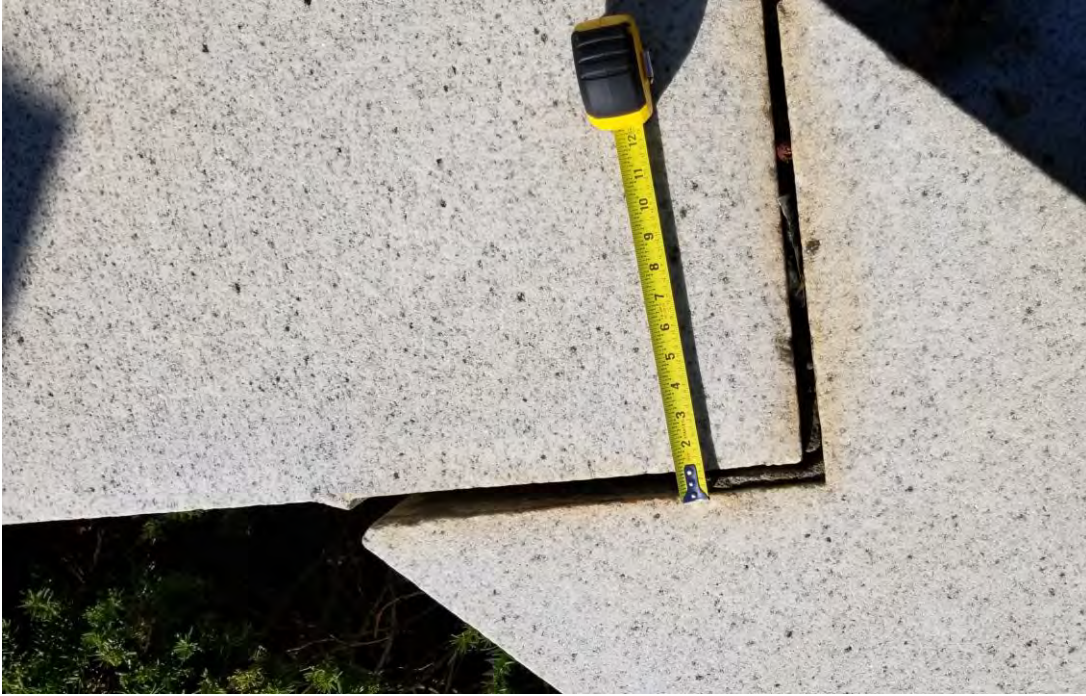
Photo No. 5: Displaced wall stone (knee high wall).

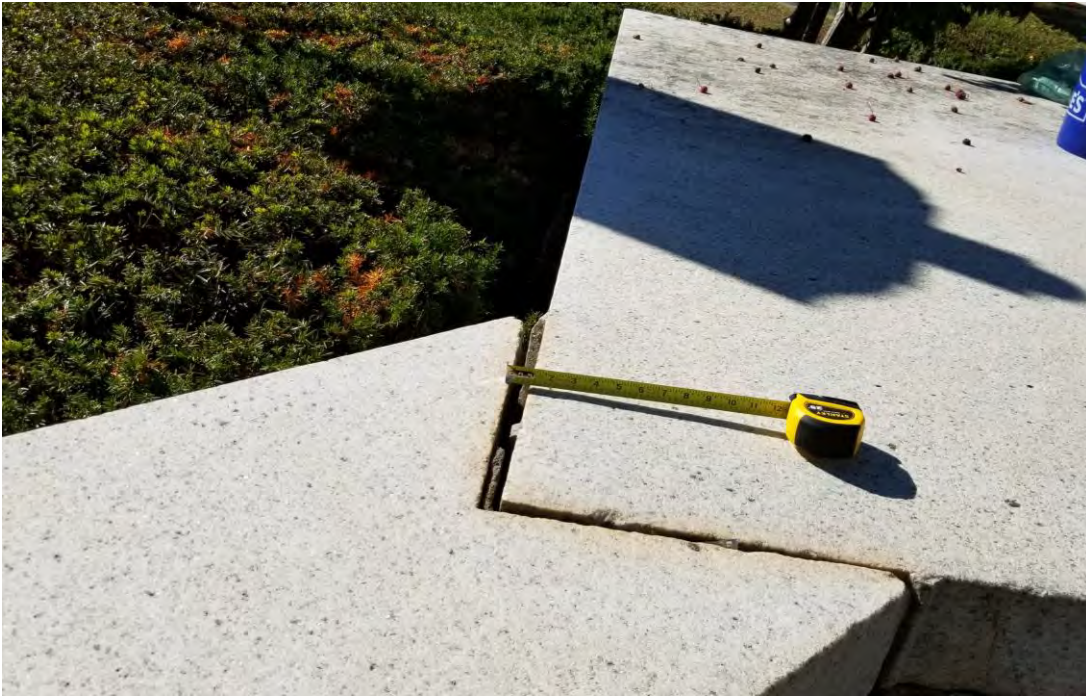
Photo No. 6: Displaced wall stone (knee high wall).

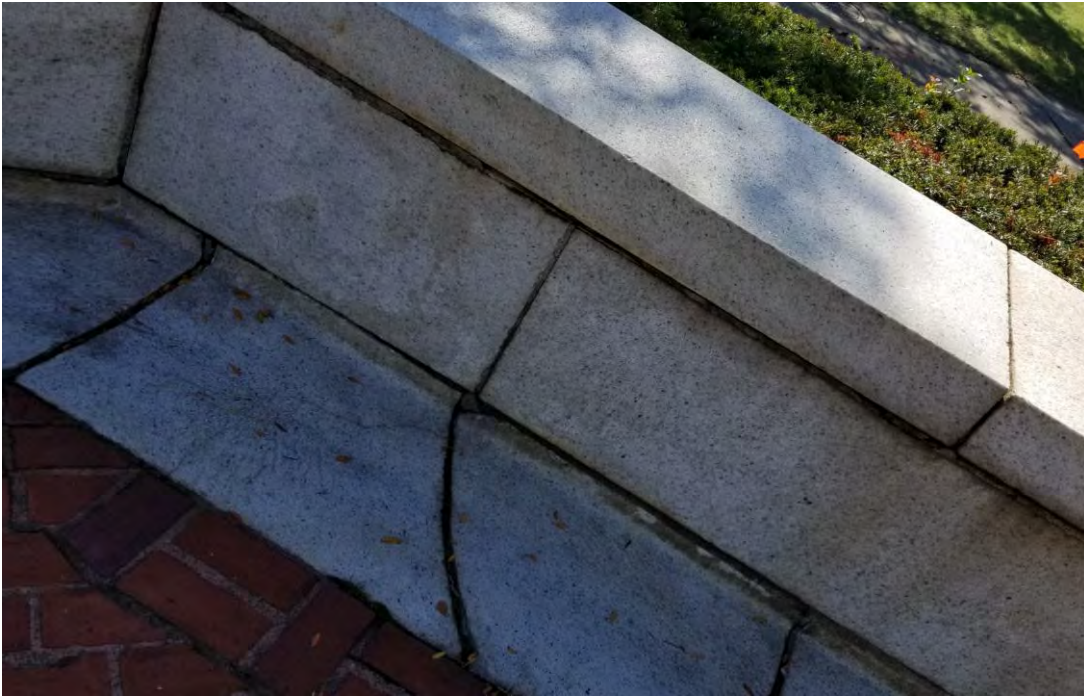
Photo No. 7: Crack in ground stone and displaced wall stones (knee high wall).

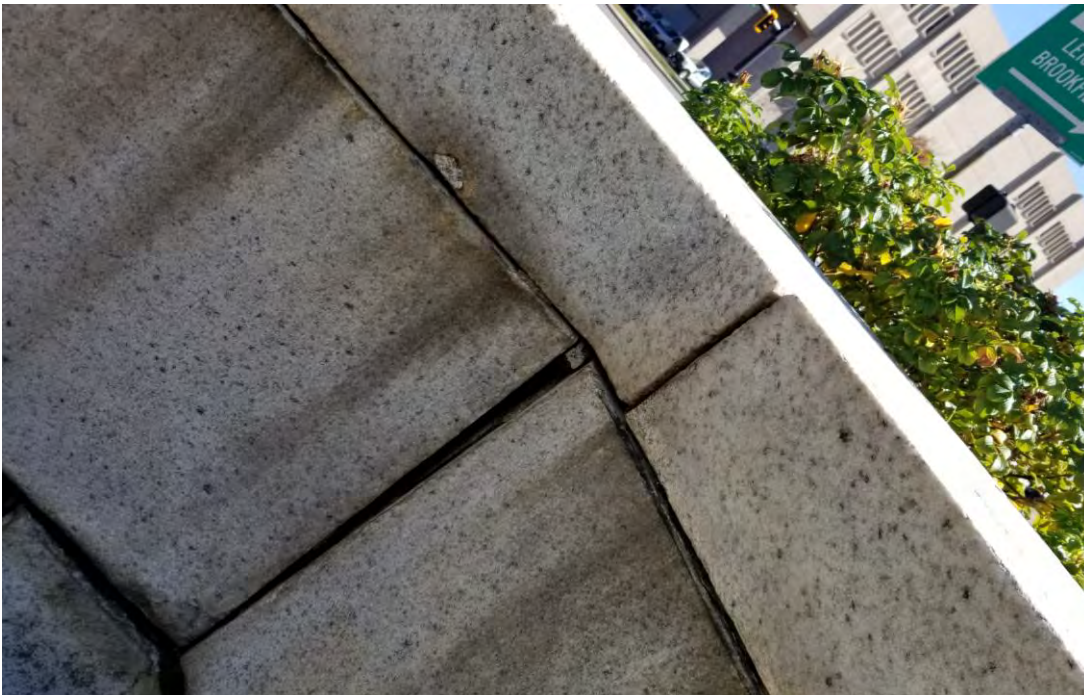
Photo No. 8: Filled wall stones (knee high wall).

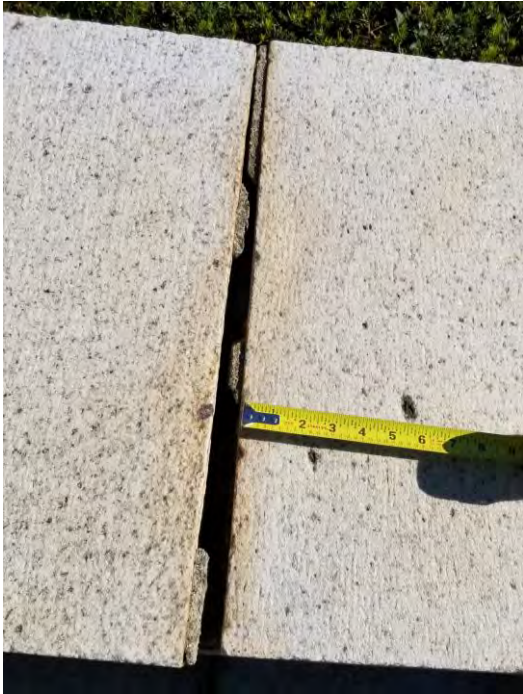
Photo No. 9: Filled and displaced wall stone (knee high wall).

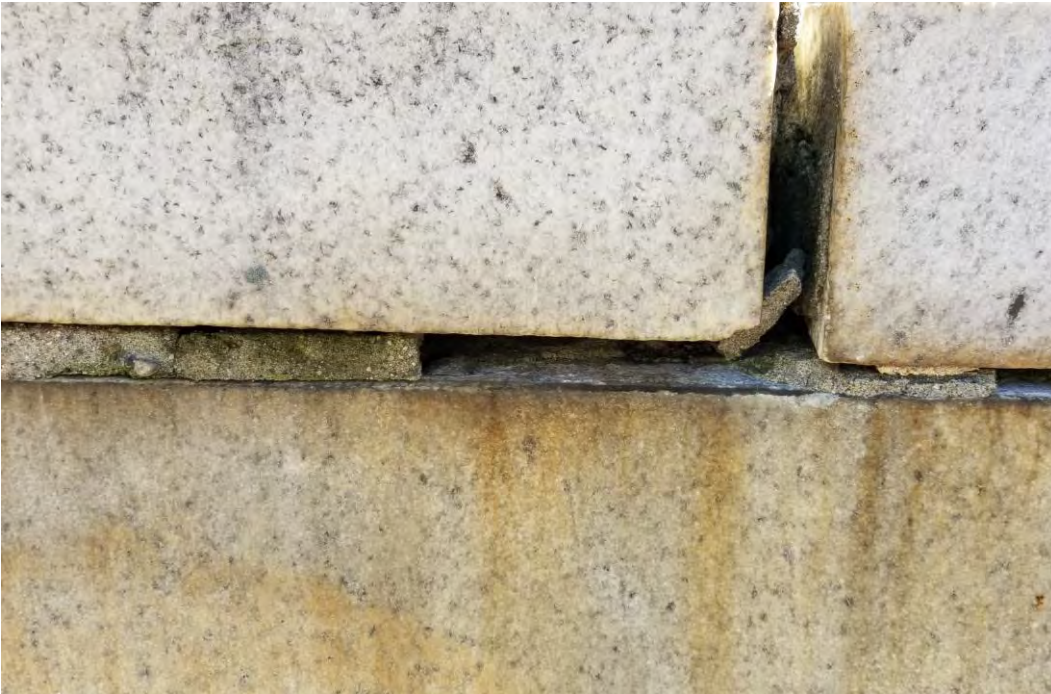
Photo No. 10: Displaced wall stones (knee high wall).

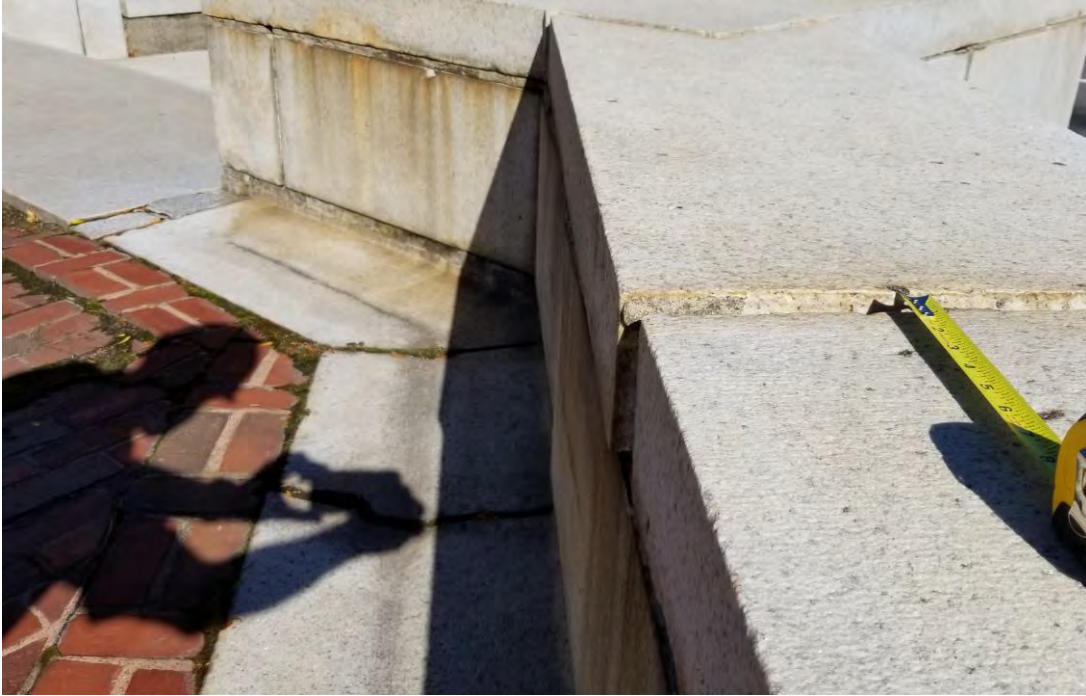
Photo No. 11: Displaced wall stones (knee high wall).

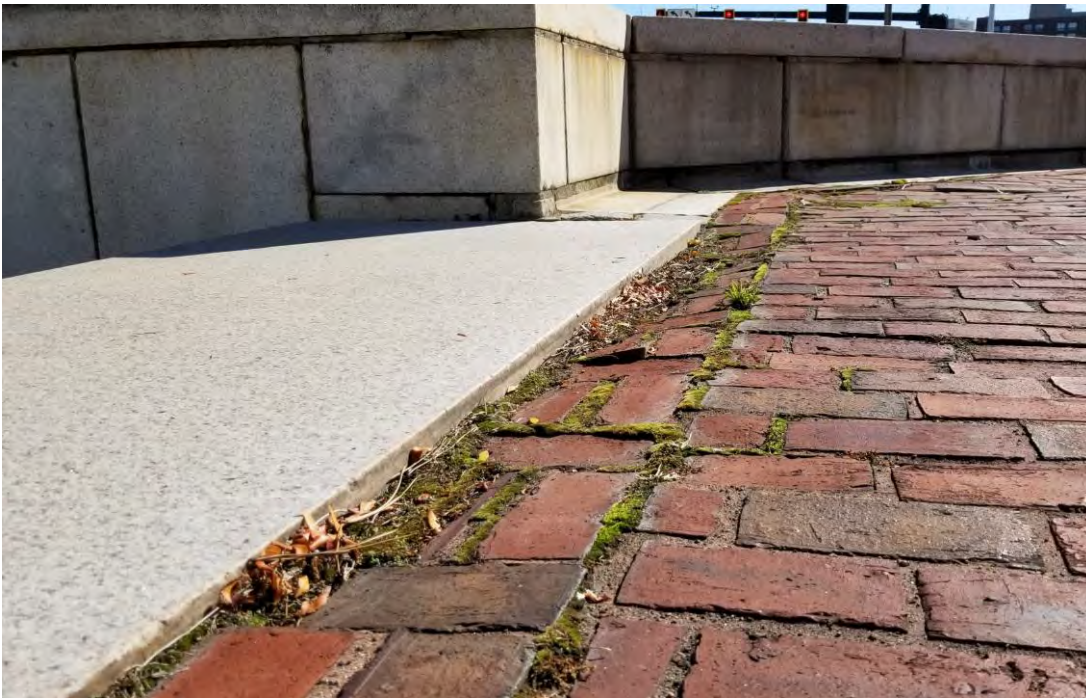
Photo No. 12: Depression in brick pavers at interface with stairs.

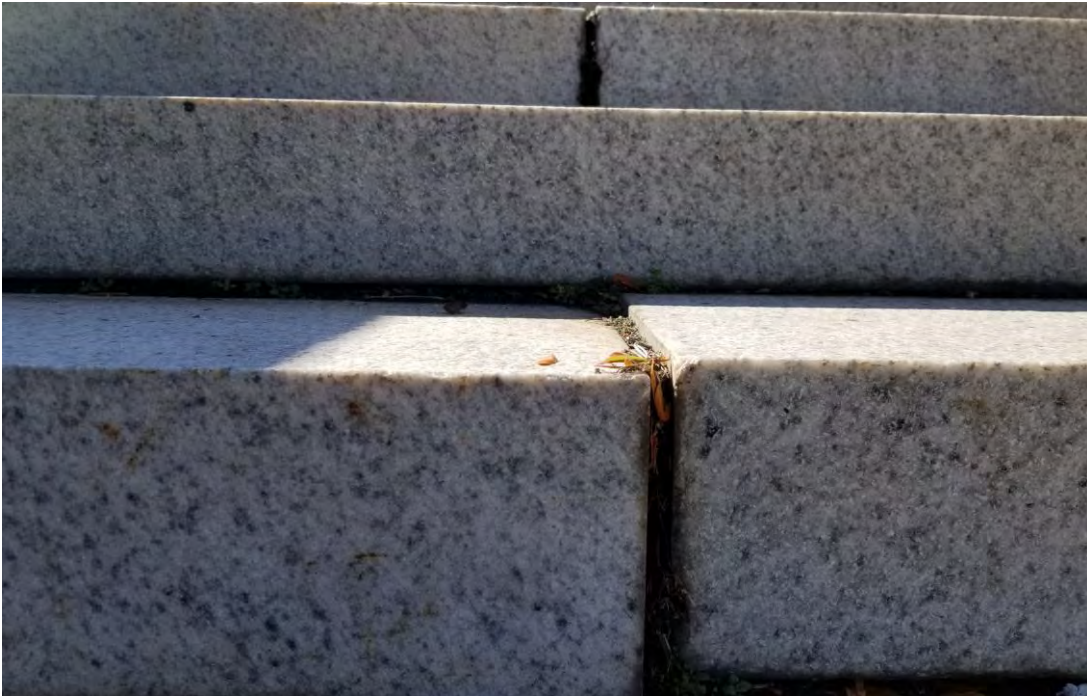
Photo No. 13: Uneven stairs.

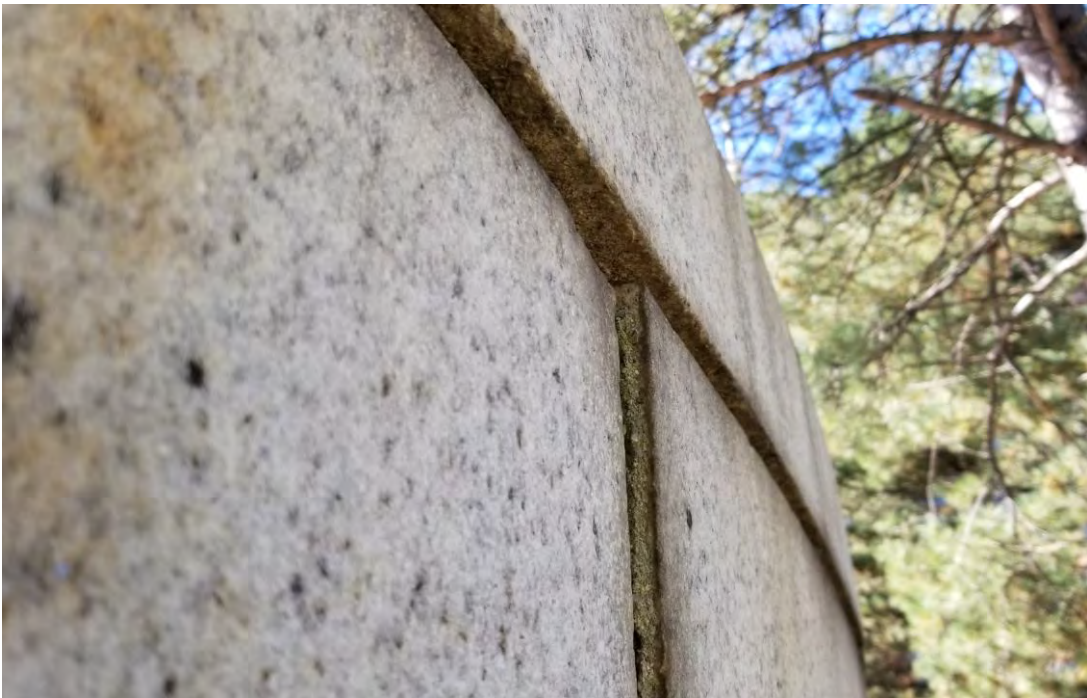
Photo No. 14: Displaced stone (whisper wall).

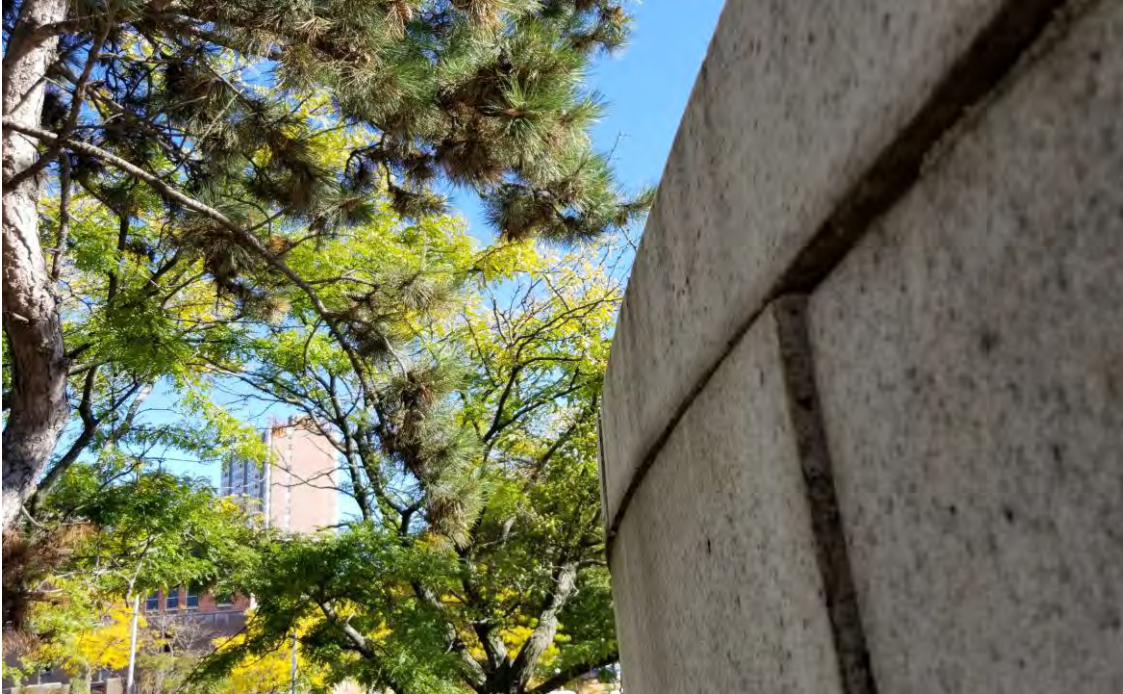
Photo No. 15: Displaced stone (whisper wall).

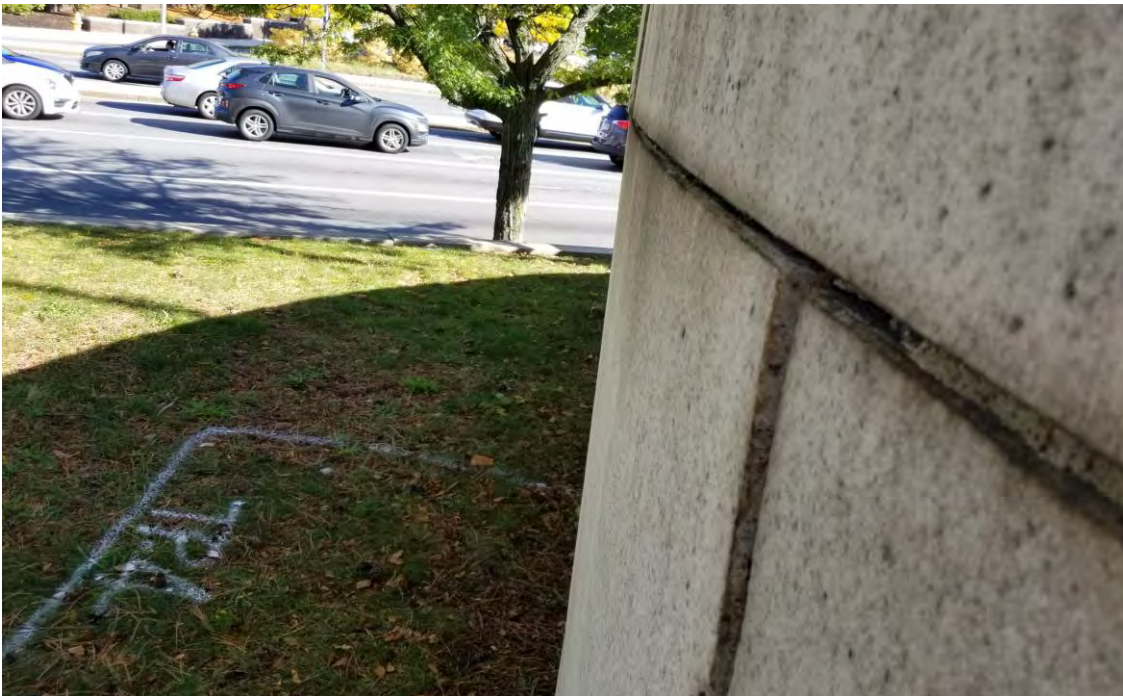
Photo No. 16: Displaced stone (whisper wall).

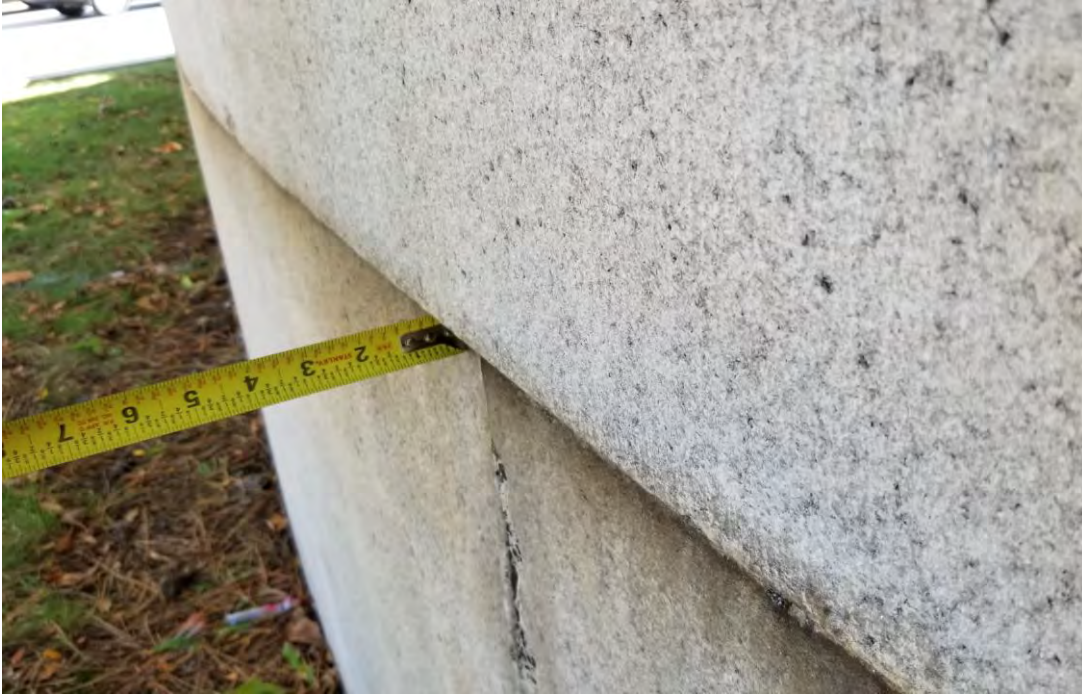
Photo No. 17: Displaced stone (whisper wall).

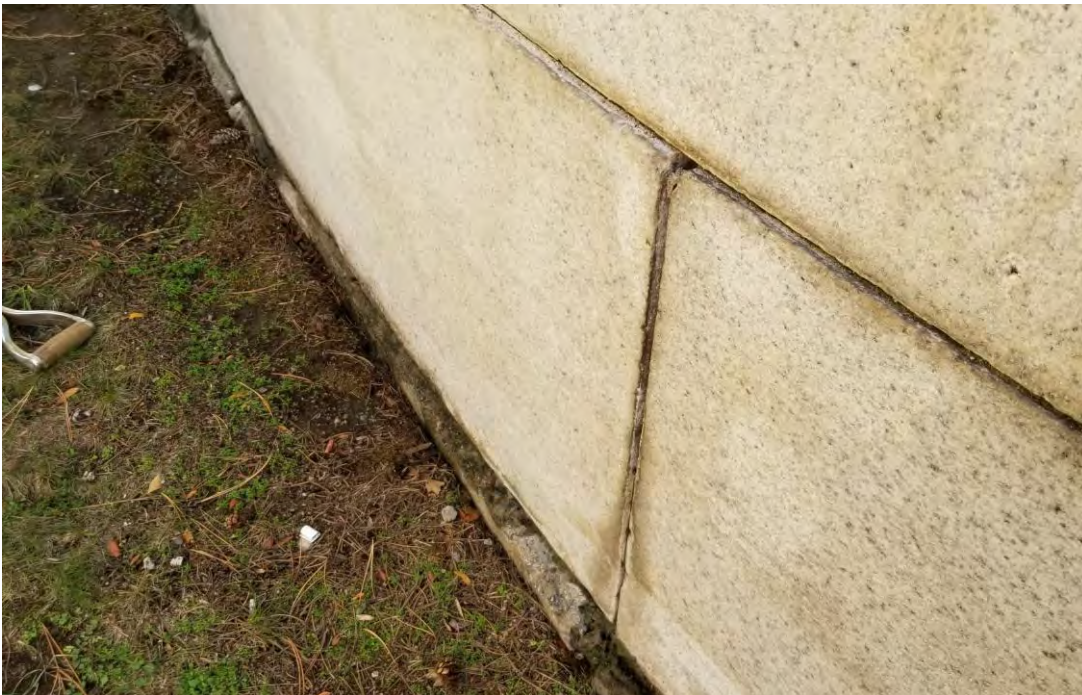
Photo No. 18: Displaced stone (whisper wall).

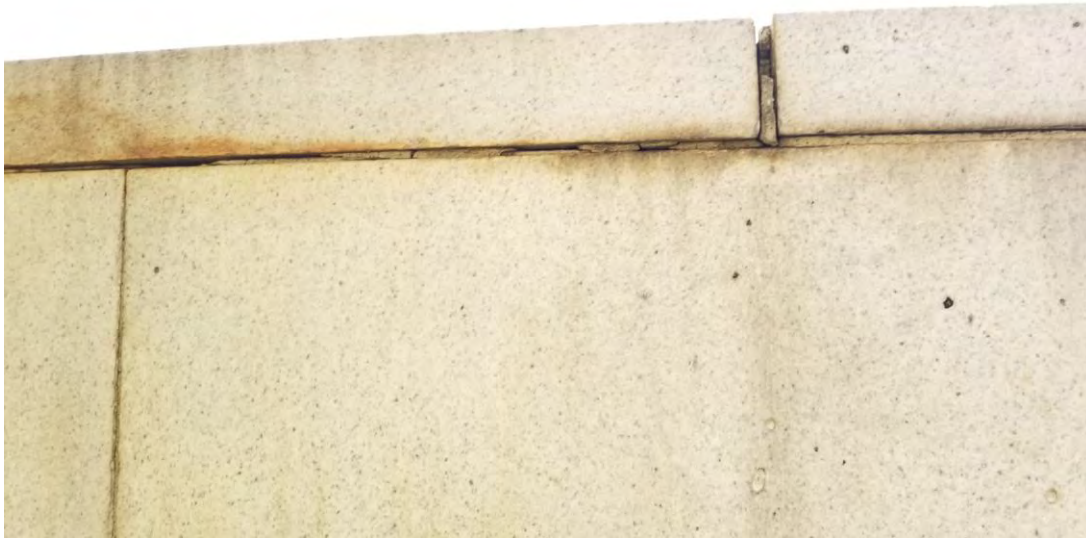
Photo No. 19: Displaced stone (whisper wall).

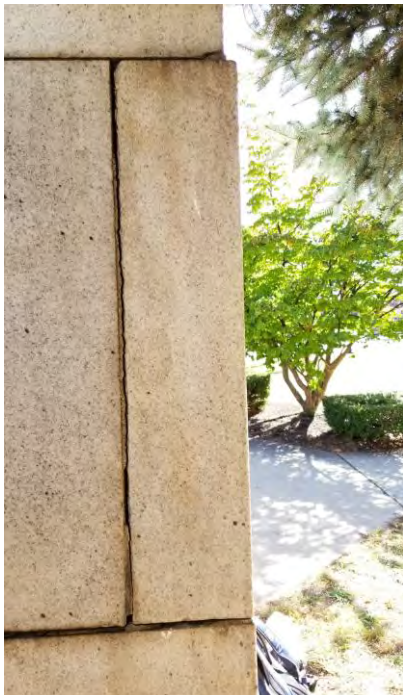
Photo No. 20: Displaced stone (whisper wall).

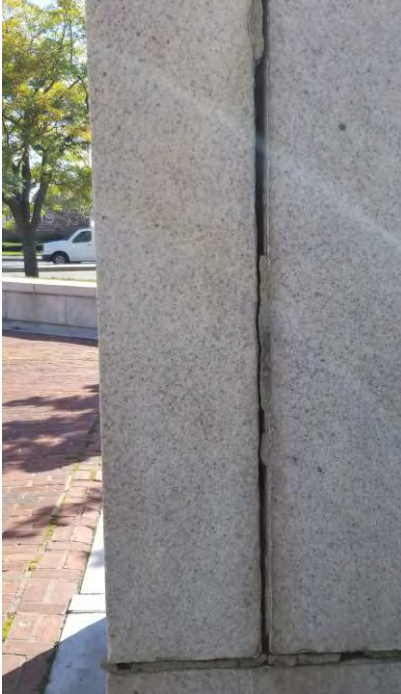
Photo No. 21: Displaced stone (whisper wall).

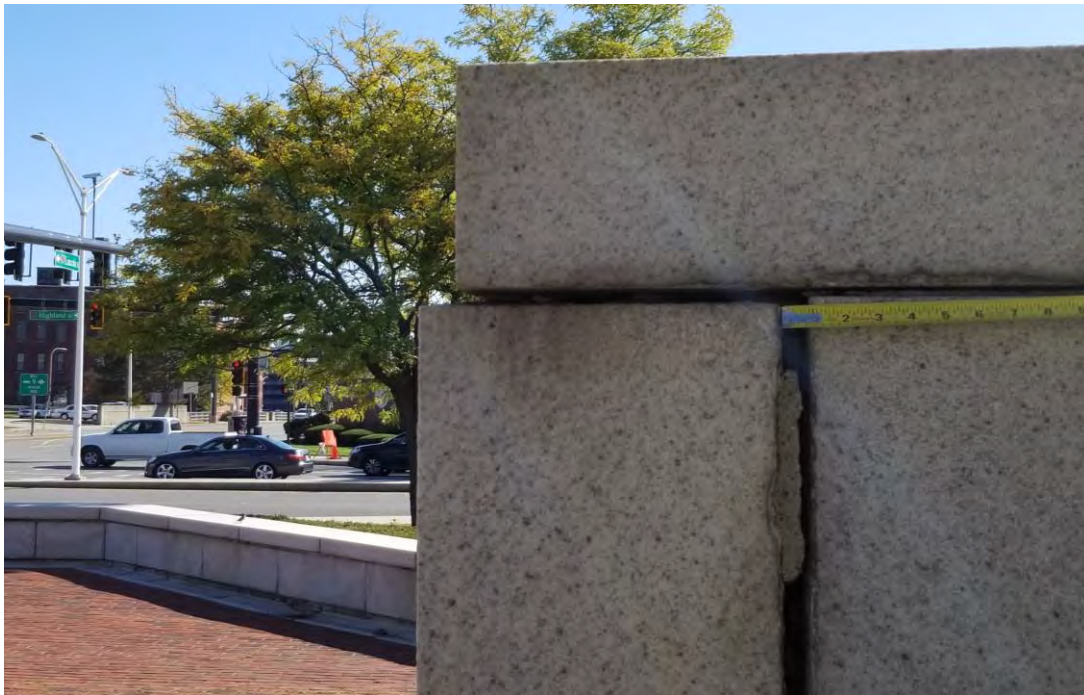
Photo No. 22: Displaced stone (whisper wall).

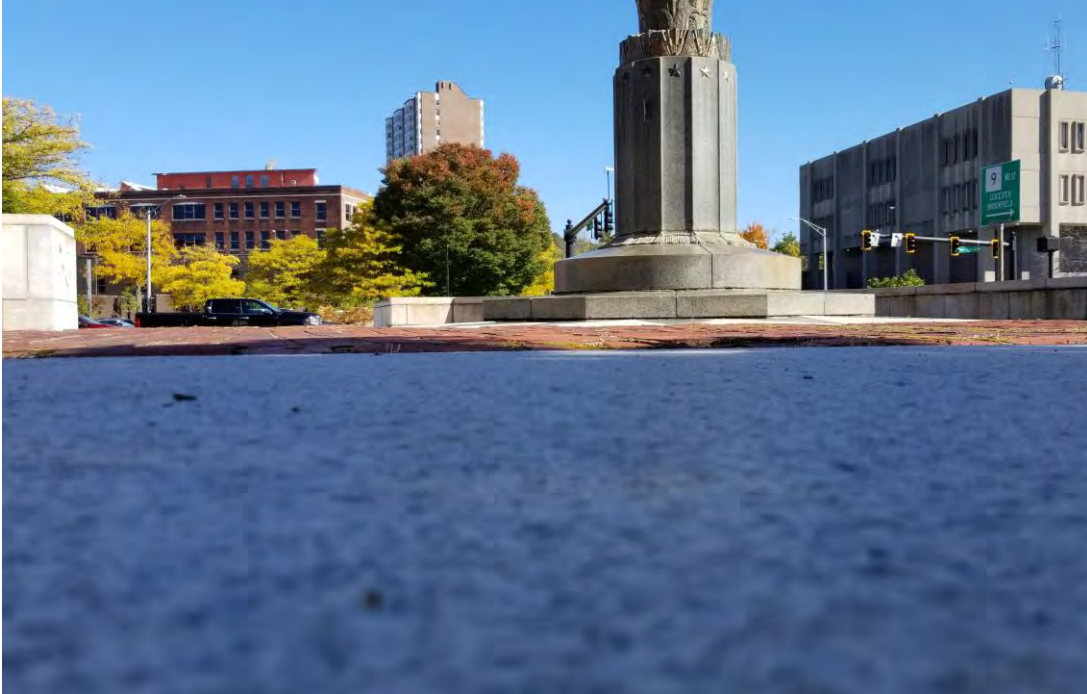
Photo No. 23: Uneven ground surface around monument.

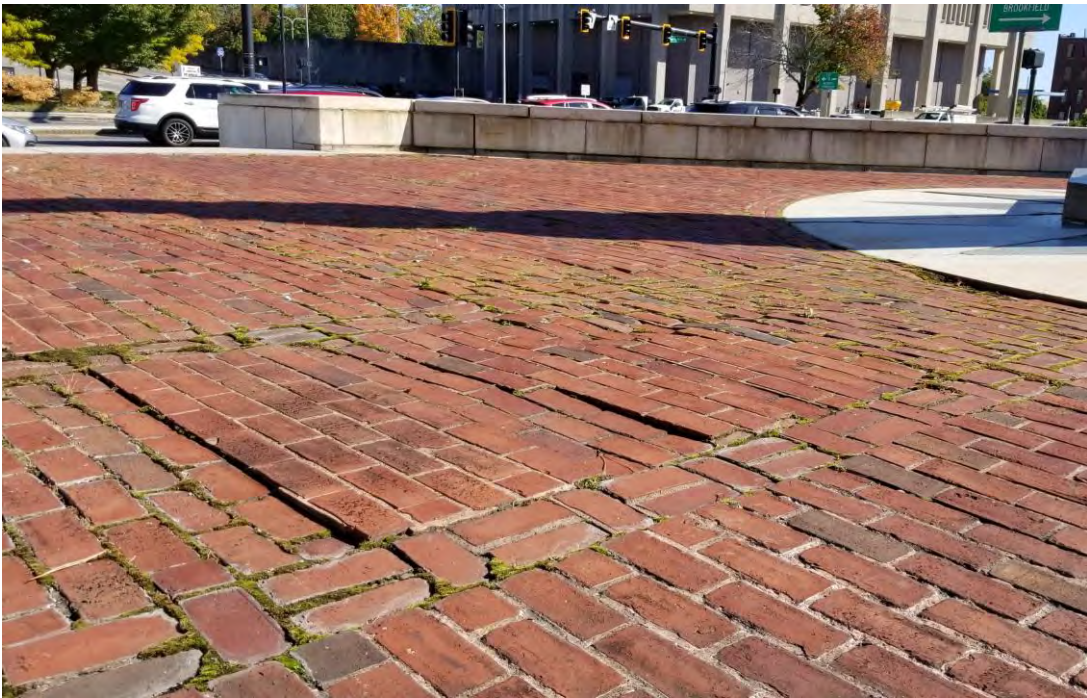
Photo No. 24: Uneven ground surface around monument.

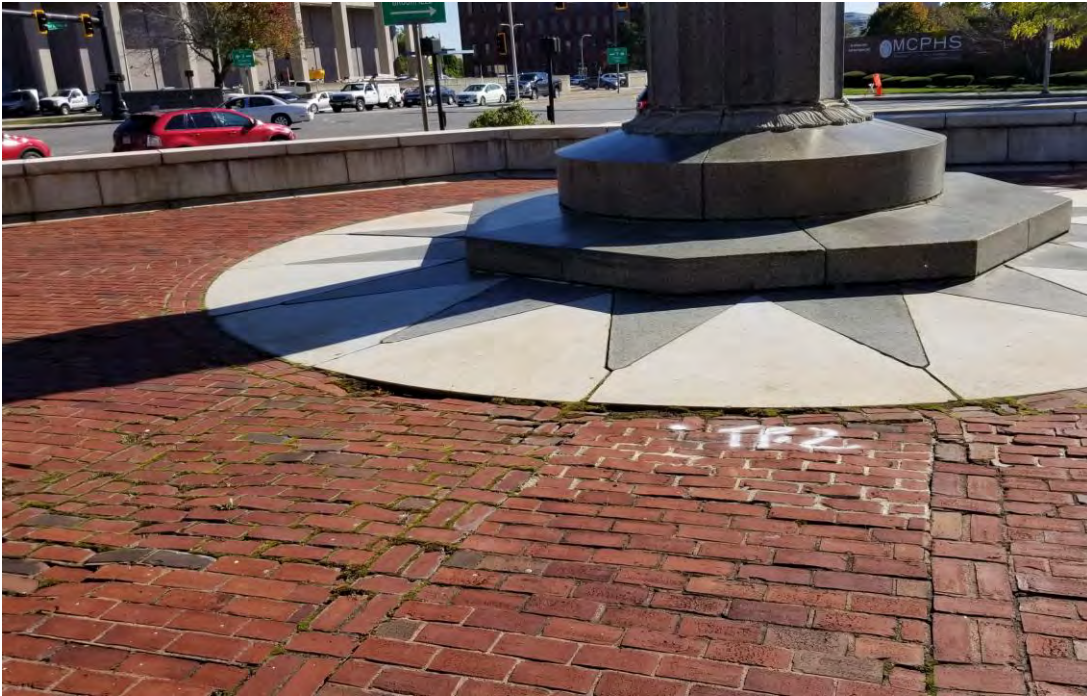
Photo No. 25: Uneven ground surface around monument.

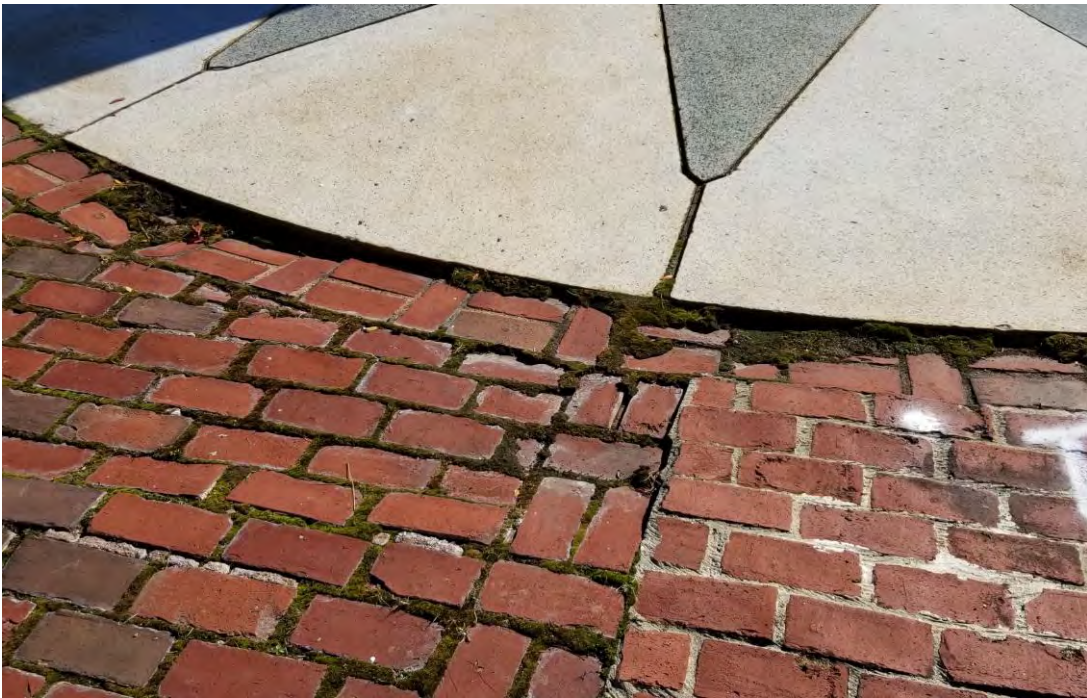
Photo No. 26: Uneven ground surface around monument.

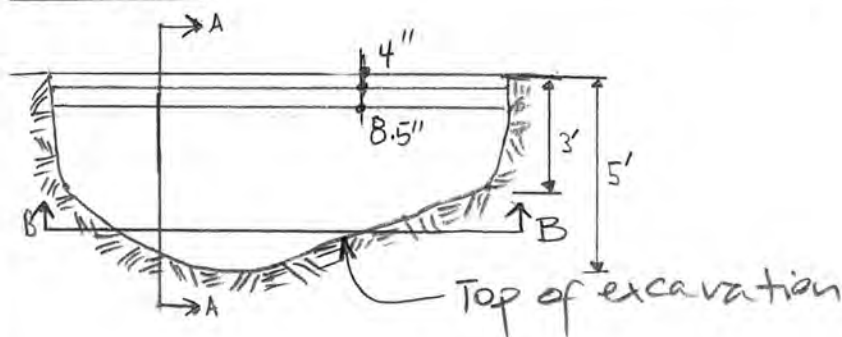
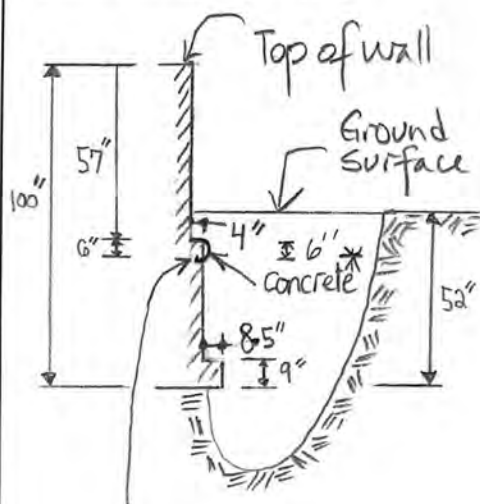
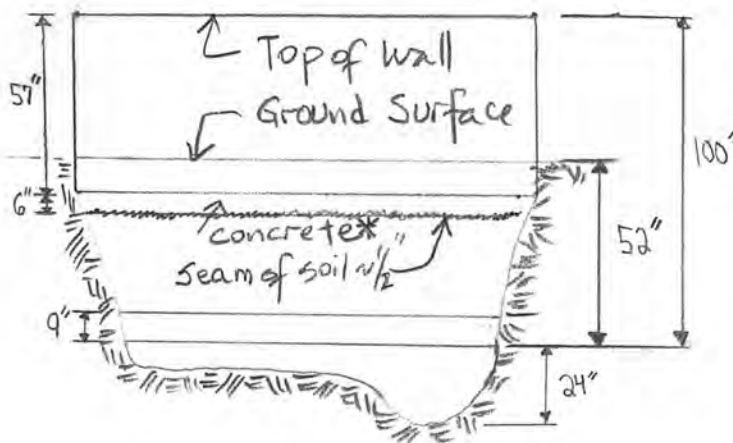
## Test Pit TP 1

Seam of soil ~ 1/2"

Scale - 1/4" = 12"

\* Concrete over-pour appears to possibly be a leveling pad for wall. The leveling pad appears to have been placed on foundation without thoroughly cleaning top of foundation.

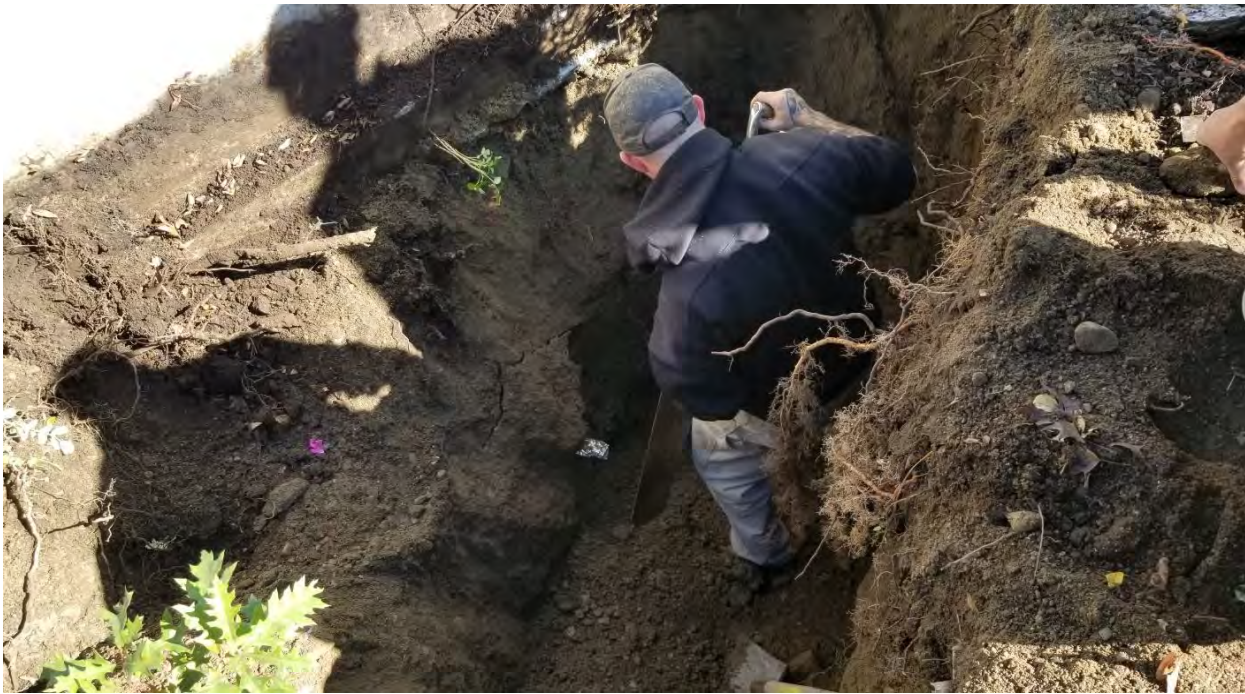
Photo 1 - TP-1 - Overall View

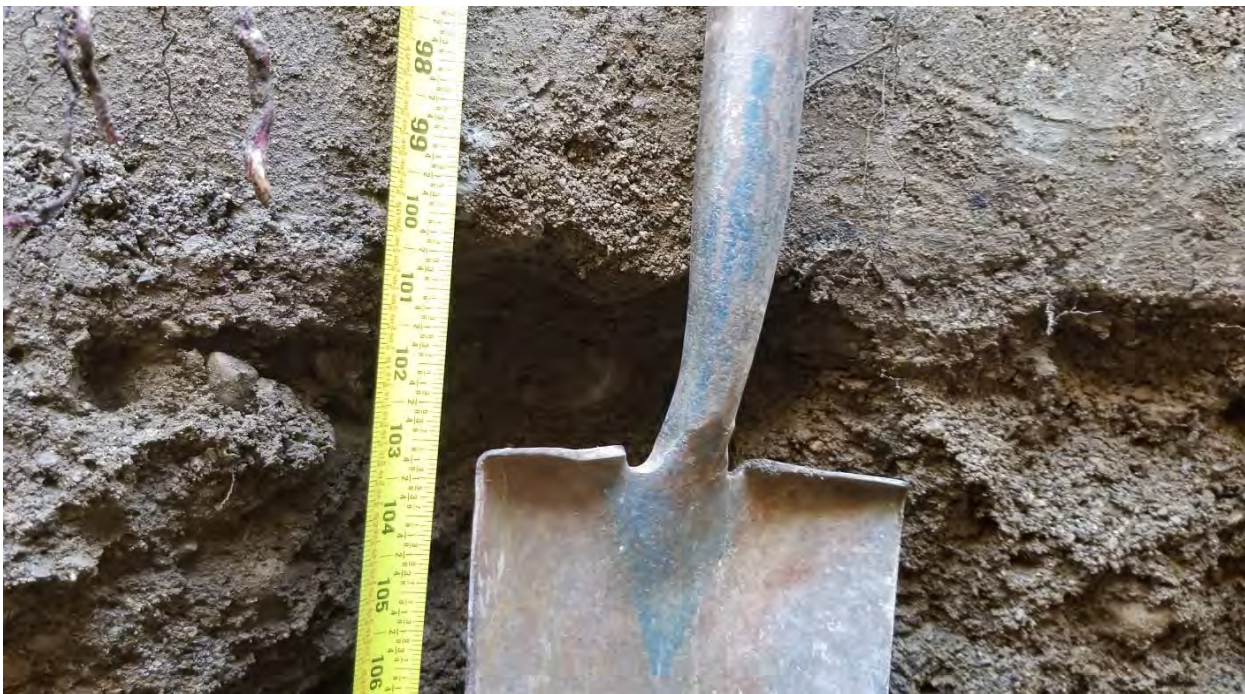
Photo 2 - TP-1 - Depth to bottom of foundation
