Subject: **Bid #: 8319-W5, Lincoln Square Improvements / DPWP**

**Date:** November 15, 2024  
**Project:** Lincoln Square Improvements  
City of Worcester Department of Public Works and Parks  
Parks, Recreation and Cemetery Division

Lahlaf Geotechnical Consulting, Inc. (LGCI) has completed a geotechnical study for the proposed Lincoln St. WWI Monument Renovation in Worcester, Massachusetts. This report contains the results of our explorations and our foundation design and construction recommendations.

**Geotechnical Report**  
**Proposed Lincoln St. WWI Monument Renovation**  
**Worcester, Massachusetts**  
**LGCI Project No. 2031**

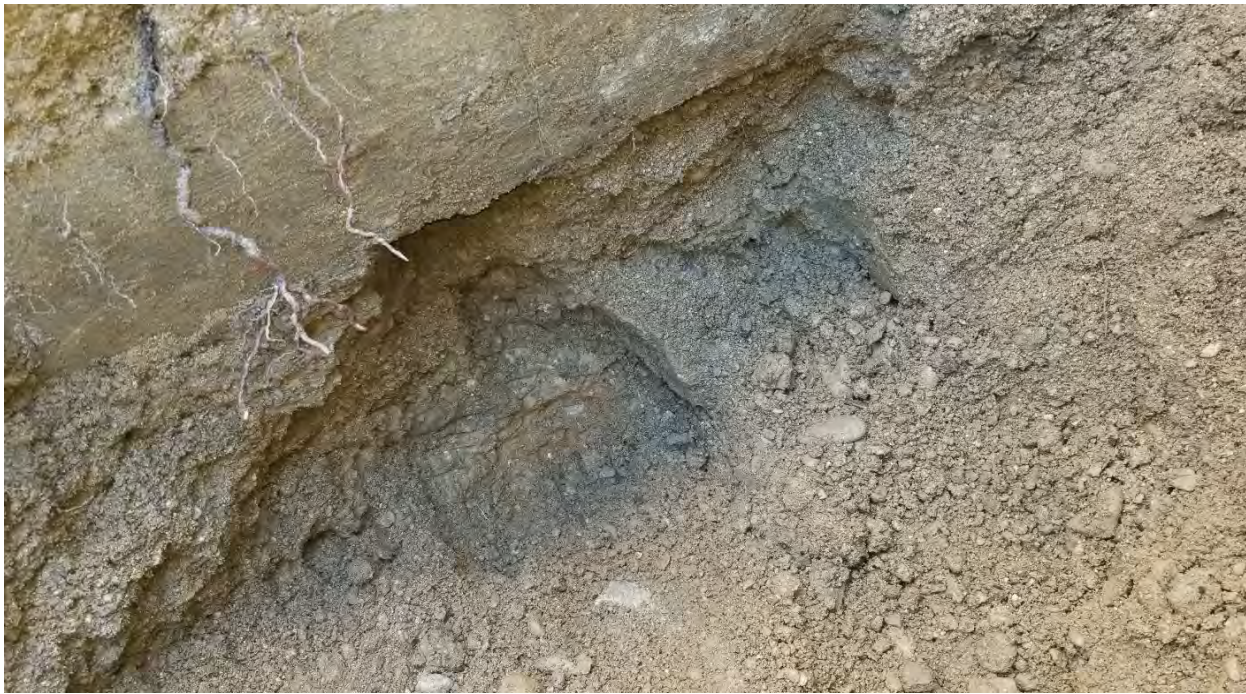
Photo 3 - TP-1 - Existing Fill under foundation

Settlement – We believe that the monument foundations were placed on fill that was not placed in compacted lifts. Furthermore, the fill appeared to contain traces of organic soil. Existing fill that was not placed with strict moisture, density, and gradation control presents risks of unpredictable settlement that generally result in poor performance of foundations.

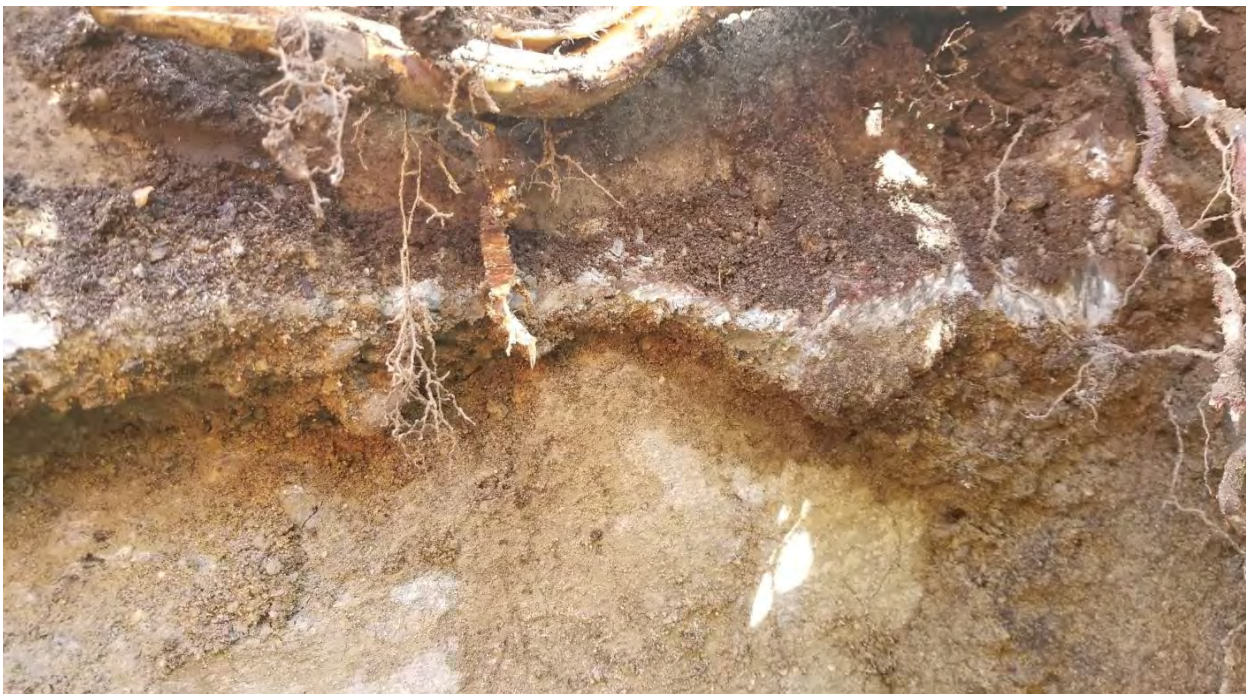
Photo 4 - TP\_1 - Seam of soil between foundation and leveling pad

Frost Heave – Our test pits indicated that the walls of the monument were set on what appears to be a concrete “leveling pad” cast on top of a concrete foundation. The “leveling pad” was only a few inches beneath the ground surface. In all three (3) test pits a seam of soil was observed between the “leveling pad” and the underlying concrete foundation. We believe that as water seeps in the soil seam and freezes, it causes an uplift movement of the wall. We believe that this repeated action has caused cracks to open in the walls and in the mortar between stone blocks. The movement was exacerbated by water entering the cracks and the separations between the stone blocks and freezing, causing further movement.

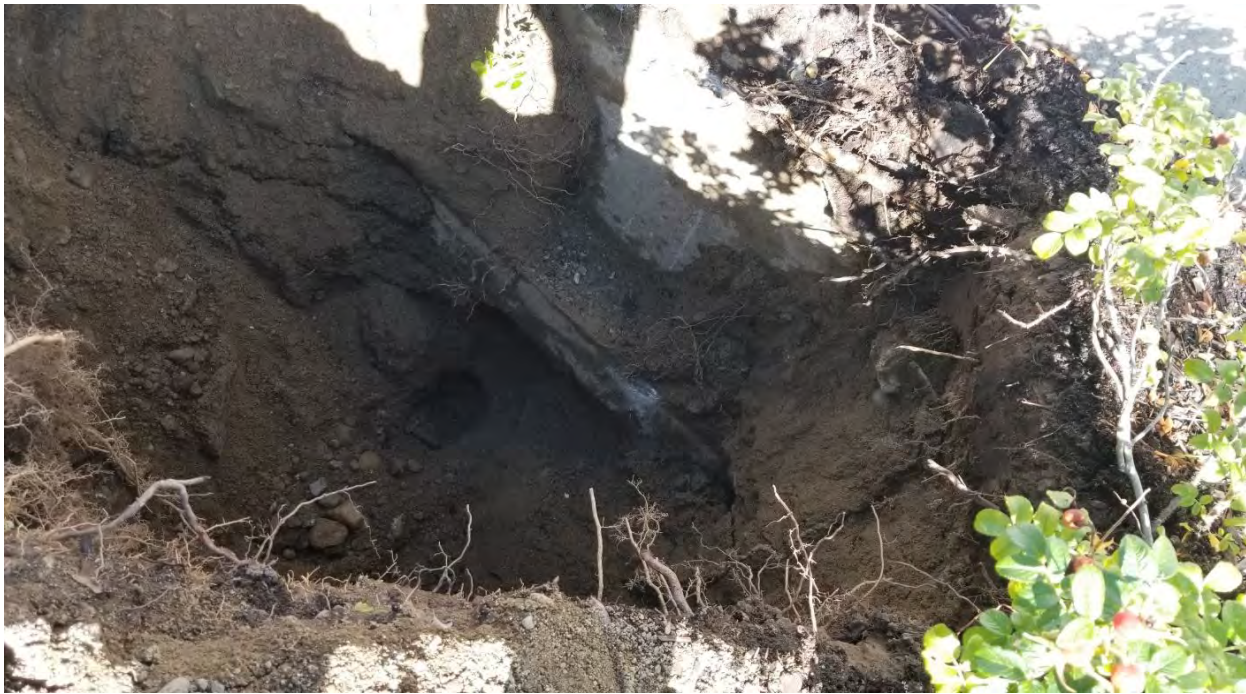
Photo 5 - TP-1 - View of foundation

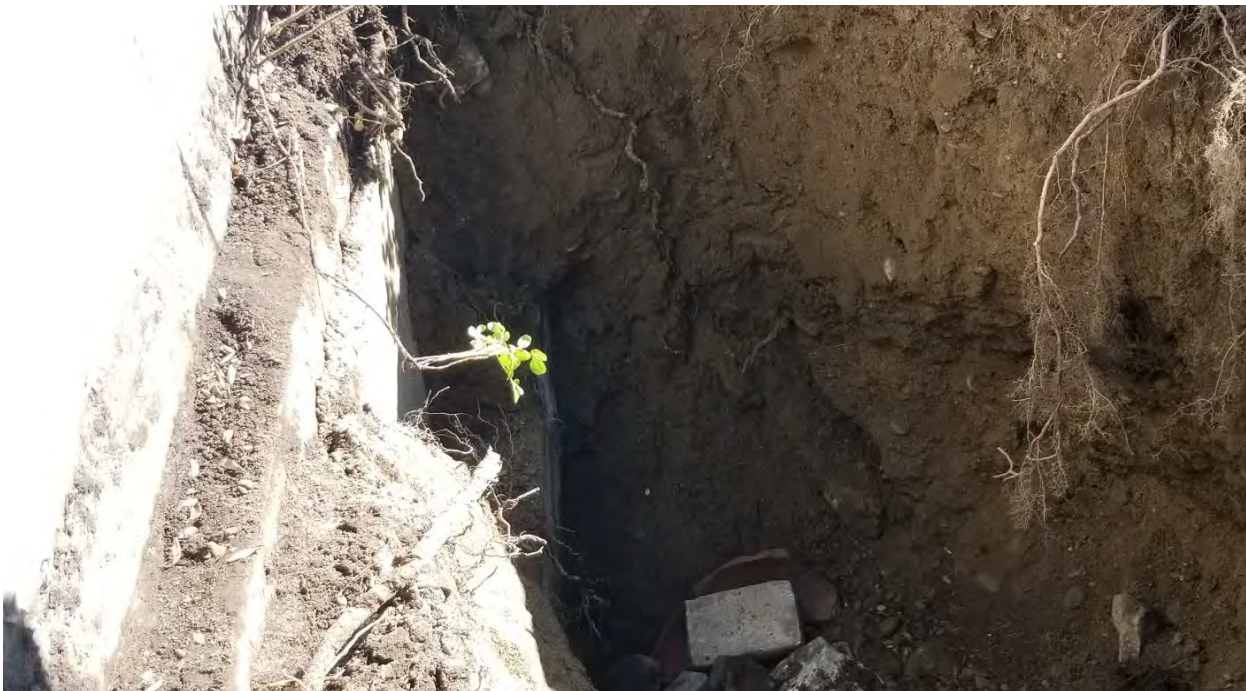
Photo 6 - TP-1 - View of foundation

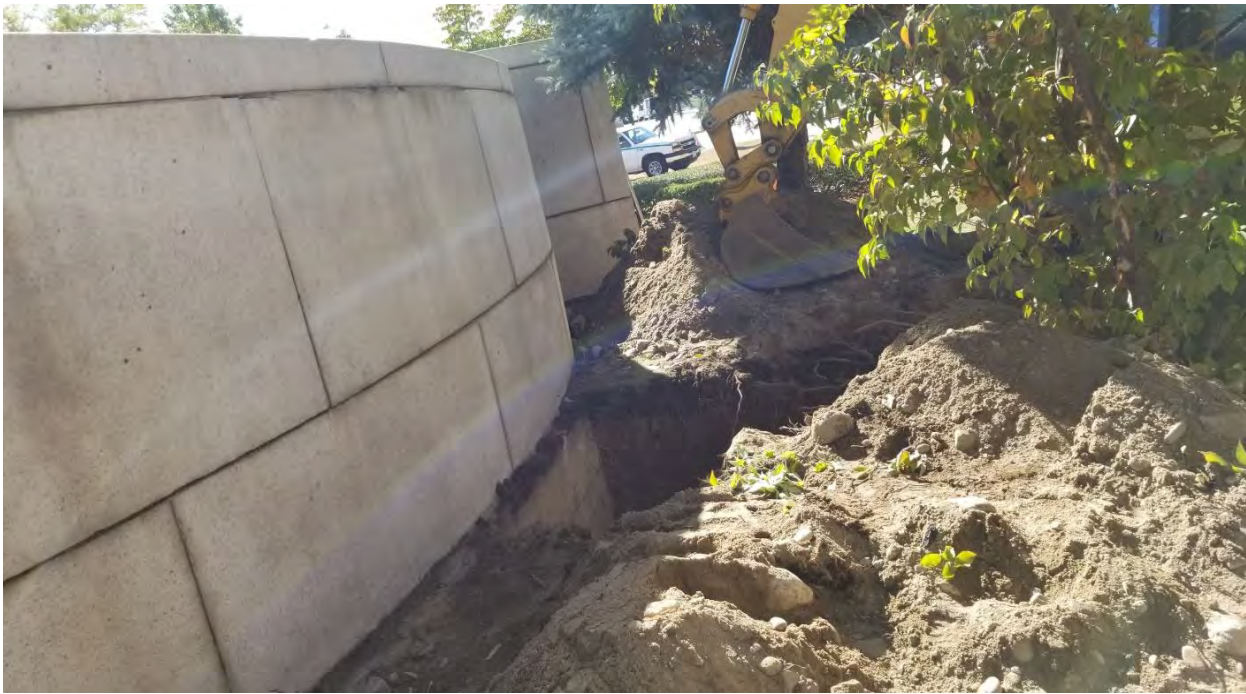
Photo 7 - TP-2 - Overall View

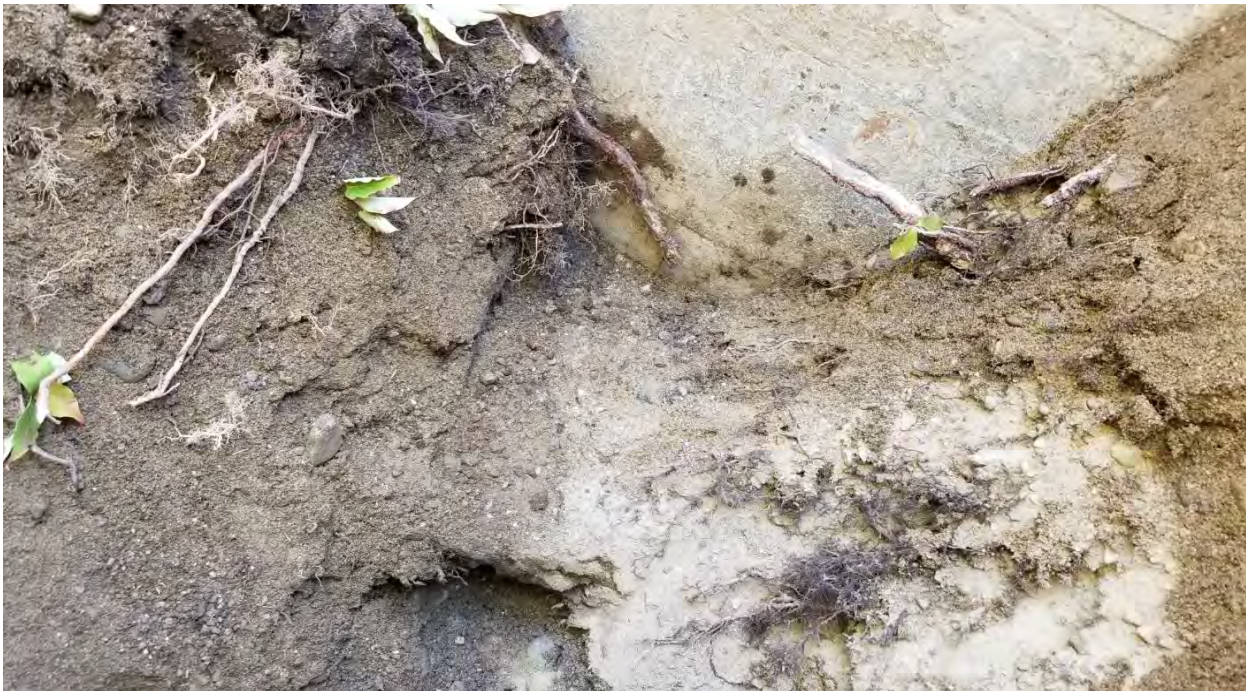
Photo 8 - TP-2 - View of foundation

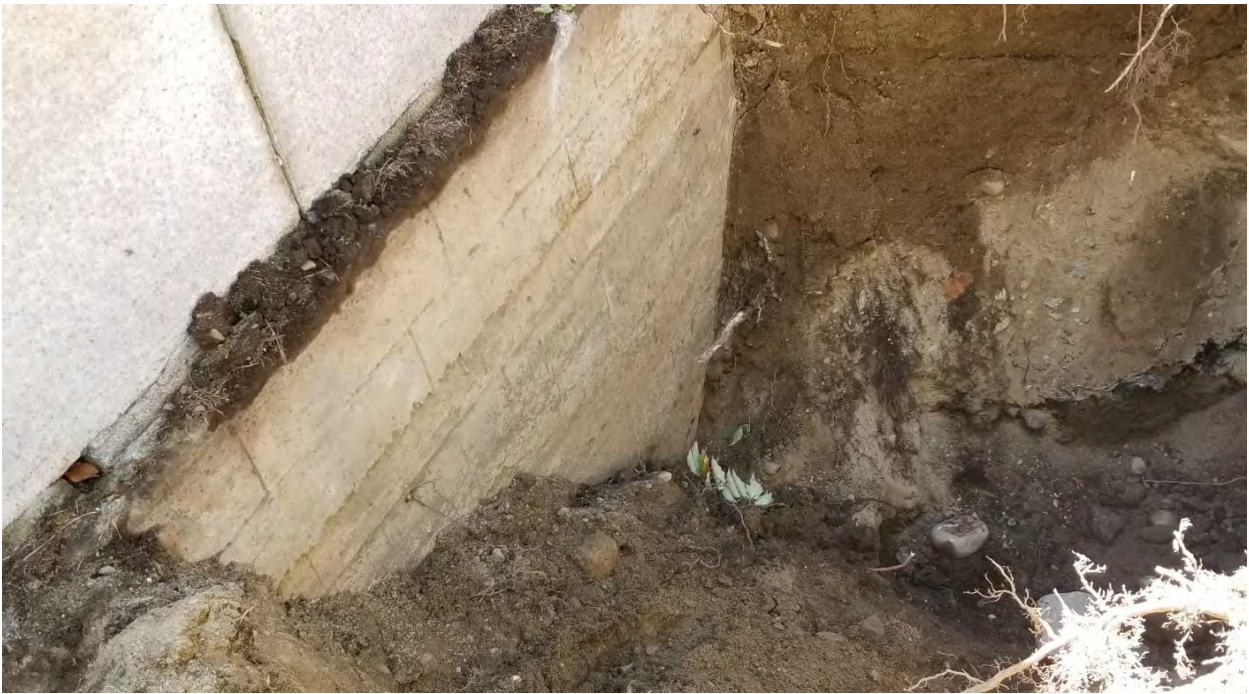
Photo 9 - TP-2 - Seam of Soil

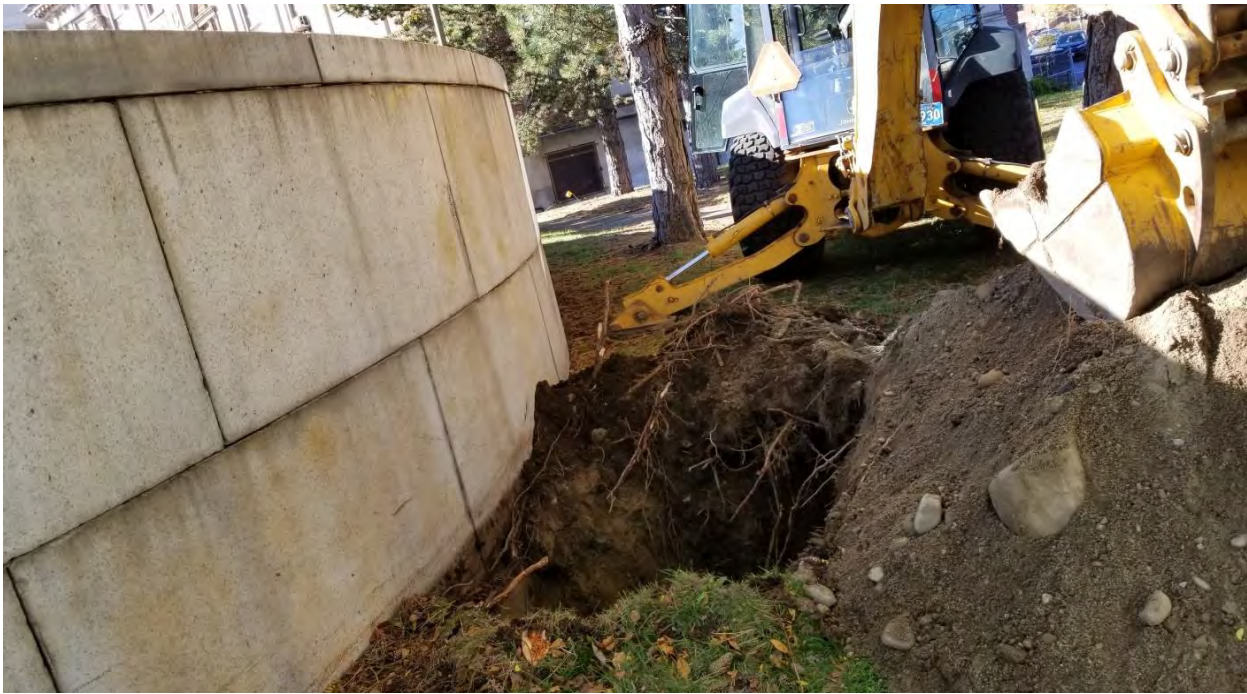
Photo 10 - TP-3 - Overall View

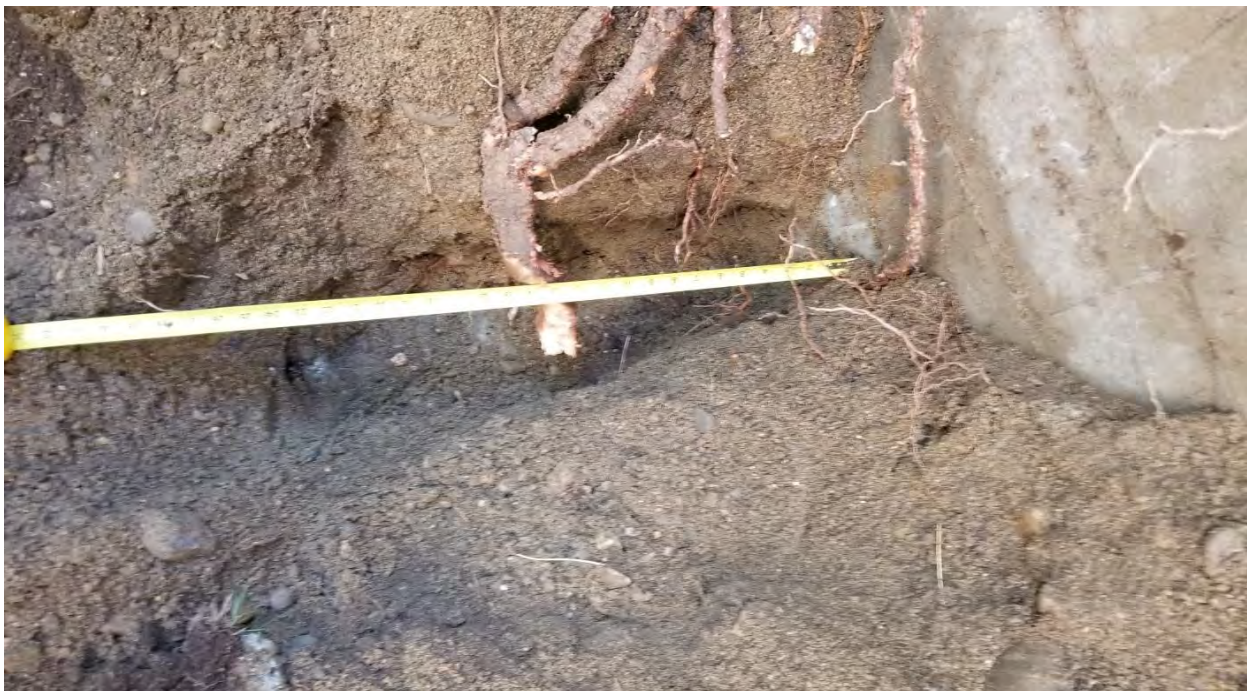
Photo 11 - TP-3 - View of Foundation

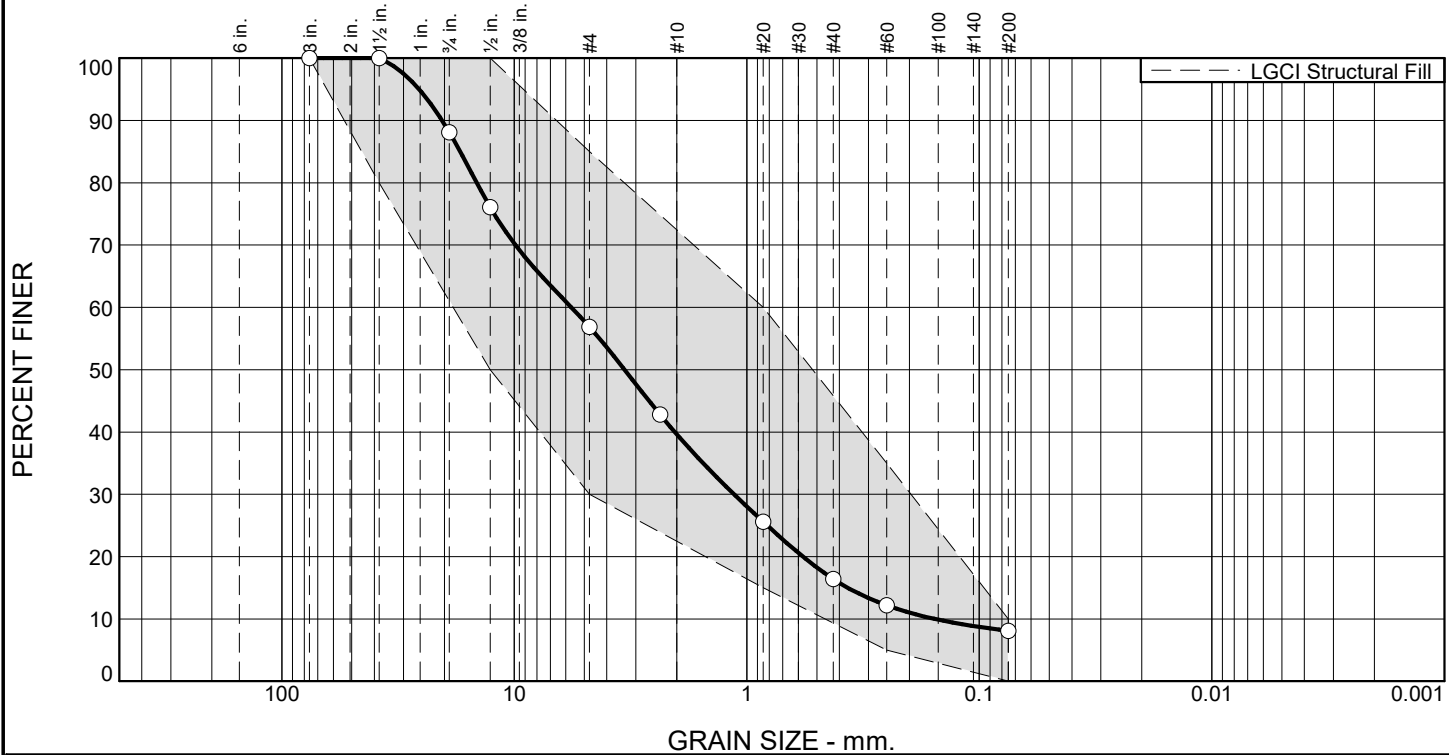
# Particle Size Distribution Report

% +3"	% Gravel		% Sand			% Fines	
	Coarse	Fine	Coarse	Medium	Fine	Silt	Clay
0.0	11.9	31.2	17.3	23.2	8.3	8.1

TEST RESULTS			
Opening Size	Percent Finer	Spec.* (Percent)	Pass? (X=Fail)
3"	100.0	100.0	
1.5"	100.0	80.0 - 100.0	
0.75"	88.1		
0.5"	76.1	50.0 - 100.0	
#4	56.9	30.0 - 85.0	
#8	42.8		
#20	25.6	15.0 - 60.0	
#40	16.4		
#60	12.2	5.0 - 35.0	
#200	8.1	0.0 - 10.0
