Project Blue Worcester for the Tatnuck Brook, Mill Brook, and Lake Quinsigamond Watersheds

Summary of all
watersheds
April 2, 15, and 24,
2025

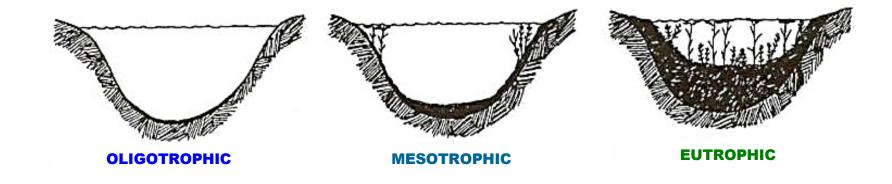
EUTROPHICATION: The natural process by which nutrients, organic matter and sediments

gradually accumulate within a water body, resulting in decreased depth and increased biological productivity.

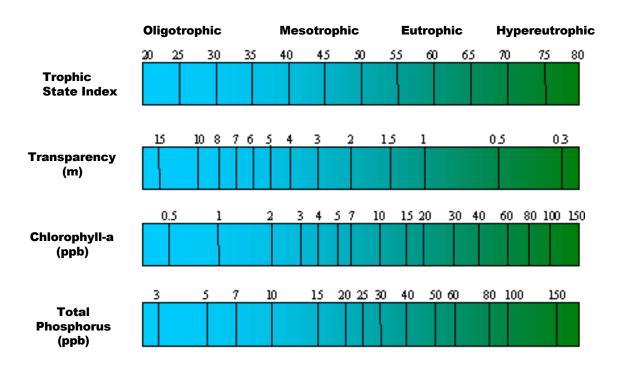
Carlson Trophic Status Index (TSI)

Each 10 point TSI increase = doubling of phosphorus, 2.8 fold increase in algal biomass

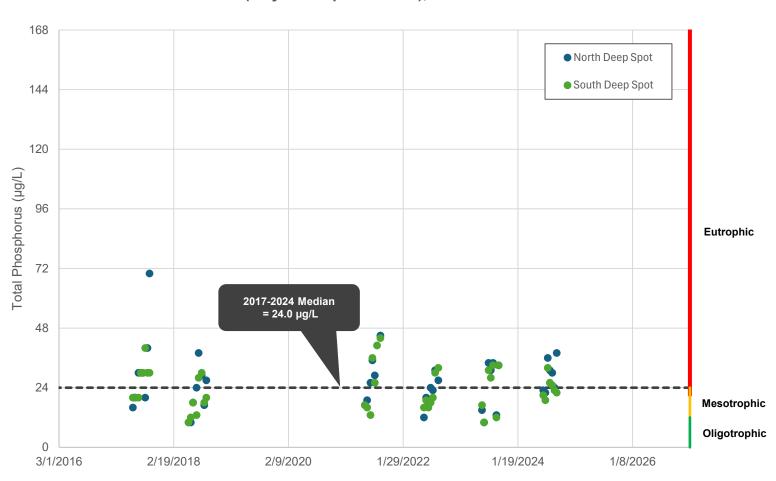
Coes Reservoir

Deep Spot (Surface Water) Total Phosphorus (μg/L) Summer Data (May 21- September 21), 2017-2024

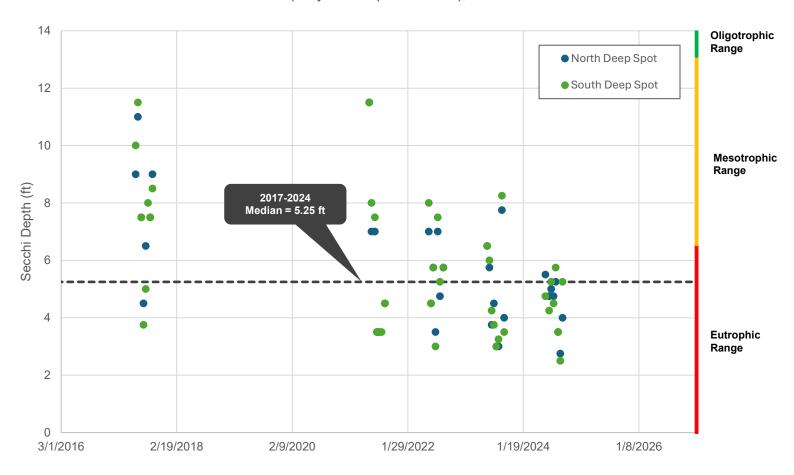
Coes Reservoir

Deep Spot Secchi Disk Water Clarity (ft)
Summer Data (May 21- September 21), 2017-2024

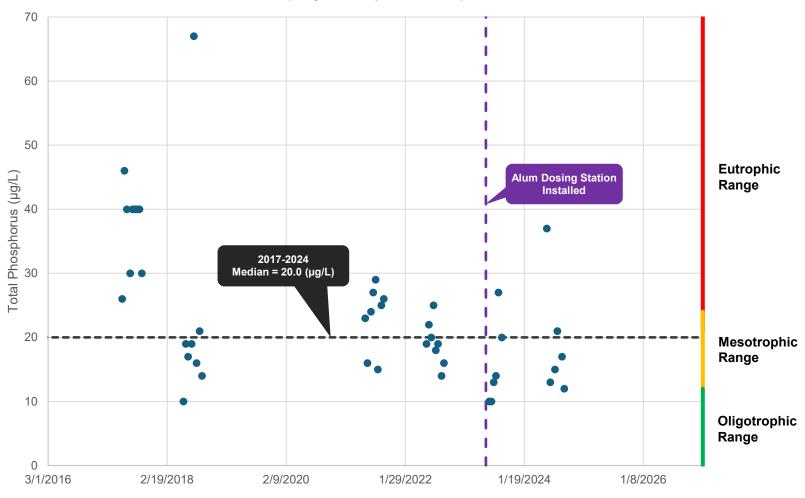
Indian Lake

Northern Deep Spot (Surface Water) Total Phosphorus (µg/L) Summer Data (May 21- September 21), 2017-2024

Median TP

- 2017-2024: 20 ug/L
- Before dosing station: 22 ug/L
- After dosing station: 15 ug/L

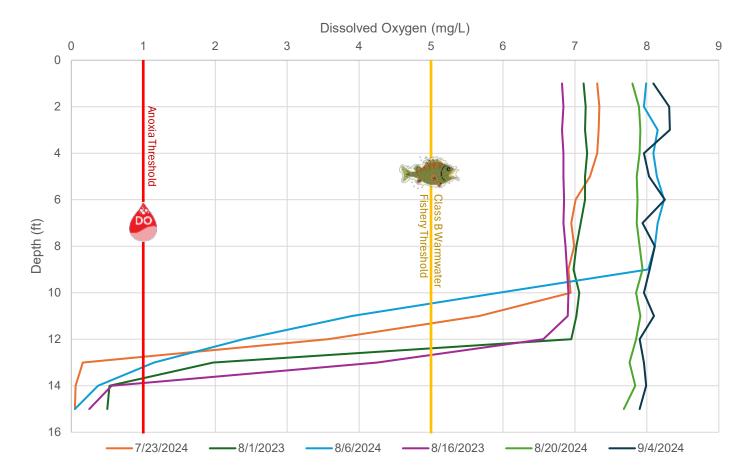
Indian Lake

Northern Deep Spot Example Late Summer Dissolved Oxygen Profiles (2023-2024)

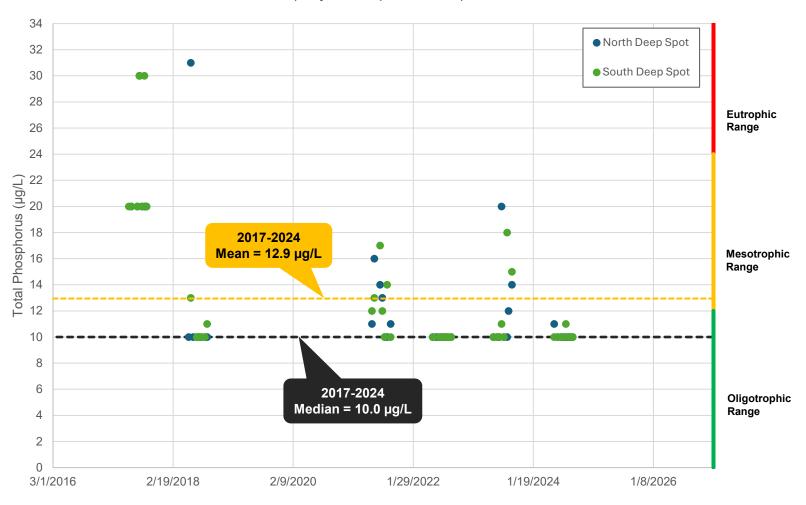
Lake Quinsigamond

Deep Spot (Surface Water Total Phosphorus (μg/L) Summer Data (May 21- September 21), 2017-2024

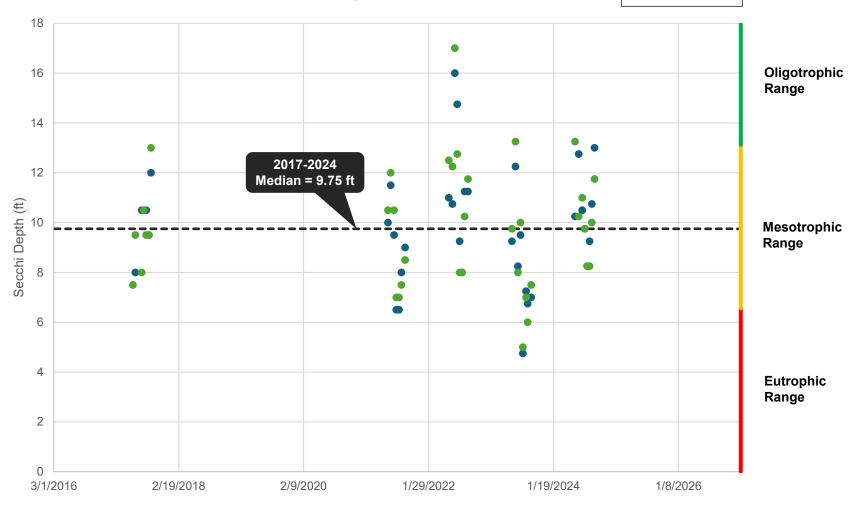
Lake Quinsigamond

Deep Spot Secchi Disk Water Clarity (ft) Summer Data (May 21- September 21), 2017-2024

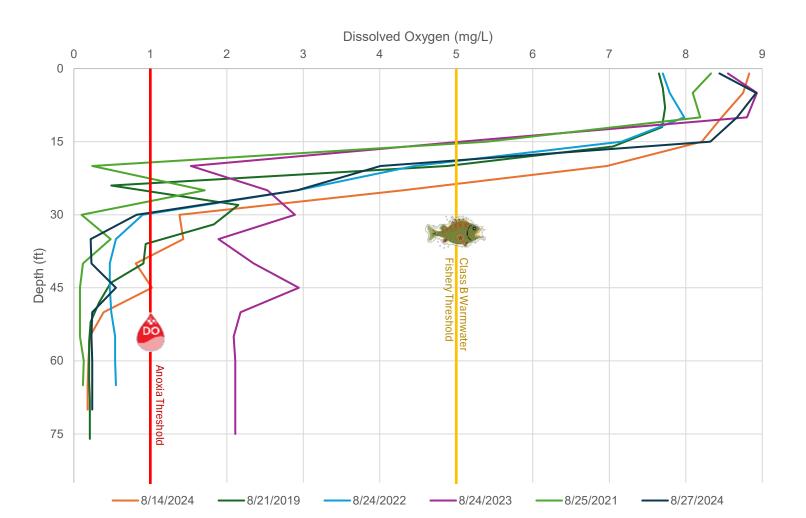
Dissolved Oxygen (DO)

Lake Quinsigamond South Deep Spot Example August Dissolved Oxygen Profiles (2019-2024)

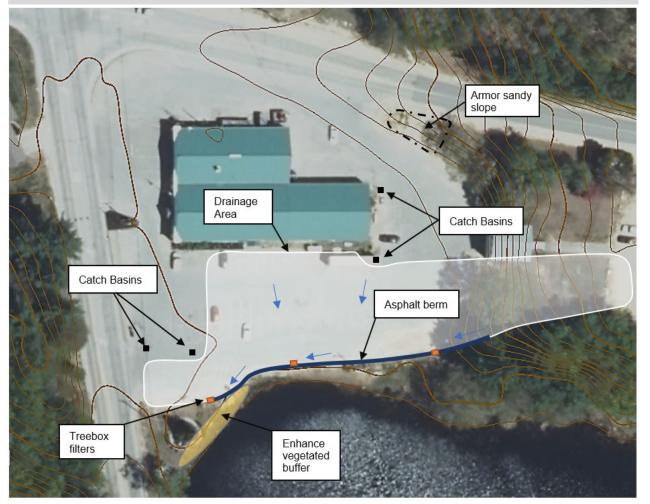
AREA 2: Bow Parks and Recreation Parking Lot

Photo 2-4: Proposed BMP configuration for Bow Parks and Recreation Parking Lot

- 1. Install **asphalt berm** on south side of parking lot; direct runoff into treebox filters.
- 2. **Re-pave /re-grade parking lot** to eliminate ponding and unwanted flow channels, promoting positive drainage to tree box filters.
- 3. Increase **vegetated buffer** along shoreline areas with a double row of shrub plantings.
- 4. **Stabilize steep slope** with riprap and vegetation
- 5. Install **sediment traps** in existing catch basins.

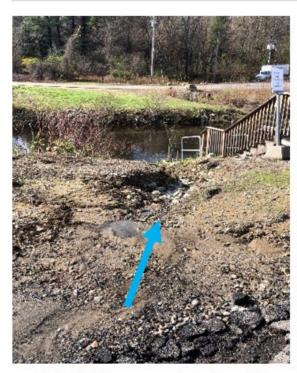
Photo 3-1: Severe erosion adjacent to water access point.

Stabilize eroding bank with native vegetation / bio-stabilization techniques.

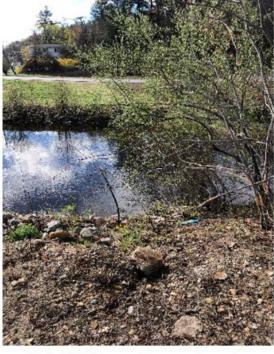
Photo 3-2: Loose stone and sand on slope.

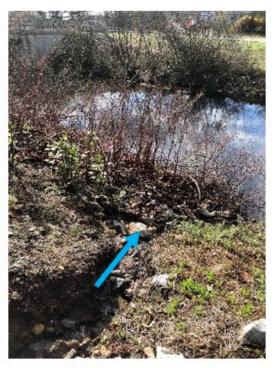
Photo 3-3: Severe erosion adjacent to water access point.

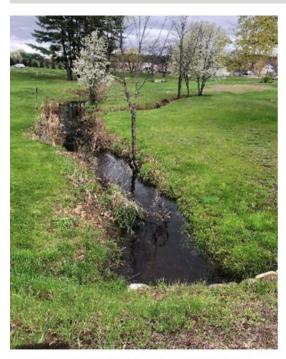
Photo 7-1: Western portion of Bow Brook.

- 1. Develop **20-ft "no-mow" zone** along 1000 feet of Bow Brook; stabilizing the bank and increasing pollutant uptake
- 2. Stabilize roadway erosion with riprap

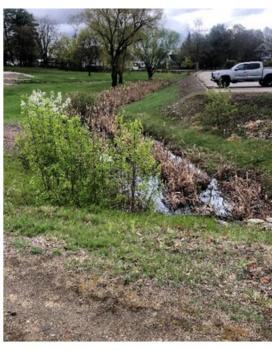
Photo 7-3: Eastern portion of Bow Brook
