Background

Water Quality Summary

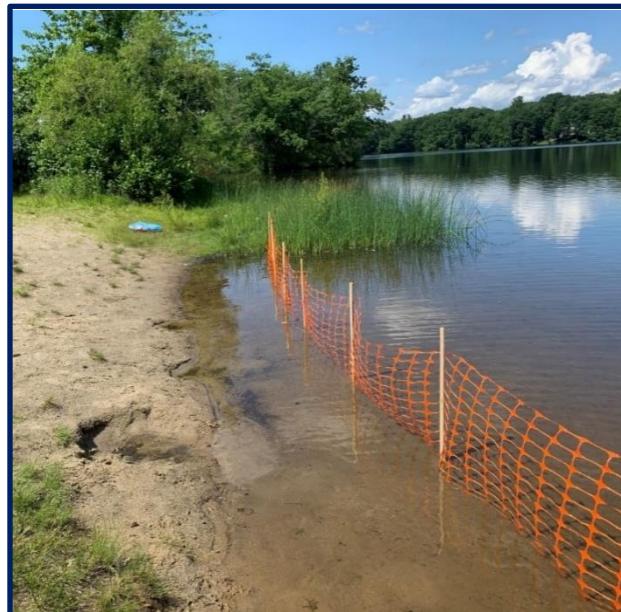
Figure A - Goose fencing was developed and installed during off-hours at the beach, reducing goose congregation and possibly contributing to fewer beach closures for fecal bacteria in 2021.

Coes Reservoir has had management plans for cyanobacteria and invasive aquatic plants for several years now. Additionally, in 2021 a plan was implemented to deal with the increased number of closures due to *E. coli* bacteria that were witnessed in 2020. Following monitoring data aimed at assessing the risk of cyanobacteria blooms, there were two treatments of algaecide applied to the surface of Coes Reservoir, one in July and one in September. Together, these treatments kept cyanobacteria densities safe for recreation and wildlife. To address the three invasive aquatic plants presently found at Coes, including water chestnut, fanwort, and Eurasian milfoil, the Lakes and Ponds Program used a combination of physical removal and herbicide strategies. It should be noted that in 2019 a successful systemic herbicide treatment significantly reduced the fanwort and milfoil density through 2020, and in 2021 minimal intervention was necessary to control grow-back. To address the ongoing water chestnut concern, two rounds of the herbicide Clearcast were applied in June and July, and hand pulling was performed in September. Together, these activities were successful in reducing the density of the invasive plant during the season. Unfortunately, due to its unique reproductive strategy, it will be many more years before the water chestnut will be completely eradicated. Following high *E. coli* readings in 2020 and a suspected relation to goose activity, goose fencing was developed and installed during off-hours at the beach. This ultimately reduced goose congregation on the beach and may have contributed to fewer beach closures for fecal bacteria in 2021 (see *Figure A*).

Goose Fencing Pilot Project In 2020, Coes Reservoir beach was closed for 13 days due to high concentrations of the fecal bacteria indicator, *E. coli*. Further examination of the beach area during this revealed that geese that were leaving large amounts of droppings on the shore and in the shallow water. In 2021, the Lakes and Ponds Program implemented a pilot project that aimed to reduce the number of beach closures by keeping geese away from the beach in a humane way while not inconveniencing beach users. Geese usually enter the beach from the water, and are not good and getting over even low barriers. Additionally, they do not like barriers between the beach and the water, as the water is their escape route from land predators. After erecting a small fence between the shore and water during the evening hours, use of the beach by the geese was significantly reduced. In 2022, the Lakes and Ponds Program intends to improve the constriction of the fencing using higher quality materials and make installation easier so as to increase usage during the summer.

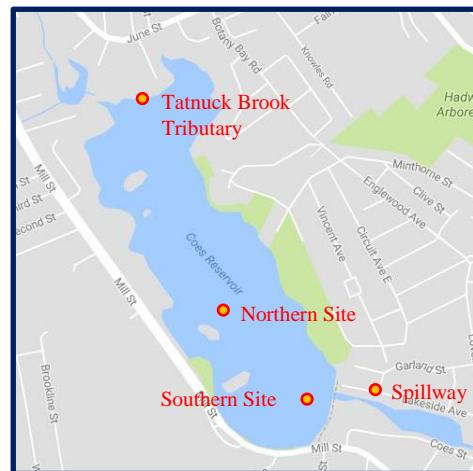
Coes Reservoir was visited semimonthly in 2021 from May through November and sampled at four locations: The major aboveground tributary, Tatnuck Brook; the two deepest parts of the reservoir (the northern is about 13 feet deep and the southern is about 15 feet deep); and the outlet at the spillway located in the southern part of the reservoir (see *Figure B*). Parameters evaluated included: Secchi transparency, temperature, dissolved oxygen, pH, total phosphorus, total dissolved phosphorus, *E. coli*, phycocyanin, and litter. Samples analyzed for total suspended solids, ammonia, and nitrate were collected on a monthly basis. Altogether, there were 14 sampling events. For 12 of these events, there had been no rainfall 24 hours prior to data collection. However, on 7/8 there was 0.32 inches of rain in the previous 24 hours to sampling, and on 8/19 there was 3.05 inches of rain. These days are categorized as “wet weather” sampling events.

Figure B - Coes Reservoir map and approximate sampling locations.

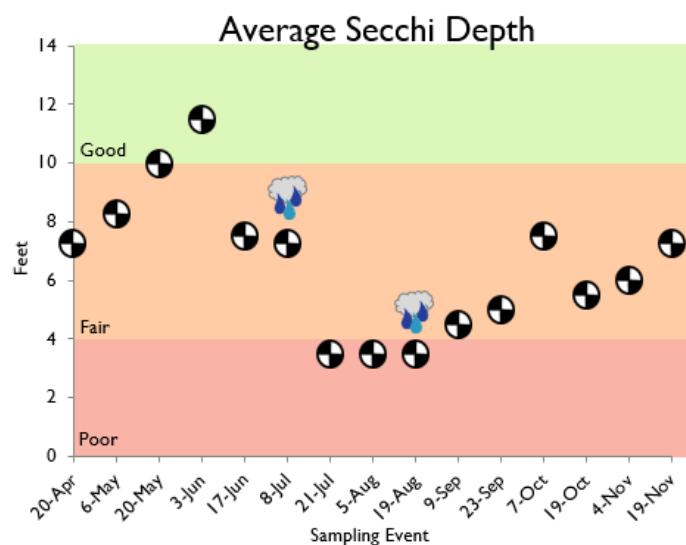
Figure D – Secchi depth decreased after May through August, but only increased into the “fair” category again before the season ended in November.

Water clarity at Coes Reservoir. At Coes Reservoir, Secchi depth was rated as “fair” to “good” in the beginning of the season, with a maximum clarity of 12 feet in early June (see *Figure D*). As the season went on, Secchi fell from “fair” to “poor”, only increasing again at the end of September. Clarity did not reach a rating of “good” again for the rest of the season. Compared to previous years, clarity was lower than average at Coes Reservoir.

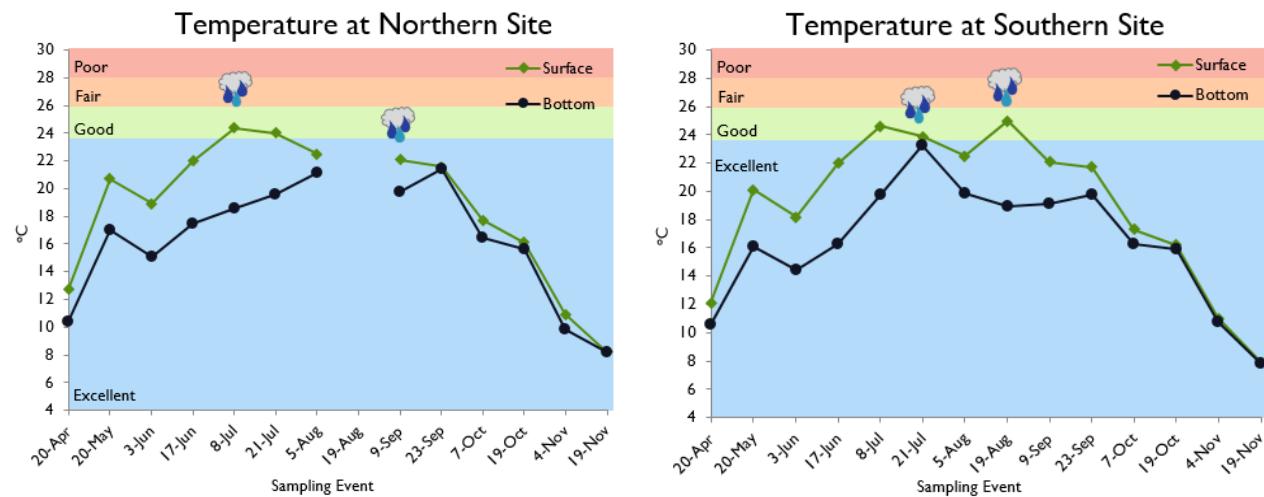
Figure E – Temperature stayed in the “excellent” category for the majority of the season at the surface and bottom at both sampling sites.

Temperature at Coes Reservoir. Temperatures at Coes Reservoir stayed in the “excellent” category at the bottom for the entire season. The surface fared similarly, only dipping into the “good” category 2 or 3 times in July and August (see *Figure E*). This is a noticeable improvement from 2020, when the surface temperature was an average 0.9 degrees higher. It is possible that the cooler, rainier summer dampened water temperatures. Surface and bottom temperatures at the two in-lake sites were very similar, suggesting that water was well mixed.

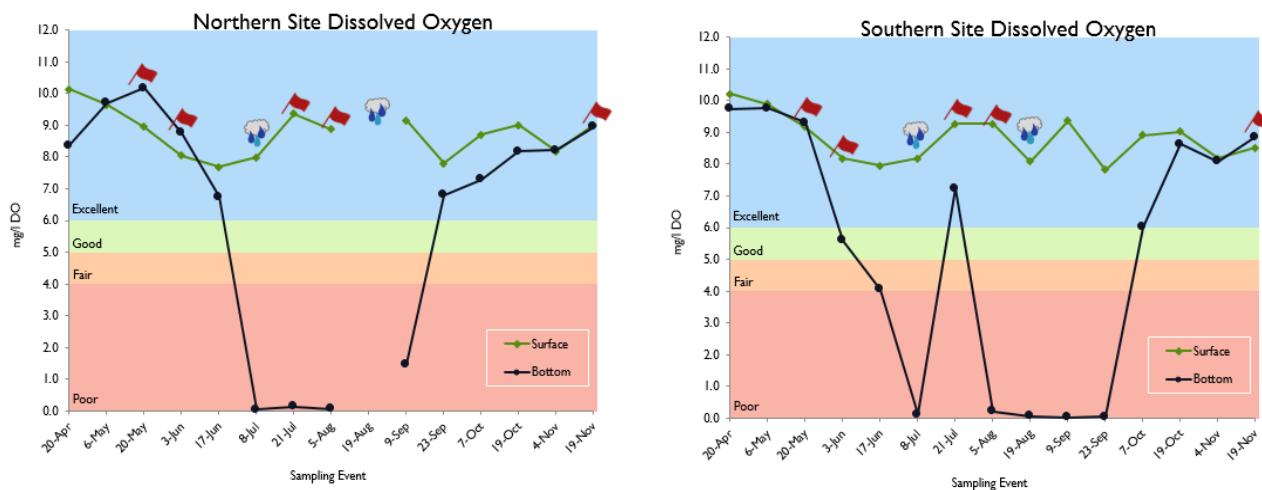
Dissolved Oxygen at Coes Reservoir. In 2021, DO at the surface of the Reservoir was rated as “excellent” at both in-lake locations, all season long (see *Figure F*). At the bottom, DO began to decline in early June, with bottom DO concentration rated as “poor” between July and the end of September, with the exception of one event at the southern site. Most bottom measurements in this time period were close to 0 mg/l, or anoxic. These results are in line with results from previous years. In past years, depth profiles showed decreasing DO in July and August, approaching the bottom of the lake. However, concentrations did not fall below 4mg/l until a depth of around 9 feet, leaving plenty of the lake with enough DO for aquatic life. However, to ensure that this remains the case, additional profiles will be performed at Coes Reservoir in 2022.

Figure F – Surface DO stayed in the “excellent” category all season at both sampling locations. Readings at the bottom of the lake were very low between July and September.

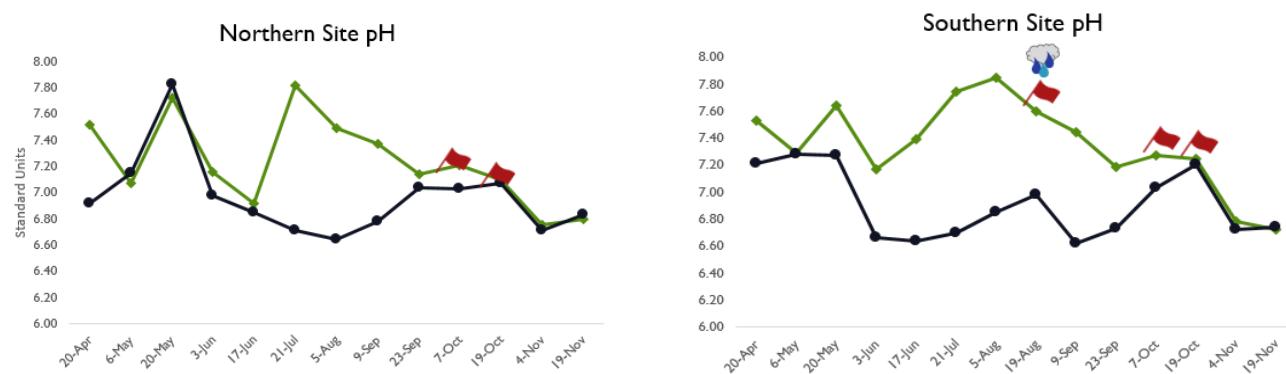
pH at Coes Reservoir. This year at Coes, pH ranged between 6.6 and 7.8, which falls within a healthy range for lakes in this region (see *Figure G*). As expected, surface pH tended to be higher than bottom pH. The difference between the surface and bottom readings was smallest in the beginning and the end of the season. During the months of June through August, bottom pH decreased compared to the surface, which follows the observation of low DO during this time period. It is common for high rates of decomposition on the lake bottom to result in increased dissolved CO₂, lowering the pH. In general pH at Coes Reservoir is in a normal range and is not a hindrance to aquatic life or recreation.

Figure G – pH was generally lower in the deep vs shallow parts of the reservoir, however all results were in the expected range and safe range.

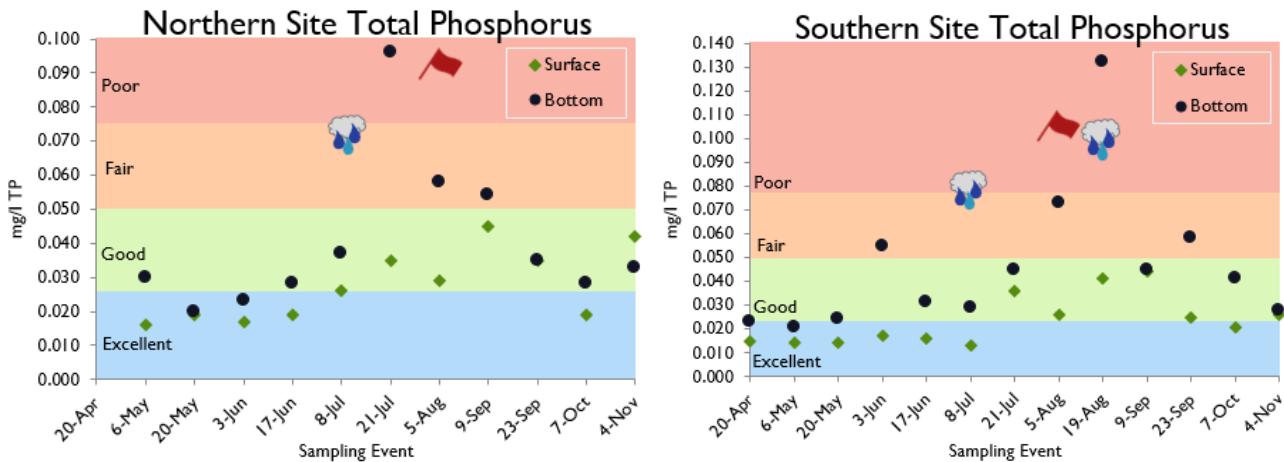
Figure H – Total Phosphorous stayed in the “excellent” and “good” categories at the surface at both sites but strayed into the “fair” category at the bottom.

Nutrients at Coes Reservoir. While TP was in the “excellent” category at the surface in the beginning of the season, concentrations began to rise into the “good” category in mid-July (see *Figure H*). This is generally in line with what has occurred at Coes over the past few years. TP at the bottom increased to the “fair” category in August, but readings returned to the “good” category by the end of the season. There were also results in the “poor” category on 7/21 and 8/19. Although this trend was generally mirrored between the northern and southern sampling sites, the southern site experienced more bottom sample results in the “fair” category over the course of the season. The increase of the TP concentration as the season went on may have put Coes at higher risk for cyanobacteria blooms.

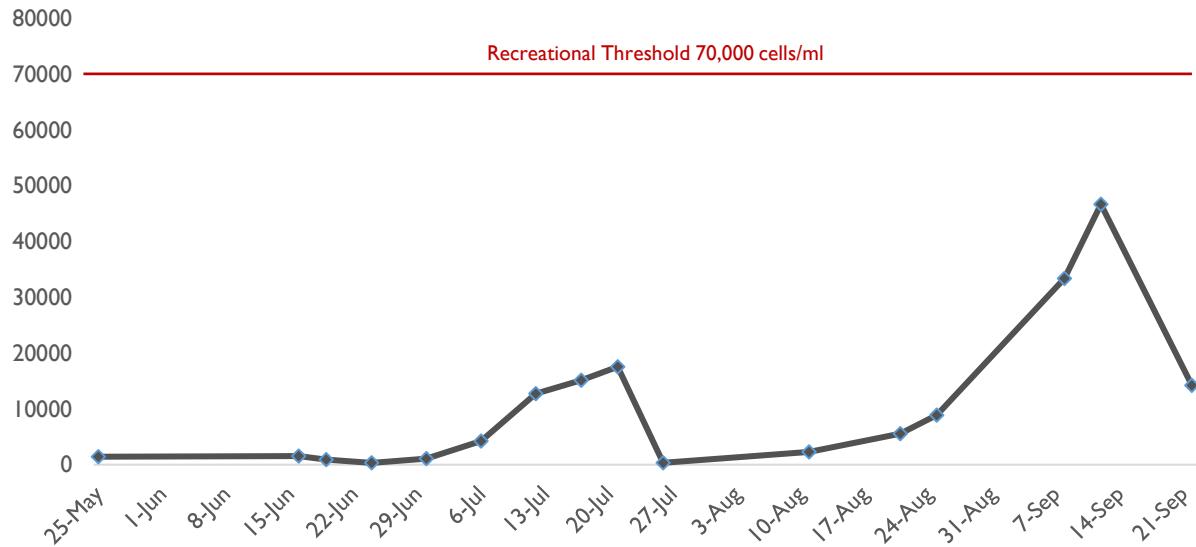
Cyanobacteria at Coes Reservoir. There were no closures due to cyanobacteria exceedances at Coes Reservoir in 2021. Cyanobacteria cell counts remained low in the early season, beginning to increase in early July (see *Figure J*). A preventative algaecide treatment was conducted on 7/22, which brought the density down at the end of July. Previously, one treatment was enough to keep densities low at Coes for the rest of the season. However, as the 2021 season progressed, the cell count increased again in late August, and a second treatment was conducted for 9/16. 2021 was the first year that two treatments have been applied in the same year at Coes. After the second treatment, the cell count fell and did not rise again for the remainder of the season.

Figure J – Cyanobacteria counts peaked in late August and fell after the treatment on 9/16. They rose again in September and required a second treatment in September.

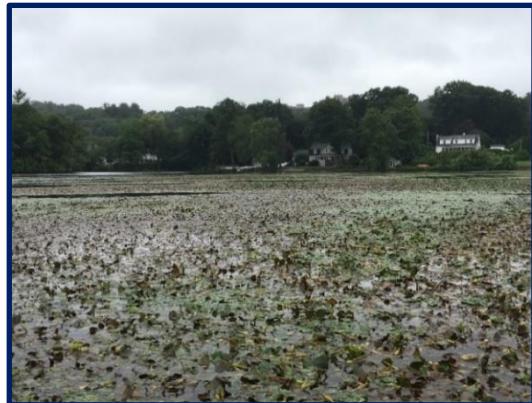
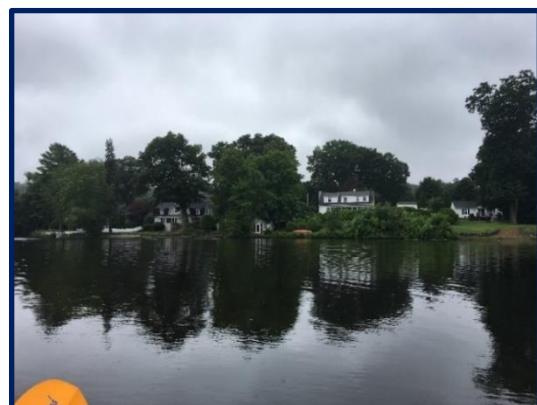
Figure K – Northern end of Coes Reservoir before and after treatment for invasive water chestnut.

Previously, the invasive aquatic plant water chestnut, which is found primarily in the northern portion of the reservoir, was managed using a mechanical harvester, which acts similarly to a floating lawn mower, cutting back and removing the floating vegetation before it matures to a reproductive state. Unfortunately, the size of the infestation and geography of the reservoir makes it difficult to eradicate all plants with this method. In 2021, the contact herbicide Imazomox (trade name Clearcast) was applied on 6/18 and 7/21 and greatly reduced the density of water chestnut (see *Figure K*). A hand pull was conducted on 9/13 by Lakes and Ponds Program staff to address the remaining patches of water chestnut outside of the main treatment area. Unfortunately, the reproductive strategy of the water chestnut means that it will need to continue to be managed over the next 5-7 years before the infestation is eradicated. But, overall, while present, invasive aquatic plants are being successfully managed at Coes Reservoir.

In 2022, the Lakes and Ponds Program plans to continue administering the invasive aquatic plant management plan at Coes Reservoir similar to how it was enacted in 2021. The use of herbicides and physical hand pulling of the water chestnut will continue, as well as spot treatments of the Eurasian milfoil. At the end of the 2022 season, an aquatic plant survey will be performed to map progress and inform the management plan for 2023.

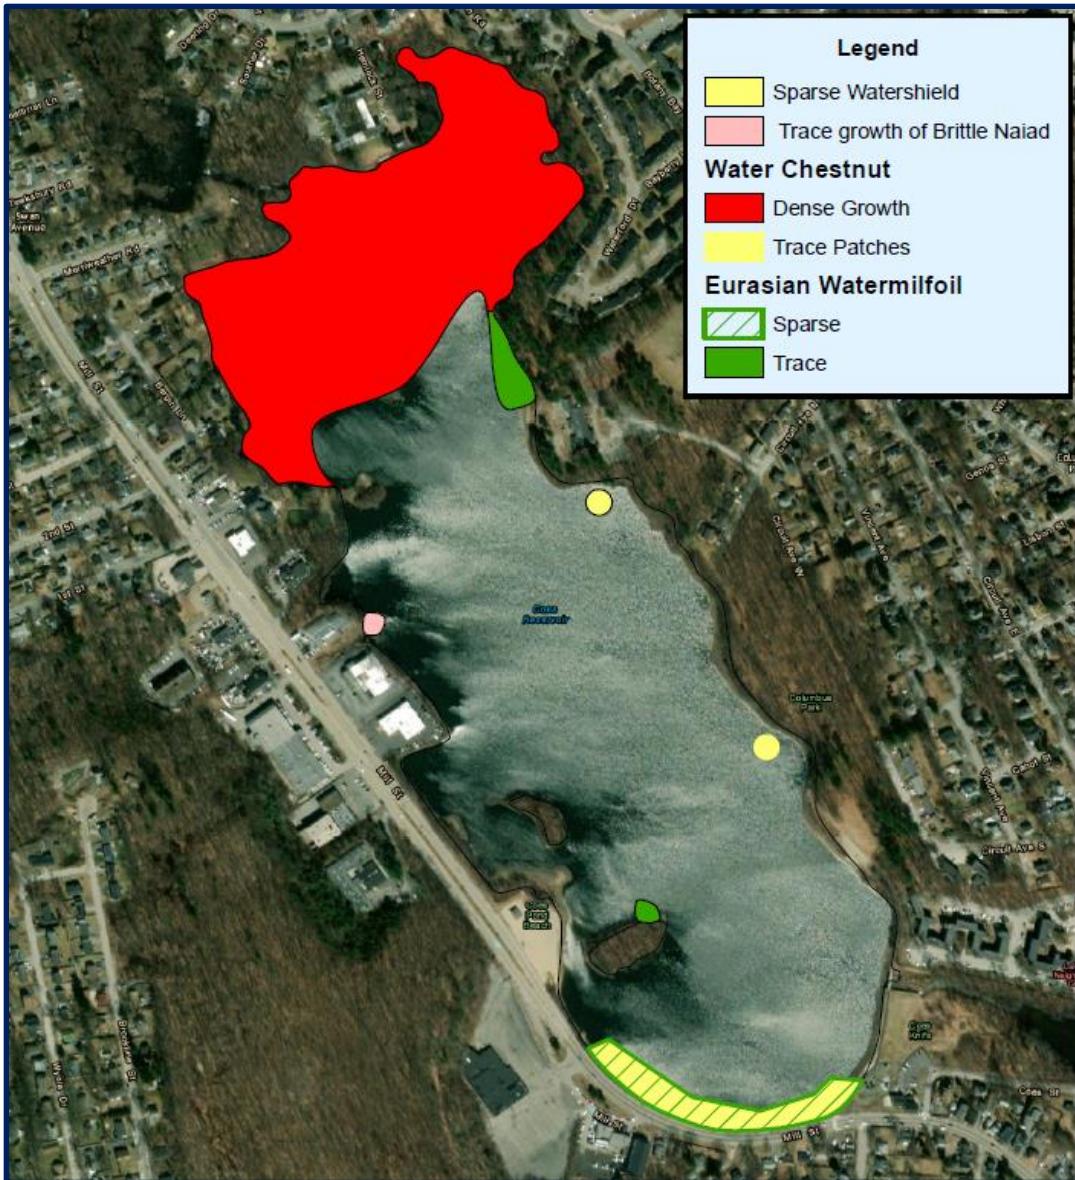
Invasive aquatic organisms at Coes Reservoir. Coes Reservoir is managed for three invasive aquatic plants: water chestnut (*Trapa natans*), fanwort (*Cabomba caroliniana*), and Eurasian milfoil (*Microphyllum spicatum*). Over the years, the Lakes and Ponds Program has continued to refine its plan for each of them based on present conditions. At the end of 2020, the disbursal of aquatic plants was mapped in order to track progress and more effectively manage them in coming years (see *Figure L*).

Figure L – Aquatic invasive plant coverage at the end of the season in 2020.

All treatments are approved by the Worcester Conservation Commission and applied by licensed professionals. In 2019, the systemic herbicide fluridone (trade name: Sonar) was used to address both the Eurasian milfoil and fanwort. As a systemic herbicide, the herbicide killed the milfoil at the root, which means that affected plants were not expected to grow back the following year. The treatment was successful and very little was present in the 2020 end-of season survey. In 2021, those patches were

treated with the contact herbicide diquat dibromide (trade name: Reward) so remaining plants would not reproduce.

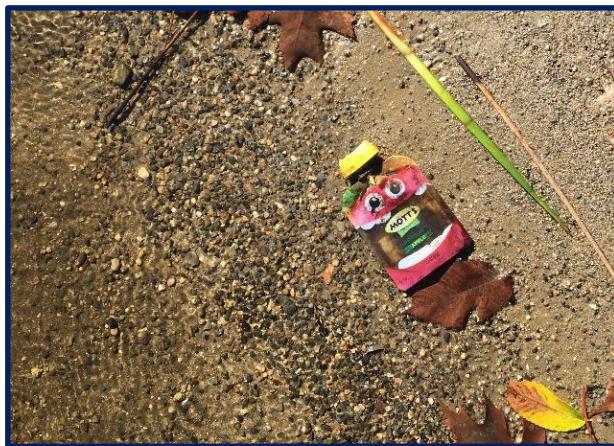
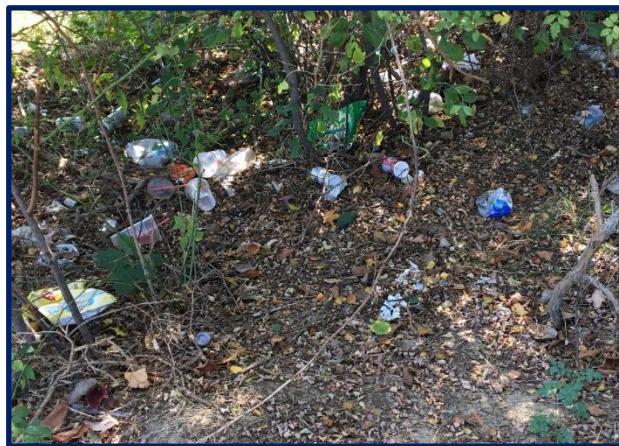
Figure M – Litter on Binienda Beach.

Litter at Coes Reservoir. Litter was characterized at Binienda Beach on Mill Street. Through the sampling season, the beach scored an average of 2 in each of the categories “Clean-up effort”, “At a glance”, “Safety”, “Litter density”, and “Impact/functionality”. This indicates that litter was present but conditions were not severe and cleanup would not be extremely difficult. Relative abundance of the different types of litter were also noted. Of the litter categories assessed, “small items”, “tobacco products”, and “food packaging and containers” usually scored 3 or higher, while the rest scored 2 or below. Before September, it was often observed that litter had gathered in the reeds along the shore, but this was not as common later in the season. A large accumulation of trash was observed on the southern side of the beach as the season went on. The hope is that this information can help to guide management decisions.

The Lakes and Ponds Program plans to continue to refine its new Litter Tracking Tool to better understand patterns in litter and trash at Coes Reservoir. In addition, the Lakes and Ponds Program will work with its partners, including the Department of Public Works & Parks, and Worcester Green Corps, to use this data to develop litter reduction strategies.

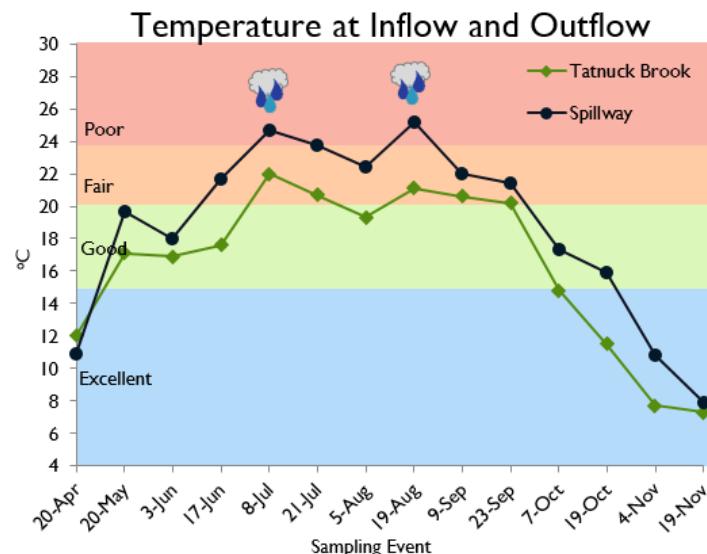
Tributaries at Coes Reservoir. At Coes Reservoir, the major natural tributary is Tatnuck Brook, which enters the pond from the north. The major outlet of the reservoir is the spillway, located on the southern end. Tatnuck Brook is considered a Coldwater Fisheries Resource (CFR), which means that it is a stream in which reproducing coldwater fish have been found. Tatnuck Brook, therefore, has higher standards for temperature than many local urban waterbodies. Over the 2021 sampling season, the brook had a maximum temperature of 22 degrees on July 8, and was in the "fair" temperature range for 5 of the 14 sampling events (see *Figure N*). As water from Tatnuck Brook enters Coes Reservoir, it slows down and is more exposed to the sun and air, warming it up. On average, the water leaving the Coes Reservoir spillway is 2.4 degrees higher than when it enters.

Figure N – Water temperature at the Coes Reservoir spillway was on average 2.4 degrees higher than when it entered.
