Coes Reservoir

2025 Water Quality Report

The City of Worcester

Department of Sustainability and Resilience
Lakes and Ponds Program

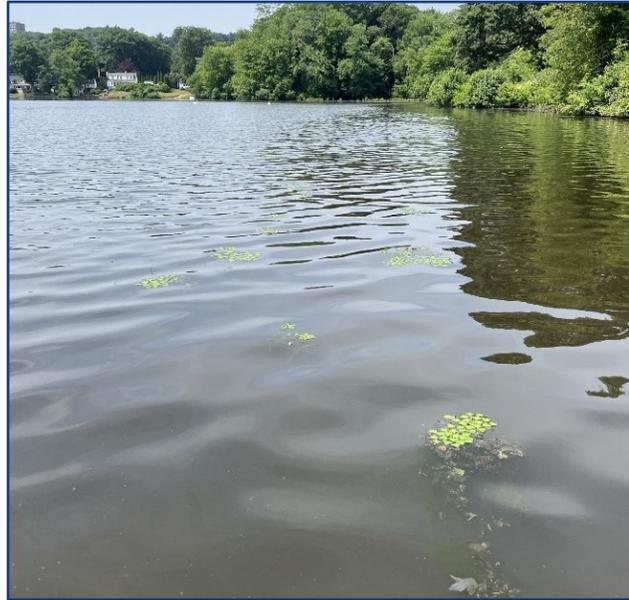
Coes Reservoir is managed for several invasive aquatic plants: Water Chestnut (*Trapa natans*) (see Figure 16), Fanwort (*Cabomba caroliniana*), and Eurasian Milfoil (*Myriophyllum spicatum*). Curly-Leaf Pondweed (*Potamogeton crispus*) has also been noted with peak growth in early spring, though the species has not been documented in contracted aquatic plant surveys nor actively managed. L&P plans to conduct a targeted survey in spring 2026 to better assess its distribution and potential impacts. Before the utilization of chemical treatments, Milfoil and Water Chestnut threatened to overtake the entire reservoir. To manage populations of these plants, L&P has used a combination of physical removal and herbicide strategies. A successful systemic herbicide treatment of fluridone (trade name: Sonar) in 2019 significantly reduced the Fanwort and Milfoil density through the present. Dense Water Chestnut growth has been managed annually by L&P at Coes Reservoir since 2017. Invasive Water Chestnut populations commonly require a minimum of eight to twelve years to eradicate and remove most of the seed bank, with sparse growth continuing in later years. After years of consistent management of dense growth, the remaining Water Chestnut can be managed with volunteer and contracted hand pulls. L&P and the Tatnuck Brook Watershed Association (TBWA) co-hosted a community hand pulling event in late June where 15 volunteers removed 50 pounds of water chestnut plants throughout the lake. A follow-up contracted hand pull removed the remaining visible plants. While hand pulling will remain necessary for years to come, it is expected that more robust techniques will not be necessary if hand pulling events receive sufficient volunteers.

Figure 16 – A reduced population of invasive Water Chestnut at Coes Reservoir was managed with volunteer and contracted hand pulls in 2025.

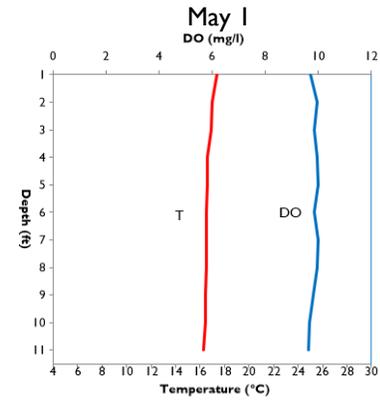
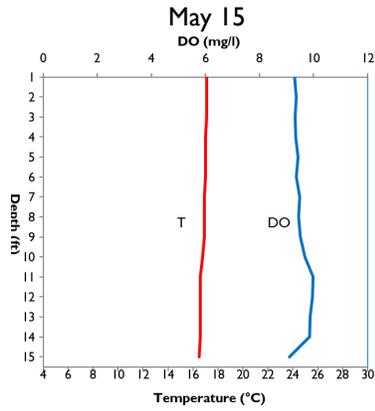
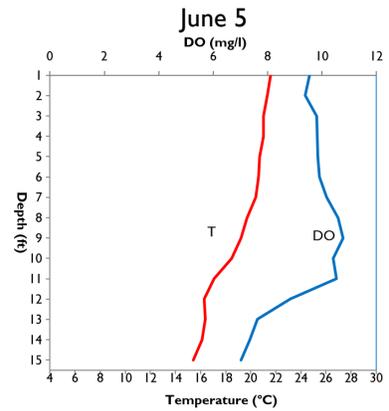
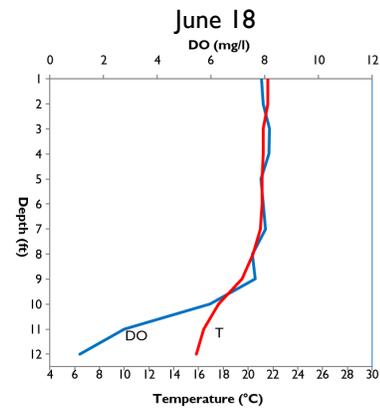
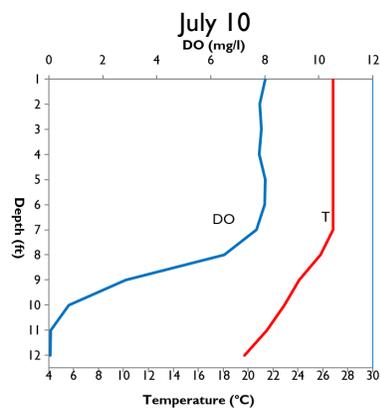
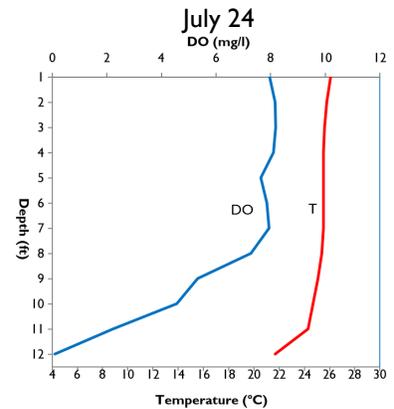
Appendix: Depth Profiles

To determine the extent of warming throughout the entire water column, depth profiles were taken at the Southern in-lake site (see Appendix). During the first two sampling sessions, temperature was relatively consistent throughout the water column. Profiles recorded between 18-Jun and 7-Aug exhibited

temperature stratification, with the thermocline between 7 and 10 ft. The maximum temperature difference between the surface and deep water was 7.1° C, indicating relatively mild stratification.

As observed from the depth profile data, the entire water column was adequately oxygenated during the first three sampling sessions (see Appendix). In mid-June, DO concentration began to drop below 4 mg/L, the lower avoidance limit for fish, in the deepest reaches of the water column. Throughout the season all water above 9 ft was adequately oxygenated. From late May through September, an oxycline was observed in which water below 8 - 10 ft was hypoxic. By mid-September, the water column was fully oxygenated to the end of the season. Though hypoxic conditions were observed on the bottom of the lake, a large portion of the water remained adequately oxygenated, and no fish kills were observed. Despite the presence of an oxycline during summer months, the top 8 feet of the water column always had suitable oxygen for aquatic life. L&P rates DO at Coes Reservoir in 2025 as “Good”.

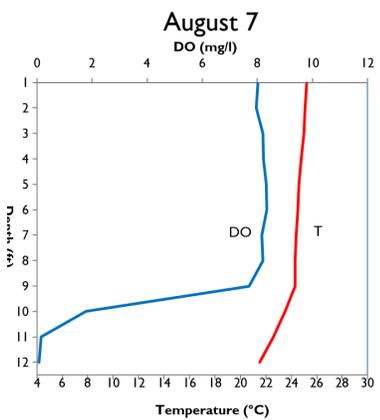
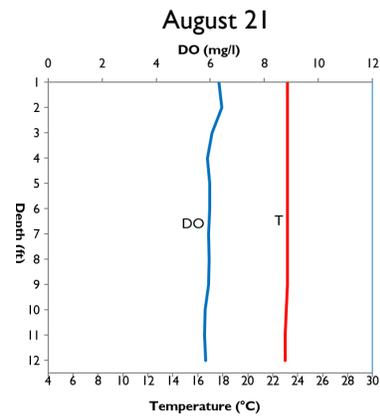
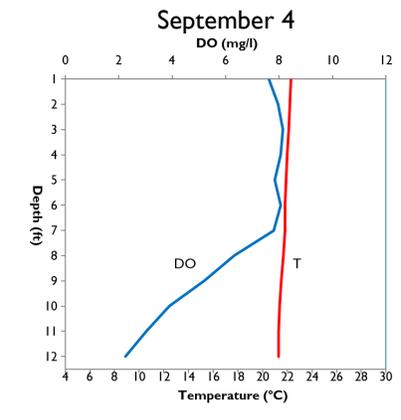
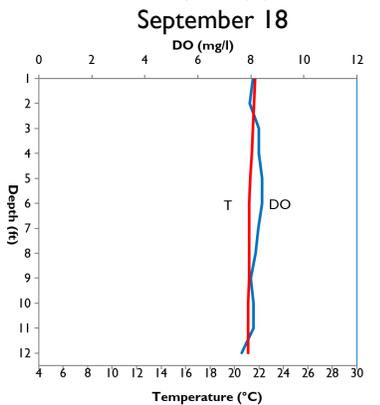
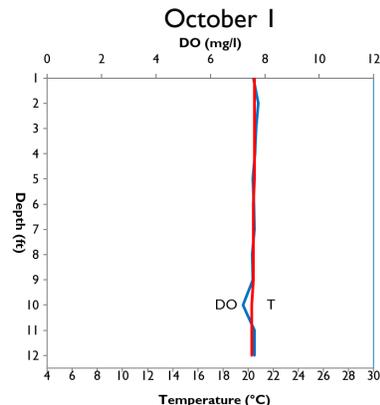
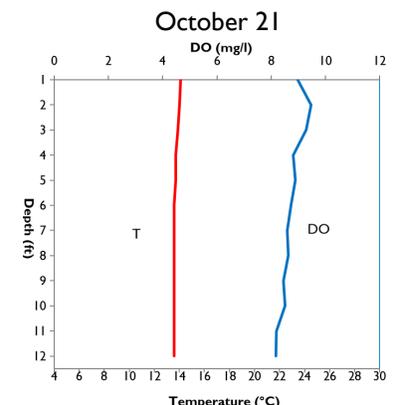
dissolved oxygen, potentially stressing aquatic organisms. Thermal stratification, or layering in the water column based on temperature, can also create a barrier to waterbody mixing, creating areas with depleted DO in some deeper portions of waterbodies. Increased algal growth followed by excessive decomposition of organic material can also lead to low oxygen (hypoxic) conditions, potentially causing fish kills. DO was measured using a galvanic DO sensor on a handheld probe at the water's surface and two feet from the bottom at the in-lake locations. To form a more complete picture of how DO changes through the water column, depth profiles were created by taking measurements at 1-ft increments through the water column.
